Land West of Fringford Road, Caversfield
Phase I Geo-Environmental Desk Study
December 2023

Report Ref: 27877-GEO-0401

CLIENT: Richborough

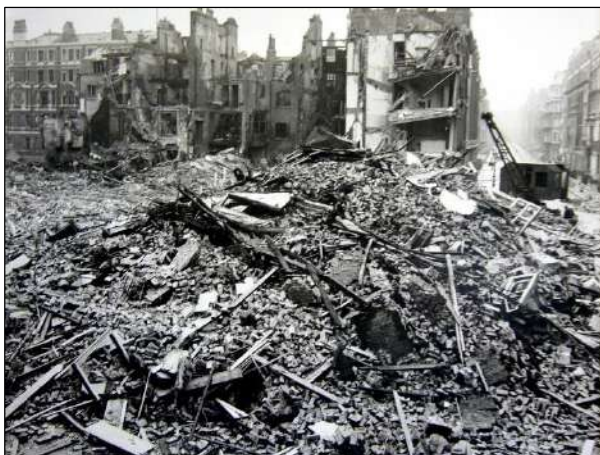
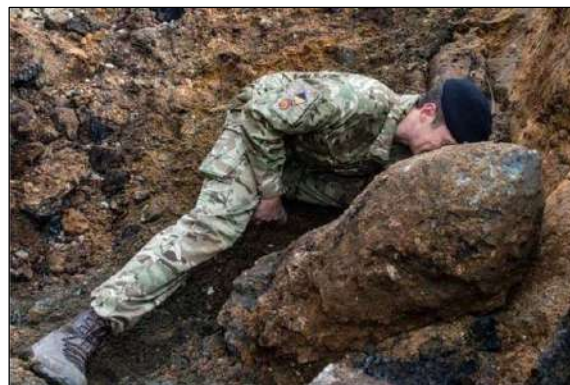
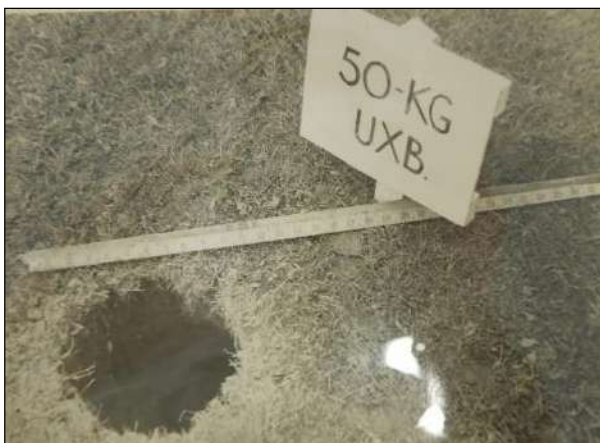
Top: J-curve Effect - Due to angle of entry, unexploded bombs would often end their trajectory at a lateral offset from point of entry, often ending up beneath adjacent extant structures/sites. The photograph above shows a 250kg unexploded bomb found in Bermondsey in 2015, pointing upwards, demonstrating 'J-curve'.

One of the most common scenarios for UXO going unnoticed was when a UXB fell into a 'bomb site' (such as the area shown **Top Left**), the entry hole of the bomb obscured by any debris and rubble present. Note that the entry hole of a 50kg UXB could be as little as 20cm in diameter (**Left**).

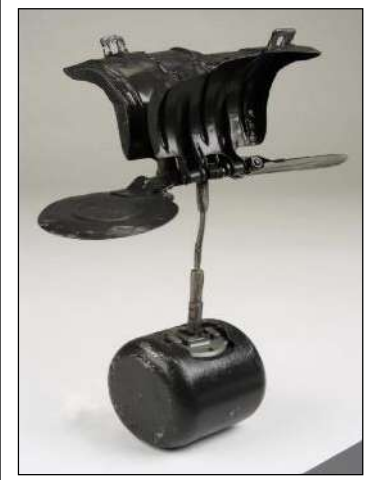
Parachute Mine (Luftmine B / LMB)

Bomb Weight	Approx. 990kg (2176lb)
Explosive Weight	Approx. 705kg (1,554lb)
Fuze Type	Impact/time delay/hydrostatic pressure fuze
Dimensions	2.64m x 0.64m (3.04m with parachute housing)
Use	Against civilian, military and industrial targets. Used as blast bombs and designed to detonate above ground level to maximise damage to a wider area.
Remarks	Deployed a parachute when dropped in order to control its descent. Had the potential to cause extensive damage within a 100m radius.

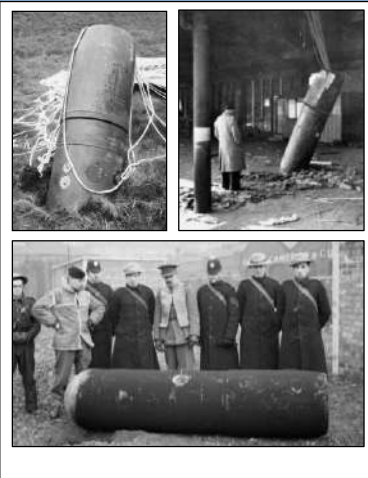
SC 1000kg

Bomb Weight	Approx. 993-1027kg (2,189-2,264lb)
Explosive Weight	Approx. 530-620kg (1168-1367lb)
Fuze Type	Electrical impact/mechanical time delay fuze.
Filling	Mixture of 40% amatol and 60% TNT, but when used as an anti-shipping bomb it was filled with Trialen 105, a mixture of 15% RDX, 70% TNT and 15% aluminium powder.
Bomb Dimensions	2800 x 654mm (110 x 25.8in)
Body Diameter	654mm (18.5in)
Use	SC-type bombs were General Purpose Bombs used primarily for general demolition work. Constructed of parallel walls with comparatively heavy noses, they are usually of three-piece welded construction.

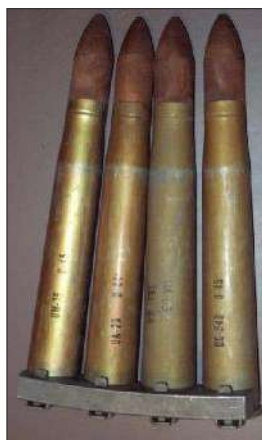
3in Unrotated Projectile (UP) Anti-Aircraft Rocket ("Z" Battery)

HE Projectile Weight	3.4kg (7.6lb)
Explosive Weight	0.96kg (2.13lb)
Filling	High Explosive – TNT. Fitted with aerial burst fuzing
Dimensions of projectile	236 x 83mm (9.29 x 3.25in)
Remarks	As a short range rocket-firing anti-aircraft weapon developed for the Royal Navy. It was used extensively by British ships during the early days of World War II. The UP was also used in ground-based single and 128-round launchers known as Z Batteries. Shell consists of a steel cylinder reduced in diameter at the base and threaded externally to screw into the shell ring of the rocket motor.

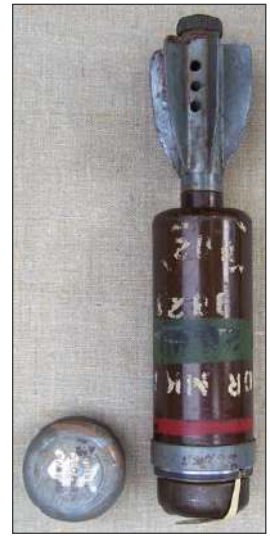
2 inch Mortar Smoke

Weight	Approx. 910g (2lb)
Maximum Range	460m (500yards)
Filling	White phosphorus and smoke fill
Dimensions	51 x 290mm (2in x 11.4 in)
Fuze Type	An impact fuze which initiates a bursting charge. This ruptures the mortar bomb's body and disperses the phosphorus filler.
Identification	Smoke mortars have a recess and emission holes. May still see light green body paint. Look for stained ground around munition.
Use	As a screening device for unit movement or to impair enemy field of vision.

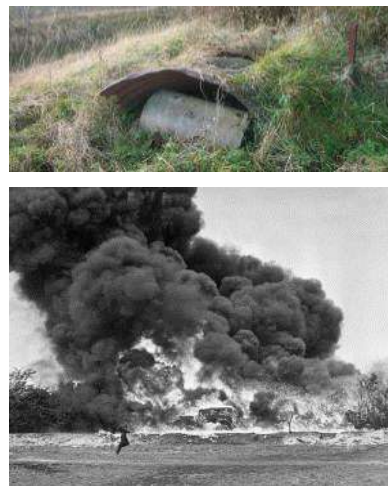
Flame Fougasse Bomb

Weight	Various
Filling	Initially a mixture of 40% petrol and 60% gas. Ammonal provided the propellant charge.
Design	Usually constructed from a 40-gallon drum dug into a roadside and camouflaged.
Use	As an improvised anti-tank bomb. When triggered the Fougasse could project a beam of burning sticky fuel in a fixed direction from up to 3m (10ft) wide and 27m (30yards) long.
Remarks	A highly unorthodox weapon designed by the Petroleum Warfare Department to address a critical lack of weapons in 1940. 50,000 are estimated to have been distributed around the UK.

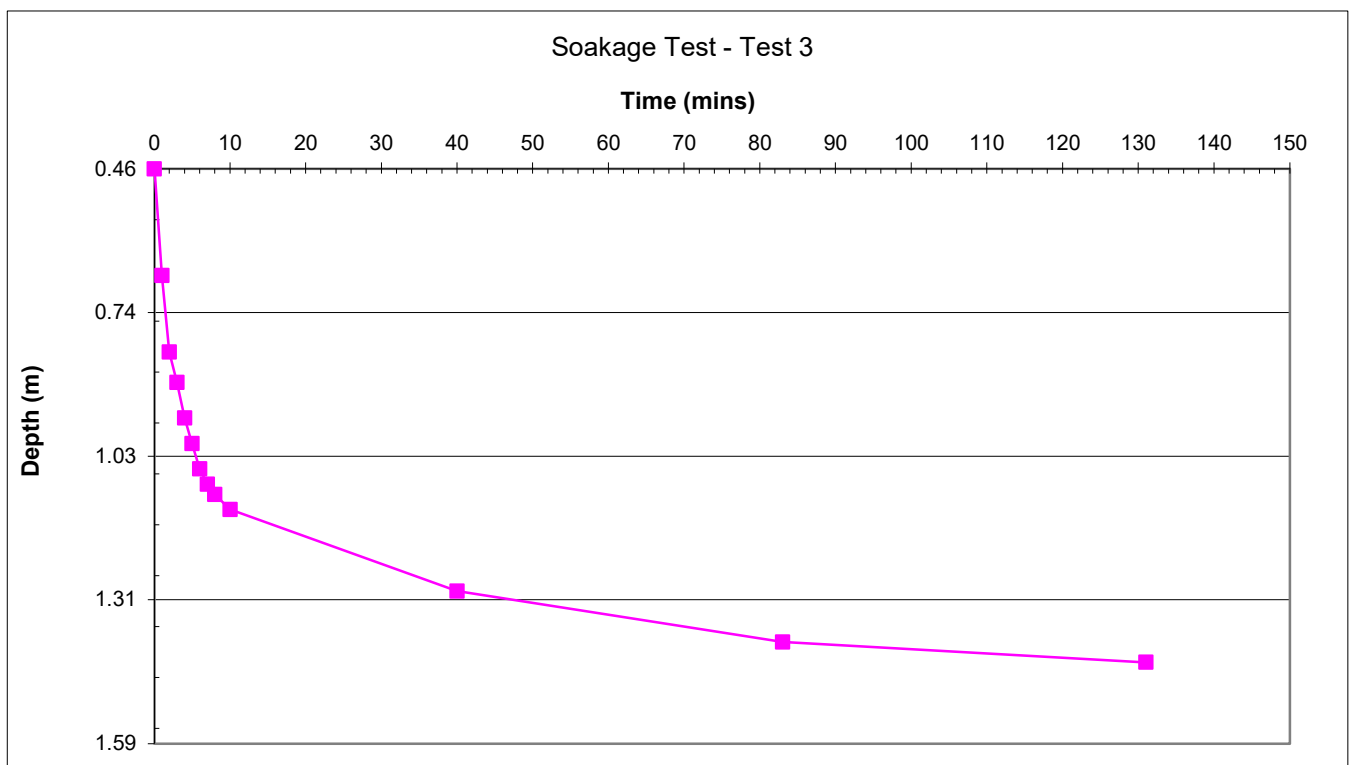
SOIL INFILTRATION RATE = 1.95E-05 m/s

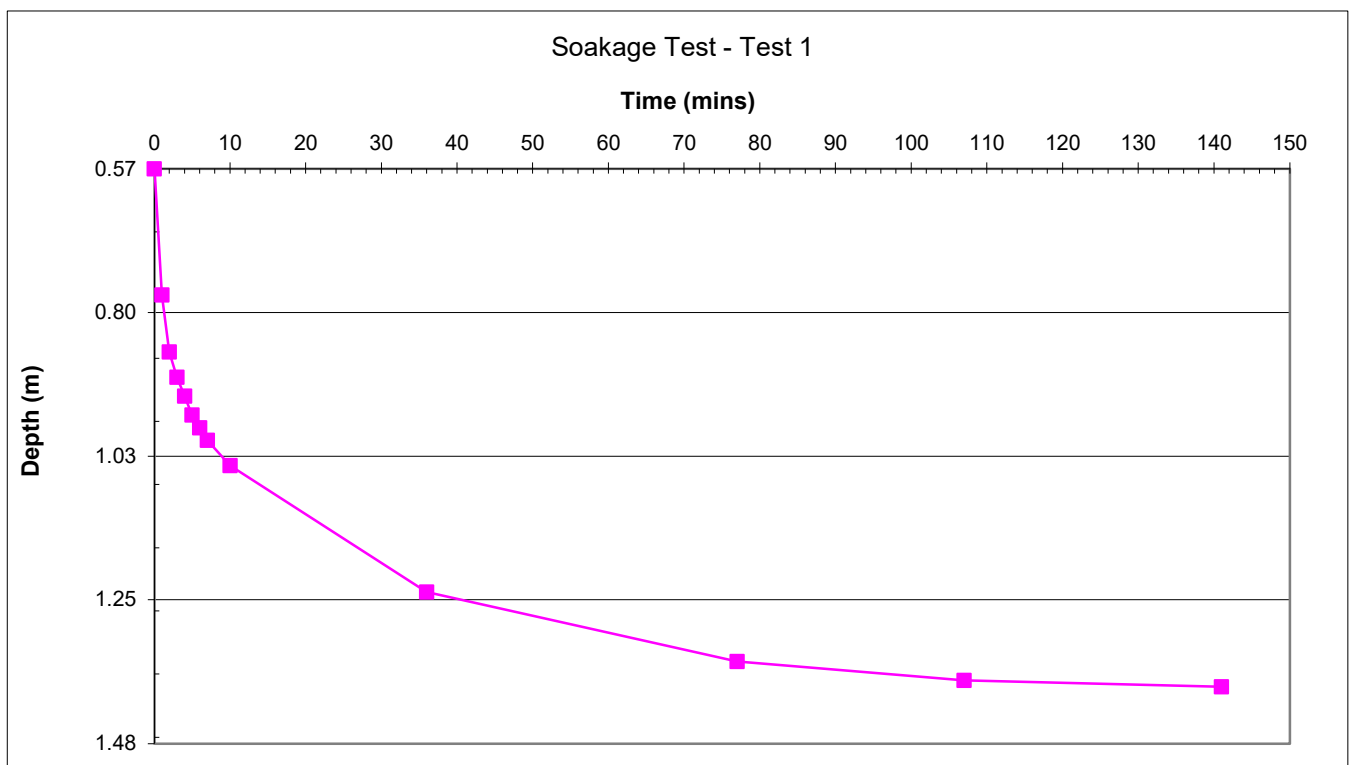
SOIL INFILTRATION RATE = 2.57E-05 m/s
