The Small House, Sibford Ferris Bat Report

Prepared for Will Ikin/Hayward Smart Architects

Project Number: TT4359

Document Reference: R01-Bat Report-Rev00

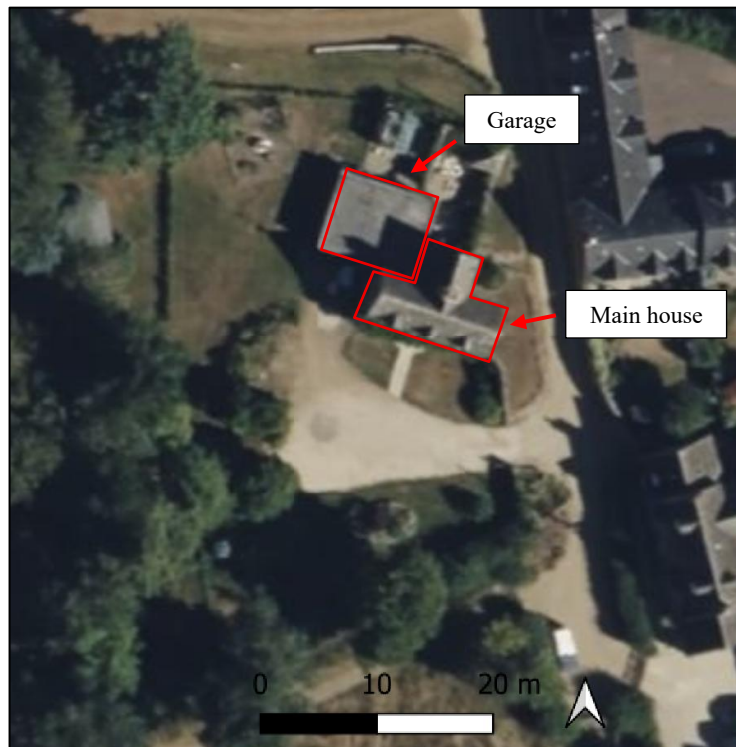
The site comprises a residential dwelling and an adjoined garage (*Figure 2*). The site is situated within the village of Sibford Ferris and lies approximately 10 km south-west of Banbury. The buildings are immediately surrounded by residential dwellings, tree lines and fields.

Figure 2. Overview of the buildings surveyed and wider immediate site (QGIS 2025)

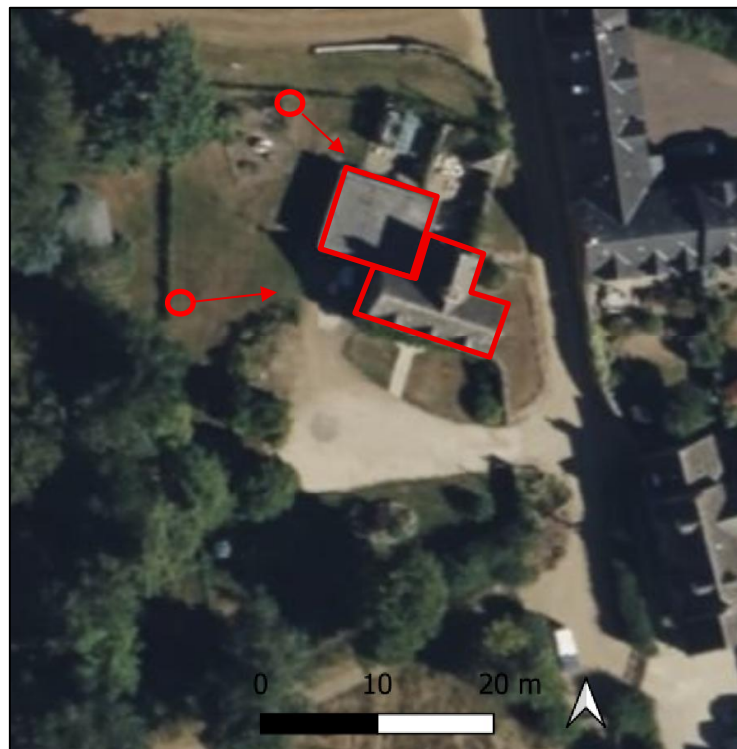
Figure 4. Locations and directions of view of surveyors

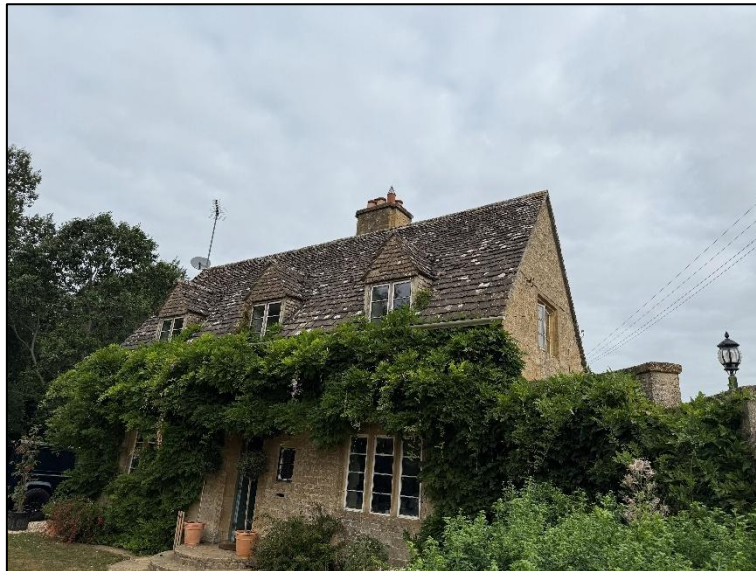
The house is a two-story building constructed of Cotswold stone with a pitched ‘T’ shaped roof with stone tiles and ridge tiles. There are two loft spaces. There is an existing single storey extension to the north constructed of modern brick/artificial stone, which the garage adjoins, used as utility/storage area. At the front of the roof there are three dormer windows with stone tiles and hanging tiles.

Plate 1. The front of the House as seen from the South

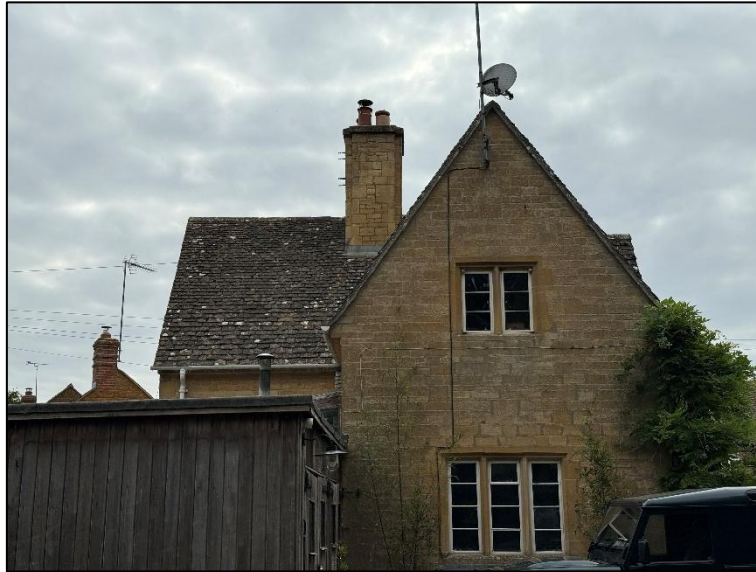
Plate 2. The house as seen from the West, with adjoining garage

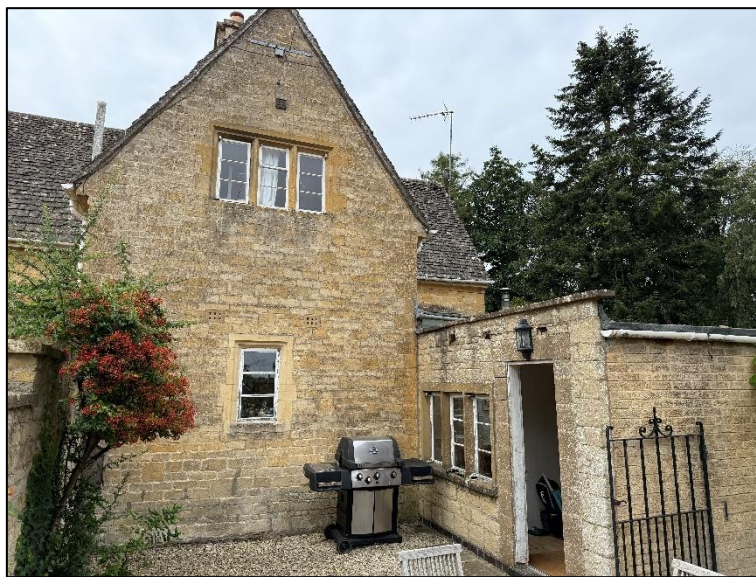
Plate 3. The house as seen from the north, with adjoining extension and garage

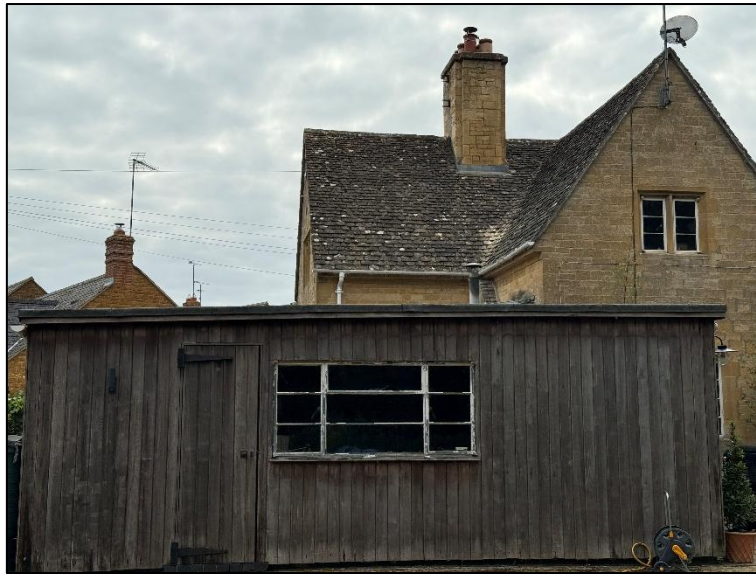
The garage is a single-story building constructed of timber frame and clad with timber boards. The roof is flat and covered in bitumastic felt. There are no roof voids.

Plate 4. The Garage as seen from the west

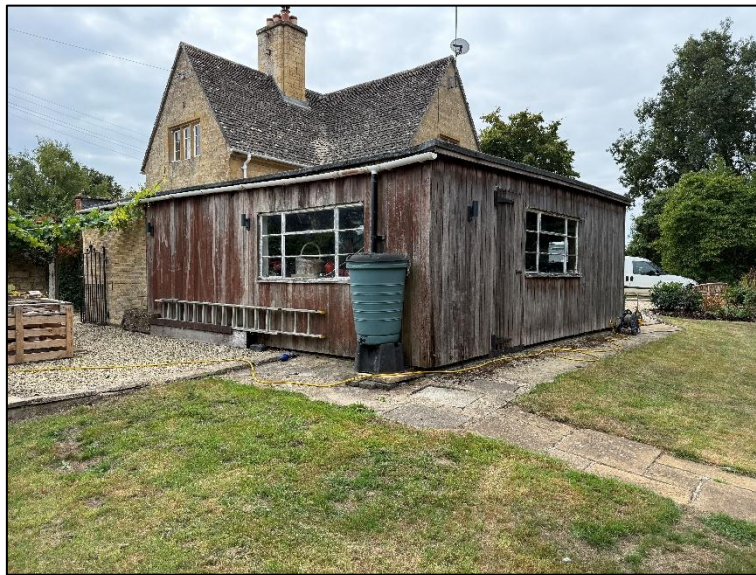
Plate 5. The Garage as seen from the north-west

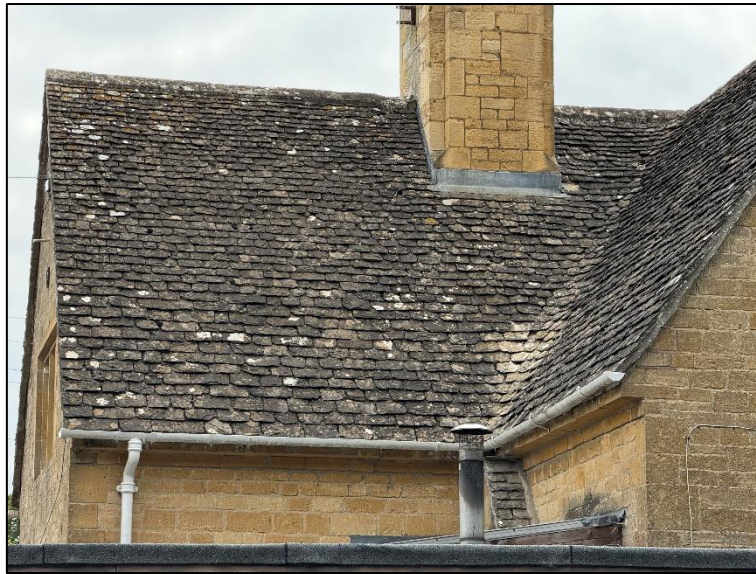
No evidence of bats was observed on the exterior of the house. The stone roof tiles are uneven and have numerous gaps allowing access (*Plate 6*). The walls have stone eaves with no gaps and there were no observable gaps in the gable ends and verges.

Plate 6. North-western roof sections, tiles and stone eaves

During suitable weather conditions (dry and above 8°C) work can commence to remove the roof tiles of the area of proposed work. Where there are gaps under tiles that could provide access for bats, the roof tiles must be removed carefully by hand one at a time. During the removal each tile must be checked for presence of live bats or evidence of use by bats, i.e. dead bats or droppings. If no bats or evidence of use by bats are found, the removal of tiles can continue and the work can be undertaken without a mitigation licence.

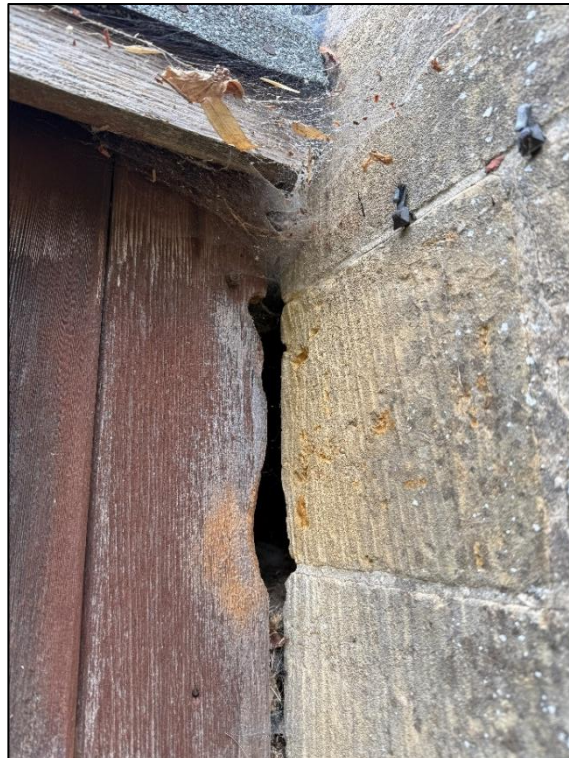
No evidence of bats was observed on the exterior of the garage. The timber cladding and roof are well sealed and potential access/roost features are very limited. There is a gap between the garage and the house (*Plate 7*) and between the garage and the single storey extension, the latter being full of cobwebs at the time of survey. There are also gaps above the double doors.

Plate 7. Gap between garage and house

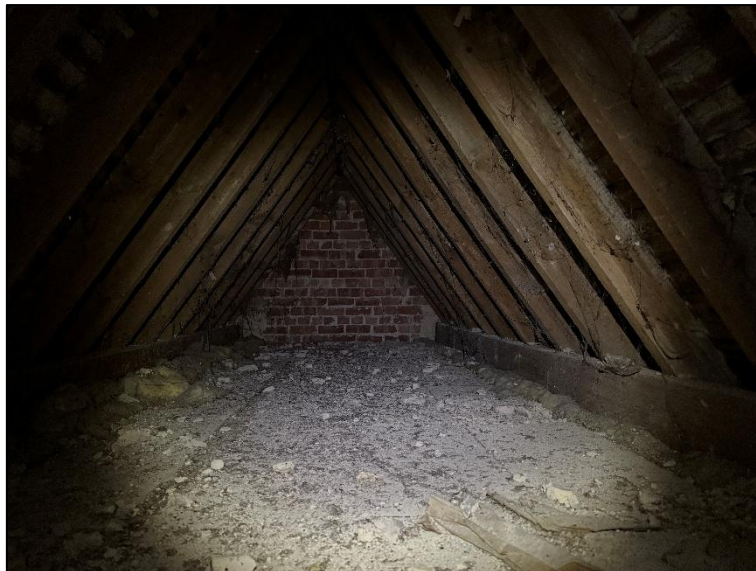
There are two loft spaces, a large one and a smaller one, separated by a brick chimney. Both loft spaces are approximately 1.2 m high to the ridge. They are constructed from a simple timber frame with ridge boards, complete with stone tiling and mortar torching. The torching is generally in good condition although there are some gaps. The smaller loft space is very cluttered with insulation and large accumulations of cobwebs. The larger loft space is more open, but again with many cobwebs, particularly at the ridge and other areas of frame joints.

Plate 8. Larger of the 2 loft spaces in the House

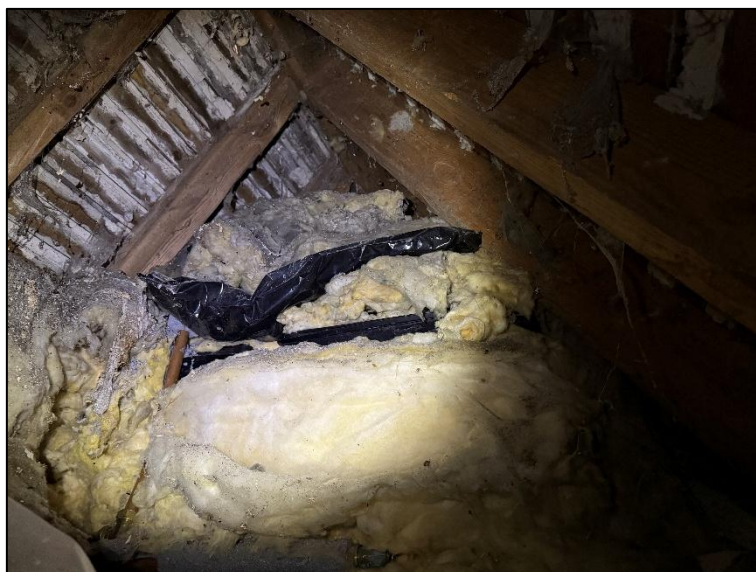
Plate 9. Insulation clutter in the Smaller of the 2 loft spaces in the House

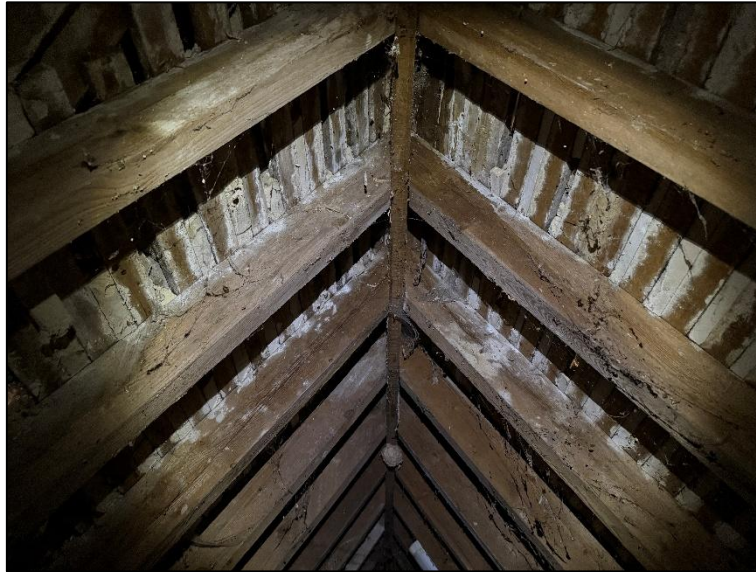
Plate 10. Image showing timber frame and torching in loft

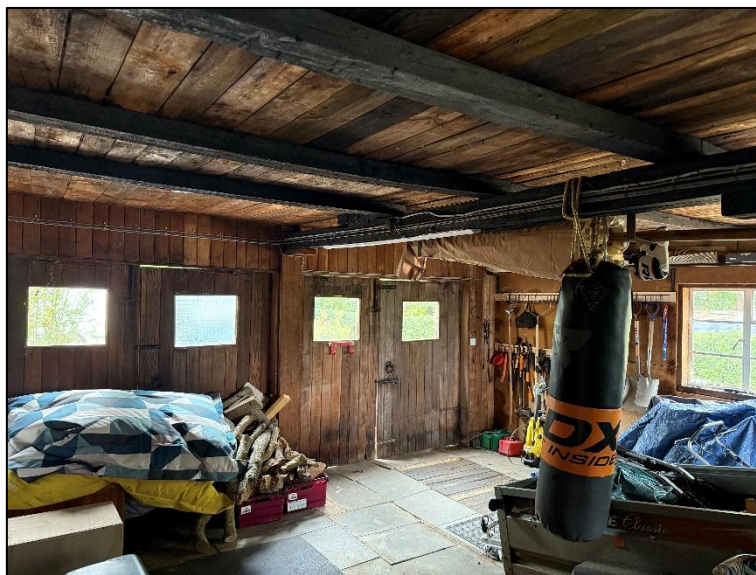
The Garage is a simple single-story room, with timber beam and timber clad ceiling and walls. Due to the windows, the inside is very light which means suitability for use by roosting bats is further limited. There are very few suitable roosting features in the garage, such as crevices where wall materials join.

Plate 11. Garage interior

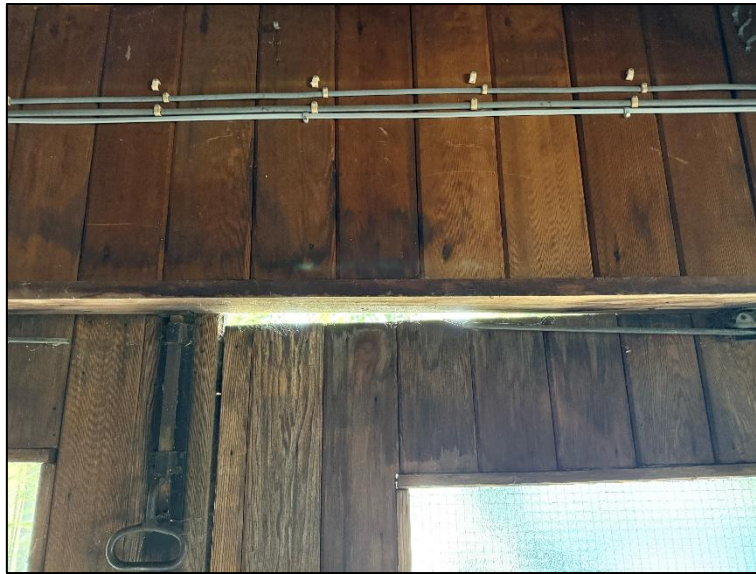
Plate 12. Gaps above doors

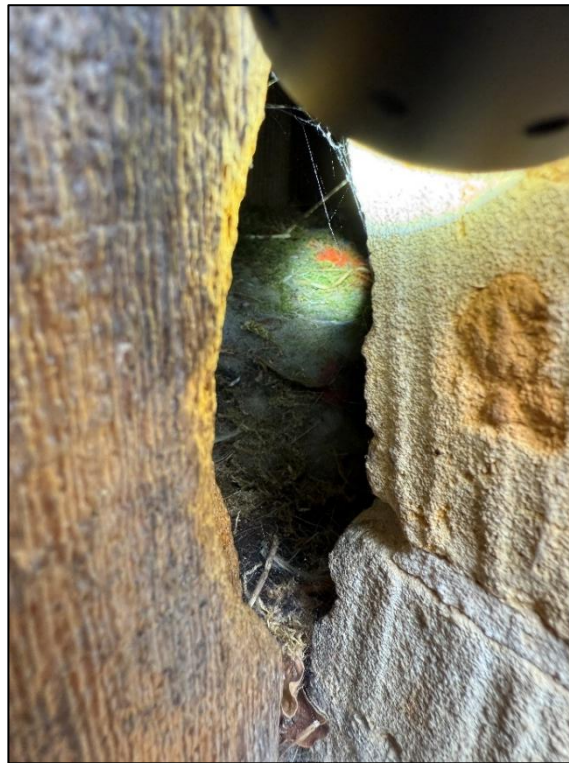
The buildings have some potential to be used by nesting birds. During the PRA survey, a disused bird nest was located in the gap between the Garage and House. No evidence was found inside the garage or house.

Plate 13. Bird nest in cavity between Garage and House

Works affecting any suitable nesting habitats, i.e. the buildings themselves, should ideally be completed outside the breeding bird season (March – August inclusive). If this is not possible then a pre-construction bird survey will need to be completed by a suitably qualified ecologist and depending on the presence and location of nesting birds, breeding effort may have to be allowed to finish before works commence.

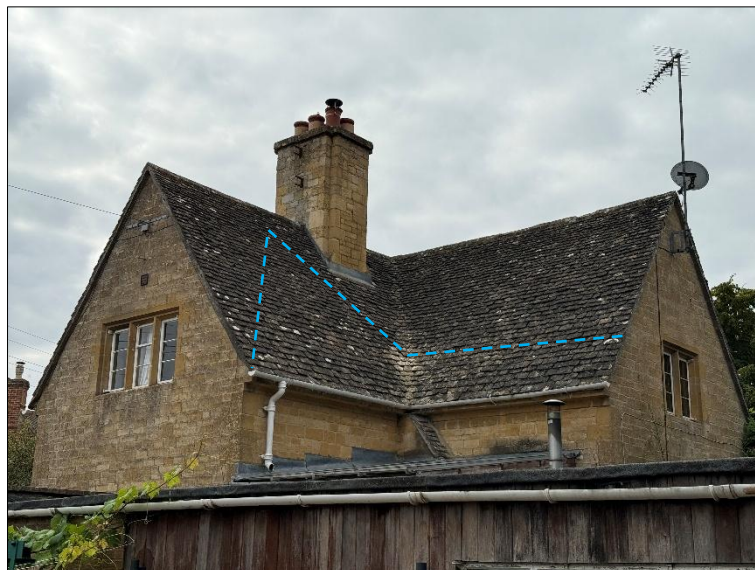
The external crevice features have been identified as suitable for use by individuals or small numbers of roosting bats. Bat activity surveys have confirmed there is a bat roost of a single Common Pipistrelle under tiles around a dormer window on the front (southern aspect) of the House, but no other roosts were confirmed in the area of the proposed work.

Plate 14. Location of the work (blue dashed line)
