Geo-Environmental Assessment
Land off Fritwell Road
Somerton, Oxfordshire
OX25 6NJ

Client: Laxton Properties

Issue Date: September 2024
Report Ref: 21318R1 (Issue A)

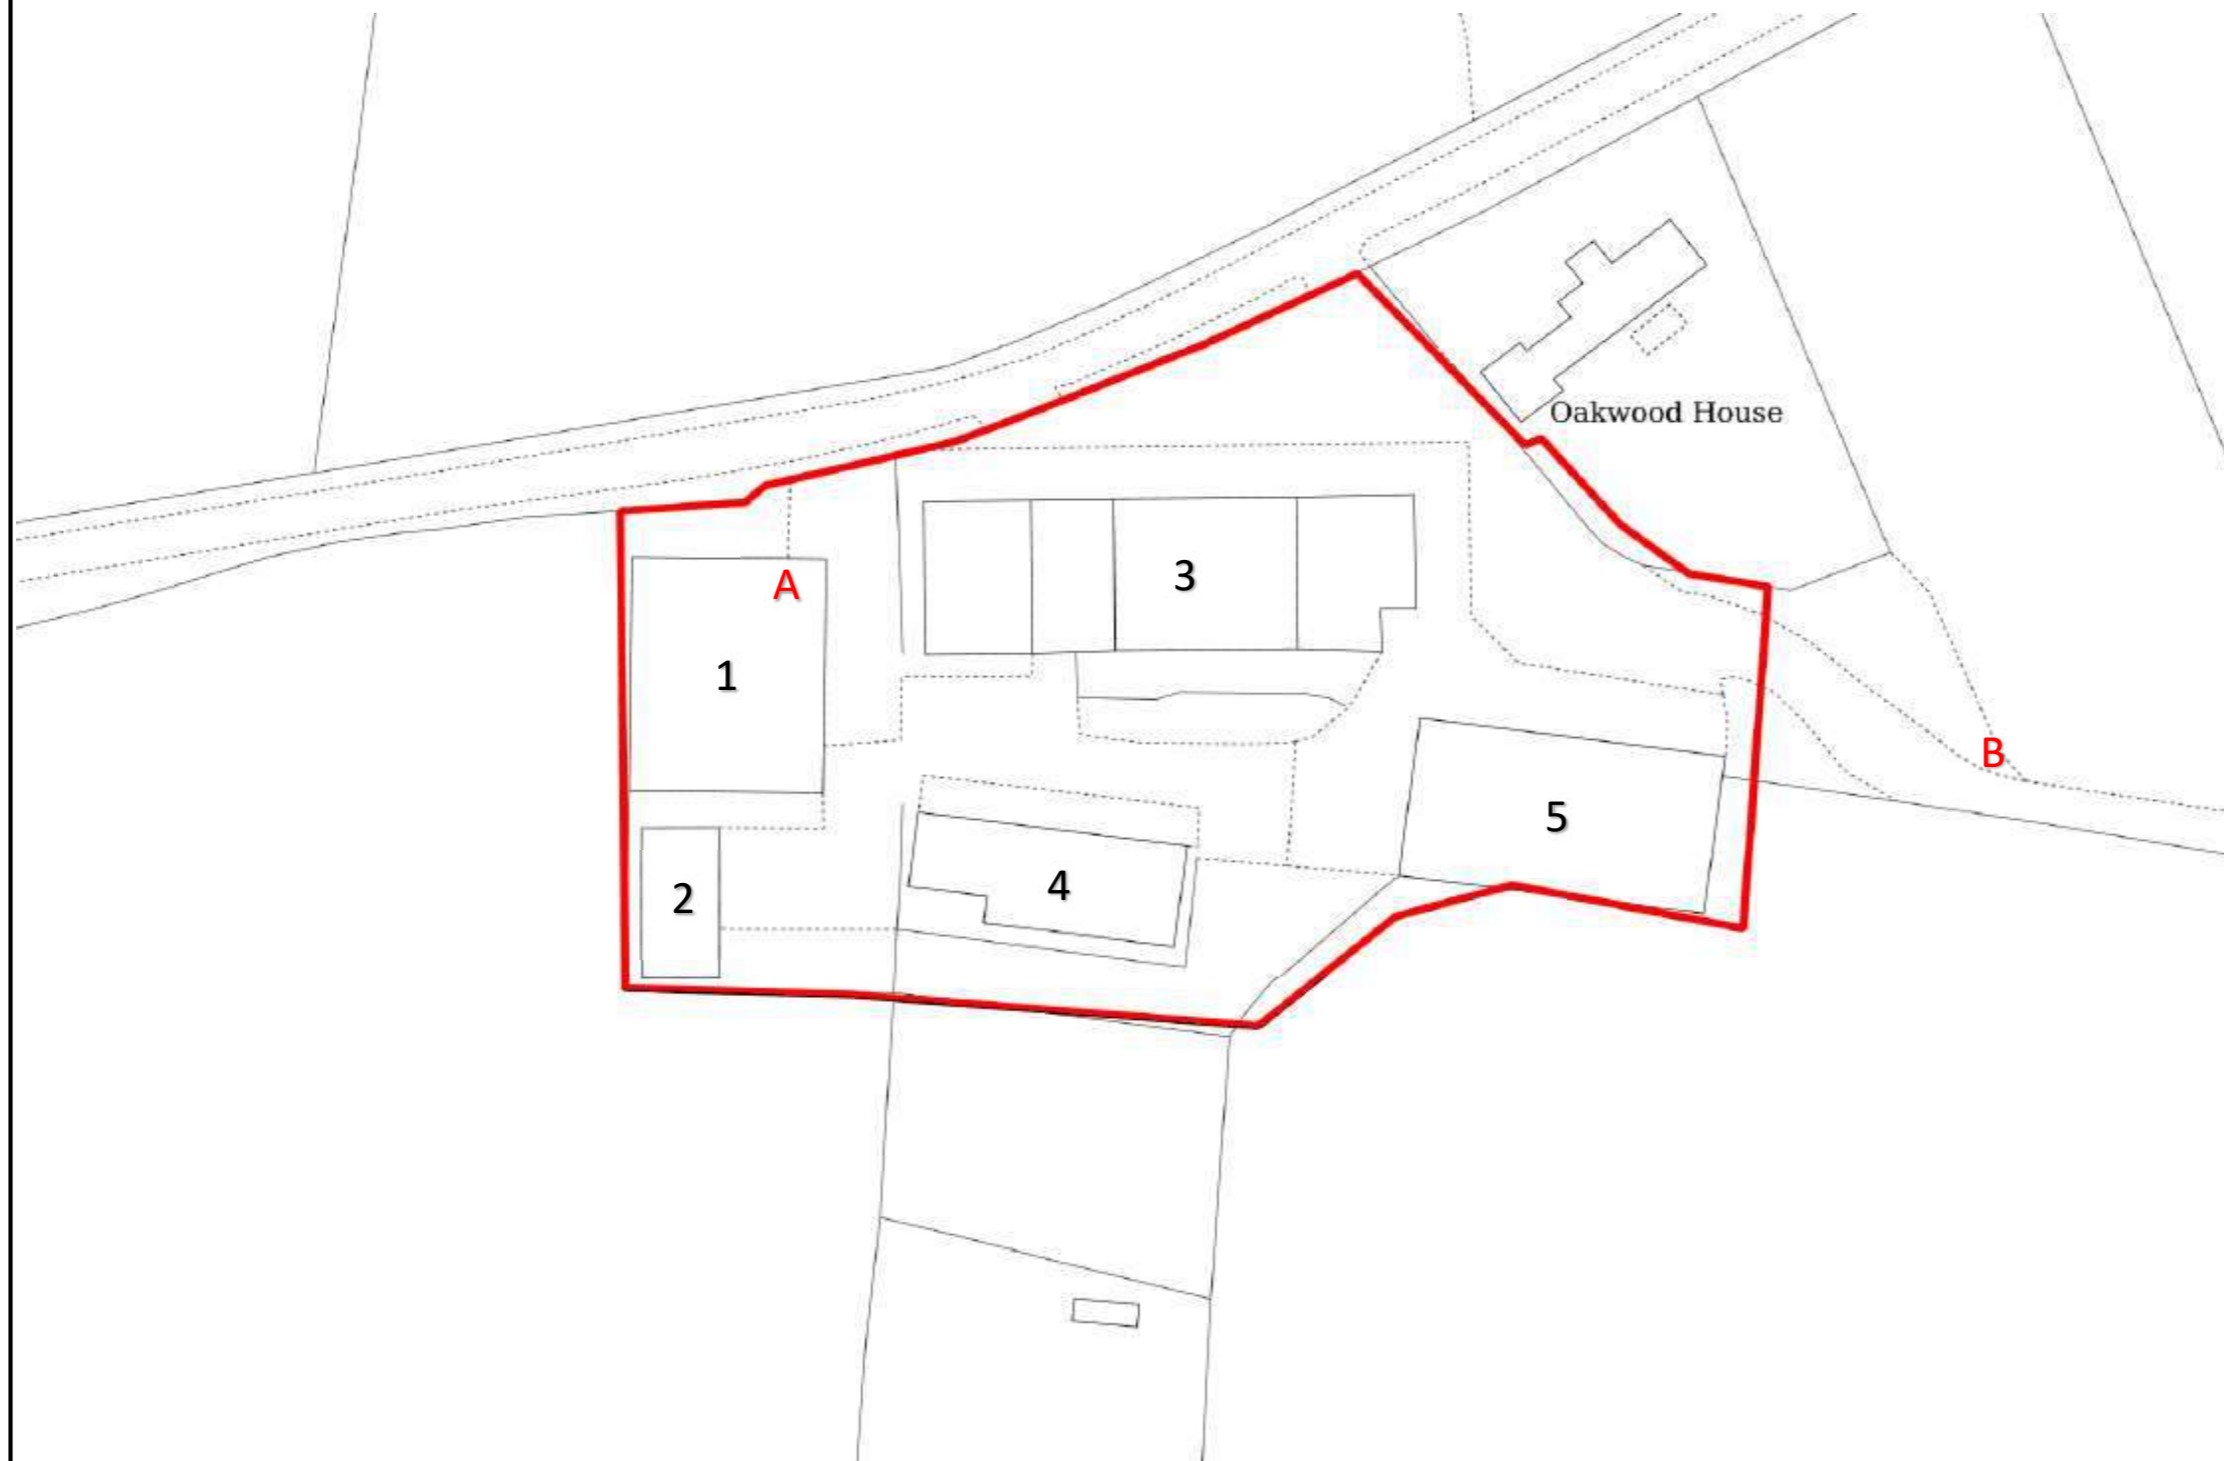
**FIGURE 2: CURRENT SITE
PLAN/AREAS OF CONCERN**

The site consists of an agricultural farmyard comprising five barns/sheds (Figure 2) of surrounding hard standing. Access is via Fritwell Road to the north.

It is understood that the site is being considered for residential development comprising demolition of the existing farm buildings (Figure 2 & 3) and construction of 10no new dwellings.

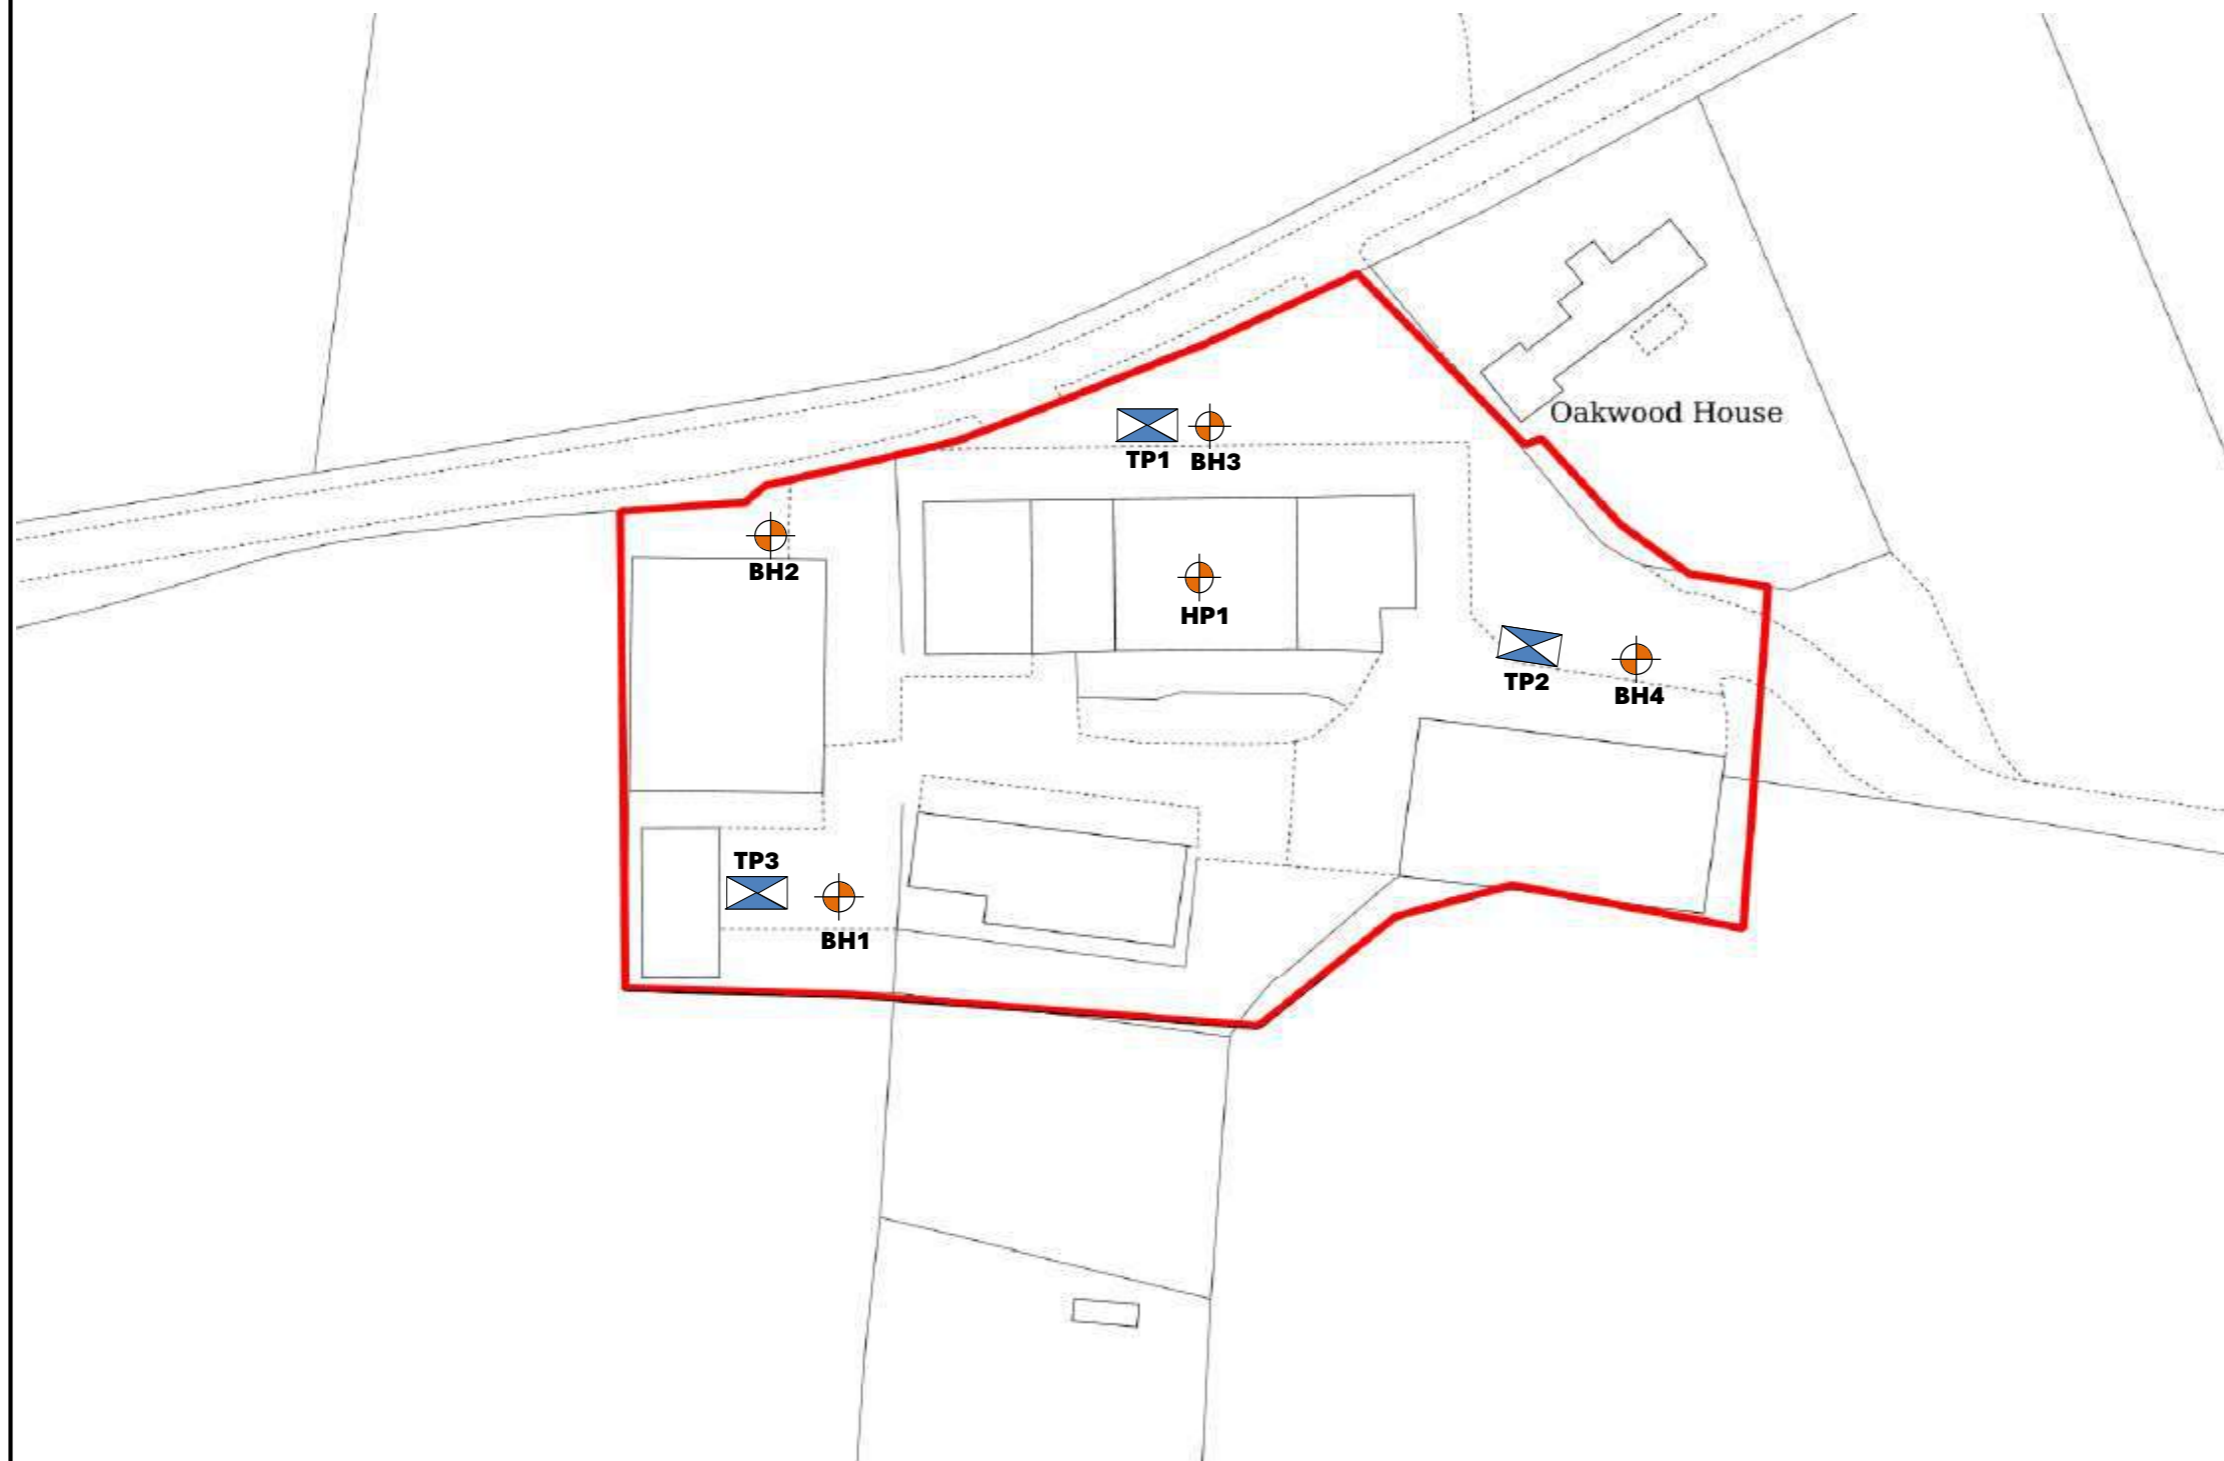
The identified ASTs are summarised in Table 4 and referenced on Figure 2.

The list of potential areas of concern on site and in the surrounding area are summarised in Table 5, and presented on Figure 2.

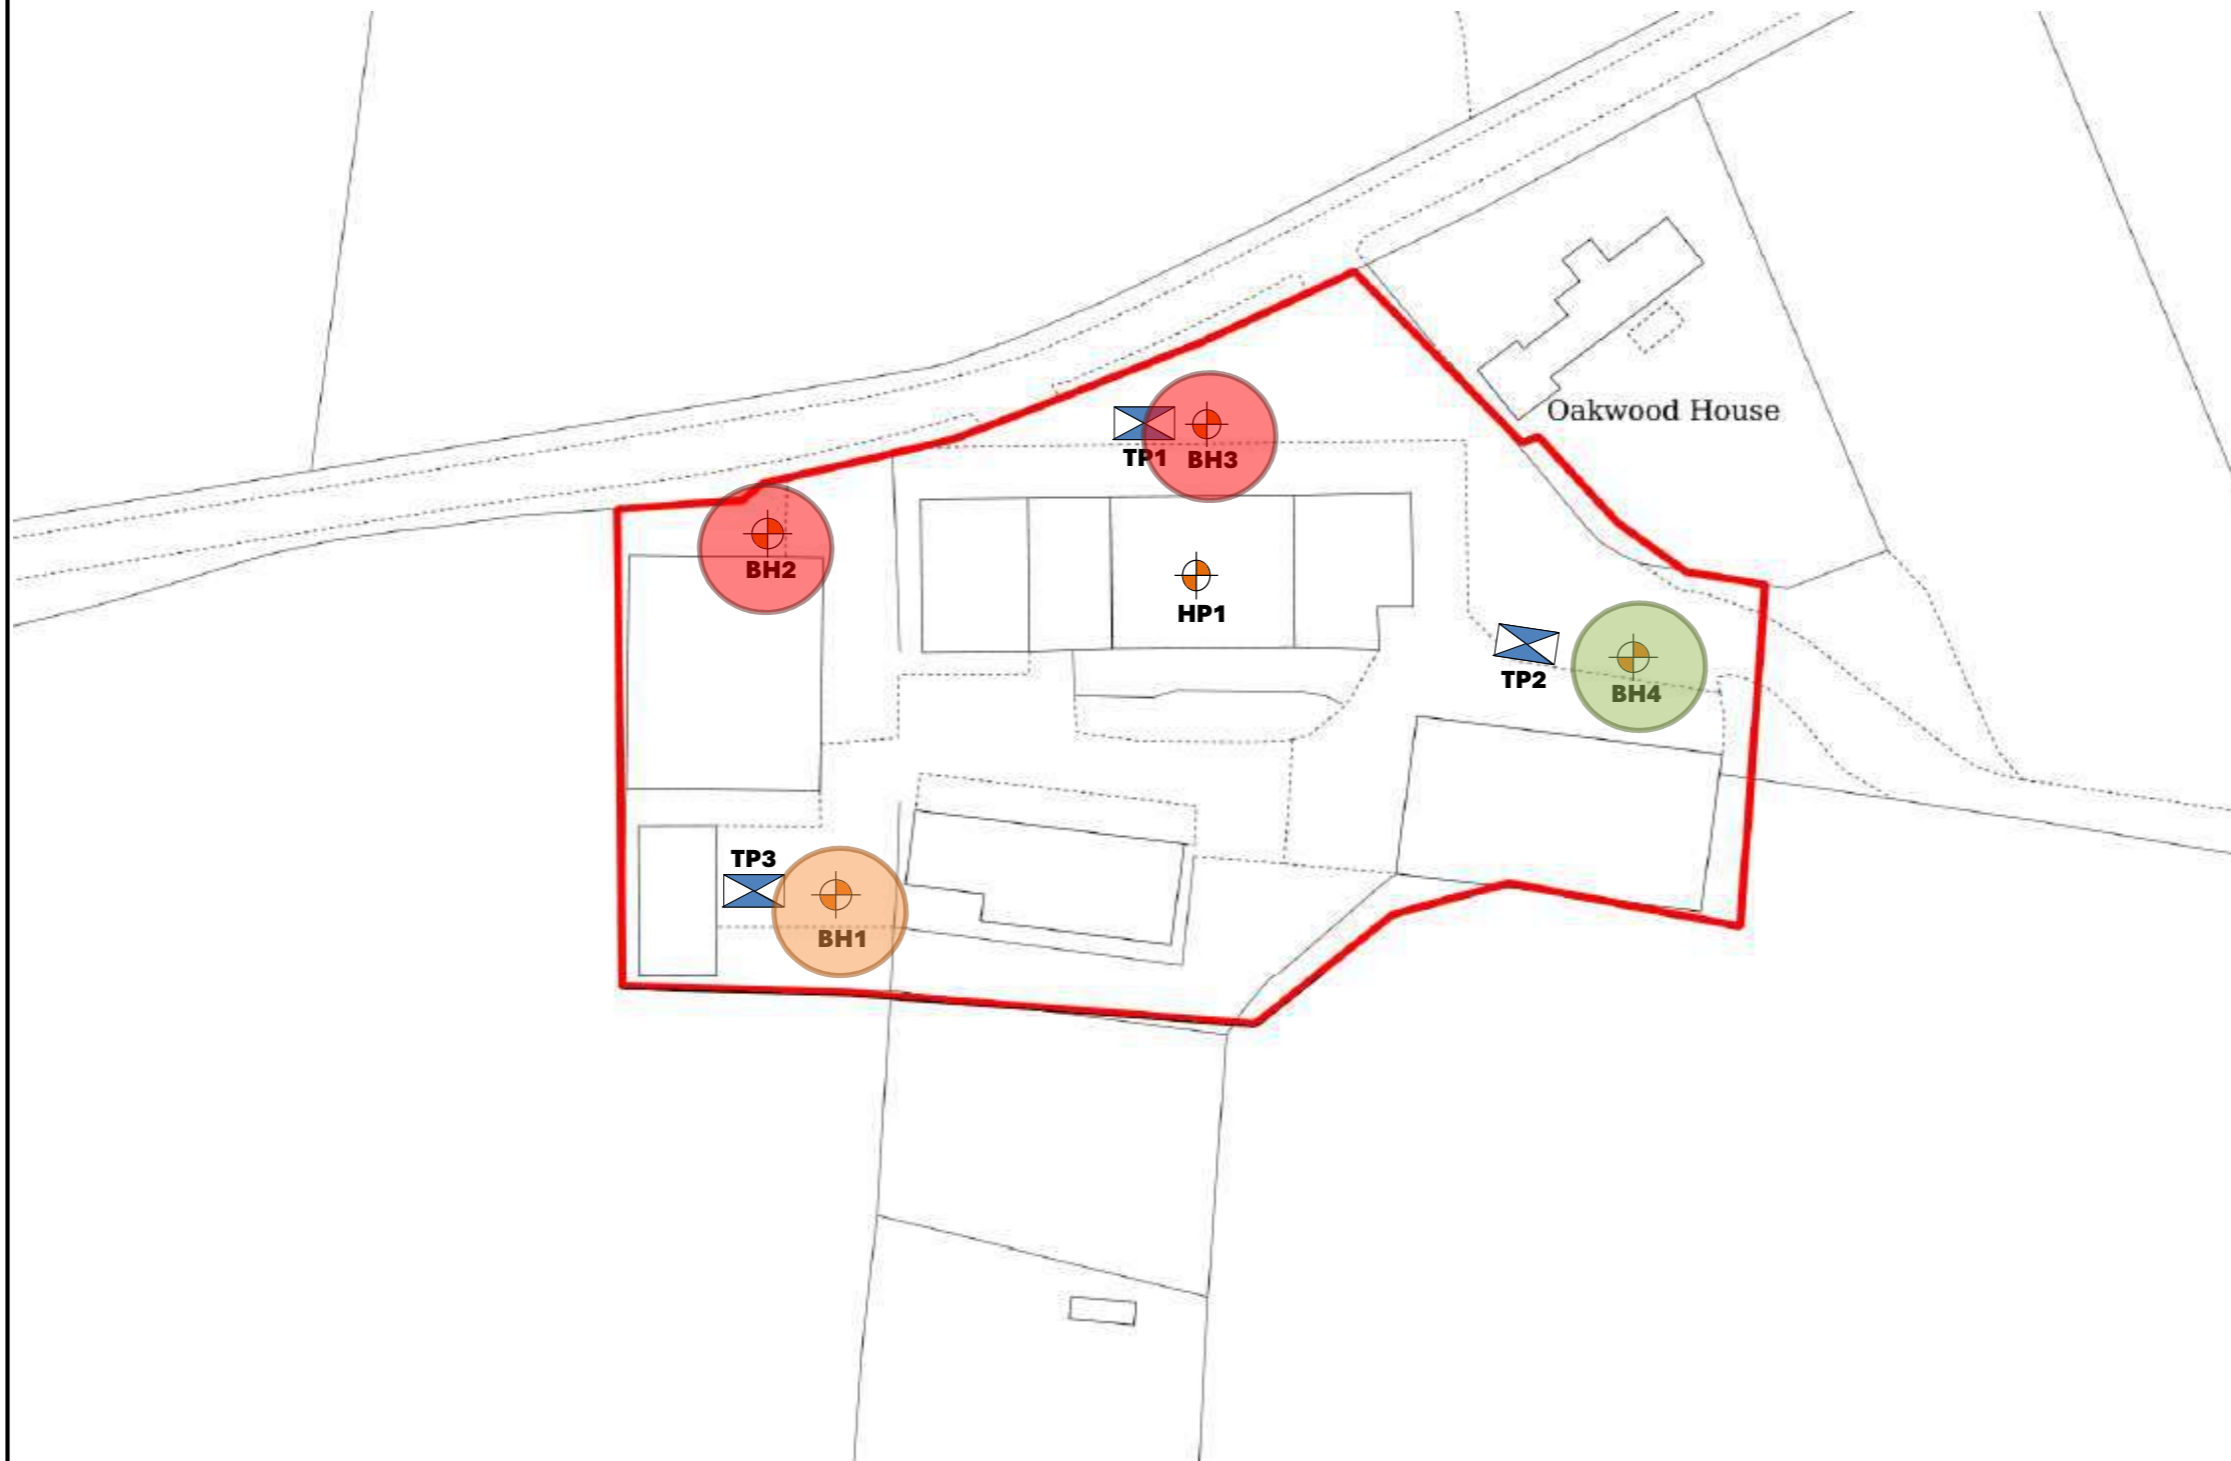
**FIGURE 4: INTRUSIVE LOCATION
PLAN**

BRE365 trial pit

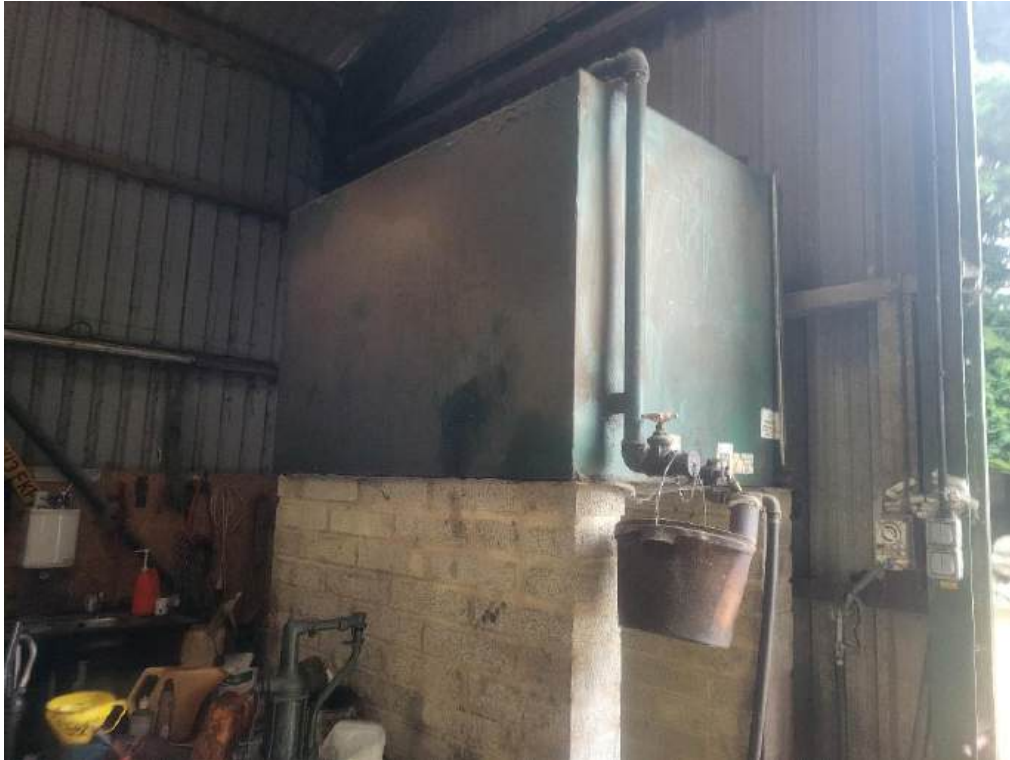
Photo 1 - AST within Building 1

Steel corrugated shed with open sliding doors and measuring ~600m² with a concrete slab floor in good condition. A bunded above ground storage tank (AST) of ~5,000L is located on the north-east of the shed (Photo 1). A site operative indicated that the tank is empty and no longer in use, although previously was previously filled with gas oil. The electrical fuse box is located in this area also, along with numerous old empty fuel containers ranging in size from 20L jerry cans to 210L drums. No spillages or gross contamination was observed in this area. The remaining shed is used as storage of farm machinery including tractors.

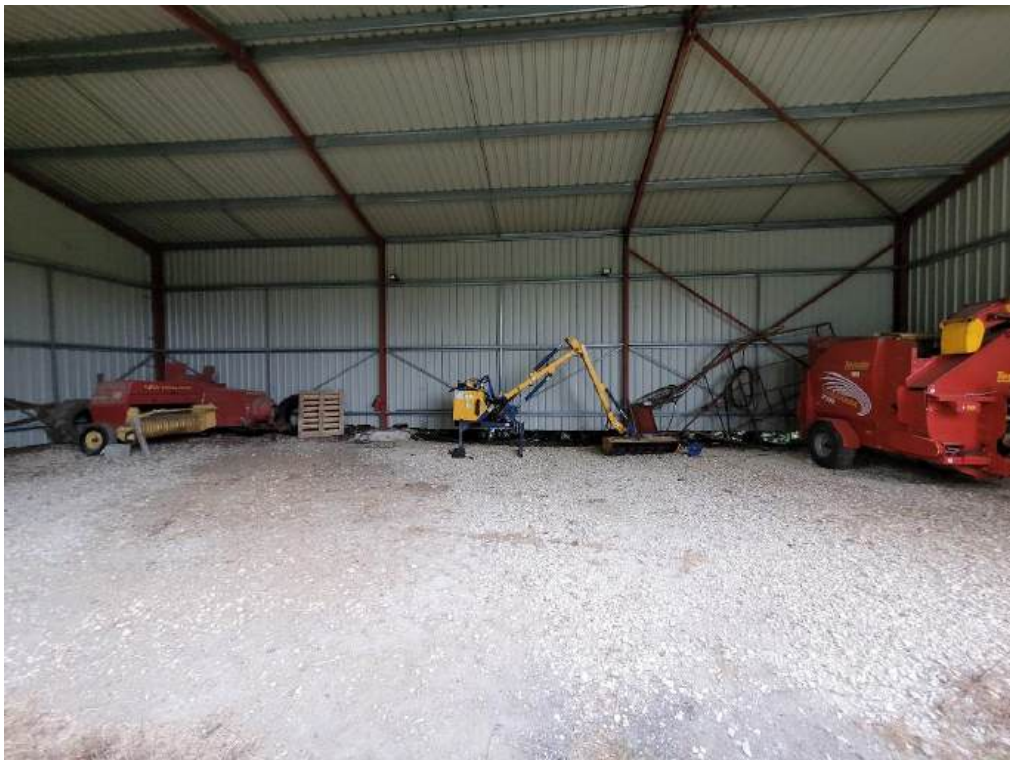
Photo 2 - Building 2

An open access steel corrugated shed used for storage of farm vehicles and machinery and measuring 150m², laid on a compacted Type 1 fill (Photo 2).

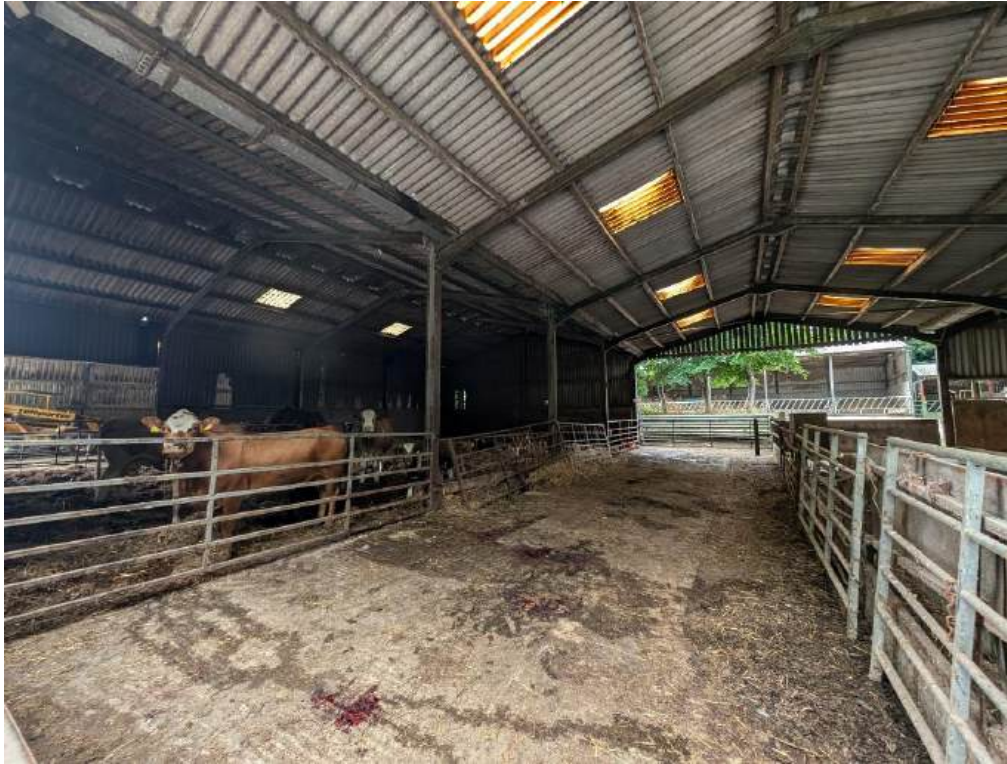
Photo 3 - Building 3 (cattle sheds)

A part block work and corrugated steel barn with sliding doors, gates and open access measuring ~1,000m² (Photo 3). This barn is used primarily to house cattle and is laid on a concrete slab. A water tank is located in the west.

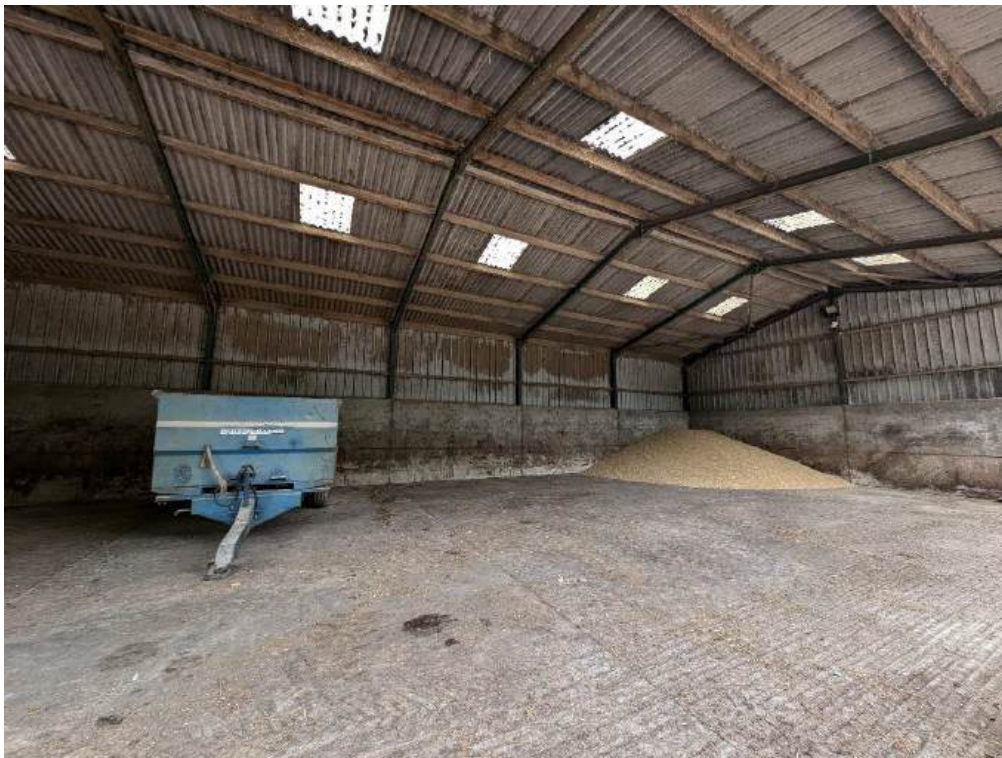
Photo 4 - Building 4 (grain storage)

An open access steel corrugated shed used for grain storage and measuring 350m², which has a concrete slab floor (Photo 4).

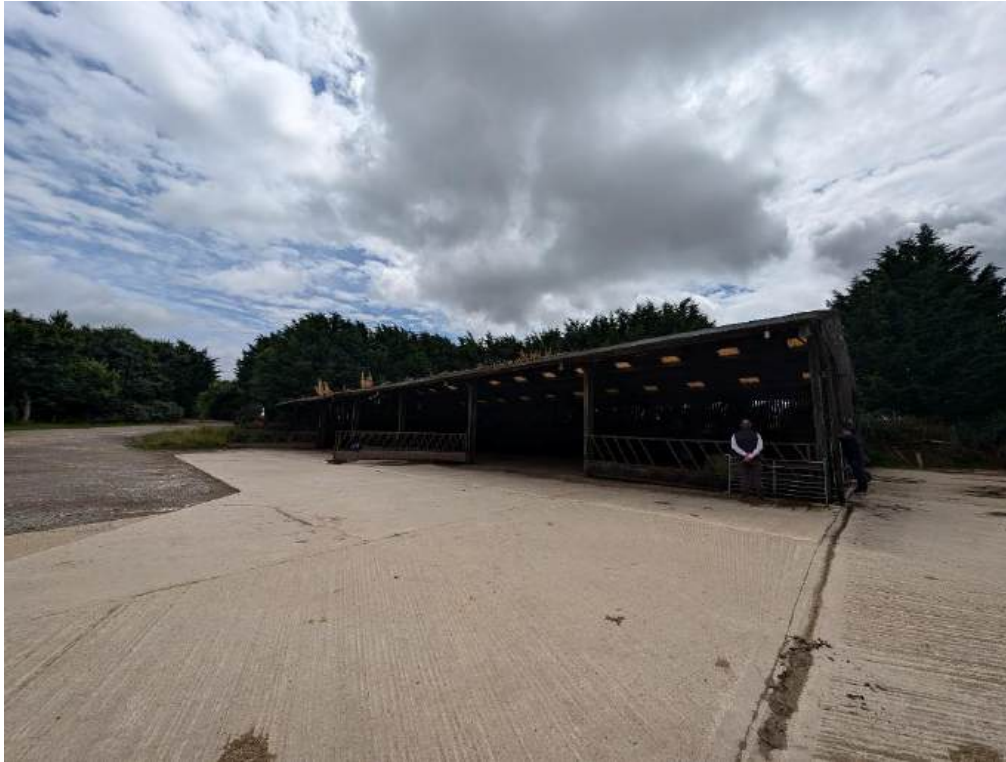
Photo 5 - Building 5

A gated semi-open access steel corrugated shed used for storage of farm vehicles and machinery and measuring 700m², with a concrete slab form (Photo 5).

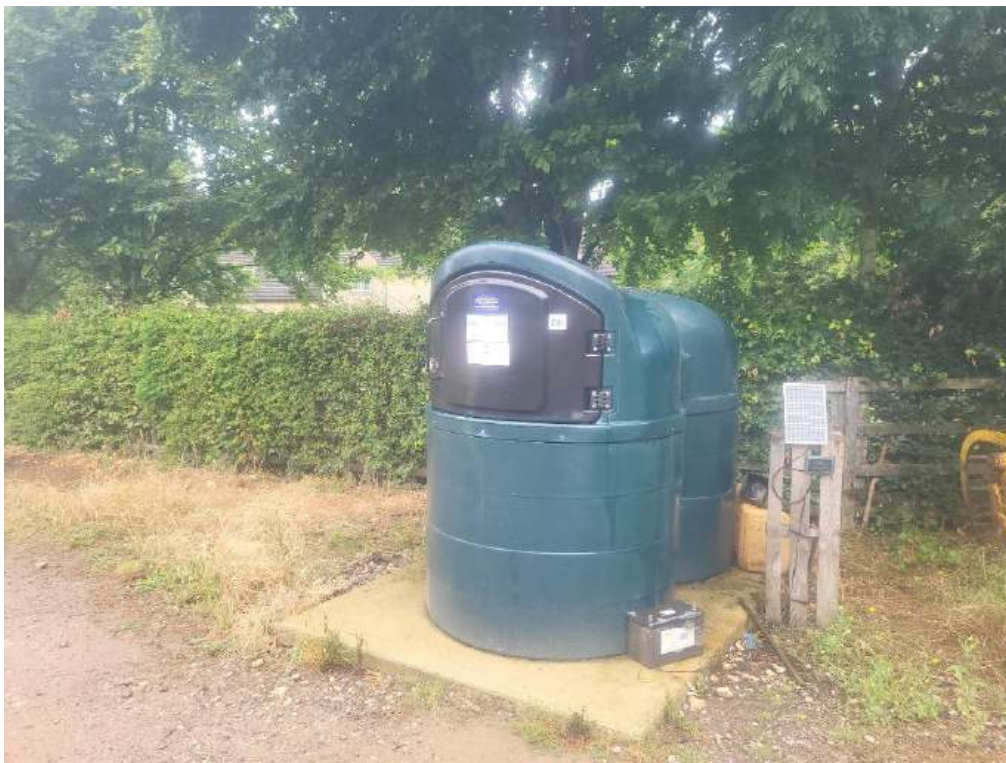
Photo 6 - Offsite AST

A further AST for diesel storage (volume ~2,500L) was located ~20m east offsite which is used by farm workers for the filling of machinery (Photo 6). No grossly contaminated materials or invasive species were identified during the site walkover.

Ref	Fuel Type	Volume (L)	Status	Photo
A	Gas oil	~5,000	Inactive	Photo 1
B	Diesel	~2,500	Active	Photo 6

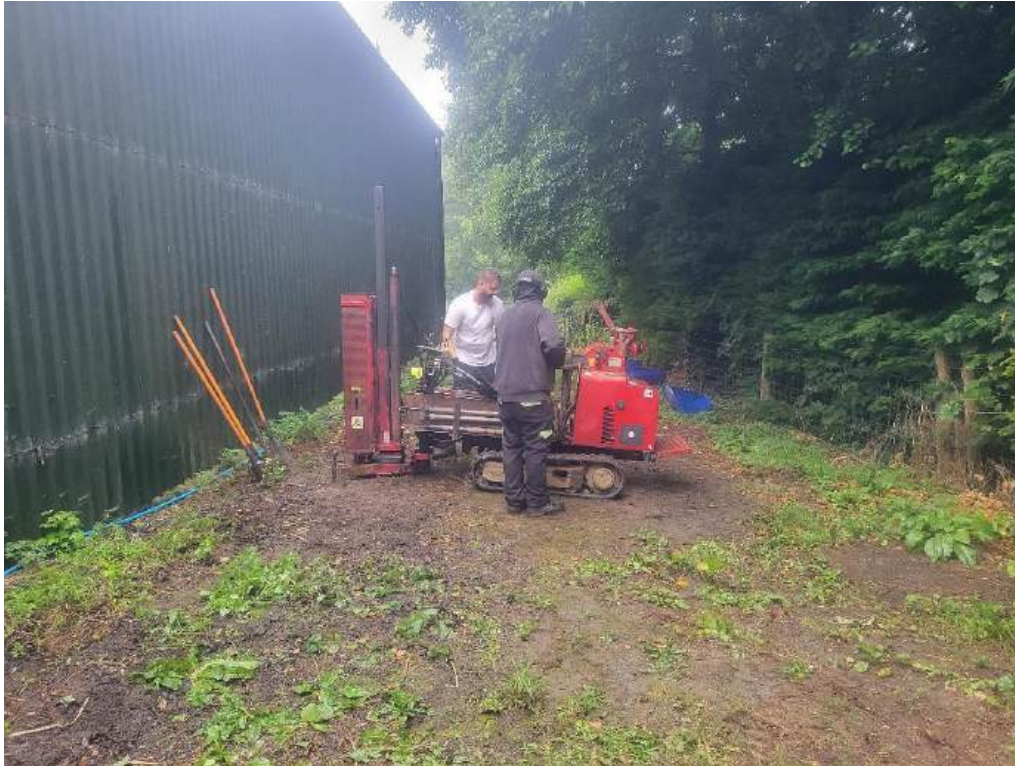
Photo 7 - Window sampler at BH2

Location	Depth (m bgl)	PID ppm(v)	Visual Observations
BH2	0.20 – 1.10	0.0	Broken asbestos containing materials (ACM) >50mm.

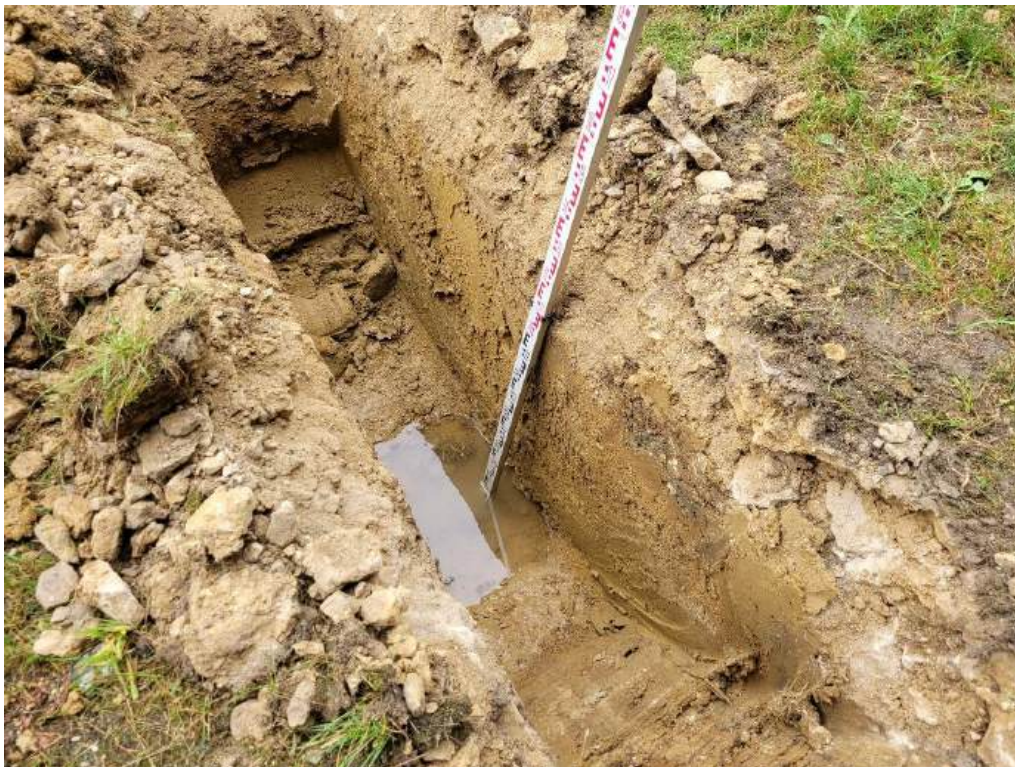
Photo 8 - BRE365 test being undertake in TP3

The BRE365 soakage testing indicate moderate to good permeability (E-04 to E-05m/sec) within the limestone materials. It is recommended that a drainage engineer is consulted to formulate the drainage design.

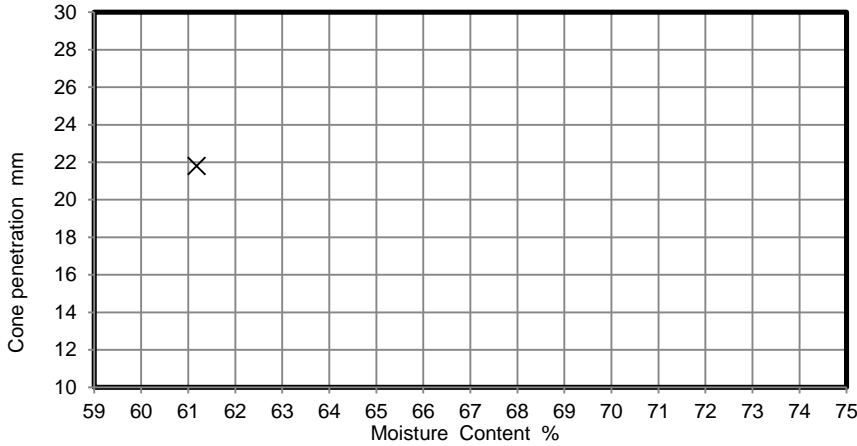
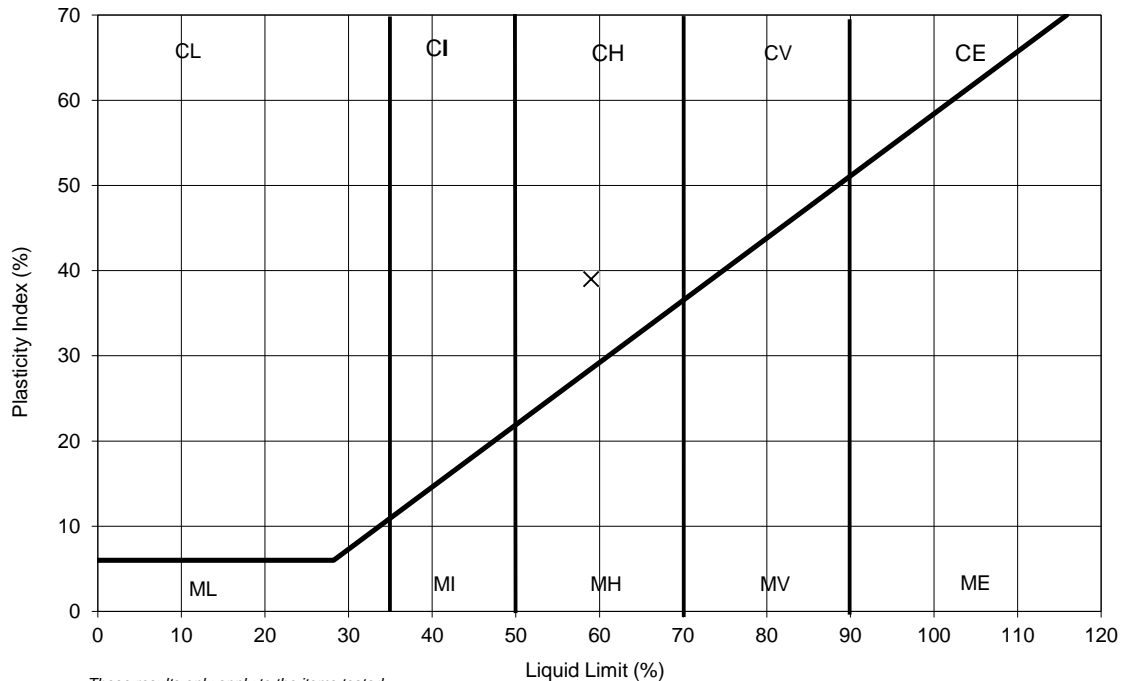
NATURAL MOISTURE CONTENT	21	%
% PASSING 425µm SIEVE	90	%
LIQUID LIMIT	59	%
PLASTIC LIMIT	20	%
PLASTICITY INDEX	39	%

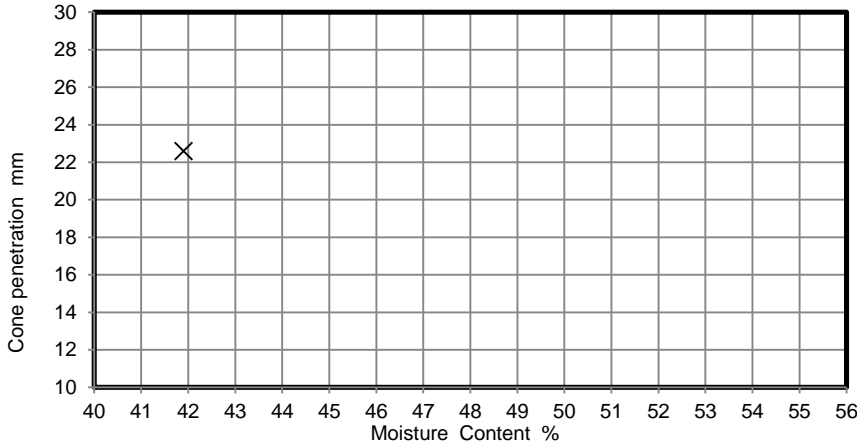
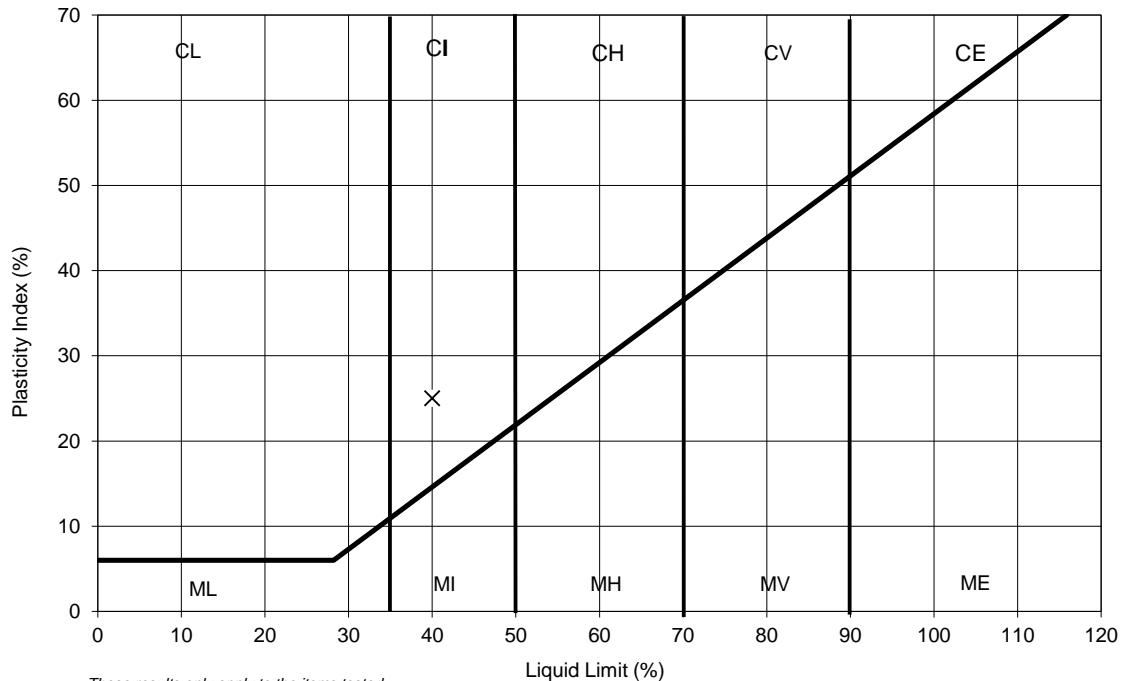
NATURAL MOISTURE CONTENT	15	%
% PASSING 425µm SIEVE	90	%
LIQUID LIMIT	40	%
PLASTIC LIMIT	15	%
PLASTICITY INDEX	25	%

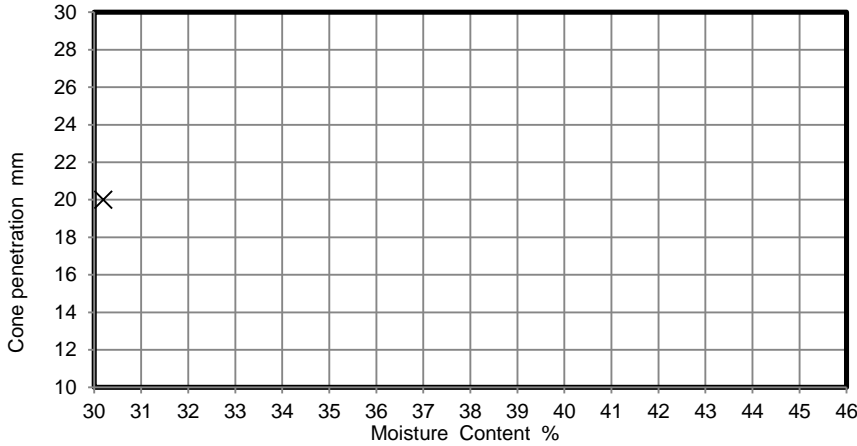
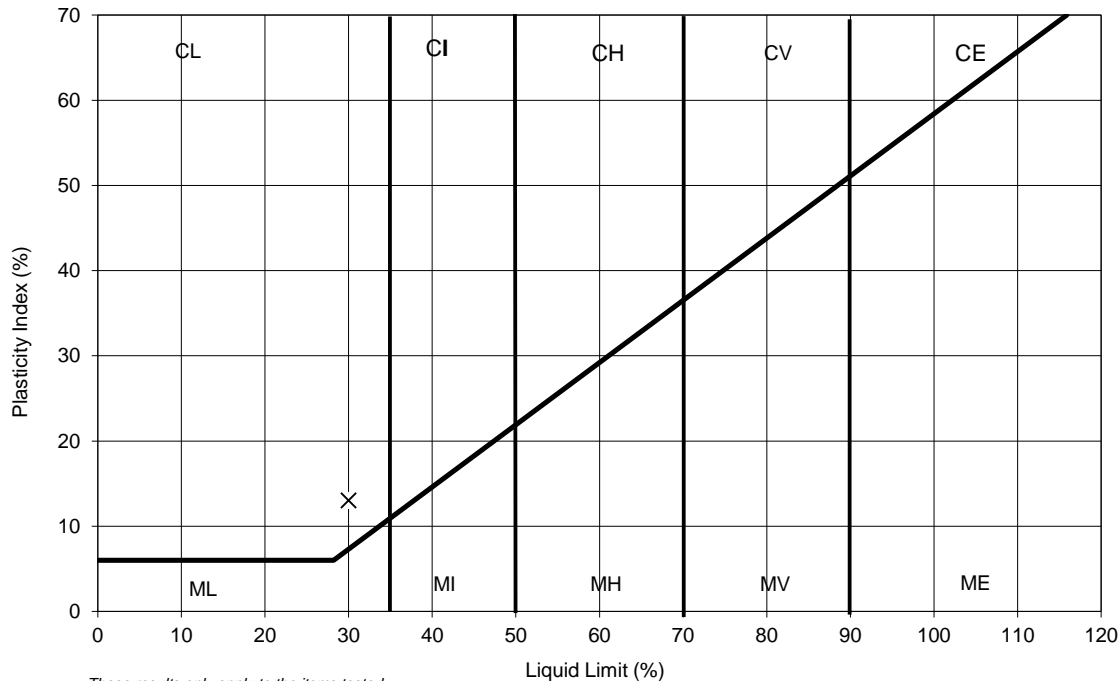
NATURAL MOISTURE CONTENT	12	%
% PASSING 425µm SIEVE	41	%
LIQUID LIMIT	30	%
PLASTIC LIMIT	17	%
PLASTICITY INDEX	13	%

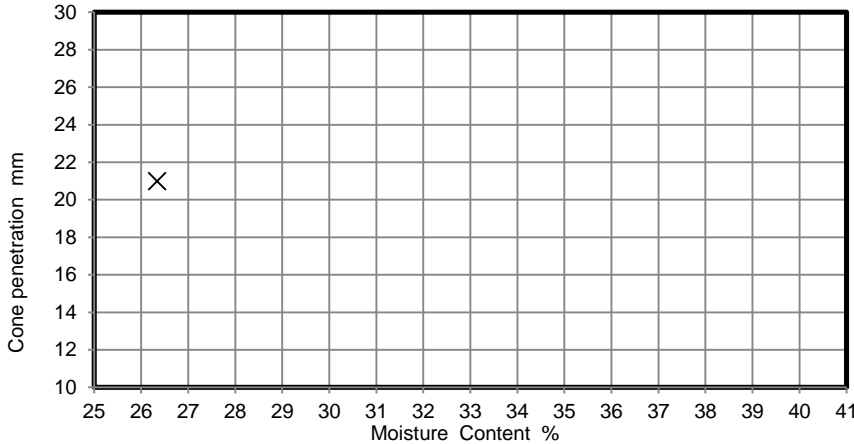
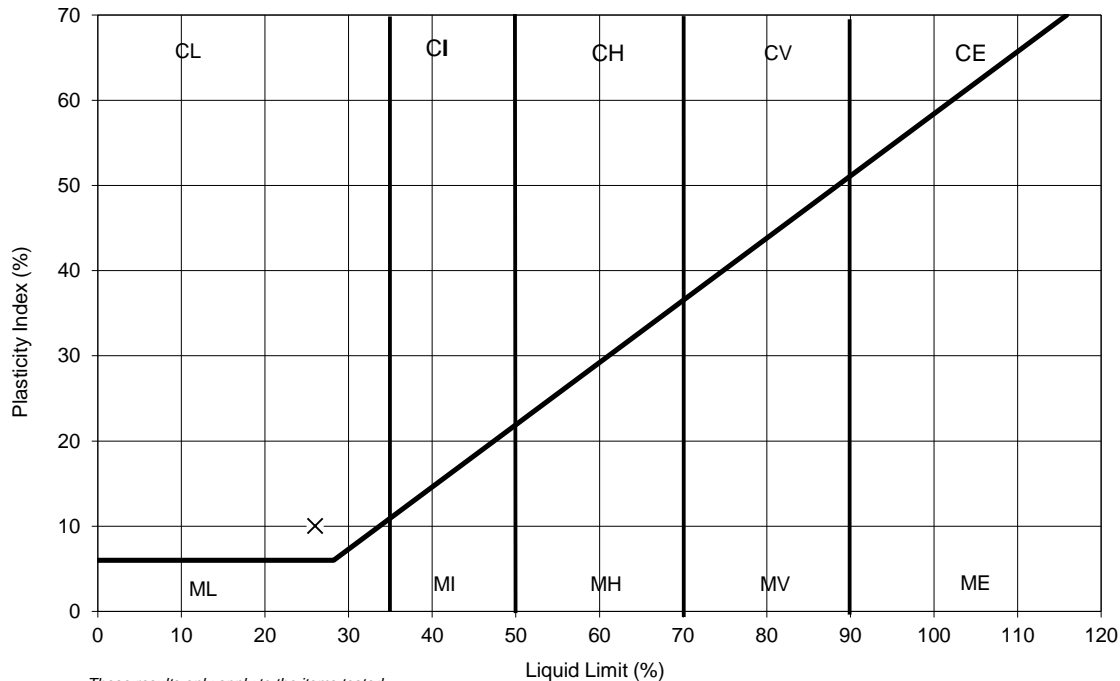
NATURAL MOISTURE CONTENT	4.8	%
% PASSING 425µm SIEVE	23	%
LIQUID LIMIT	26	%
PLASTIC LIMIT	16	%
PLASTICITY INDEX	10	%

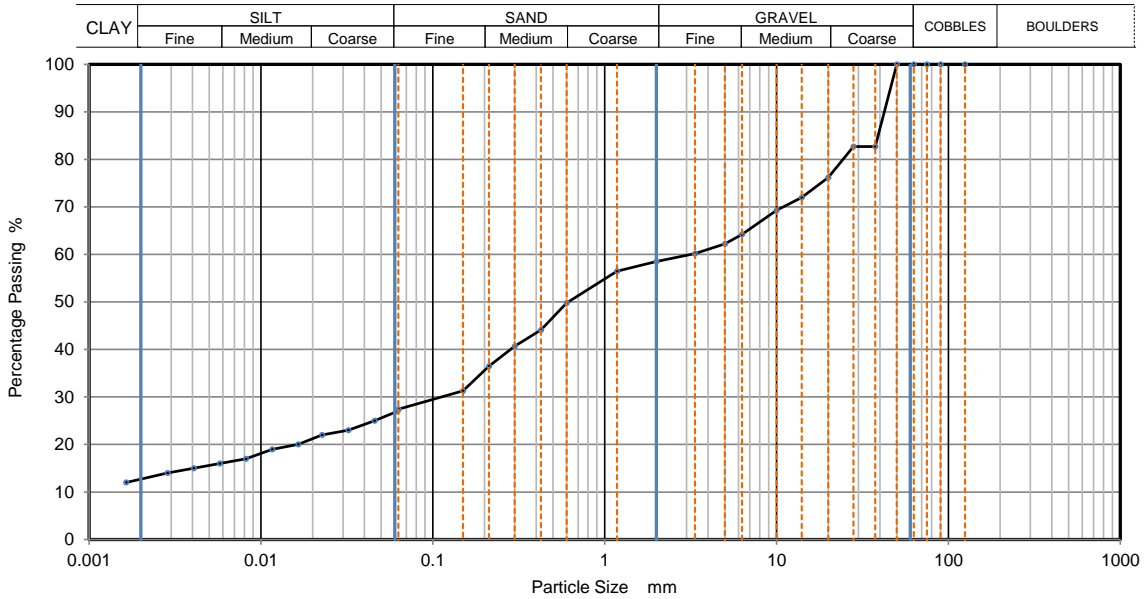
Job Ref	35820
		Borehole/Pit No.	BH2
Site Name	Somerton, Ox	Sample No.	2
Project No.	21318/PO 24-314	Client	WDE Consulting
		Depth Top	1.00 m
Soil Description	Medium strength brown mottled light grey slightly sandy very gravelly silty CLAY with occasional black carbonaceous deposits (gravel is fmc calcareous fragments)	Depth Base	2.00 m
		Sample Type	B
		Samples received	07/08/2024
		Schedules received	07/08/2024
Test Method	BS1377:Part 2: 1990, clause 9.0	Project started	07/08/2024
		Date tested	14/08/2024

Sieving		Sedimentation	
Particle Size mm	% Passing	Particle Size mm	% Passing
125	100	0.0621	27
90	100	0.0459	25
75	100	0.0323	23
63	100	0.0227	22
50	100	0.0165	20
37.5	83	0.0116	19
28	83	0.0082	17
20	76	0.0058	16
14	72	0.0041	15
10	69	0.0029	14
6.3	64	0.0016	12
5	62		
3.35	60		
2	59		
1.18	57		
0.6	50	Particle density (assumed)	
0.425	44	2.70	Mg/m3
0.3	41		
0.212	37		
0.15	31		
0.063	27

Sample Proportions	% dry mass
Very coarse	0
Gravel	42
Sand	31
Silt	14
Clay	13

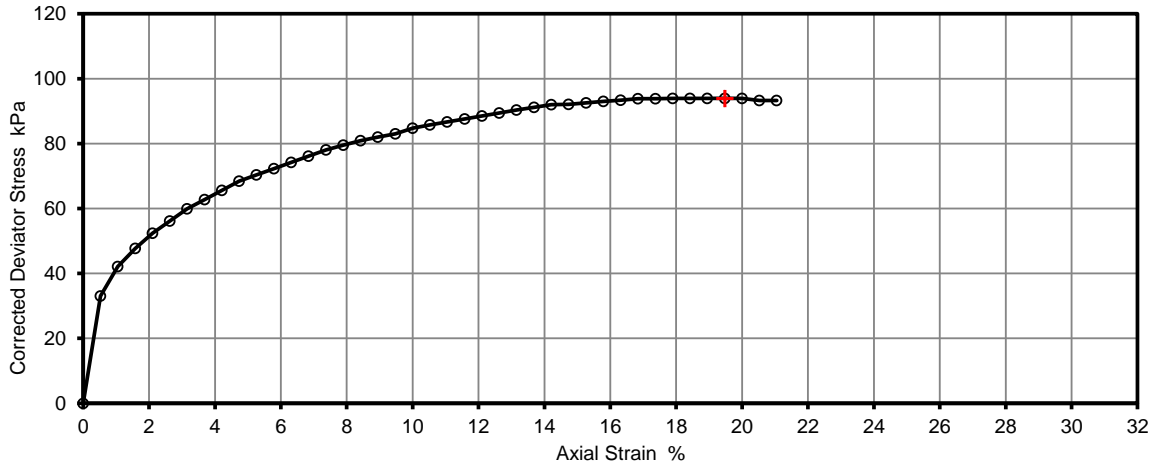
Deviator Stress v Axial Strain

Test Number	1	
Length	76.0	mm
Diameter	38.0	mm
Bulk Density	1.95	Mg/m ³
Moisture Content	25	%
Dry Density	1.56	Mg/m ³
Rate of Strain	2.0	%/min
Cell Pressure	25	kPa
Axial Strain	19	%
Deviator Stress, (σ ₁ - σ ₃) _f	94	kPa
Undrained Shear Strength, c _u	47	kPa ½(σ ₁ - σ ₃) _f
Mode of Failure	Compound

Deviator stress corrected for area change and membrane effects
