Geo-Environmental Assessment
Land off Fritwell Road
Somerton, Oxfordshire
OX25 6NJ

Client: Laxton Properties

Issue Date: September 2024
Report Ref: 21318R1 (Issue A)

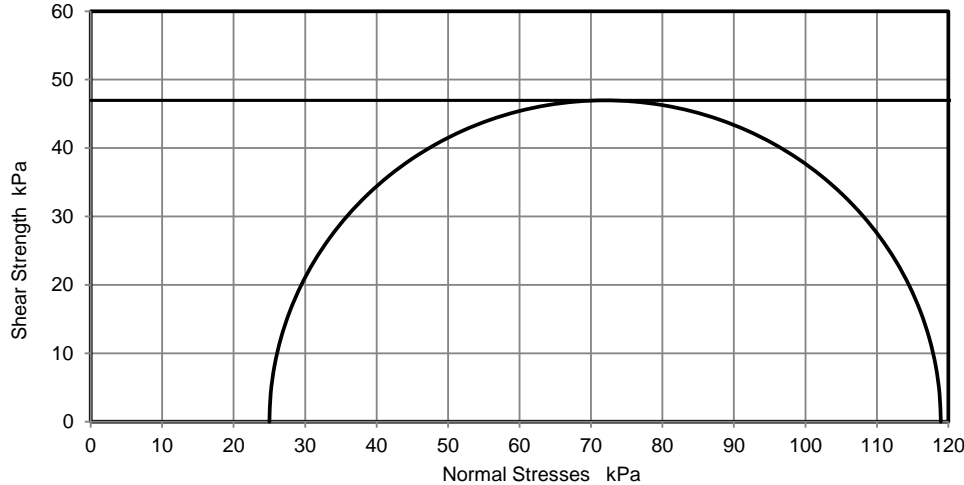
Mohr Circles

Mohr circles and their interpretation is not covered by BS1377. This is provided for information only.
