**New Settlement Area, Heyford Park  
Oxfordshire**

**Dorchester Phase 1b: Area 1  
Remediation Earthworks  
Completion Report**

**November 2014**

**Report Ref: R1742-R07-v1**

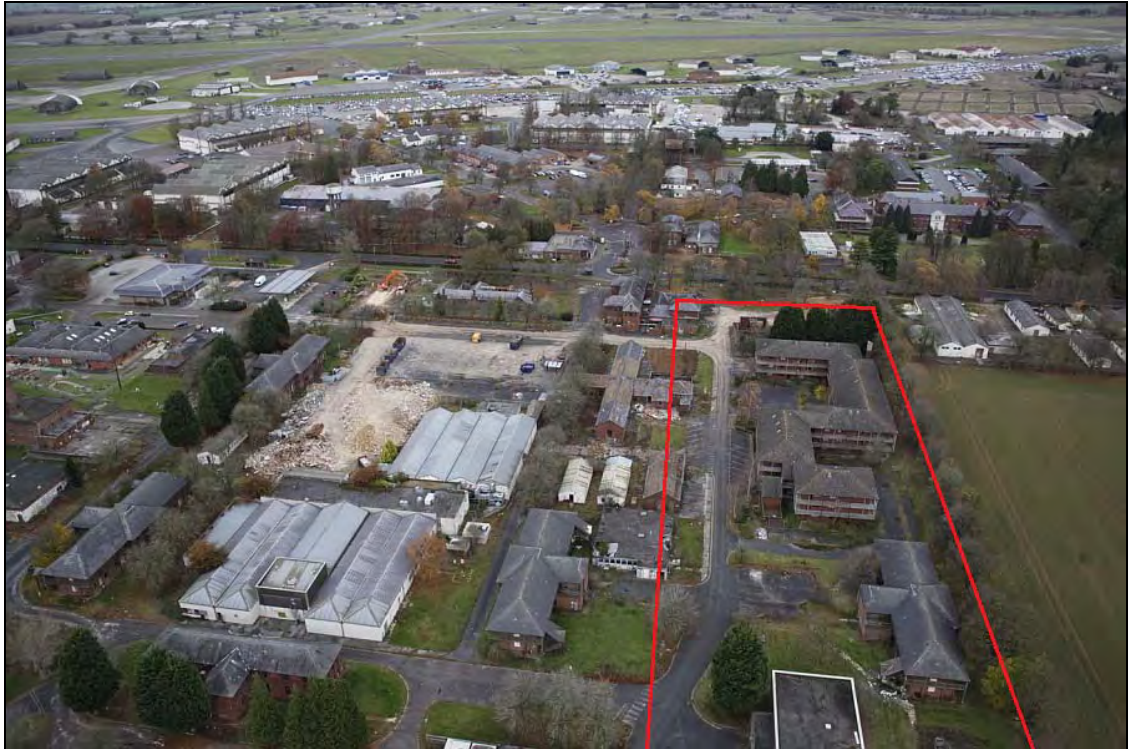
**Figure 1.1 Approximate boundary of Phase D1B: Area 1**

- 1.6. This report deals with the completion of remediation by URL for Dorchester Group (the Developer) across Dorchester Phase D1b: Area 1. The site location is shown below and the site boundary that makes up the wider Dorchester Phase 1b area (D1B) and the sub-phase area (referred to by the Developer as Phase 3) of intended handover is marked on Drawing D02. A separate Completion Report will be completed for the remainder of the D1b phase upon completion in due course.
