FORMER RAF UPPER HEYFORD, OXFORDSHIRE

HISTORIC BUILDING RECORDING AND INVESTIGATION

VOLUME 2: GAZETEER OF RECORDED STRUCTURES

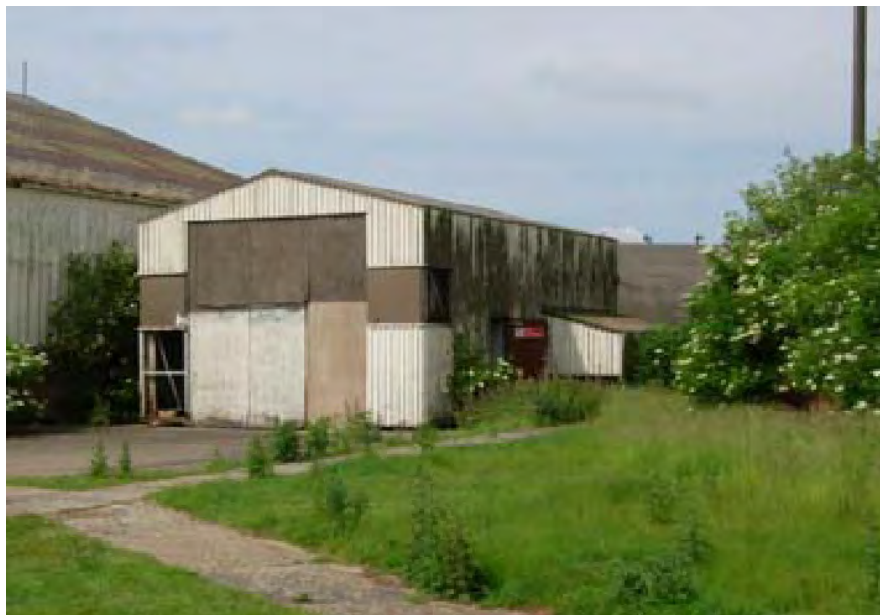
Plate UH31.1 Building UH31

This is a single storey steel-framed structure on a concrete base. It has a shallow-pitch gabled roof and large doorways to each end. It has a rectangular plan (c.10 m x 6 m). The building is clad in metal sheeting and a cantilevered metal box to one side.

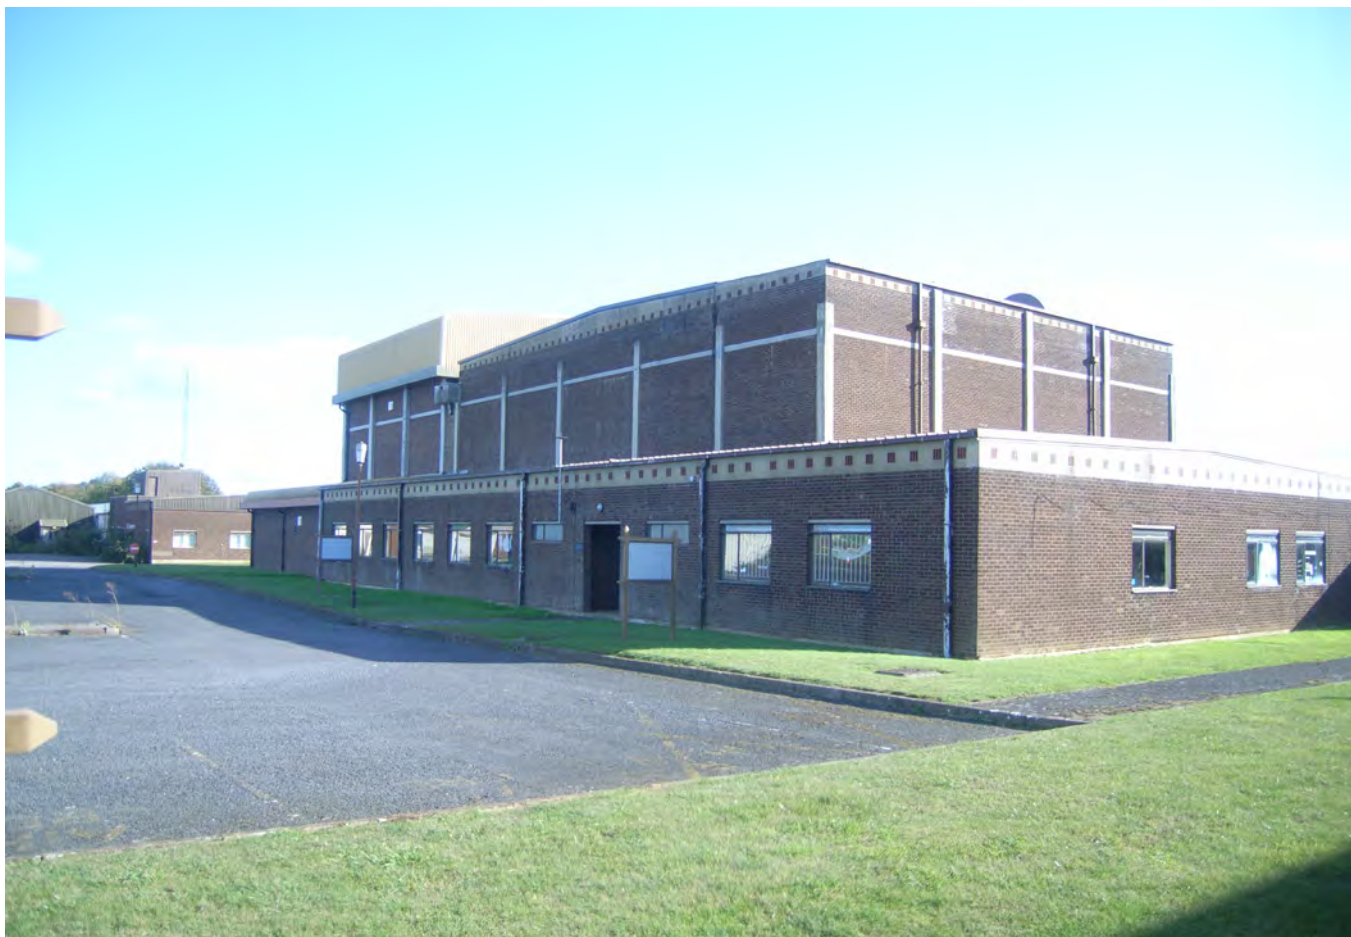
Plate 293.1 Front (south) entrance and elevation

The building is clearly comprised of two distinct parts the western half having an orange clad roof and the eastern half has a metal sheet roof with low central pitch, this latter building is the original building which has been extended to the west (Plate 293.1).

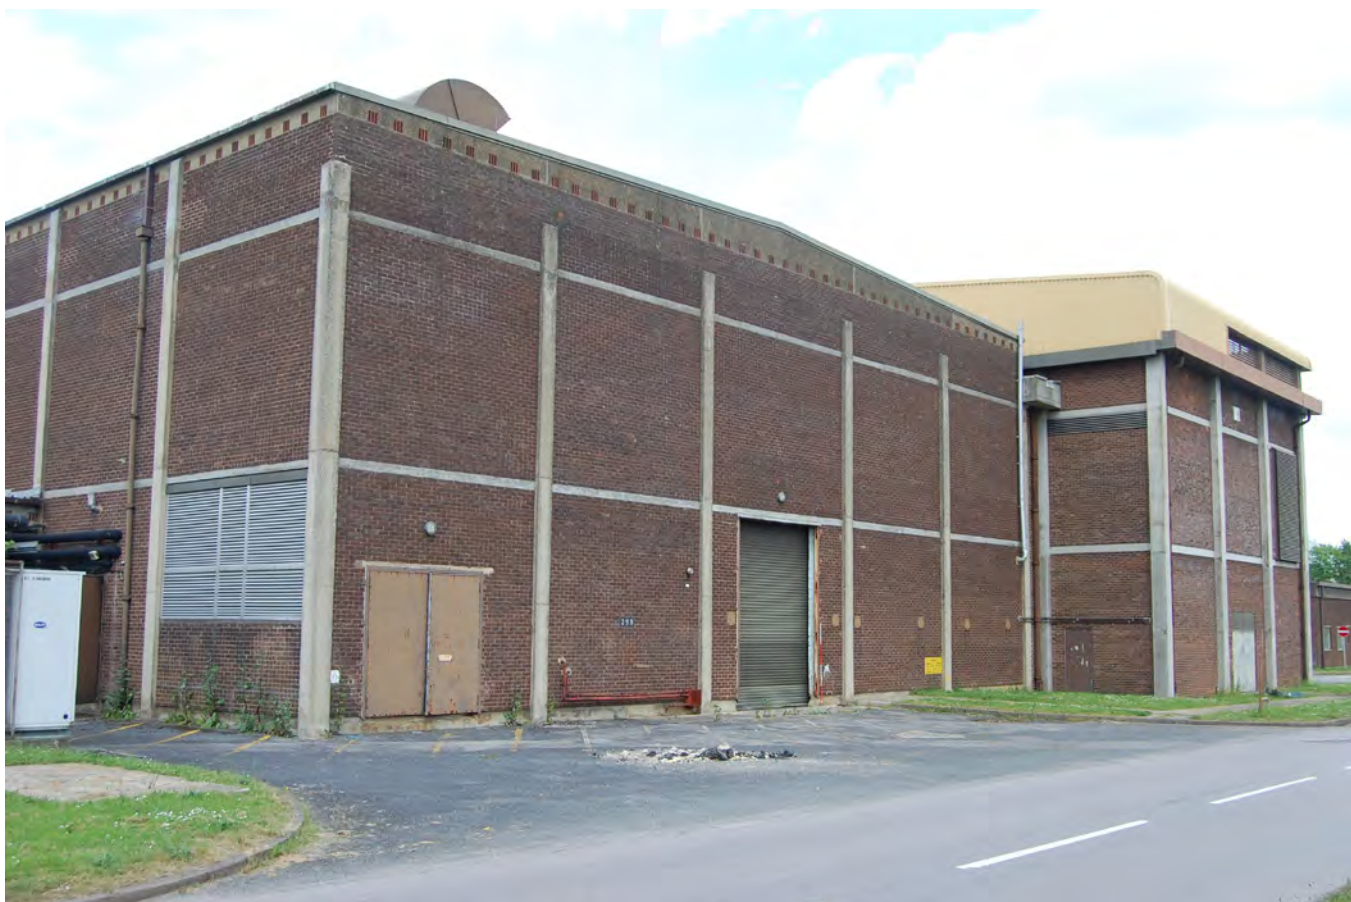
Plate 293.2 West elevation of extension

To the west the extension is also of brick construction and comprises a tall windowless structure with a windowless single storey section in front (Plate 293.2). The tall building has the horizontal concrete band and concrete columns as seen on the original building. The roof for both sections is clad in yellow coloured sheeting, shallow pitched with curved outer arris and orange and grey coloured detail.

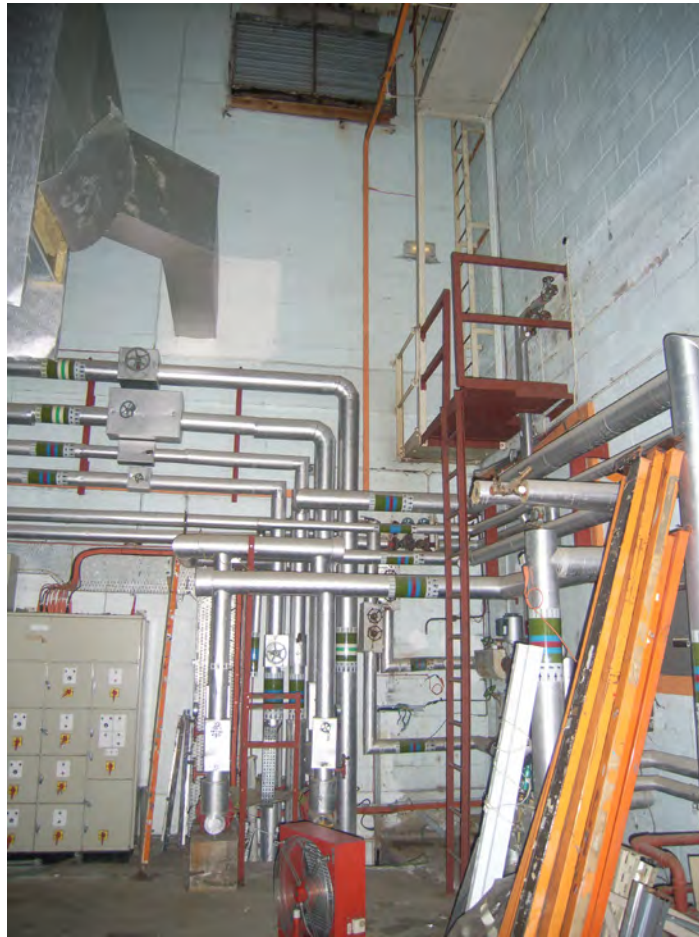
Plate 293.9 South-east view of plant room

The plant room has no suspended ceiling and extends almost up to the roof with a metal ceiling structure providing a platform for insulation beneath the roof. The room is dominated by a series of steel pipes fixed to the wall and air conditioning ducts which are fixed higher in the wall and cross the room. There is a window within the western elevation that is not shown on the as built plan but is a simple single glazed window. On the southern elevation there are a series of ladders reaching up into the roofspace allowing access to high level vent ducting (Plate 293.15). There are two balcony structures at intervals on the ladder which were presumably used as working platforms as well. The upper part of the ladder is above the metal clad ceiling in a shallow space and is filled with insulation material (Plate 293.17). Large vents continue through this space to the roof. Beneath and attached to the ceiling and adjacent wall is a metal frame, although it is unclear what this is for (Plate 293.16). On the southern elevation, there are large external double wooden doors which are fixed shut with a metal bar.

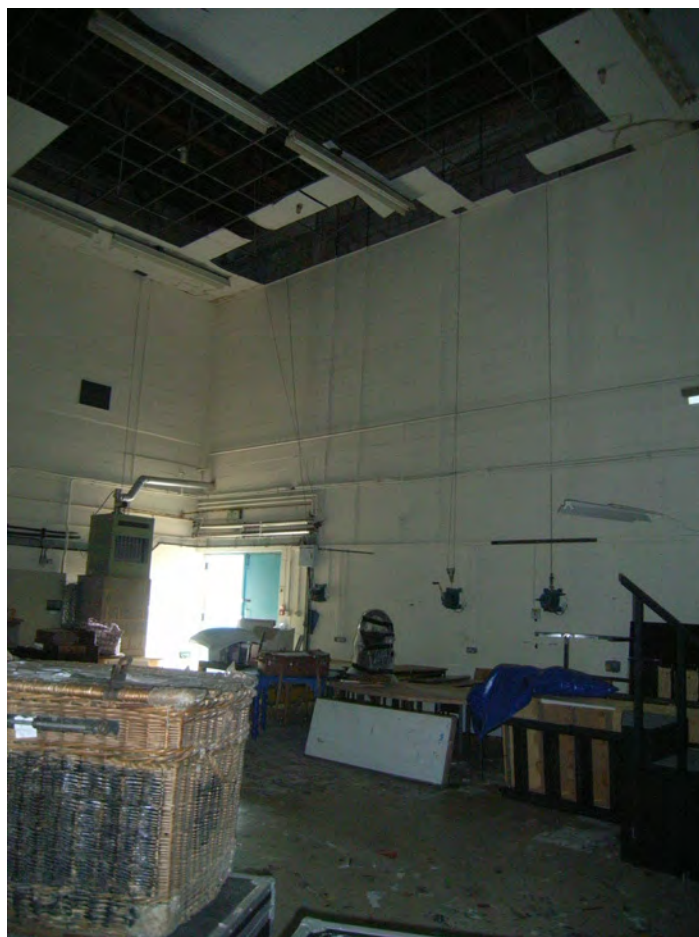
Plate 293.12 South-west view of tactical delivery missile trainer room

To the north of the plant room is a large room referred to on the as built plan as 'tactical delivery missile training'. This is accessed via a metal door from the corridor. The room has concrete block walling, painted white and a suspended ceiling with lighting on a pulley system as seen within the flight simulator room (Plate 293.7). An additional doorway has been inserted into the partition wall providing access to the flight simulator room (Plate 293.7). This door is a double door with standard doors however within the missile training room there are two metal barred panels that swing close and lock over these doors preventing access from the flight simulator room to the missile training room (Plate 293.8).

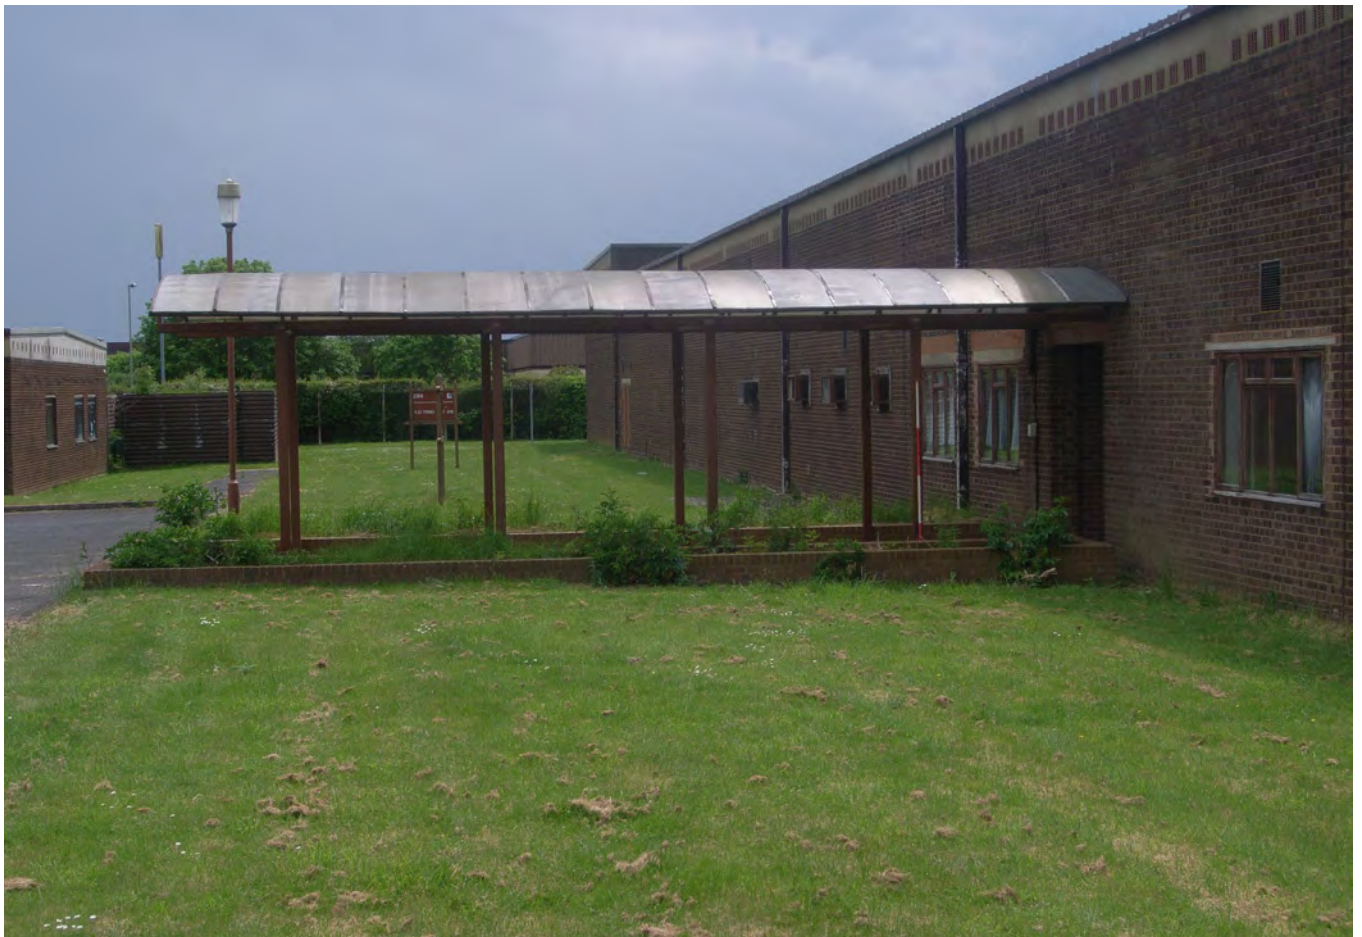
Plate 294.1 Front (east) entrance and elevation

The building is large single storey structure, rectangular in plan with a very shallow pitched metal roof (Plate 294.1). It is constructed in brick (English bond) with wood casement windows, and a large car park to the front that is shared with 292 and 294. This building forms part of a group of administrative/ operational buildings with these two structures.

The front (main) entrance has an entrance porch with plastic barrel vault roof, and double wood and glass doors recessed within the front elevation (Plate 294.1). There are two windows to each side of the entrance which are clearly later insertions, with replacement brickwork surrounding the windows. There are a series of metal vents along the elevation, with four to the south of the entrance projecting from the face of the brickwork and four to the north set within the brickwork. Directly below the roof line is a band of concrete render with clay ventilation tiles in groups of sixteen set within this. At the south end of the elevation is a set of double metal doors providing a further point of entry for goods to the main building, directly to the south the roofline is higher suggesting a possible later build. However, the external appearance of this end block suggests that it is contemporary with the main body of the structure as described below.

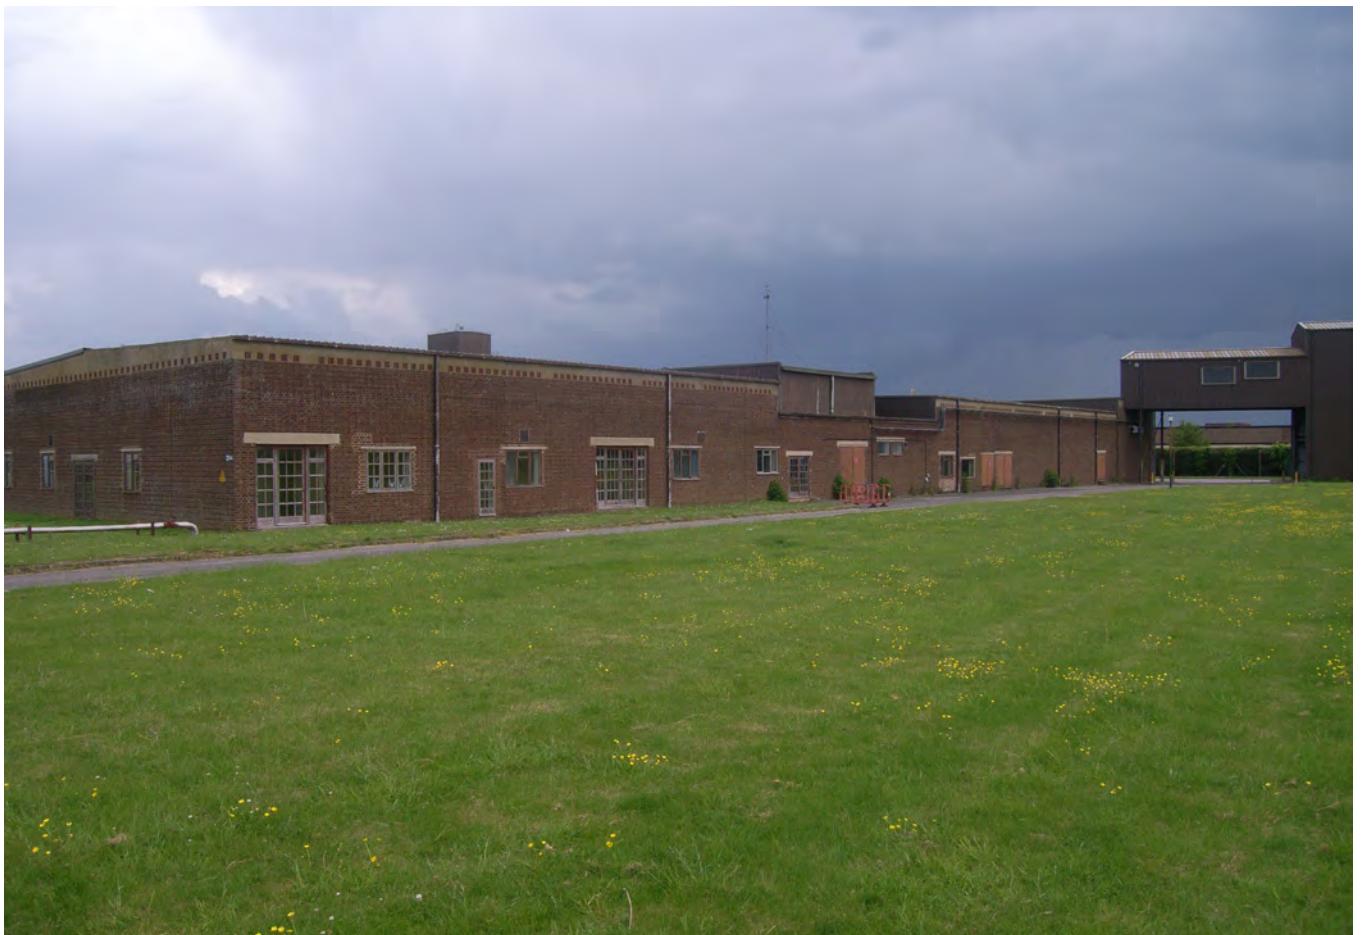
Plate 294.2 Rear (west) elevation

The west elevation is of the same form as the front elevation with the concrete band and vents continuing around the building and a series of double metal doors (four) and timber framed windows with concrete lintels (Plate 294.2). Within the north half of the building are three sets of double and one single glass and timber doors (of the same type at the front entrance), which would have provided access for staff and a light working environment. There has clearly been some reconfiguration of this elevation with sections of replacement brickwork surrounding the doors and windows, and a blocked door. A large section of the roof is recessed, with a taller metal clad section of roof projecting above the main flat roof with an aerial situated on the roof (Plate 294.3).

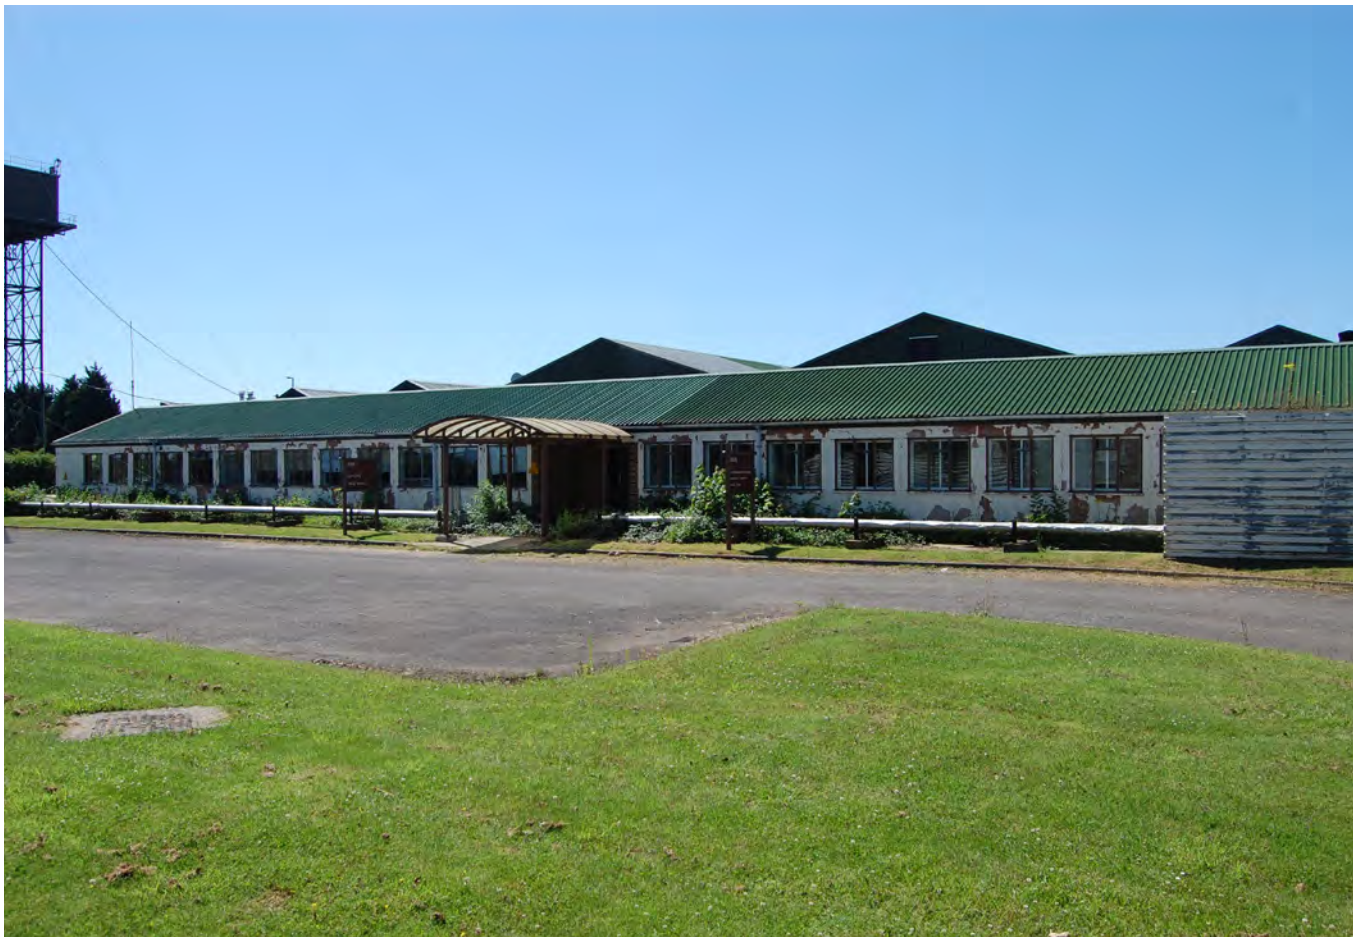
Plate 300.1 Front (east) elevation of 300a

Section 300a is rectangular in plan with a pitched roof and modern cladding (Plate 300.1). The gabled building is constructed from concrete panels on a brick plinth and structurally is thought to date from the earliest phase of construction (1953). The north and south elevations have three critical windows with modern plastic inner glazing. The east elevation has 26 windows and a central doorway which reflect the primary phase of construction, with a later porch constructed over the entrance. Other features of interest include blast protection banks around the north-east edge of the building, these are corrugated sheeting infilled with earth.

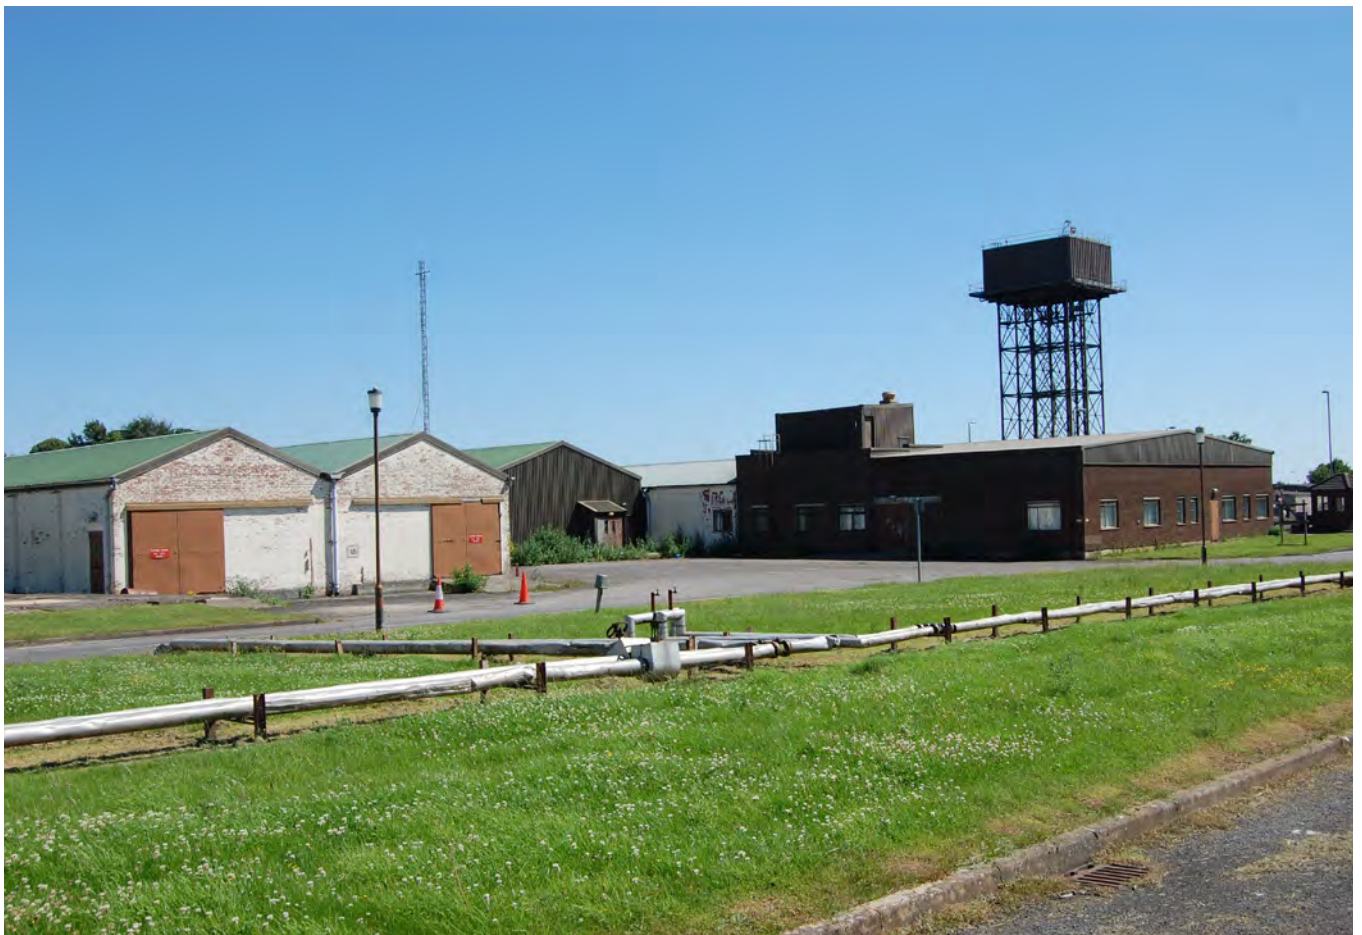
Plate 300.2 South elevation of 300b, 300c and 300d

Section 300c is rectangular in plan and thought to date from the 1970s/ 1980s (Plate 300.2) It is double gabled with corrugated cladding, and thought to date from the primary phase of construction although it has been refaced probably in the 1970s/ 80s. The west elevation only is visible, the others are enclosed within the building’s other ranges. This has two gables, a brown brick plinth and one projecting porch to each bay. There is war art on the north gable ‘20th Equipment Maintenance Squadron’.

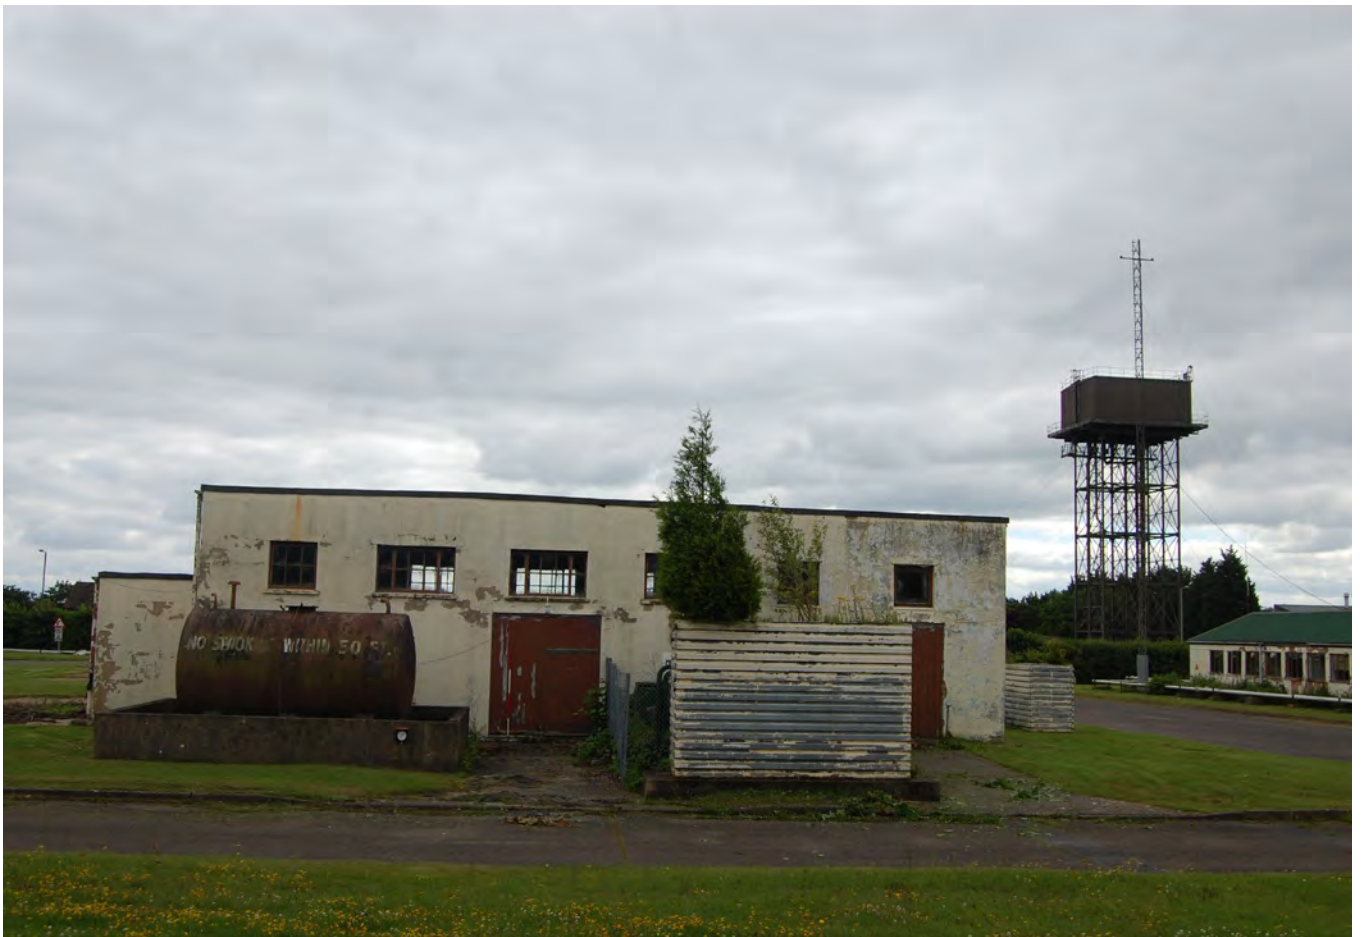
Plate 301.1 North (front) elevation

The front (north) elevation was large double timber doors with six windows above which would have provided considerable light to the mechanics within the internal space (Plate 301.1). The windows are of various sizes (2 windows with 2 rows of 3 lights, 2 windows with 2 rows of 5 lights, and 2 windows with single panes). There is a blast wall to the front of the building which is constructed from corrugated metal sheeting infilled with earth. The primary double wood panelled doors remain extant situated roughly centrally within the elevation.

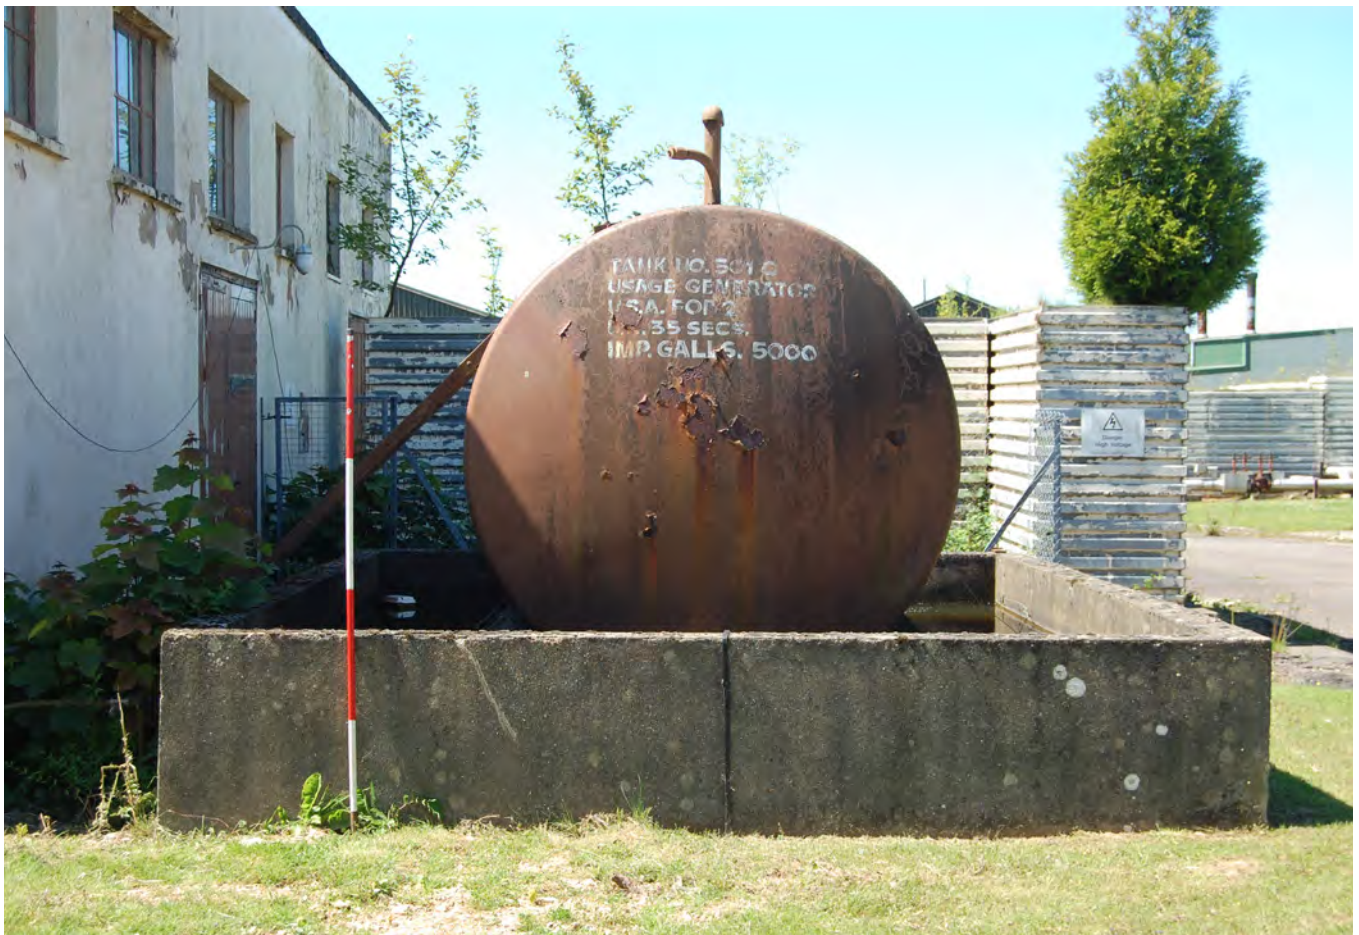
Plate 301a.1 South-east view

Building 301a is a metal storage tank sitting on concrete feet and surrounded by a short perimeter wall (0.75m high) (Plate 301a.1). Pipes extend from the top of the tank, and printed in white on the south-east end of the tank is: 'Tank No 5010, Usage Generator, USA for 2, 235 secs, Imp Galls 5000'. Also printed on the front of the tank is: 'No smoking within 50 feet'.

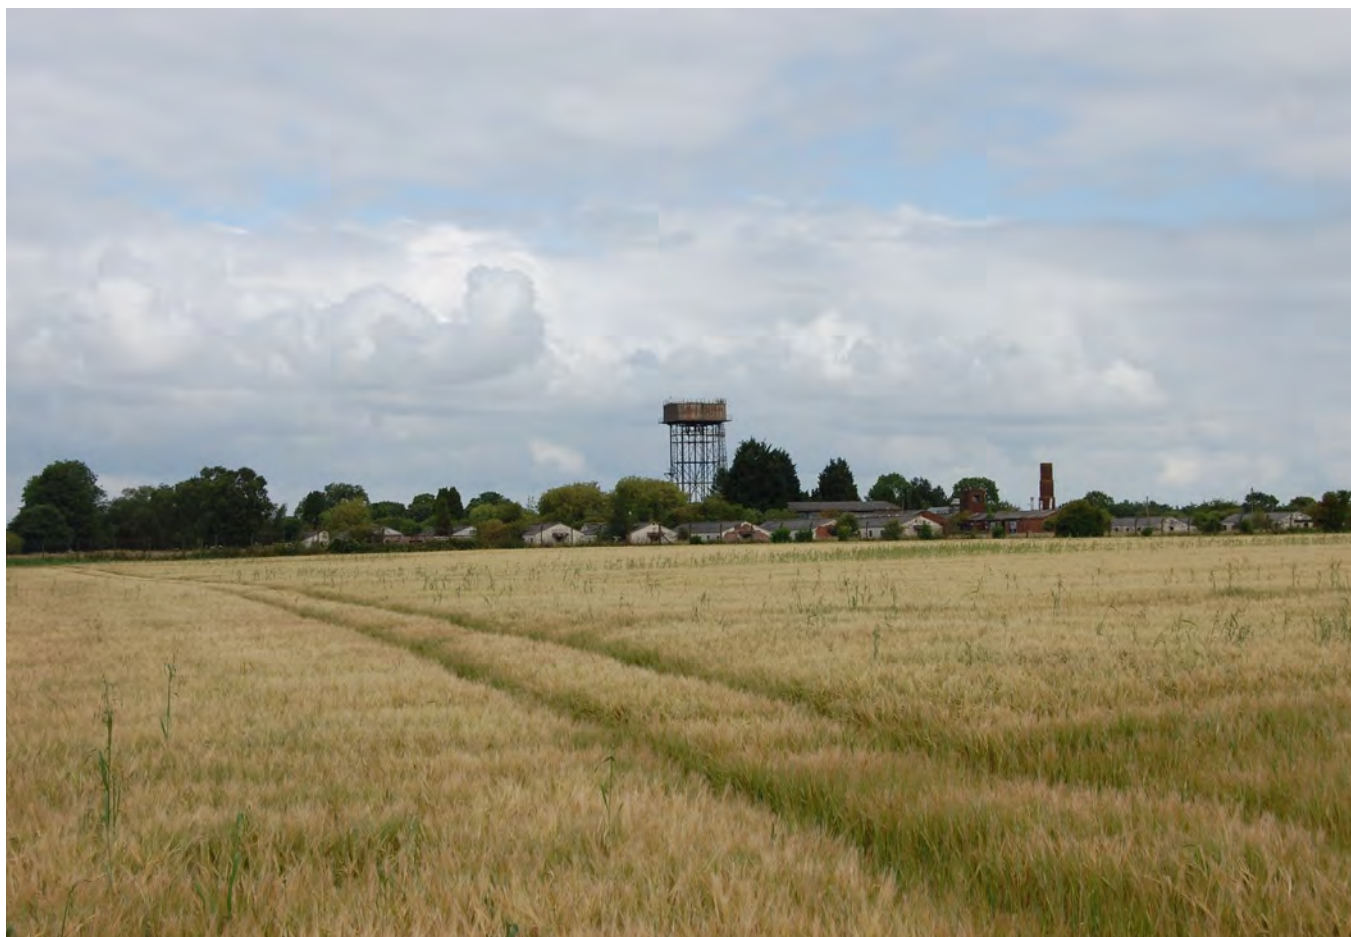
Plate UH74.1 View of water tower from south

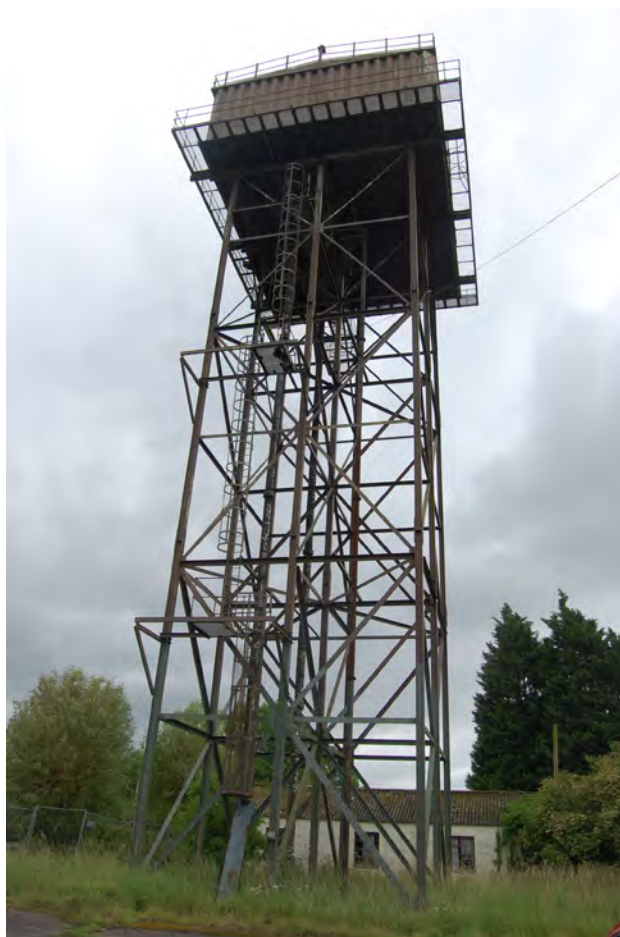
Plate UH74.2 North face of tower from Camp Road

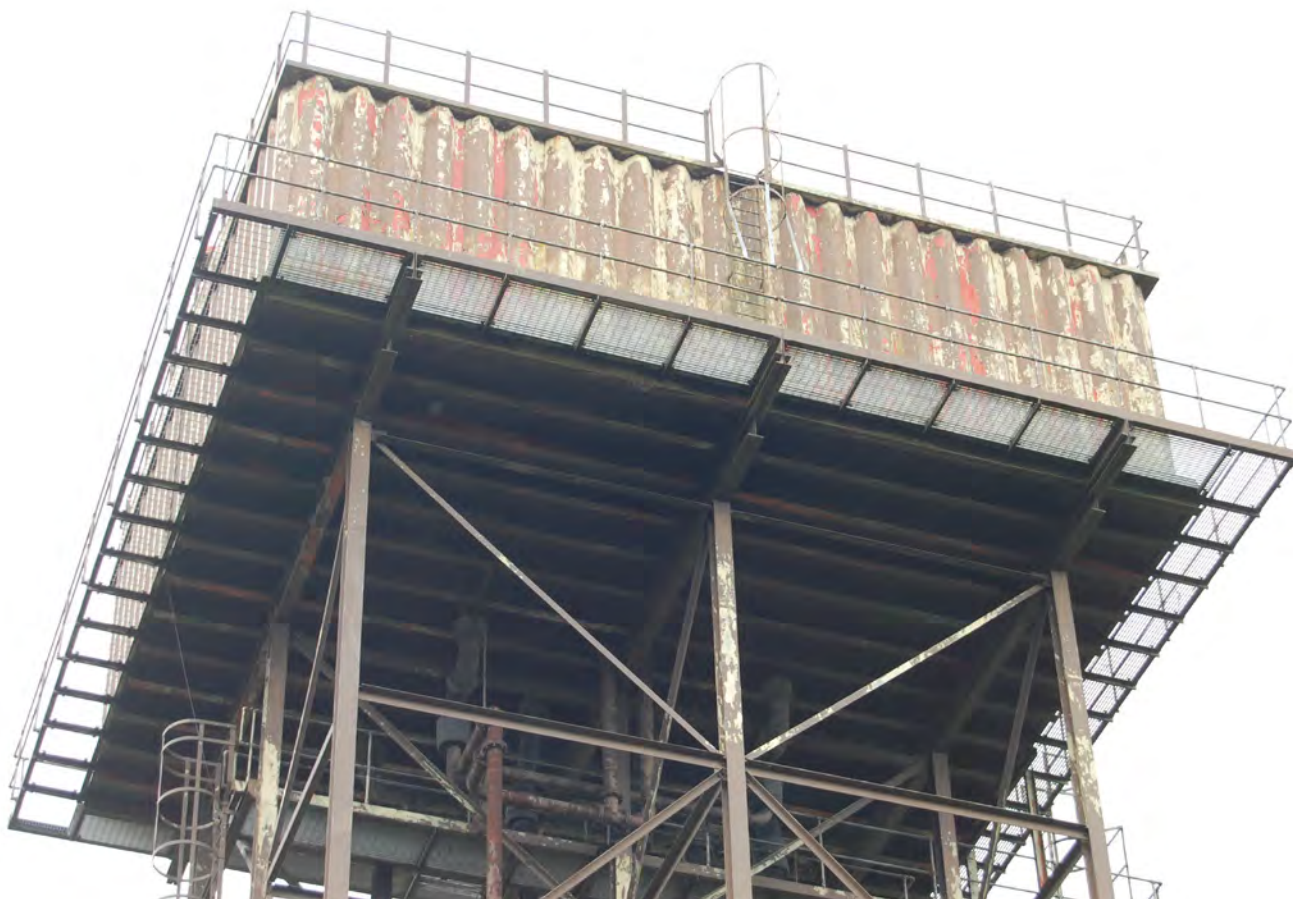
Plate UH74.3 View of water tank at top of tower

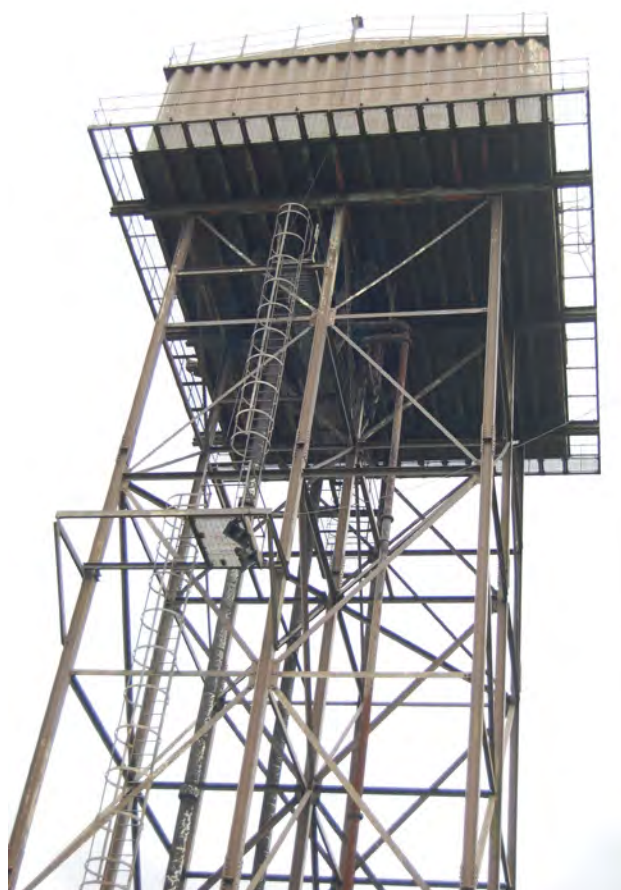
Plate UH74.4 View of supporting tower posts

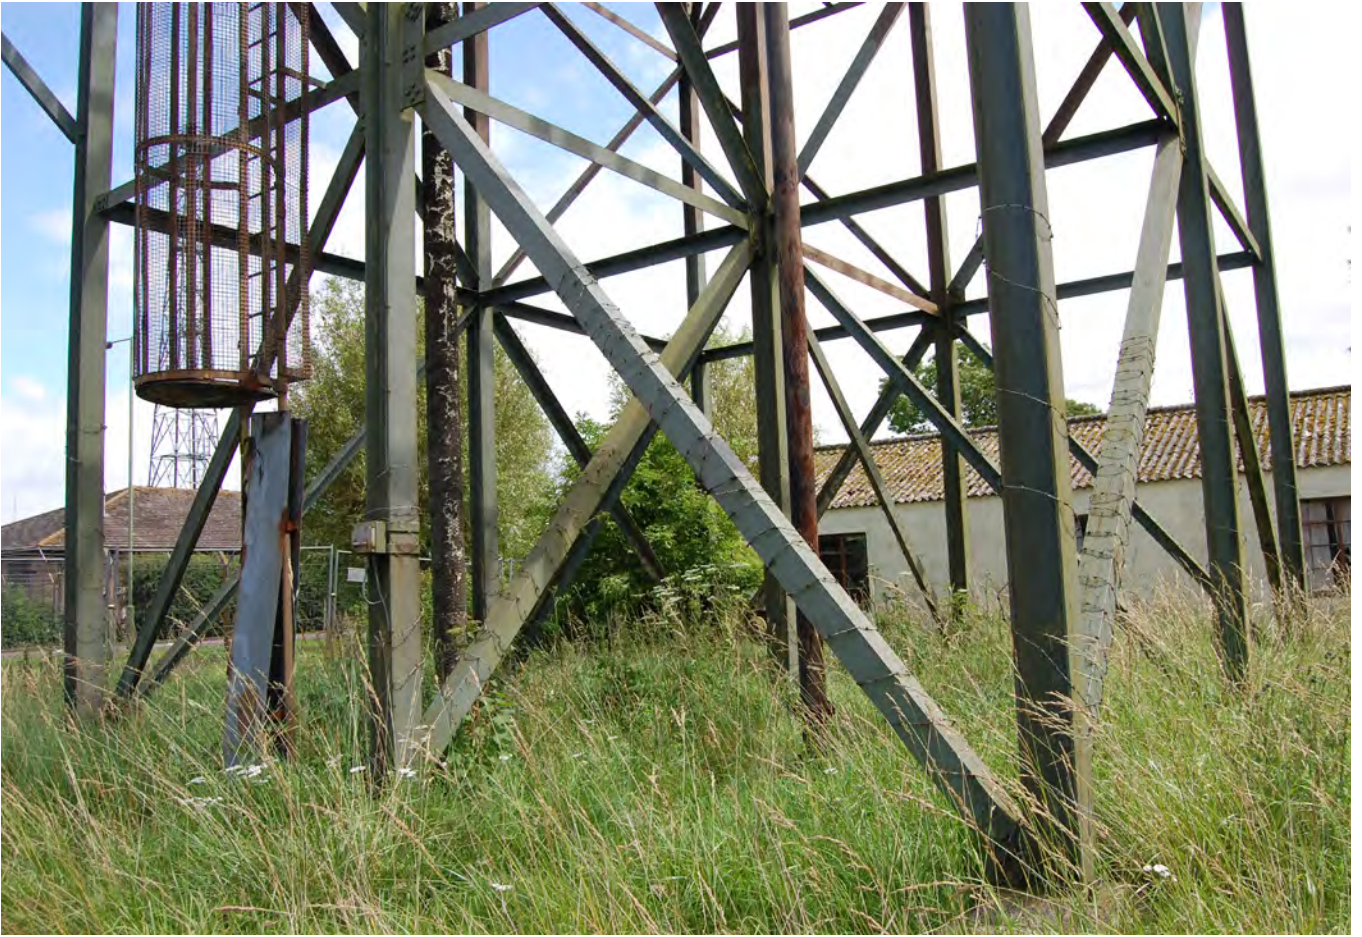
Plate UH74.5 Base of tower, with concrete pads just visible

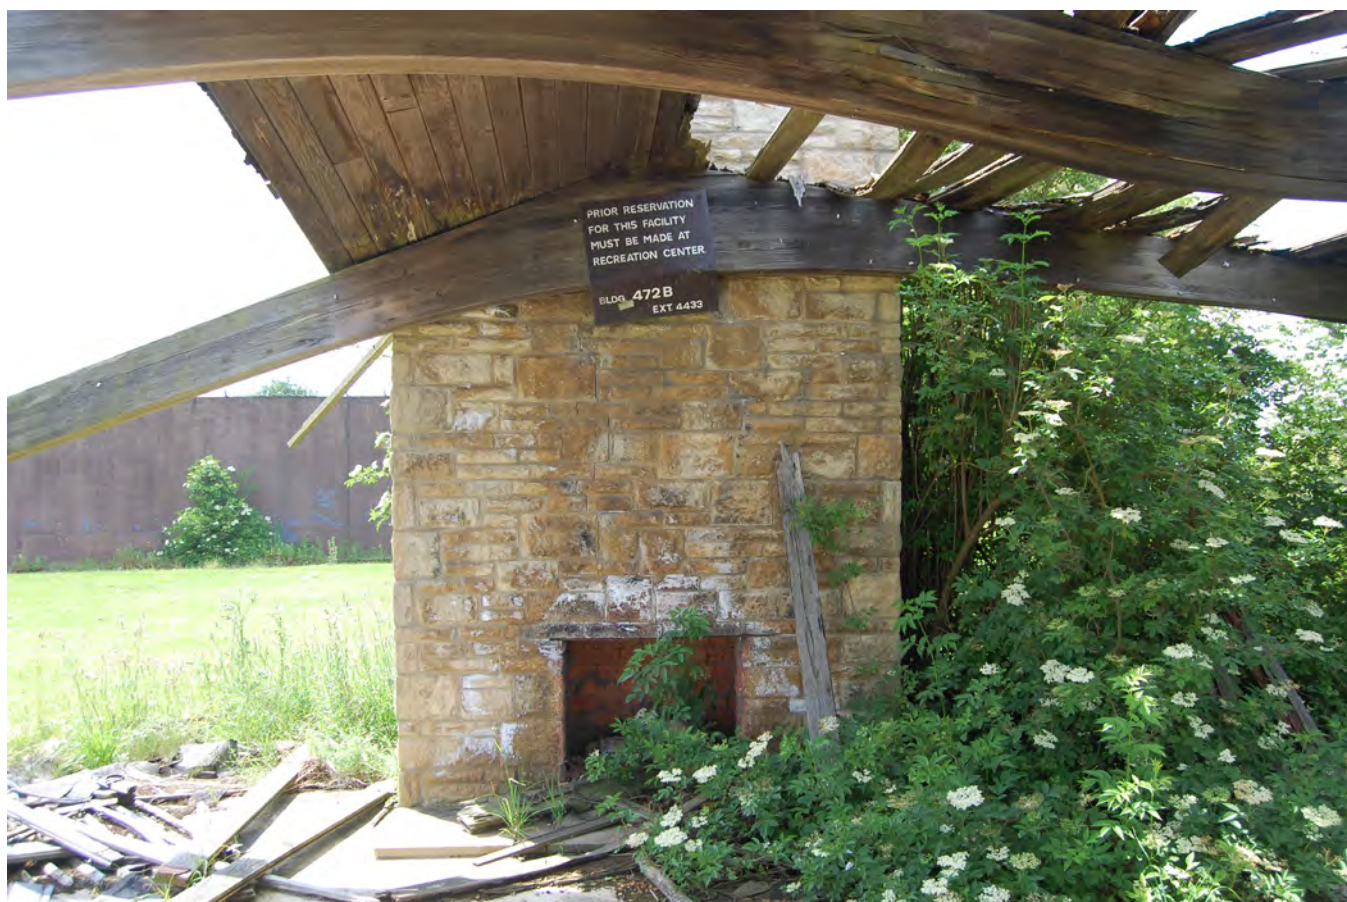
Plate 515.1 Fireplace at south end of 515

At the south end of the building there is a large 'rustic American' freestanding fireplace formed from brick clad in concrete to look like stone.

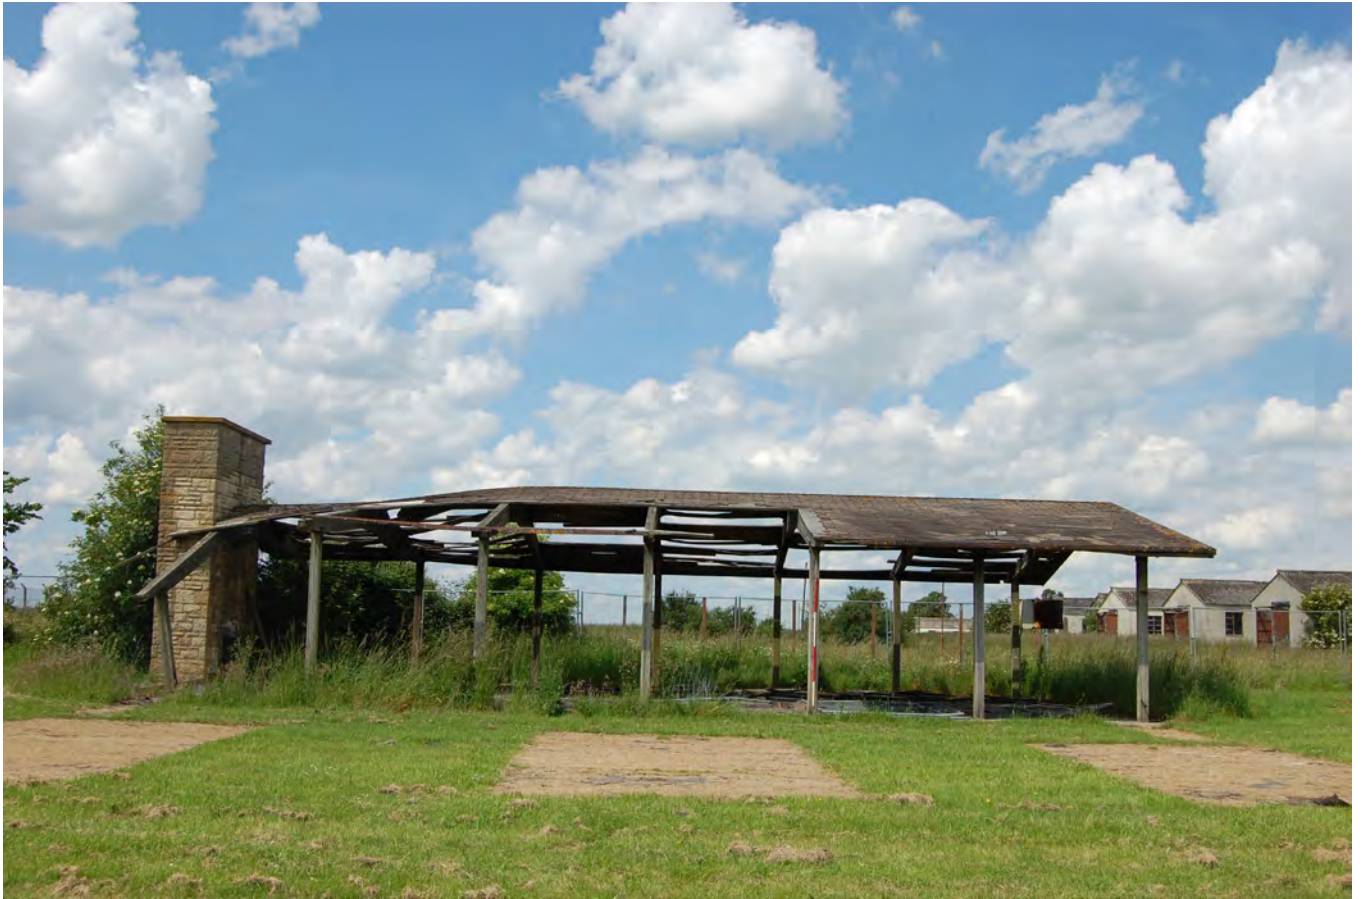
Plate 515.2 General view of 515 from east

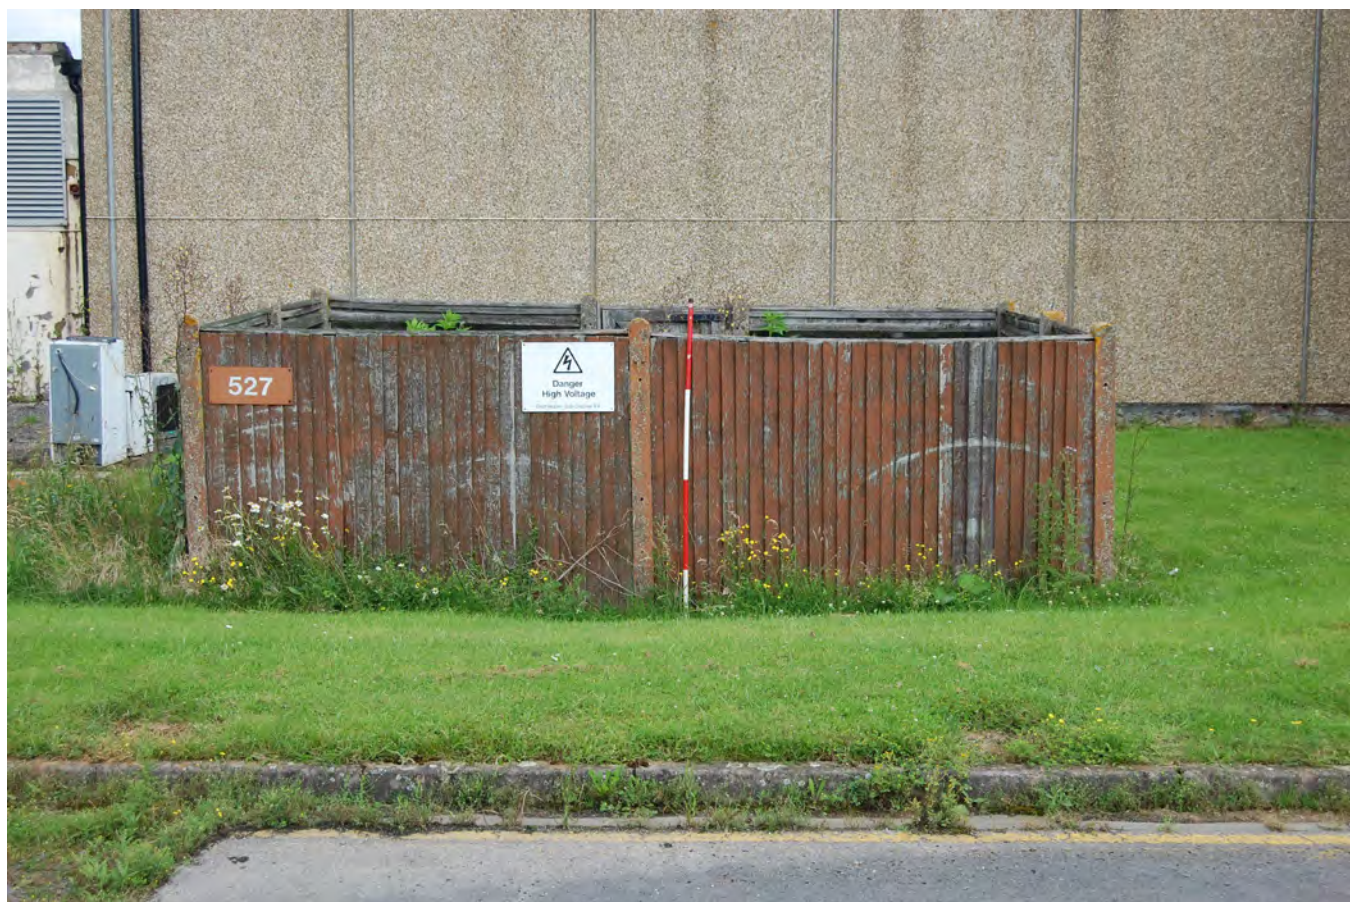
Plate 527.1 General view of substation

This is a small, rectangular plan, open enclosure (5 m x 4 m) for the substation plant. The enclosure is formed from standard reinforced concrete fence posts and timber fence panels. The concrete posts are found at each corner and one mid-spaced to each side wall. The enclosure is c.1.8 m tall and there is a door in one wall.
