FORMER RAF UPPER HEYFORD, OXFORDSHIRE

HISTORIC BUILDING RECORDING AND INVESTIGATION

VOLUME 2: GAZETEER OF RECORDED STRUCTURES

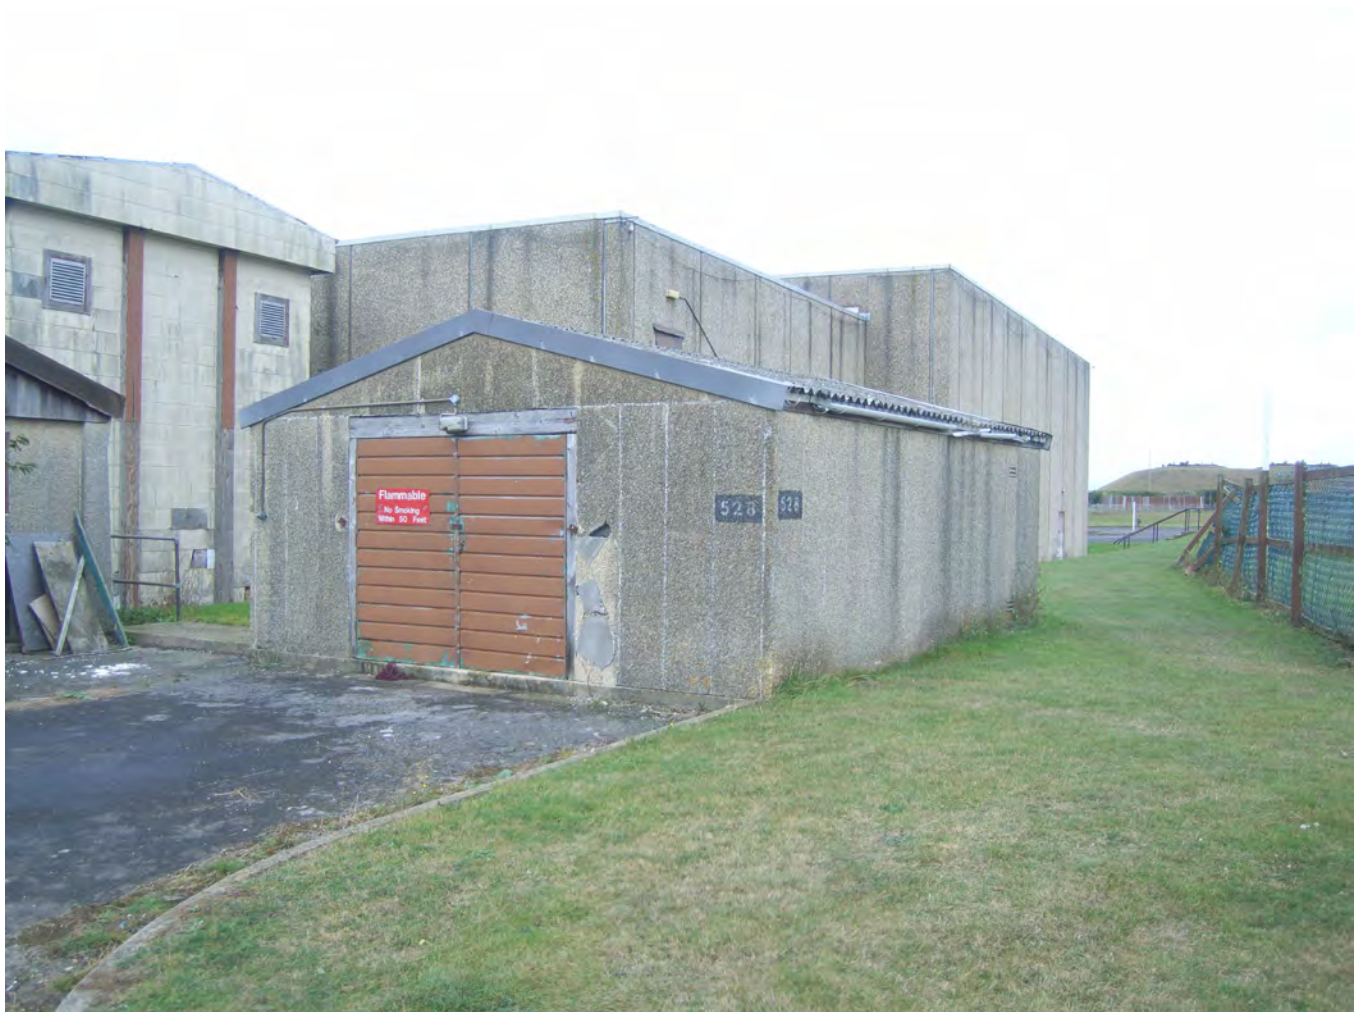
Plate 528.1 General view of store

This is a simple, single storey store building with rectangular plan (c.5.5 x 6.5 m) and gabled roof covered in corrugated sheeting. The building has a concrete plinth and structural frame and the walls are clad in pebble-dashed panels. Access is via a set of double garage doors.

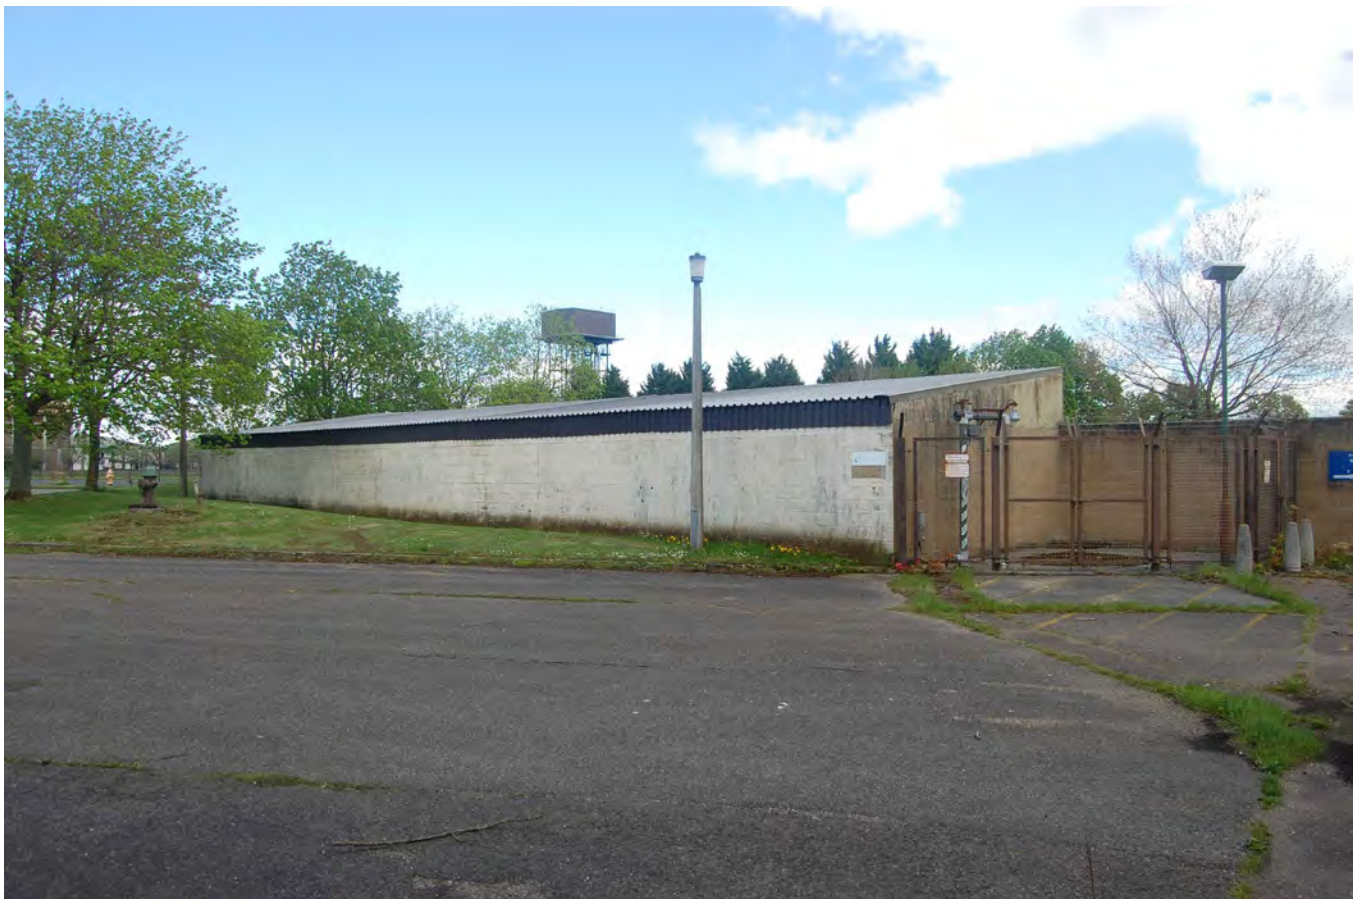
Plate 566.1 General view of 566 from north-east

This is a long, single storied, rectangular plan building (25 x 6.5 m) with a single pitch roof clad in corrugated metal panels. The walls are formed from concrete block and there are no windows.

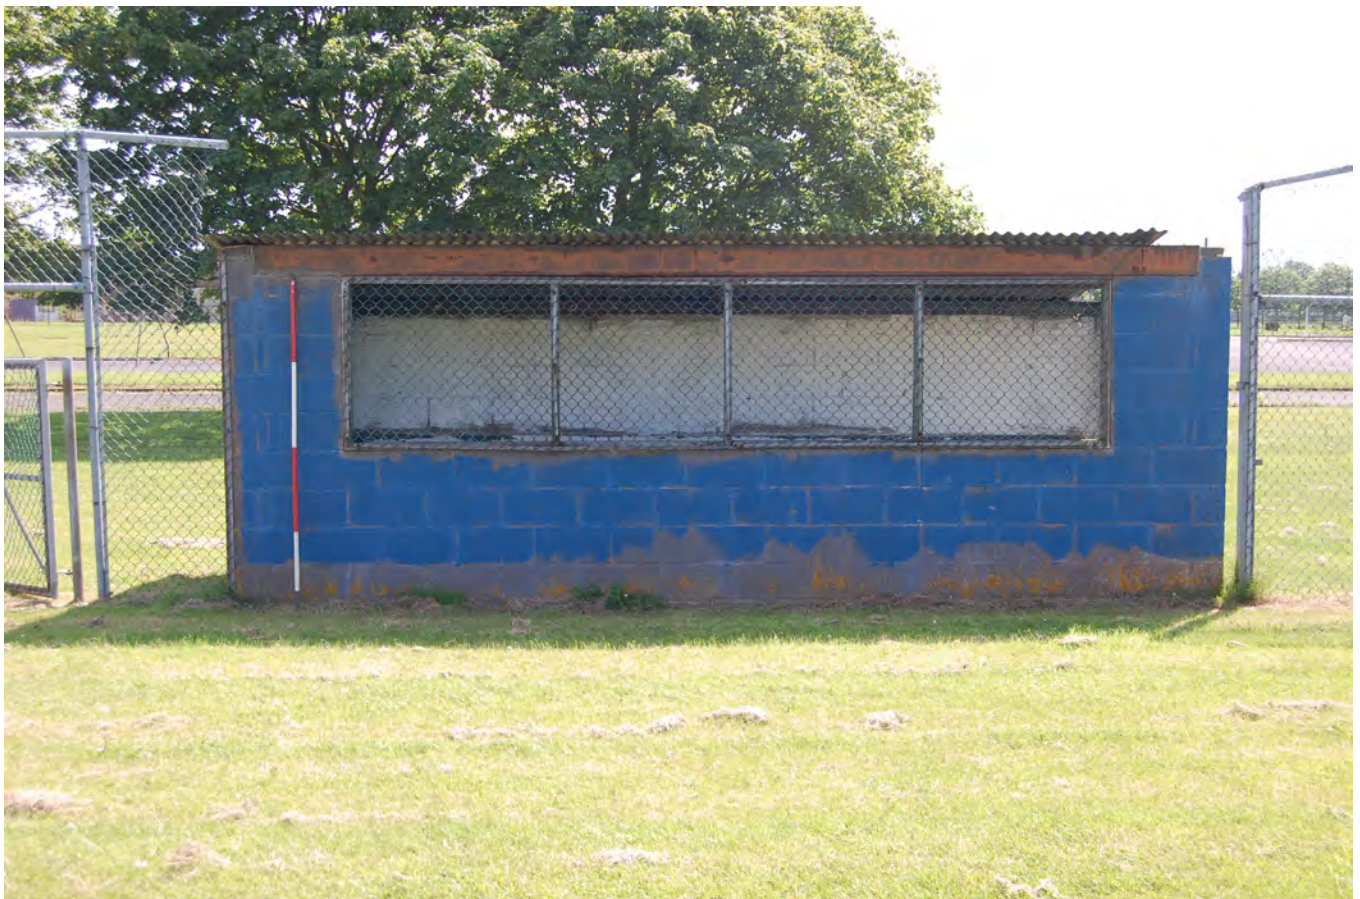
Plate 567.1 Dugout

This is a very simple structure constructed from concrete block walls and with a single pitch roof clad in corrugated sheeting. The dugout has a rectangular plan (c.6 m x 3 m), a doorway in one end and a long window facing the pitch. The window has a wire mesh (chicken wire) to add protection.

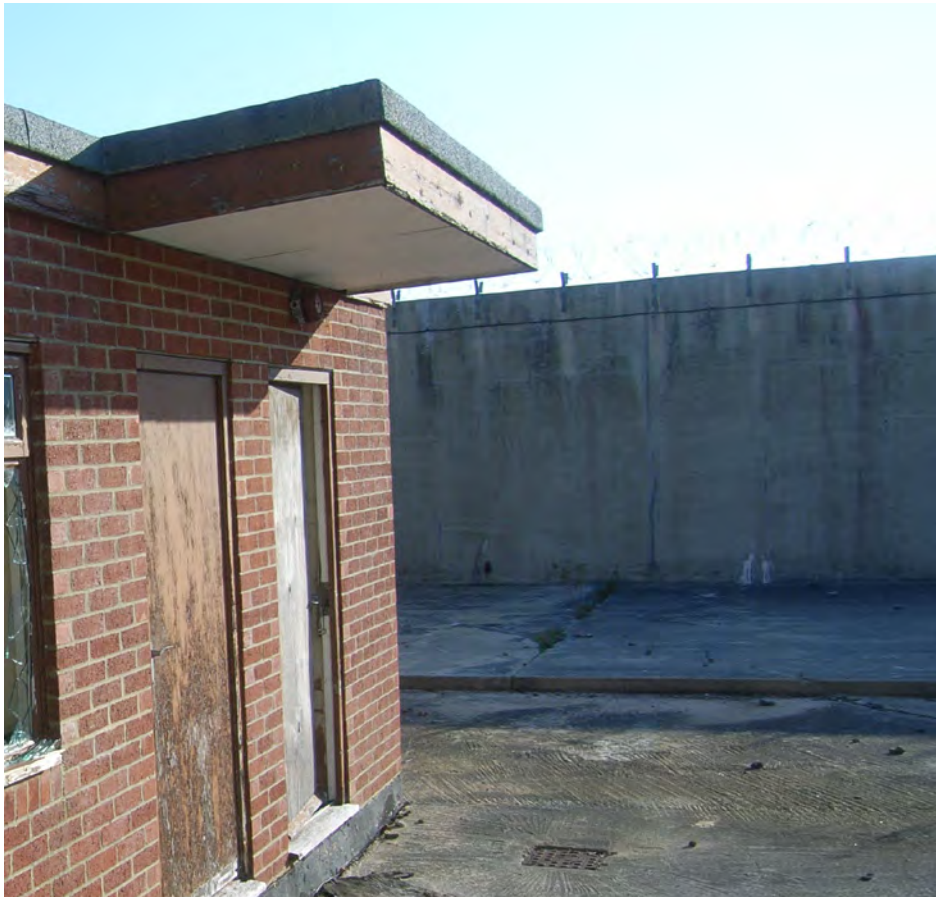
Plate 570.1 Building 570 to reart

This is a single storey square plan building (19 x 19 m) with a flat roof and plant upon the roof. There is a concrete plinth and the walls are formed from panels (probably concrete). There is barbed wire to the tops of the walls.

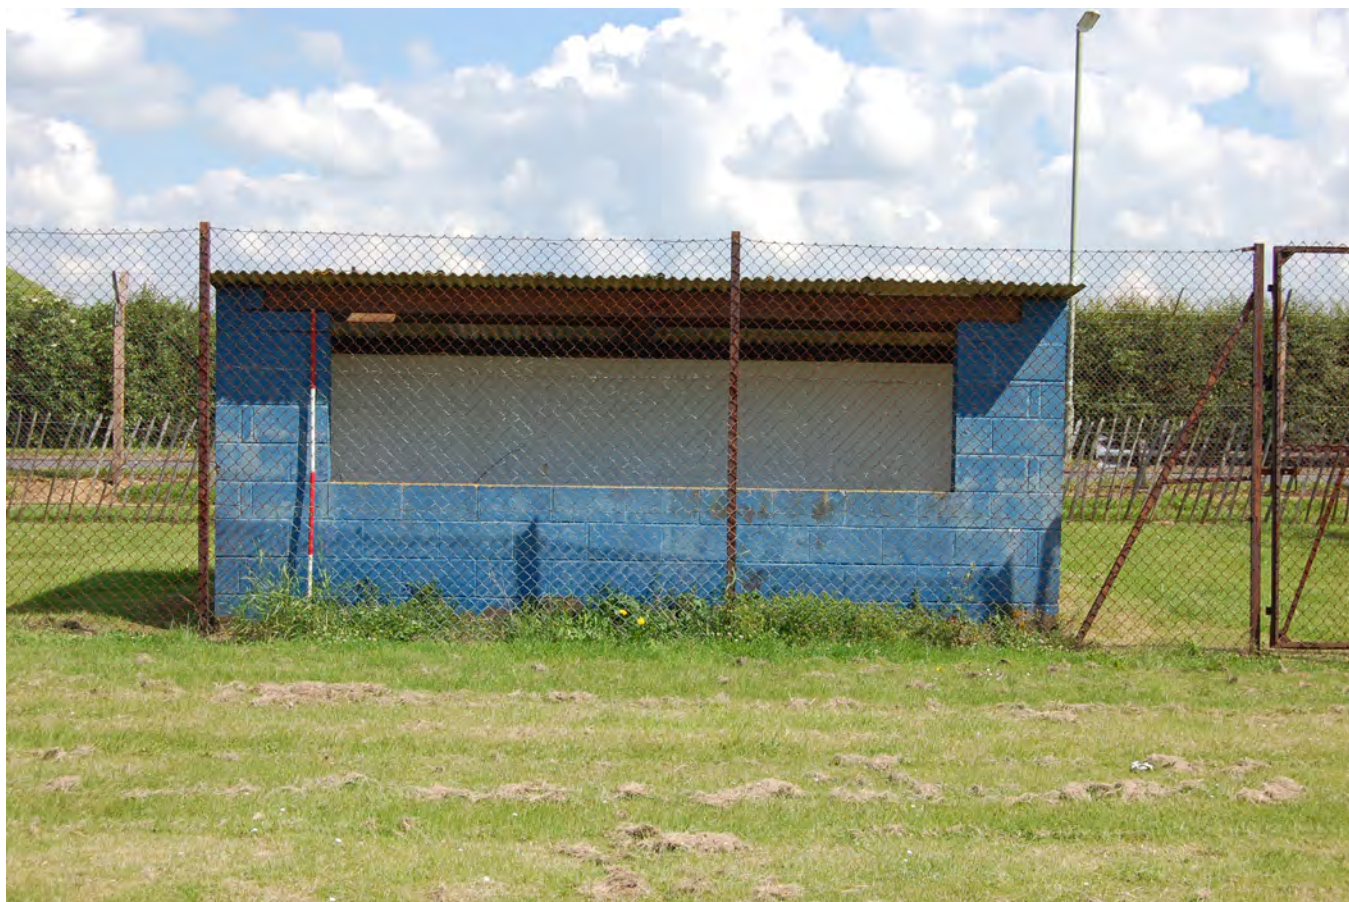
Plate 577.1 Dugout

This is a very simple structure constructed from concrete block walls and with a single pitch roof clad in corrugated sheeting and supported by metal rafters. The dugout has a rectangular plan (c.6 m x 3 m), a doorway in one end and a long window facing the pitch. The window is open but the structure is immediately behind a protective wire mesh (chicken wire) fence. There is a bench inside the dugout for the players waiting to bat.

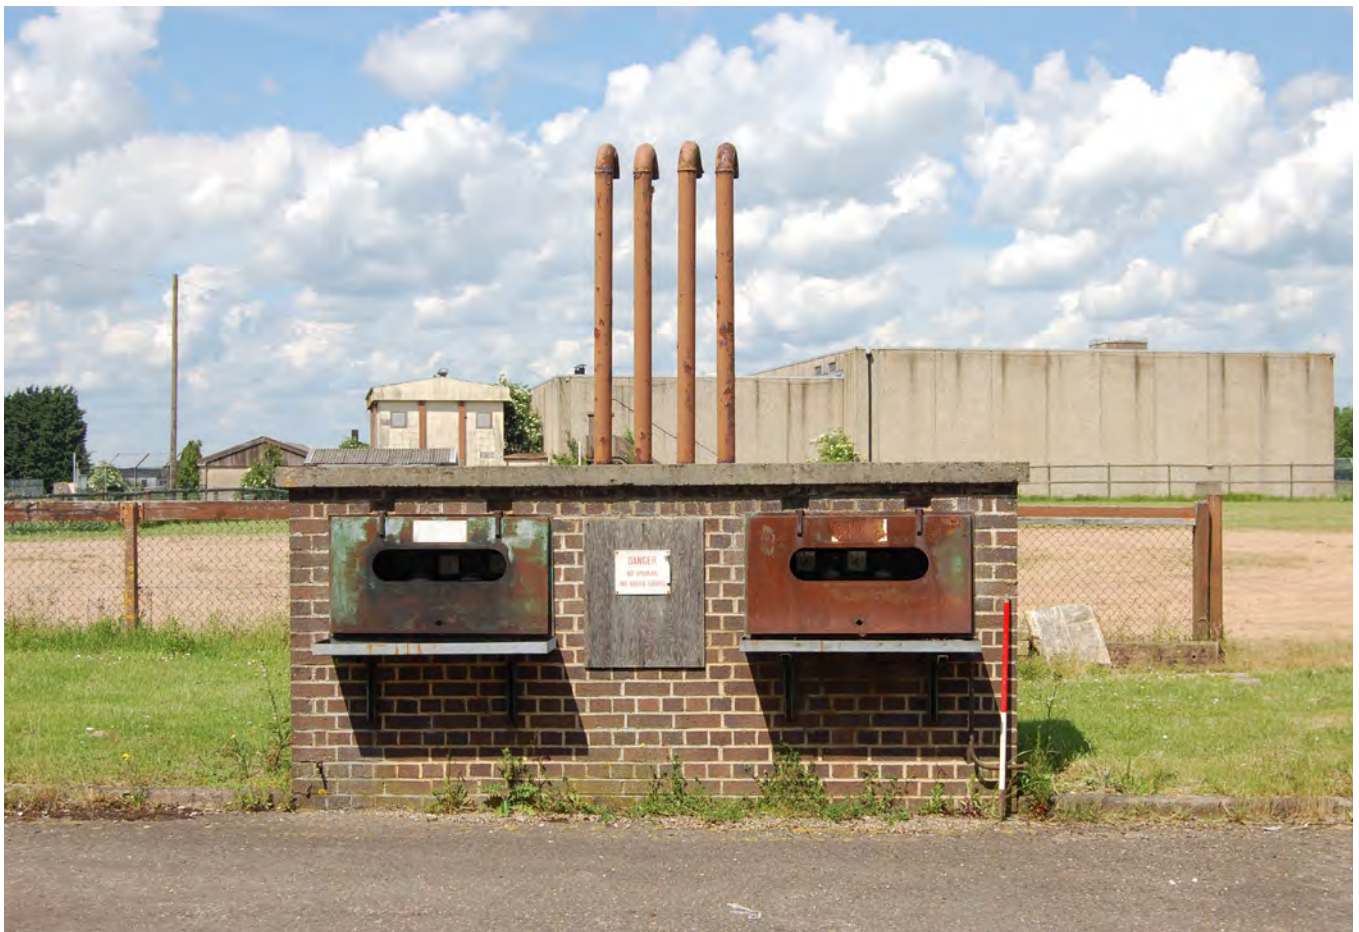
Plate 578.1 Front elevation

This oil inlet is a small brick construction (1.8m high) with a flat concrete covering and four pipes extending from the top (Plate 578.1). Dials and a tap are evident on the front elevation. Openings for below-ground storage tanks are visible to the front of the floor inlet.

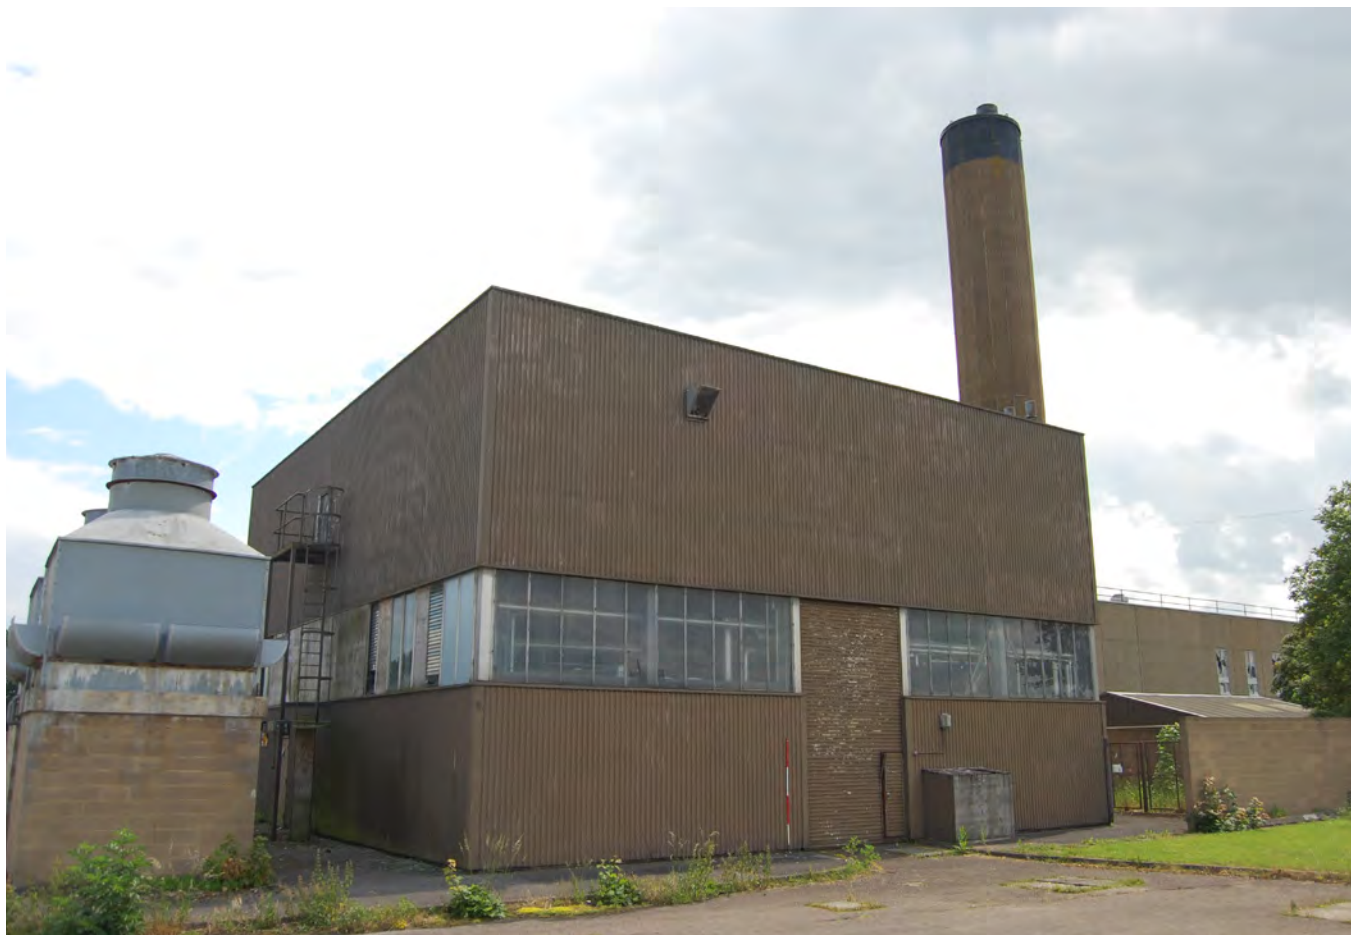
Plate 579.1 Front elevation

Building 579 is rectangular in plan, of steel frame construction with a flat asphalt roof and faced in corrugated metal sheeting (Plates 579.1 and 579.2). The building is c.8m in height with a band of basic metal vertical windows situated at roughly a third of the height of the building. Some windows have plain glass openings, others have glass shutters, and some are boarded up.

The west elevation is metal clad with a metal roller door and windows extending the width of the building. Internally, it is possible to see machinery and plant equipment, although in deteriorating condition.

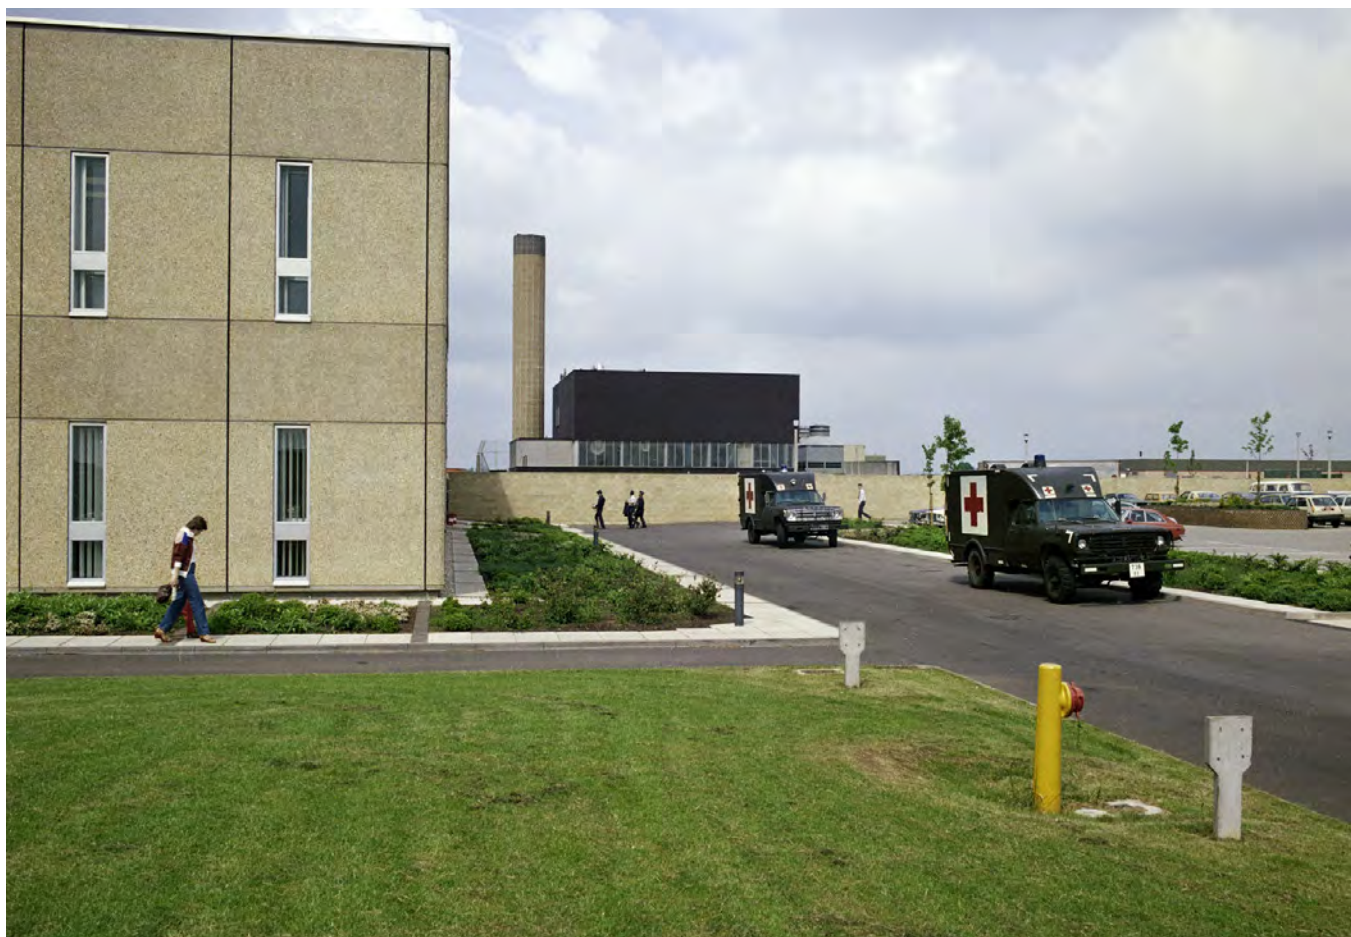
Plate 579.2 Contemporary image of building 579 (EH archive ref.-p_g25408_022a)

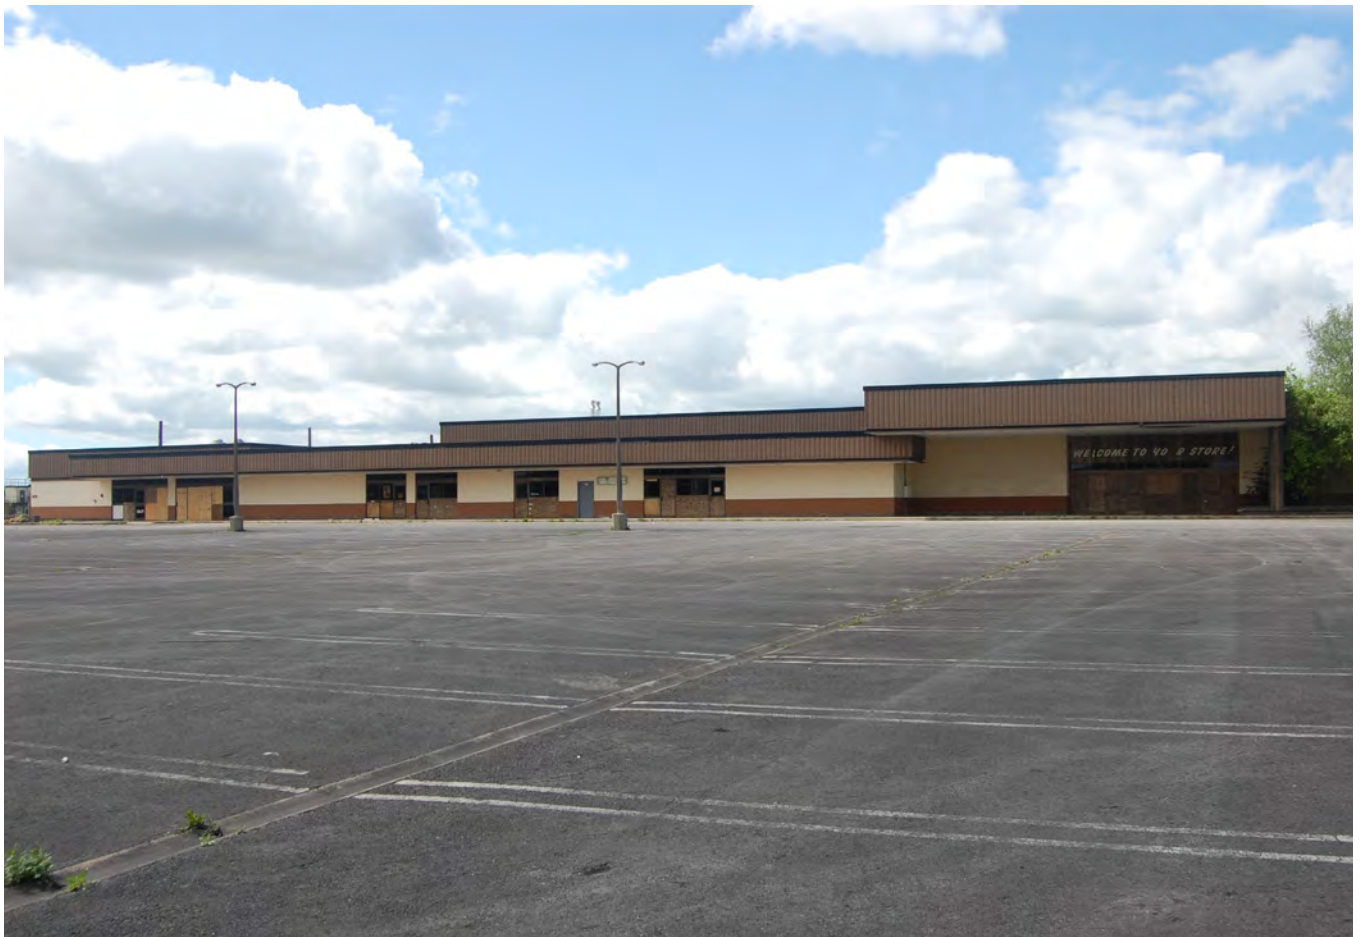
Plate 581.1 Front elevation

At the front elevation is the main customer entrance to the supermarket with 'Welcome to Your Store' written across the doors (Plate 581.1). The fascia extends from the front of the elevation providing a covered entrance to the supermarket and shops. At the north end, the elevation is stepped back, stepping forward again to meet a garden bed immediately to the north of the entrance door. To the south of the supermarket entrance door are a series of smaller shops: 'Elite Beauty', a barbers shop, 'Supreme Hardware', an insurers and a canteen. These are all accessed from metal (brown) glass tinted doors with individual opening hours printed on the front, and metal framed glass tinted windows. This arrangement with smaller shops surrounding a large supermarket reflects 'little America' in rural Oxfordshire, and untypical of 1970s commercial architecture in Britain.

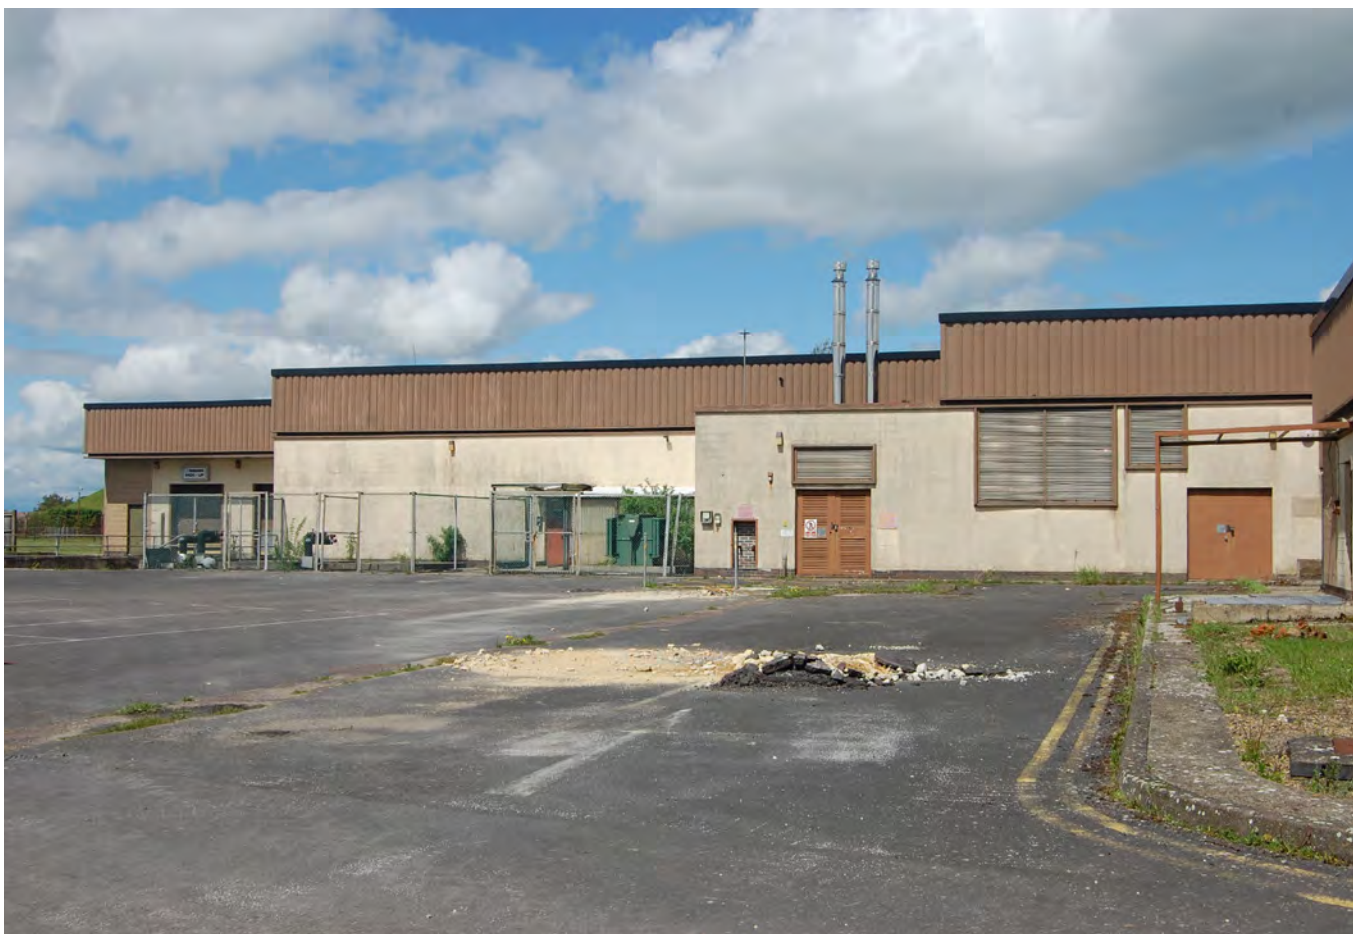
Plate 581.2 Rear elevations

At the east end of the south elevation there is a short brick and breeze block wall running along this short section of side elevation (which also has metal framed windows and doors), before the block work substantially steps in to the rear service area (Plate 581.2). The south elevation contains plant and provides the entrance point for goods, there is also a (much smaller) car park to the front. In the area to the east there are four double timber doors and large vents for plant, a sign states: 'No Parking Access to the Boiler House and Underground Fuel Tanks/ Keep Clear At All Times' and 'Fuel Tanker Off Loading Area/ No Parking/ Danger'. An area is surrounded by a metal fence within which are two below-ground fuel tanks and a green transformer. Further to the west, a single door provides access for employees and there is a 'Fire Exit' located next to a covered area for smokers. At the west end of the elevation is the goods entrance which has double roller doors and a metal loading platform. Here, the floor level slopes down to facilitate the unloading of goods, and steps lead up to a single timber doors providing access from this lower area. To the west is a further roller door with a sign stating: 'Merchandise Pick Up', and at the very west of the elevation is a single timber door painted green.

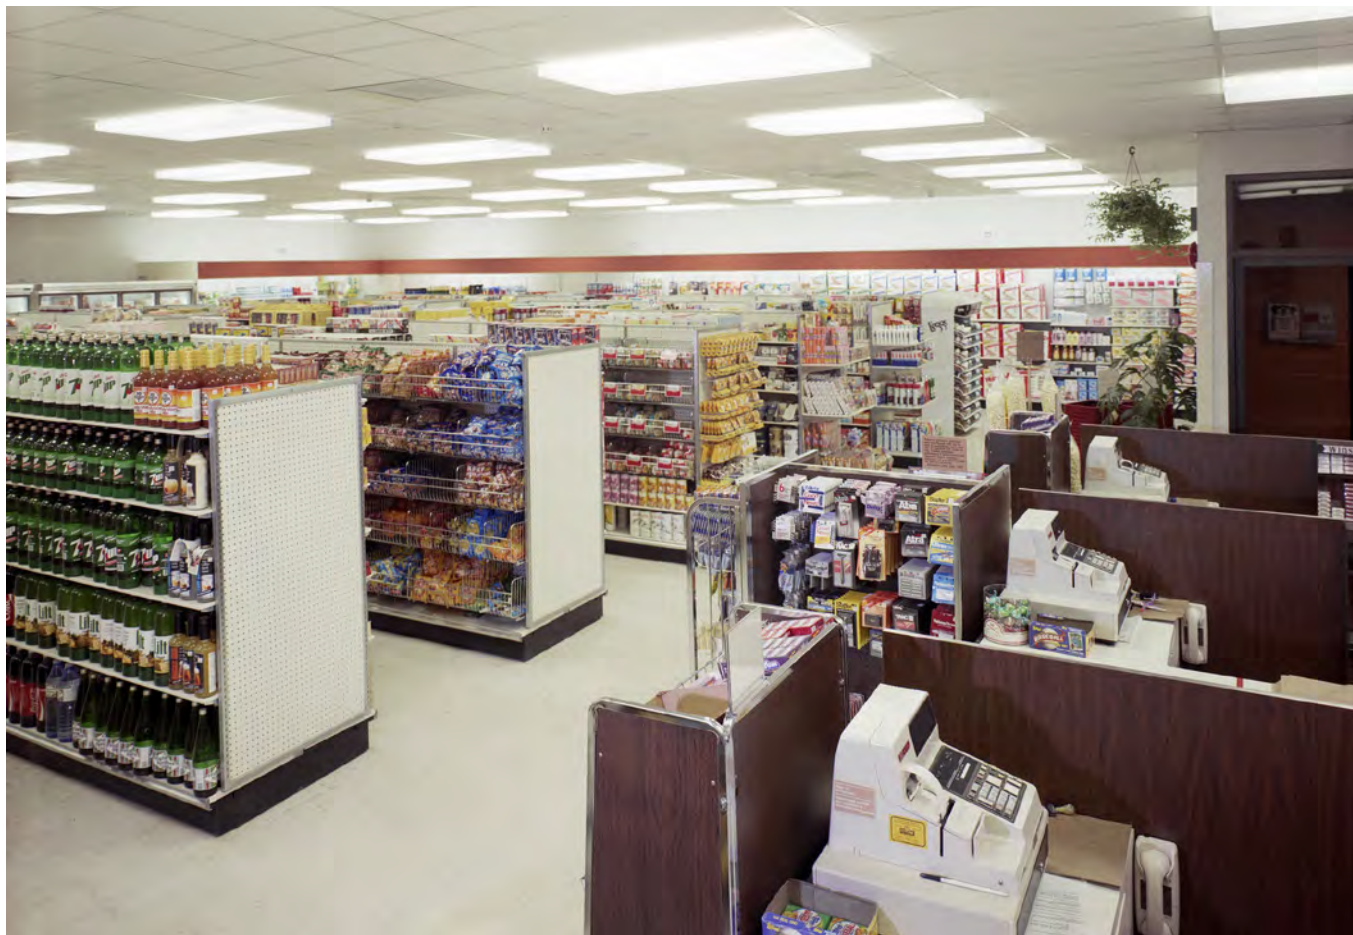
Internally, the supermarket space is largely empty and fixtures and fittings relating to the supermarket have been removed (Plate 581.3). There is a suspended ceiling supported in places by pilasters in the main shopping area, and to the rear some plant can be seen including overhead ventilation ducts.

Plate 581.3 Contemporary internal view (HE archive ref.-p_g25408_022a)

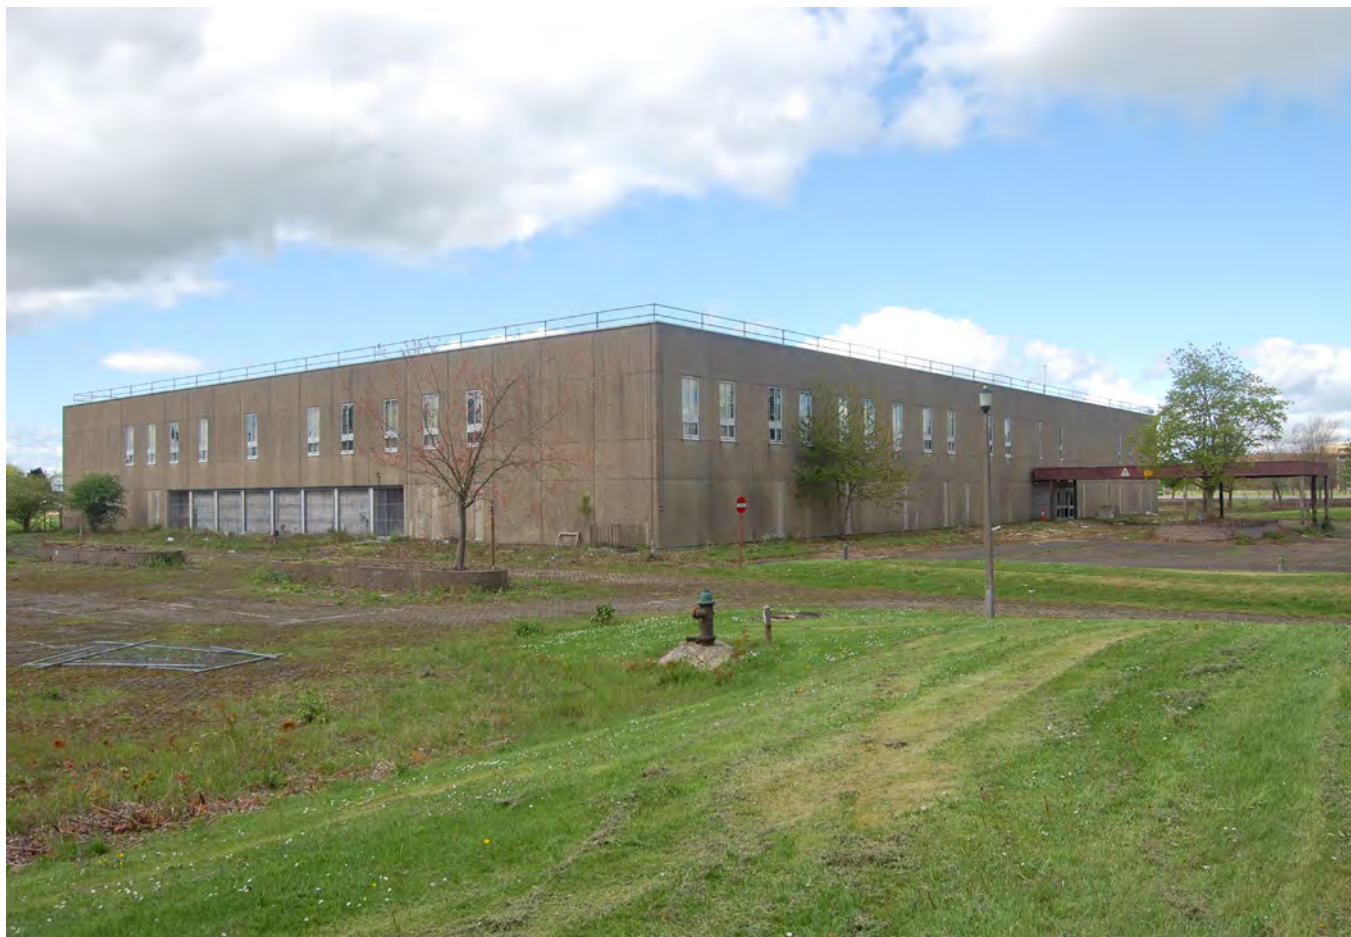
Plate 582.1 Front and west elevations

The south (front) elevation has a substantial front entrance with a long 'L' shaped canopy extending into the car parking area, which is supported on 2 sets of 3 steel posts at the front, and a timber post to either side of the metal and glass sliding entrance doors (Plate 582.1). It is of steel frame construction with lighting incorporated within the roof. At first floor level the windows have been infilled, but there are several single or double rectangular windows along the first floor (6 single in the east half, and 11 double in the west half). To the south of the entrance is a small spiral stair in metal and concrete which provides access to the basement.

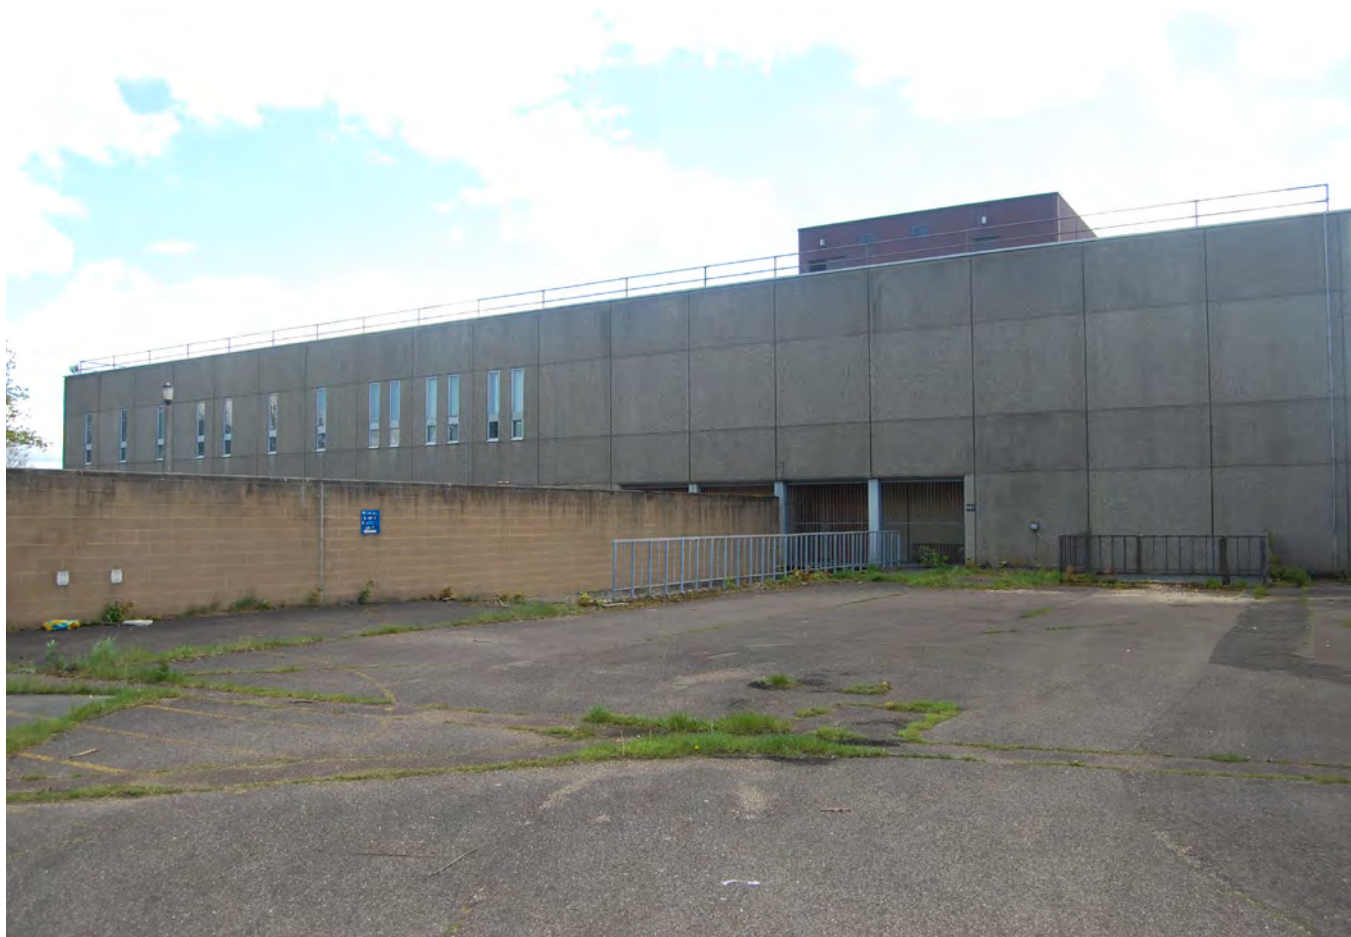
Plate 582.2 East elevation

The east elevation has a set of concrete steps leading down to a basement area (which is flooded). Immediately to the south of these is a loading bay which has an incline extending down to the entrance, that has a metal grill to the front to prevent access (Plate 582.2). This area is separated from the remaining hospital by a breeze block wall which extends to the east from the elevation. Further to the south is another boarded up area which formerly served as the 'Dental Clinic'. There 2 infilled single windows between the loading area and the dental clinic, and a further 10 windows to the south of this at ground floor level. At first floor level are 13 single windows with the glass intact.

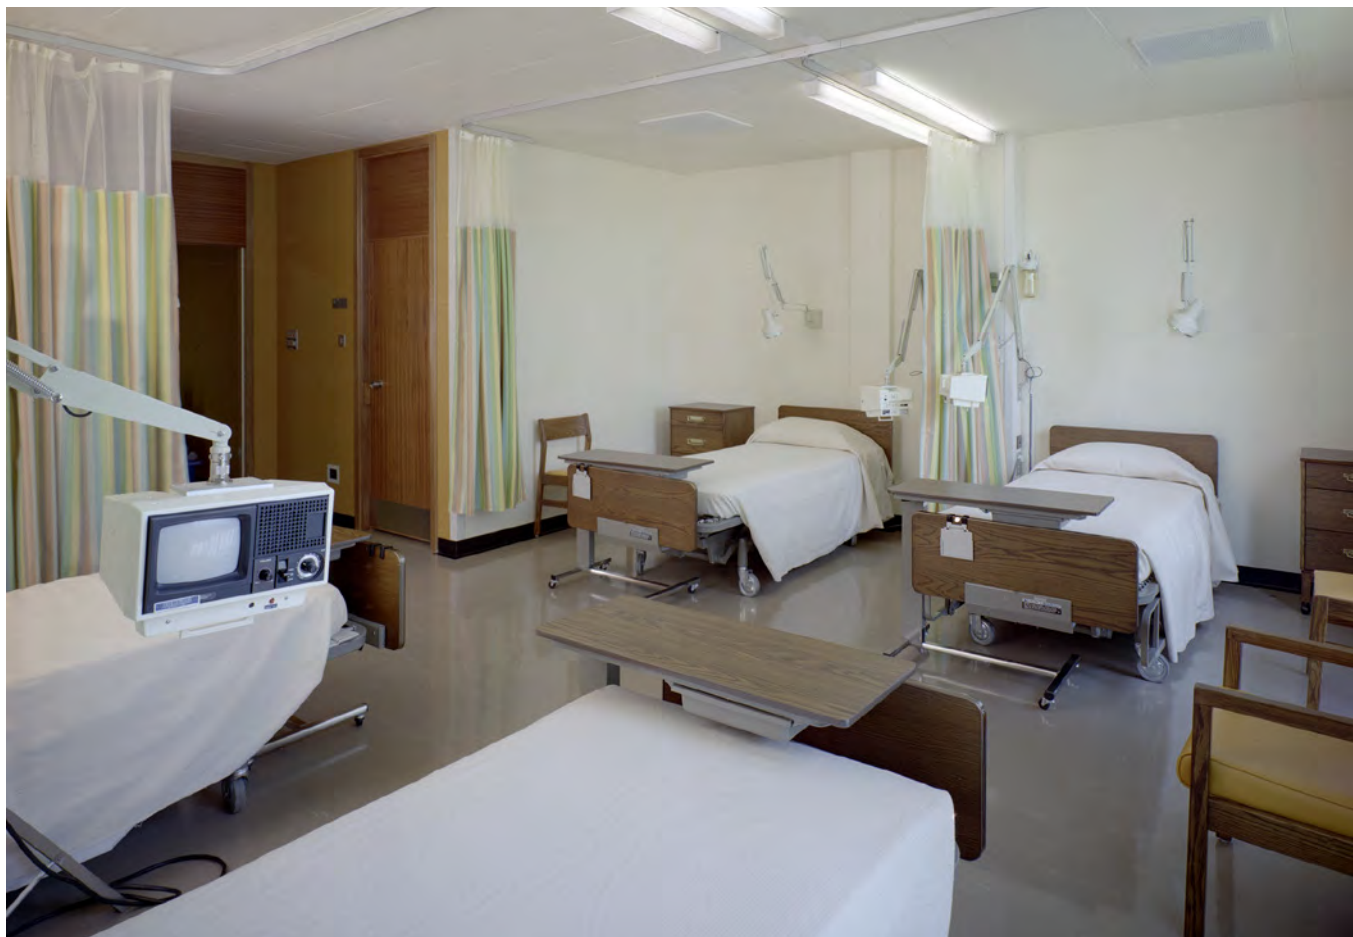
The level of asbestos in the building prevented internal access, contemporary images of the building however illustrate its layout (Plate 582.3)

Plate 582.3 Contemporary internal view (HE archive ref.-p_g25408_022a)

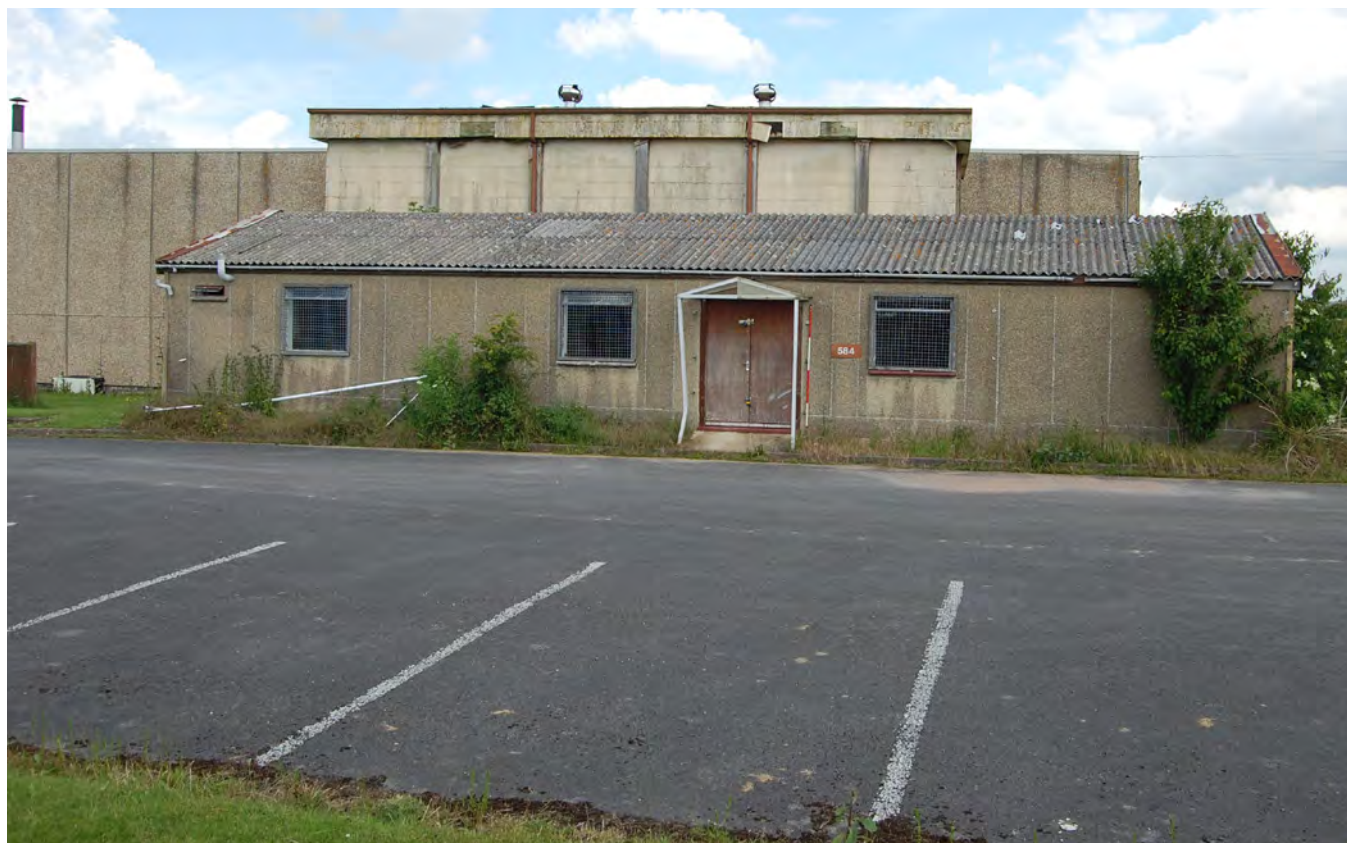
Plate 584.1 West elevation

The functional structure has little architectural embellishment, it is constructed in pebble dashed concrete panels set on a concrete base with a pitched possibly corrugated asbestos roof (Plate 584.1). It is single storey and rectangular in plan with roughly square timber framed windows.

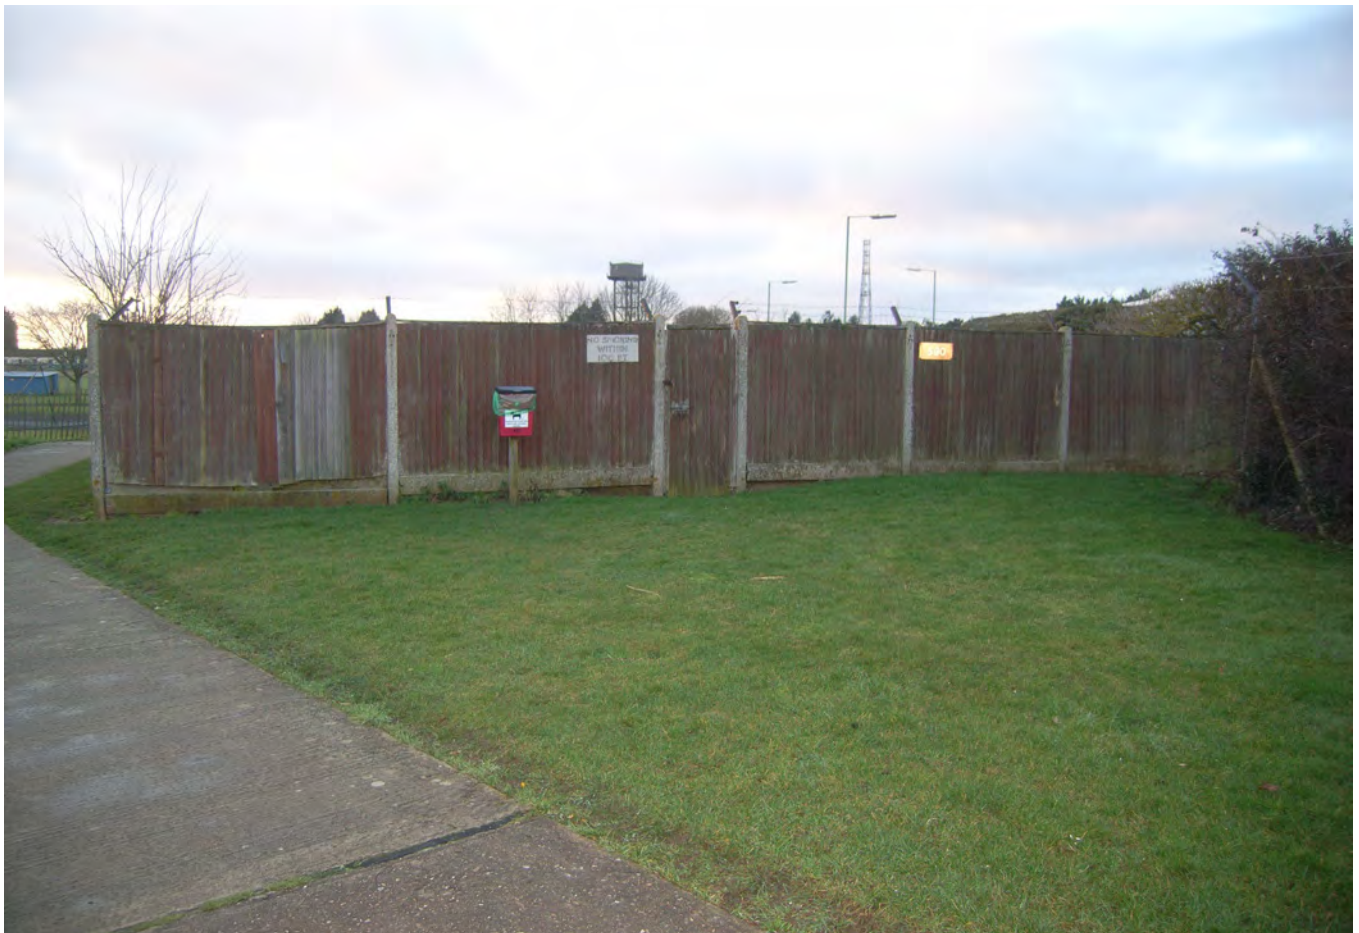
Plate 590.1 East elevation

The sewage pit is roughly rectangular in plan and surrounded by wood fence panels (1.8m high) (Plate 590.1). These are supported on concrete posts and panels at the base with barb wire running along the top of the timber panels. Access is via a single timber door in the east elevation which is padlocked. Internal views are limited, but through the panels it is possible to see the brickwork of the sewage pits which are sunk into the ground.
