FORMER RAF UPPER HEYFORD, OXFORDSHIRE

HISTORIC BUILDING RECORDING AND INVESTIGATION

VOLUME 2: GAZETEER OF RECORDED STRUCTURES

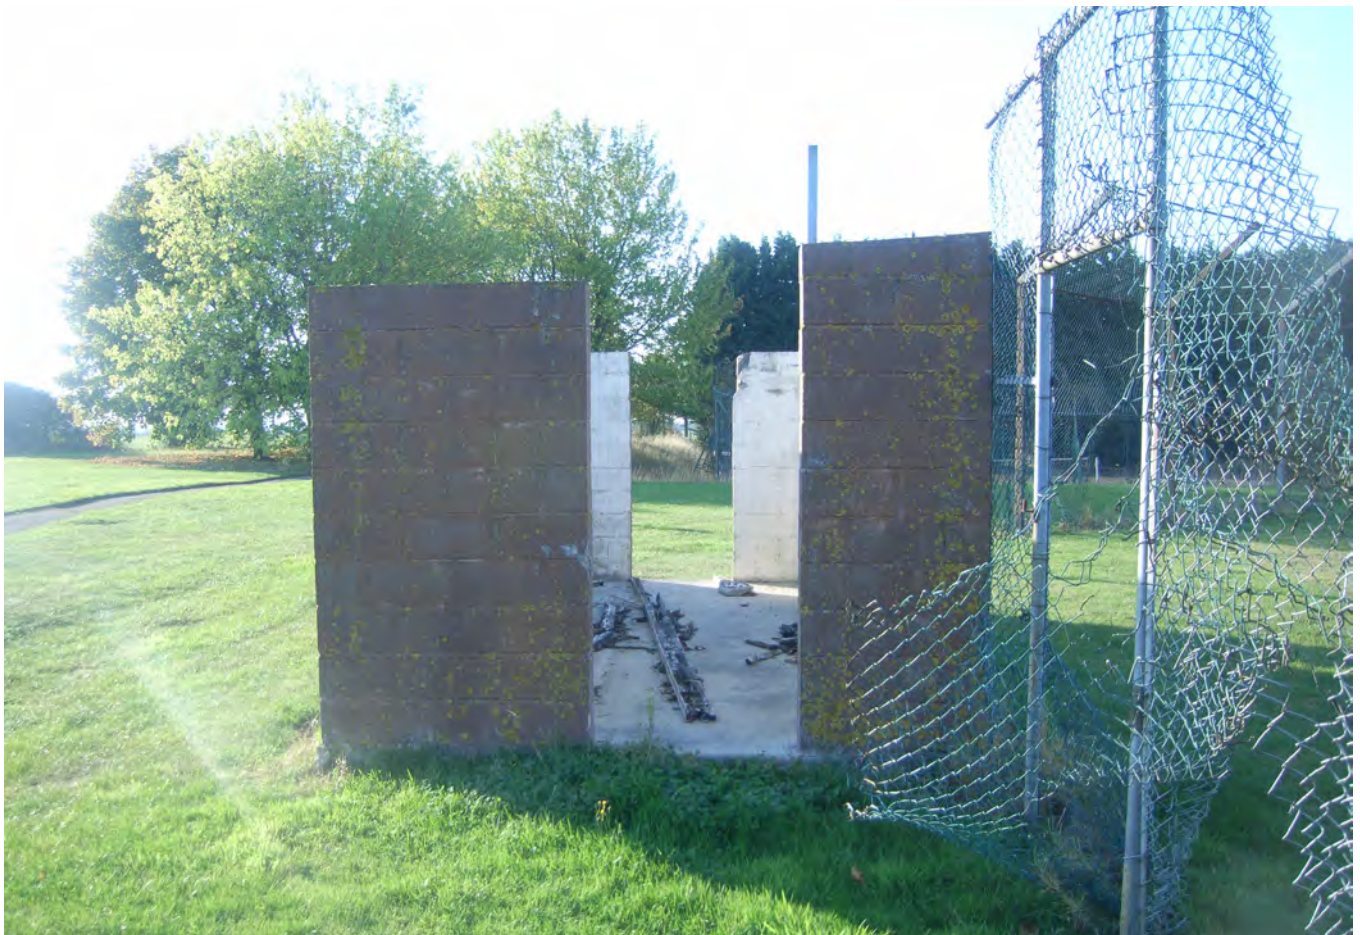
Plate 595.1 East elevation

The baseball dugout is a rectangular in plan, constructed from breeze blocks which formerly had a metal monopitch roof but is no longer *in situ* (Plate 595.1). The simple structure would have had an internal bench for players which is also no longer extant. The north elevation faces onto the pitch and has a large opening to view the game, this formerly would have held a timber frame and mesh wiring over the opening (as evident on building 599). The rear elevation has no features of interest and the two side elevations have openings but without doors.

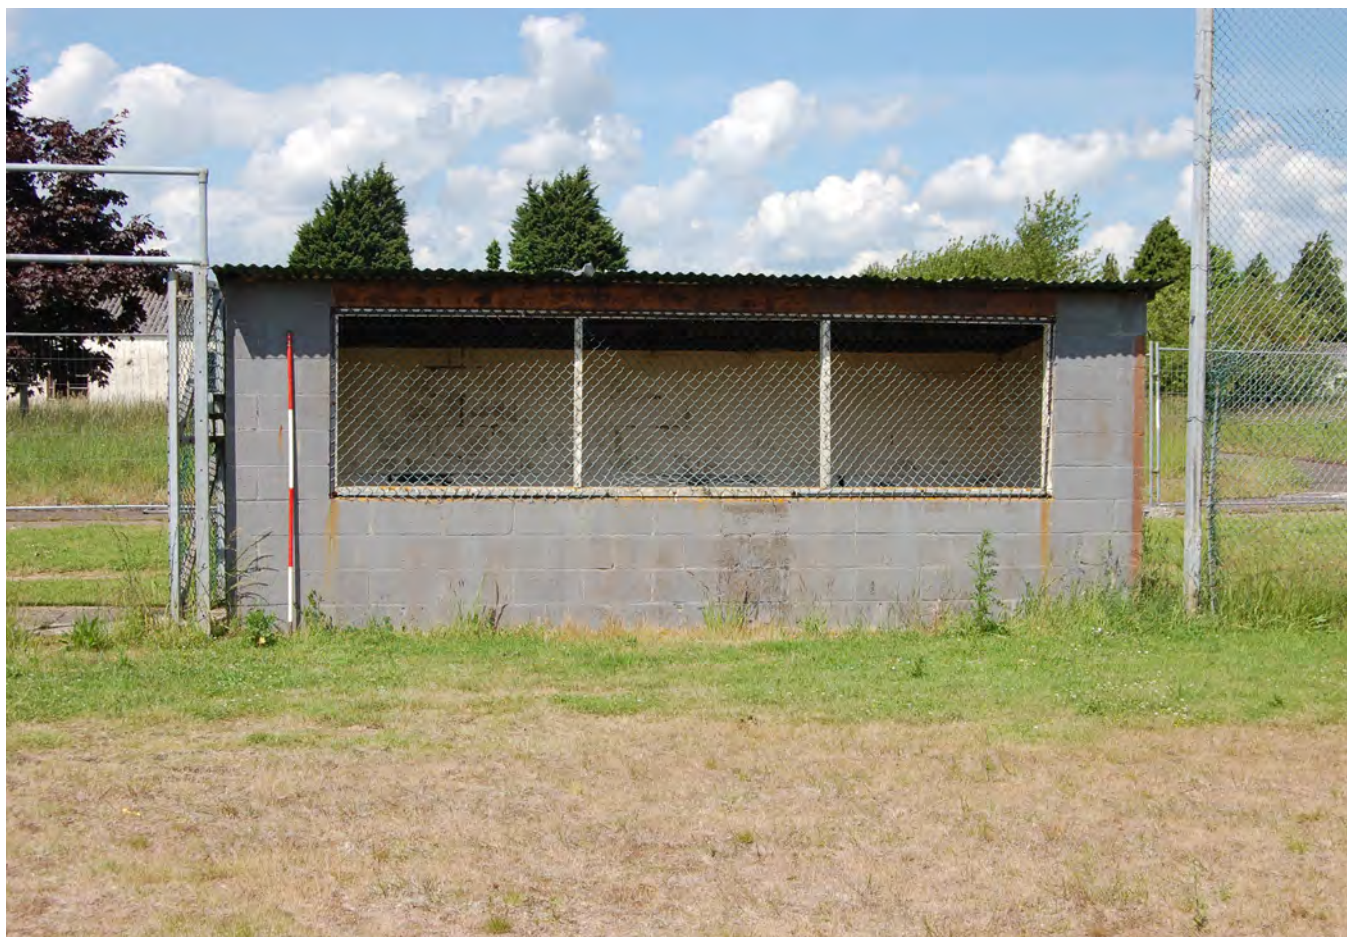
Plate 599.1 South elevation

The baseball dugout is a rectangular in plan, constructed from breeze blocks with a metal monopitch roof. The south elevation faces onto the pitch and has a large opening to view the game, this has a timber frame and mesh wiring over the opening to stop players being hit by the ball (Plate 599.1). The fence surrounding the pitch is attached to the south elevation at each side of the window. The west elevation has an opening in the block work (without a frame) to provide access, the north and east elevations have no features on interest consisting of blockwork only. The simple structure has an internal bench (painted cream) for players along the rear wall and a concrete floor.

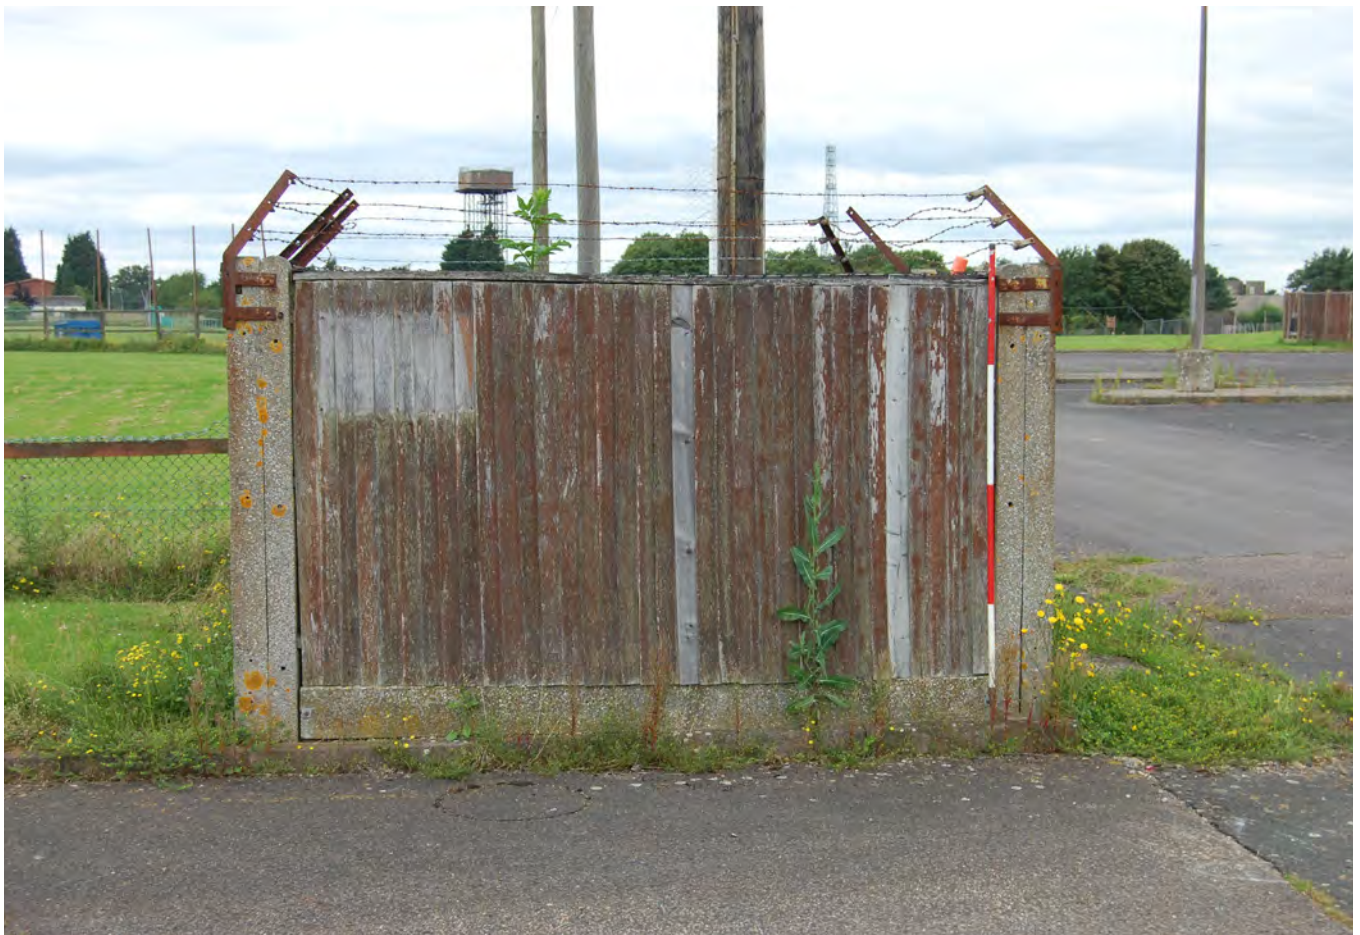
Plate UH3.1 East elevation

The substation is roughly rectangular in plan, surrounded by a timber fence (c. 1.8m high) which is supported on concrete posts and topped with a barbed wire fence (Plate UH3.1). A sign on the south elevation states '*Distribution Sub-substation*'.

The interior space is much overgrown with foliage, but it is possible to see metal equipment on a concrete platform. A sign states: '*Customers Intake Heyford*'.

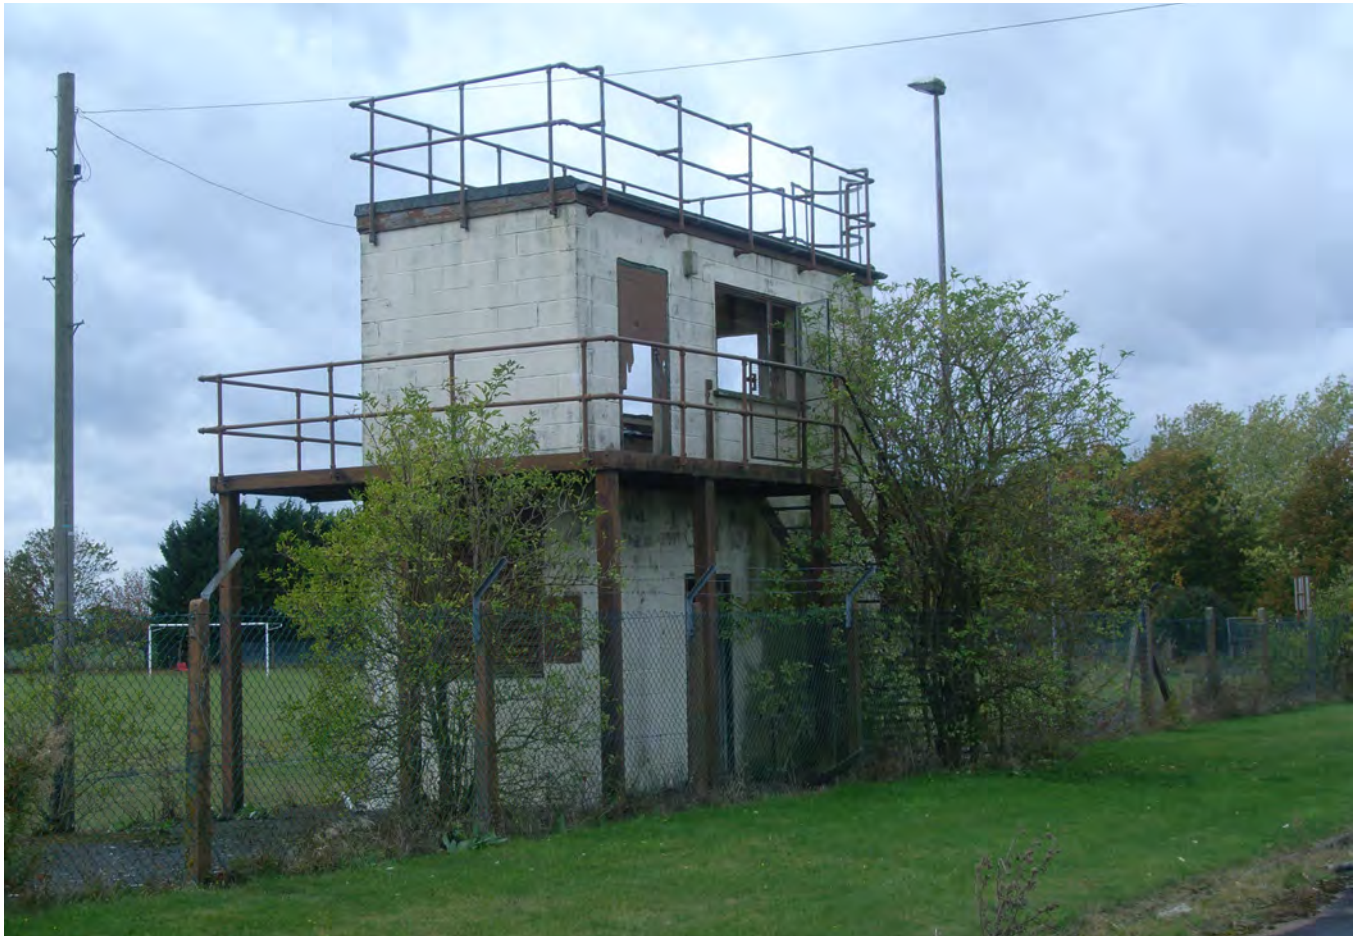
Plate UH5.1 North-west elevation

The viewing platform is two storeys high (4.8m) with a flat asphalt roof that has a viewing gantry. It is constructed from blockwork with simple metal windows, and an external viewing platform at first floor level (Plate UH5.1)

The north elevation faces out to the pitch with viewing provided from the roof and first floor viewing platforms. It has two metal framed windows on the first floor although only one half of one window is extant. The viewing platform continues to the east elevation, and there is an opening at first floor level although the frame is no longer *in situ*. There is ladder access to the roof at the top of the elevation. At ground floor level is a window with a roller shutter, thought to be for serving drinks and snacks during the game.

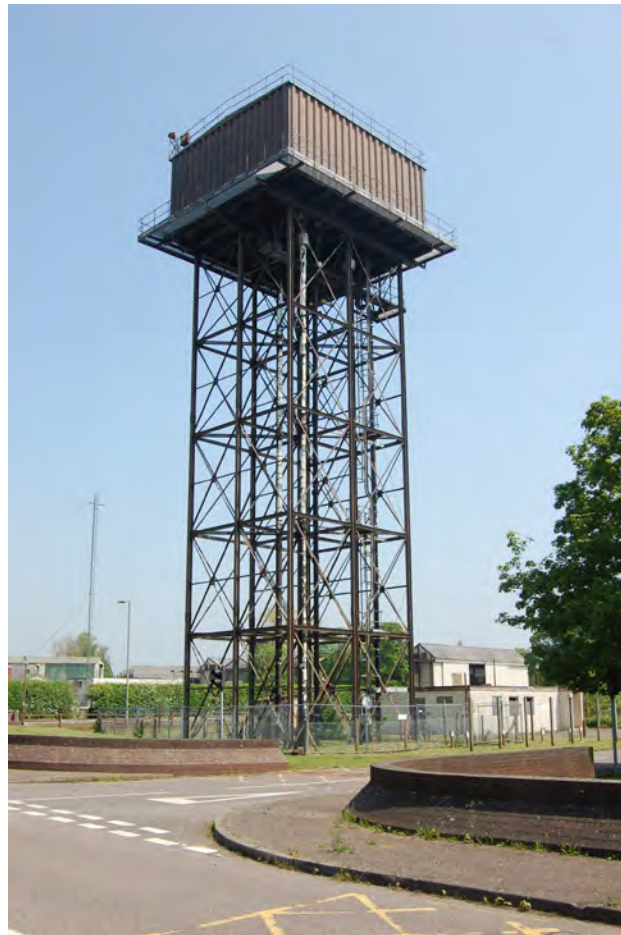
Plate 291.1 North-west elevation

The water tower is situated directly on Camp Road and has a very visible presence on the landscape, its functional design enhances the military character of the site (Plate 291.1 and Plate 291.2).

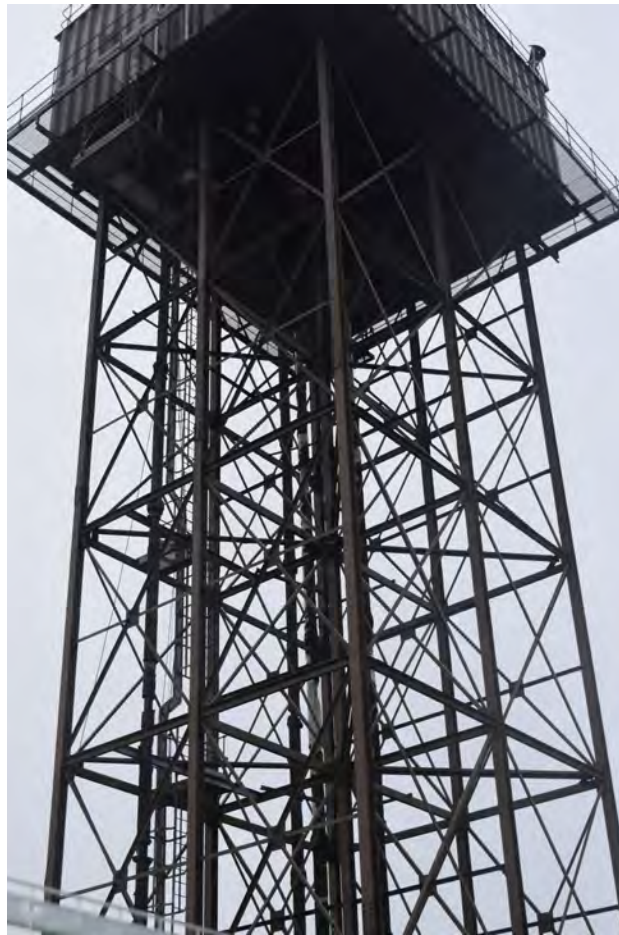
Plate 291.3 Metal frame supporting the water tank

The water tank is supported on a steel frame measuring c.25m in height, and surrounded by mesh security fence (Plate 291.3). It is painted olive-daub and roughly square in plan (Plate 291.4). The bolted frame is two bays by two bays, of five lifts with vertical and horizontal diagonal bracing (Plate 291.5).

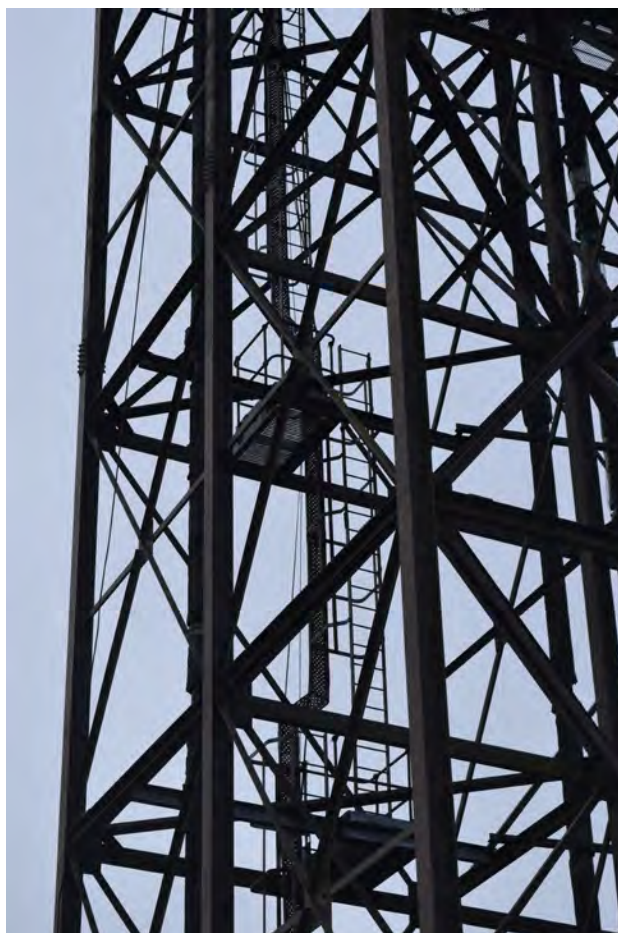
Plate 291.6 Metal tower extending the height of the tower

A ladder extends the height of the tower providing access to the large square tank at the top (Plate 291.6). The steps run up the south elevation, meeting a platform just below the height of the tank, and then projecting to the east meeting a platform with railings situated at the base of the tank (Plate 291.7). From here, the steps extend up the east face of the tank providing access to the top, where there are further railings surrounding the top perimeter.

There is a set of stairs running up the west face of the structure, which are enclosed by metal hoops, with additional wire around them at the base only (for safety) (see Plate 291.6). There are two platforms along the stairs before meeting a platform just below the tank. This extends from the west to the east face with metal railings running either side of it for safety. A short set of the same stairs runs between the platform just below the tank to the base of the tank. Various metal water pipes extend from the centre of the tank, with three extending down to the ground (Plate 291.9). One in the north-east corner has a section of pipe extending to the west, formerly there was further pipe extending from this which has since been removed. There are two water pipes which are in the north-west and north-east quarter of the supports, which have lagging on them and wire mesh around (Plate 291.10).

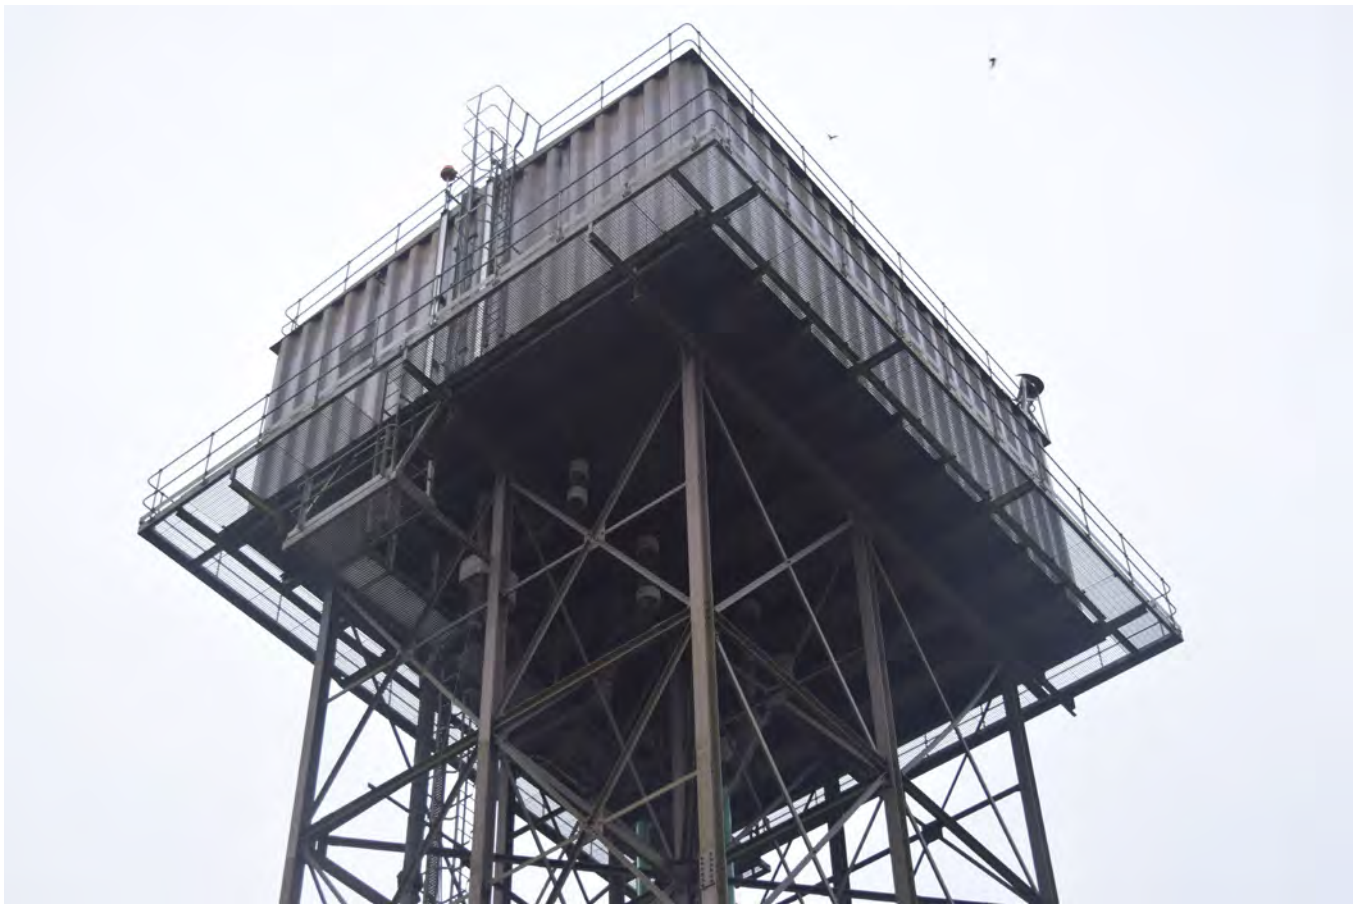
Plate 291.7 Platforms and ladders leading up to the water tank

The tank, which was replaced in 1987 and is built from corrugated pressed steel, sits on a platform of metal trusses running east to west, which provide the basis of support for the metal frame below (see Plate 291.7). These in turn are supported on three north to south RSJs, with long vertical posts extending from this platform to the ground. The vertical posts are arranged in a grid of 3 rows of 3 posts, the posts are constructed from three upright sections bolted together with metal plates and 16 bolts (2 metal plates per post). The posts are given additional support by diagonal and horizontal metal bars providing greater rigidity in this 25m high structure. Each of the 9 verticals sit on a concrete square pad measuring 74cm.

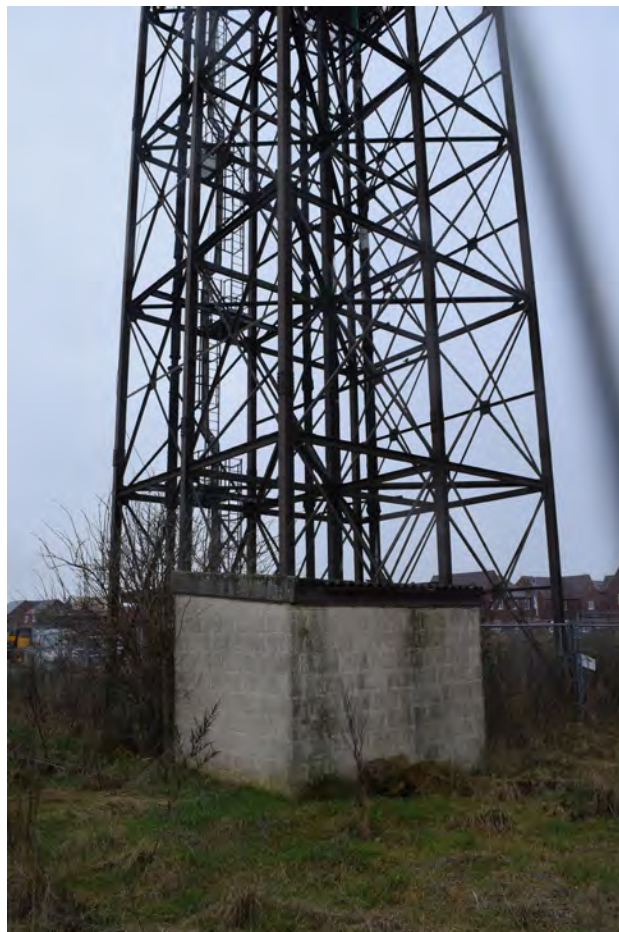
Plate 291.8 Blockwork shed associated with the tower

At the corner of the plot is a small blockwork shed with a monopitch, asphalt roof, this stands 2m high with double timber doors (painted brown) (Plate 291.8). This was constructed in 1989 to house the controls for thermal imaging equipment added to the top of the tower.

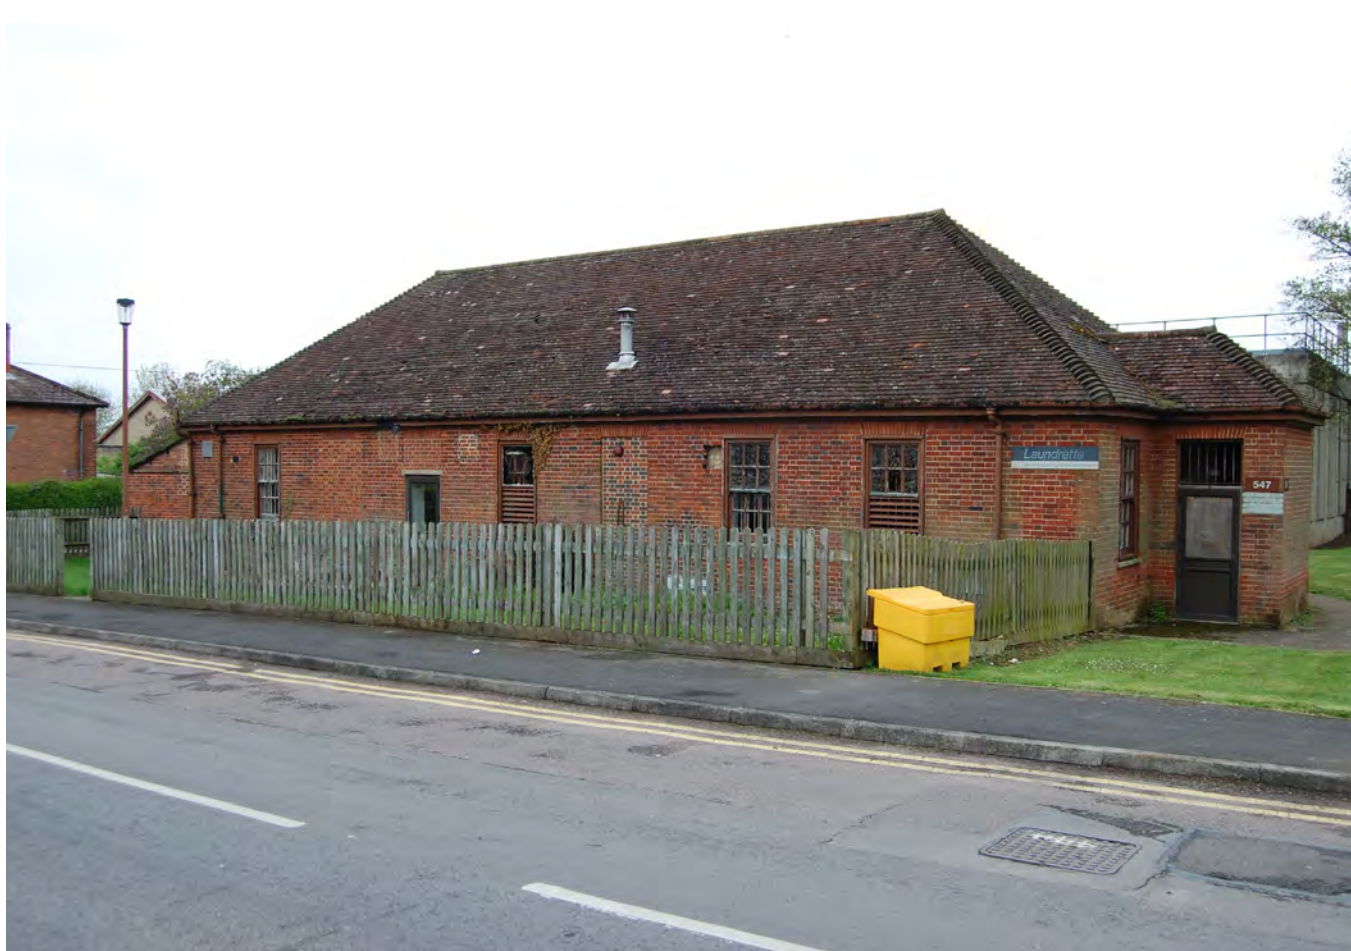
Plate 547.1 East elevation

The single-storey brick building has a plain-tiled hipped roof with bonnet hip tiles. The walls are in Flemish bond with adjustments such as closers and additional headers between windows where necessary (Plate 547.1).

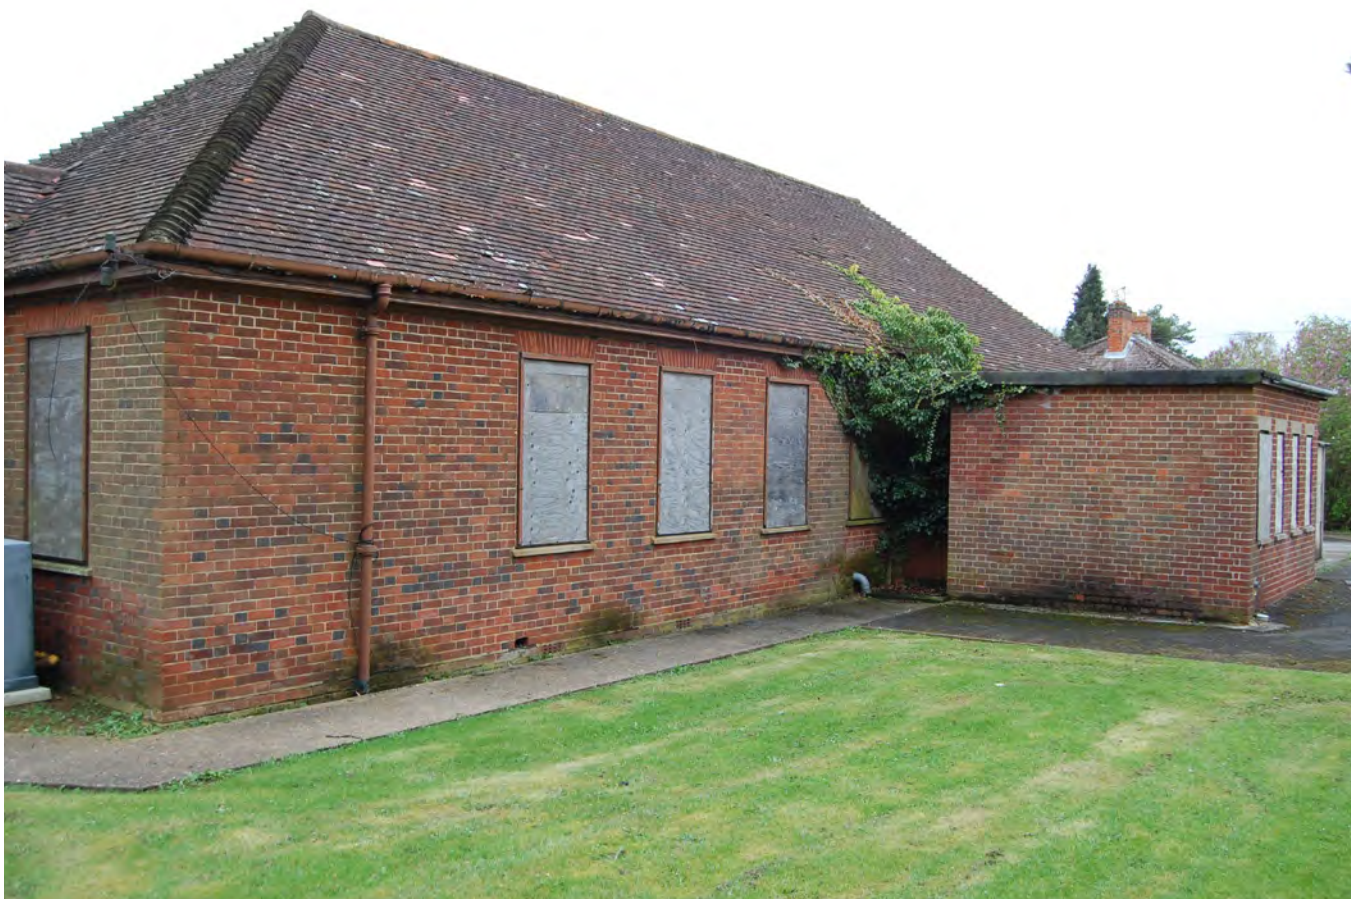
Plate 547.4 West elevation, northern end

A flat roofed brick extension is linked to the centre of the west elevation by a short corridor and currently contains men's and women's WCs (Plate 547.4).

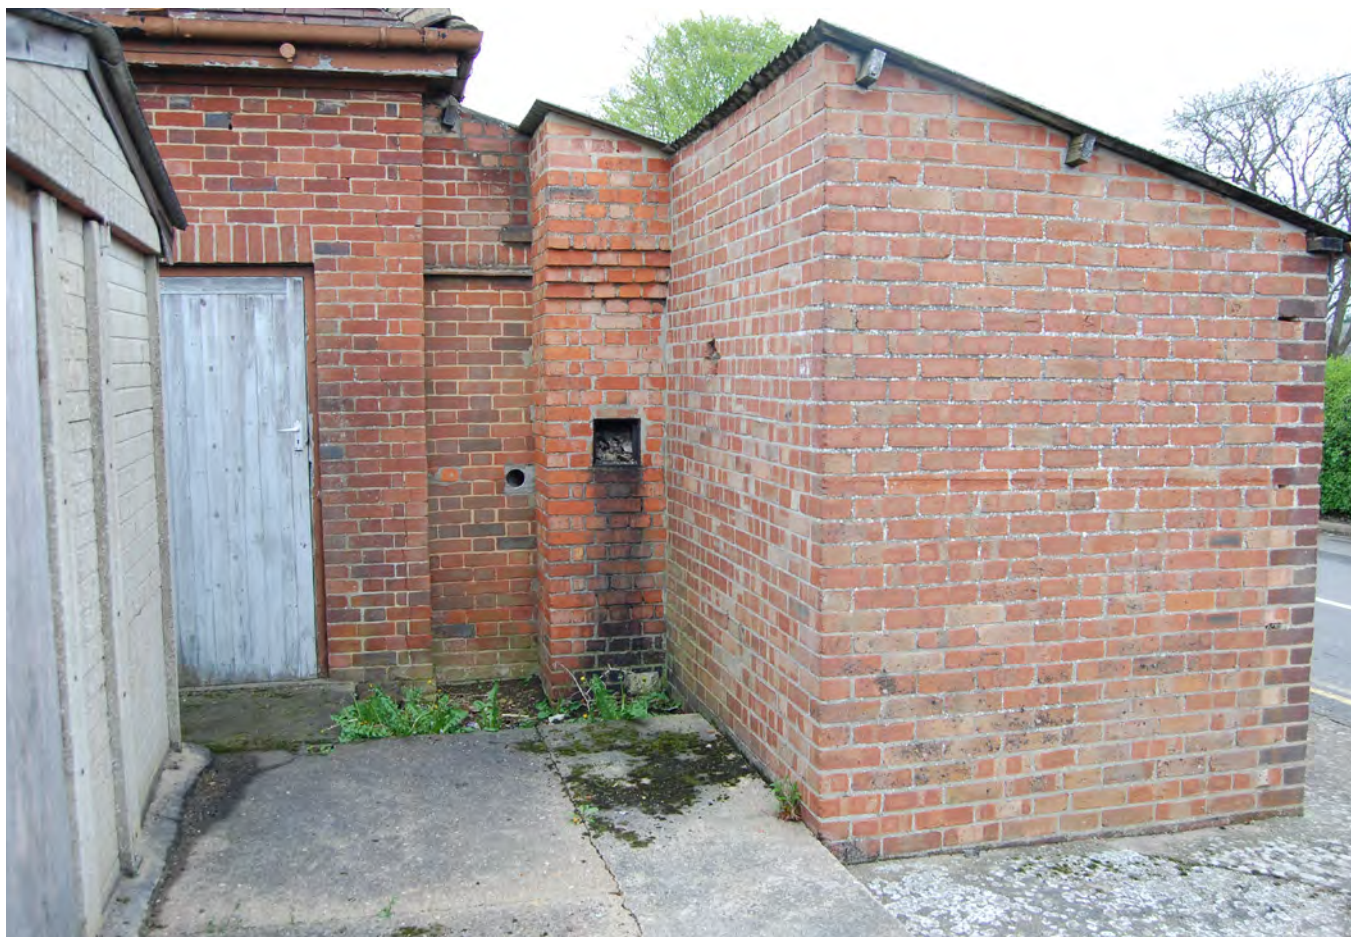
Plate 547.6 Former chimney serving the kitchen

A chimney with soot door abuts the two southern extensions, which previously served the cooking range noted on the plan (Plate 547.6).

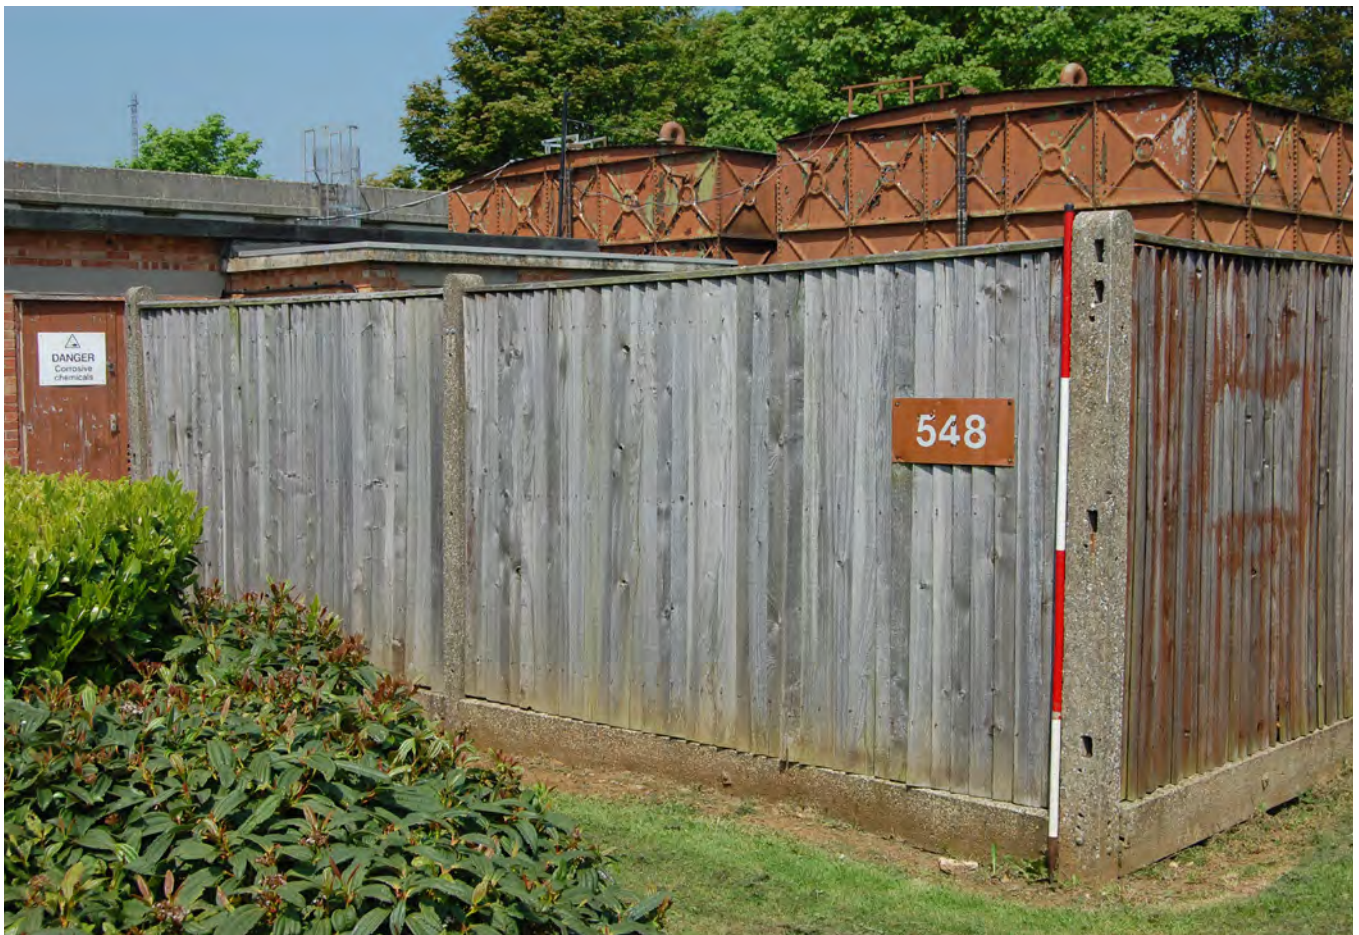
Plate 548.1 General view of sub-station

This is a simple open enclosure for the substation formed from vertical timber fence panels supported by concrete fence posts at the corners and mid spaced within each wall. The panels also have a concrete plinth. The enclosure is c.2 m tall and there are double doors to one side.

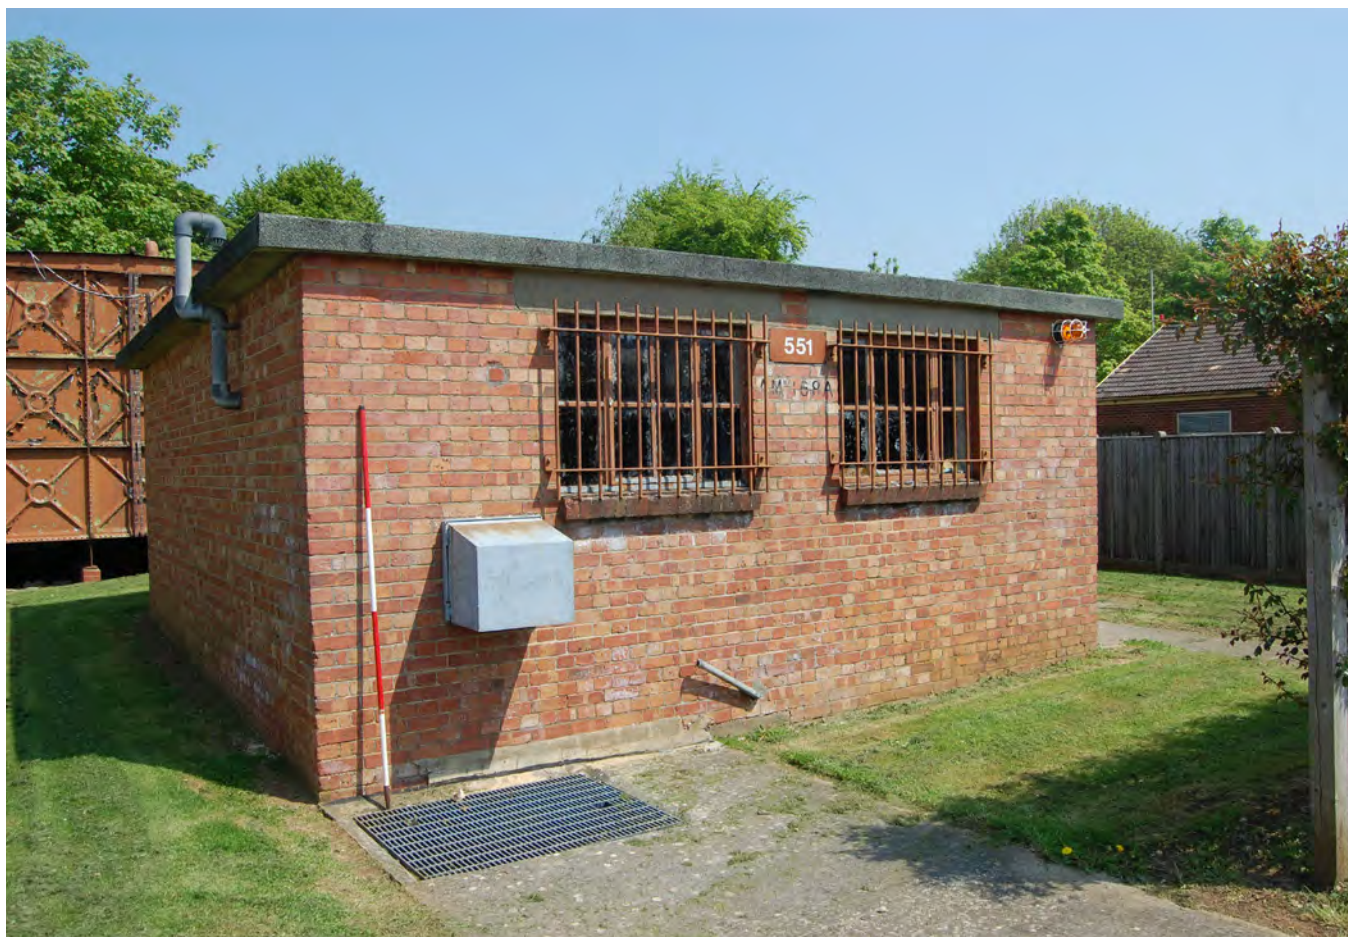
Plate 551.1 South side of Building 551

This is a single storey, rectangular plan building with a shallow, single-pitch roof clad in asphalt. The walls are constructed from orange/red brindle bricks. The north and south walls each have two metal windows with metal security bars while the east wall includes a door. The east wall is plain.

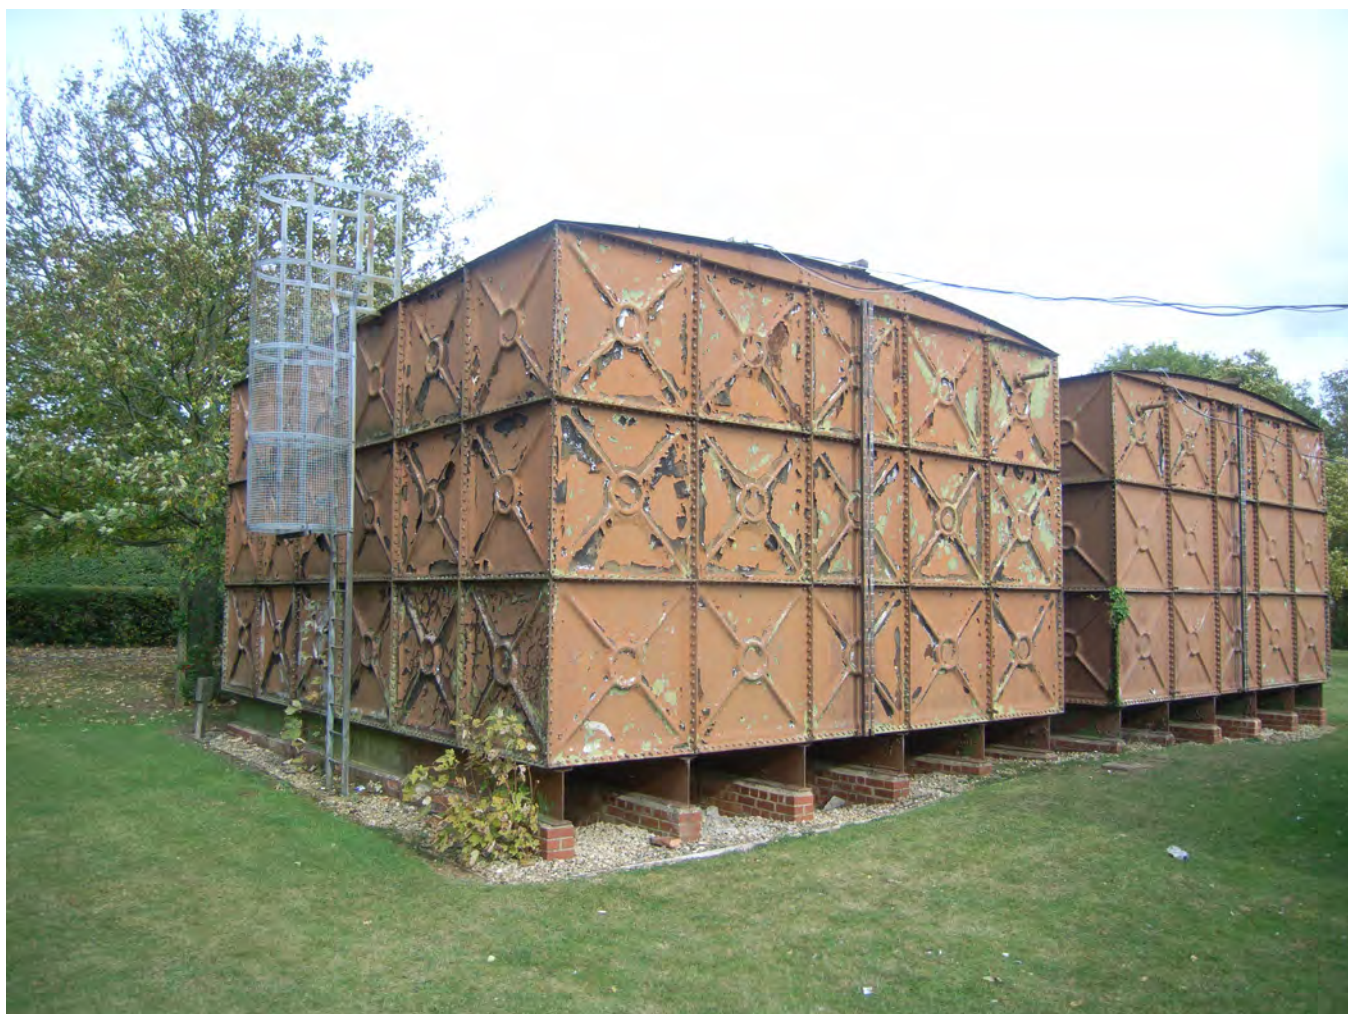
Plate 552.1 View of tank

Two square-plan water tanks formed from embossed metal panels bolted together and painted brown. Each wall of each tank is five panels wide and three panels tall (c.3.5 m tall). Each tank is set on six rolled steel joists which themselves are set on brick sleeper walls. Each tank has a slightly arched roof and a simple timber gauge to the side showing how full the tank is. A secondary aluminium ladder has been added to the side.

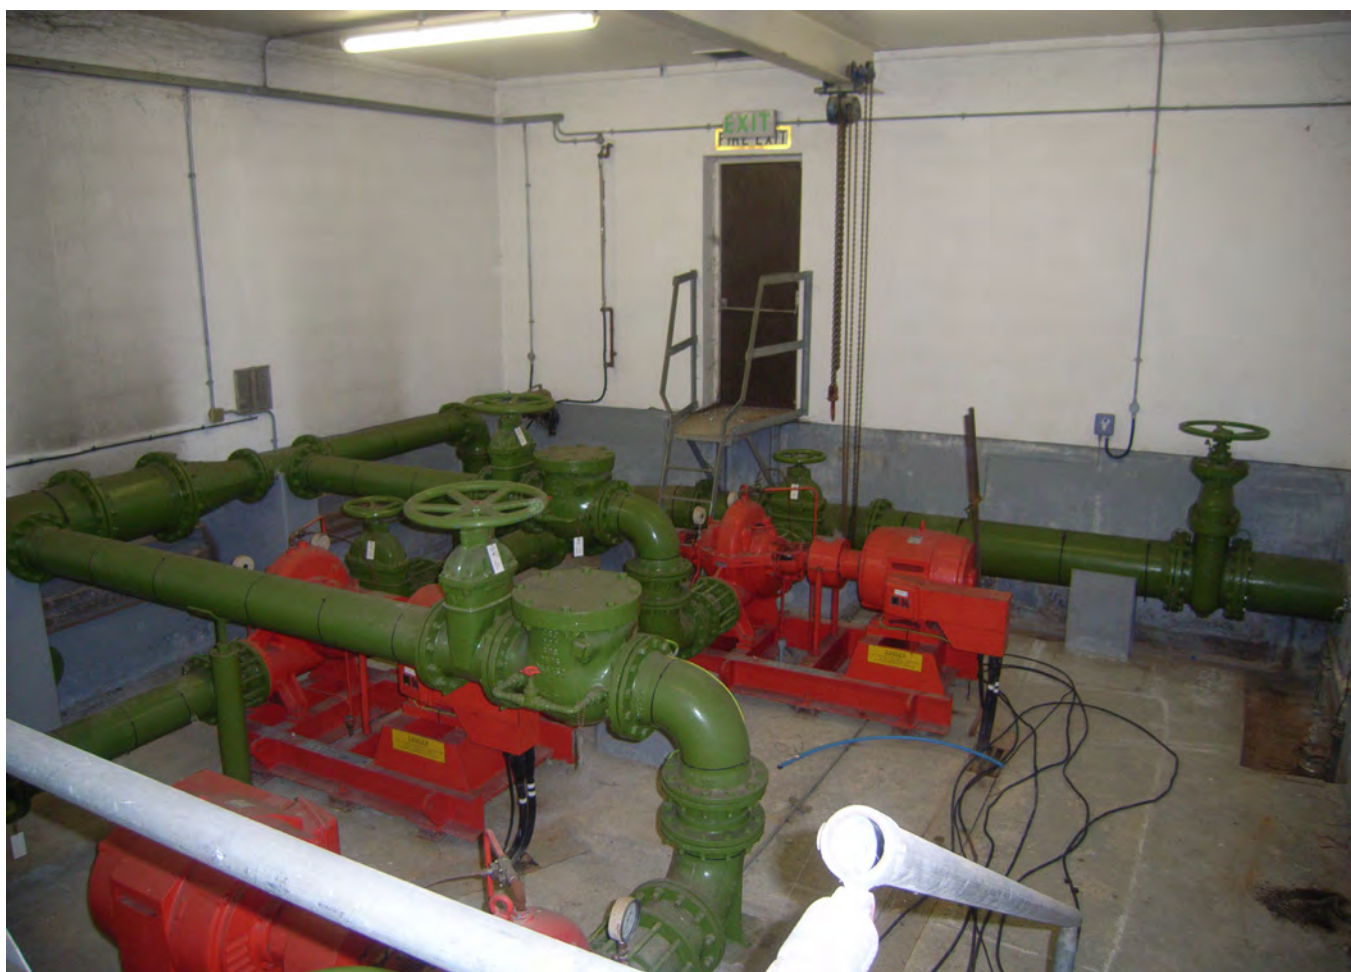
Plate 564.2 Interior

The pump house is a rectangular plan single storey building with a gabled roof clad in ridged concrete tiles. The walls are formed from stretcher bond orange/red brick and they are set on a concrete plinth. There is a single set of plain double doors in the west wall but the other walls are all relatively featureless other than a vent in the south wall. At the south end of the building there is a separate open enclosure formed from horizontal boards and this is to house a substation. The interior of 564 is open plan and retains various pumps and machinery on concrete bases.

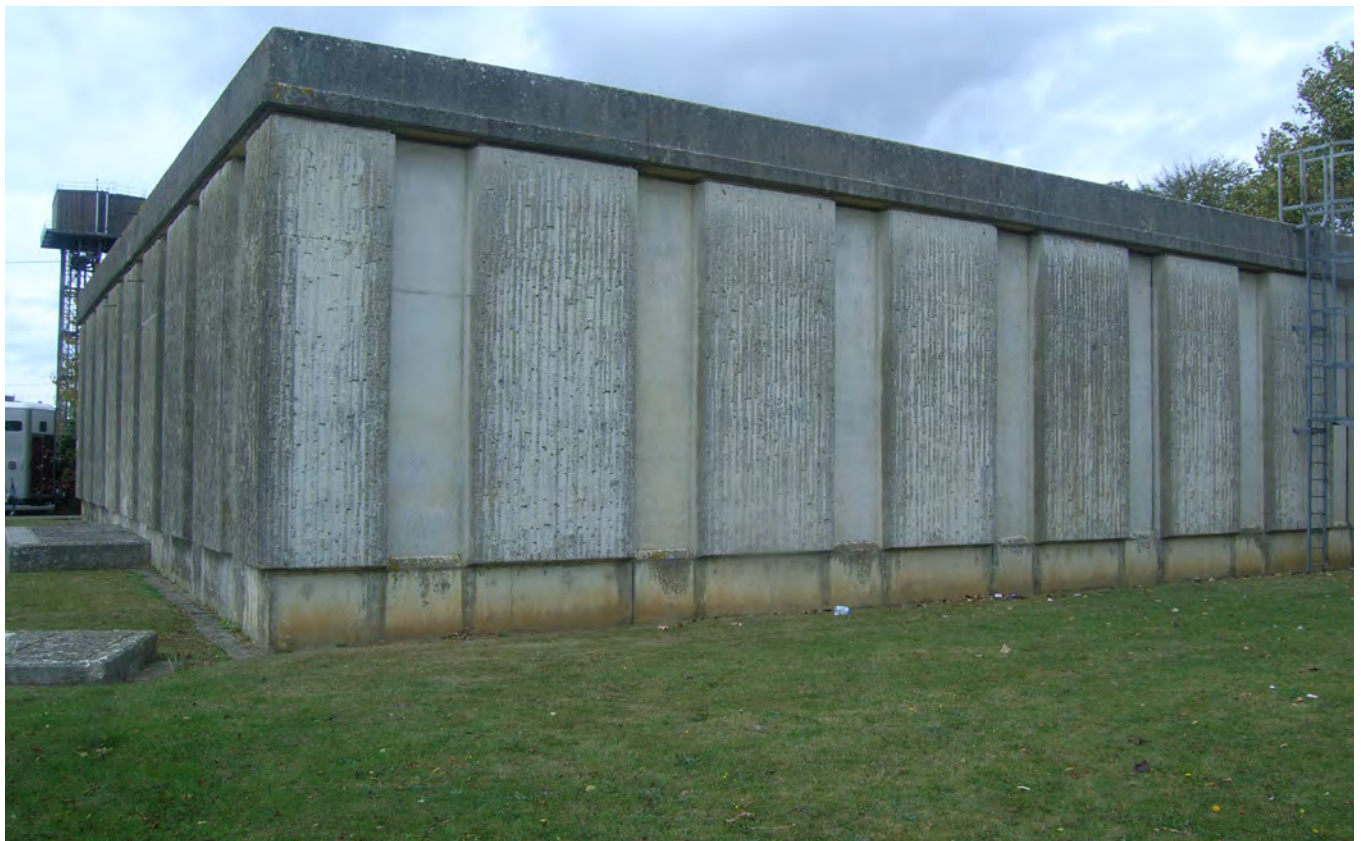
Plate 565.1 East elevation

The water tank is c.3m in height, constructed from poured concrete with a flat concrete roof surrounded by metal railings (Plate 565.1). Some architectural detail has been afforded to the structure with projecting textured panels.

Situated at ground level the tank has two concrete platforms to the front of the building, and one to the rear. The north-east elevation has a pipe extending from just below roof level into the ground, a line of paving slabs to the front of the north-east elevation indicates the alignment of pipes below ground. There is a ladder on the east elevation providing access to the roof. Building 565 is identical to building 573, but with a ladder to the east face.

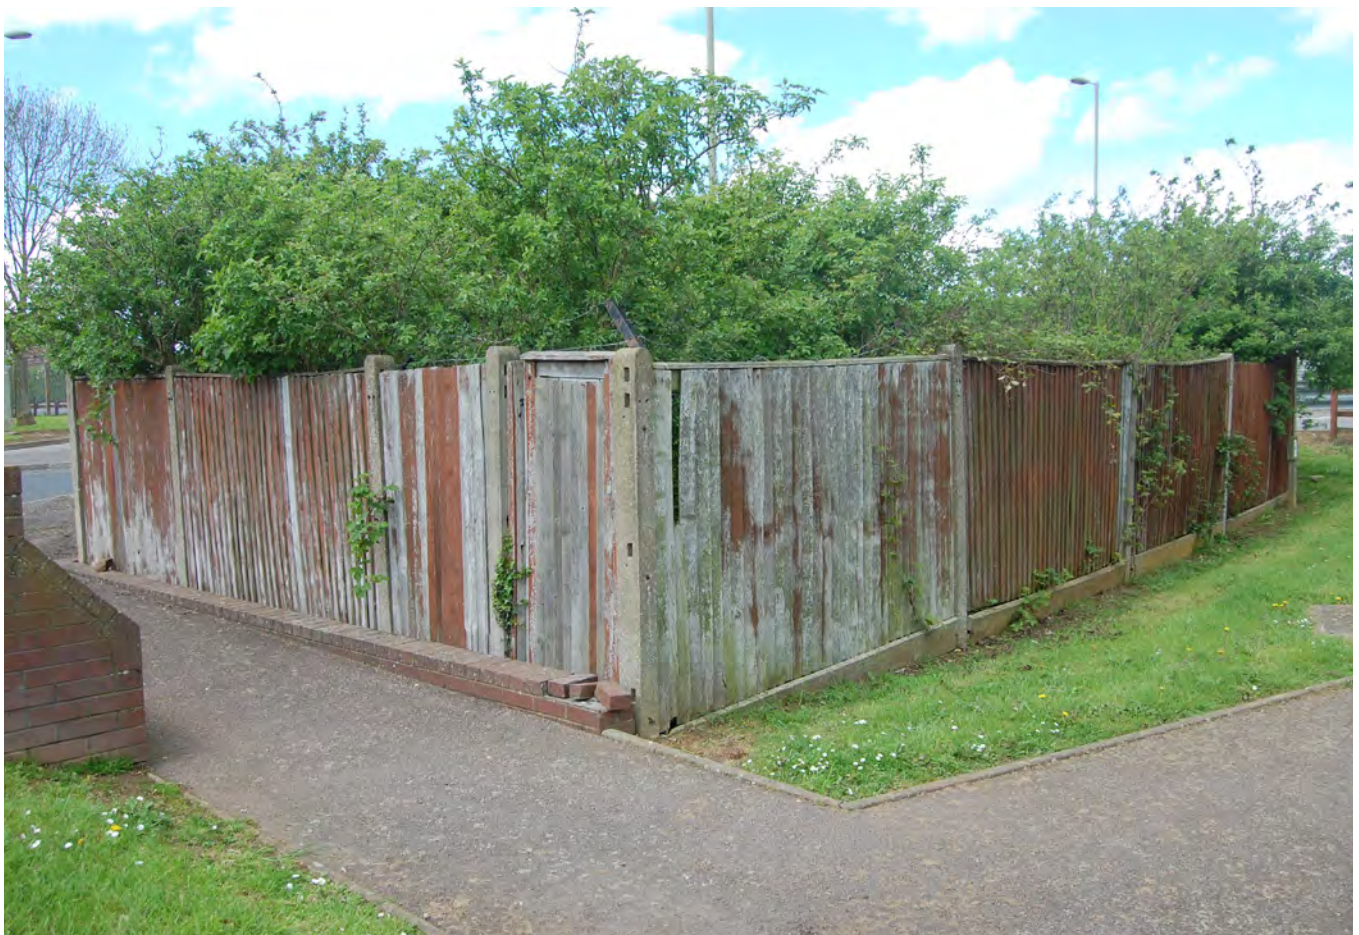
Plate 568.1 East elevation

The waste disposal pit is surrounded by a timber fence (c.1.8m in height) and supported on concrete posts with barb wire around the top perimeter (Plate 568.1). Internally the space is now overgrown with trees.
