FORMER RAF UPPER HEYFORD, OXFORDSHIRE

HISTORIC BUILDING RECORDING AND INVESTIGATION

VOLUME 2: GAZETEER OF RECORDED STRUCTURES

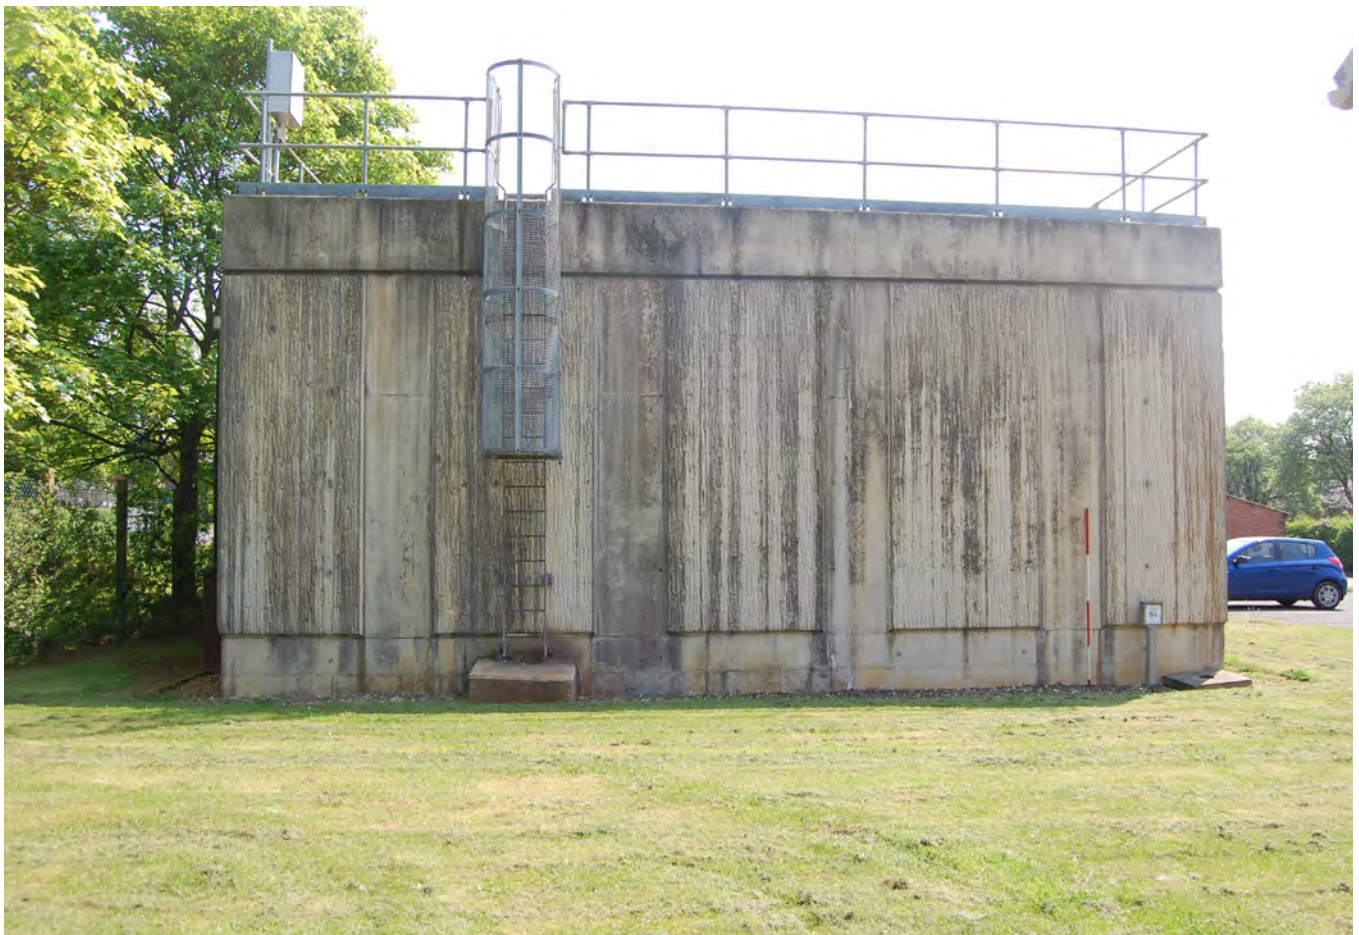
Plate 573.1 West elevation

The water tank is c.3m in height, constructed from poured concrete with a flat concrete roof surrounded by metal railings (Plate 573.1). Some architectural detail has been afforded to the structure with projecting textured panels.

The north and south elevations have pipes extending from just below the roof level into the ground. There is a ladder on the west elevation providing access to the roof.

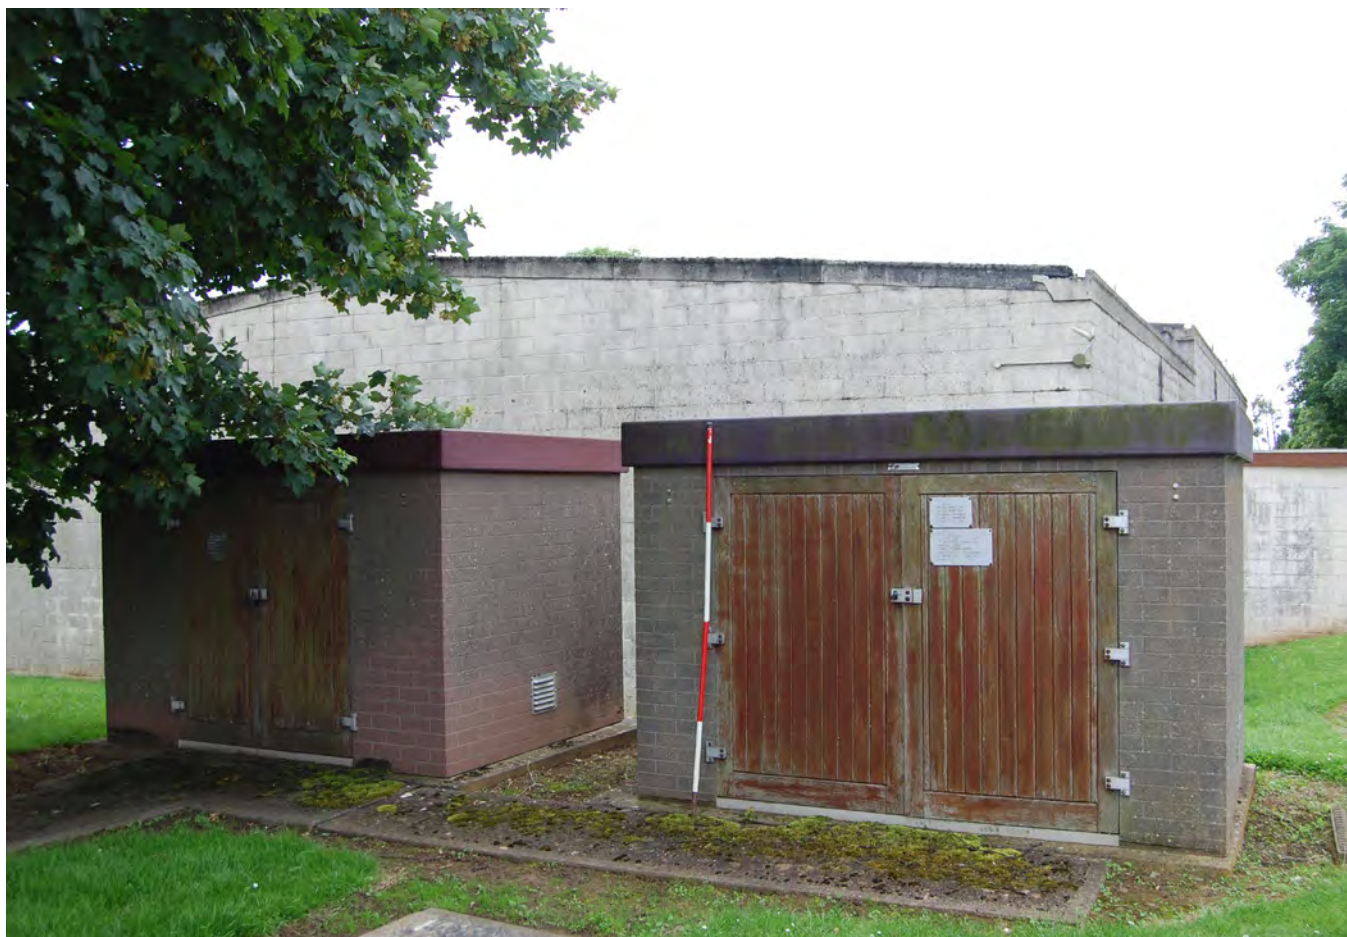
Plate UH2.1 West elevation

The two almost identical substations are rectangular in plan, constructed in brick set on a concrete base with flat asphalt roofs (Plate UH2.1). The west substation is slightly larger. There are paving slabs in front of and leading off from the two substations.

The south elevations have double timber panelled doors with large hinges, otherwise the structures have no features of interest with the exception of low metal vents on the west and east elevations.

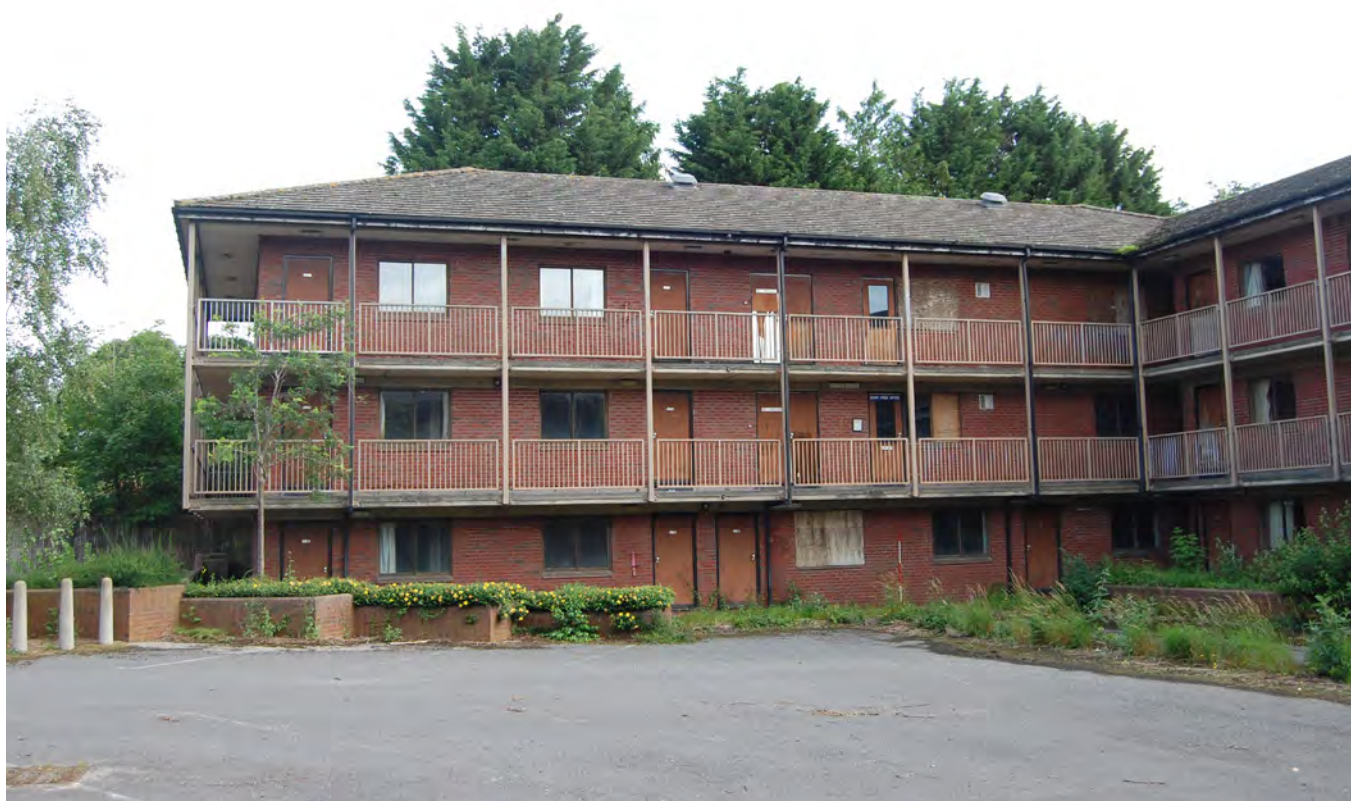
Plate 440.1 Sign and front elevation

To the front of the building there is a standard freestanding Upper Heyford brown sign which shows that Building 440 was by the 20th Security Police Squadron (Plate 440.1).

At the front of the building there are various raised brick planters and cobbled landscaping beneath the galleries (visible in Plate 440.1). The detached sub-station in the south-western corner is recorded separately as building no.476.

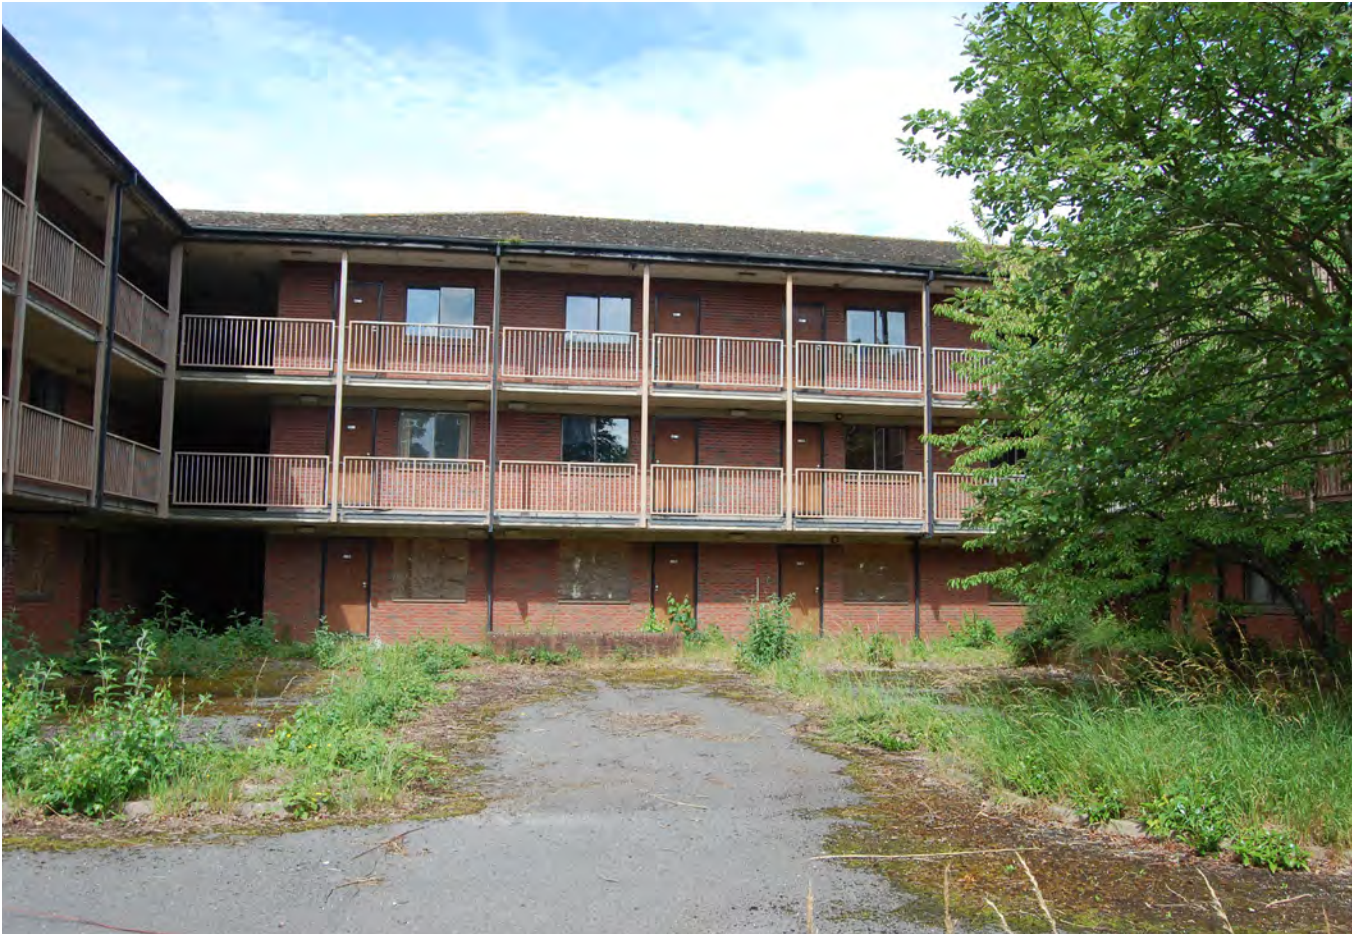
Plate 440.2 South side of northern range

Each of the main ranges is three storeys tall and has a similar overall form with red brick walls (stretcher bond), bands of reinforced concrete at floor levels and a shallow, tile-covered hipped roof over the whole structure (Plate 440.2). There are external walkways or galleries at each of the upper two storeys which wrap around the five main ranges and the deep overhang to the hipped roof covers the upper walkway (Plate 440.3). As stated above these galleries link the separate ranges of the building. The concrete walkways are cantilevered out from the main concrete floor structure of the building and which also forms the lintels above each window and door opening (Plate 440.4).

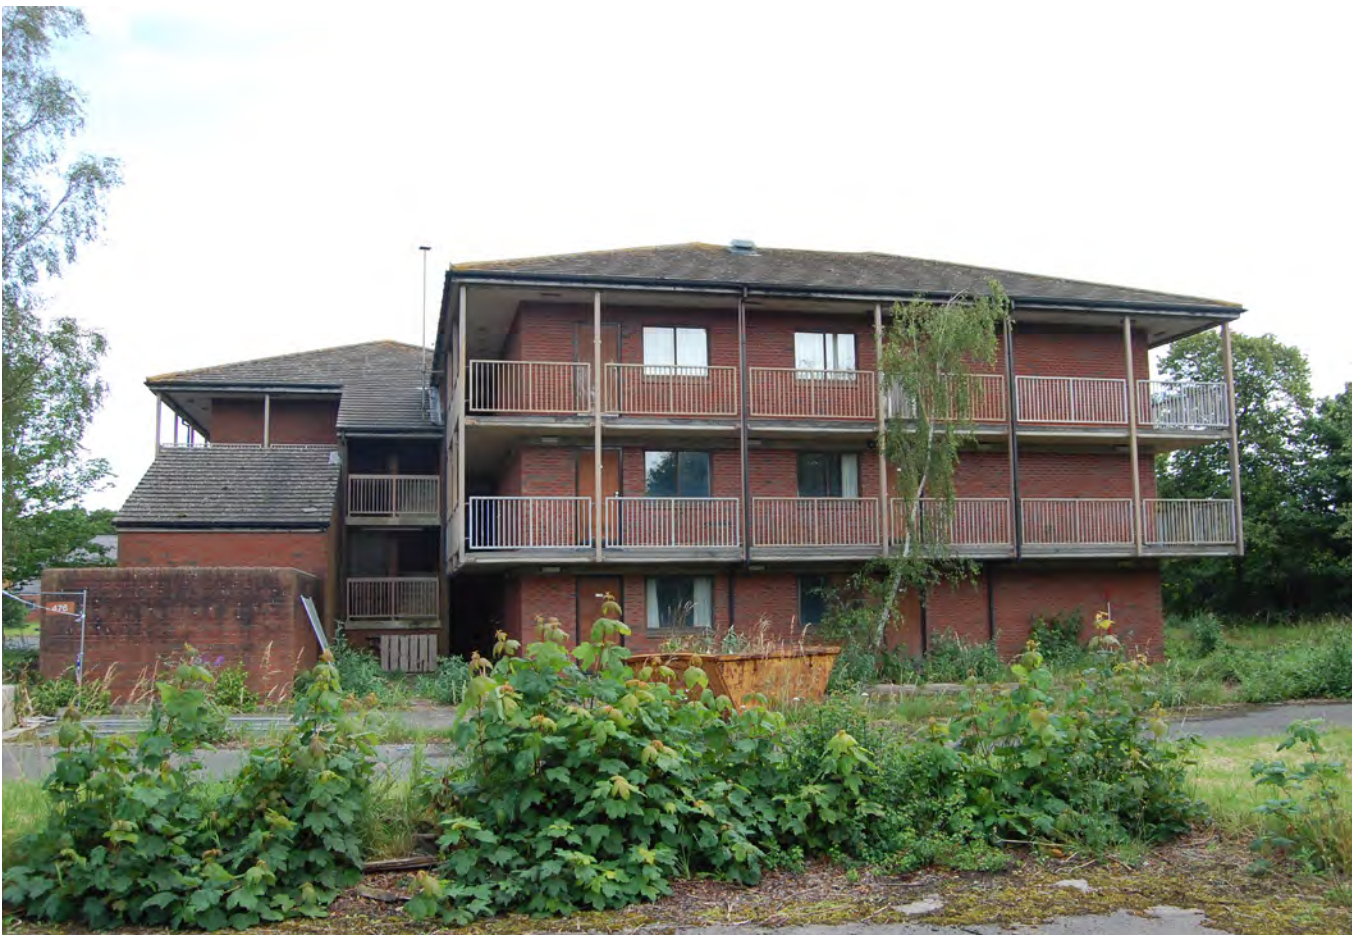
Plate 440.5 Rear (east) elevation

At the outer edge of each gallery there is a series of vertical box-section posts which rise up to the roof eaves and which support the simple vertical metal railings (Plate 440.5). The third floor walkway is lit by electric lights in the underside of the

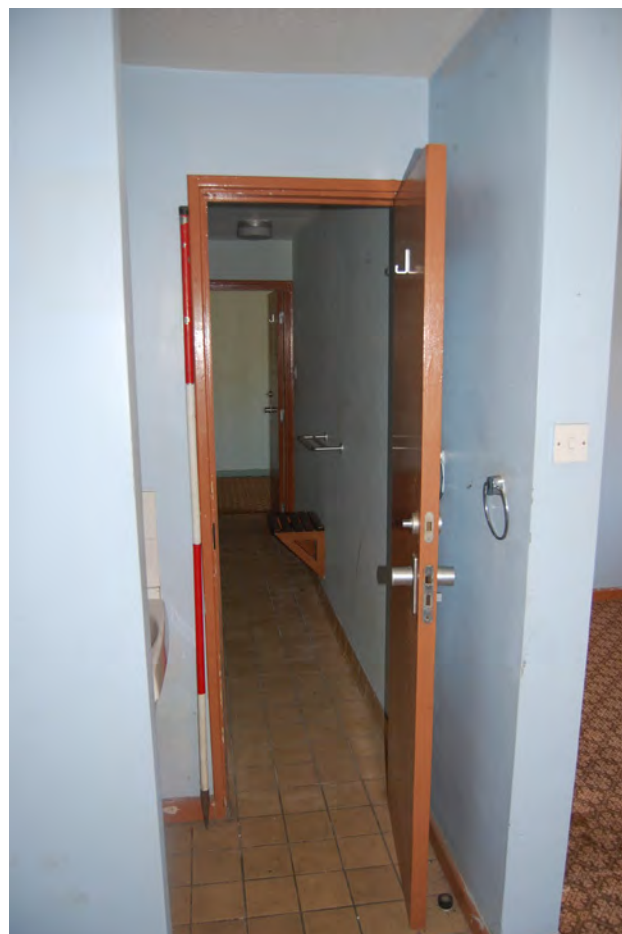
Plate 440.7 Typical internal room

The interior of the building largely comprises small individual apartments on all three floors for the members of the squadron. The external galleries appear to have provided all the circulation space around the building and avoided the need for any internal corridors. Therefore the interiors of the buildings comprised self-contained rooms only accessible from the galleries (Plate 440.7 & .8). There does not appear to have been internal staircases with vertical circulation only possible by several covered external staircases between the blocks.

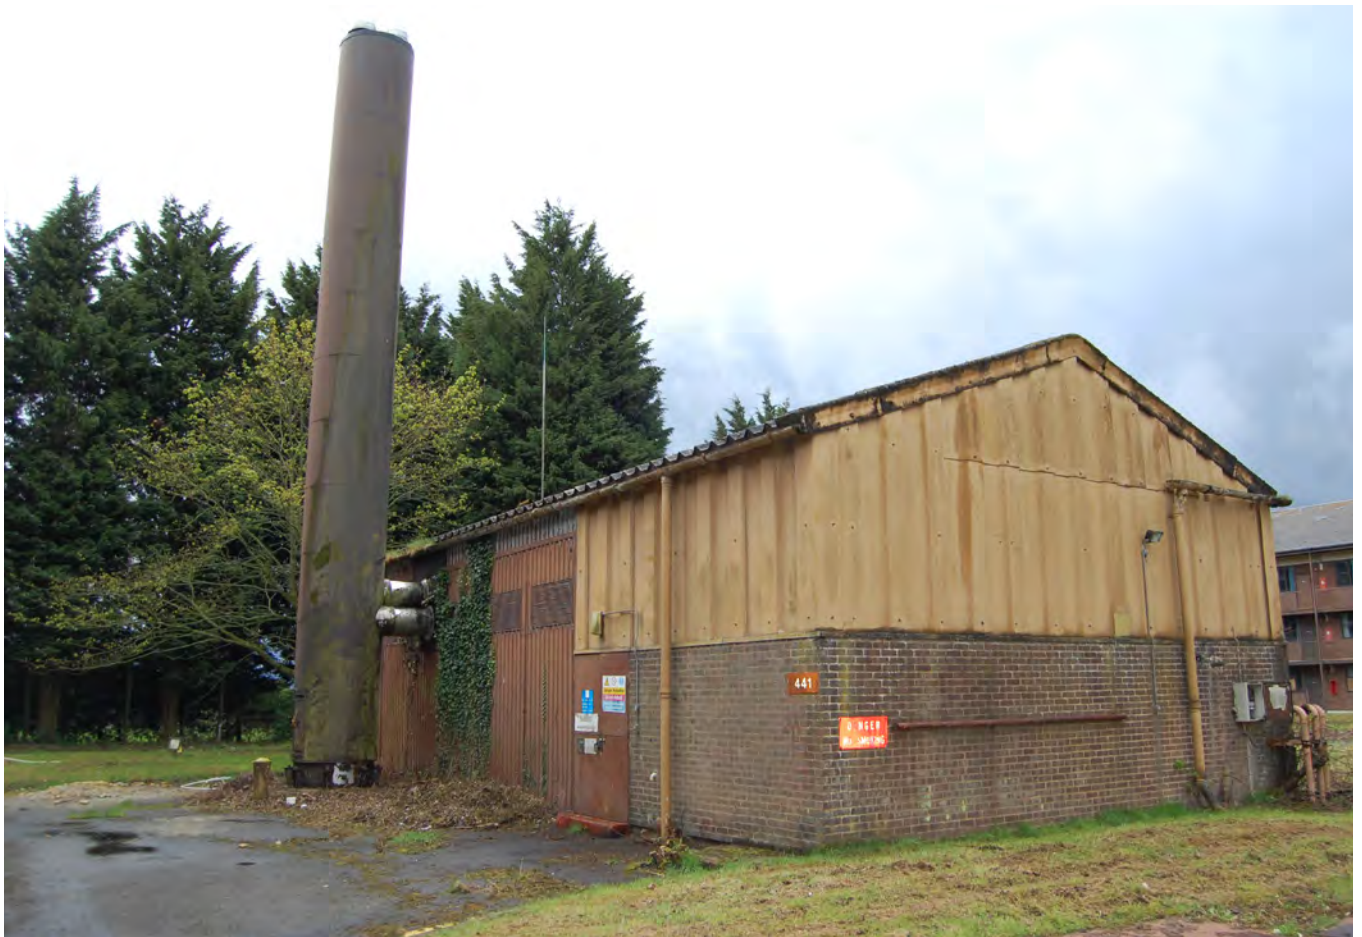
Plate 441.1 North-east elevation

The north-east elevation has a large steel self-supporting chimney which is joined to the building via two pipes entering into the upper half of the elevation (Plate 441.1). Surrounding this the building is clad in brown corrugated metal that incorporates large vents, there are double doors at the north end of the building providing access. The upper half of the elevation is clad in light brown metal sheeting, as evident elsewhere on the building.

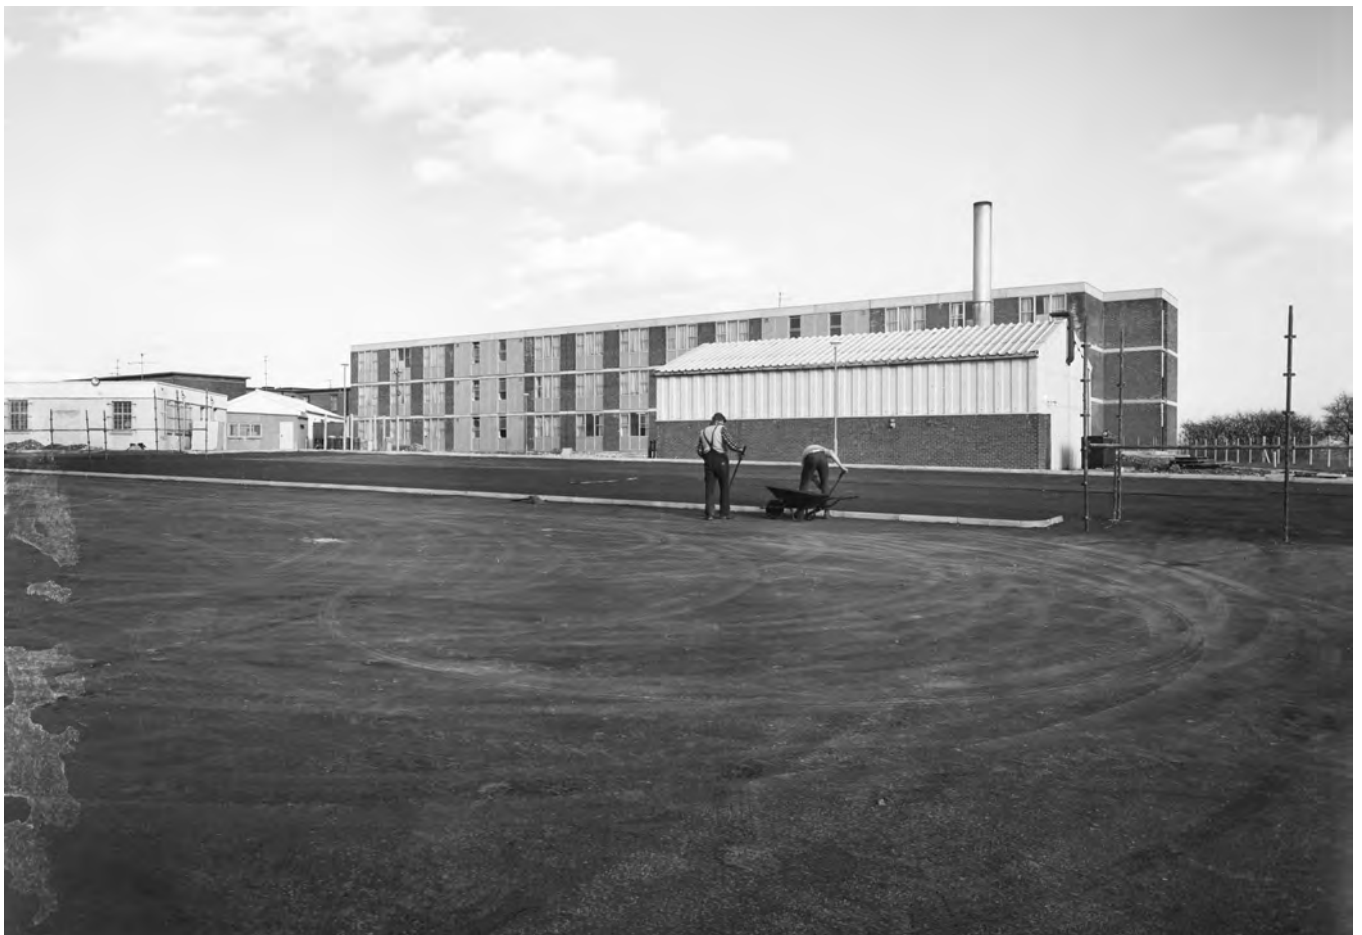
Plate 441.2 Contemporary (1970-2) view looking east (HE archive ref.-p_g14942_01)

The north-west elevation is metal clad in the upper half, with three short pipes leading from the internal space into the ground. The south-west elevation is also metal clad on the upper half and has two large square metal within the lower brick half (Plate 441.2).

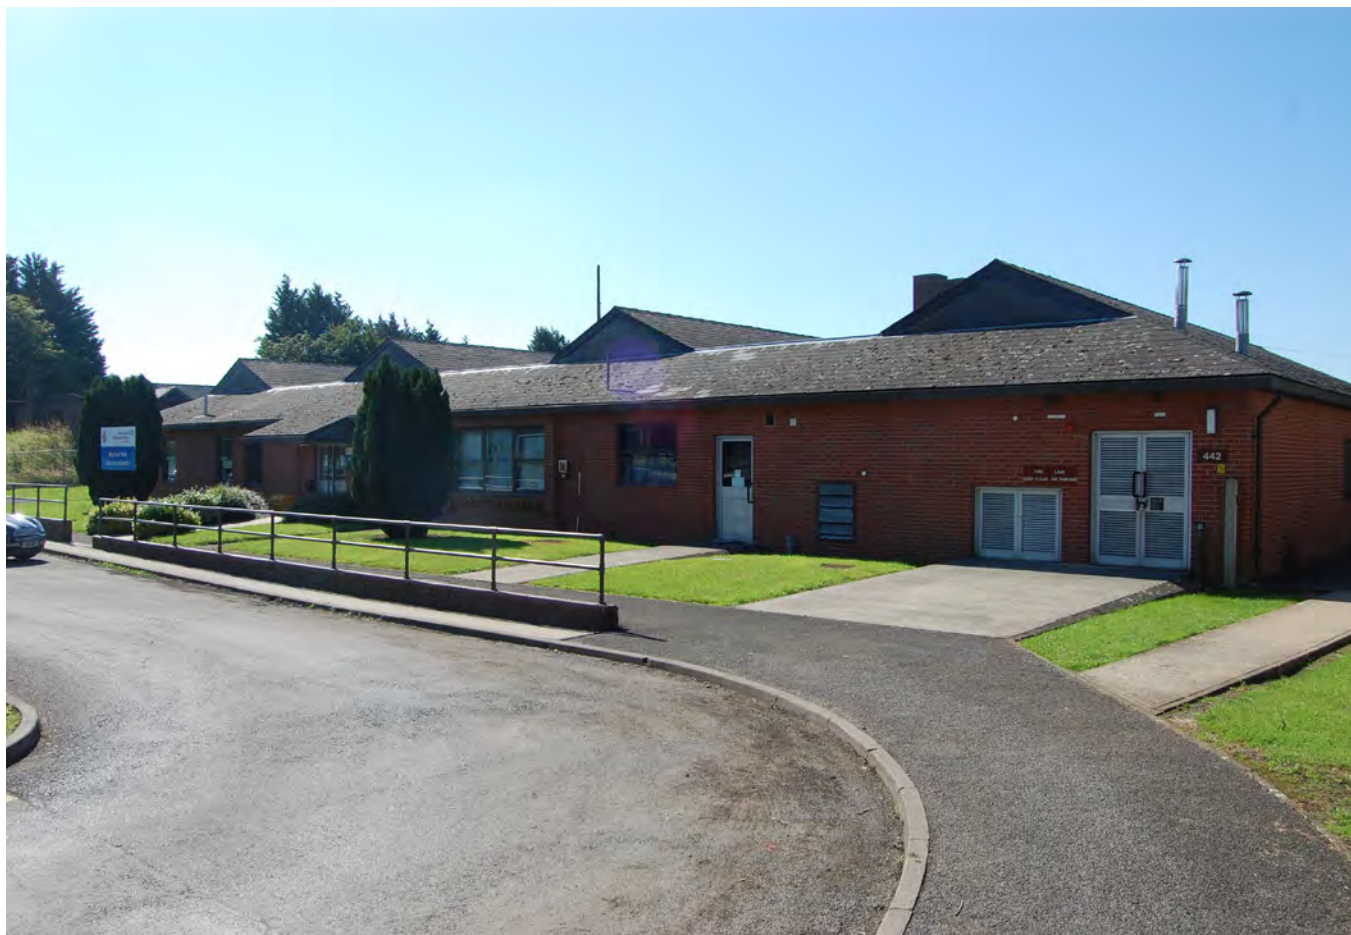
Plate 442.1 Front (north-east) elevation

The front of the north-west elevation has a single timber door and a wood framed window (painted brown), the rear is fenced off by the nursery and difficult to view.

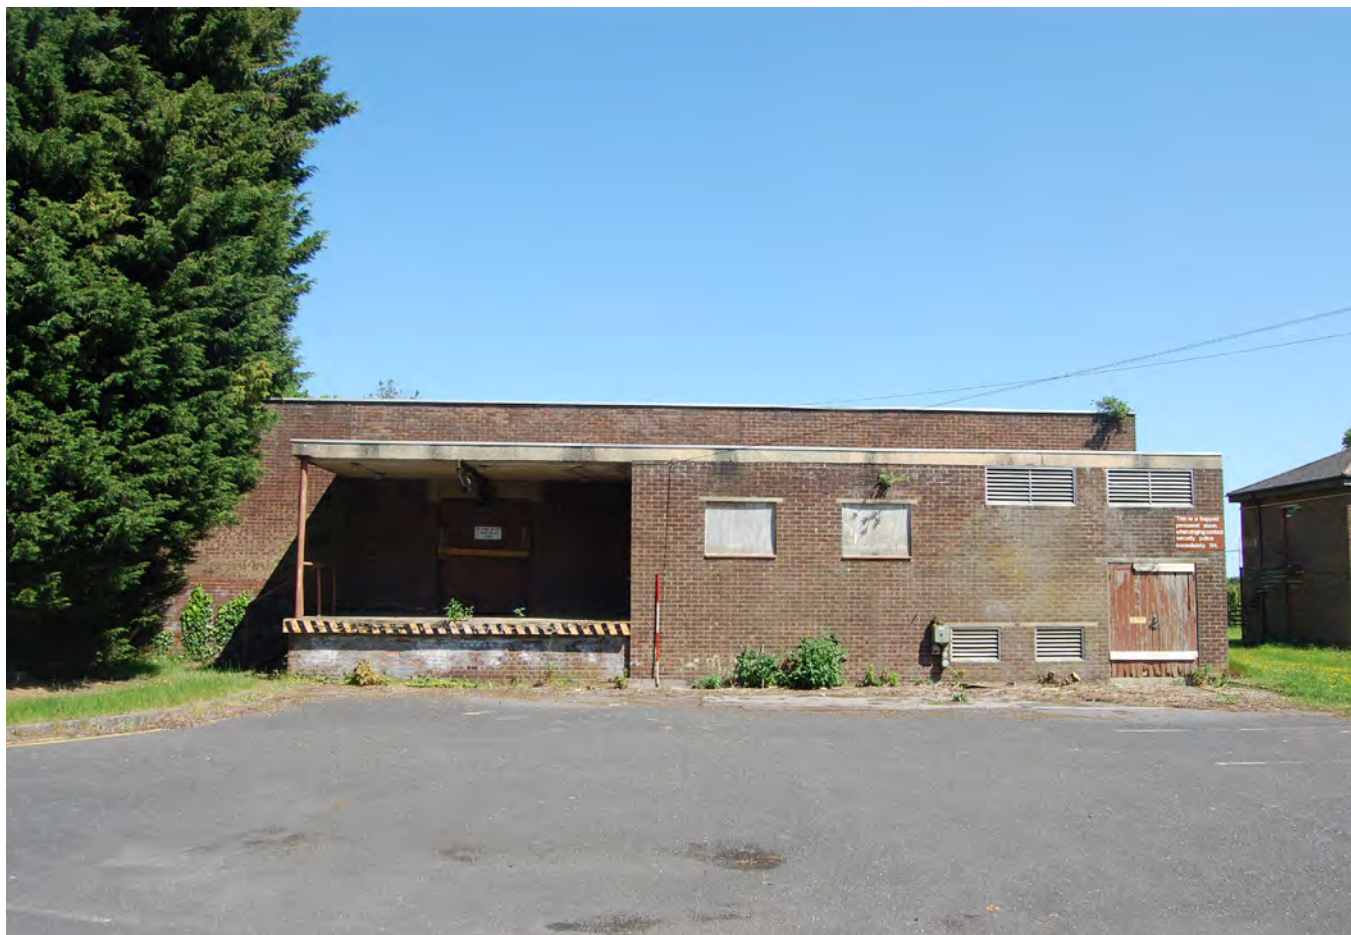
Plate 443.1 West elevation

The west (front) elevation has a brick built loading bay projecting to the front of the building, there is a gantry running along the platform roof into the store used to transport goods (Plate 443.1). There are brown painted metal railings surrounding the platform which is accessed by a set of steps. A substantial metal door provides access to the store. Two vents possibly windows have been boarded up. To the east of the platform is a small internal 'food service office' with water closet. Further to the east, and accessed not from the platform but via a door at ground level to the east of the building, is a plant room.

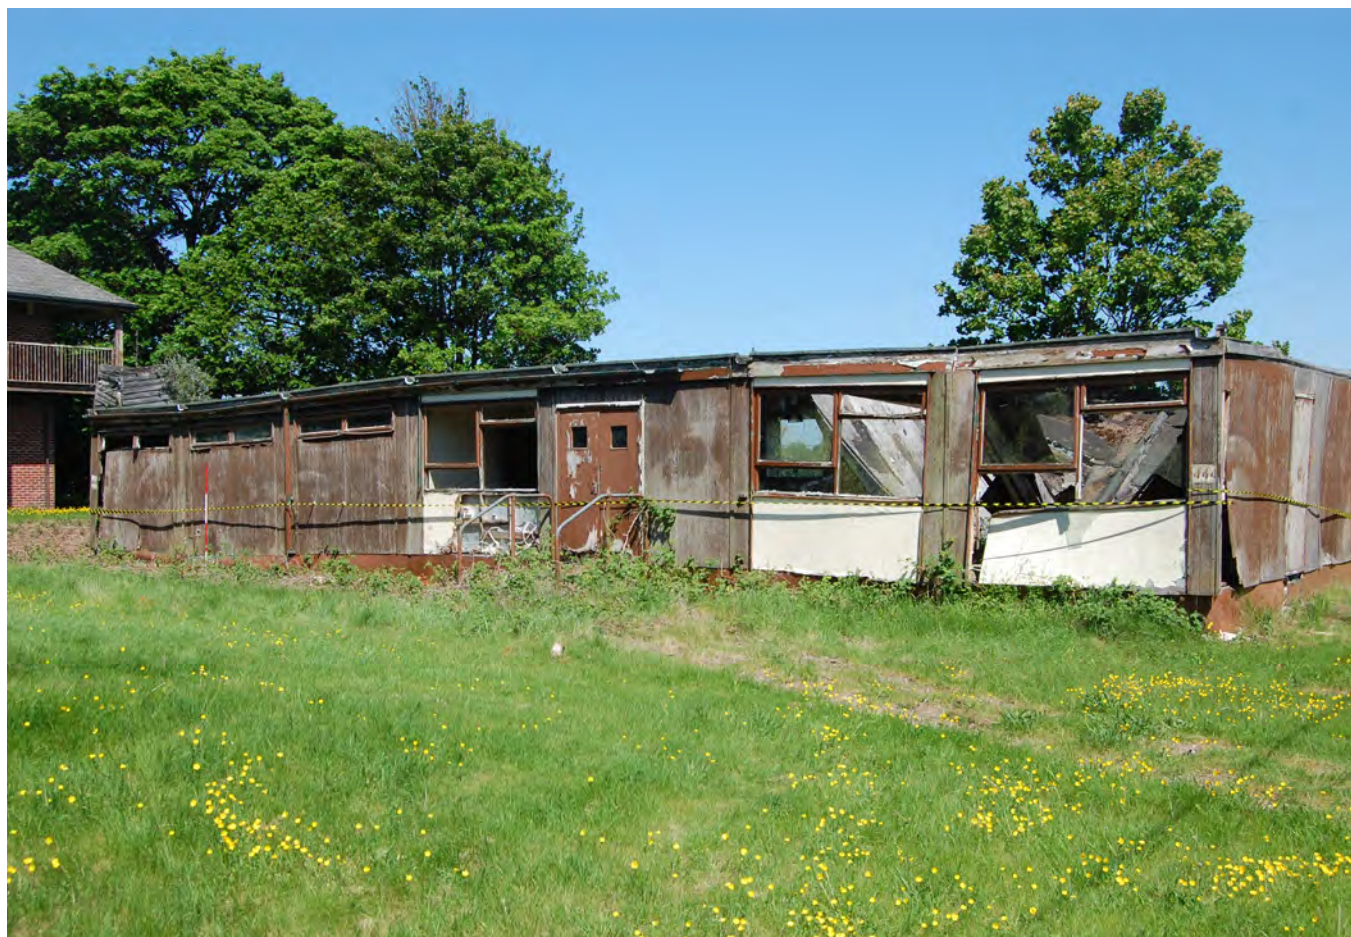
Plate 444.1 West elevation

The prefabricated timber unit is rectangular in plan with a flat asphalt roof and timber framed windows (Plate 444.1). There is timber cladding to the elevations surrounding the windows and doors, and to the two end elevations. The building is now in poor condition and partially collapsed.

The west (front) elevation has three large metal windows and a double timber door (all painted brown). There are three sets of two thin rectangular lights at the north end. The east (rear) elevation has six windows, some now collapsed in. The north and south elevations are timber clad, each with a single door but otherwise have no features of interest.

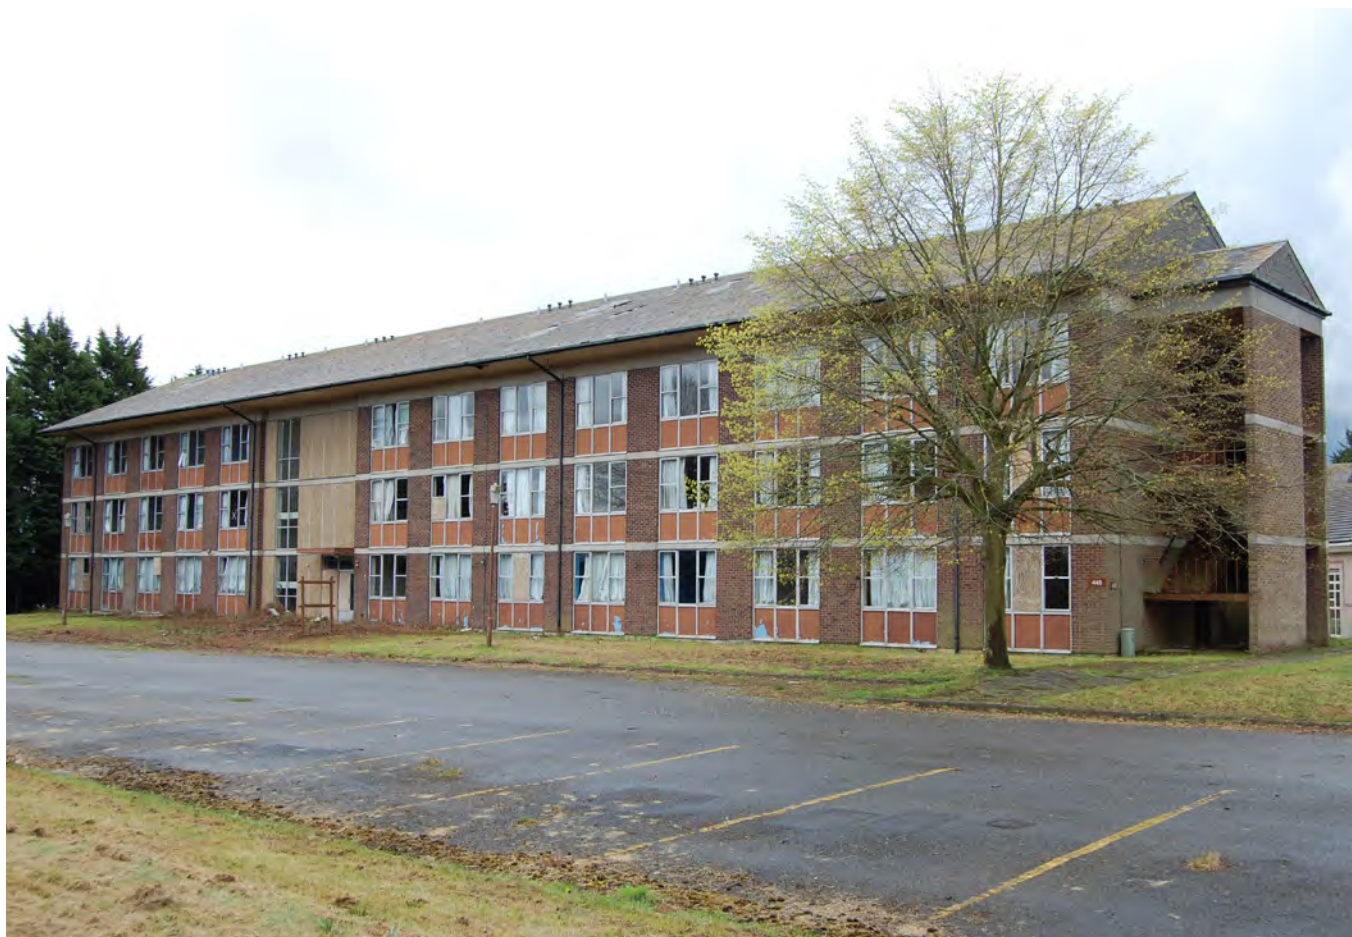
Plate 445.1 East elevation

The front (east) elevation has three windows at three levels running the length of the building separated by horizontal lines of concrete slabs (Plate 445.1). The windows light each internal barrack room, with a central rectangular pane and two square windows to each side. Below this arrangement, are three sections that are the same size as the windows above, and hold orange coloured boarding, which offer some basic architectural embellishment to the building. These three sections are separated by the same metal framing as the windows.

There is a staircase approximately centrally with pebble dash infill panels and a glass door (partly boarded) and porch overhang. Within the pebble dashed area to the north of the door are four windows at each level held in metal frames which are used to light the internal stairwell (the windows consist of two long rectangular ones at the top, and two roughly square ones at the base).

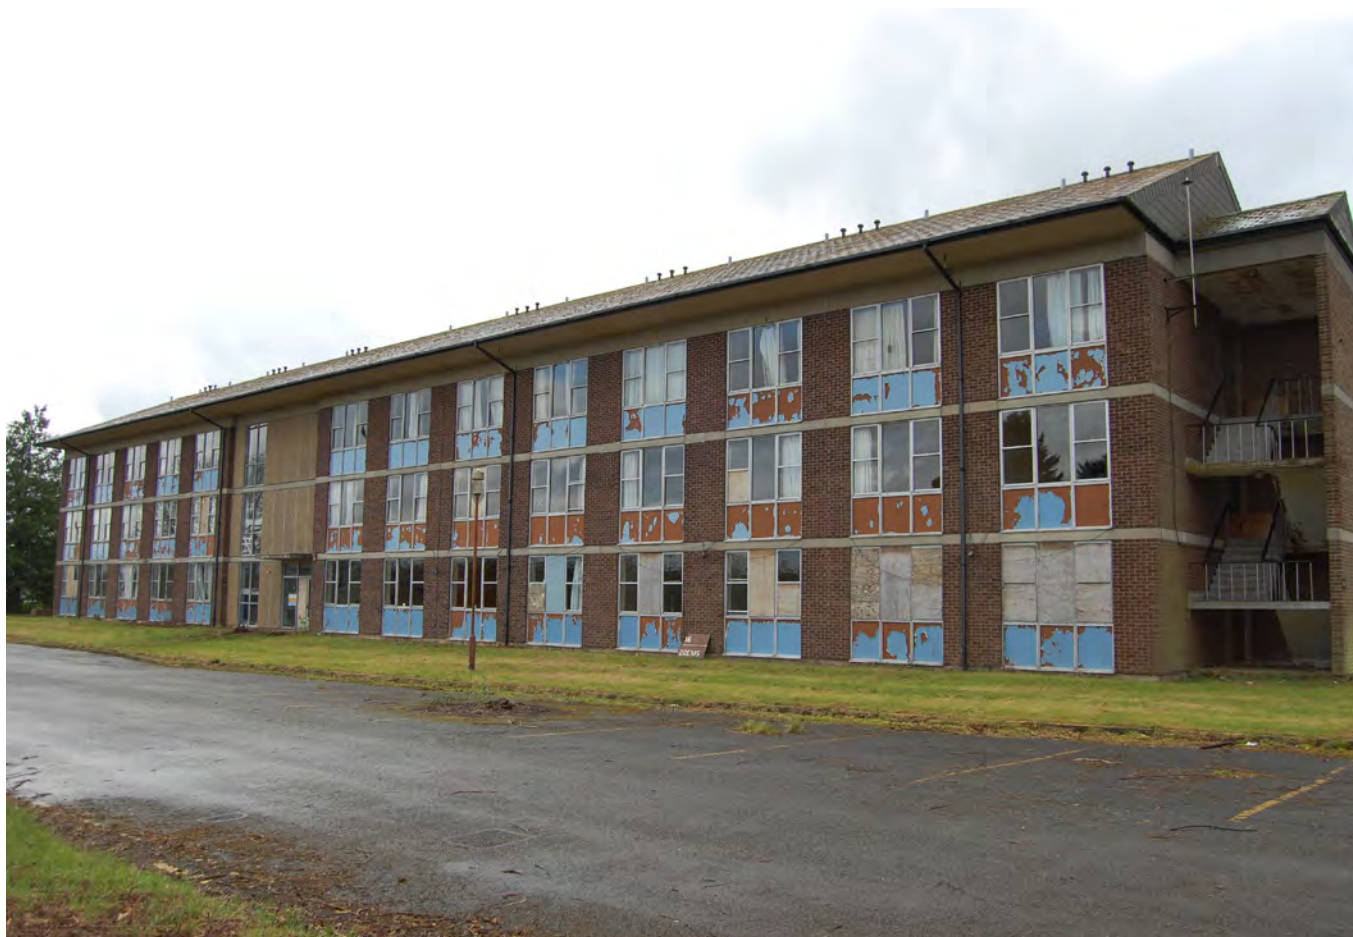
Plate 446.1 East elevation

The east elevation has thirteen windows at three levels running the length of the building separated by horizontal lines of concrete slabs (Plate 446.1). The windows light each internal barrack room, with a central rectangular pane and two square windows to each side. Below this arrangement, are three sections that are the same size as the windows above, and hold orange coloured boarding, which offer some basic architectural embellishment to the building. These three sections are separated by the same metal framing as the windows.

There is a staircase approximately centrally with pebble dash infill panels and a glass door (partly boarded) and porch overhang. Within the pebble dashed area to the north of the door are four windows at each level held in metal frames which are used to light the internal stairwell (the windows consist of two long rectangular ones at the top, and two roughly square ones at the base)

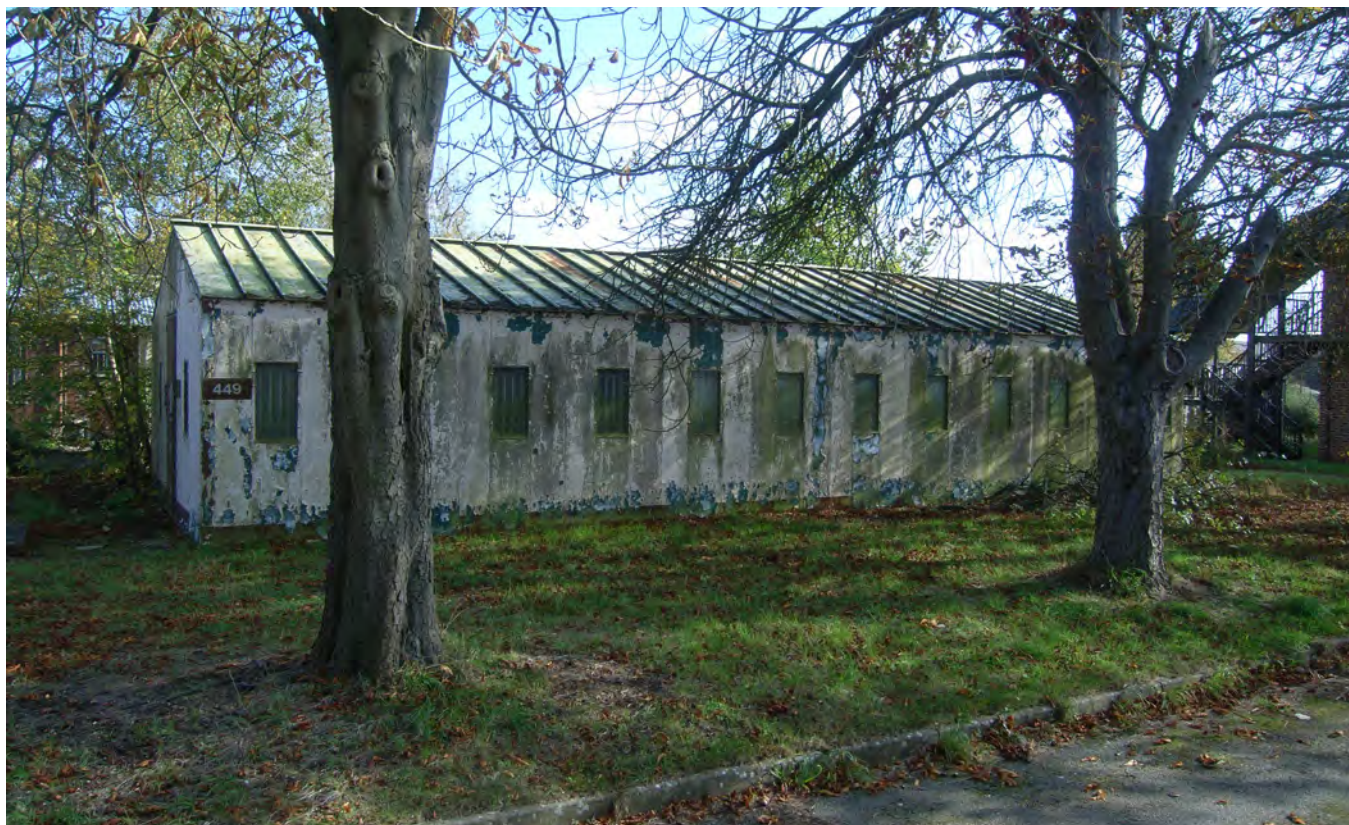
Plate 449.1 East elevation

Building 449 is clad in metal (painted brown with cream at the base), over a timber construction (Plate 449.1). It is rectangular in plan with a pitched corrugated roof. It has simple rectangular metal framed windows (painted brown) have timber sills and internal bars with reinforced glass.

The east and west elevations have thirteen windows. The rear elevation has a single timber door with a vent above and windows to each side.

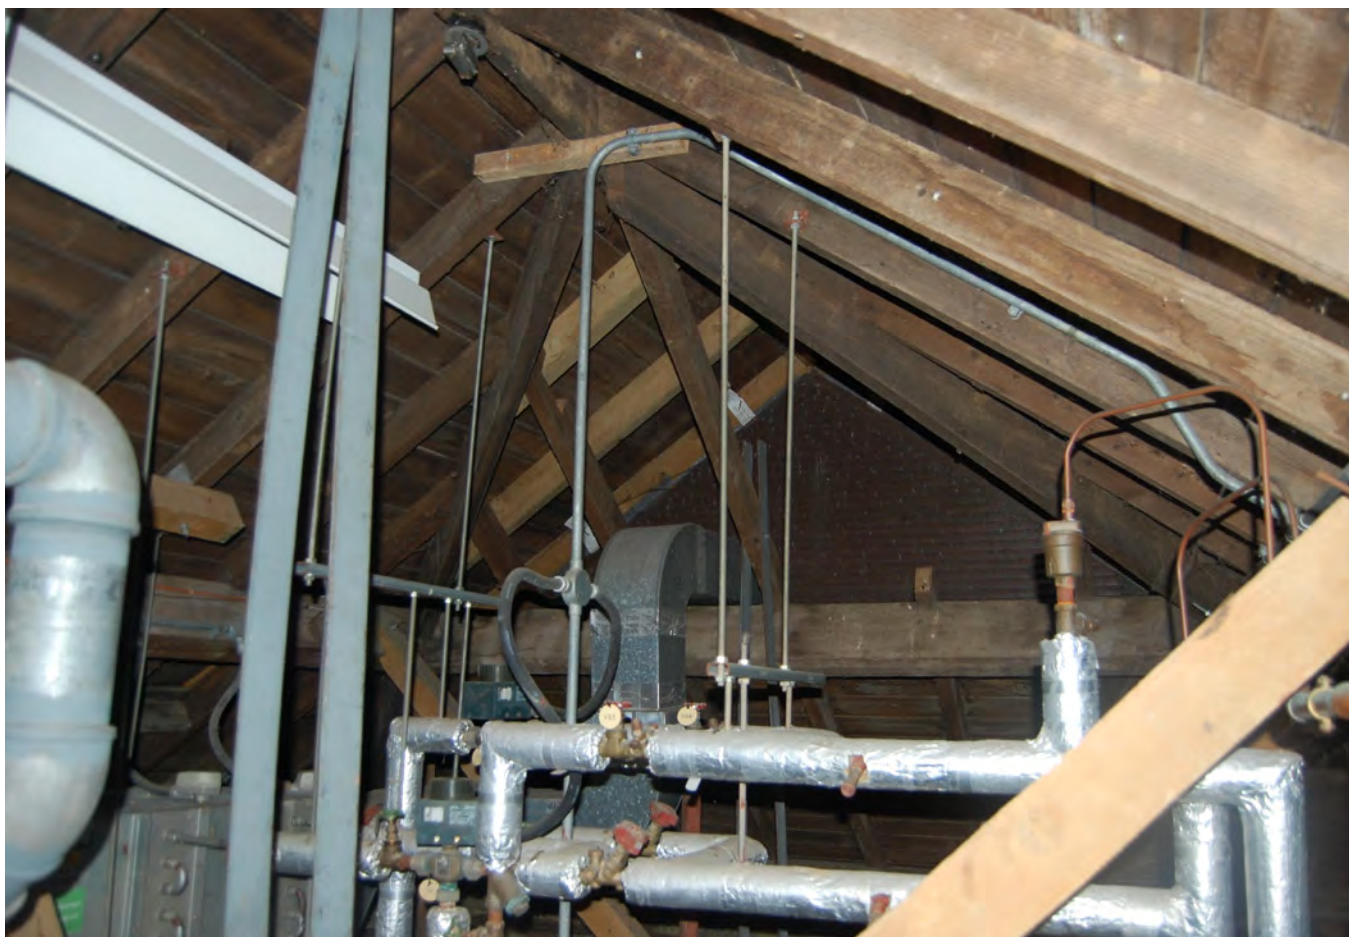
Plate 466.15 Central shared room at first floor

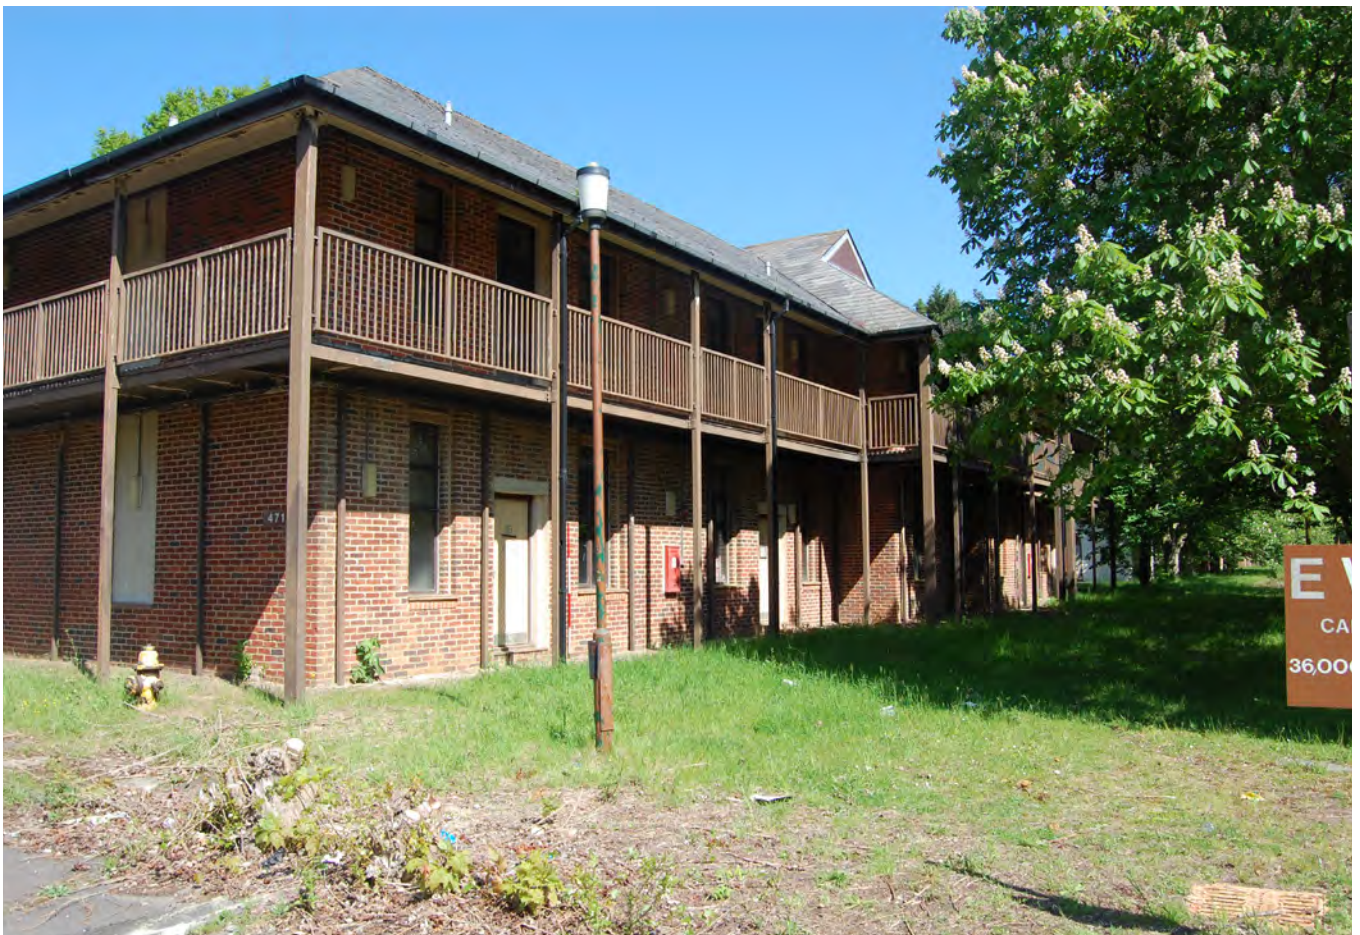
Plate 471.1 West elevation

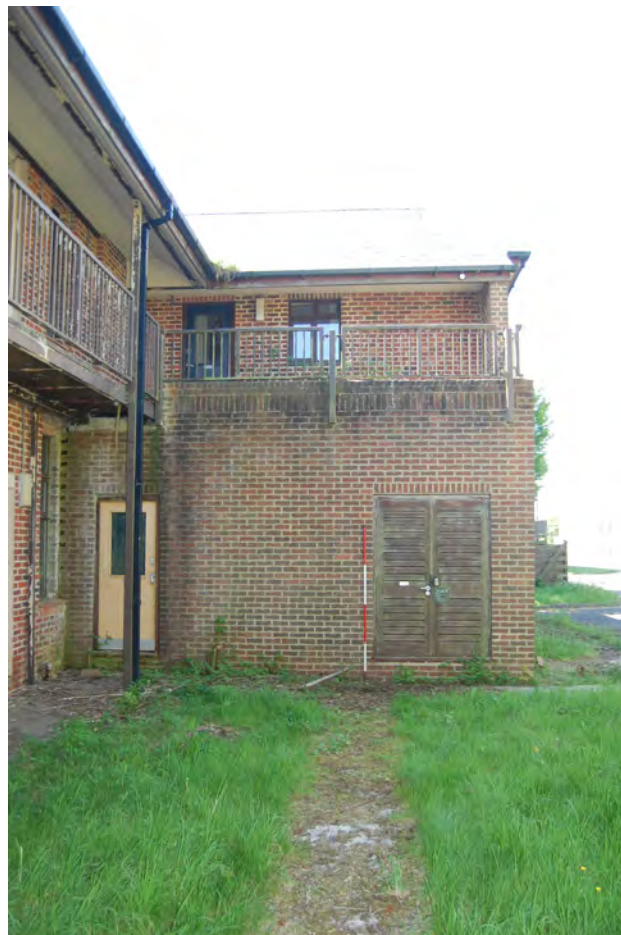
Plate 471.7 Door to plant room

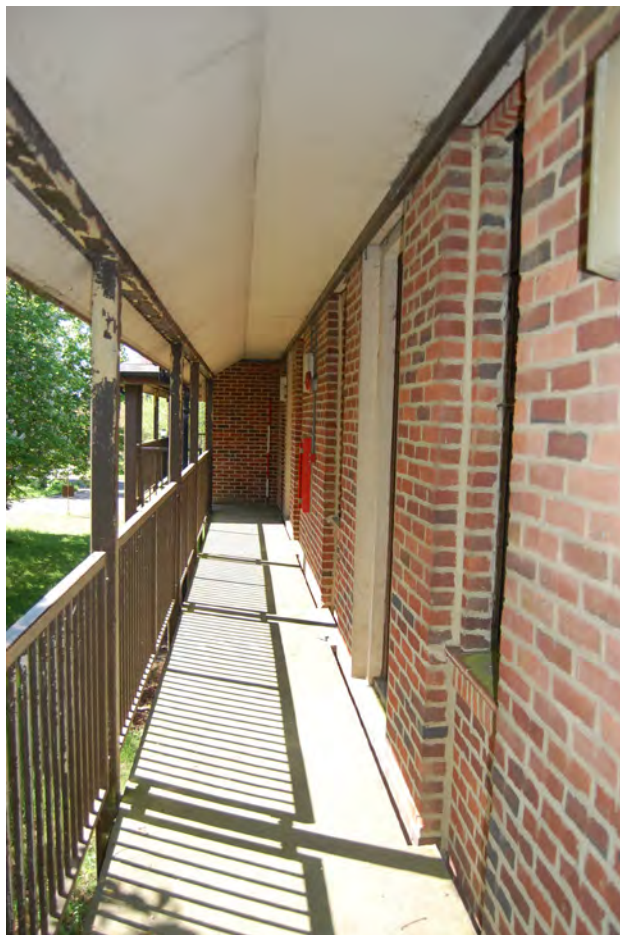
Plate 471.9 Typical window
