FORMER RAF UPPER HEYFORD, OXFORDSHIRE

HISTORIC BUILDING RECORDING AND INVESTIGATION

VOLUME 2: GAZETEER OF RECORDED STRUCTURES

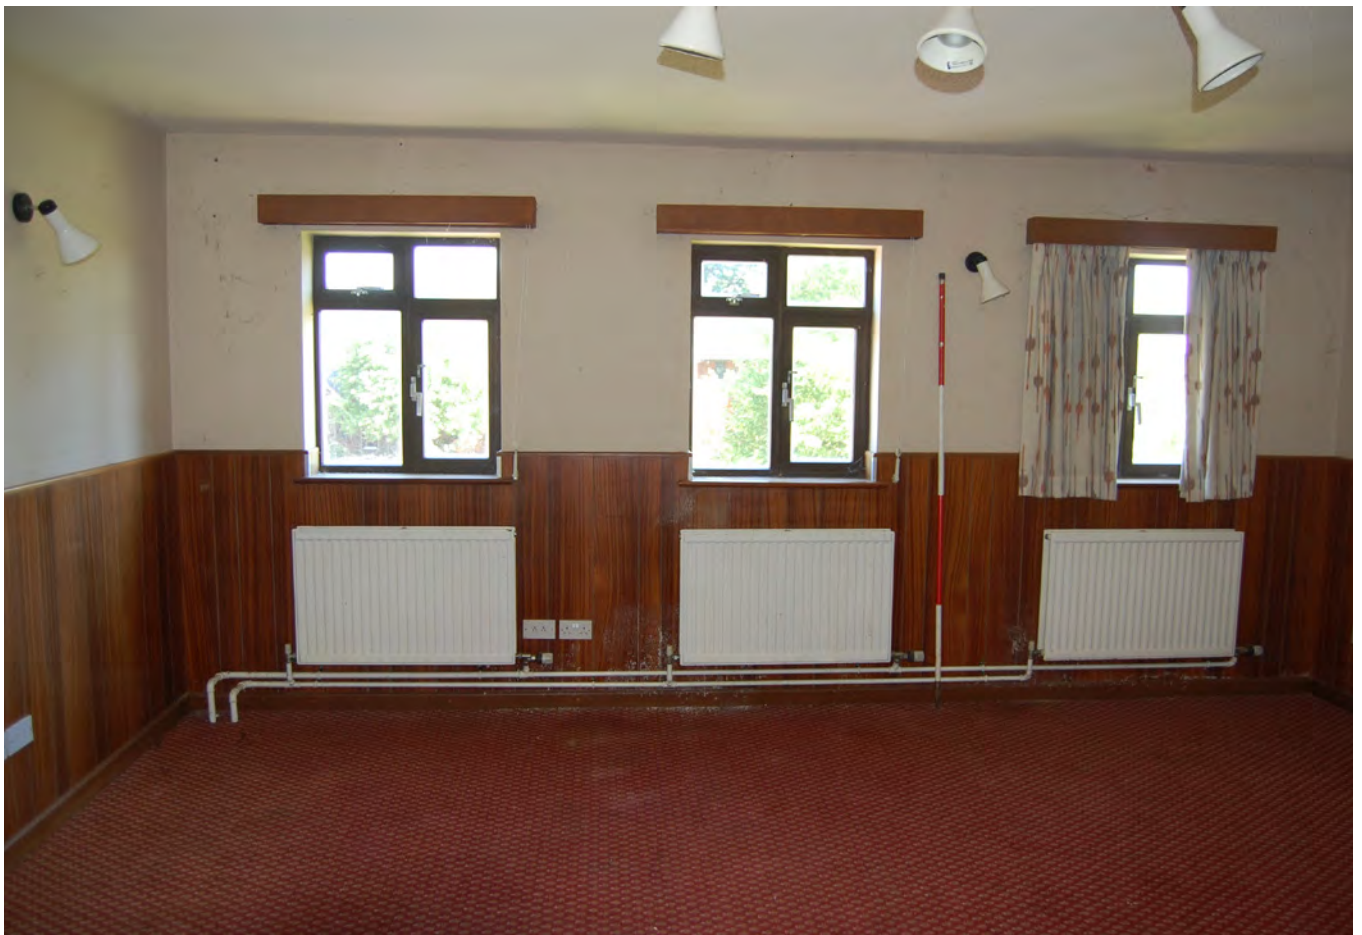
Plate 471.11 Typical interior of 1980s refurbished room

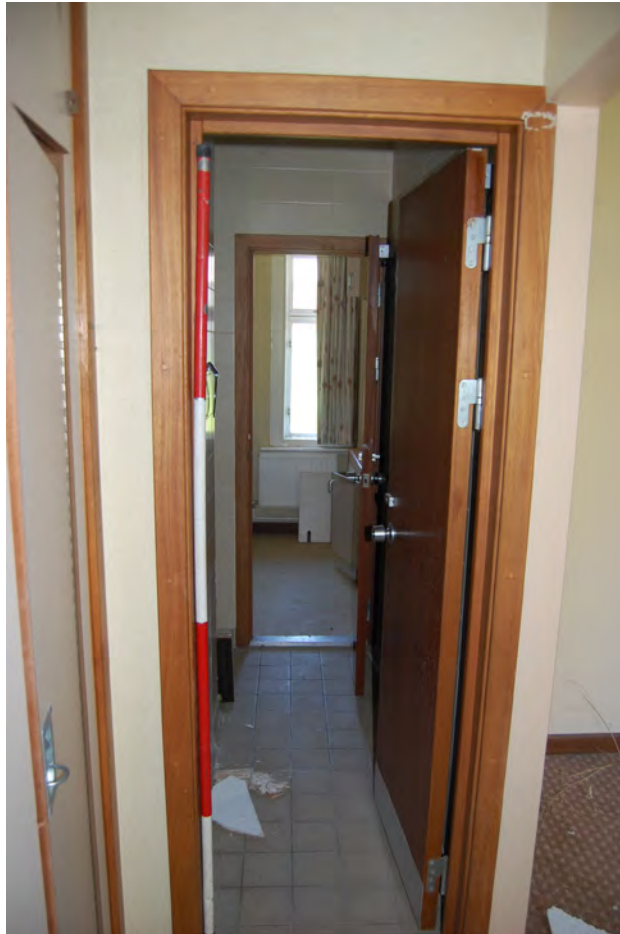
It appears that the occupants of Building 471 were allowed more freedom than those of the other C-Type barracks to paint their rooms with a degree of individuality. The inspection of this building found rooms painted a wide range of different colours, sometimes with stripes or decoration. In Building 471 there was one room (Room 1) where the rooms were painted a lilac colour below a layer of red paint, and with a dado bank and large triangular decoration. Another room (Room 12) had white and dark brown chequerboard decoration on one wall and isolated diamonds on another.

Plate 471.14 Typical room

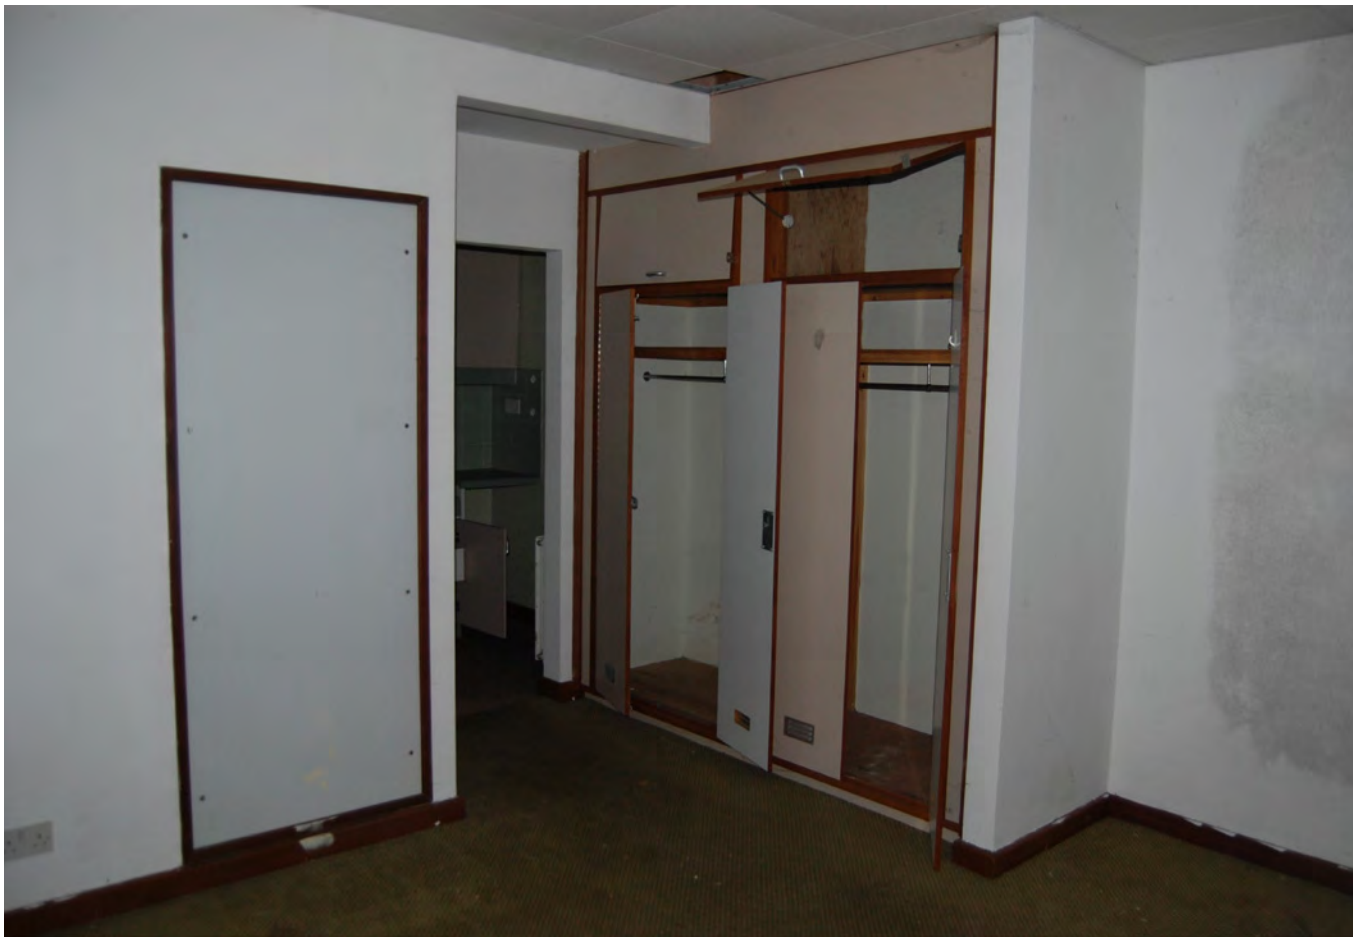
Plate 480.4 Doors at centre of east elevation

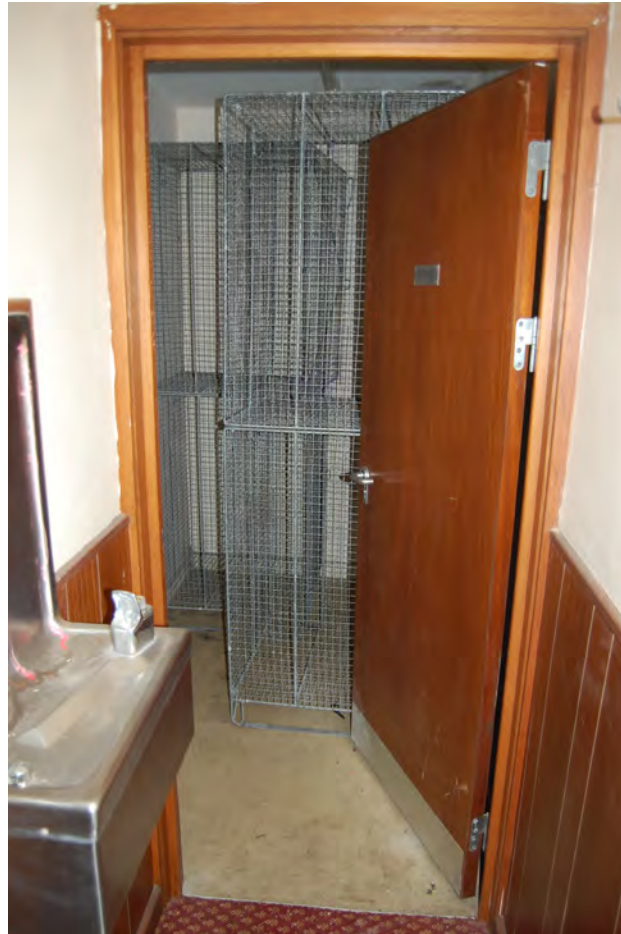
Plate 480.10 Drinking fountain in Building 480

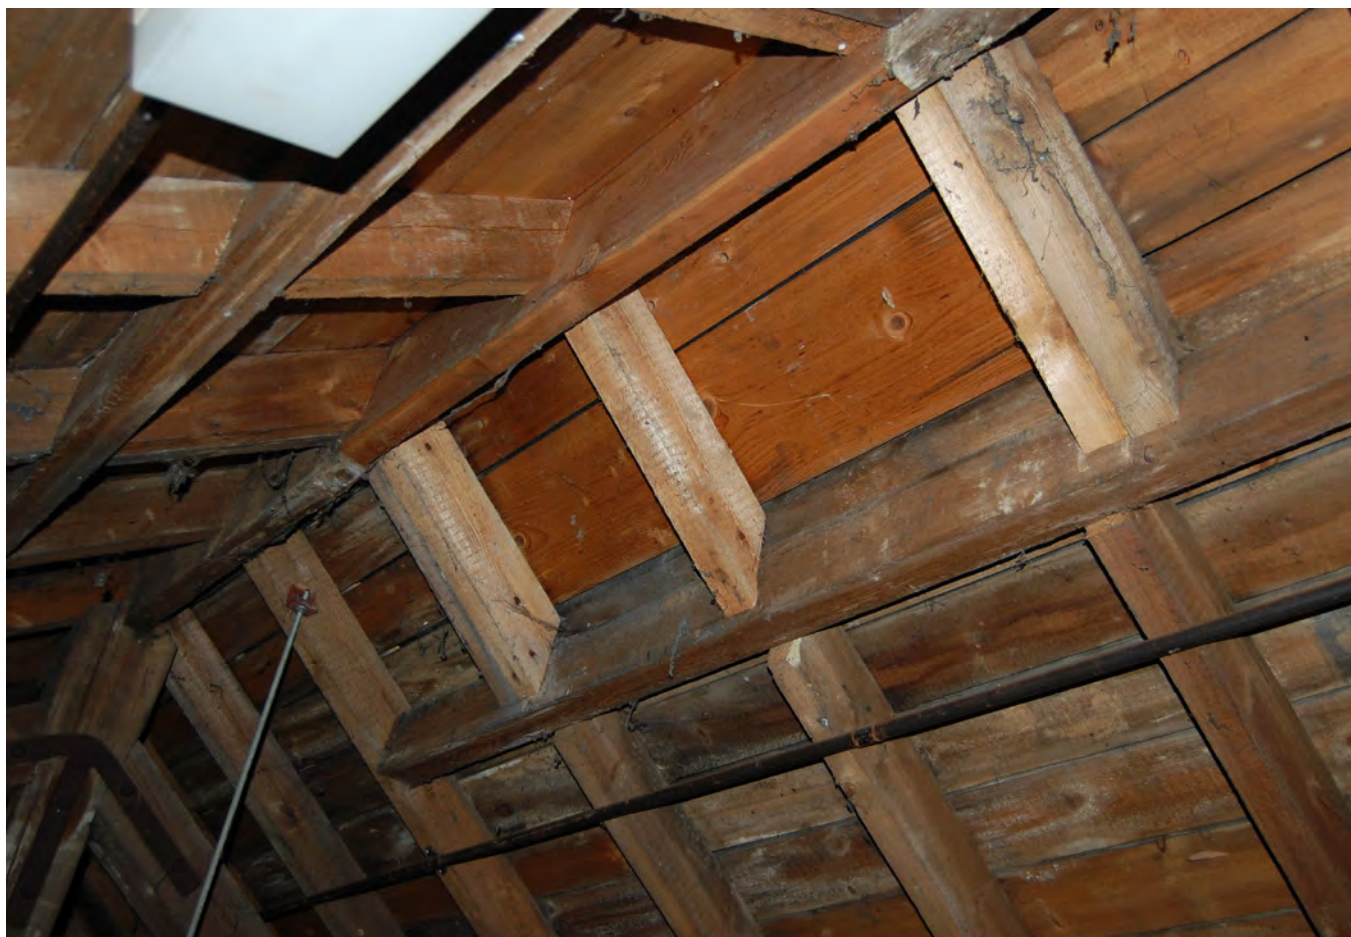
Plate 480.13 General view of trusses

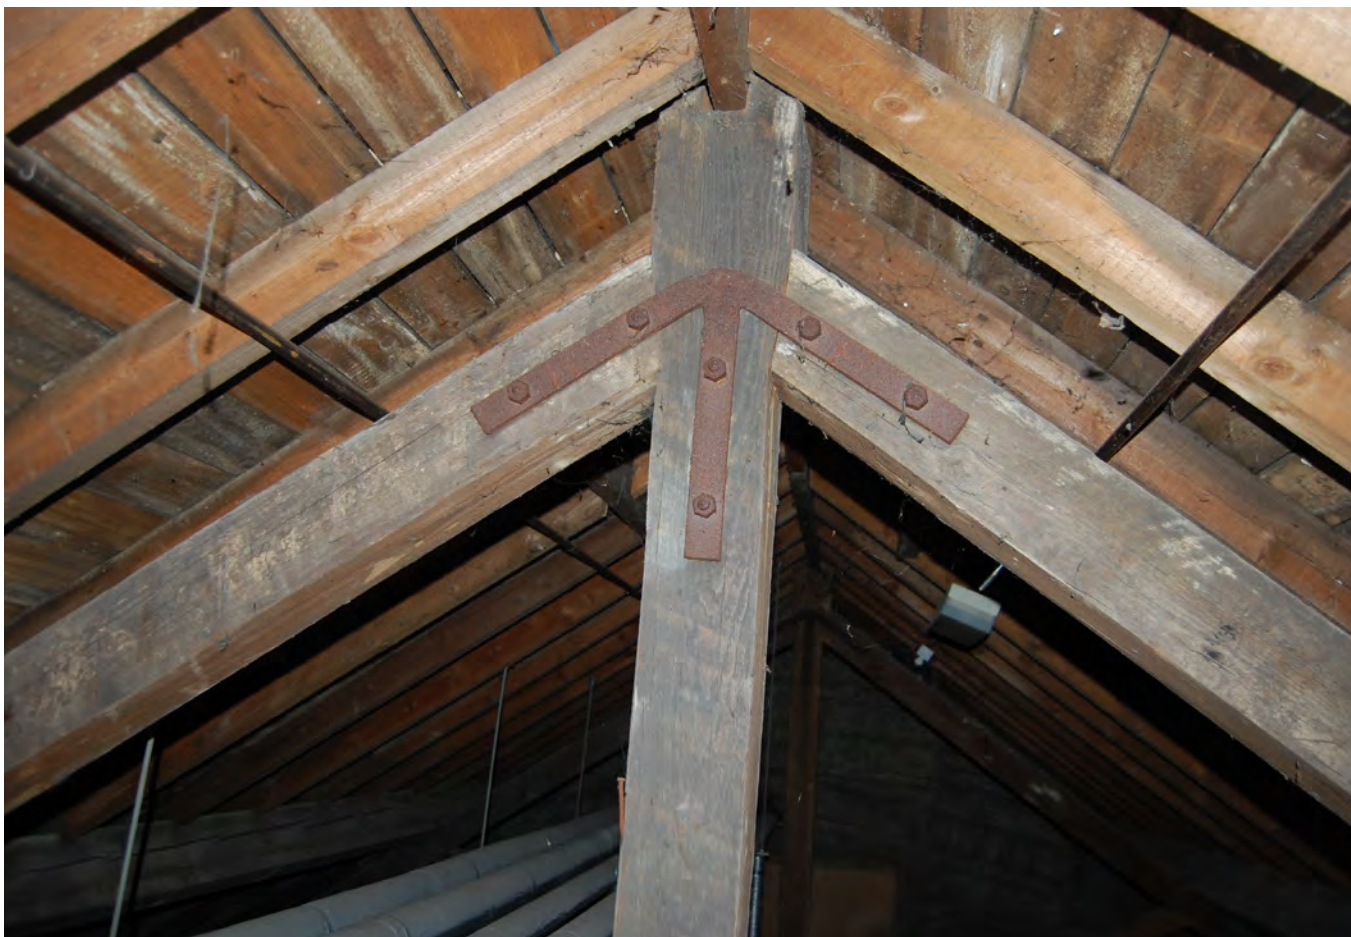
Plate 480.14 Roof ridge detail

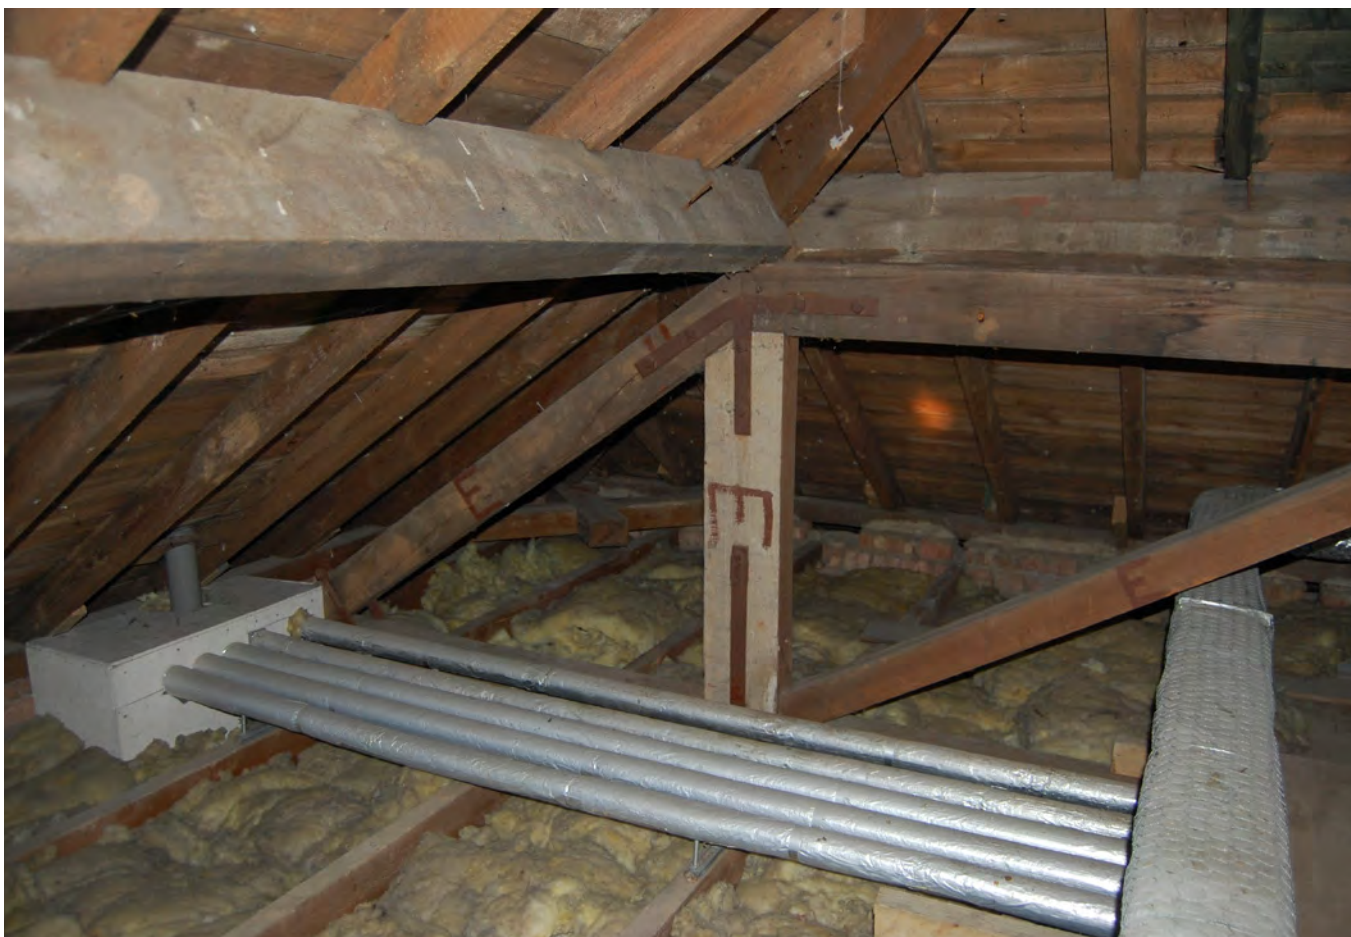
Plate 480.15 Truss apex detail

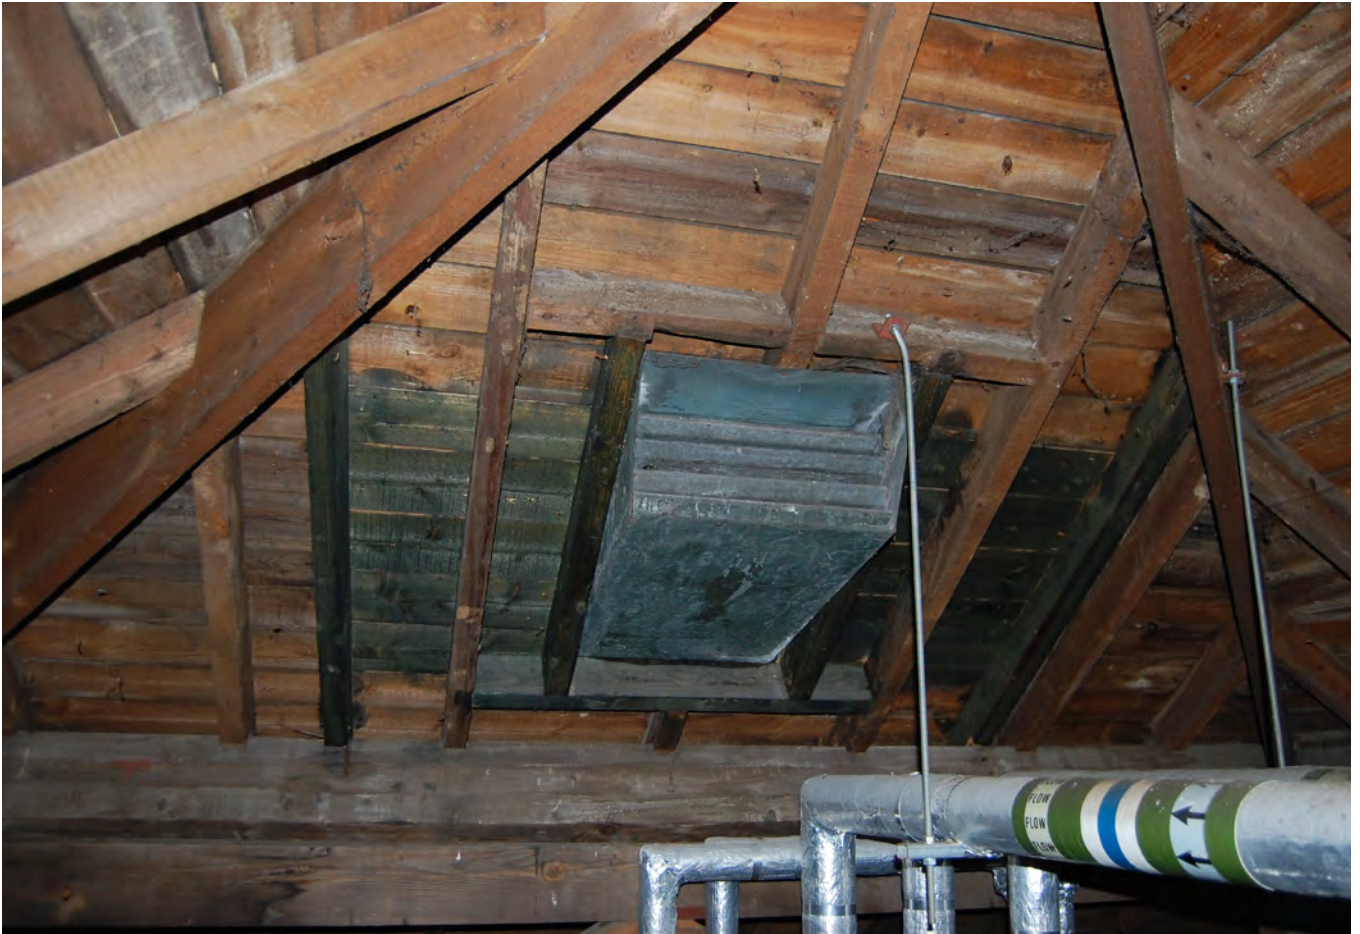
Plate 480.16 Truss detail

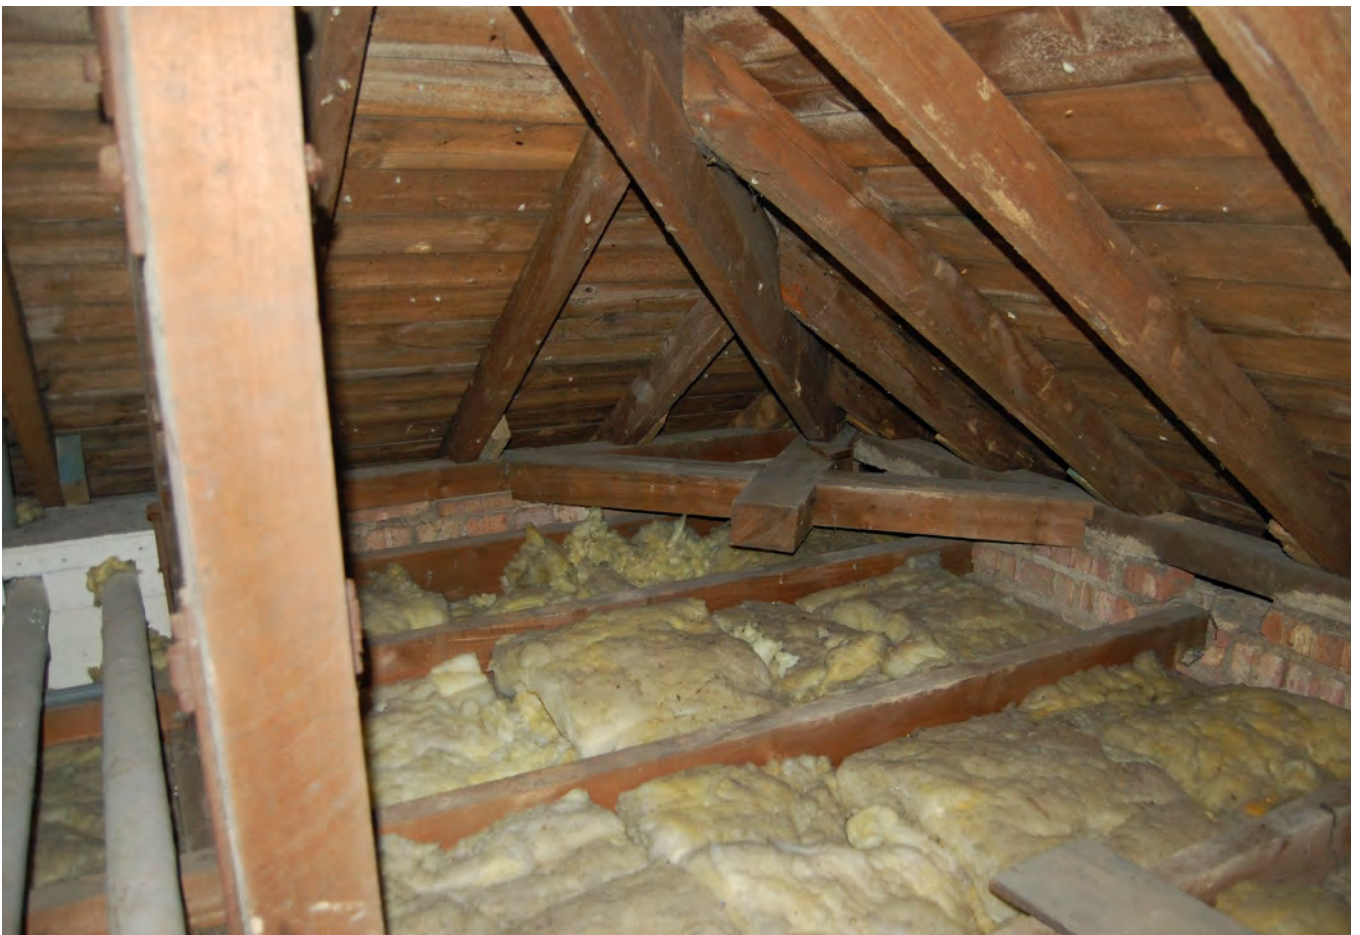
Plate 480.17 Vent in roof

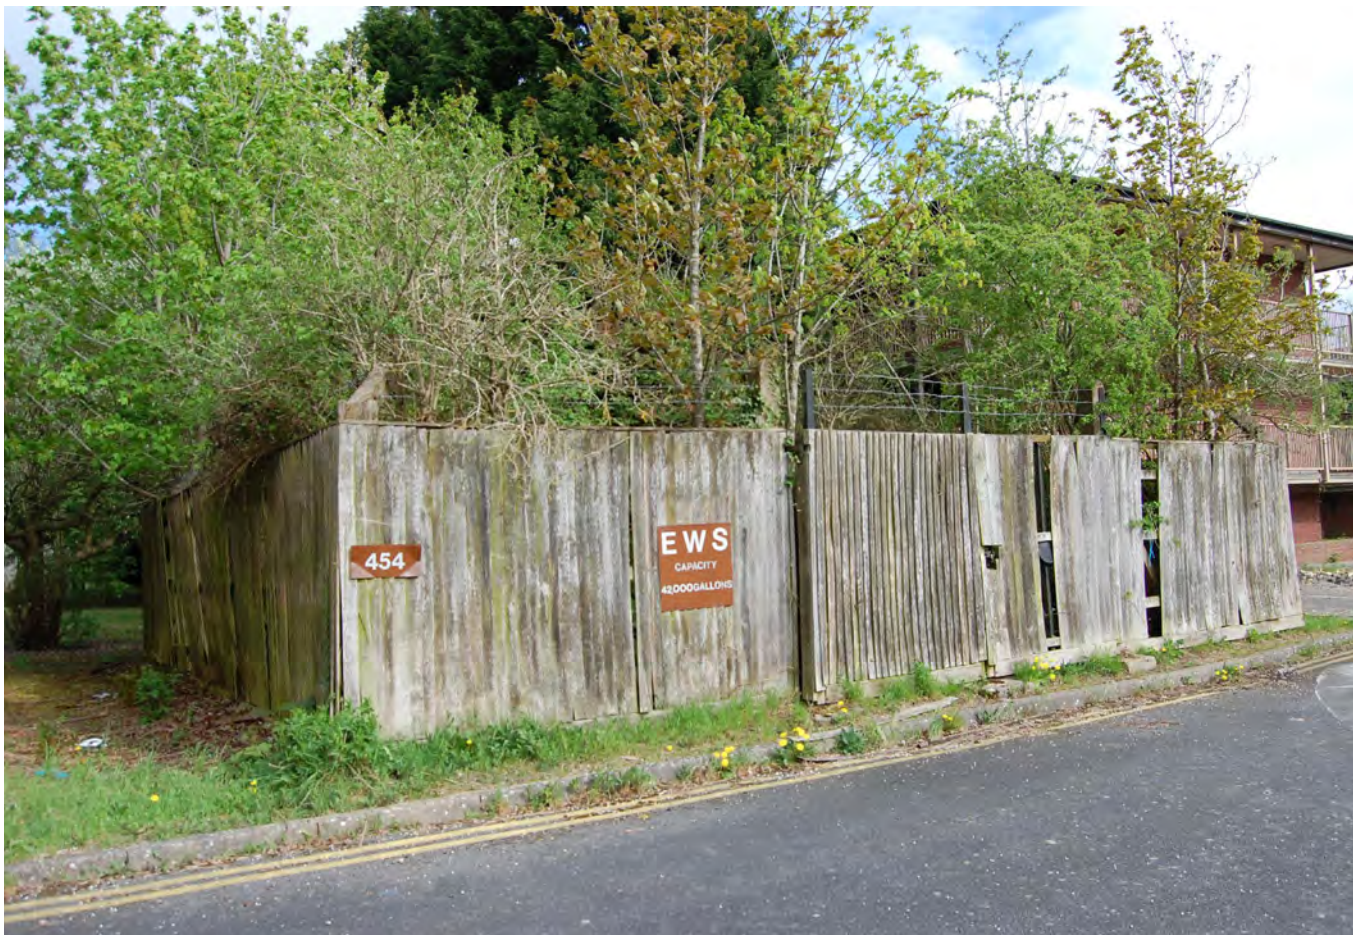
Plate 454.1 East elevation

The tank is constructed from concrete and roughly square in plan, it is 1.8m high with barb wire at the top (Plate 454.1). It is surrounded by a timber fence, making assessment difficult but it is possible to see the water reserve extant within the fence.

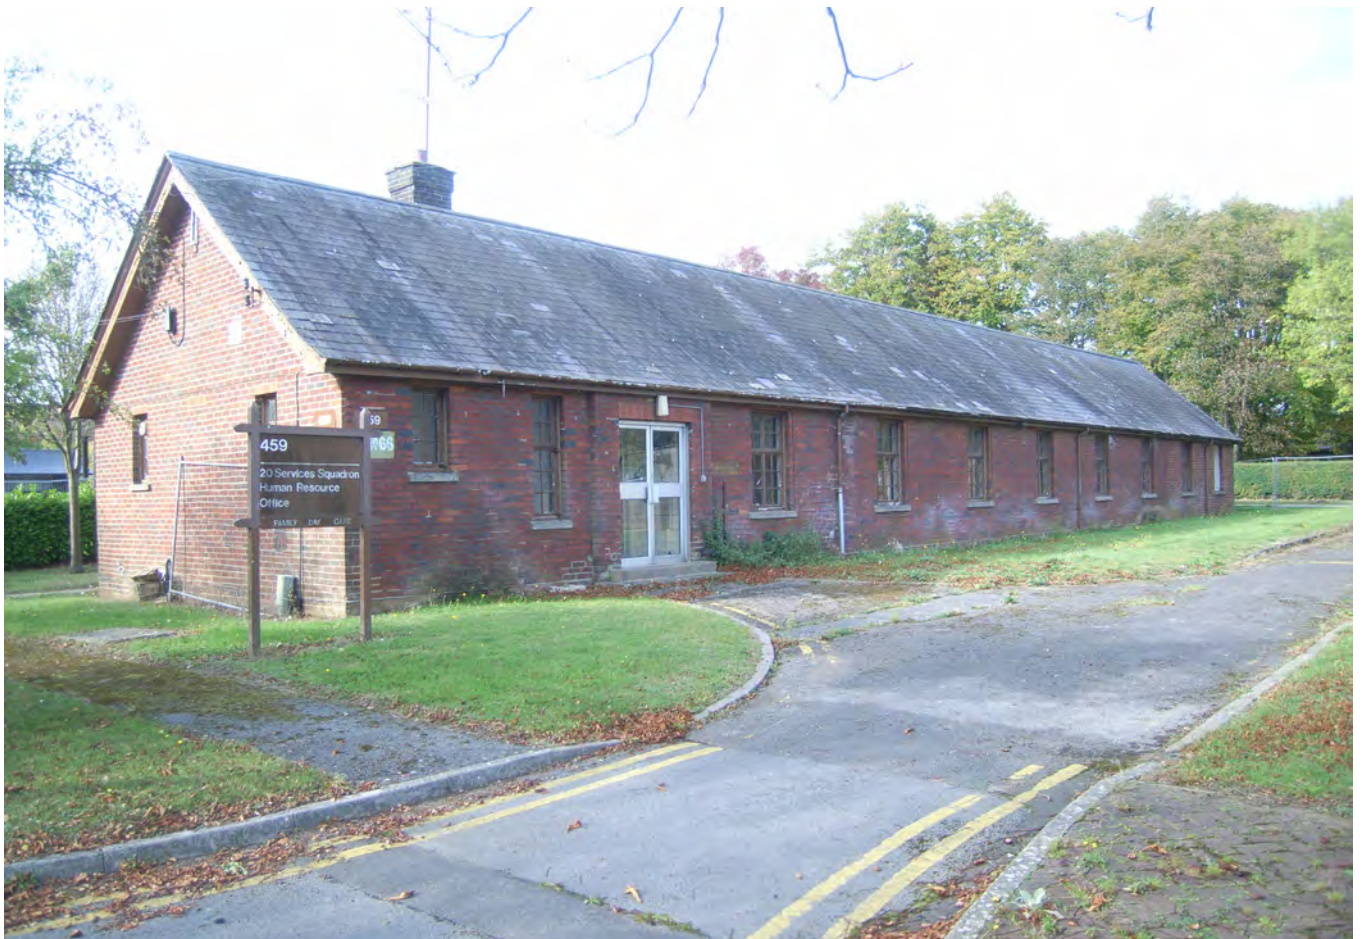
Plate 459.5 View from south-east

At the south-eastern corner of the building is a free-standing brown sign of a similar design to many others at Upper Heyford showing that Building 459 was used for the 20 Services Squadron Human Resource Office' Below this 'Family Day Care' has also been added to the sign possibly showing a later use (Plate 459.5).

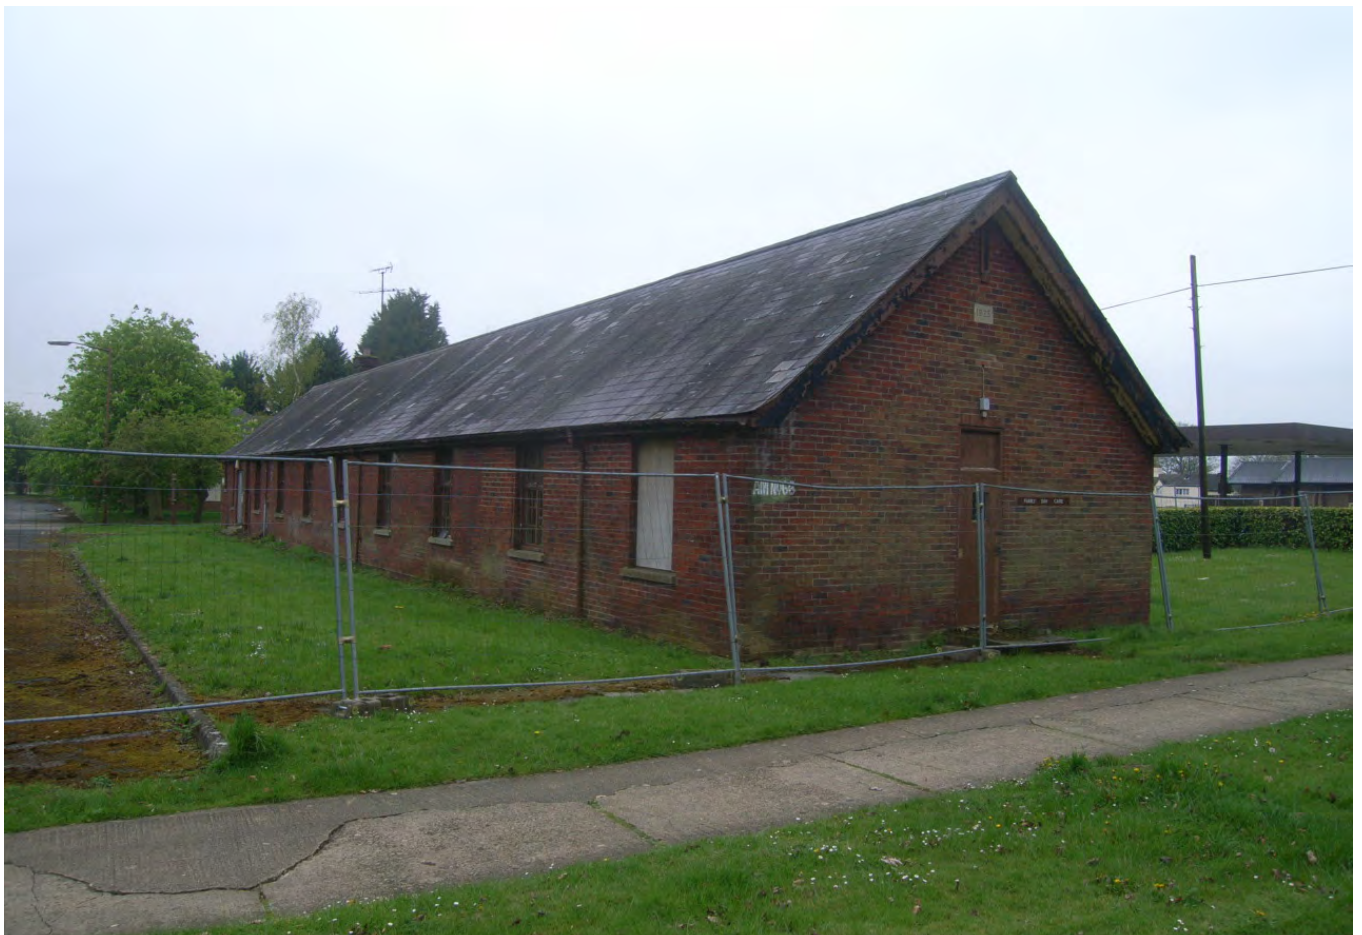
Plate 459.6 View from north-east

The *north elevation* has a central secondary door and no windows (Plate 459.6). The airfield plan from 1947 shows a pathway leading to a doorway at this end of the building and it may be that there was always an entrance at this end. The most interesting feature in the north elevation is a stone showing the date 1925. This is partly interesting as it appears to confirm the date of construction of the building but also the fact that it is on the extension which we know from map evidence post-dates 1926. It may be that the date stone was removed from the original north end wall when the extension was built and added to the new gable.

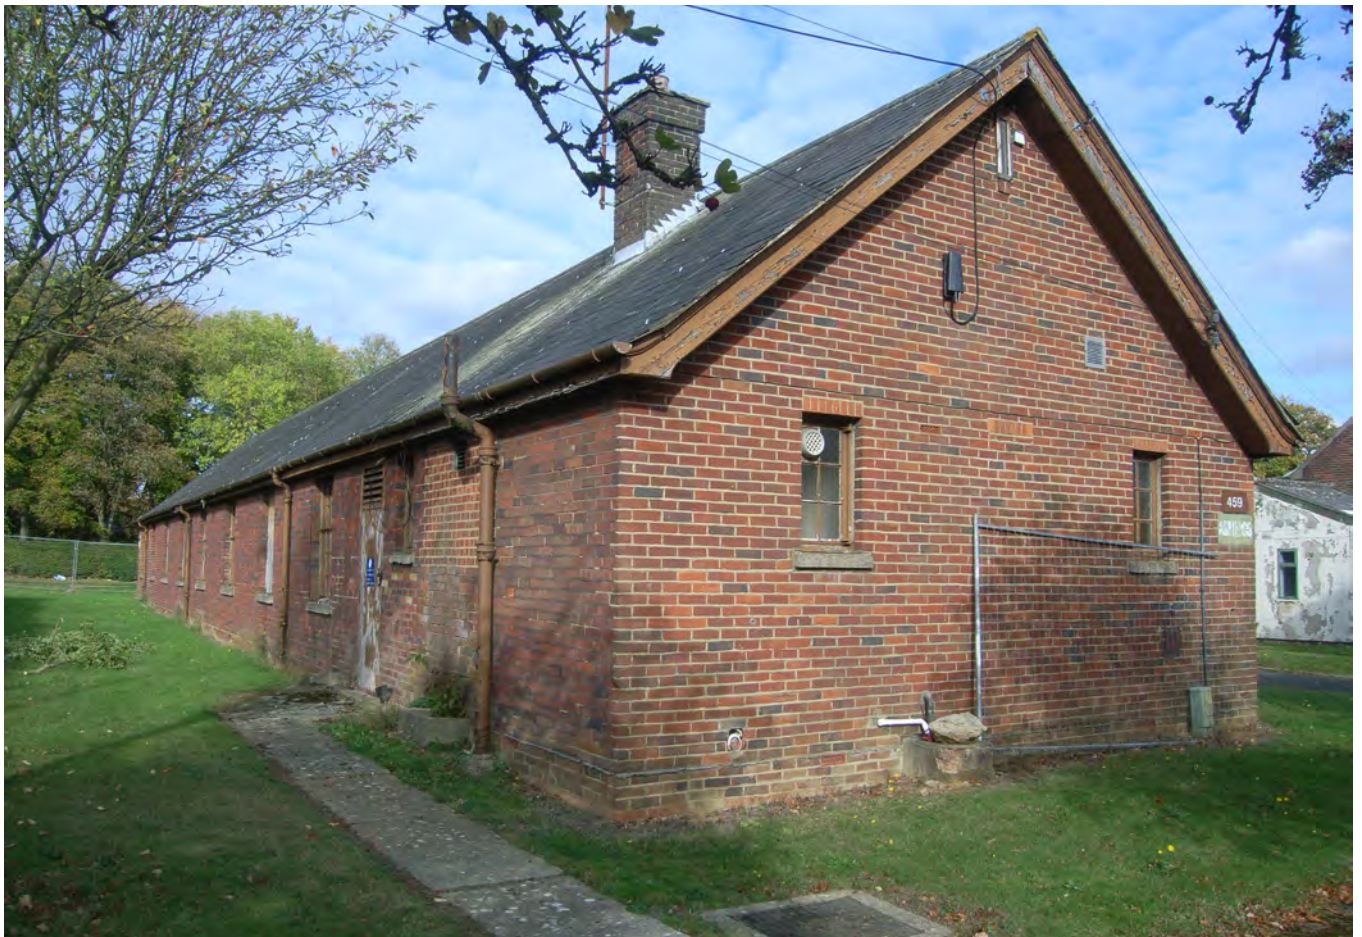
Plate 459.7 View from south-west

The *south elevation* has two tall thin 6-light crittal casement windows which would have illuminated and helped vent the utility/WC block as well as a tall thin vent at the apex (Plate 459.7). The 1978 plan shows that an existing central window was bricked up at this time and the brick soldier course from this remains in-situ.

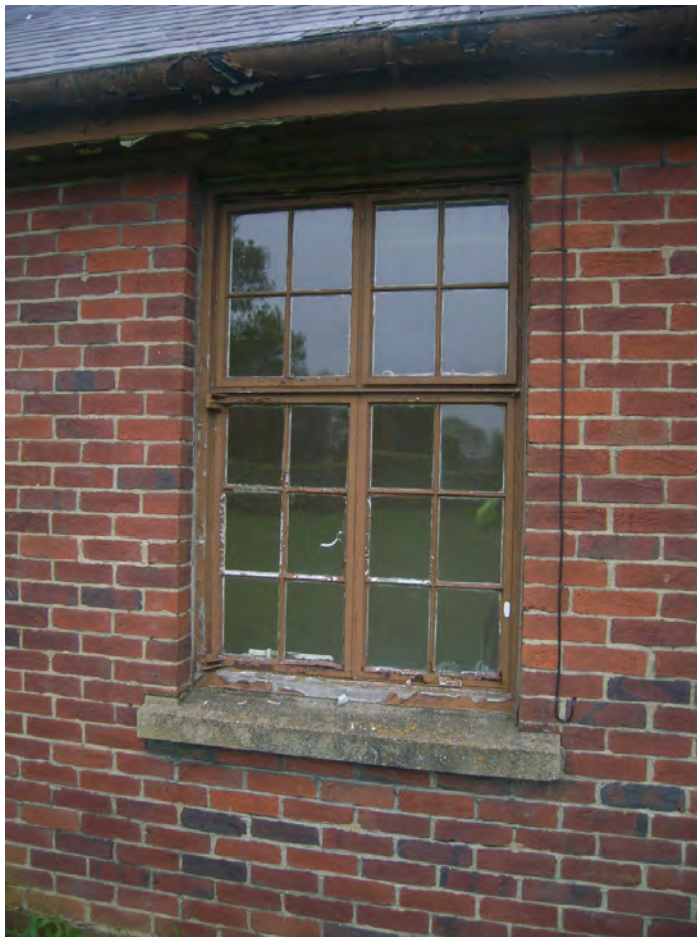
Plate 459.9 Typical primary window

The windows to the former bedrooms are generally original, metal-framed crittal-types with mullions and transoms painted a chocolate brown colour (Plate 459.9). Each main window has 4 casements (20-light) with two 4-light top-hung casements to the top and two 6-light side-hung casements to the bottom. The windows have concrete sills and they are beneath square-headed soldier course lintels although many of these are largely hidden by the boxed-in eaves. The boxed-in eaves has subtle

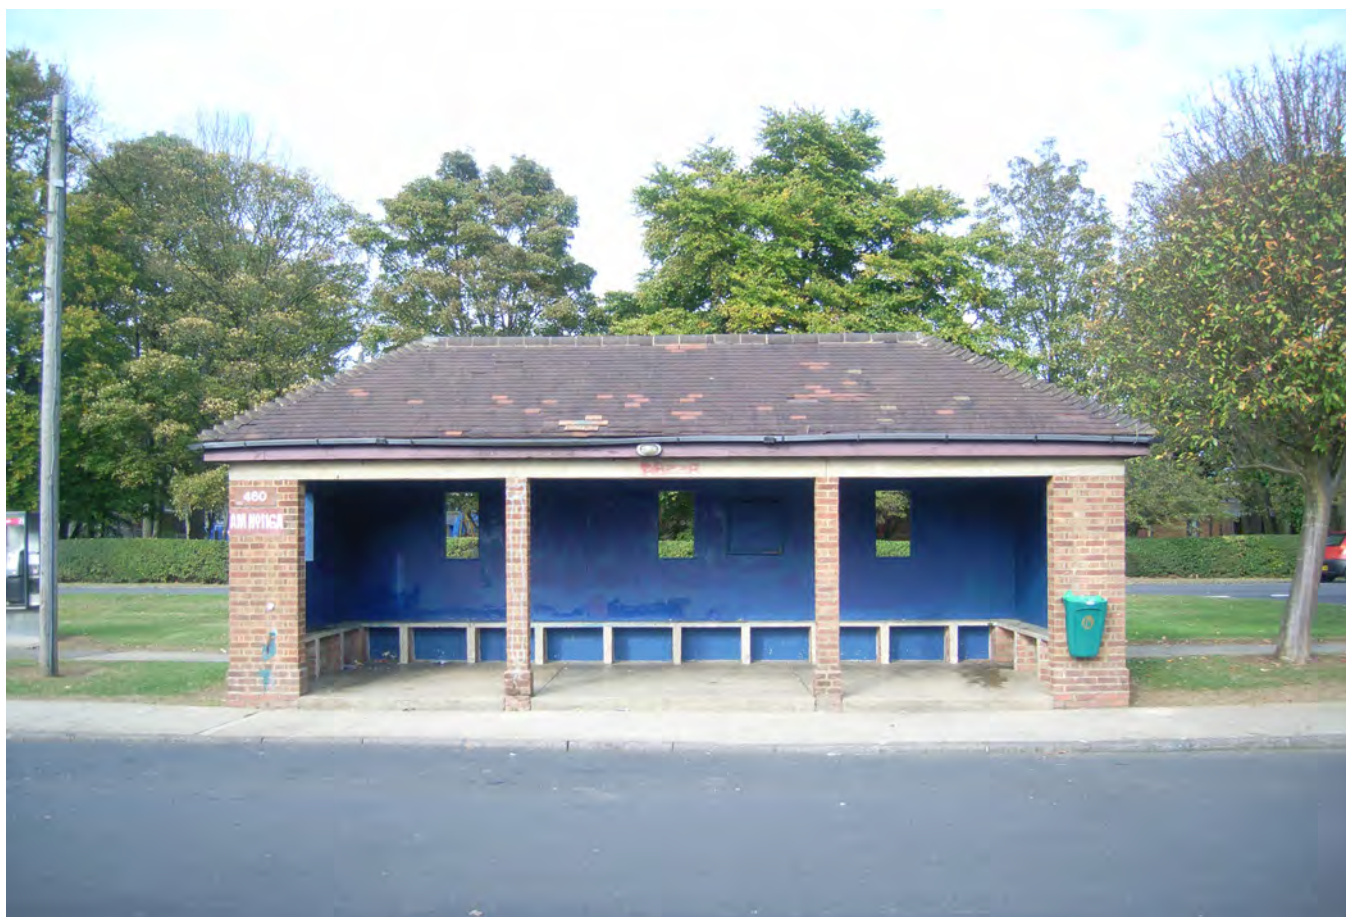
Plate 460.1 South-east elevation

The red brick bus shelter is rectangular in plan with a pitched tiled roof, timber fascia and simple brick openings instead of windows (Plate 460.1). A sign to the front elevation states 'AMNo.116A'.

The south-east (front) elevation has an open front with a roof supported on two brick pillars. An area to the front of the elevation allows buses to pull up and passengers to embark, the road loops round in front of the shelter entering and exiting from Camp Road to the rear. The north-west and south-east elevations have single rectangular openings within the brickwork, and the north-east (rear) elevation has three such openings. There are benches internally running along each elevation.

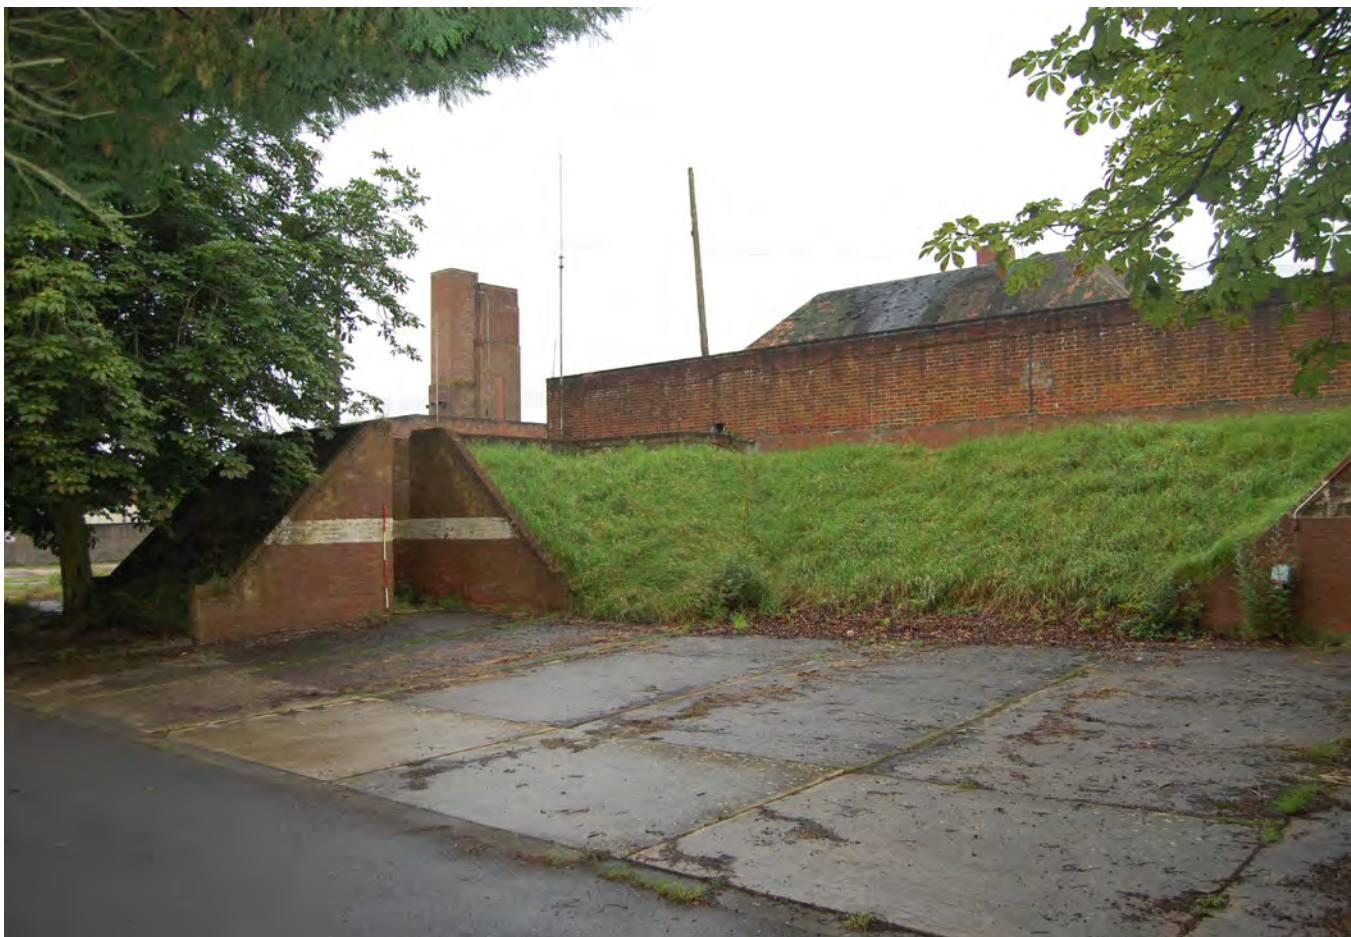
Plate 465.1 North-west (front) elevation

The Decontamination Centre is a windowless single-storey structure with 18-inch (0.45m) thick brick walls protected by earth banks (Plate 465.1). It is constructed in flemish bond with red brick which probably faces reinforced concrete walls beneath. The roof consists of a thick-section reinforced concrete lower sub-roof and a thin-section reinforced concrete upper roof, separated by a composite wall made of an inner skin of concrete and faced on the outside with 4.5-inch (0.11m) brick. In the centre of the lower sub-roof was a hipped-roof water tank house with thick-section reinforced-concrete walls that were cast as part of the lower roof. The protected tank house contained 4 500-gallon water tanks for the water closets and showers and was centrally located above the bleaching room. The cavity between the upper and lower roof sections was filled first with sand, then a layer of shingle so that the tank house had enough protection from the sand and shingle, the centre of the upper roof section was also hipped. This centre section can be seen prominently above a brick-parapet wall that hides the remaining flat concrete roof (Plate 465.2). The whole external surface of the upper roof was covered with asphalt for weather protection. A tall aerial extending from the roof indicates its secondary Cold War use as a Command Post.

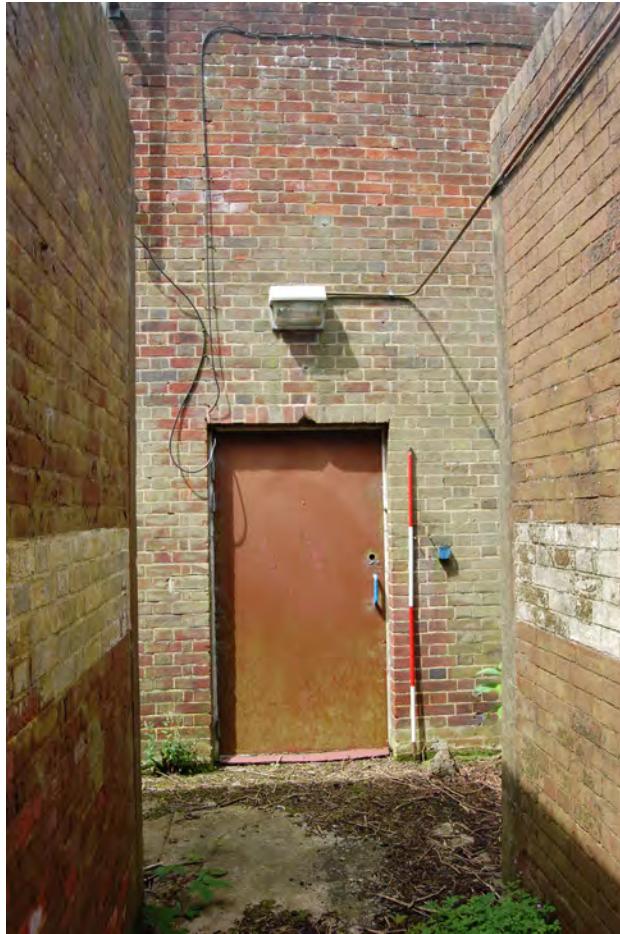
Plate 465.3 Metal door to front elevation

The north-east (front) elevation has two metal doors (painted brown) providing access to the bunker (Plate 465.3). The south-east door is accessed via a protected gap in the earth bank which surrounds the front elevation. The passage way (detailed as passage 1 on the 1985 plan, Fig.465.1) has tall brick walls (3.5m in height) to each side, and to the front (north-east) is a revetment which consists of brick walls surrounding an earth bank which provides additional protection (Plate 4). The north-west passage (passage 2 in Fig.465.1) is of a similar design with a revetment bank. The brick walls are 0.23m thick with reinforced concrete lining the inside, the red brick has a white stripe running roughly centrally along the brick blast walls. Closer inspection suggests that the brick has been painted red above and below the white stripe to enhance the external appearance of the building. The area between the two entrances is protected by an earth bank built between the two internal brick walls of the passage ways, with reinforced concrete lining the inner wall.

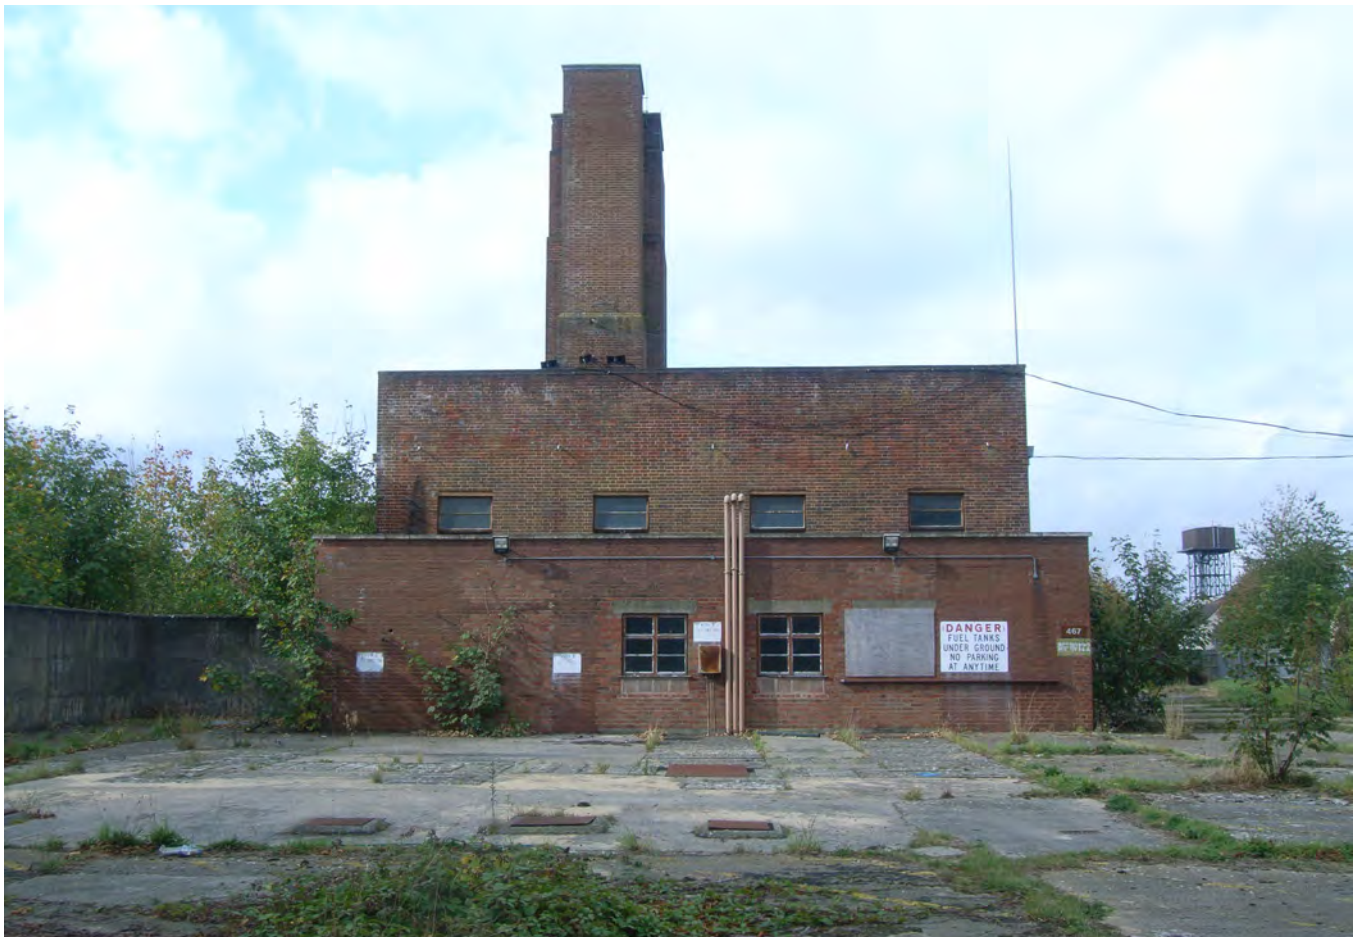
Plate 467.1 Front (south-east) elevation

The boiler house is a distinctive feature within the Barrack Area, it is a stark cube of brickwork housing the main plant out of which rises a slightly stepped brick shaft (Plate 467.1). It is constructed from red brick in Flemish bond, with a flat concrete roof built for protection against incendiary devices. It has large four light crittal windows set high with georgian wired glass. The building is single-storey to the front that is thought to be a later addition, and double height to the main structure which dates from 1925.

To the front (south-east) elevation of the building is a large concrete area below which are fuel holding tanks (see Plate 467.1). A large notice to the front elevation reads: *'Danger Fuel Tanks Underground, No Parking At Anytime'*. There are three manhole covers used to access below-ground and areas of concrete slabs. To the south-west a reinforced concrete wall runs from the front of the concrete area (adjacent to the road) alongside the south-west elevation of the building to the point the structure becomes double height, at which point it turns in to adjoin the building. This wall is reinforced concrete to the front face and 1930s red brick to the rear face (Plate 467.2).

were extant. This reorganisation of the front elevation may have been to allow for the installation of internal plant against the elevation (as described below) (see Plate 467.1).
