FORMER RAF UPPER HEYFORD, OXFORDSHIRE

HISTORIC BUILDING RECORDING AND INVESTIGATION

VOLUME 2: GAZETEER OF RECORDED STRUCTURES

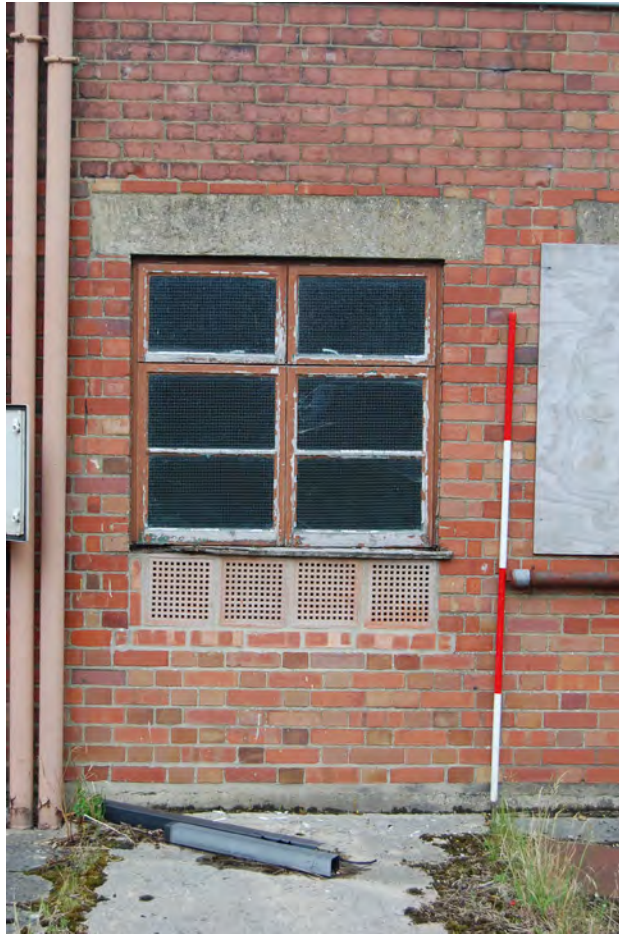
Plate 467.3 Front elevation, window and surrounding infill

The later extension to the front elevation has three windows centrally with concrete lintels, wood frames (painted brown with green paint visible beneath). Each window has six rectangular lights and georgian wired glass to act as reinforcement against a blast. Below the sills of the two south-west windows are four terracotta vents with a row of replacement brickwork beneath suggesting these are later additions. Centrally in the elevation are three pipes that extend from below-ground to above the height of the single storey front elevation bending down at the top. At the north-east edge of the elevation, the building number is on a brown metal plate with 'Am No 122' painted in white on green below this.

Surrounding the three windows is a large area of replacement brickwork, and to the south-west of the windows are two further areas of infill (one larger one to ground level and roughly door sized, and a smaller one above which is roughly 10 courses of brickwork in height). At the very south-west of the elevation (at the corner) is a further area of infill which is roughly 20 courses in height and two bricks deep (see Plate 467.2). The infill around the existing windows is evident below the windows to ground level, and surrounding the windows to the height of the lintels. The bricks above the existing windows appear to have been cut to facilitate the insertion of the window (Plate 467.3). Above the north-east window (which is boarded up) is a further area of infill which is level with (and just below roof height) to the area of infill described to the south-west of the building. It is possible that the two existing windows are later insertions, and that to either side of these two windows doors

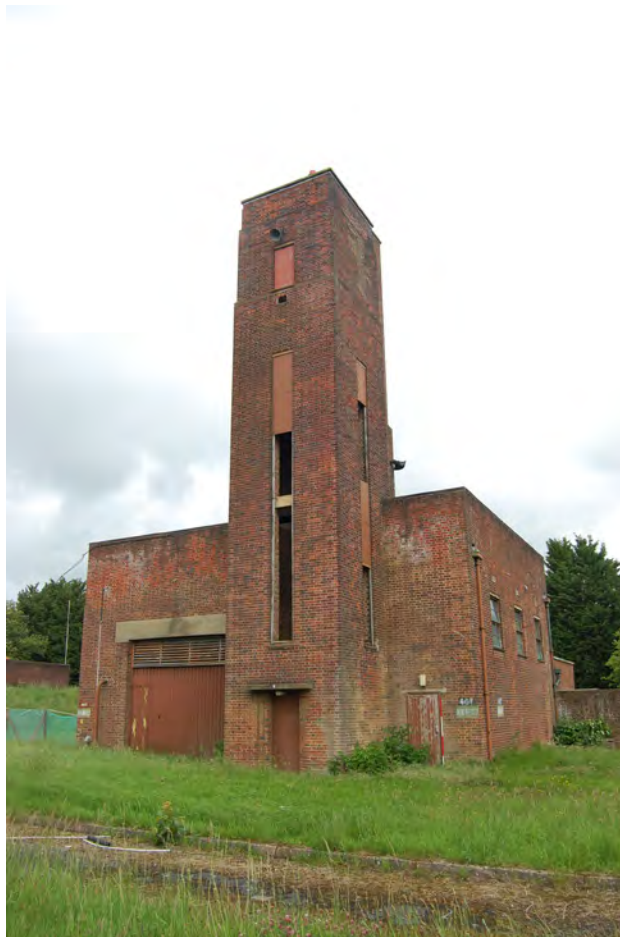
Plate 467.5 Rear elevation and brick shaft

The brick shaft at the rear of the elevation has a central panel of metal sheeting, several panels of which are now missing (also evident on the north-west and north-east elevations described below) (Plate 467.5). This is held in place by a timber frame on the internal edge of the brickwork, onto which the sheets are attached. The brickwork is slightly recessed at two points towards the height of the chimney typical of Art Deco fashion, with concrete capping above. There is an area of repair on the south-west face, clearly delineated by the light coloured mortar at the top of the chimney.

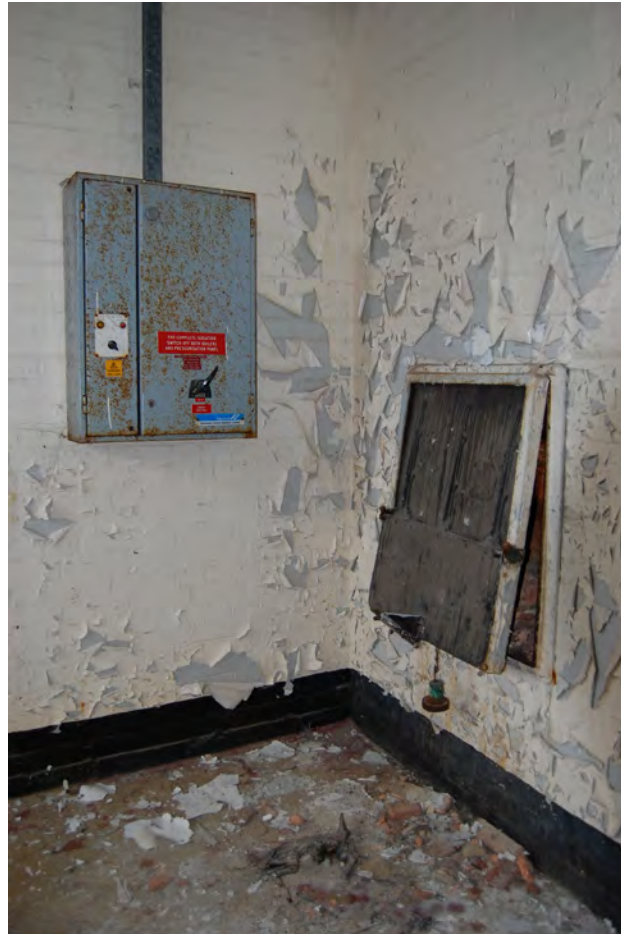
Plate 467.13 Internal view of flue, at west corner of boiler room

The key feature of the north-west (rear) elevation is a tall flue which extends from the face of the rear elevation. A timber door (painted brown) provides access to the flue which has stepped headers to either side of the door providing some architectural embellishment typical of the Art Deco period. Above the entrance is a flat concrete roof (Plate 467.6). As described for the south-west elevation, the flue has a central panel of metal sheeting, some of which are missing at the base, and a canopy at the survives at the height of the flue.

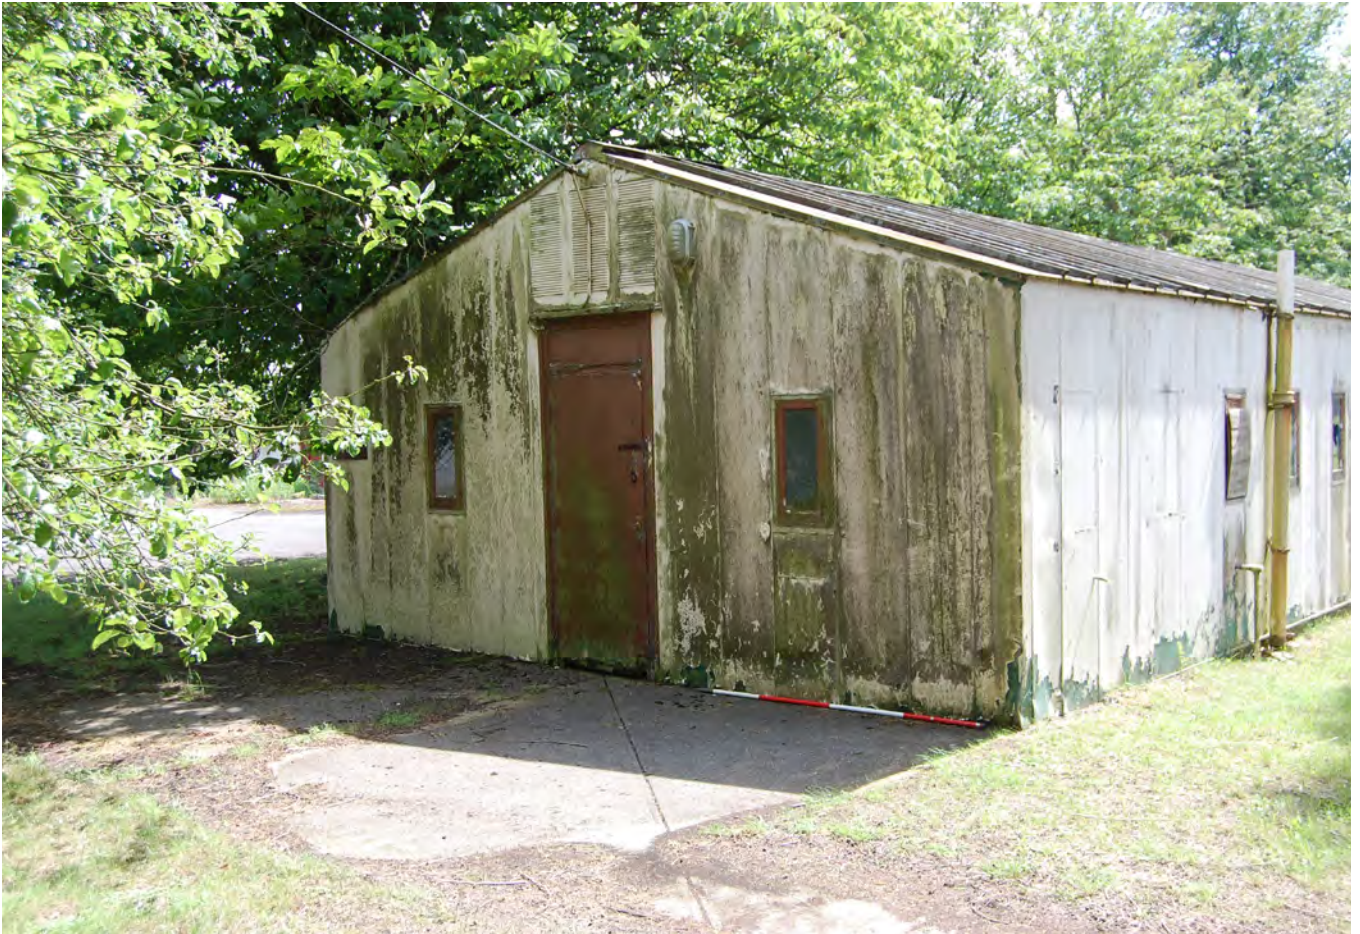
Plate 468.1 Front (south) elevation

This small rectangular hut (14.6m by 6.12m) is constructed from metal panels (painted white with earlier green paint visible beneath) on a concrete base (Plate 468.1). The gabled roof is made from inter-locking metal panels. The north and south elevations have central timber doors with single-light timber framed windows to each side, situated below the roof's apex are three vents. The east and west elevations have twelve single-light windows, although two are blocked up at the north end of the west elevation.

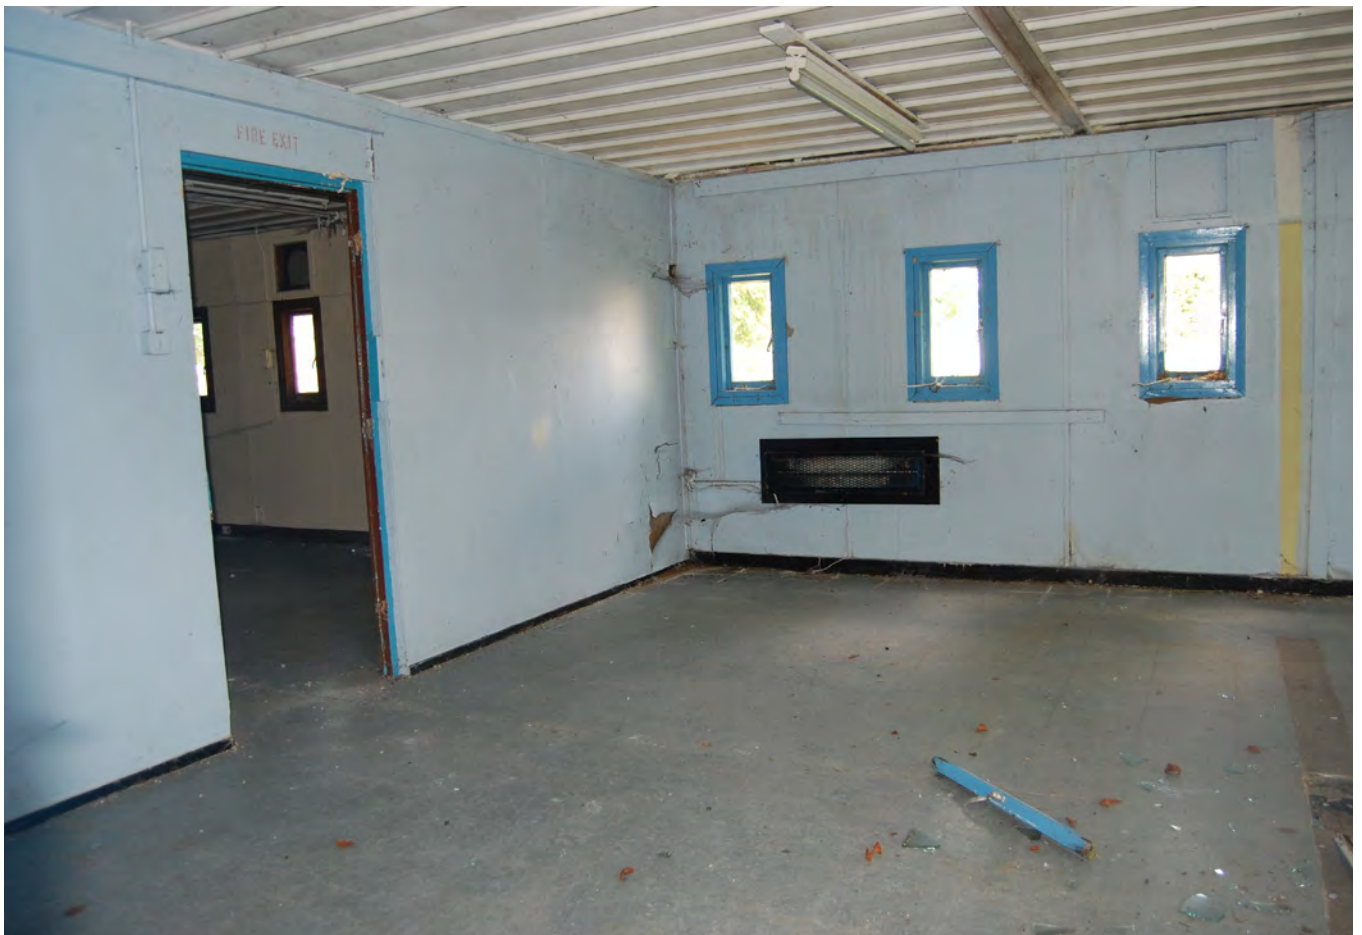
Plate 468.2 Internal view of north room

Internally, the hut is roughly divided into two areas by a partition wall, with the south end further divided in the west half into a bathroom and store-room. The main entrance is at the south end where there remains a minimalist decor consisting of a lino floor, white walls and strip lighting. There is an opening (no door) connecting the north end of the building to the south which has the same decor albeit blue walls and frames (Plate 468.2).

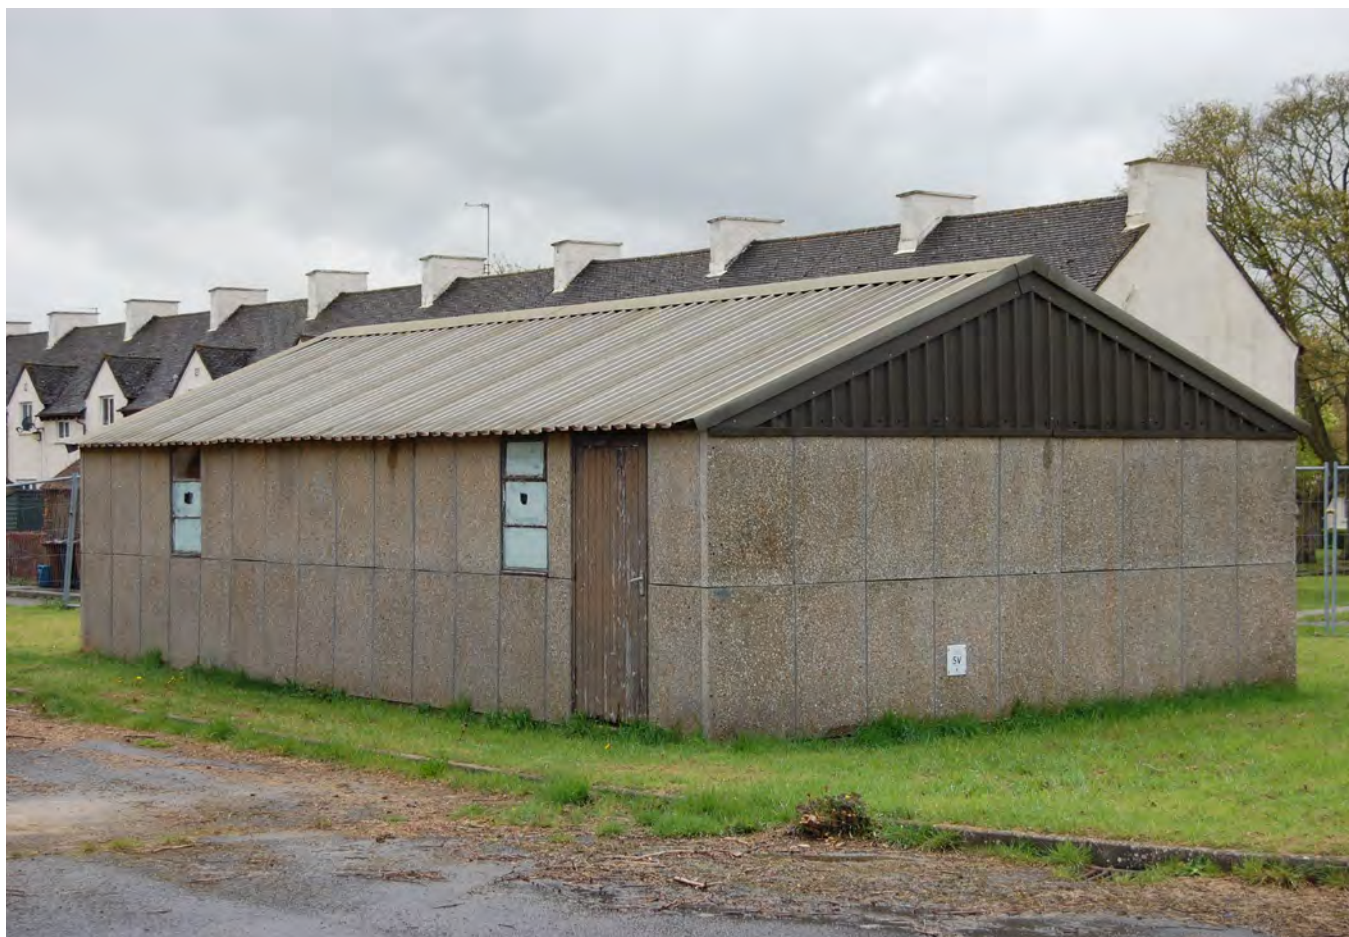
Plate 470.1 North-east elevation

The north-west elevation has no features of interest, the north-east elevation has two windows and a single door providing access to the north-west end (Plate 470.1). The south-west elevation has two windows. The rear (south-east) elevation appears to have been rebuilt in breeze blocks, although it too has been pebble-dashed.

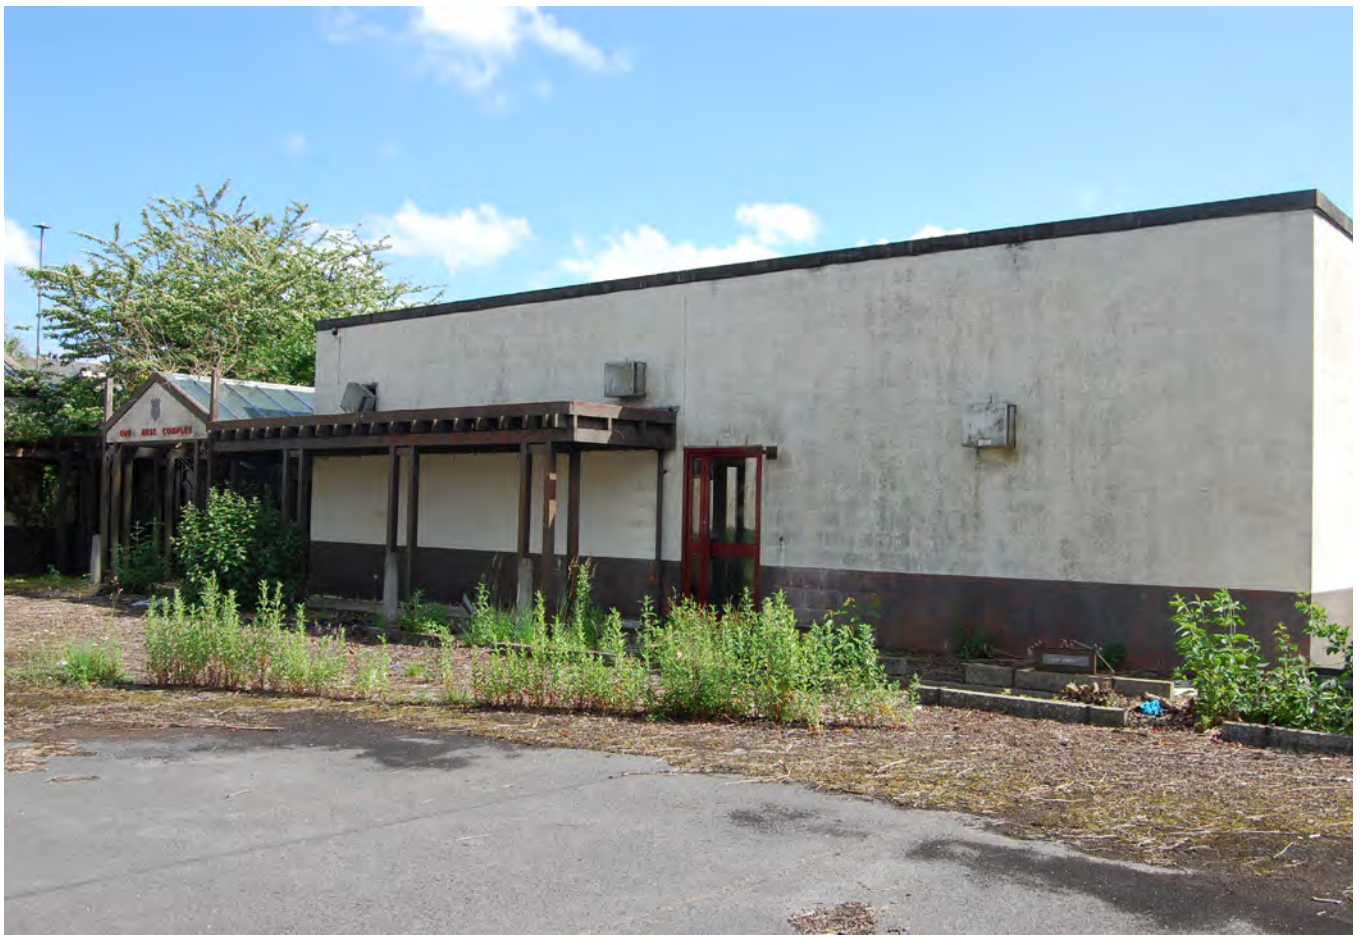
Plate 472.2 Entrance on north side of building

The north facing elevation of building 472 is split into two sections: the projecting east half is the north wall of 472B (Plate 472.10) dates from c.1950 while the west half forms a secondary (1980s) element of 472A (Plate 472.2).

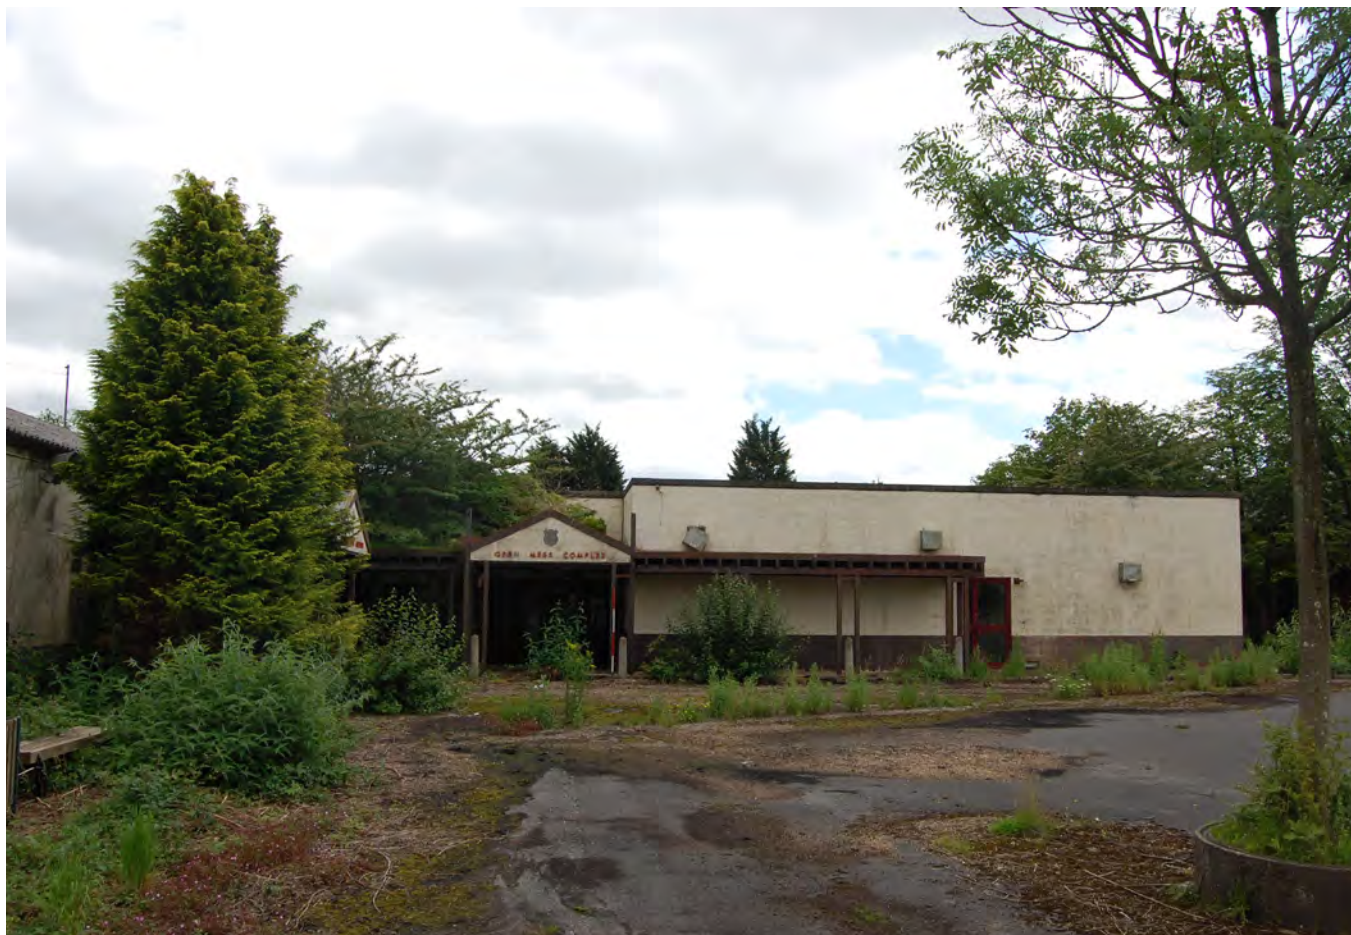
Plate 472.3 Entrance on north side of building

The *north facing* elevation of 472A is set well back from the north wall of 472B and provides the main entrance to the Mess Complex with the car parking area to the front (Plate 472.3). The entrance is within the later flat-roofed central range which connects 472A and 472B and which was built during the remodelling of the base for the USAF during the 1970/80s. The canopy entrance is very much of the period with a pitched timber roof supporting glass roof lights supported on timber posts, with a sign 'Open Mess Complex' just below the apex of the canopy roof (Plate 472.2). The entrance leads into an internal foyer area via red metal framed glass doors, within this foyer area is an example of war art (OA 2013). There is a single large rectangular window to the east of the entrance door, and to the west the building steps out to the north with a single red metal framed glass door. In front of the elevation the covered entrance extends to the east and west, in front of which are car parking spaces for military personnel ('CMSGT', '20FW/SEA' and '20FW/CC'). Extending from this to the east and west is a covered area, also constructed on timber posts with a flat roof held on timber rafters. The remaining east element of the north elevation is of breeze block construction with a flat roof of little architectural merit, it has three box shaped vents and a metal and glass door providing another point of access.

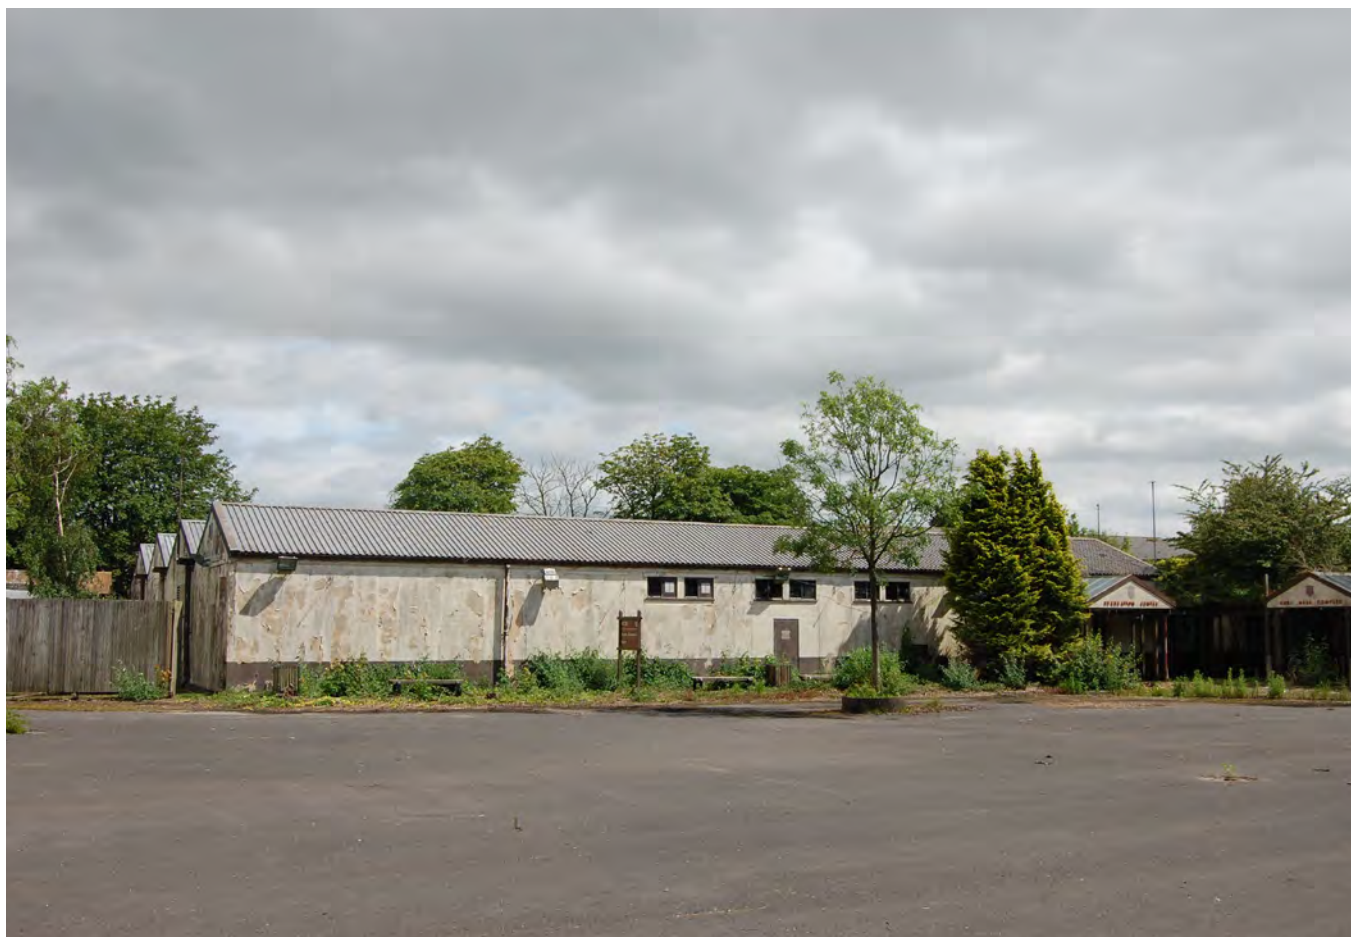
Plate 472.4 West side of northern range

The *west elevation* is constructed from precast concrete panels to the north (ie 472B [Plate 472.4]) and blockwork to the south (472B [Plate 472.8]). The north section faces the parking area and is part of the c.1950 construction of Building 472B. There are three sets of two small rectangular windows, within one of the panes of the north set of windows is a metal vent. Below the central set of windows is breeze block infill which has a single timber door (painted brown) within the blockwork but with no handles. Presumably there was previously a much larger entrance here. At the south end of the elevation is a porch entrance (of the same style as the north elevation). The concrete blockwork used at the west end of the flat-roofed link structure appears to be different to the rest of the concrete blockwork to the west elevation and may be from a slightly earlier phase of alterations (1970s).

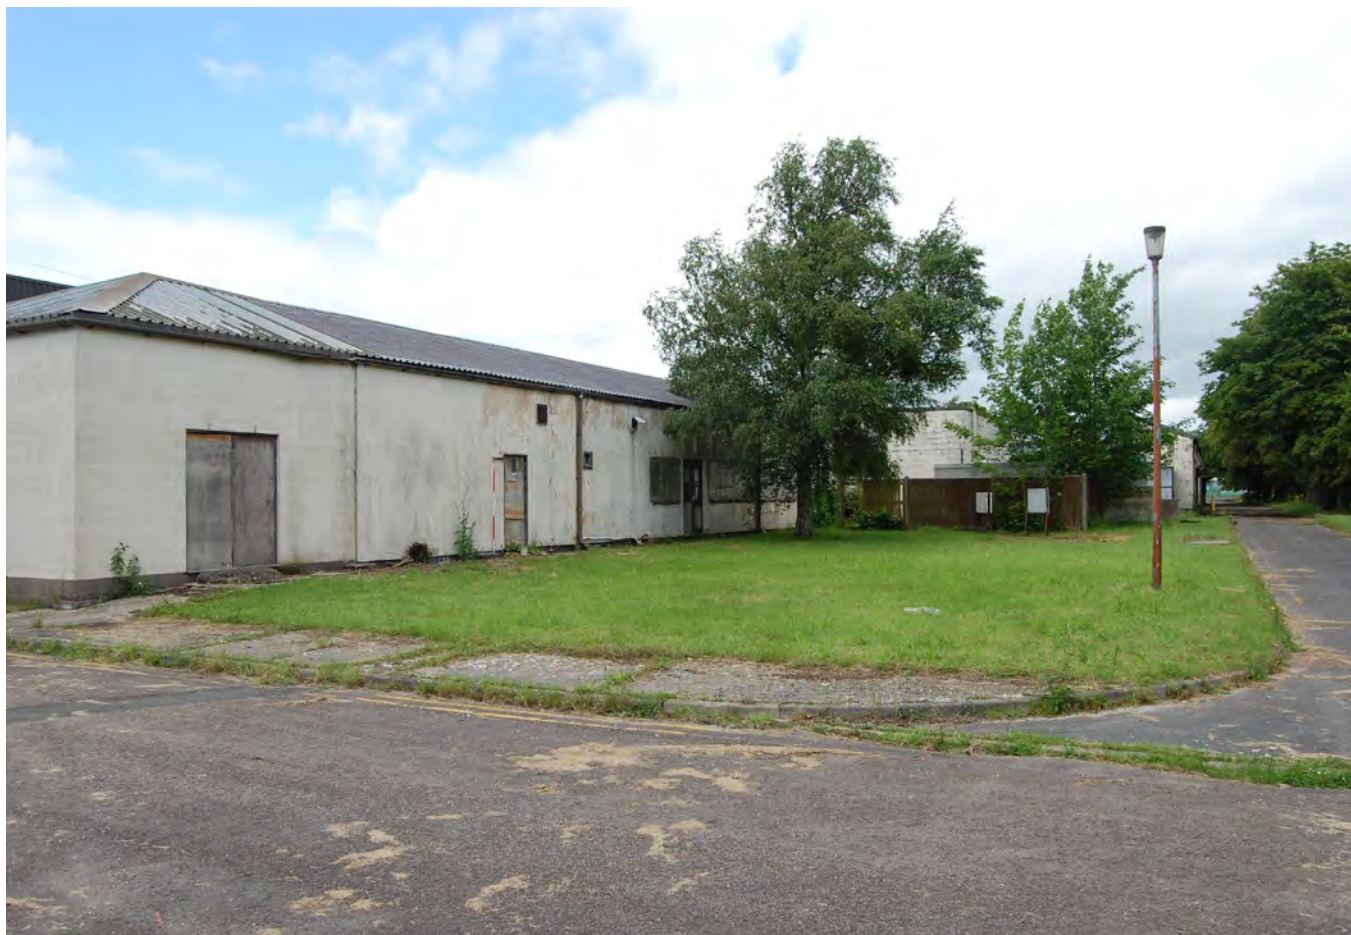
Plate 472.11 South-eastern corner of building

The main part of the east elevation of 472A is also formed from primary (c.1950) vertical concrete panels and this is the only substantially surviving primary external wall from 472A (Plate 472.11). The panels are painted cream and this section has seven critical windows (1.5m by 1.2m), each with three large rectangular and one small light, and timber sills. With the exception of the north window these are now boarded up. A double timber door is situated within the row of windows at the south end, which has four glass lights and a timber sill with a light overhead. The roof is pitched with later metal corrugated sheeting, this appears to be a later replacement and it is possible that this was once higher in profile. The east end of the flat roofed range between 472A and 472B is formed from concrete block, possibly dating from the 1970s while at the southern end of this elevation is a further section of concrete block which probably dates from the c.1984 alterations.

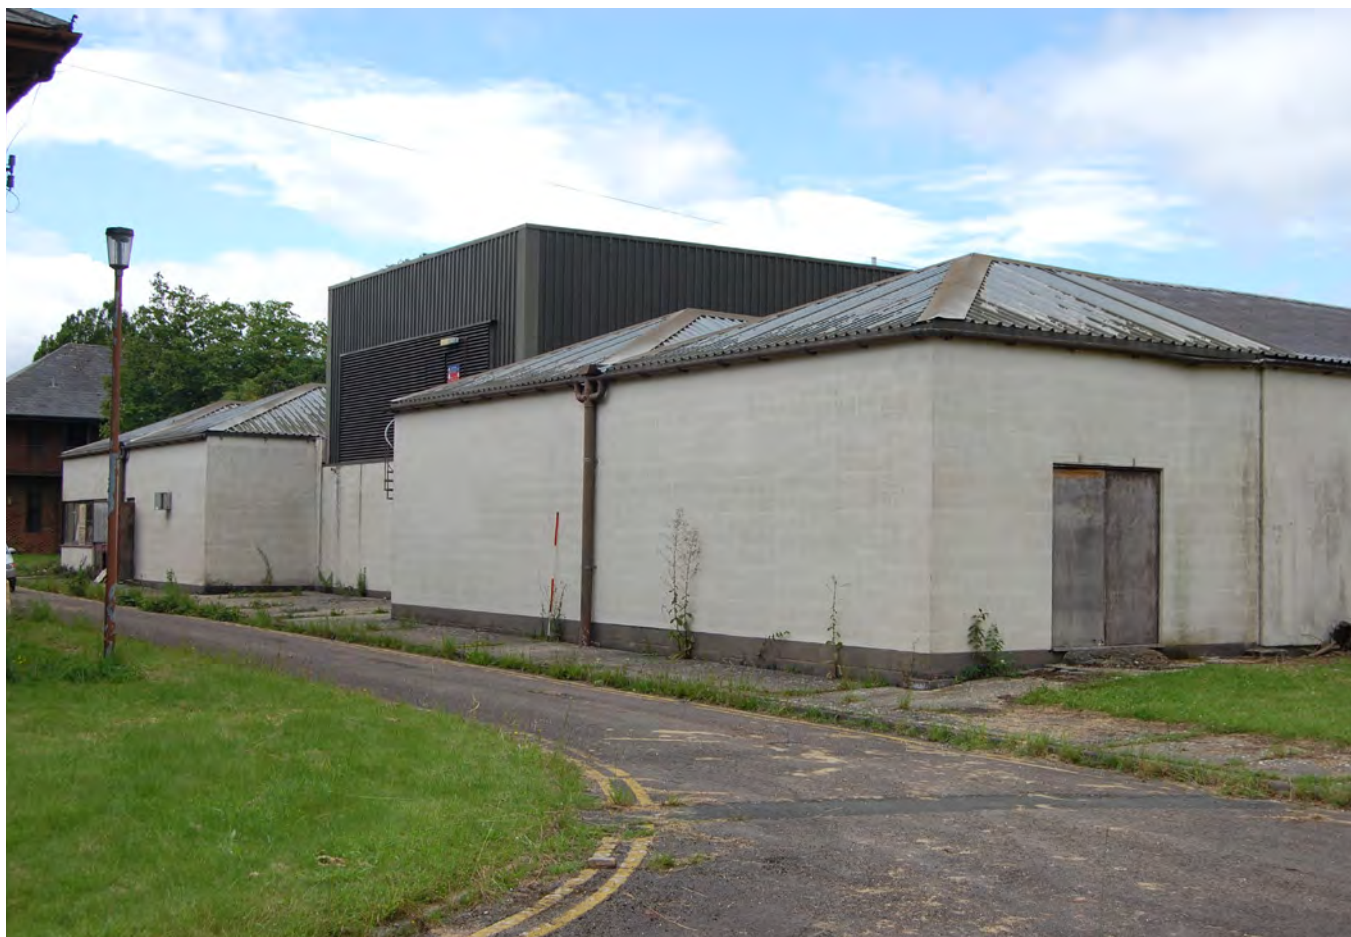
Plate 472.12 South-eastern corner of building

The *south (rear) elevation* is predominantly within building 472A and is constructed from blockwork (painted cream), probably dating from the 1984 works (Plate 472.12). There is a small section of the rear of Building 472B visible which is described below. At the very west of the south elevation a small section of the building projects to the west, which is part of the large ballroom. It has five large rectangular modern red framed which are in keeping with the building as described below. The large proportion of the rear elevation sits directly on the road, opposite building 485. At the west end are four rectangular windows (0.84 by 1.3m) and a set of double doors, all of which are red plastic framed with darkened glass in keeping with the remaining building. There is a single timber fire door immediately to the east of this, which provides access to the service area at the rear of the bar (see internal description). This rear element of the building has a double-pitched corrugated metal roof. Set back from the main rear elevation by 2.5m is a plant area also constructed from breeze blocks with a large area of vents above, metal cladding and a flat metal roof. The top metal clad section can be accessed by a door at the top of a metal spiral staircase. To the east of this and set directly on the road the remaining elevation of the 472A is blockwork and contains no features of interest (15m in width). It is possible to see a small section of the rear elevation of 472B with the upright concrete panels supporting the pitched roof, although the majority of the elevation is hidden behind plant.

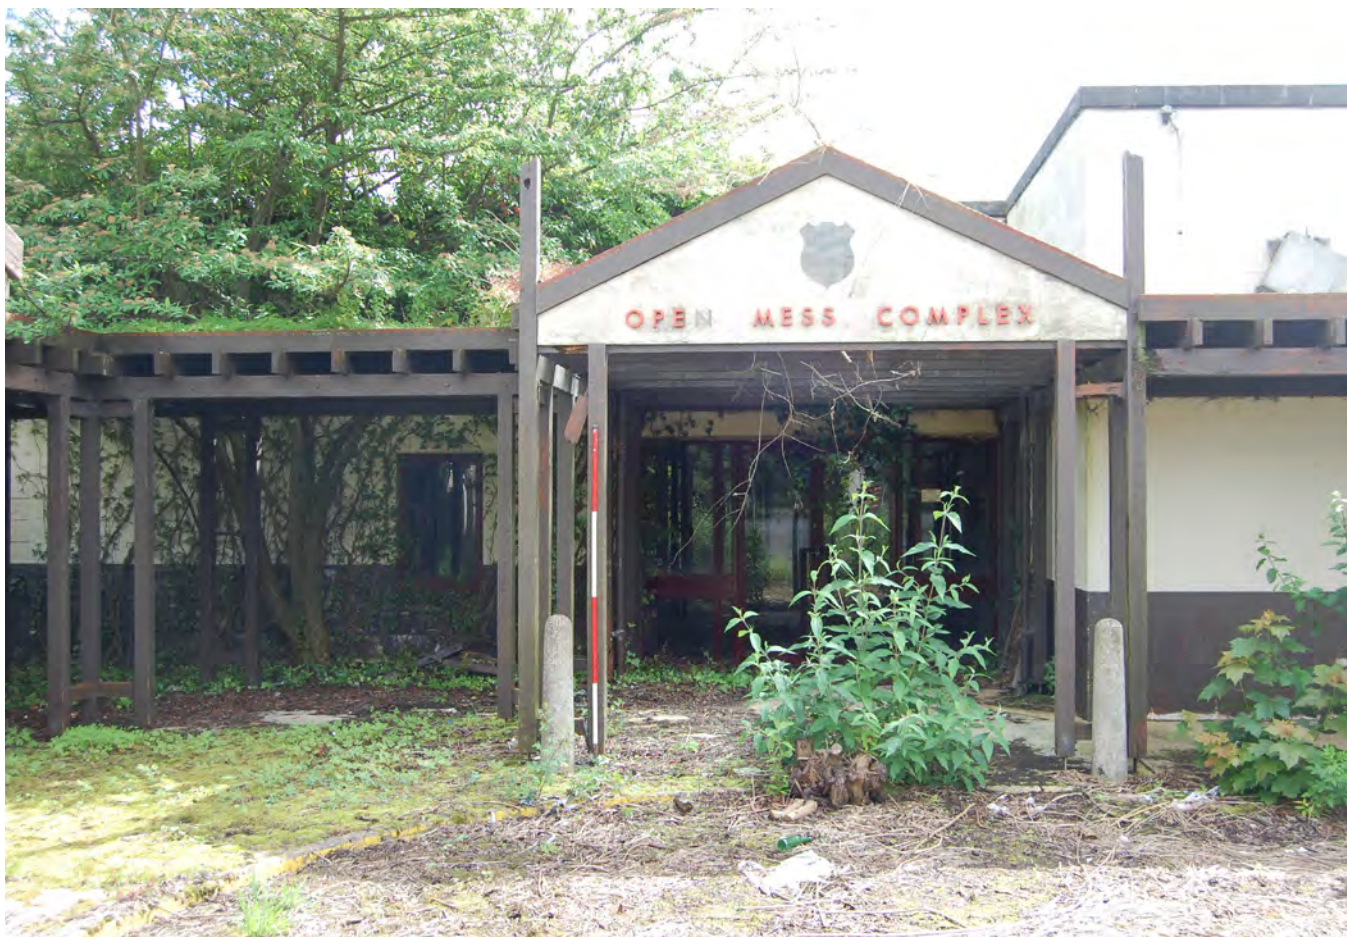
Plate 472.14 Detail of entrance on north side

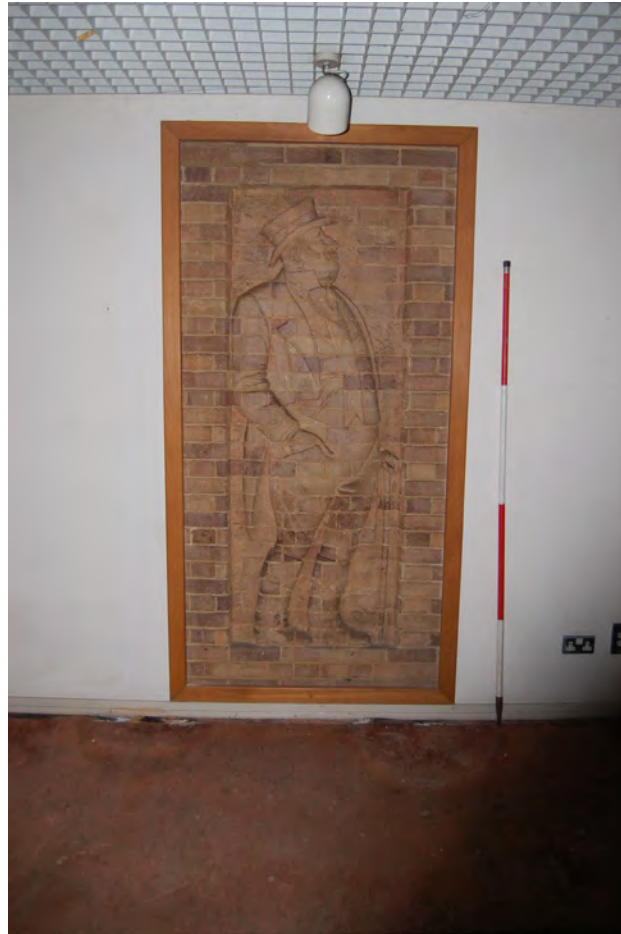
Plate 472.19 John Bull brick relief in hall

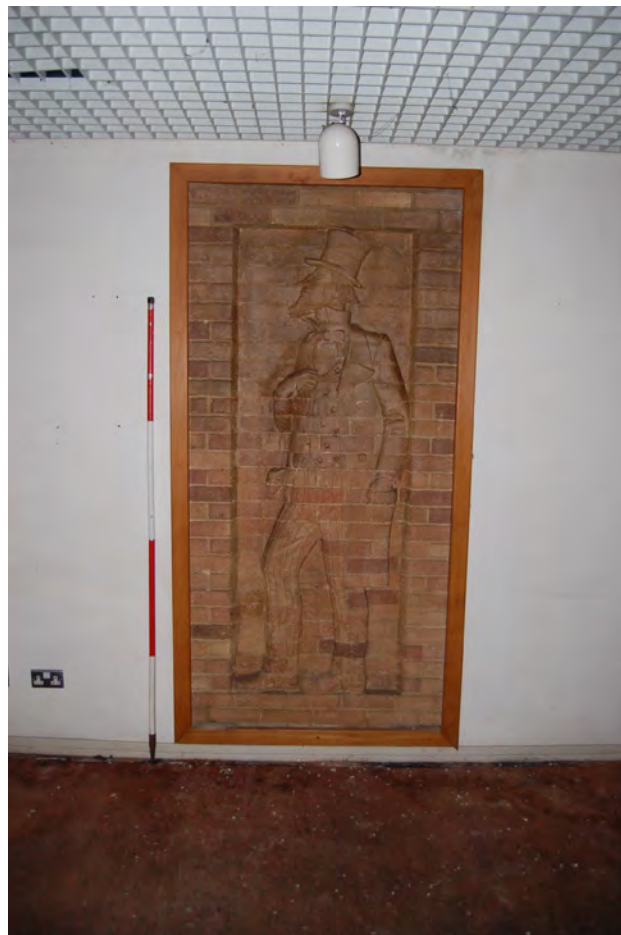
Plate 472.20 Uncle Sam brick relief in hall

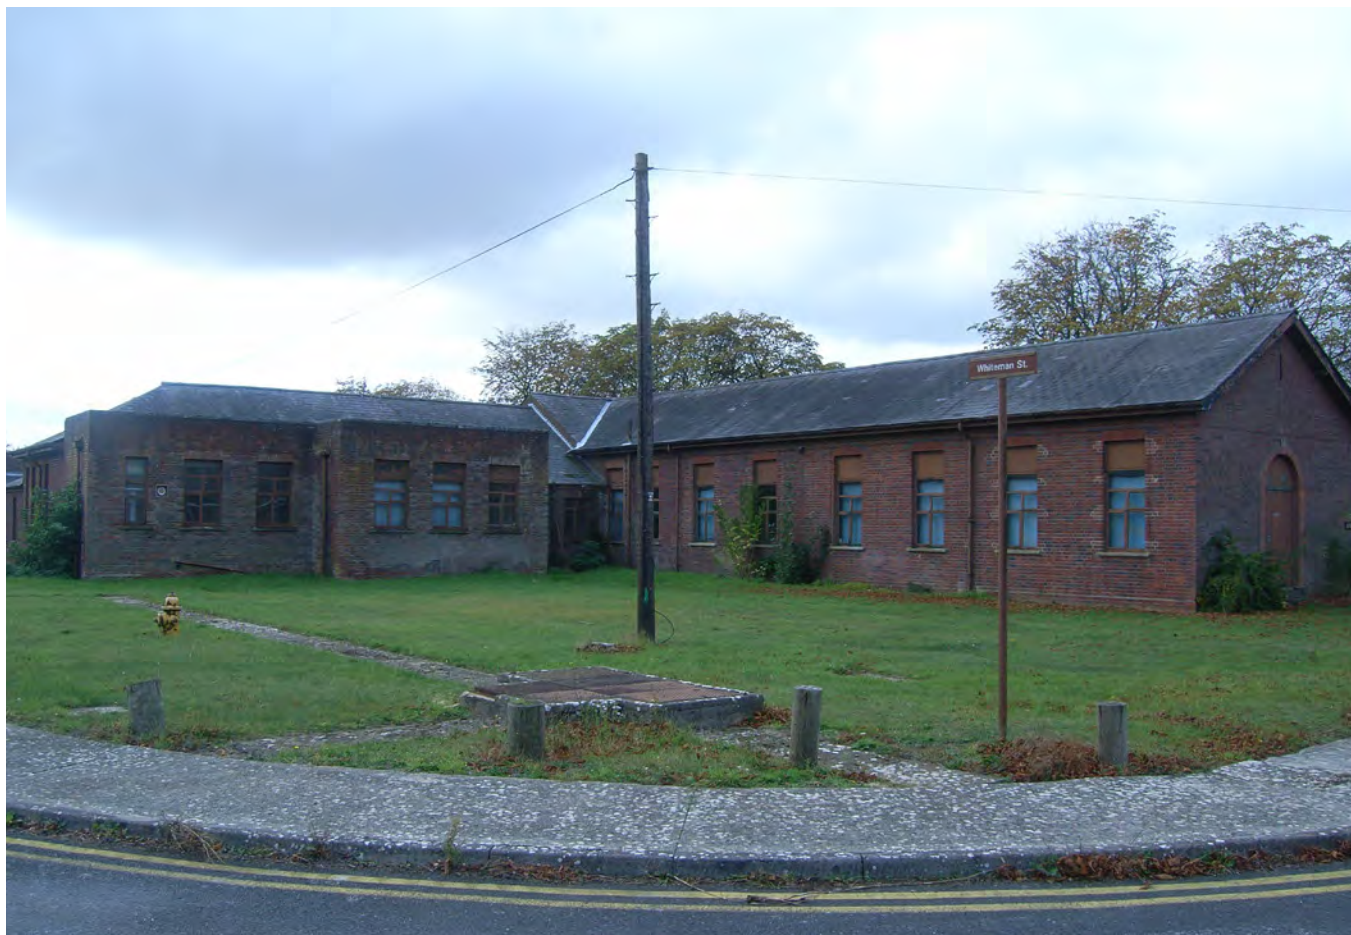
Plate 474.1 General view, looking south west

The cross-shaped building is aligned roughly north – south with the principal façade to the west elevation facing the former Parade Ground; the rear of the building is facing the access road and contains the service rooms including the ablutions which were formerly the kitchens (Plate 474.1) (Fig.474.2). The window frames and panels, doors, rainwater goods and other woodwork are painted in the standard brown colour evident throughout the airfield; the former dark green scheme can be seen in most elements where the paint has peeled.

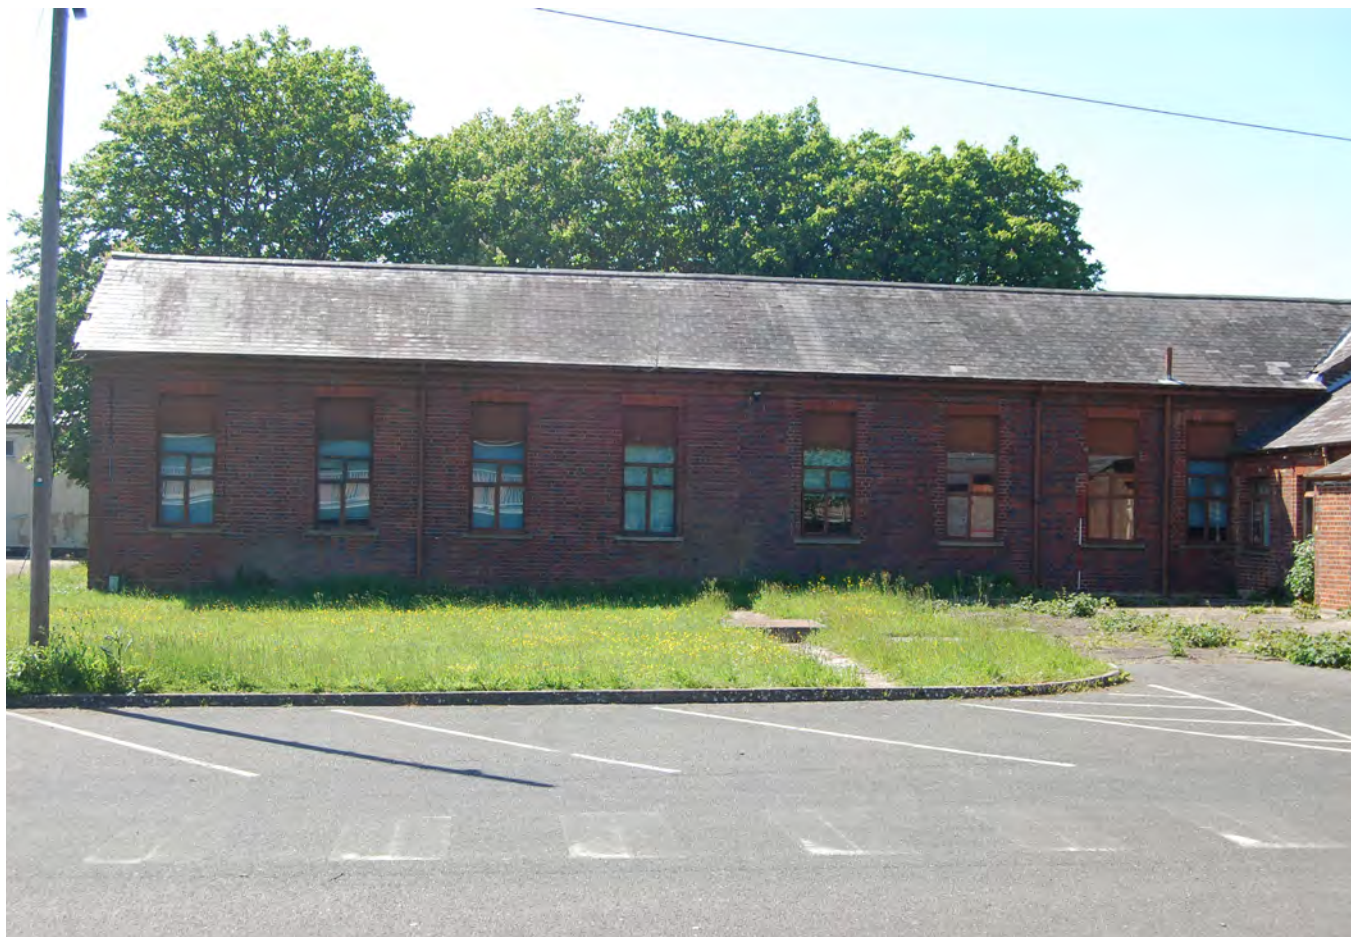
Plate 474.2 East elevation, southern end

The north and south wings were doubled in length at the time of the building's conversion from a dining room to a barrack block, shown clearly in the east and west elevations of the wings via the join in the brickwork between the two central windows and a very slight undulation in the roofline (Plate 474.2). The roof and brickwork are in keeping with the original as are the window openings with their brick flat-arches above and concrete sills, however, all of the window frames have since been replaced. The door in the gable wall of the western range appears to have been the original main entrance and a date stone of 1925 is set in the gable above the brick relieving arch of the doorway (Plate 474.3). The door is a fairly modern replacement set between brick pilasters with a small porch set on brackets over. The fanlight above the porch was probably boarded over at the same time as the upper light on the surrounding windows when the suspended ceiling was installed c1978 or when the current window frames were installed at a later date. The 1977/8 elevation drawings suggest the windows at that time were of 15 panes, set out in a row of three panes at the top with two sets of two rows below giving the impression of a sash window with a light above.

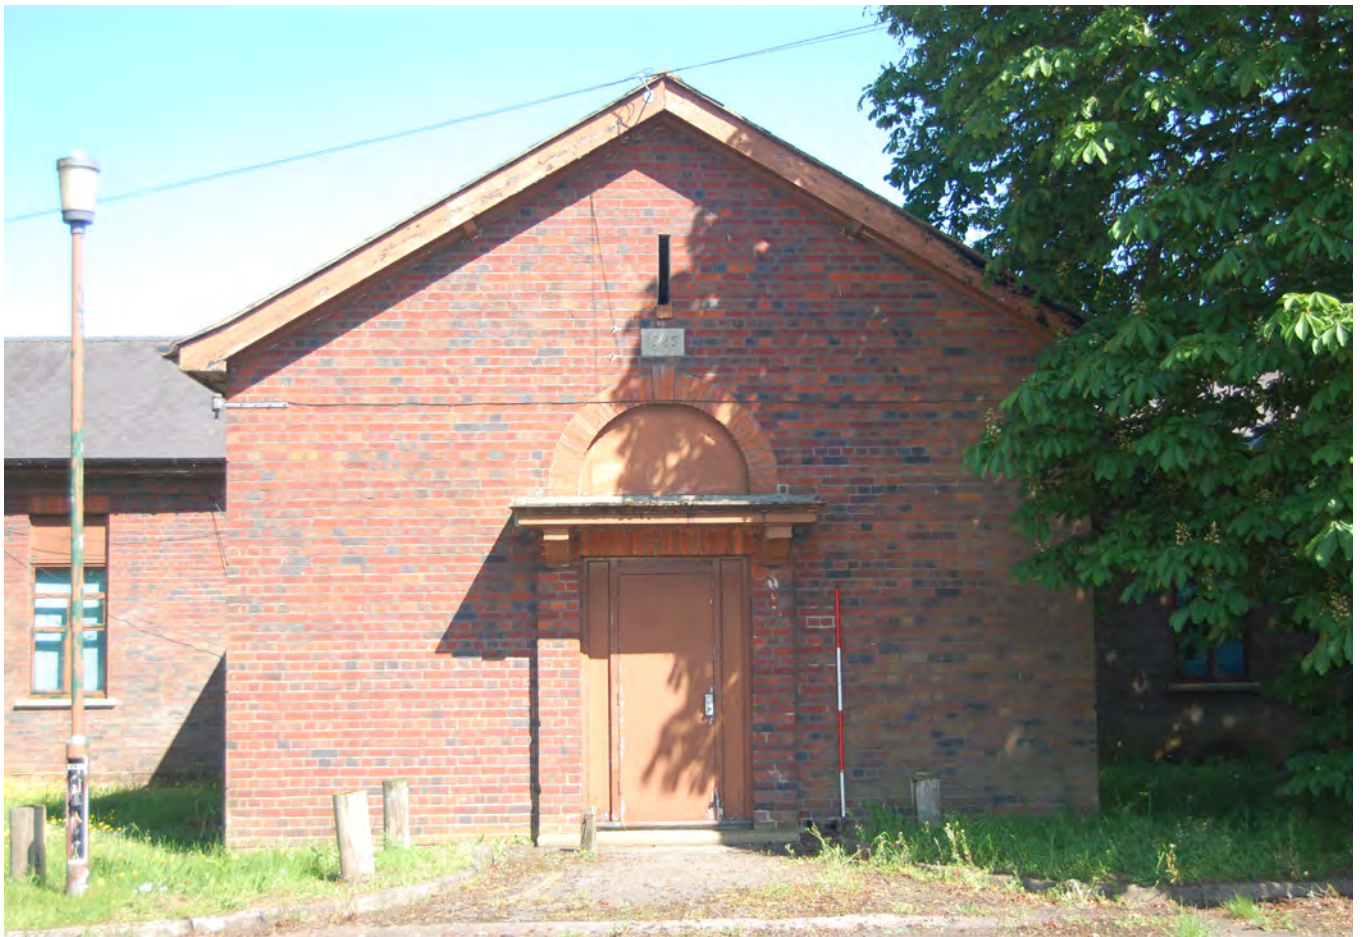
Plate 474.3 West elevation of the west wing

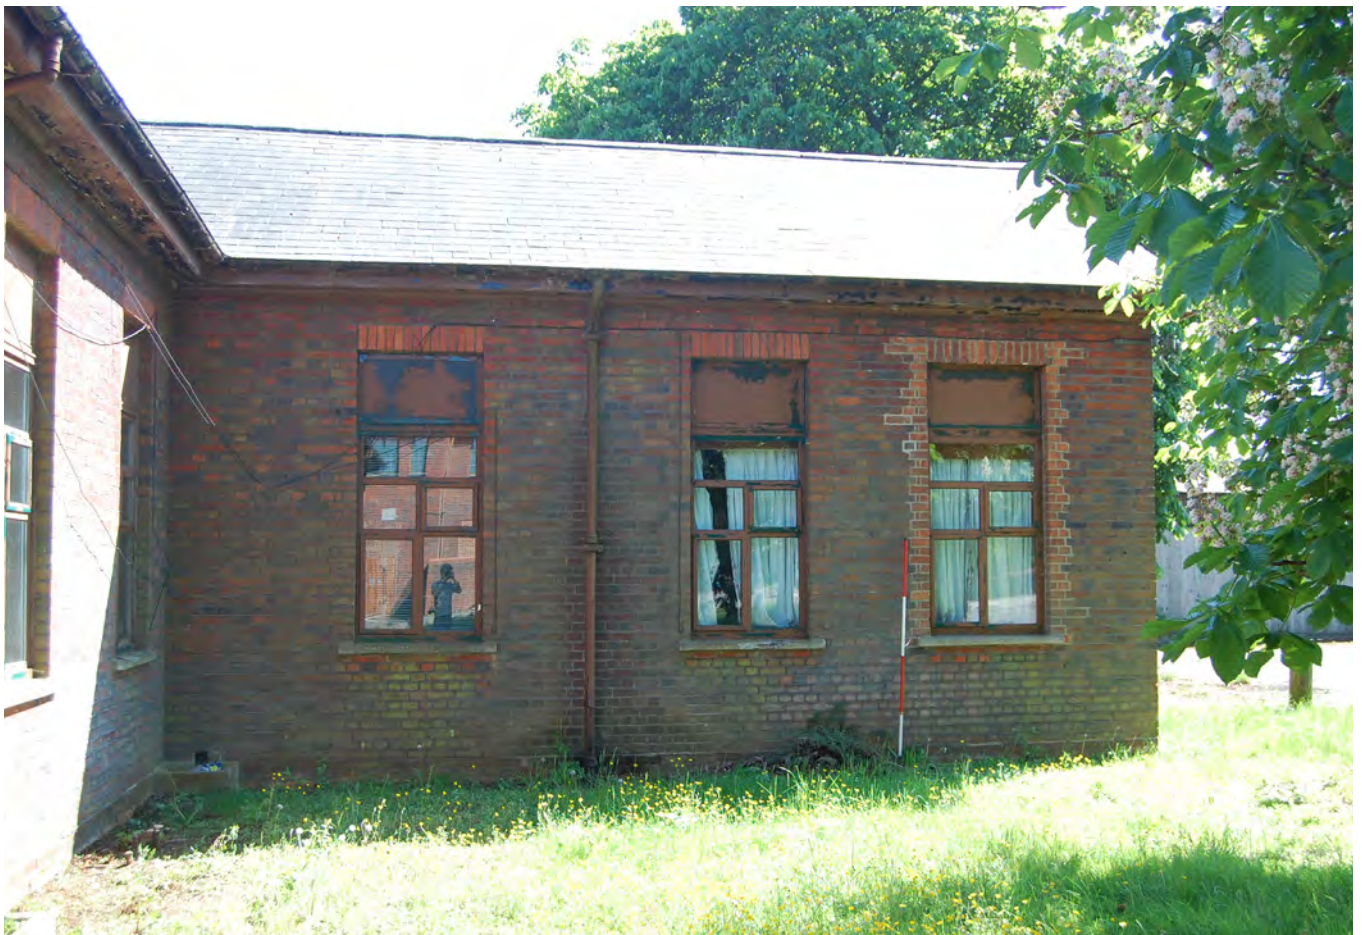
Plate 474.4 North elevation of the west wing

The north and south elevations of this original entrance way are unaltered other than the replacement window frames (Plate 474.4). The brickwork around the westernmost window on each elevation has been replaced and pointed in a contrasting mortar; these could potentially be a later opening, however, the window frames have since been replaced and the surviving plans all show these openings, and so it may be that these are simply heavily repaired jambs, especially as this treatment was also necessary in the east elevation of the ablutions block.
