FORMER RAF UPPER HEYFORD, OXFORDSHIRE

HISTORIC BUILDING RECORDING AND INVESTIGATION

VOLUME 2: GAZETEER OF RECORDED STRUCTURES

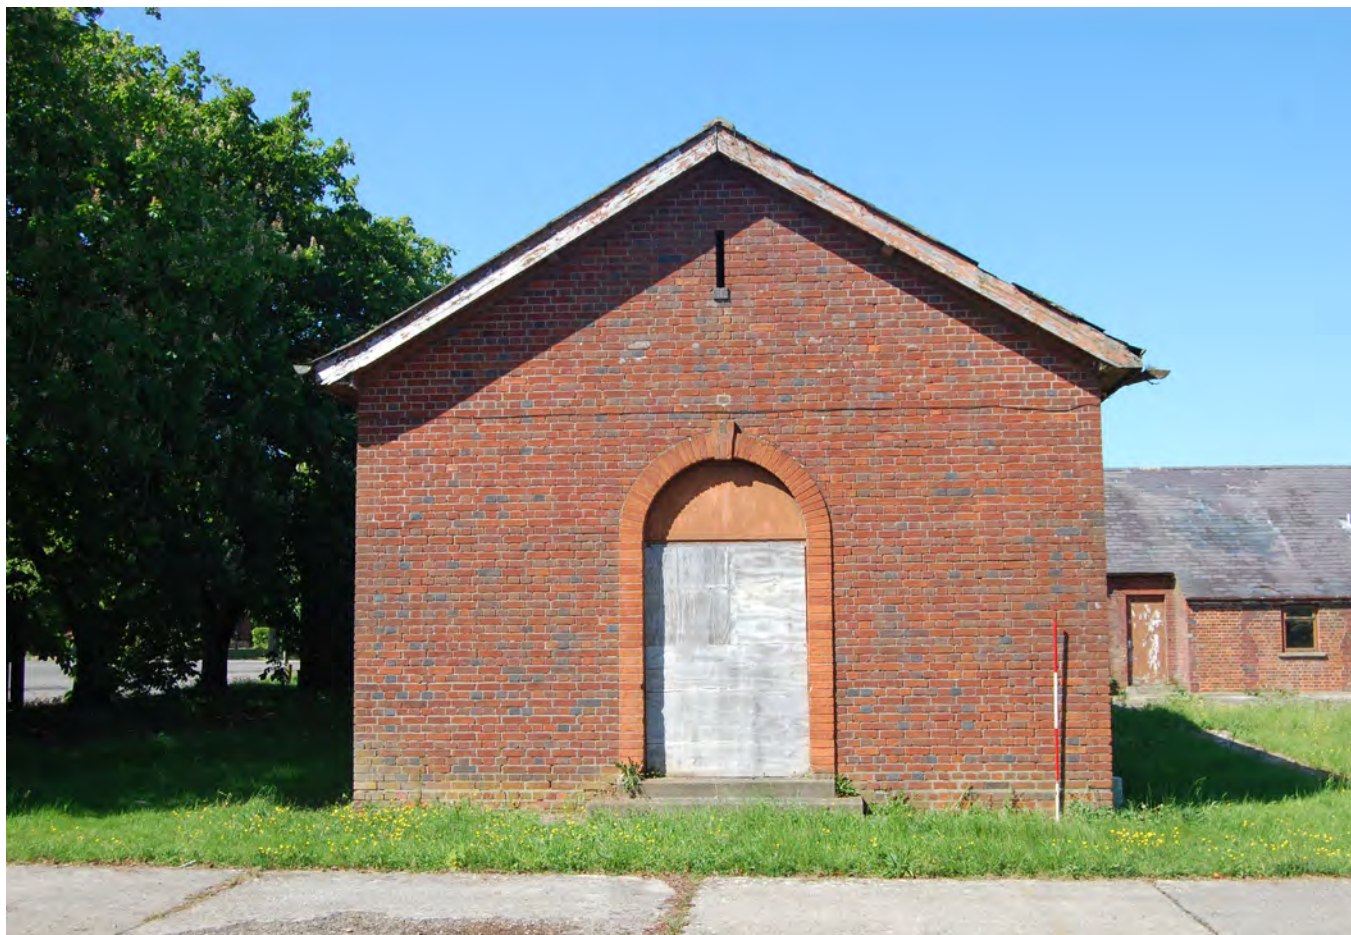
Plate 474.5 South elevation of the south wing

The north and south elevations of the north-south range are identical and remain unaltered other than the replacement doors (Plate 474.5). Each gable contains a vent near to the apex and the door is set in a brick archway with the keystone formed from brick, all set on two concrete steps.

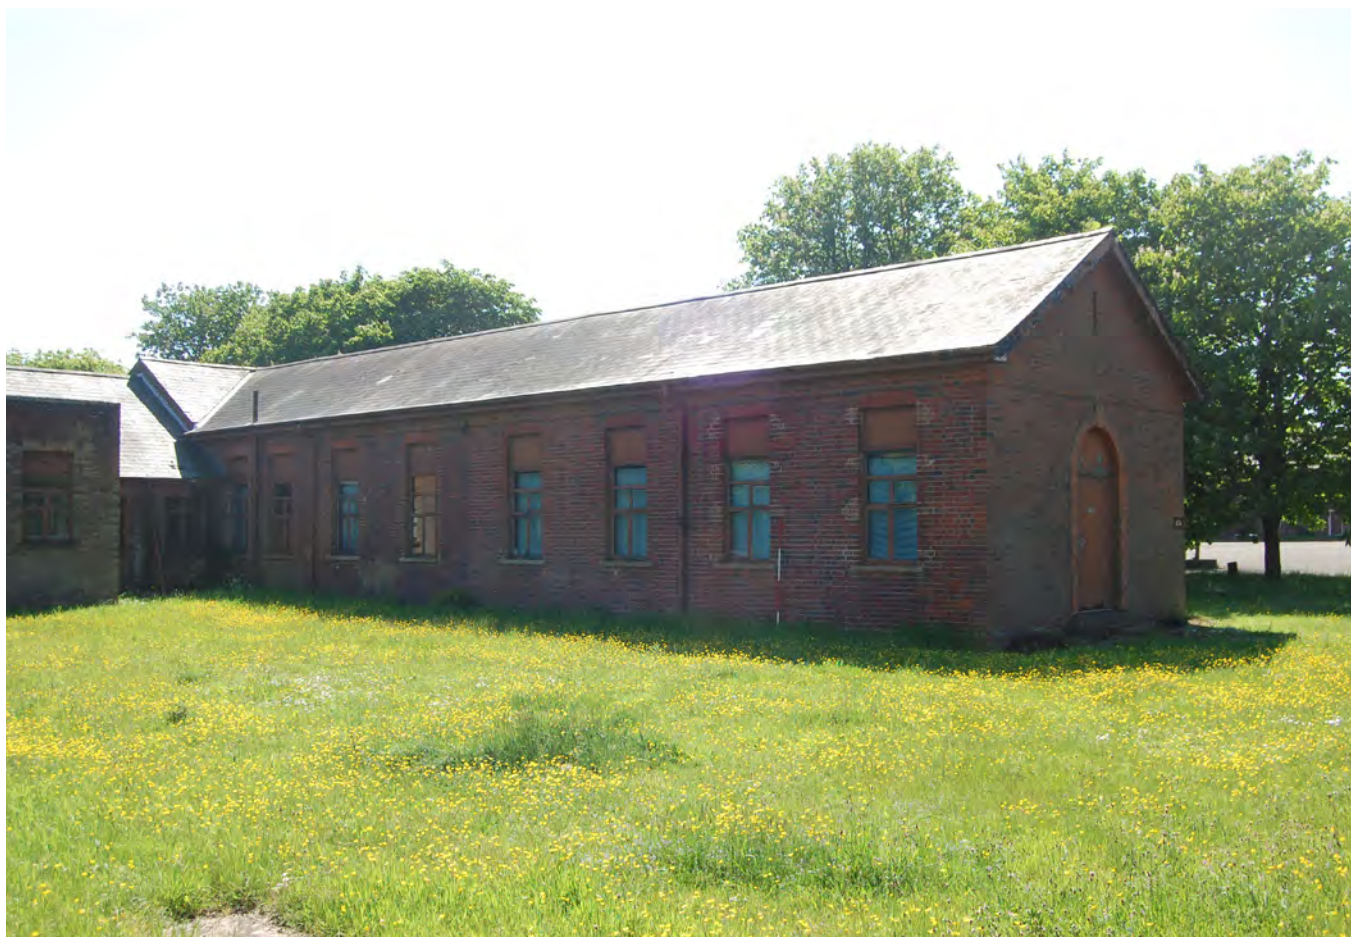
Plate 474.6 East and north elevations of the north wing

The east elevation of the north-south range is largely as per the west elevation, although the later extensions either side of the adjoining eastern range, with catslide roofs, have caused the adjacent windows to be moved and each now has a jamb formed from the extension wall (Plate 474.6).

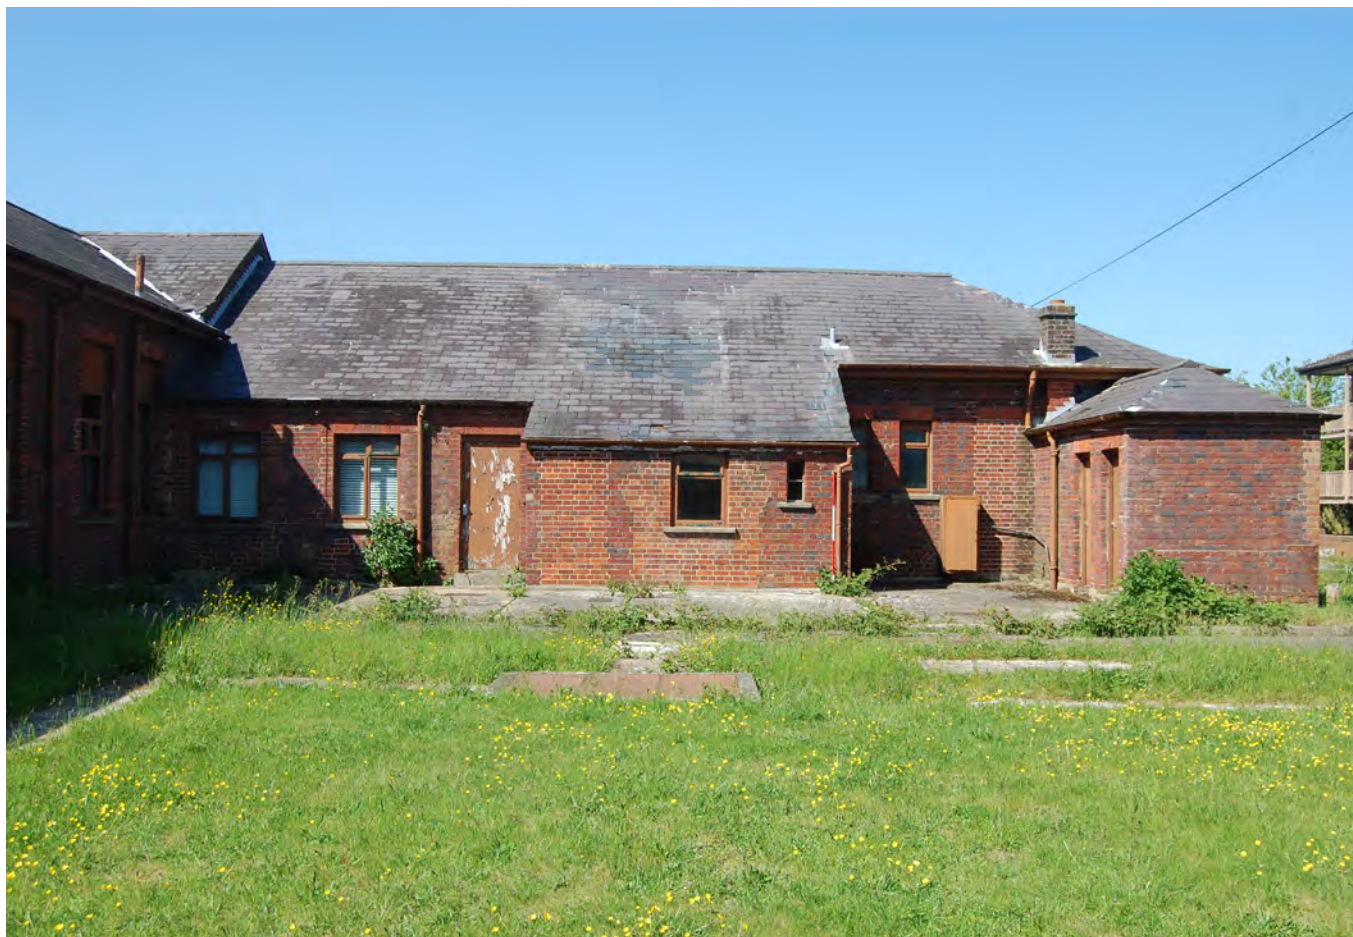
Plate 474.7 South elevation of the east wing

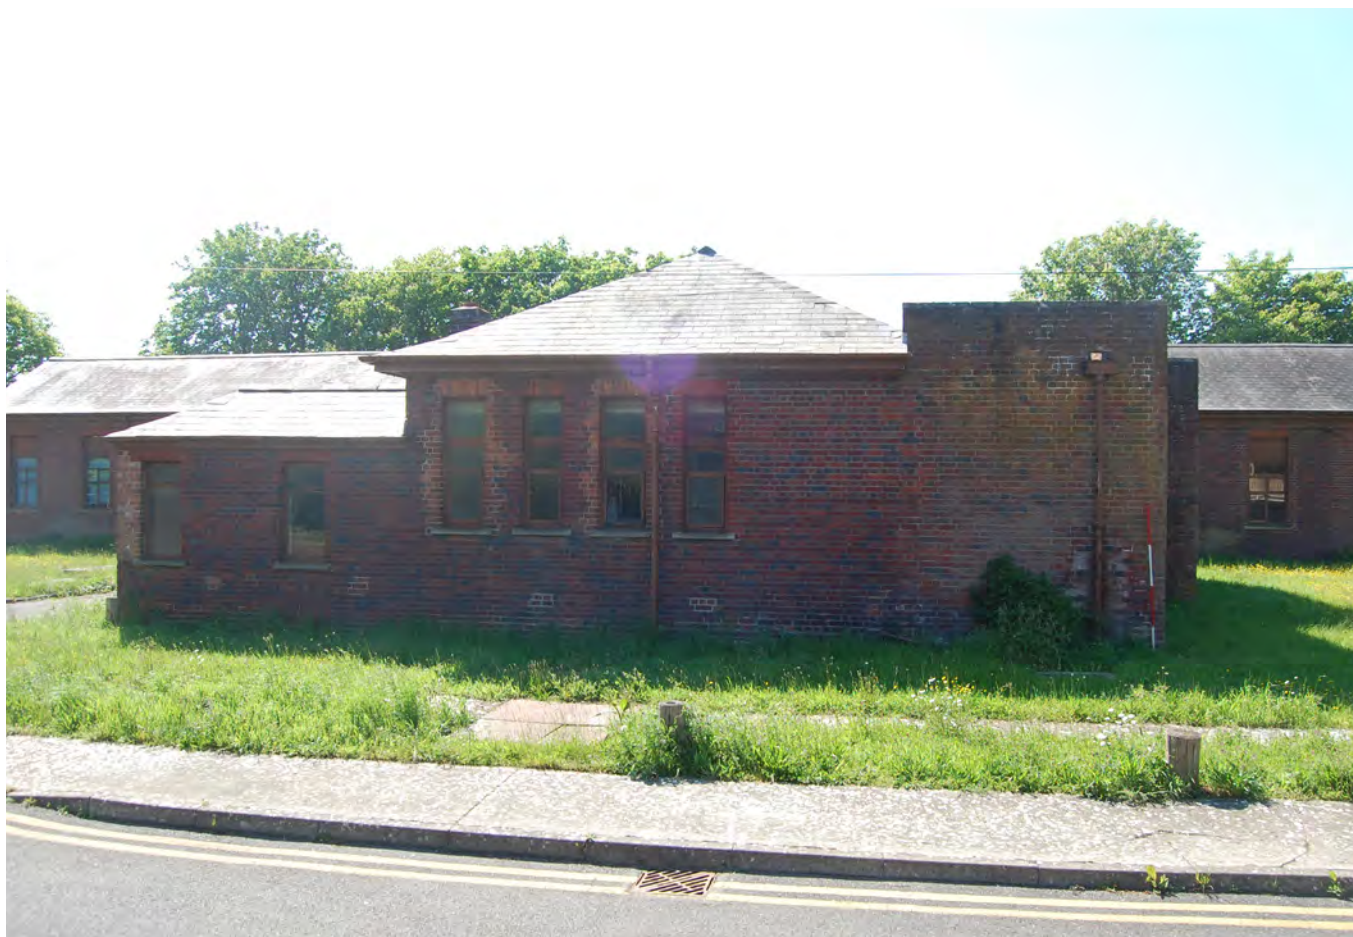
Plate 474.8 East elevation of the east wing

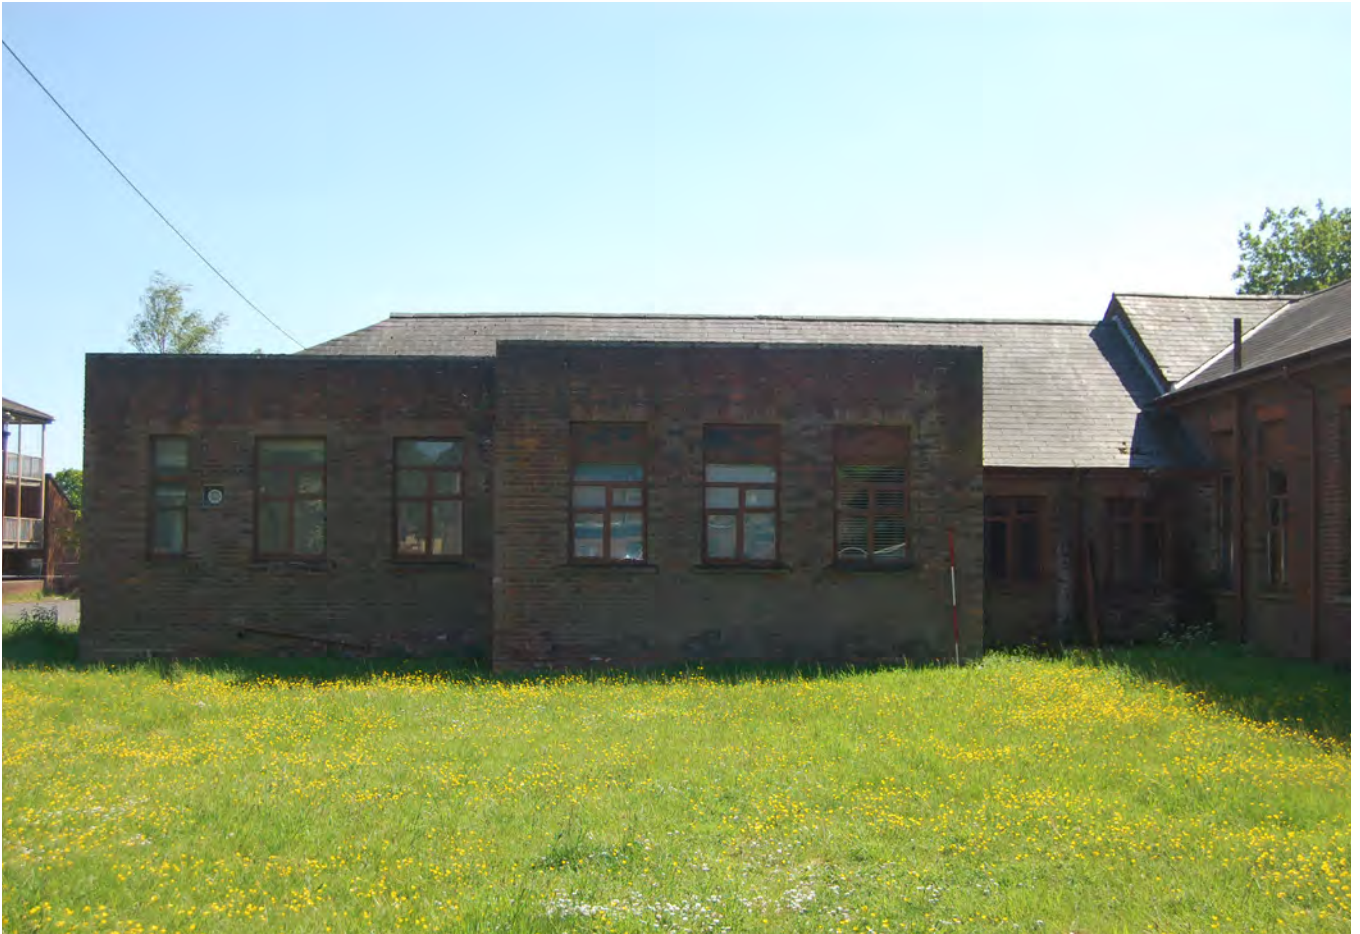
Plate 474.9 North elevation of the east wing

The flat roofed extensions to the east of the north elevation of the ablutions block are probably contemporary with each other (Plate 474.9). The remains of the flue, ceiling beam and pillars are visible in what was most recently the supply storeroom, indicating the line of the original external wall (Plate 474.10). Although the window frames have since been replaced, it is obvious that the windows of the extensions were in keeping with the windows in the original ranges as they display the same brick flat arch and concrete sills and are roughly proportional, albeit with the window at the far left hand side of this elevation being narrower.

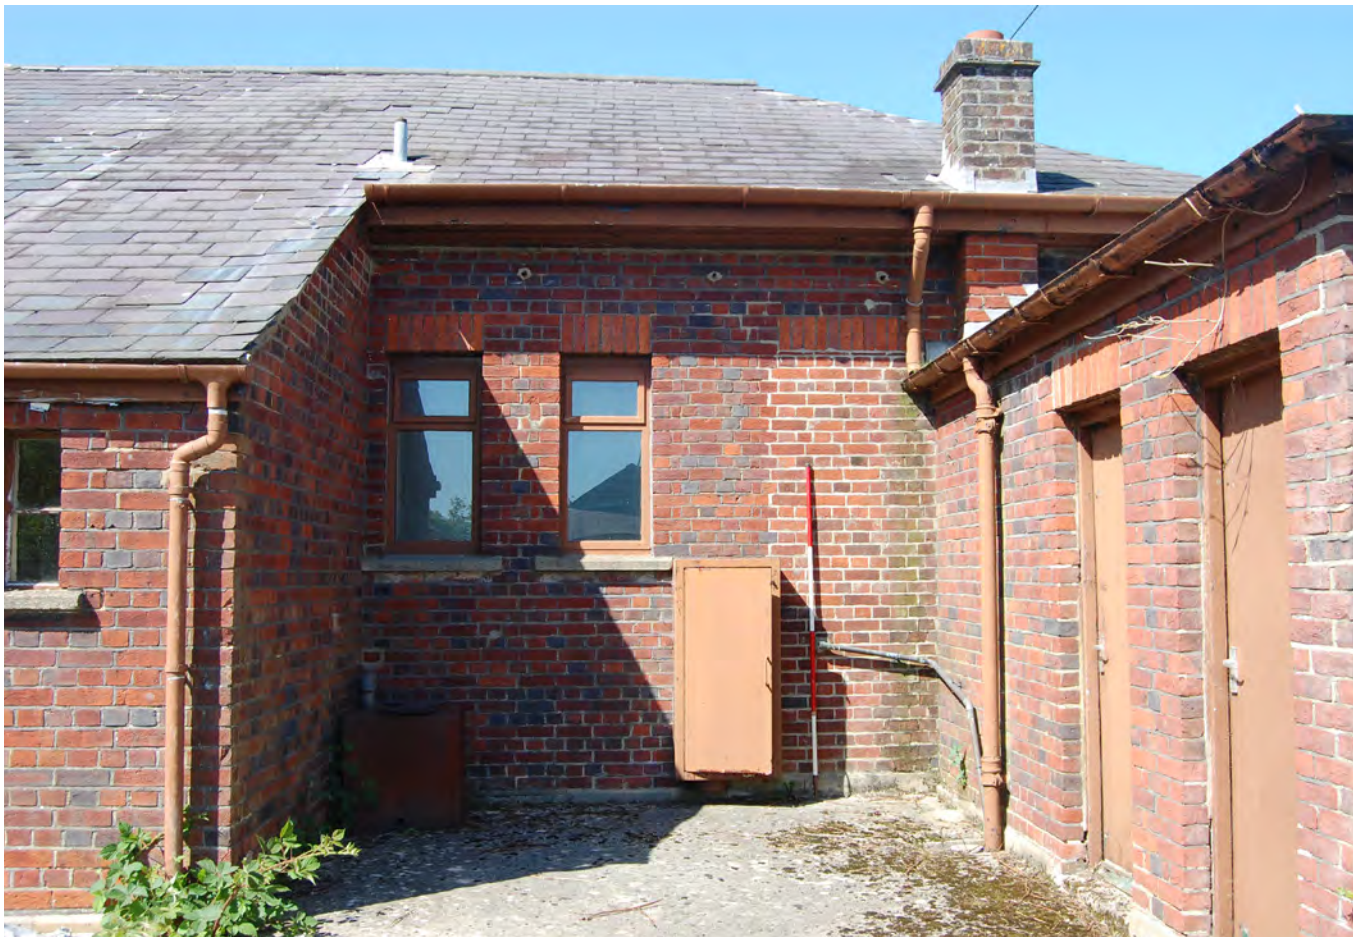
Plate 474.11 Eastern end of the south elevation of the east wing

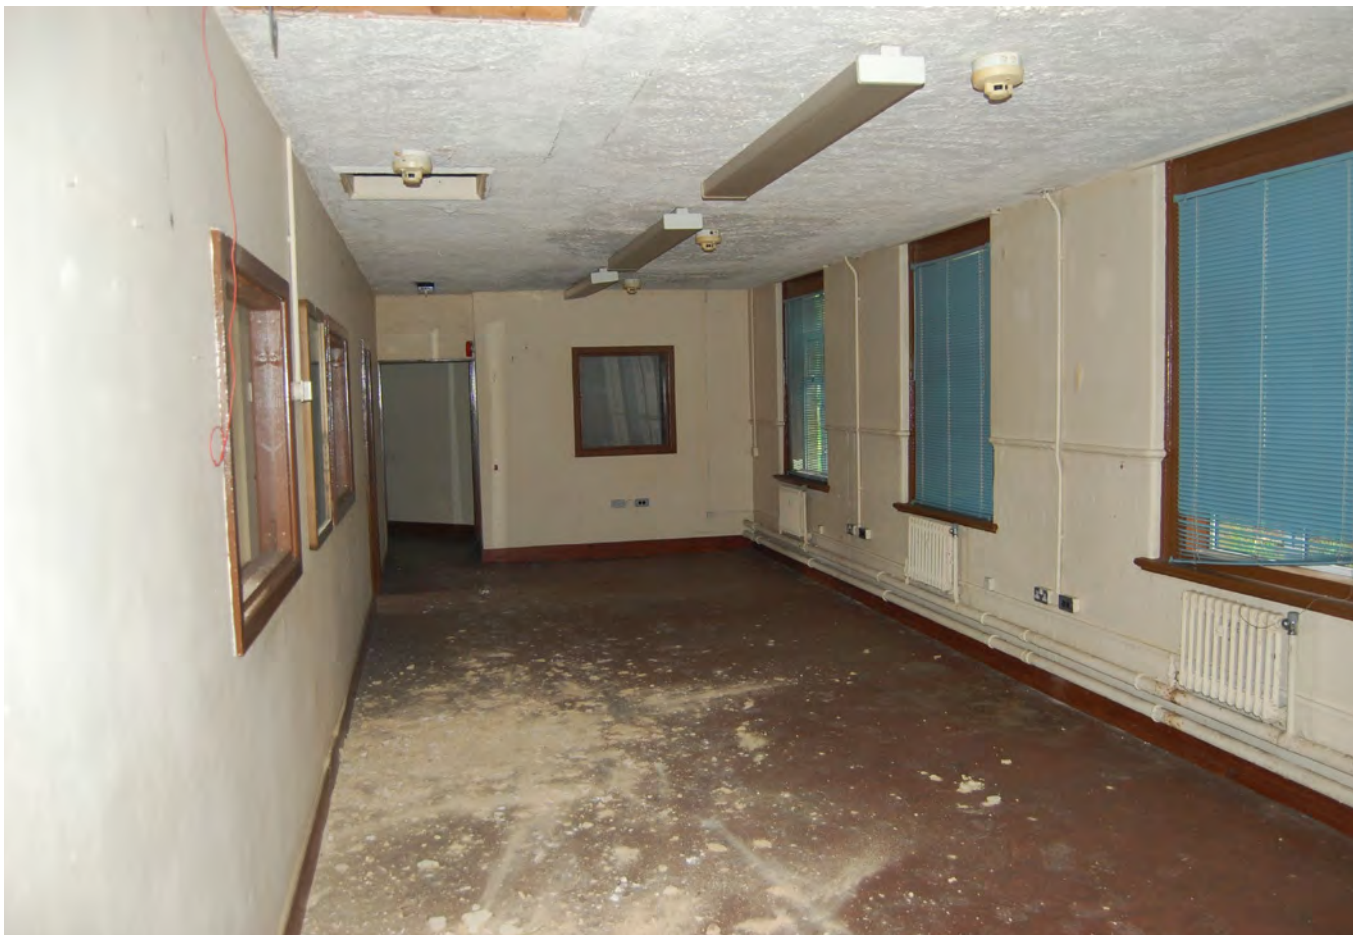
Plate 474.12 Remains of a central corridor of the dormitory wings

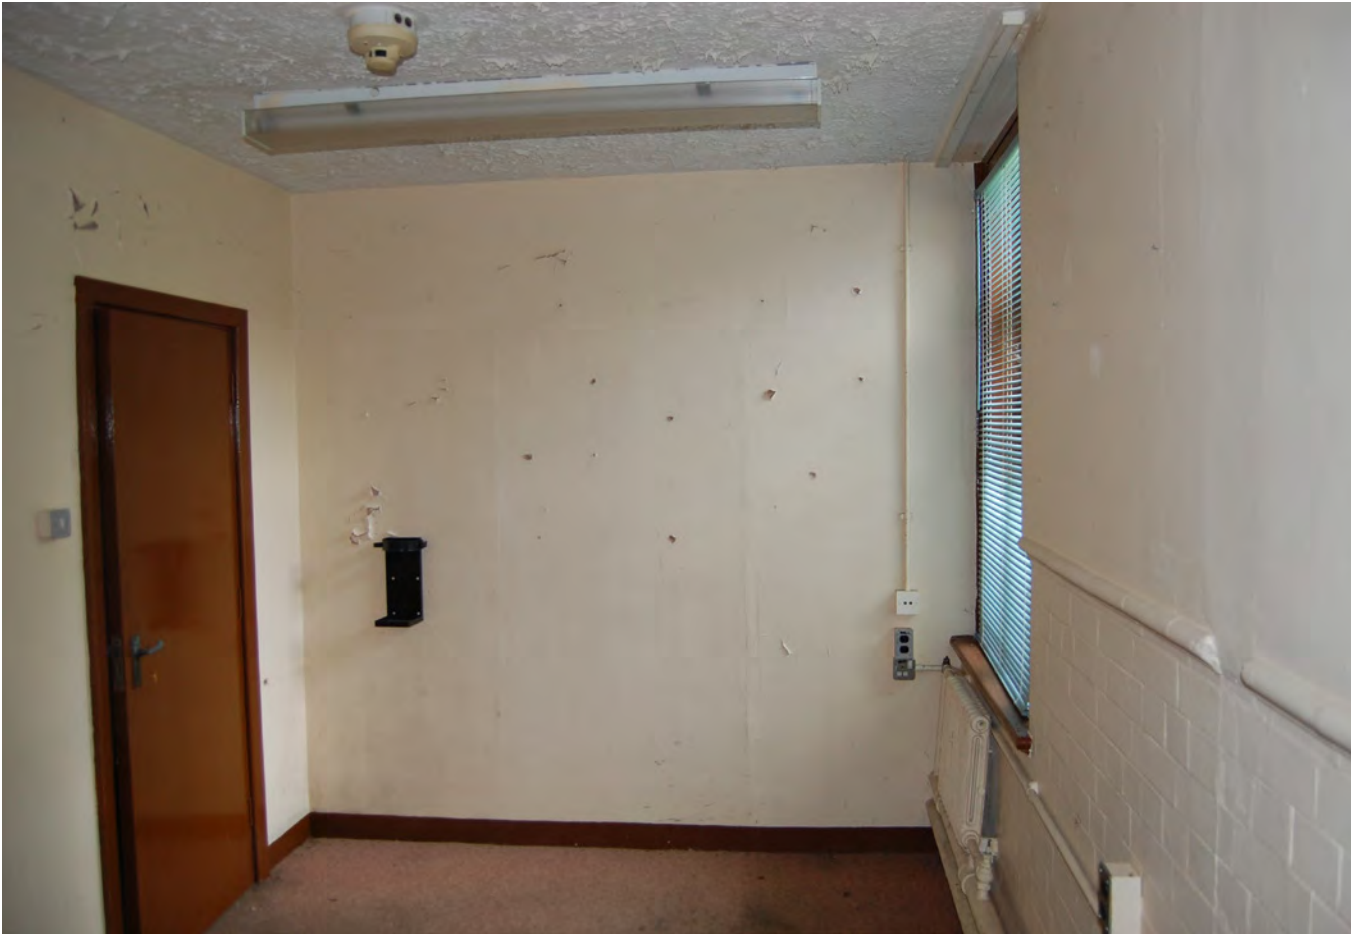
Plate 474.13 An example of a blocked door between bed-sits

corridor. The interconnecting doors were removed and the opening made good, new doors were added where necessary and any interconnecting doors not required were blocked (Plate 474.13).

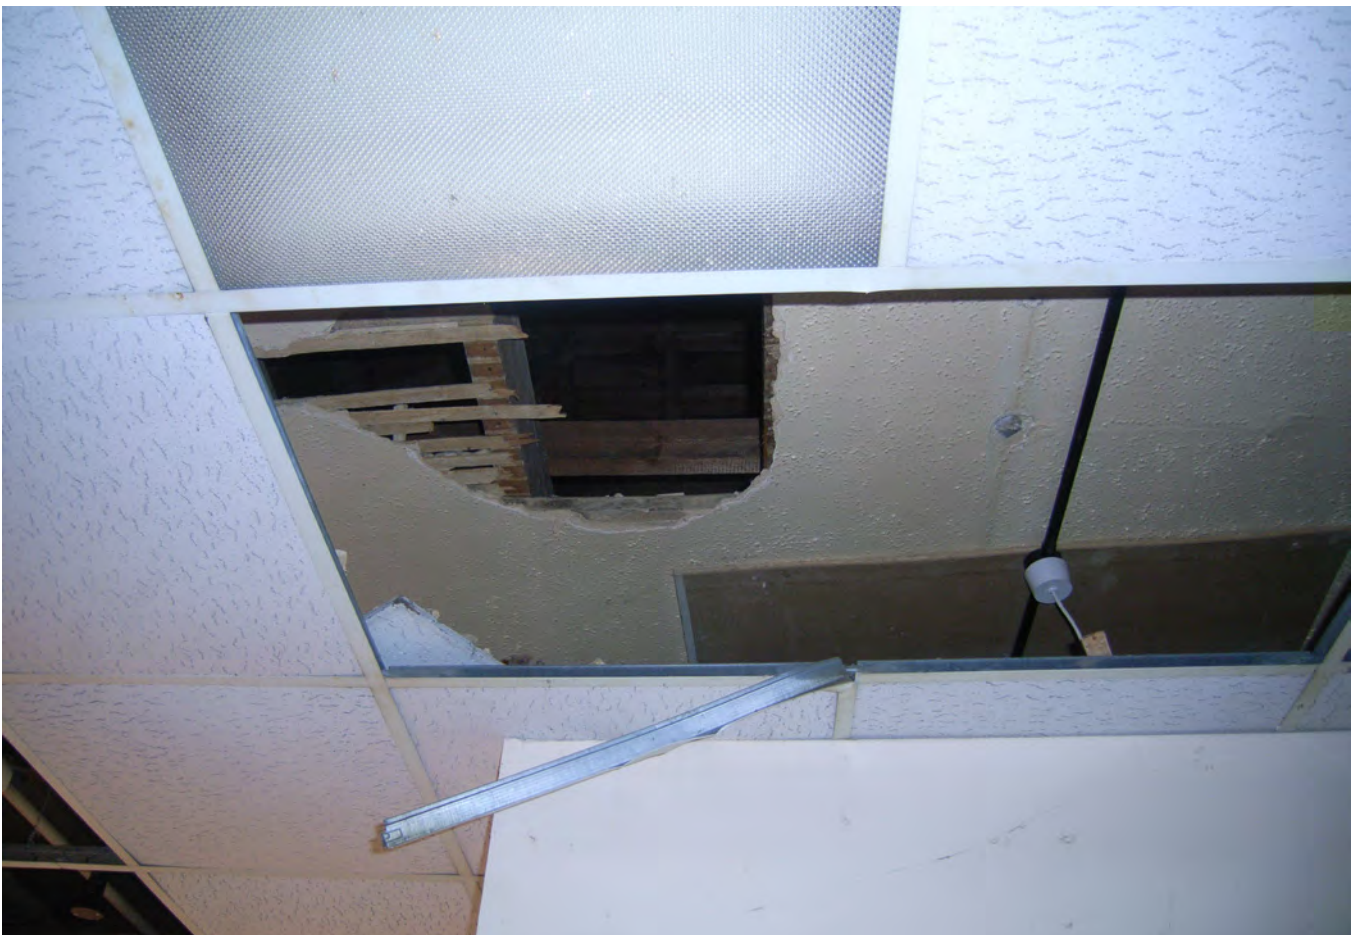
Plate 474.14 The original ceiling above the ablutions area

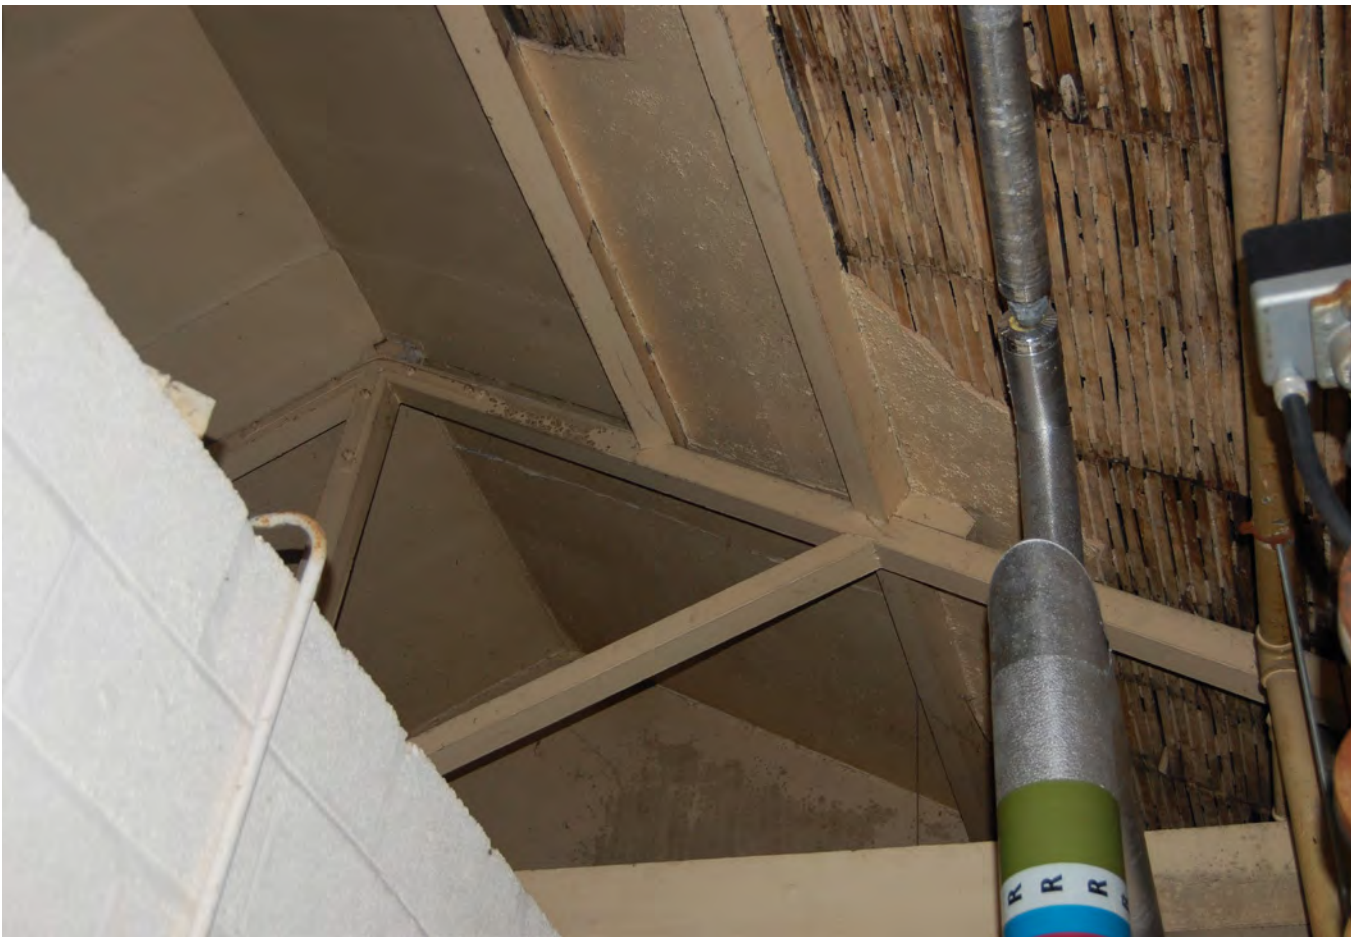
Plate 474.15 The roof truss and original ceiling above the calorifier and supply store

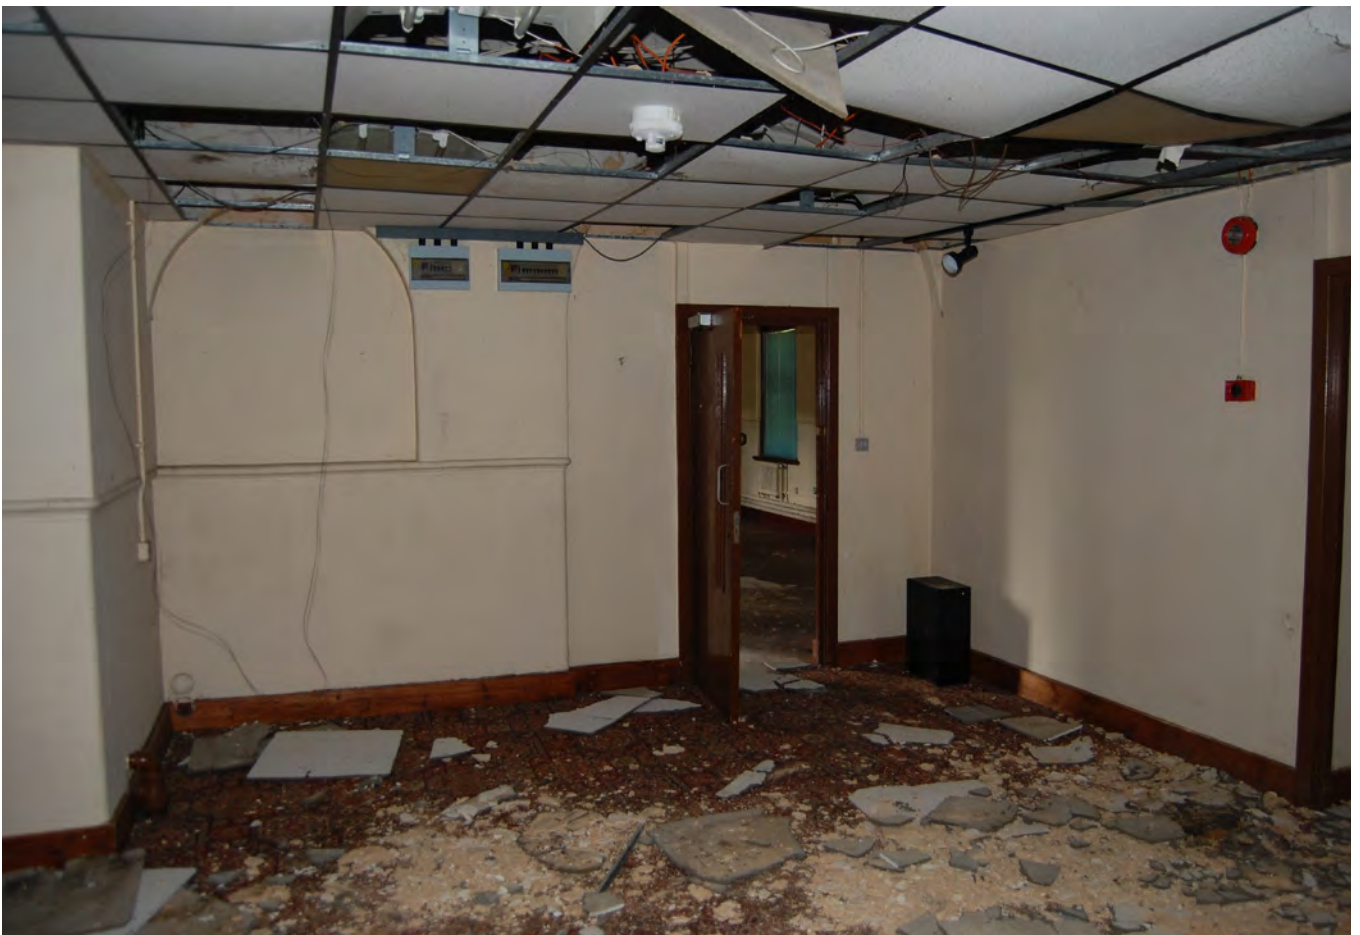
Plate 474.18 The door and window arches to the south wall of the lobby

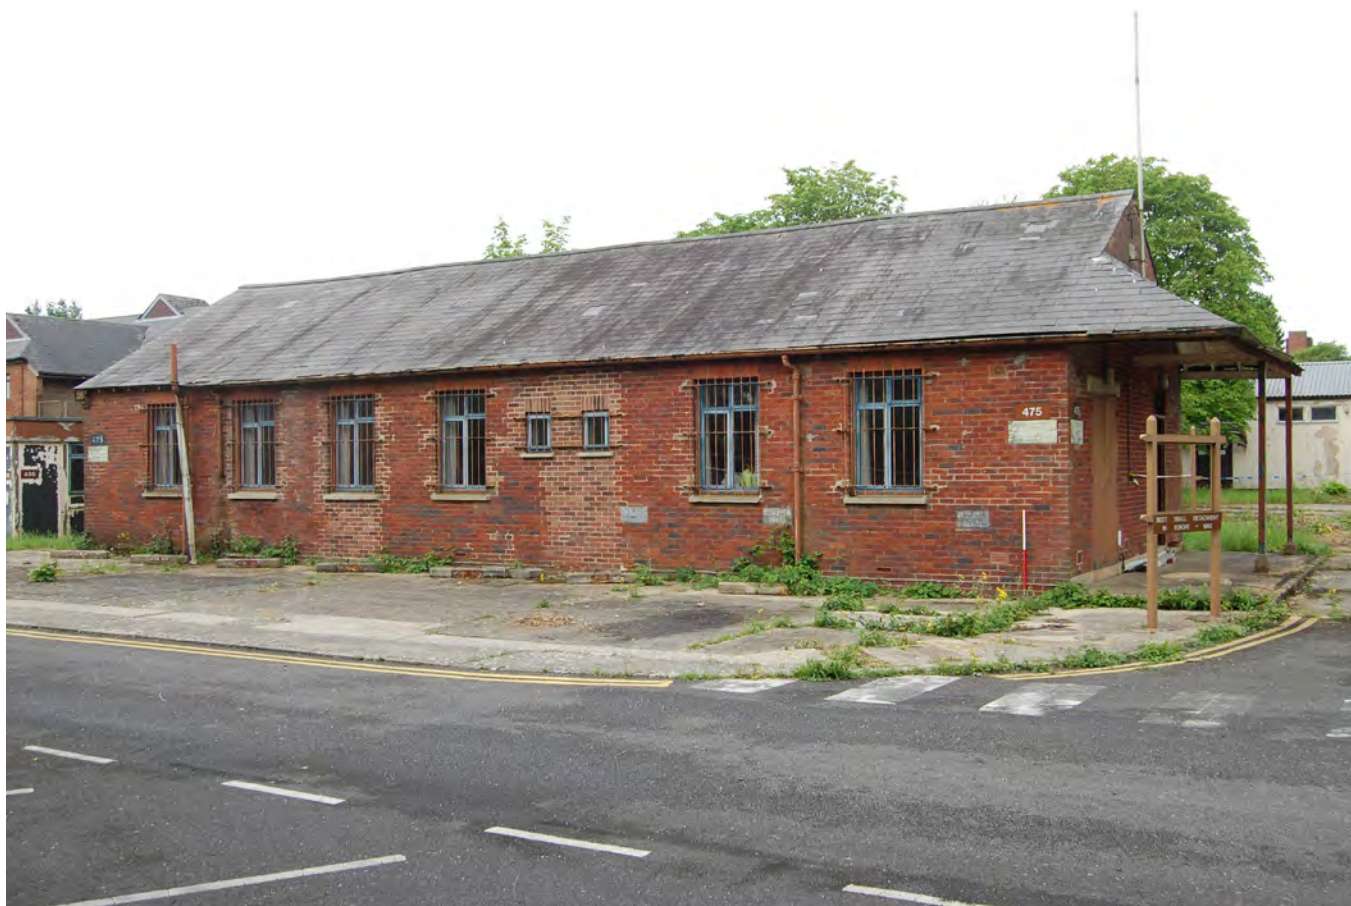
Plate 475.1 North and east elevations

This Ration Store is located close to the Airmen's Dining Room and dates from 1925 (a stone date plaque is visible below the roof's apex) (Plate 475.1). It is numbered on a 1926 plan of the site as 55 'Shops and Stores (Adjutants)'. A plan of 1946 numbers the building as 80 and describes it as '? & Shops'. It is also visible in aerial photography of the site.

The **east elevation** has modern blue metal-framed windows each with four lights, the windows have concrete sills and brick footers form the lintels (see Plate 475.1). Across the windows are primary metal bars providing security, these are a later addition relating to the buildings use by the police. The east elevation has several areas of brick repair/ infill particularly surrounding the windows. There are two windows at the north of the elevation, and immediately to the south of this are two small rectangular windows, these have concrete lintels and brick headers above forming the lintels (Plate 475.4). Internally these two windows (which have frosted glass) light a sanitary area, and the brick infill probably relates to the later reconfiguration of the building for use by the police.

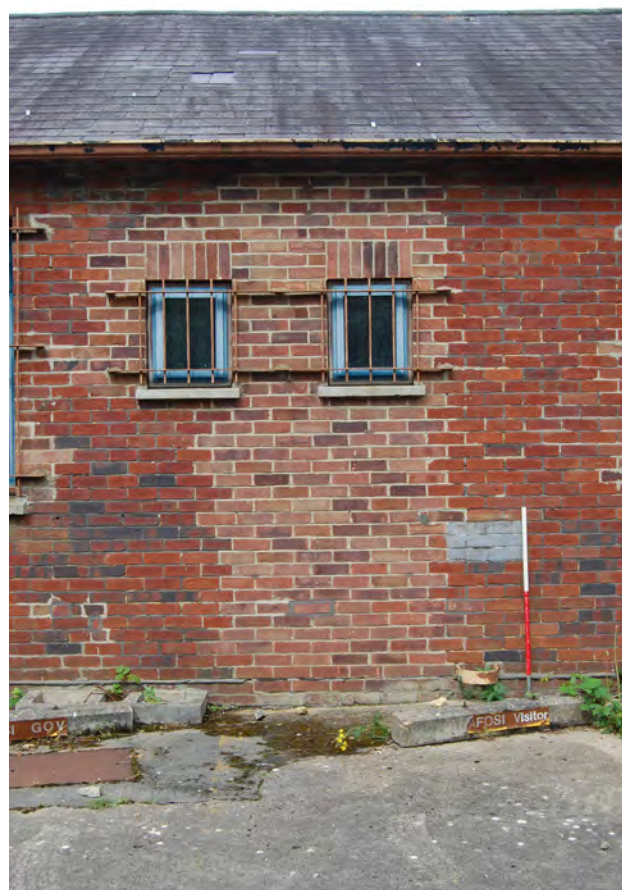
Plate 475.4 East elevation, replacement windows for internal sanitary area

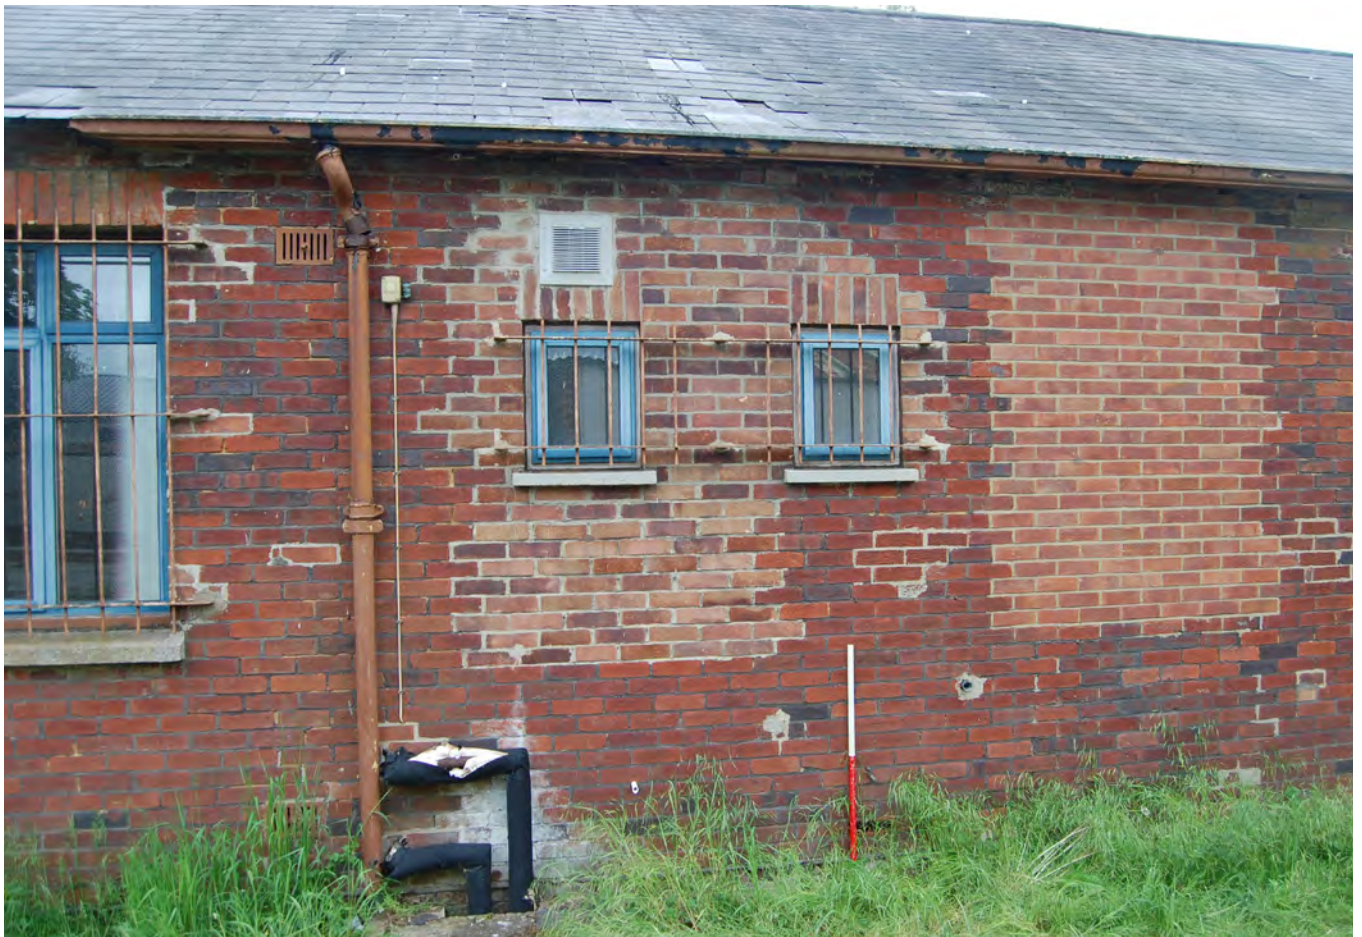
Plate 475.7 West elevation, replacement windows for internal sanitary area and holding room

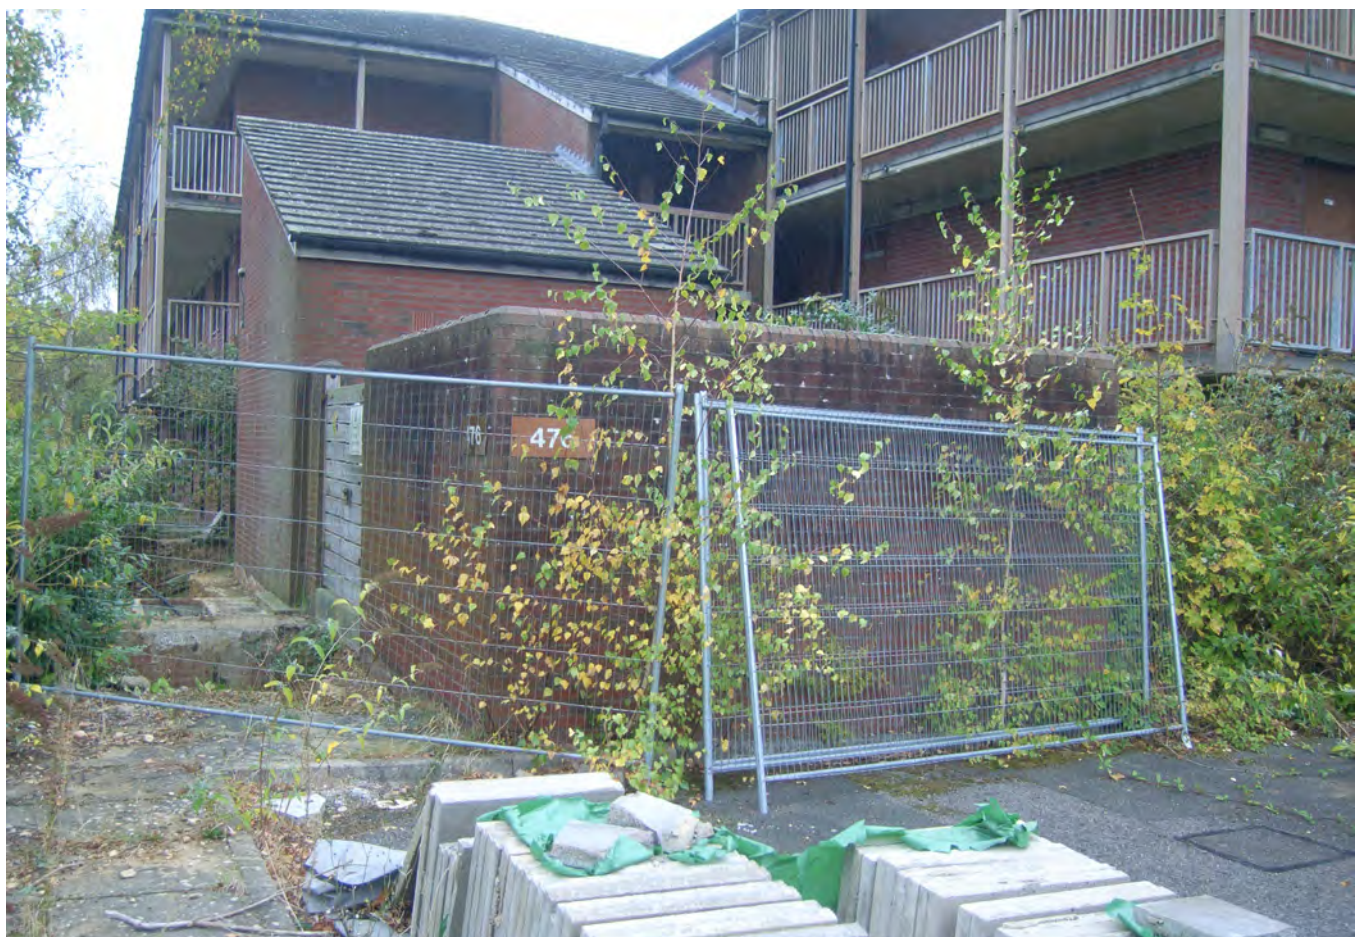
Plate 476.1 South and west elevations

The sub-station is 2.4m in height and consists of a red brick enclosure surrounding the substation (Plate 476.1).

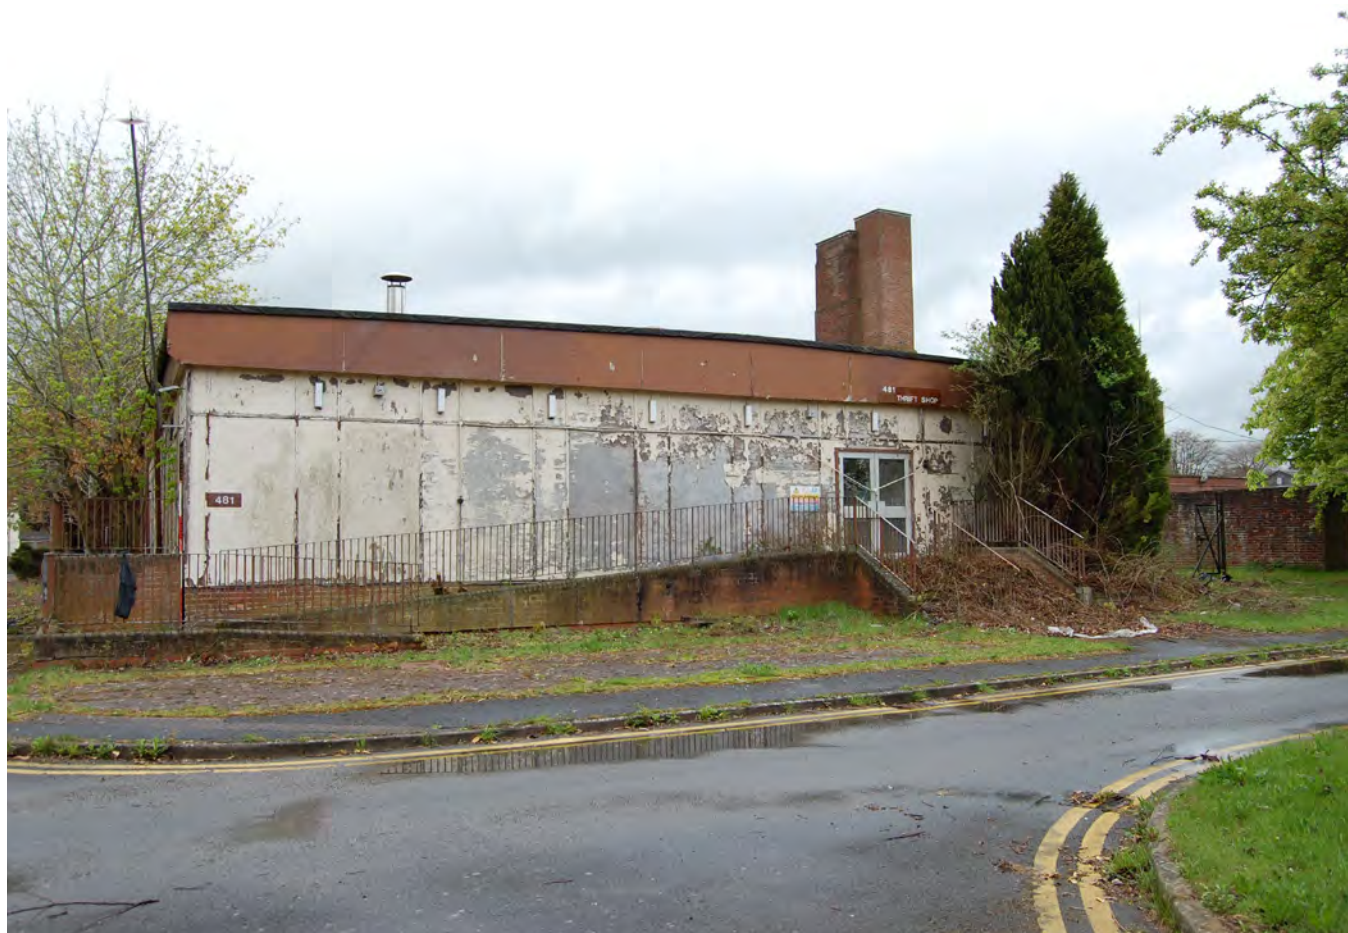
Plate 481.1 North-east (front) elevation

Internally, the structure is in poor condition and full access was not possible. Initial inspection shows that it was built largely according to the plan (dated March 1982), which show large 'Stock and Receiving' rooms at the rear end of the building and stores to the front of the building. There are also smaller rooms at the entrance of the building including an office, sanitary area, plant room and 'breakroom'.

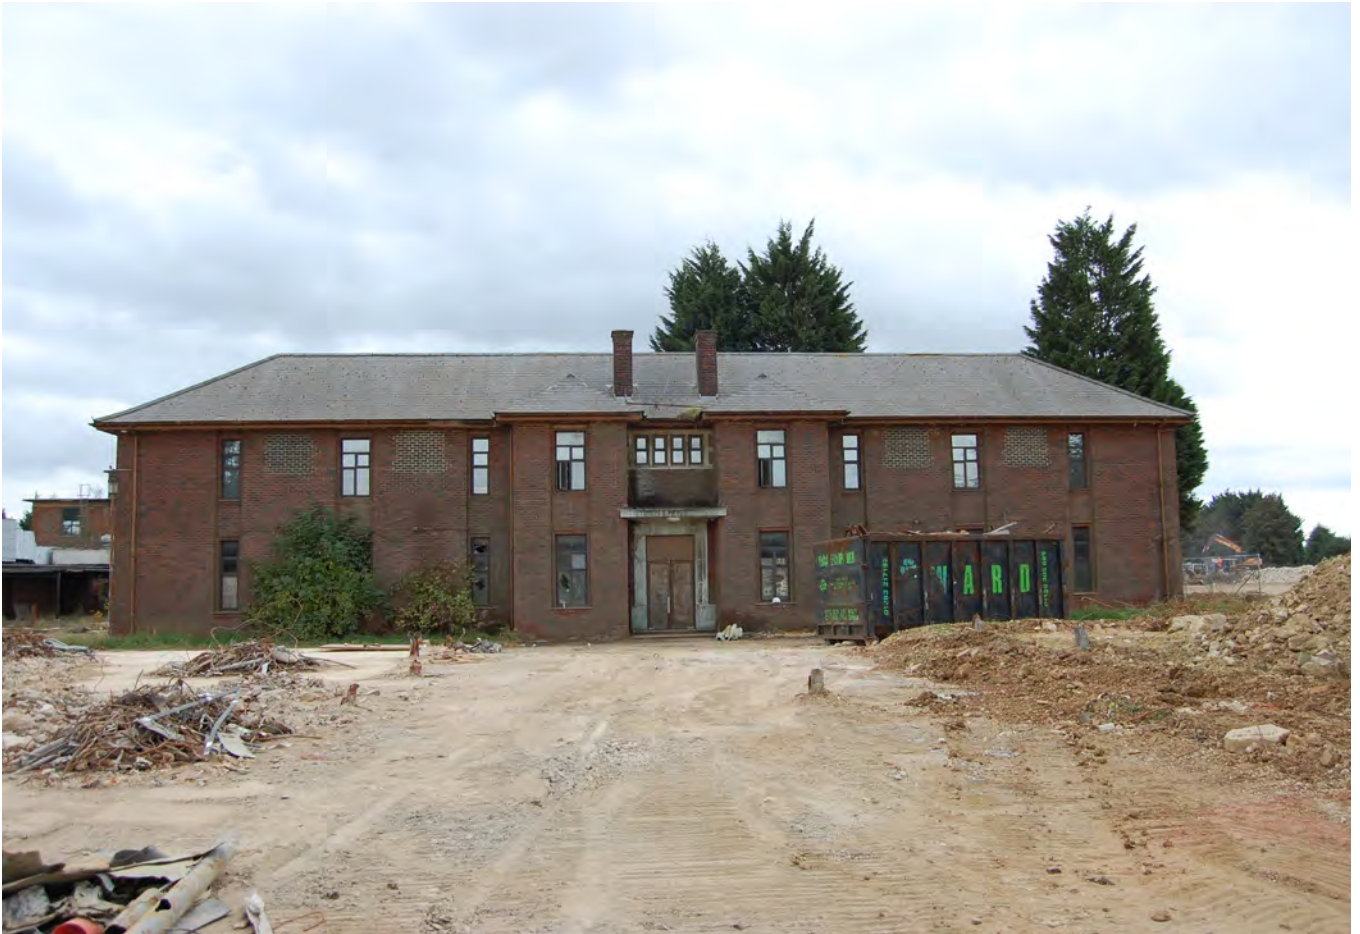
Plate 485.1 North, front, elevation

The building is a short 'T' shape in plan, with the dormitory wings to the east and west and the rear ablution unit branching off to the south (Figures 485.1 & 2). Two false towers are formed in a central entrance feature of the front elevation to the north, with the entranceway in the centre (Plate 485.1).

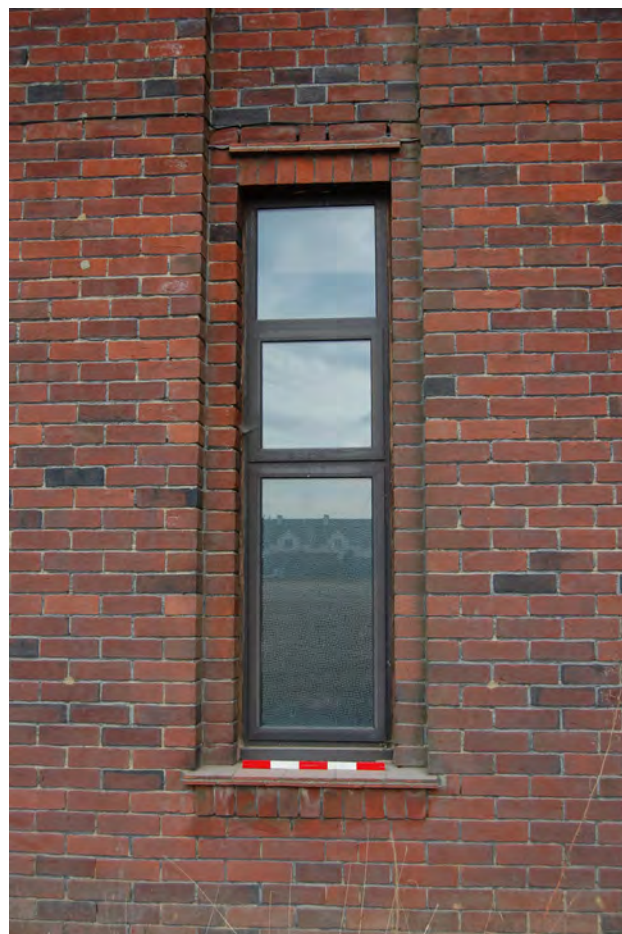
The walls are of dark red brindled brick in stretcher bond with a cream-coloured mortar. The window sills are tiled (Plate 485.2).

Plate 485.2 Single window in a side elevation
