FORMER RAF UPPER HEYFORD, OXFORDSHIRE

HISTORIC BUILDING RECORDING AND INVESTIGATION

VOLUME 2: GAZETEER OF RECORDED STRUCTURES

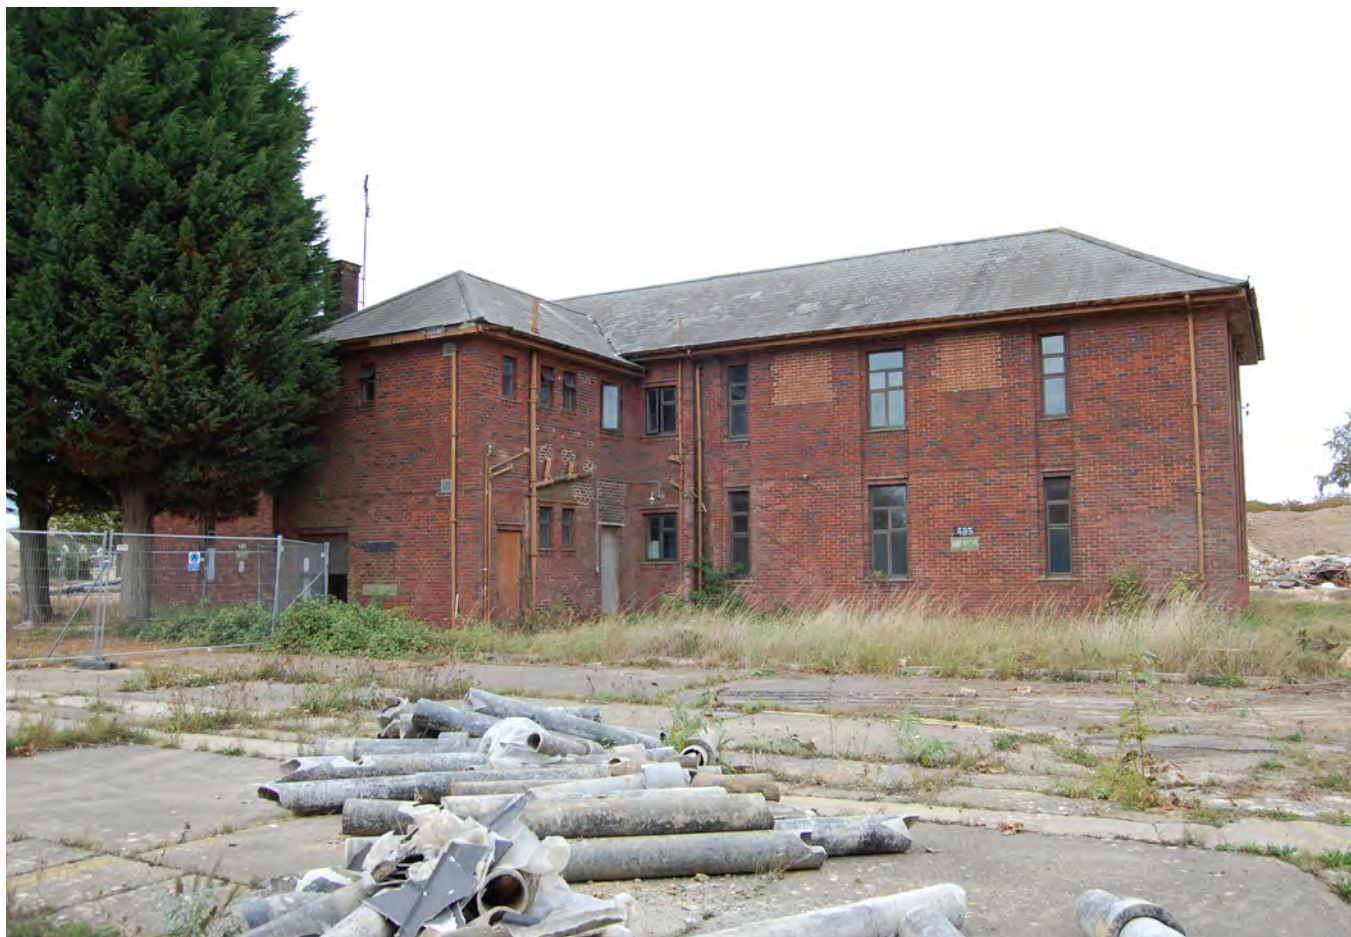
It has a slate covered hipped roof. Two redundant chimneys are within the slope of the roof between the two 'towers' and one chimney is to the rear of the ablutions block, over the current boiler room. A vent is in the slope of each hip of the main roof. Blocked windows are to the first floor on the north and south elevations and a blocked window is to the east of the boiler room door. The ablutions block shows signs of repair and alteration of plumbing where pointing and patching is visible (Plate 485.3).

Plate 485.3 Rear, south, elevation: east end and ablutions block

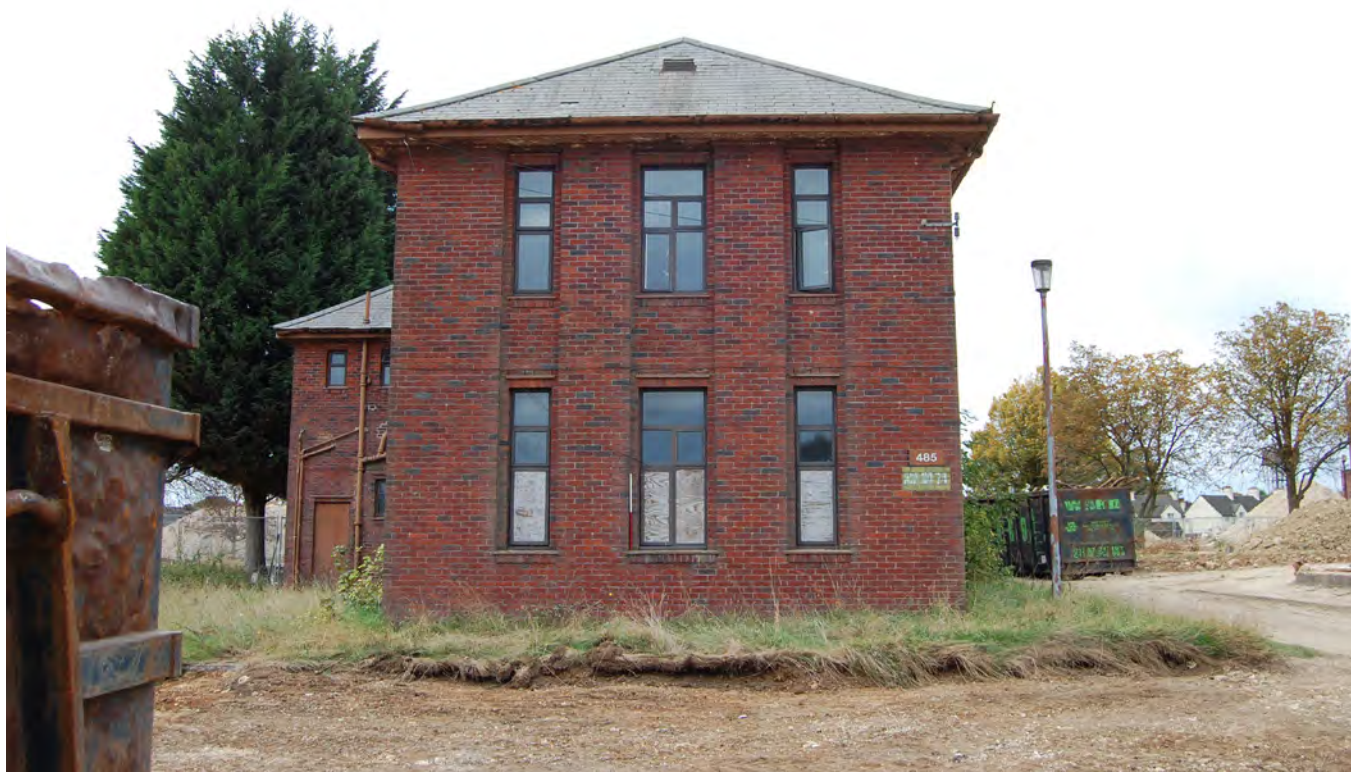
Plate 485.4 East elevation

The later aluminium window frames are coloured brown externally and white internally. The windows in the 'towers' and the central window in each wing are double lights; the windows at either end of the wings are singles, with a similar arrangement to the east and west elevations (Plate 485.4). The existing windows are all set within a recess in the brickwork which runs from the ground to the eaves, whereas the now-blocked windows were flush with the outer profile of the brickwork.

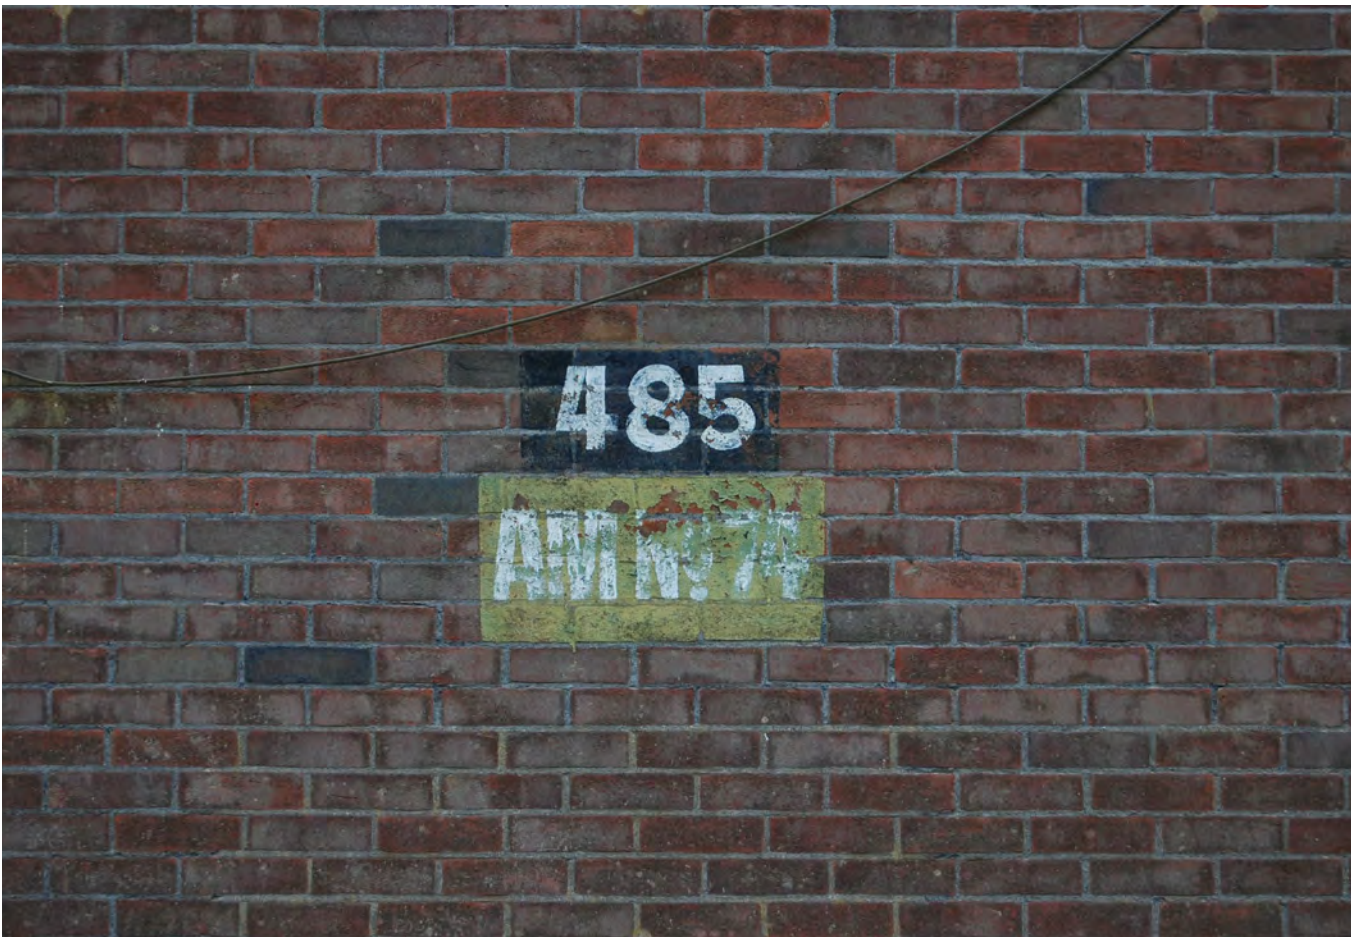
The woodwork, rainwater goods and external plumbing are painted in the standard brown colour as seen elsewhere on the estate. The building numbers are painted in white letters on a black background on the north, south and west elevations with a brown and white plaque to the east elevation; the former number is painted in white on a light green background (Plate 485.5).

Plate 485.5 New and old building numbers

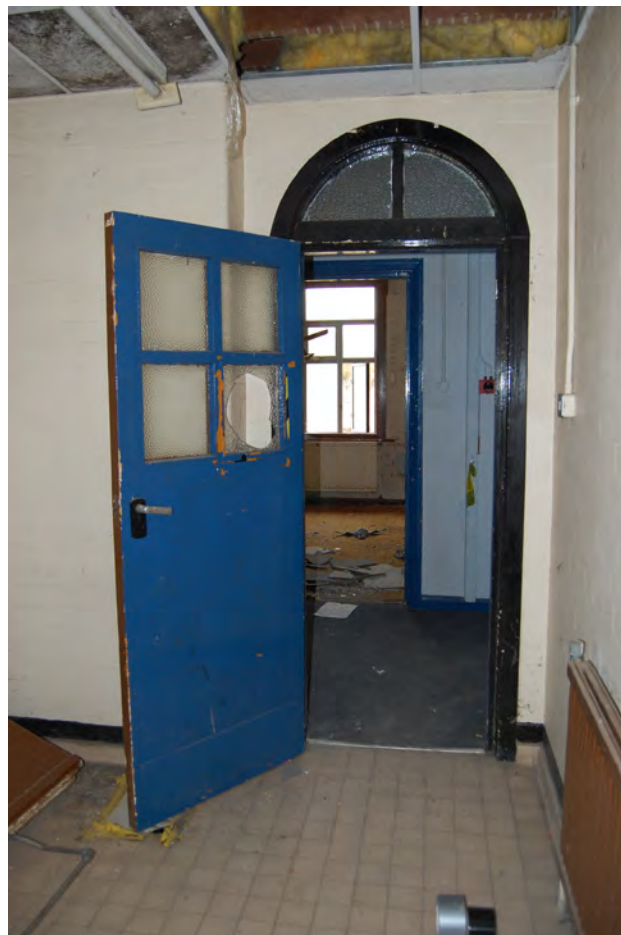
The central unit contains the entrance hall with an NCO's bedroom to either side, set within the false towers on both floors. The stairwell is opposite the entrance and is flanked on both floors by doorways with arched lights over to the ablution areas (Plate 485.6). A recess is adjacent to each doorway to the ablutions (Plate 485.7), but there is no indication of the function of these on either side of the wall, nor is there any indication in the visible areas of the roof structure of their purpose. The farthest-south rooms consist of externally accessed store and plant rooms to the ground floor and a laundry/sluice room and a store to the first floor.

Plate 485.6 Example of a doorway between the ablutions and the corridor

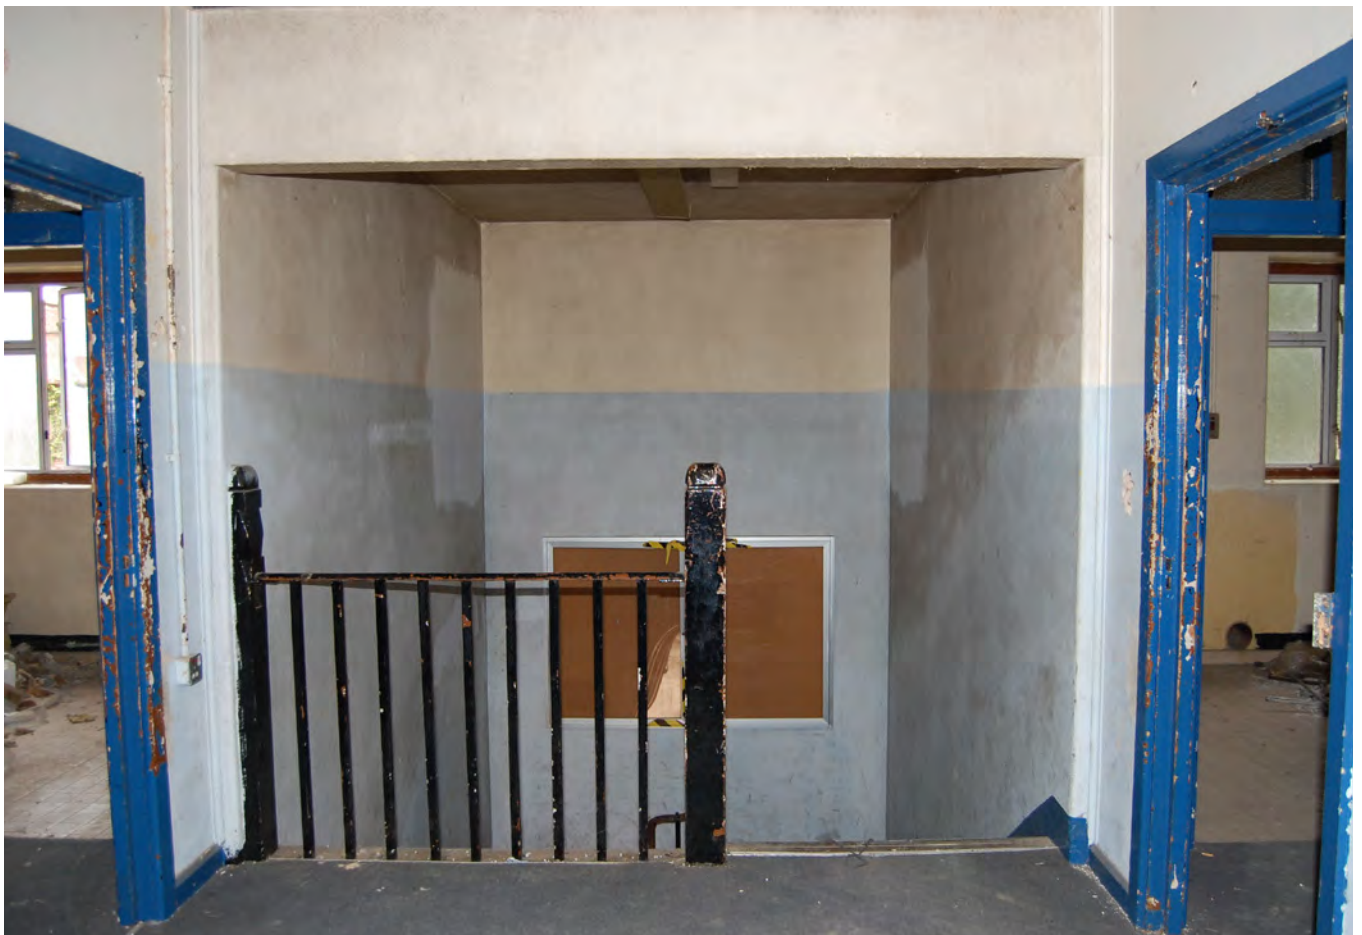
The staircase is concrete with metal balusters and handrail and wooden newel posts. All are painted black with the former brown and white colour schemes visible in where the paint is damaged (Plate 485.8).

During these works, the lights between the first floor ablutions and the landing, presumably previously intended to provide light for the stairwell, were blocked, just visible in the painted brickwork inside the toilet area (Plate 485.12) and visible in pattern staining on the landing walls (see Plate 485.8).

Plate 485.8 The stairwell, also showing the location of blocked lights to ablutions

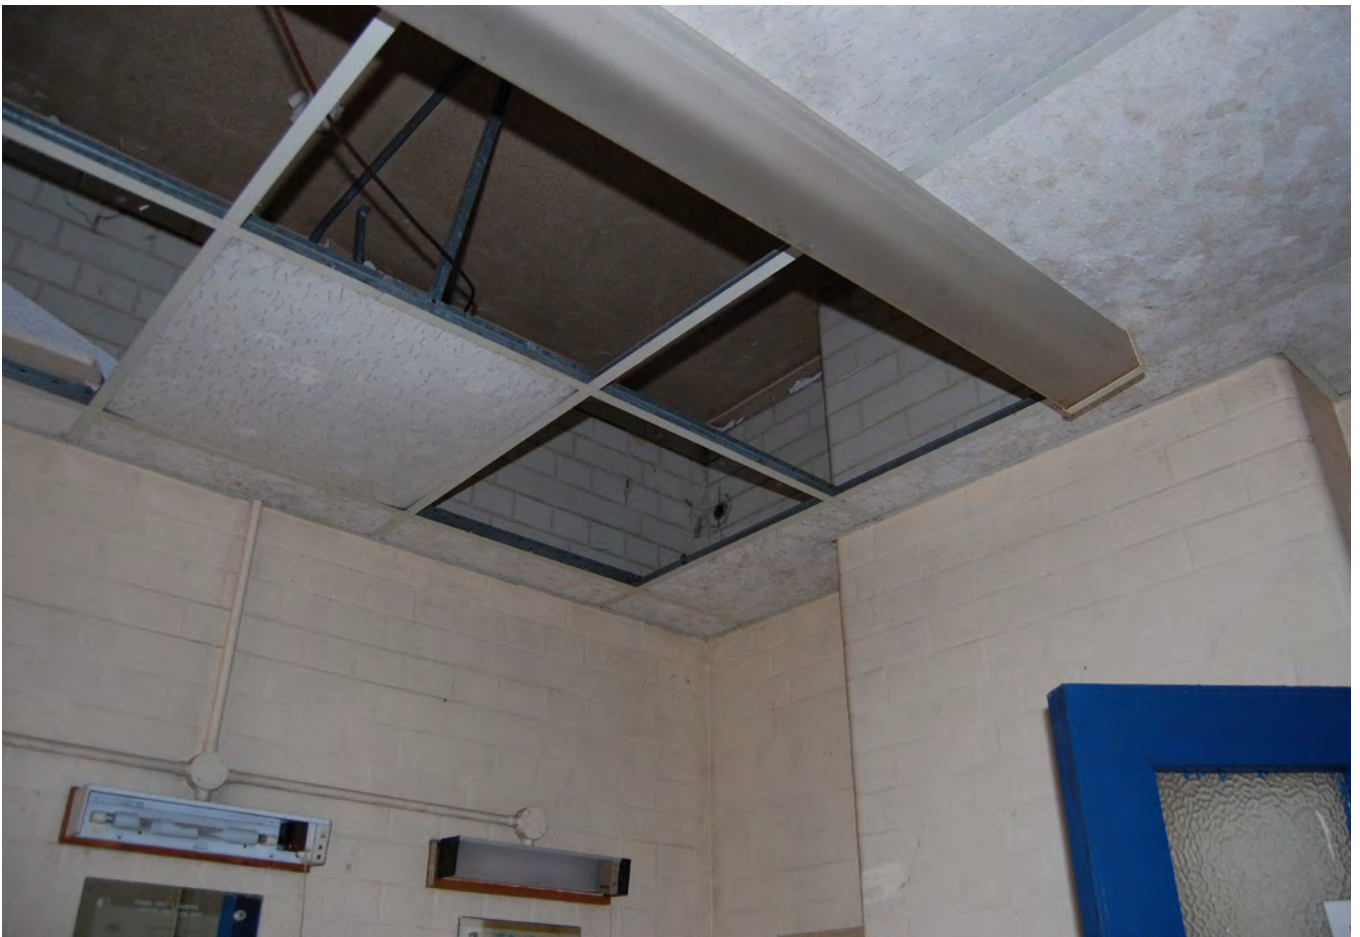
The walls of the ablutions areas are faced in glazed brick which has been painted below the height of the suspended ceiling; the original face is visible above the ceiling (Plate 485.9). The sanitary ware mostly predates the 1978 works, which included adding melamine privacy panels between the showers. There are modern white ceramic tile splashbacks behind the sinks and urinals; the showers have been tiled in the same. The floors are of cream non-slip tiles. The woodwork and metalwork is painted in the same shade of brown as the external features (Plate 485.10).

Plate 485.9 The glazed brickwork in the ablutions, visible above suspended ceiling

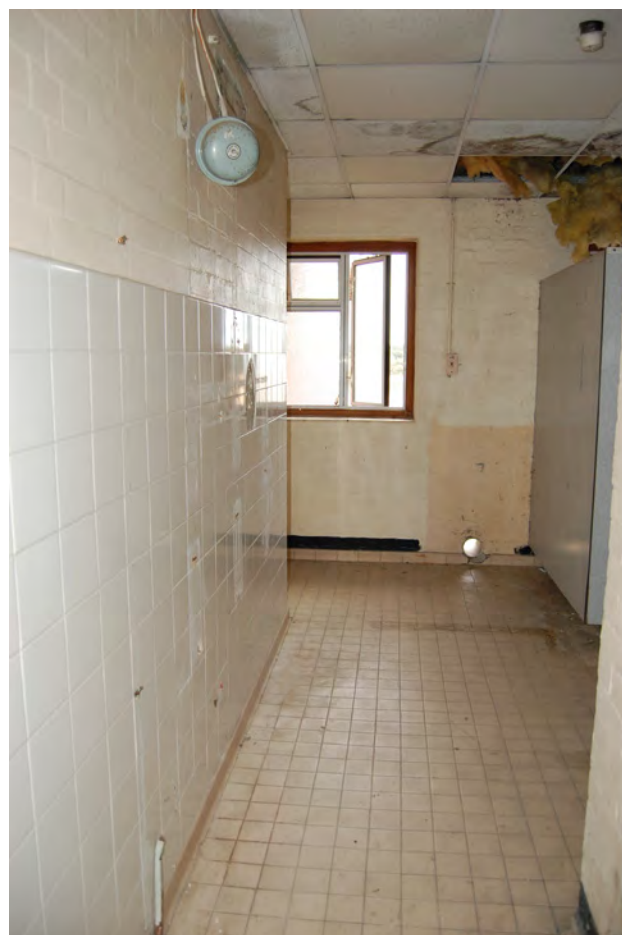
Plate 485.10 The range of finishes in the ablutions block

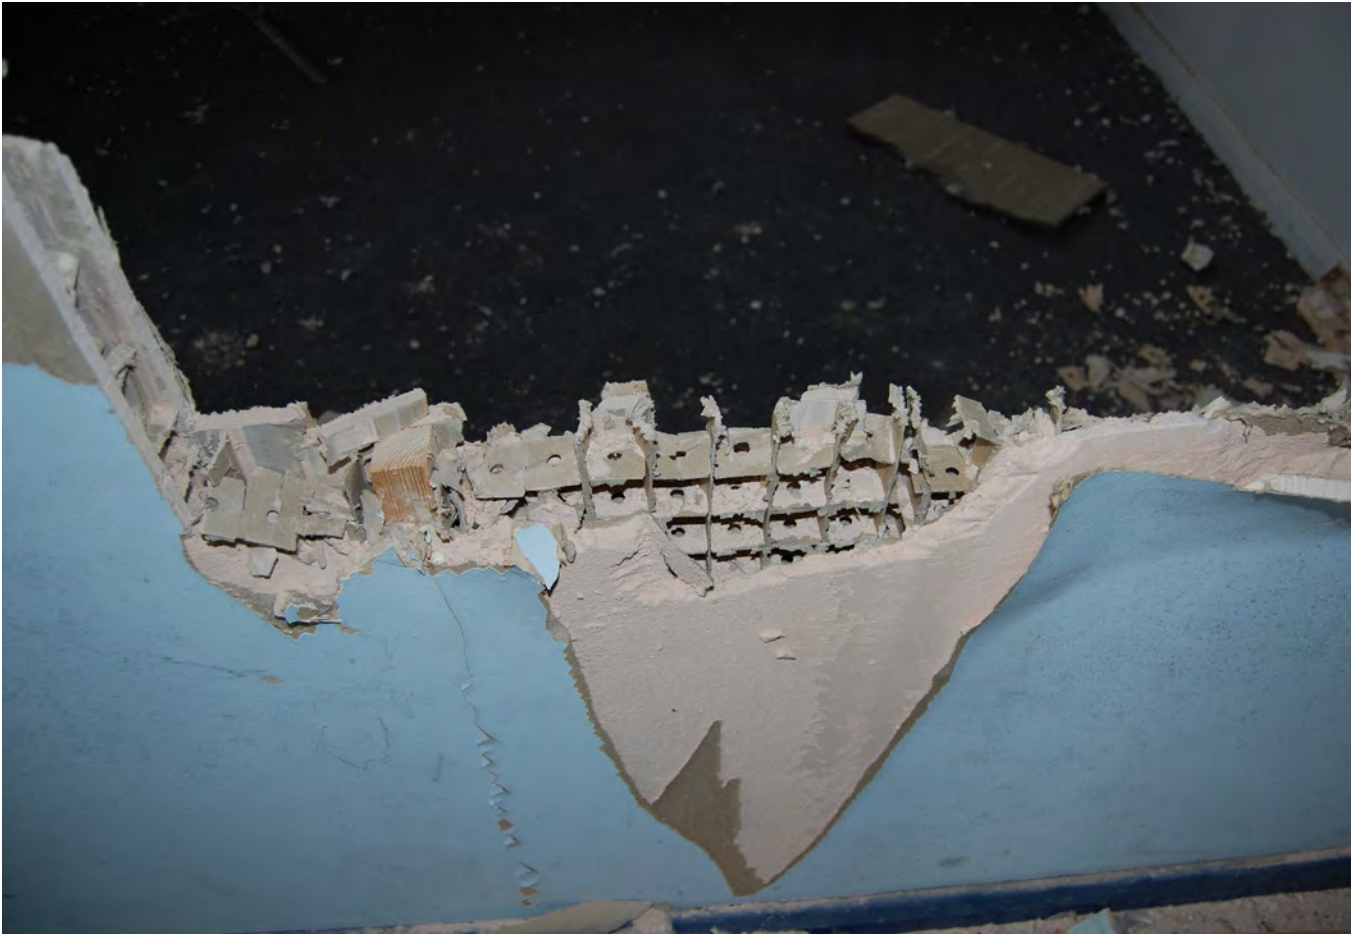
The internal partitions between the bedroom and corridors are made of panels of cellular cardboard between sheets of plaster (Plate 485.11). Where exposed, the joists between the first floor and the roof space show signs of the former lath and plaster ceilings.

Plate 485.11 The partition panel construction

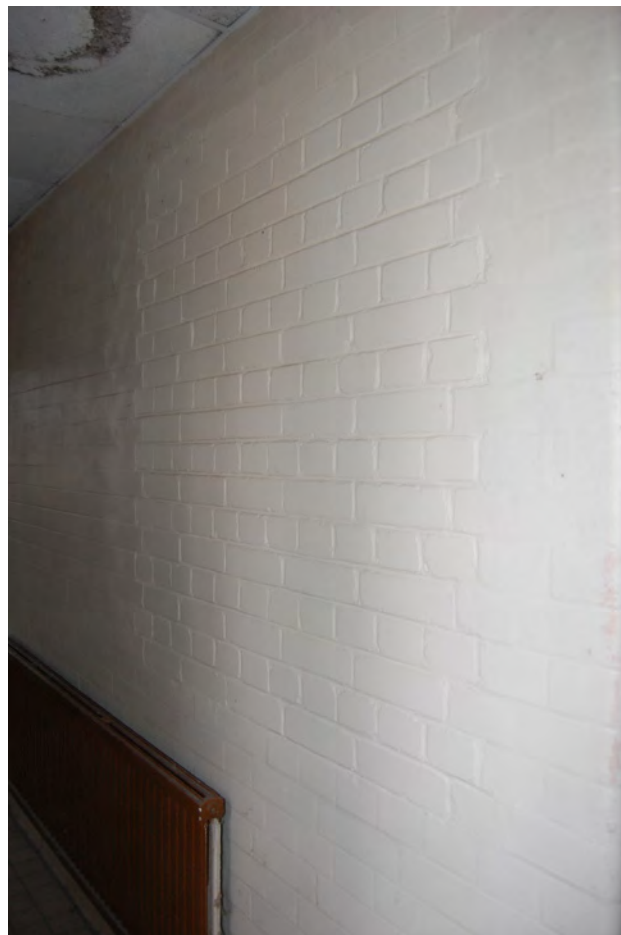
Plate 485.12 The blocked lights visible in the ablutions brickwork

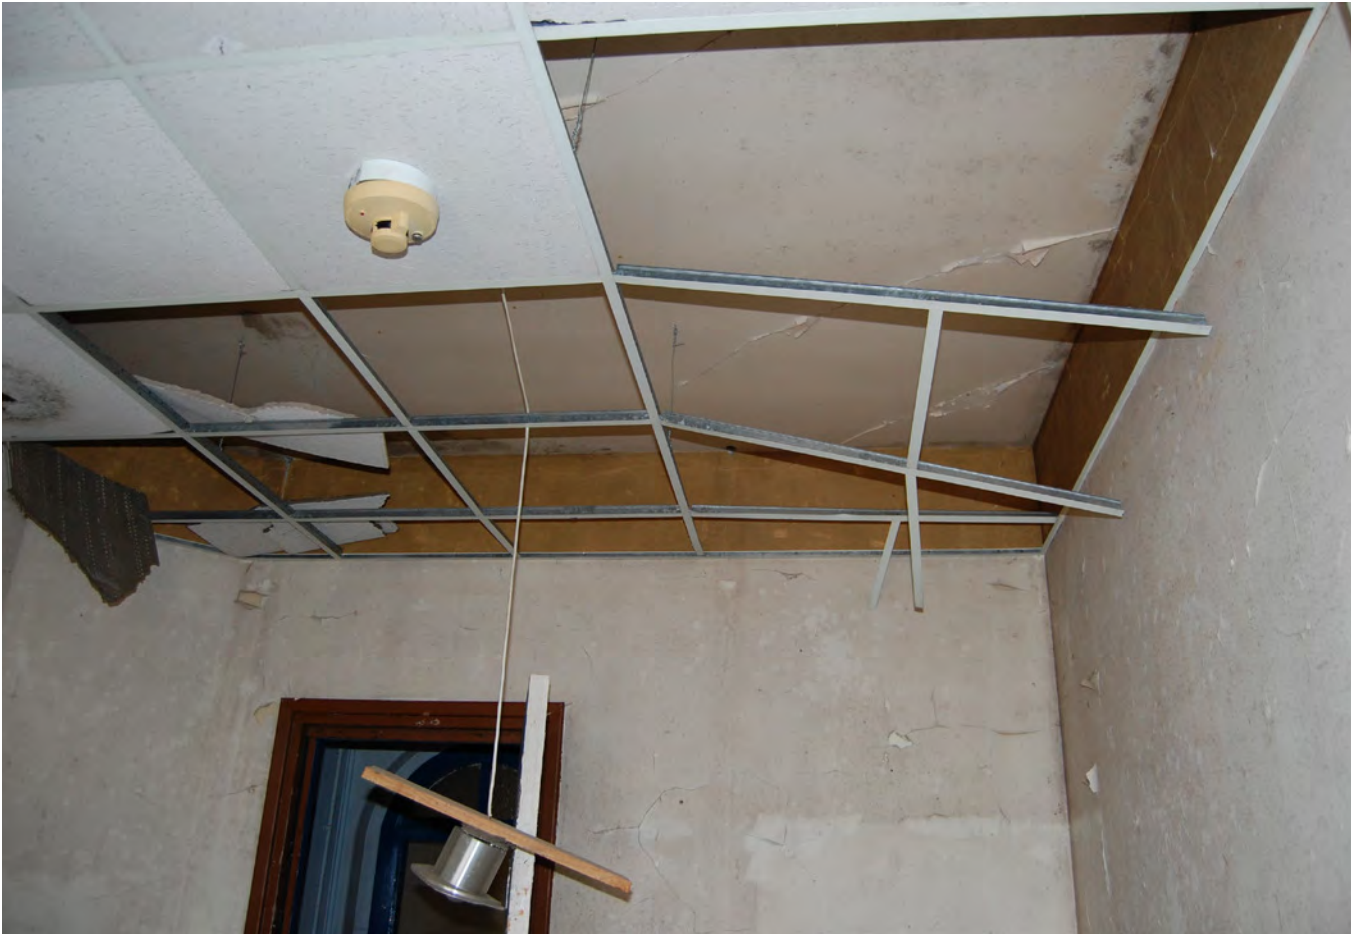
A note refers to the whole building being redecorated. The current decorative scheme to the communal areas consists of pale blue walls and mid-blue woodwork. The bedrooms are individually decorated with the majority having cream, blue or white walls and grey, blue, black, brown or burgundy woodwork. Previous colour schemes can be seen above any missing ceiling tiles; the rooms are painted with different colours, confirming that the partitions were in place and individual rooms were in use well before the suspended ceiling was installed during the 1978 works (Plate 485.13).

Plate 485.13 An example of a former decorative scheme

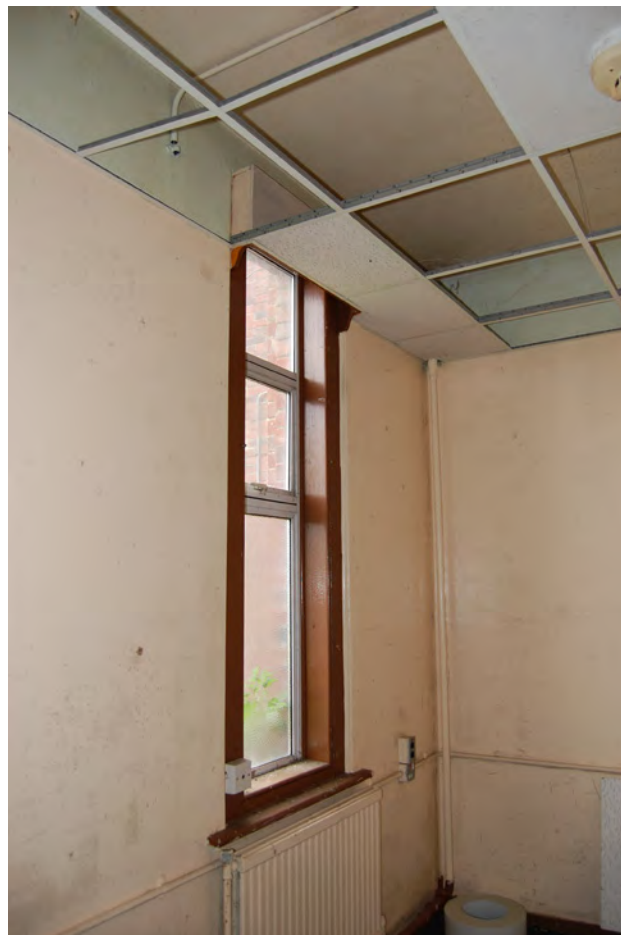
The suspended ceiling cuts across the top of the window openings of the ground floor, leaving just the ends of the wooden pelmet exposed (Plate 485.14); the first floor pelmets are abutted by the suspended ceiling (Plate 485.15).

Plate 485.14 The suspended ceiling obscuring a ground floor window pelmet

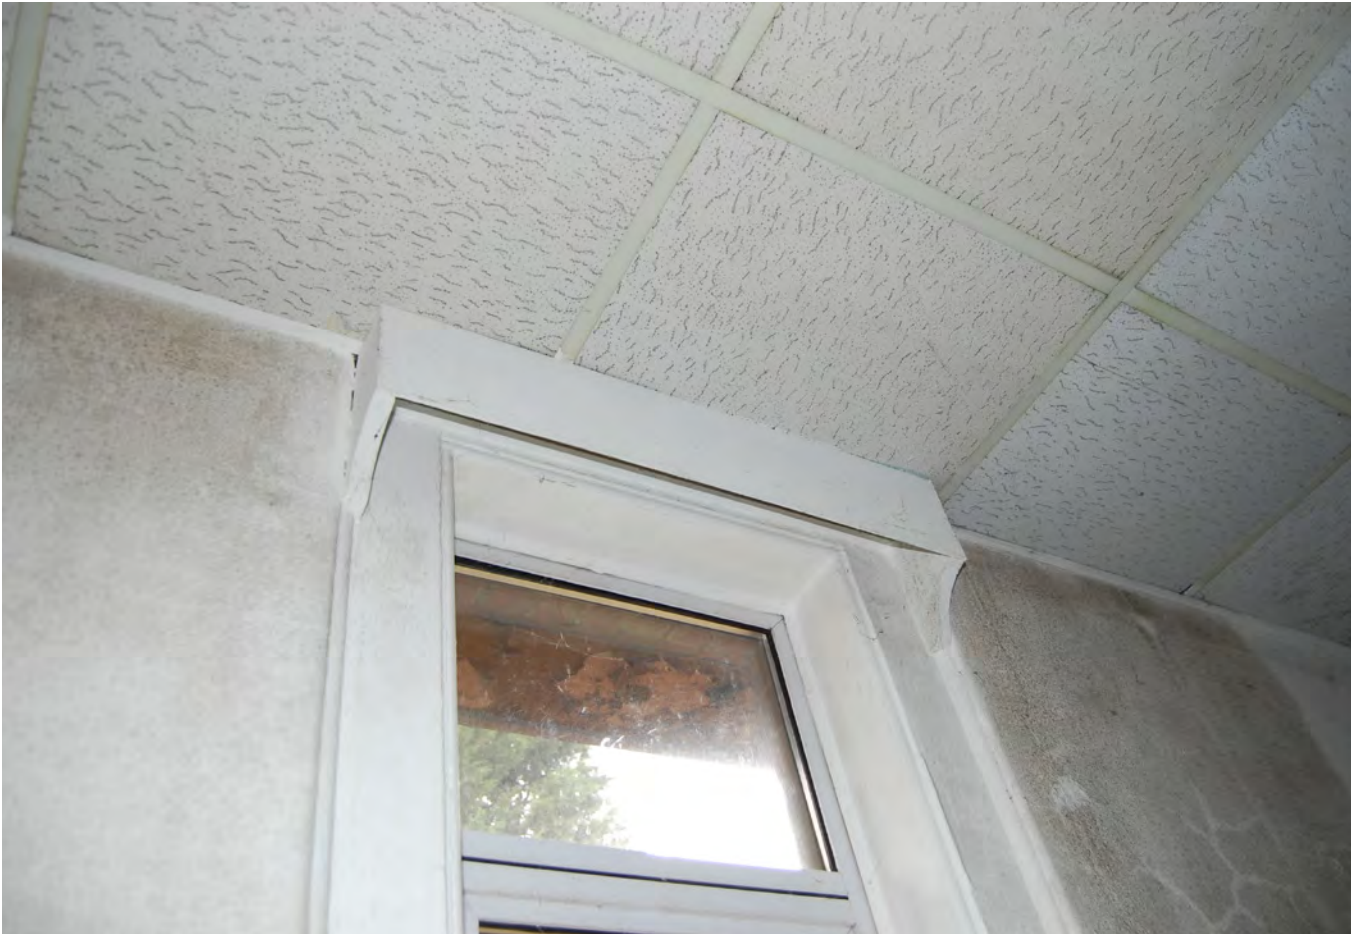
Plate 485.15 The suspended ceiling abutting a first floor window pelmet

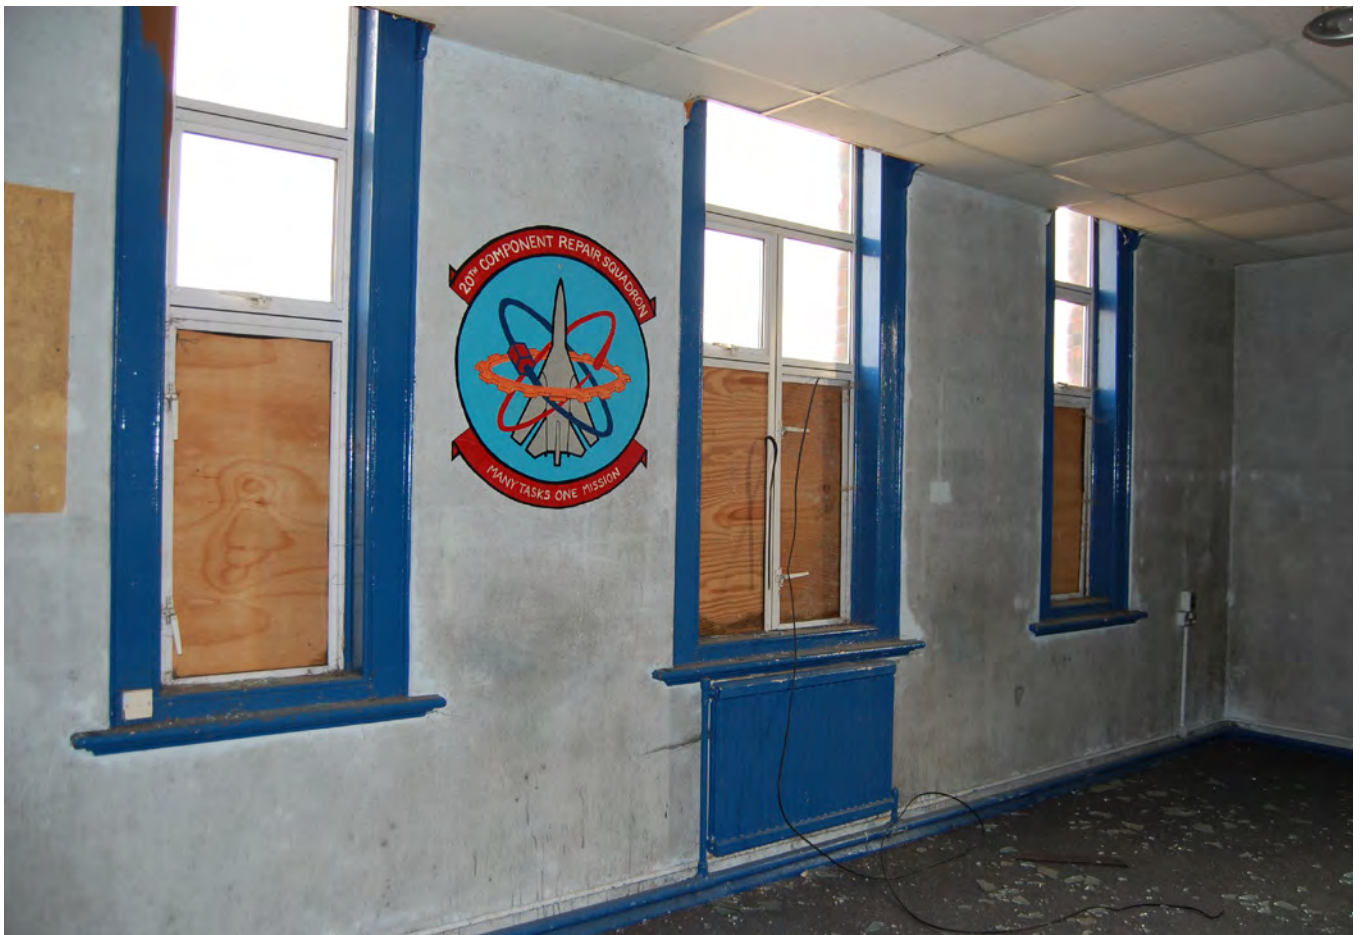
In the day room at the eastern end of the ground floor, the emblem of the 20th Component Repair Squadron, consisting of a shuttle surrounded by orbiting engineering components and the slogan 'many tasks one mission' (sic) is painted on the eastern wall (Plate 485.18).

Plate 485.18 The eastern wall of the day room and squadron emblem

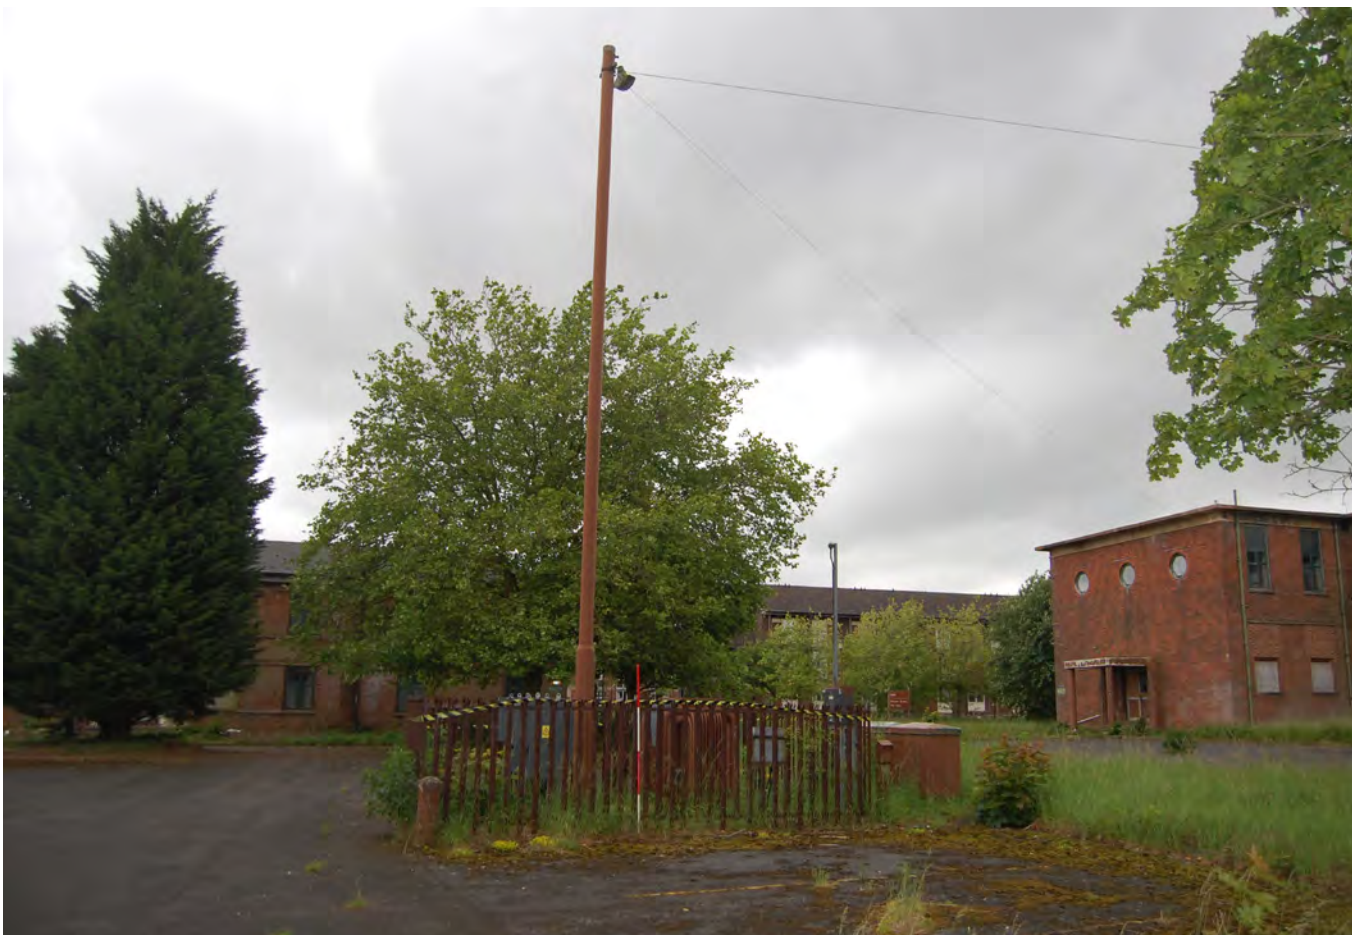
Plate 487.1 North-west view

The substation is a roughly square metal fenced enclosure (c1.5 m in height) (Plate 487.1). Internally are three sets of electric equipment (EMU1 and EMU2) and an electricity pole.

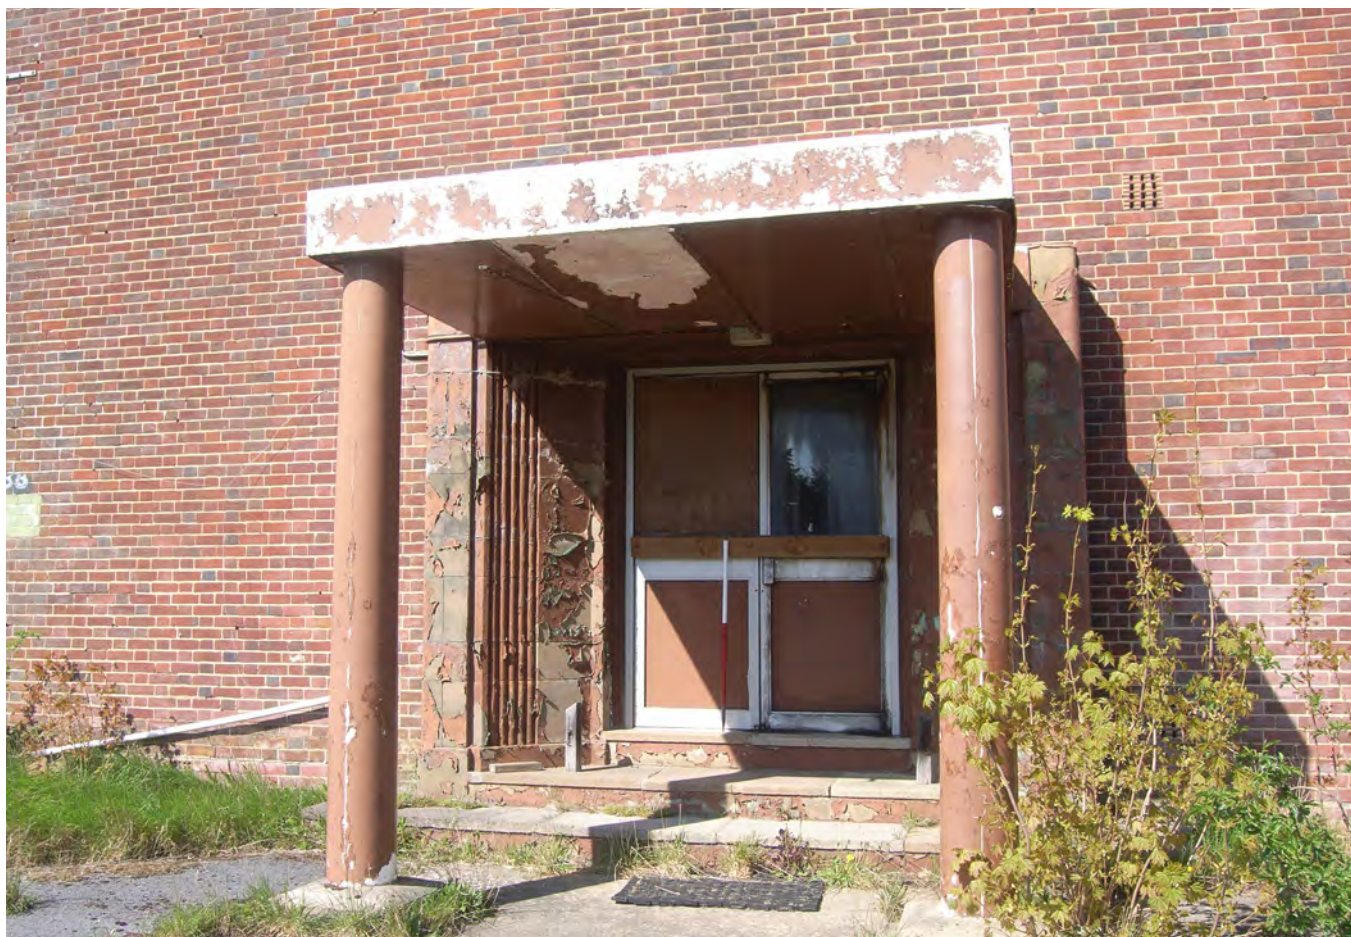
Plate 488.4 Example of an Art Deco wing entrance doorway and porch

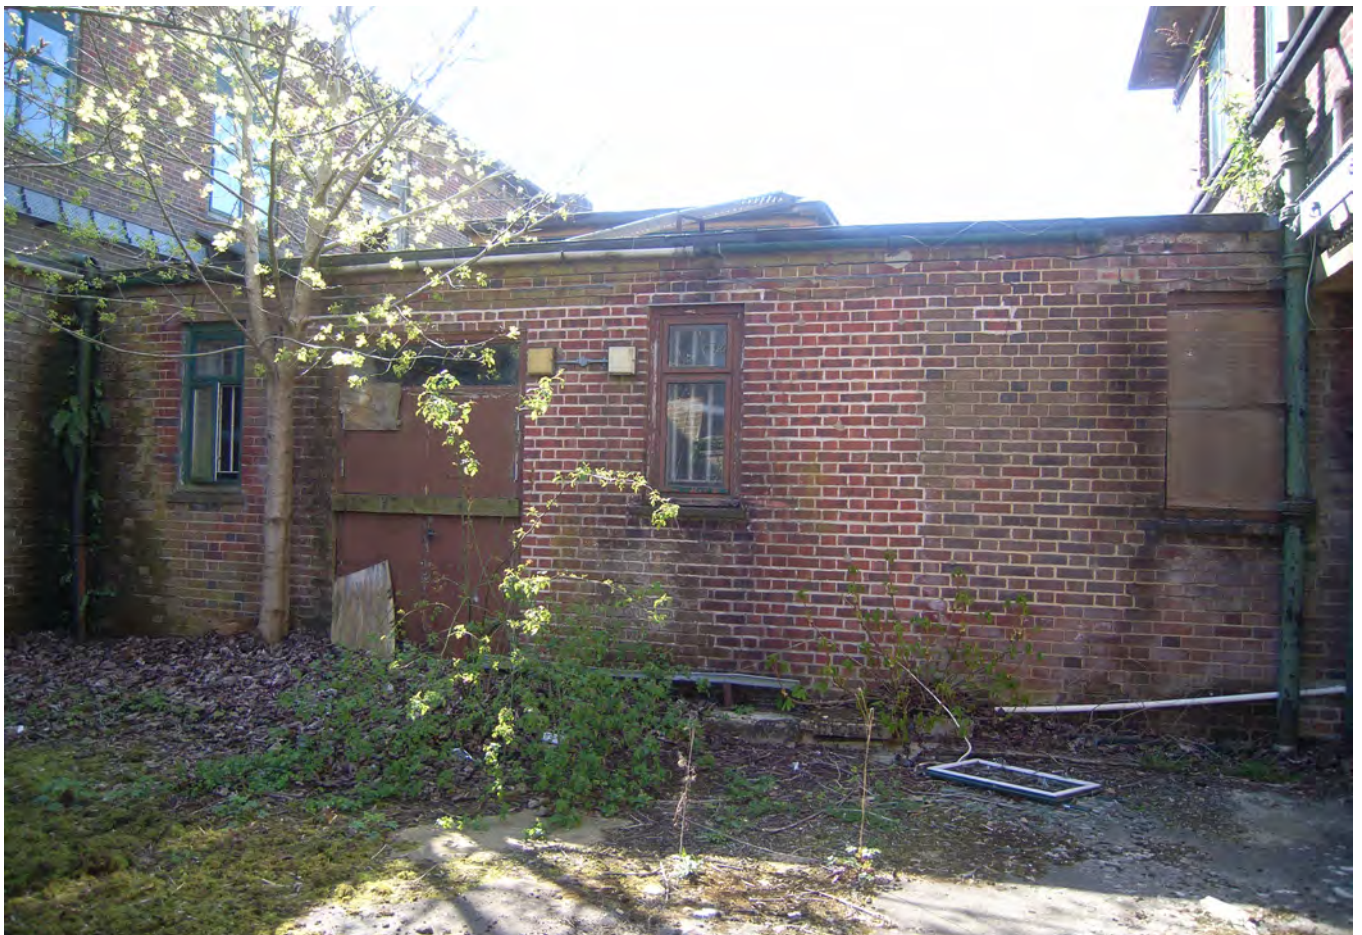
Plate 488.8 An example of alterations to the apertures in the rear range

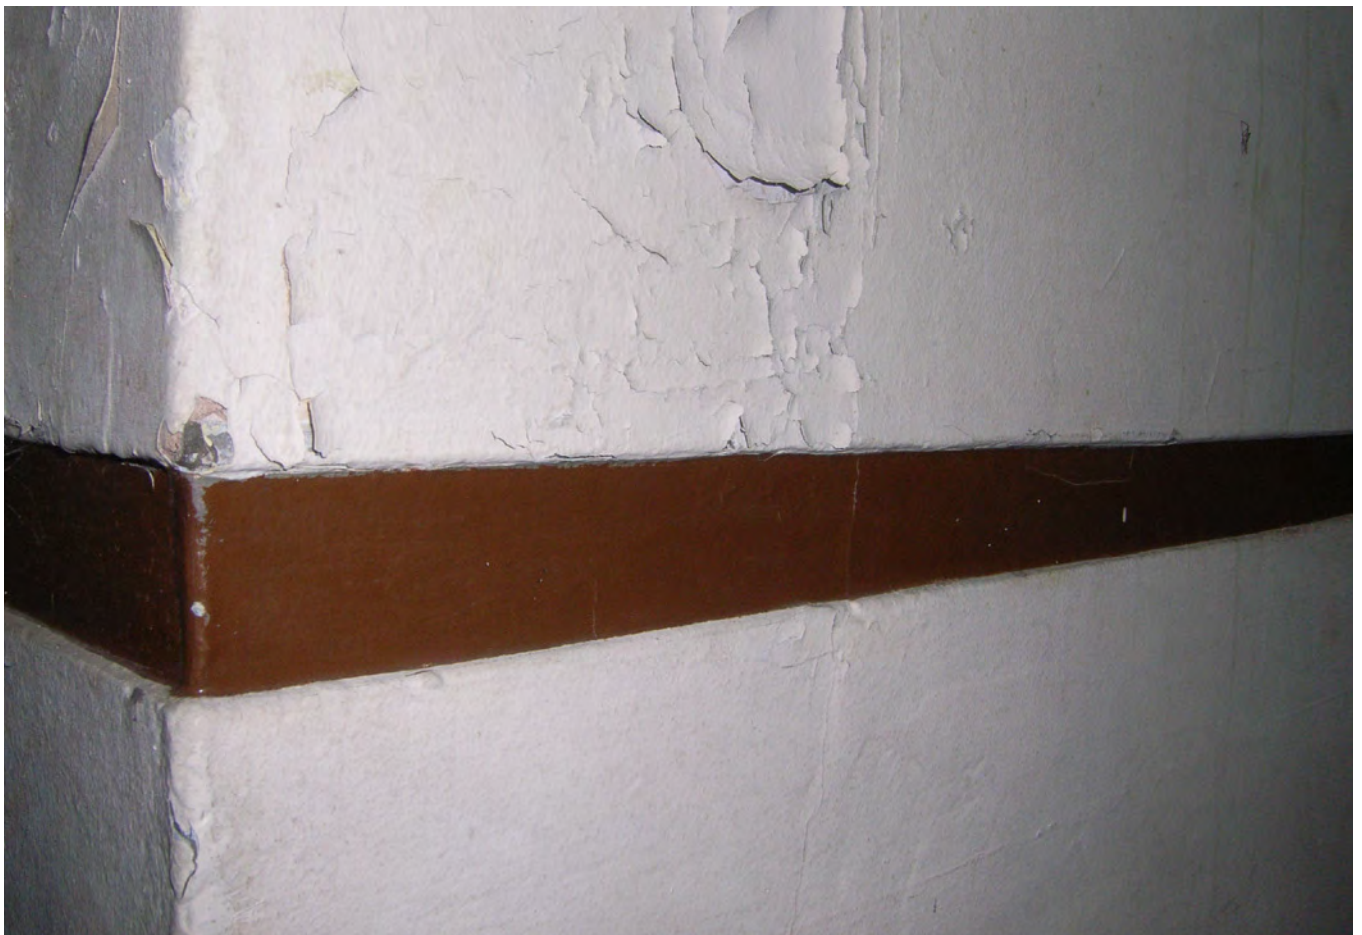
Plate 488.12 An example of the recessed dado

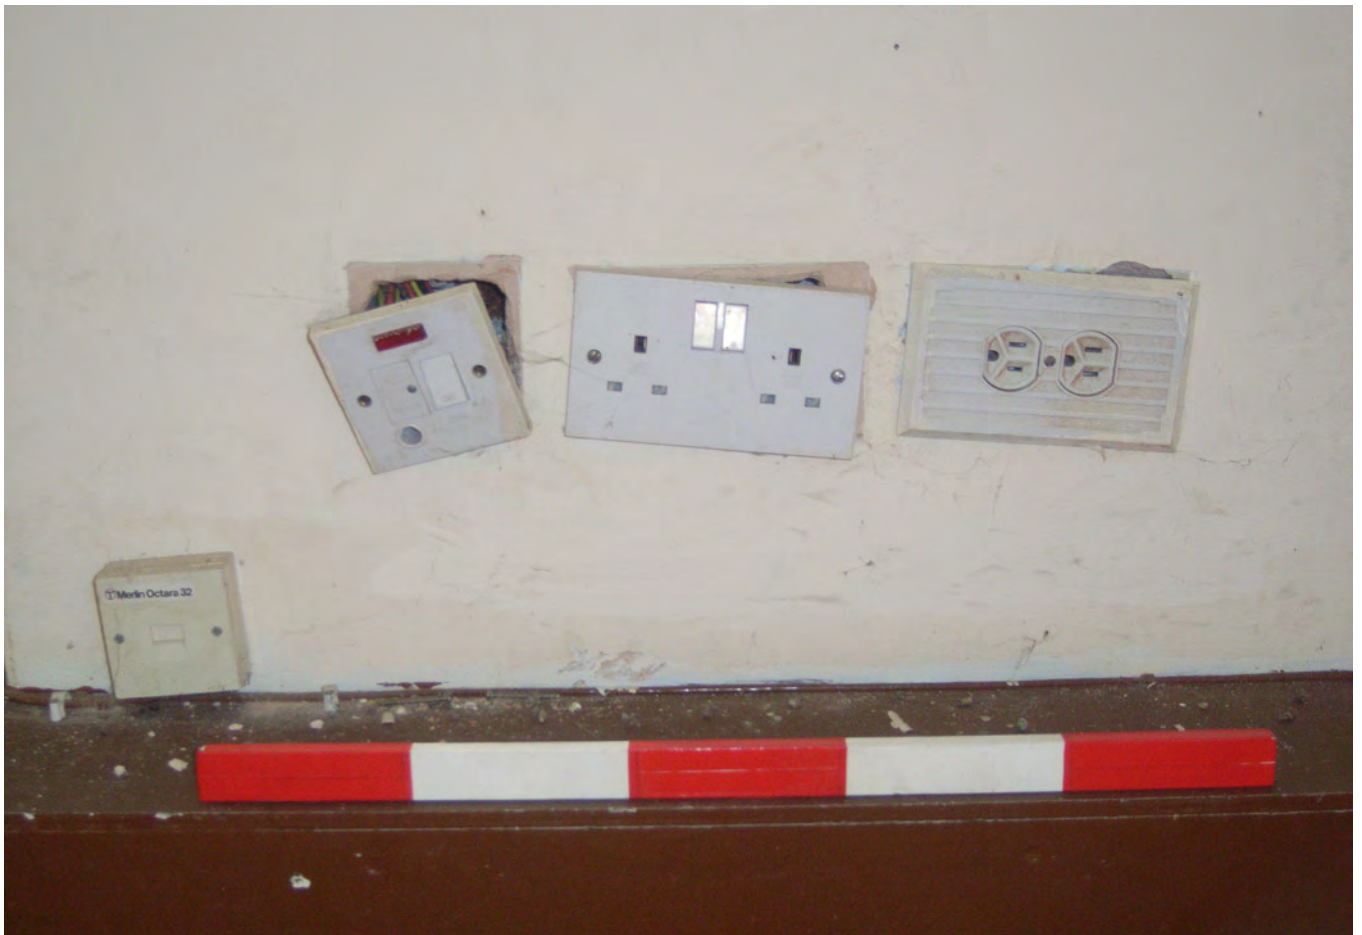
Plate 488.13 An example of the American and British power sockets

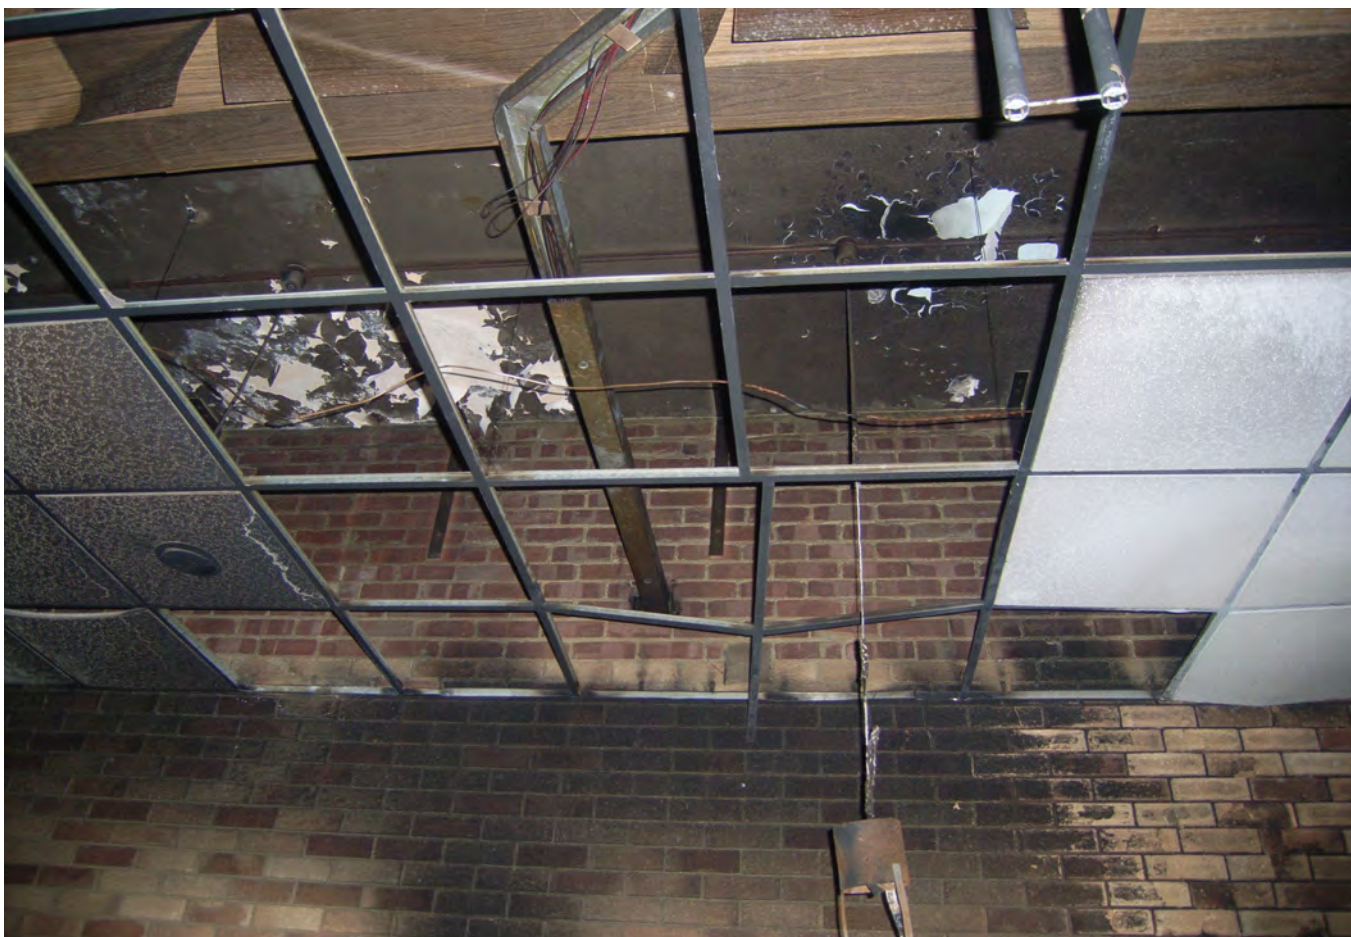
Plate 488.20 The types of brick used in the servery wall
