FORMER RAF UPPER HEYFORD, OXFORDSHIRE

HISTORIC BUILDING RECORDING AND INVESTIGATION

VOLUME 2: GAZETEER OF RECORDED STRUCTURES

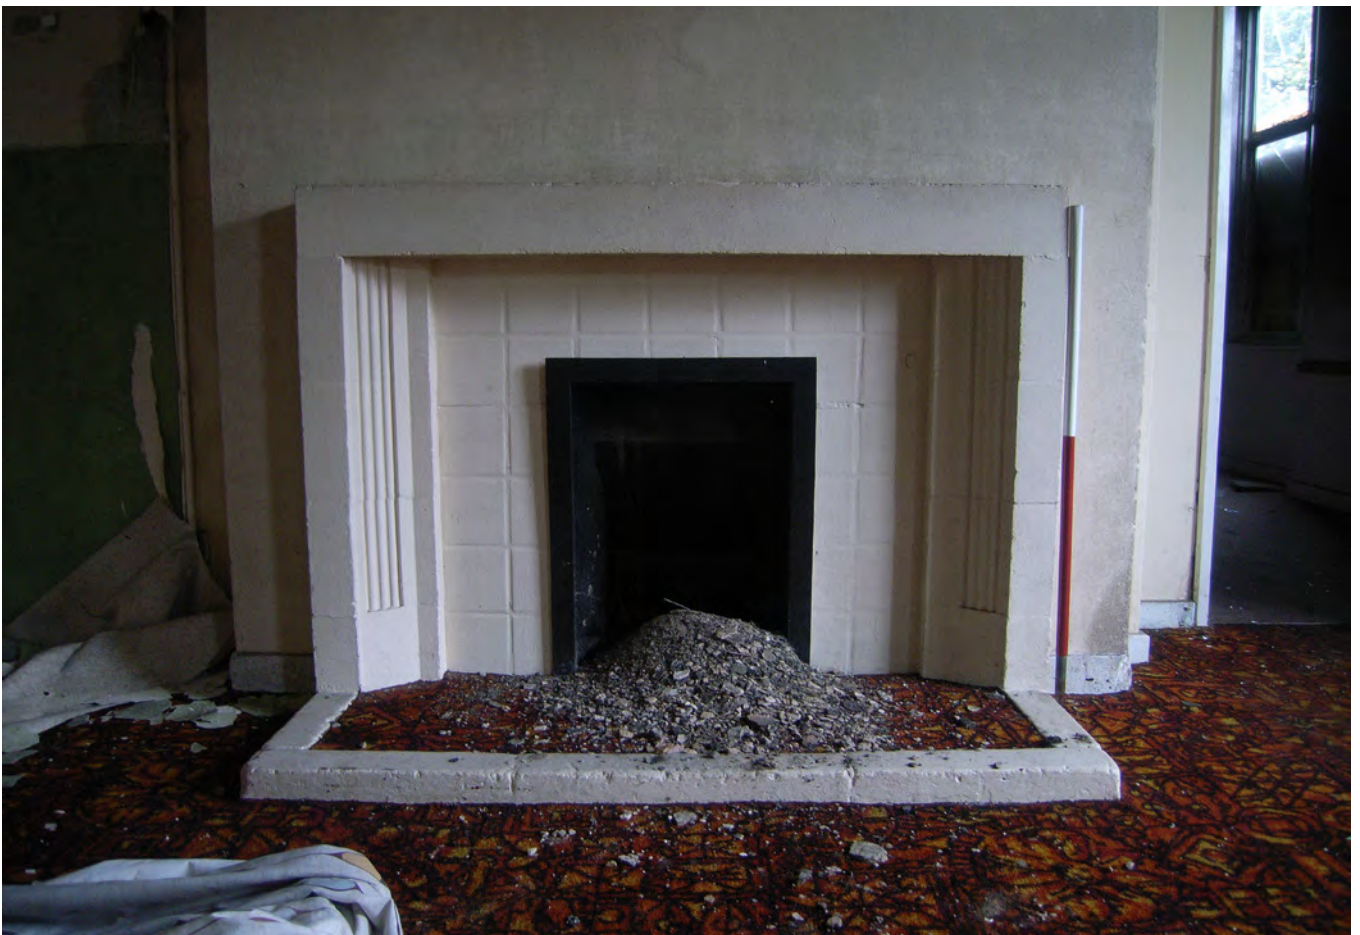
Plate 488.22 The Art Deco fireplace in the linen exchange

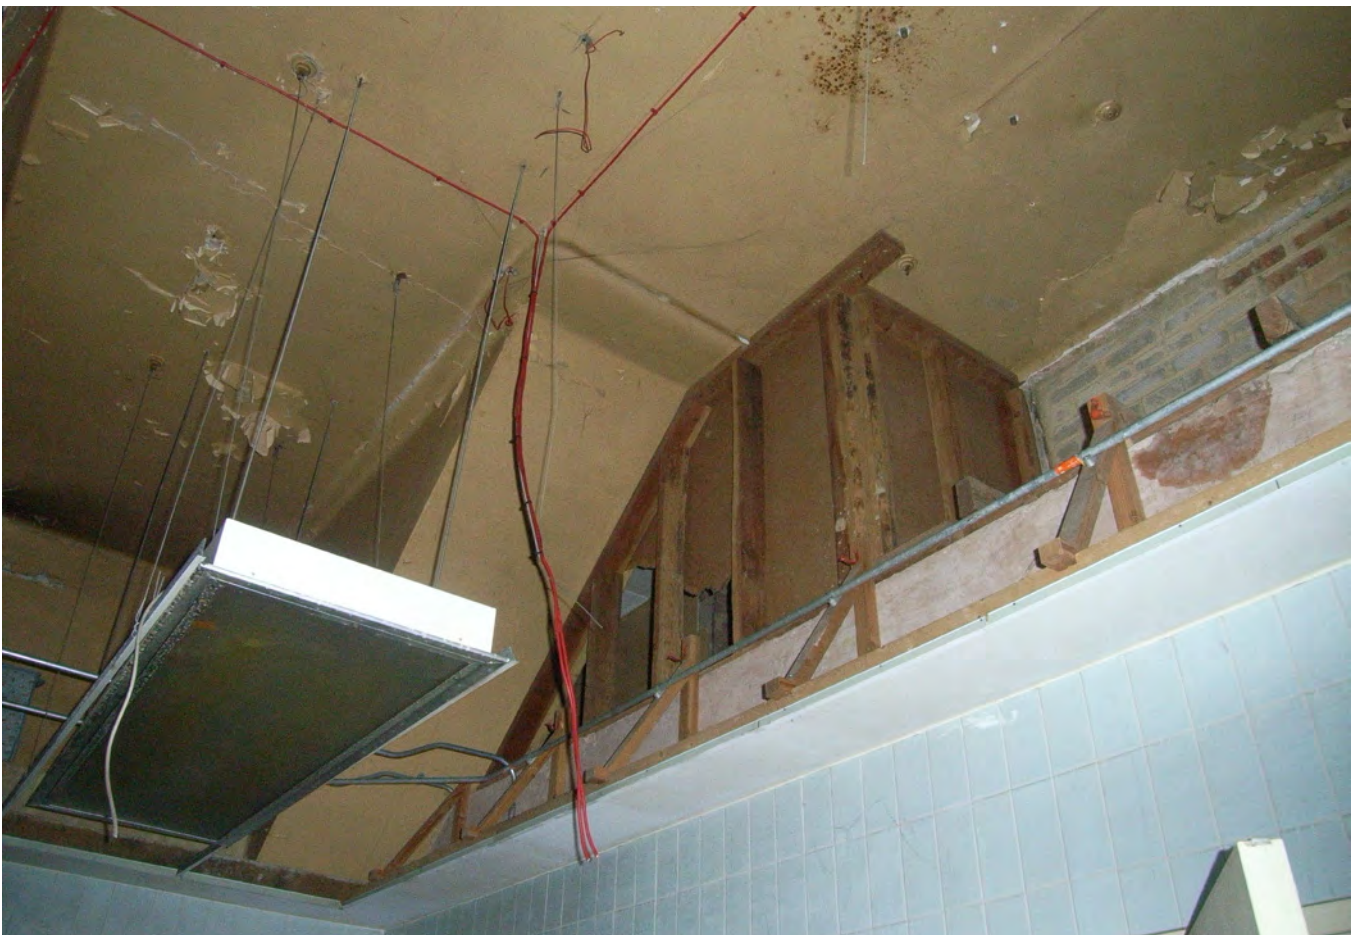
Plate 488.28 The former décor in the corridor and blocked-in staircase

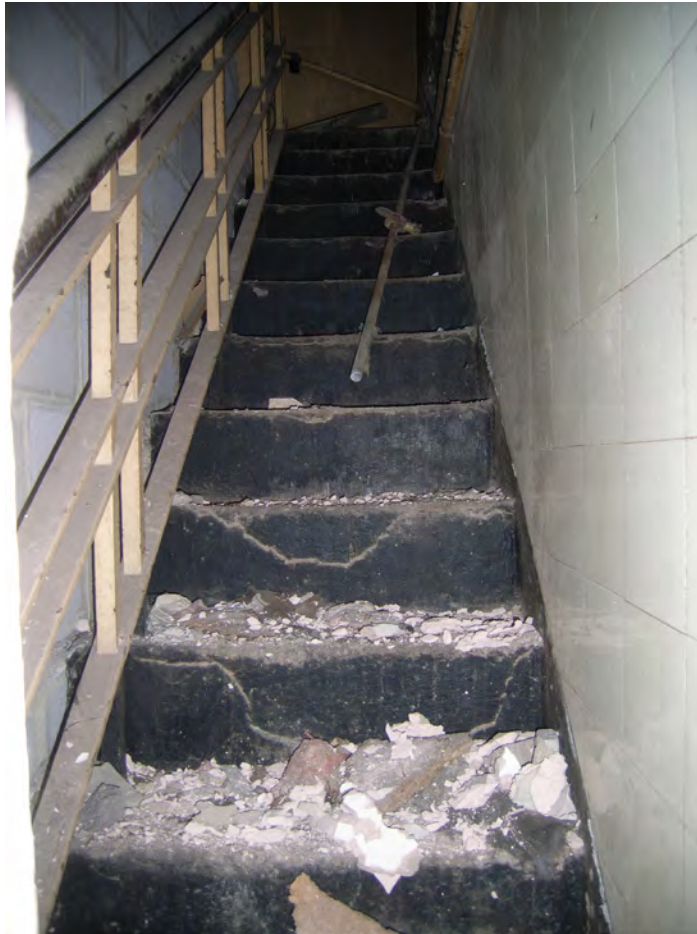
Plate 488.29 The blocked in staircase

The corridor between the platewash and the kitchen houses the electrical control panels; to the east of this is a blocked-in area and cupboard concealing an original staircase which formerly lead to the upper dining room. This was photographed via a small hole in the aerated concrete block partition which covers it (Plate 488.29). No evidence of the staircase is visible on either floor.

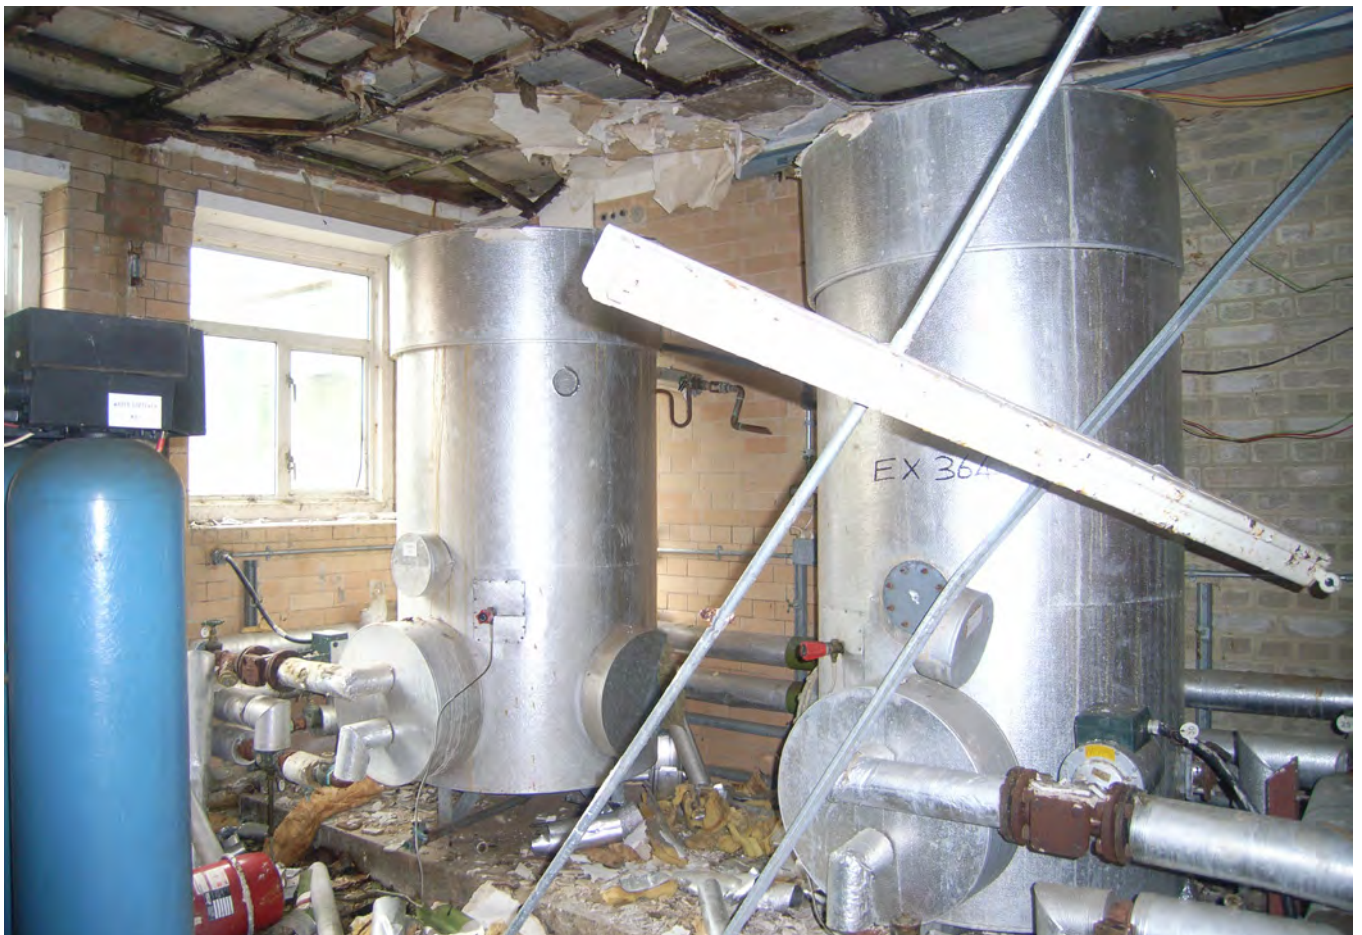
Plate 488.30 The calorifier room

A Calorifier Room is now located in the room originally designed as a scullery. The room retains the original cream tiles. A blocked doorway, originally leading to the now-platewash room, is visible which was blocked during the 1986 works (Plate 488.30). The service corridor from which this room is accessed contains an original door which leads out into the smallest, and enclosed, courtyard which is also accessed from the lobby beside the Recreation Room (Plate 488.31).

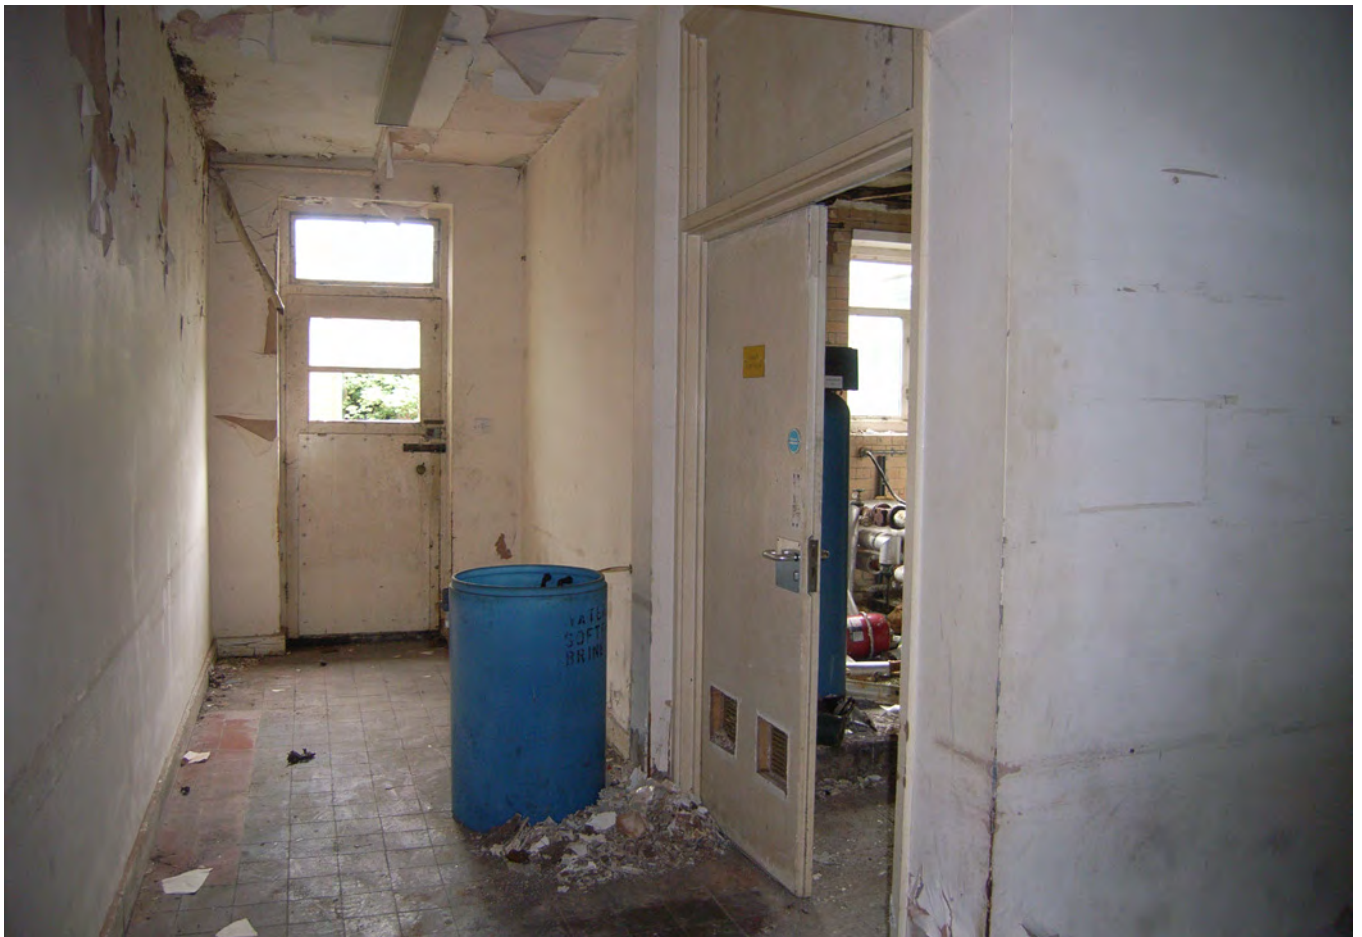
Plate 488.31 The corridor to the enclosed courtyard

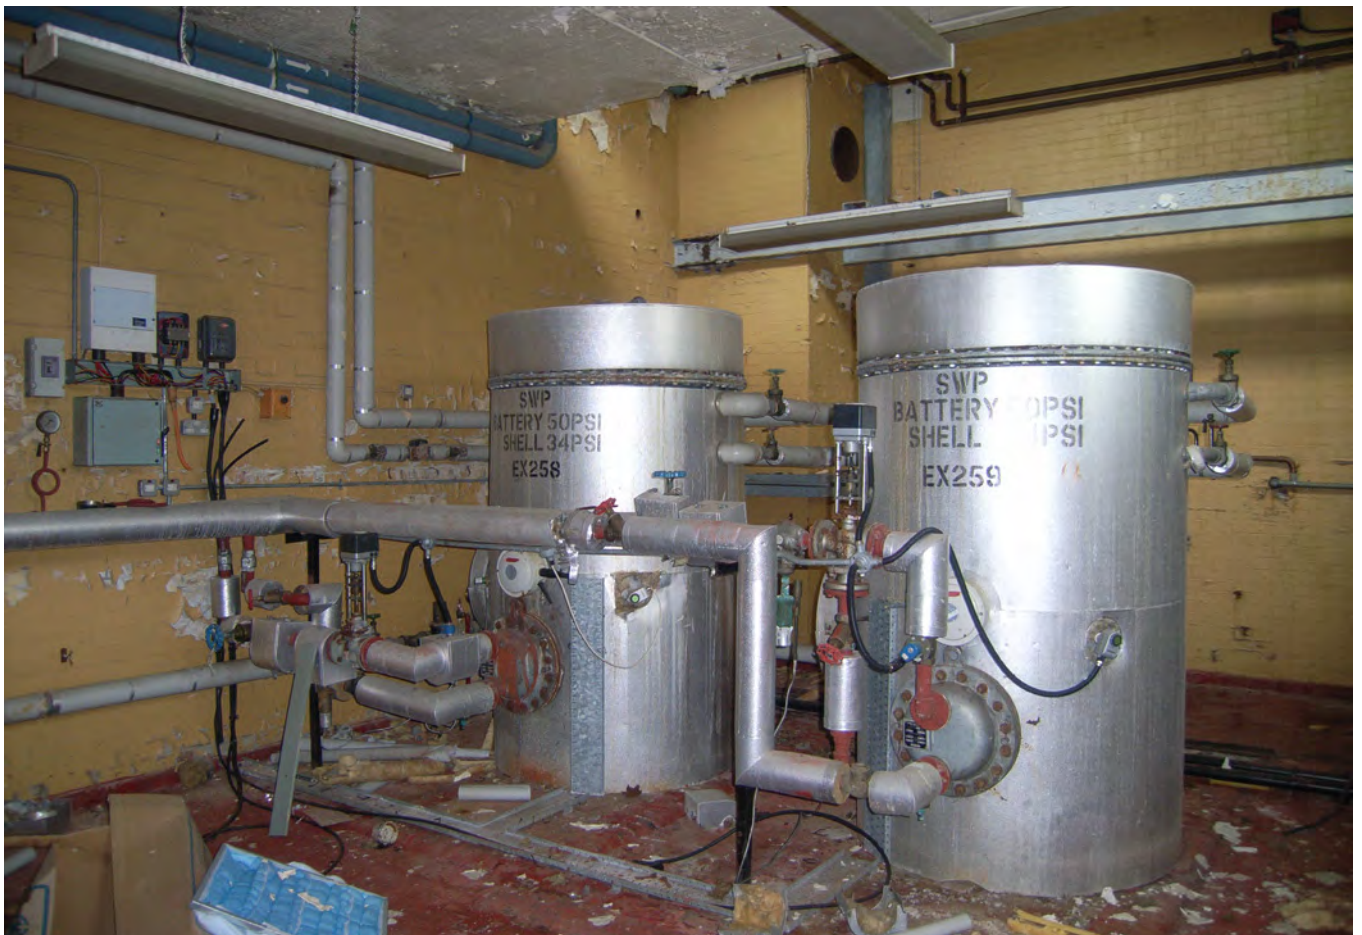
Plate 488.32 The boiler room

To the south of the service yard is the below-ground Plant/Boiler Room and the adjacent Valve Room. Now containing modern plant, the Boiler Room does retain trenches and brick bays for former equipment (Plates 488.32 & 33).

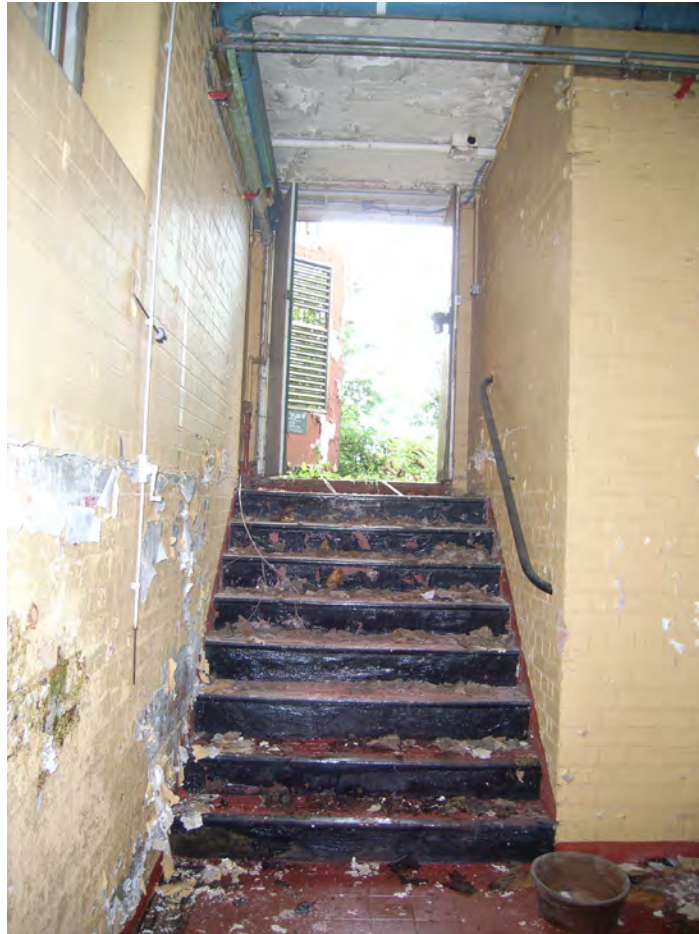
Plate 488.33 The steps from the boiler room to the yard

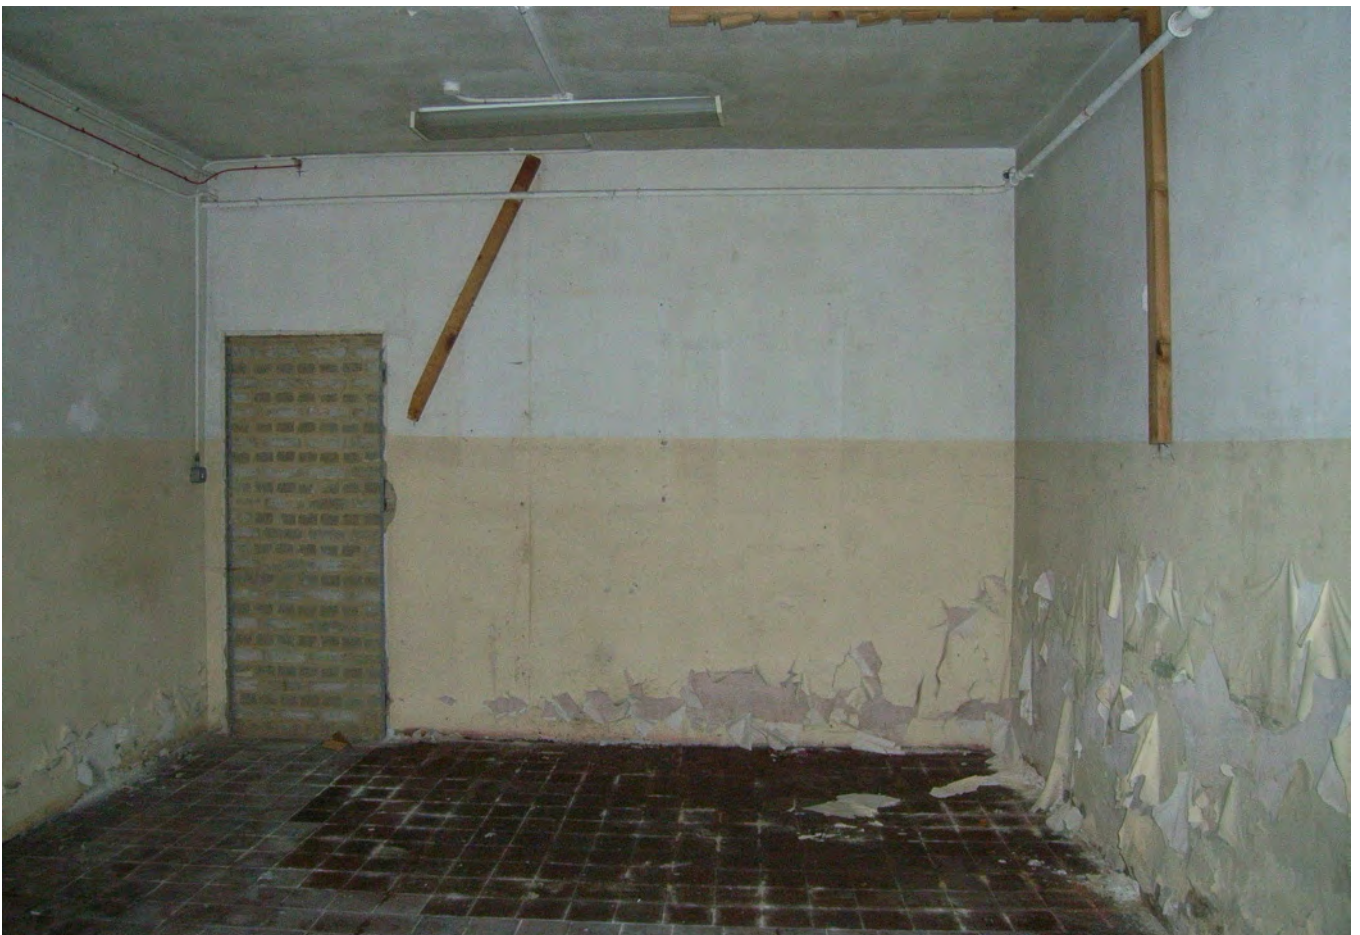
Plate 488.34 The former kitchen equipment store

The former Kitchen Equipment Store was indicated on the 1986 drawings as a shower and WC room for women, with the same for men to the west of the Recreation Room and the Recreation Room was intended for lockers. At the time of recording, the women's shower and WC area was empty and did not show any evidence of having contained those facilities, although the floor was tiled; a door to the platewash area had been blocked, indicating that it had previously been the kitchen equipment store (Plate 488.34).

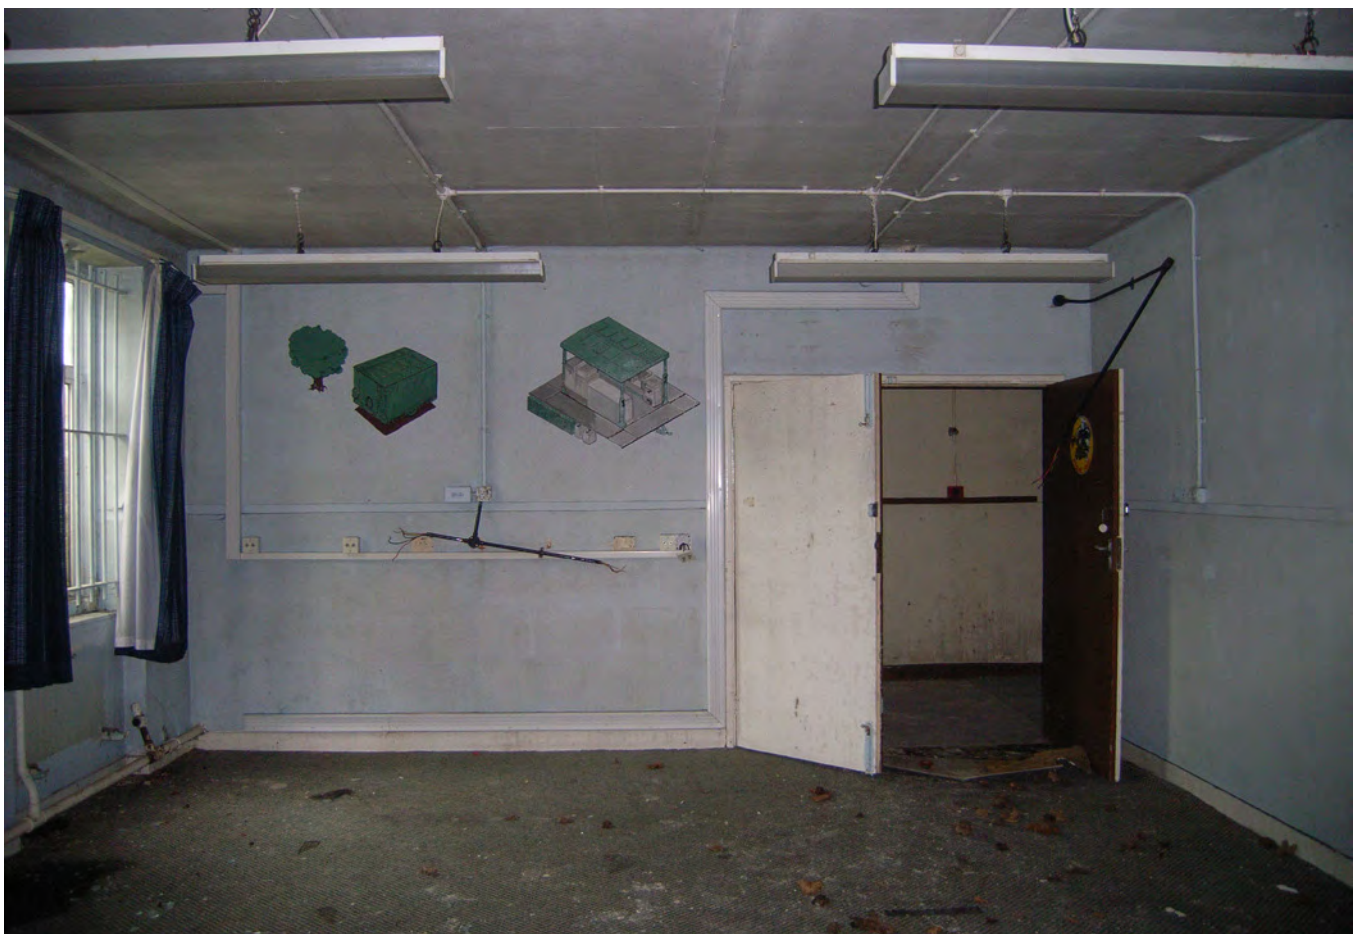
Plate 488.36 The east wall of the recreation room with field kitchen artwork

The Recreation Room contains the only artworks found in this building; these have been recorded fully as part of the artwork project. Briefly, the artwork consists of a sticker on the entrance door and identical painted logo on the south wall of a snorting bull dressed in a camouflage shirt and a chef's hat, holding pots and pans whilst driving a Jeep. 'Prime Ribs' is in red capital letters beneath this (Plate 488.35). On the east wall is a closed field kitchen trailer next to a tree; adjacent to this, an open similar trailer displays cooking equipment and water containers (Plate 488.36).

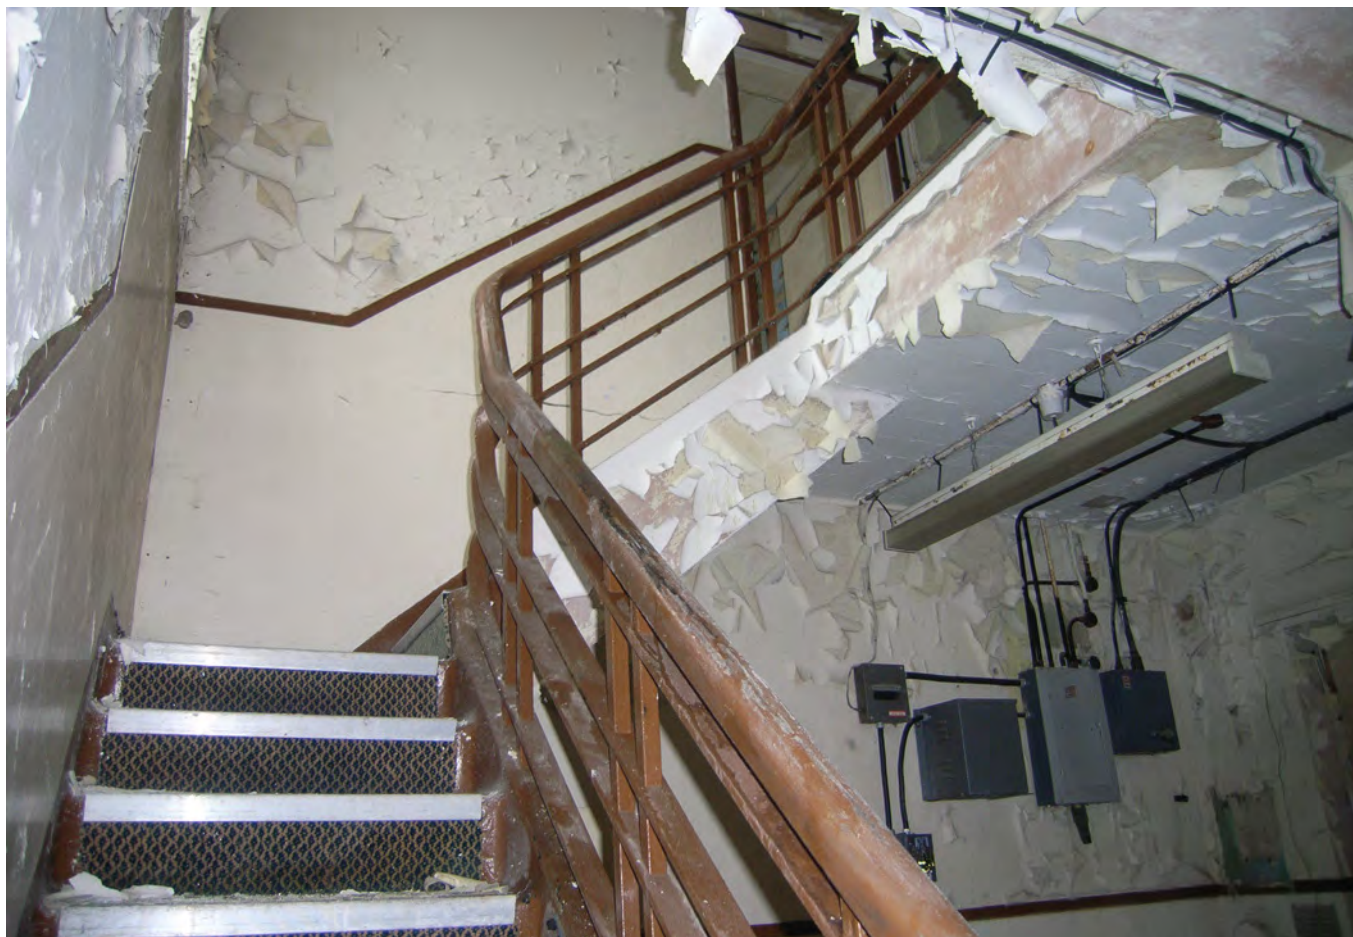
Plate 488.37 The staircase to the NAAFI dormitories

An original Art Deco staircase (Plate 488.37) in an identical style to the others in the building leads up to a corridor with five bedrooms, a bathroom and a WC leading off (Plate 488.38). All of the walls are primary and it appears that there has been little alteration other than the conversion of the cupboard in the former lavy, now the south west bedroom, into an electrical cupboard and the later window replacement work. A small hatch has been cut through the partition between the two easternmost rooms, formerly the two dormitories, although it is not clear if this is original or later, although the current hatch door is modern.

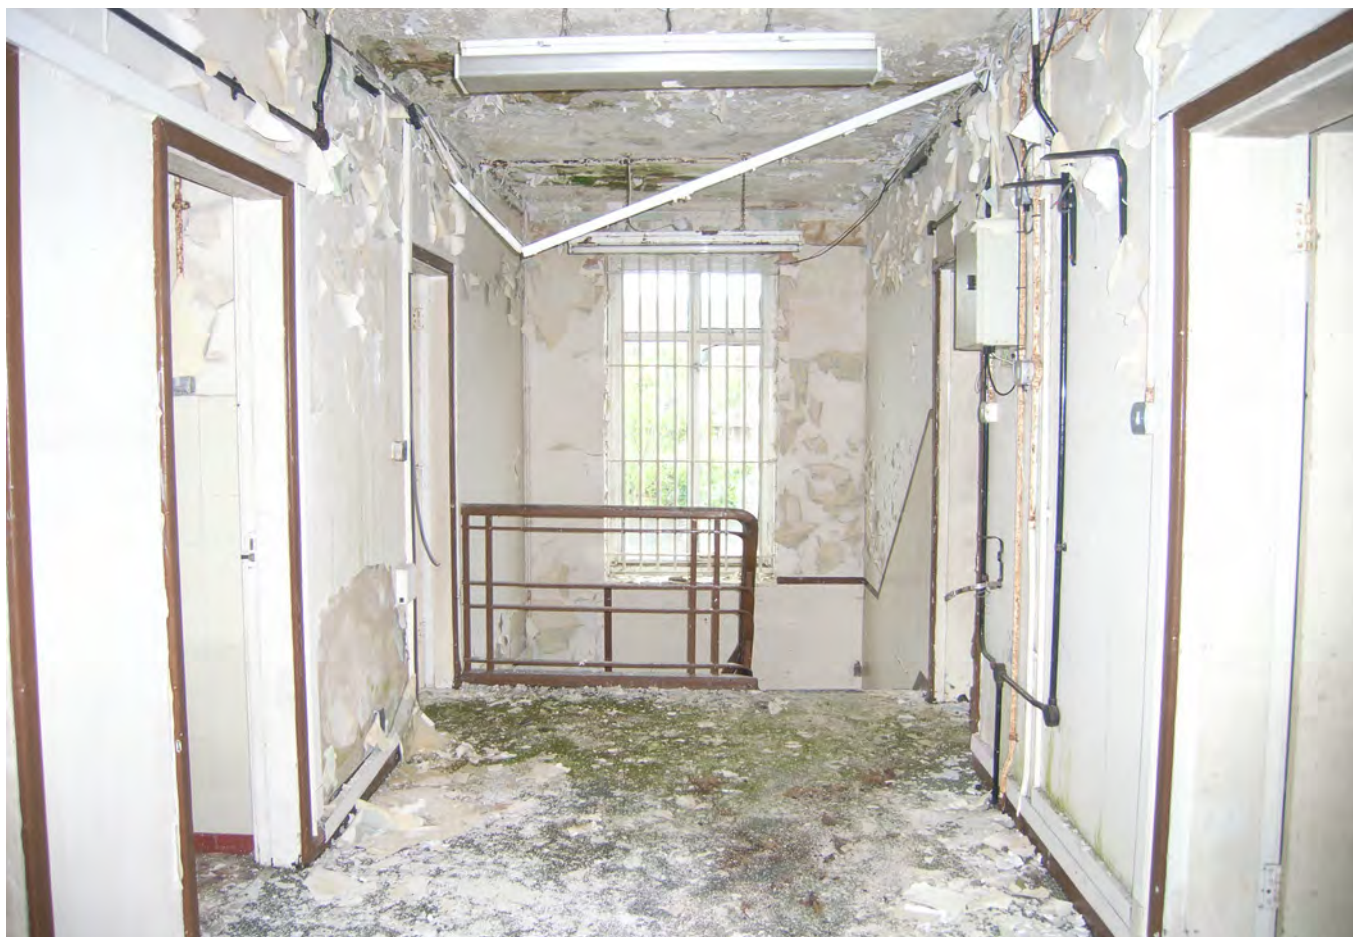
Plate 488.38 The landing of the NAAFI dormitories

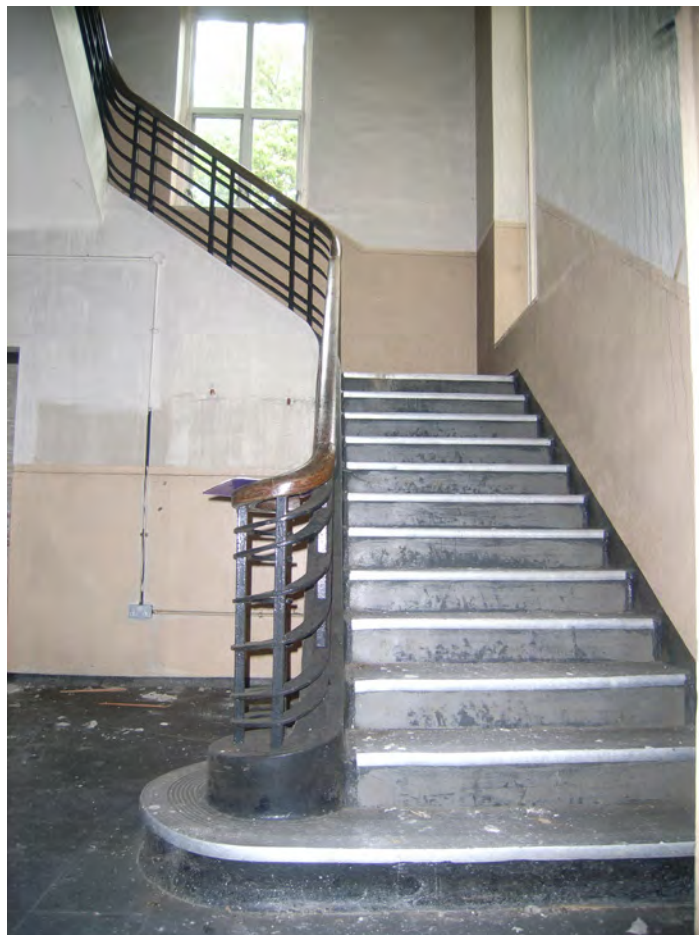
Plate 488.40 The staircase in the west wing

One of the original staircases leads to the first floor; typical Art Deco metal balustrades with a wooden handrail are continuous from the stairs to the landing above (Plate 488.40). The bottom of the staircase is squared, rather than rounded, as is seen in the east wing.

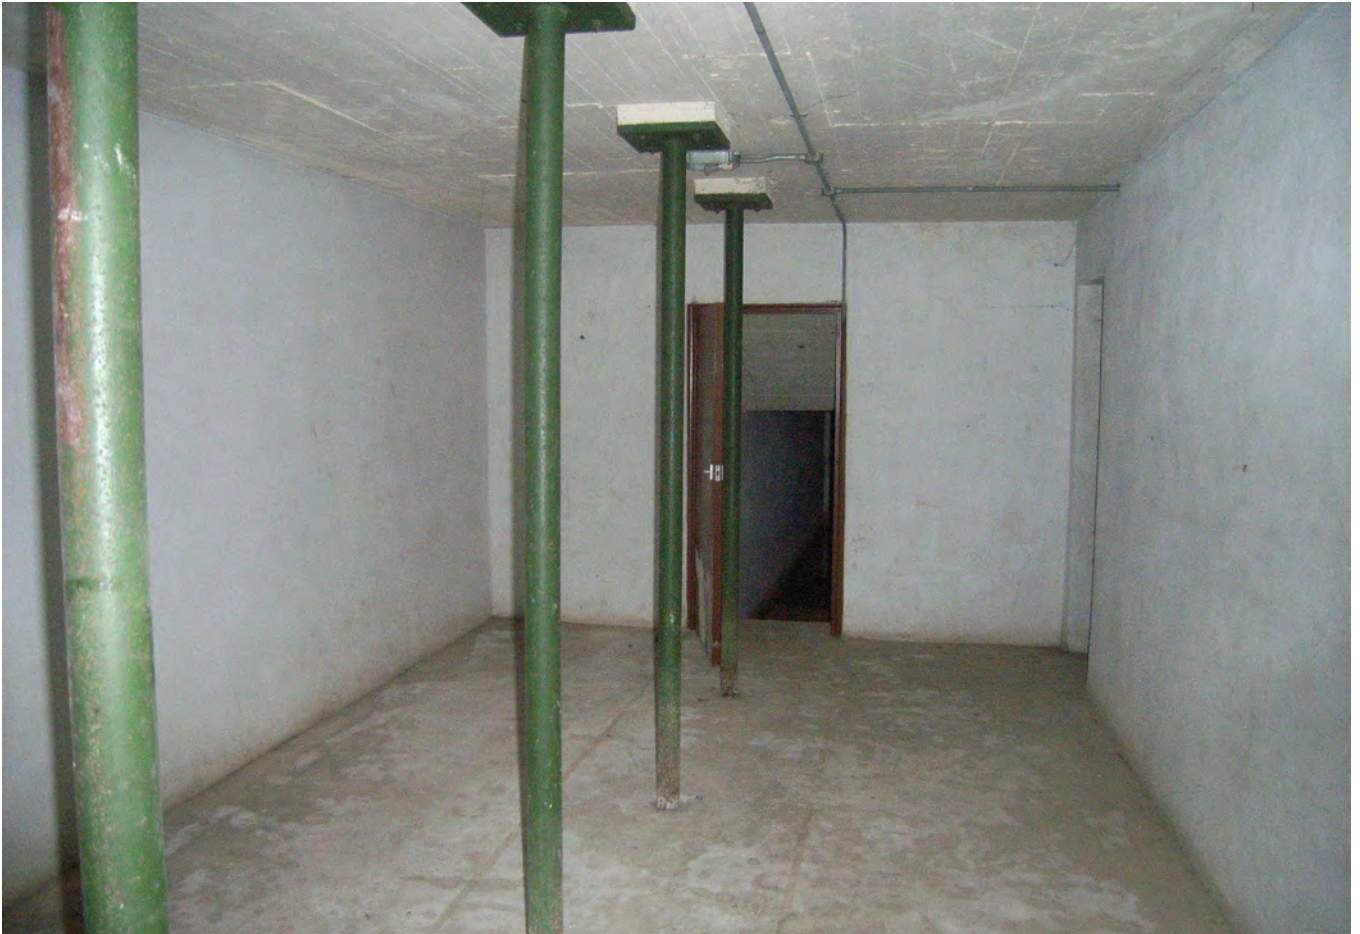
The basement is accessed via the doorway beneath the staircase in the west wing. Insufficient light and structural problems prevented recording, but rooms leading off the main room were evident. The poured concrete structure can be clearly seen in the ceiling (Plate 488.41).

Plate 488.41 The basement

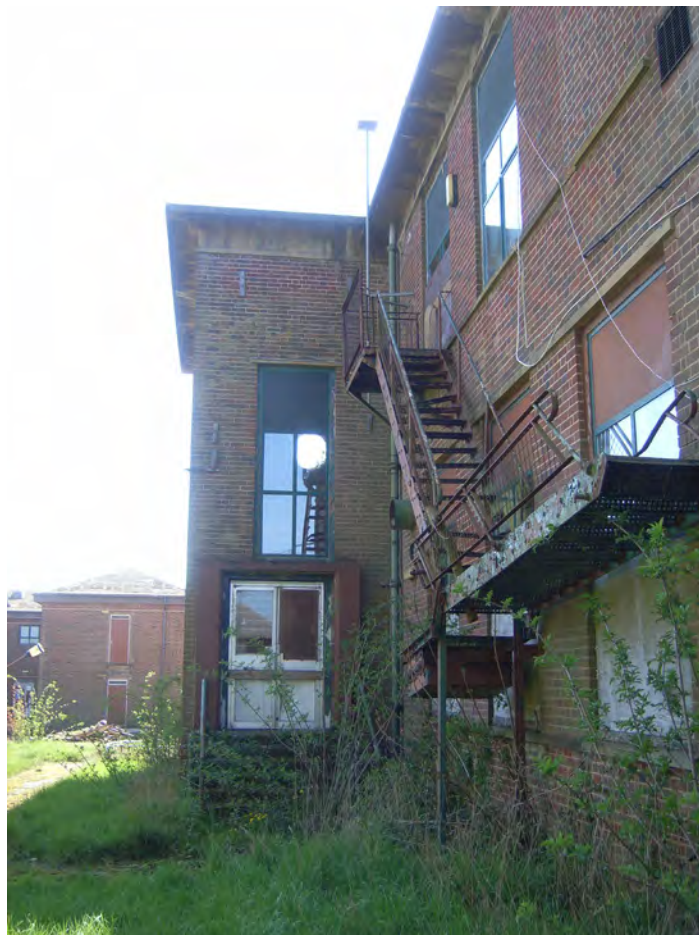
The original design shows an open hall and cloakroom with the entrance door to the front elevation. A second external doorway is located to the rear, north elevation. This does not appear on the original standard drawings, but the style is contemporary to the building, albeit in a plainer form (Plate 488.42). It appears on the drawings of 1981.

Plate 488.42 The doorway to the north of the east wing

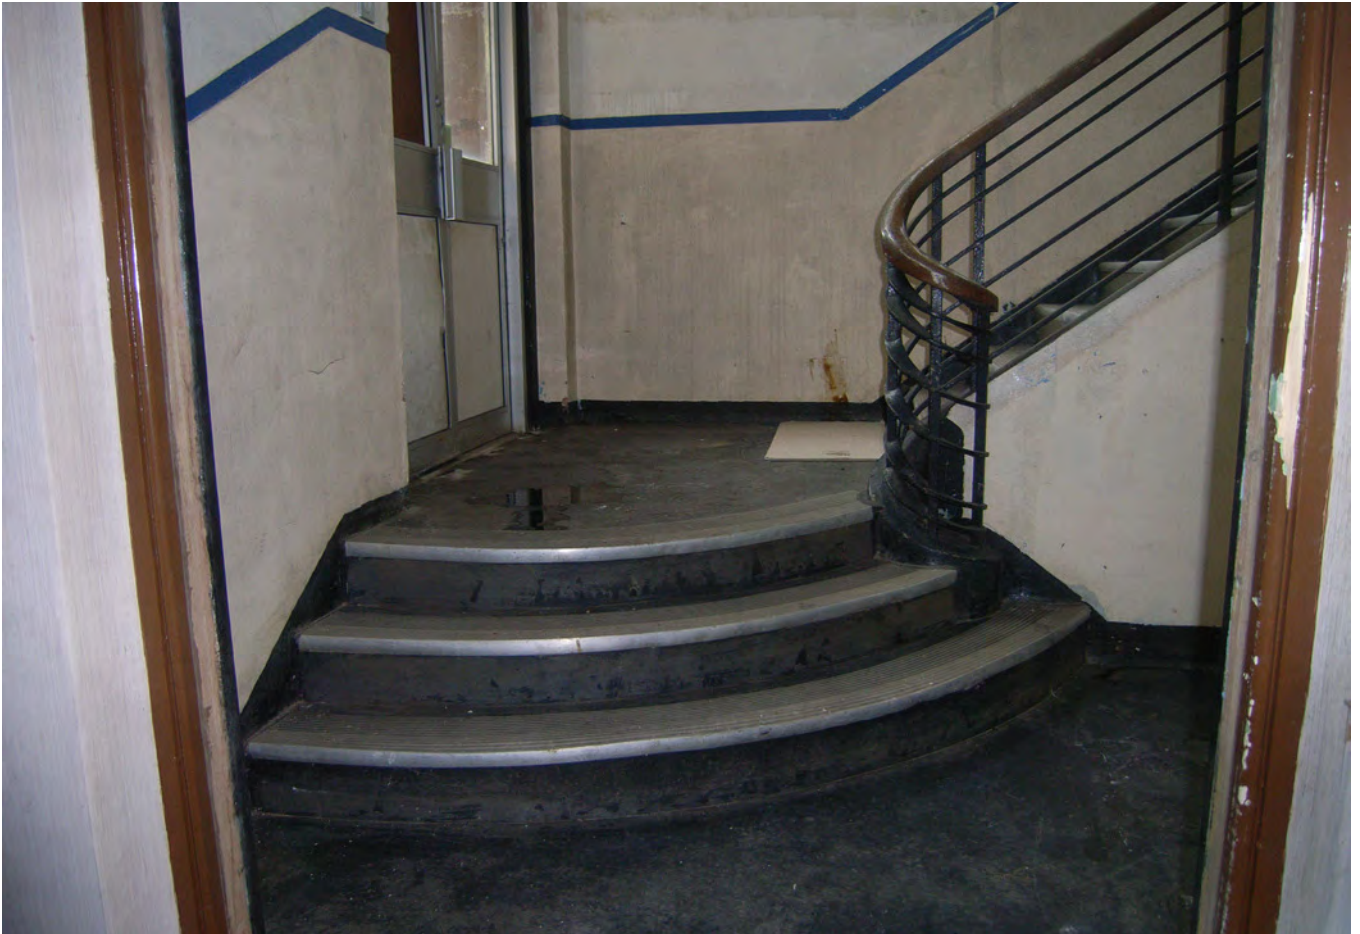
The style of the staircase is identical to the west wing, although the base of the staircase is rounded, rather than square (Plates 488.43 & .44).

Plate 488.43 The staircase in the east wing

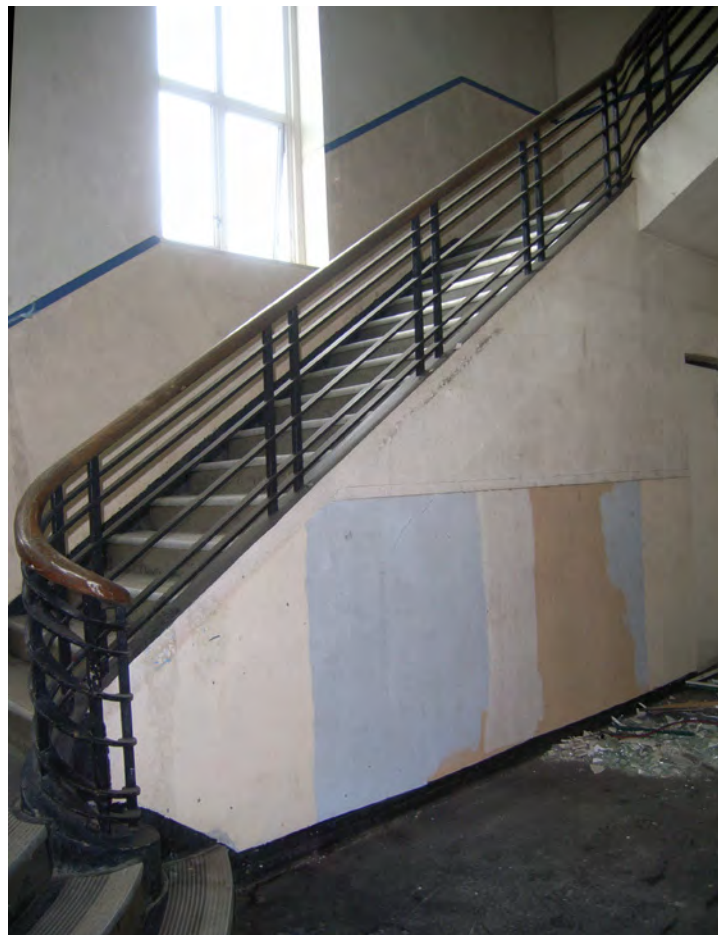
Plate 488.44 The staircase in the east wing

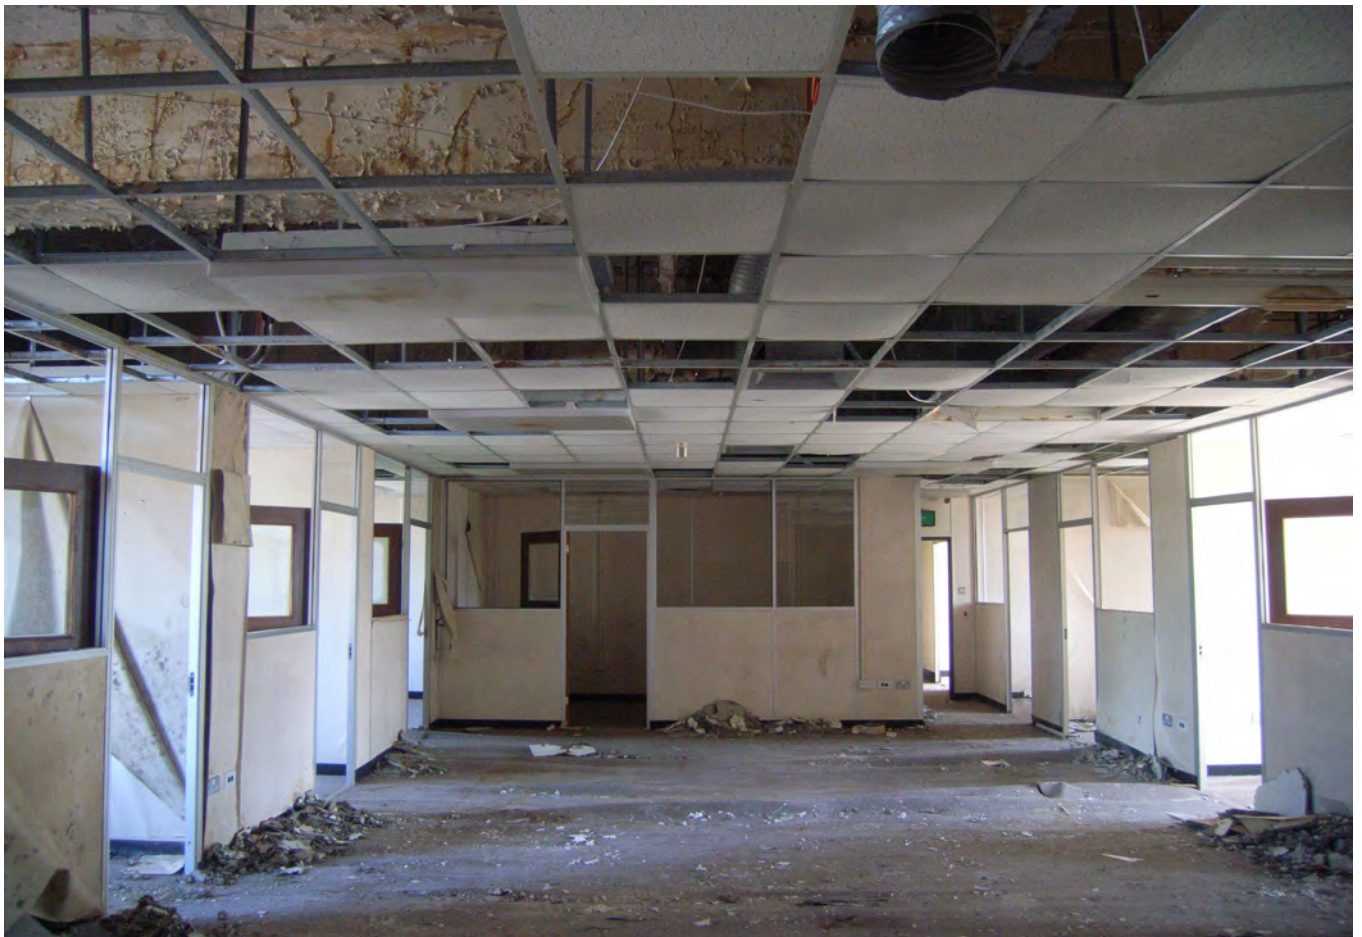
Little remains which predates the 1981 conversion to offices. The floor was open plan dining to the east, with the service rooms along the north east edge and a games room to the west of the central dividing wall; this dividing wall has been replaced, albeit in the same location, by the modular office walling (Plate 488.45). There is no evidence of the original construction.

Plate 488.45 The open plan area of the first floor offices

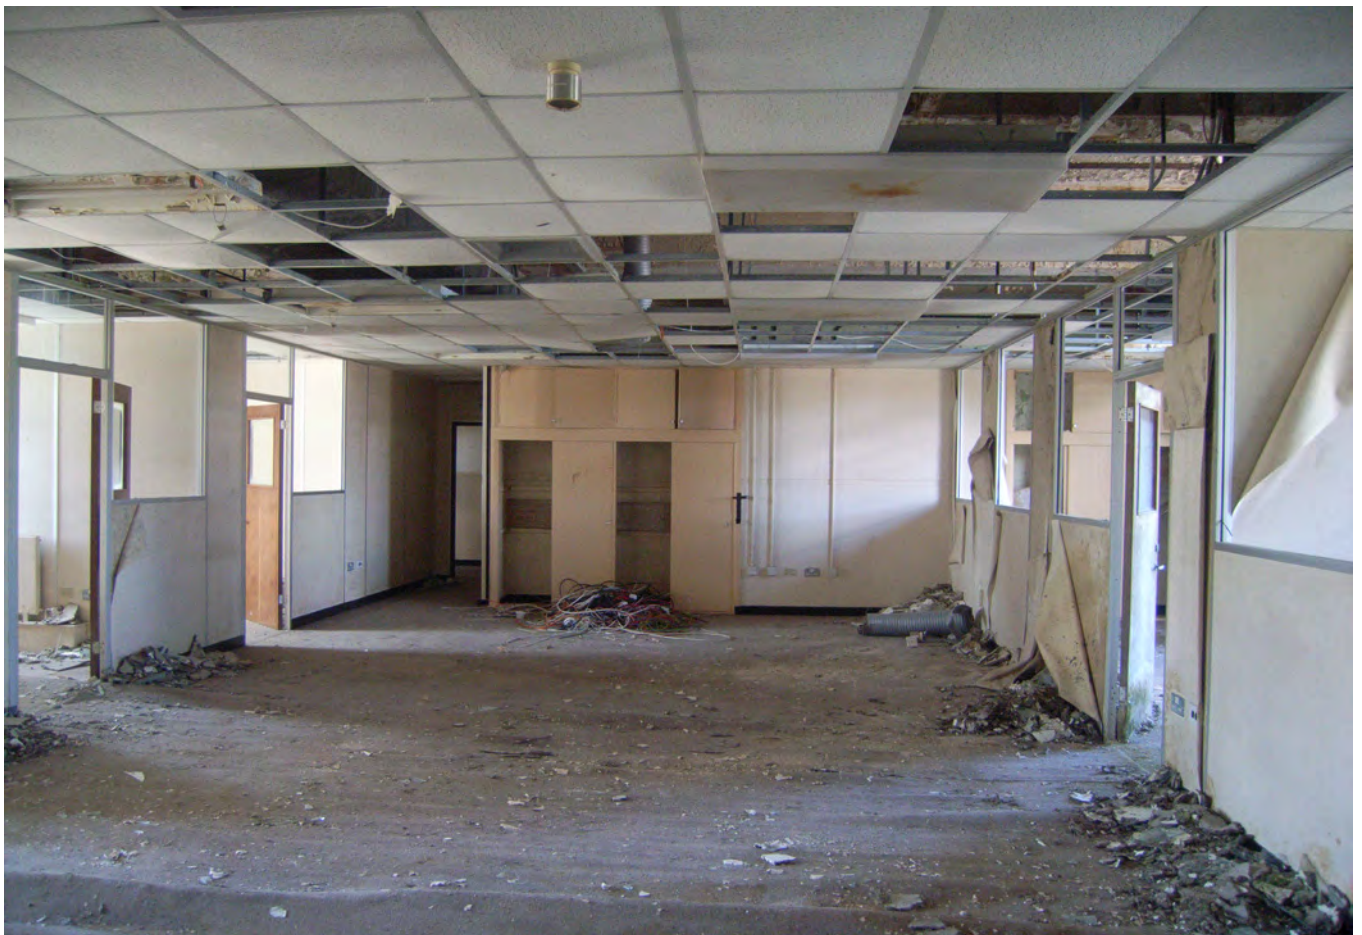
The open plan area in the centre of the western end of the first floor was the former games room, now with offices to the north, east and south. No evidence of the former use is visible, although the function may not have called for fixtures, however, the original cupboards are at the western end of the room (Plate 488.46), the northernmost cupboard now within room F8.

Plate 488.46 The original cupboards at the west end of the open plan area

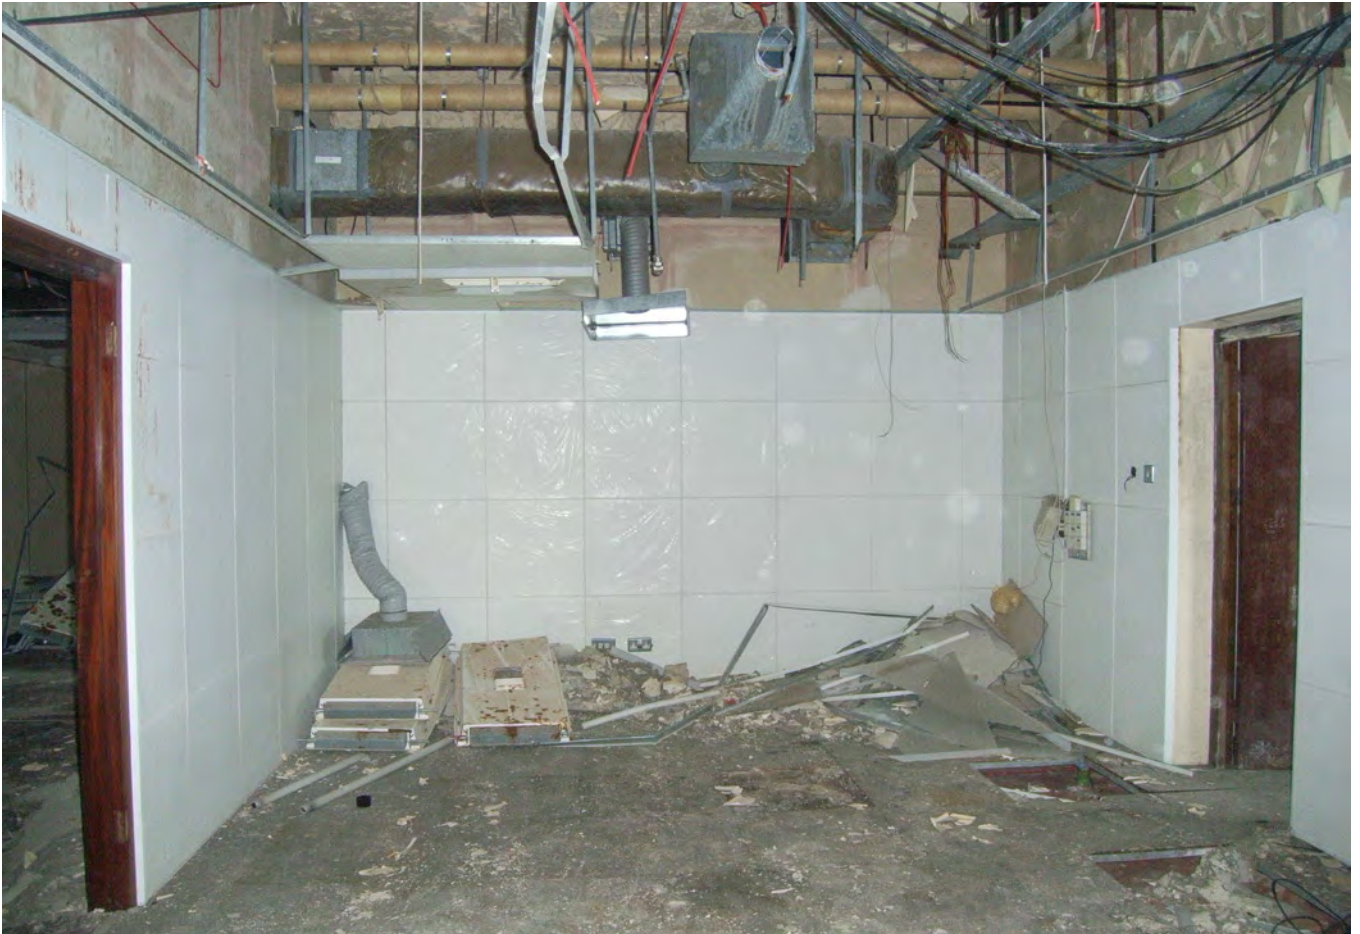
A server room towards the north east corner in F31 has caused a computer floor to be installed, and a ramp has been installed to allow access from F30. The window in the east wall has been blocked at an unknown date, although it was still open in 1981 when the floor was divided up into offices; presumably the window was blocked specifically to allow for the change of use. The walls of this room are clad in plastic tiles to help prevent dust. The suspended ceiling has recently been removed, showing the extractor fans required to cool the room (Plate 488.47).

Plate 488.47 The server room
