FORMER RAF UPPER HEYFORD, OXFORDSHIRE

HISTORIC BUILDING RECORDING AND INVESTIGATION

VOLUME 2: GAZETEER OF RECORDED STRUCTURES

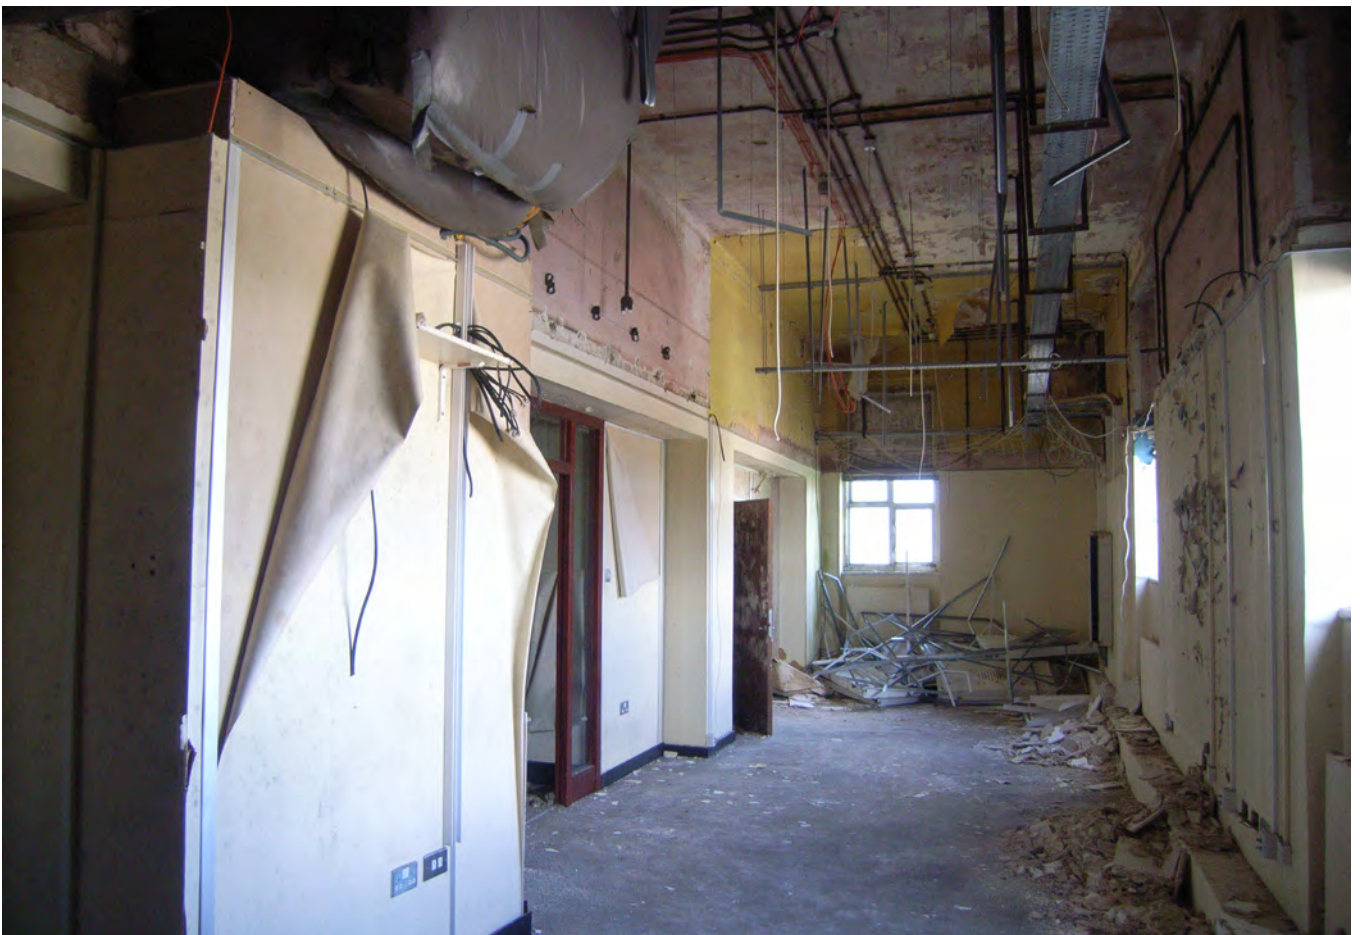
The few remaining primary walls are distinguished by the recessed dado. These are the walls of the Reading Room and Writing Room at the western end of the floor and the structural wall between the former Dining Room and service rooms. There is no remaining evidence of the service room lifts or staircase or other fixtures (Plate 488.48).

Plate 488.48 The former service rooms on the first floor

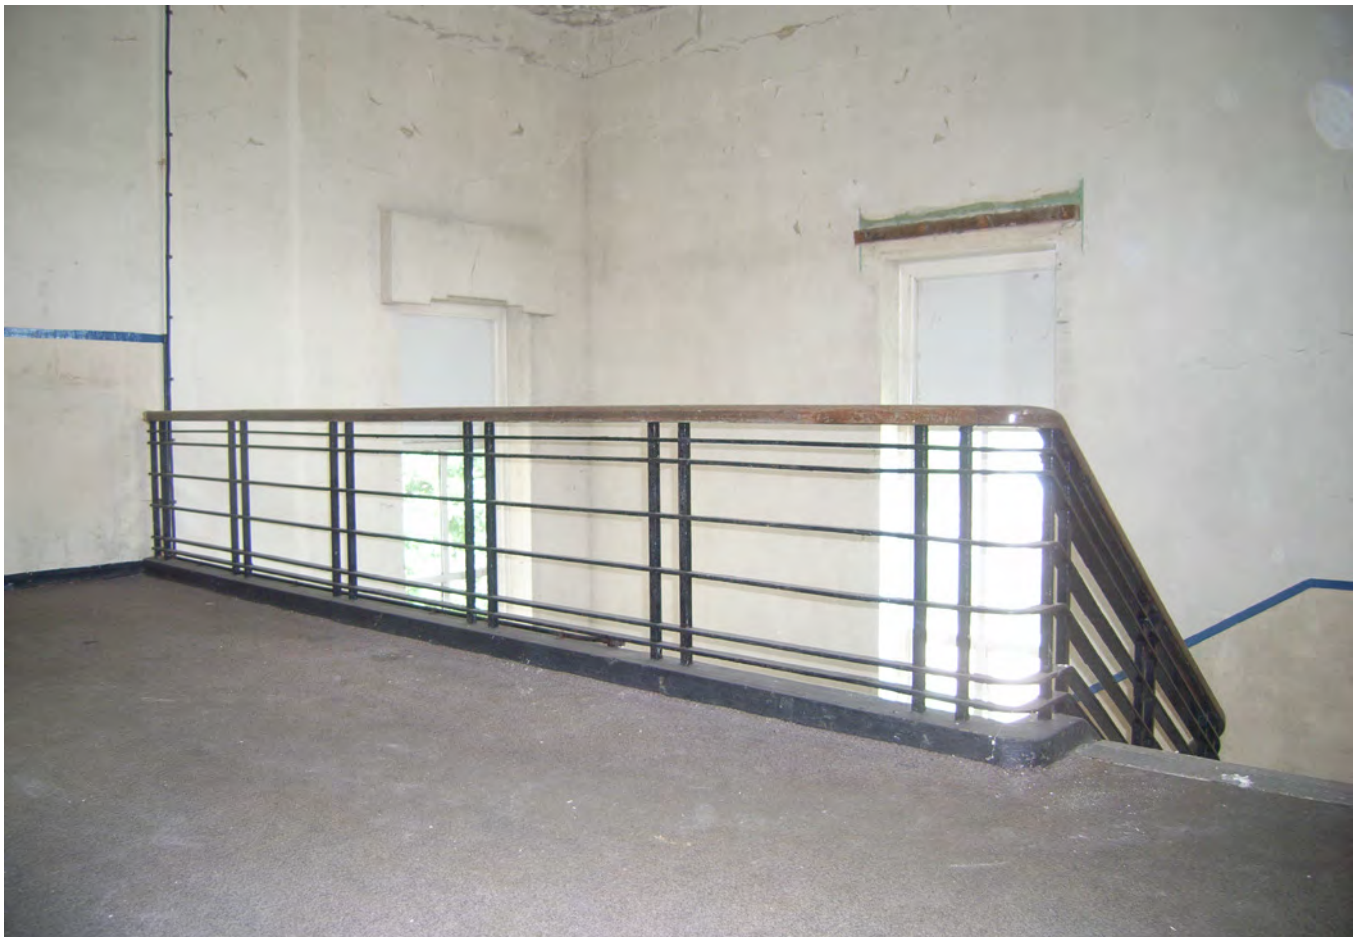
The tall windows in the stairwell have the wooden pelmets and blanking-off panels as described in the West Wing (Plate 488.49).

Plate 488.49 The landing in the east wing

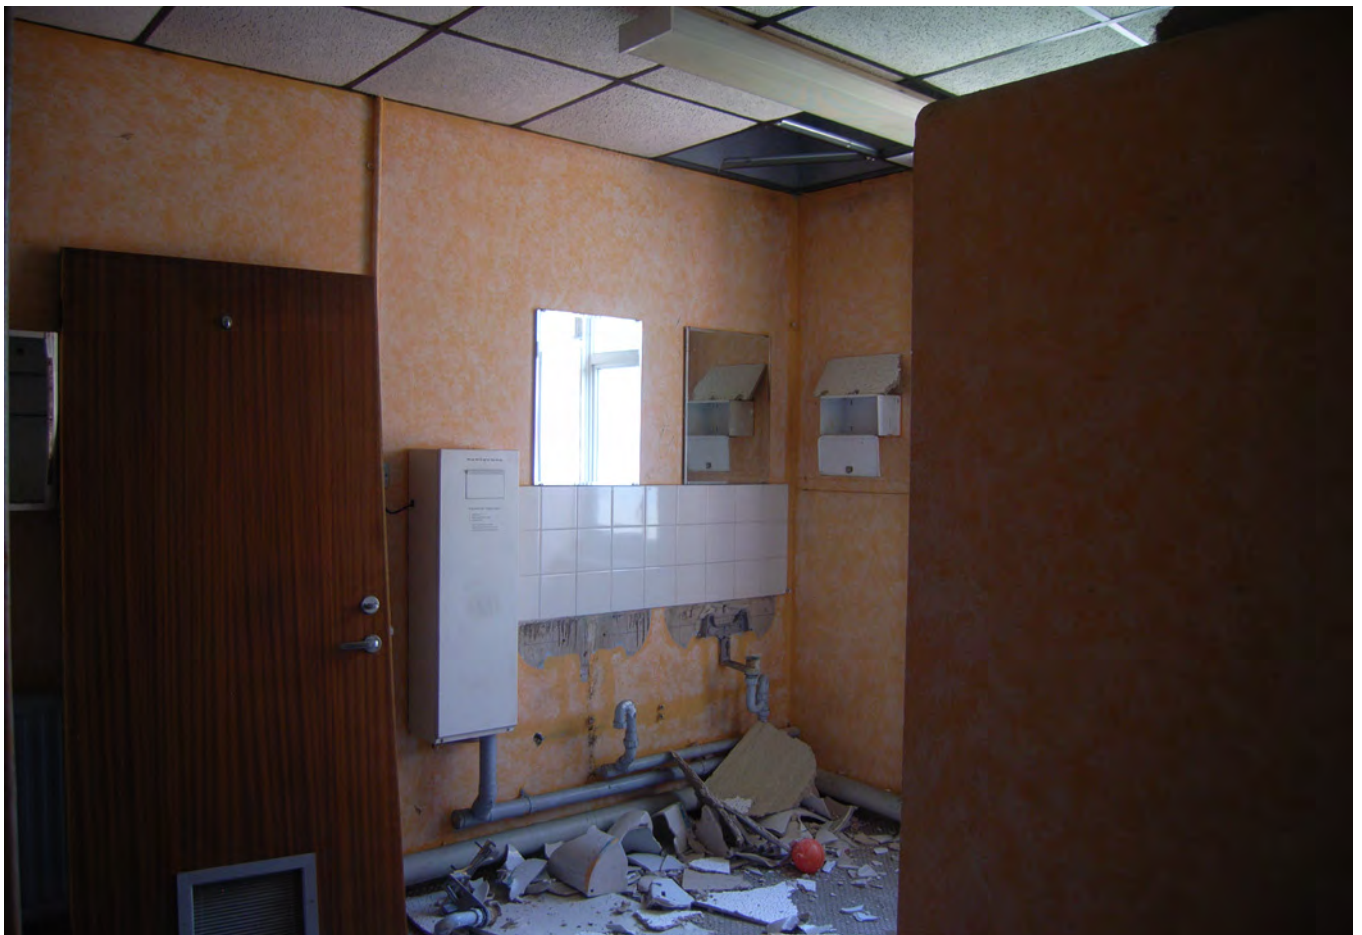
The ladies WC has been redecorated in stippled orange with the former blue décor visible above the suspended ceiling, the men's is the same blue, which extends above the suspended ceiling, suggesting that the WC additions probably occurred before the 1981 works (Plate 488.50).

Plate 488.50 The ladies WC in the east wing

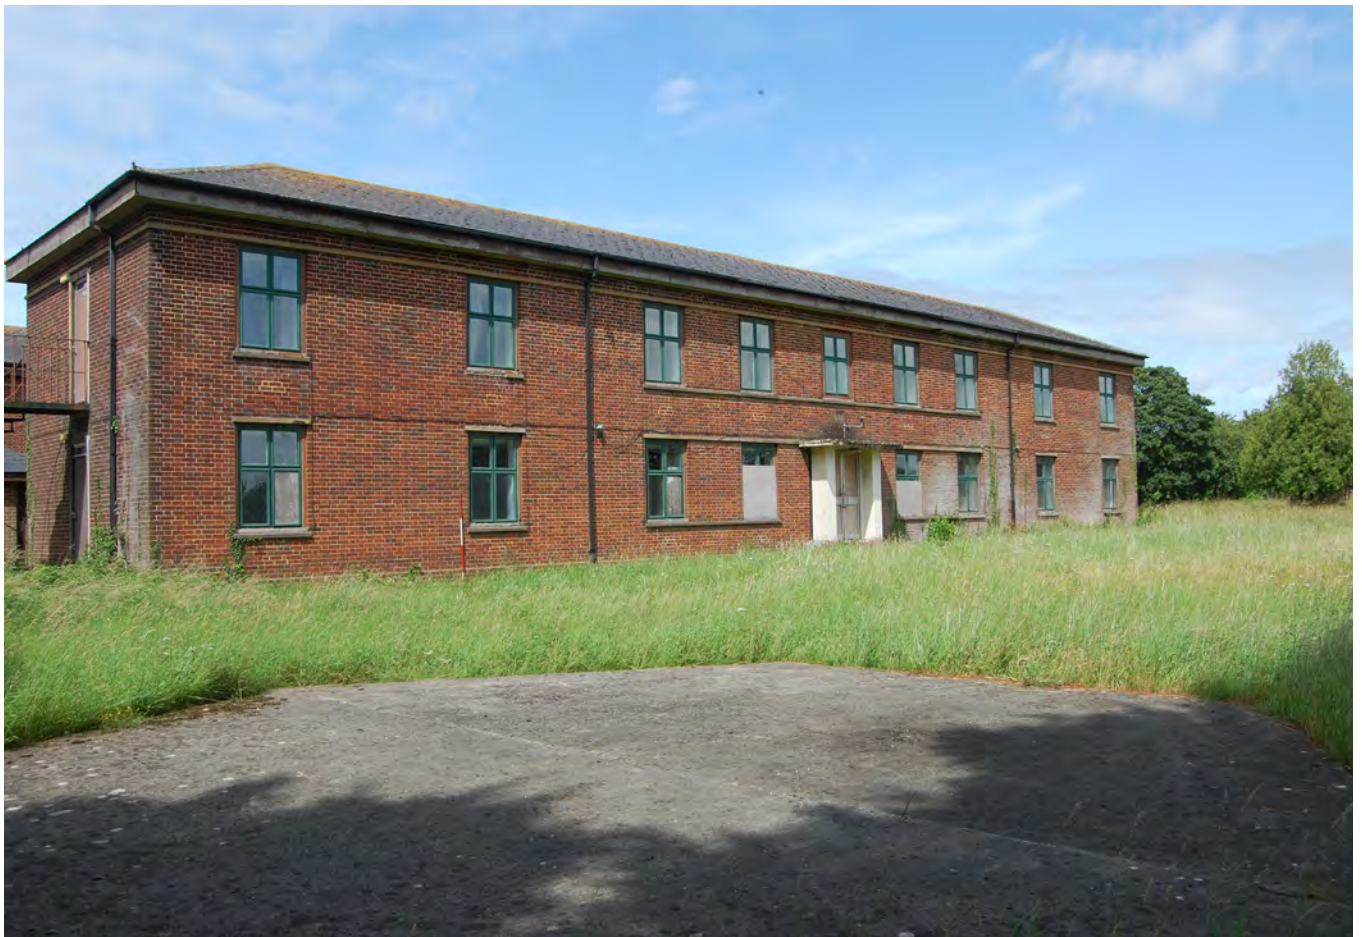
The H-type barrack blocks are substantial red brick structures (flemish bond) with architectural presence enhanced by the entrance canopies on the front and rear elevations (Plate 489,498 & 500.1 & .2). The windows are later green plastic replacements (probably dating from the 1980s), each with four lights (two small rectangular ones at the top, and two larger rectangular ones below) sitting in timber sub-frames. The windows have concrete sills and lintels, some of which run continuously along the elevation. The buildings would have originally had a flat roof, but this has subsequently been replaced with a pitched tiled roof, there is a timber fascia below. The buildings have various patches of infill, which are described below, and are thought to relate to changes in floor levels.

Plate 489, 498 & 500.1 Building 489 front (west) elevation

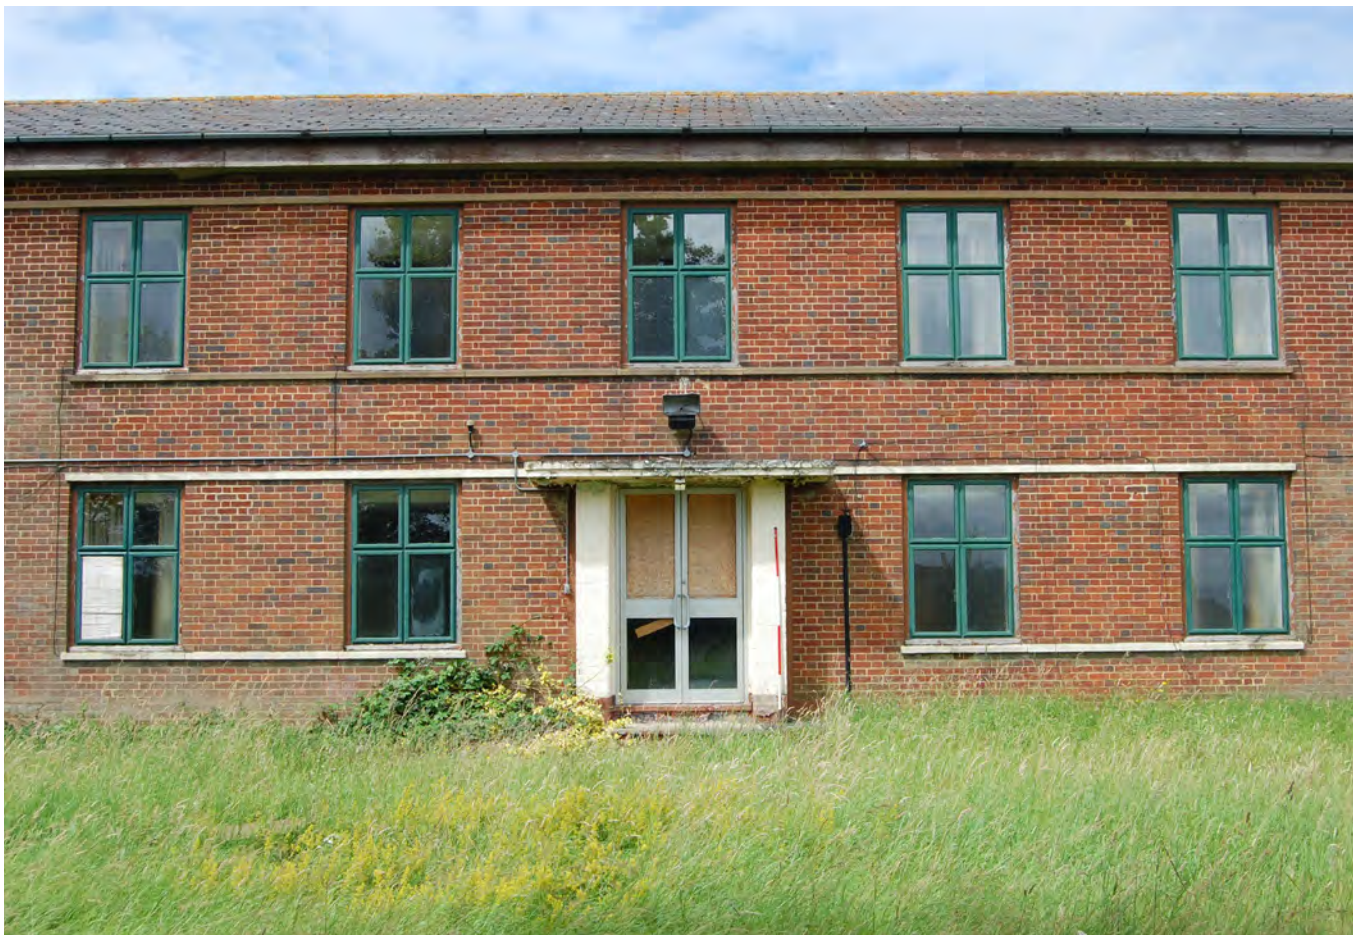
Plate 489, 498 & 500.2 Building 498 rear elevation

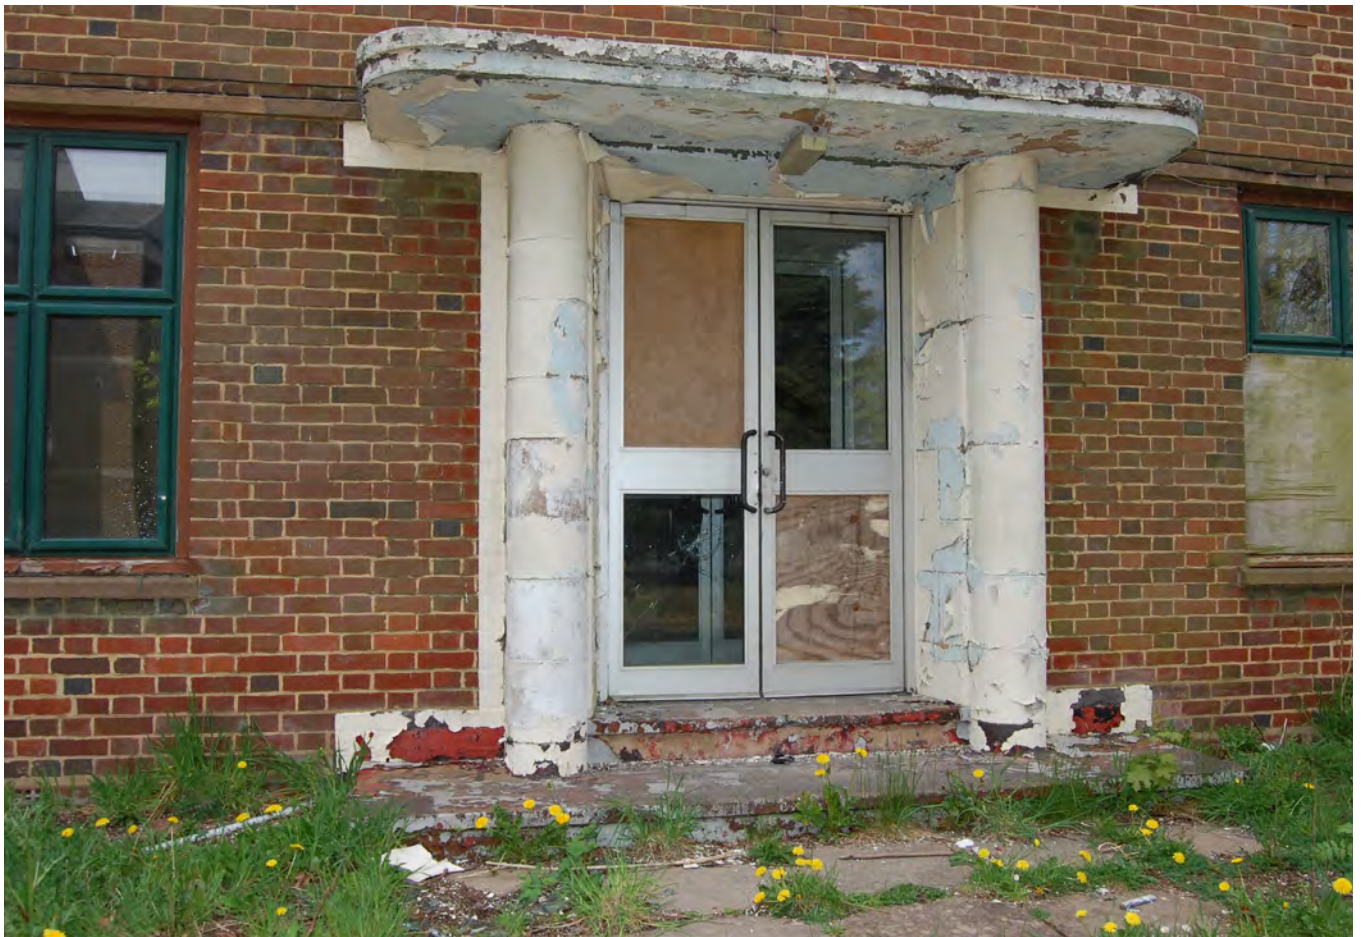
over the entrance providing grandeur to the building, these are rounded in section (whereas those on the rear facing elevations are square) (Plate 489, 498 & 500.3). The columns and canopy are constructed from concrete blocks that are painted white, with blue paint visible beneath. Three concrete steps lead up double glass doors that are a later replacement (probably dating from the 1980s). There are four windows at ground-floor level to each side of the entrance, and nine at first floor level. In the central area to each side of the door (with five windows above, and two to each side of the door), there is a concrete band above and below the windows at cill and window height (Plate 489, 498 & 500.4). At first floor level above the lintels this band continues the full width of the front elevation, and continues round the entirety of the building. To each side of the central area are modern plastic drainpipes, leading up to a timber fascia below roof level. The brickwork is also single phase with the exception of some brick infill centrally between ground and first floor windows (but not between the entrance and first floor window), and below the ground floor windows (Plates 489, 498 & 500.5). These probably represent the locations of former vents, which have subsequently been infilled with brick (usually four bricks over two courses). Just below the height of the timber fascia and above the concrete band are 12 areas of brick infill (c. 6 bricks over 2 courses). These are thought to reflect the former location of trusses, following the replacement of the roof from flat to pitched.

Plate 489, 498 & 500.3 Building 500, rear elevation entrance

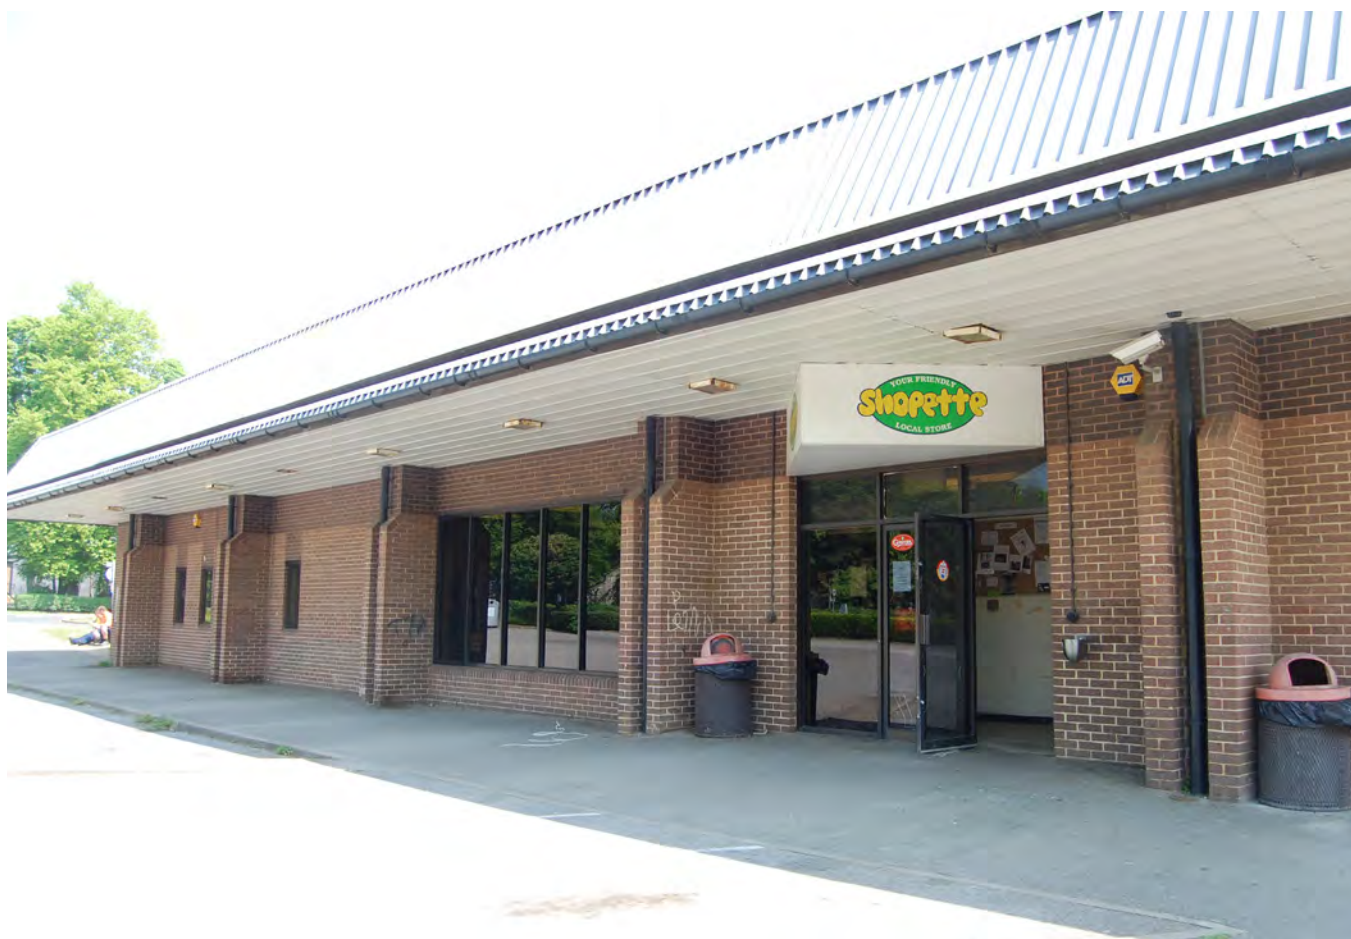
The shop is rectangular in plan, constructed in brown brick with a flat metal roof and a deep angled fascia (Plate 492.1). The metal framed windows have dark glass. The building has been afforded some architectural details with a band of darker bricks directly below the roof level. There is a shop car park to the front of the elevation.

Plate 492.1 South (front) elevation

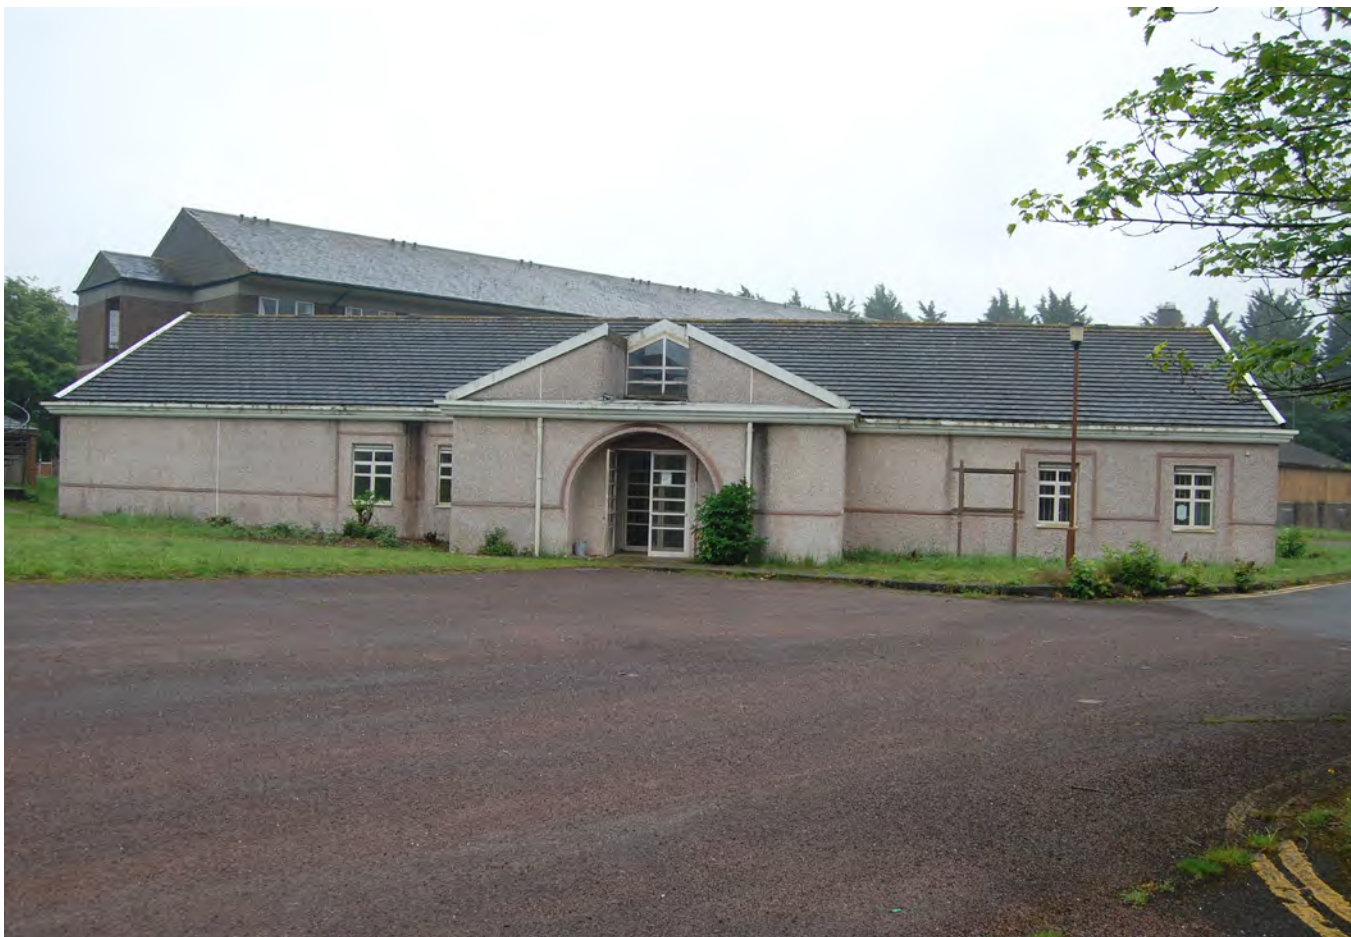
Stylistically the building is reminiscent of the 1930s art deco style, with pebble dashed external elevations painted cream (Plate 502.1). It is rectangular in plan, single storey with interlocking concrete tiles and modern UPVC windows. Elements of the building to the south-west date from 1939, but the building has had a complete overall in the 1980s (Fig.502.1). There is a moulded plastic fascia running around the front and rear elevations, which ends at the side elevations where it meets plastic drainpipes at the edge of each elevation. A straight plastic fascia extends at roof level along the two side elevations, and along the alignment of the projecting porch roof. Further decorative detail is added to the building by a concrete band extending above and between the doors and windows. The windows and doors are modern plastic UPVC, also with UPVC sills.

There north-west elevation, which extends to either side of the porch, has two windows to each side, which are rectangular windows with six lights (see Plate 502.1). The decorative concrete band extends above and between the windows, extending on a level situated at roughly one third the height of the elevation. At the height of the elevation is a rounded plastic fascia with flat plastic fascia running along the sloping edges of the roof to either side of the recessed porch window.

Plate 502.1 General view, front elevation

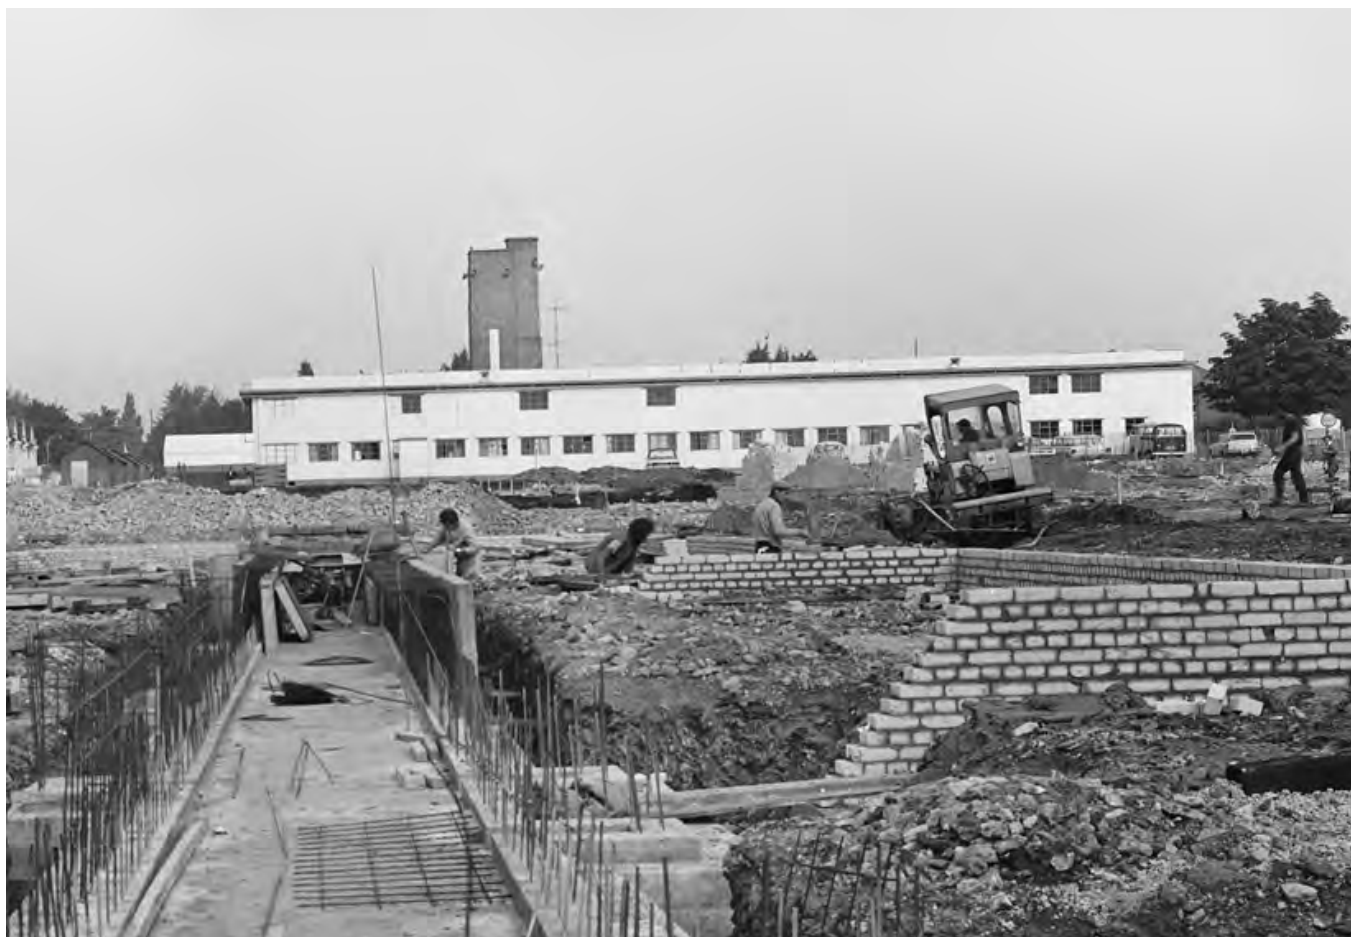
Plate 529.1 Historic north-west view of south elevation (1970-2) (EH archive ref.-p_g18127_014)

There are two useful PSA photographs which were taken during the construction of the barrack blocks to the south (594 etc) in 1970-72, which show the south elevation of Building 529 in the background before the later conversion of the building (discussed below) (Plates 529.1 & .2). The photographs show that at this time the south elevation was painted white and incorporated two rows of regular, horizontal 9-light metal-framed windows (Plates 529.1 and 2). The lower row continues across the elevation with c.19 (or 18) windows, punctuated by at least one doorway while the upper row had only six windows.

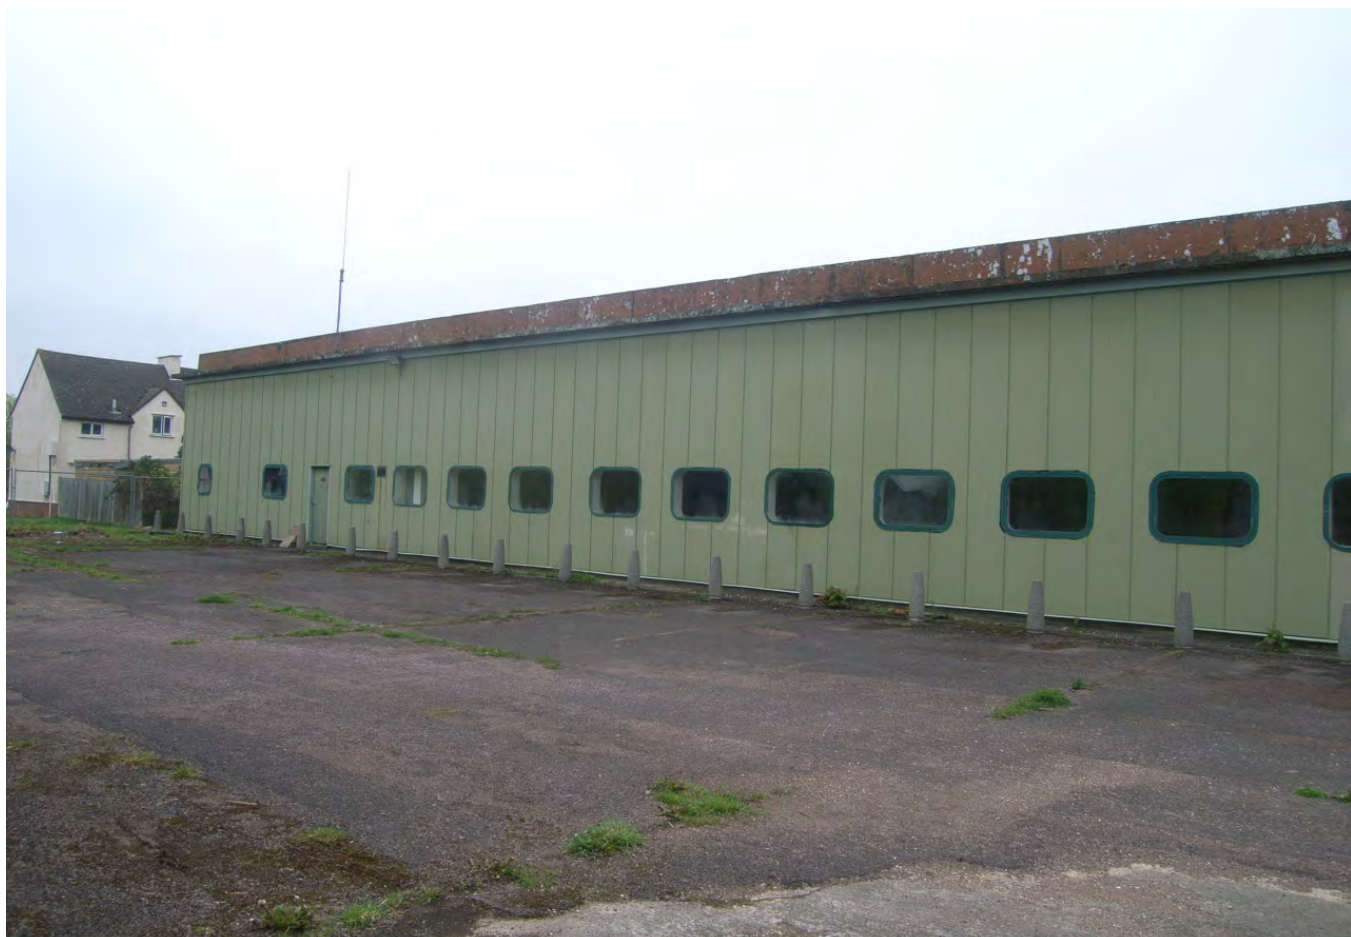
Plate 529.3 General view from south-east

The external form of building 529 has been radically altered by conversion works, almost certainly in 1982, and from the outside the building could very easily be mistaken for an entirely modern structure. The 1980s conversion works included covering the exterior in light-weight, lime-green vertical cladding which extends from the ground up to a projecting concrete lip at roof level. This horizontal lip forms part of the primary flat reinforced concrete roof which also incorporates a vertical parapet. The visible primary parapet is painted a chocolate brown colour although much of the paint is peeling off the concrete (Plates 529.3).

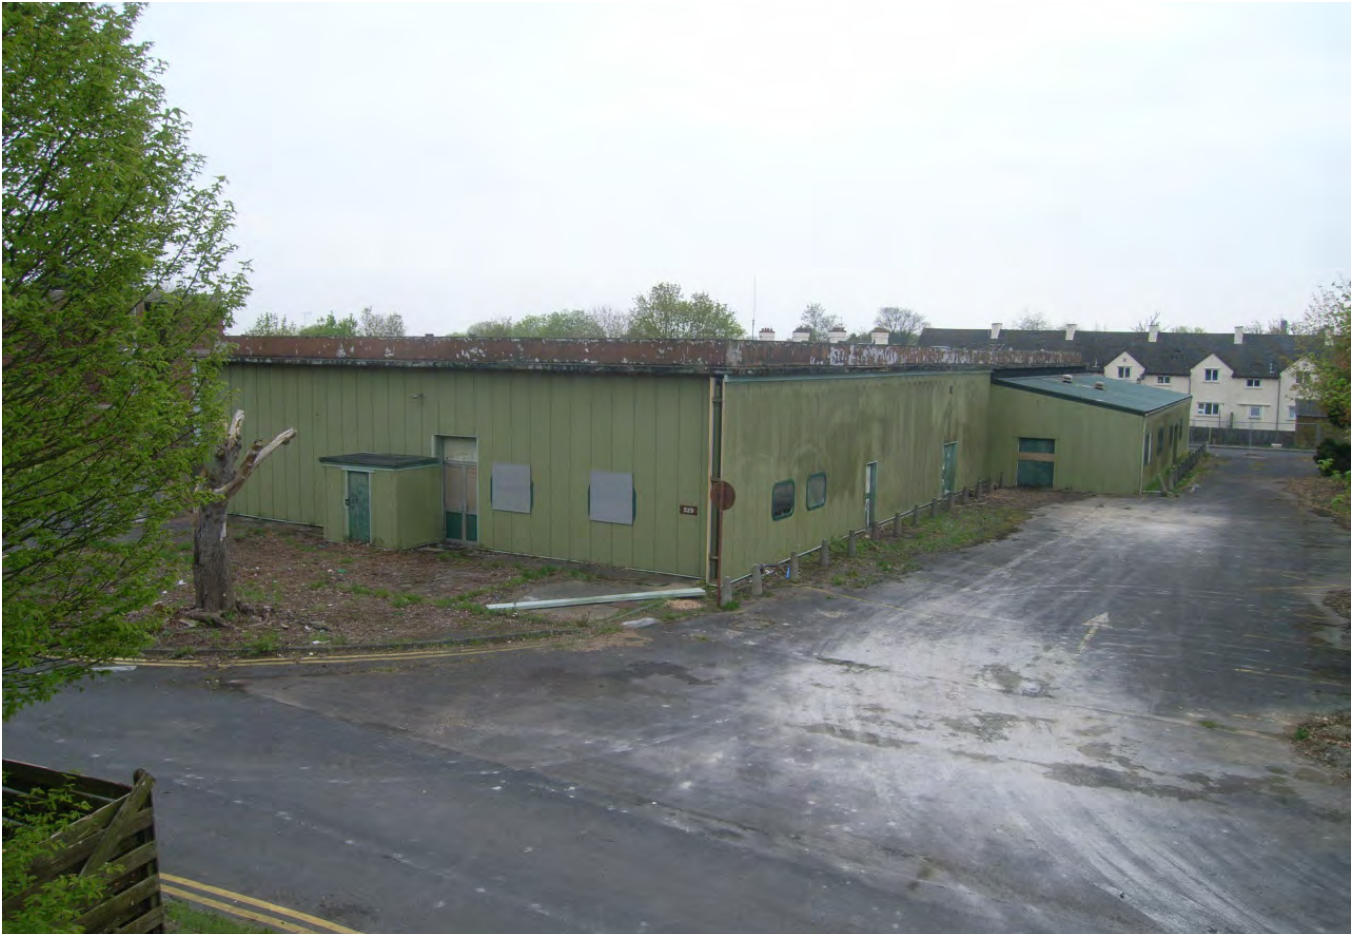
Plate 529.8 Extension on north side of building

The north elevation incorporates a large projecting extension to the western half of the building which is clad in the lime-green panels and which has a lean-to roof extending down from just beneath the concrete roof of the primary building (Plates 529.8). This c.23 m extension, which is not shown on historic airfield plans and was clearly entirely added in the 1980s works, obscures the western half of the original building while the eastern half includes two 1980s windows towards the east end and two doorways.

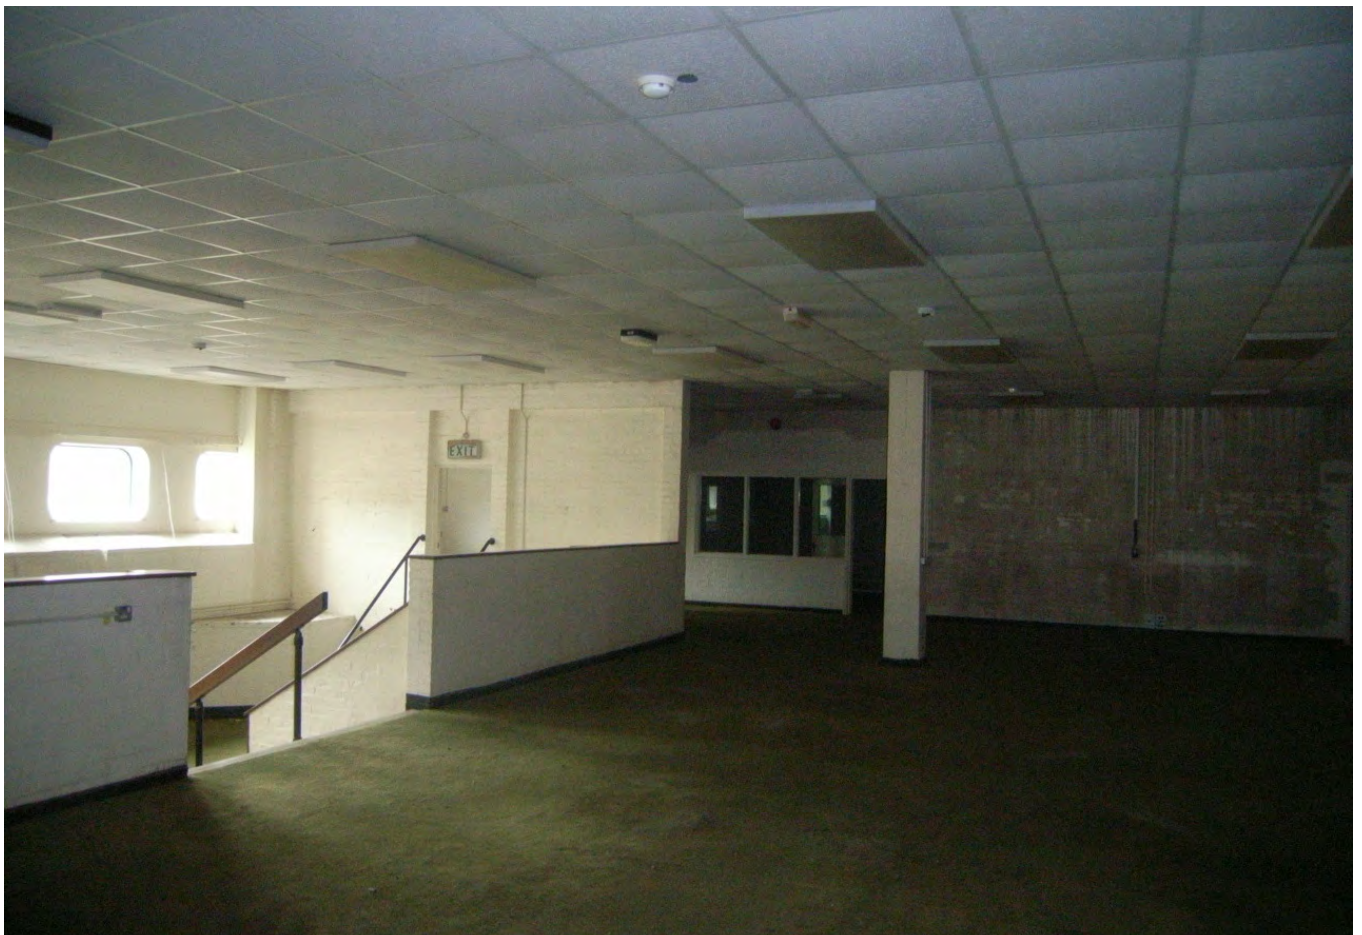
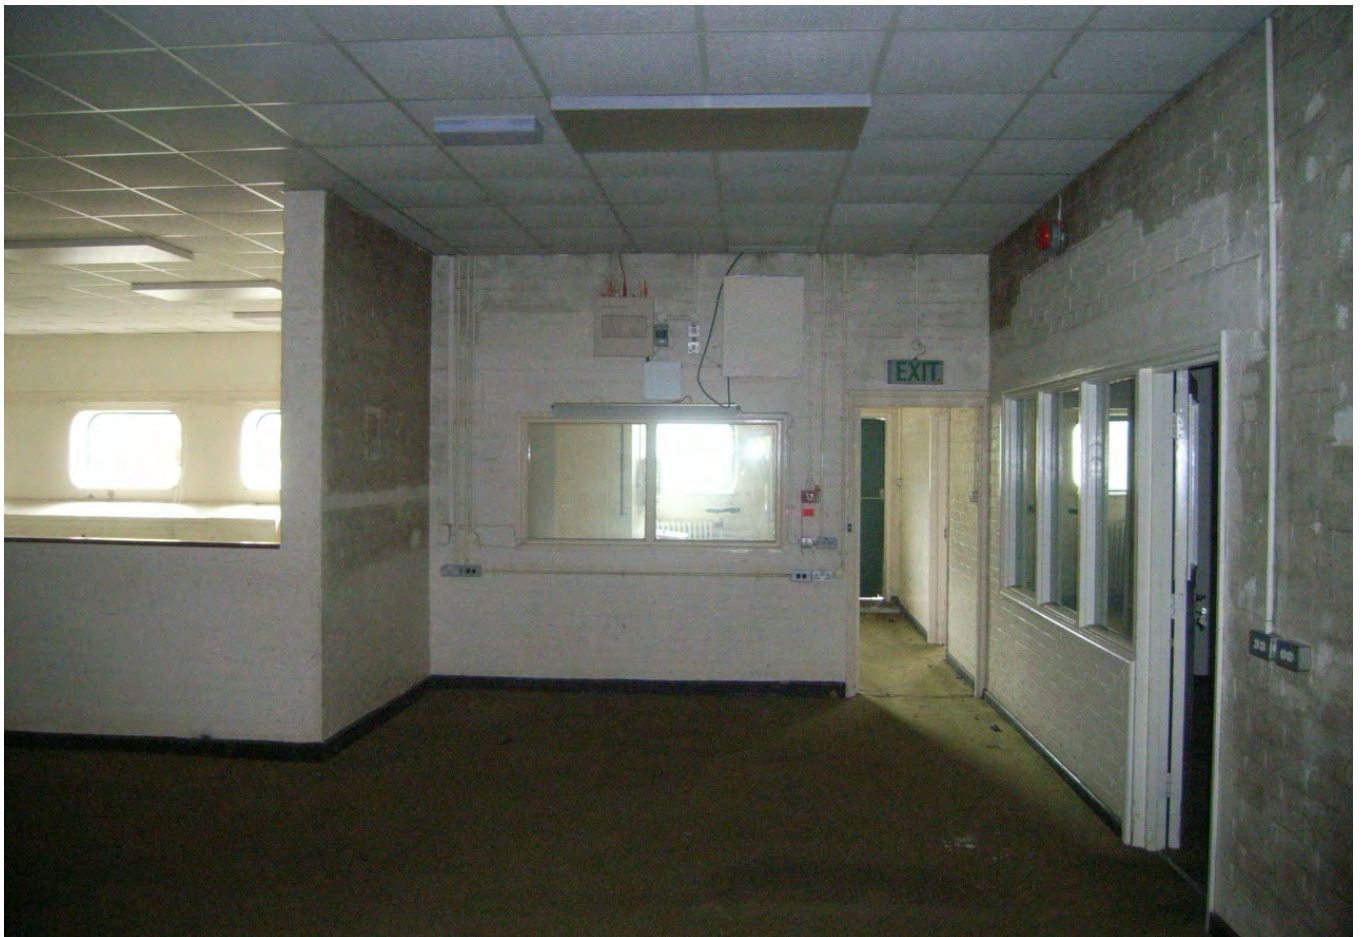
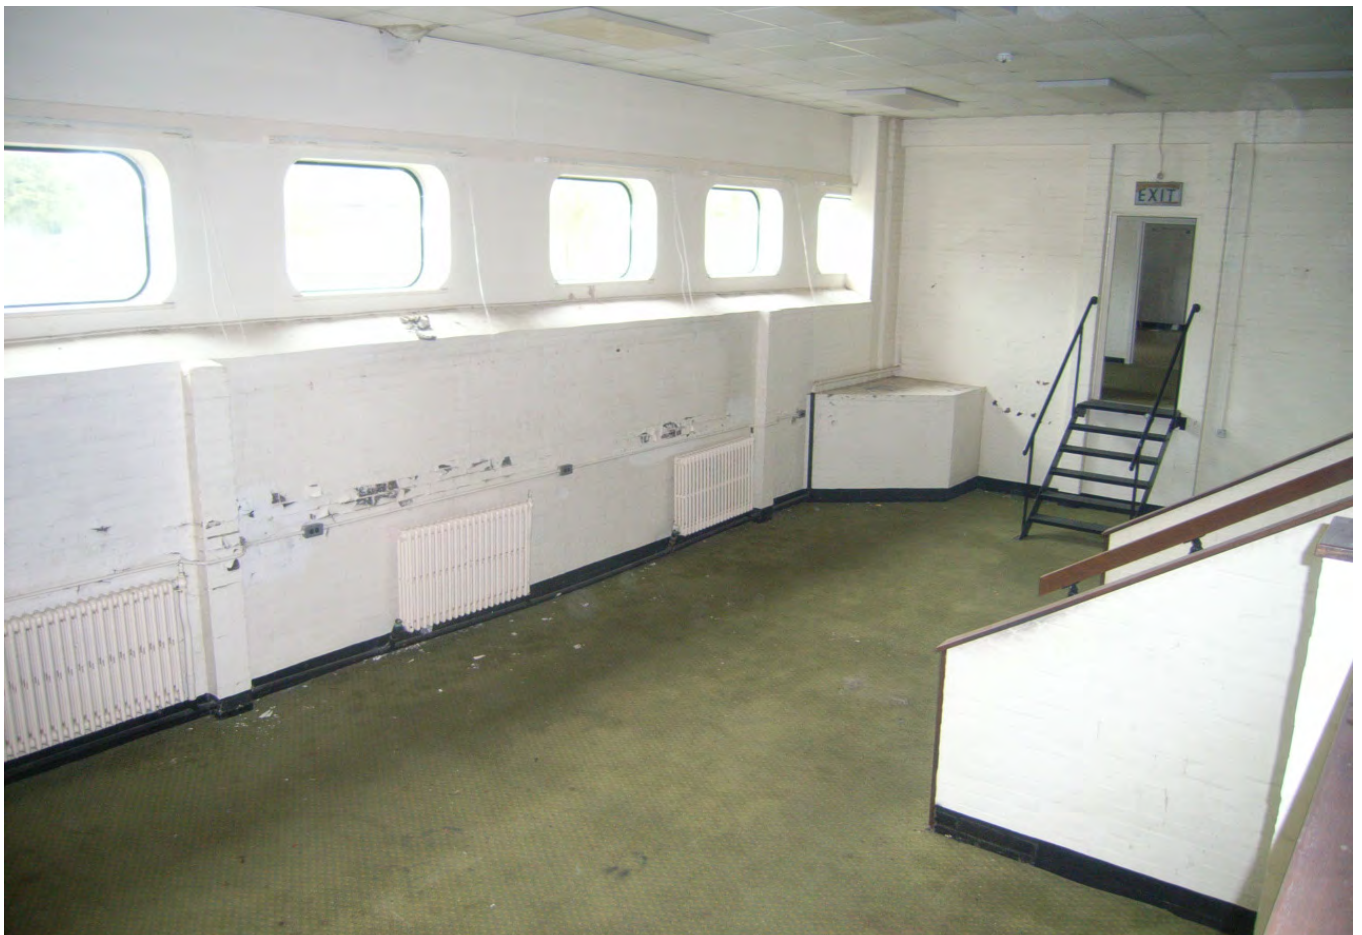
Area 1 is a large central open-plan library space with carpets, ceiling tiles and generally painted (not plastered) walls, some of which are brick and some of concrete block. Above the ceiling tiles there is a deep, reinforced concrete ceiling with integral concrete beams (Plates 529.11-13).

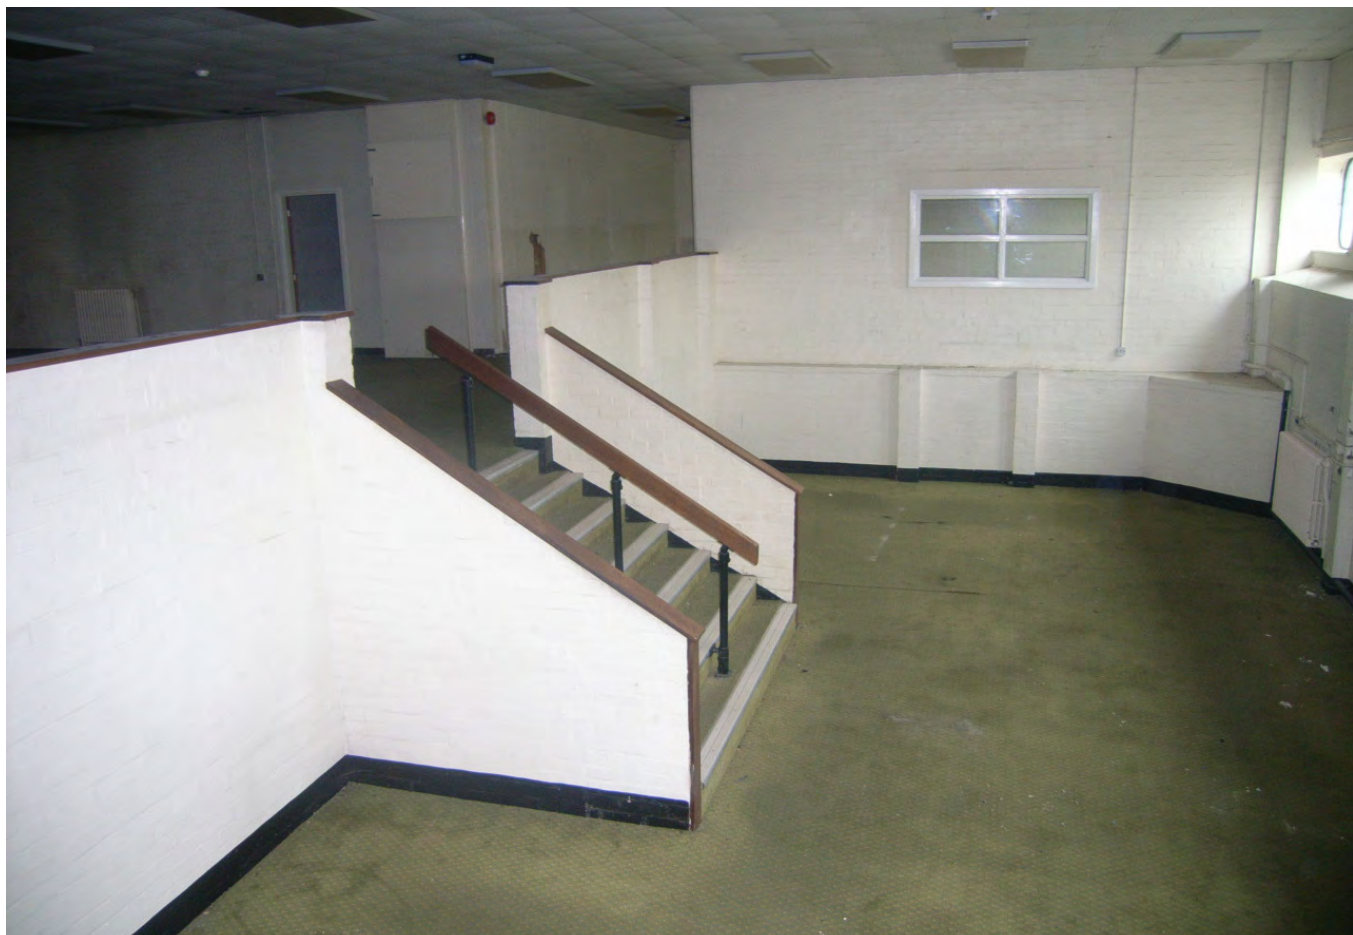
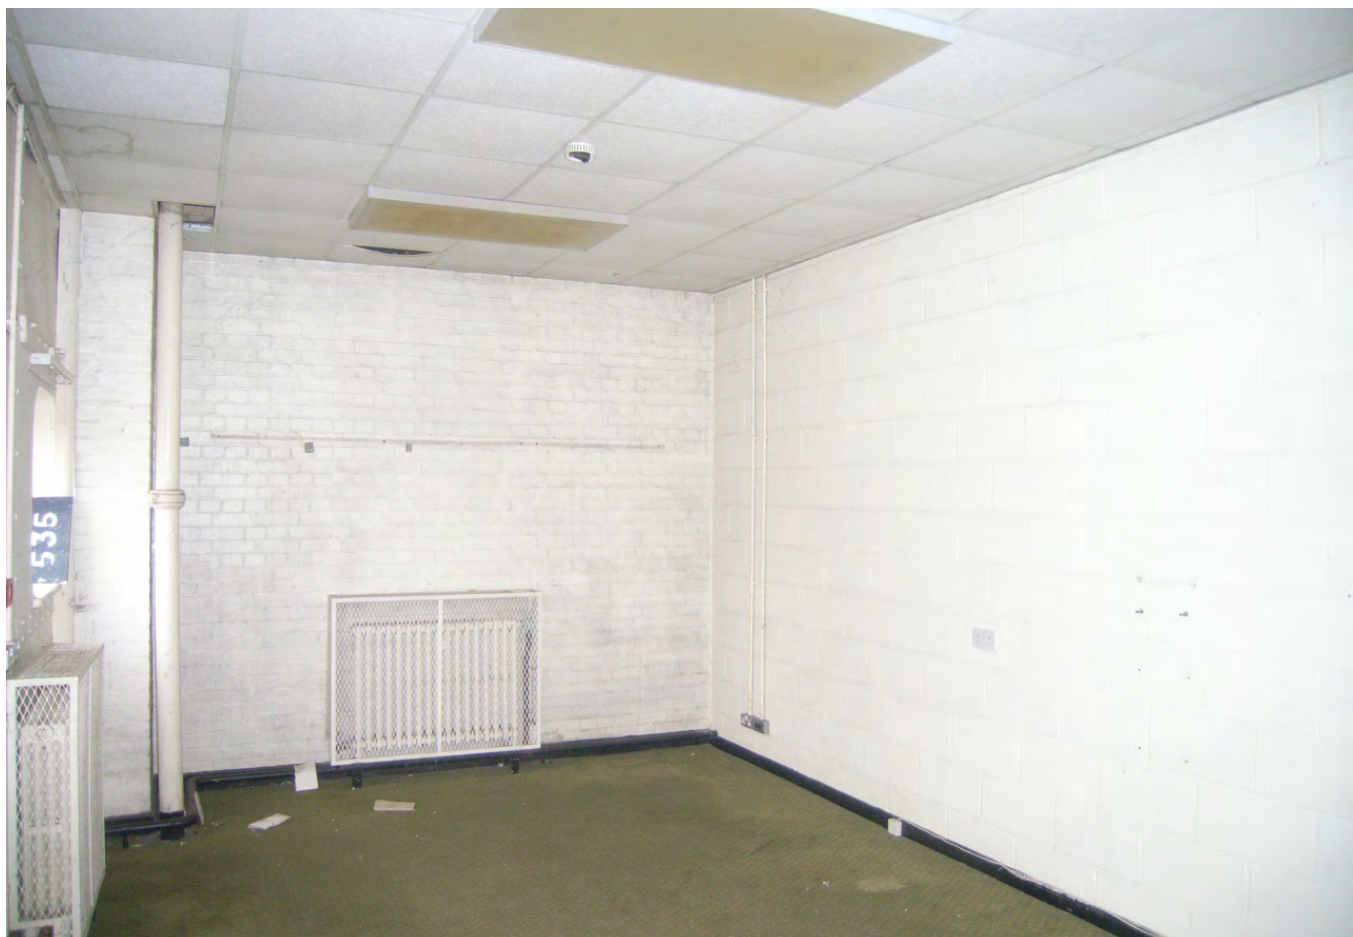
Area 5 is a sunken area on the southern side of the building which is shown to have been an area for periodicals in the 1980s library conversion (Plates 529.14 & .15). The walls of this area are formed from primary brick with regular projecting piers. It seems likely that the wall and piers on the north side of this area would formerly have continued up to the ceiling to divide the room from the area to the north. This floor of this area is sixteen brick courses (c.1.2 m) below the main ground floor level in the rest of the building, and it is accessed by a set of stairs from the north.
