FORMER RAF UPPER HEYFORD, OXFORDSHIRE

HISTORIC BUILDING RECORDING AND INVESTIGATION

VOLUME 2: GAZETEER OF RECORDED STRUCTURES

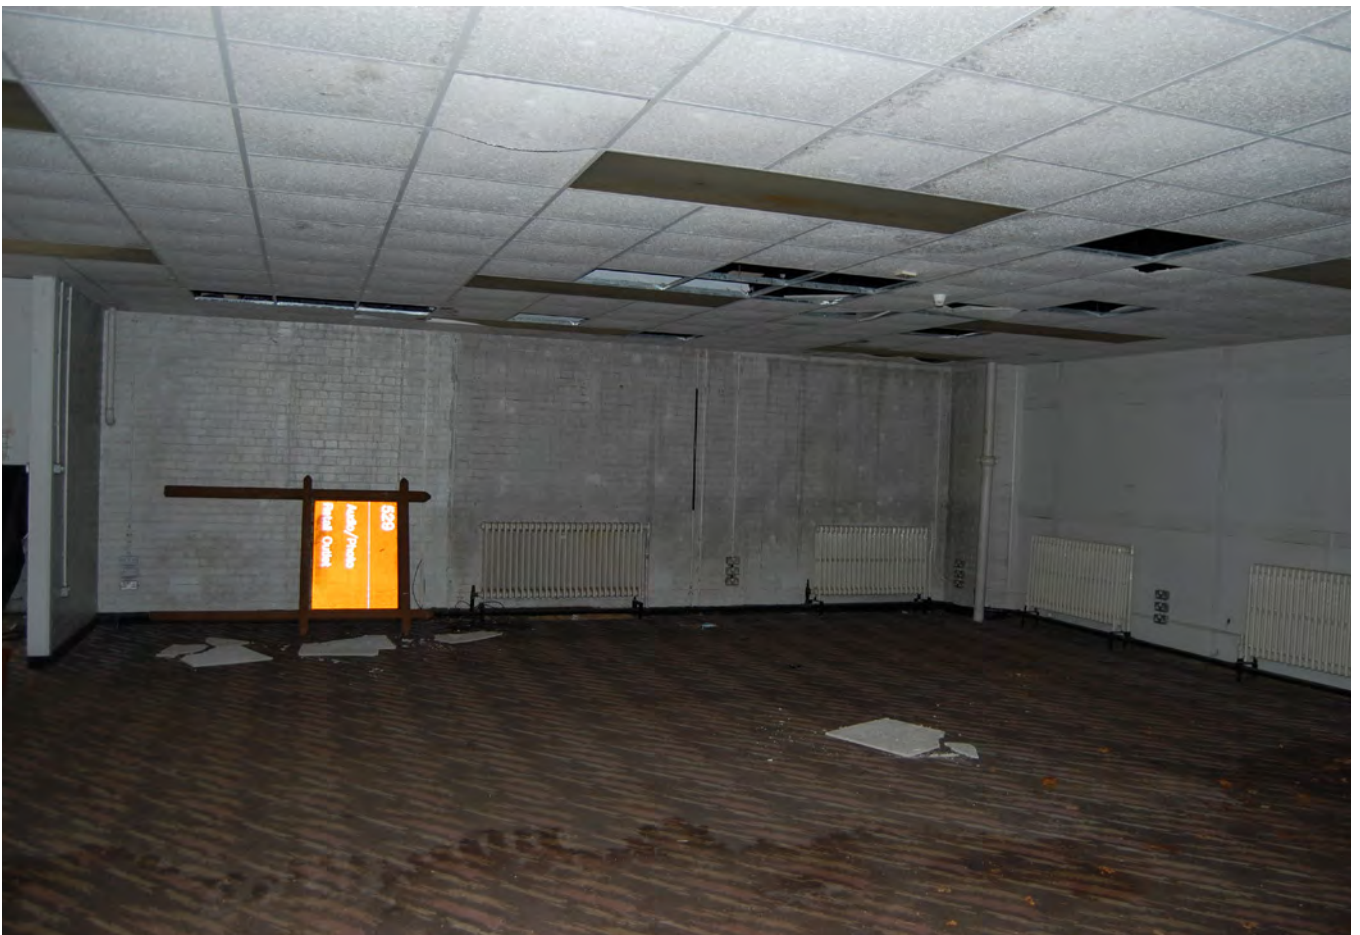
Plate 529.19 Open plan room

Area 12 is the principal, largest room in the east half of the building and most of the other rooms in this area open off it (Plates 529.19 & .20). The area is carpeted and has a suspended 1980s ceiling but some of the ceiling panels have been dislodged and it is possible to see that although the lower part of the walls (beneath the ceiling) are painted white, the area above the ceiling is painted black. It is also possible to see a deep concrete beam in the roof, spanning above this area east to west.

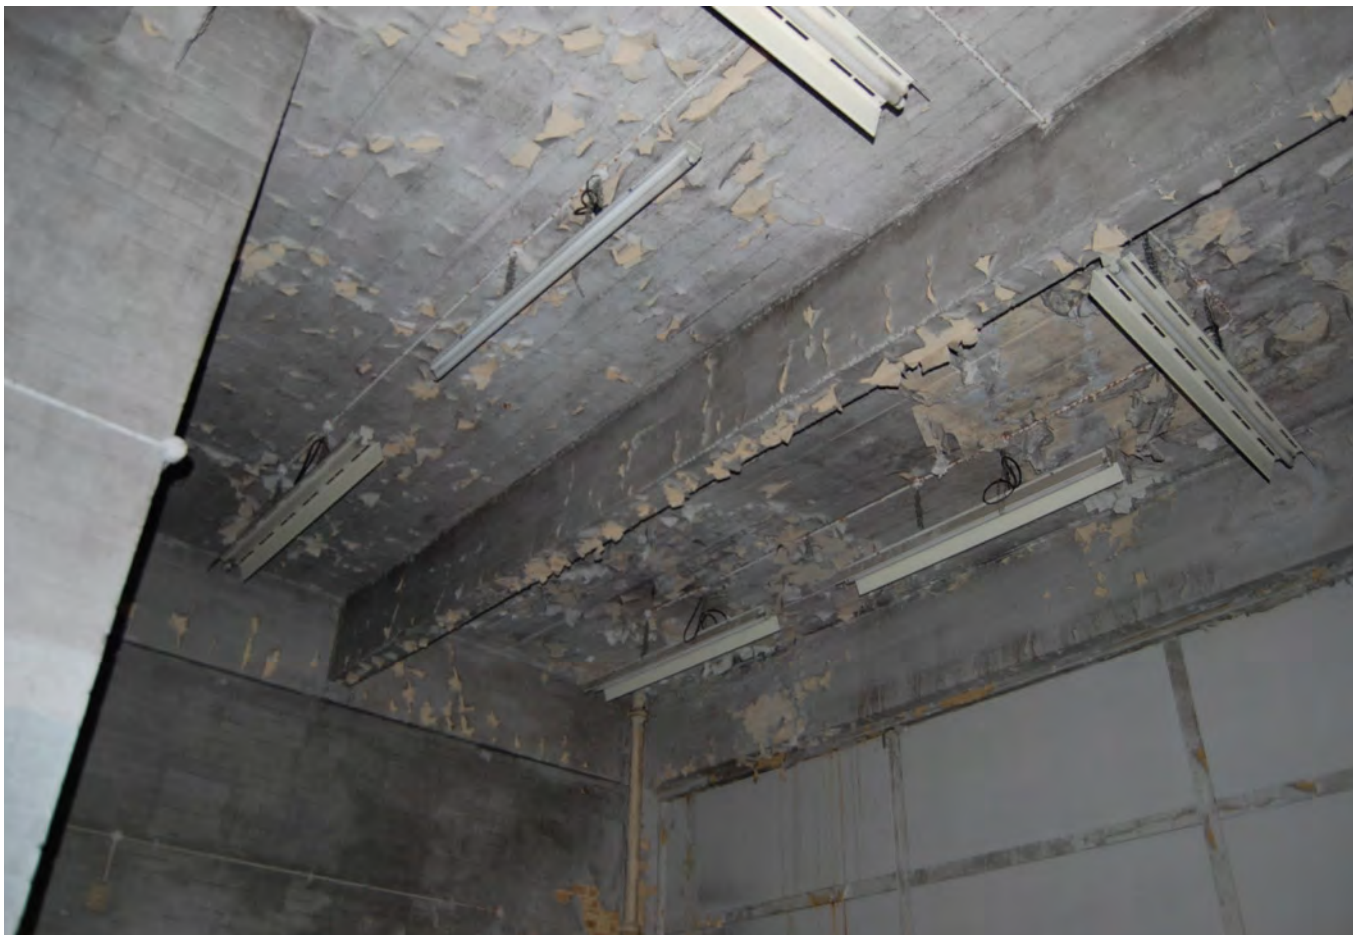
Plate 529.23 Room in east half

Room 11 is a tall, double height space (without the 1980s ceiling panels) and it appears to have served as a store area (Plates 529.23 & .25). It is accessed from the south (with stores type liftable counter) and there is also an internal roller shutter door to make the room secure. The underside of the flat concrete ceiling is visible, with white paint peeling from it, and the structural frame is visible in the north wall.

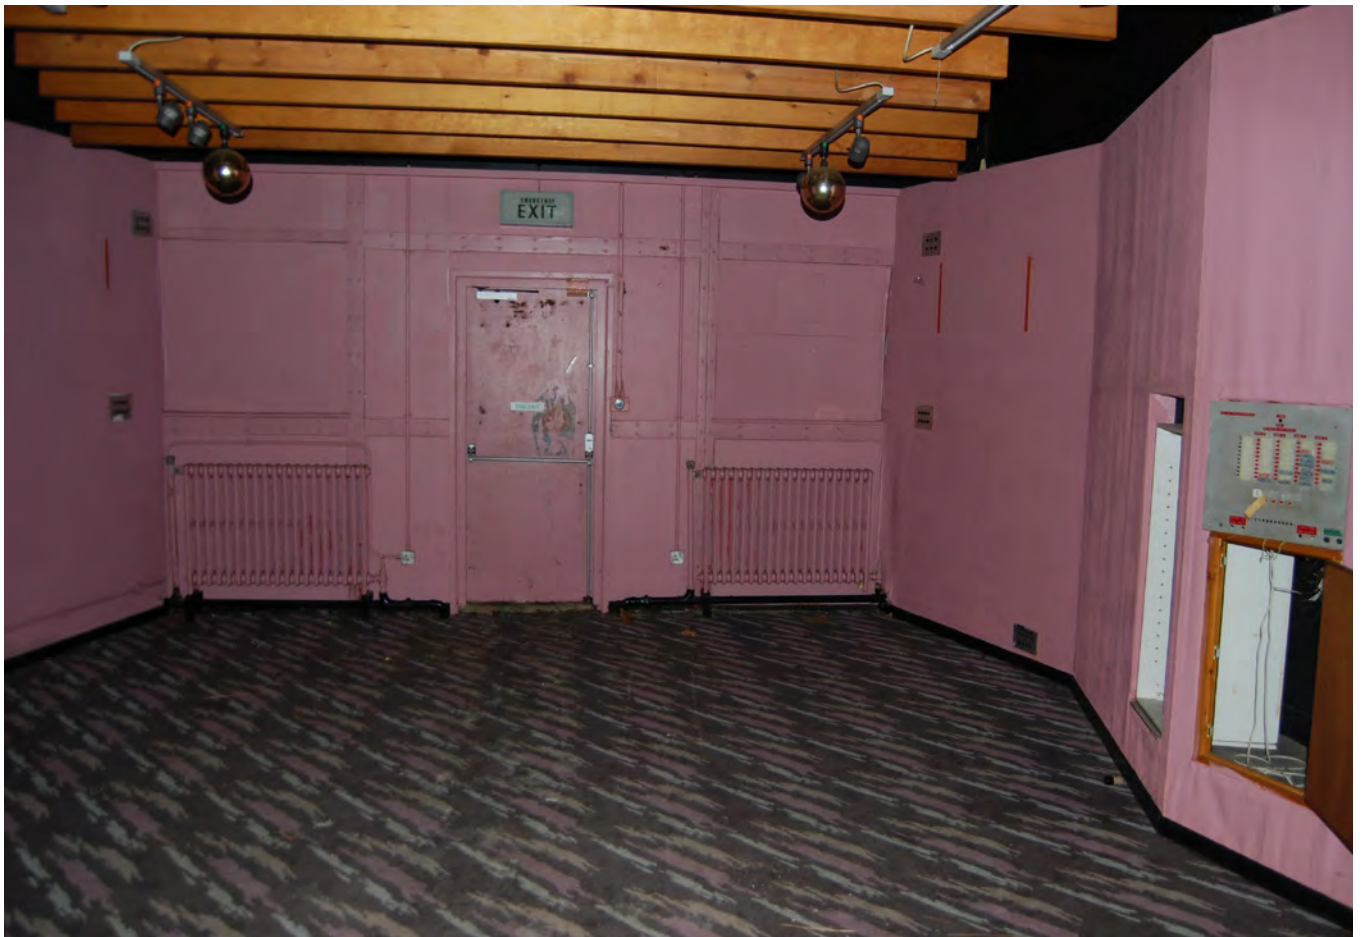
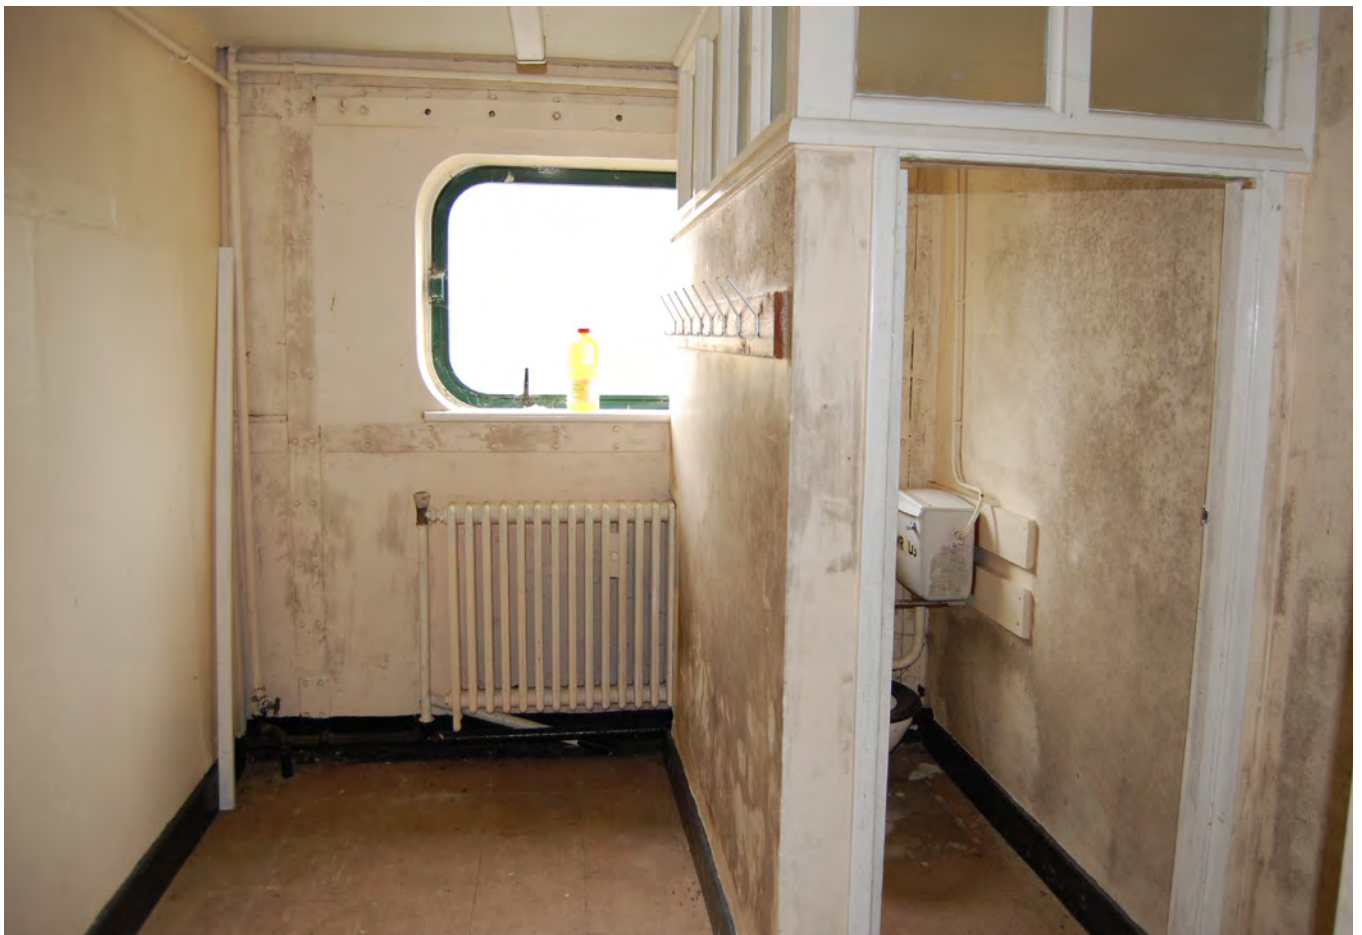
Room 16 appears to have been a small social room with a fridge, pink walls and spotlights (Plates 529.26 & .27).

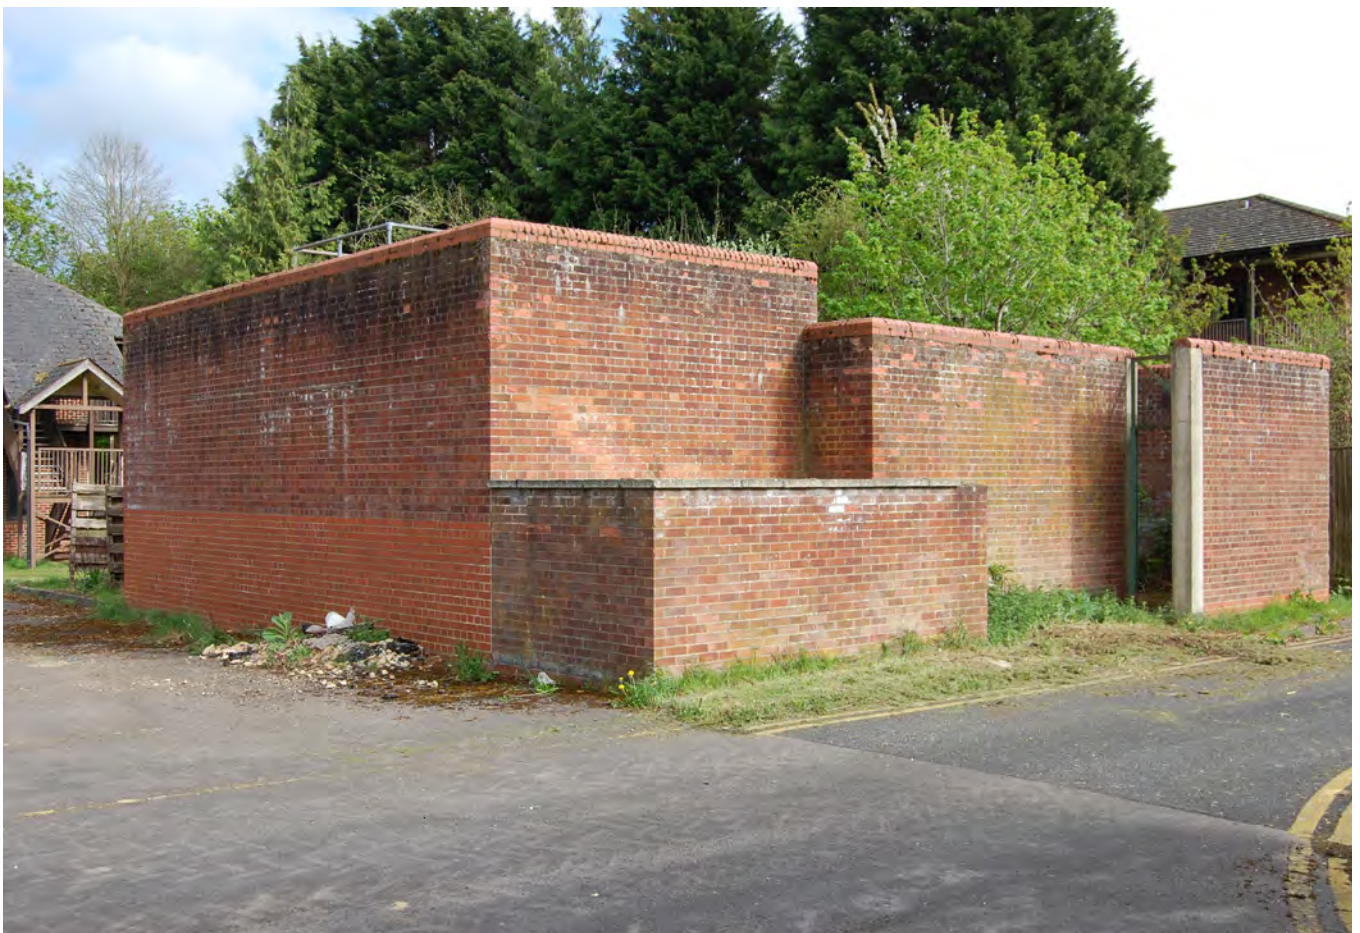
Plate UH8.1 South and west elevation

This brick built enclosure is roughly square in plan, with an open roof and an entrance in the west elevation. Internally, an oil tank is extant with 'Drained May 1984' stamped on it. Gauges for oil are extant on the west elevation. The brick elevations are of varied heights (between 1.8m and 3m), and contain areas of replacement brickwork. There are concrete lintels and posts to the opening, in addition to concrete posts around the internal enclosure.

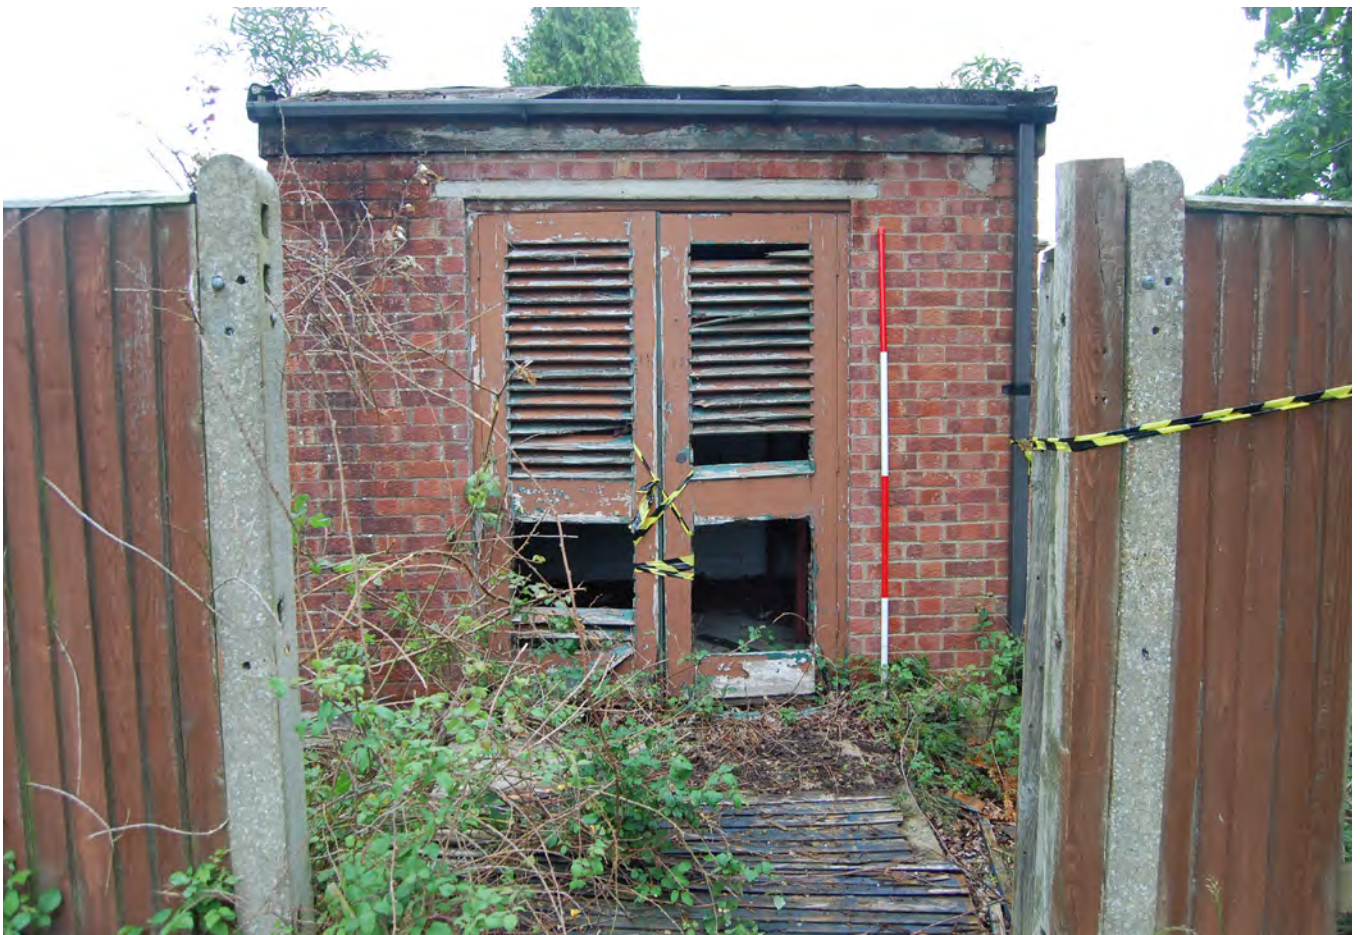
Plate UH9.1 Front (east) elevation

This simple brick built structure is rectangular in plan, with a flat ashfelt roof. The building has double timber louver doors to the front (east) elevation, and a concrete floor. It is possible to see extant electrical equipment internally.

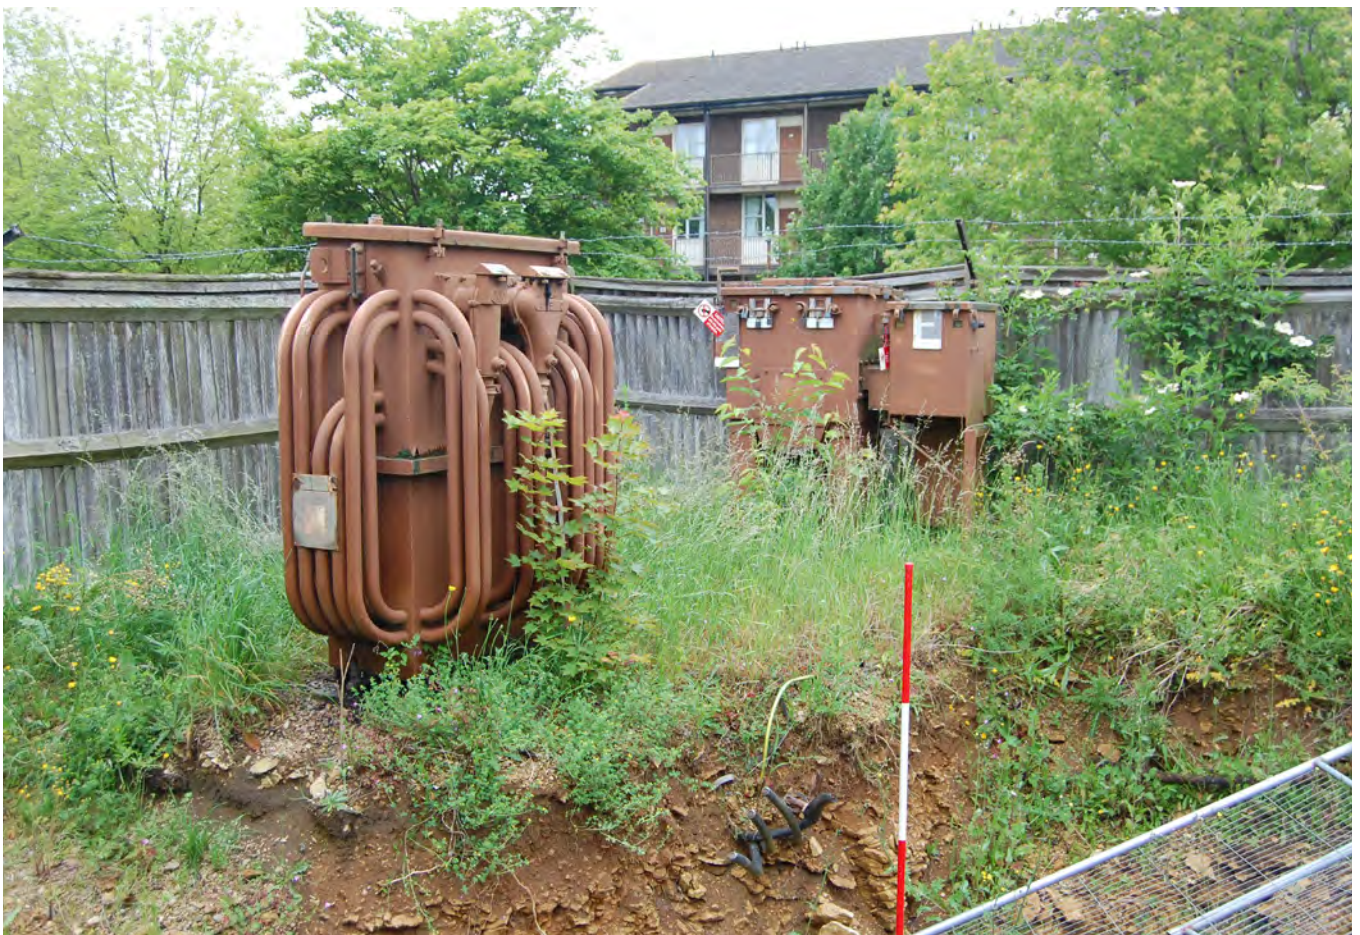
Plate UH10.1 East view of substation

The electrical substation is surrounded by a 1.8m timber fence supported on concrete posts, topped with barb wire (UH10.1).

Two pieces of plant are extant (painted brown), but the earth surrounding this has been excavated at the time of recording.

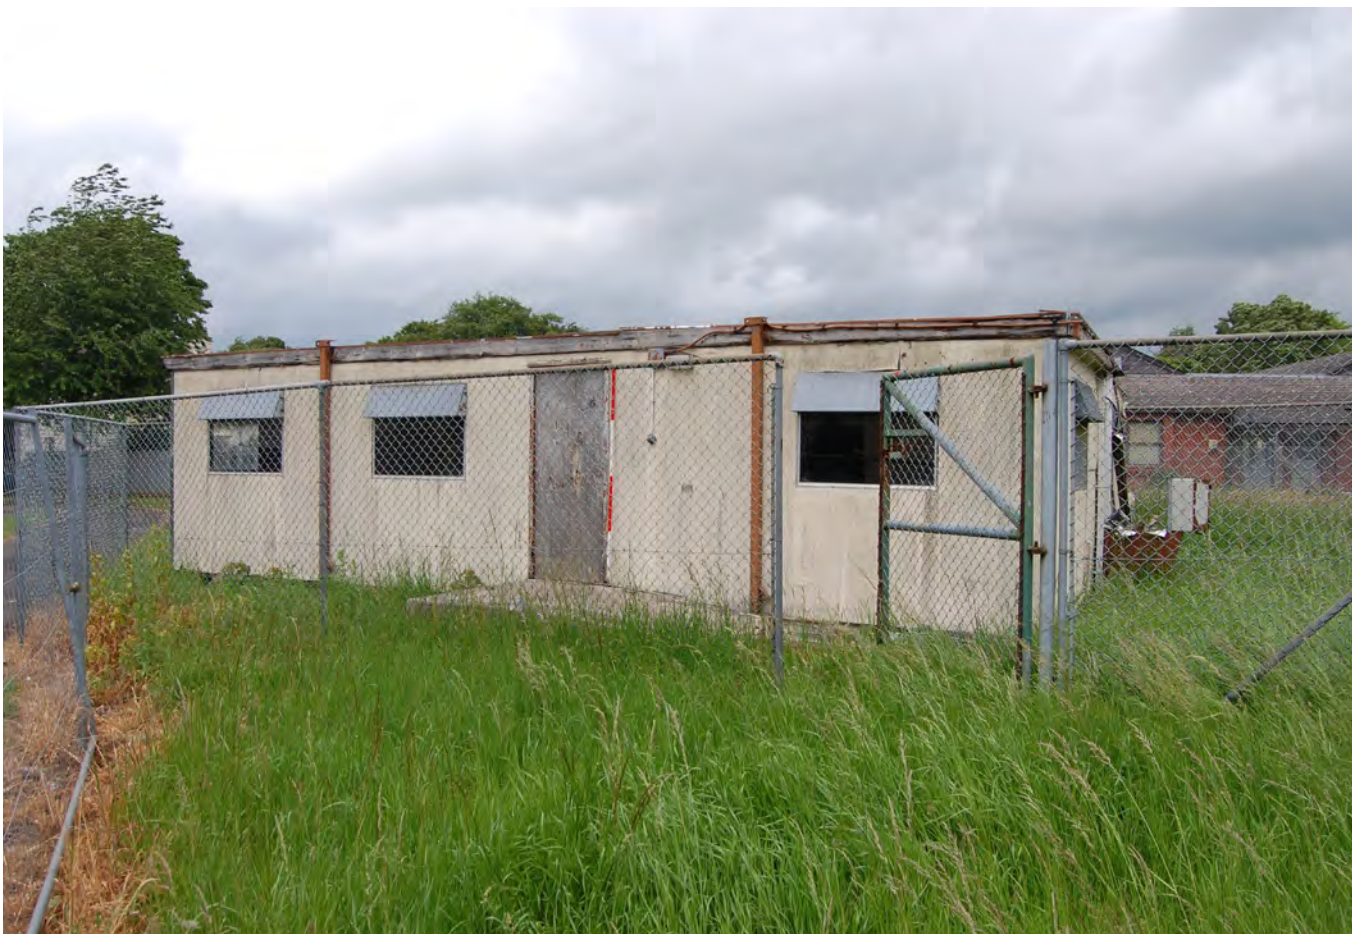
Plate UH11.1 Front (north) elevation

This simple portacabin is rectangular in plan and now in very poor condition. It is painted white with simple metal windows and timber doors, and a flat ashfelt roof. The building is surrounded by a metal fence, the reason for this is unknown.

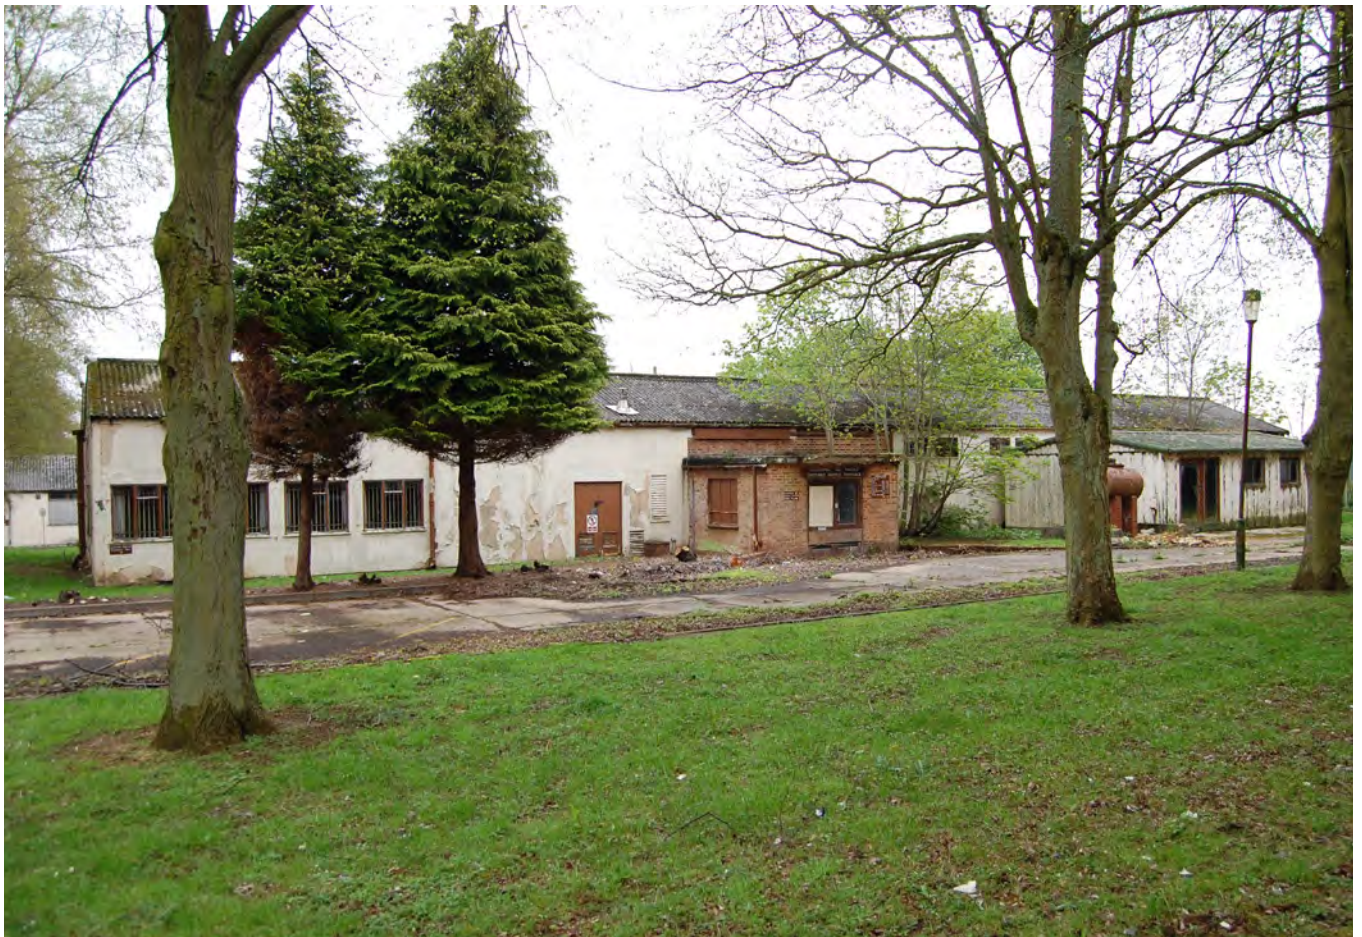
Plate 400.1 West elevation

The *west elevation* (Plate 400.1) divides into three sections: the longest section is to the south (over half the total length of the building) and comprises twelve 2-light metal framed windows high up the wall towards the eaves. To the north of this section is a secondary brick entrance block which projects from the main wall of the building and it is believed that this section was originally an open vehicular entrance into the building. The northern part of the elevation has an entrance to a plant room and four primary crittal type windows towards the north. These windows are larger and lower than those in the southern half of the elevation and illuminate the offices. Each pair of windows in the southern section is beneath a single concrete sill.

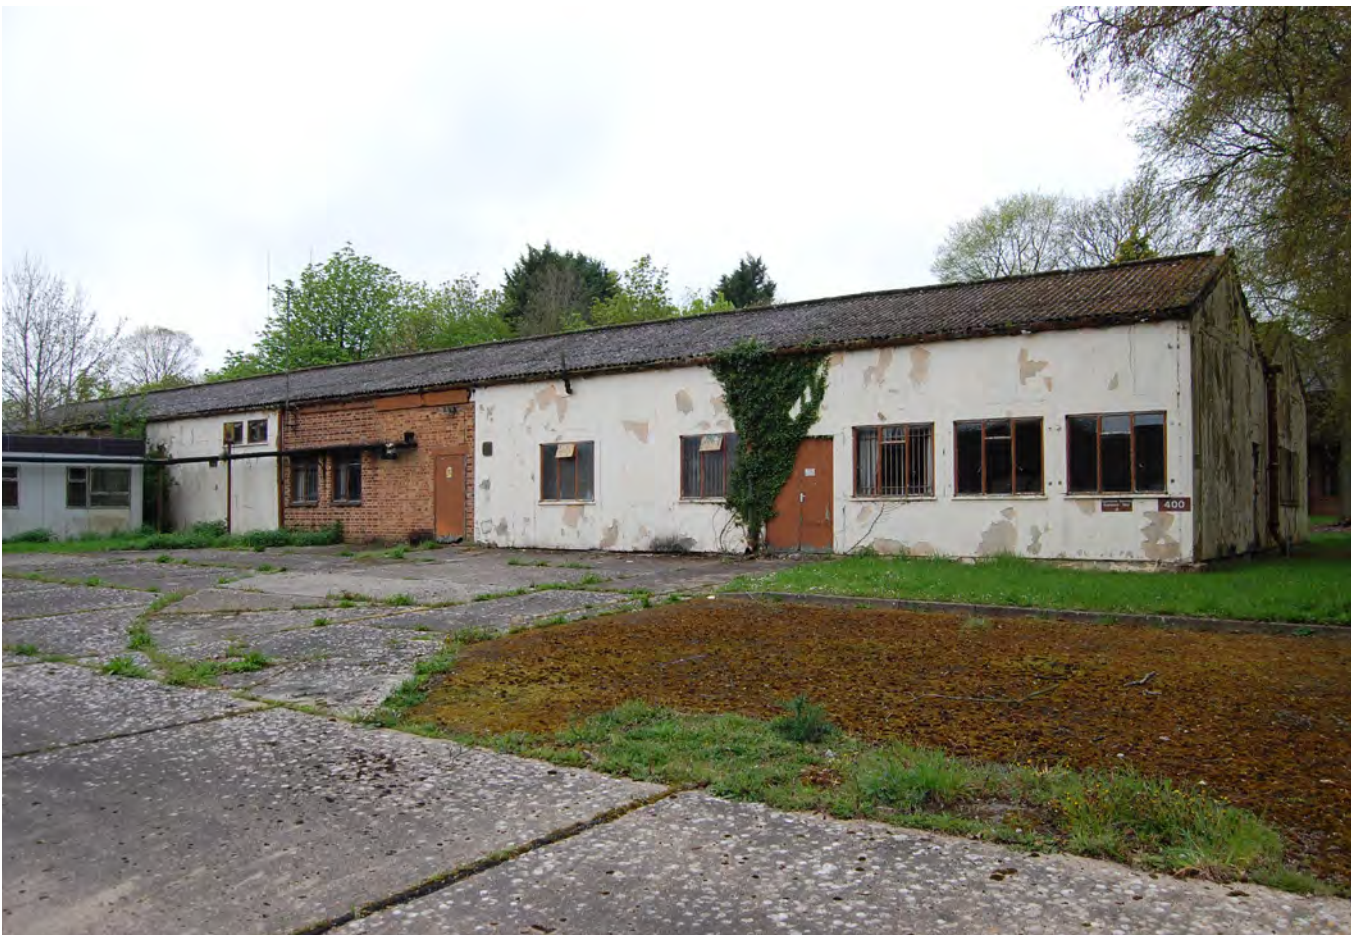
Plate 400.6 East elevation

The division of the *east elevation* (Plate 400.6) broadly follows that of the west elevation with five primary 4-light windows in the northernmost third and a bricked-up section immediately south of this which is believed to have originally been an open-faced vehicular entrance. There are two phases of brick infill here and the remains of what appears to have been a sliding door. Most of the southernmost section of the elevation is obscured by a modern projection but there are two high windows visible to the north of this.

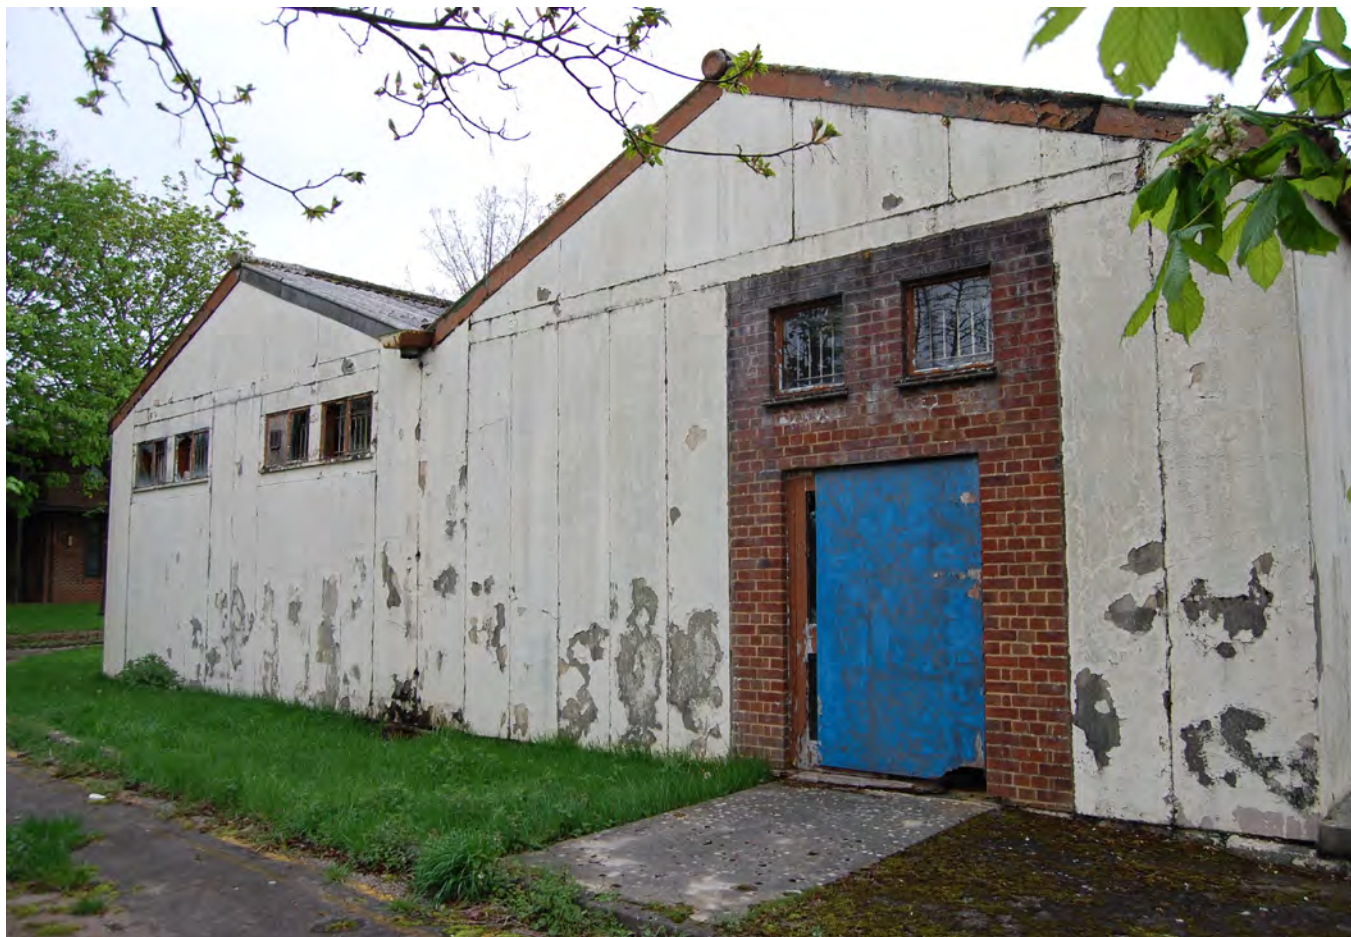
Plate 400.7 South elevation

The *southern wall* has four primary 2-light windows high in the western gable of the wall, beneath a long lintel (Plate 400.7). In the eastern gable there's a panel/section with secondary brick infill (1960s/70s) with two windows above a door. Presumably this infilled section would originally have been a vehicular entrance and there is a shallow concrete ramp adjacent to it.

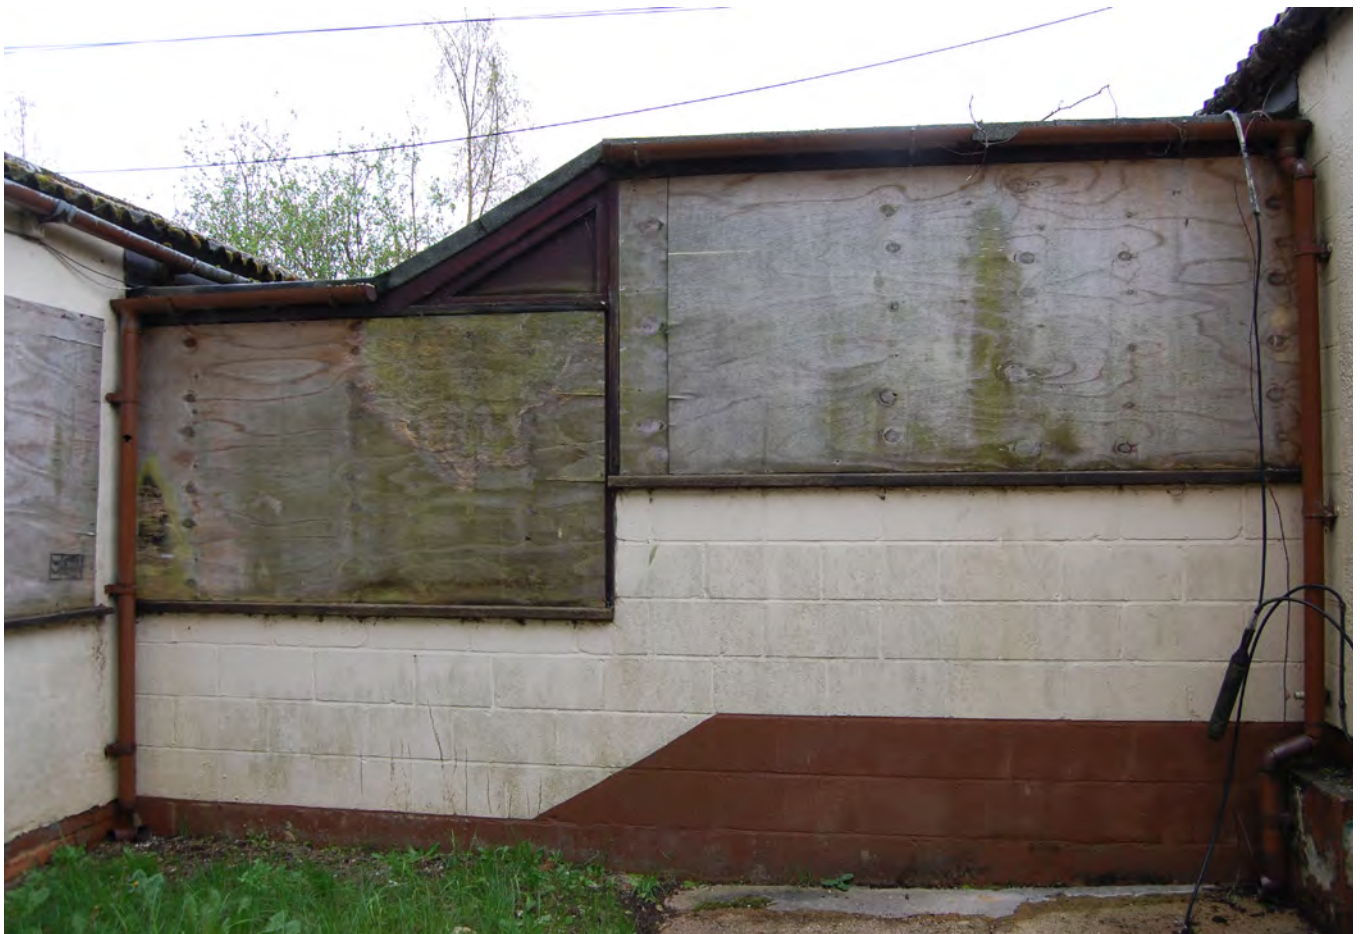
Plate 401.4 Concrete block connecting structure

Building 401 forms the north-westernmost block of the complex of huts connected to each other. It is linked by a short corridor to 402 on its east side although this is constructed from secondary concrete blockwork and this corridor is not shown on the 1954 aerial photograph. It may have been added as late as the 1980s (Plate 401.4). The building was originally linked by a corridor at the southern end to the rest of the complex.

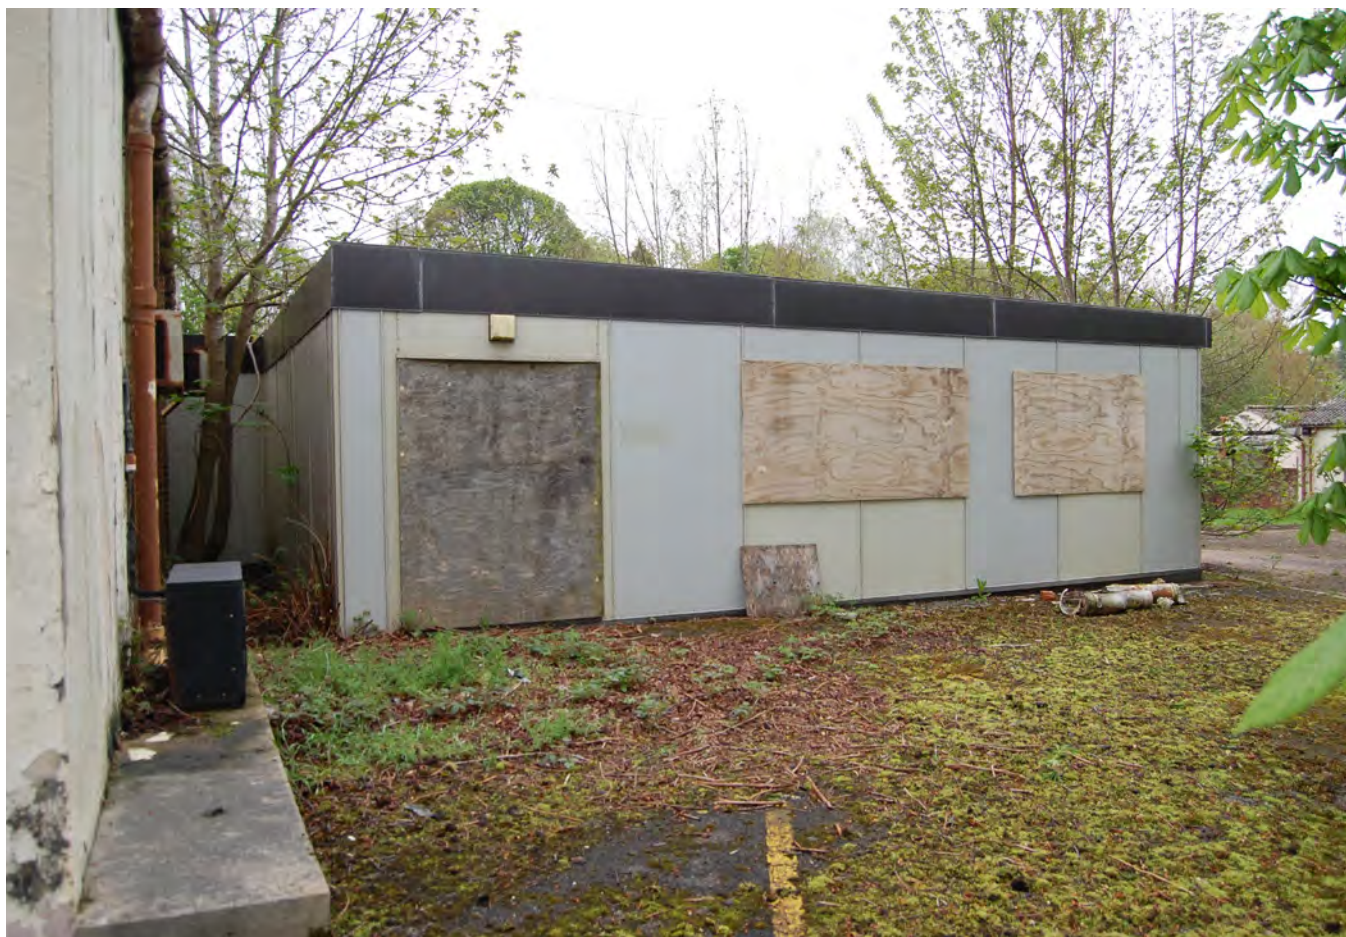
Plate 403.1 General view of 403 from south

Building 403 is a single storied, square-plan building with metal panels to the walls and flat roof. The windows have modern aluminium frames. There are three windows to the north wall, four windows to the east wall (with entrance door), and two boarded windows to the south wall. The west wall is connected to building 400. The interior was not fully accessed but it appears to be standard modern offices.

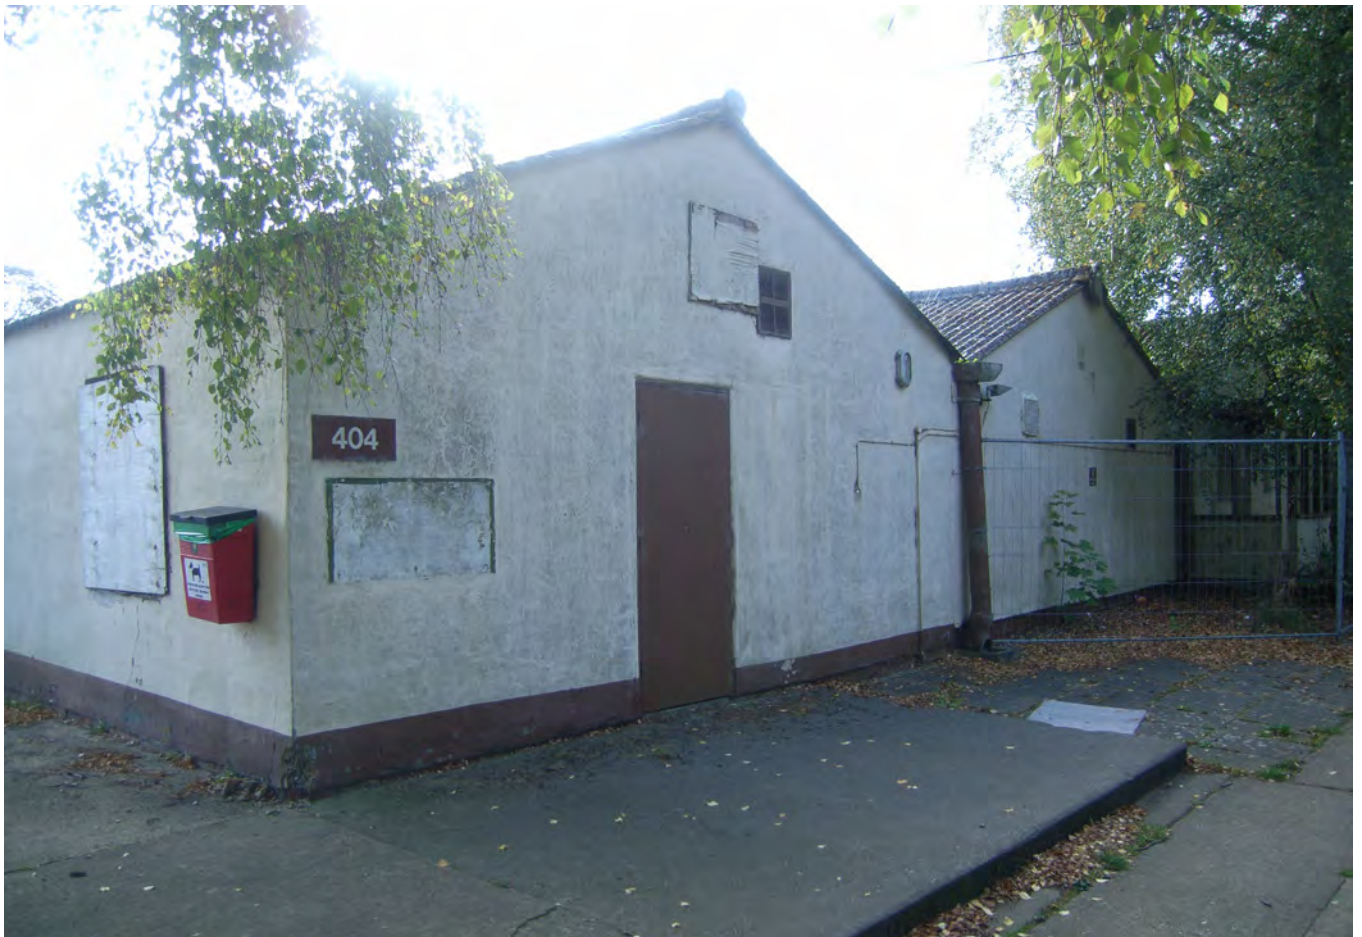
Plate 404.1 North end of building 404

The *north elevation* has a single doorway beneath a boarded panel in the eastern bay, a secondary roofed lobby in the western bay (with several patches from former signs) while the central bay is featureless (Plate 404.1).

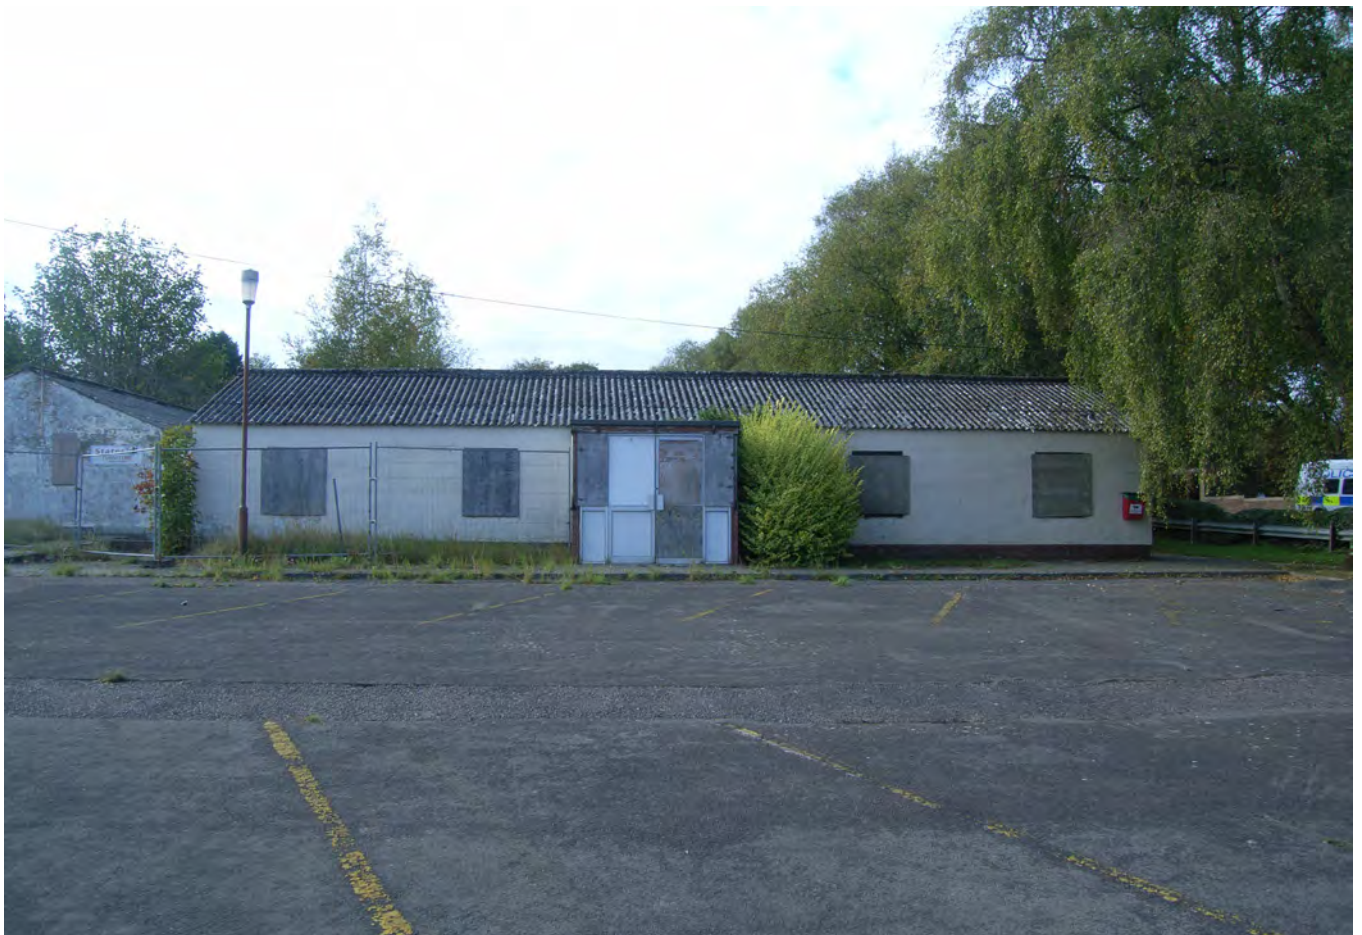
Plate 404.2 East side of building 404

The *east elevation* has five windows but an entrance porch has been constructed over the central one (Plate 404.2).

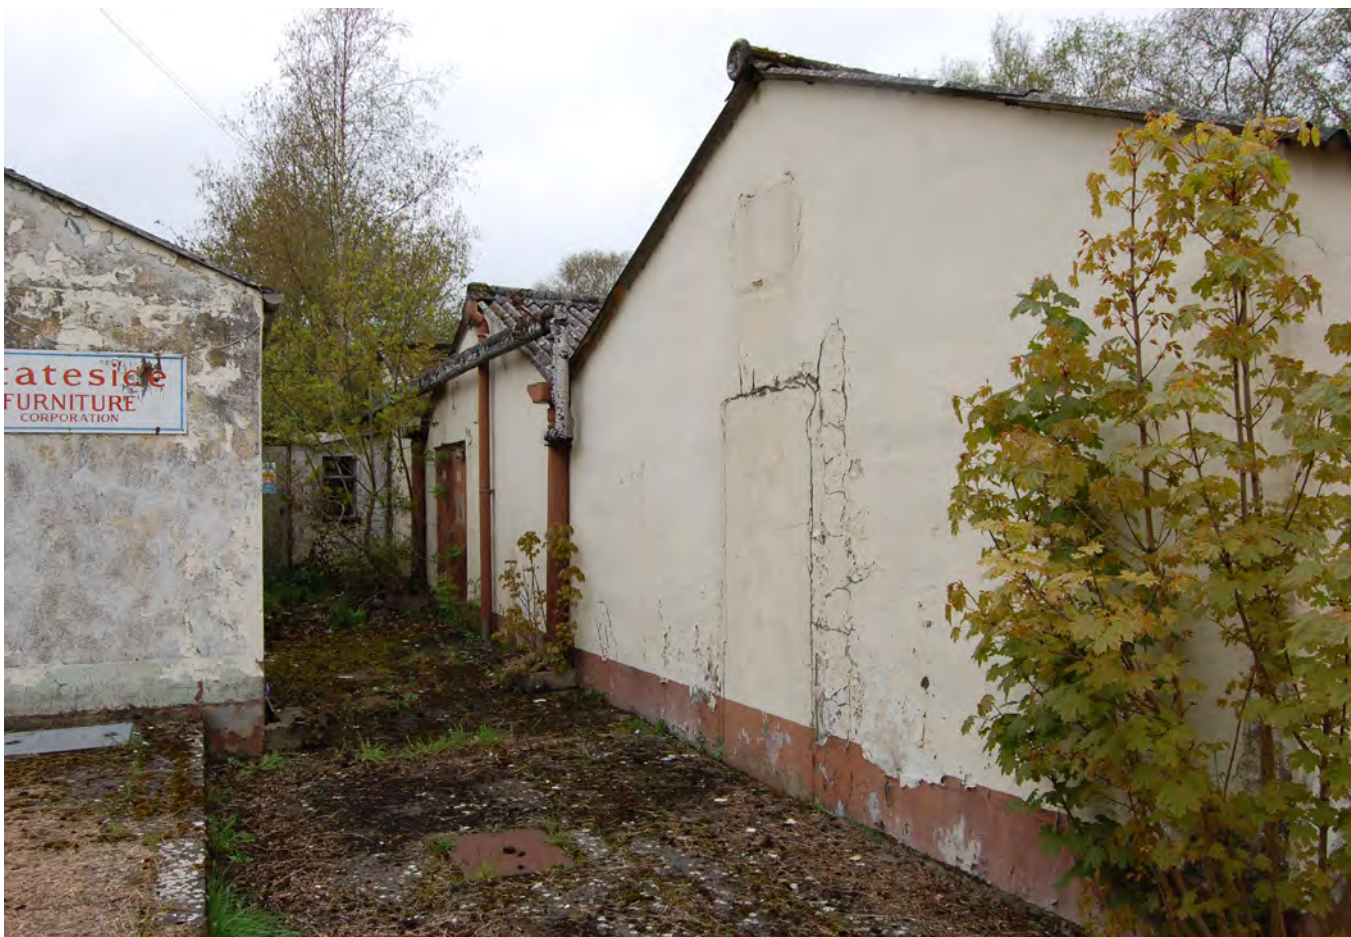
Plate 404.4 South end of building 404

The *south elevation* has a blocked doorway in the east gable (rendered over), and an existing secondary double doorway in the central gable. The western gable is largely overlain by a lobby structure (Plate 404.4).
