FORMER RAF UPPER HEYFORD, OXFORDSHIRE

HISTORIC BUILDING RECORDING AND INVESTIGATION

VOLUME 2: GAZETEER OF RECORDED STRUCTURES

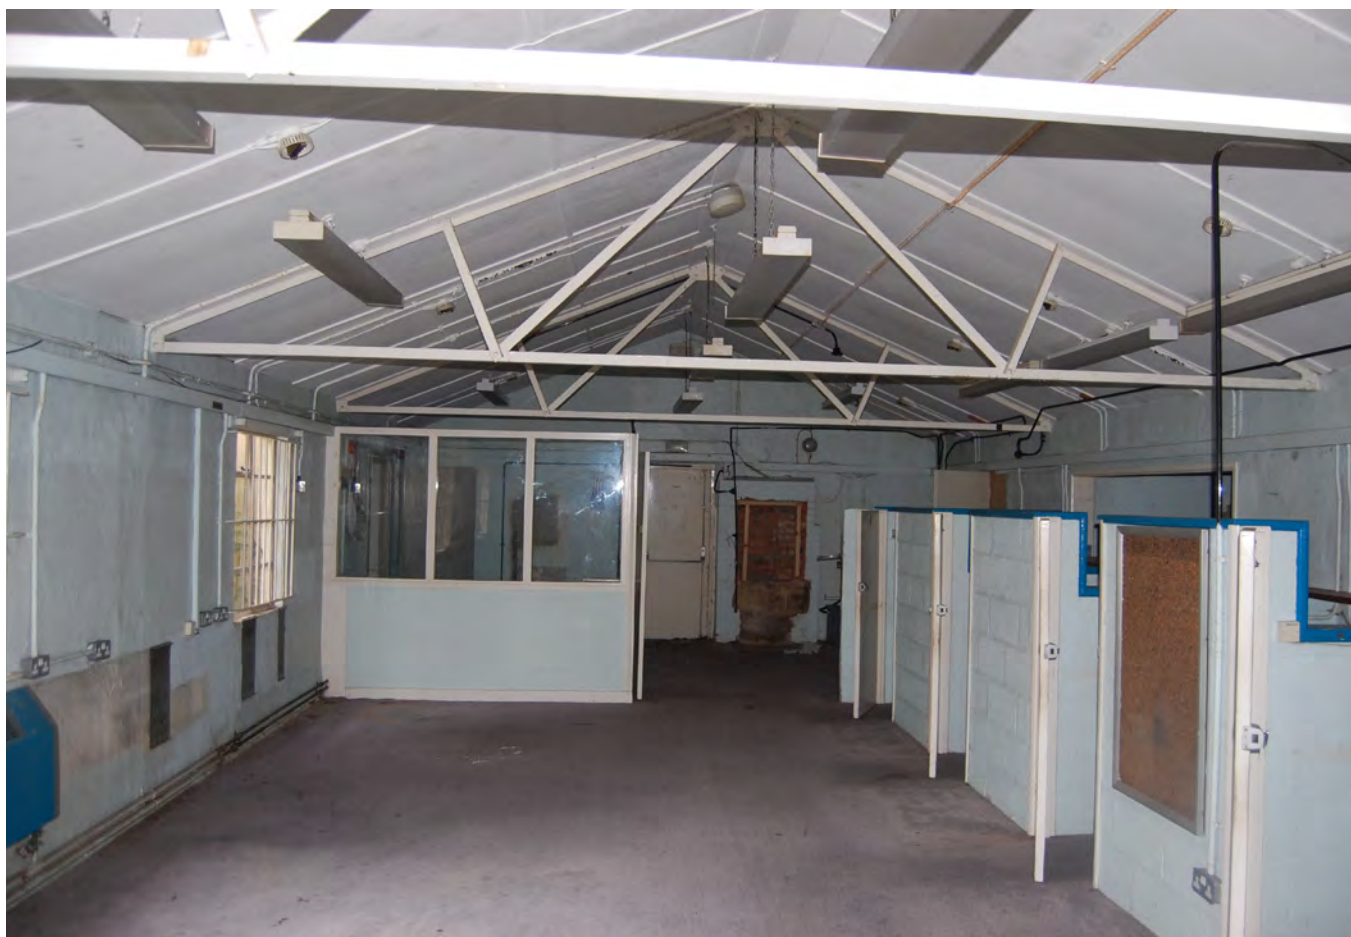
Plate 404.5 Western part of interior of 404

The open-plan public area (Plate 404.9-12) is contained within the central and eastern bays, accessed from the double doors in the east elevation, while the open-plan area in the western bay is the bank's administrative area (Plate 404.5-8). This administrative area is behind a row of seven bank counters along the eastern side of the western bay, with private lockable booths for the cashiers. The booths are constructed with concrete blockwork.

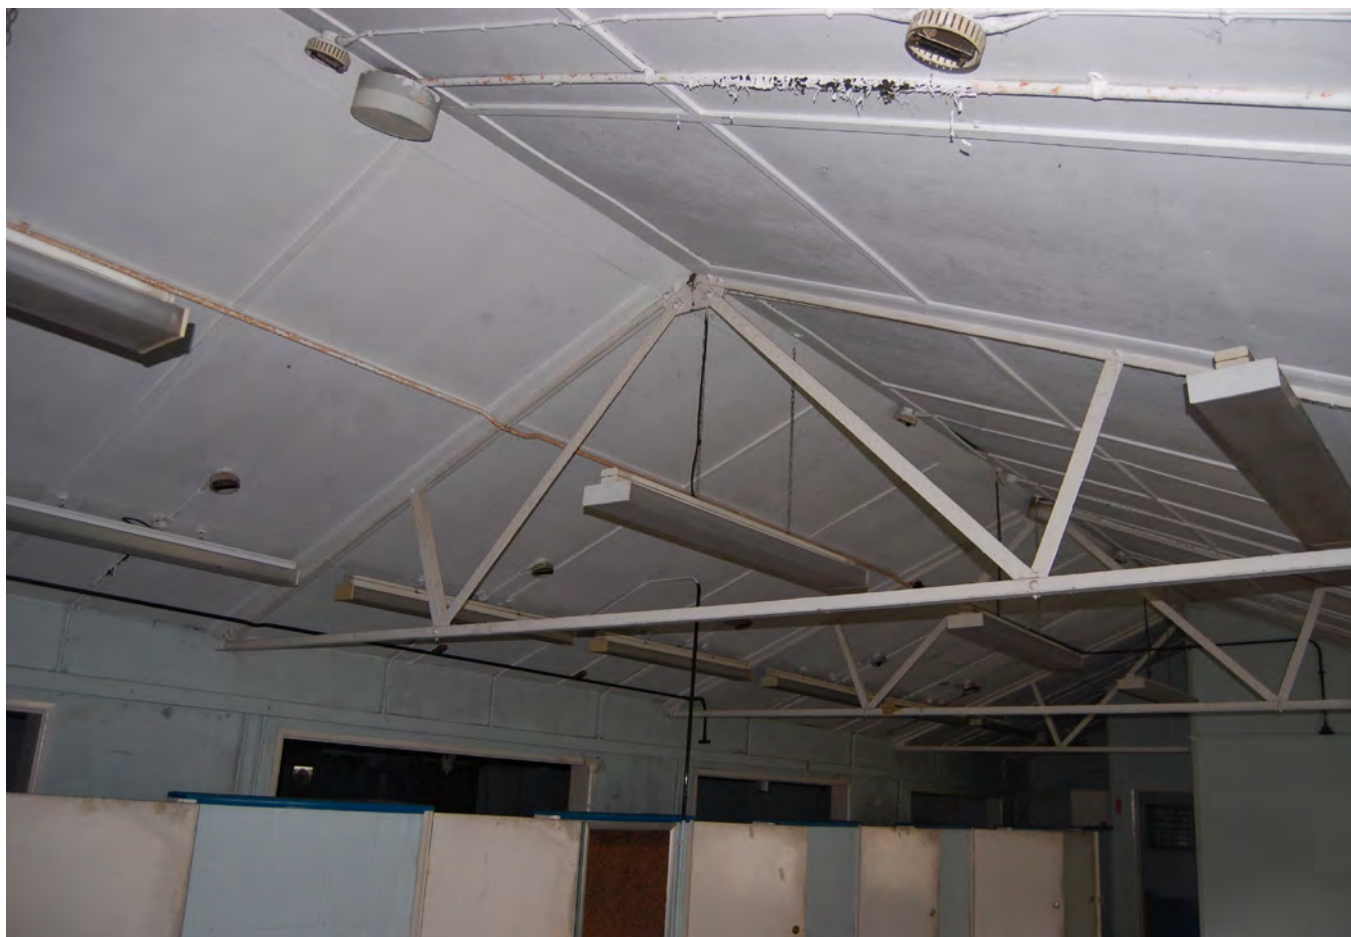
Plate 404.6 Typical roof truss

As referred to above there is an aerial photograph from 1954 which shows that the central bay is a secondary addition to the older flanking bays and although the construction is broadly similar there are some clues to the later date of this area. The main difference is the nature of the roof trusses in the secondary, central bay from those in the primary eastern and western bays. The trusses are all metal, largely constructed from L-section members, and typical for the mid 20th-century, but the primary trusses are slightly simpler. They have two raking struts to each side whereas the later trusses in the central bay also have a vertical strut as well as the two raking members. The secondary trusses in the central bay also have connecting plates at each junction between members which the primary trusses do not have. Another distinction between the bays is the fact that the end rooms in the eastern and western bays are constructed from stud partitions (potentially primary), whereas those in the central bay are constructed from concrete block.

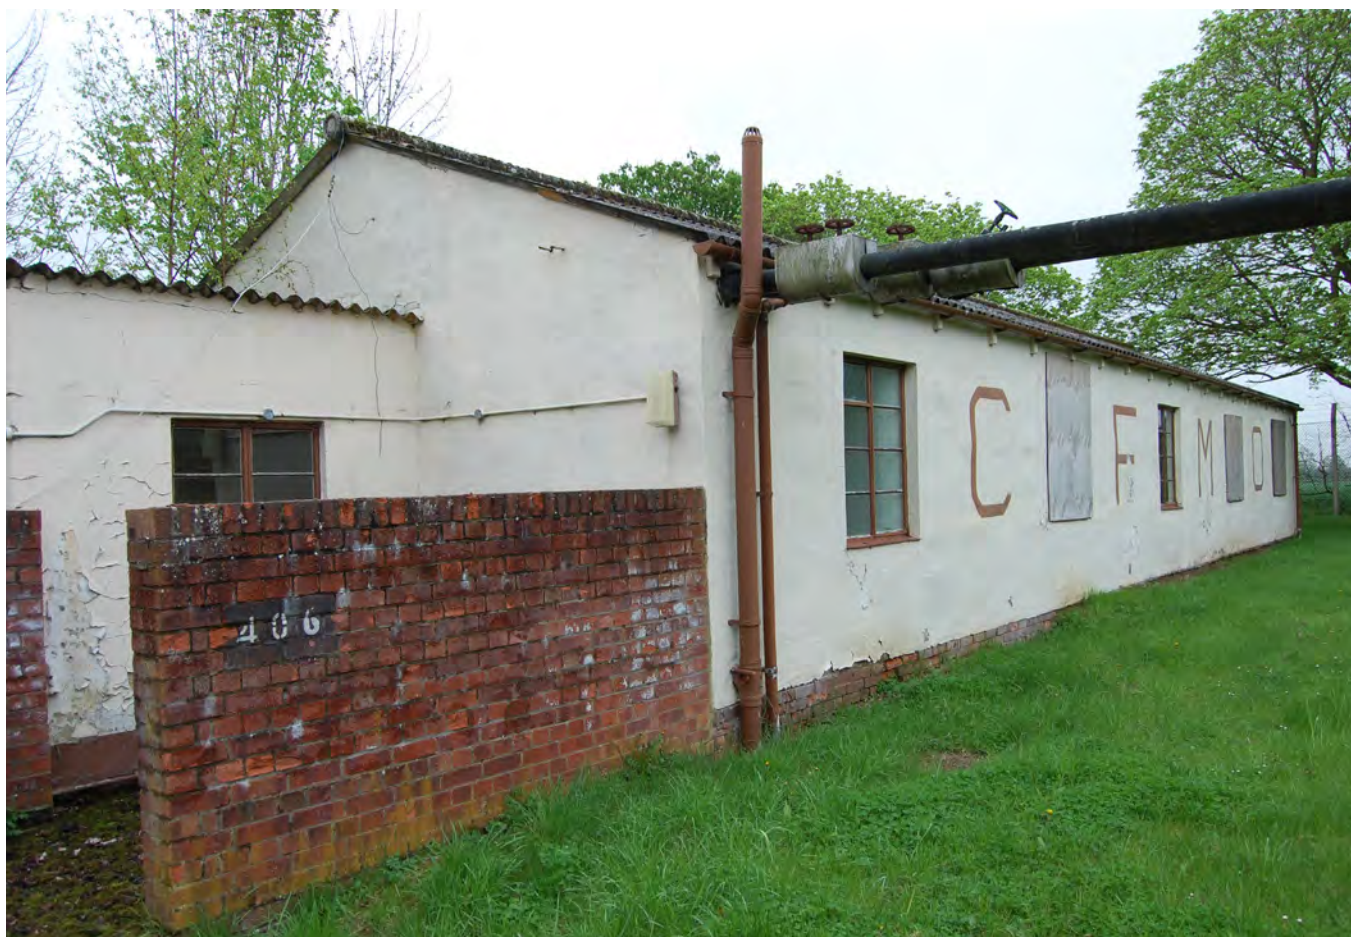
Plate 405.1 Exterior from north-west

Building 405 is located towards the south-western corner of the group of post-war eastern huts and it appears to remain broadly similar to its primary layout and form. It is a single storey rectangular plan building, orientated north-to-south, which is connected to the central east-to-west range (408) via a small corridor at the north end. The building has a gabled roof, clad in corrugated sheeting and the walls are rendered a cream colour. The primary metal framed, crittal-type windows largely survive, painted brown to match the widely used colour scheme at Upper Heyford, and the sills are tiled. The east and west elevations each have five windows although some are boarded externally. There is a single doorway at the centre of the south elevation, which appears to have been created within a formerly wider double doorway. One of the dominant features of the building are the very large letters: CFMO painted in brown between the windows in the west wall. At the north end of the building is the low corridor with single pitch roof providing access to building 408.

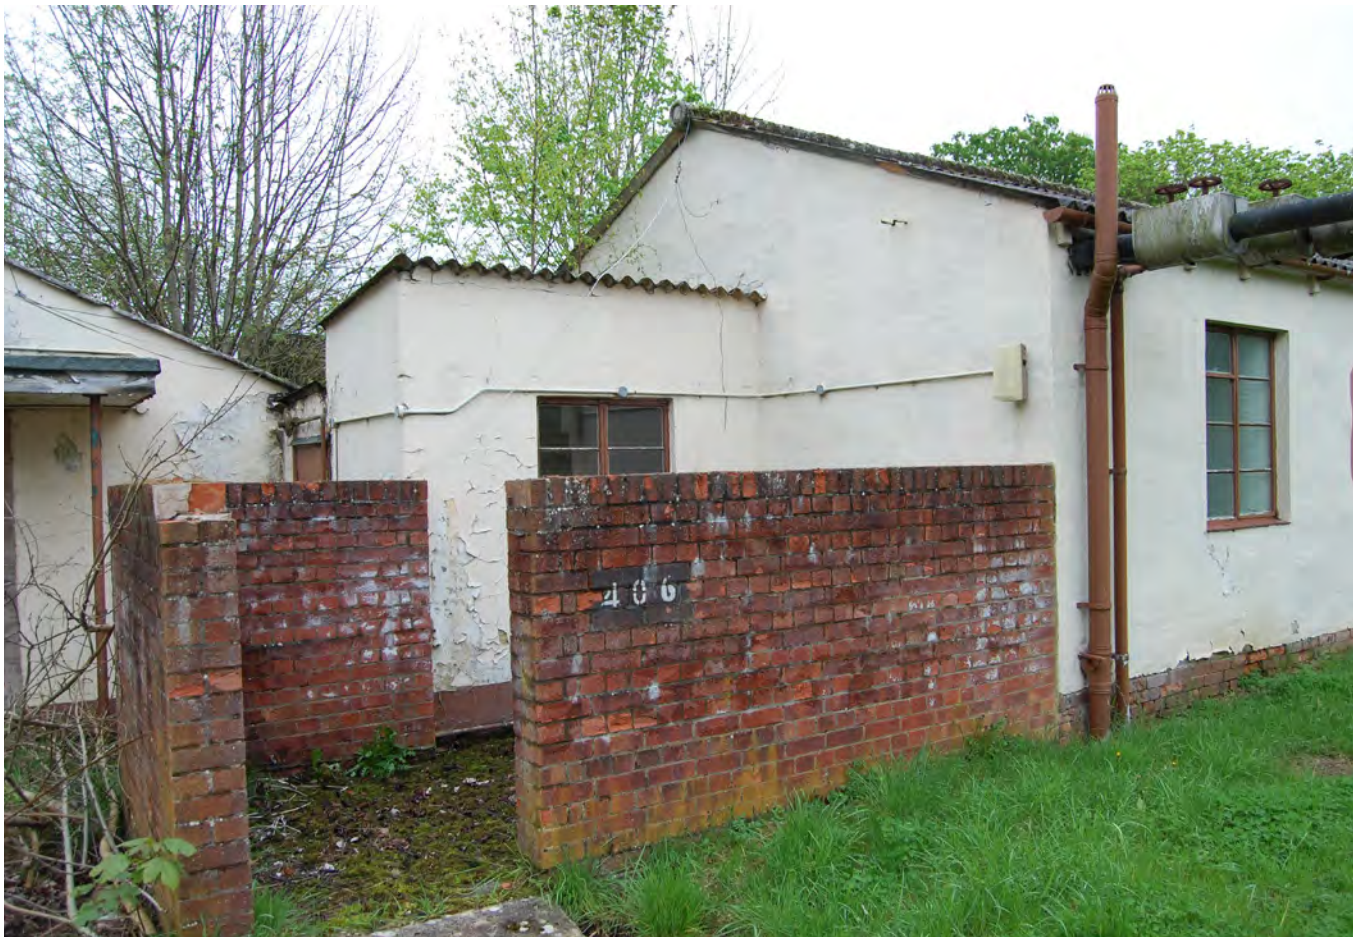
Plate 406.1 Exterior view

Adjacent to this corridor at the north-west corner is a set of low brick walls (English bond) with 406 painted on it. It appears that this was a small roofless enclosure which contained some form of plant. This small enclosure is c.4 m x 2.5 m in plan and the walls are 1.4 m tall. The enclosure has a concrete floor but there is no clear evidence of the plant that was contained here.

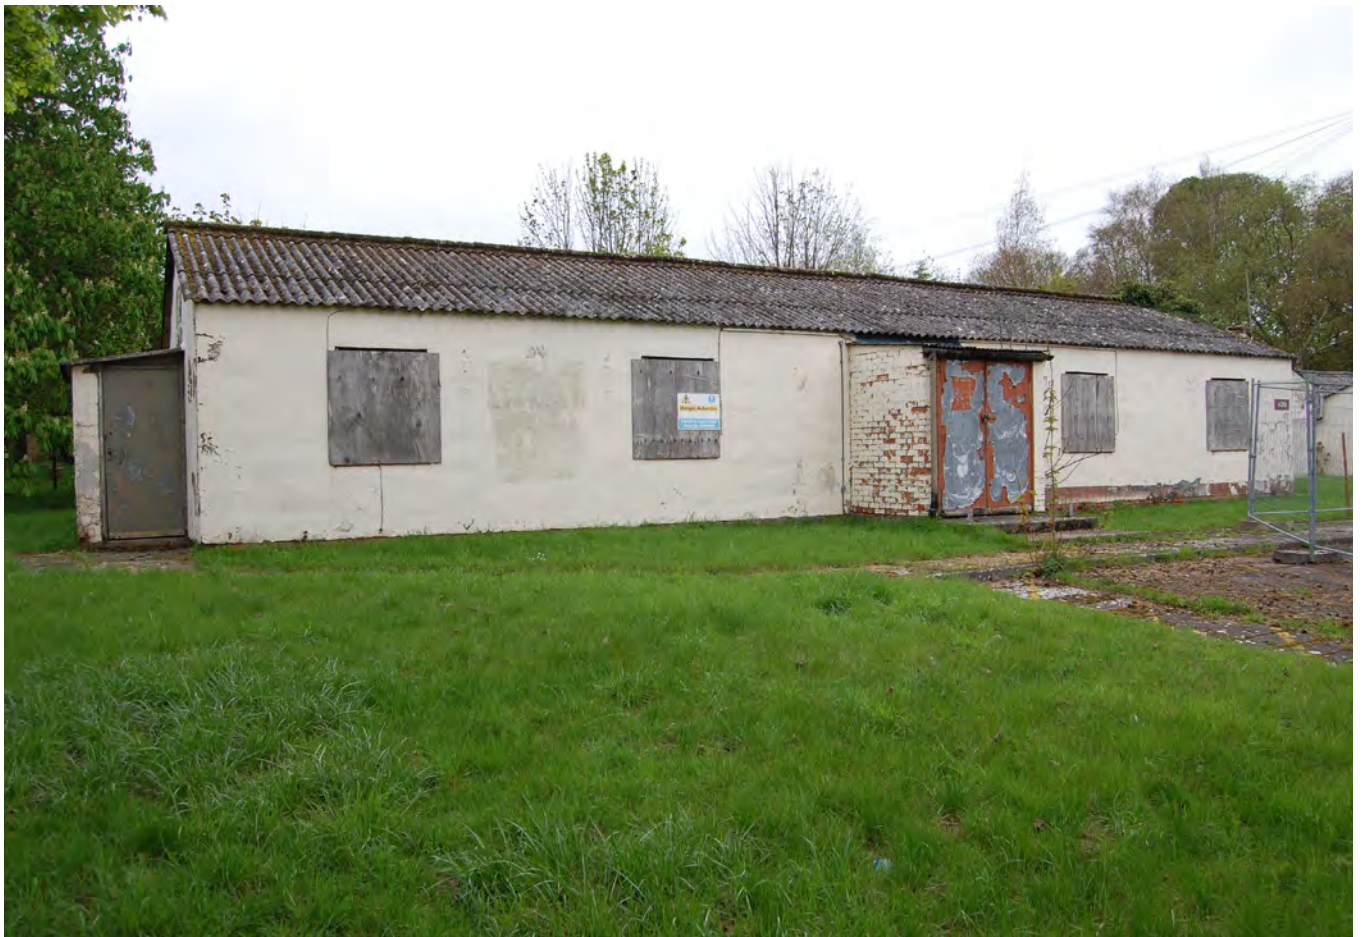
Plate 409.1 East side of building

The west and east walls each had five windows although most are boarded and the central one in the west wall has been blocked and rendered over. At the centre of the east wall there is a projecting brick lobby (Plate 409.1) which is shown on a plan of the overall complex from 1971.

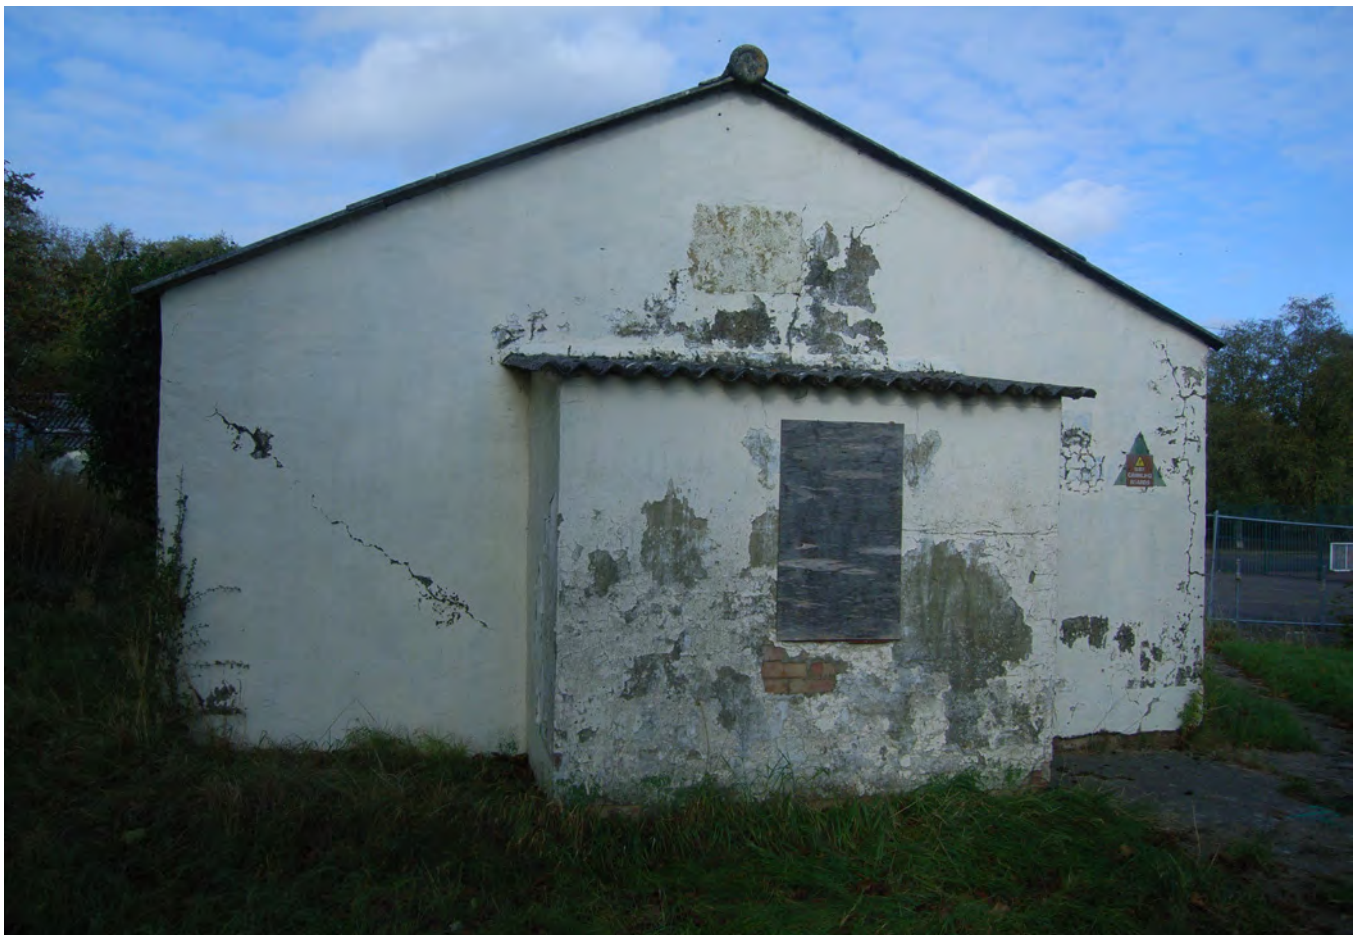
Plate 409.4 South end of building

At the centre of the south elevation is a small rendered brick lean-to extension (Plate 409.4) which could be original. The 1954 aerial photograph appears to show a small projection at the south end of each of the three corresponding ranges here. Above the projection is the same infilled panel (vent/ window?) found in the other huts.

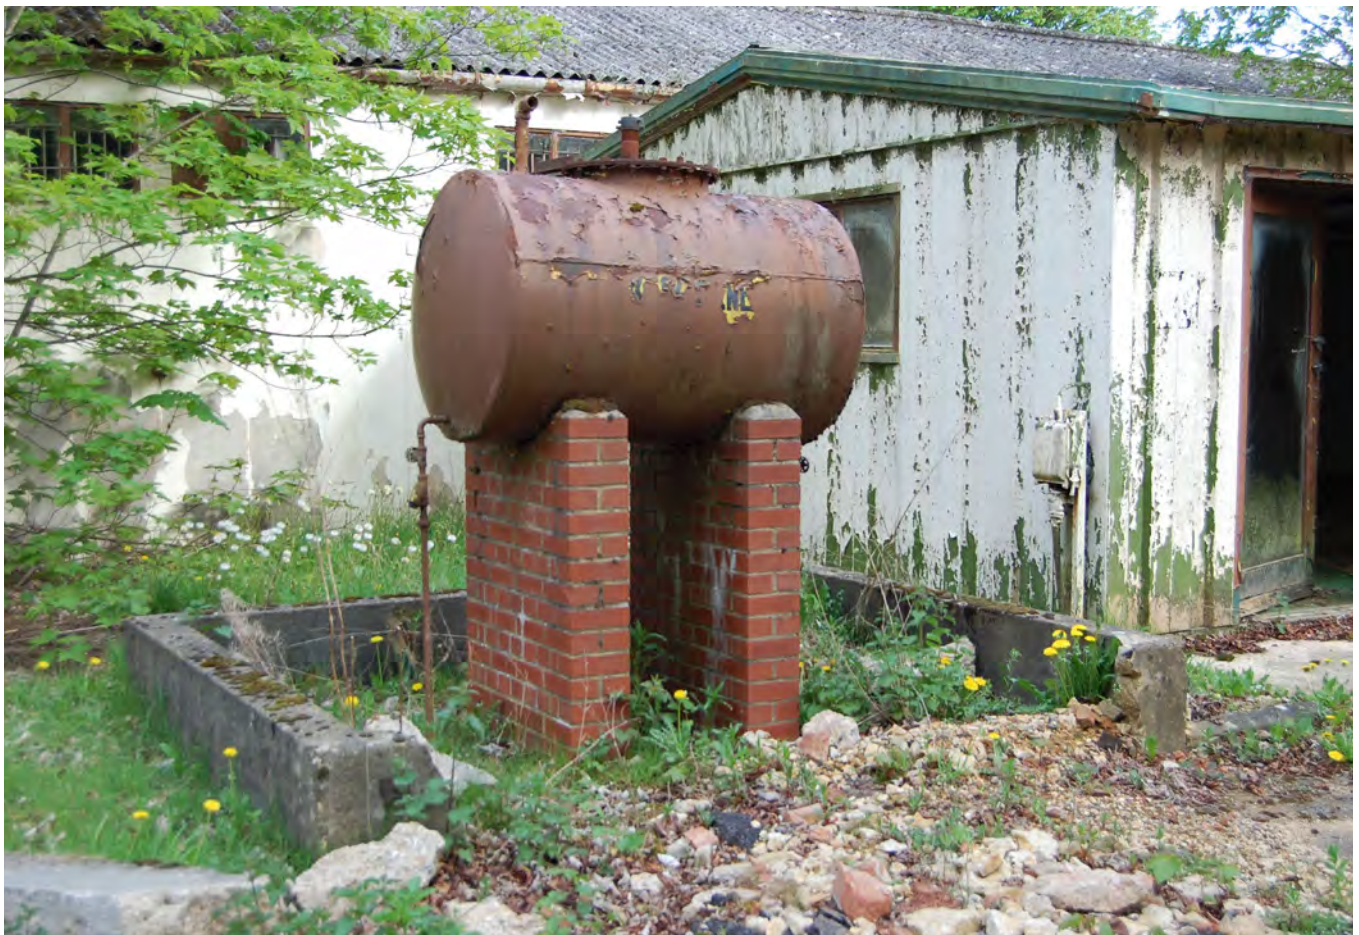
Plate UH12.1 East elevation

The cylindrical tank (painted brown) sits on two brick plinths at a height of 2m (Plate UH12.1). It is surrounded by a concrete wall which is thought to have formerly supported a timber fence, although this is no longer extant.

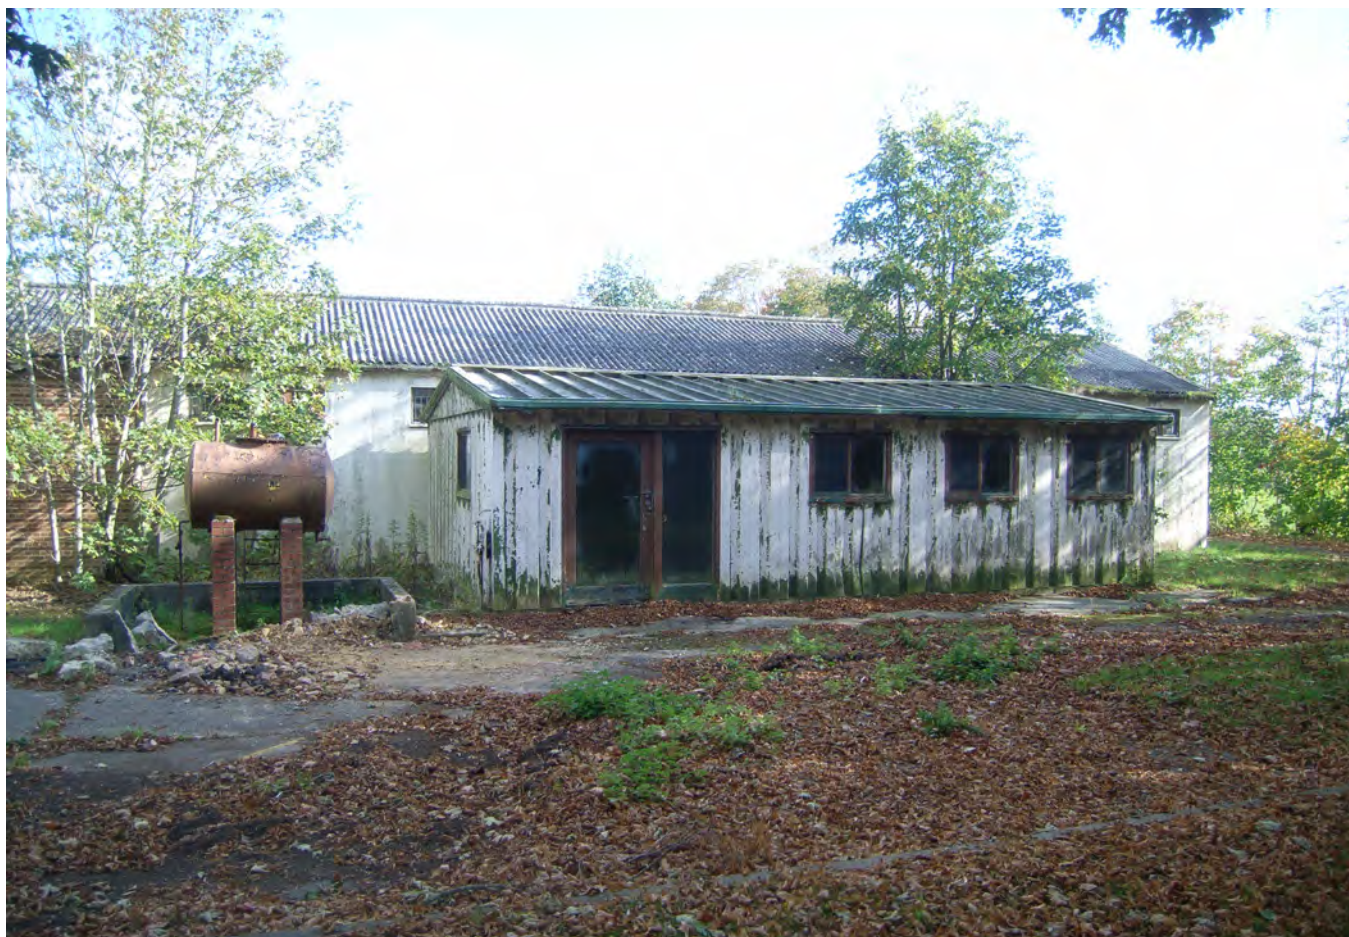
Plate UH13.1 East elevation

This single-storey structure has a pitched metal roof, and is clad in corrugated metal sheeting which is painted cream with earlier green paint visible beneath (UH13.1). It has simple two-light metal windows, and sits on a concrete plinth. The front (east) elevation has a double metal and glass door providing the only point of access. Internally, it is possible to see that it is carpeted with several electrical sockets (5 plus) running around the room at desk height. The building is thought to have had an administration function, the large access door suggests it was used regularly by the public.

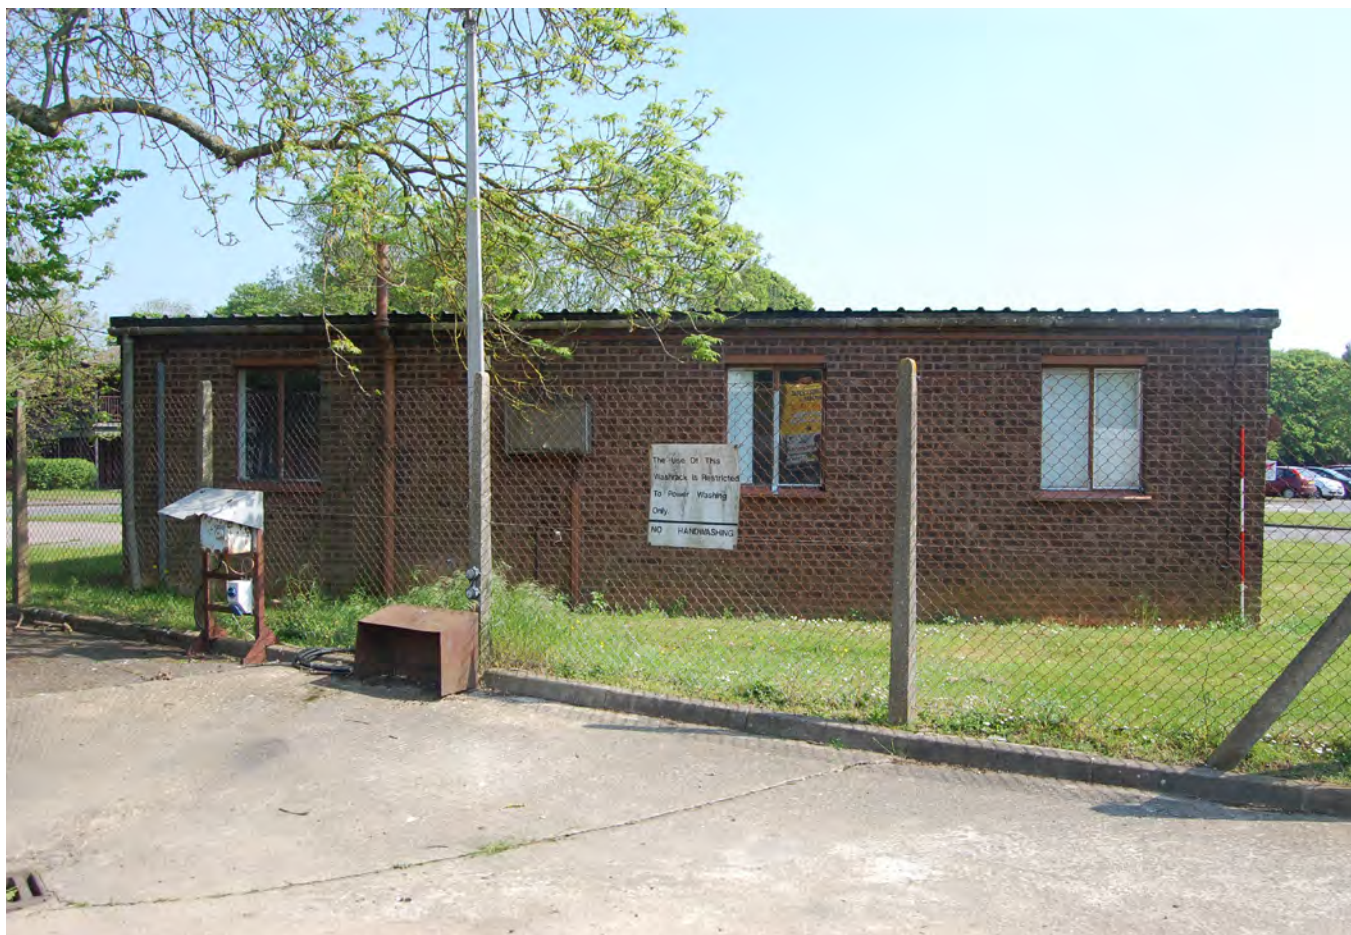
Plate 36.1 North-east elevation

This simple single-storey brown brick structure is rectangular in plan and single phase. It has a flat asphalt roof with timber fascia and crittal windows (Plate 36.1) These have timber lintels and tile sills, which (with the exception of the north-east elevation) are painted white. The south-east (front) elevation has a single timber and glass door with windows to both sides which have two rectangular lights. There is a further window at the north-east end of the elevation, which is a larger four-light window of the same type as the south-west elevation.

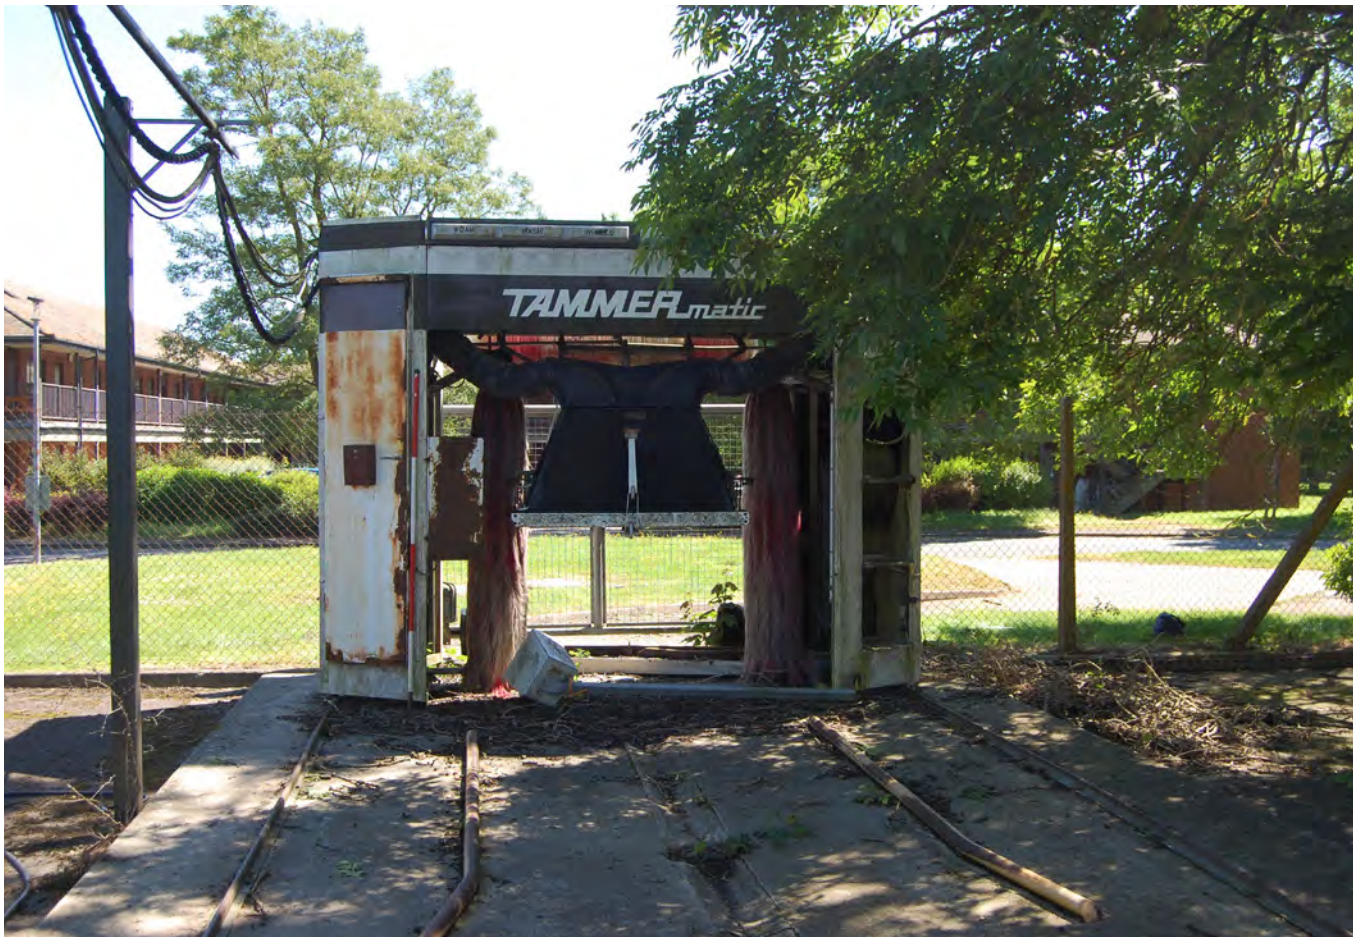
Plate 38.1 South-east facing view of car wash

This 'Tammermatic' carwash has pink brushes to the front and each side. The car wash is access from a side road extending around building 36, with the exit via the front of building 86. The brushes are held on a metal clad frame through which the cars drive, overhead buttons state: 'Foam' 'Wash' and 'Wheels'

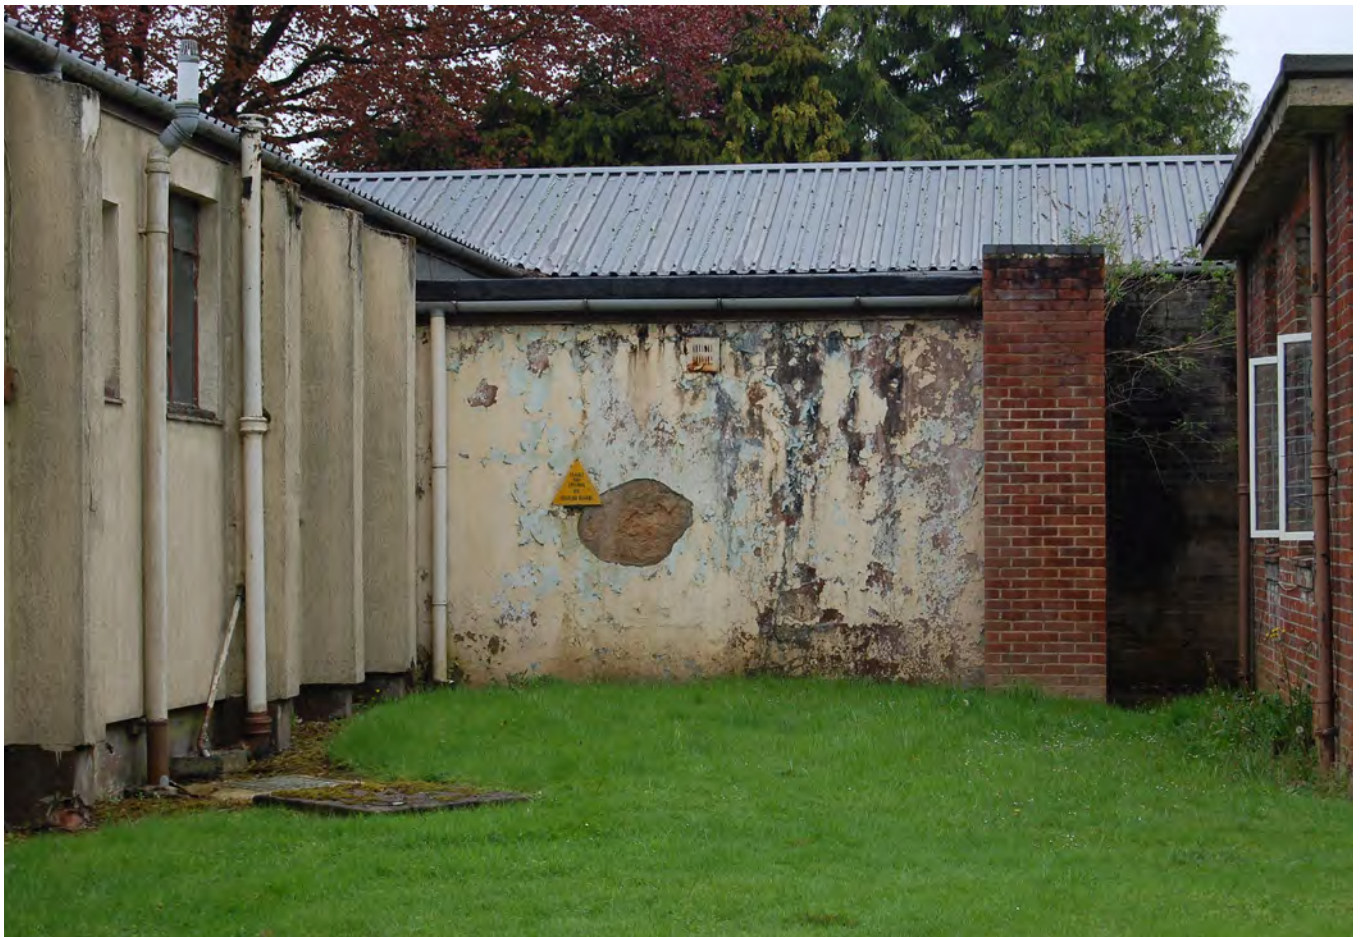
Plate 51.1 Concrete vault, looking west

Building 51 consists of two phases of building: the original north-south range is 18.6m by 6.2m. The east-west extension is 27.1m by 5.9m and is set just south of the centre of the east wall of the original range. A concrete vault, near contemporary with the extension, is located at the north-west corner of the extension, abutting the eastern wall of the original building (Plate 51.1). A similar vault is located in building 66.

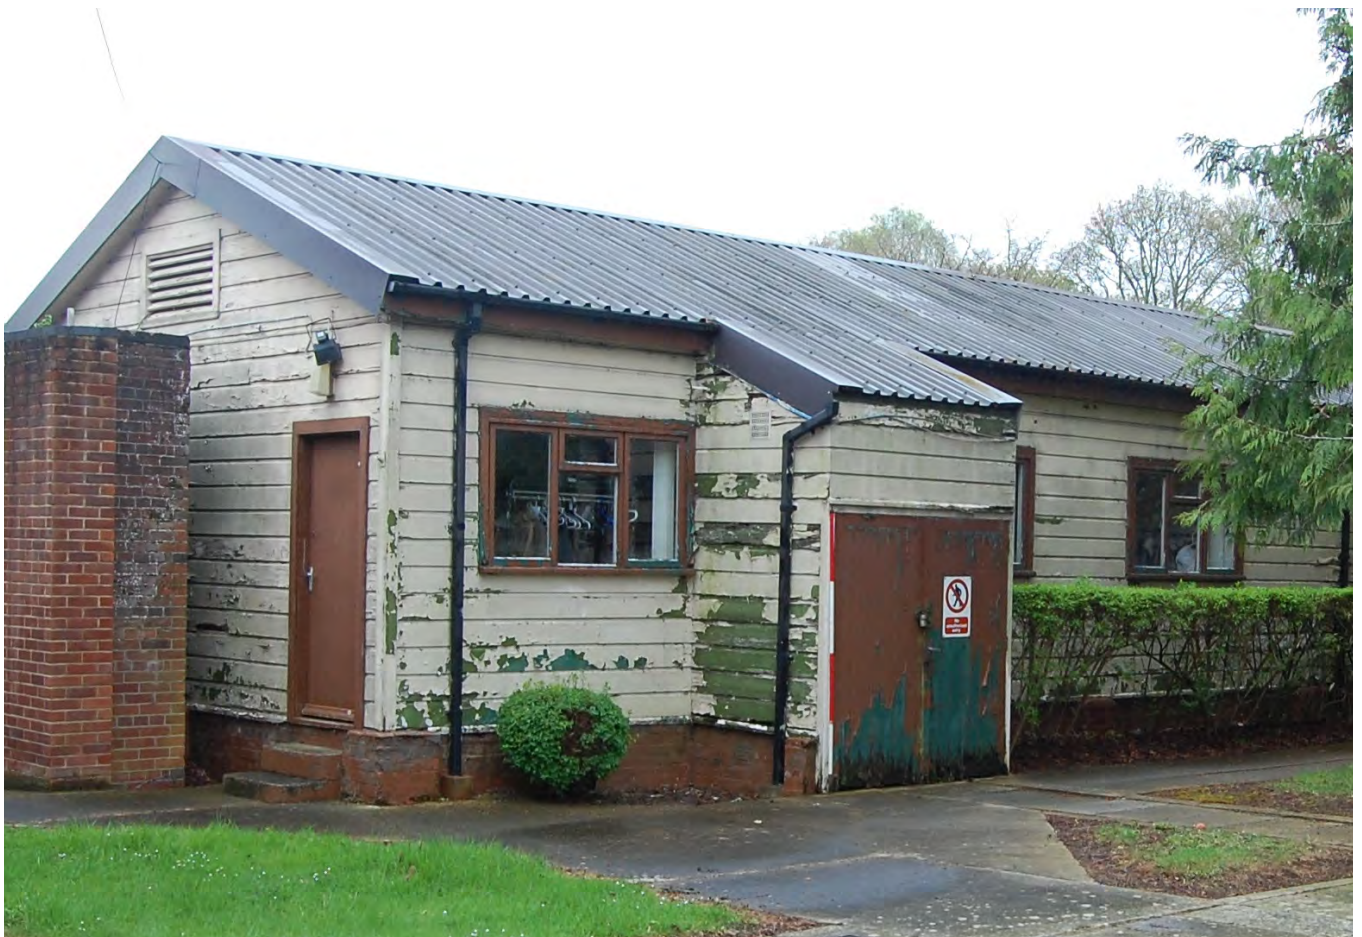
Plate 51.2 West elevation

The original range is a timber-framed weather-boarded structure with a later metal clad gabled roof on a brick plinth (Plate 51.2); the extension has rendered walls over a probable steel frame (Plate 3), a rendered brick plinth (Plate 51.4) and an identical roof covering. The vault is flat roofed with rendered walls. A brick wall which surrounds the adjacent building and is abutted by the vault, appears on the 1942 AP and has since been reduced in length.

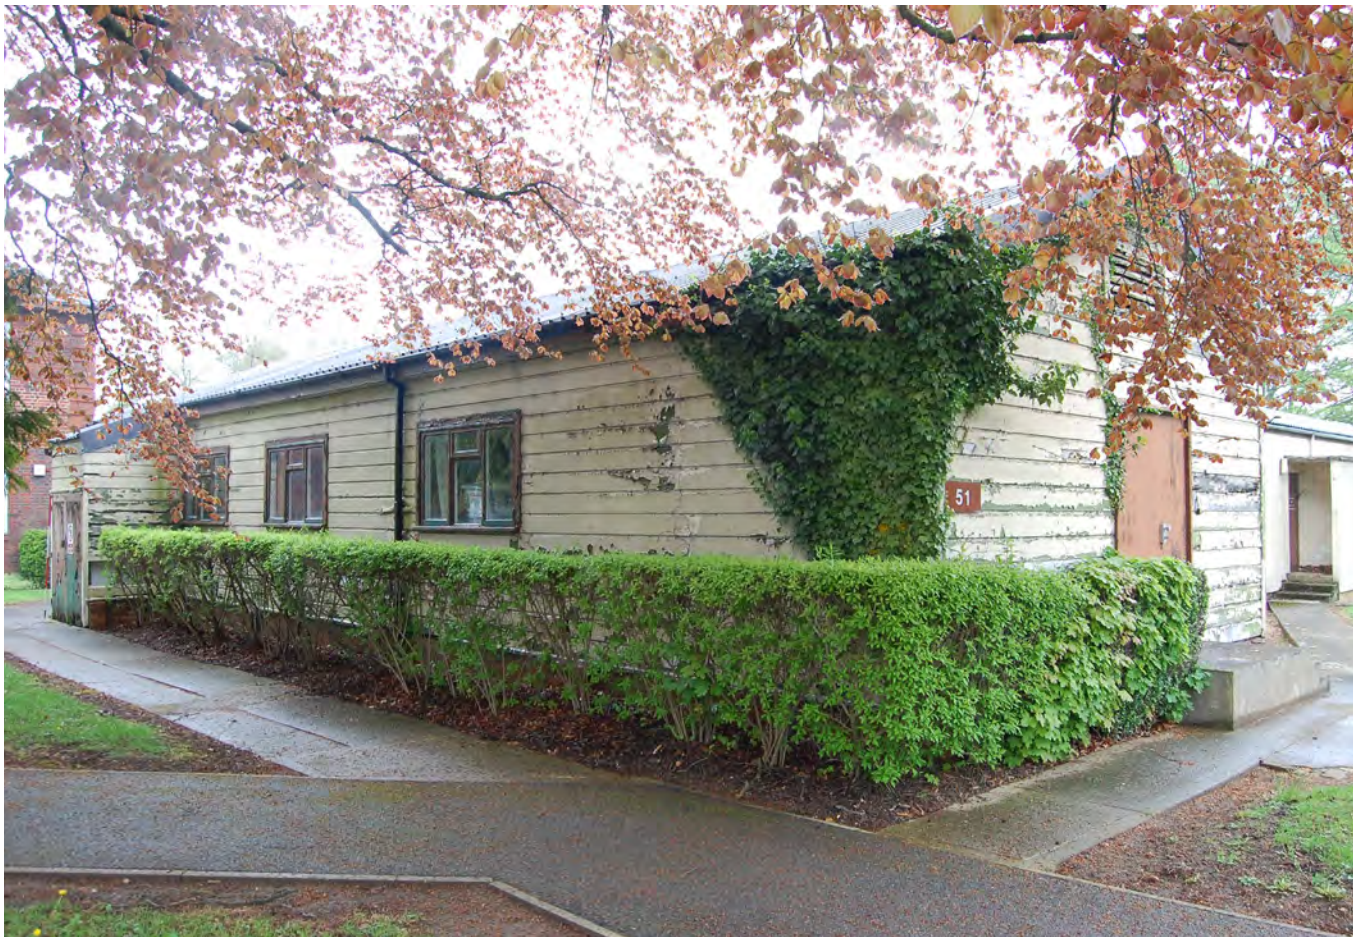
Plate 51.5 Original range, looking north east

The windows in the original range are replacement wood-framed casement windows. Blocked windows are visible to the southern ends of the east and west elevations, evident in the weather-boarding and confirmed in the building plan (Plate 51.5). The extension retains its crittal-style metal casement windows (Plate 51.6). All external doors are fairly modern replacements. The windows to the WCs at the rear of the building are set higher than the other windows, the smaller, easternmost window to the separate WC cubicle being a later insertion and does not appear on the building plan. The two windows in the extension adjacent to the vault are a later reconfiguration as they are plain single opening casement windows and the internal brickwork has been altered.

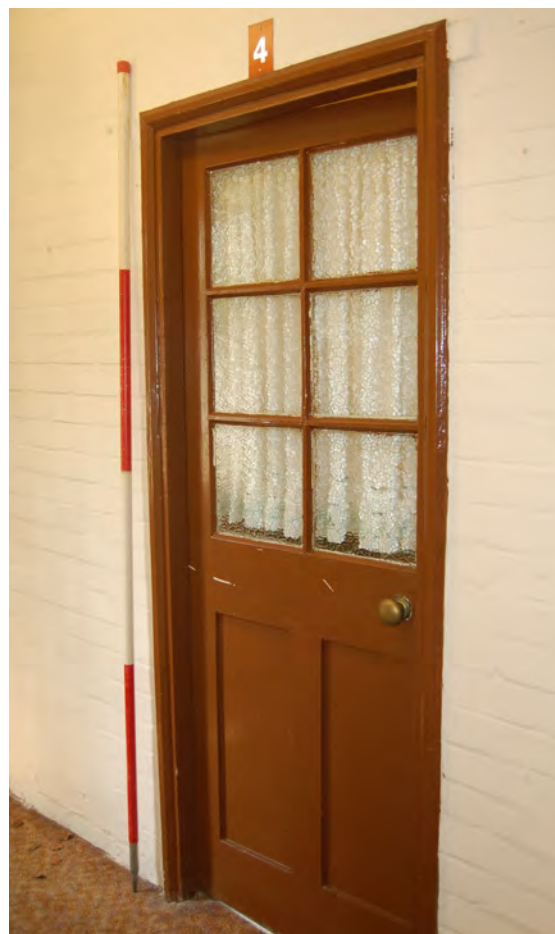
Plate 51.12 An example of an original internal glazed door

The internal doors to the original range are largely modern replacements and in the extension are either half glazed doors or with four horizontal panels and are original to the construction (Plates 51.12 & .13). No vault door is marked on the plan and no evidence of a frame remains on the jambs, however, the door to the vault in building 66 is fitted to the outside of the opening which may be reflected in the gap between the skirting board and the opening (Plate 51.14).

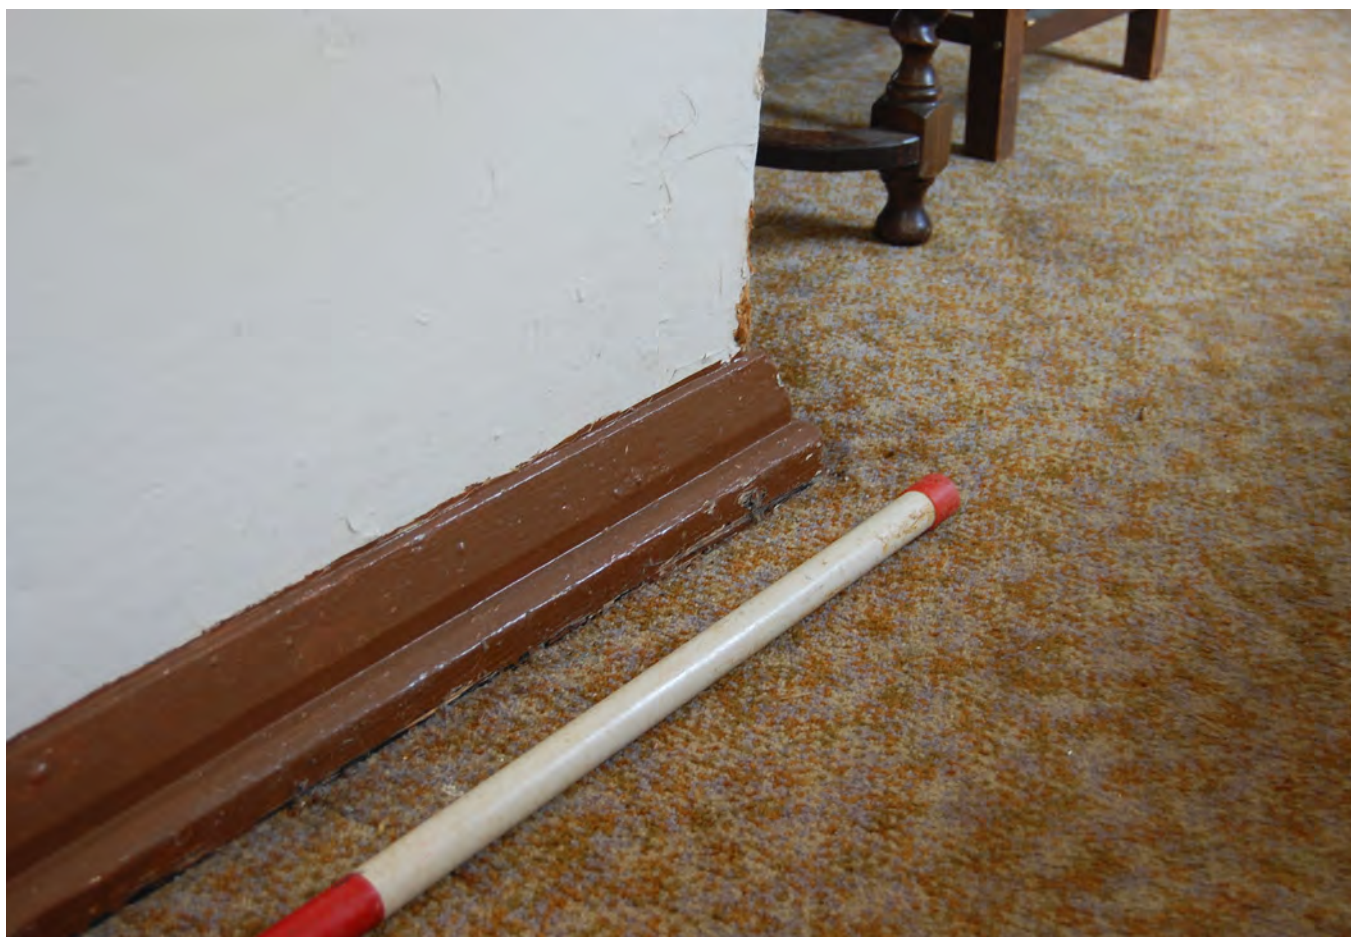
Plate 51.15 An example of the moulded skirting board

The skirting boards to the majority of the building, where visible, as of a plain bull nose profile, but the easternmost partitioned office has a wider, chamfered, skirting to the outer side of the partition (Plate 51.15).

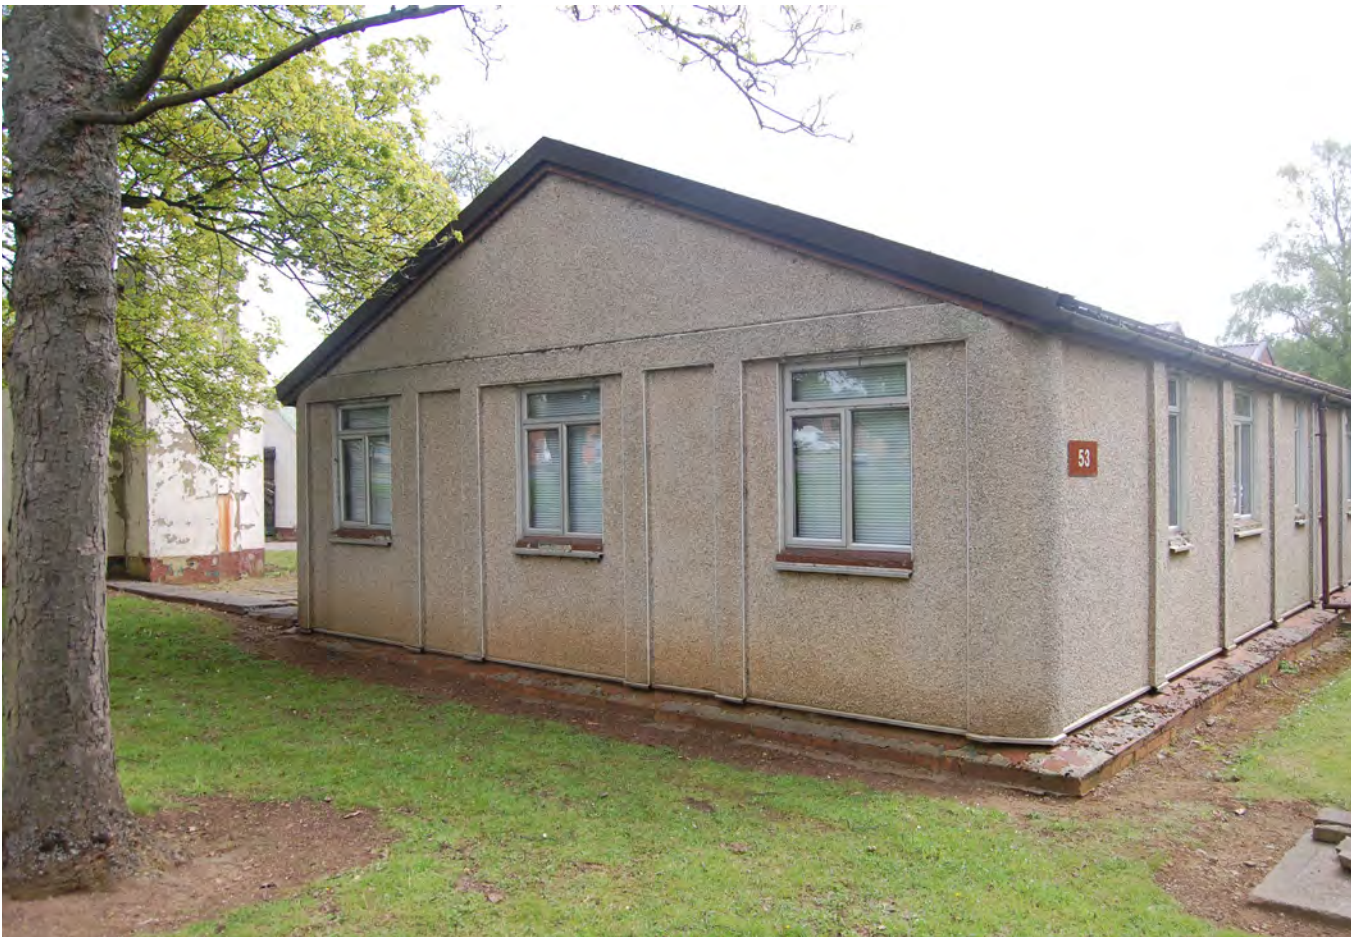
Plate 53.1 West elevation

The external face has been rendered with modern stone chip pebbledash with raised areas emphasising the steel frame (Plate 53.1). The plinth, woodwork, rainwater goods and window sills are the standard brown of the estate colour scheme with the former dark green scheme showing where paint has peeled. The main entrance door is relatively new with the majority of the remaining external doors being painted white but showing the former brown and green schemes beneath the peeling paint (Plate 53.2). The sheet metal pitched roof covering is also a later replacement of the original.
