FORMER RAF UPPER HEYFORD, OXFORDSHIRE

HISTORIC BUILDING RECORDING AND INVESTIGATION

VOLUME 2: GAZETEER OF RECORDED STRUCTURES

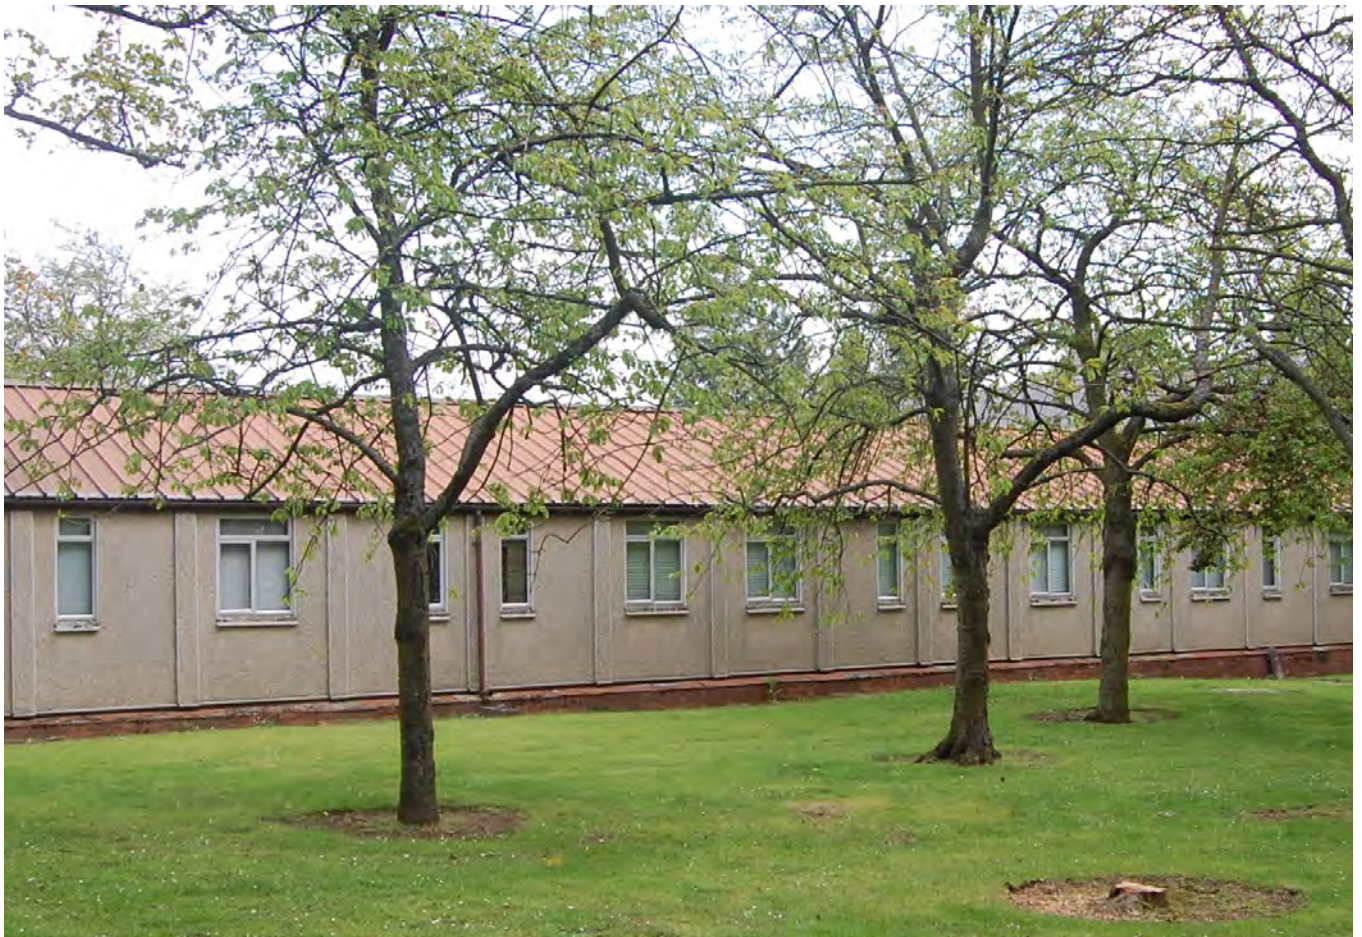
Plate 53.3 South elevation

The aluminium-framed casement windows are also a later replacement of the original frames, although they appear to repeat the original positions (Plate 53.3). Only four panels do not contain windows: one towards the east end of the north elevation, the two end panels at the west end of each elevation and the panels either side of the door at the east end of the building, but no evidence, physically or on the plan, suggests windows have been blocked.

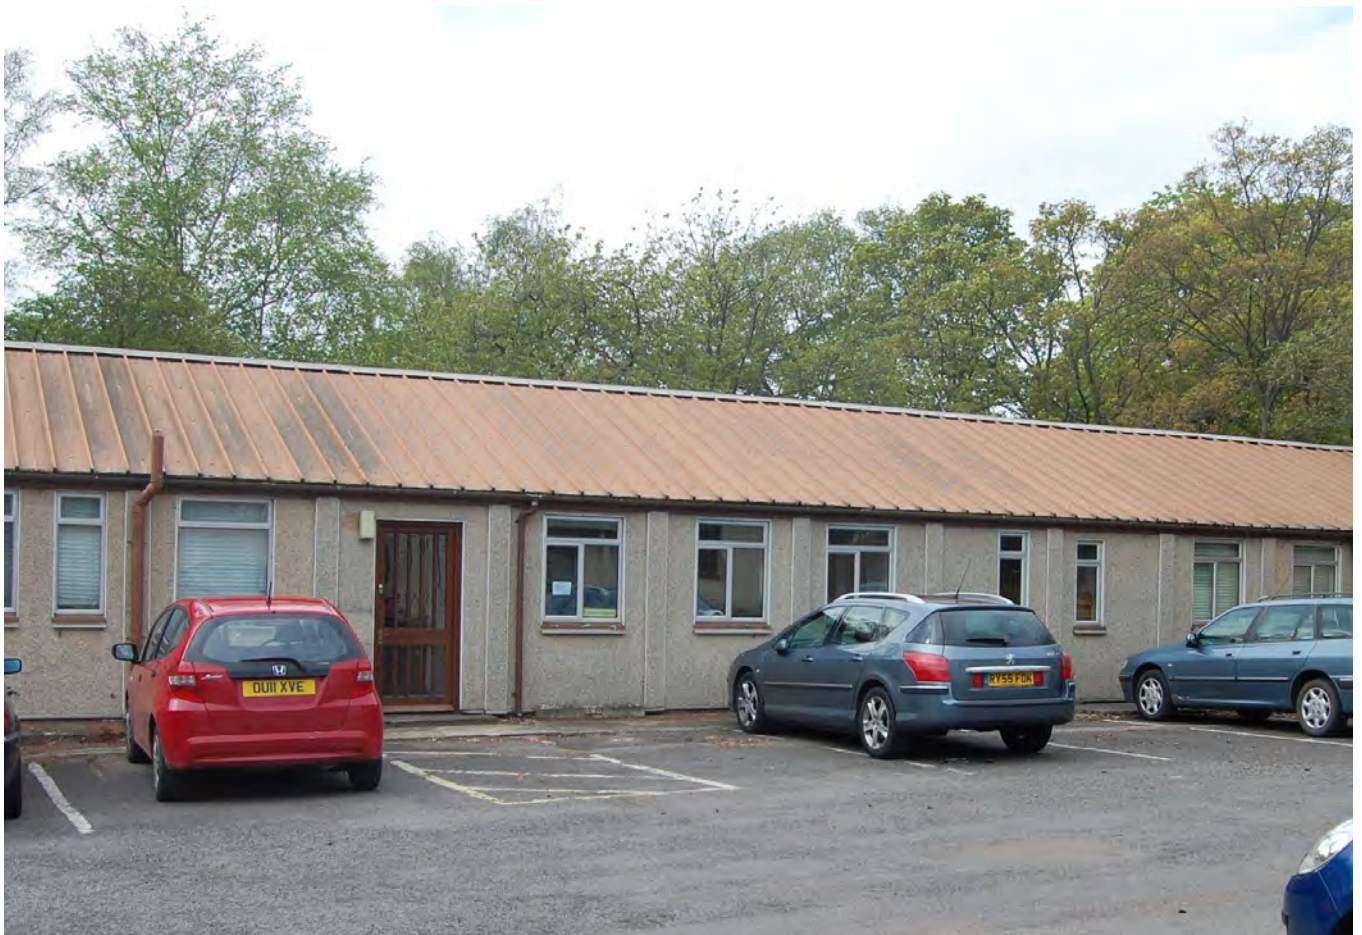
Plate 53.4 North elevation, western end

A small, flat roofed extension is located at the north west of the building with an external door to its east side (Plate 53.4). Despite being windowless it is labelled as an office on the plan.

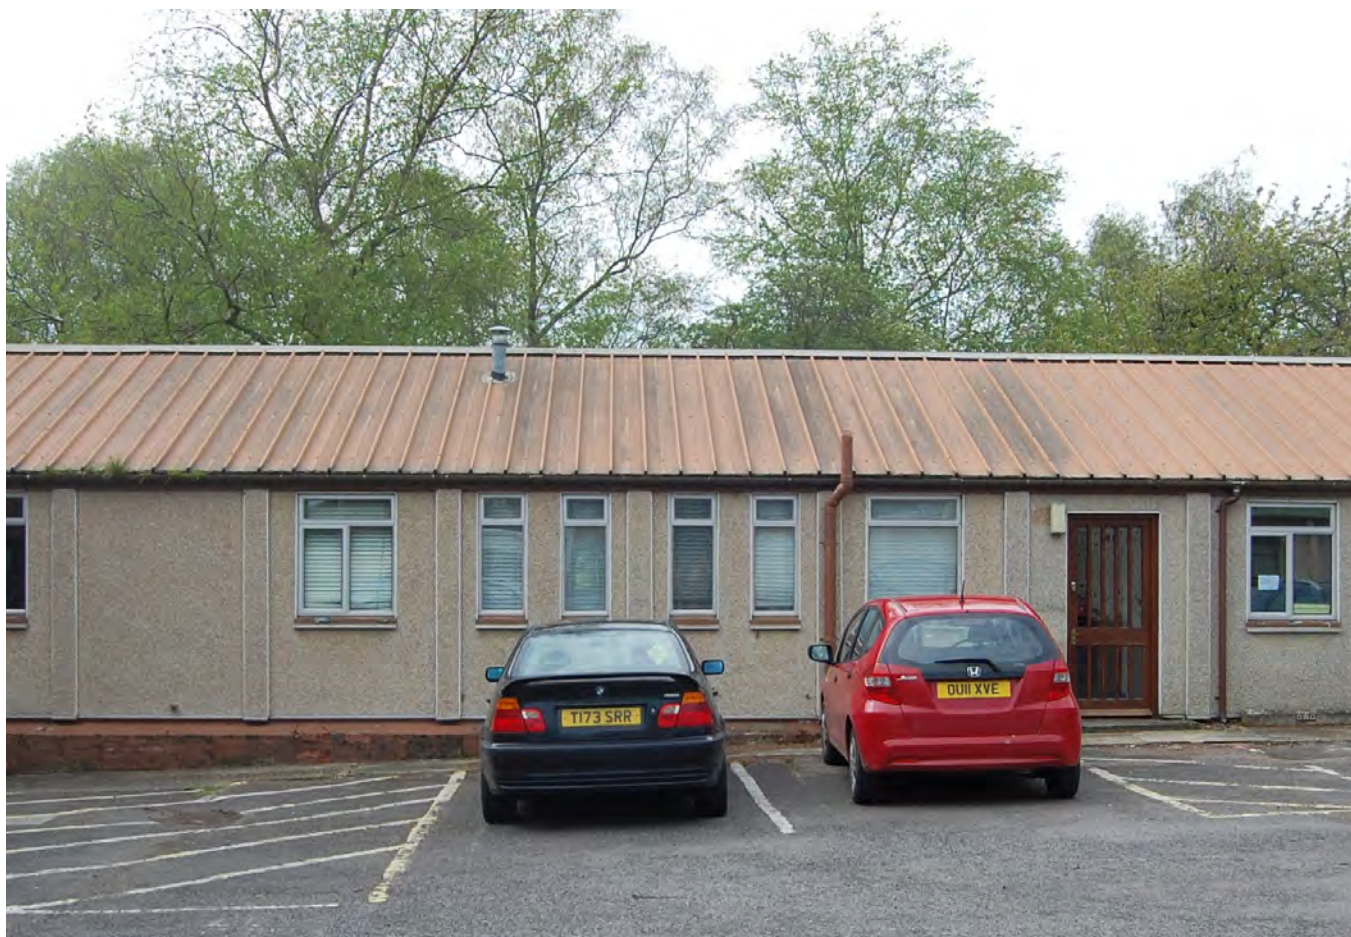
Plate 53.5 North elevation, eastern end

The sloping ground level necessitates differences in the level of the plinth around the building (Plate 53.5) with a concrete platform and steps at the east end. A horizontal handrail added after painting and the exposure of the unfinished poured face of a portion of the centre of the platform suggest a past reconfiguration of the platform or a change of function (Plate 53.6).

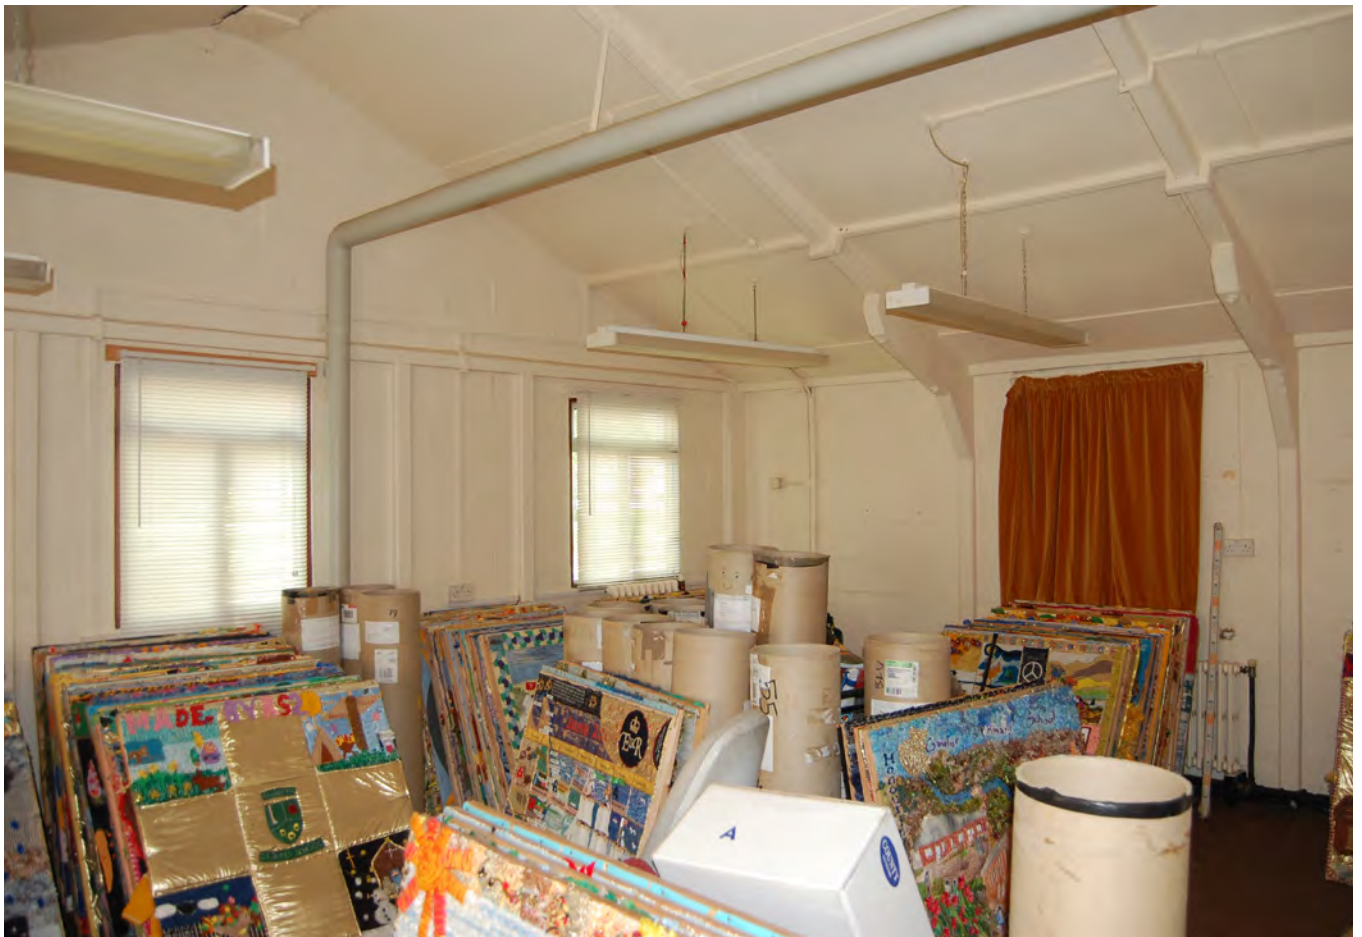
Plate 53.7 Interior of the westernmost room

The finish of the internal face of the external walls and the majority of the internal partitions is painted aerated concrete block (Plate 53.7). The plan of 1990 details some minor alterations to the internal layout, some of which can be seen in scars in the walls indicating former partitions and two blocked doors to the south offices.

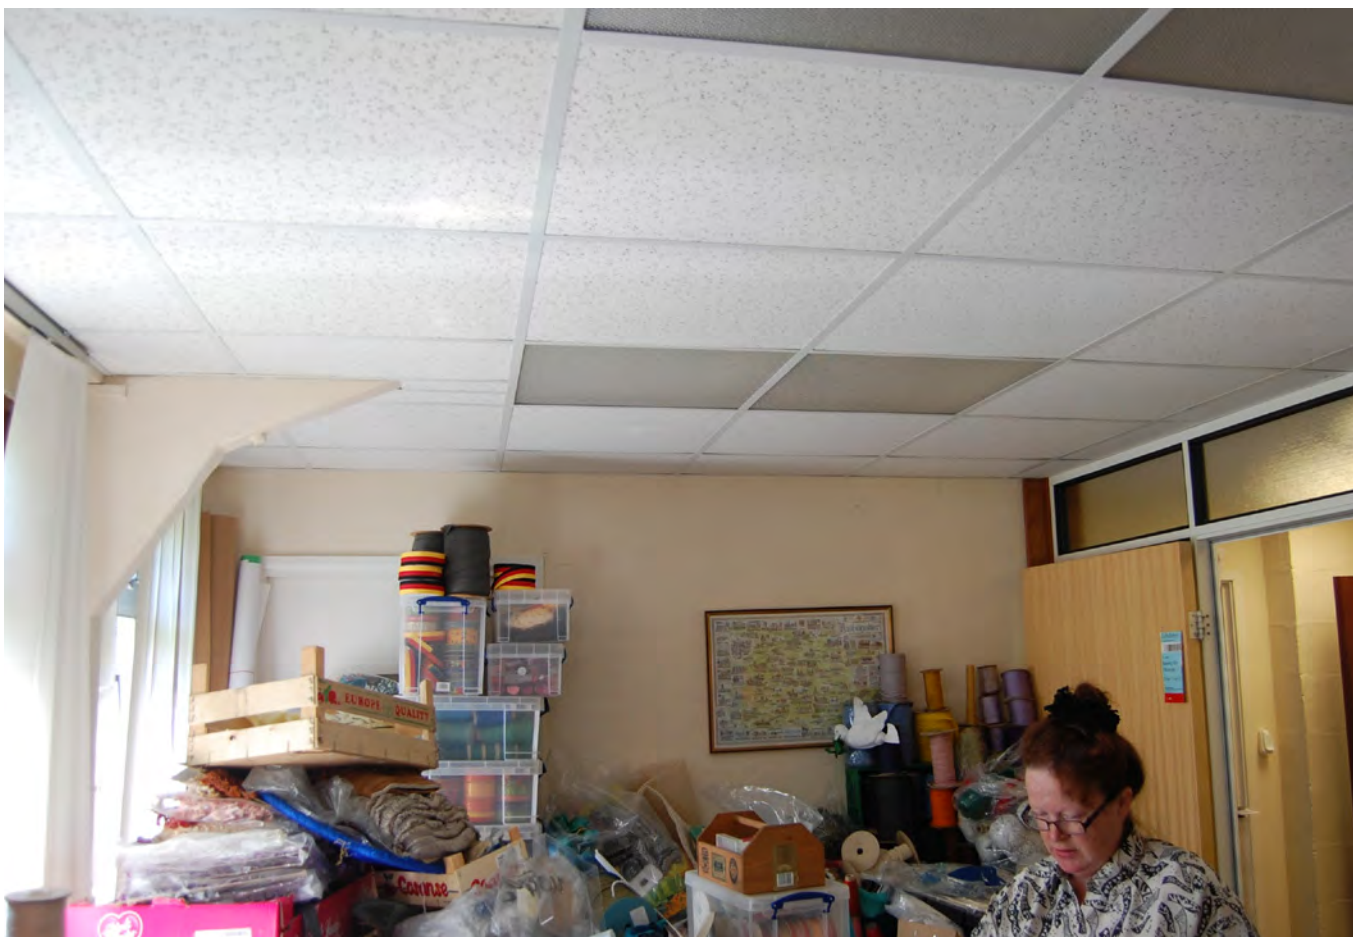
Plate 53.8 The later suspended ceiling and partitions

The majority of the internal spaces have a suspended ceiling (Plate 53.8), although the roof structure can be seen in the westernmost storage area and several of the offices along the southern wall (Plate 53.9).

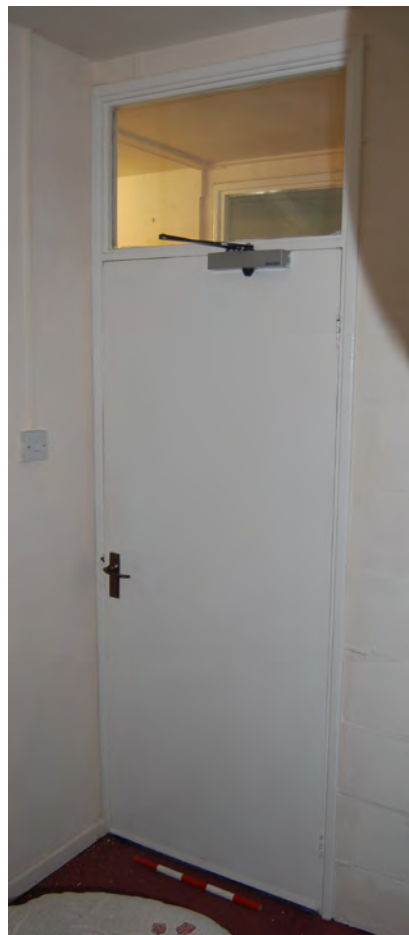
Plate 53.10 An example of an original internal door

Few fixtures and fittings indicate the age of the building; some internal doors retain their original bronze door furniture (Plate 53.10), but most have been replaced with aluminium.

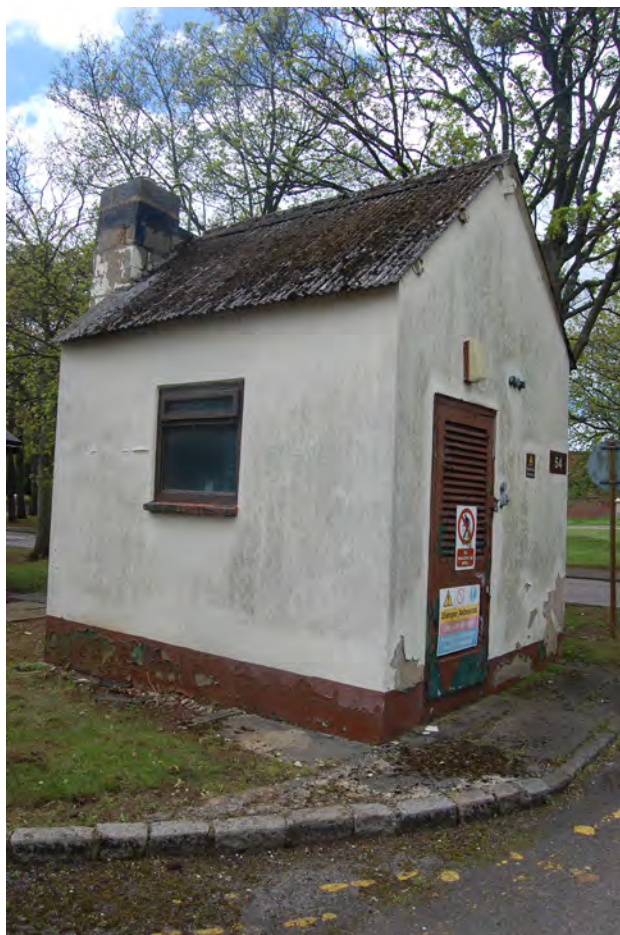
Plate 54.1 North and east elevations

This single-phase rectangular hut, (approximately 3m by 4m, by 4m in height) is constructed from rendered concrete blocks on a concrete base with a corrugated asbestos cement pitched roof. The ends of the roof timbers project from the north gable. The walls are painted off-white with brown plinth and woodwork to match the airfield colours; where the paint has peeled, the former two-tone dark green colour scheme is visible. The sole door to the building is in the north elevation and is a louvered replacement dating to circa the 1980s (Plate 54.1); the windows to the east and west elevations are also later replacements, and contain obscure glass in the standard Pilkington Cotswold high privacy pattern type (Plate 54.2). The south elevation contains a chimney consisting of two rendered block stacks, the easternmost of which contains an iron soot door and a fairly recent upward extension, the westernmost contains a high level overflow pipe (Plate 54.3). A redundant footpath and the route of an external cable indicate the potential for a blocked opening or other removed-feature to the west of the chimney.

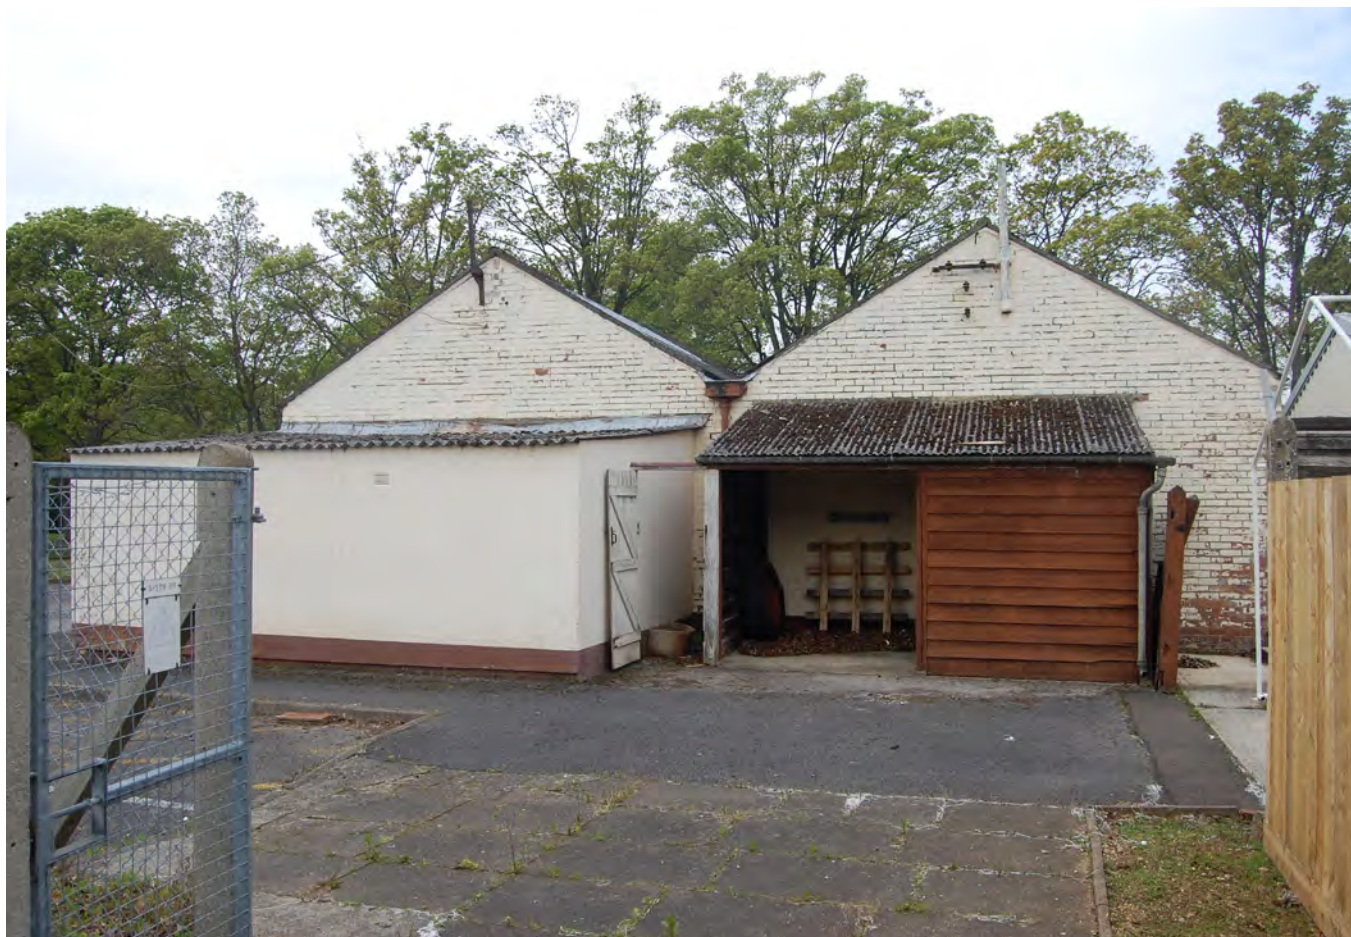
Plate 59.4 East side of building 59

The *east elevation* (Plate 59.4) forms the rear of the building and includes two brick gables although these are now largely obscured by two small secondary lean-to projections. A paint store, which is shown on the 1985 plan and to which no access was possible, covers the lower part of the southern gable while a bike shed (post 1985) covers the lower part of the northern gable.

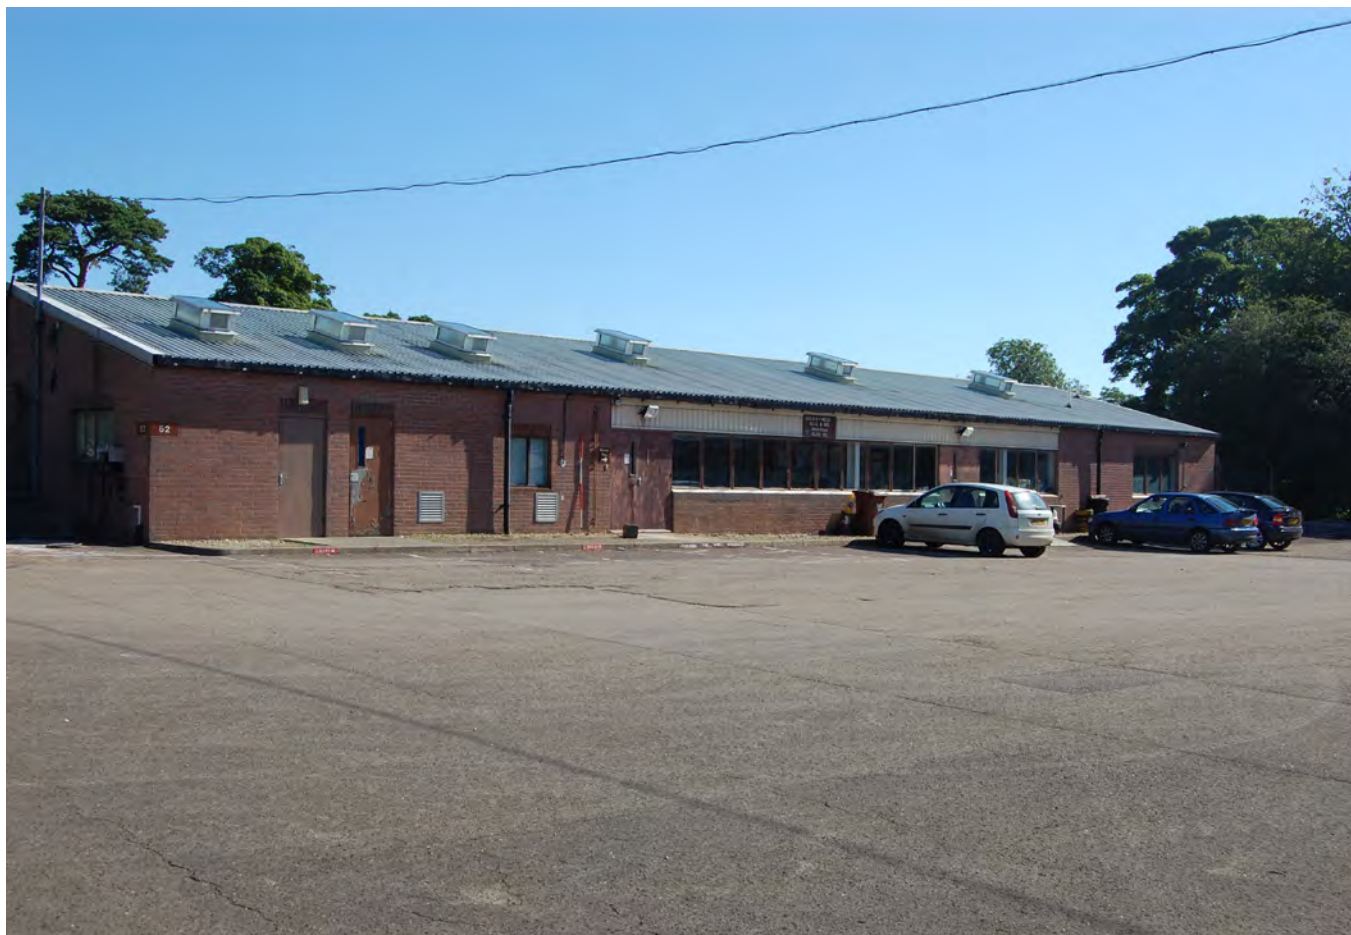
Plate 62/69.1 Front (south) elevation

This structure is rectangular in plan, constructed from red brick in stretcher bond with internal block work walls (Plate 62/69.1).

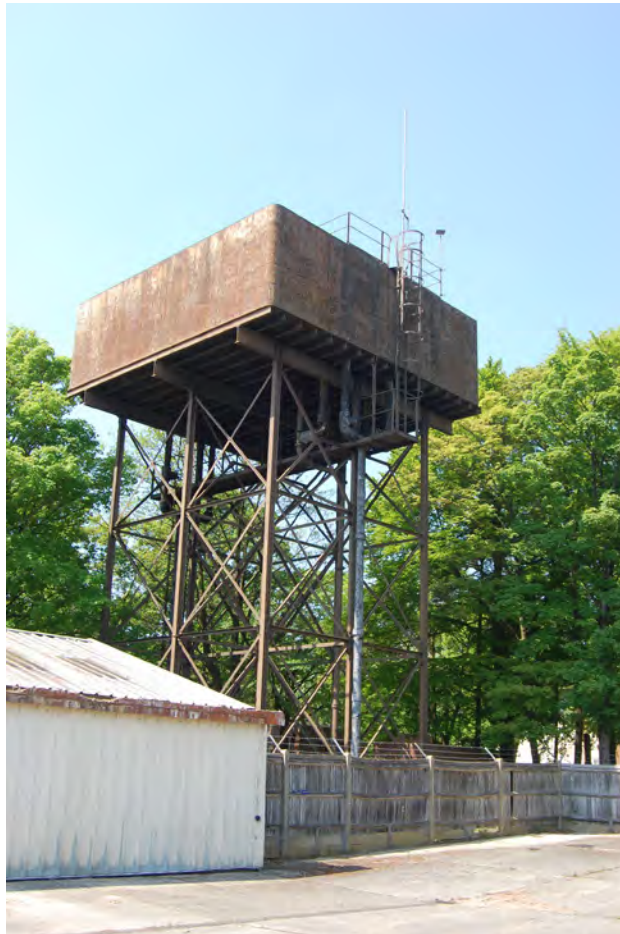
Plate 63.1 View of east and south elevations

The water tower has a very visible presence on the landscape, its functional form enhances the military character of the site. It is one of three within the airbase (with buildings UH74 and 291) (Plate 63.1).

A ladder extends the height of the tower on the west elevation fronting the road, providing access to the large square tank at the top. The steps also meet a platform just below the height to of the tank. This platform then projects to the east with railings running along each side. From here, the steps extend up the side of the tank on the east face providing access to both sides. On top of the tank, railings are evident in the central area. Two main pipes extend from the water tank to the ground. The water tower is painted brown (now peeling).

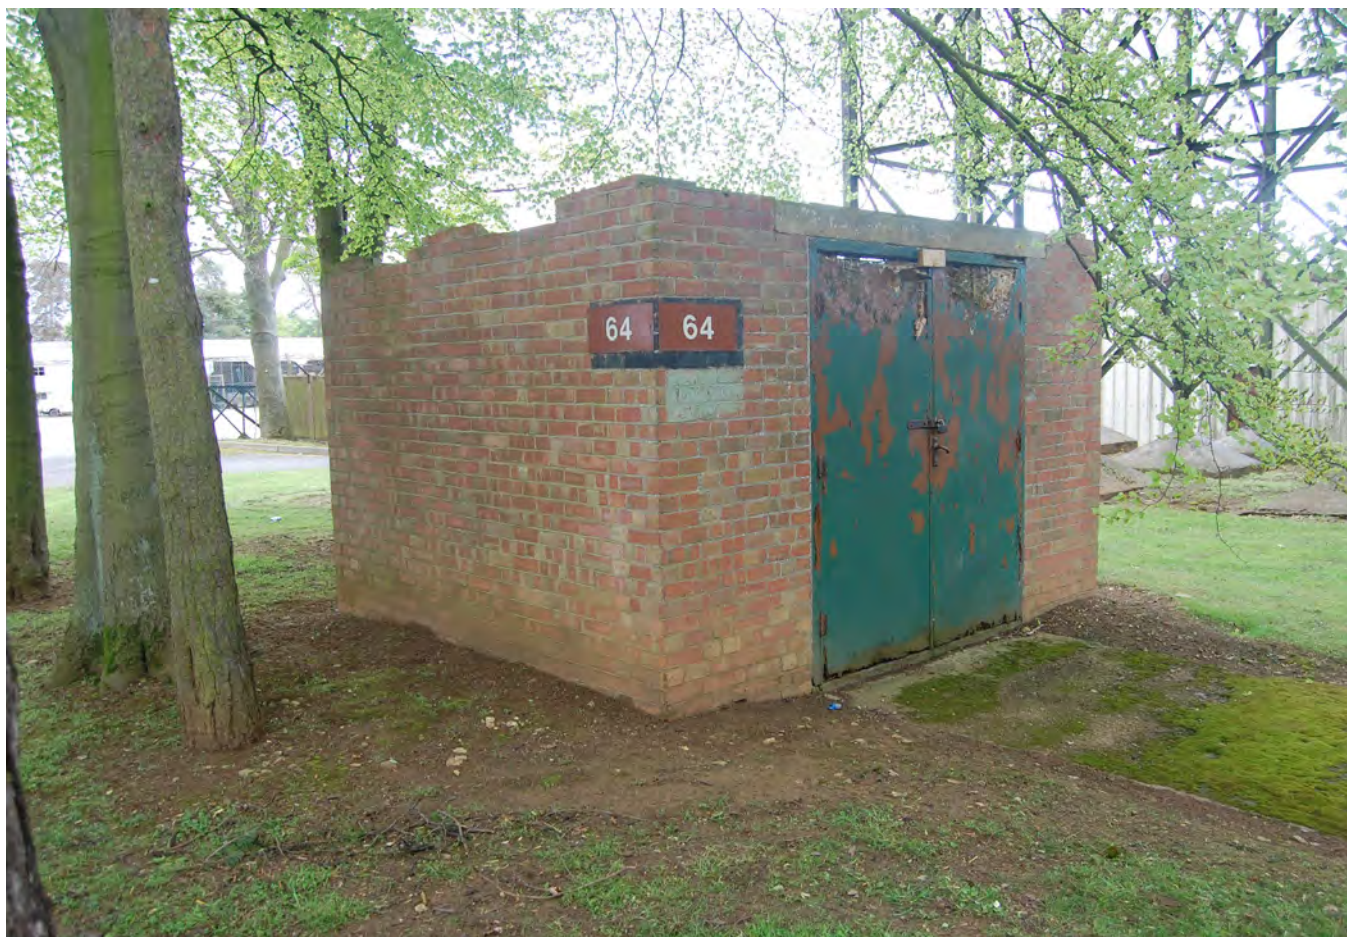
Plate 64.1 Front (north) elevation

This simple red brick structure is single storey constructed in stretcher bond, measuring 4m by 3.3m, with a non-extant roof (Plate 64.1 and .2) The front (east) elevation has large double timber doors (painted brown and green), which is accessed from a path with joins the road. Otherwise the structure has no features of interest.

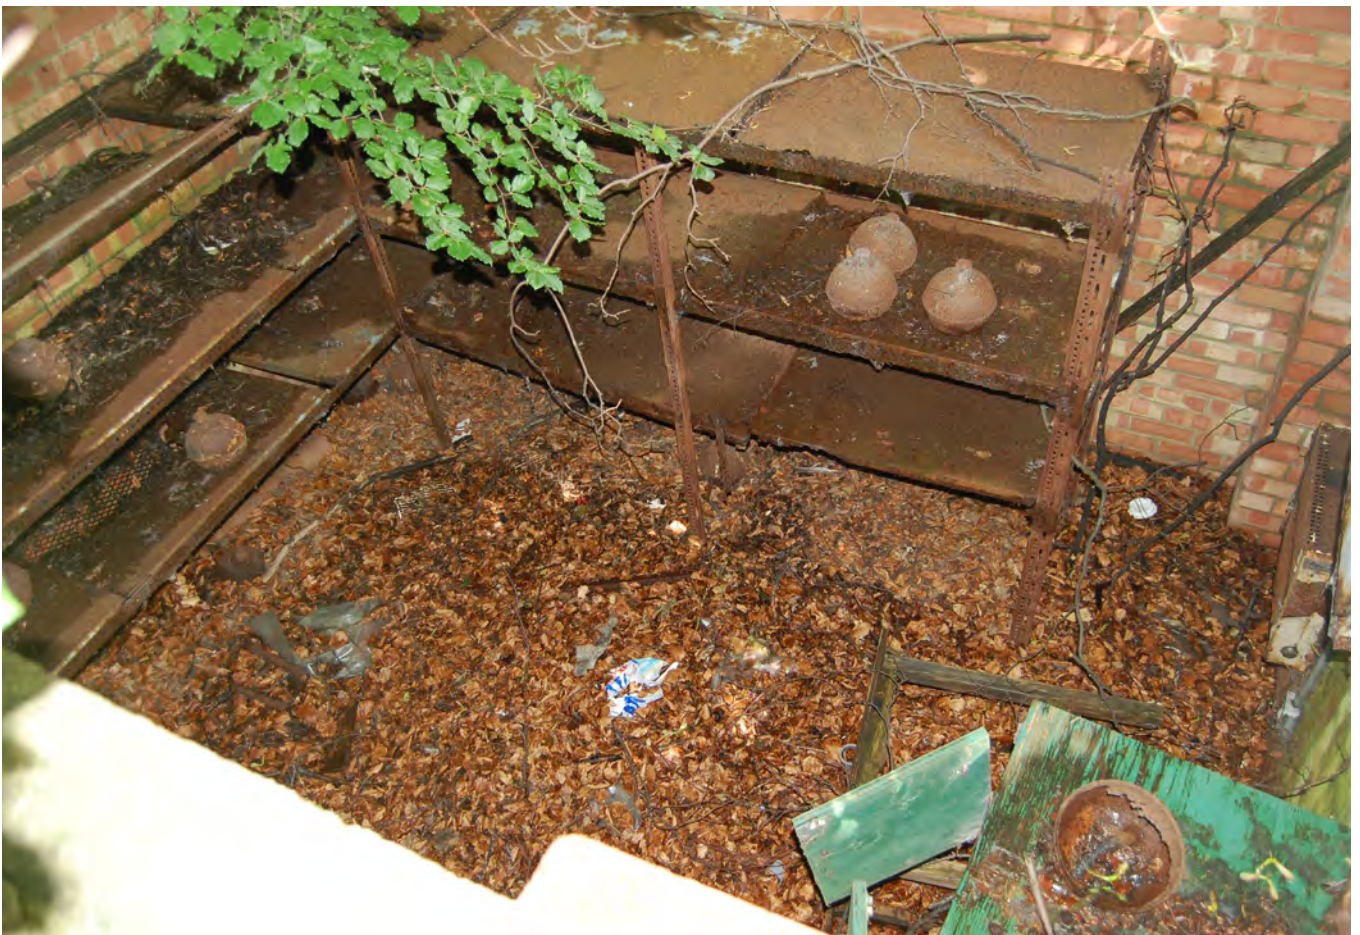
Plate 64.3 Internal view of store

It was not possible to gain access, however a ladder was put up against the wall to gain an internal view of the space (Plate 64.3). This showed largely empty metal shelves, vegetation and leaves due to the removed roof.

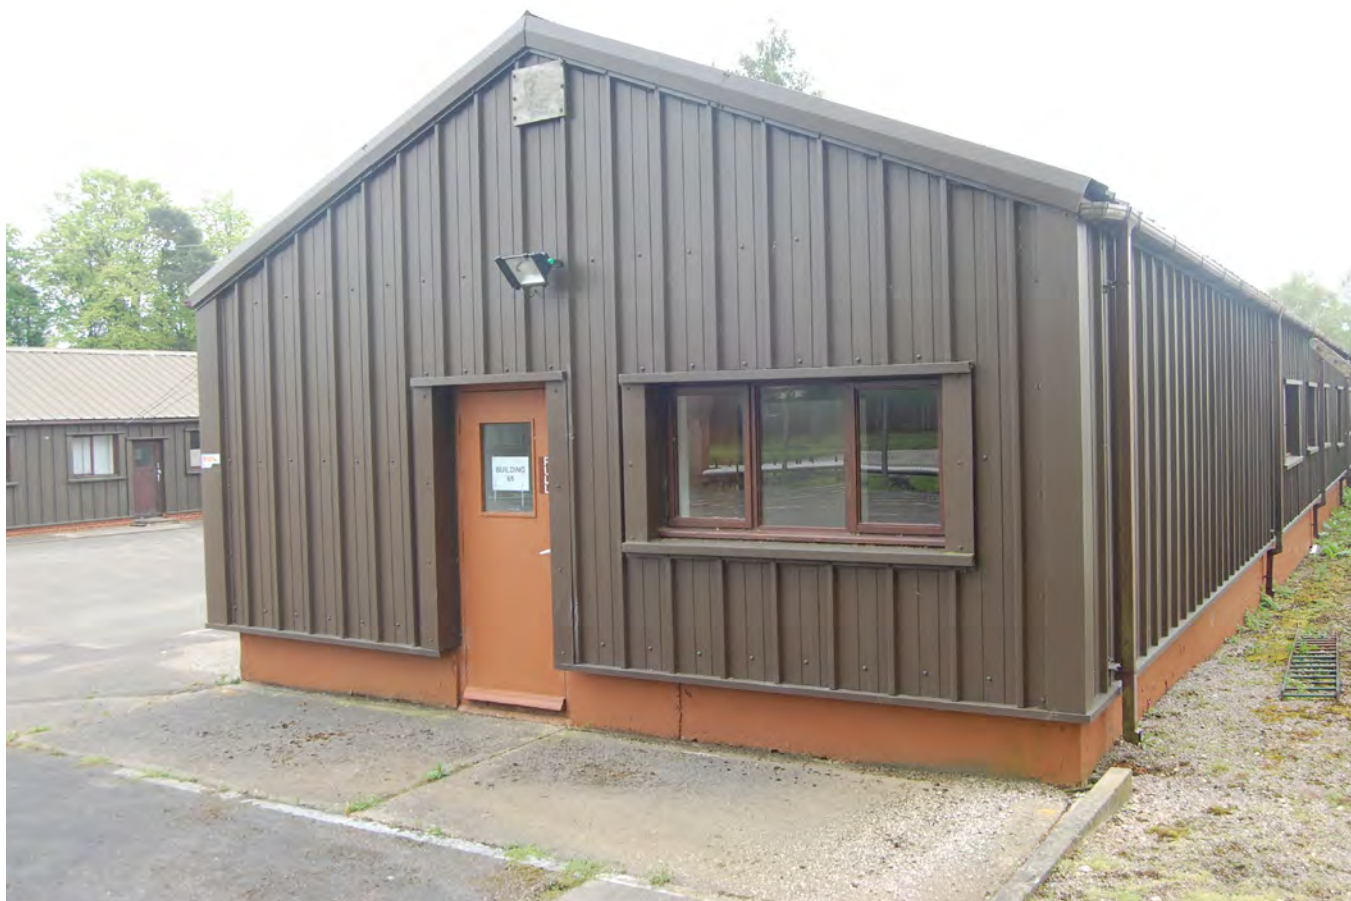
Plate 65.1 Northern end of building

Building 65 is a single storied, rectangular plan building (c.30 m x 6 m), the walls and roof of which are entirely clad in overlapping, vertical panel sheets suggestive of a later 20th-century date (probably 1980s or later) (Plate 65.1). The cladding is painted a dark army green colour and the building is set on a brown concrete base or plinth which appears to be older than the cladding. Some flecks of the brown paint have been lost to reveal an older green surface to the concrete base.

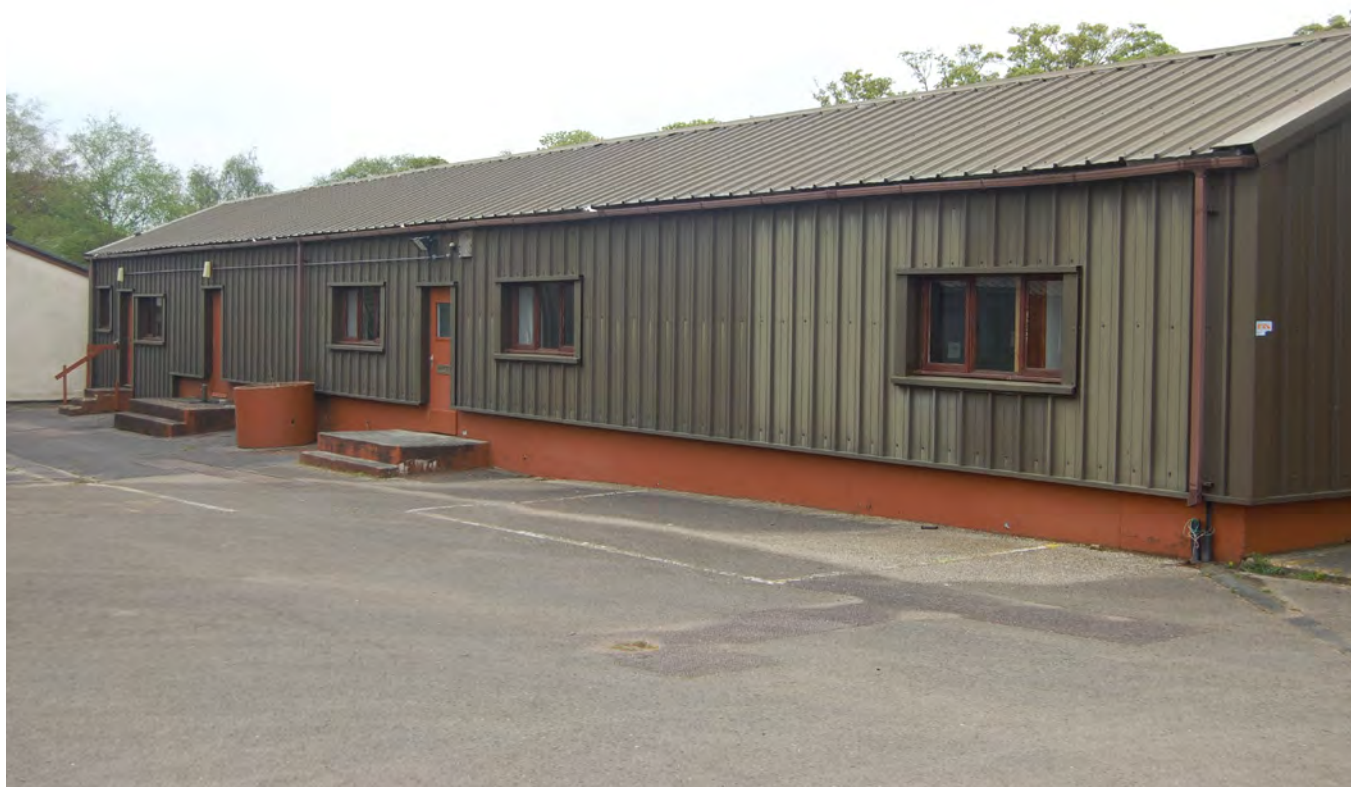
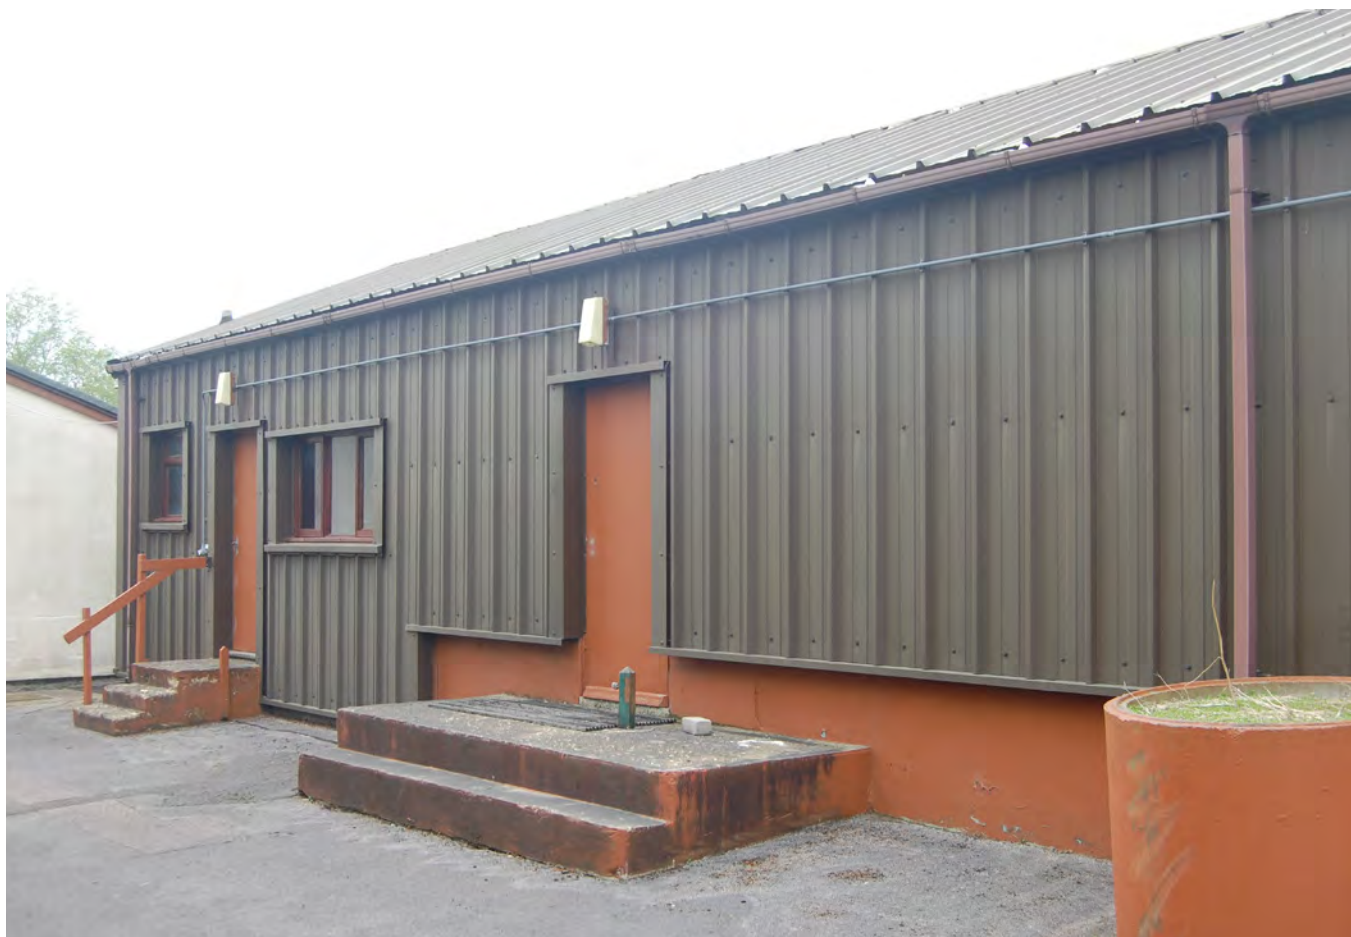
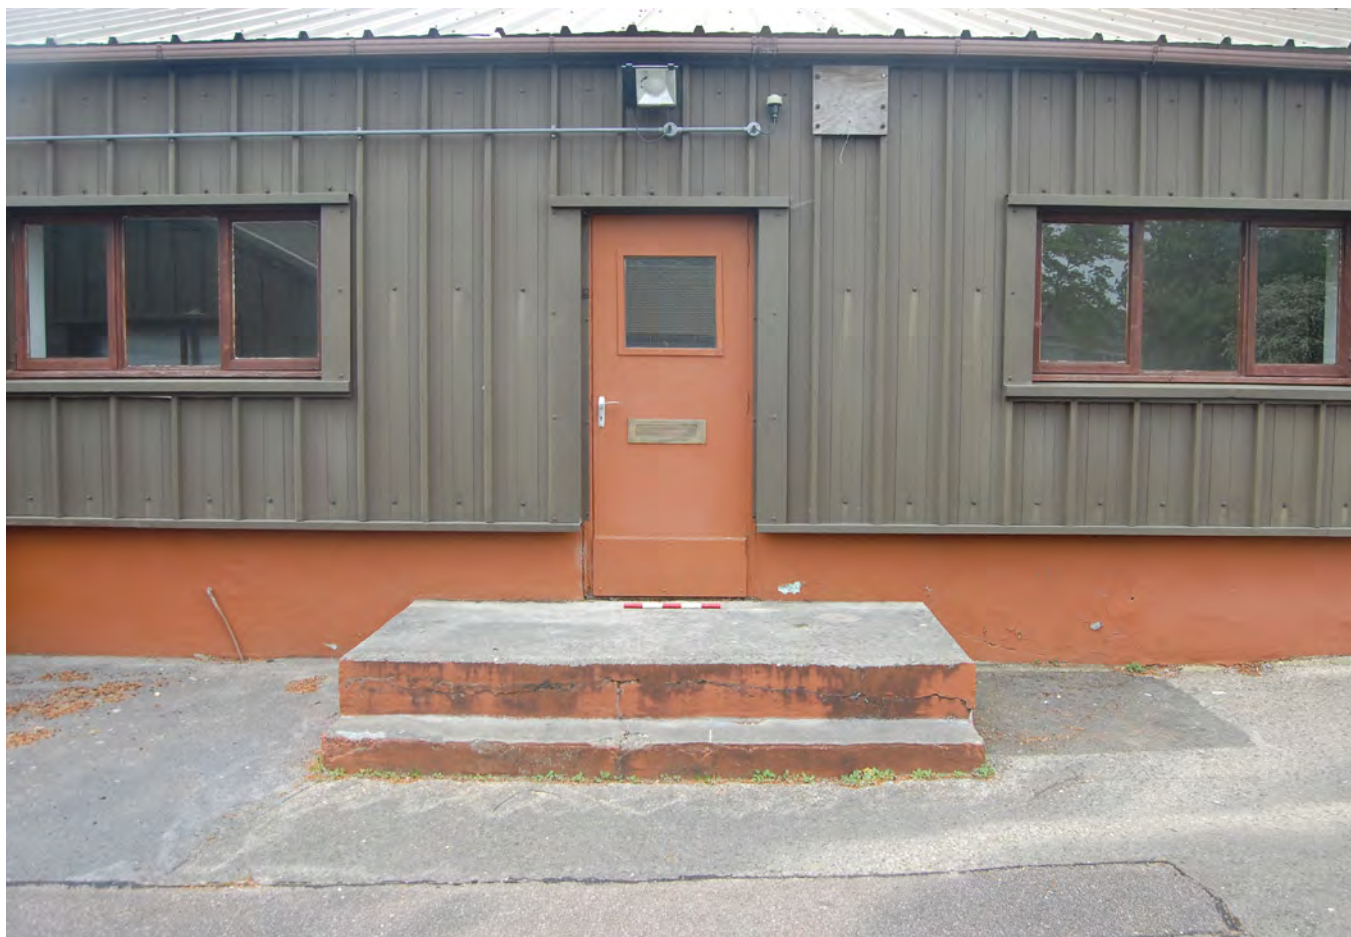
The east elevation is the principal elevation with five modern varnished timber casement windows and three doors reached by simple sets of concrete steps (Plate 65.2,.3 and .4). Towards the centre of the elevation there is a large concrete drum/pipe which has been reused for planting. The west elevation is to the rear and has five modern windows, one of which is longer than the others (Plate 65.5).

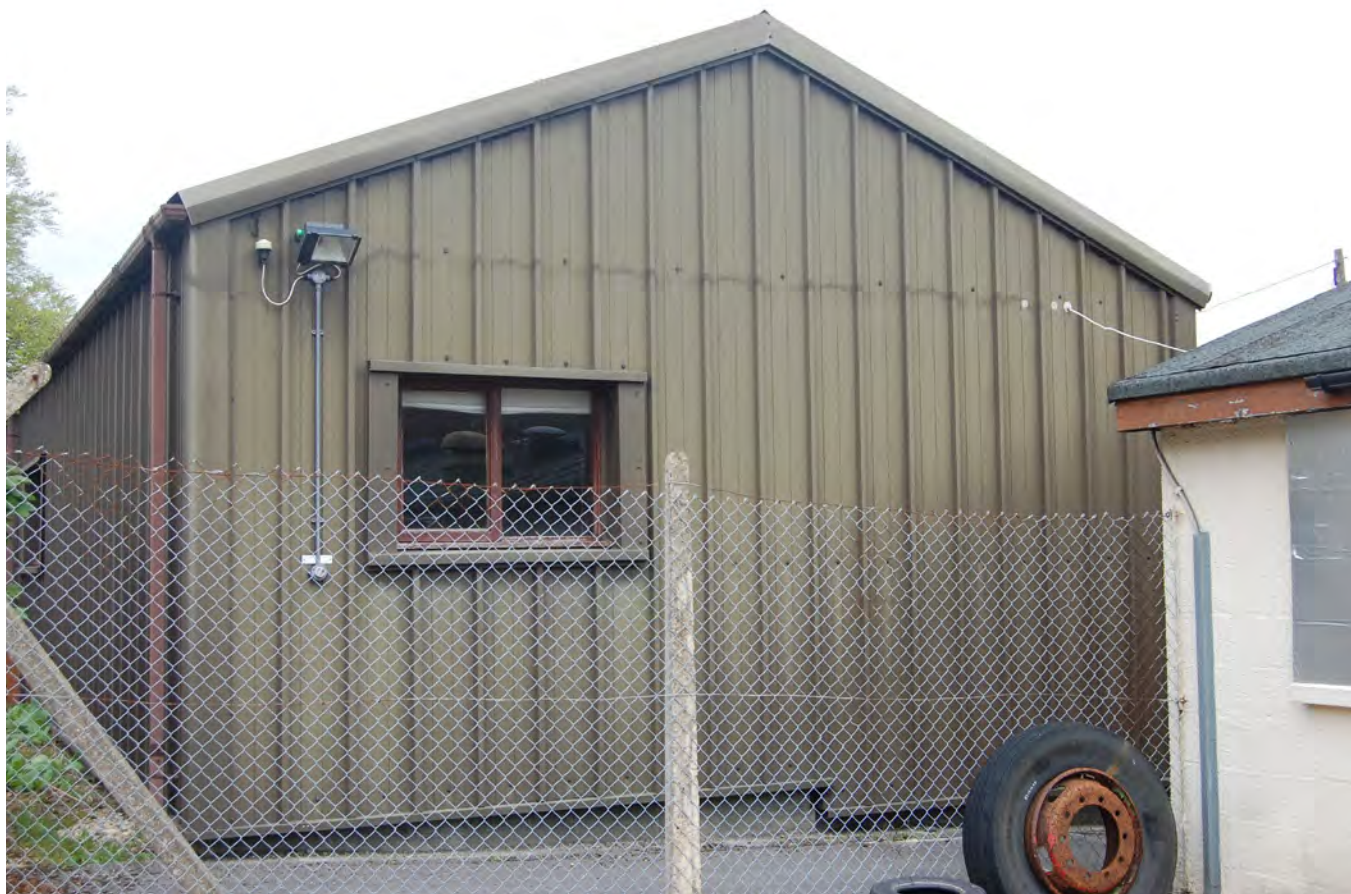
Plate 65.5 Southern elevation

The north elevation is gabled and is relatively featureless other than a door and modern window while the south elevation is similarly plain other than a single modern window (Plate 65.5). Each gable end has a floodlight and blackout switch.

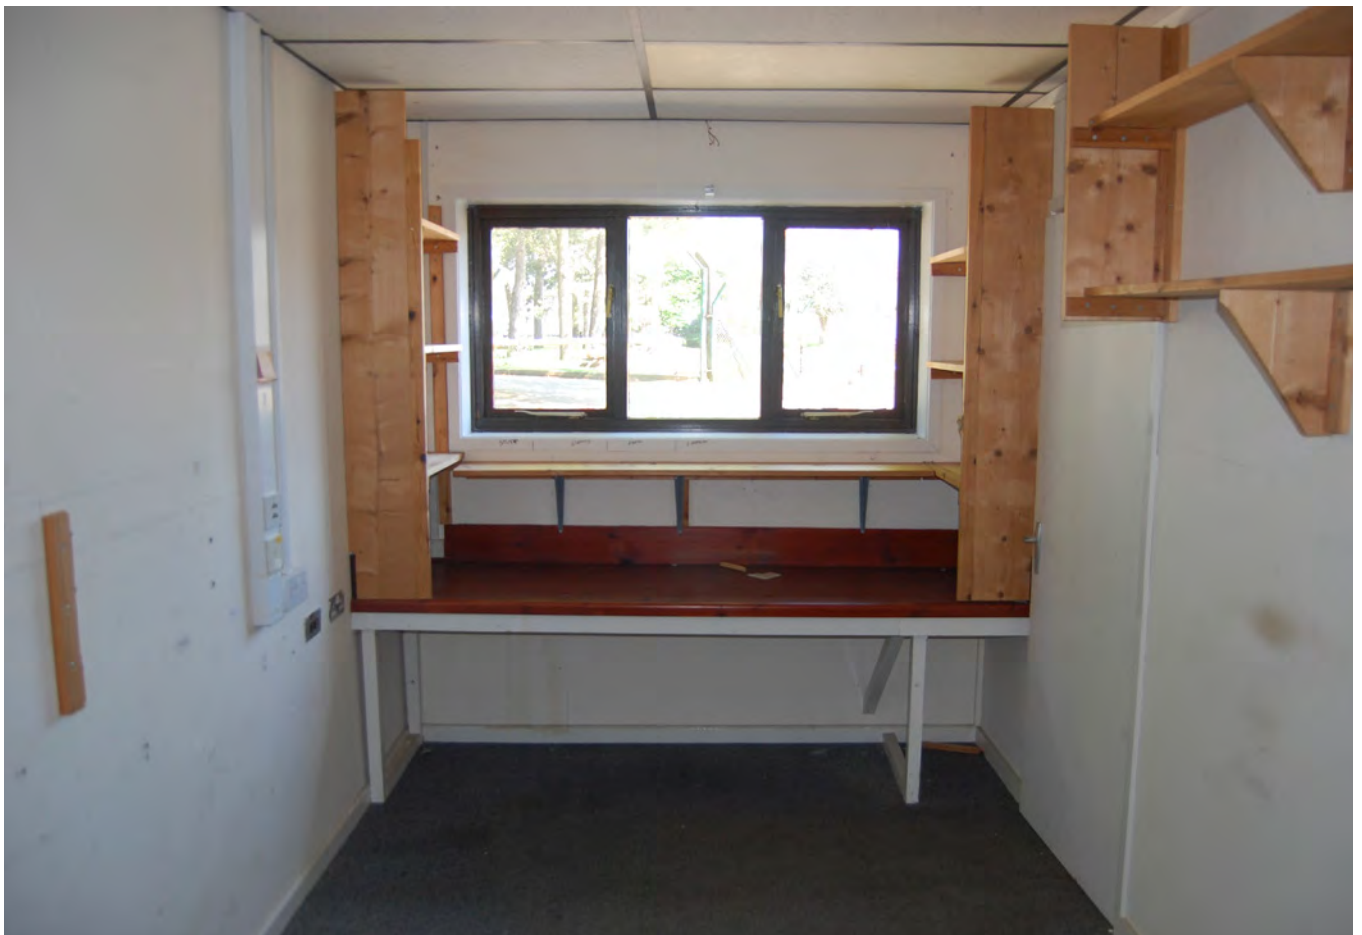
Plate 65.8 Typical room

Internally the building has been substantially altered in the late 20th century. It is carpeted throughout and has a suspended ceiling with integrated lighting (Plate 65.8). A missing ceiling panel reveals a second boarded ceiling above this but unfortunately no access was possible to the roof space above. The internal partitions, doors, windows and other features are all modern (Plate 65.9).
