FORMER RAF UPPER HEYFORD, OXFORDSHIRE

HISTORIC BUILDING RECORDING AND INVESTIGATION

VOLUME 2: GAZETEER OF RECORDED STRUCTURES

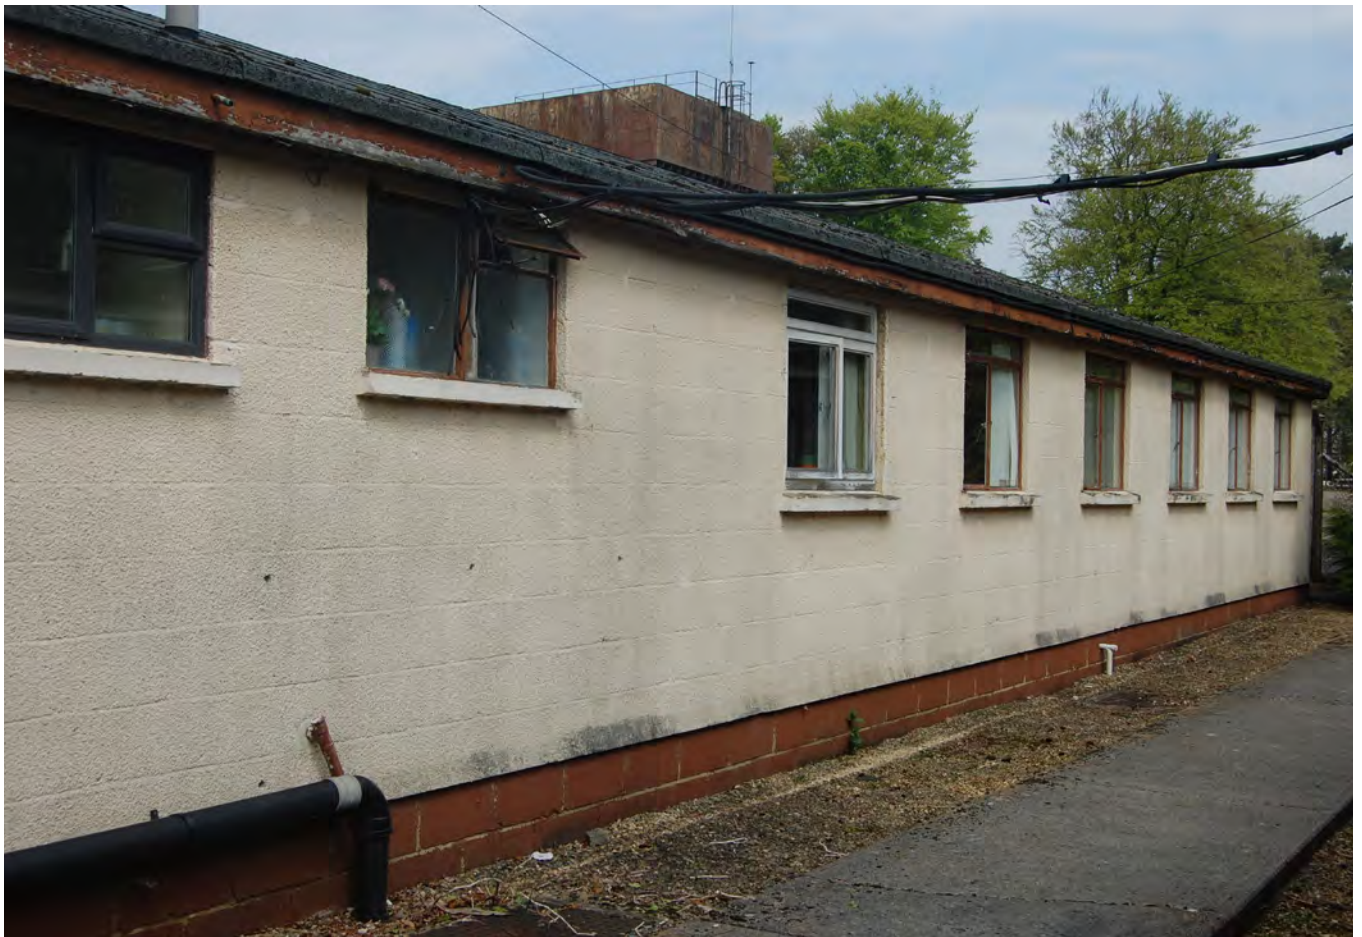
Plate 66.1 East elevation, northern end

The earlier building has blockwork walls finished in cream-painted thin-coat render with a bellcast near the base of the wall to deflect rainwater away from the two lower courses of blockwork (Plate 66.1). The pitched roof is re-covered in bituminous felt. The external door in the north elevation is set back in a small open porchway (Plate 66.2).

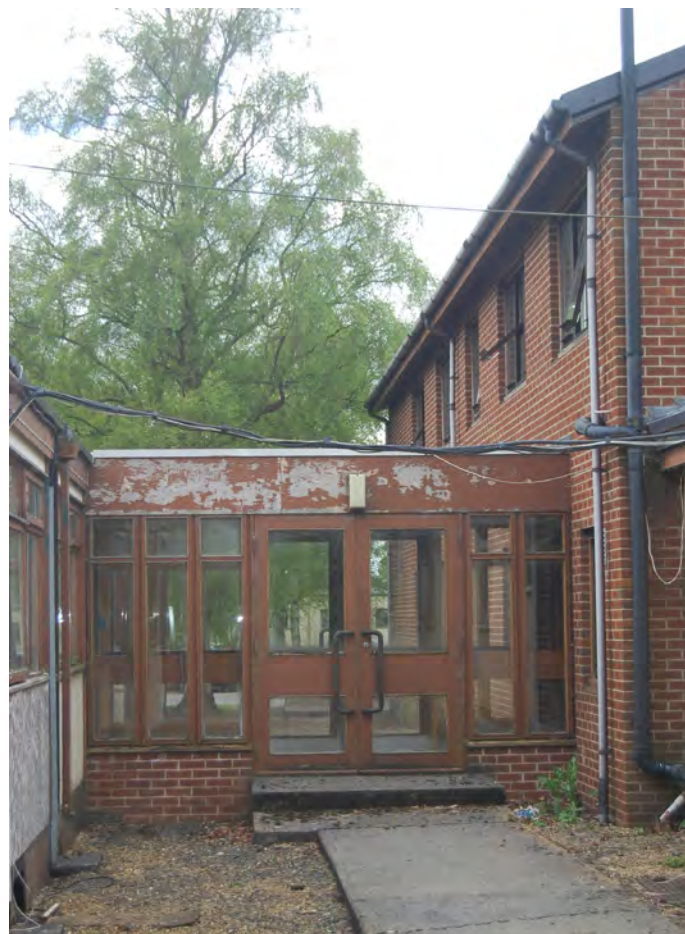
Plate 66.4 The enclosed walkway between the buildings, looking south

The later range is a brick outer skin and block inner skinned two-storey building with a metal clad pitched roof. The building plans of 1984 indicate that it replaced the southern portion of the existing building. At this point, an enclosed walkway consisting of a flat roofed timber framed glazed structure on a brick base with double doors to either side was constructed between the new range and the adjacent Building 70 (Plate 66.4).

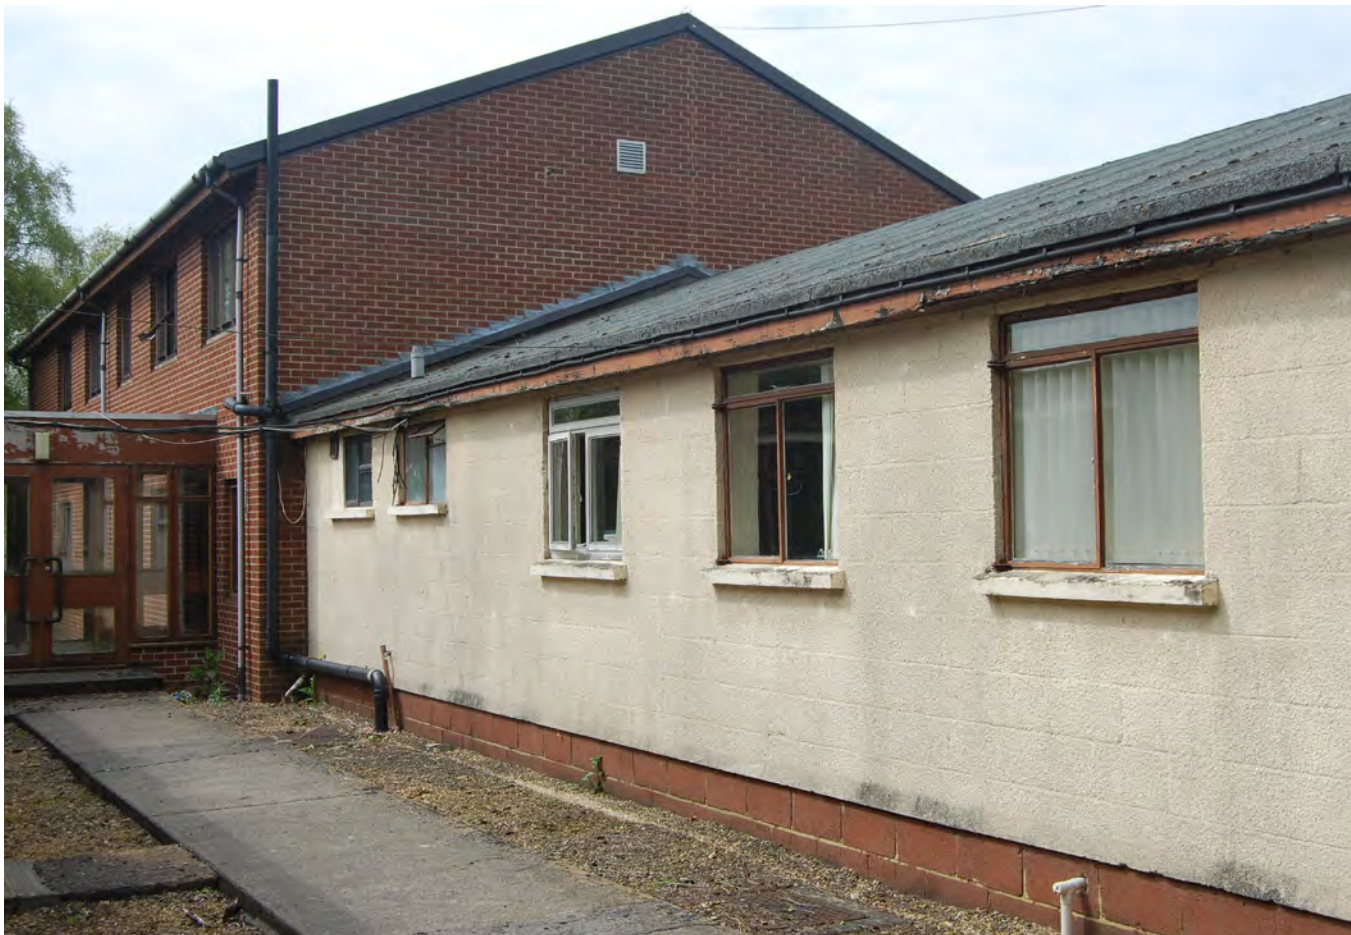
Plate 66.5 The two storey extension, looking south

The early range retains the majority of its Crittall-style metal framed casement windows with two later wooden replacements to much the same design, one to the ladies WC, painted black externally, and the office next to the WCs, painted white externally (Plate 66.5). The north western office window has been covered over externally, the north eastern office windows have been covered over internally, all of which retain the window frame.

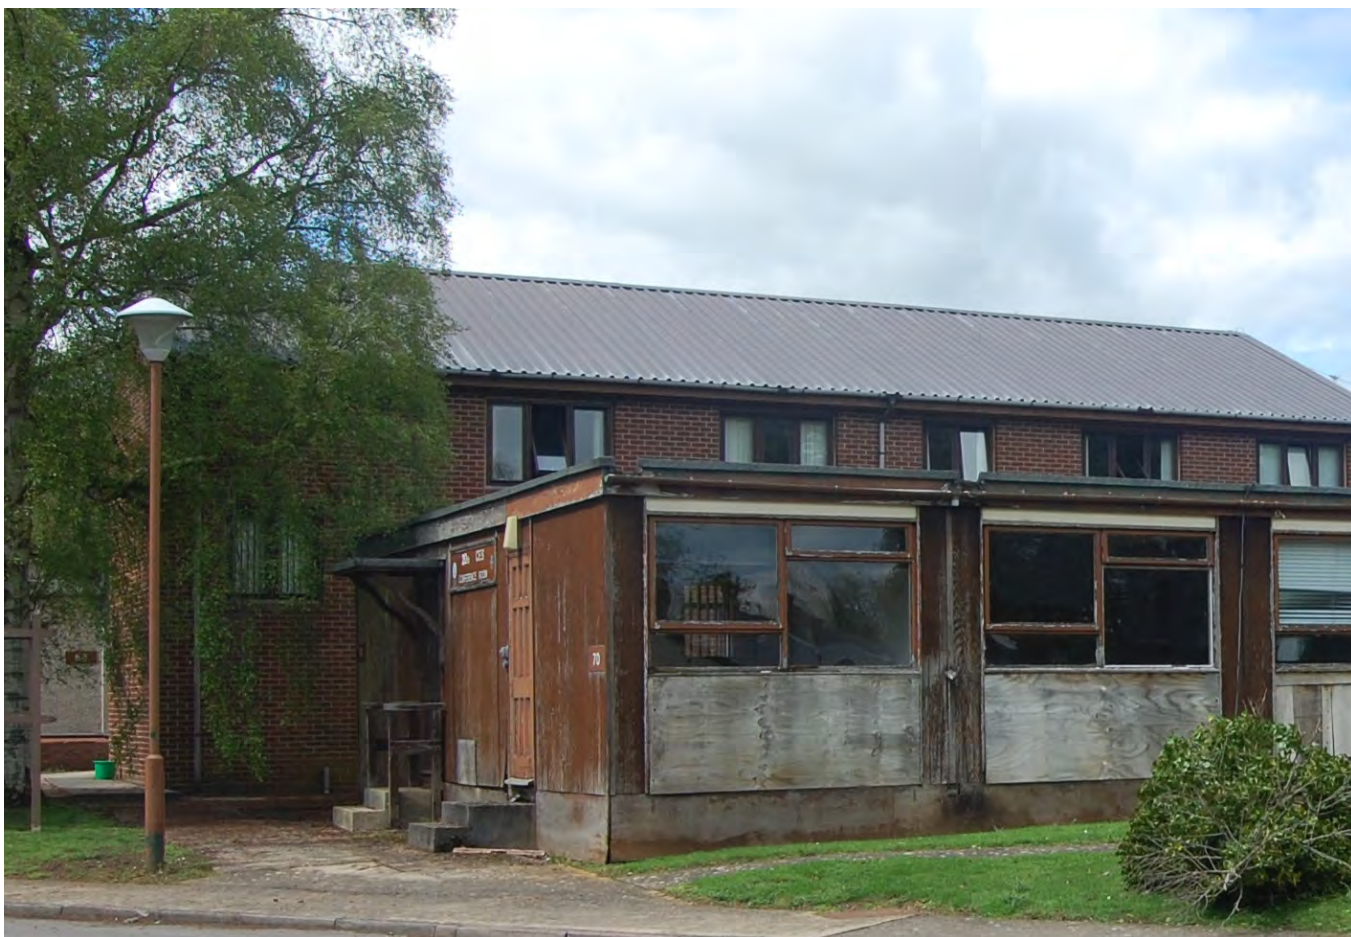
Plate 66.6 East elevation obscured by building 70

The later range has its original double glazed windows in brown powder coated aluminium frames. A window at mid-storey height at the south end of the east elevation indicates the location of the stairs at the far end of the building (Plate 66.6).

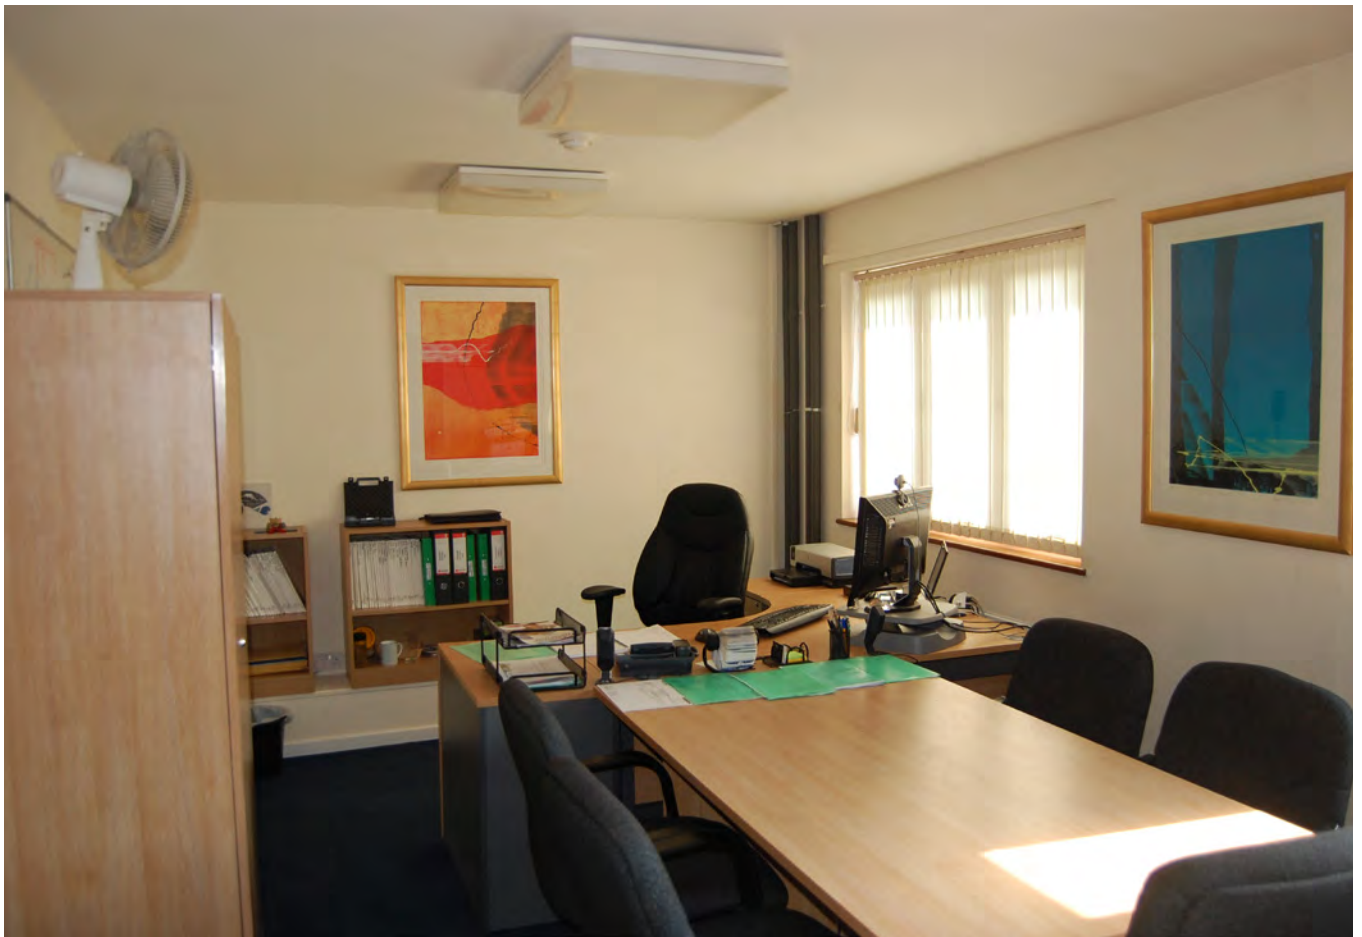
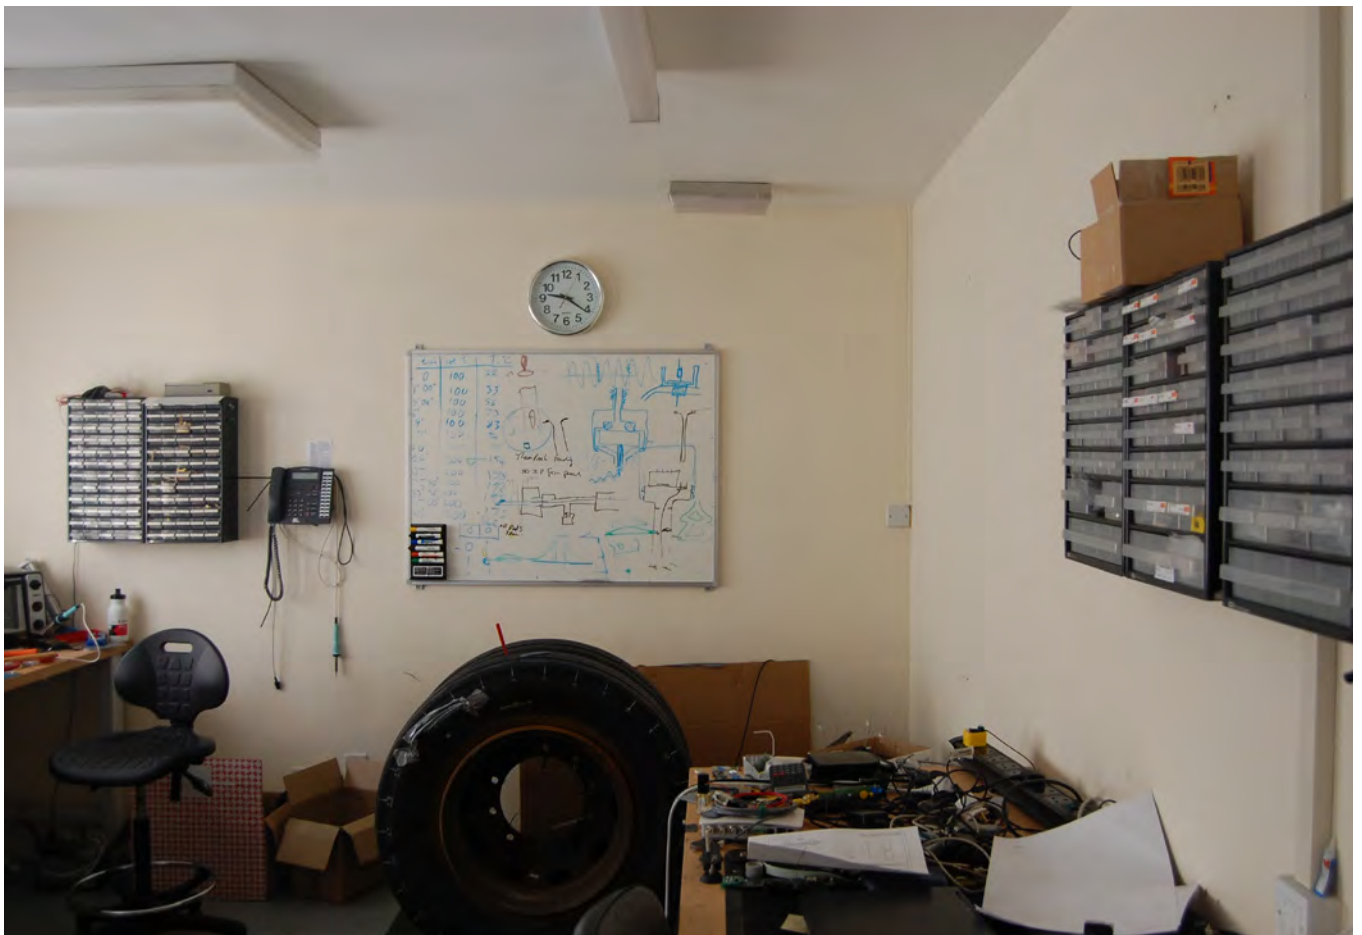
The later range is used as mainly as offices with some light workshops on the ground floor, the walls and ceilings are plastered and painted and the floors are carpeted (Plates 66.7 & .8). The décor is plain with white doors and woodwork and magnolia walls, however, the metalwork and skirting of the staircase, of which architect's drawings survive, is painted with the brown gloss used on external areas of the estate (Plate 66.9). The two-storey block is as-built with the exception of one blocked doorway on the first floor between the central corridor and an office where the opening has been boarded, but the architrave remains (Plate 66.10).

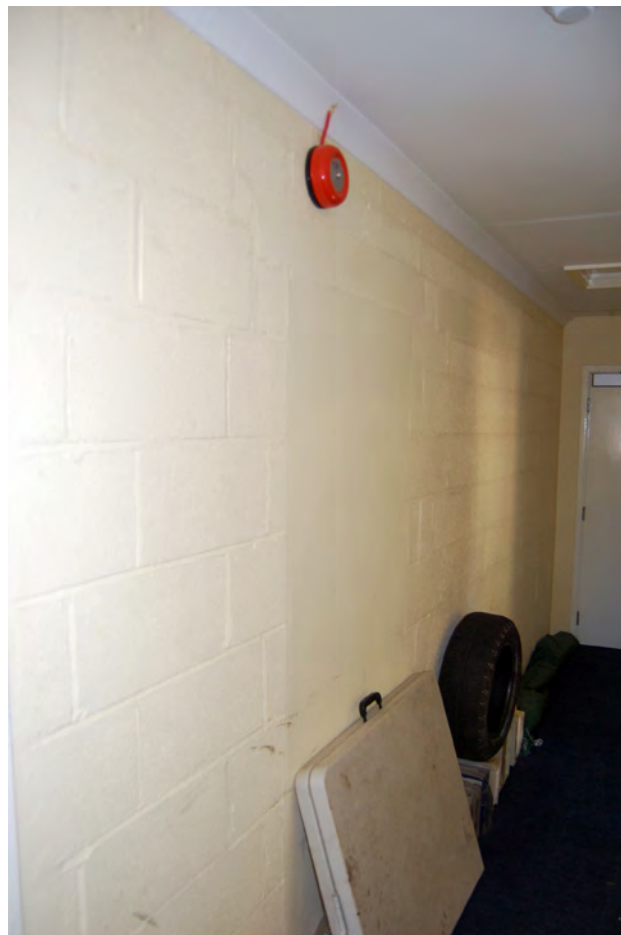
Plate 66.14 An example of a blocked door in the earlier range

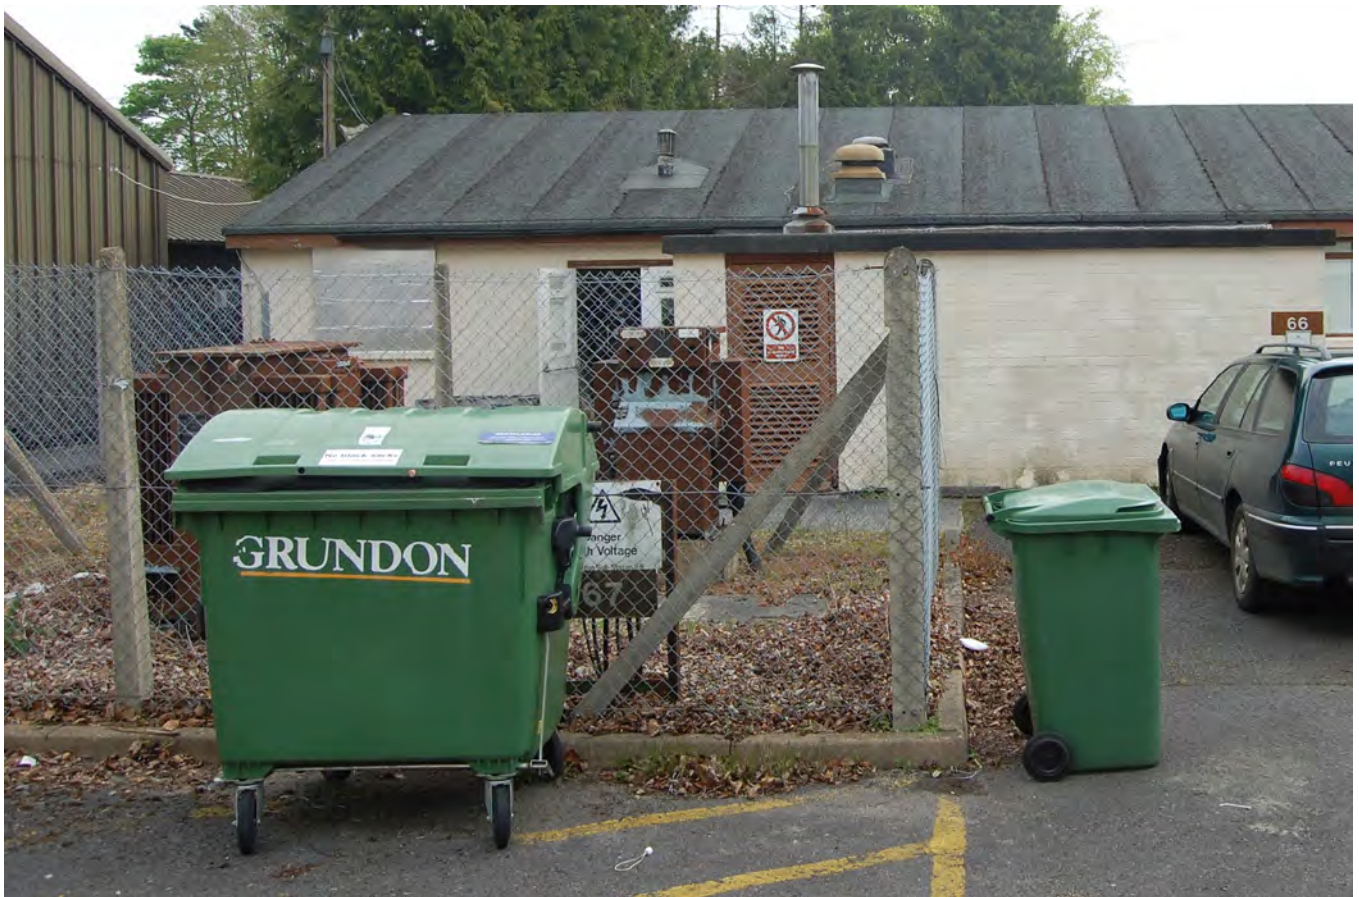
Plate 67.1 Sub-station looking north

Very simple enclosure around electrical substation plant. Enclosure formed from chain-link fencing and supported by concrete posts at each corner with diagonal bracing.

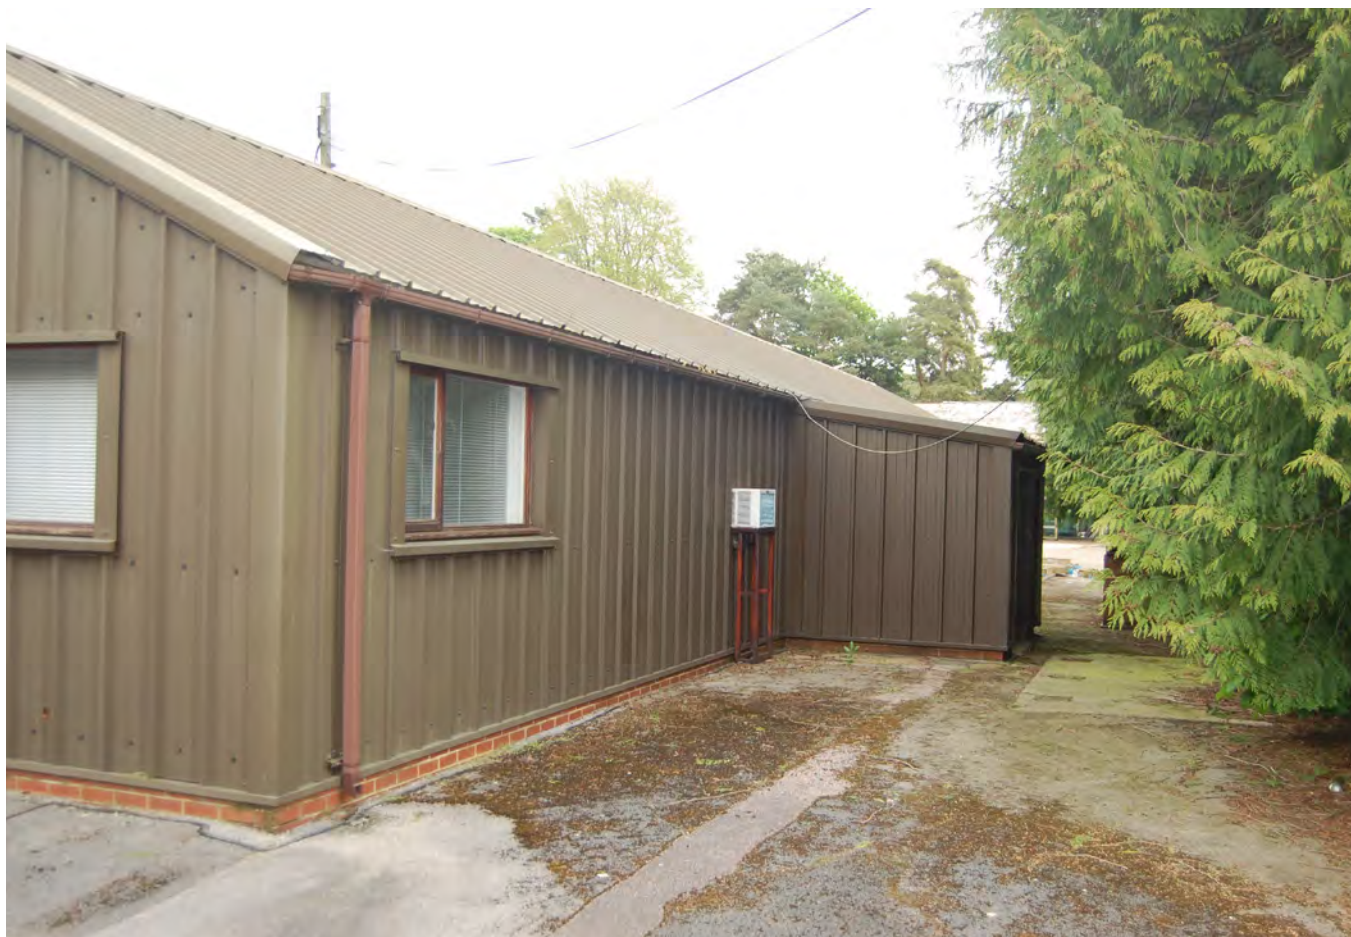
Plate 68.2 South elevation, western end

By the time of the 1992 plan, the external and internal windows had been rationalised to reflect the extension and the internal partitions. The plan, however, does not reflect the current internal layout, indicating that the building has since undergone another scheme of alteration or was not built as planned. The probability of further alteration is demonstrated by the windows and door of the north elevation of the extension: the door and easternmost window are not on the 1992 plan, yet in reality they are contemporary with the westernmost window and the cladding is unaltered (Plate 68.2).

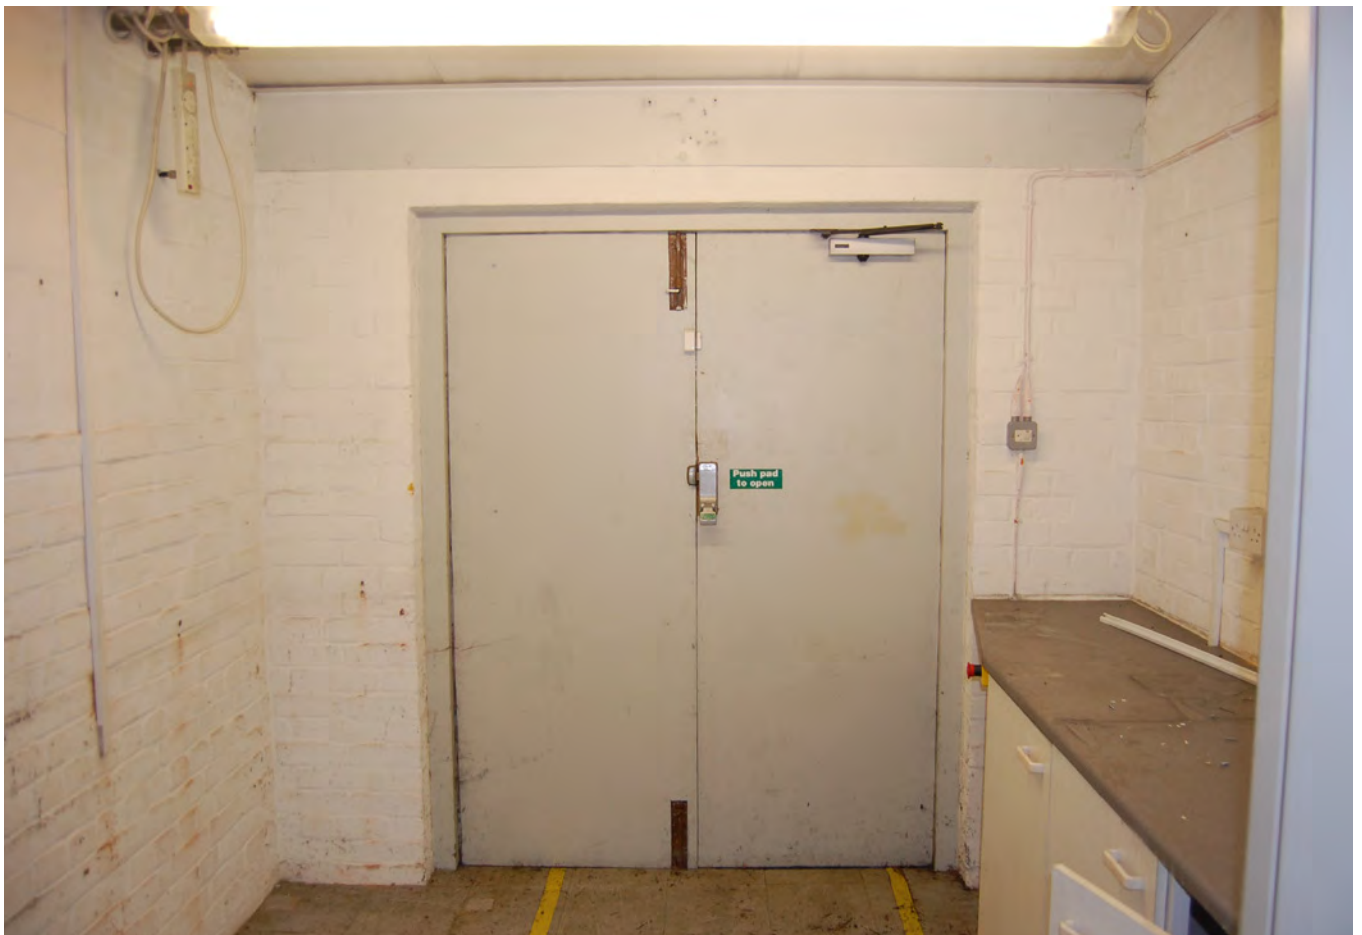
Plate 68.4 Interior of the small southern extension

The small southern extension with the double doors has painted brickwork to the interior (Plate 68.4), while the internal walls to the southern end of the north range are of painted aerated concrete block. All other wall finishes are plaster. The room to the immediate west of the original eastern unit has timber panels to dado level with plaster above, albeit with several gaps indicating potential former openings or fixtures (Plate 68.5).

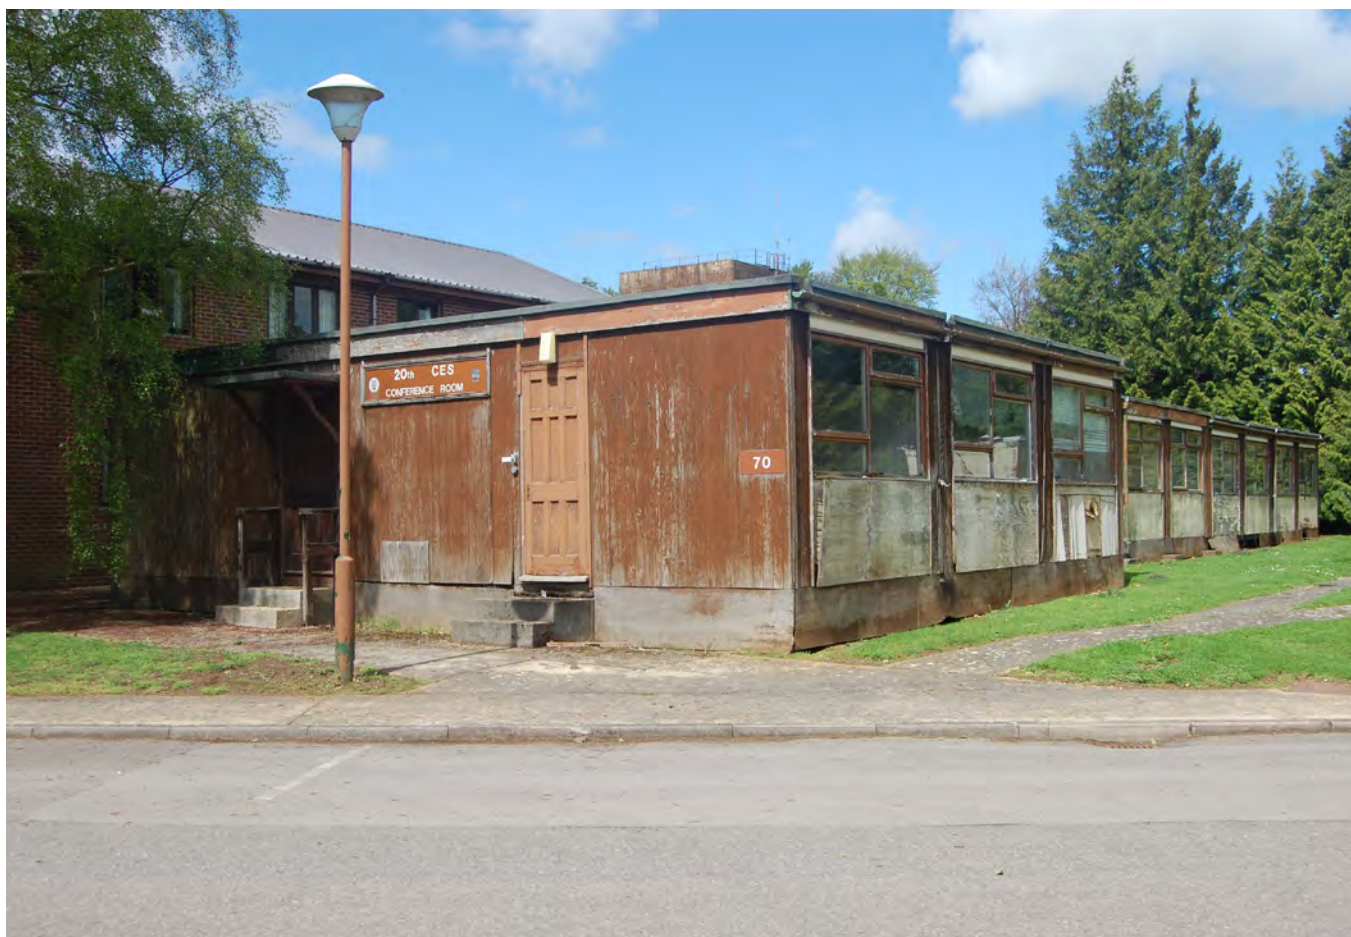
Plate 70.1 Front (south) and side elevations

Building 70 is a prefab structure roughly rectangular in plan connected to Building 66 via a short link-through passage. The former paint scheme was a uniform brown and cream including brown timber cladding and windows with sections of cream coloured timber below the windows. The numerous timber windows are split in half each containing a roughly square larger section and a smaller rectangular section. The building now survives in poor condition with rotting/ fallen timber and very poor internal condition.

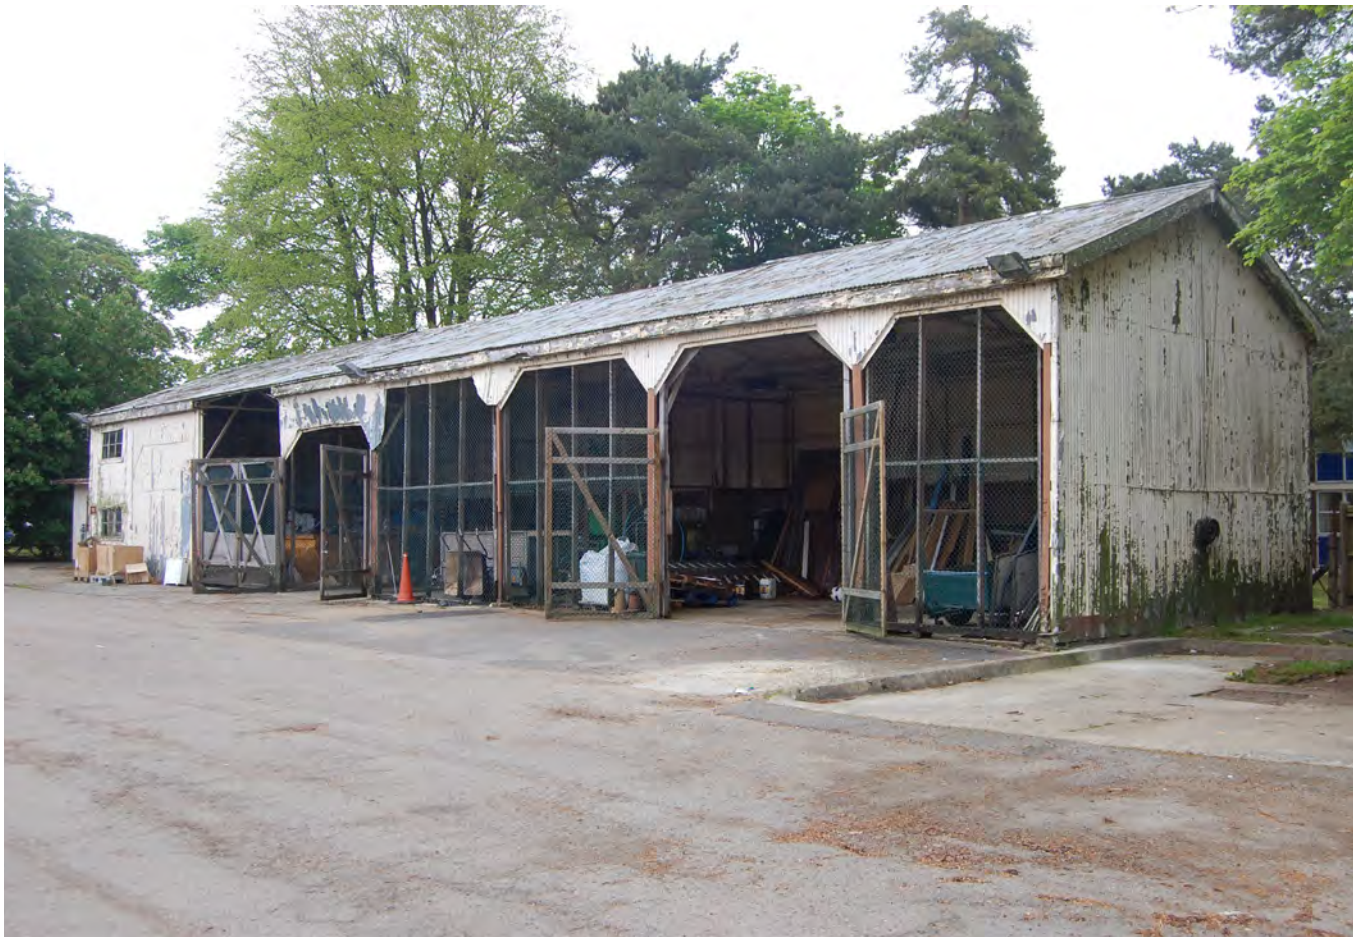
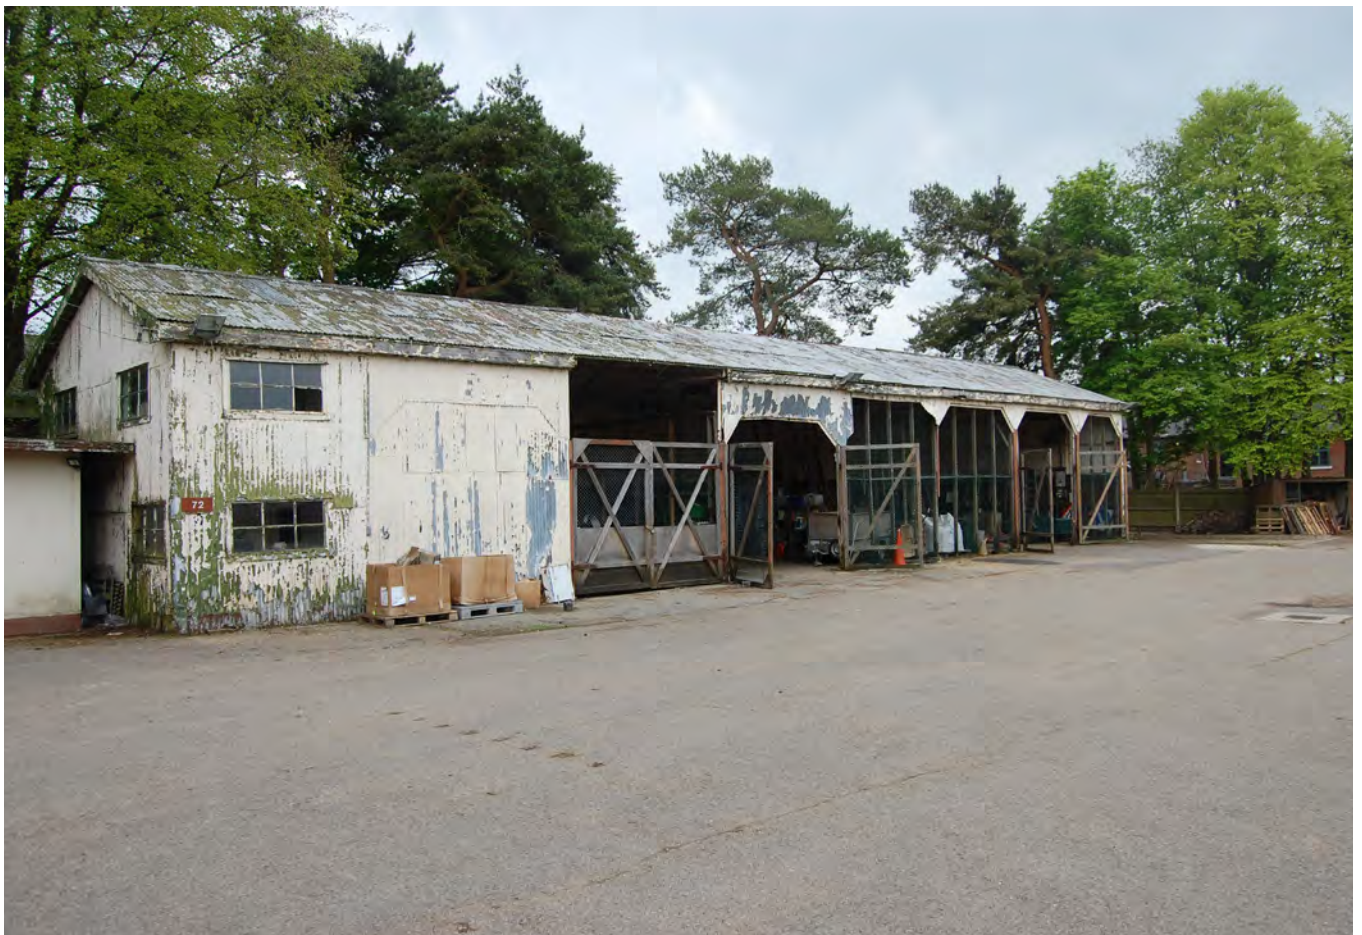
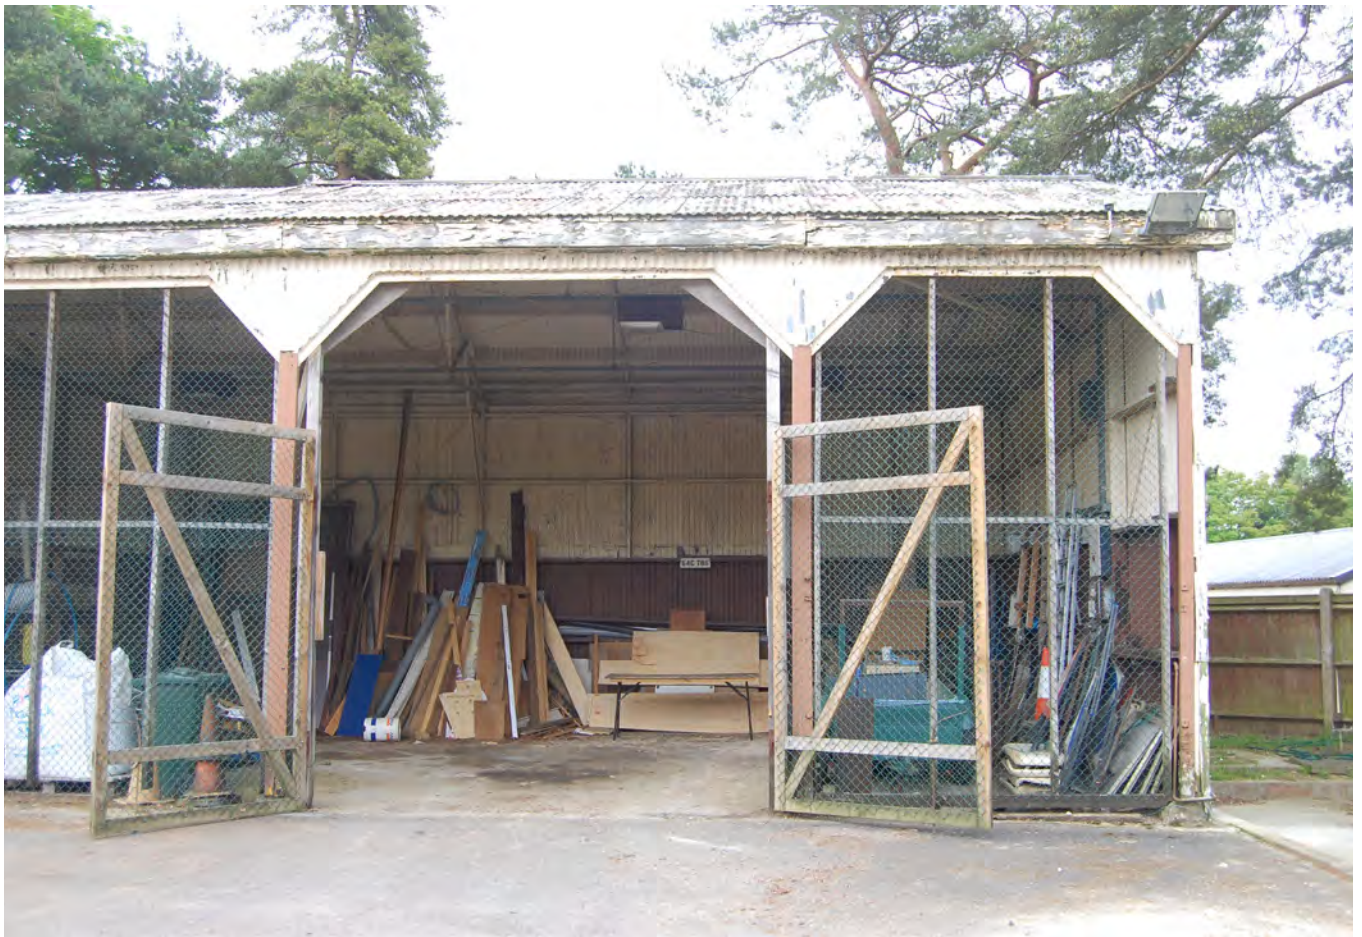
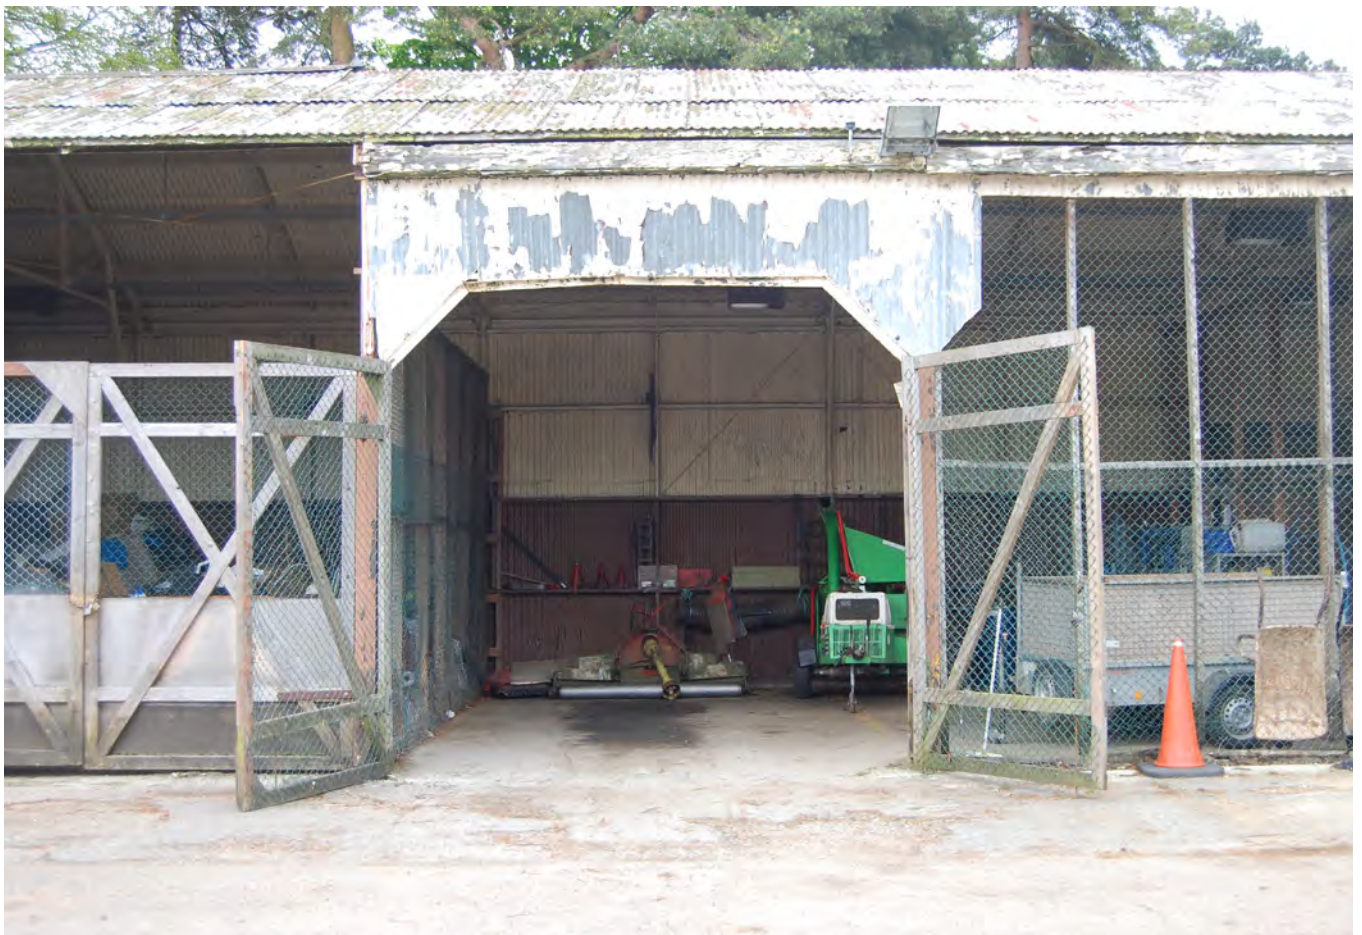
The storage shed is a single storey, rectangular plan (29 by 8 m) building with a gabled roof clad in corrugated metal (probably aluminium) sheeting and incorporating projecting barge boards (Plate 72.1 - .4). The building divides functionally into two distinct sections: by far the largest area is to the south and comprises open storage space while at the northern end there is a narrow, two storey bay which housed individual rooms (offices etc) (Plate 72.5 and .6).

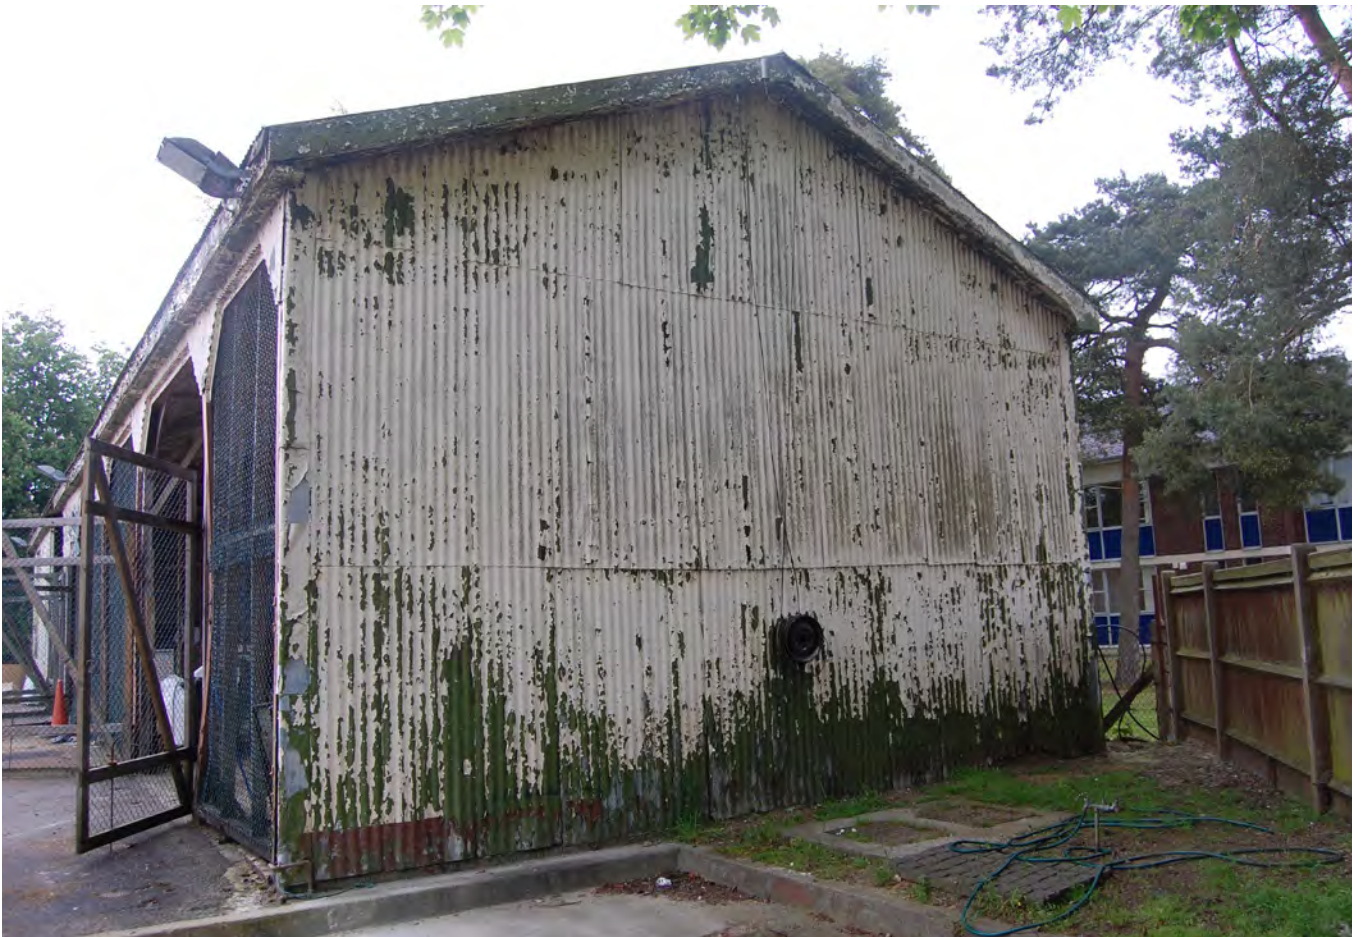
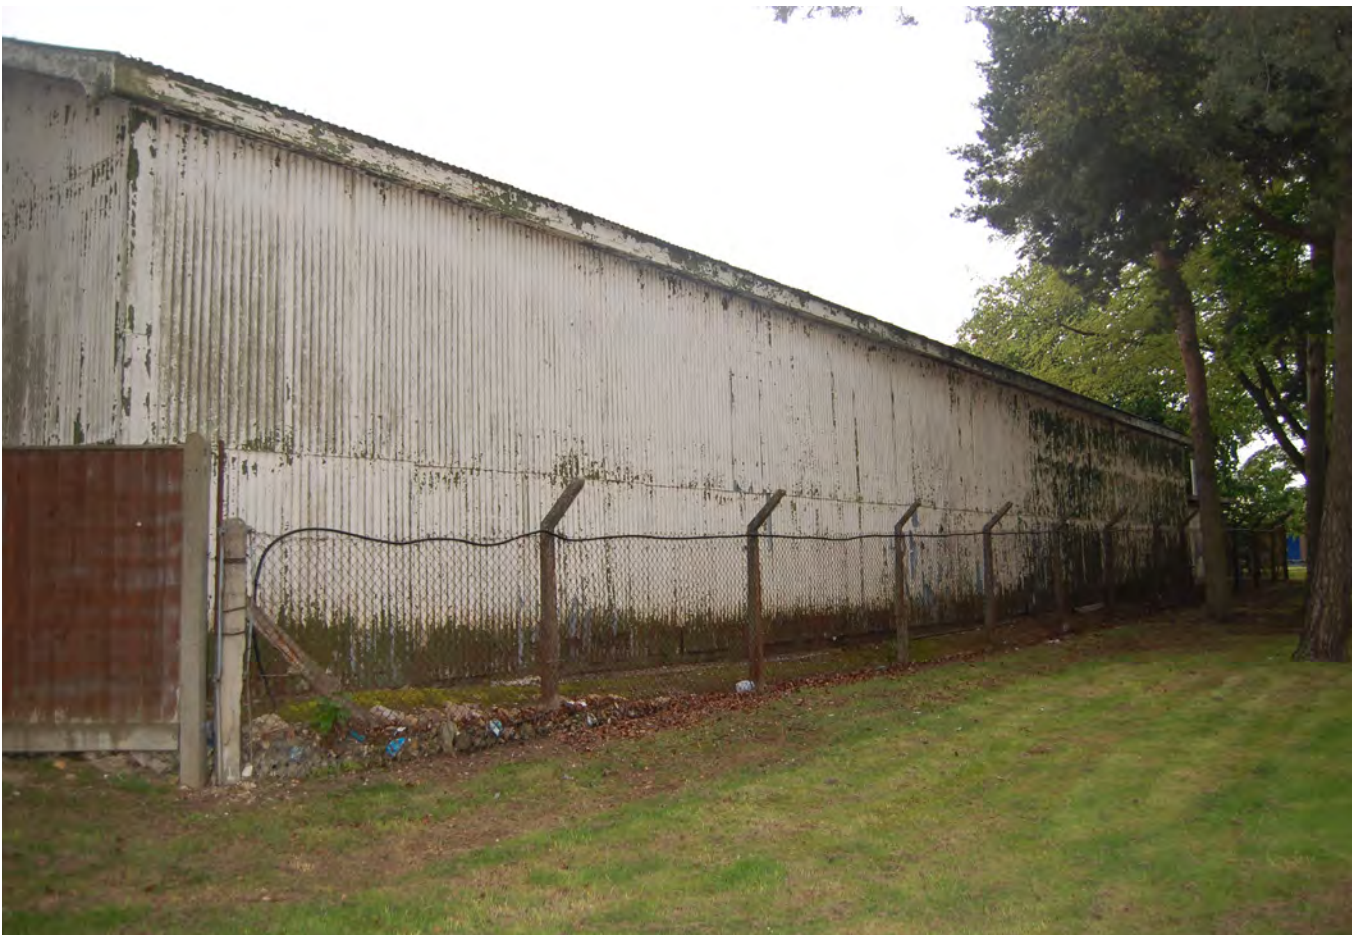
The south and east walls are relatively featureless and clad in plain corrugated sheeting and the north elevation also has a similar cladding but this elevation also incorporates four six-light windows to illuminate the offices (Plate 72.7 and .8). The windows are metal framed and there are two at ground floor and two at first floor level. This end of the building is now partly covered by a later, lower structure constructed c.0.5 m away from the main building 72. The wall cladding panels are painted a cream colour, with a brown plinth, but this is peeling off in many places to reveal an earlier moss green colour beneath.

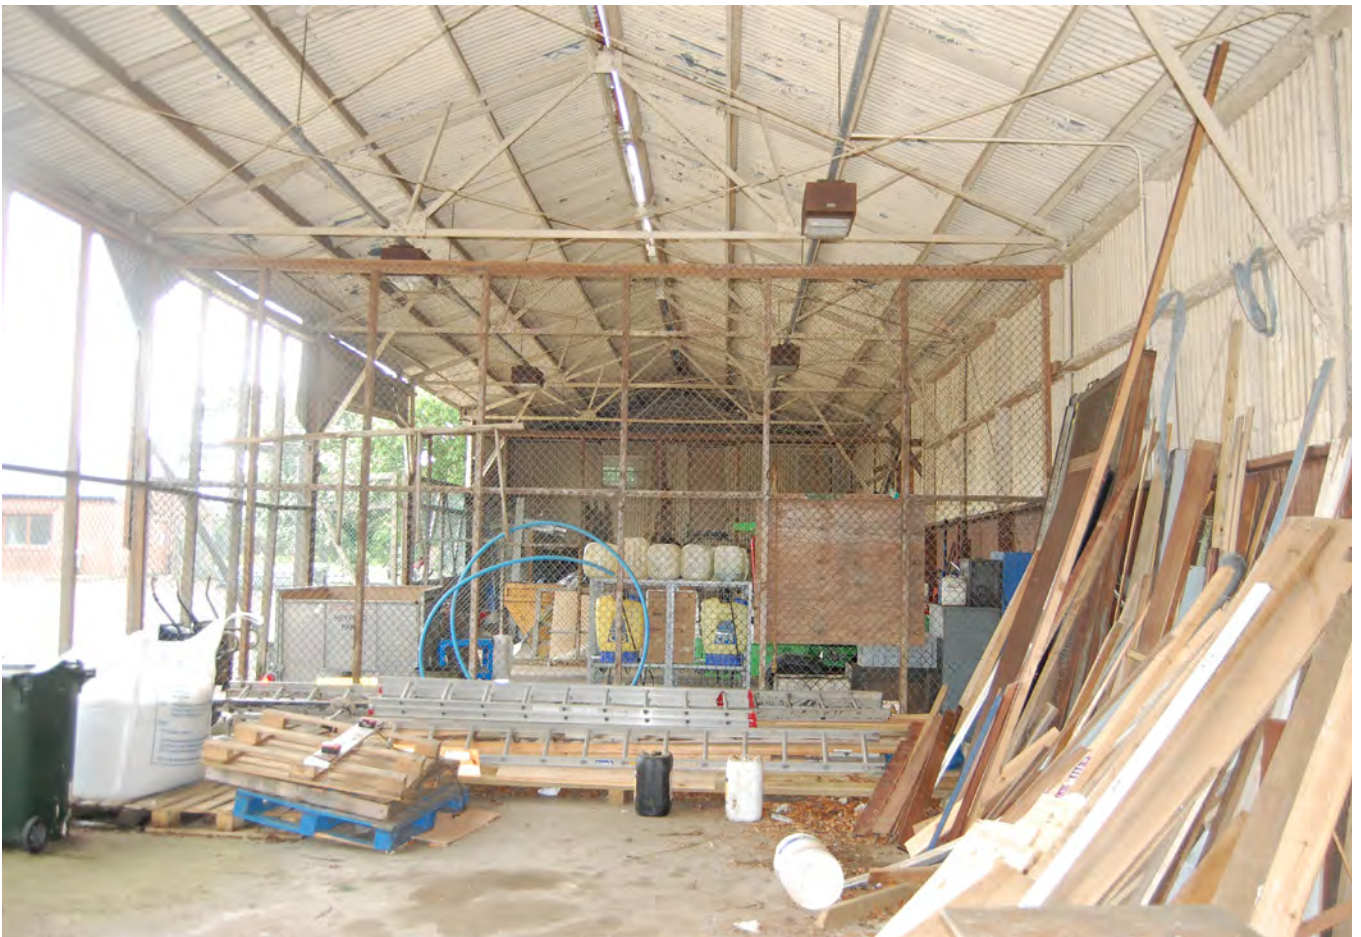
Plate 72.9 Interior looking north

The seven main storage bays are visually a single open space although there is a secondary plastic-coated wire mesh on a softwood stud framework which prevents access along the building and divides bays 2 to 5 from bays 6 to 8 (Plate 72.9).
