FORMER RAF UPPER HEYFORD, OXFORDSHIRE

HISTORIC BUILDING RECORDING AND INVESTIGATION

VOLUME 2: GAZETEER OF RECORDED STRUCTURES

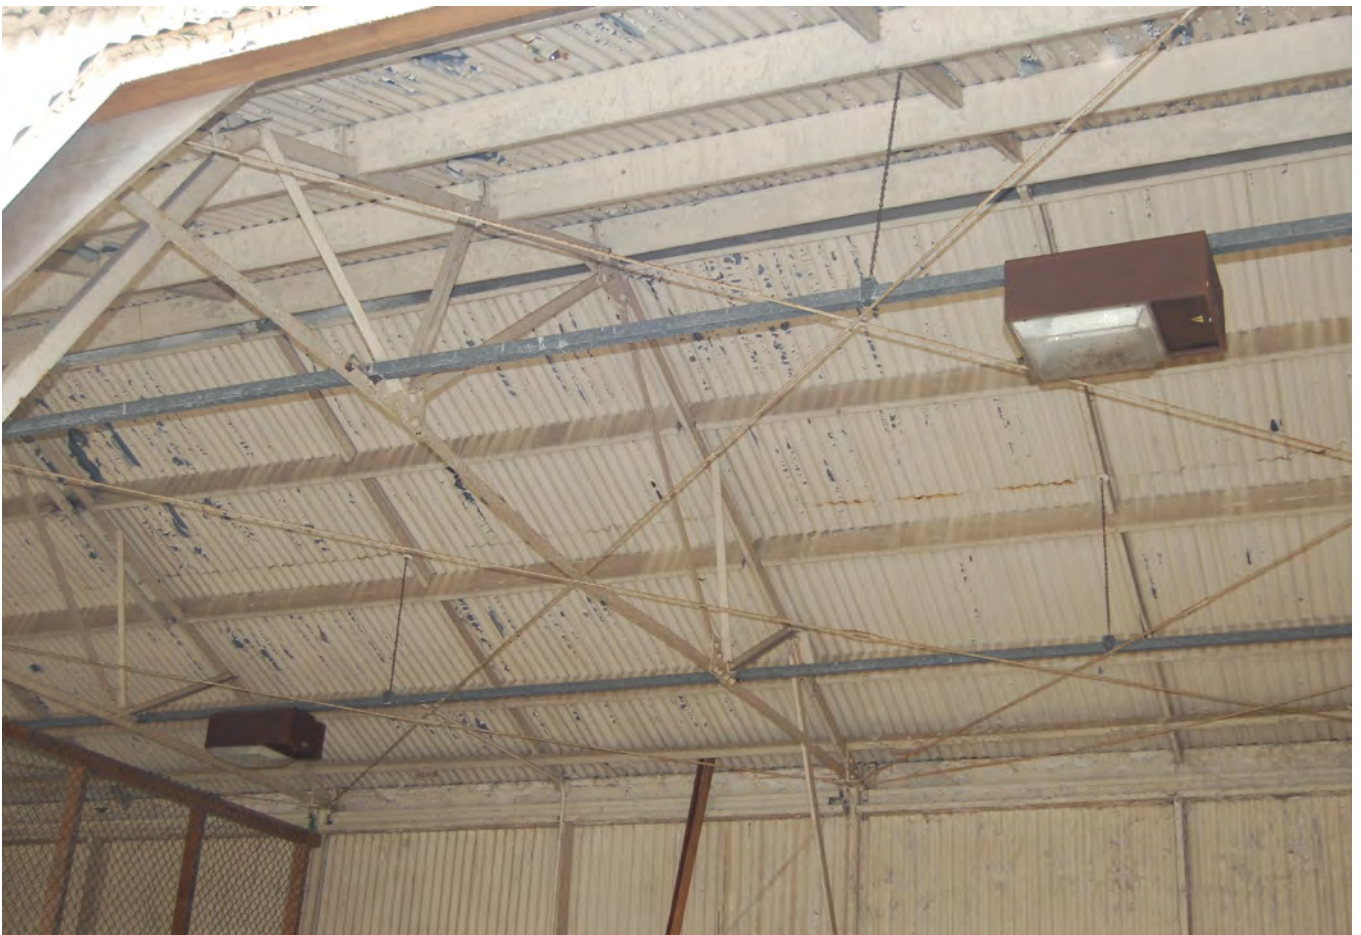
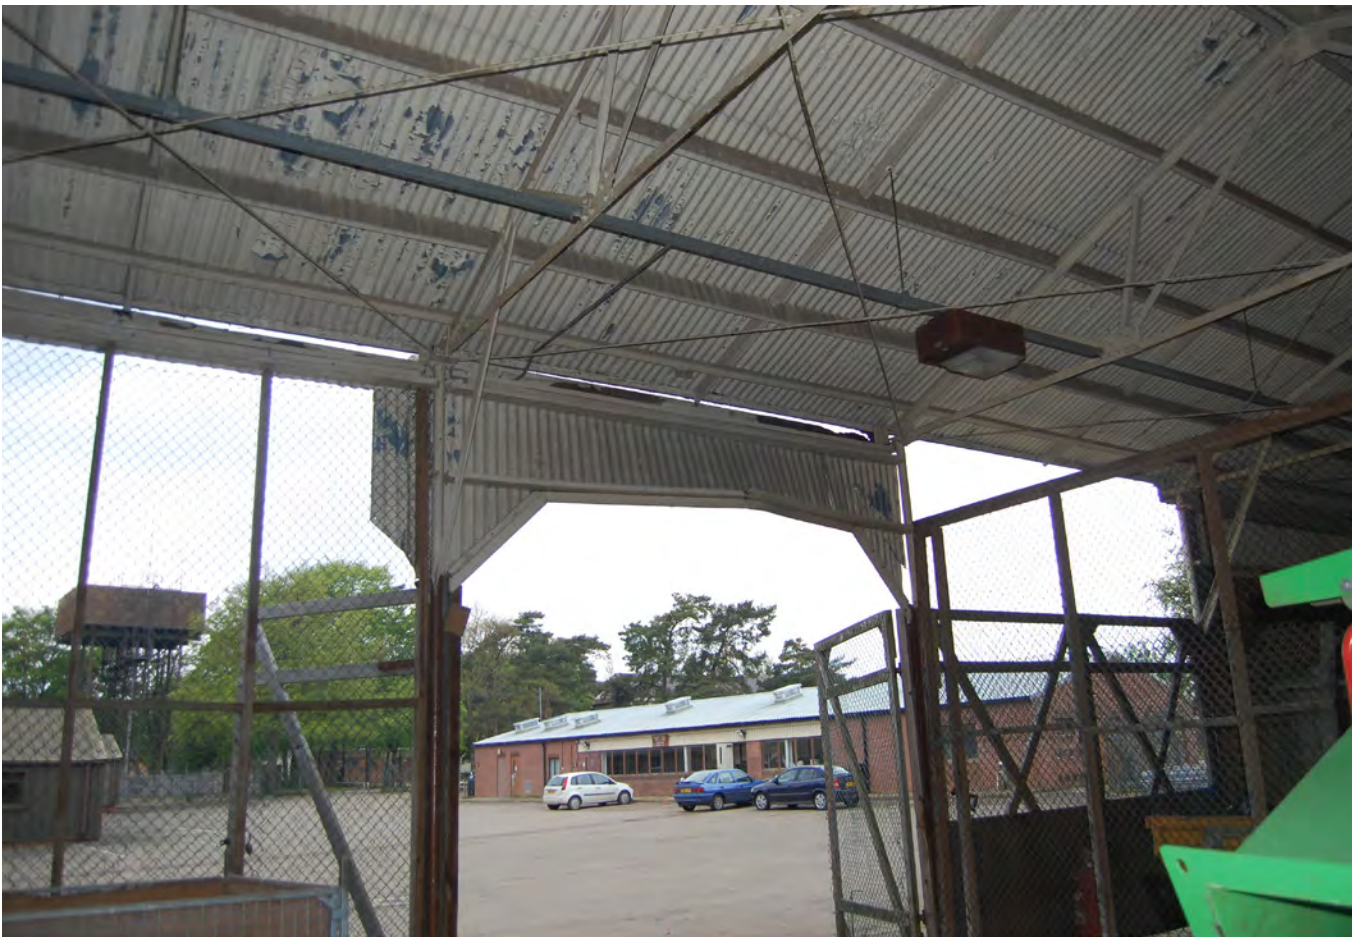
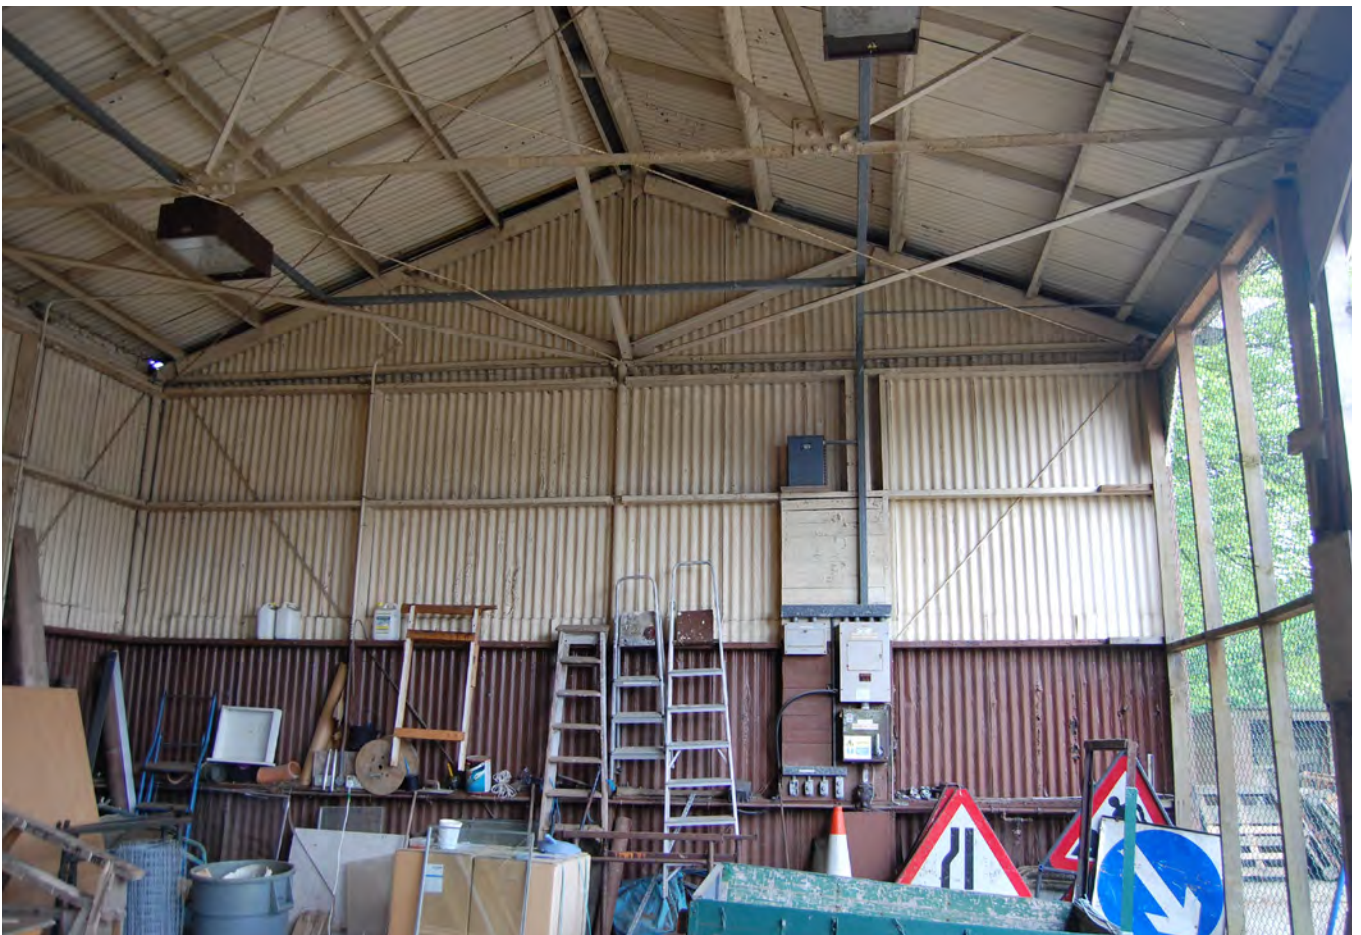
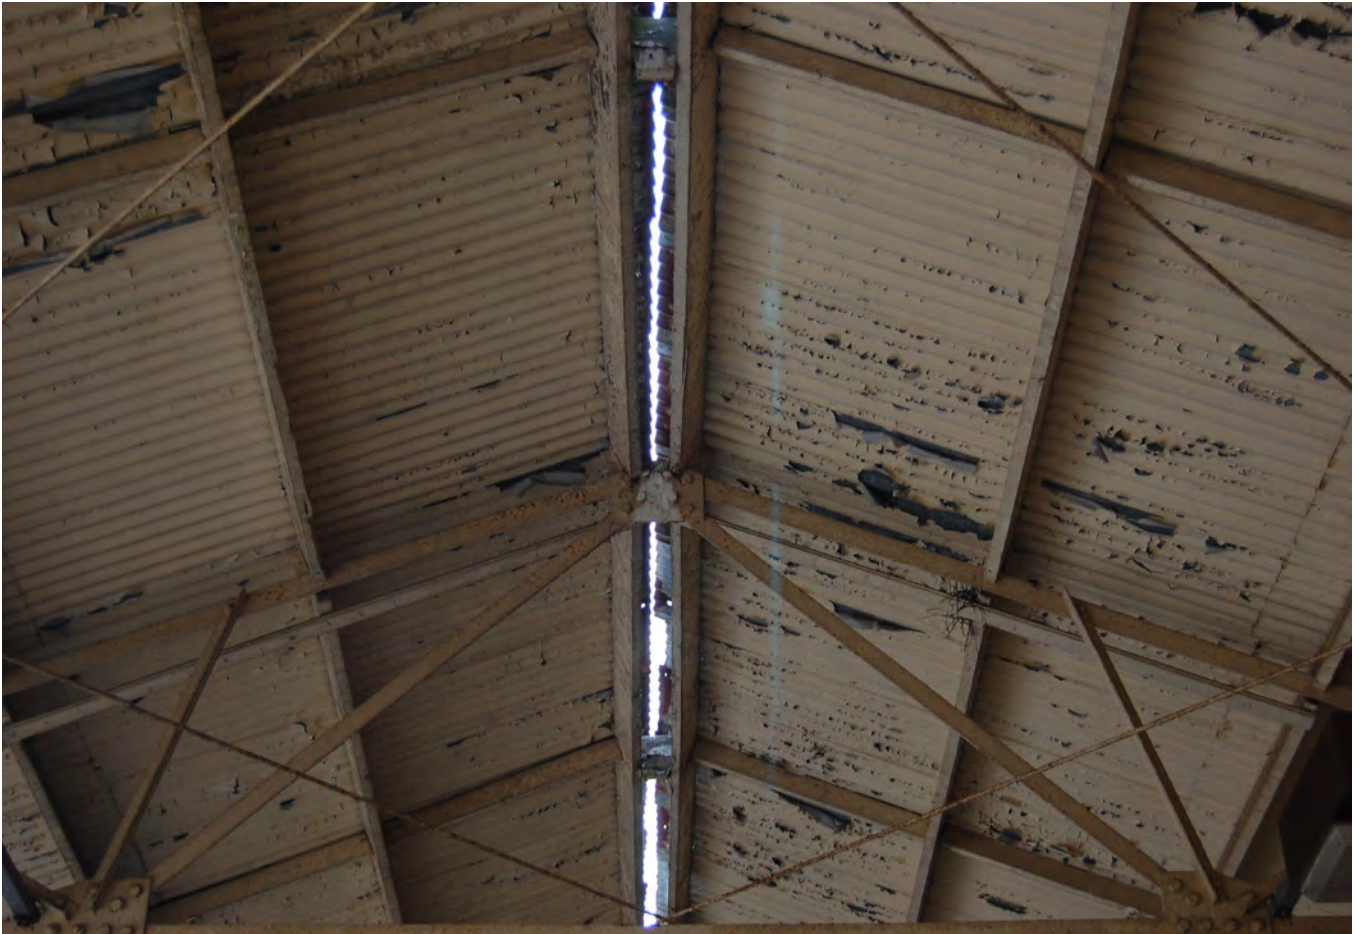
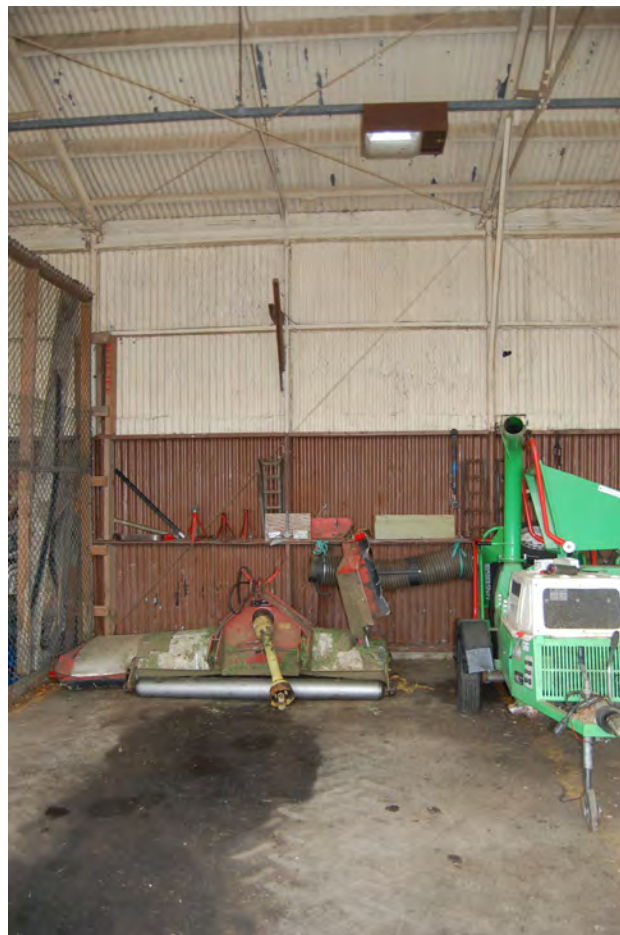
The structural frame of the building is entirely open in the storage areas with the nine roof trusses supported at each end by a circular section steel post, and between each of these the corrugated cladding is supported by a central softwood post and three horizontal rails (Plate 72.10 to .14). The softwood members are not part of the main structure and are just intended to carry the cladding. It is interesting to note that the horizontal softwood rails extend with a single member between the steel posts and the verticals are shorter members fixed to the horizontals (rather than vice versa). The horizontals are fixed to the main steel posts by small iron brackets.

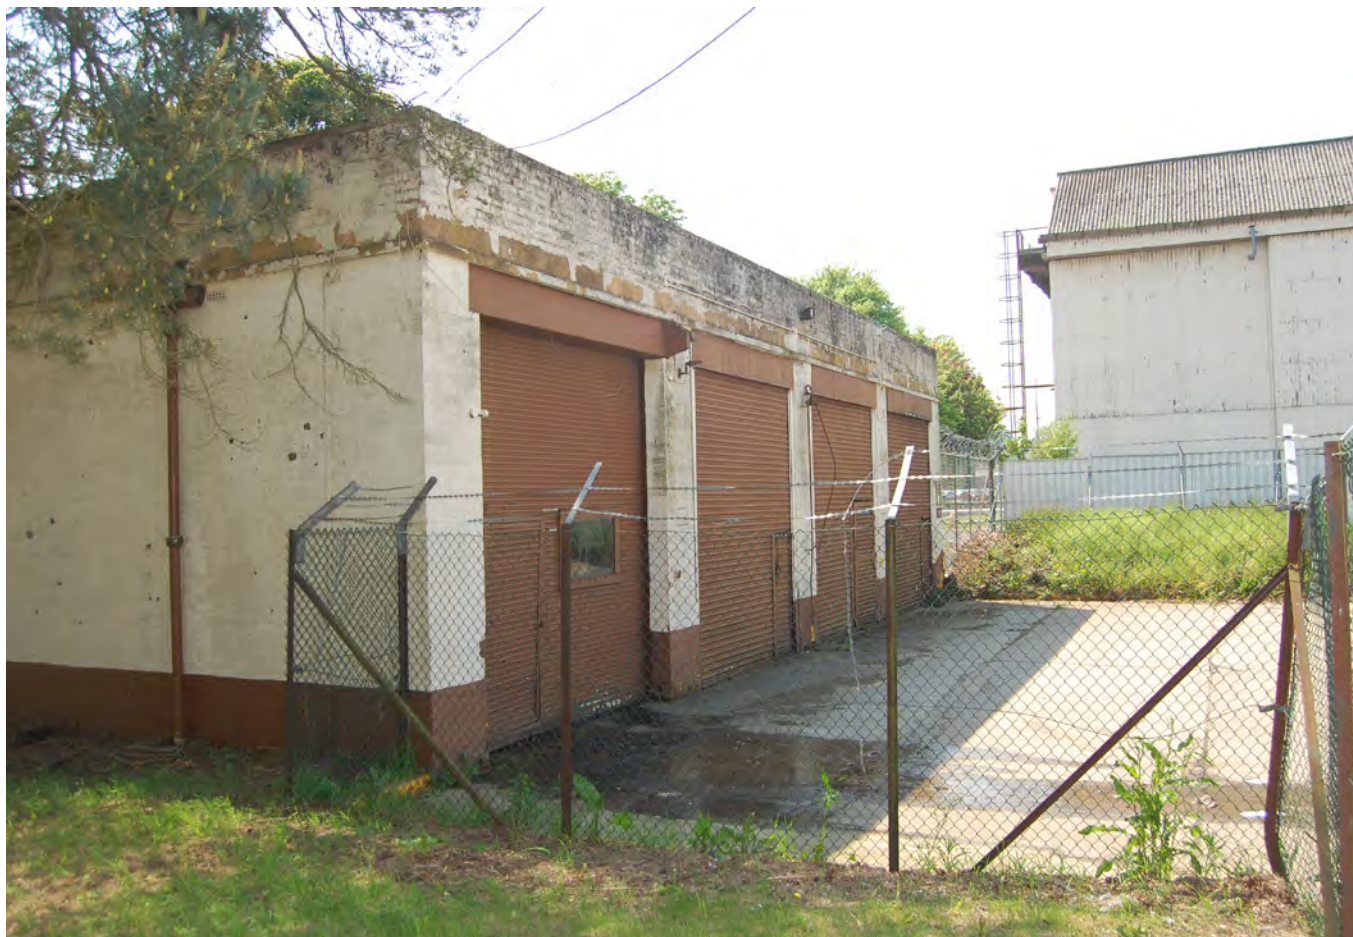
Plate 79.1 Rear (north) elevation

The west and east elevations are painted cream with brown at the base and two drainpipes painted brown. There are central heating pipes leading above ground height from the east elevation. The north elevation faces the airfield and is similar in form to the south elevation, which fronts the technical area of the airbase. It has four roller doors, that are painted brown with single door openings for each which are also corrugated metal. There is also a small wood framed window in the east door. On the most eastern door is a pulley with a chain, there is also an old external light (now not in use).

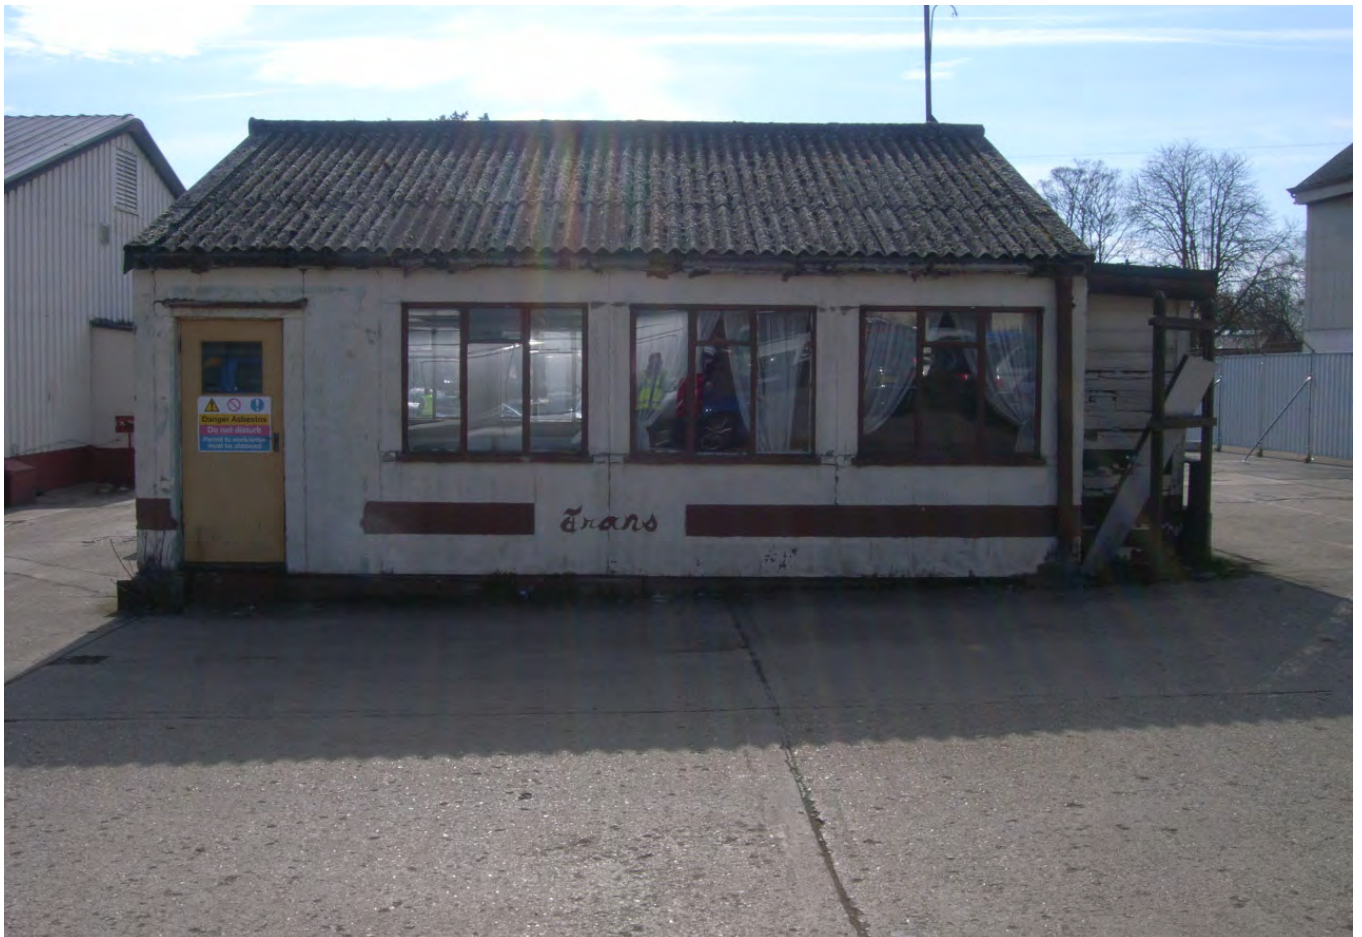
Plate 81.1 North elevation

The north façade has two windows in the west half and another window and a doorway in the east half (Plate 81.1). Each window has three tall rectangular panes; those at either end being casements. The doorway is the easternmost opening and it is accessible by means of a step due to the ground sloping towards the east. The west façade has a doorway slightly to the south of the mid-point and has no windows (Plate 81.3). A small timber-clad lobby projection (3.45 x 1.3m) overlies the doorway. The upper half of the lobby's door has a square pane with a horizontal casement window on it; the lower half has vertical boards. To the north of this door there is a window currently boarded. This structure is covered by a flat roof with waterproof mesh.

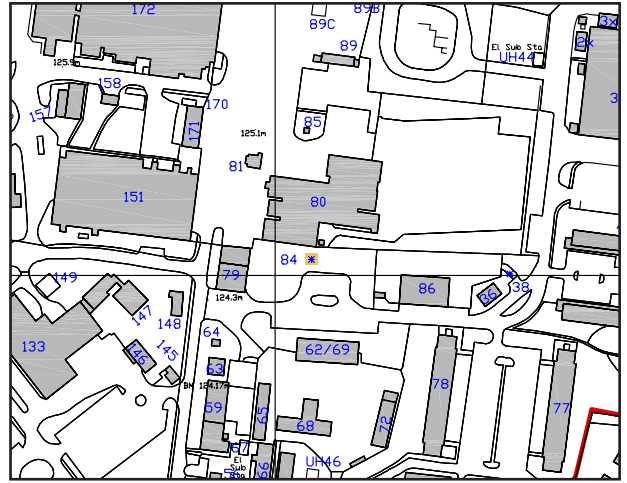
The petrol kiosk is constructed from painted concrete blocks and has a flat asphalt roof (Plate 84.1). The south-east face is now boarded up, the north-east face has a red emergency switch and piping extending from it. There is a concrete channel leading up to the kiosk and a half circular road extends from the main road to access the petrol kiosk.

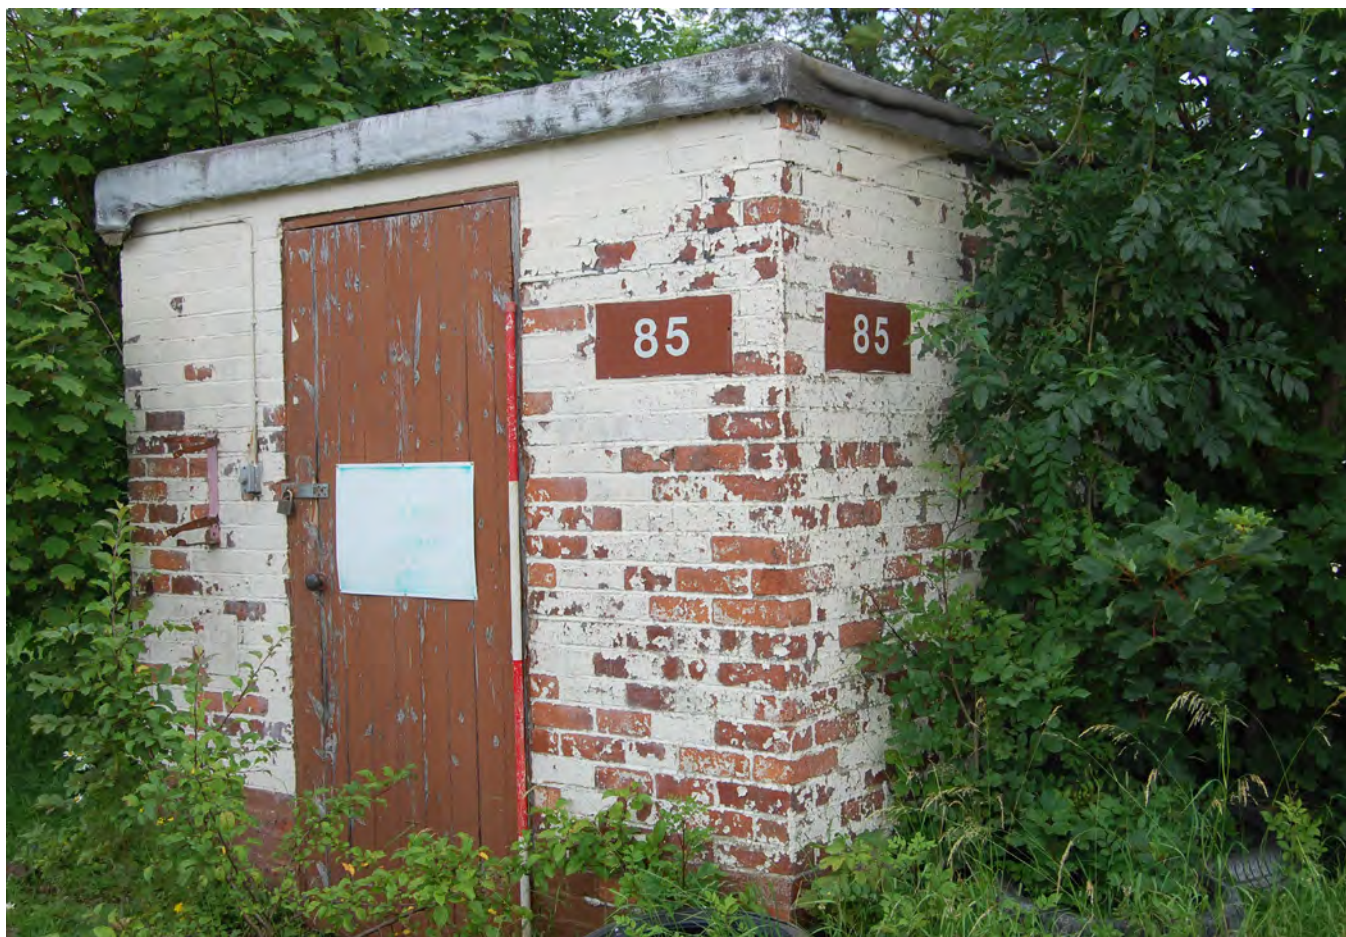
Plate 85.1 West elevation

The store is a simple brick structure with a flat bitumen roof measuring roughly 2m² (Plate 85.1). The west (front) elevation has a plain wood panelled door in a timber frame, the south elevation has a single wood framed window with a concrete sill. The red brick was previously painted white although this is largely peeling off, and the wood panelled door is brown.

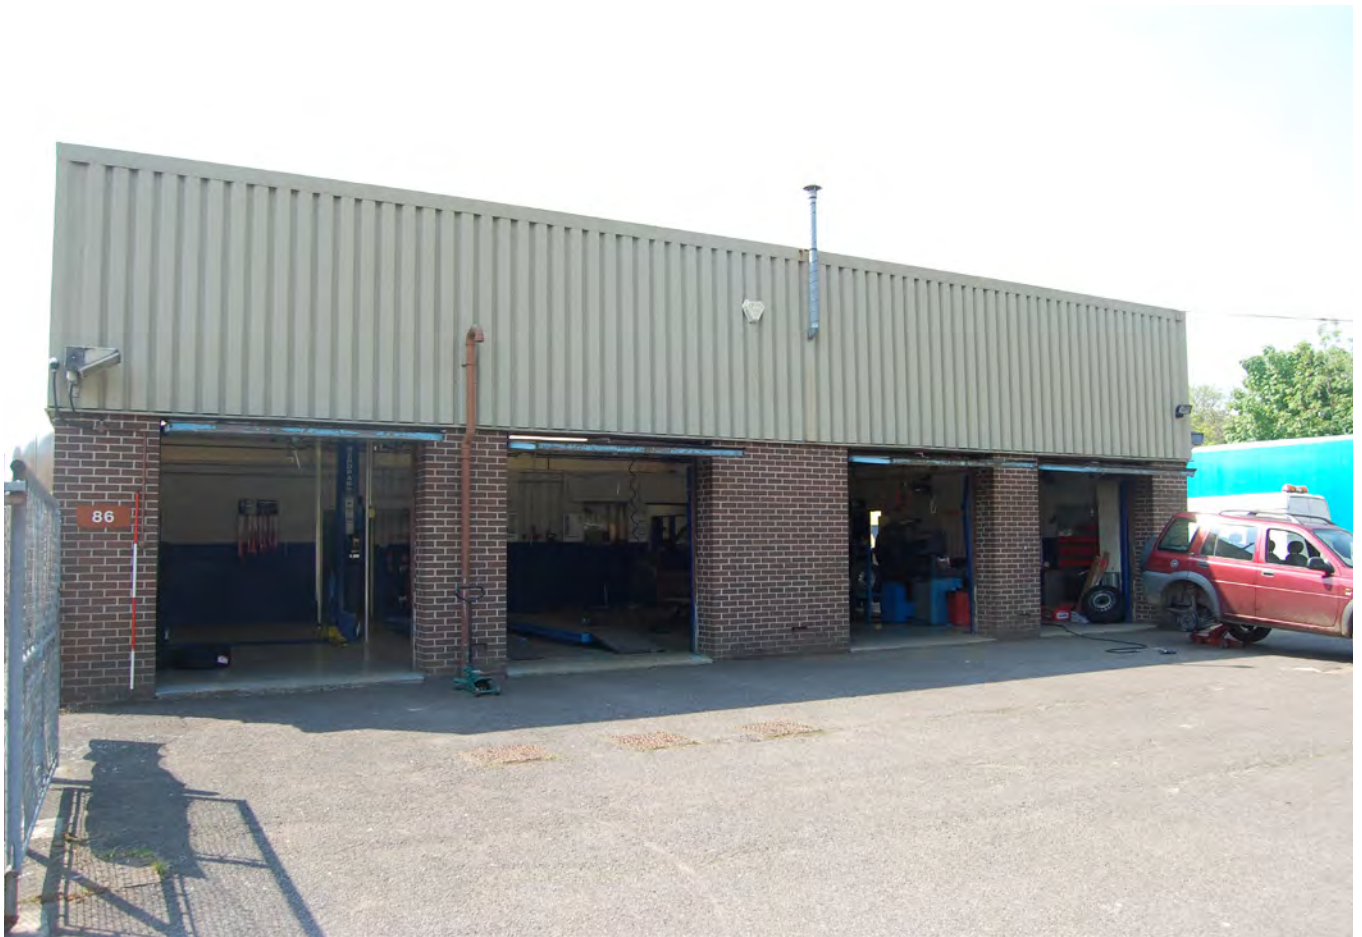
Plate 86.1 Front (east) elevation

This single-phase building is rectangular in plan and constructed in brown brick with metal cladding used for the roof and continuing above the level of the doors (Plate 86.1). The roof has an inverted pitch sloping to the west and is taller to the rear of the building.

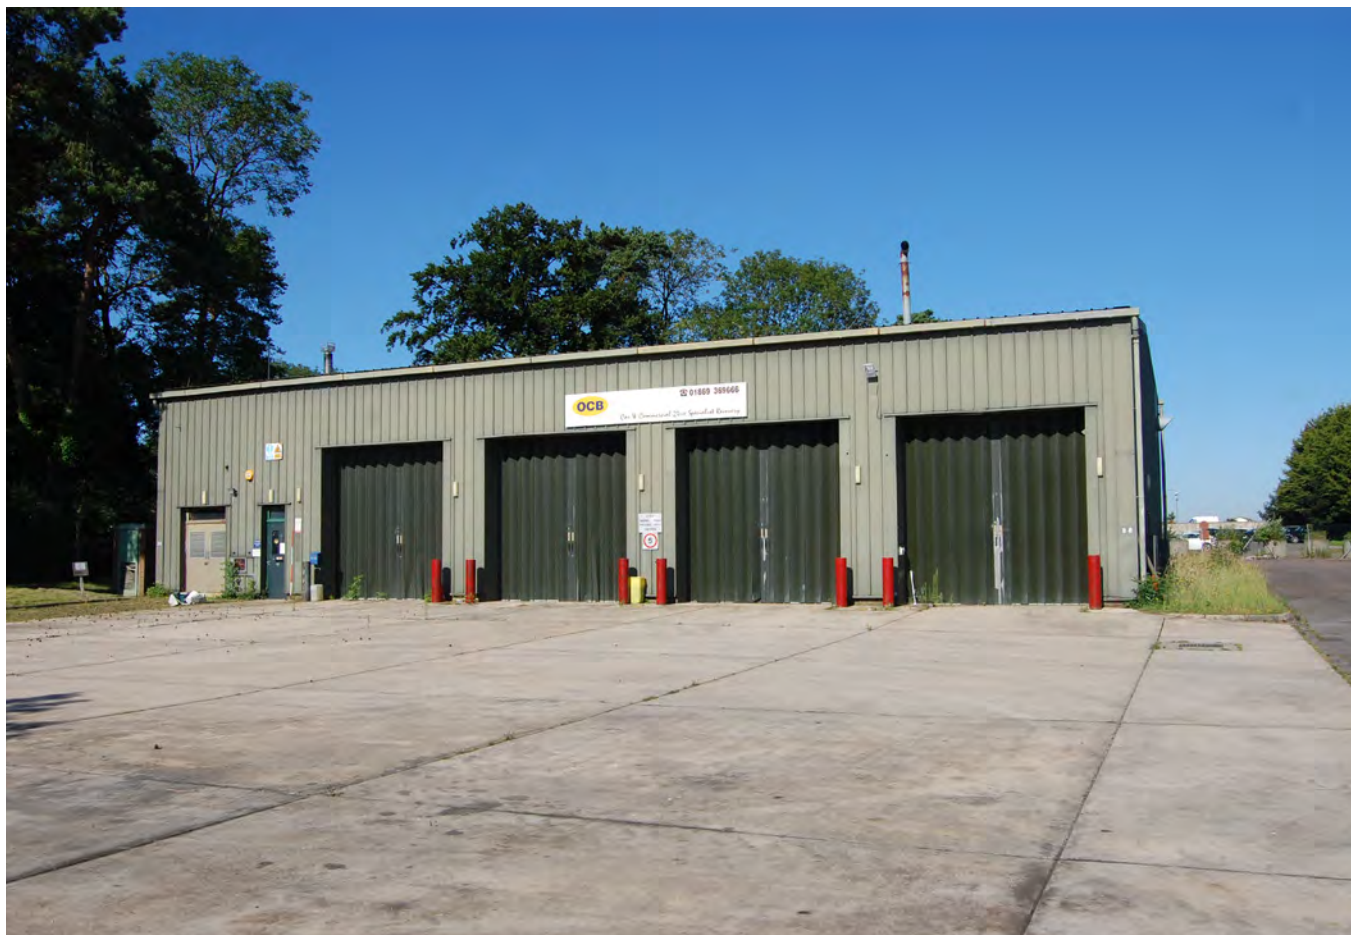
Plate 88.1 Front (east) elevation

The front (east) and rear elevations have four double folding metal doors with red bollards between sets of doors with a single one at the end (Plate 88.1). At the south end a single timber and glass door provides access to the building's main internal space, whilst a set of double doors with air vents in the upper half provide access to a separate plant area. This was maintained by the PSA and contains Hot Water Boilers, Fire Detection Systems and a Ventilation Control Panel.

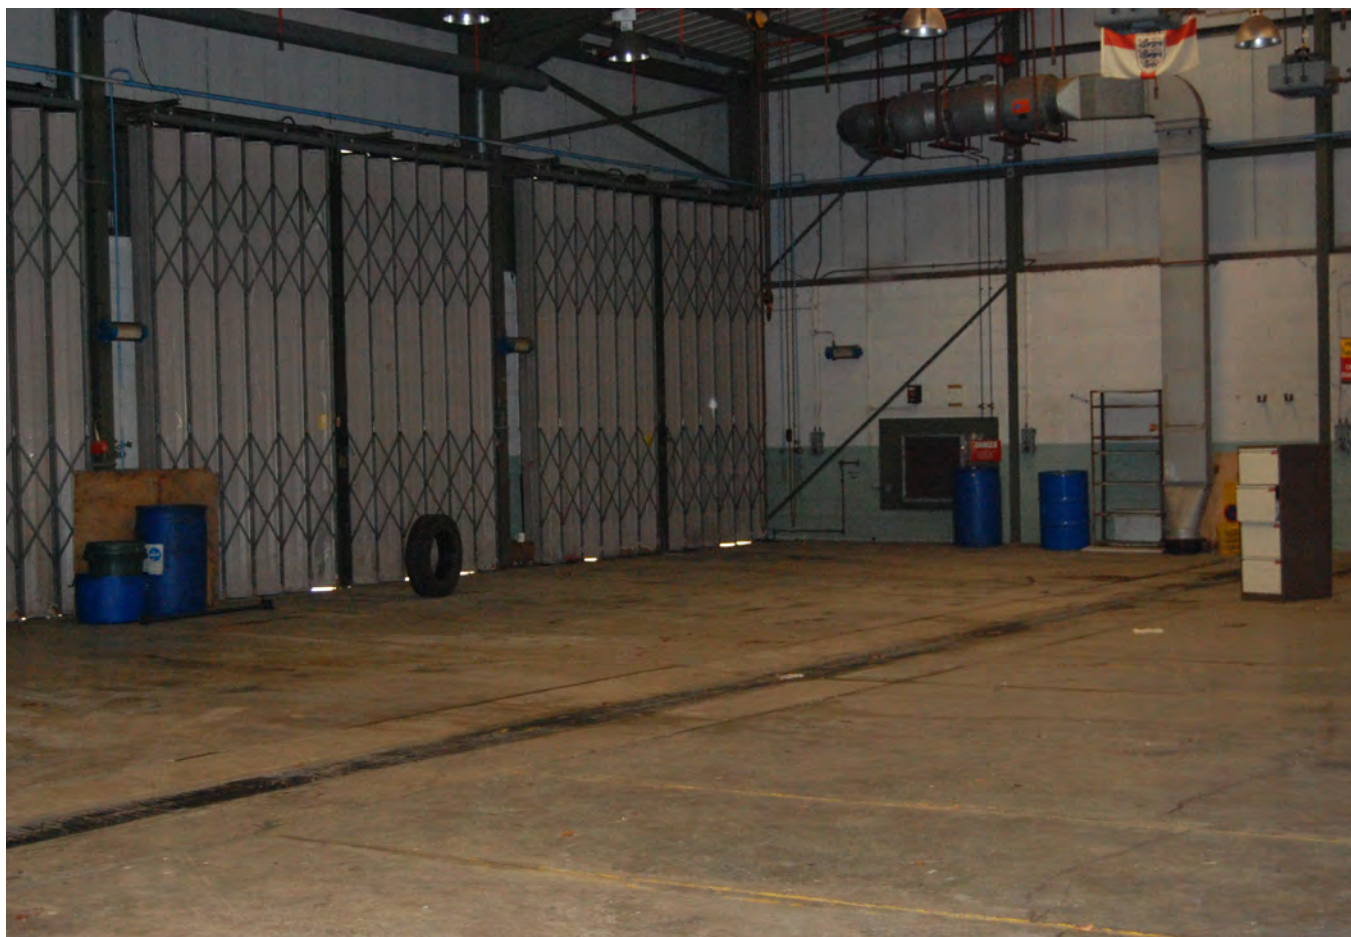
Plate 88.2 Internal view to east

Internally, the layout appears to be little changed despite its secondary use, as shown in the plan (Plate 88.2). It consists of a large open area used for maintenance with offices, W.Cs and a recreation area at the southern end of the building. The 'Store Workshop' shown on the plan has been refitted as an office for the car recovery business, which have occupied the building more recently. Above these rooms there is a mezzanine floor holding plant. Internal military fixtures and fittings remain such as overhead storm lights, extractor vents, a gantry and signage. There are internal breeze block walls painted in green and cream.

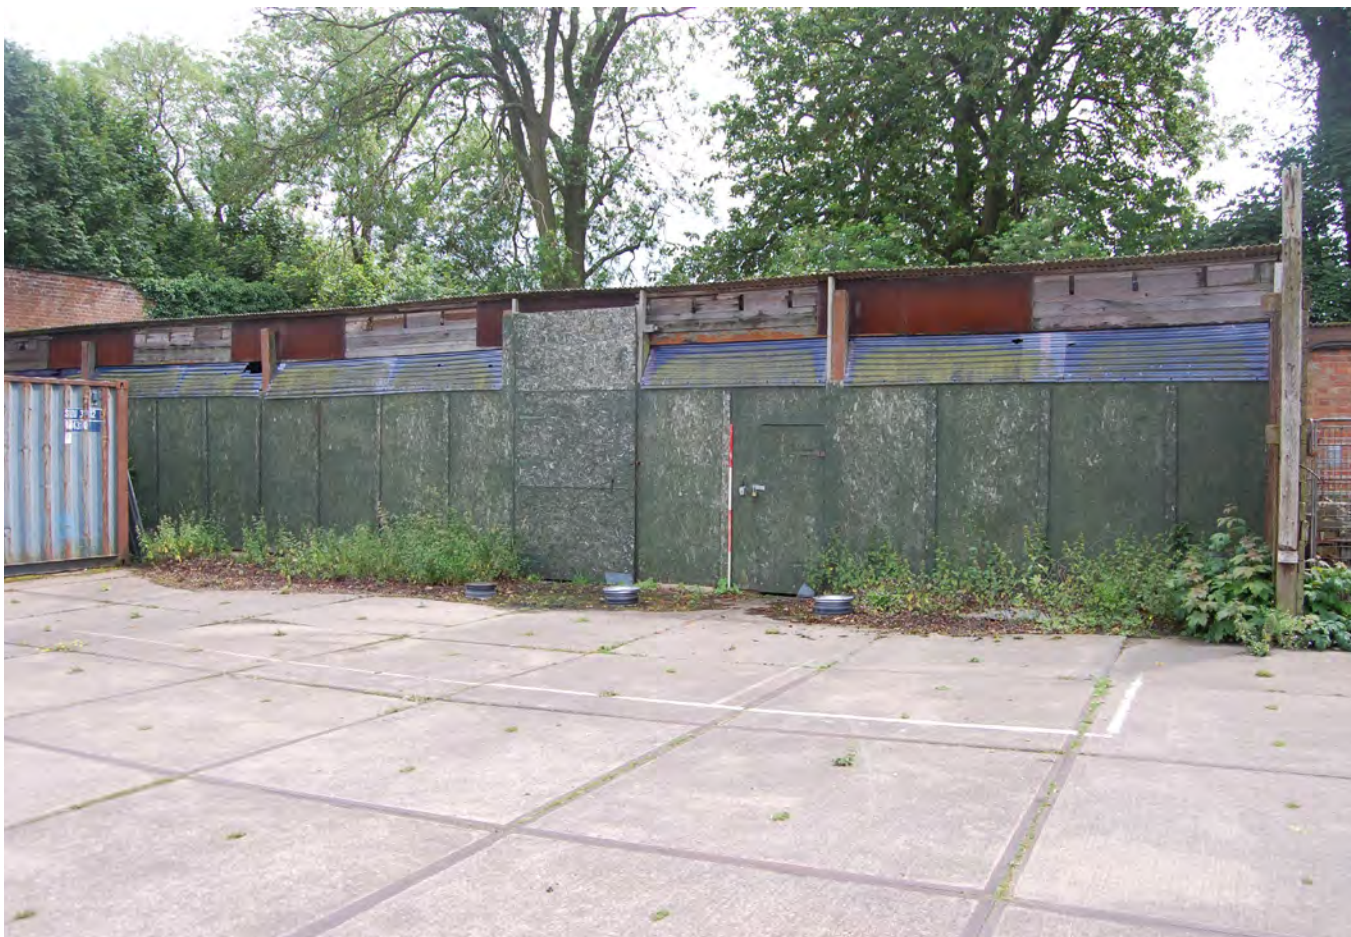
Plate 89.1 Front (north) elevation

This building is an unusual configuration, it is an earlier red-brick firing range with has been extended to the front to enable the internal space to be used for storage (Plate 89.1). The building is built up to the firing range wall that comprises its east elevation, and the west elevation consists of timber panelling to the east built on to an earlier red brick rectangular projection to the rear of the building (Plate 89.2). This west elevation also consists of a tall central red brick element, which is situated between the timber panelling and rear single-storey red brick element (Plate 89.3). The rear (south) elevation is also constructed from red brick, and contains crittall windows (Plate 89.4).

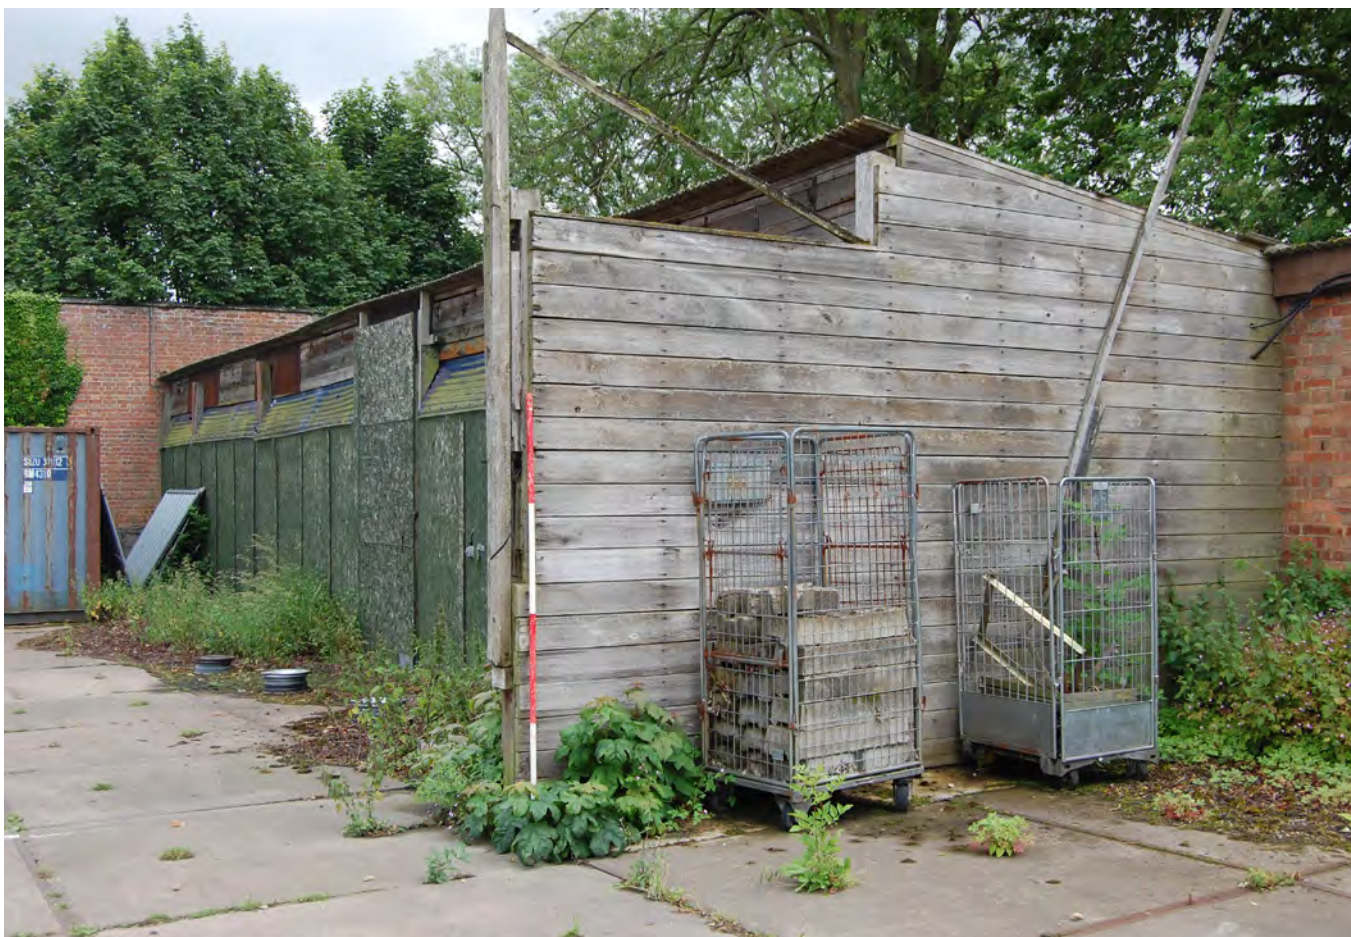
Plate 89.2 West elevation

The east elevation consists of the red brick firing wall range, which the building has been built up to (Plate 89.6). The west elevation consists of three elements, to the north is timber boarding which extends beyond the front (plywood) elevation and pre-dates this later addition (see Plate 89.2). This boarding extends to the rear single-storey element of the building, which has a timber fascia below a corrugated sheeting roof and a painted sign which gives the earlier 'AmNo', although it is now not possible to read the number (Plate 89.7). A door has been infilled within the west facing element of the single storey section, and a concrete lintel is visible above (Plate 89.8). To the rear a wood panelled door remains *in situ* (although access is not possible), and two crittall windows. The purpose of the tall double-storey element of the building, which is situated at the western extent of the structure, is unclear and access is not possible.

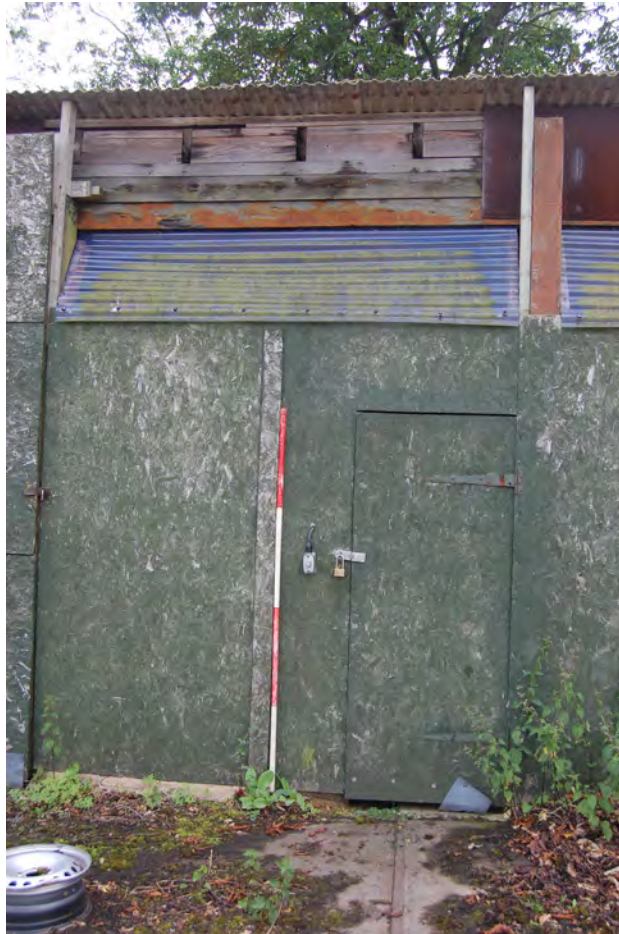
Plate 89.5 Door to front (north) elevation within plywood extension

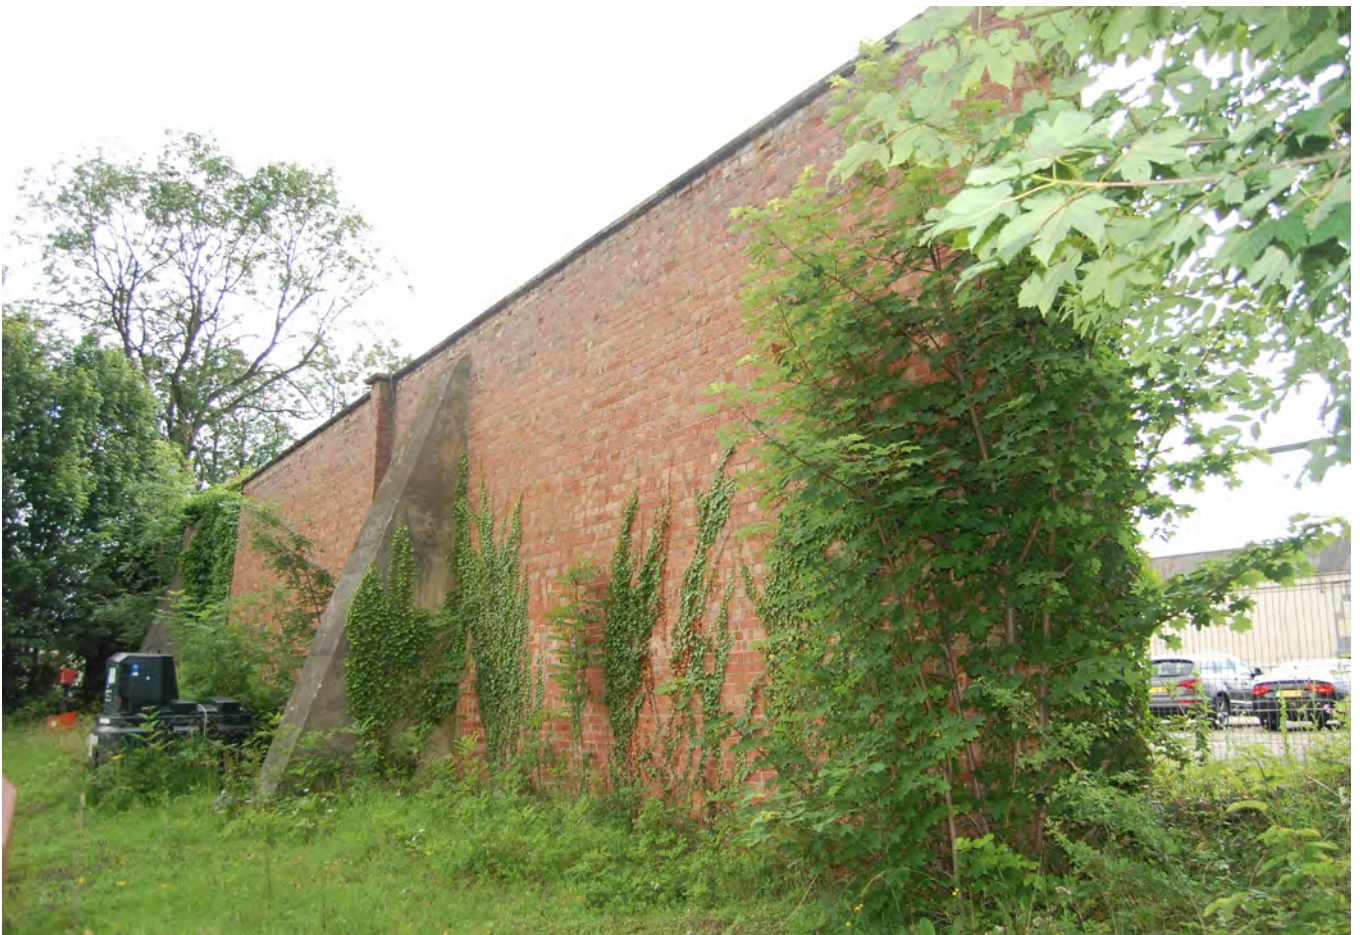
Plate 89.6 Firing range wall (east elevation)

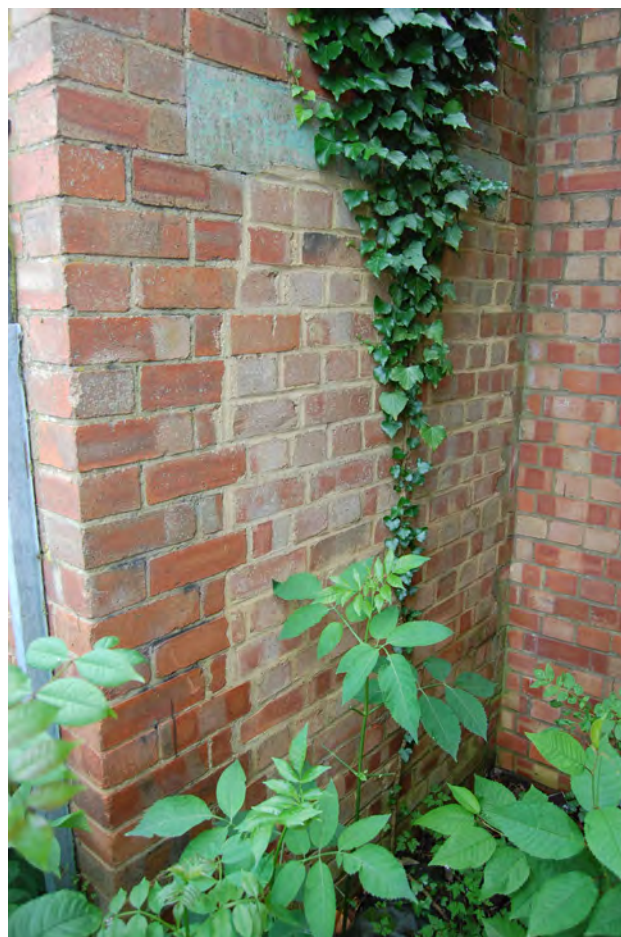
Plate 89.8 Infilled door at west element of north elevation

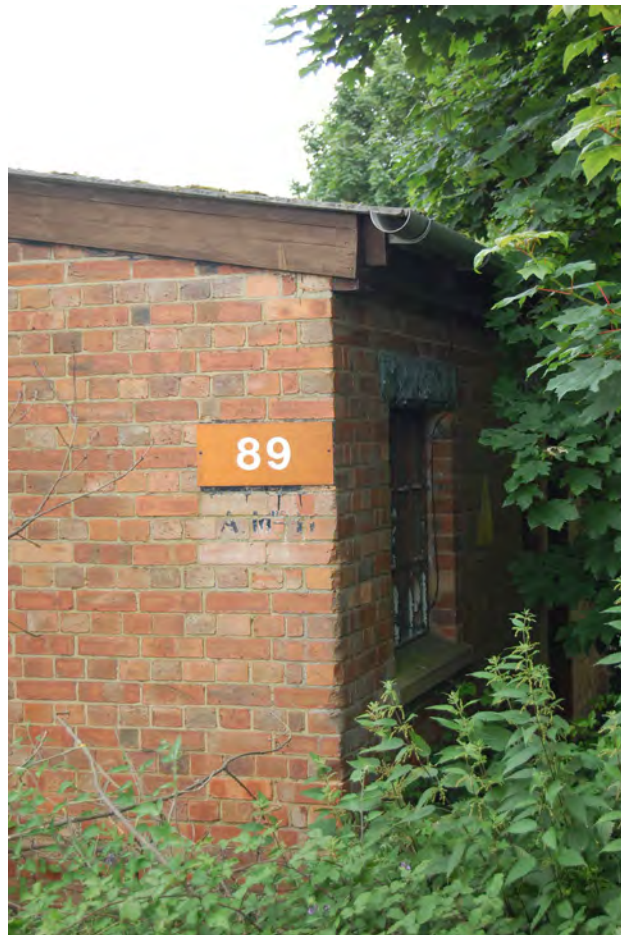
The rear elevation is very overgrown with vegetation inhibiting interpretation. As described above, at the west end of the elevation are two crittall windows, and concrete sills (Plate 89.9). There is a further door to the east, which also has a concrete lintel above, and is painted green with brown paint visible beneath (Plate 89.10). There are also two large vents (1m square) at the base of the elevation which have concrete lintels and metal bars over the openings.

Plate 89.9 Rear elevation, crittall window

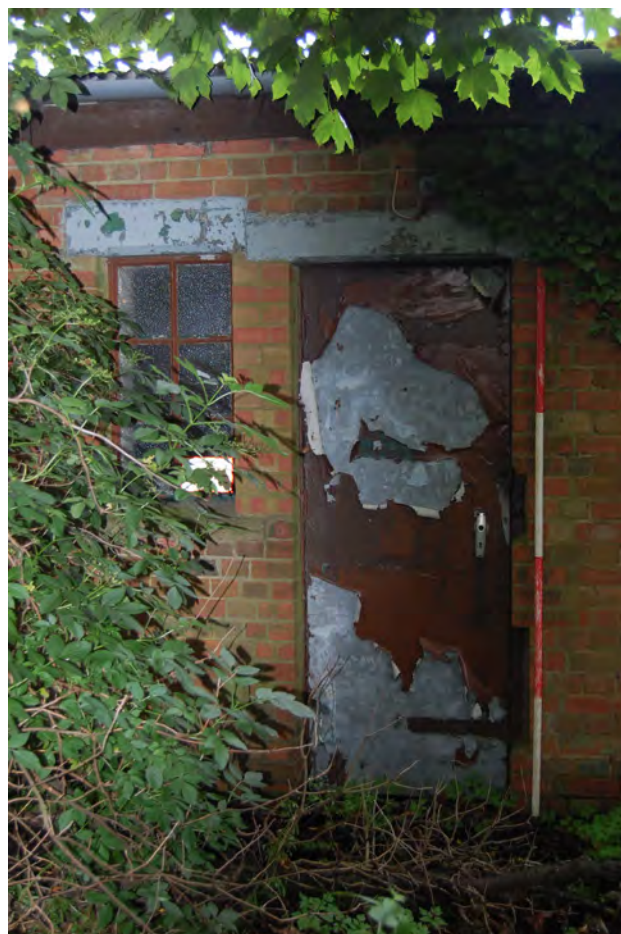
Plate 89.10 Rear elevation, crittall window and door

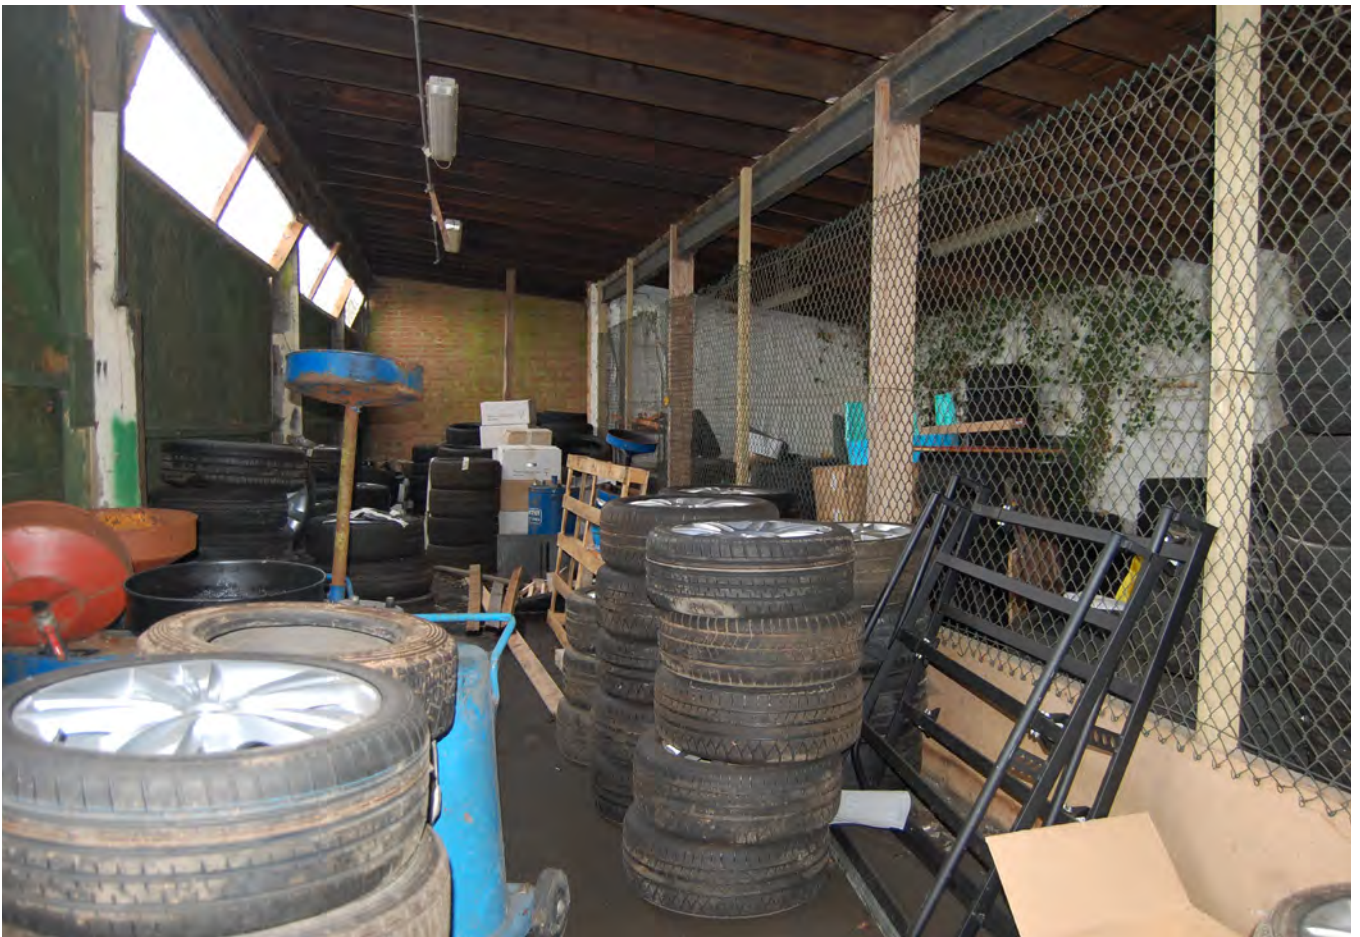
Internally, access was possible to the main body of the building via the extended front elevation. Access was not possible to the west end, in particular the tall double-storey element of the building. The building is used for storage, predominantly tyres, and has been separated recently in half longitudinally (Plate 89.11). Modern timber posts extend up to an overhead steel girder running the length of the building and orientated east to west, with wire mesh fencing between the posts. This has created a separate storage area to the rear of the building. Internally the building has exposed brick elevations (painted white) with a timber roof supported on joists orientated north to south. There is overhead strip lighting. The vents (also described above) are situated along the rear wall at ground level and painted green, these have been built into the brick elevation and are contemporary with the primary build of the former firing range (Plate 89.12). These may have been used to extract fumes resulting from practice fire.

Plate 89.11 Internal view, looking east
