FORMER RAF UPPER HEYFORD, OXFORDSHIRE

HISTORIC BUILDING RECORDING AND INVESTIGATION

VOLUME 2: GAZETEER OF RECORDED STRUCTURES

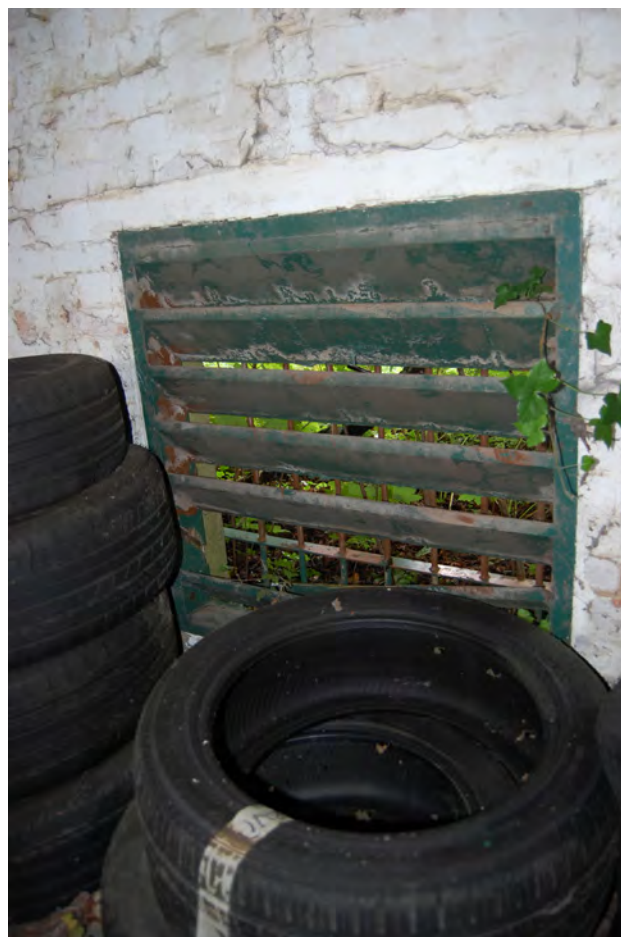
Internally, access was possible to the main body of the building via the extended front elevation. Access was not possible to the west end, in particular the tall double-storey element of the building. The building is used for storage, predominantly tyres, and has been separated recently in half longitudinally (Plate 89.11). Modern timber posts extend up to an overhead steel girder running the length of the building and orientated east to west, with wire mesh fencing between the posts. This has created a separate storage area to the rear of the building. Internally the building has exposed brick elevations (painted white) with a timber roof supported on joists orientated north to south. There is overhead strip lighting. The vents (also described above) are situated along the rear wall at ground level and painted green, these have been built into the brick elevation and are contemporary with the primary build of the former firing range (Plate 89.12). These may have been used to extract fumes resulting from practice fire.

Plate 89.12 Internal view of vents in rear wall

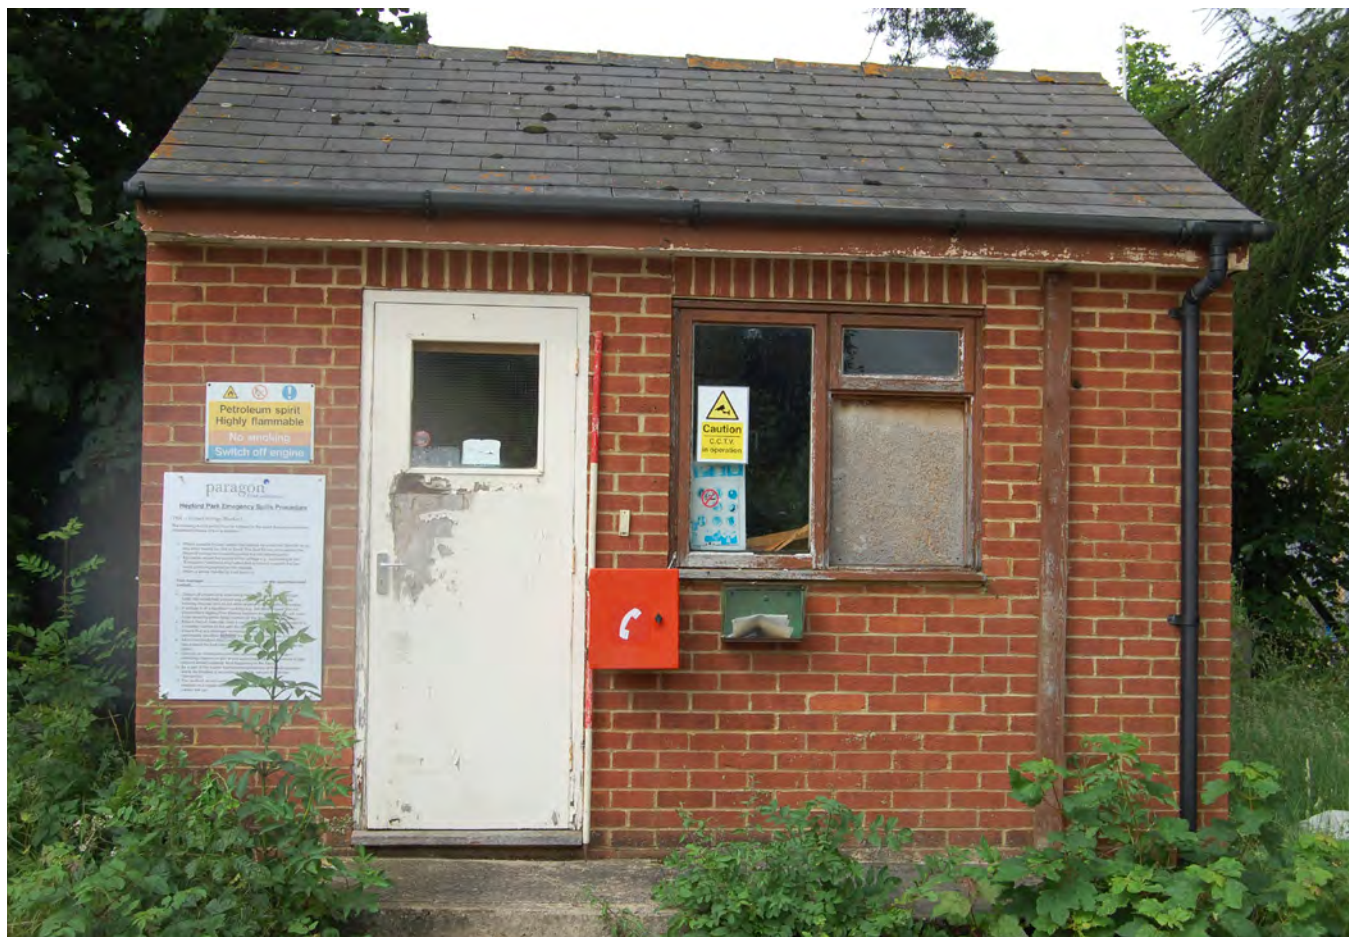
Plate 89A.1 Front (south) elevation

Small single storey brick shed with a pitched tiled roof and timber fascia. The building is roughly square in plan with brown timber framed windows, and remains in use by Paragon for refuelling. The south (front) elevation has a plain timber door and a three-light window.

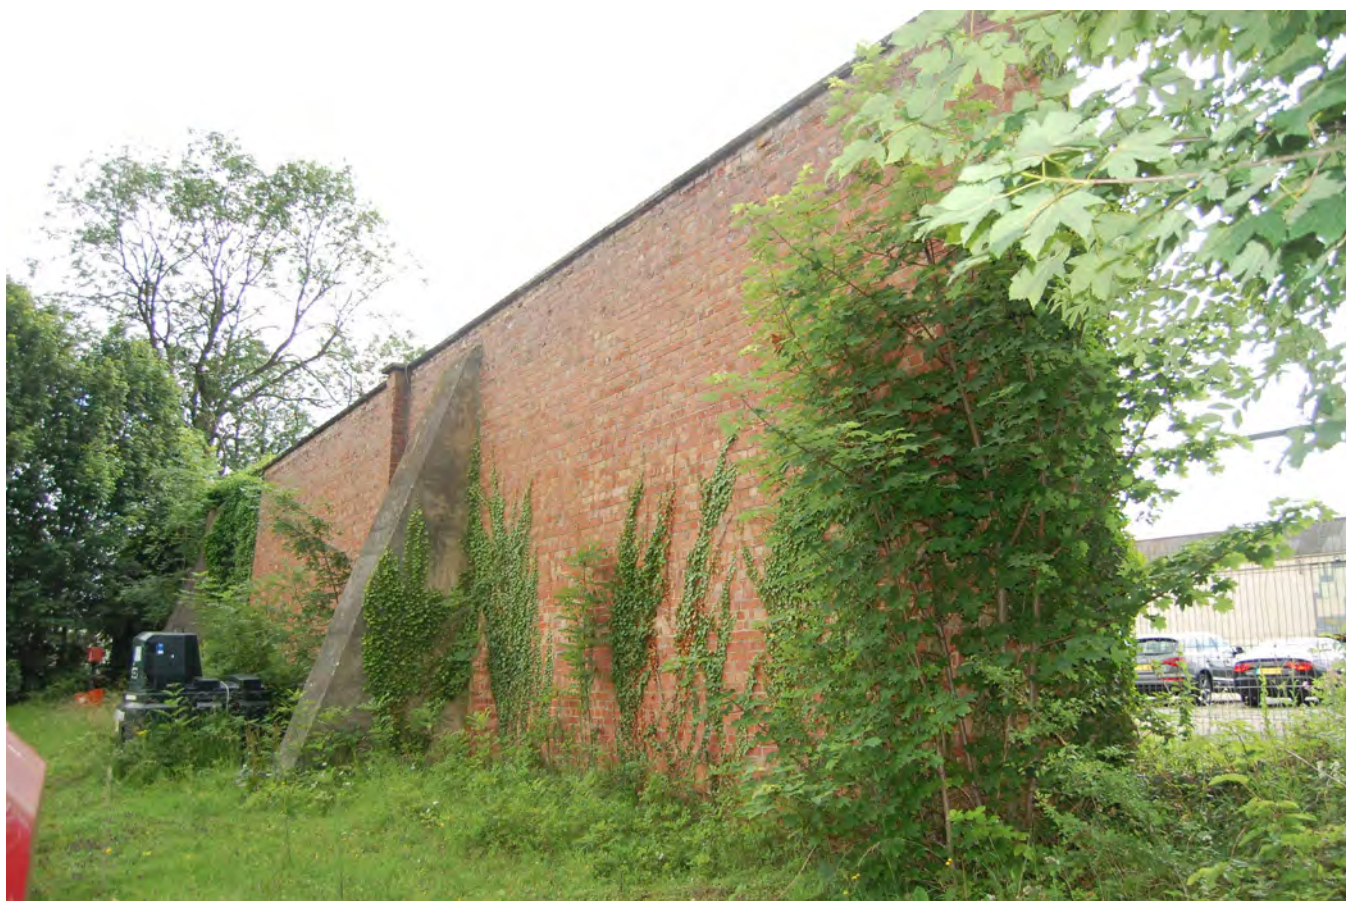
Plate 89B.1 East side of wall 89B

The blast separation wall is constructed from typical, mid 20th century red/orange brindle bricks laid in English bond. It is approximately c.35 m long and c.5.5 m tall. To the east side there are three sloping concrete buttresses and there is also a brick pier towards the centre of the structure.

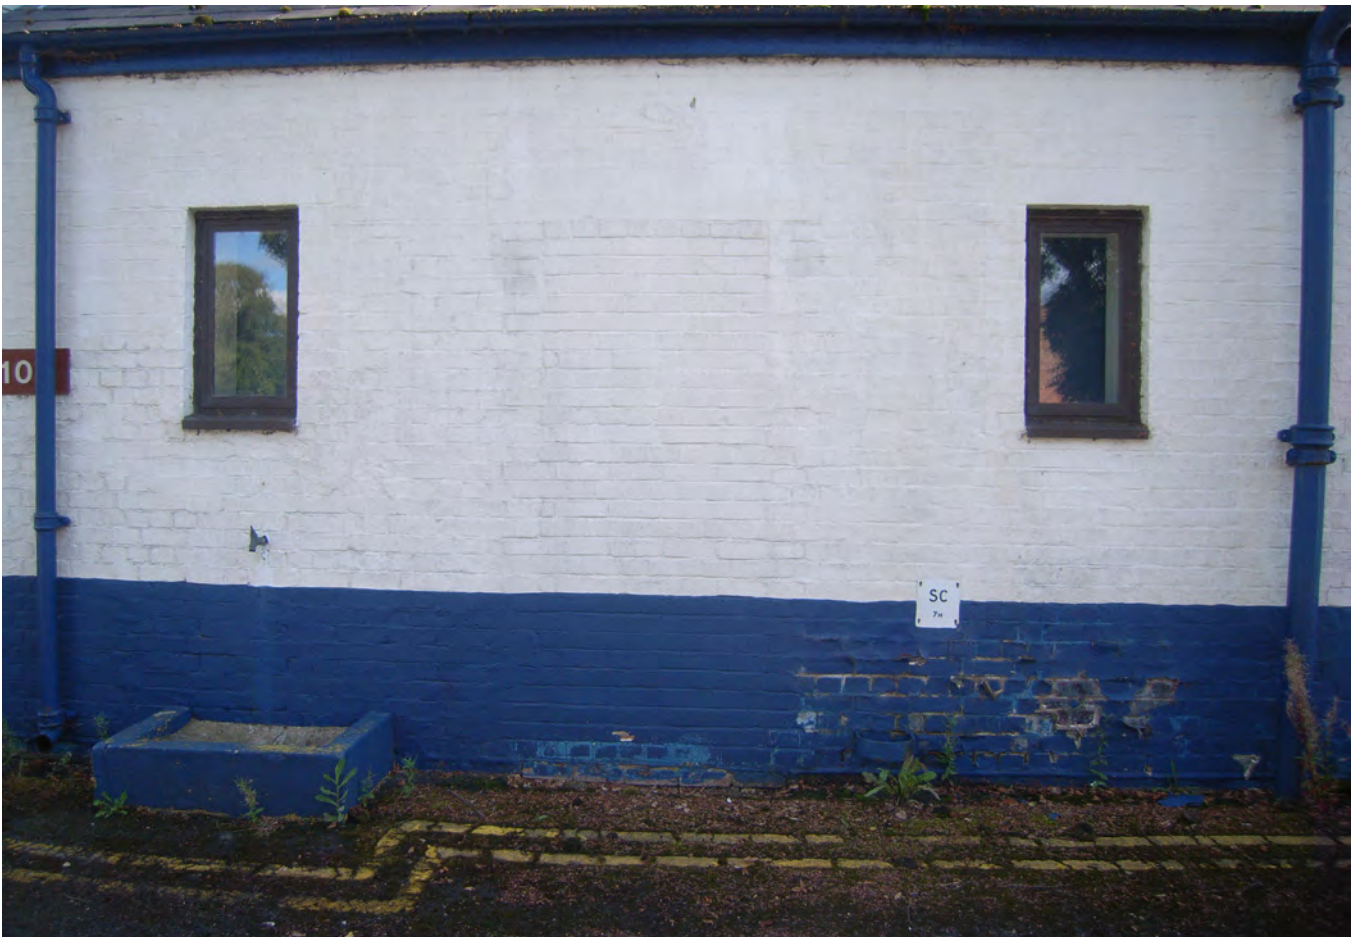
101/2.7 Ready Station, infilled door to front elevation

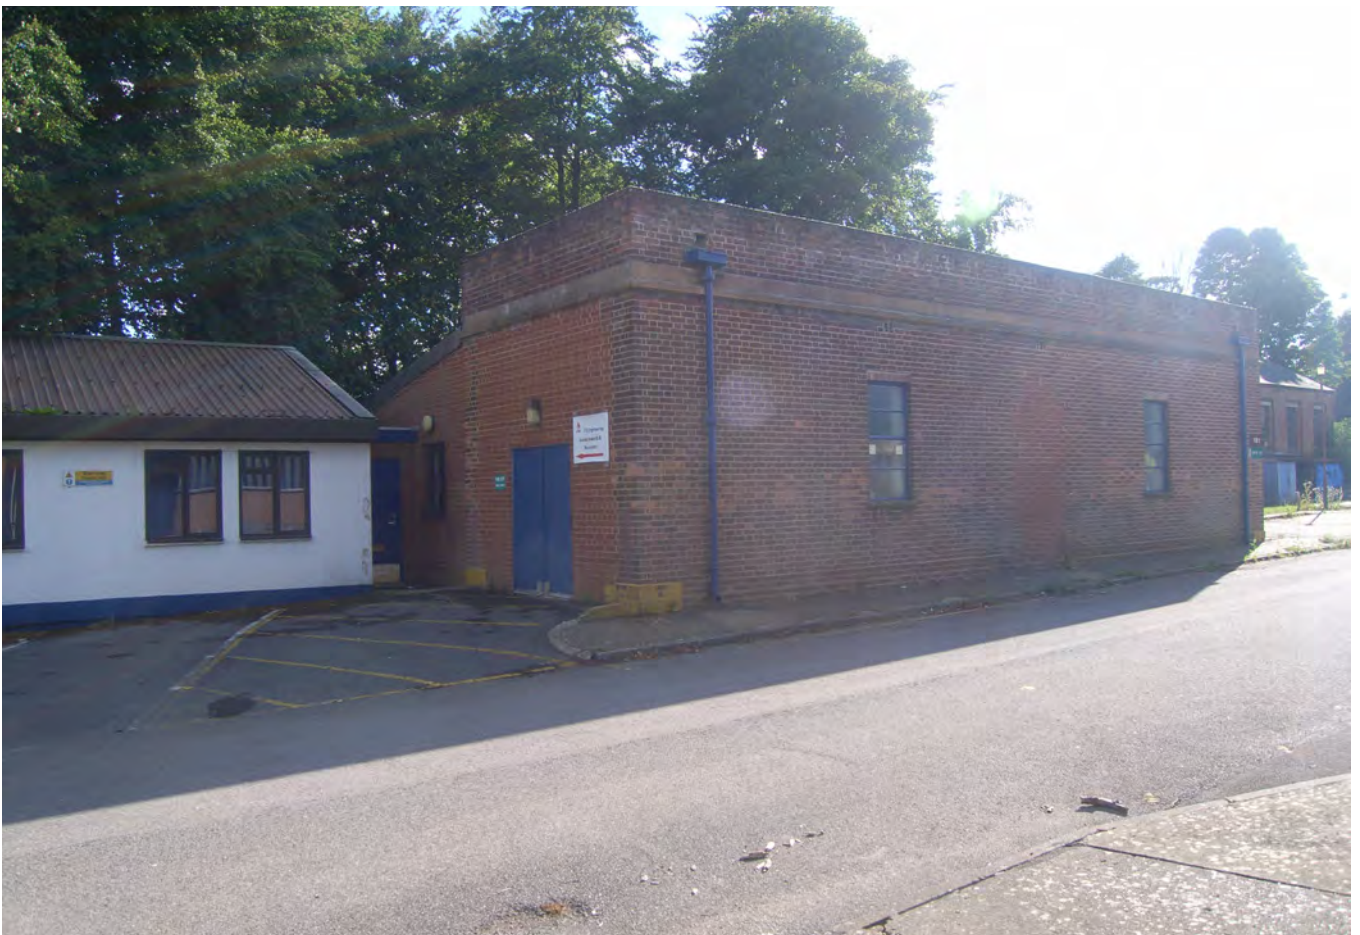
101.2/14 Maintenance Shop, showing brick infill to south and west elevations

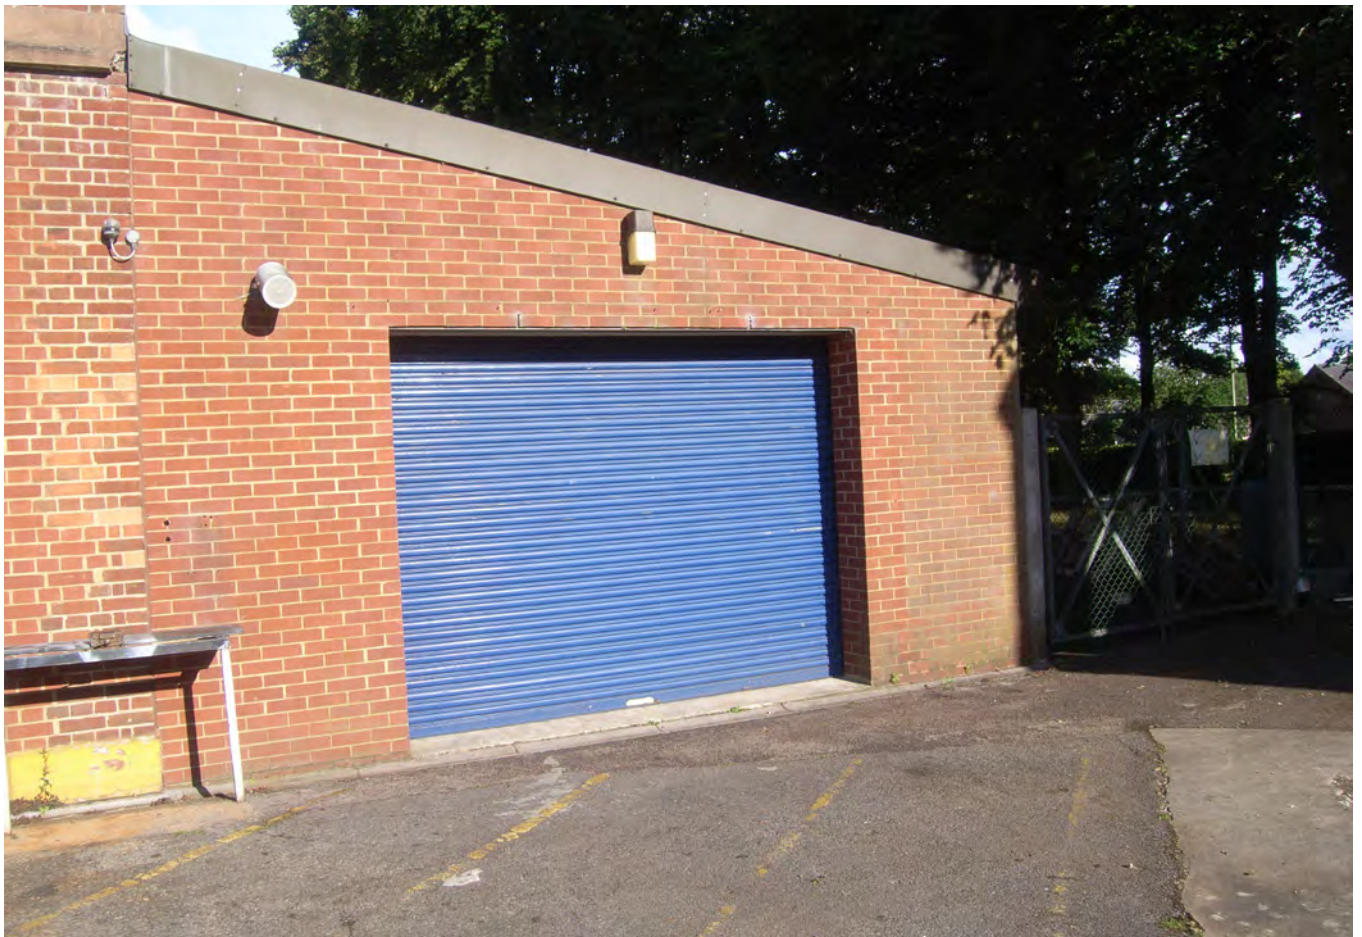
101/2.17 Maintenance Shop, front elevation showing 1970/ 80s extension

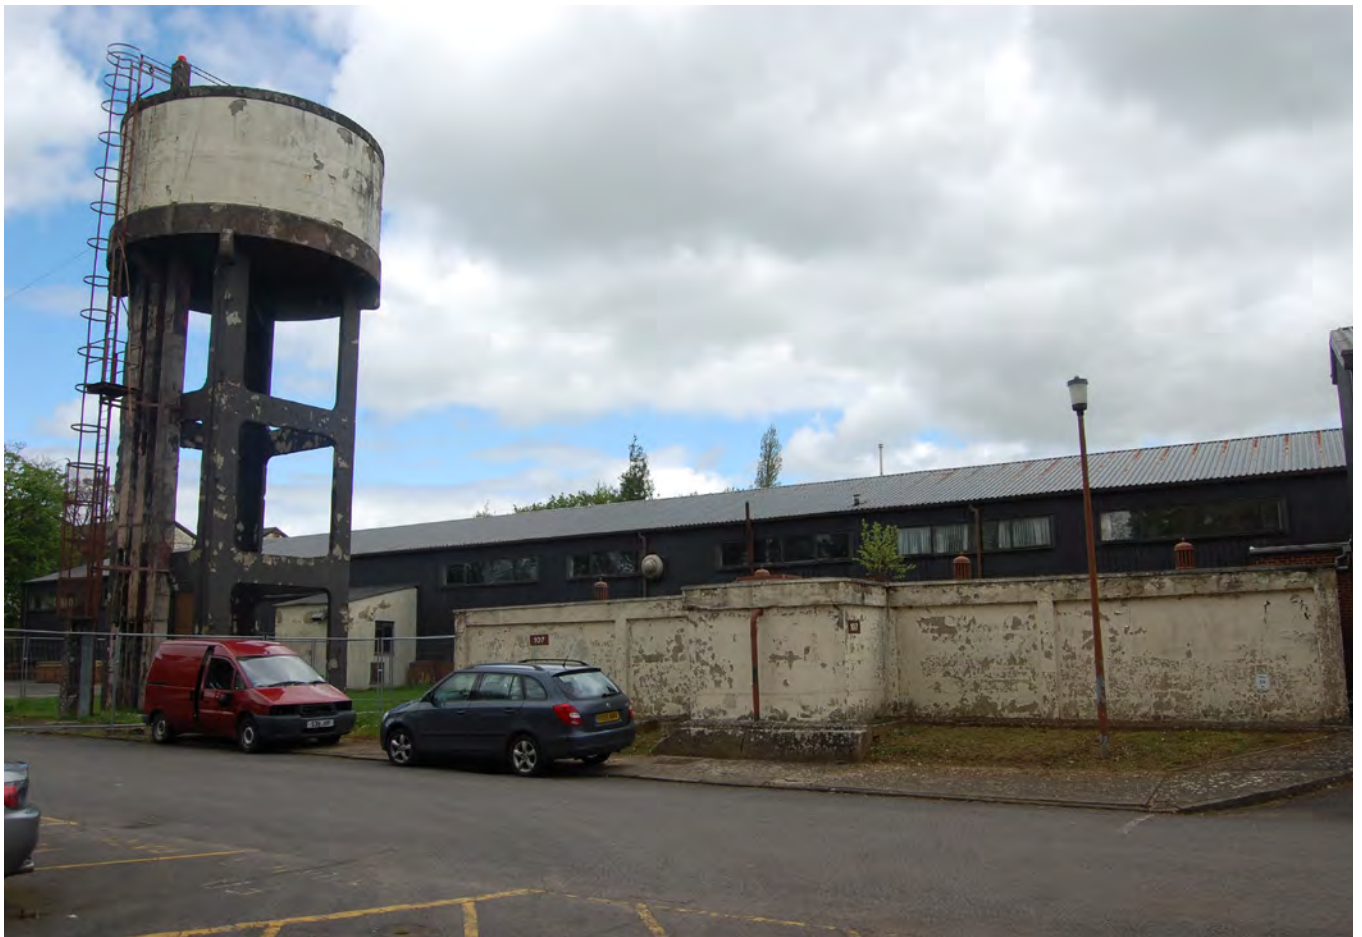
Plate 107.1 South elevation

The internal tank has a flat metal roof, with two rows of four metal cowls visible sitting internally on top of the water tank (Plate 107.4). The building is now in relatively poor condition with badly peeling paint, and a tree growing from the top of the tank.

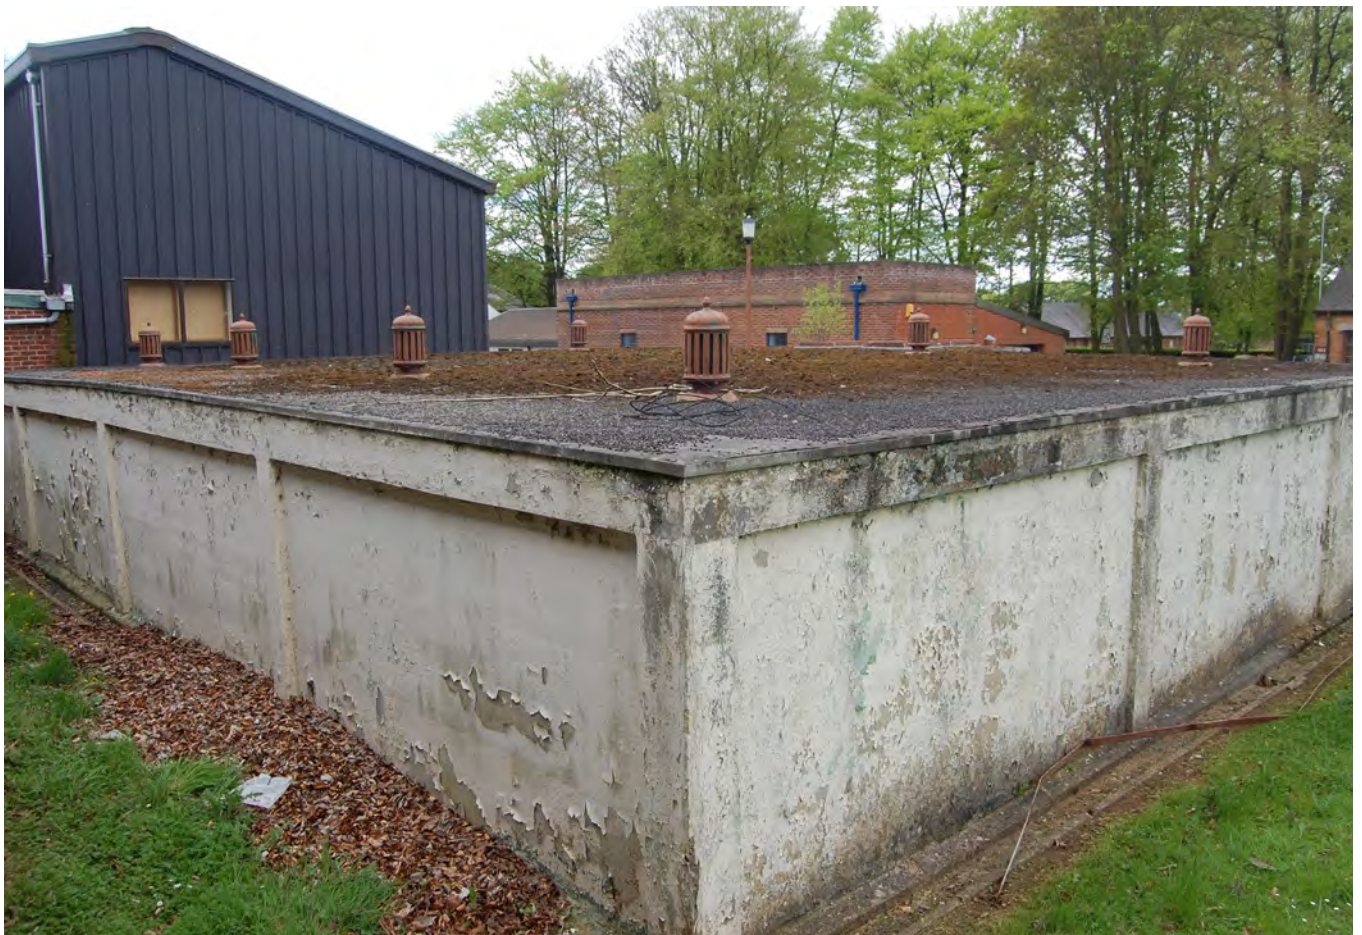
The reservoir sits directly adjacent to the water tower (108), and is one of an interesting group of structures of this period within the area (Plate 107.1). It is constructed from concrete panels with reinforced concrete bars which are painted white, and sits on a concrete raised base (Plate 107.2). There are four concrete panel sections to the rear, and three to each side elevation. The building is rectangular with a rectangular projecting element to the front (projecting 1.62m, and 2.67m in width). There is a channel running around the footprint of the building (Plate 107.3).

Plate 107.2 Rear view showing concrete panels

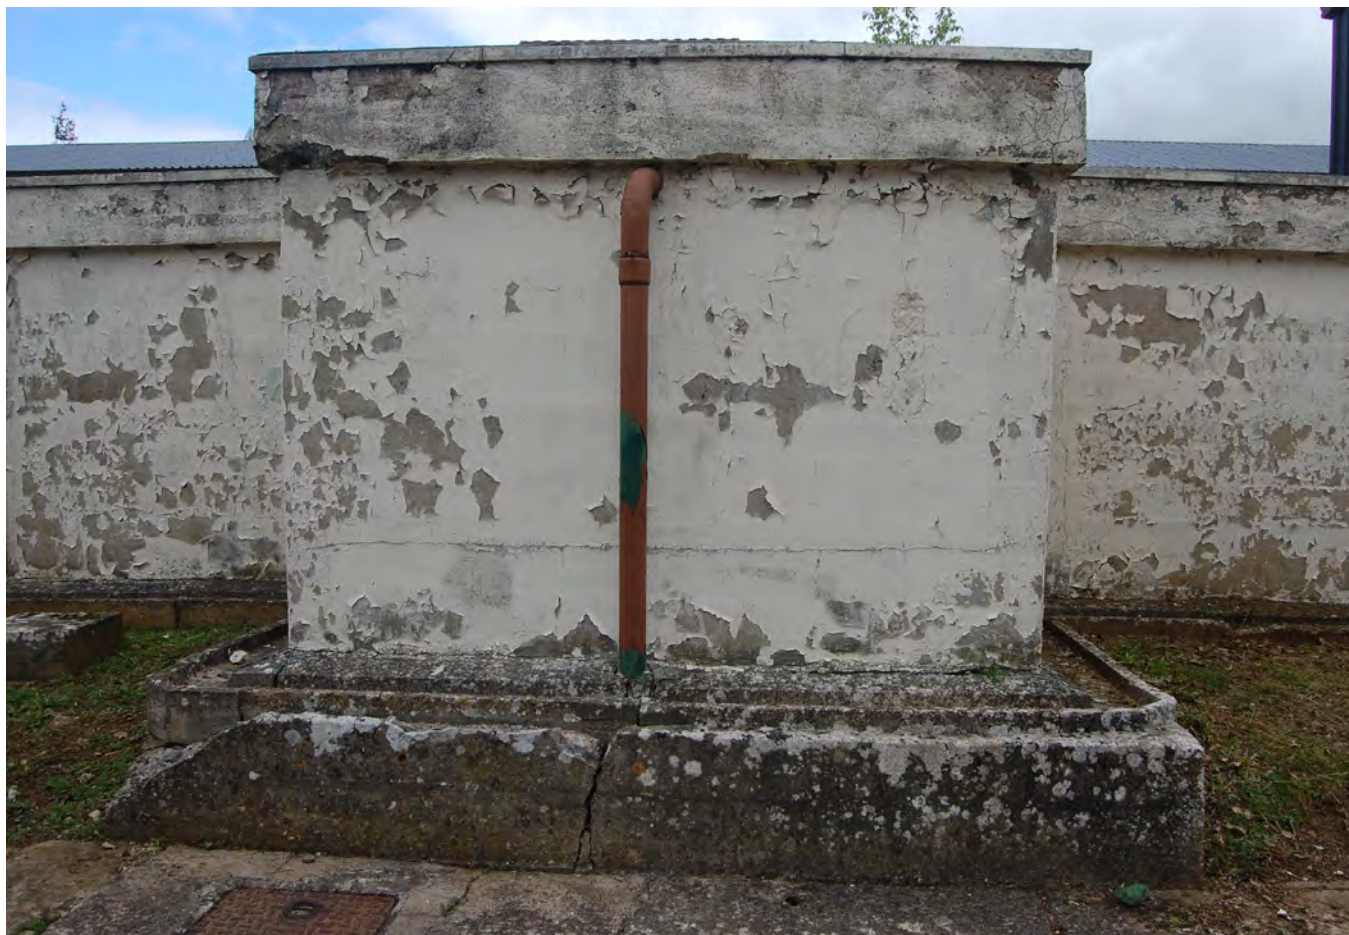
Plate 107.3 Base of water tank showing projection and channel running around the footprint

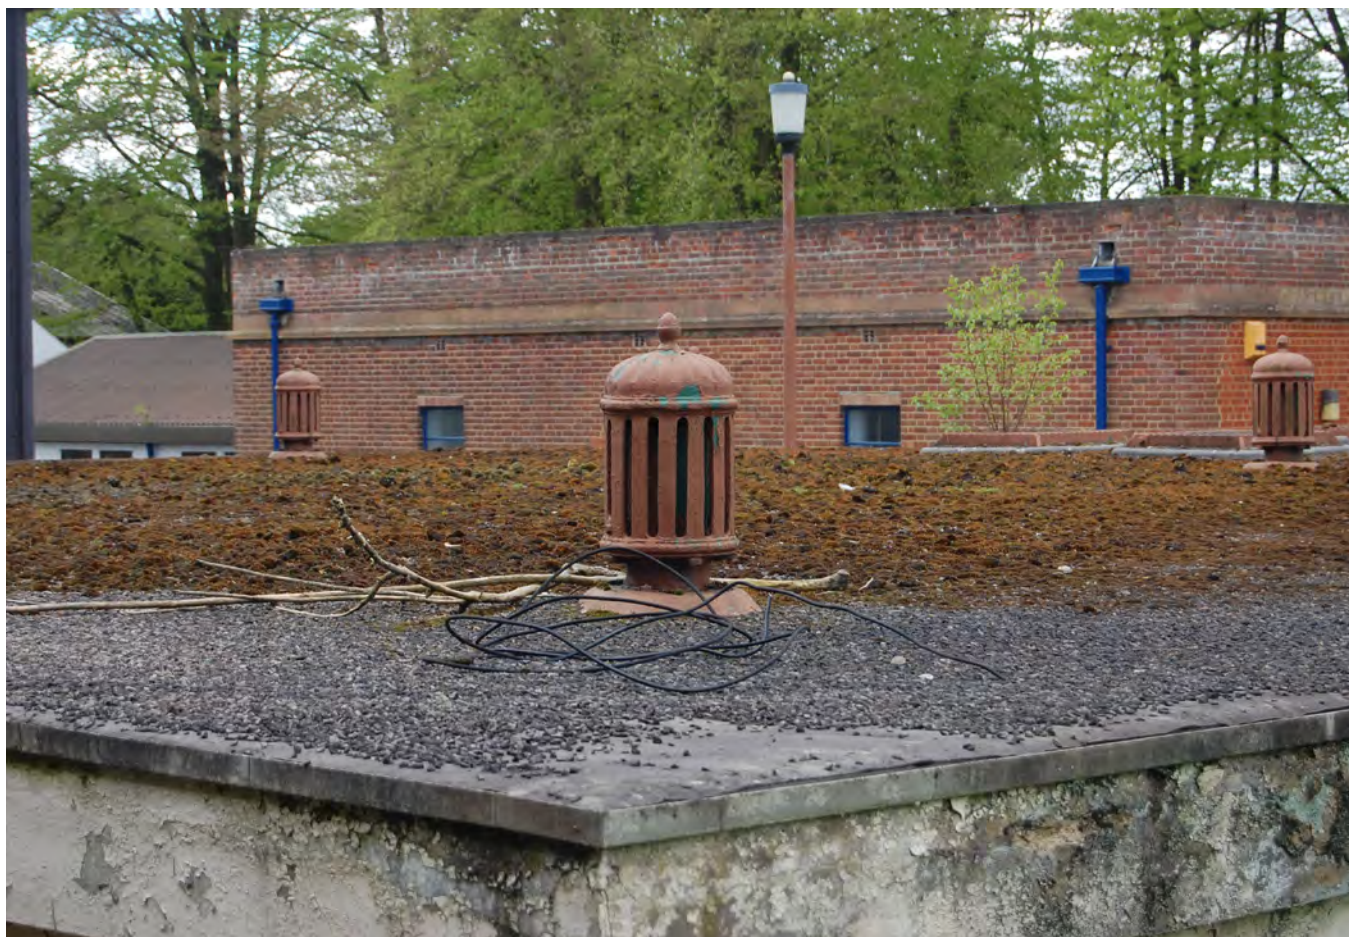
Plate 107.4 Top of tank showing cowels

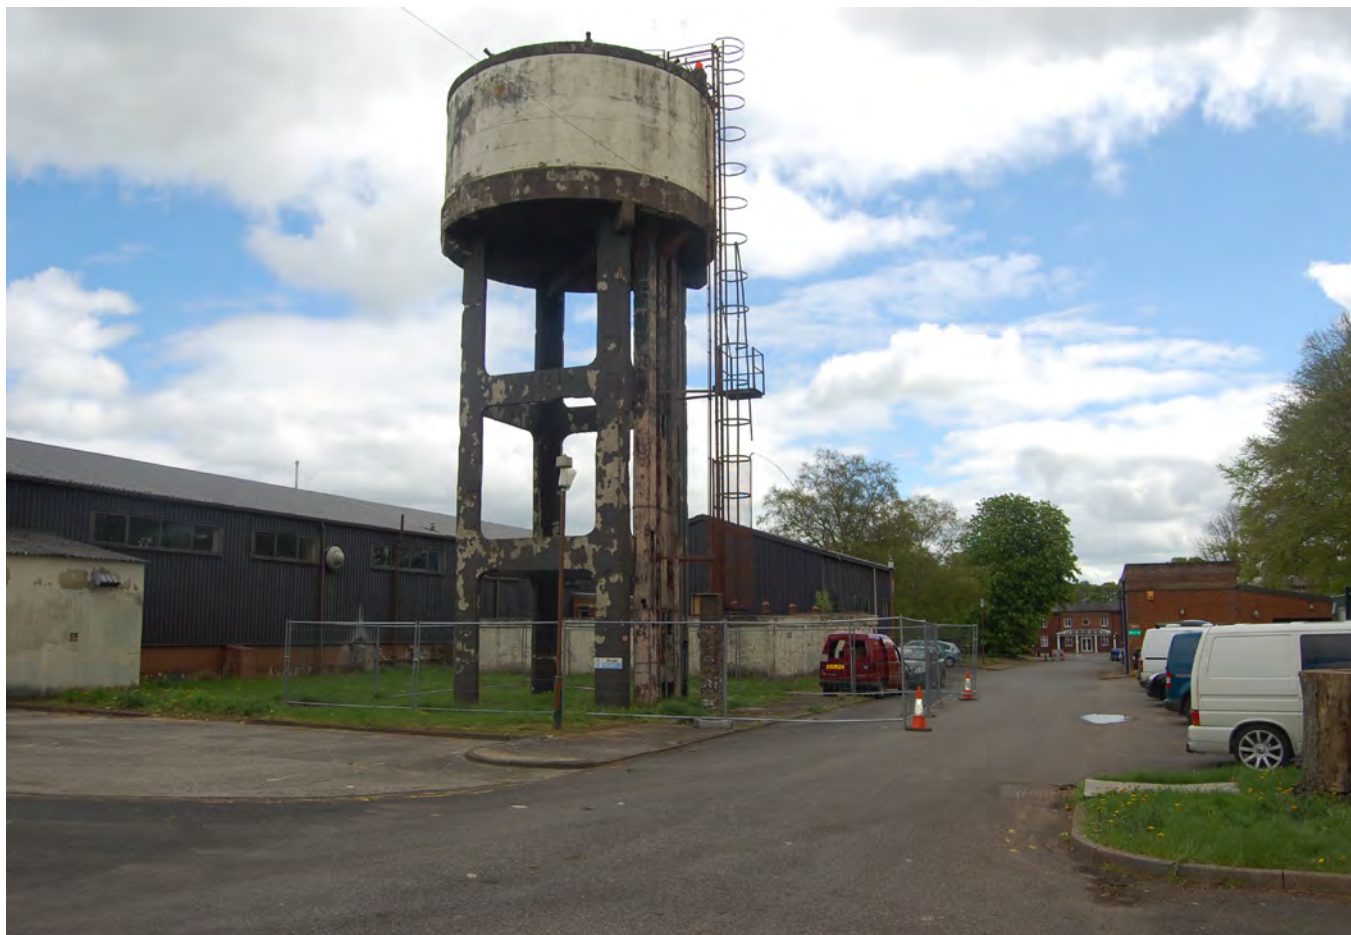
Plate 108.1 View from west of tower

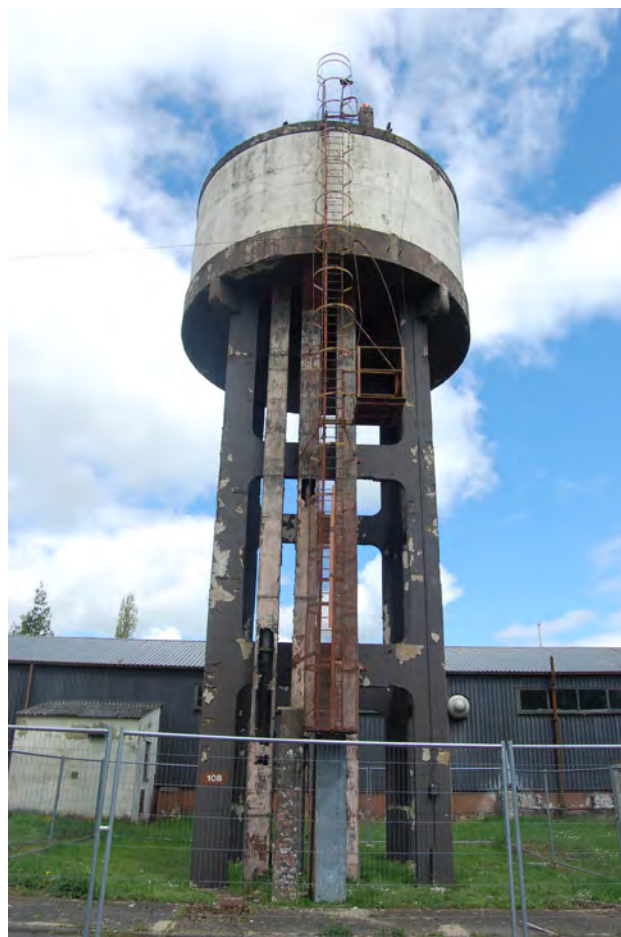
Plate 108.2 South elevation

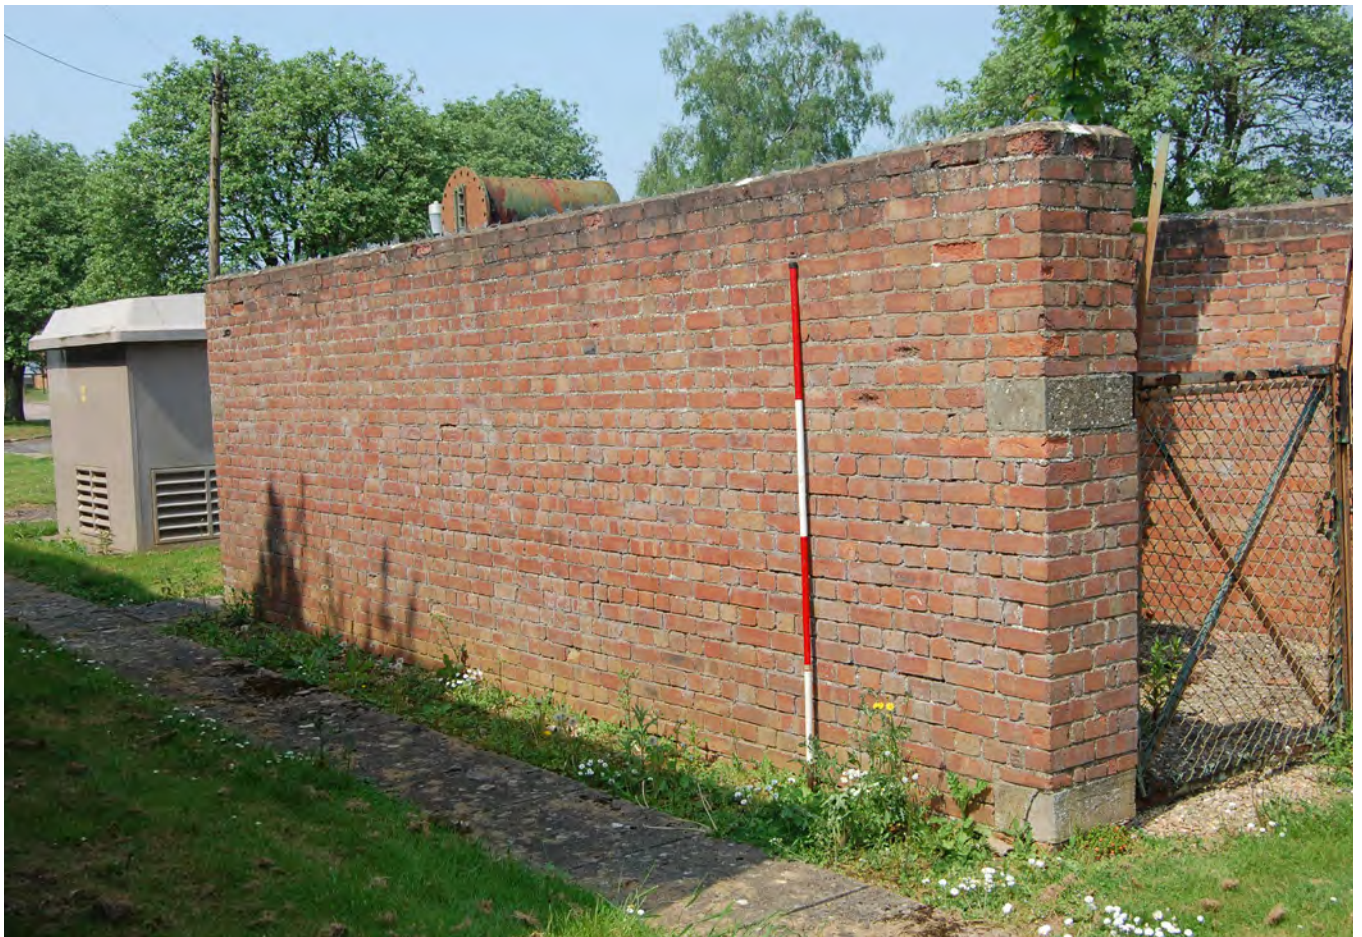
Plate 113.1 North east and south west elevations

The Transformer House is now disused, but still in fairly good condition

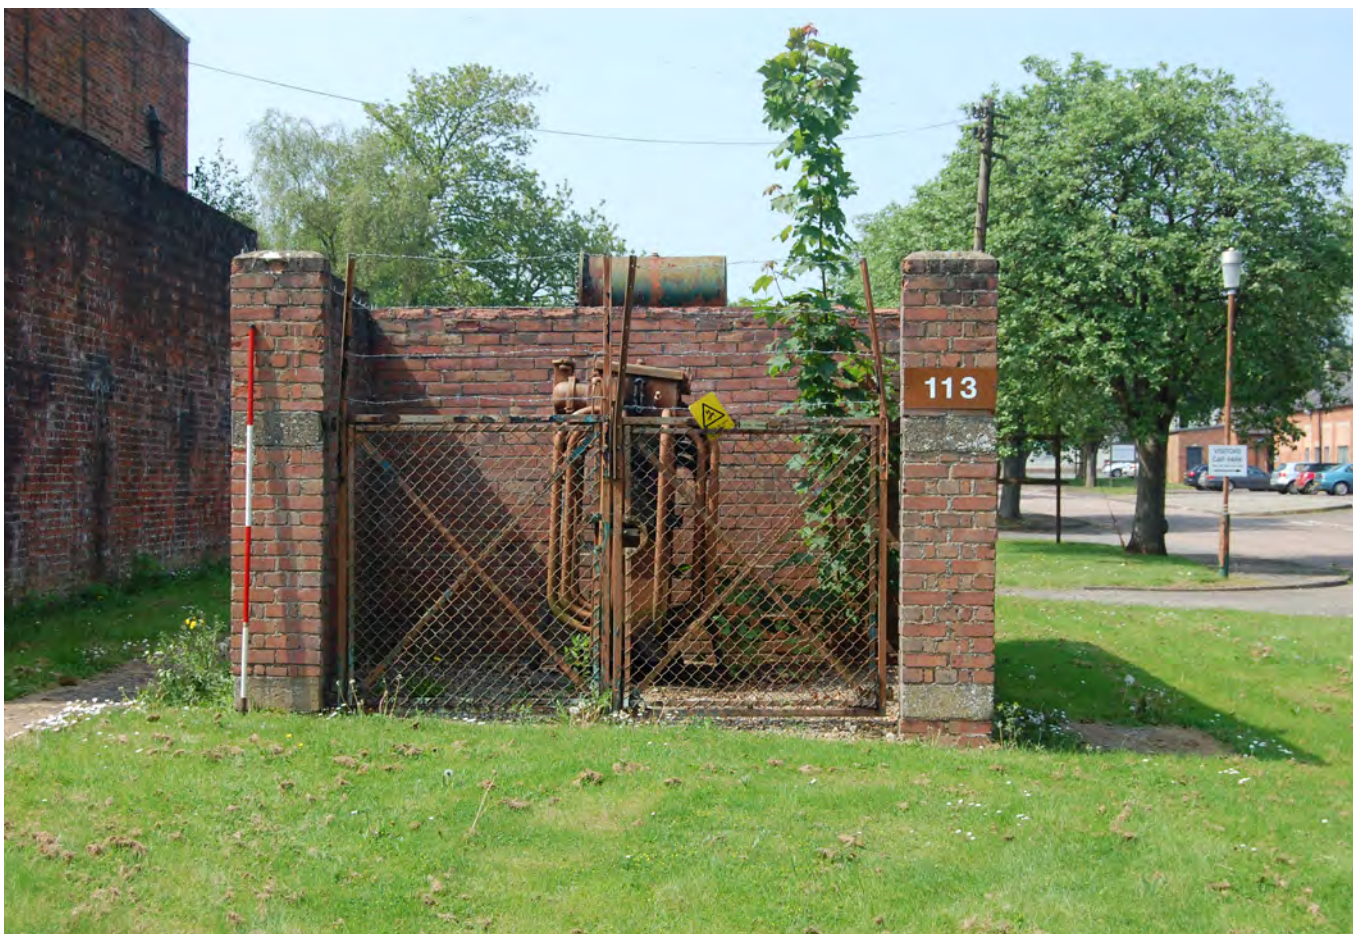
This enclosure is built in English Bond brickwork to a height of approximately 2.3m and in plan is 3.8m (north-east to south-west) by 7.2m (north-west to south-east). It is essentially of one phase, although the dividing wall to the south-east of centre may be a later addition as it abuts the walls either side. The outer walls are topped with a layer of mortar set with shards of window glass set on edge to discourage trespassers. The sides of the building, the north-east and south-west walls, are featureless (Plate 113.1); the end walls are open with a short return to the inside and contain built-in concrete blocks which support the hinges of the mesh and barbed wire metal gates (Plate 113.2). The gates and machinery are painted in the brown used across the airbase, but where the paint has peeled the dark green paint of the former colour scheme is visible. The brown metal building number signs are located on the westernmost return of the north-west end and the southern end of the south-west facing wall.

Plate 113.2 South-east elevation

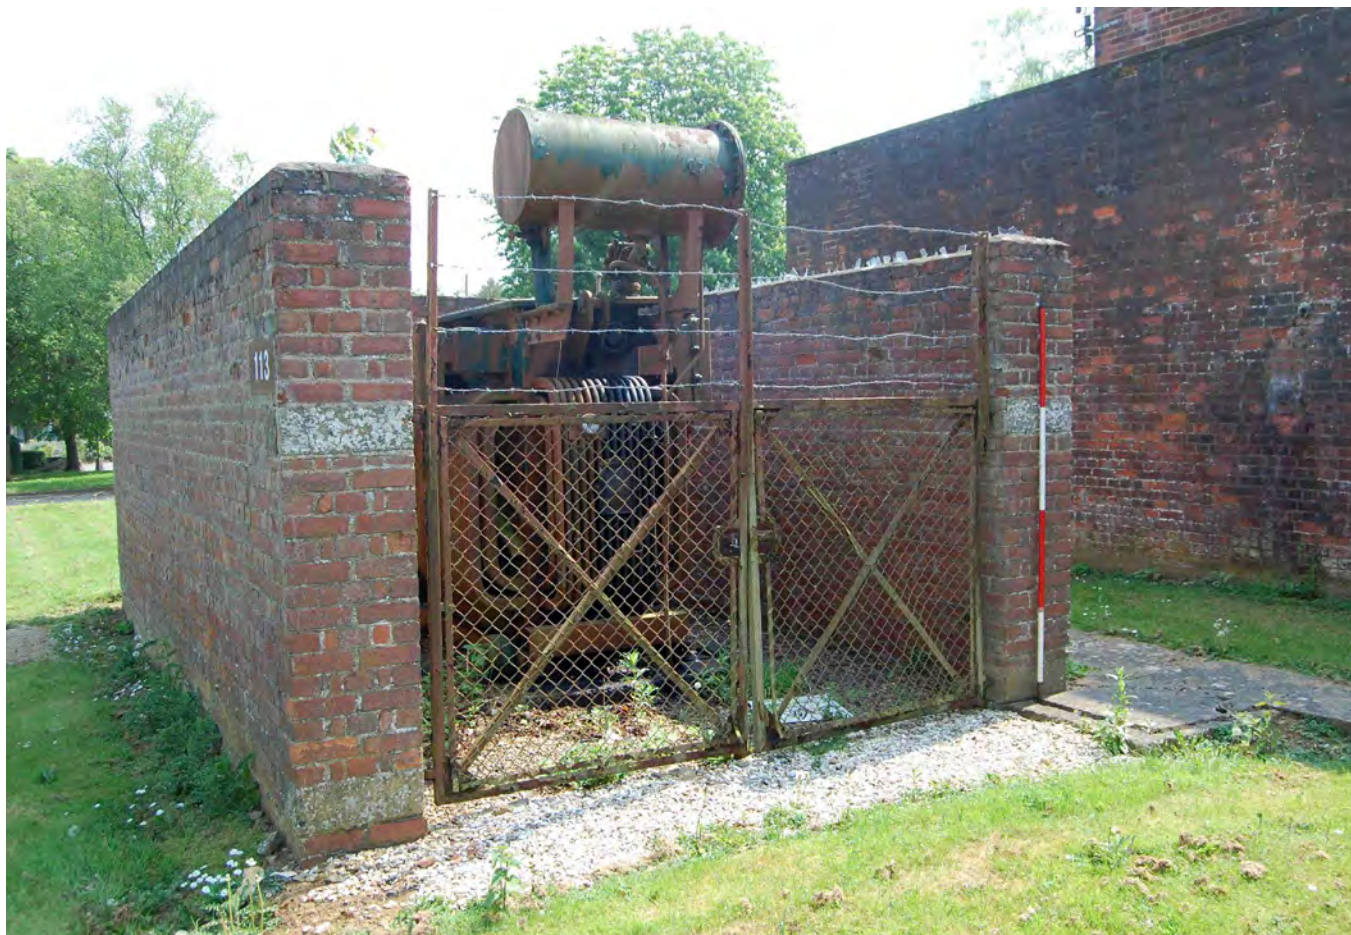
Plate 113.2 North west elevation

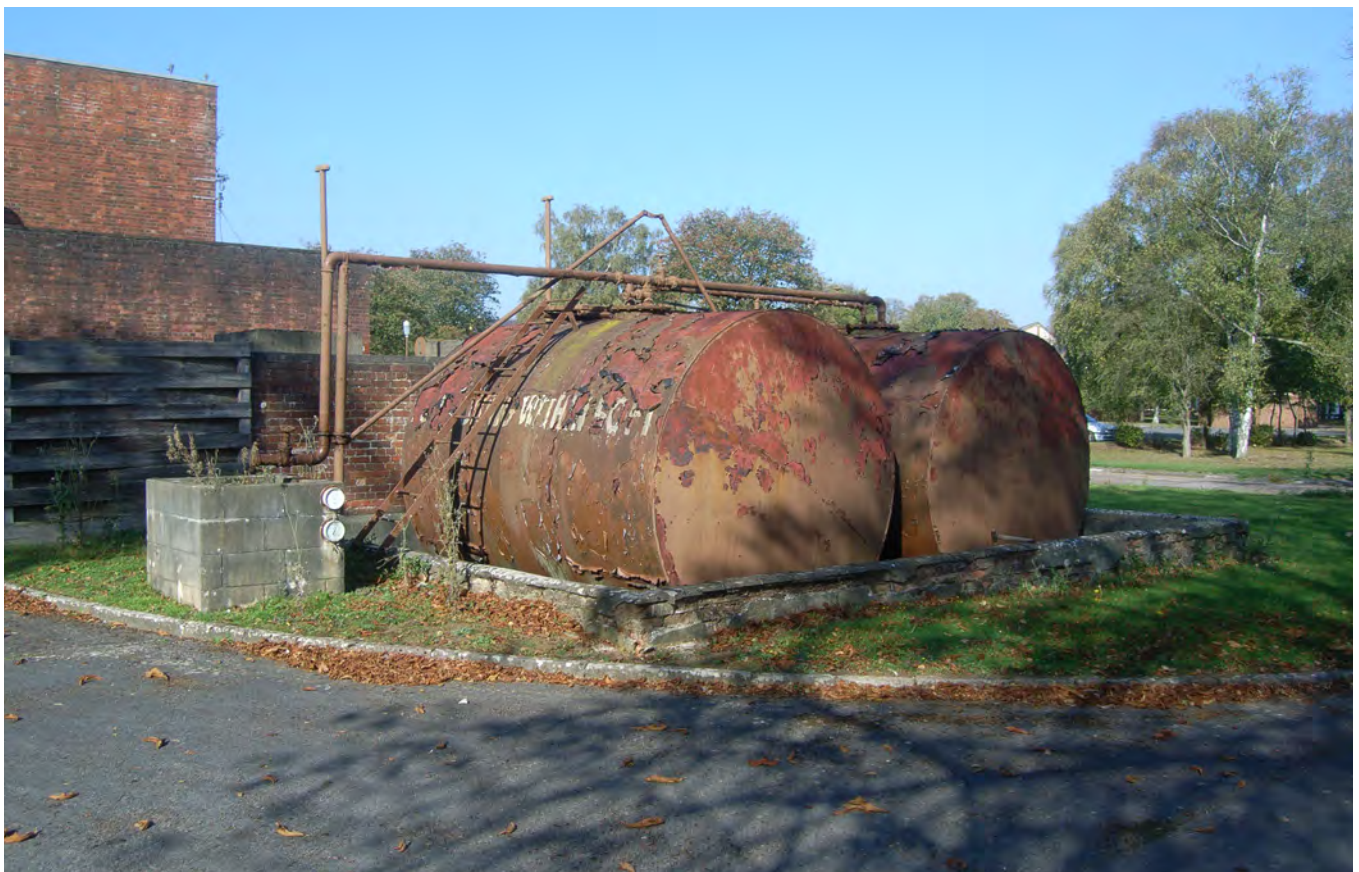
The building includes two large metal tanks which are painted brown, although now badly peeling. These are connected by pipes extending from the top of the tanks to below-ground, the point at which they extend below-ground is surrounded by a low breeze block wall. The tanks sit on concrete pads and are surrounded by a low concrete wall. To the rear is a brick built enclosure in english bond, with a metal hatch to the north elevation at the west end, which is surrounded by metal barriers. There are two pipes extending vertically from inside the enclosure.

Plate 113A South-east elevation

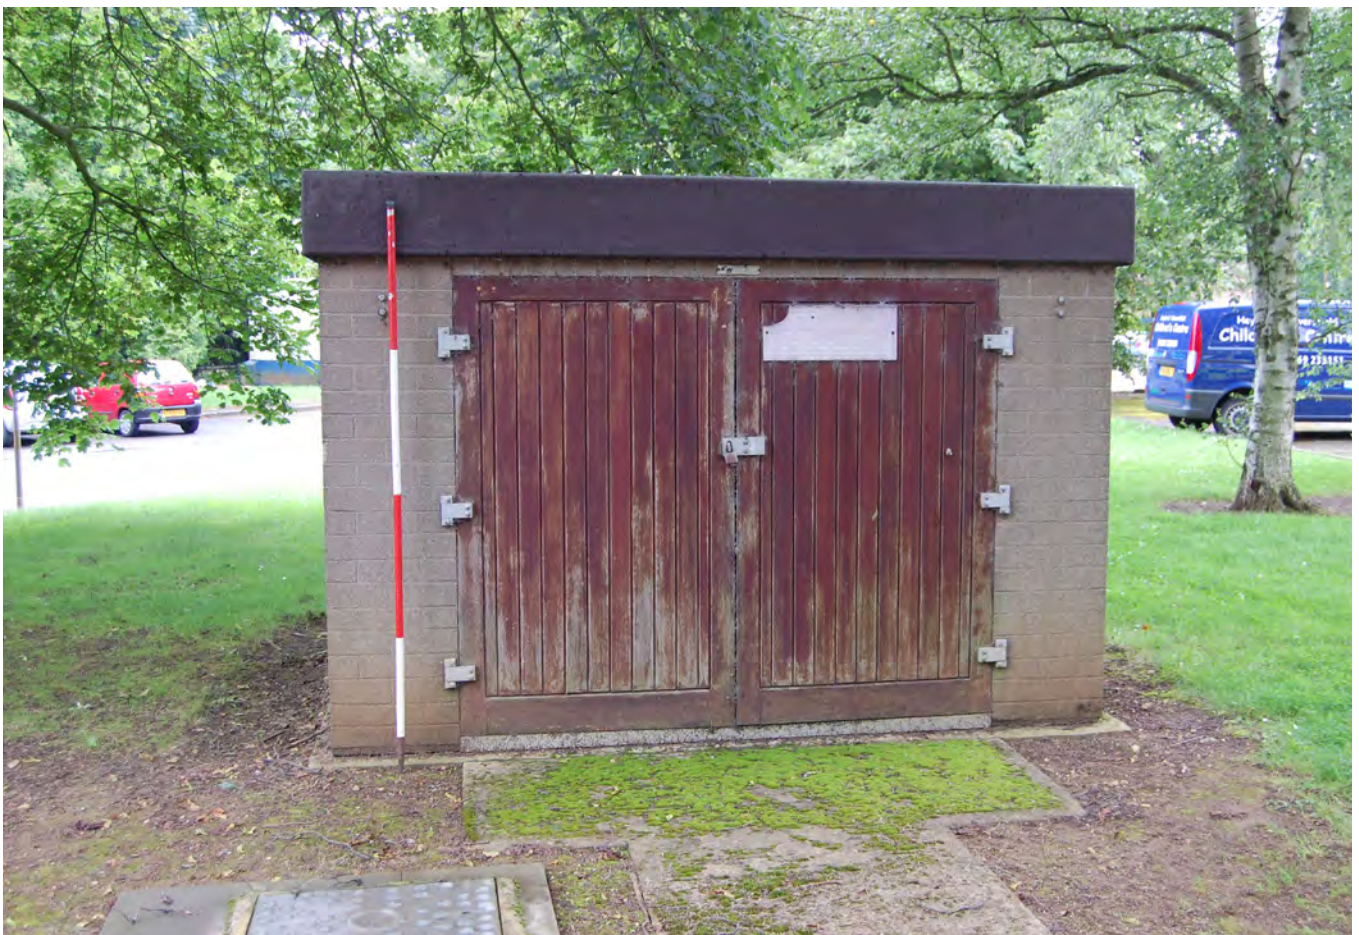
This is a small electricity sub-station with a flat concrete roof, covered in bitumen. It is rectangular in plan with double doors to the front (east) elevation, which are large timber panelled doors. The bricks are grey coloured modern bricks which are thought to date from the 1980s.

Plate 113B East elevation

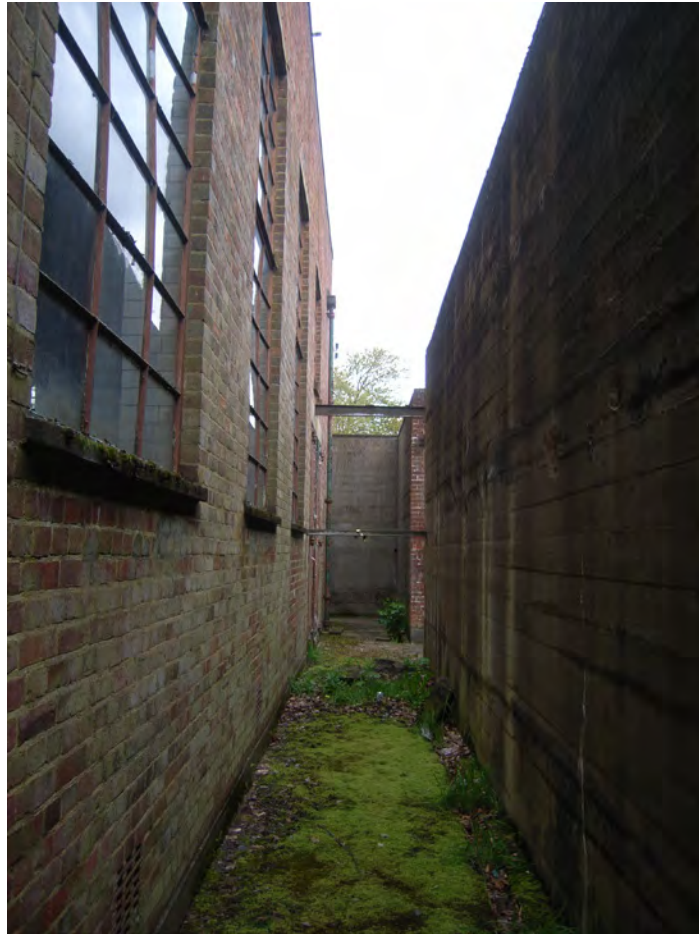
Plate 114.1 View between the blast wall and the north-east elevation
