FORMER RAF UPPER HEYFORD, OXFORDSHIRE

HISTORIC BUILDING RECORDING AND INVESTIGATION

VOLUME 2: GAZETEER OF RECORDED STRUCTURES

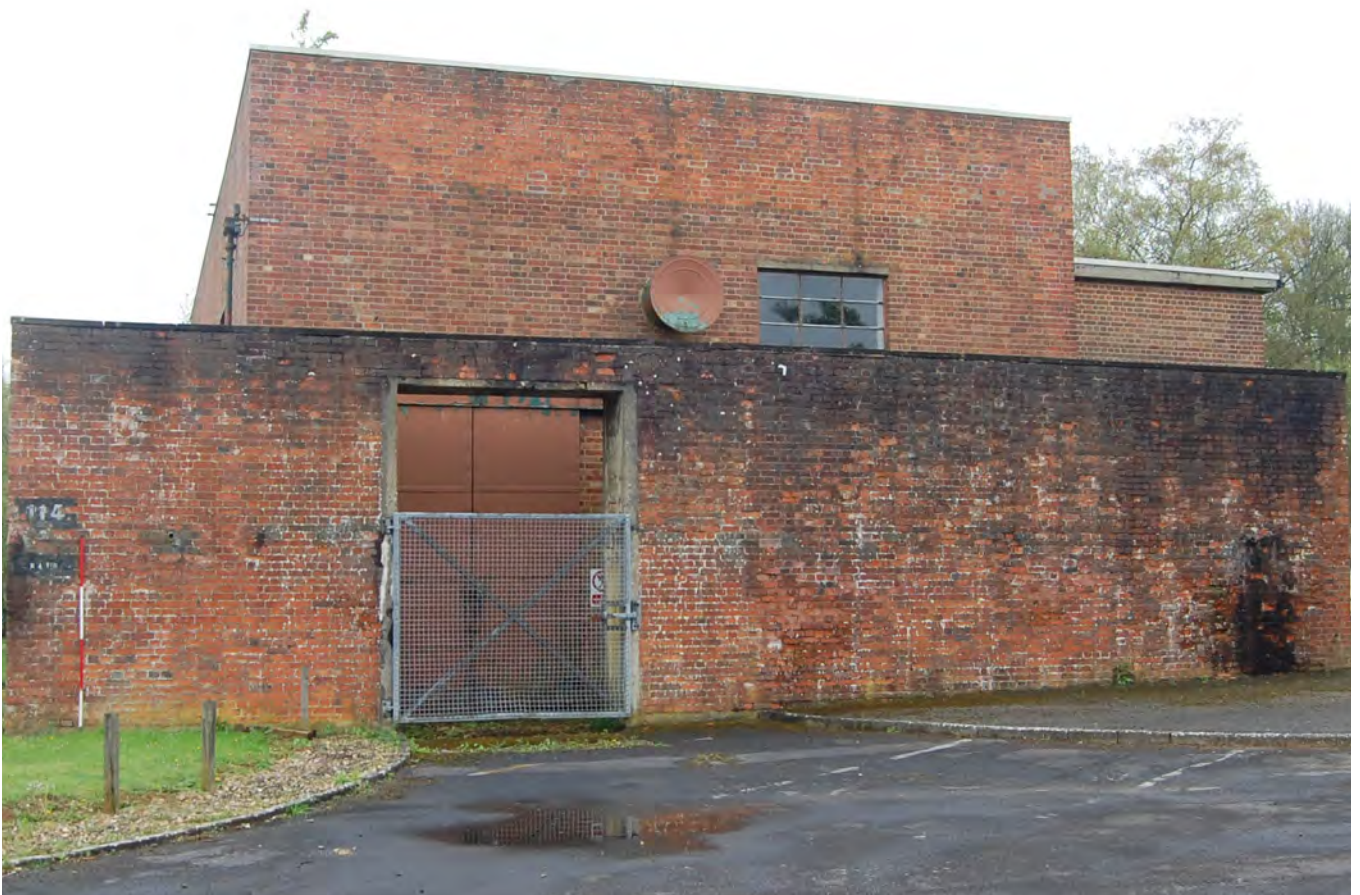
The north west elevation of the blast wall contains a wide gateway with concrete lintel and jambs and is currently fitted with a modern hinged metal gate. An overflow pipe is towards the north east end of the elevation. Two black painted rectangles are to this edge of the elevation with white figures stating '114' above and 'NATO' below. The elevation of the building behind the blast wall features metal double sliding doors in line with the gateway in the blast wall, a flue at high level and one adjacent window to which a vent had been added at low level are to the right of the doors (Plate 114.2). A wall has been constructed between the blast wall and the building to create a single storey space at the west corner of the building which was inaccessible at the time of survey.

Plate 114.2 North-west elevation

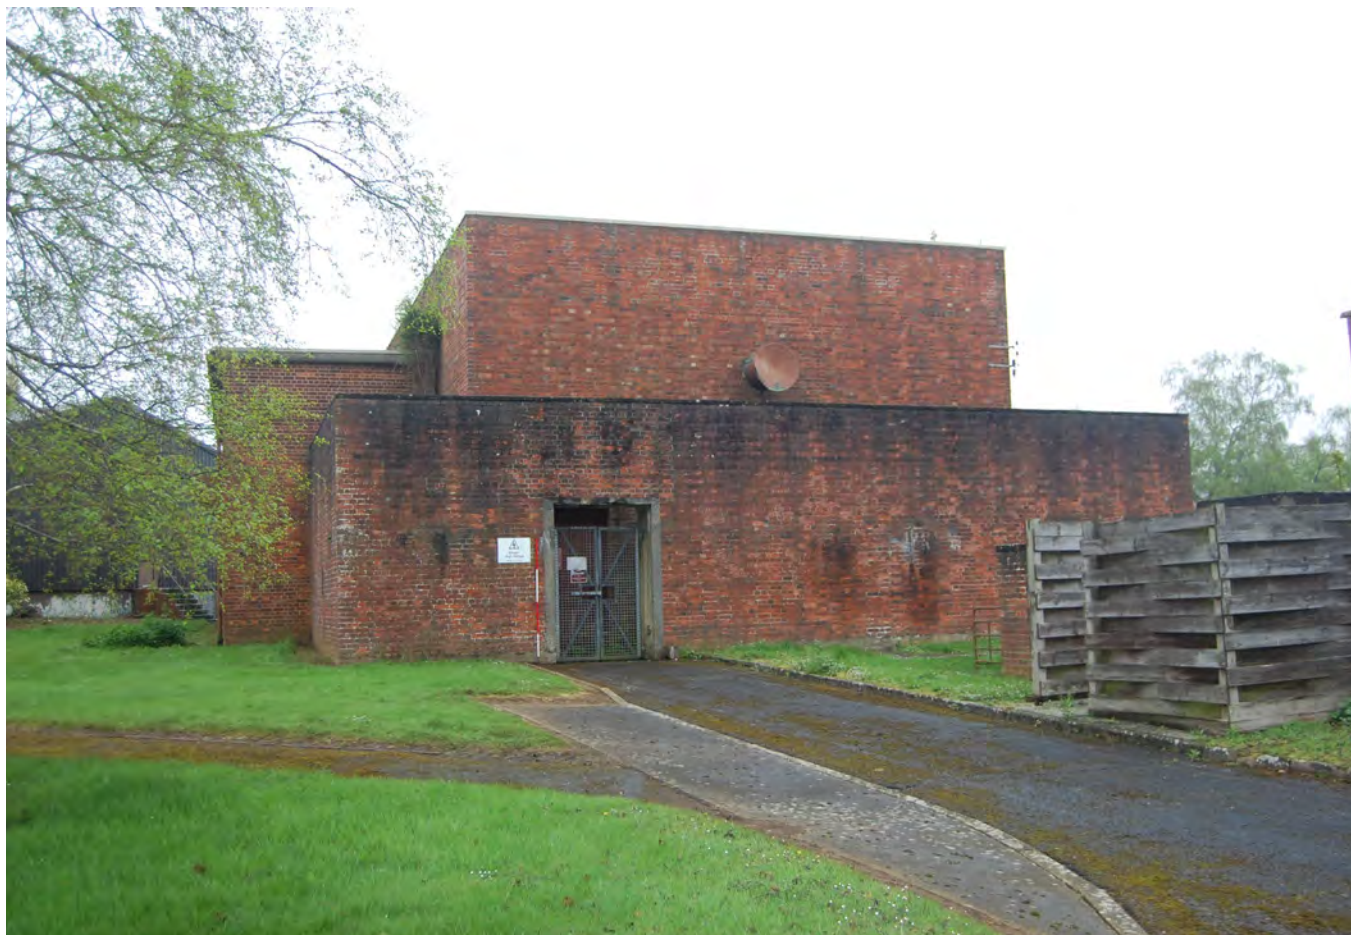
The south east elevation of the blast wall includes a gateway with concrete lintel and jambs which now has a modern hinged double leaf gate (Plate 114.3). An overflow pipe is towards the southern end of the blast wall and the building number (this time in the form of the brown plaque with white numbers used across the site), and a black painted rectangle with white letters 'NATO' beneath it are to the easternmost corner. The only visible feature on the elevation of the building above the height of the blast wall is the flue identical to that of the north-west elevation: the two windows of the offices in this end of the building have single-storey height windows only.

Plate 114.3 South-east elevation

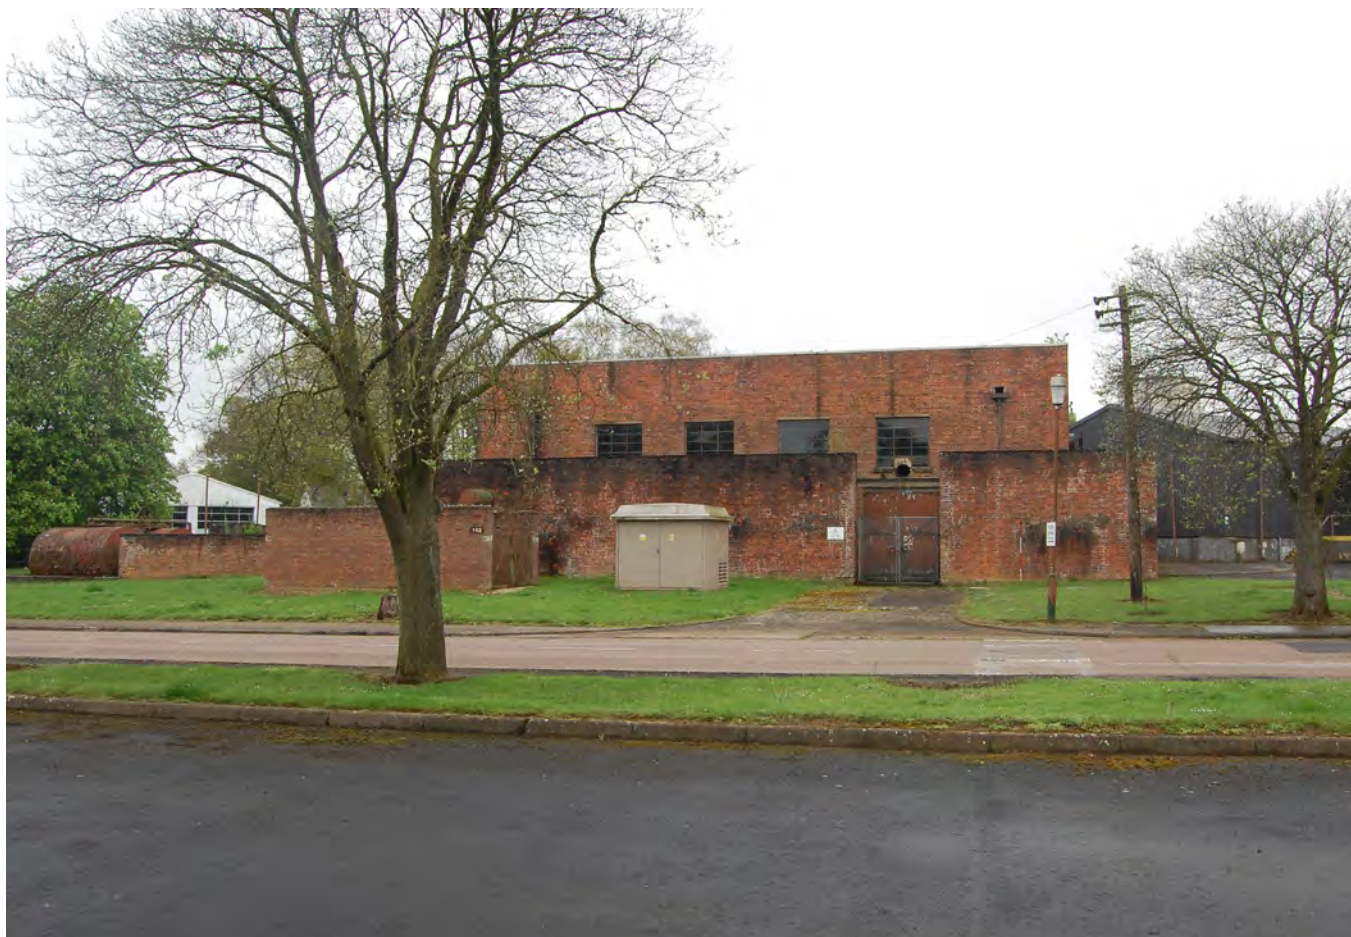
The north east elevation has a gateway towards the northern end; the opening is the full height of the blast wall and has a single rolled steel joist rather than a lintel and brick jambs (Plate 114.4). Currently there are modern hinged metal gates to the opening. The brown building number plaque and black painted rectangle with 'NATO' in white lettering is at the northern

Plate 114.4 North-east elevation

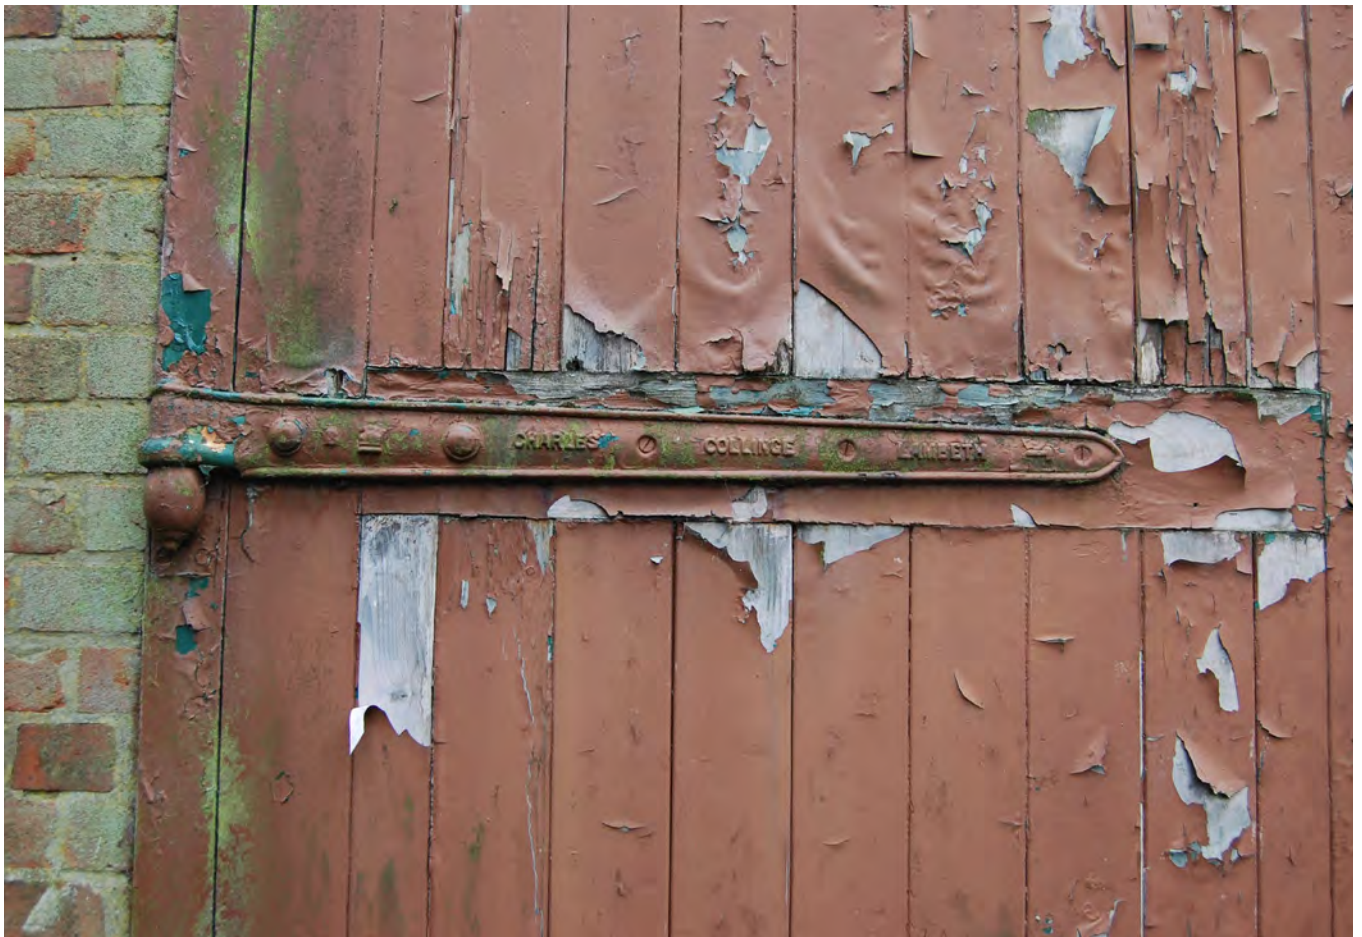
corner, and signs warning of high voltage are on and adjacent to the gates. The elevation of the building behind the blast wall includes four windows: three of which are full height and one is above the wooden double leaf door. This has hinges made by Charles Collinge of Lambeth, which are a patented pin and cup cast iron strap hinge (Plate 114.5). There are two hoppers and downpipes at either end of the elevation which lead into a gully which runs along the walkway between the building and blast wall (Plate 114.6).

Plate 114.5 A Charles Collinge, Lambeth hinge

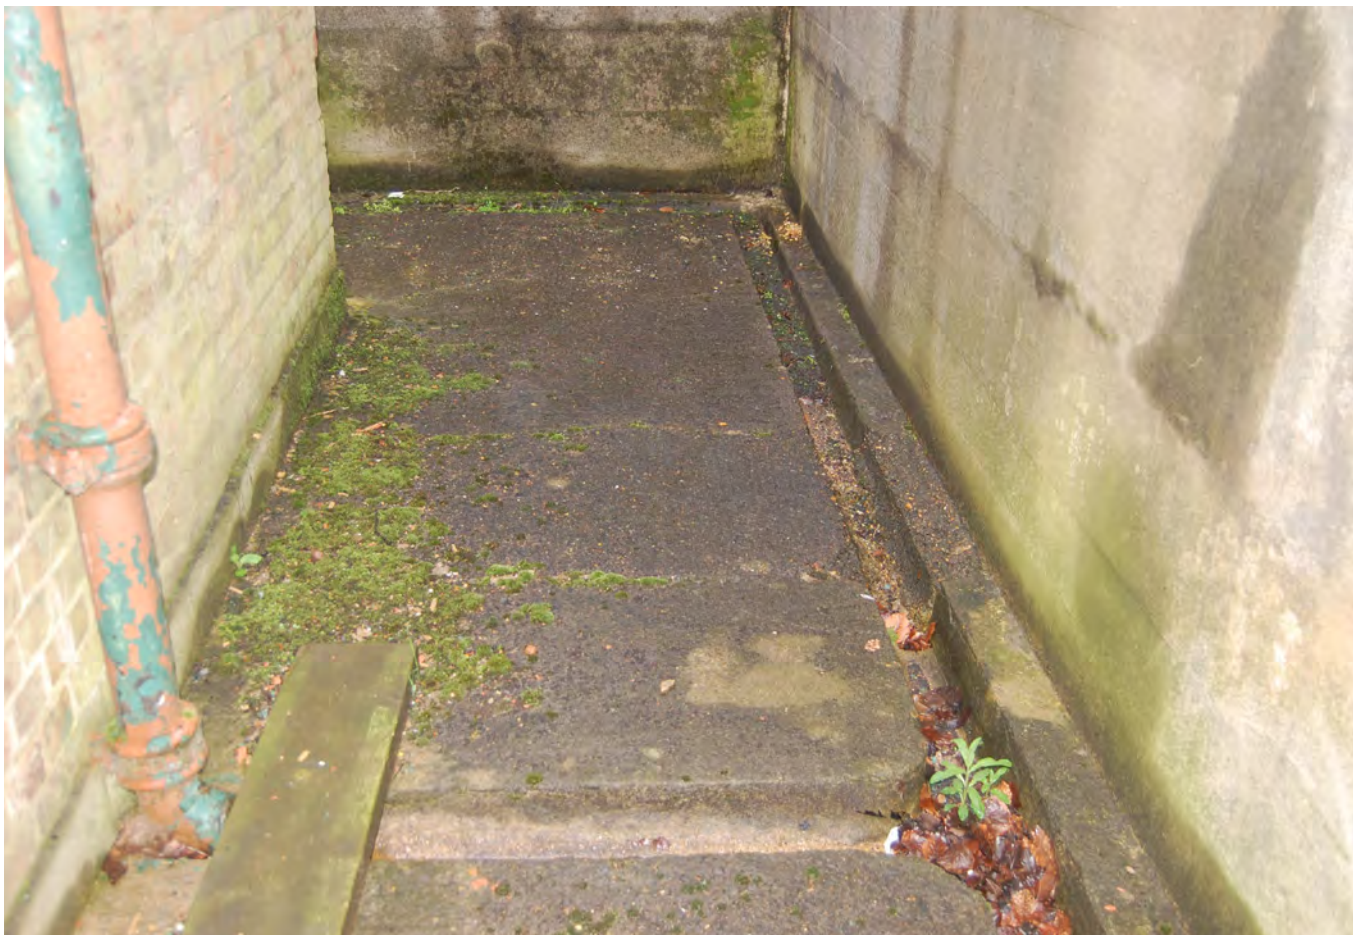
Plate 114.6 Gully in the walkway

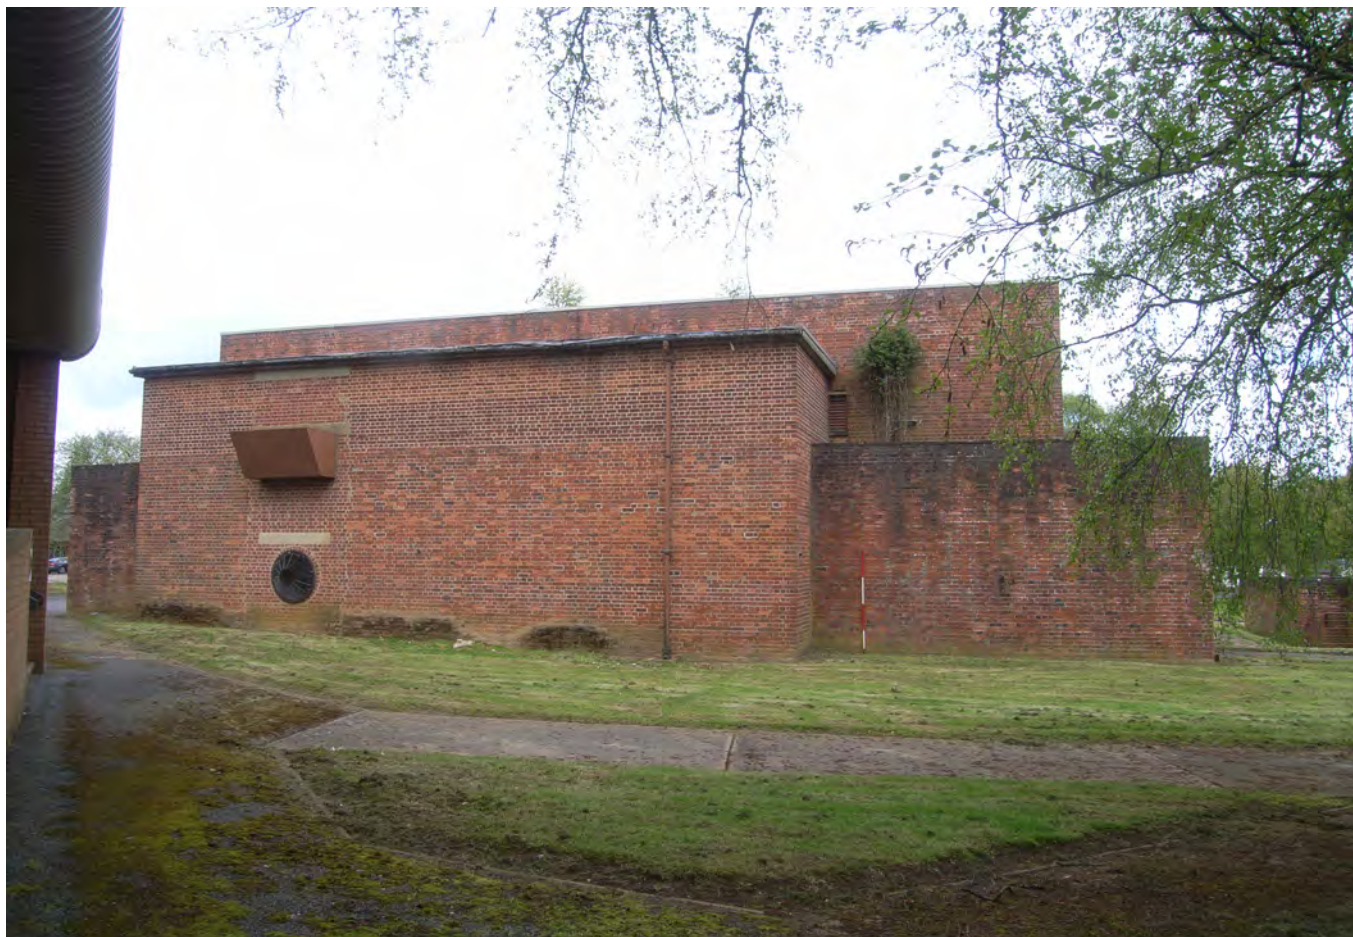
The south-west elevation displays substantial alteration (Plate 114.7). The area between the projection of the blast wall and the building within has been infilled; the blast wall has also been extended upwards by half a storey and flat-roofed as per the main building. At least two openings have been infilled with brickwork, indicated by two concrete lintels, both are above the level of the original blast wall and so it is not possible to judge if a gateway was infilled at this stage. The lintel above the modern fan outlet relates to this installation and so has been discounted as a phase of opening.

Plate 114.7 South-west elevation

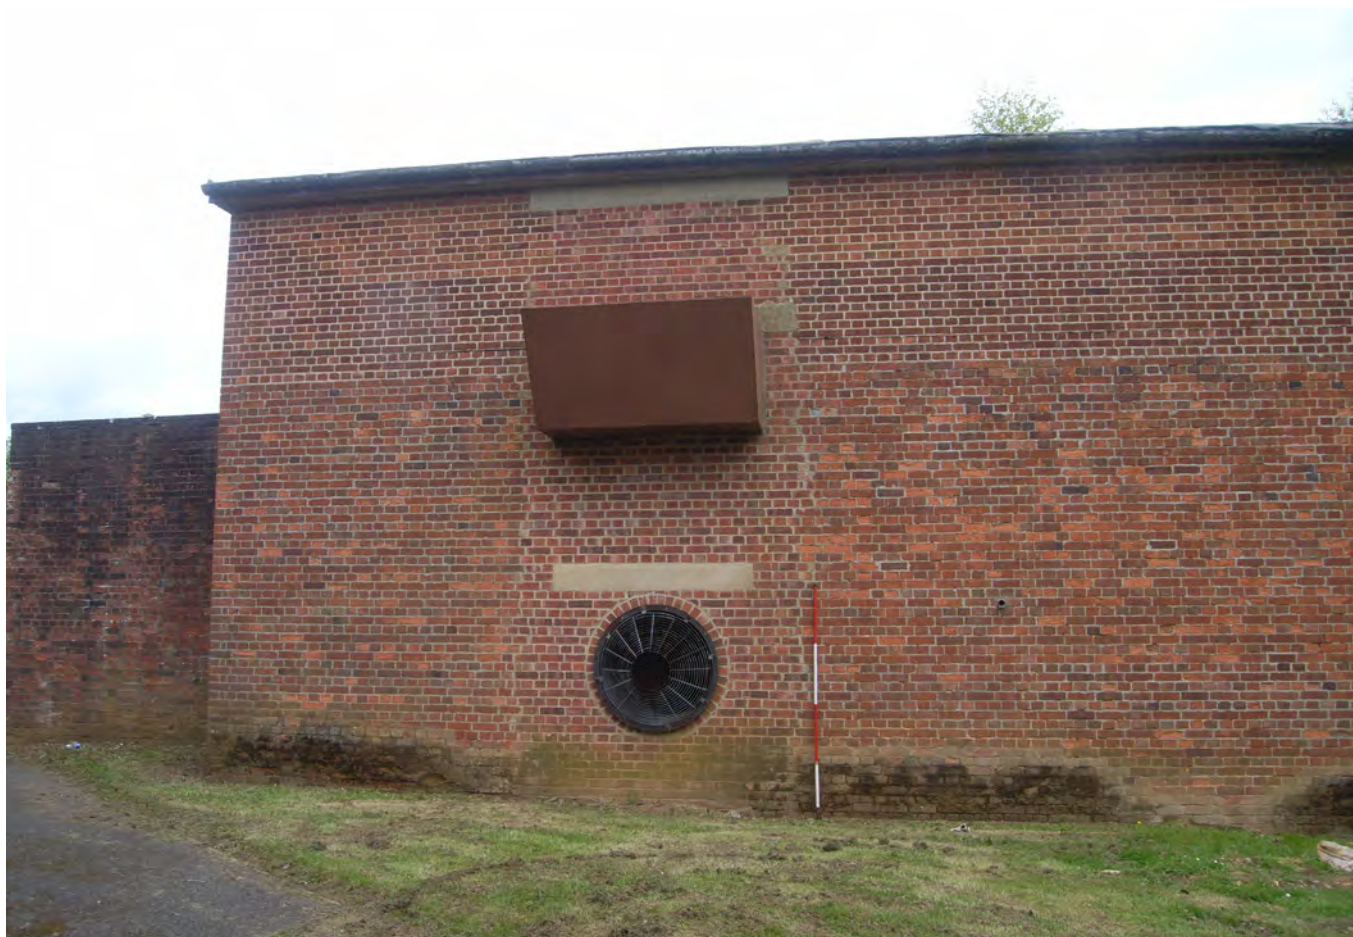
The extension in height of the blast wall to form the offices displays different colour bricks to the upper courses, although the returns either side and the brickwork to the corners indicate that this can simply be attributed to a different batch of bricks used for the second lift (Plate 114.8).

Plate 114.8 Alterations to the extension within the blast wall

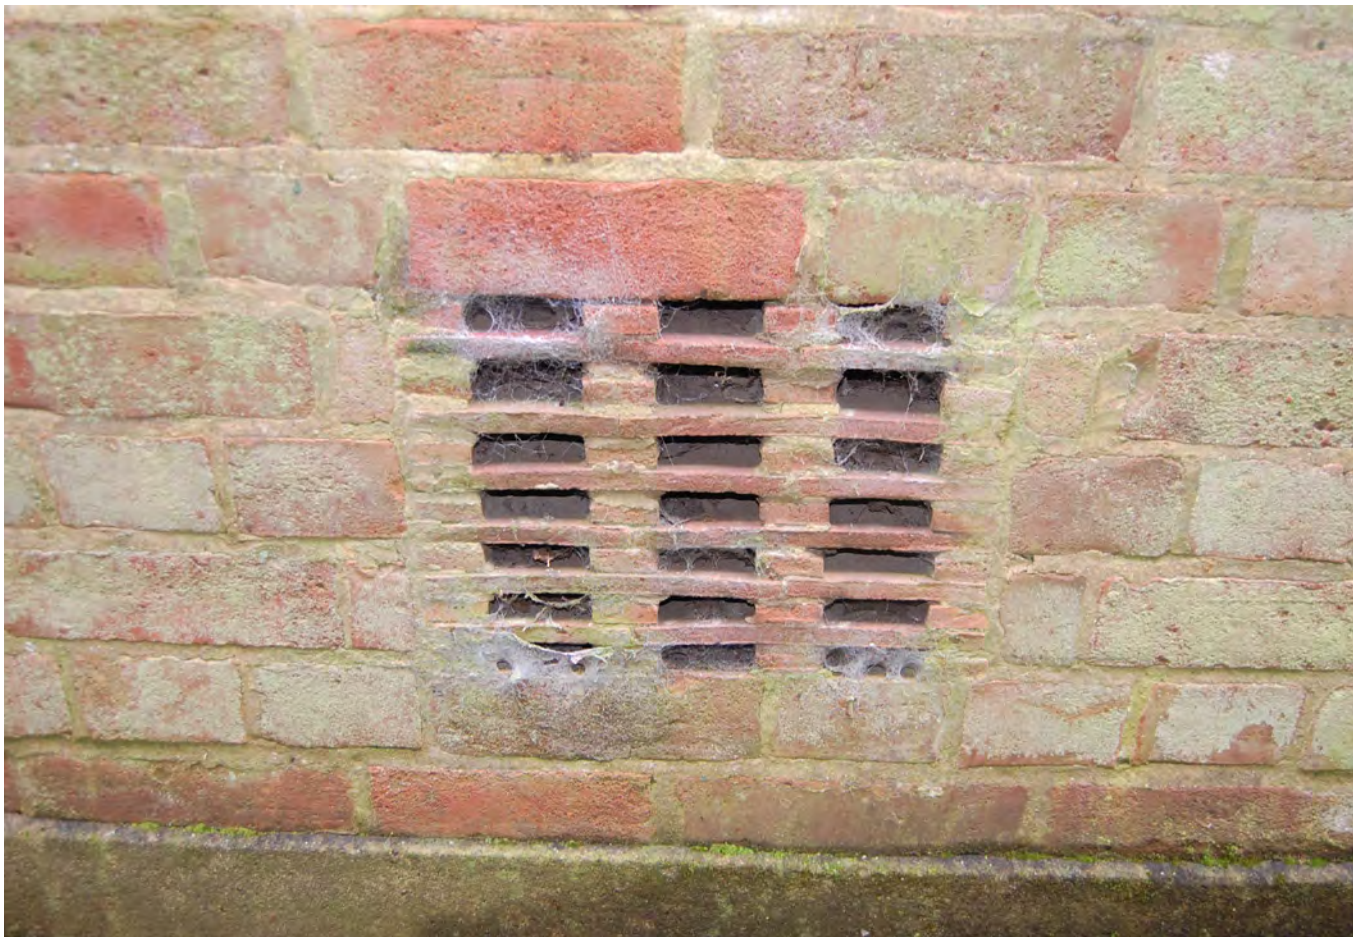
All of the remaining windows are the original crittall-style metal framed windows, the entrance doors may be replacements; the gates in the blast wall are all later replacements. The finishes to the woodwork, doors, windows and rainwater goods are in the standard brown paint of the airfield with the previous dark green colour scheme visible where the paint is flaking. The original wall vents are constructed of cut tiles (Plate 114.9).

Plate 114.9 An example of a vent

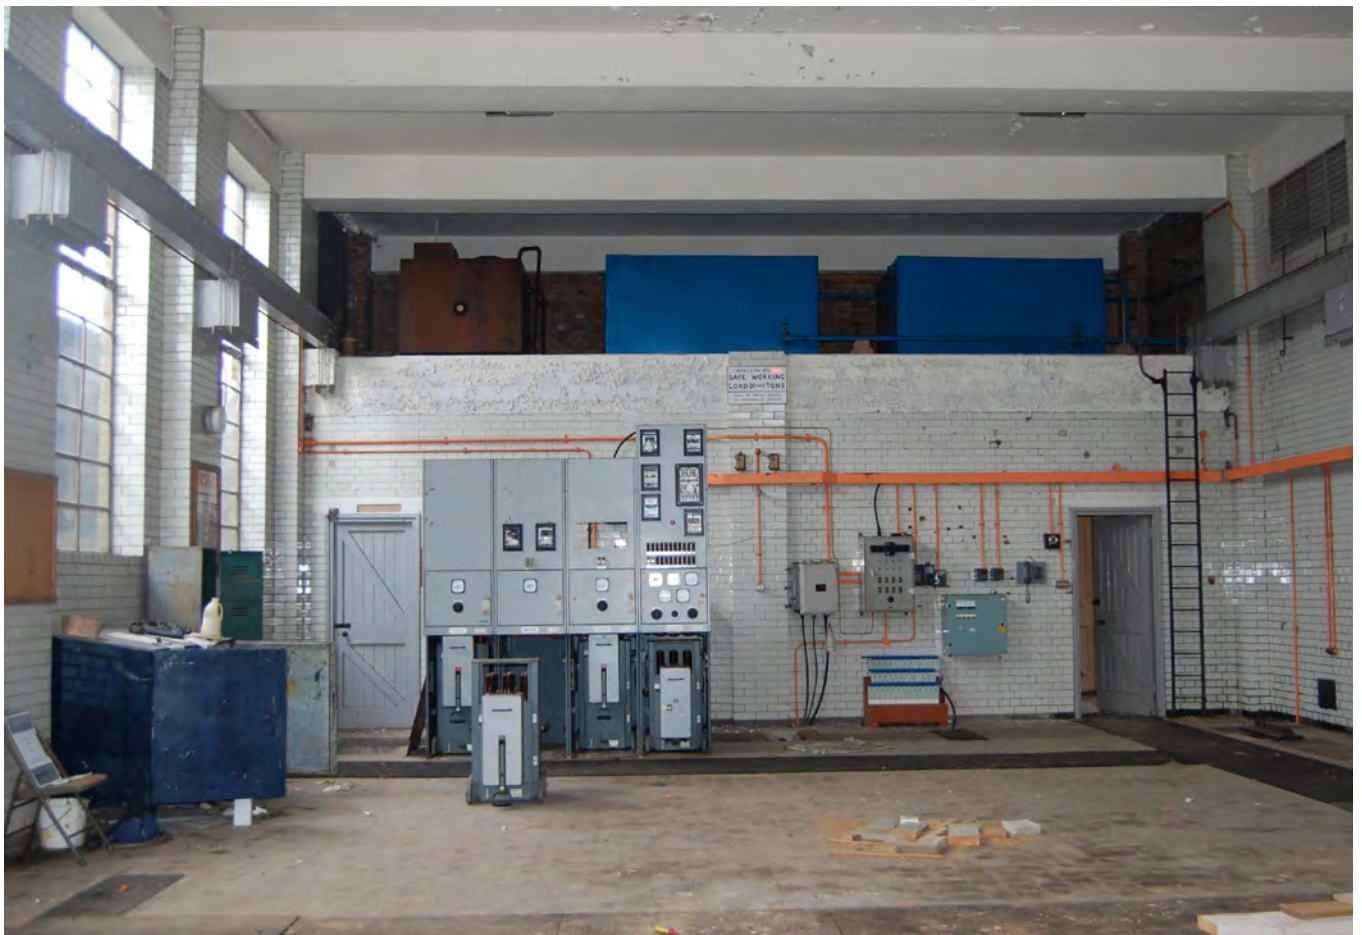
Plate 114.10 The interior of the Set House, looking south east

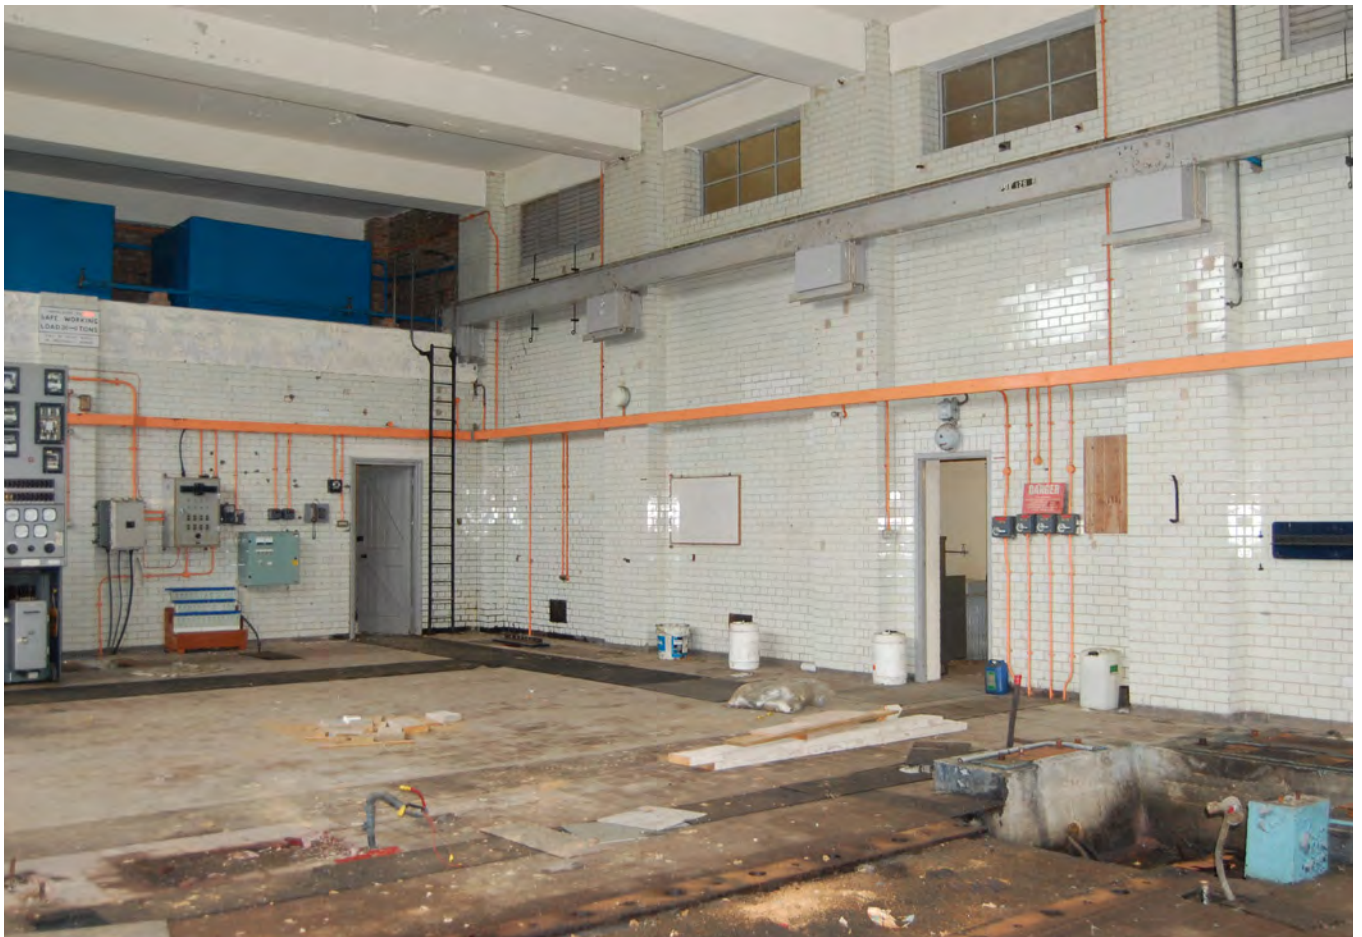
The windows in the south-western wall are at clerestorey height; the southernmost window having been replaced with a metal vent; these openings have since been enclosed by the construction of the spaces within the blast wall (Plate 114.11). A door to the enclosed area has been inserted below the central window, indicated by a slight change of colour of the surrounding glazed tiles.

Plate 114.11 The interior of the Set House, looking towards the extension

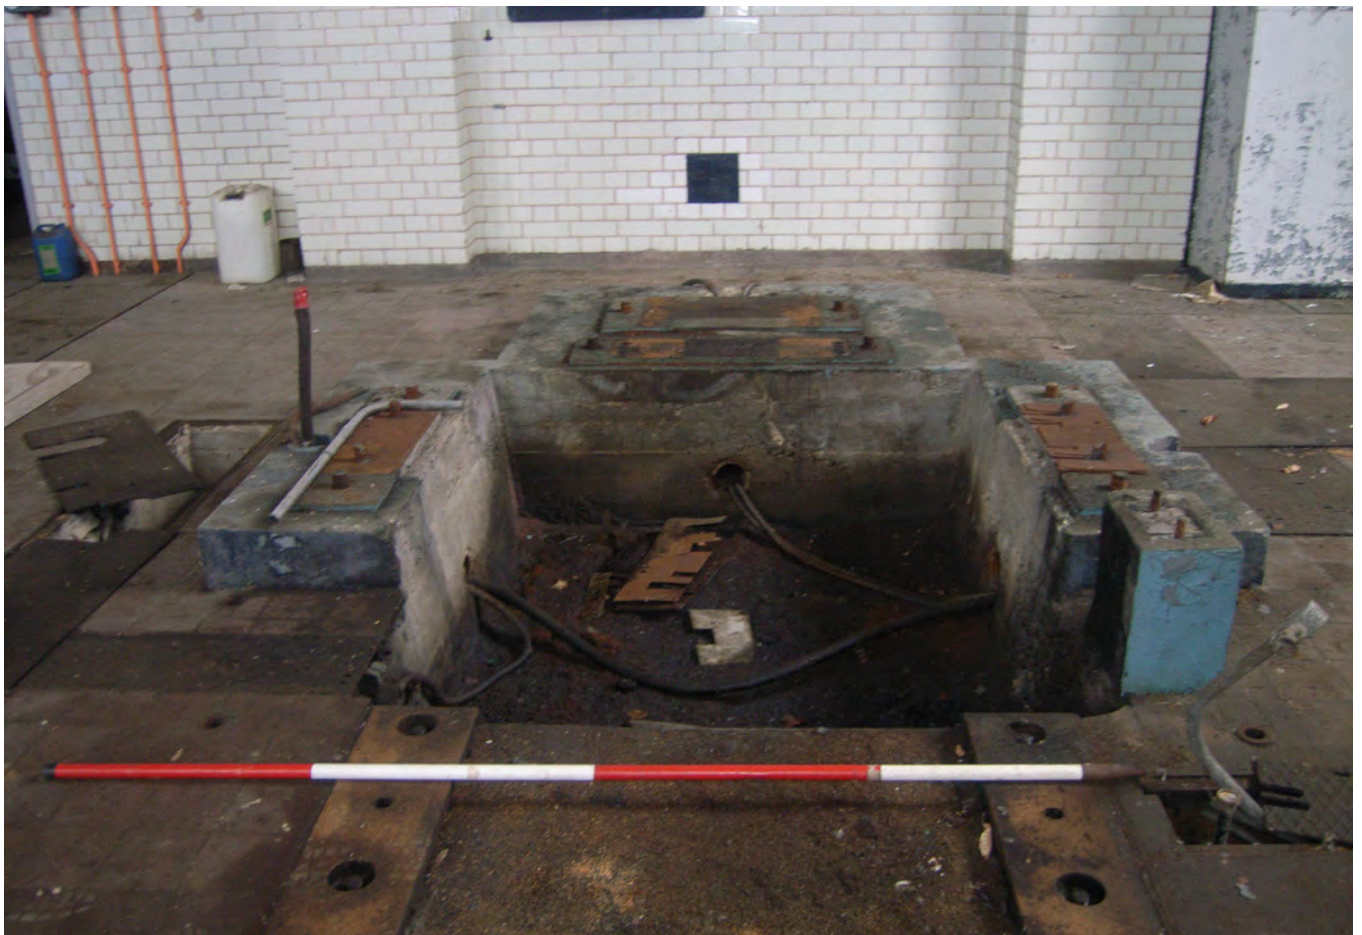
Pits and remains of stands in the floor indicate the former location of machinery (Plate 114.12); an overhead crane manufactured by Herbert Morris of Loughborough survives to the north western end of the space and some plant remains at the opposite end of the room (Plate 114.13).

Plate 114.12 The support structure for the former machinery

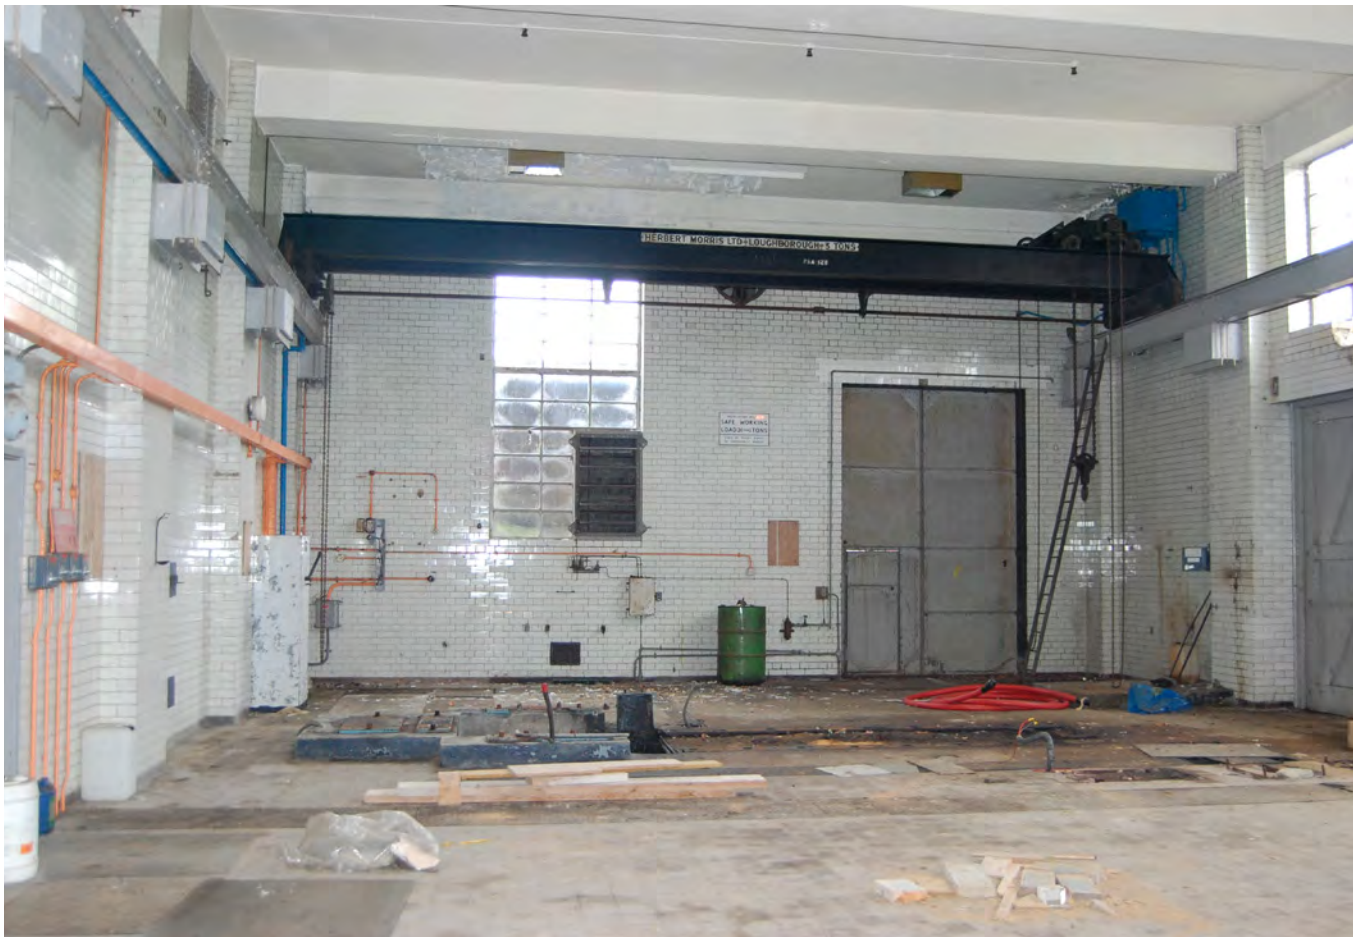
Plate 114.13 The interior of the Set House, looking north west

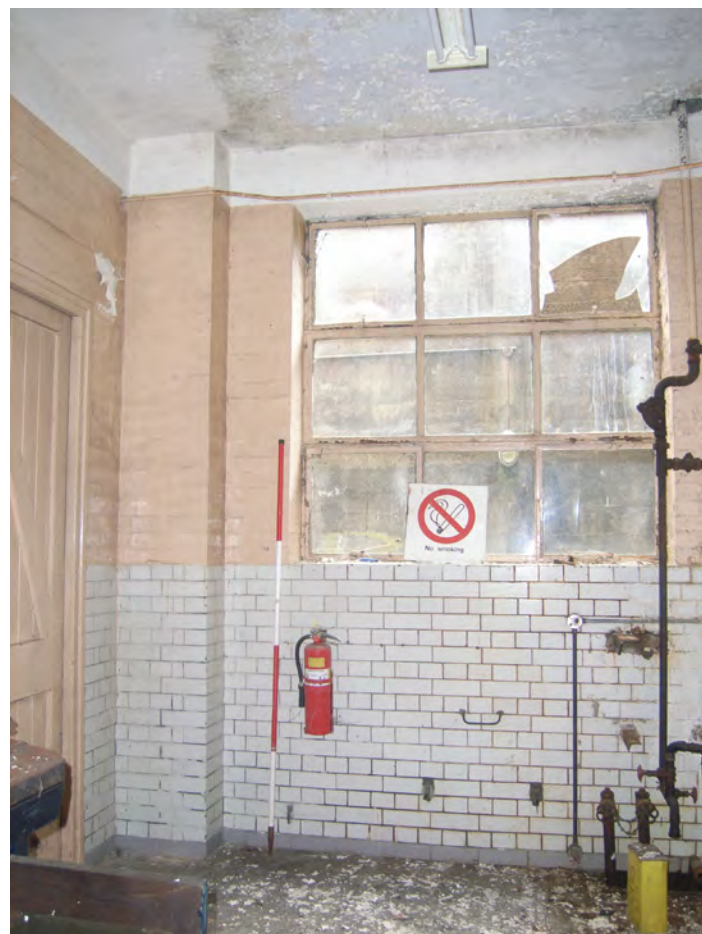
Plate 114.14 An example of a window in the workshops

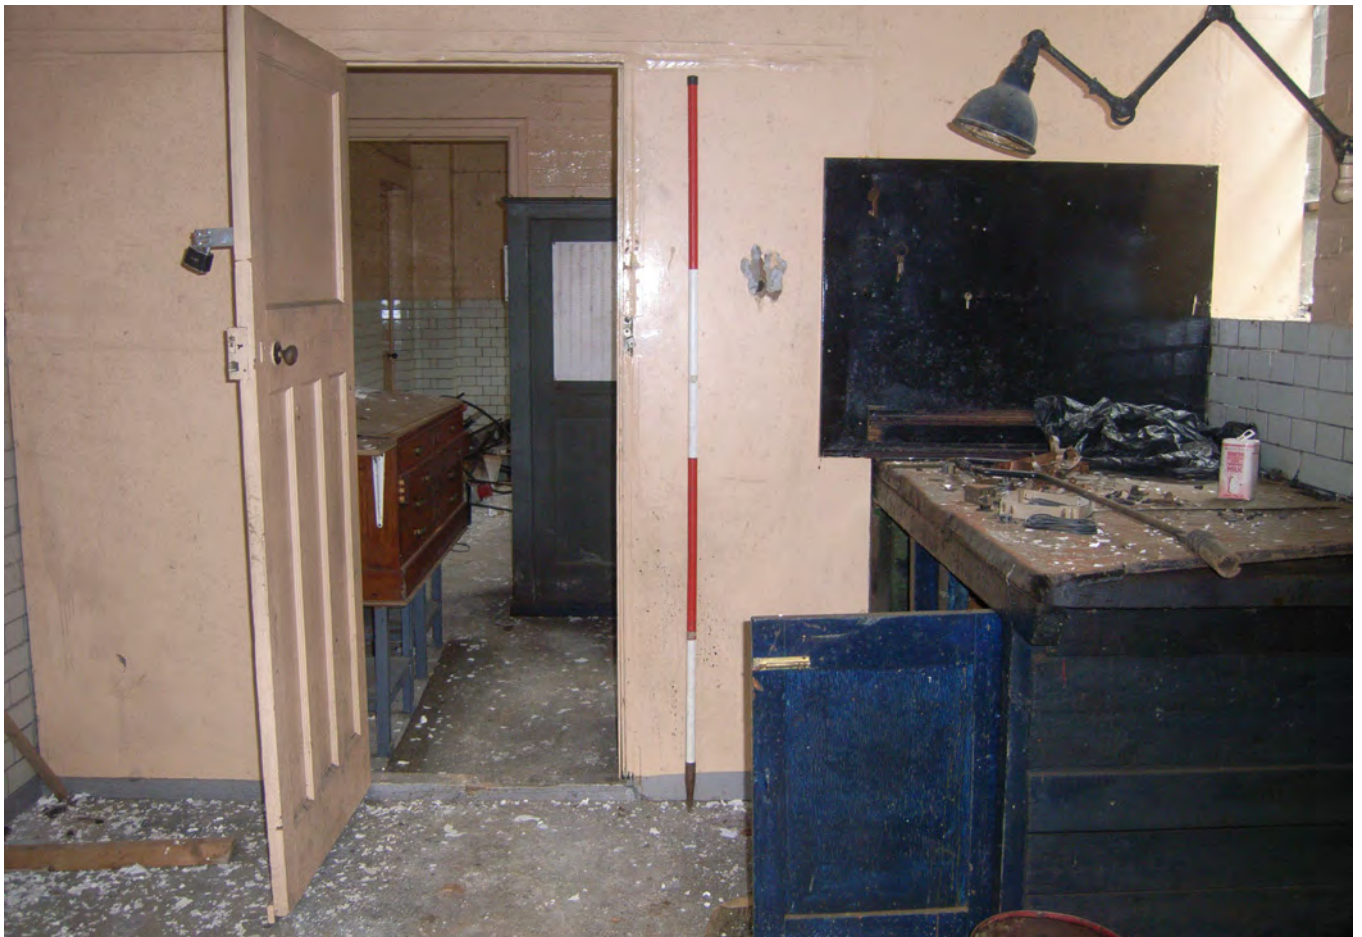
Plate 114.15 The workshops, looking north east

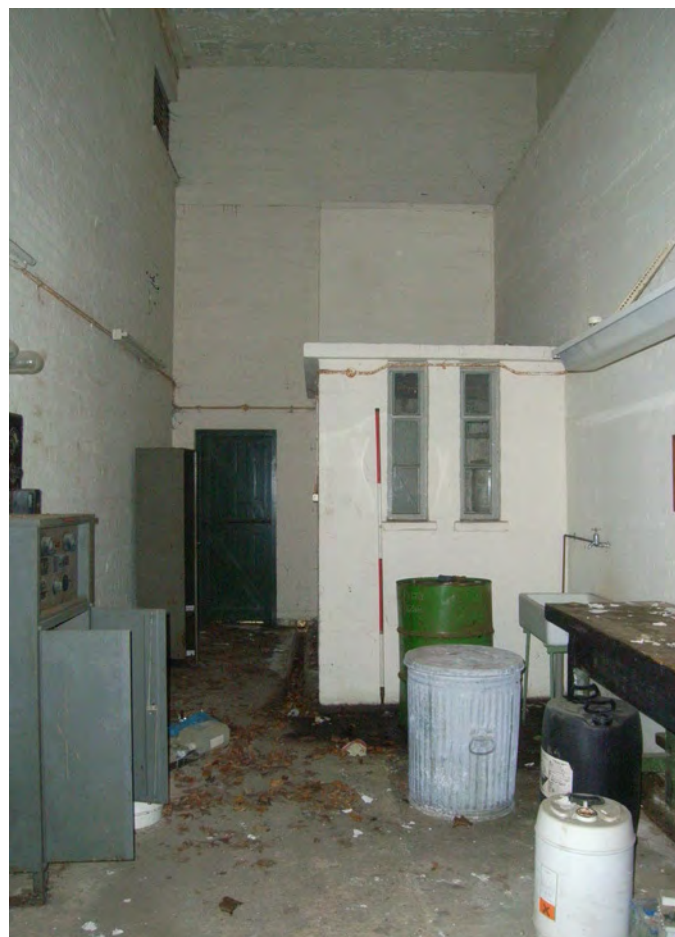
Plate 114.16 The workshops in the extension, looking south east

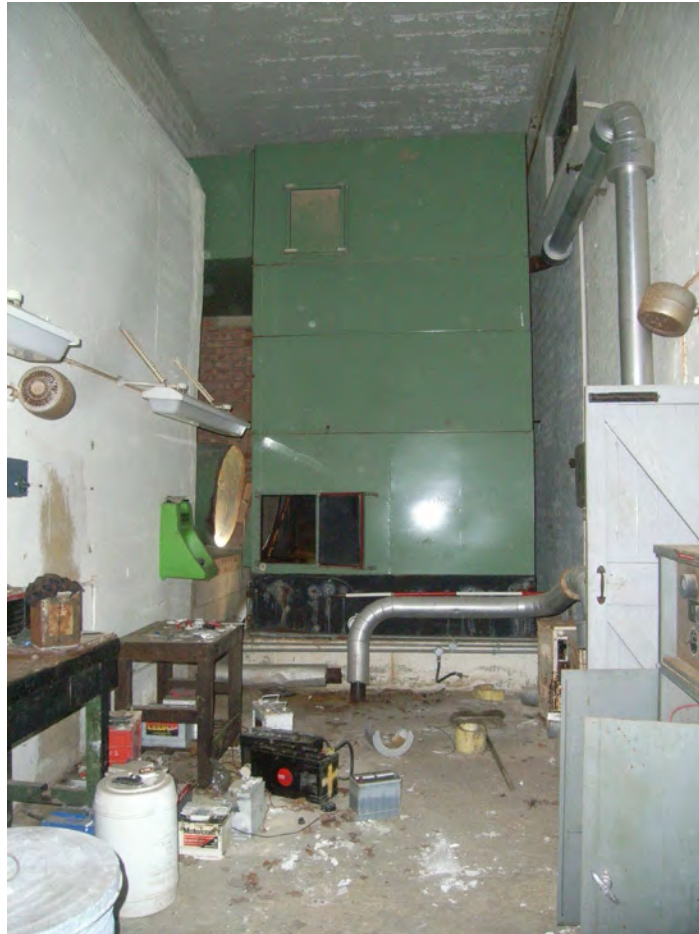
Plate 114.17 Plant in the extension, looking north west

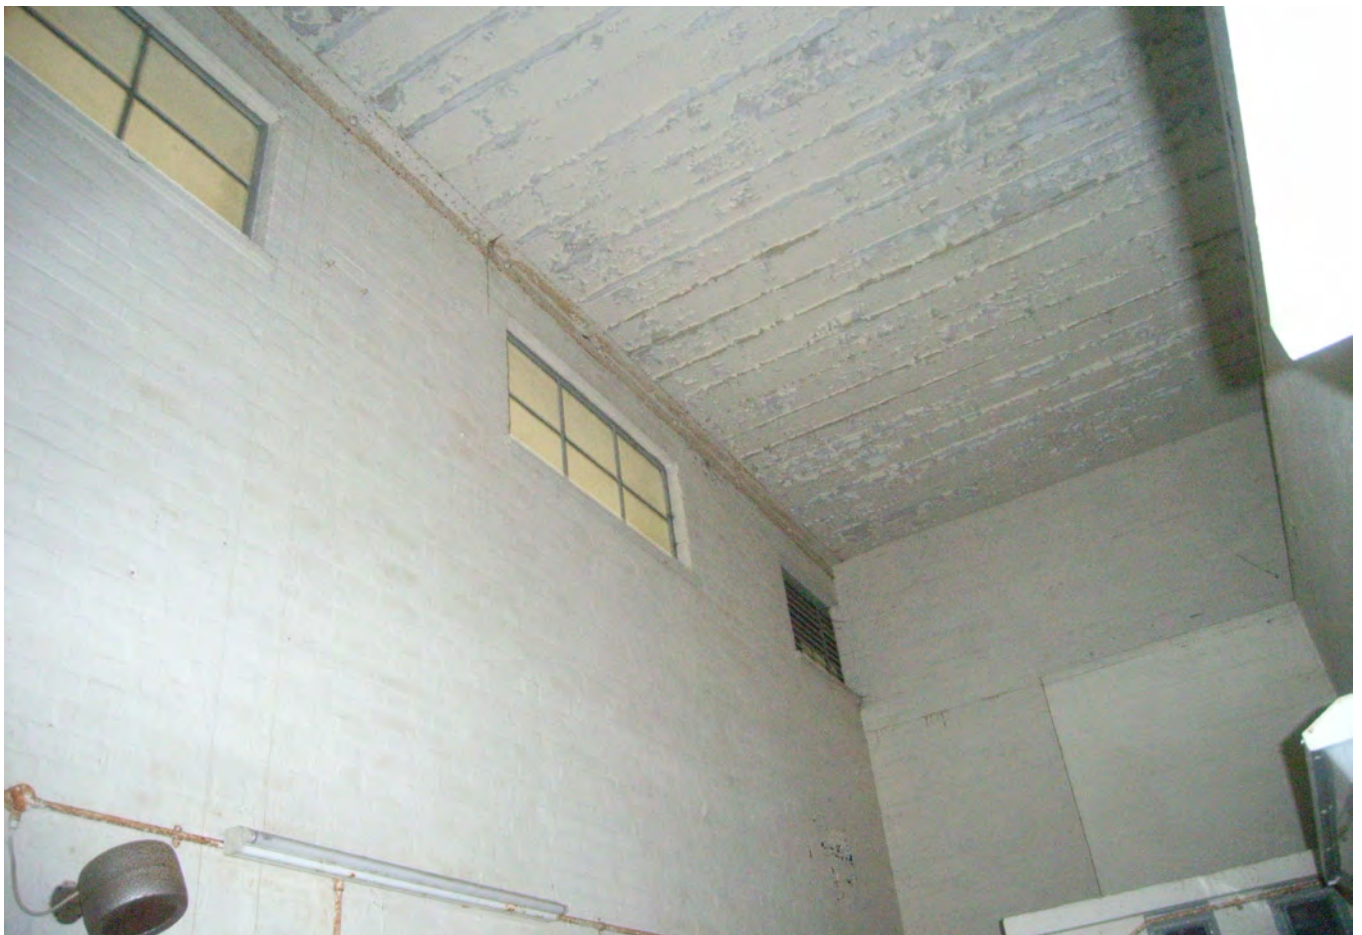
Plate 114.18 The concrete roof structure in the extension

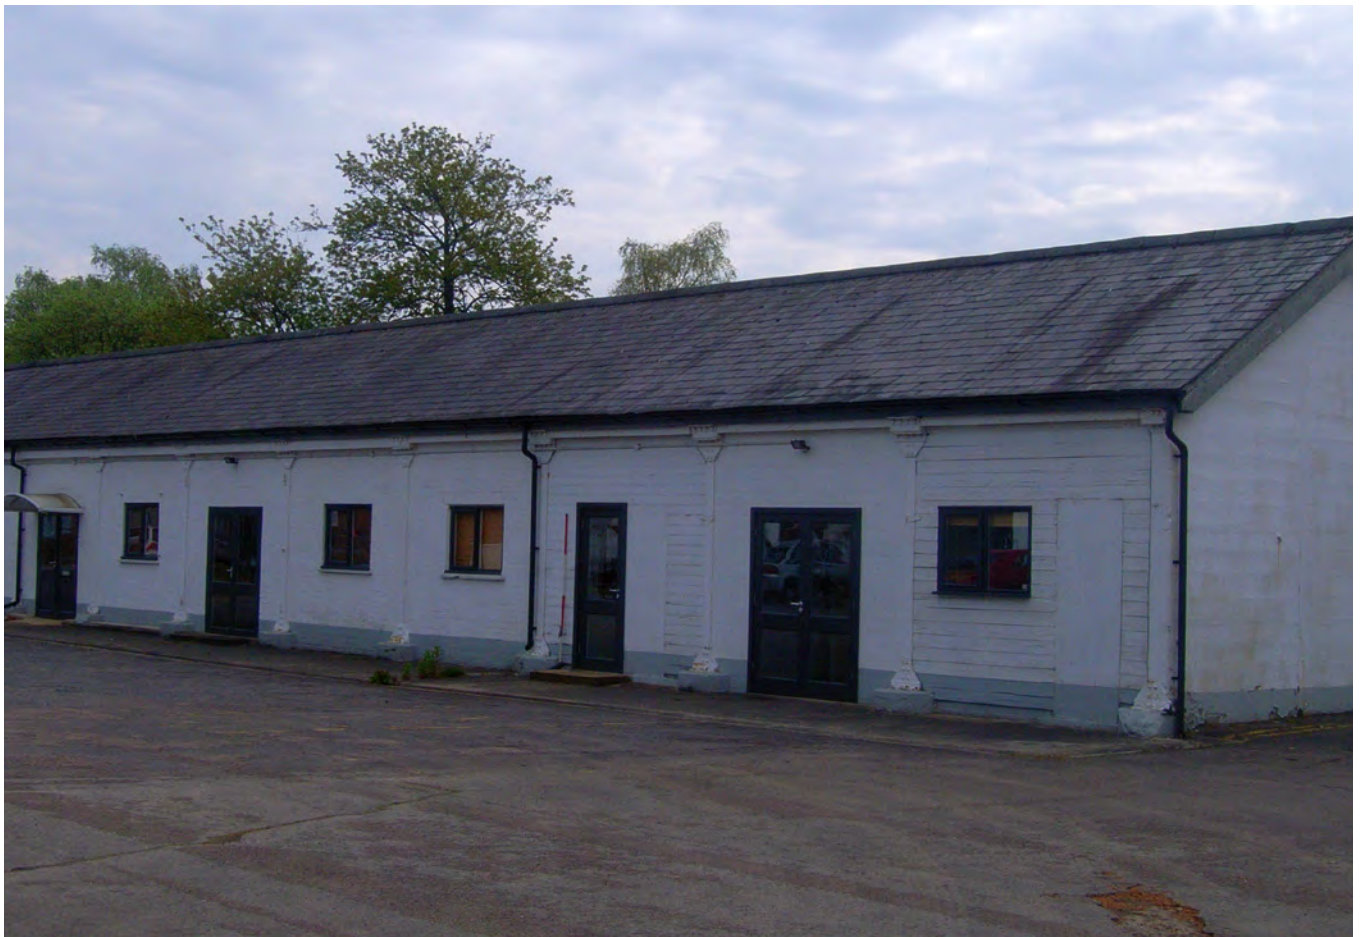
Plate 115.1 North-west elevation
