FORMER RAF UPPER HEYFORD, OXFORDSHIRE

HISTORIC BUILDING RECORDING AND INVESTIGATION

VOLUME 2: GAZETEER OF RECORDED STRUCTURES

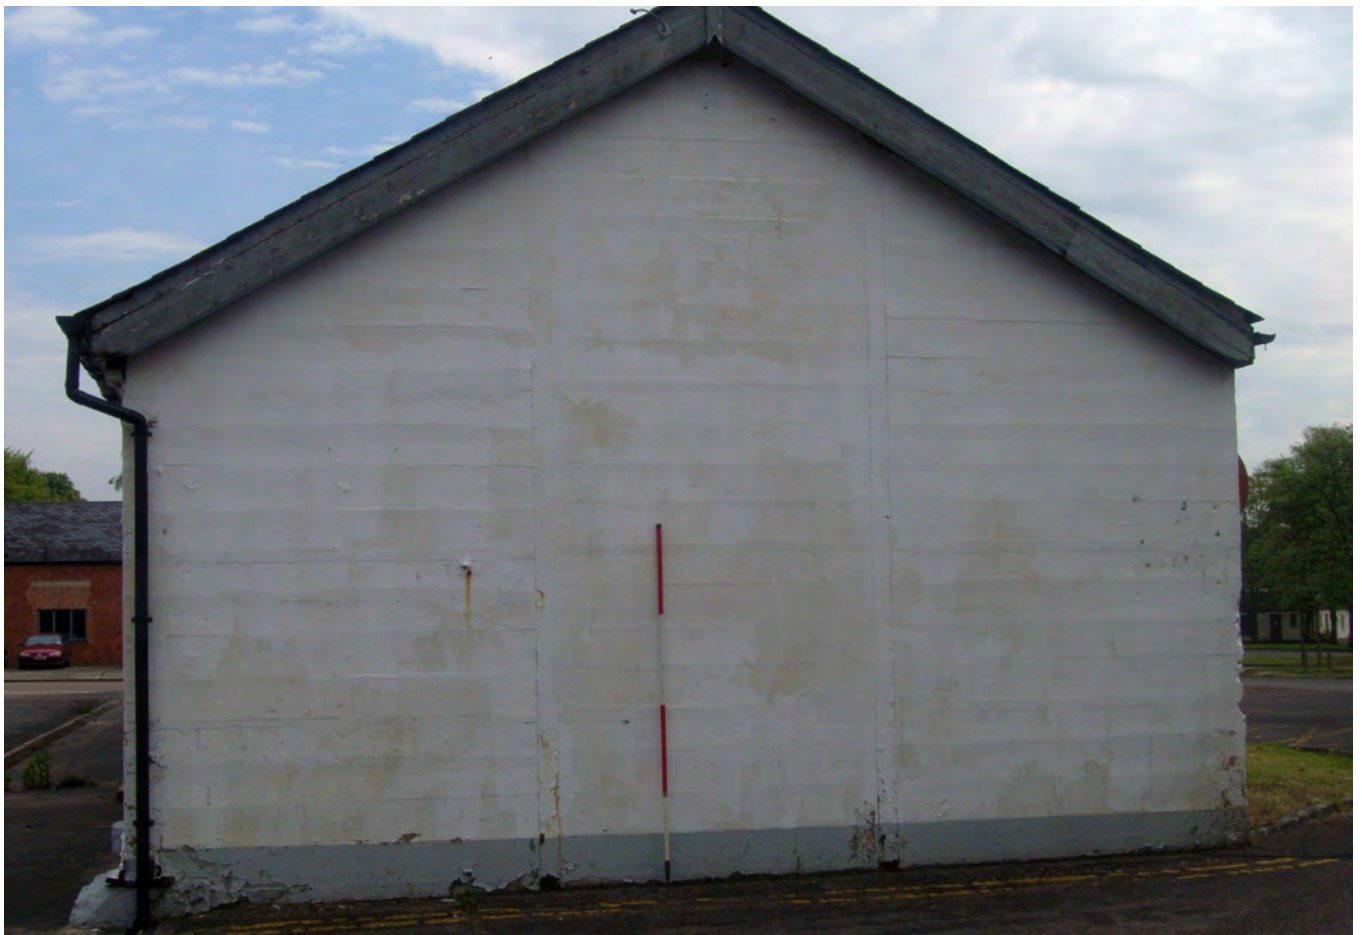
Plate 115.2 South-west elevation

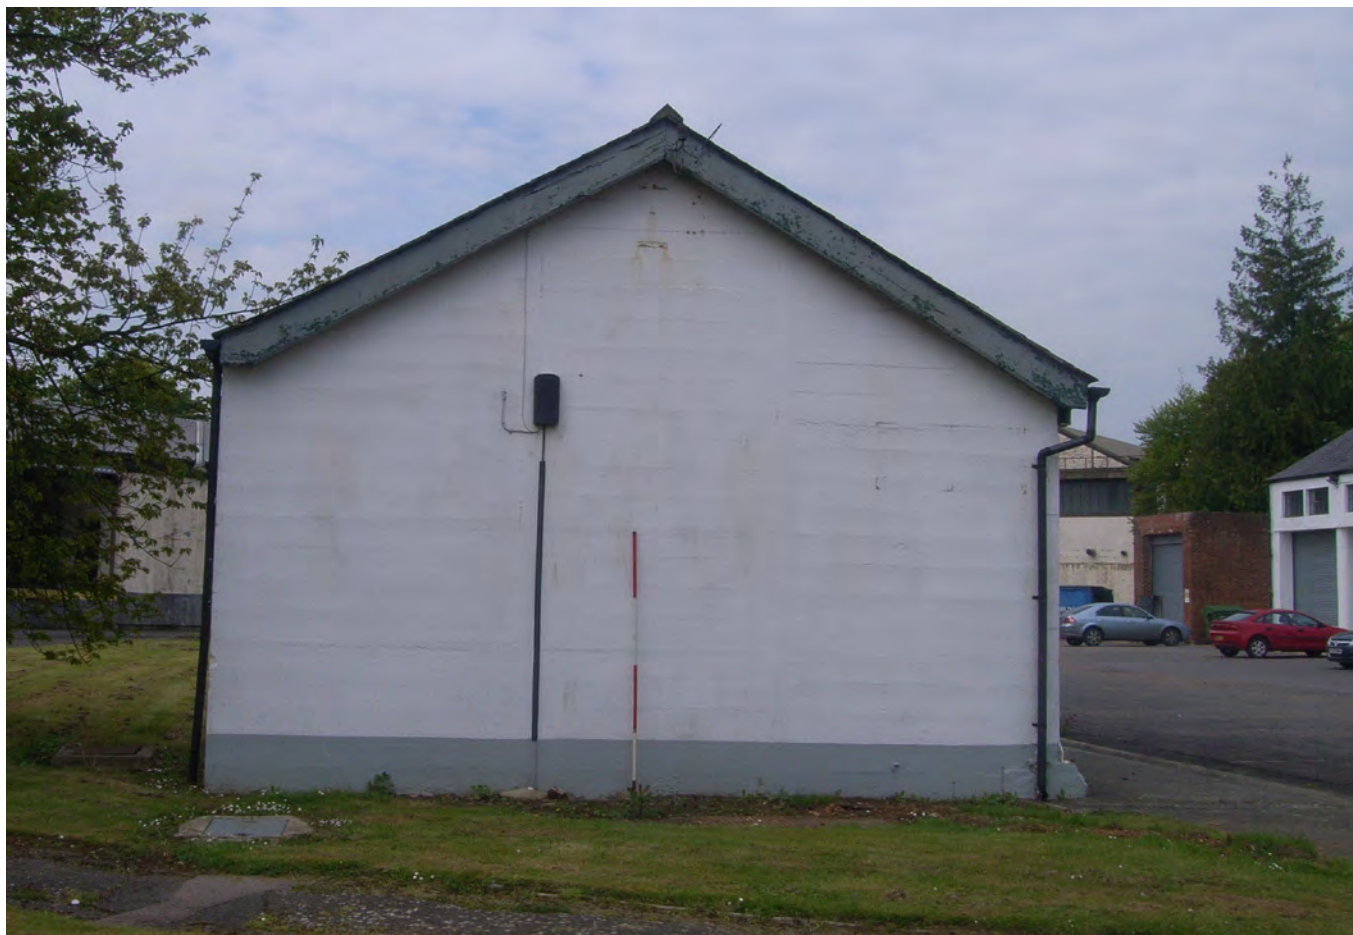
Plate 115.3 North-east elevation

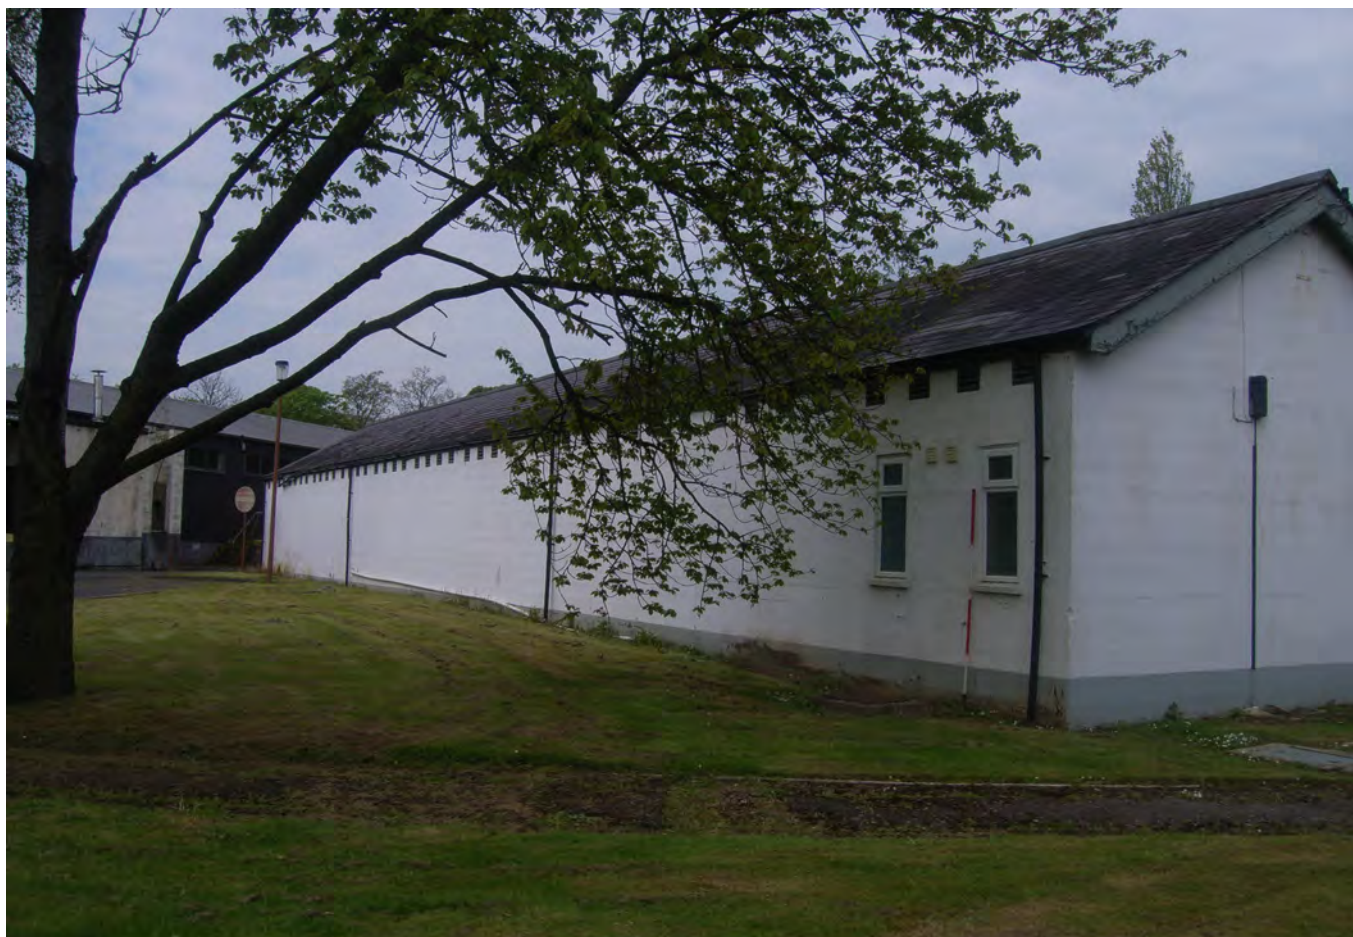
Plate 115.4 South-east elevation

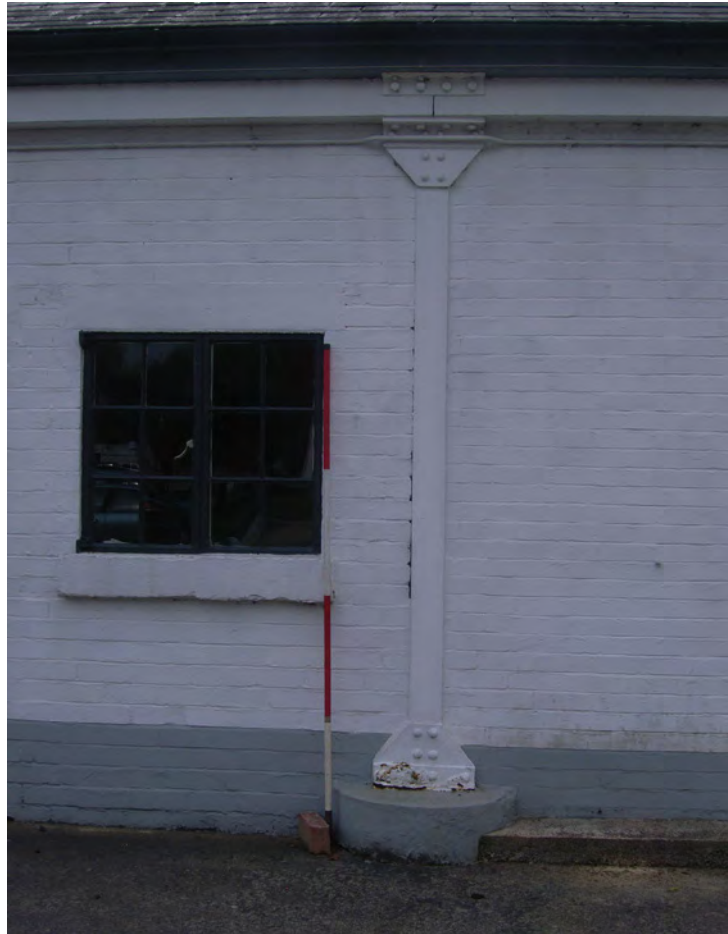
The doors and windows to the north west, front, elevation are black painted modern replacements with the exception of the crittall-style window in the north east end bay (Plate 115.5). This bay appears to be the earliest bay to be separated from the vehicle bays as there is a solid, probably block, dividing wall shown on the 1961/71 plan. The ceiling panels are batten and boards; differing from the modern suspended ceiling of the adjoining rooms. The bay doesn't appear to have been originally constructed as an enclosed space, but would have been converted within a few decades of building.

Plate 115.5 An example of a window and steel column

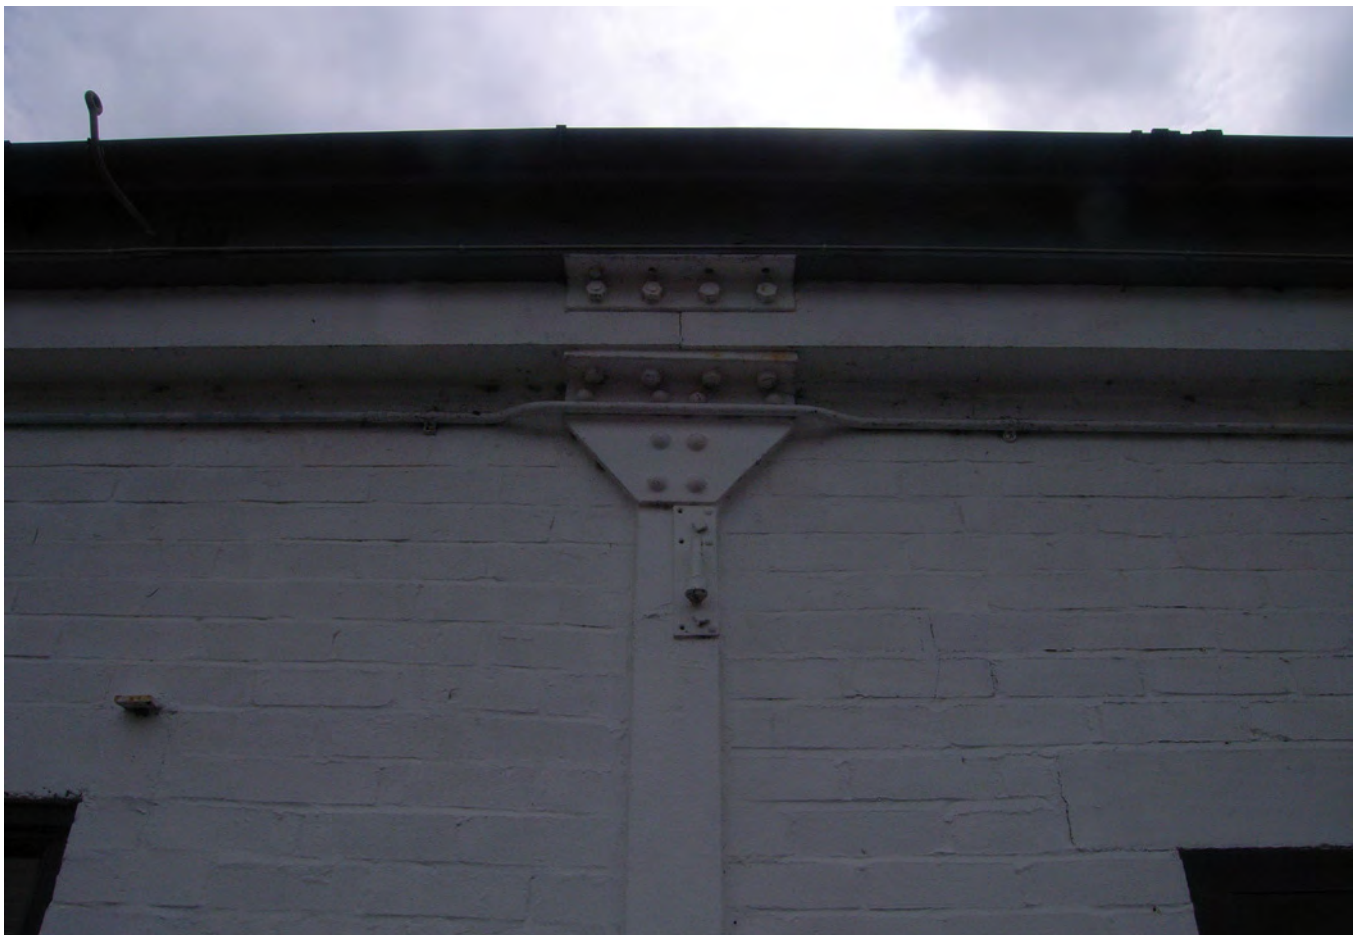
Plate 115.6 An original hinge surviving on a column

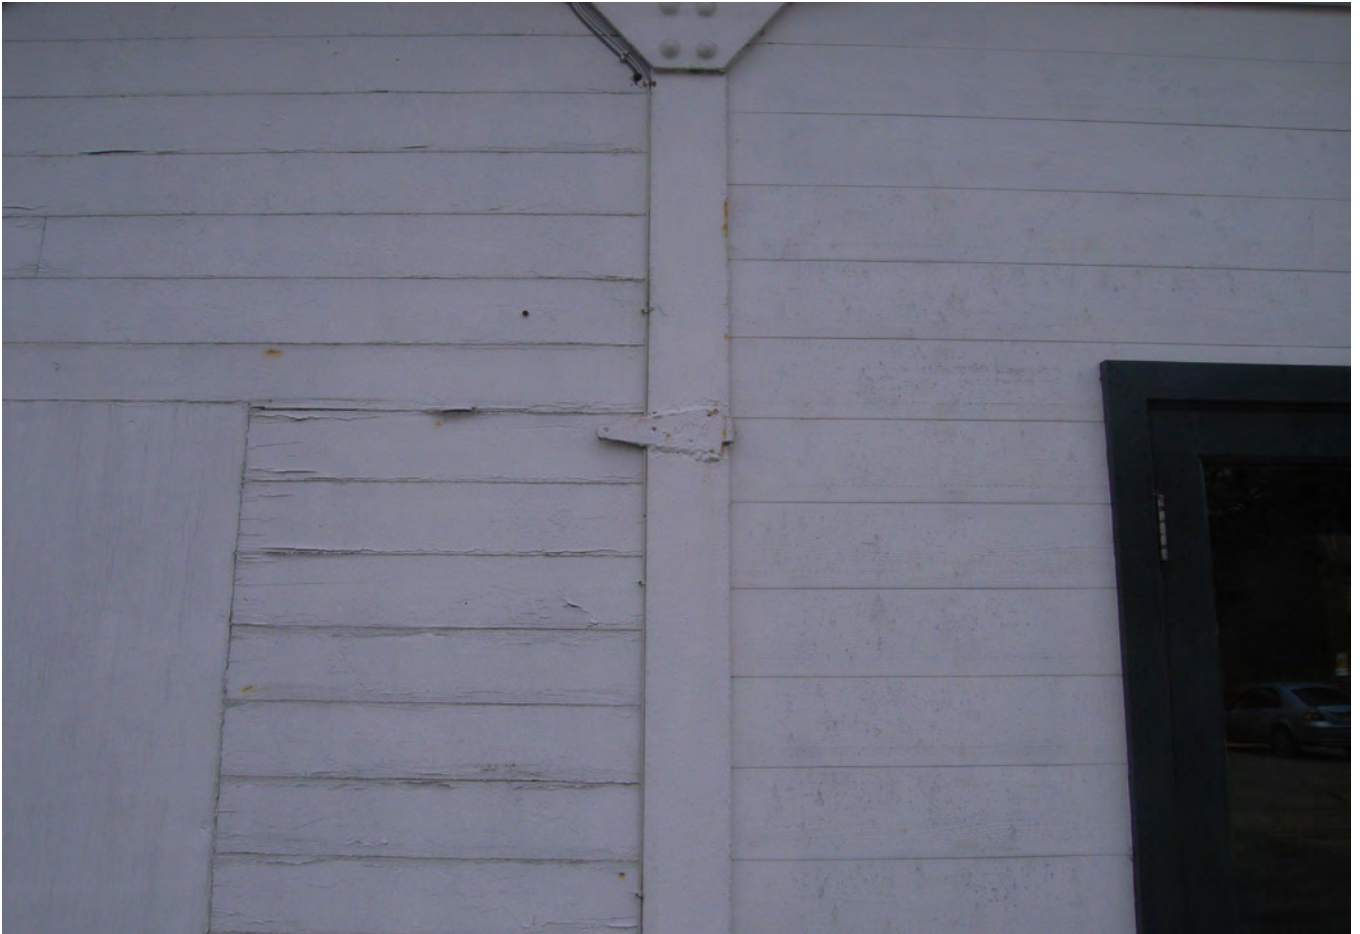
Plate 115.7 An original hinge surviving on a column

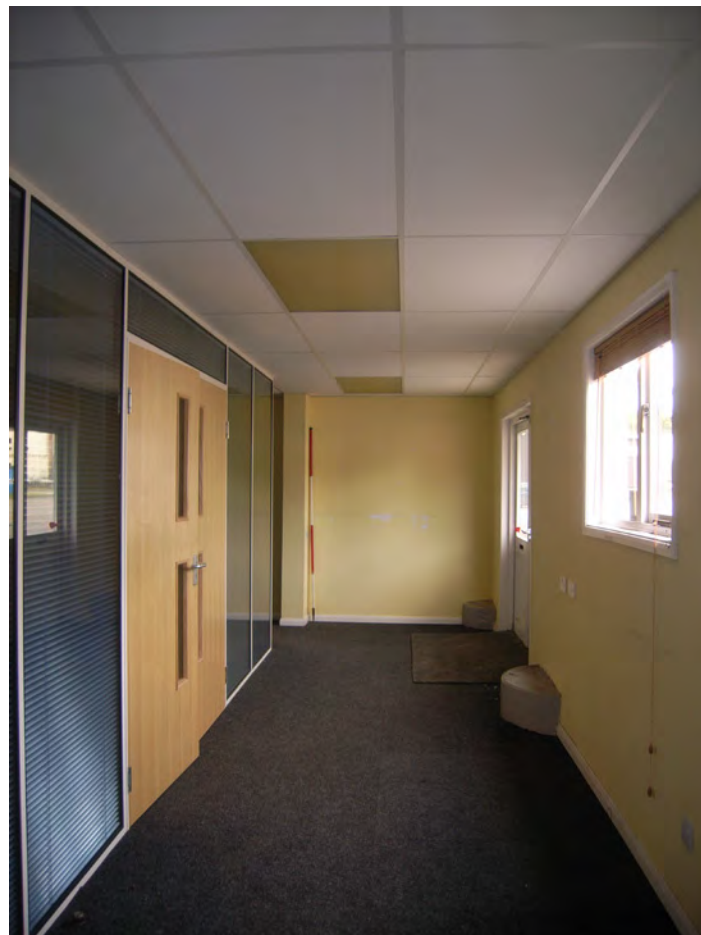
Plate 115.8 An example of the modern glazed partitions and suspended ceiling

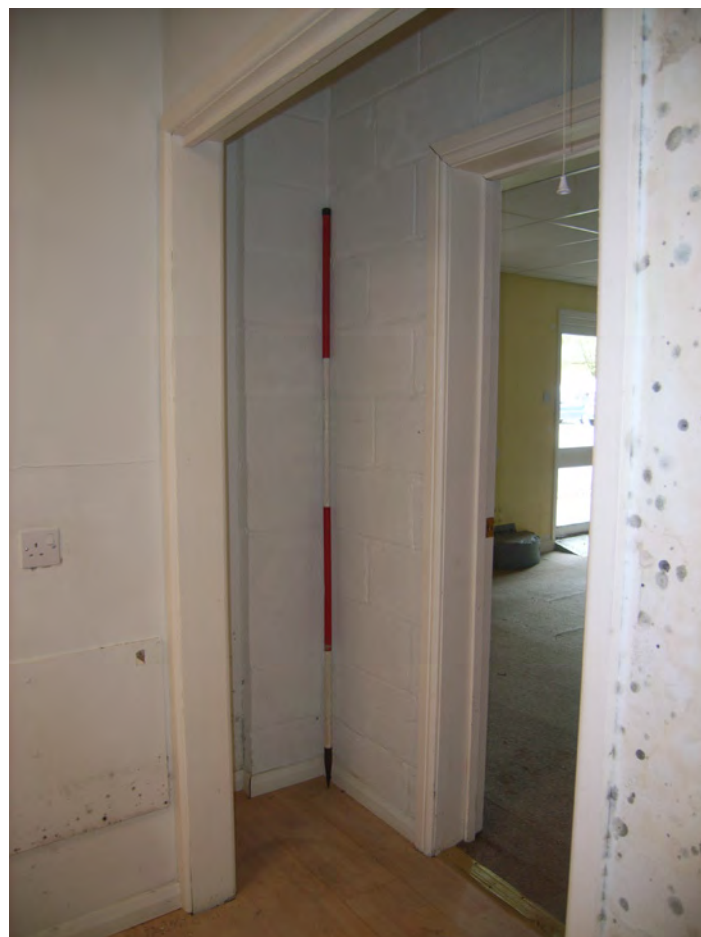
Plate 115.10 Blockwork lobby between office and kitchen

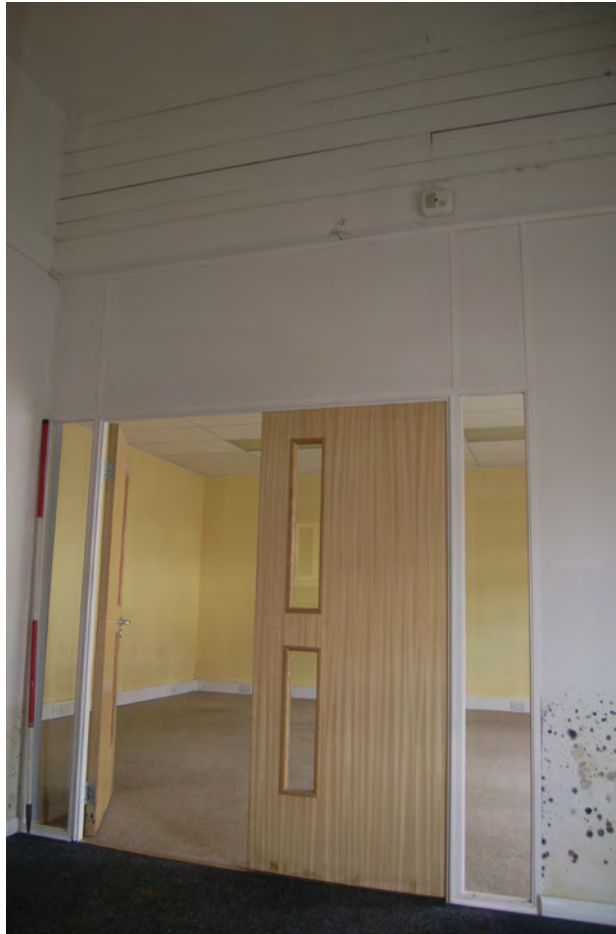
Plate 115.11 A partition pre-dating the suspended ceiling

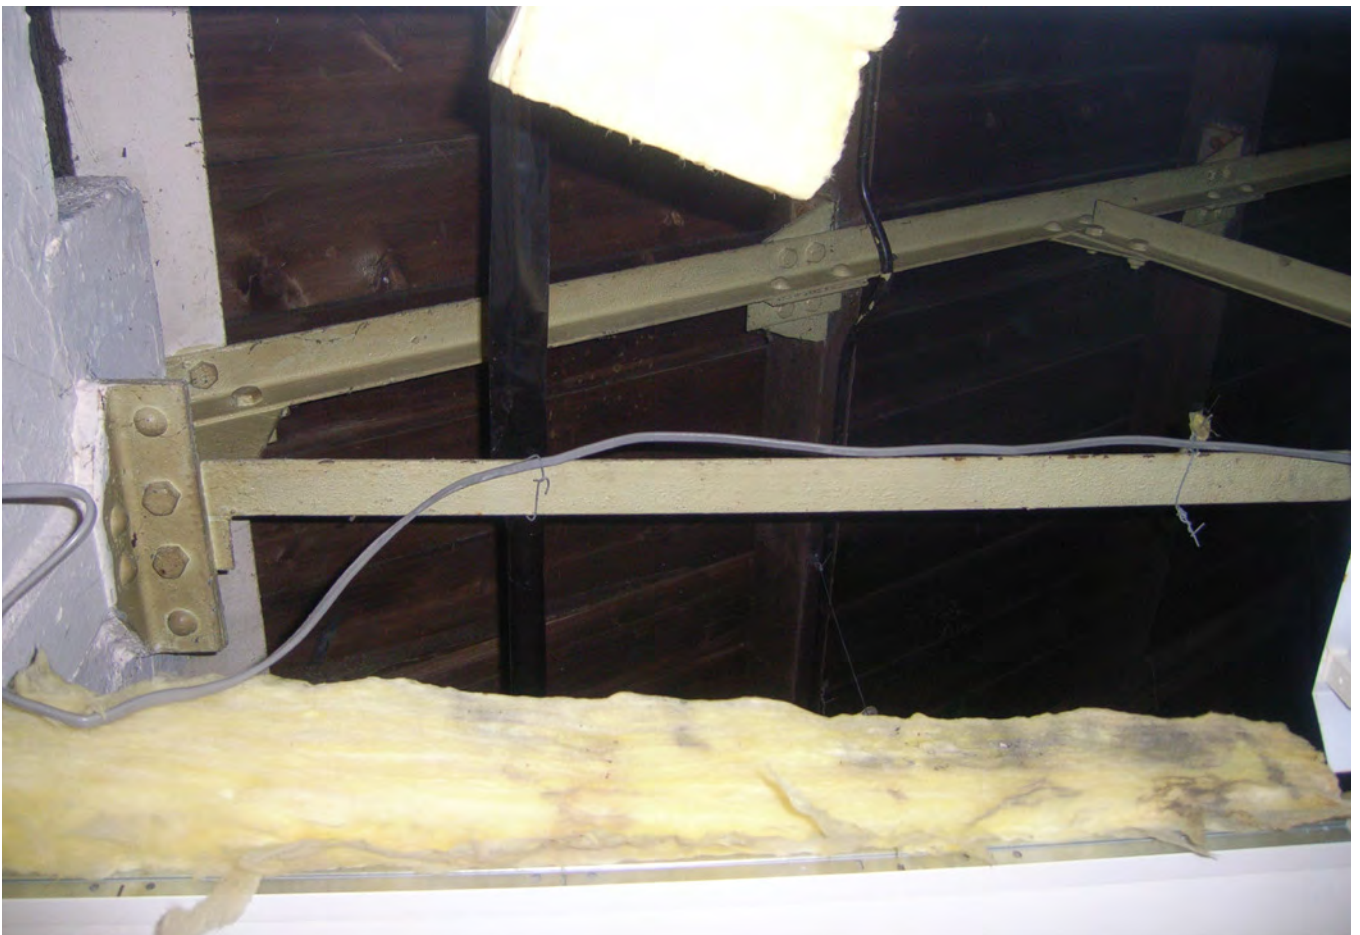
The roof construction is visible in one room above the ceiling and shows the original steel trusses remain; the rafters and sarking boards may have been replaced (Plate 115.12).

Plate 115.12 The roof structure above the suspended ceiling

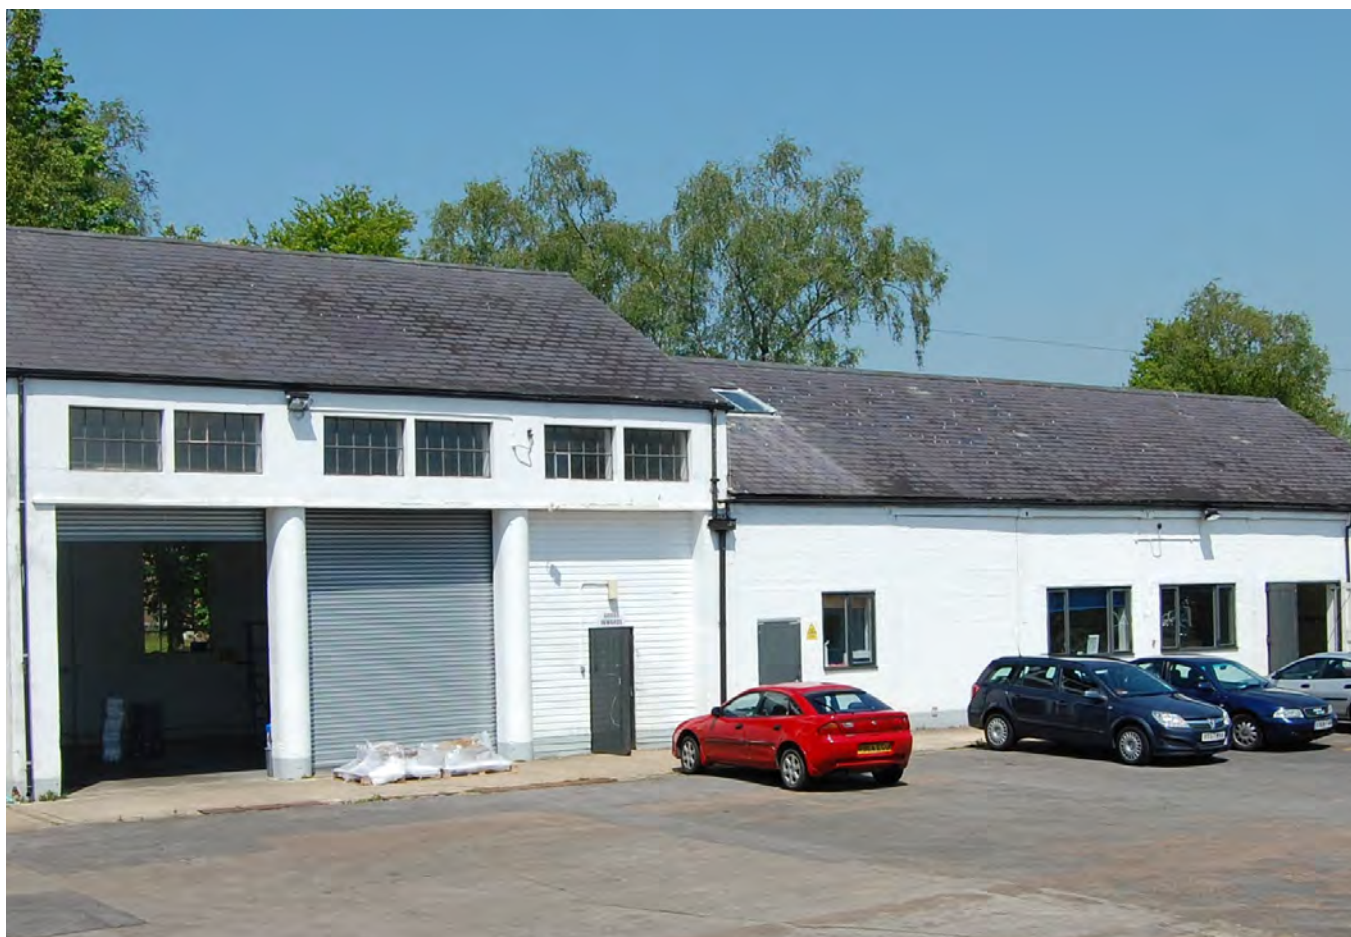
Plate 117.1 South-east and south-west elevations

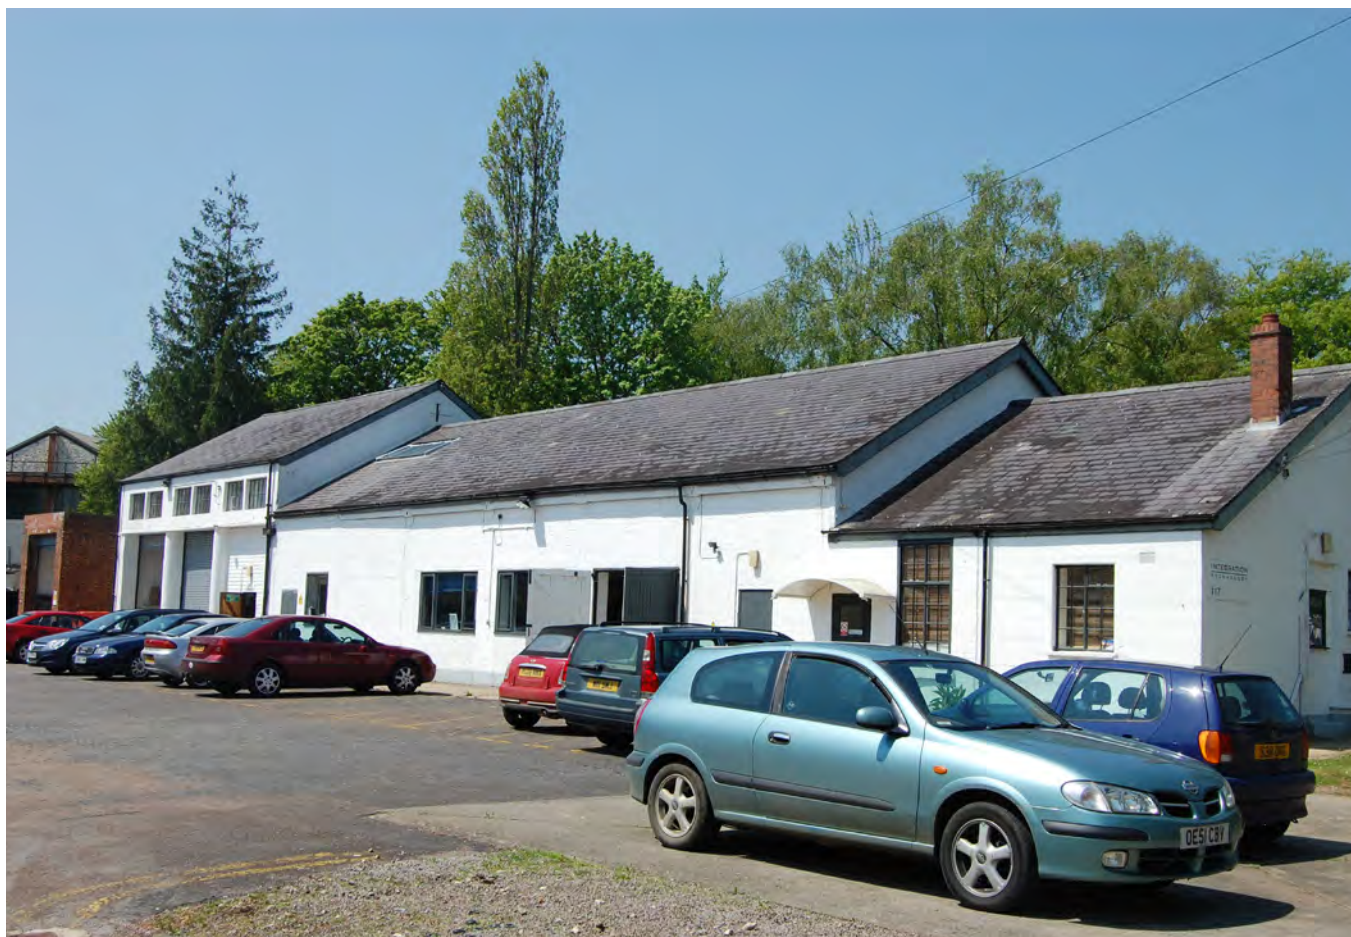
Plate 117.2 South-east and north-east elevations

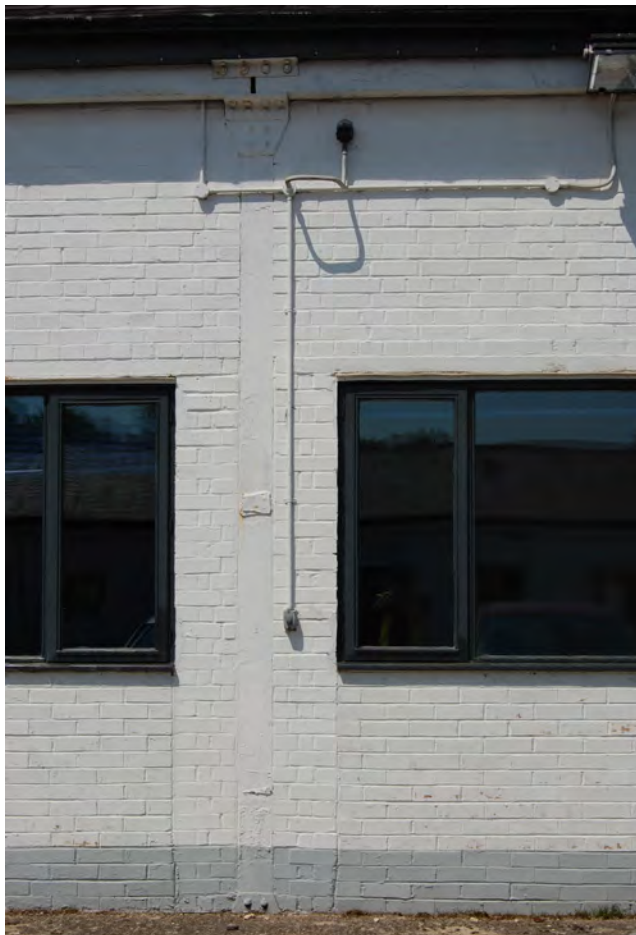
Plate 117.3 Original hinges surviving on a column

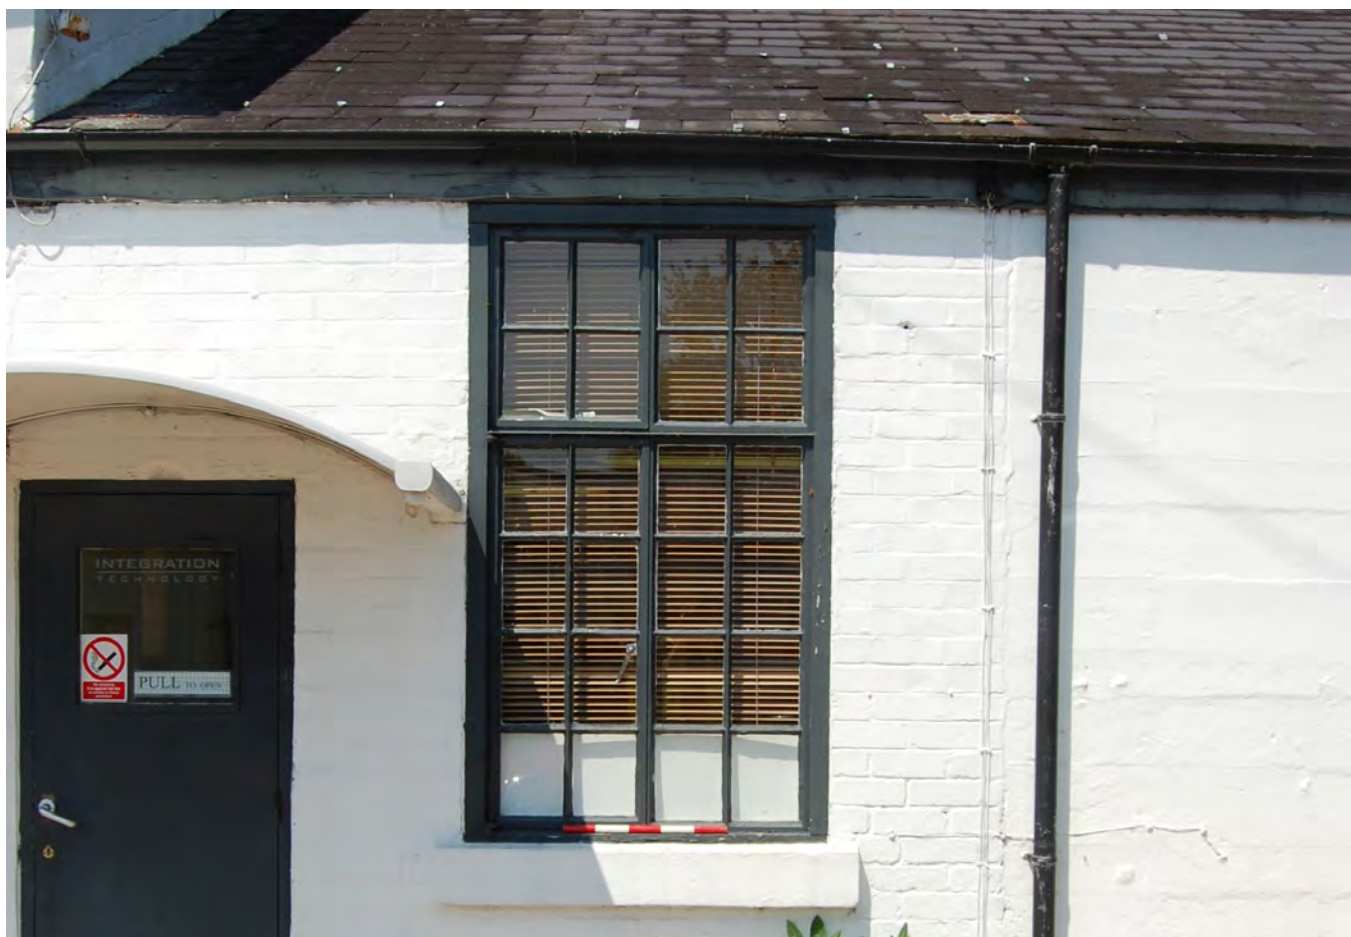
Plate 117.5 The door and window now serving the former motorcycle bay

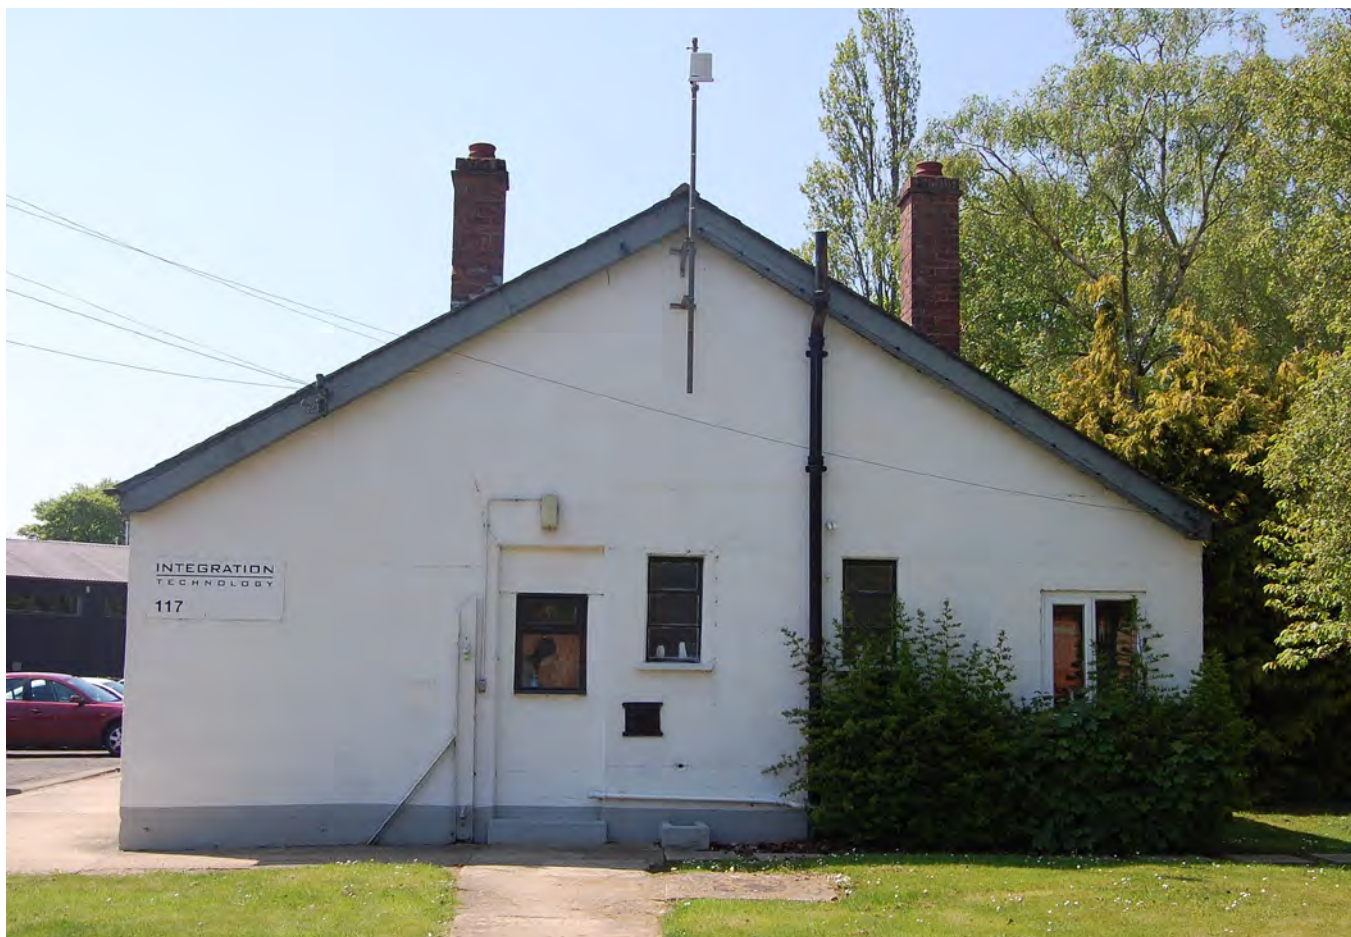
Plate 117.6 North-east elevation

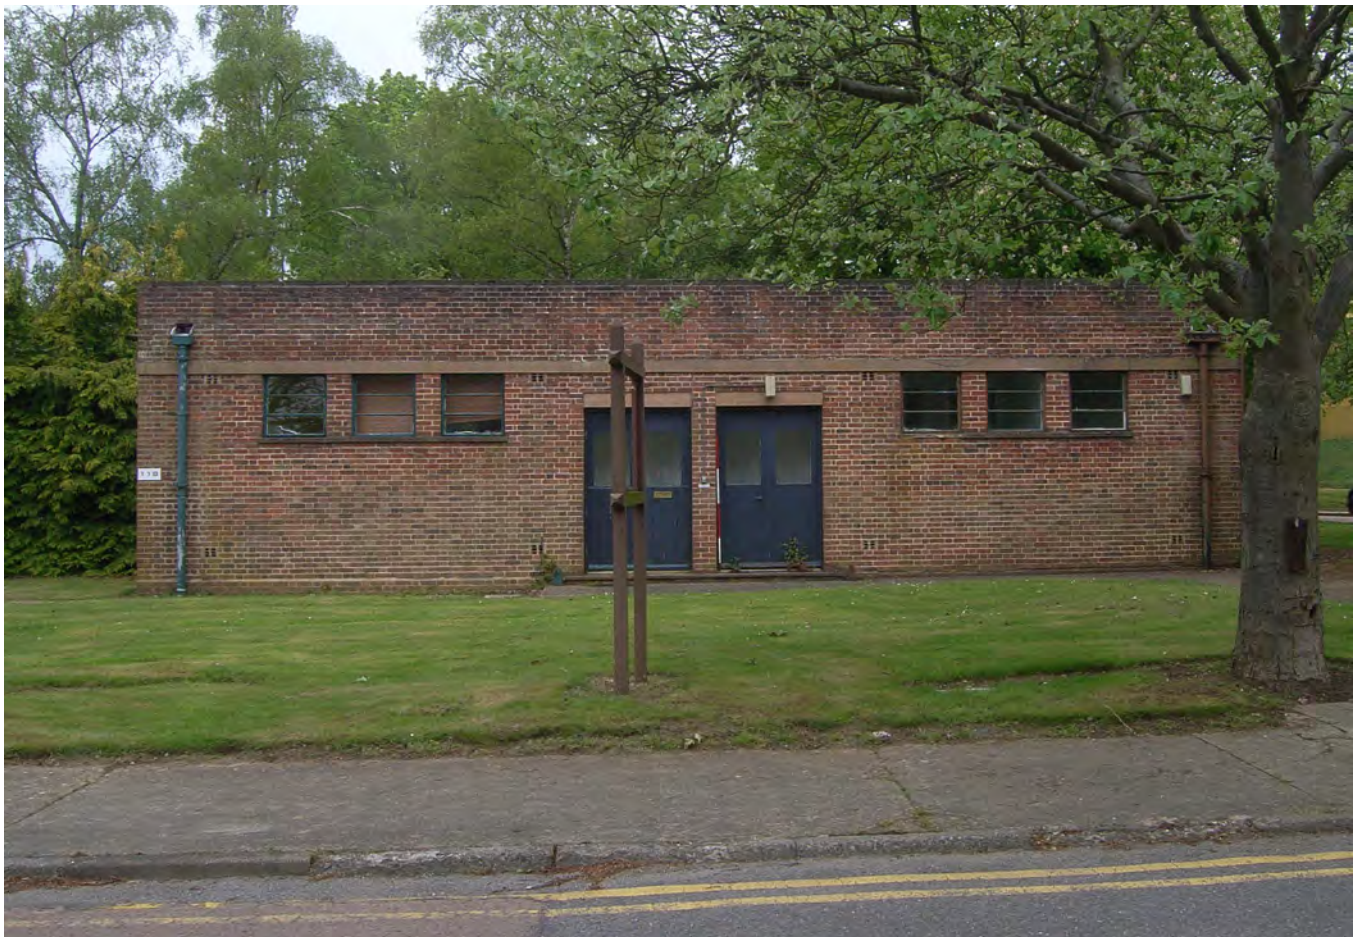
Plate 118.1 North east elevation

The building is built to drawing number 12386/38 and is of flemish bond brickwork with a flat roof behind a brick parapet. A reinforced concrete band encircles the building several courses below the roof line, acting as a continuous lintel for the windows to all elevations (Plate 118.1).

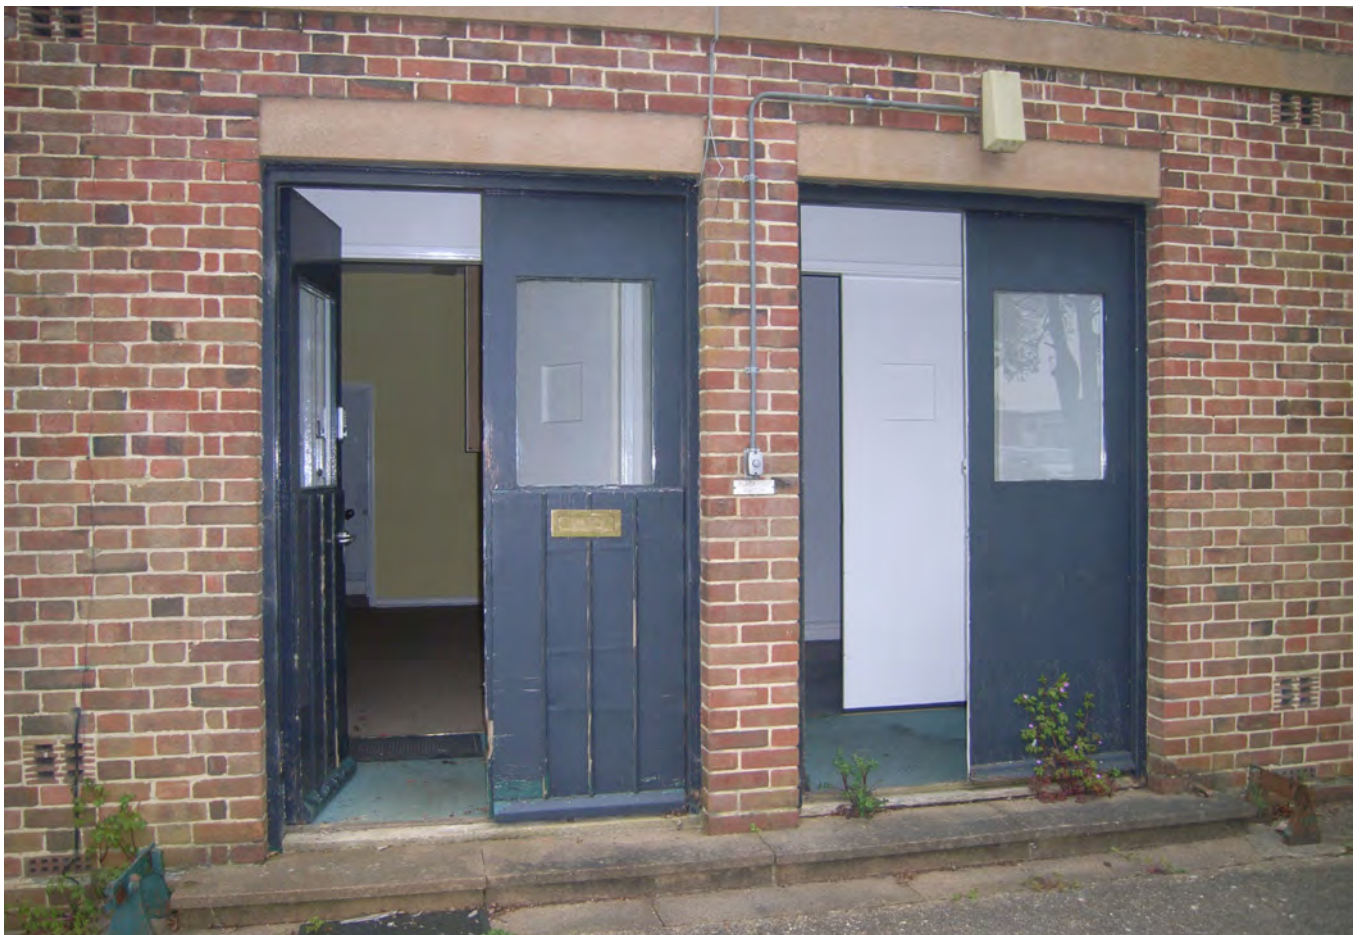
Plate 118.2 Entrance double doors to the units

Two sets of double-doors to the front, north-east, elevation have individual concrete lintels. A concrete-slabbed step extends across both doorways and metal boot scrapers are to either end. Panels, presumably for repair or reinforcement, and a letter box have been added to the left hand side unit's doorway. The 1959/ 78 plan states that the right hand side unit's doorway is blocked, however, the two doorways and the doors to the porchway behind are identical. This indicates the doorway was reinstated and all of the doors replaced soon after the latest plan update or the blocking-up was never actioned (Plate 118.2).

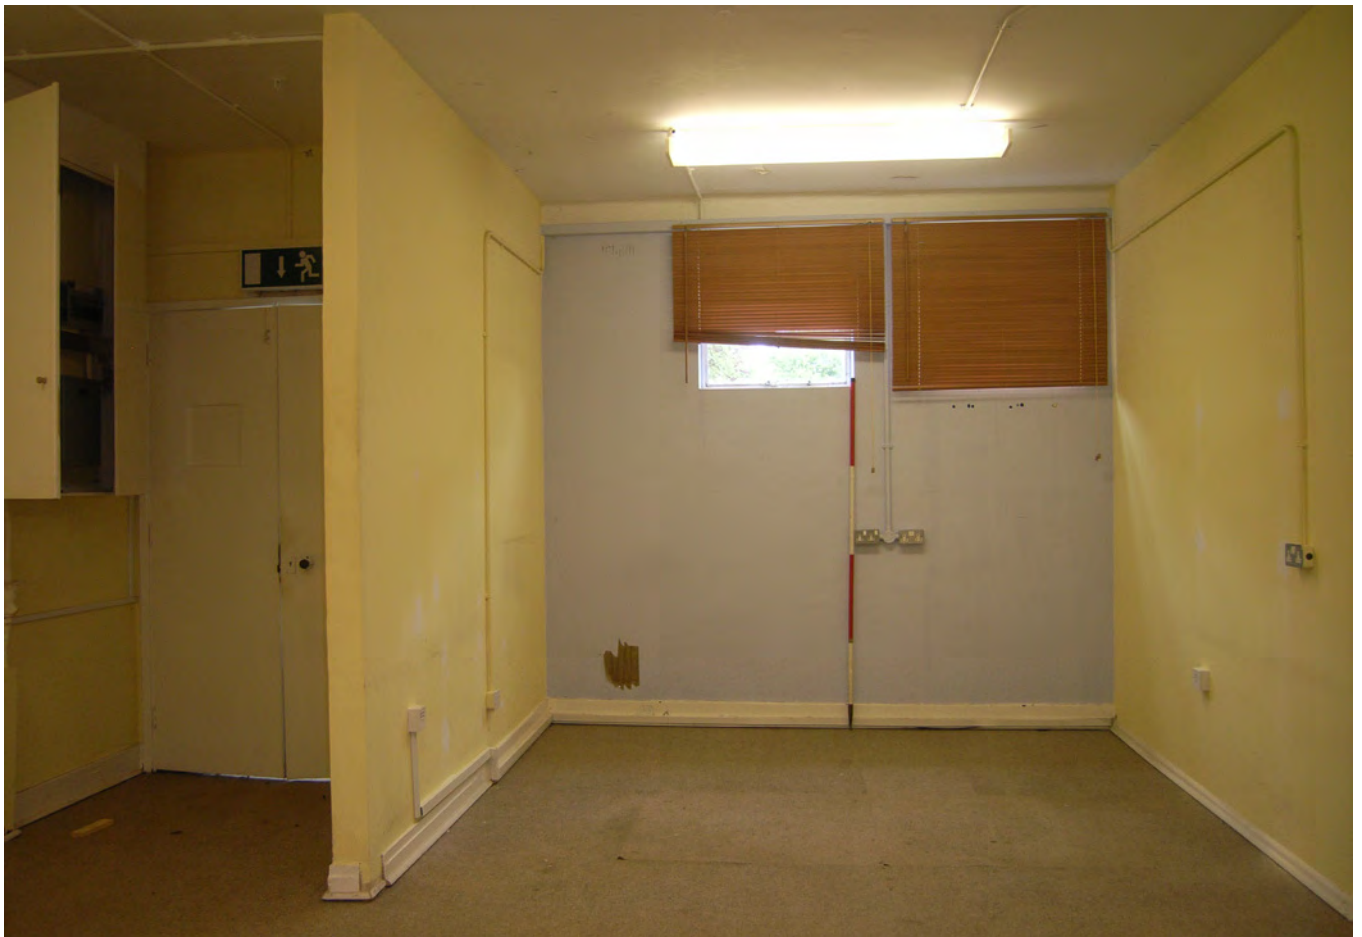
Plate 118.9 Internal view of the front elevation

The internal walls are plastered and painted. The plastered ceiling is level with the top of the concrete string course (Plate 118.9). The original WC door has moved from the south-east partition to the north-east and a kitchenette then installed to the south-east of the WC (Plate 118.10).

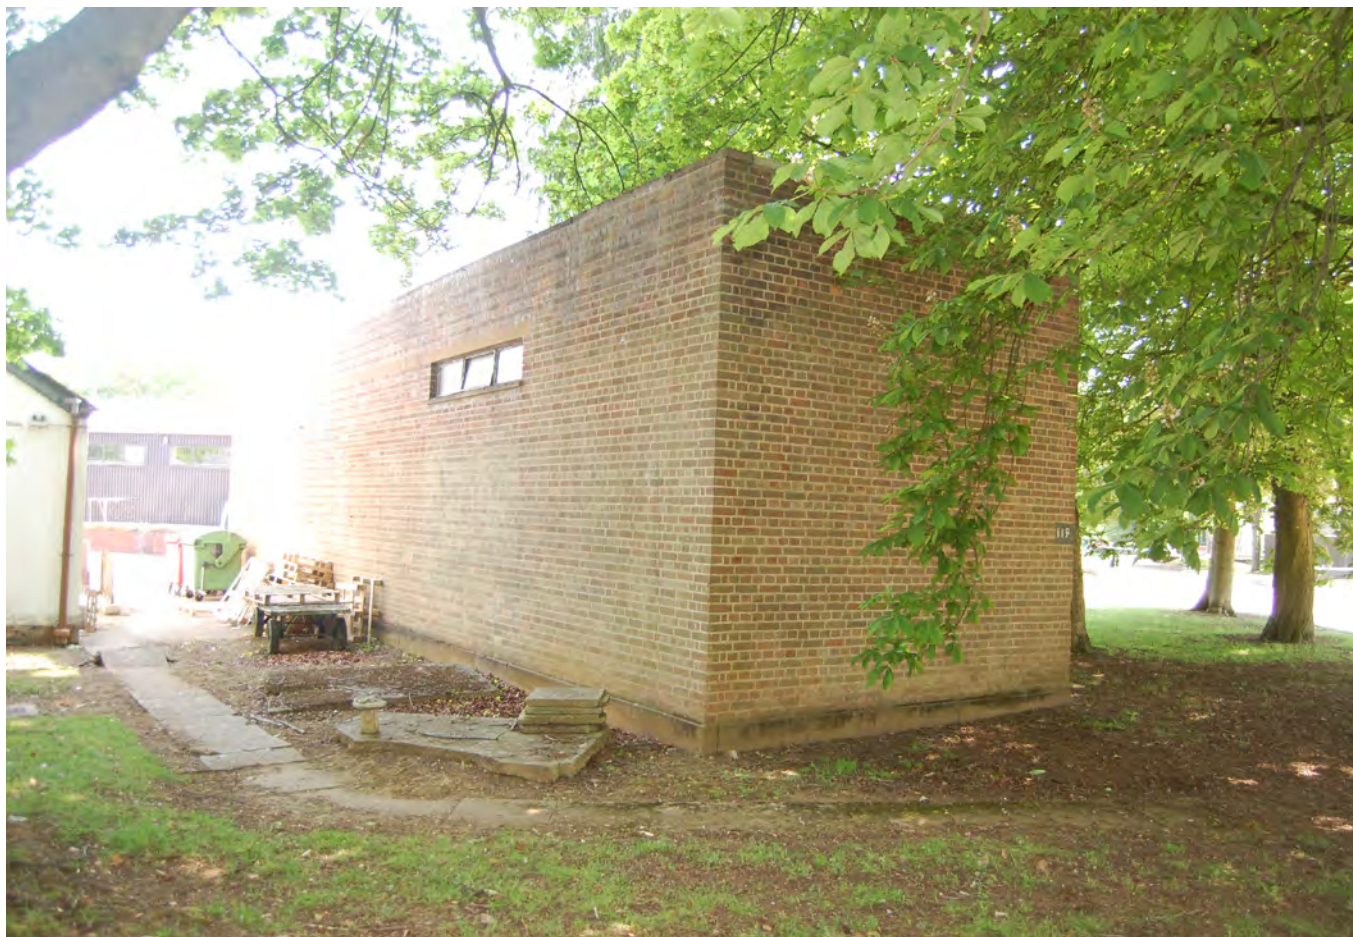
Plate 119.5 North west and north east elevations

The doorway has a concrete lintel over, above which some brickwork has been replaced. The side elevations each contain two high level windows above which a continuous concrete lintel runs above the windows and the space between, both sills are concrete (Plate 119.5). The north western elevation has no features (Plate 119.6).

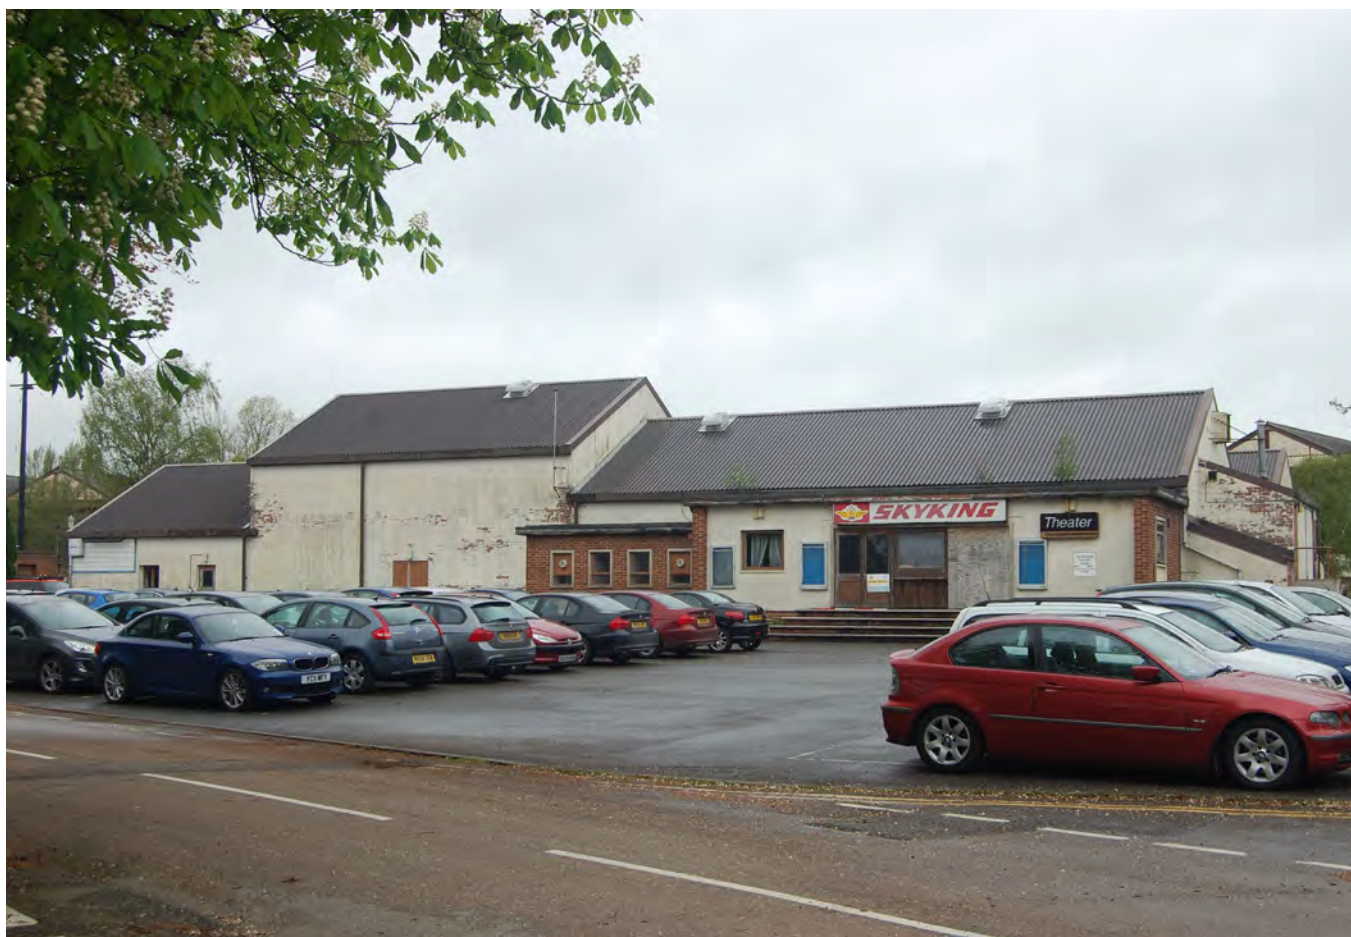
Plate 130.1 South-east elevation

The 1941 adaptations include the aforementioned structure to the south-west end of the wing to a height slightly lower than the existing building and the increase in height of the roof of the existing four bays adjoining this (Plate 130.1). A large access door for the aircraft was originally at this end of the wing; it has since been blocked and replaced with two personnel doors, although it is not clear at which point before the 1960 drawing this occurred.
