FORMER RAF UPPER HEYFORD, OXFORDSHIRE

HISTORIC BUILDING RECORDING AND INVESTIGATION

VOLUME 2: GAZETEER OF RECORDED STRUCTURES

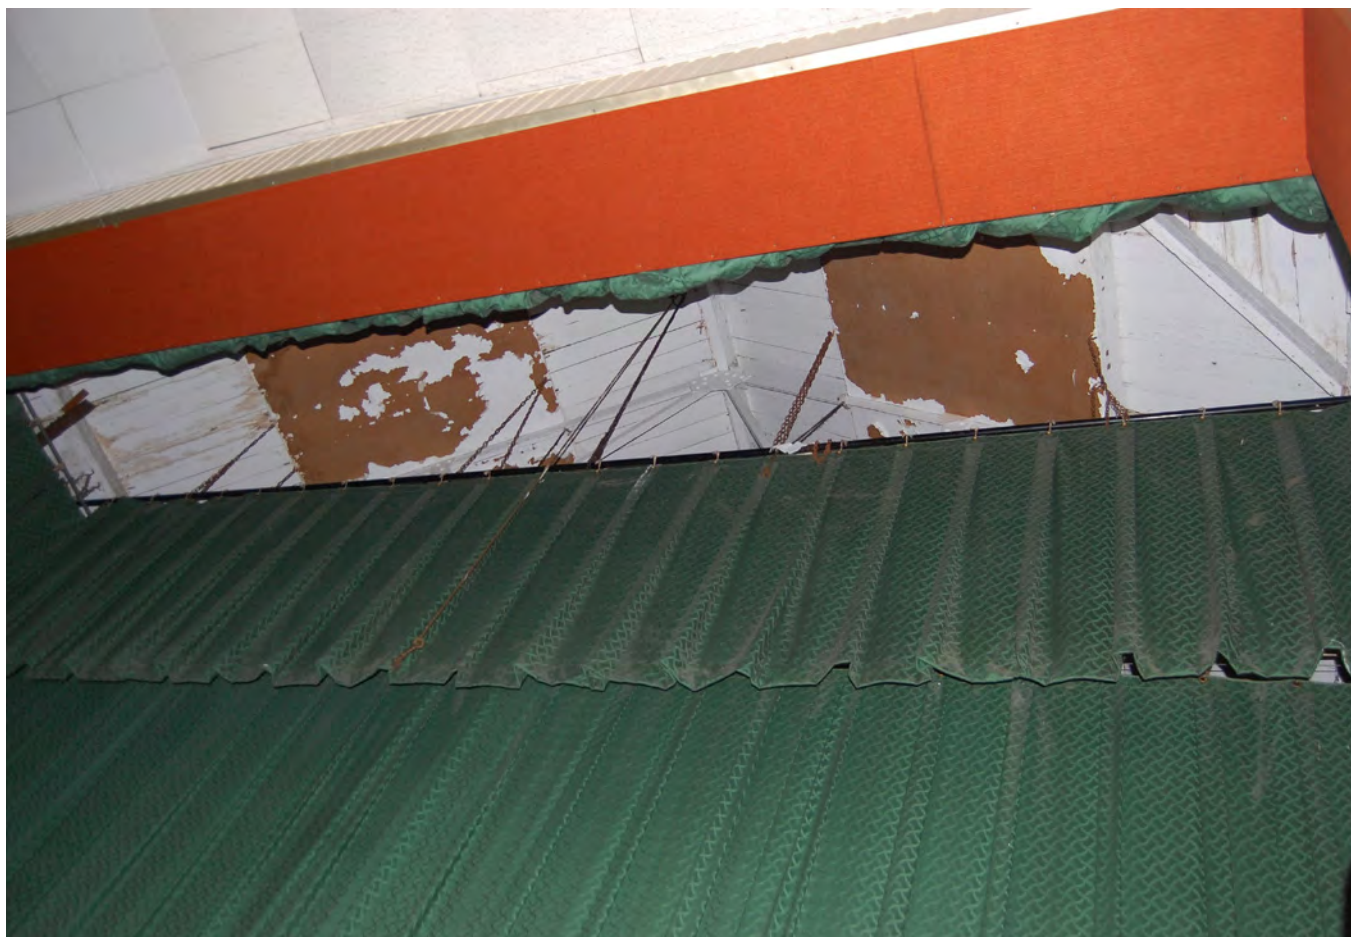
Plate 130.2 Roof structure and blocked skylights above the stage

The structure consists of steel trusses supported on brick piers on a permanent-brick structure. The gabled roofs would have originally been covered in slate (Francis 1996), but by the time of the 1986 installation of a metal-clad roof, the specification on the drawing states that the pitched roofs were of corrugated asbestos cement sheets. The original roof covering incorporated skylights, possibly along the length of each slope; boards are visible bridging the gap in the sarking boards where there are gaps in the suspended ceiling (Plate 130.2). According to the specification notes on the 1986 drawing, the roof works retained the steel trusses, softwood purlins and softwood sarking boards. The new battens, insulation and cladding were then fitted to the existing structure. This work also included the demolition of three chimneys, although the locations of these are not detailed on the drawing.

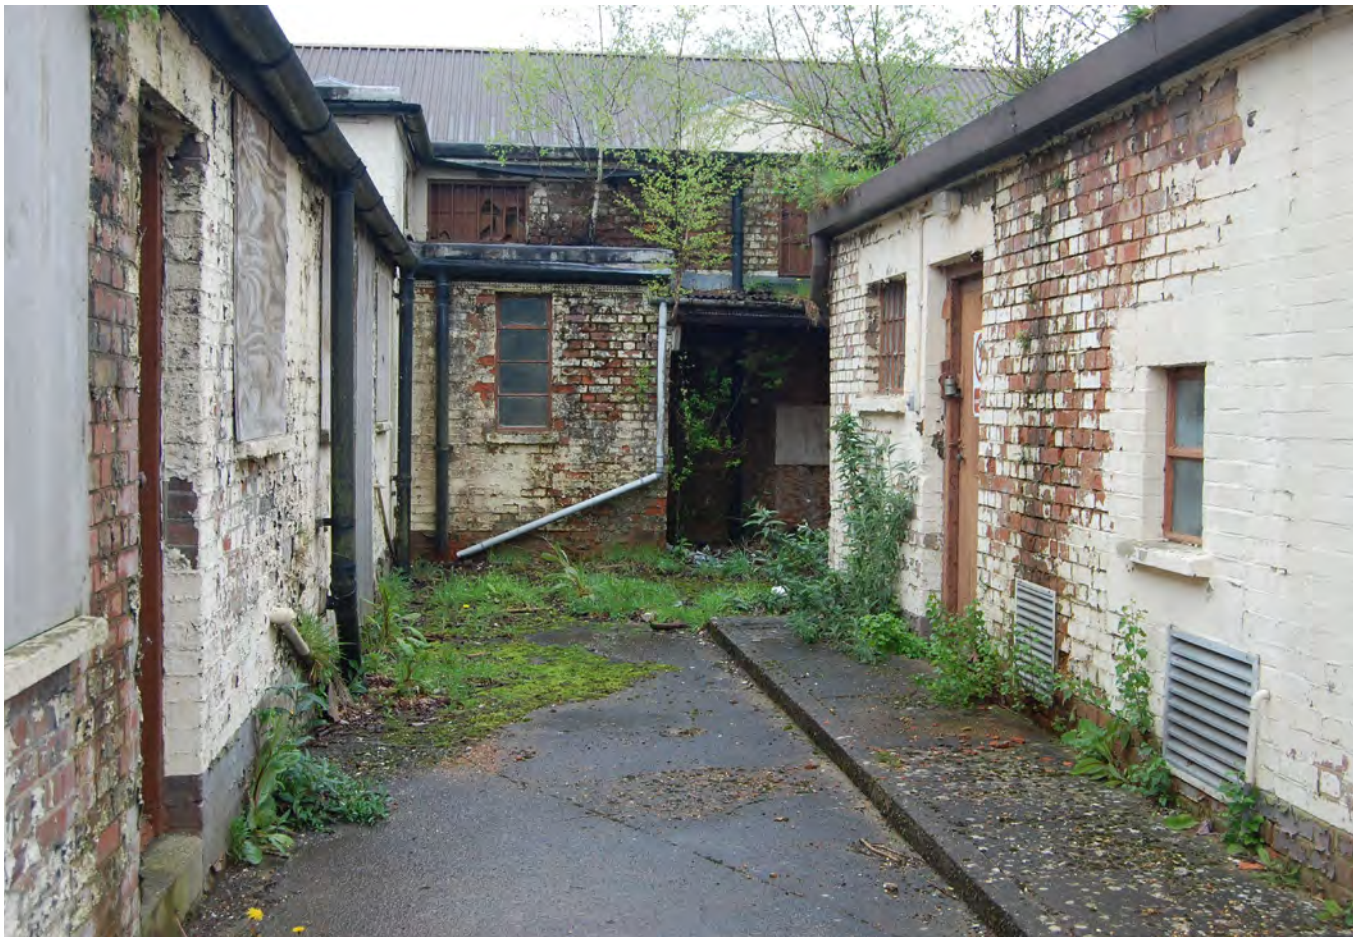
Plate 130.3 Yard area and infill between the two north east wings

The majority of the extensions are in the space between the two wings (Plate 130.3). It is not possible to ascertain the sequence of their construction from the APs, however, these extensions, although seemingly piecemeal, well pre-date the 1960 drawing and may relate to the aforementioned individual workshops associated with the original function. These small, flat roofed rooms are in either english bond or stretcher bond brickwork and have metal-framed windows and ledge and braced timber doors. These extensions obscure the majority of the original openings within this courtyard which appear to have been tall twenty-paned metal-framed windows to the majority of the bays. They are all accessed via doors into the courtyard, although the extension along the north-western edge of the auditorium, and the larger extension which bridges the space between all of the ranges to the south-west end of the courtyard have doors inserted to enable access from the main buildings.

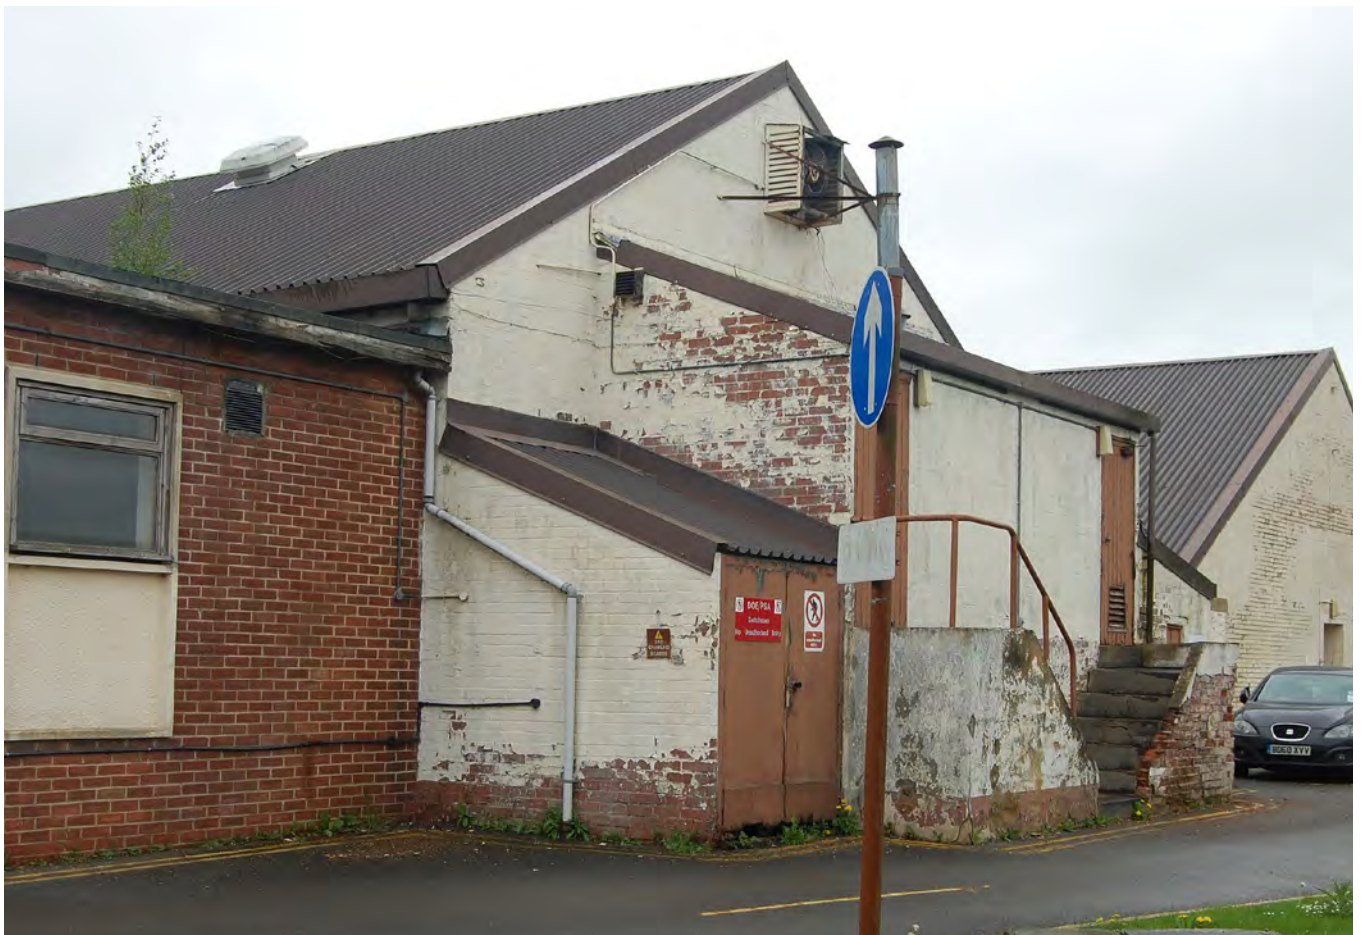
Plate 130.4 North east elevation of the south eastern wing

The extensions to the north-east end of the south-east range were most recently the projector room, battery store and film store (Plate 130.4). Although these are undated, the raised entrance accessed by steps for the projection room suggests that it

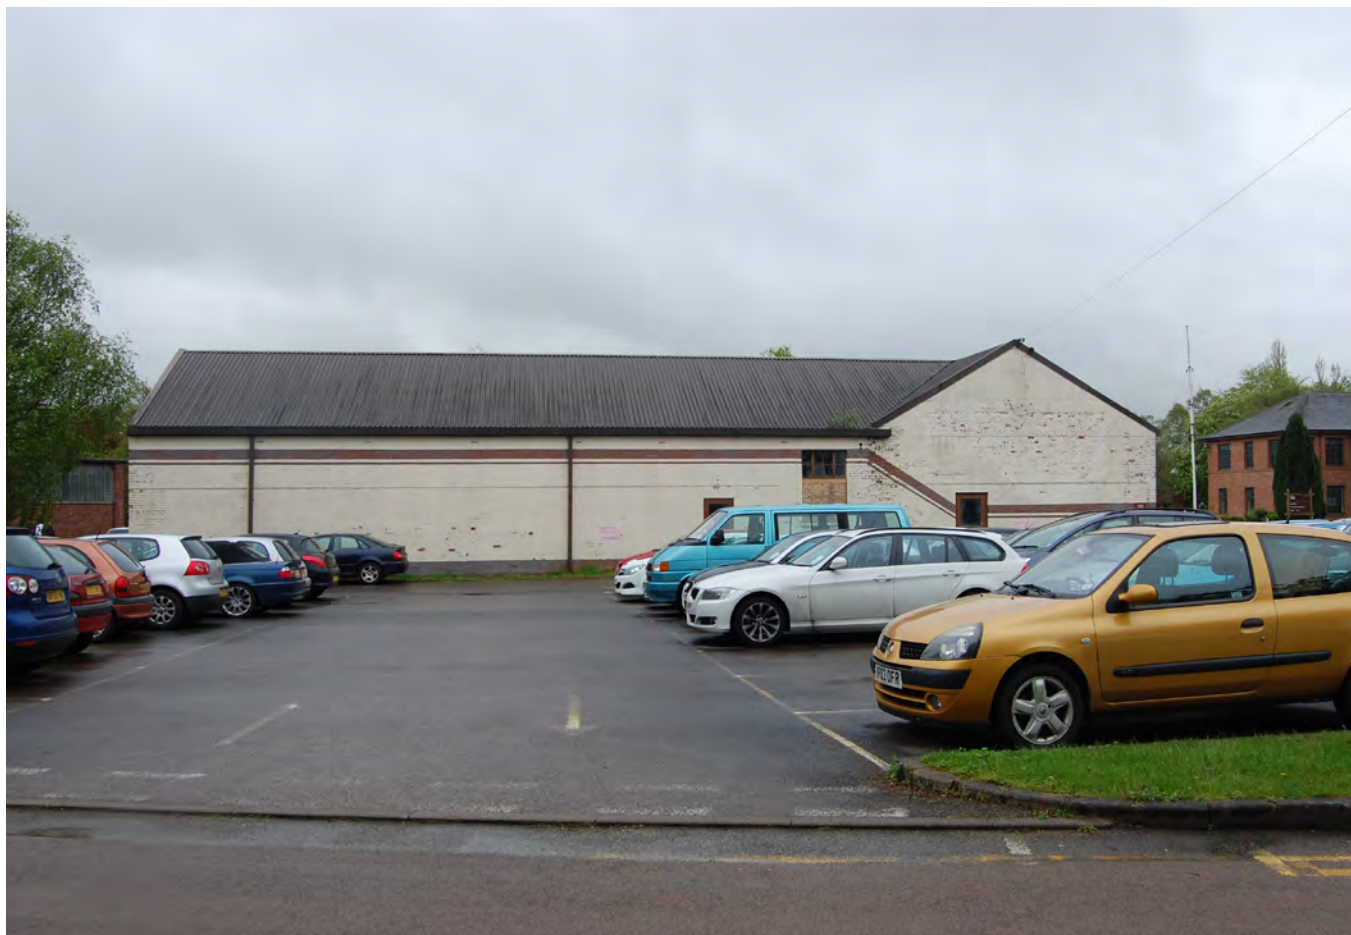
Plate 130.5 North-west elevation

The north western elevation currently contains a single doorway to this end of the south-west range (Plate 130.5), which evidently replaces a full height and width doorway which has been bricked-up; the concrete lintel being just visible on the gable wall several courses above the eaves. Originally, metal-framed windows identical to that which remains in the adjacent wing would have lit each bay, but these have since been blocked; a doorway in the bay adjacent to the window has been inserted later. Much of the visible alteration has been obscured by the heavy paintwork. A brown painted double stripe, with grey primer showing through, decorates the brickwork, differentiating between the Communications block and the theatre.

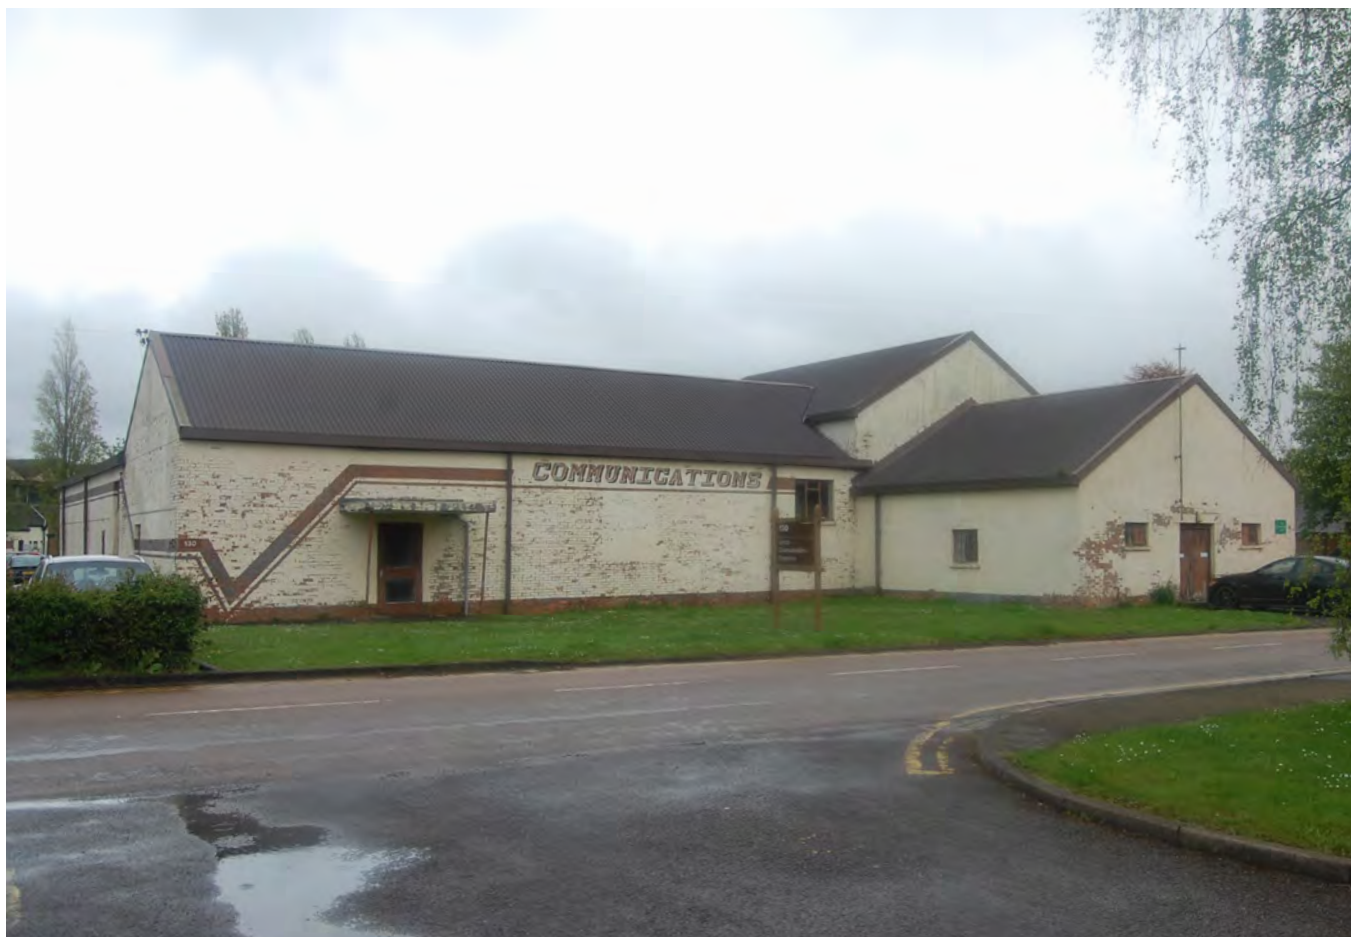
Plate 130.6 South-west elevation

The decoration continues around to the south-west elevation where the word 'COMMUNICATIONS' is painted in the same brown colour with black shadowing (Plate 130.6). A doorway identical to those in the north-west elevation replaces a window to the left hand side of the elevation with a porch over. A partially blocked window is to the bay adjacent to the 1941 extension and the two bays to the left of this have blocked windows. The two bays either side of the door do not appear to have blocked openings, however, thick paintwork obscures the brickwork. The 1941 extension obscures the original gable wall of the south eastern wing which was also increased in height as part of the same project.

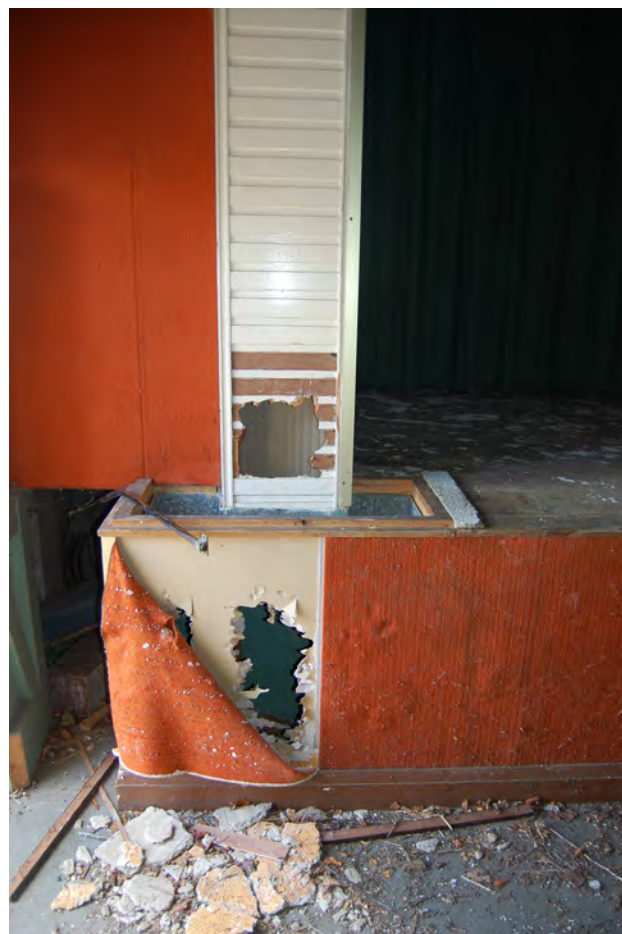
Plate 130.8 Decorative woodwork and planters to the edge of the stage

The southernmost wing has been converted into a theatre and cinema facility. This conversion possibly occurred in 1948 as a note on the modification plans of 1960 reference a schedule of specifications of 1948. This also corresponds with the style of the surviving panelling and door furniture of the vestibule-to-auditorium doorways which survived the entrance rebuild (Plate 130.7). During the 1960 works, the stage area was remodelled in order to provide a larger cinema screen. The surrounding decorative timberwork was altered and bespoke planters constructed to either side (Plate 130.8). The current interior décor obscures any indication of blocked openings.

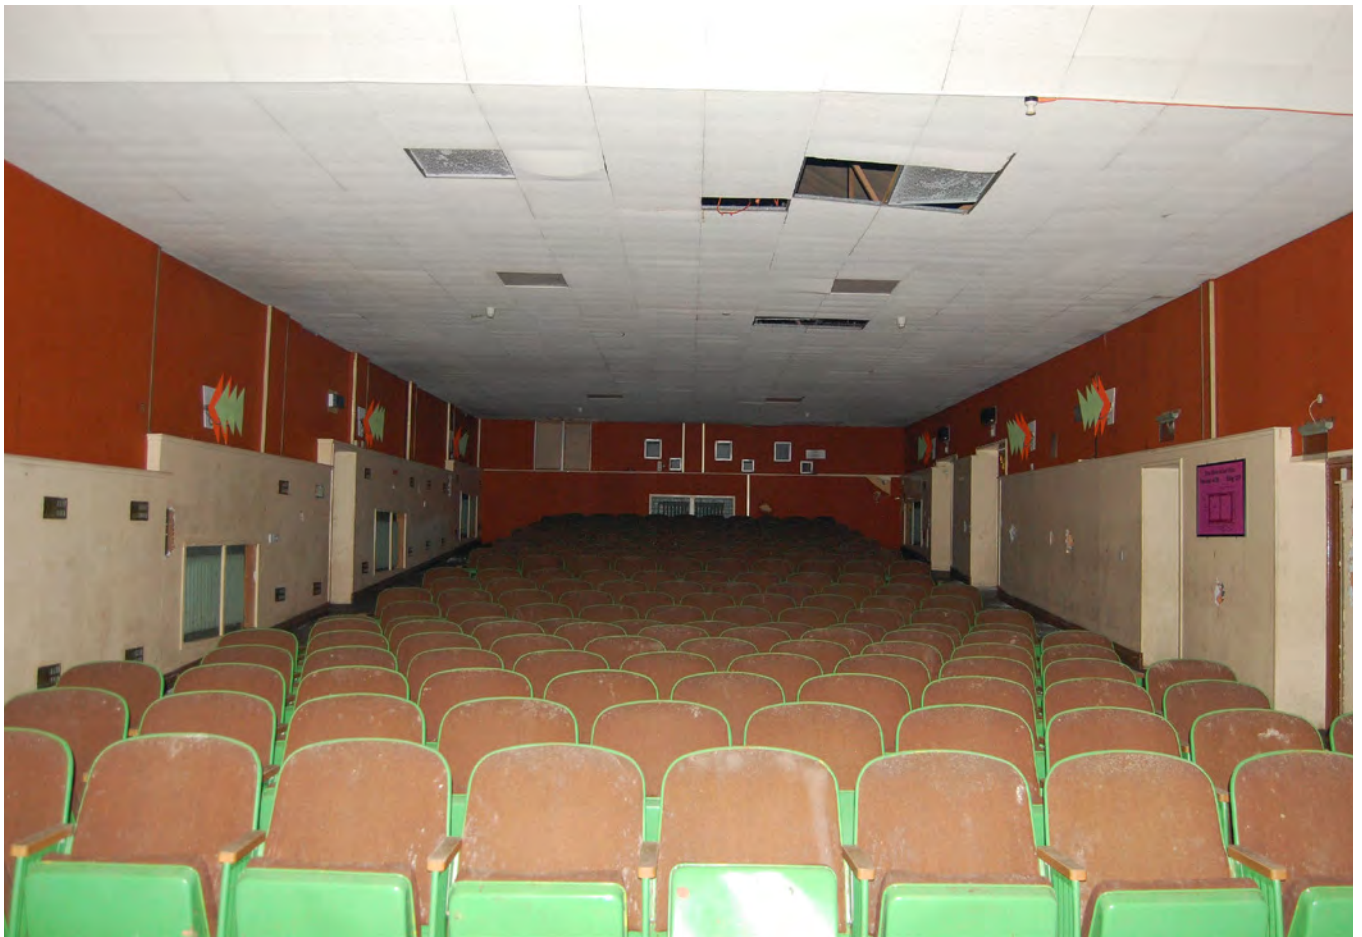
Plate 130.9 Auditorium, looking north-east towards the projector room

The floor of the auditorium has been raised towards the north eastern end (Plate 130.9). The modern suspended ceiling slopes upwards towards the screen end of the auditorium (Plate 130.10). The original radiators remain along the side walls of the auditorium which were concealed by panelling and grilles; vents allowed the heat to circulate into the auditorium. Behind the screen, the original speaker 'The Voice of the Theatre' remains in situ (Plate 130.11). The original blue leatherette and round wooden backed seats are stored underneath the stage. The stage is constructed of sawn softwood frame.

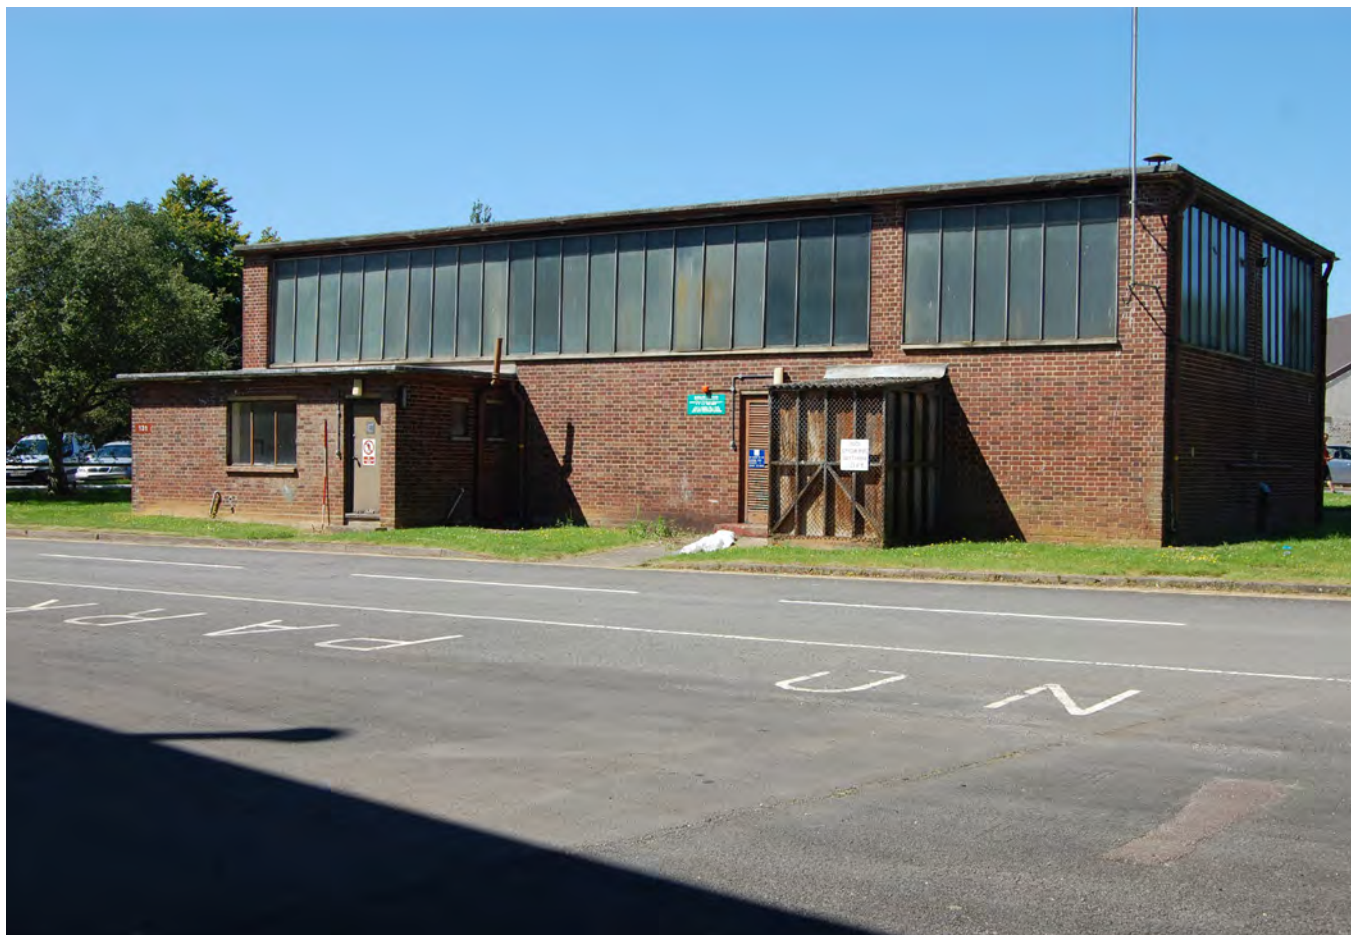
Plate 131.1 South-east (front) elevation

The south-east elevation (front) has a single storey projection, also with a flat ashfelt roof, at the south-west end (Plate 131.1).. This has a simple three light crittal window and a single timber door. On the north-east face of this projection are two small crittal toilet, which provide light to an internal sanitary area. There are double timber slated doors providing access to the plant area towards the north-east end of the building. There is also a simple timber single-storey structure with wire fencing surrounding it.

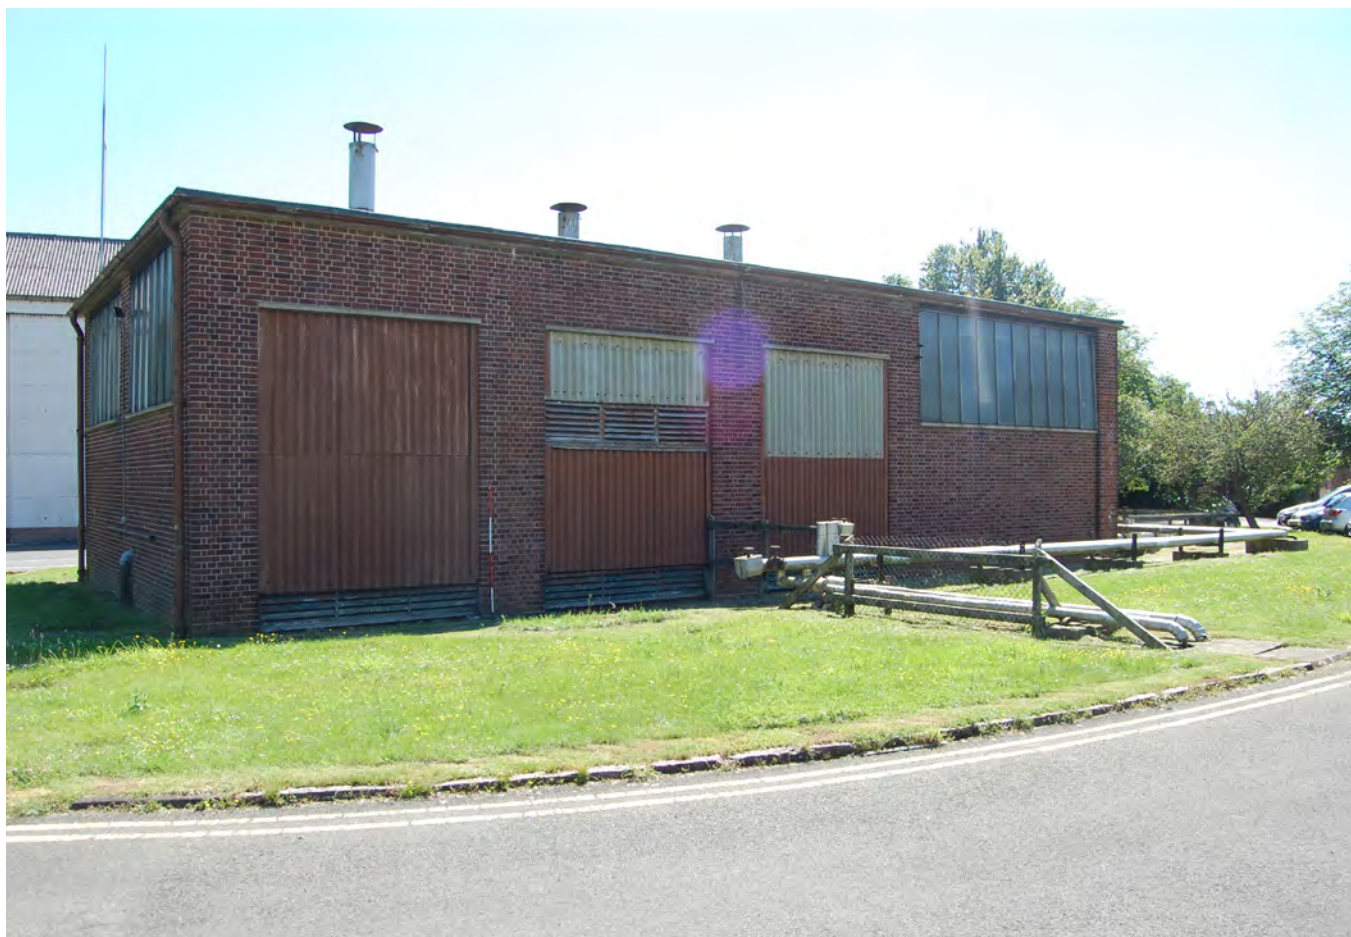
Plate 131.2 Rear (north-west) elevation

The north-west (rear) elevation has a set of vertical windows and three large rectangular areas which have been boarded up with corrugated sheets (Plate 131.2). Vents are visible in some areas of boarding and it is probable that these areas were former ventilation for the boiler house. These are brown, with green paint visible beneath. There are various pipes extending from the elevation around to the south-west elevation and into the ground.

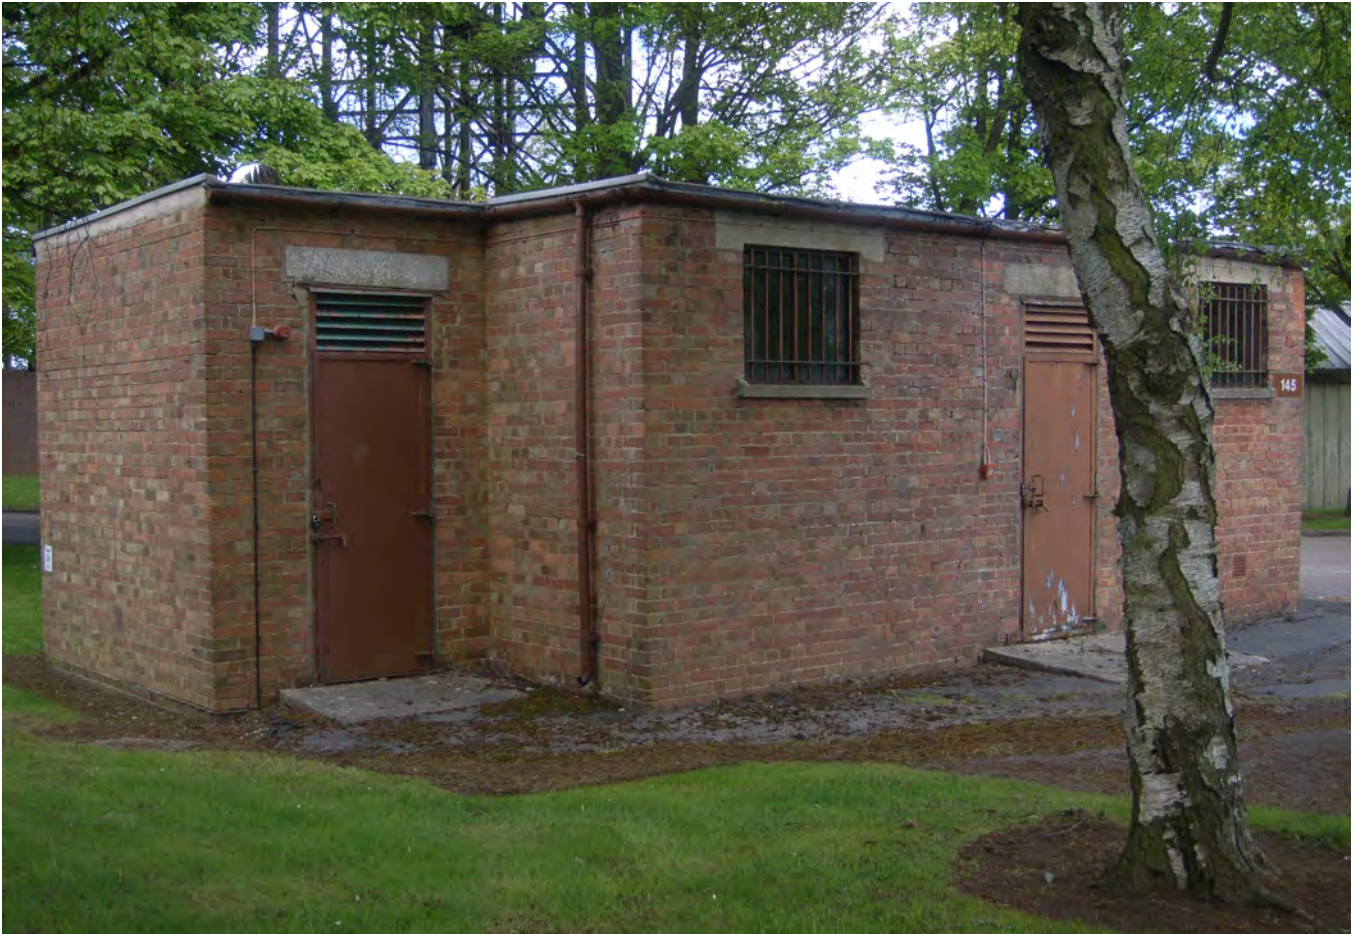
Plate 145.1 South-west elevation

The building is aligned north-west to south-east and in plan is a rectangular building of approximately 7.4m by 5.3m, with a projection of approximately 2m by 3.5m to the north of the north-west end of the building (Plate 145.1).

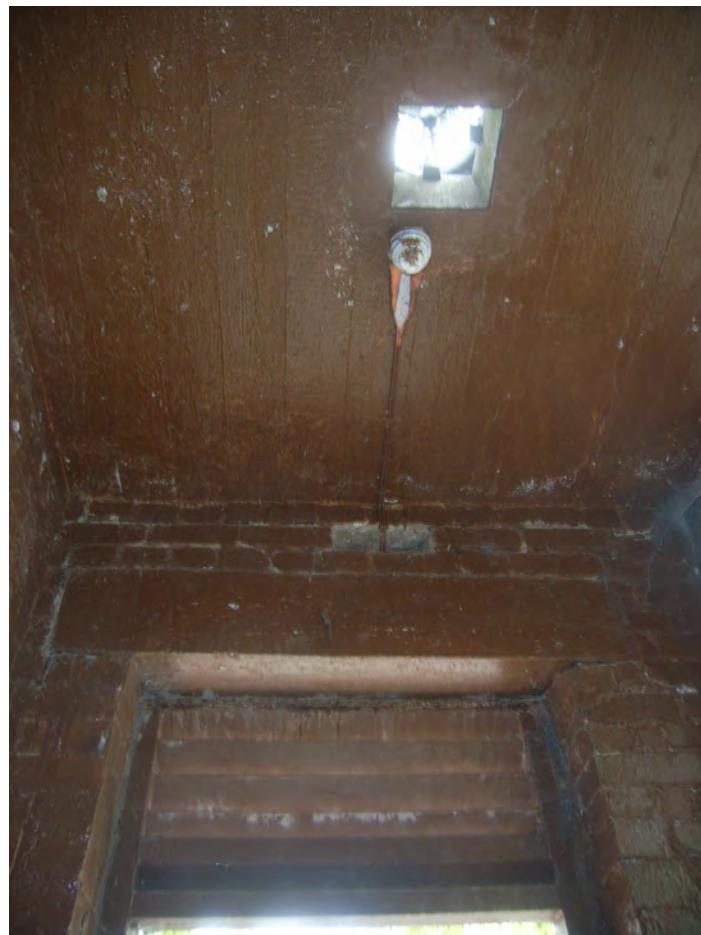
Plate 145.2 Example of the ventilation louvres above the doors and concrete roof

The doors and frames are metal with louvres above and there are vents to the roof of each room to provide ventilation of fumes (Plate 145.2). Low level terracotta vents to each room are in the south west, north-west and north-east walls which appear to be later inserts (Plate 145.3). Concrete lintels are above each opening and the window sills and door thresholds are concrete; shallow concrete ramps lead to the doors in the two south western elevations.

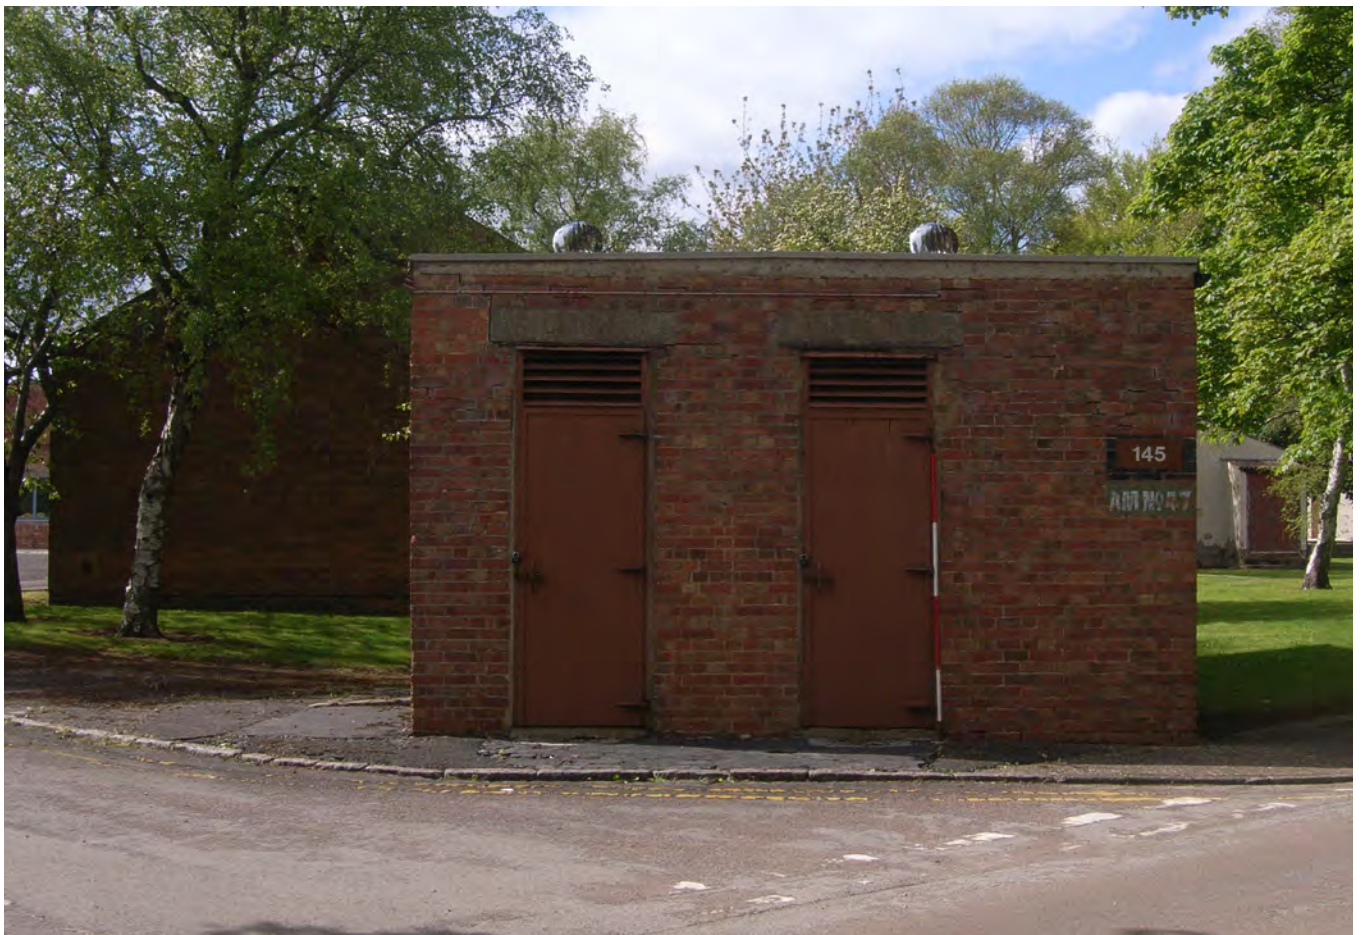
Plate 145.4 South-east elevation

A small area of brickwork has been replaced to the left of the lintel of the southernmost door of the south-east elevation (Plate 145.4).

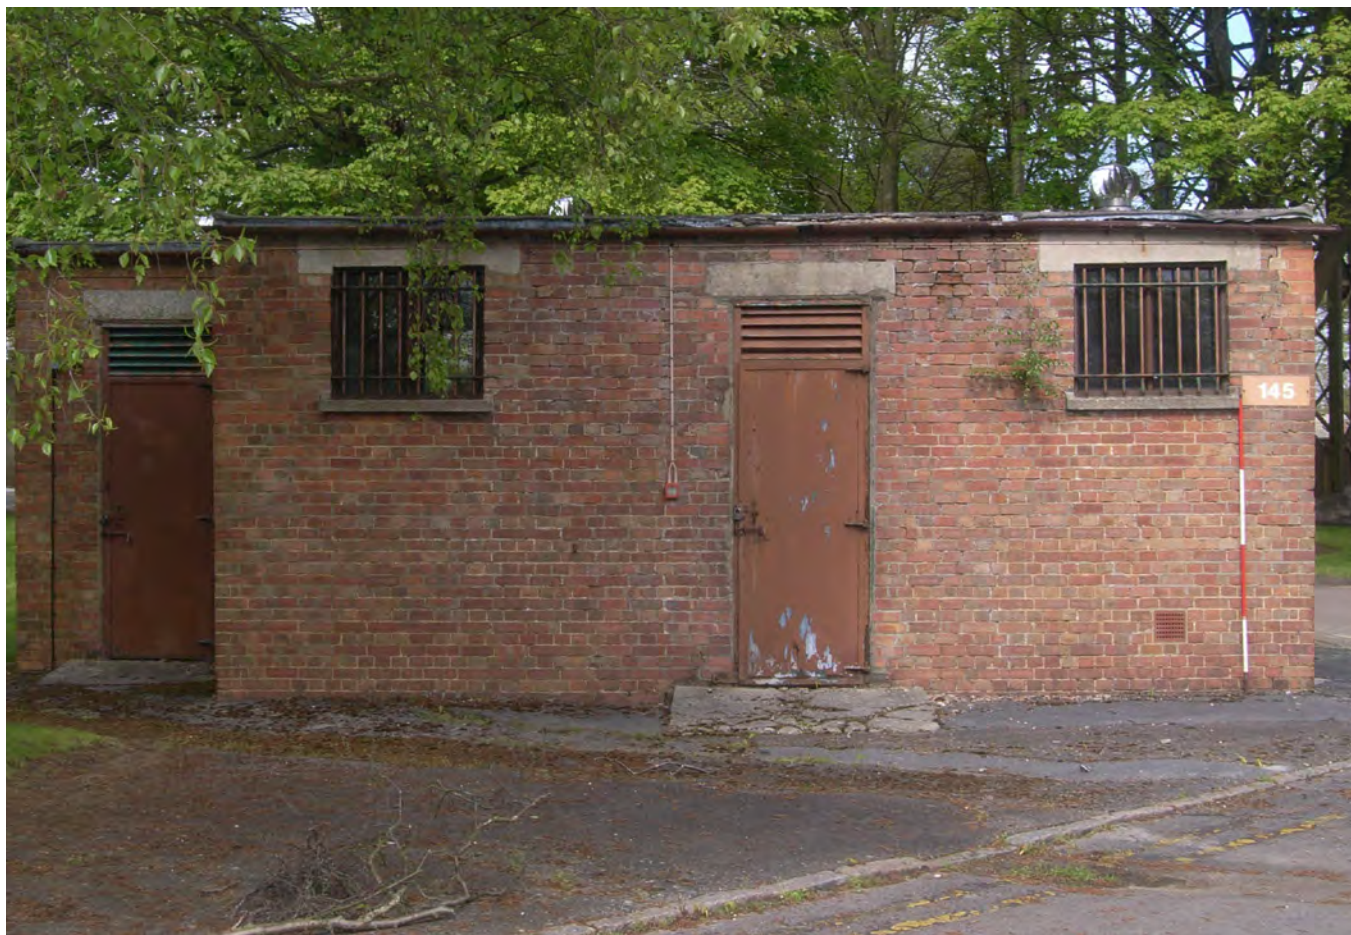
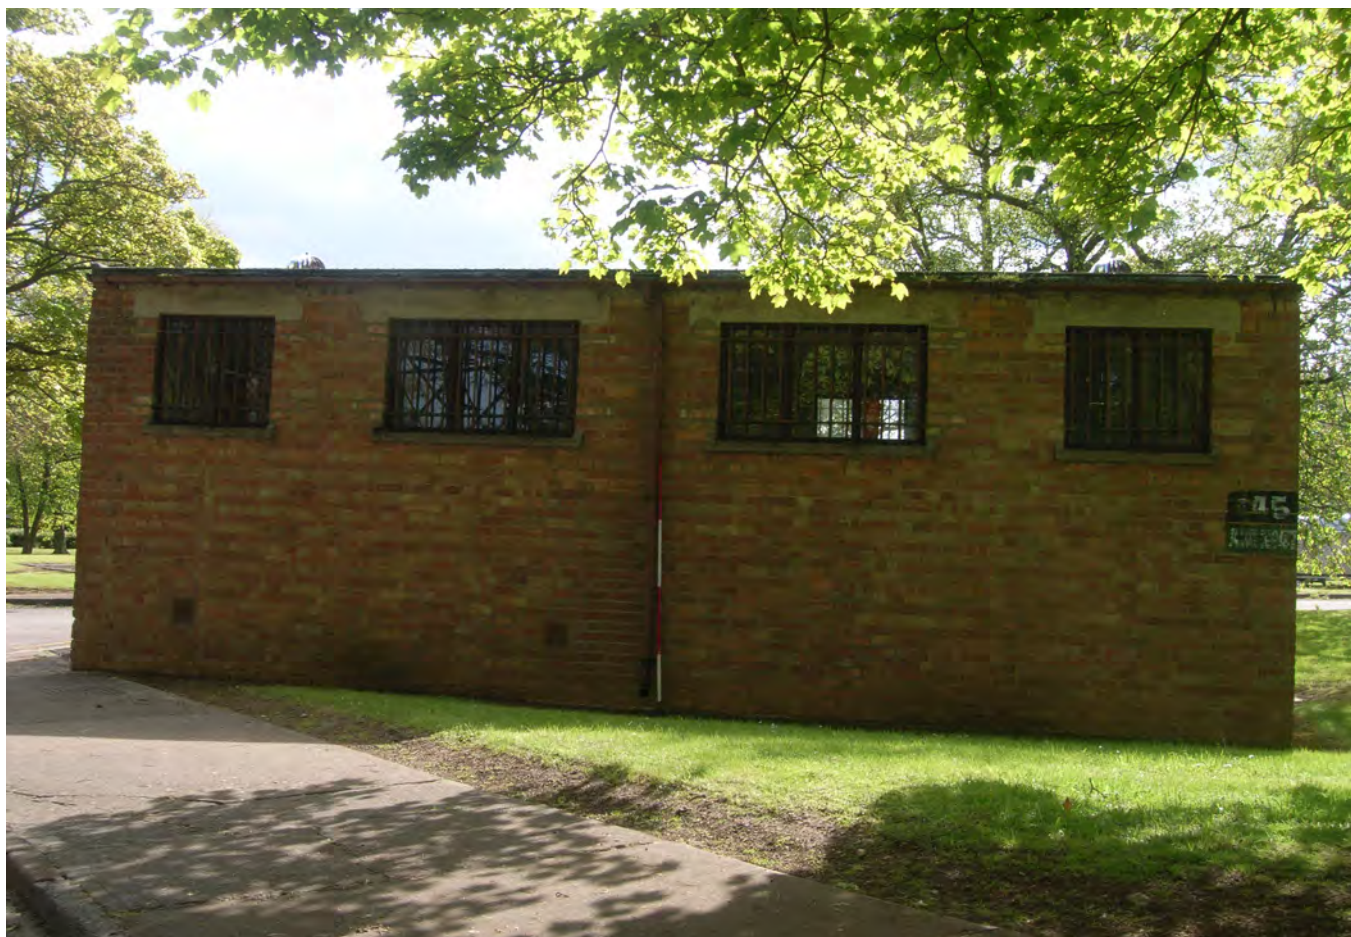
The large central room is accessed via the door in the south western elevation and also contains the window to the left of the door and the two central windows in the north-east elevation (Plates 145.7 & 8). This was not accessible.

Plate 145.7 South-west elevation

Plate 145.8 North-east elevation

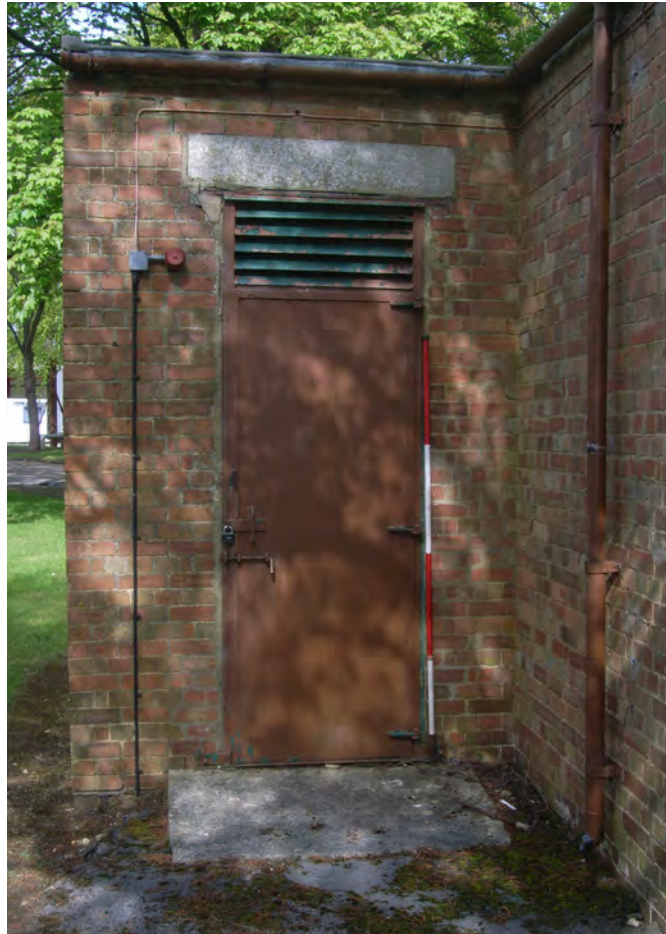
Plate 145.9 Entrance to the small north-west room

The small room in the projection to the north-west is accessed via the door in its south-west elevation (Plate 145.9), the window is opposite the door. The walls are cream painted brickwork with the same finish to the concrete skirting, the concrete of the ceiling is painted white and the floor is unfinished concrete. A red 'NO SMOKING' sign has been stencilled underneath the window. A modern wooden rack has been attached to the north western wall (Plate 145.10).

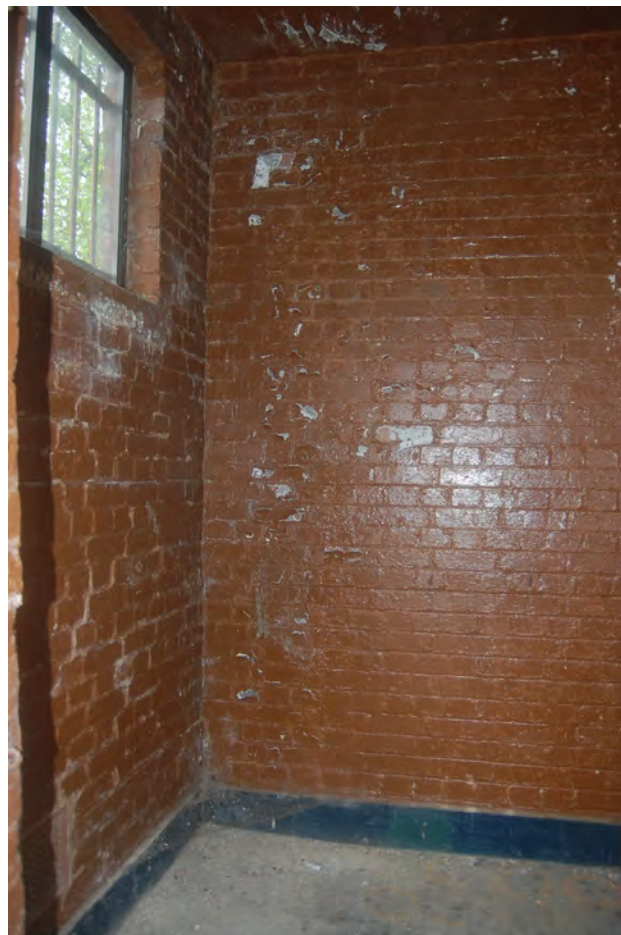
Plate 145.14 Southernmost room to the south-east end, looking north west

its window is the southernmost of the south-west elevation. The walls and ceiling are painted with brown gloss with a black painted concrete skirting. The floor is unfinished concrete (Plate 145.14).

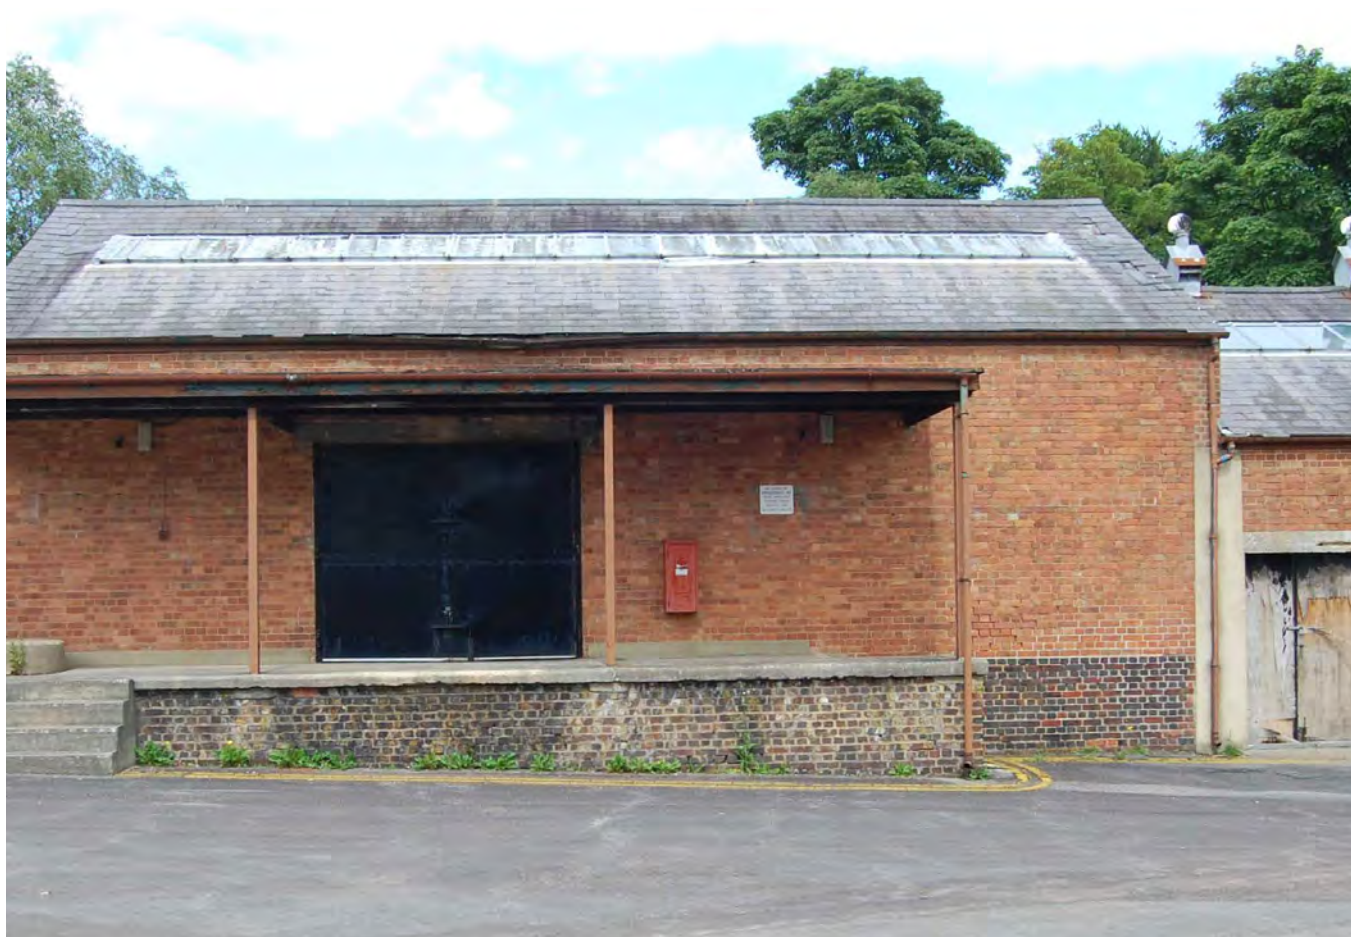
Plate 146.2 South-west elevation

The gabled, pitch-roofed rectangular building is aligned north-west to south east, approximately 18.5m by 8m in total, and consists of a raised space designed as a lubricant store and a slightly lower-roofed space of approximately 3.25m wide at the southern end of the building designed for use as a liquid container store and with its floor at ground level. Covered areas are either side of the west corner of the building (Plate 146.2).

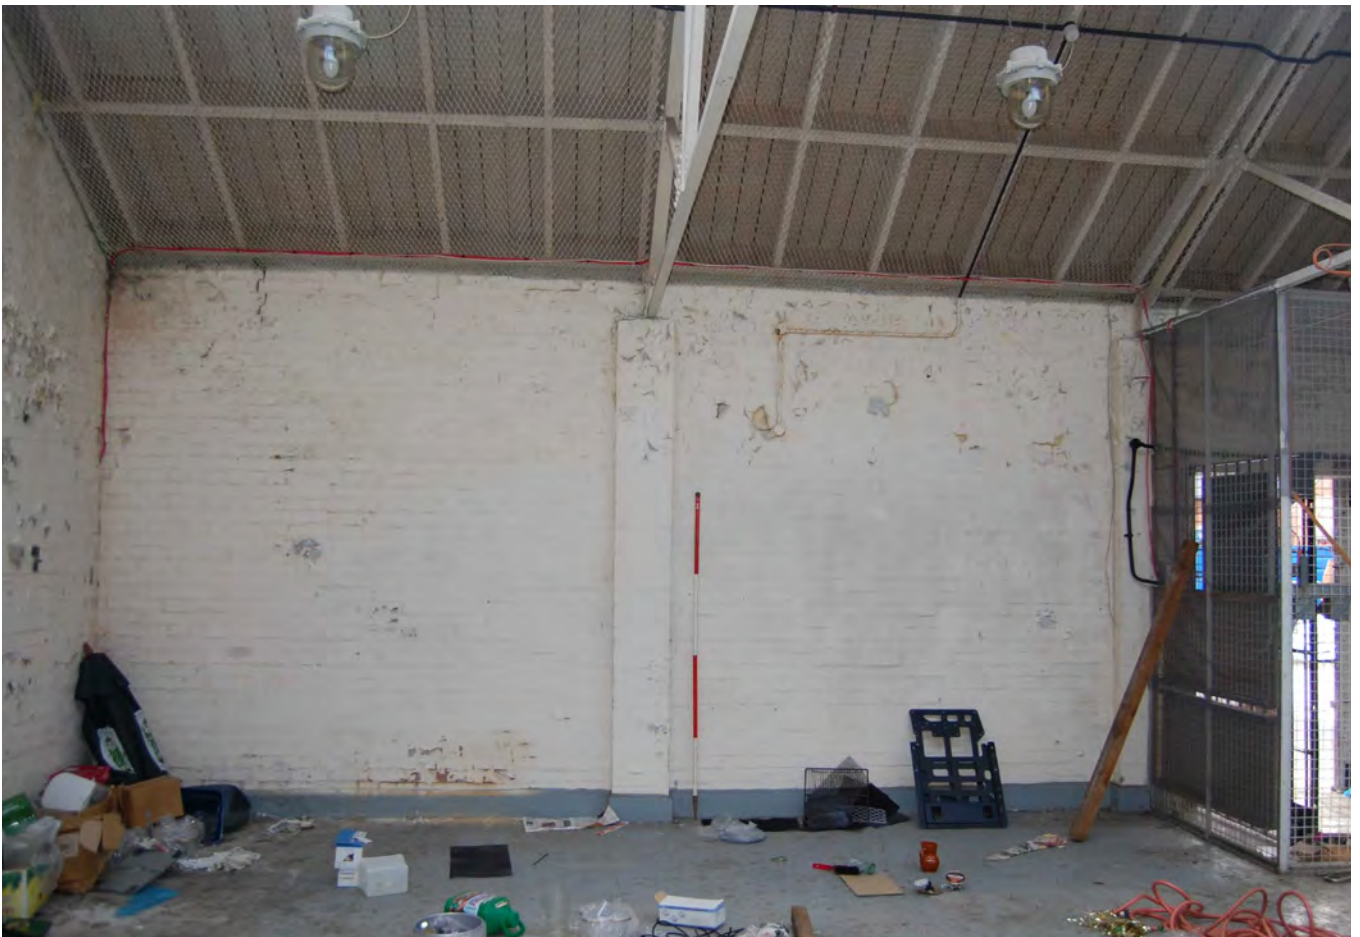
Plate 146.3 Lubricant store, looking south-west

Built to house flammable substances, the internal and external walls are of 9" (23cm) thick brickwork built in english bond with a slate damp proof course to each range according to the floor level. Steel roof trusses are supported on half-brick-thick piers supporting timber rafters, over which is a slate roof on narrow sarking boards which are laid running from the apex to the eaves. A steel cage is affixed between the trusses and timbers in the lubricant store (Plate 146.3). Both rooms are open to the roof.
