FORMER RAF UPPER HEYFORD, OXFORDSHIRE

HISTORIC BUILDING RECORDING AND INVESTIGATION

VOLUME 2: GAZETEER OF RECORDED STRUCTURES

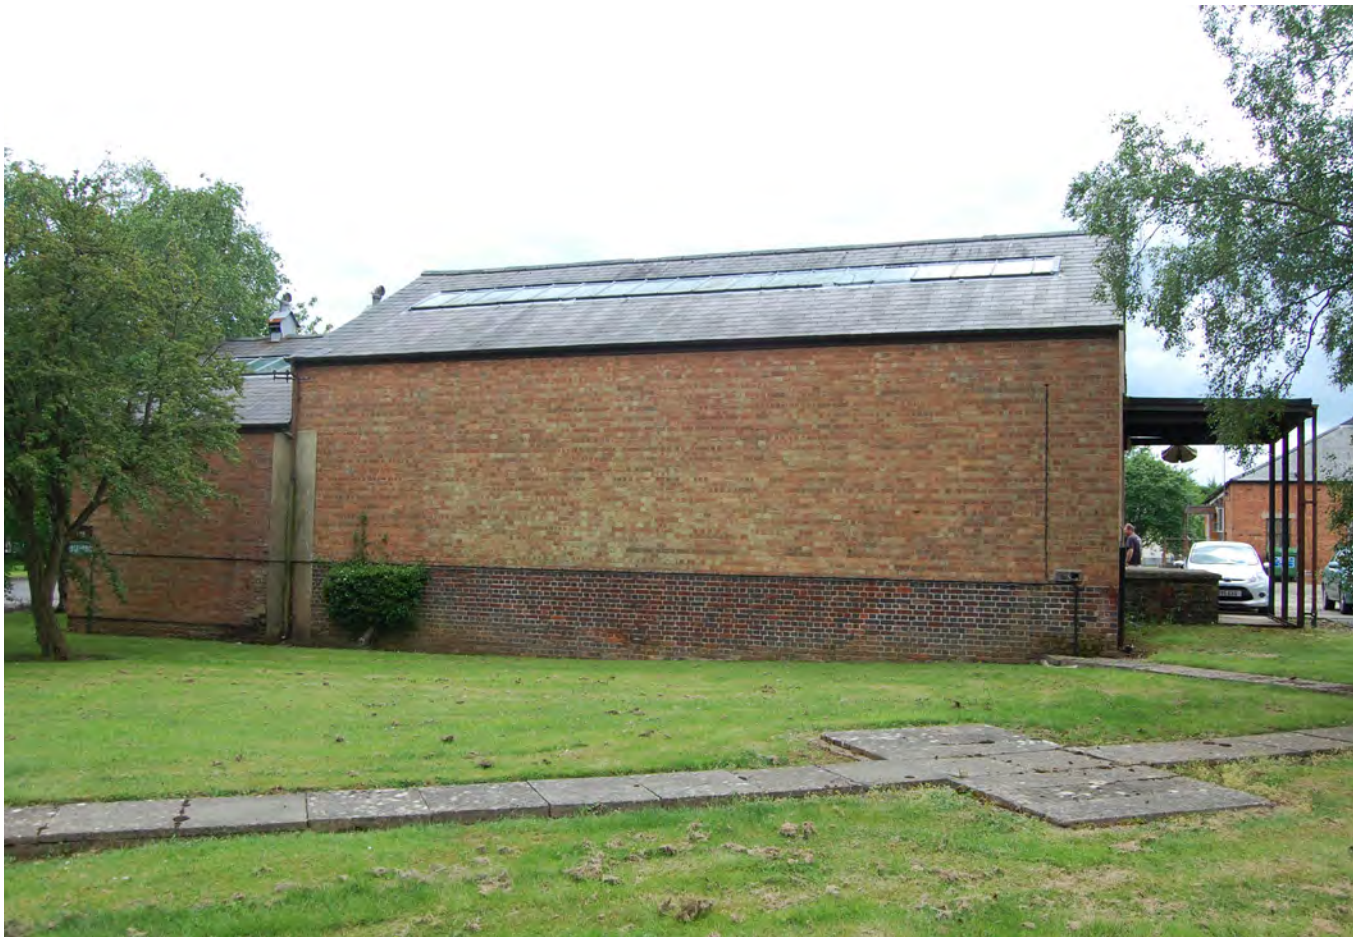
Plate 146.9 North-east elevation

The areas behind the downpipes at the join of the two spaces have been rendered (Plate 146.9). Concrete lintels are above both doors. Many areas have been repointed, especially under the eaves and verge, but no other signs of alteration are present other than the installation of the terracotta vents. The rainwater goods and woodwork are painted with the standard brown of the estate with the previous dark green colour scheme below, visible where the brown paint is peeling. The exceptions are the doors which are painted black; the liquid container store doors being much degraded.

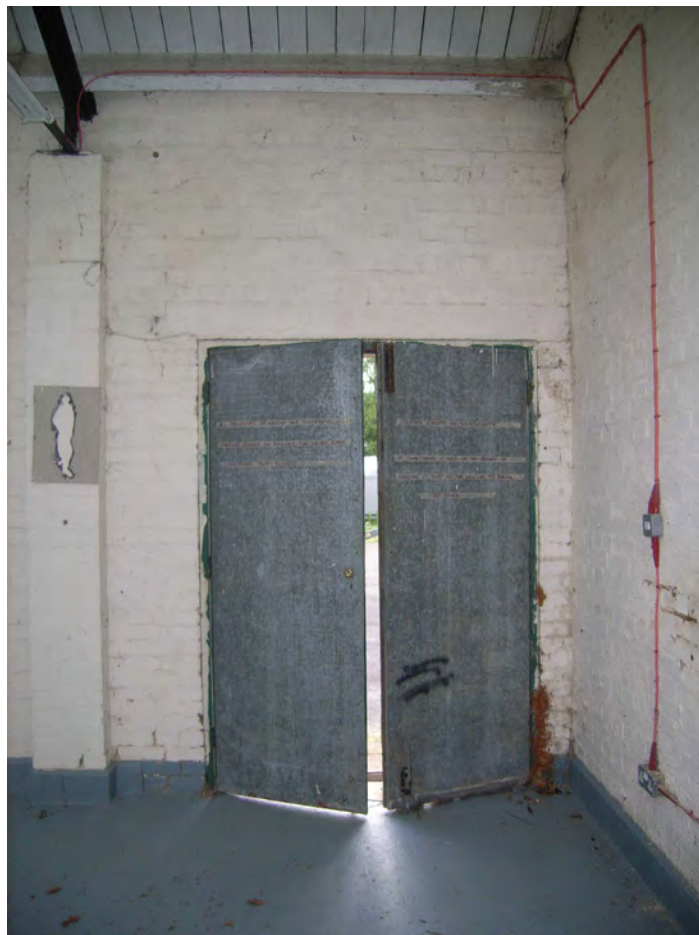
Plate 146.14 Doors to the Lubricant Store including artwork

The internal faces of the entrance doors have masking tape attached with three modern philosophies handwritten in red: *'All processes of nature are successful - nature knows no failure. She never plans anything but success'*. *'Either create or disintegrate'*, *'If something is not in the process of growing, it must, by the laws of it's being, be dying'*. To the left of the doorway on the face of the brick pillar is a grey, black and white silhouette (Plate 146.14).

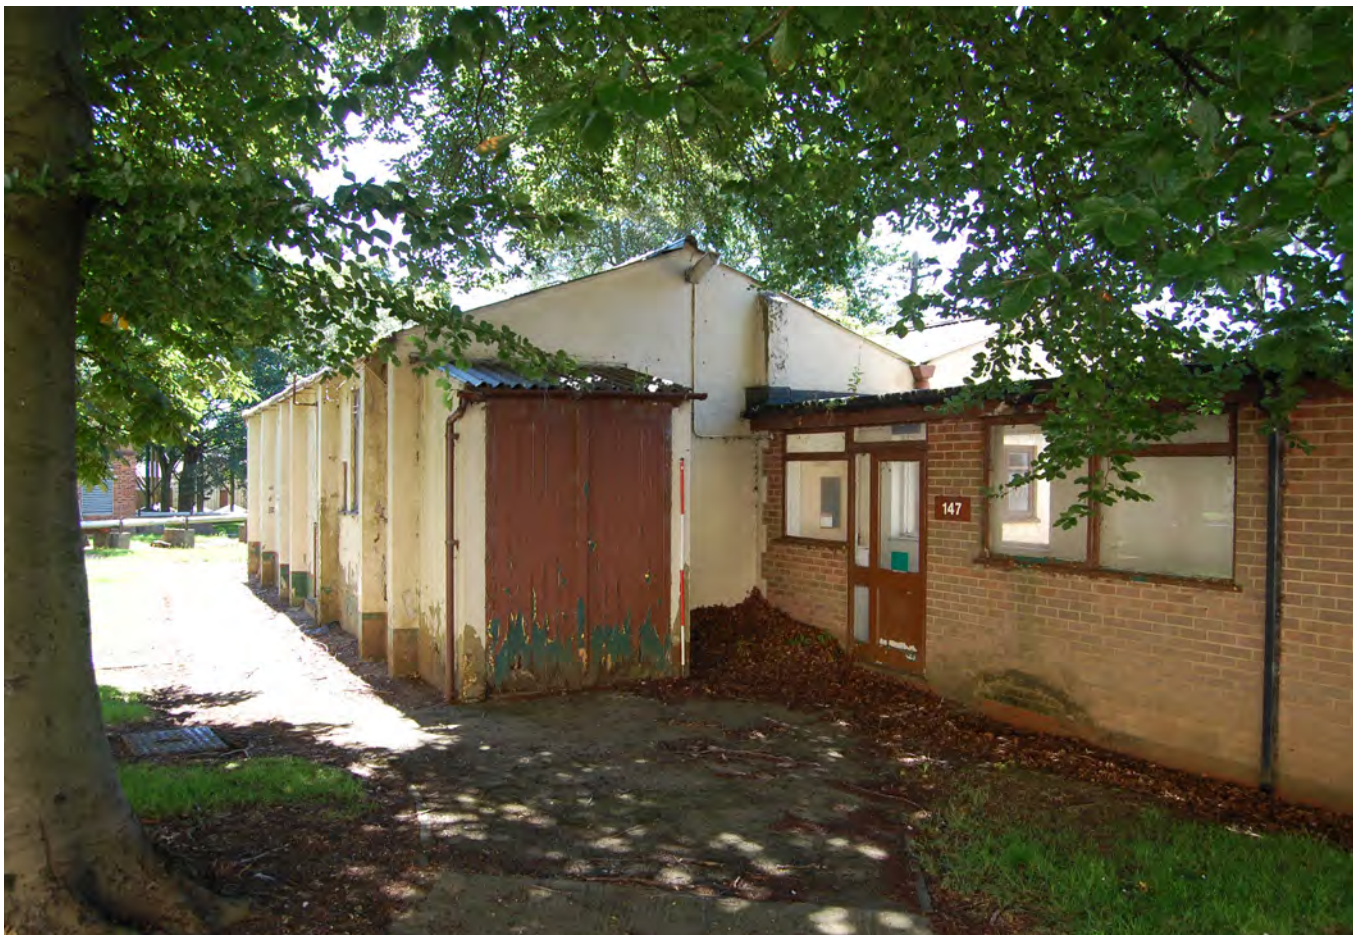
Plate 147.4 East elevation and linking structure to 1980s prefab addition

The west (rear) elevation of the primary 1930s/40s structure remains visible, but the southern half has a brick built linking building built onto the elevation which connects it to the later prefab structure (see Plate 147.4). There is a set of double timber doors (painted brown) which provide access to the earlier building, and within the brick linking structure are two infilled windows. The brick structure forms the passageway between the early building, and later 1980s prefab element. This has a flat ashfelt roof and timber fascia board (brown), and a single timber and glass door. It has large timber framed windows. It is possible to see internally that the brick is painted white, and there are overhead strip lights and a small heater.

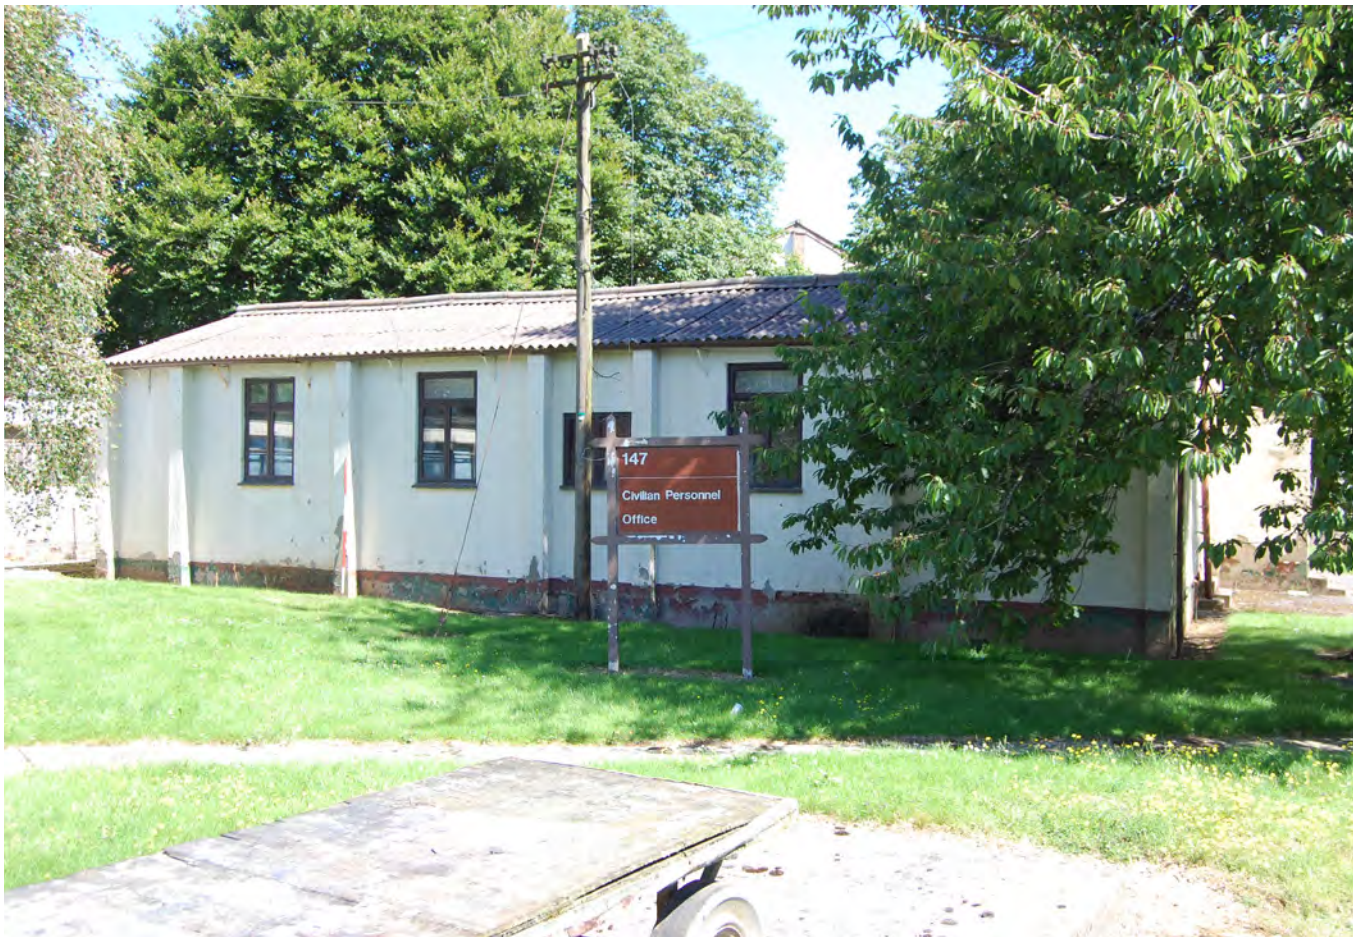
Plate 147.7 South elevation

The south elevation has five metal replacement windows, there is a small central window with two larger windows to each side (Plate 147.7). The prefab element of the building is in very poor condition and was surrounded by fencing for health and safety reasons at the time of inspection (Plate 147.8). It has large metal framed windows, and a flat ashfelt roof. Access is from the south elevation of the building, which has an overhead roof, that links building 147 to 133 (Plate 147.9).

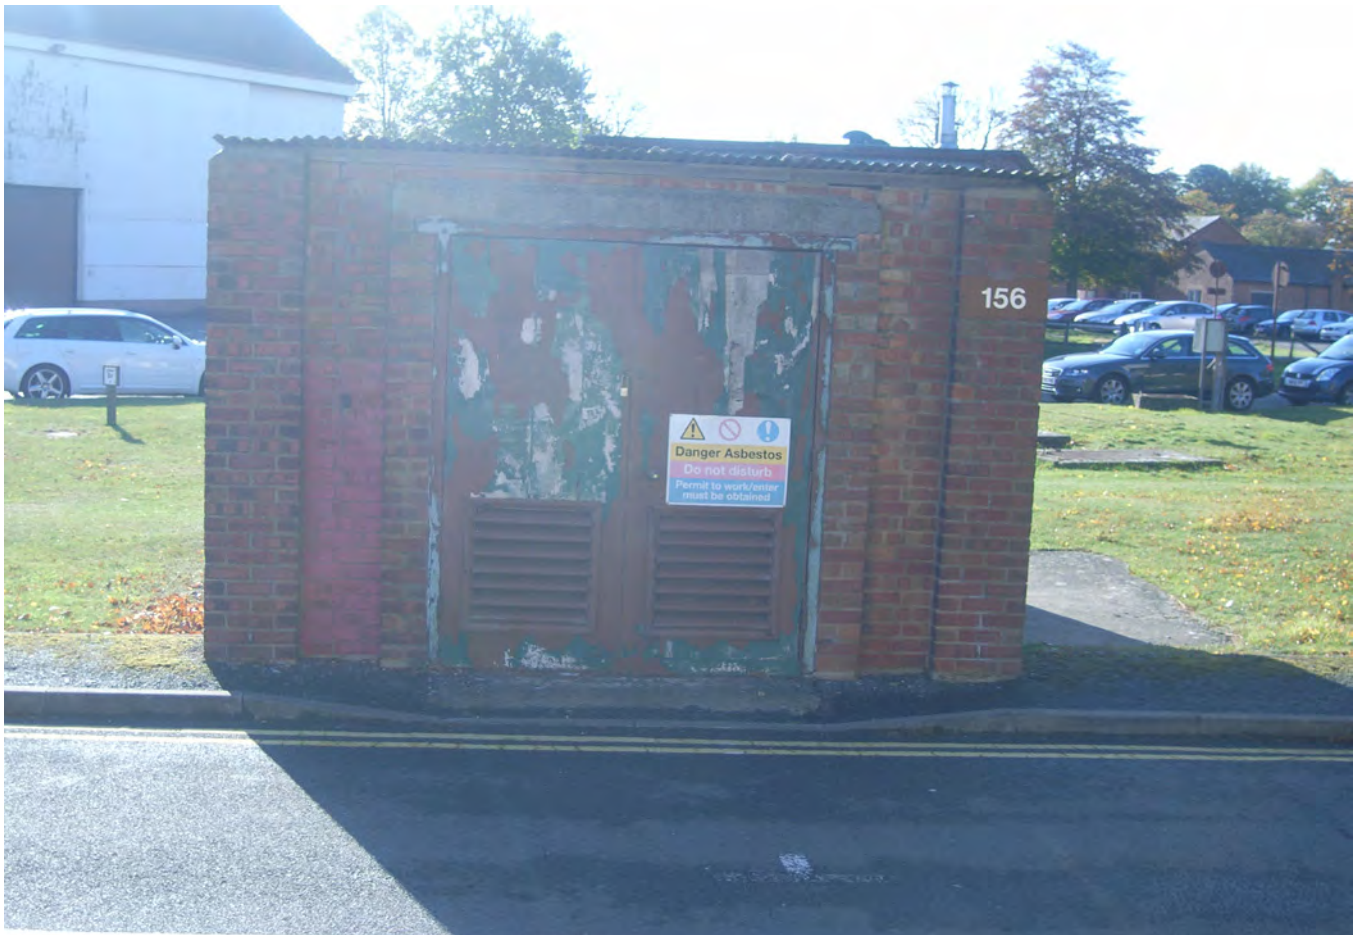
Plate 156.1 Front (north) elevation

This is a small single storey brick-built structure with a corrugated asbestos roof. The front (north) elevation has a concrete lintel over double timber doors, which have louvres to the lower half (Plate 156.1). Internally it has white painted brickwork with a concrete floor, which has been painted grey with two sprayed yellow lines (Plate 156.2). The corrugated roof sheeting lies directly on timber joists with metal brackets used to hold the joists to the brick elevations. There are several (probable 1980s) signs internally including '*Danger: Wear Face Shield and Rubber Gloves When Handling Chemicals*' and '*No Smoking*' stencilled on the south and west elevations in black. The buildings is thought to be linked to building 131 and used to store chemicals, it is now empty.

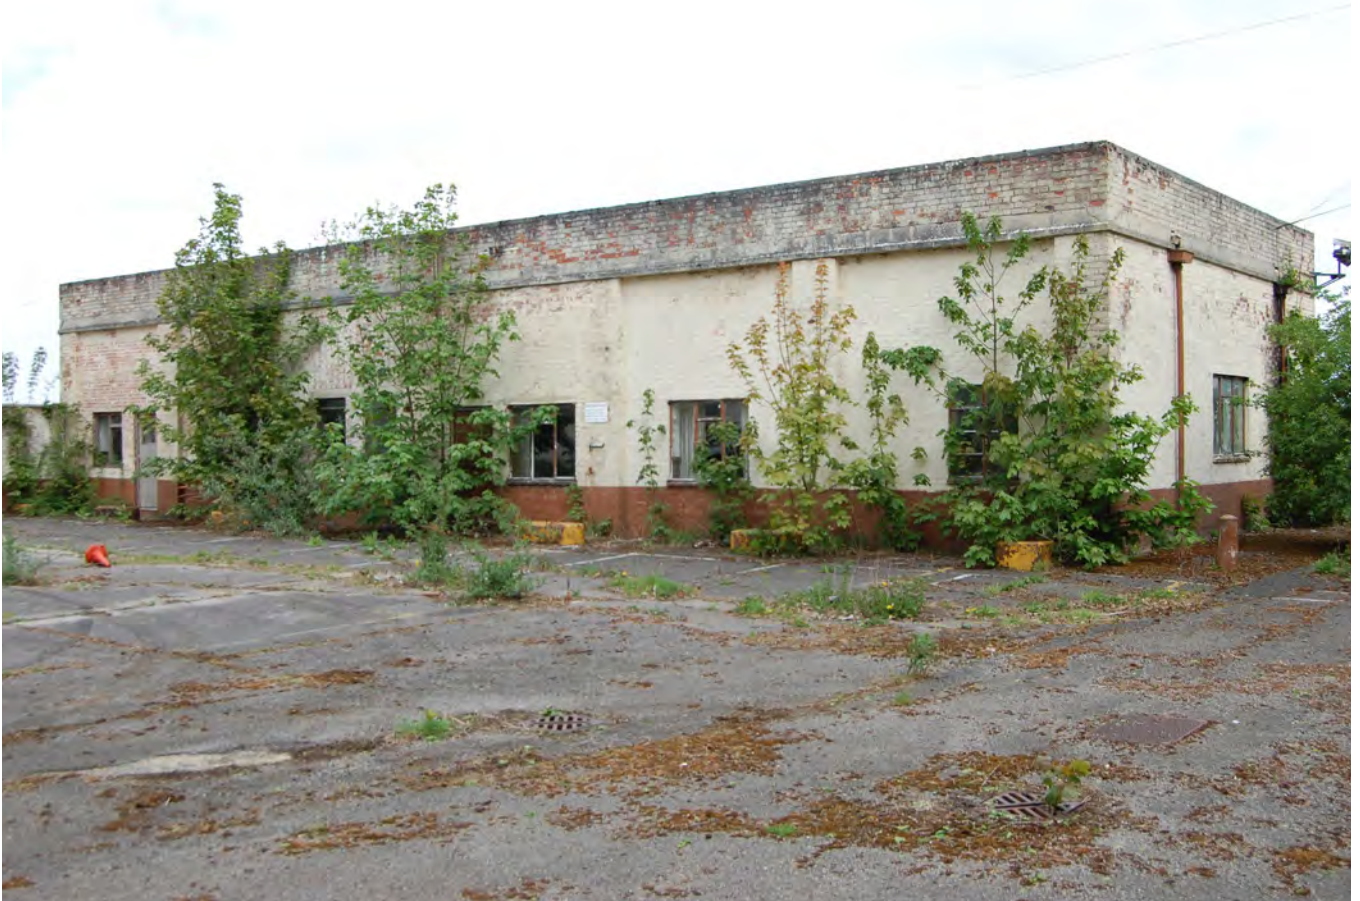
Plate 171.1 Front (west) elevation

The former petrol tanker shed is constructed in red brick with a flat concrete roof, and timber and metal windows (Plate 171.1). It has a rectangular footprint, and whilst the main body of the building has not been extended, the structure has been subject to reconfiguration and infilling of brickwork on the external faces. A surviving plan of the building dating from August 1975 for 'Proposed Modifications' shows four bays of the building (bays 1-4), with notes stating '*Replace shutters with brick infill*', and '*Remove roller shutters and infill with brickwork*'. The internal layout shows that the secondary use of the building was as a dispatch office, rooms are allocated for '*Chief Dispatcher*', '*Vehicle Ops Officer*' and '*Drivers Lounge*'. The plan shows a six-bay building, although does not show the alterations planned for two of the bays. The six bays shown are thought to be the original configuration of the building, as the 1939 plan describes it as a 6-bay building (see above).

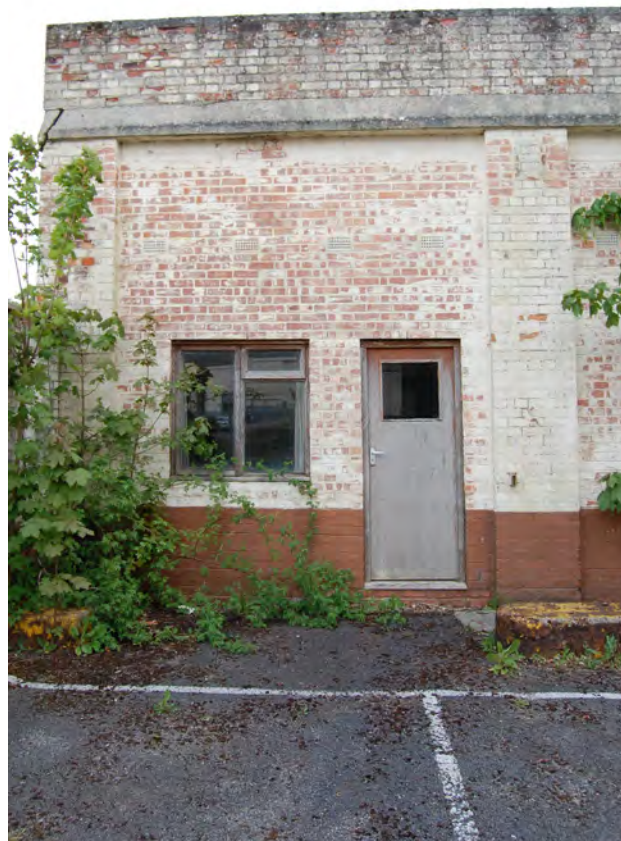
Plate 171.2 North bay of west elevation

The west elevation is (in-part) covered by trees and foliage compromising interpretation; the 6 bays are numbered 1-6 (north to south) for ease of description. The first bay has a single timber door and window which have been inserted in each bay (Plate 171.2), the third bay has two crittal windows, the fourth bay has a single timber door within a timber frame, with a crittal window immediately adjacent to it (Plate 171.3). The fifth and six bays each have crittal windows with tile cills. The elevation has various straight joints, areas of repair and evidence of tying in brickwork throughout providing evidence of the conversion of the tanker bays to an office type building. A sign on the front states '*Kedroy Services Ltd.*', who were the most recent commercial occupants of the building.

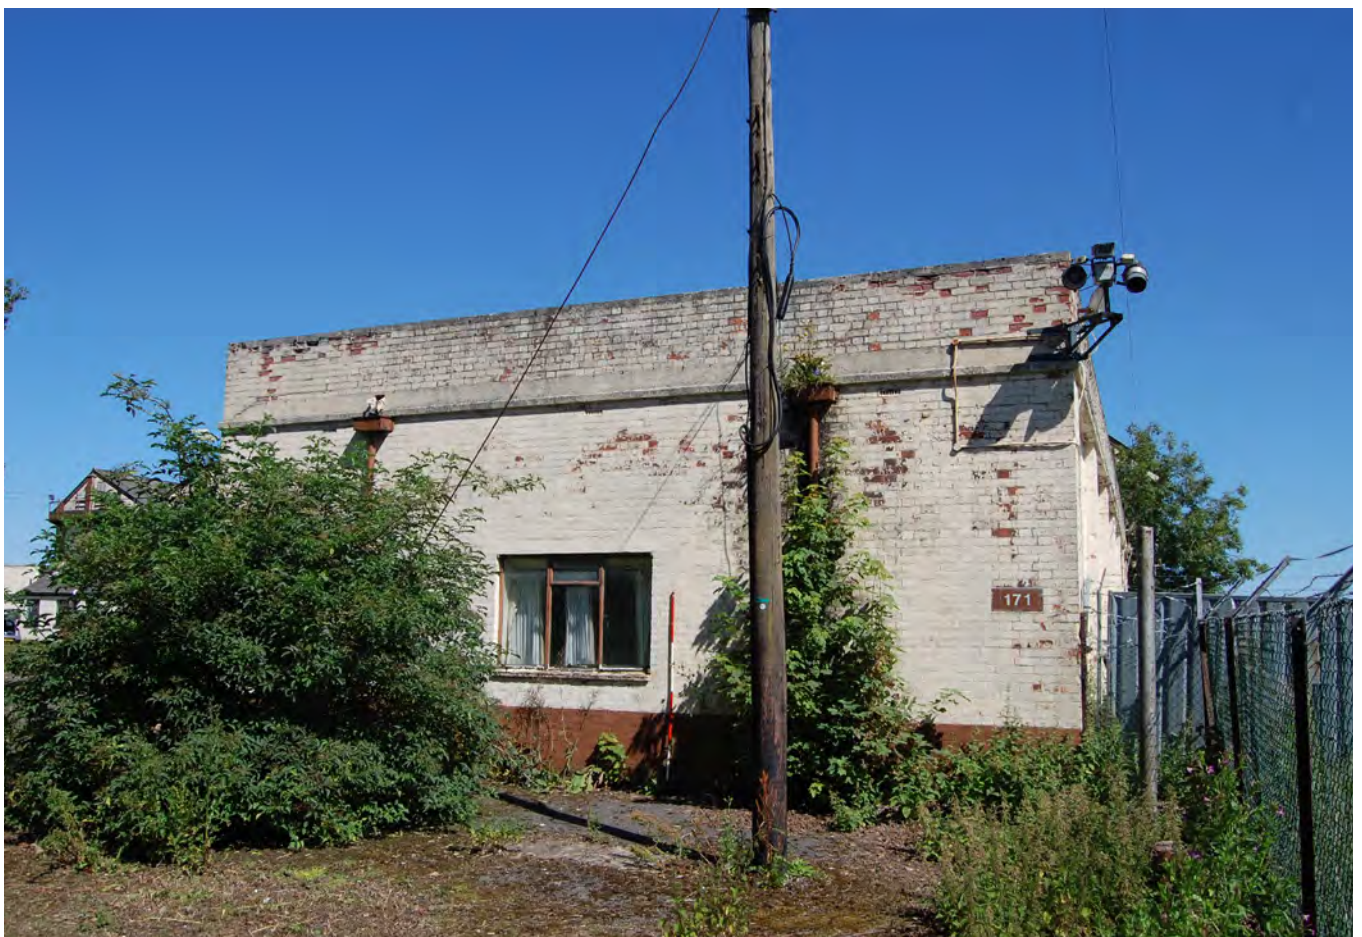
Plate 171.4 South elevation

The front (south) elevation has two iron drainpipes with hoppers (painted brown), to each side of a large crittal window (Plate 171.4). The east elevation is of the same arrangement as the west elevation, with six infilled bays (Plate 171.5). Each bay is infilled with a single timber door and a large crittal window. Again various areas of infill and repair are evidence in the conversion of the building to offices. At the north end of the building is a sub-station (170), surrounded by a low brick wall which is contemporary with the construction of building 171. The elevation has a single window between two drainpipes (as with the south elevation), but the window is a later replacement with a smaller timber window.

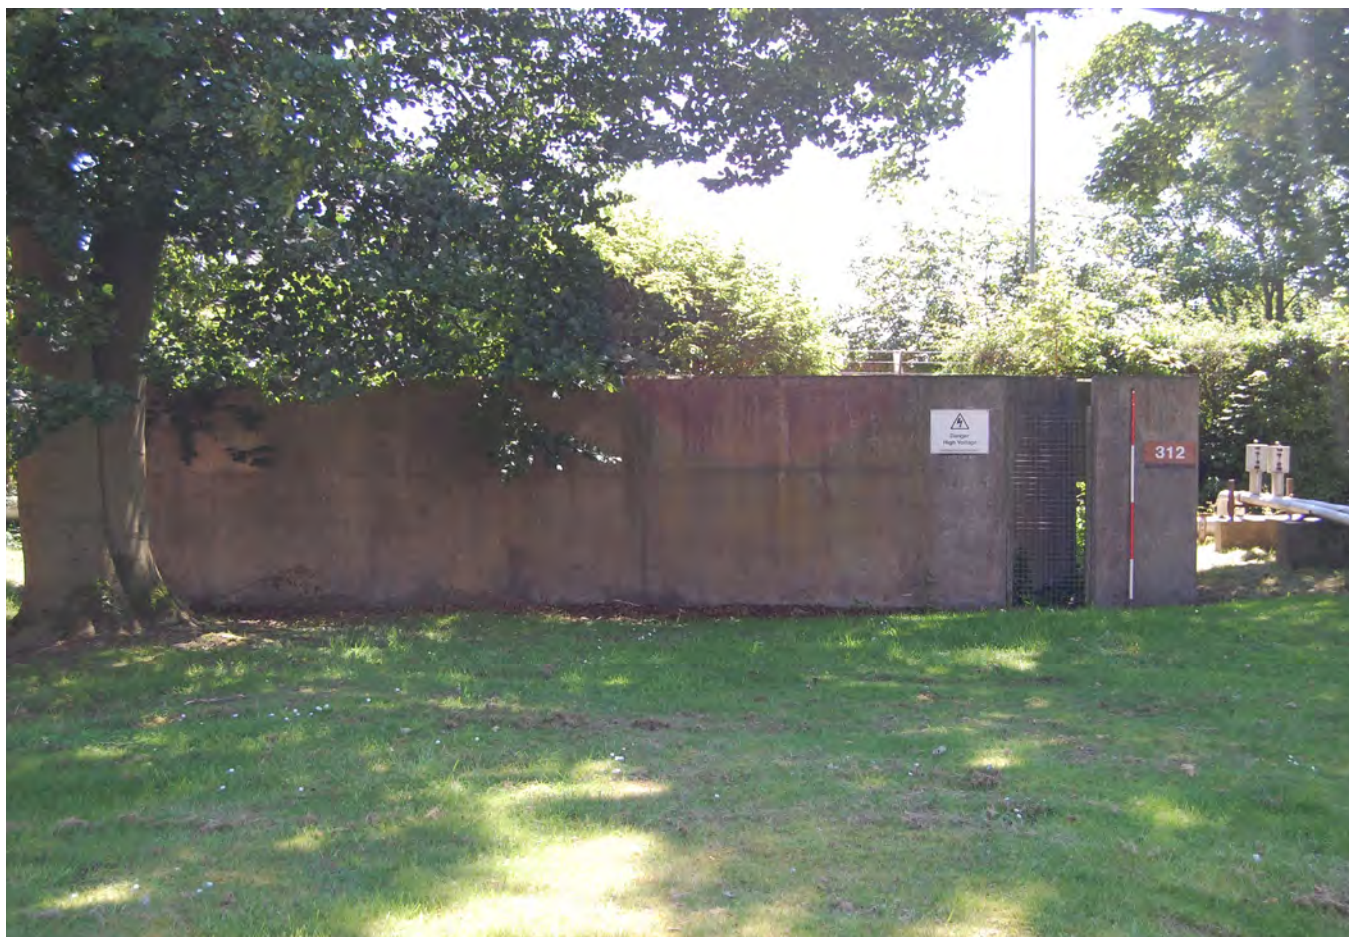
Plate 312.1 Front (north) elevation

The substation is constructed from reinforced concrete walls, it is rectangular in footprint and single phase. The concrete walls are c.2m high and surround an internal electrical substation, it has two (locked) openings at the north-west and south-east corners of the enclosure.

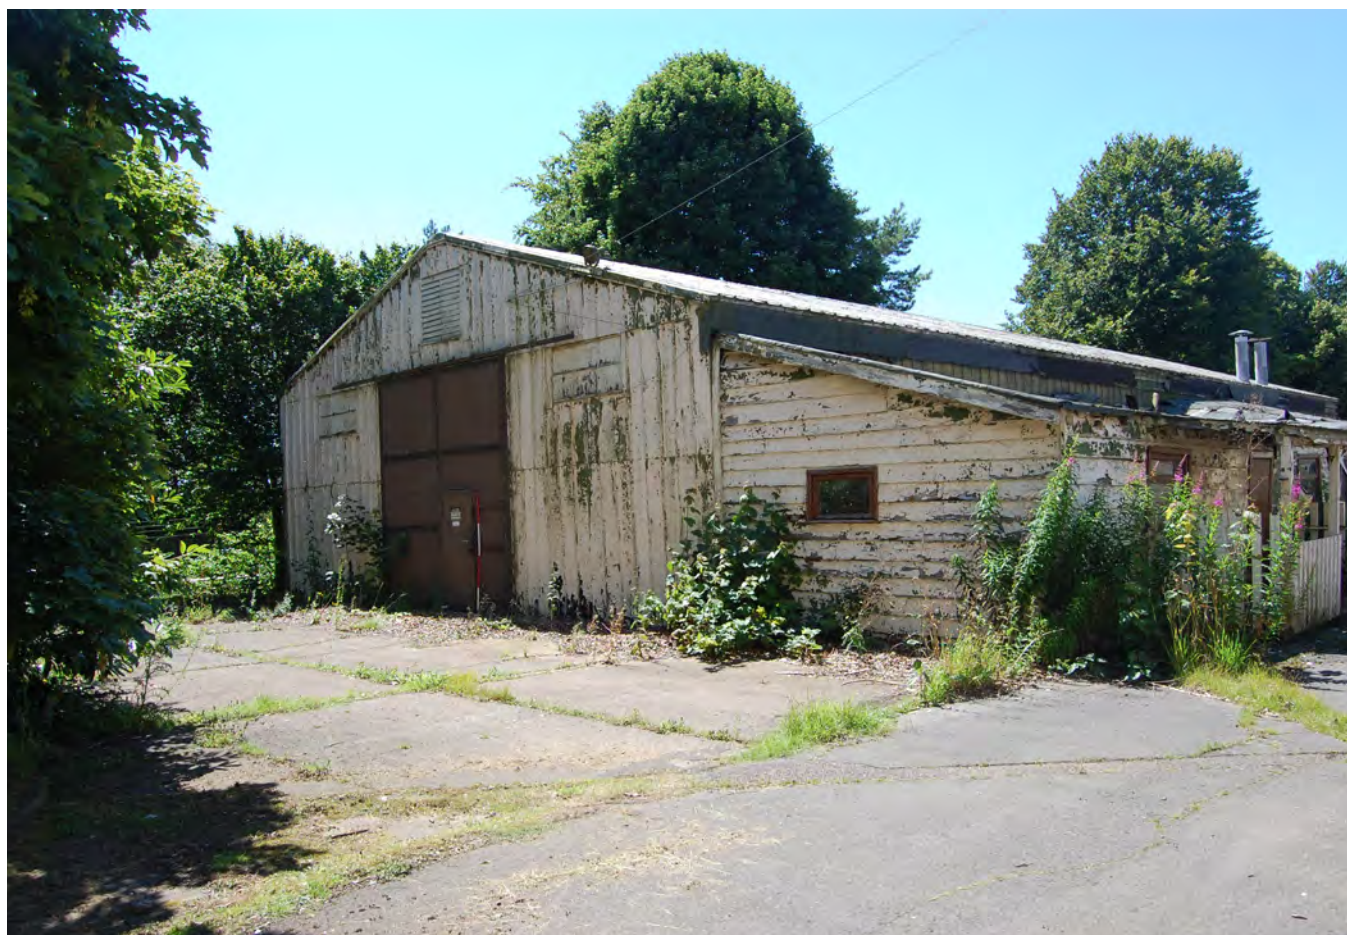
Plate 313.1 North and east elevations

The north elevation is dominated by a large (secondary) lean-to structure, which is now largely collapsed (Plate 313.1). The eastern third is weather boarded while the central third has corrugated, metal cladding and the western third is now collapsed but is thought to have been open faced. The east elevation has two-high windows of the same type as the west elevation. It has large (secondary) central double doors, and a louvre vent in the gable.

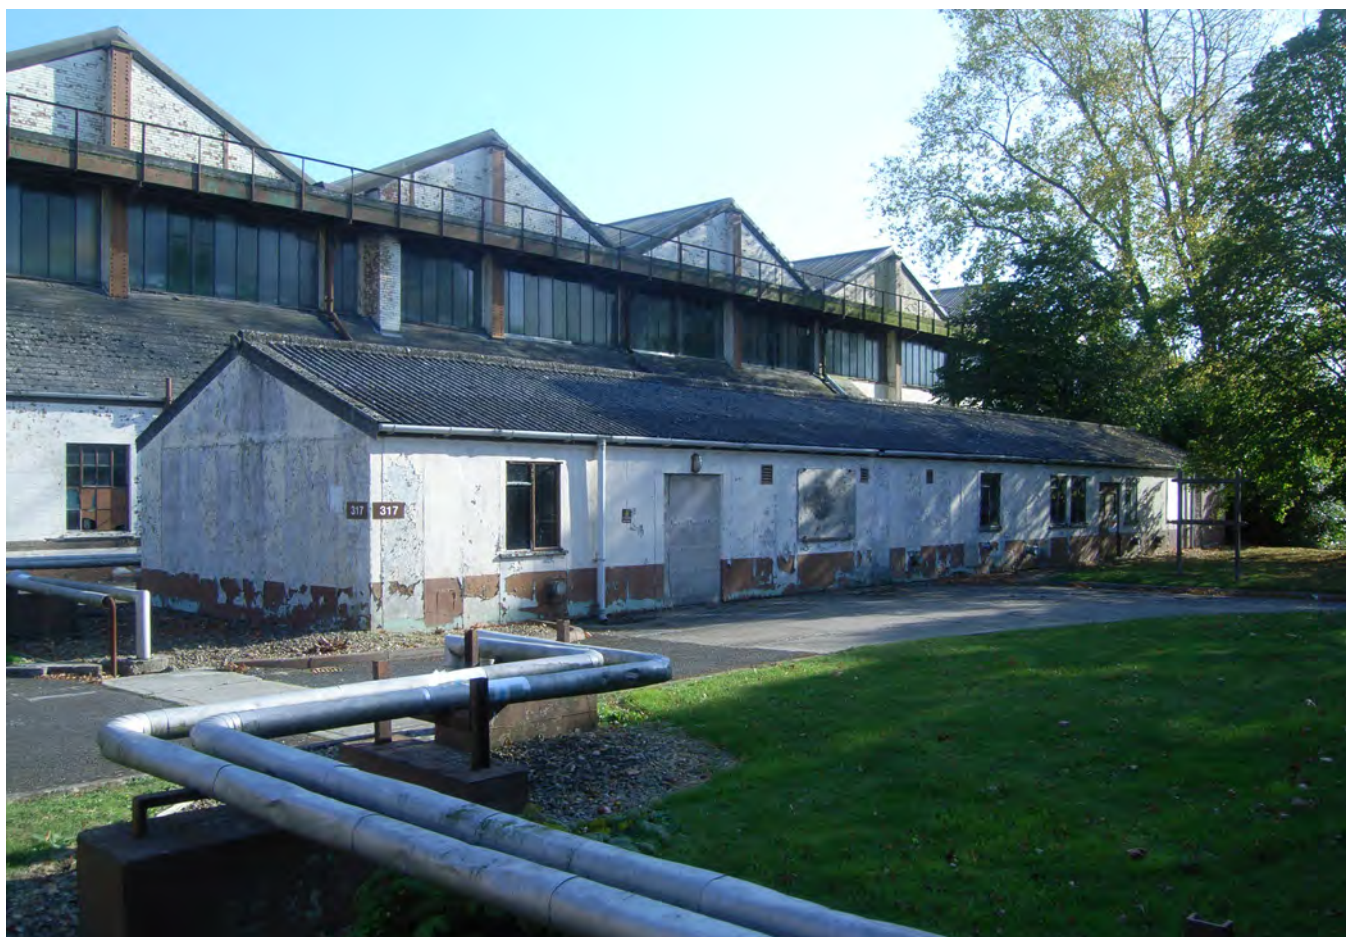
Plate 317.1 Front (west) elevation

Building 317 is constructed with concrete panels, and has a rectangular footprint with a pitched corrugated asbestos roof (Plate 317.1). The west (front) elevation has four windows (one infilled), and three sets of double timber doors. There are no features of interest on the north elevation.

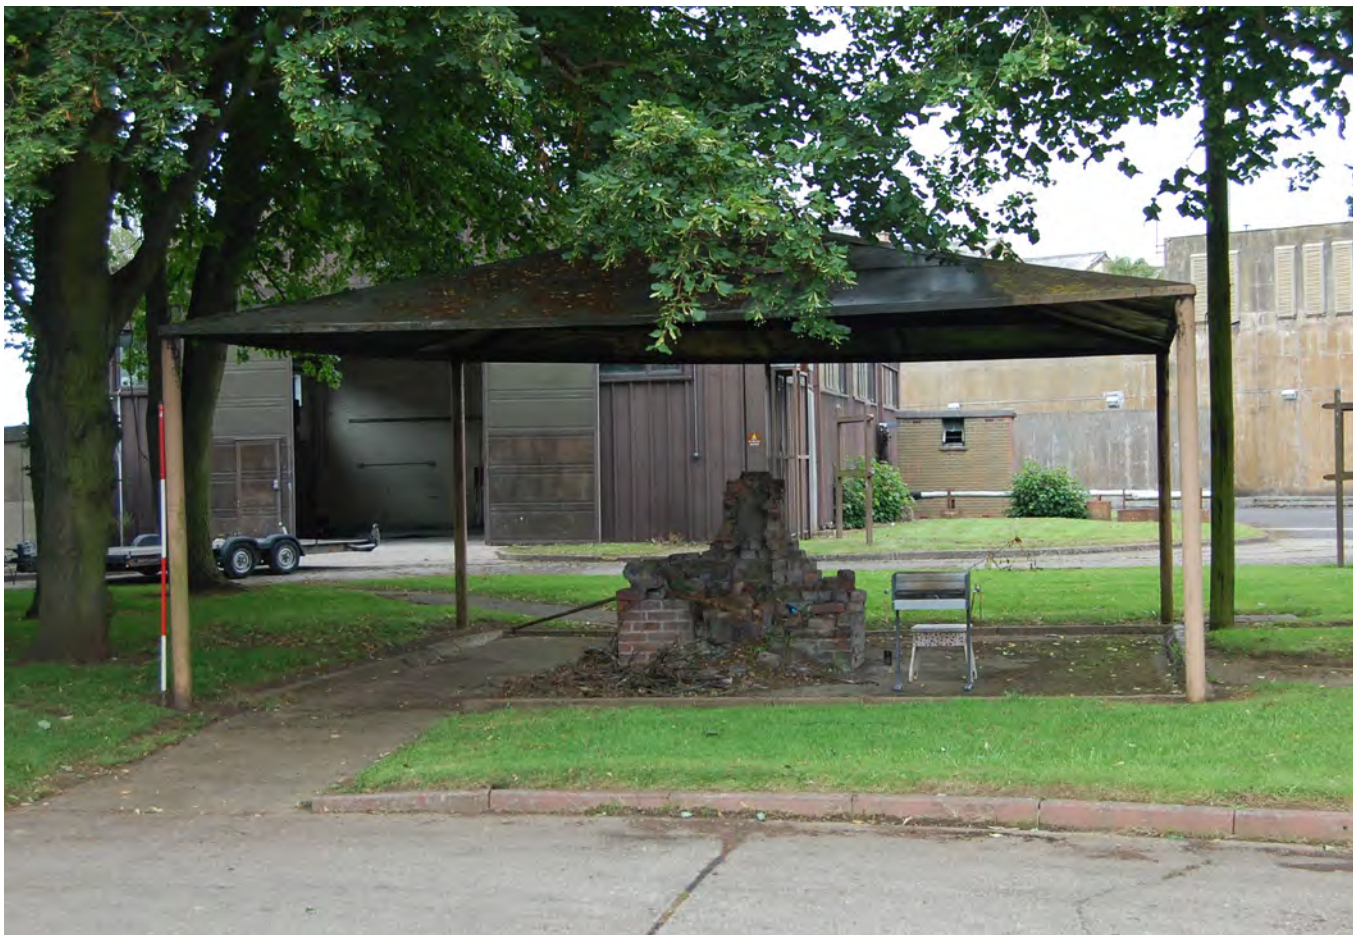
Plate 317A.1 North-east view

Building 317A has the remains of a probable brick-built hearth or barbeque measuring c.1.25 by 1.6m. It is enclosed by a pyramidal metal roof with openings at the apex for a flue.

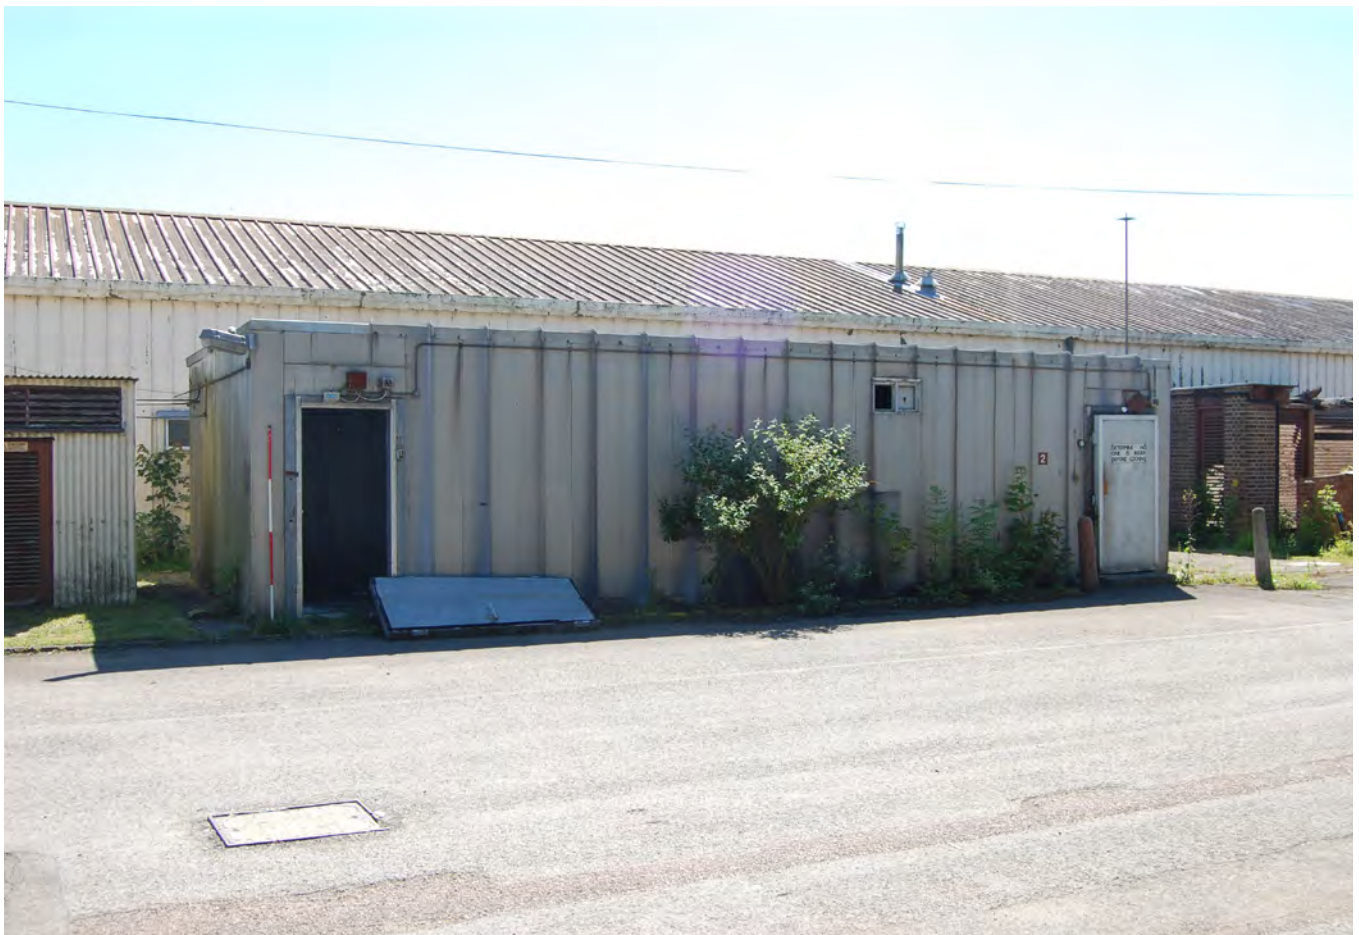
Plate 2x.1 Front (west) elevation

This is one of three refrigeration units (2x-4x) surrounding the Commissionary (Building 32-34) used to store food produce. It is rectangular in plan constructed in metal with a flat roof, which is 2.3m in height. The front (west) elevation has two metal clad doors (of which the north one is falling off), with a sign stating 'Determine No One is Inside Before Locking', otherwise there are no features of interest. Internally, there are also no features of interest.

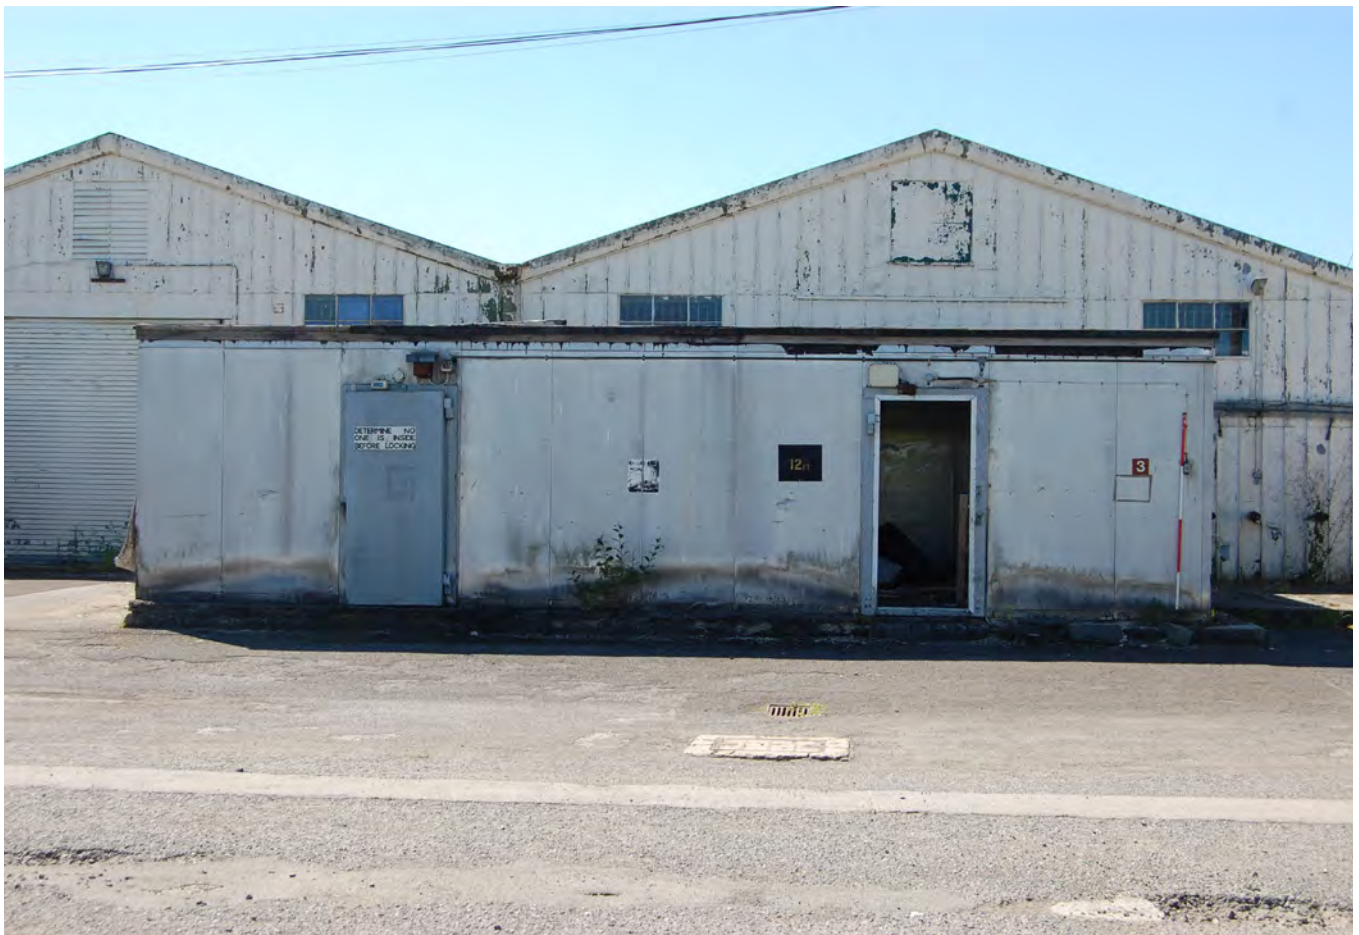
Plate 3x.1 Front (north) elevation

This is one of three refrigeration units (2x-4x) surrounding the Commissary (Building 32-34) used to store food produce. It is rectangular in plan constructed in metal with a flat roof, which is 2.3m in height. The front (north) elevation has two metal clad single doors, with a sign stating 'Determine No One is Inside Before Locking' and electric wiring above. Otherwise there are no features of interest externally and internally.

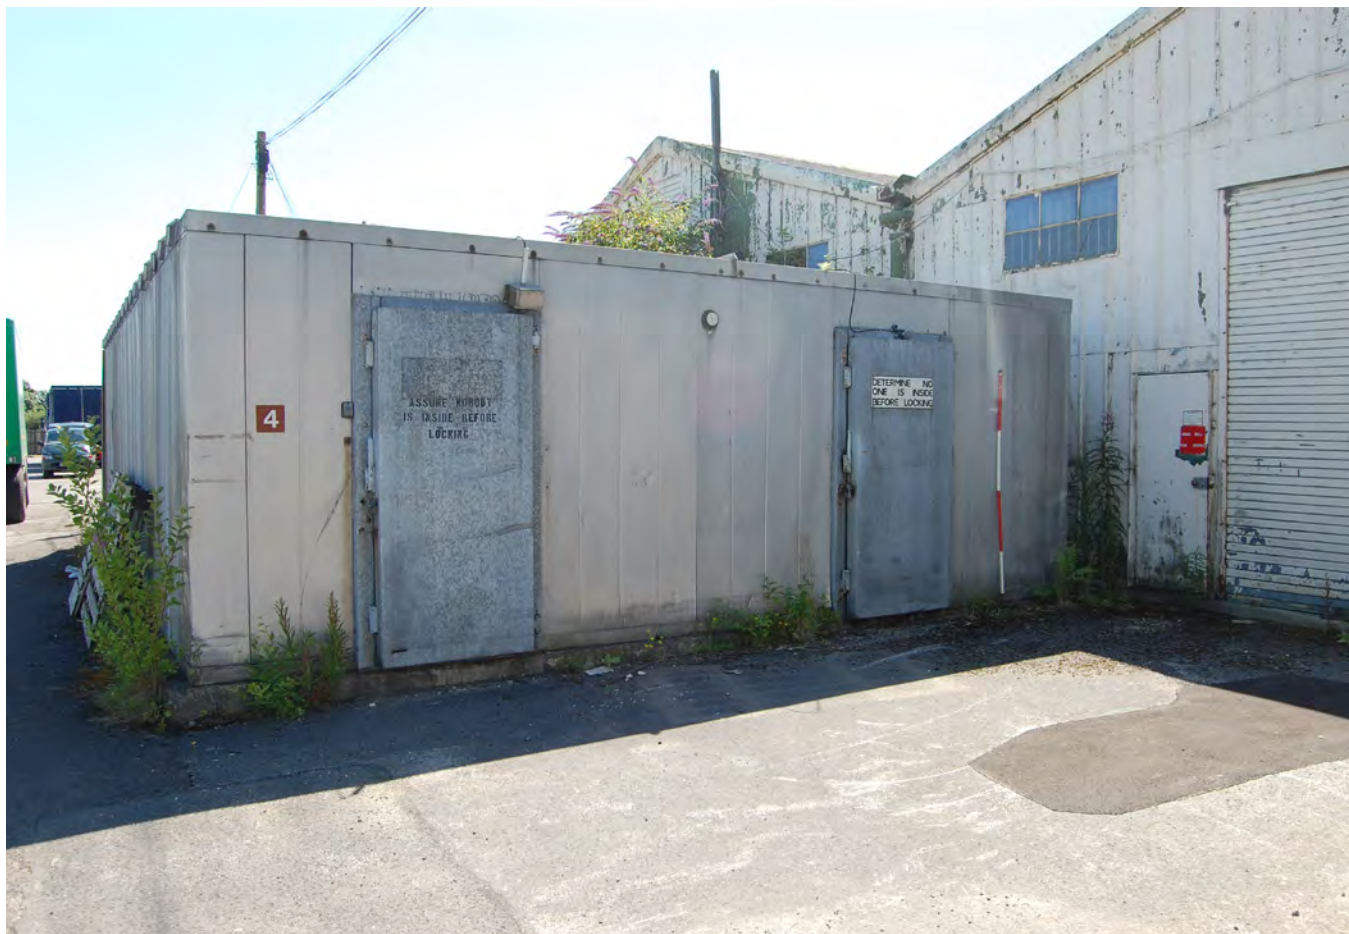
Plate 4x.1 Front (north-west) elevation

This is one of three refrigeration units (2x-4x) surrounding the Commissary (Building 32-34) used to store food produce. It is rectangular in plan constructed in metal with a flat roof, which is 2.3m in height. The front (north-west) elevation has two large metal clad doors, with a sign stating 'Assure Nobody is Inside Before Locking'. There is a temperature gauge between the two doors, otherwise there are no features of interest.

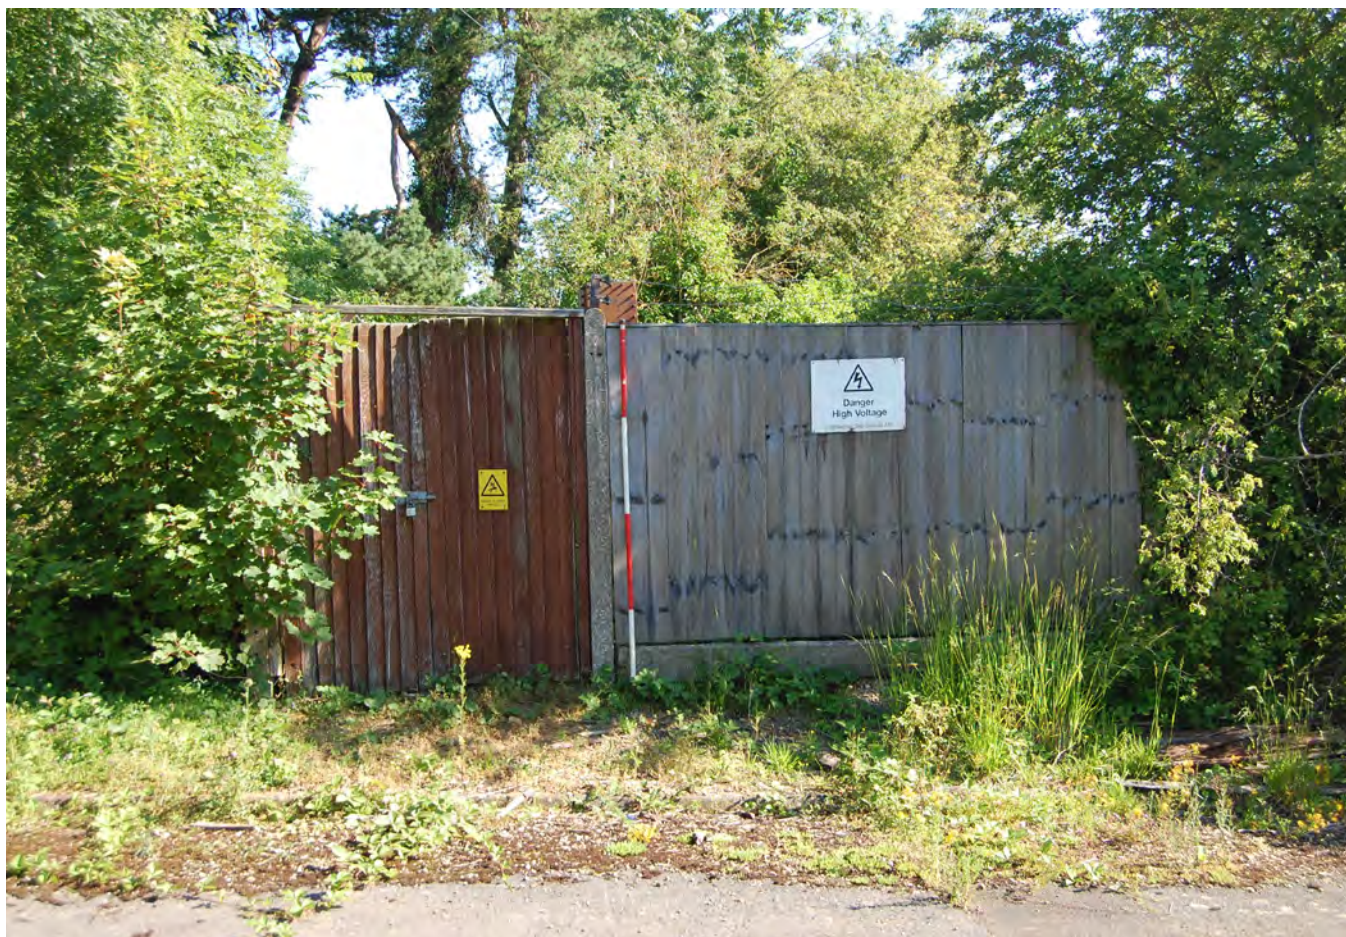
Plate UH44 Front (south) elevation

The sub-station is rectangular in plan and surrounded by timber fence panels (1.8m in height). The sub-station is in an over-grown state and difficult to accurately access.
