Project: GRAVEN HILL, BICESTER

Title: LTA 1 TREE AND HABITAT PROTECTION PLAN (Sheet 7 of 12)

Client: Graven Hill Village Development Company

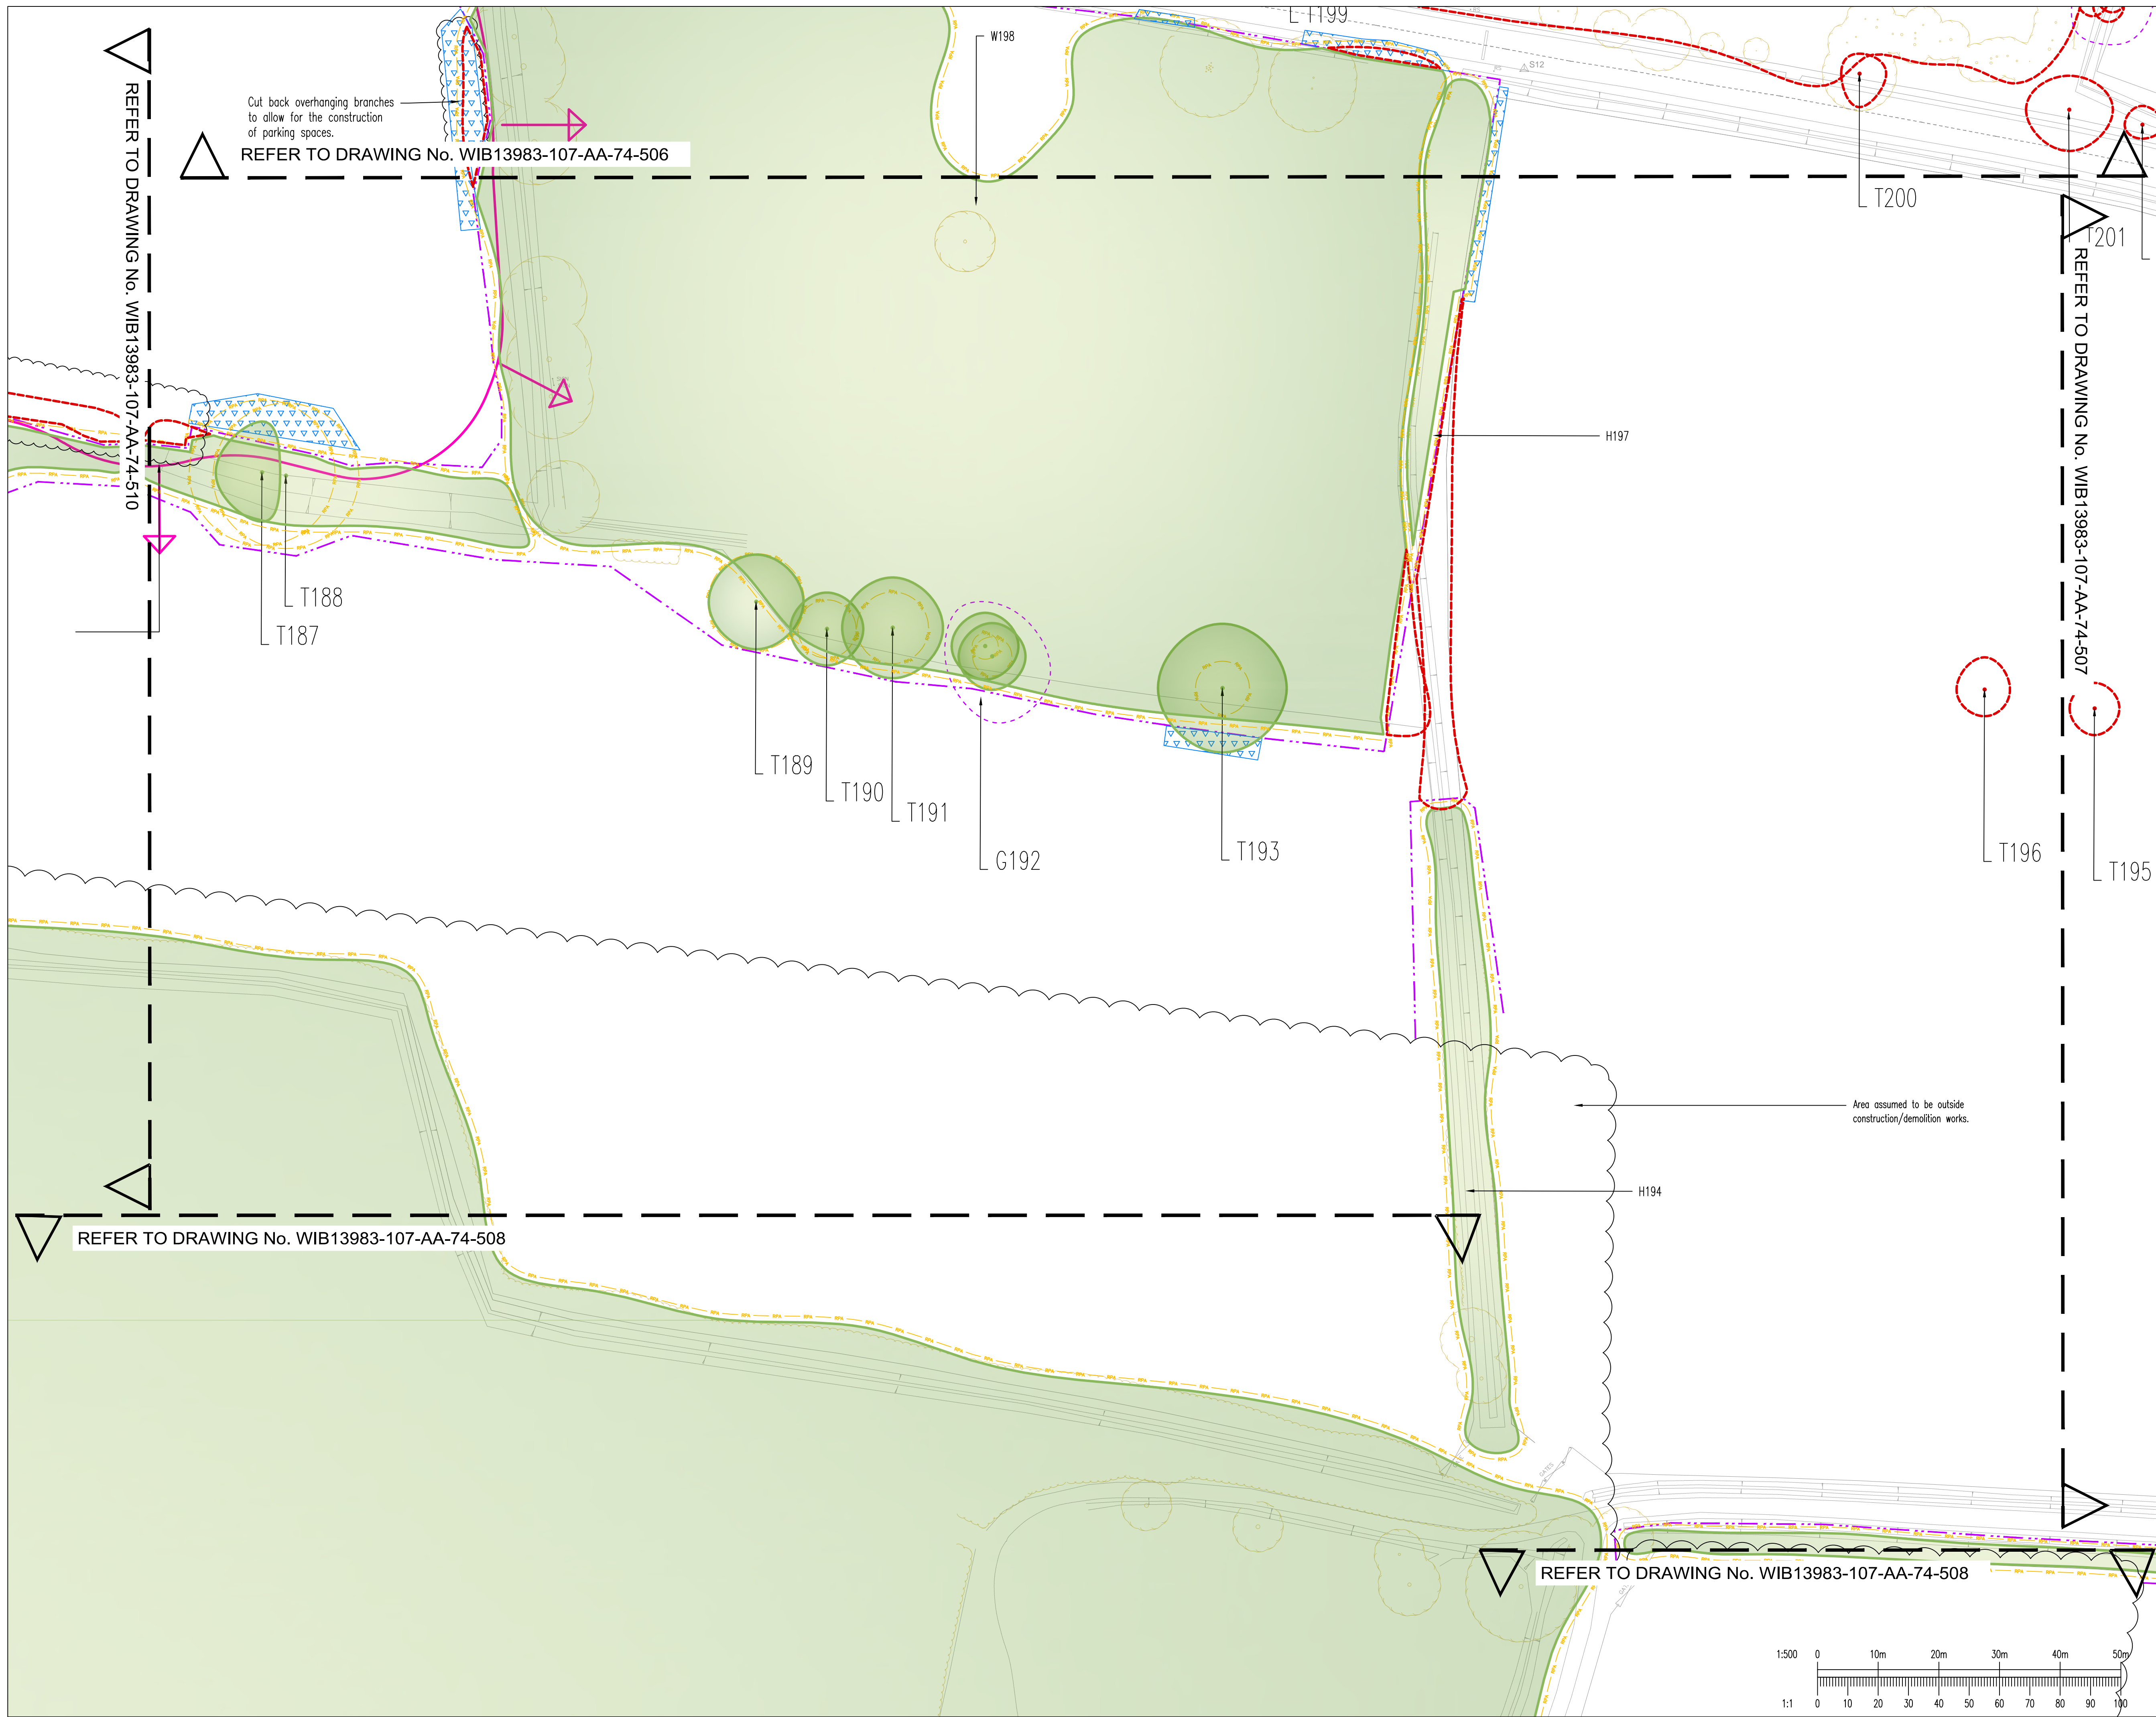
All works to be carried out in accordance with the principles of BS5837:2012 when in proximity to retained trees and hedgerows.

Tree protection fencing to be erected in accordance with the enclosed details and maintained as a Construction Exclusion Zone for the duration of all construction works.

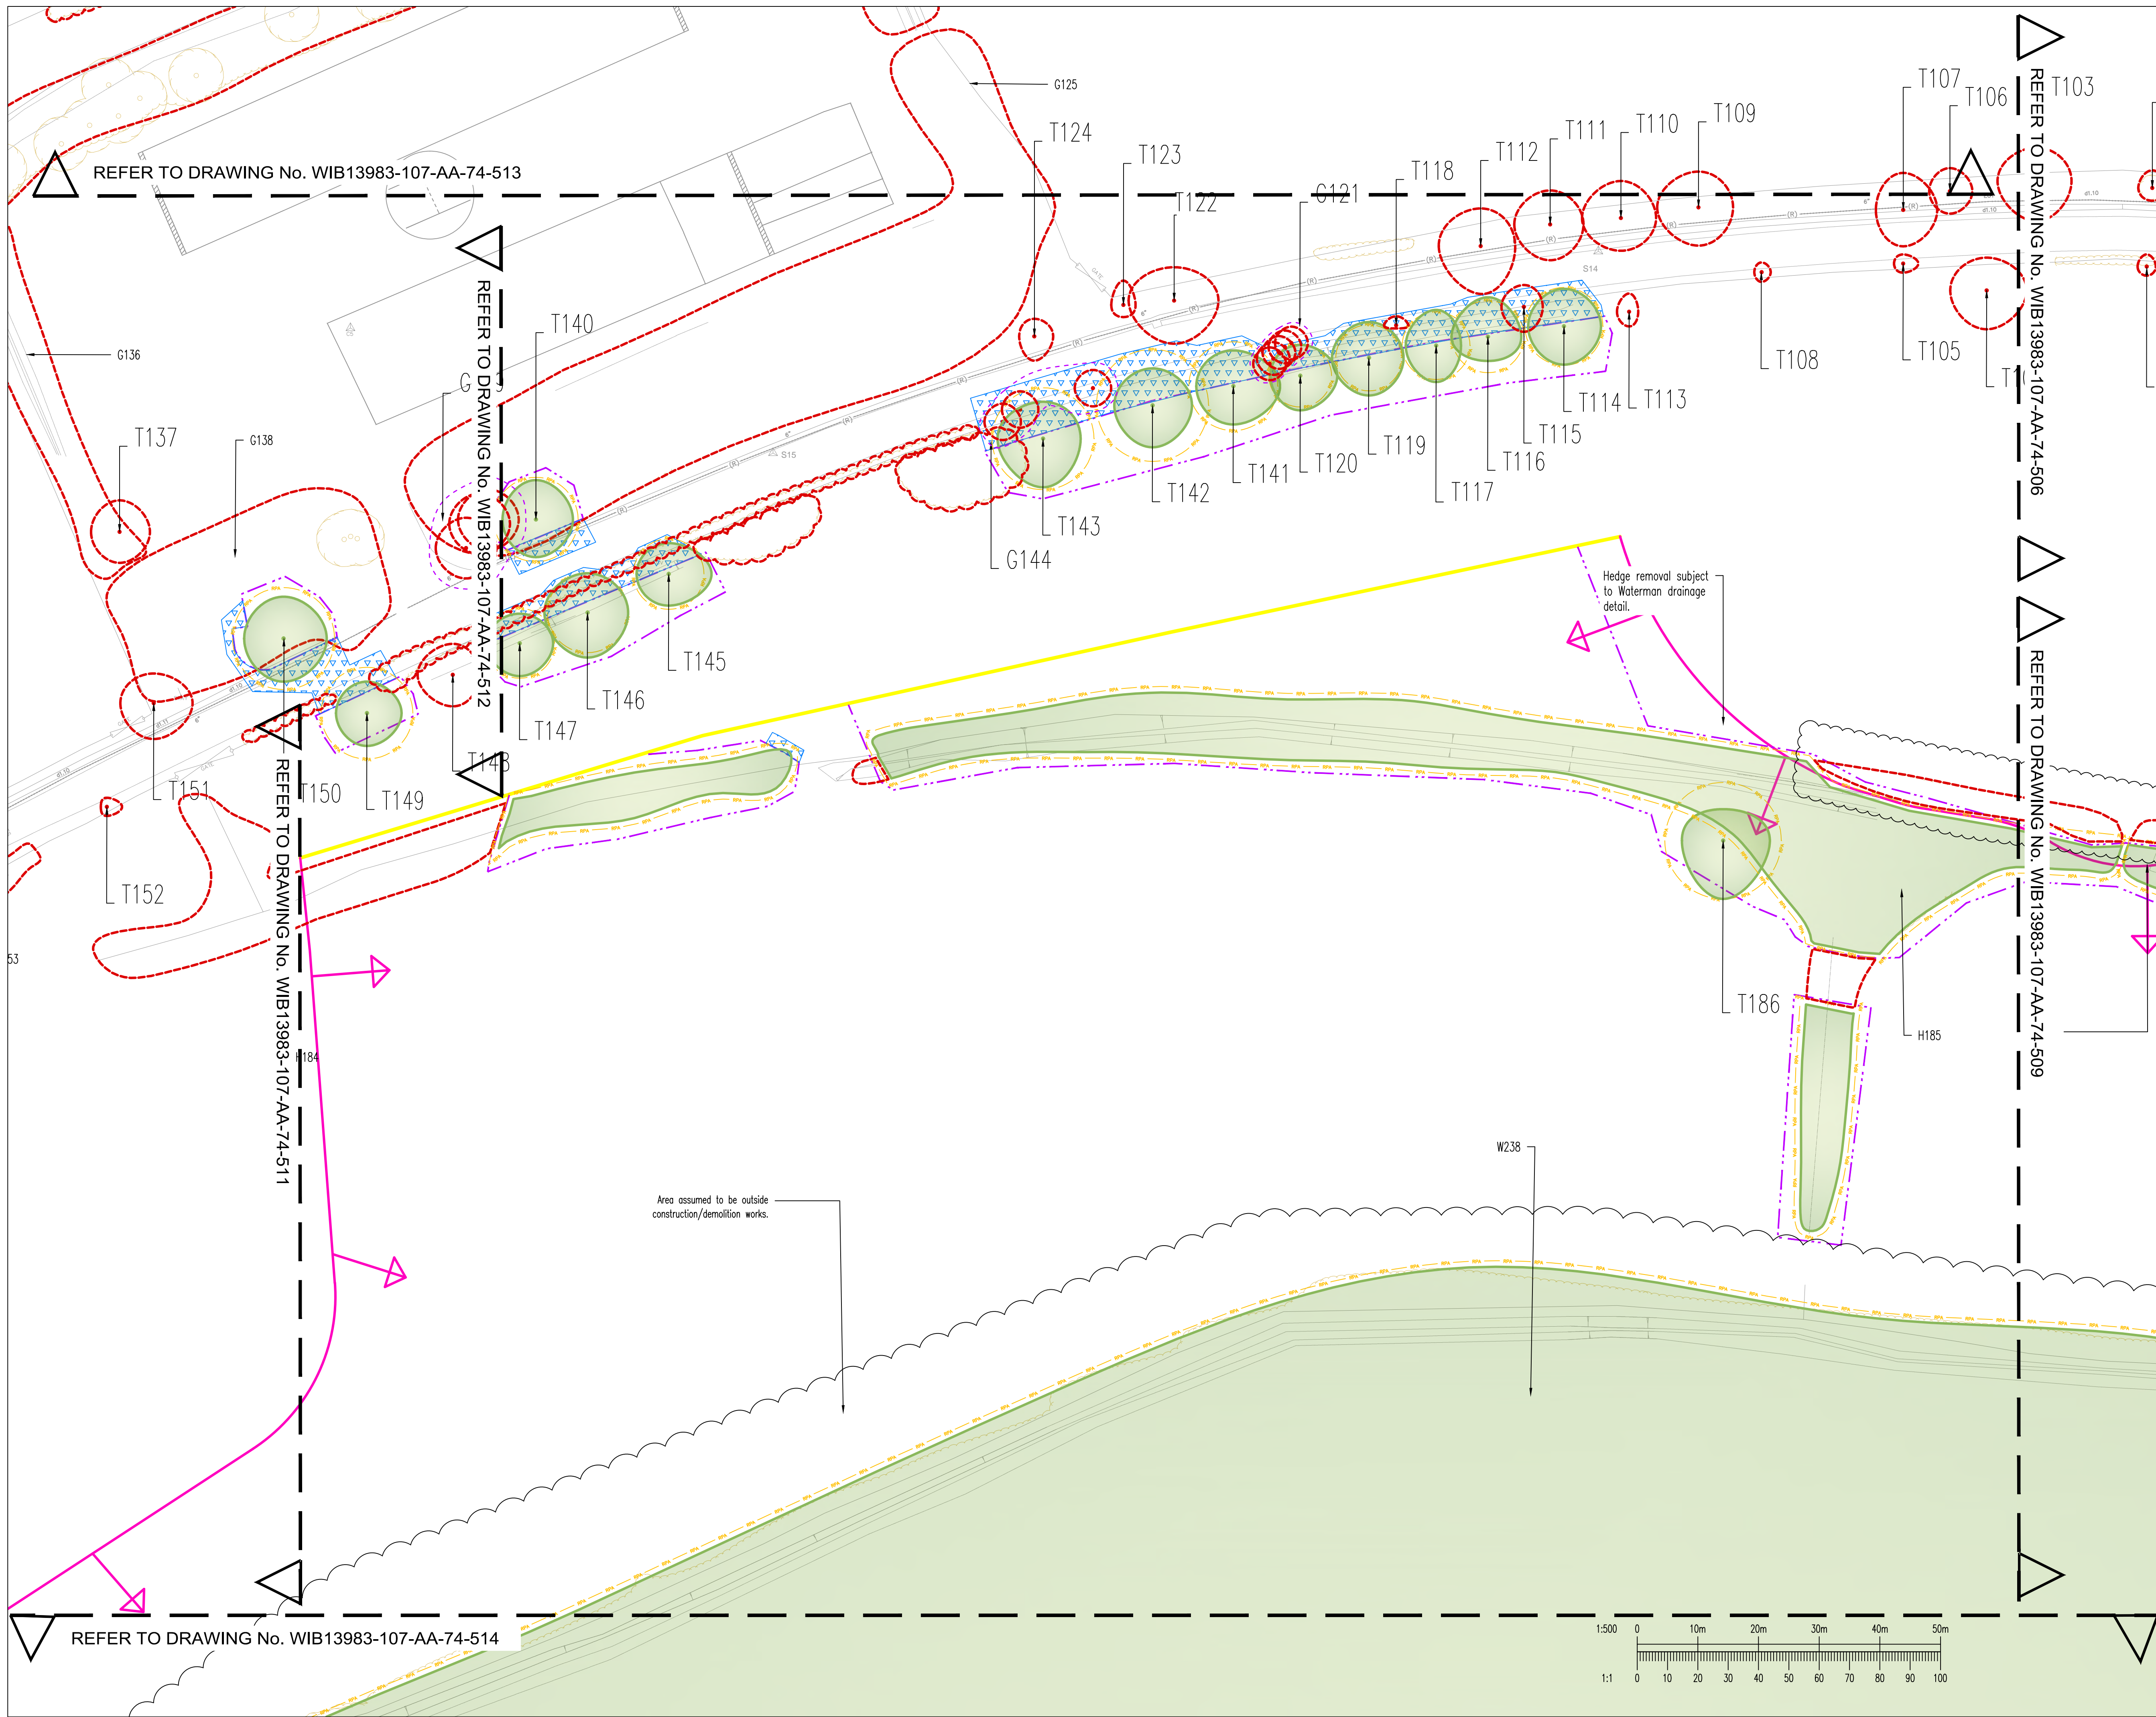
Project: **GRAVEN HILL, BICESTER**
 Title: **LTA 1 TREE AND HABITAT PROTECTION PLAN (Sheet 8 of 12)**
 Client: Graven Hill Village Development Company

Note:
 Refer to Waterman Drawing No. WIC15119-118-AA-77-002 to 004 for baseline survey data.
 All works to be carried out in accordance with the principles of BS5837:2012 when in proximity to retained trees and hedgerows.
 Tree protection fencing to be erected in accordance with the enclosed details and maintained as a Construction Exclusion Zone for the duration of all construction works.
 Refer to notes on Drawing No: WIB13983-107-AA-74-503 for further detail.

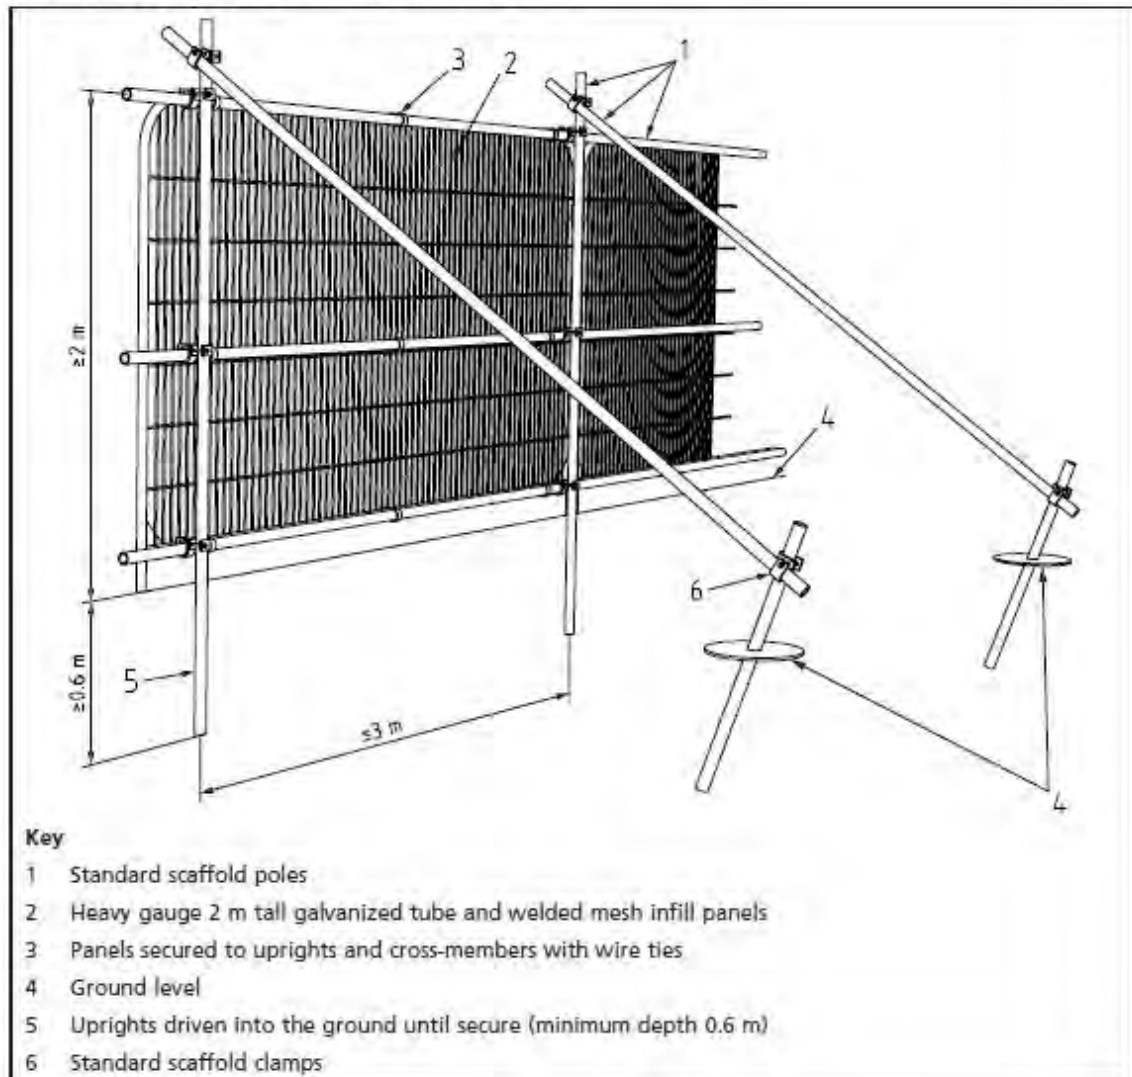
Figure 2 Default specification for protective barrier

C. Extract from BS5837:2012 – Default Specification for Protective Barrier

PROTECTION FENCING
Refer to detail (Fig 1 and Fig 2) on Drawing No. WIB13983-107-AA-74-503
-

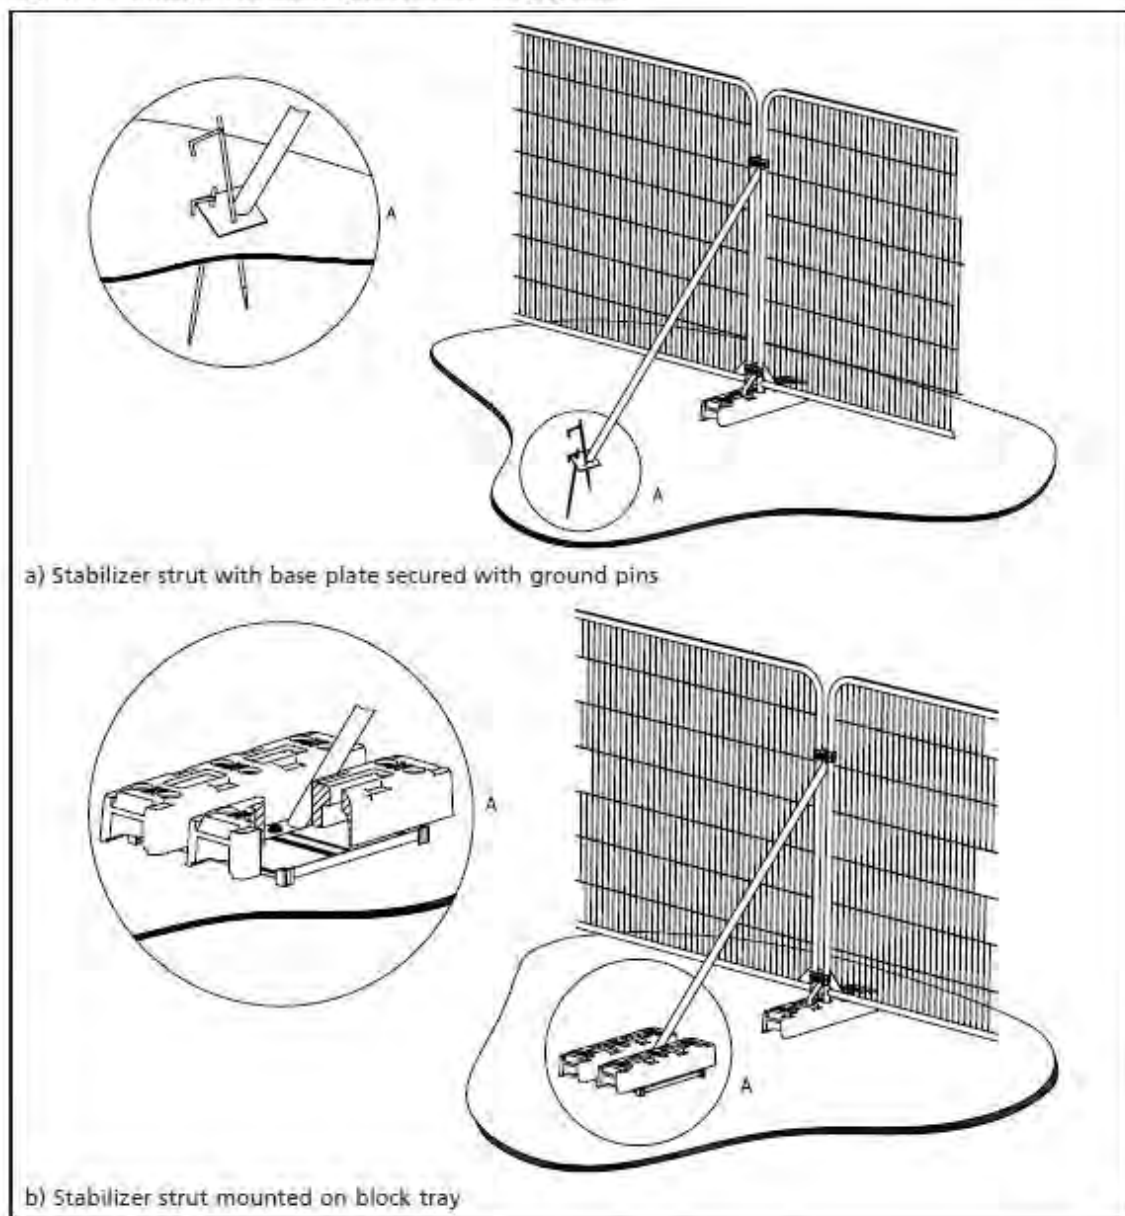
Figure 3 Examples of above-ground stabilizing systems

D. Extract from BS5837:2012 – Examples of Above-Ground Stabilising Systems
