Southam Road Retail Park, Banbury
Ground Stability and Phase 1 Contaminated Land Desk Study

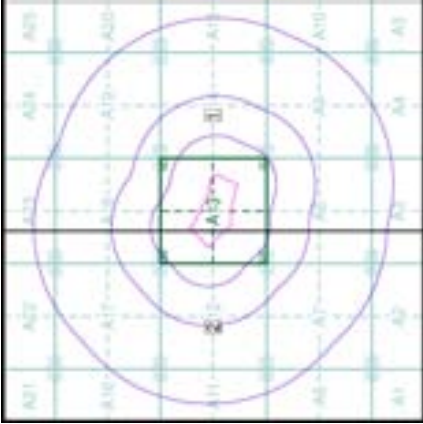
Geology 1:10,000 Maps - Slice A

Map ID:	1	2
Map Name:	SP44SE	SP44SW
Map Date:	1957	1955
Bedrock Geology:	Available	Available
Superficial Geology:	Available	Available
Artificial Geology:	Not Available	Available
Faults:	Available	Available
Landslip:	Not Available	Not Available
Rock Segments:	Not Available	Not Available

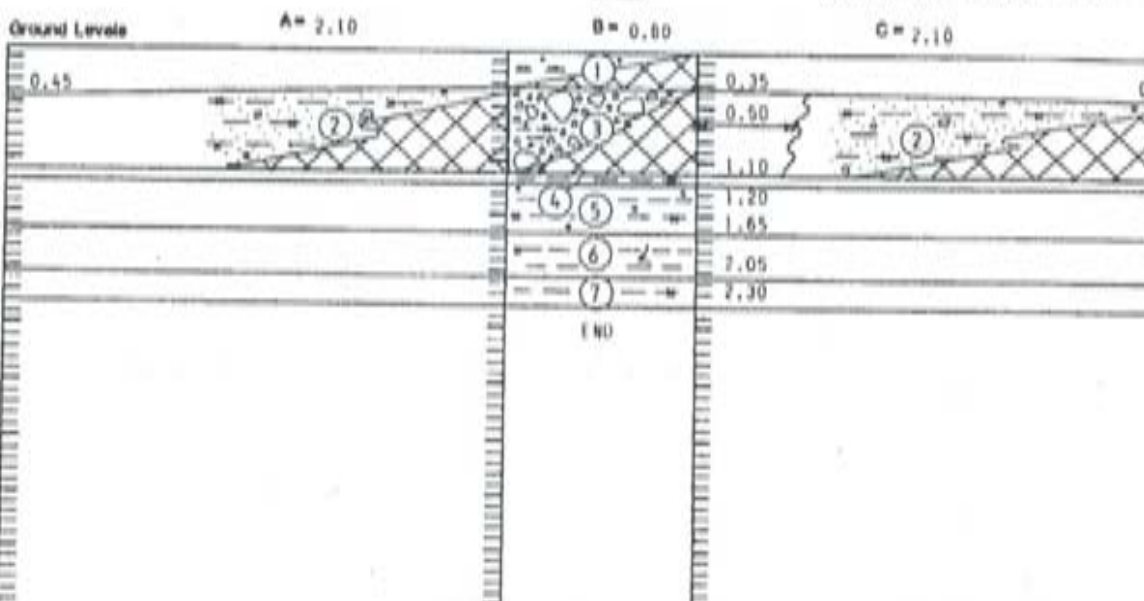
Project PROPOSED NEW COMPUTER ROOM Client GENERAL FOODS Trial Pit 1
 Location RUSCOTE AVENUE, BANBURY Engineer D G I INTERNATIONAL PLC Project No. 87-5535
 Location Plan Trial Pit Plan

Bearing SW Date 20.2.87
 Plant Case
 Shoring None
 Stability Spalling to 1.10m, overbreak 0.1m
 Water No groundwater encountered

Samples and Tests			Strata	
Depth	Type	Strength	Reference	Description
		kN/m ²		
			1	Topsoil, occasional gravel. MADE GROUND.
			2	Soft to firm dark orange brown very sandy very silty clay with much angular sandstone gravel, some brick and concrete fragments upto cobble size. Occasional wire and reinforcement bars. MADE GROUND.
			3	'Loose' angular gravel cobble and boulder sized fragments of brick and concrete, planks of wood, wire plastic etc. with some dark orange brown v sandy very silty clay. Lenses of soft light grey silty clay. MADE GROUND.

1.0	J			
1.20	H/V	130		
1.3	H/V	85		
1.4	H/V/J	85		
1.5	H/V	95		
			4	Firm dark grey green silty CLAY, organic rich, with traces of roots and decaying vegetation.

1.80	J.H.P	100		
1.95	H.P	130		
2.3	J.H/V	80		
		(Disturbed)	5	Firm light grey and orange brown silty CLAY/clayey SILT with some fine to coarse angular rounded gravel. Occasional shell fragments. DISTURBED LIAS CLAY.
			6	Firm to stiff light blue grey and orange brown very closely fissured silty CLAY/clayey SILT. Root traces present. LOWER LIAS CLAY (WEATHERED).
			7	Stiff becoming very stiff light blue grey thickly laminated very closely fissured silty CLAY/clayey SILT. Hard in parts. Discoloured orange brown along fissures. LOWER LIAS CLAY.

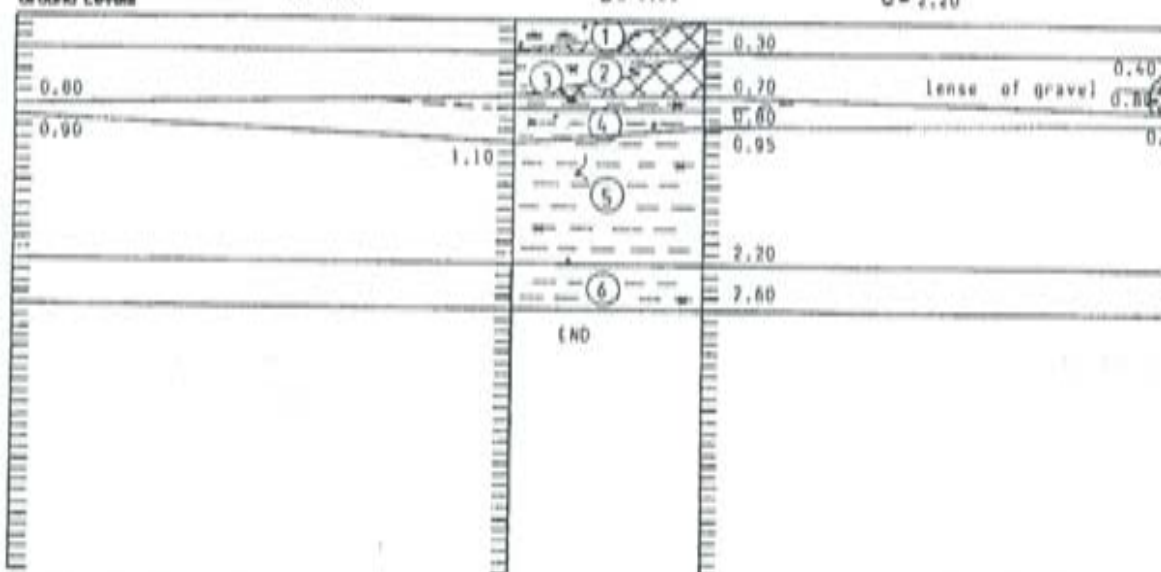
Sample and Tests			Strata	
Depth	Type	Strength	Reference	Description
		kN/m ²		
0.50	J.H/V	124	1	Topsoil, some rounded gravel. MADE GROUND.
0.70	H/V	94	2	Fine light brown grey and orange brown silty clay, very sandy in parts with occasional small pockets of topsoil and gravel. MADE GROUND.
			3	Fine dark grey green silty CLAY, organic rich with traces of decaying root and vegetation.

0.90	H/V	100	4	Fine to stiff light orange brown, grey and green brown silty CLAY/clayey SILT with some fine to coarse rounded gravel. Occasional sand sized comminuted shell fragments. GLACIALLY DISTURBED LIAS CLAY.

1.0	J.H/V	90		
1.1	H/V	112	5	Fine to stiff and stiff light blue grey discoloured orange brown poorly laminated very closely fissured silty CLAY/clayey SILT. Occasional root traces. WEATHERED LOWER LIAS CLAY.

1.2	H/P	150		
1.3	H/P	190		
1.4	H/P	160		
1.5	H/V	110	6	Stiff to very stiff light blue grey thickly laminated closely to very closely fissured silty CLAY/clayey SILT. Discoloured orange brown along fissures. Becoming hard and very thinly bedded from 2.30m. LOWER LIAS CLAY.

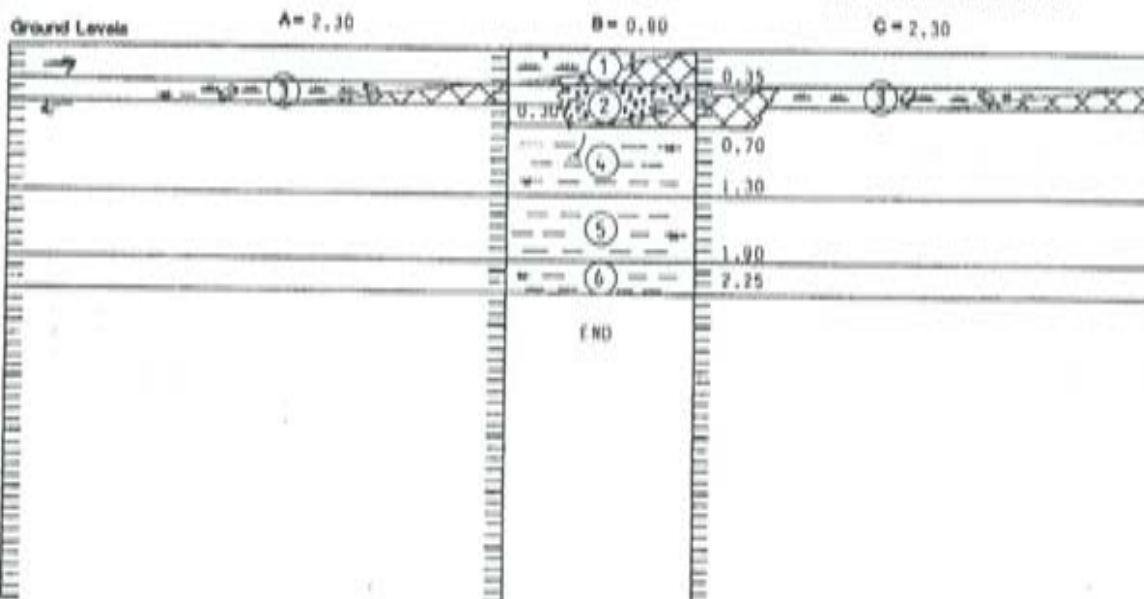
Very slight water seepage along laminations below 1.90m

Samples and Tests			Strata	
Depth	Type	Strength	Reference	Description
		kN/m ²	1	Topsoli, some rounded gravel. MADE GROUND.
			2	Land drain 100mm diameter in gravel surround. Soft light grey clay used backfill. Land drain dry. MADE GROUND.

0.70	H/V	135	3	Topsoli intermixed with bricks with lenses of firm orange brown sandy silty clay and gravel. MADE GROUND.
0.9	H/V	160	4	Firm to stiff and stiff light blue grey, orange brown and grey green poorly laminated, very closely fissured silty CLAY/clayey SILT. Root traces present. WEATHERED LIAS CLAY.

1.0	J,H/P	190		
1.1	H/V	190		
1.2	H/V	130		
1.3	H/V	110		
1.4	H/V	105		
1.5	H/P	175	5	Stiff light blue grey very close to closely fissured thickly laminated silty CLAY/clayey SILT. Discoloured orange brown along fissures. LOWER LIAS CLAY.

1.6	J,H/V	150		
2.25	J		6	Hard light to dark blue grey thickly laminated and closely fissured silty CLAY/clayey SILT. Fissures ironstained, tending to very weak mudstone to base. LOWER LIAS CLAY.

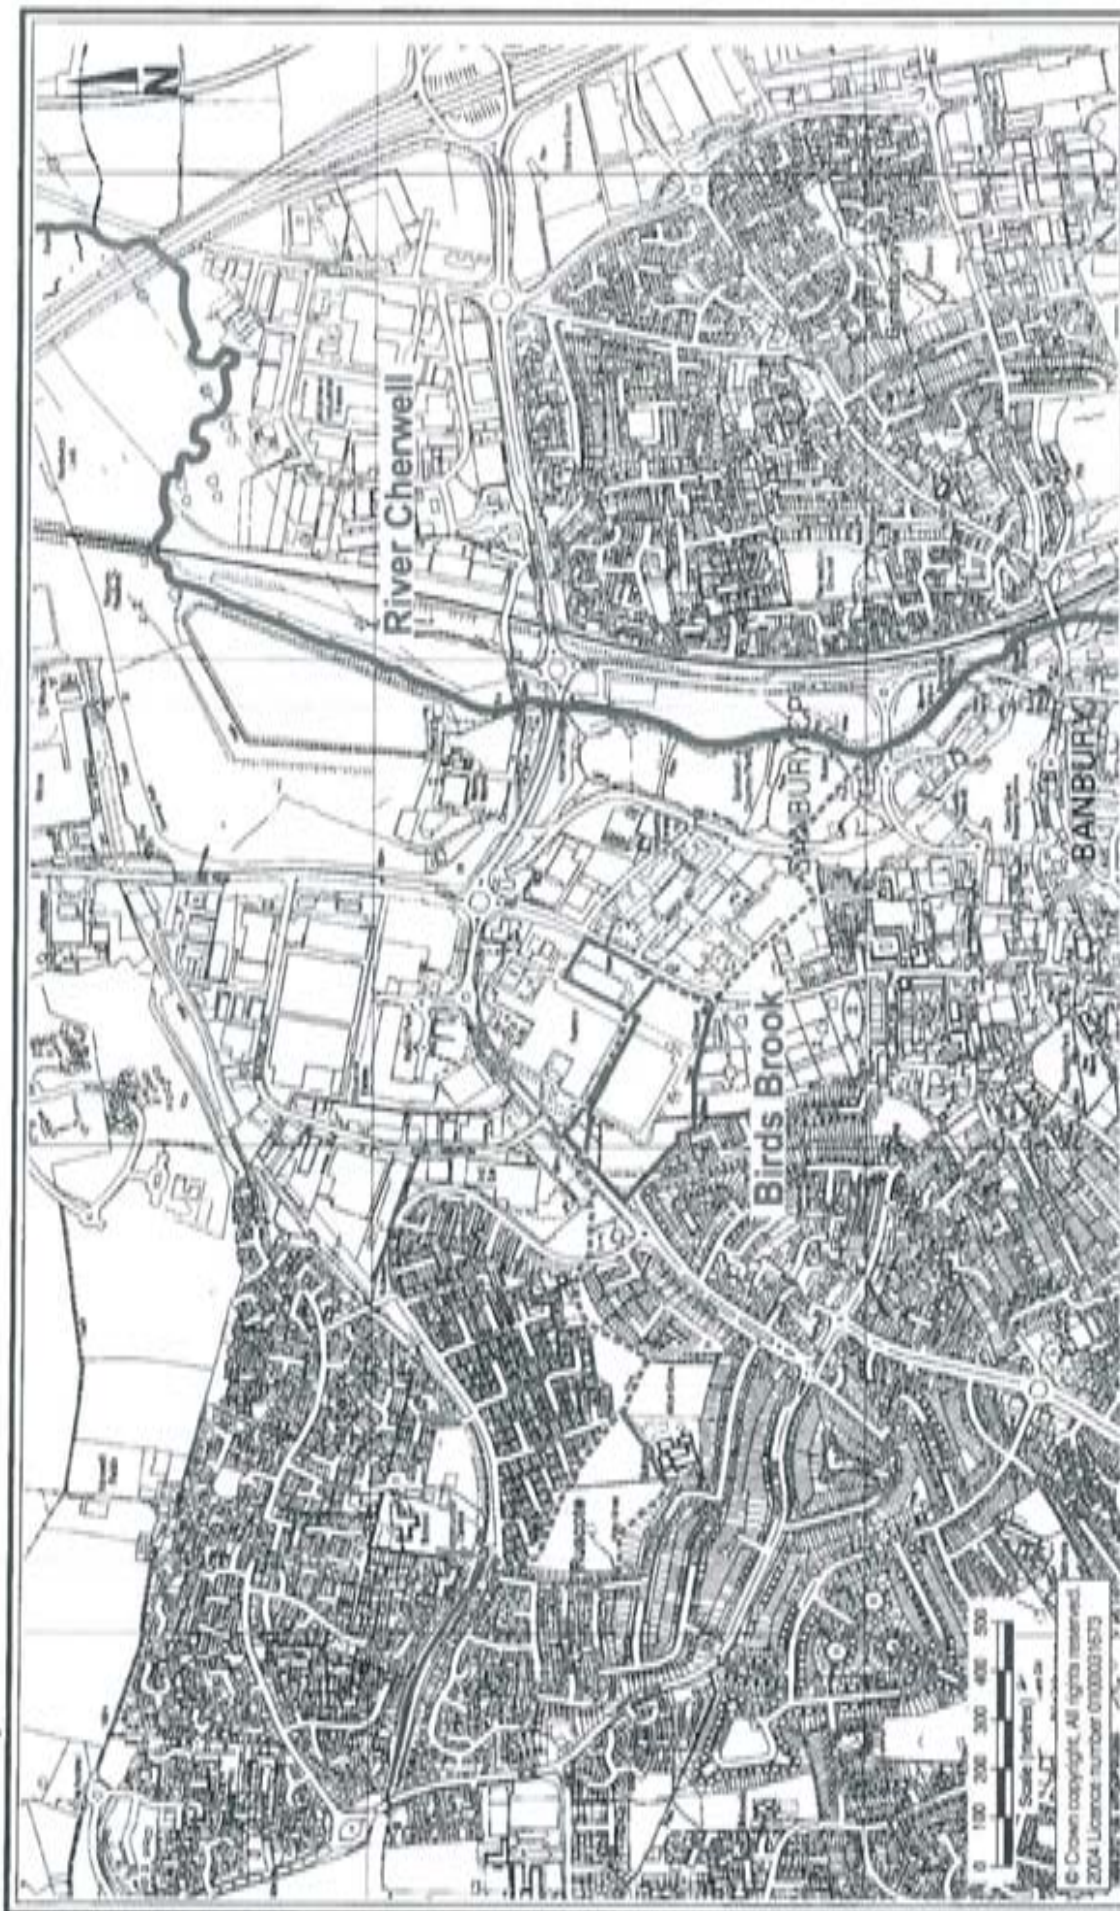
SCALE	CAN	KG0080205A
AS SHOWN	DRAWN	APR
CONTENT	DATE	JAN 2007
CHECKED	POH

**FLOOD RISK ASSESSMENT,
PROPOSED DEVELOPMENT AREA,
BANBURY**

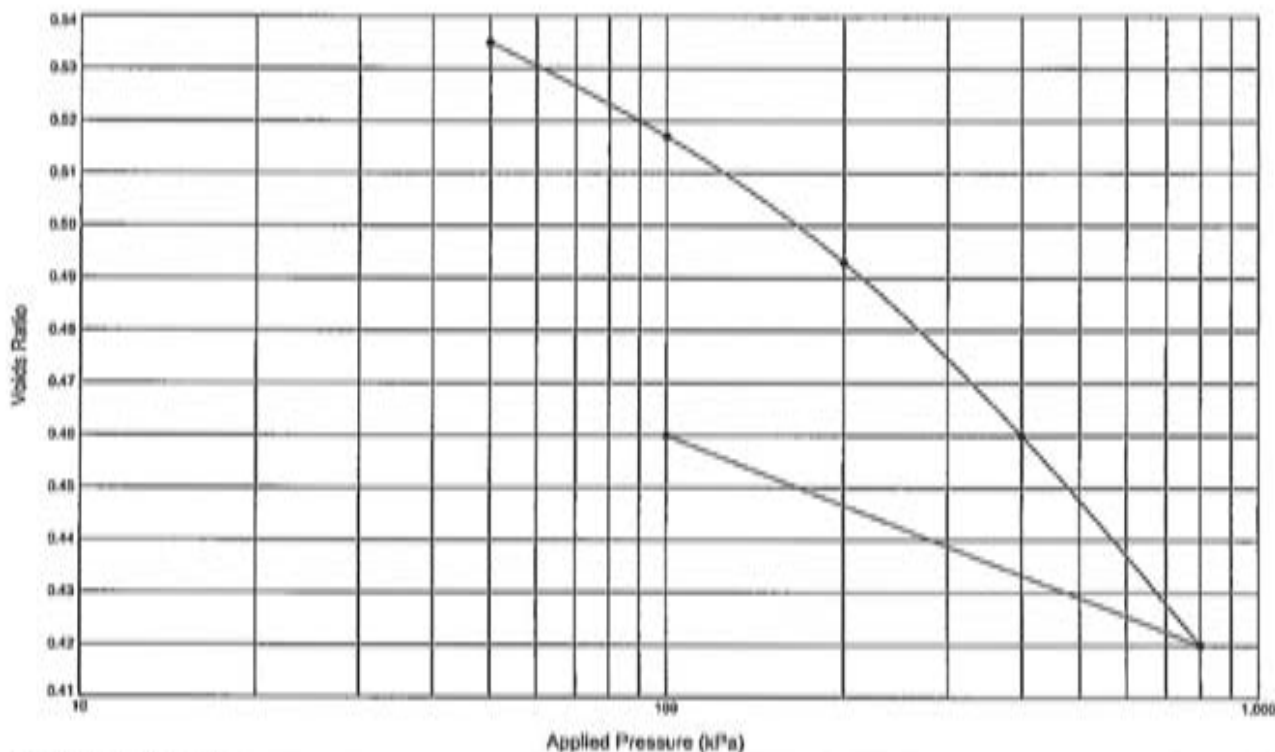
BH/TP No. BH01
 SAMPLE No./TYPE 24C
 SAMPLE DEPTH (m) 5.60
 SPECIMEN DEPTH (m) 6.80

DESCRIPTION Grey slightly sandy CLAY

Test and sample details			Test results			
			pressure stage (kPa)	voids ratio	laboratory coefficients of compressibility (m ² /MN)	consolidation (m ² /year)
specimen diameter	(mm)	63.48	50	0.535		
specimen height	(mm)	19.04	100	0.517	0.235	7.23
initial moisture content	(%)	16.1	200	0.493	0.161	4.80
final moisture content	(%)	20.3	400	0.460	0.110	4.93
initial bulk density	(Mg/m ³)	2.08	800	0.420	0.069	4.05
initial dry density	(Mg/m ³)	1.74	100	0.460	0.041	
initial voids ratio		0.548				
initial degree of saturation	(%)	94				
particle density	(Mg/m ³)	#2.70				
swelling pressure	(kPa)	N/A				
P ₀ to P ₀ +100 kPa	(kPa)	-				
laboratory temperature	(°C)	21				
method of time fitting		root time				
remarks: # denotes particle density has been assigned an assumed value Specimen swelled on first load stage at 50kPa					CONTRACT 25186	CHECKED WJ
