Cotefield Farm, Bodicote OX15 4AQ

DESK TOP STUDY AND SITE INVESTIGATION REPORT

Prepared for: **BANNER HOMES**

Report Reference: BC008 RE001

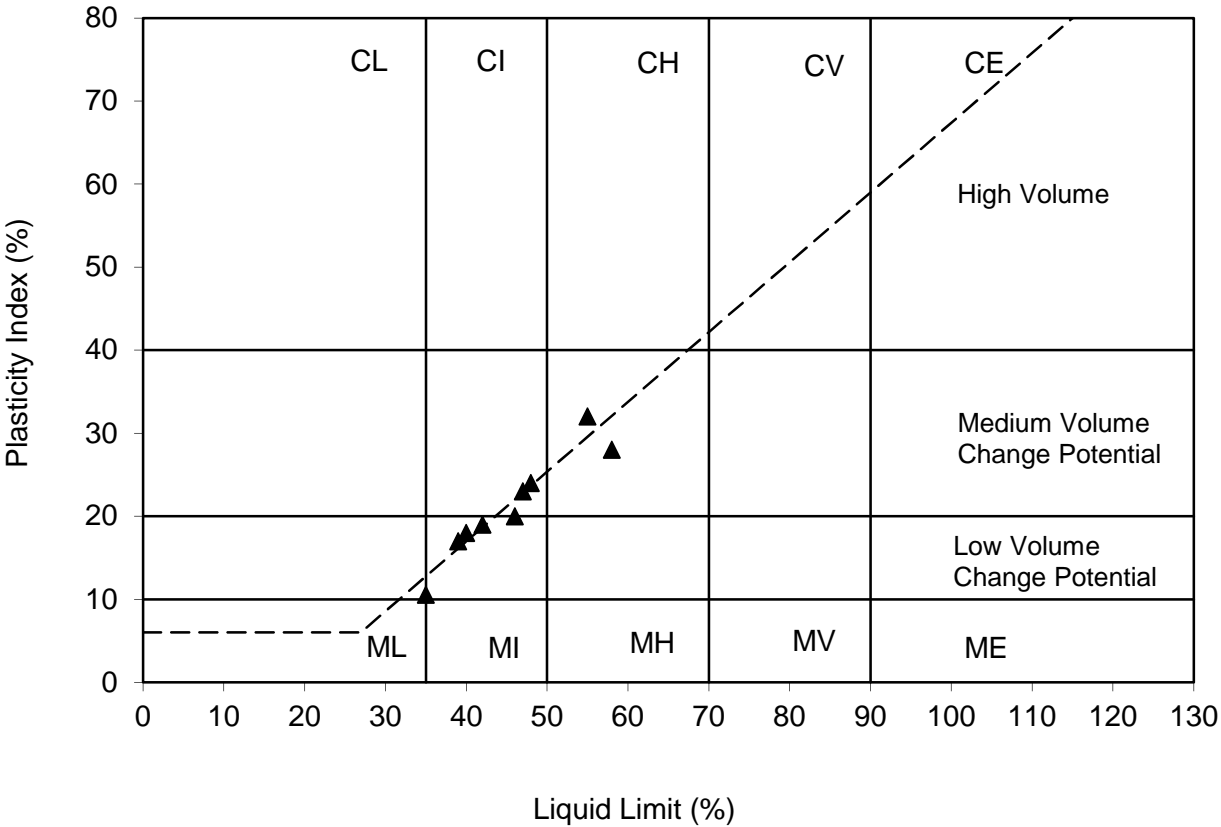
Figure 3

▲ Weathered Marlstone Rock Bed □ - - - A Line

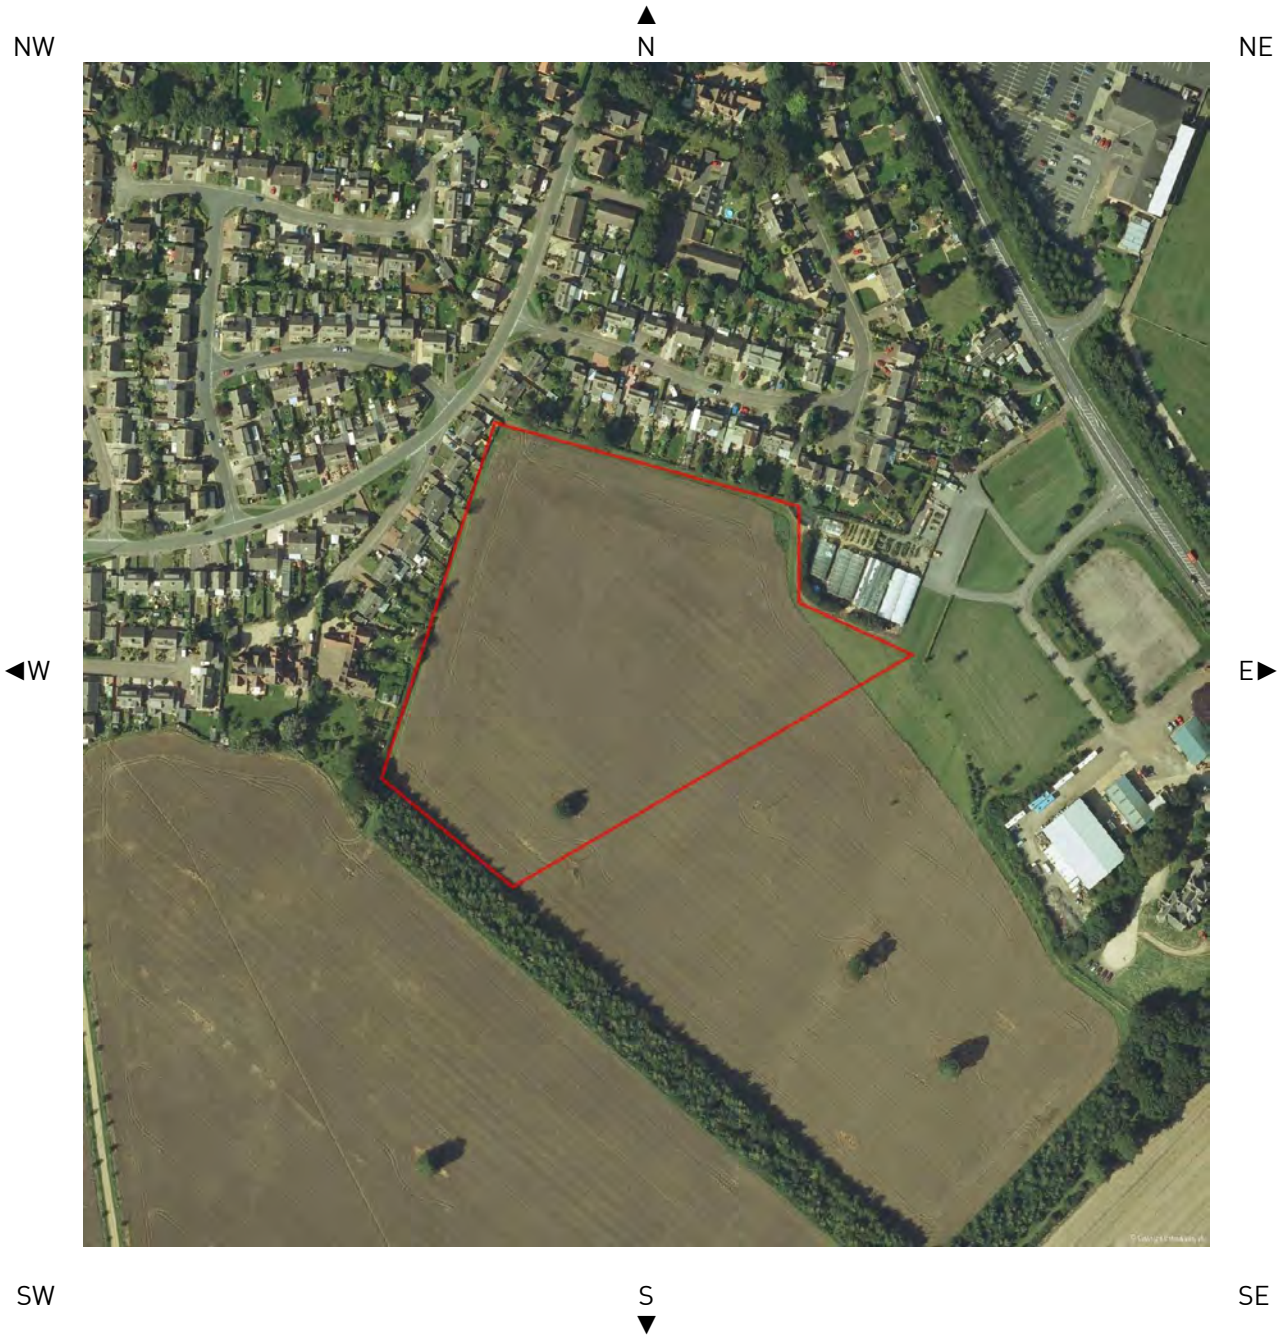
Aerial Photograph of Study Site

Site Name: COTEFIELD FARM, OXFORD ROAD, BODICOTE,
BANBURY, OX15 4AQ
Grid Reference: 446575,237487
Size of Site: 3.28 ha
