PROPOSED CAR PARK EXTENSION
LAUNTON ROAD, BICESTER

Landscape Statement

October 2012
5098.LS.001.VF

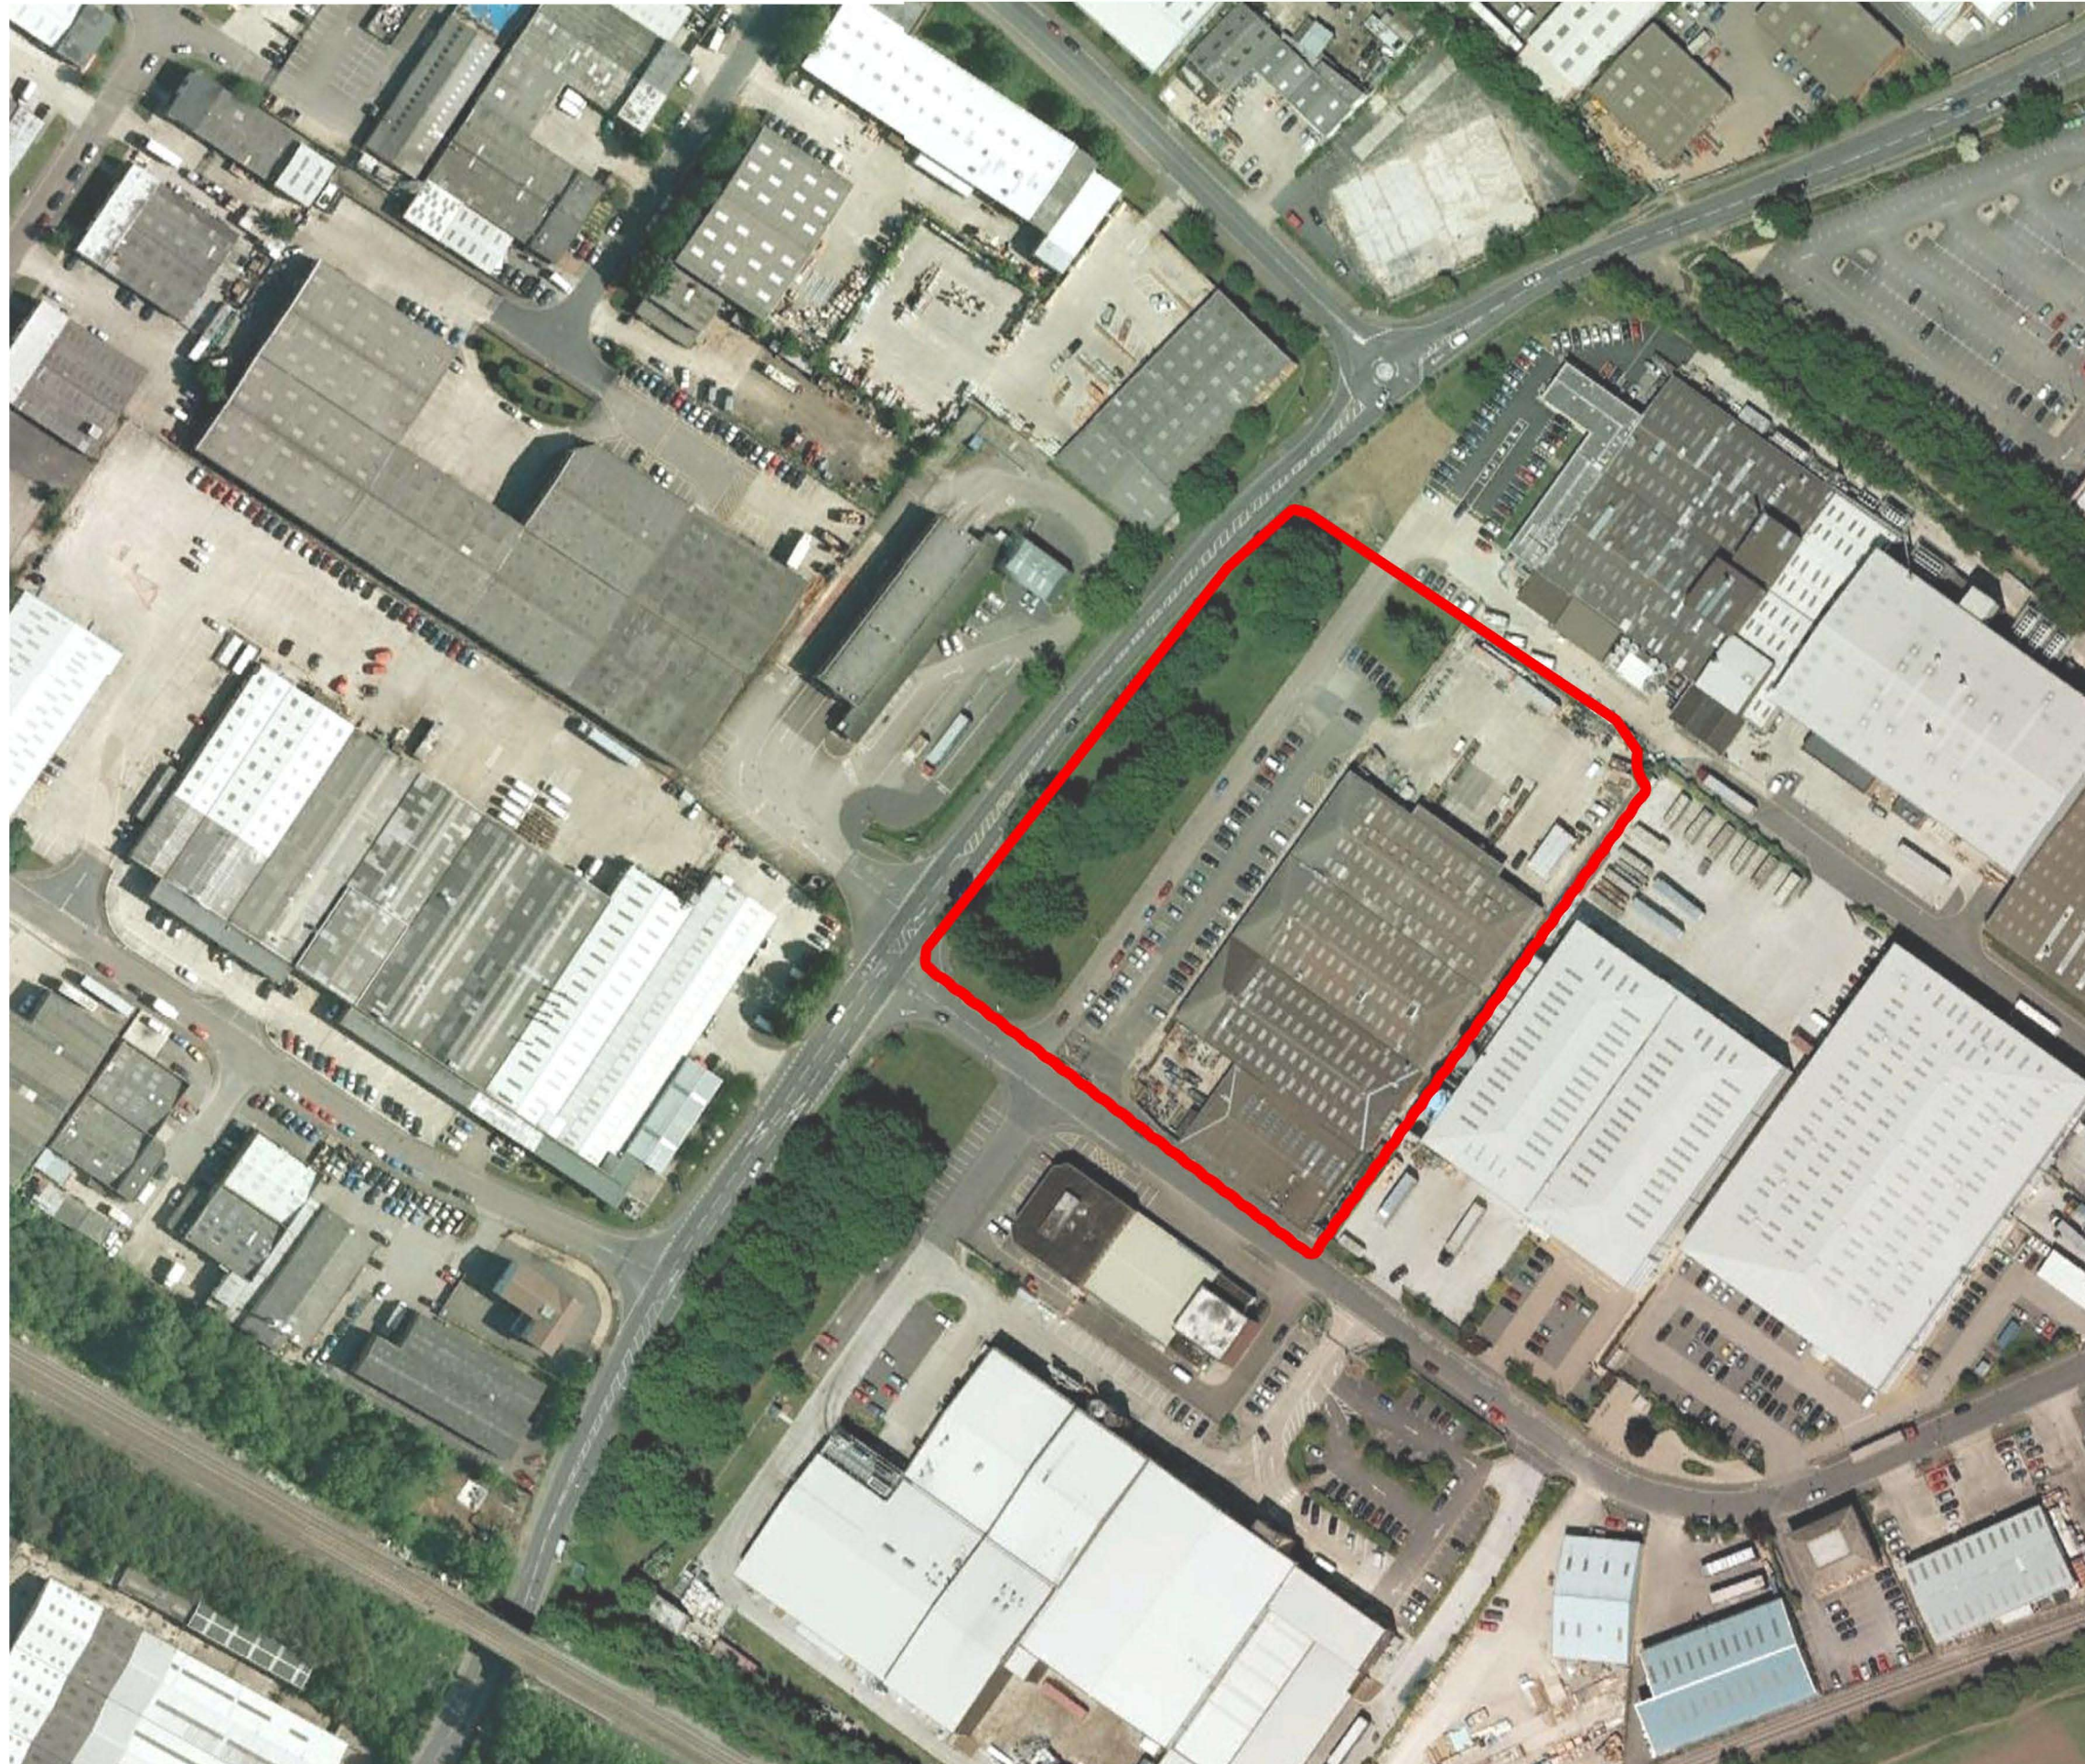
SCALE Not to Scale	DATE Oct 2012	DRAWN EW
DRAWING NUMBER 5098/ ASP1	REVISION

The existing Barrus car park is situated to the front of the building and is set back from Launton Road by a landscape strip (Refer to Existing Situation ASP1). This generous landscape strip, comprising mature trees and amenity grass, has the potential to accommodate the proposed additional car parking (Refer to ASP2 Visual Appraisal).

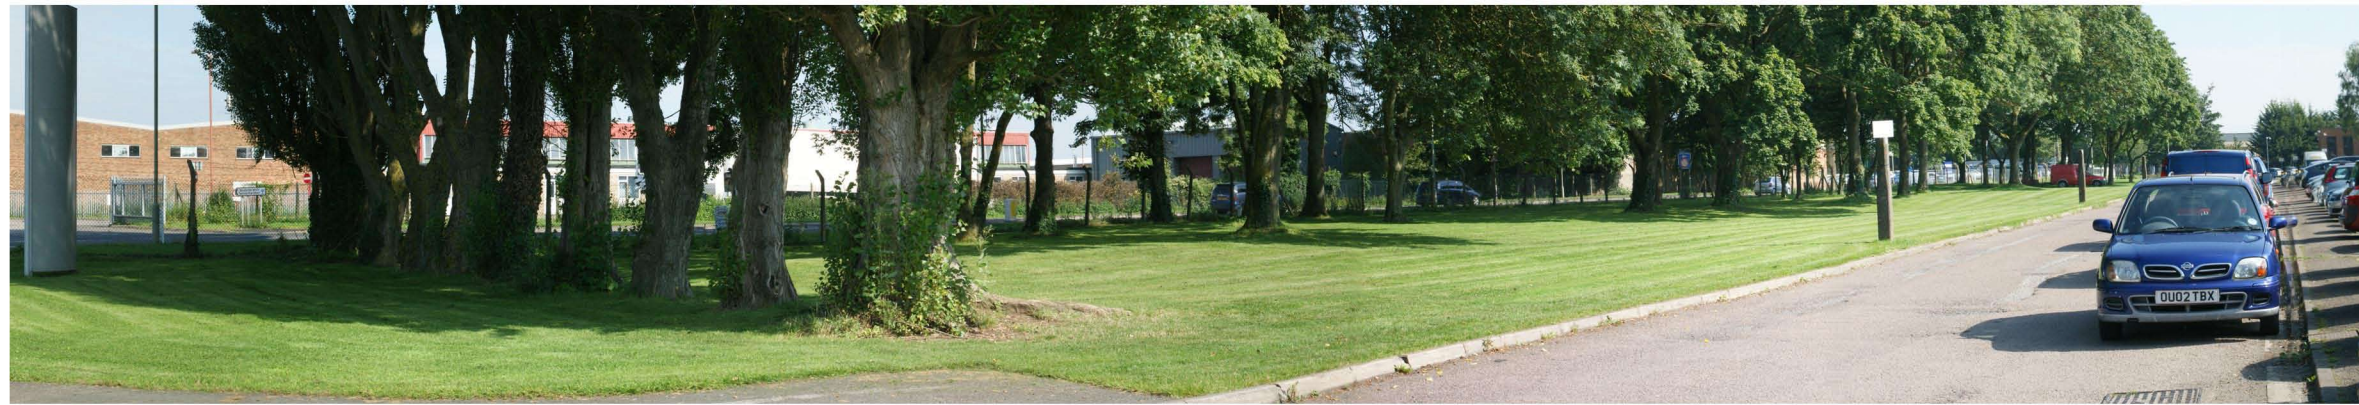
PHOTOGRAPH 1

Panorama created from multiple photographs taken using a digital equivalent of a 35mm camera with 50mm lens.
An interpretation of monocular perspective could be obtained by viewing from a distance of between 300mm and 500mm, curved through the same radius.

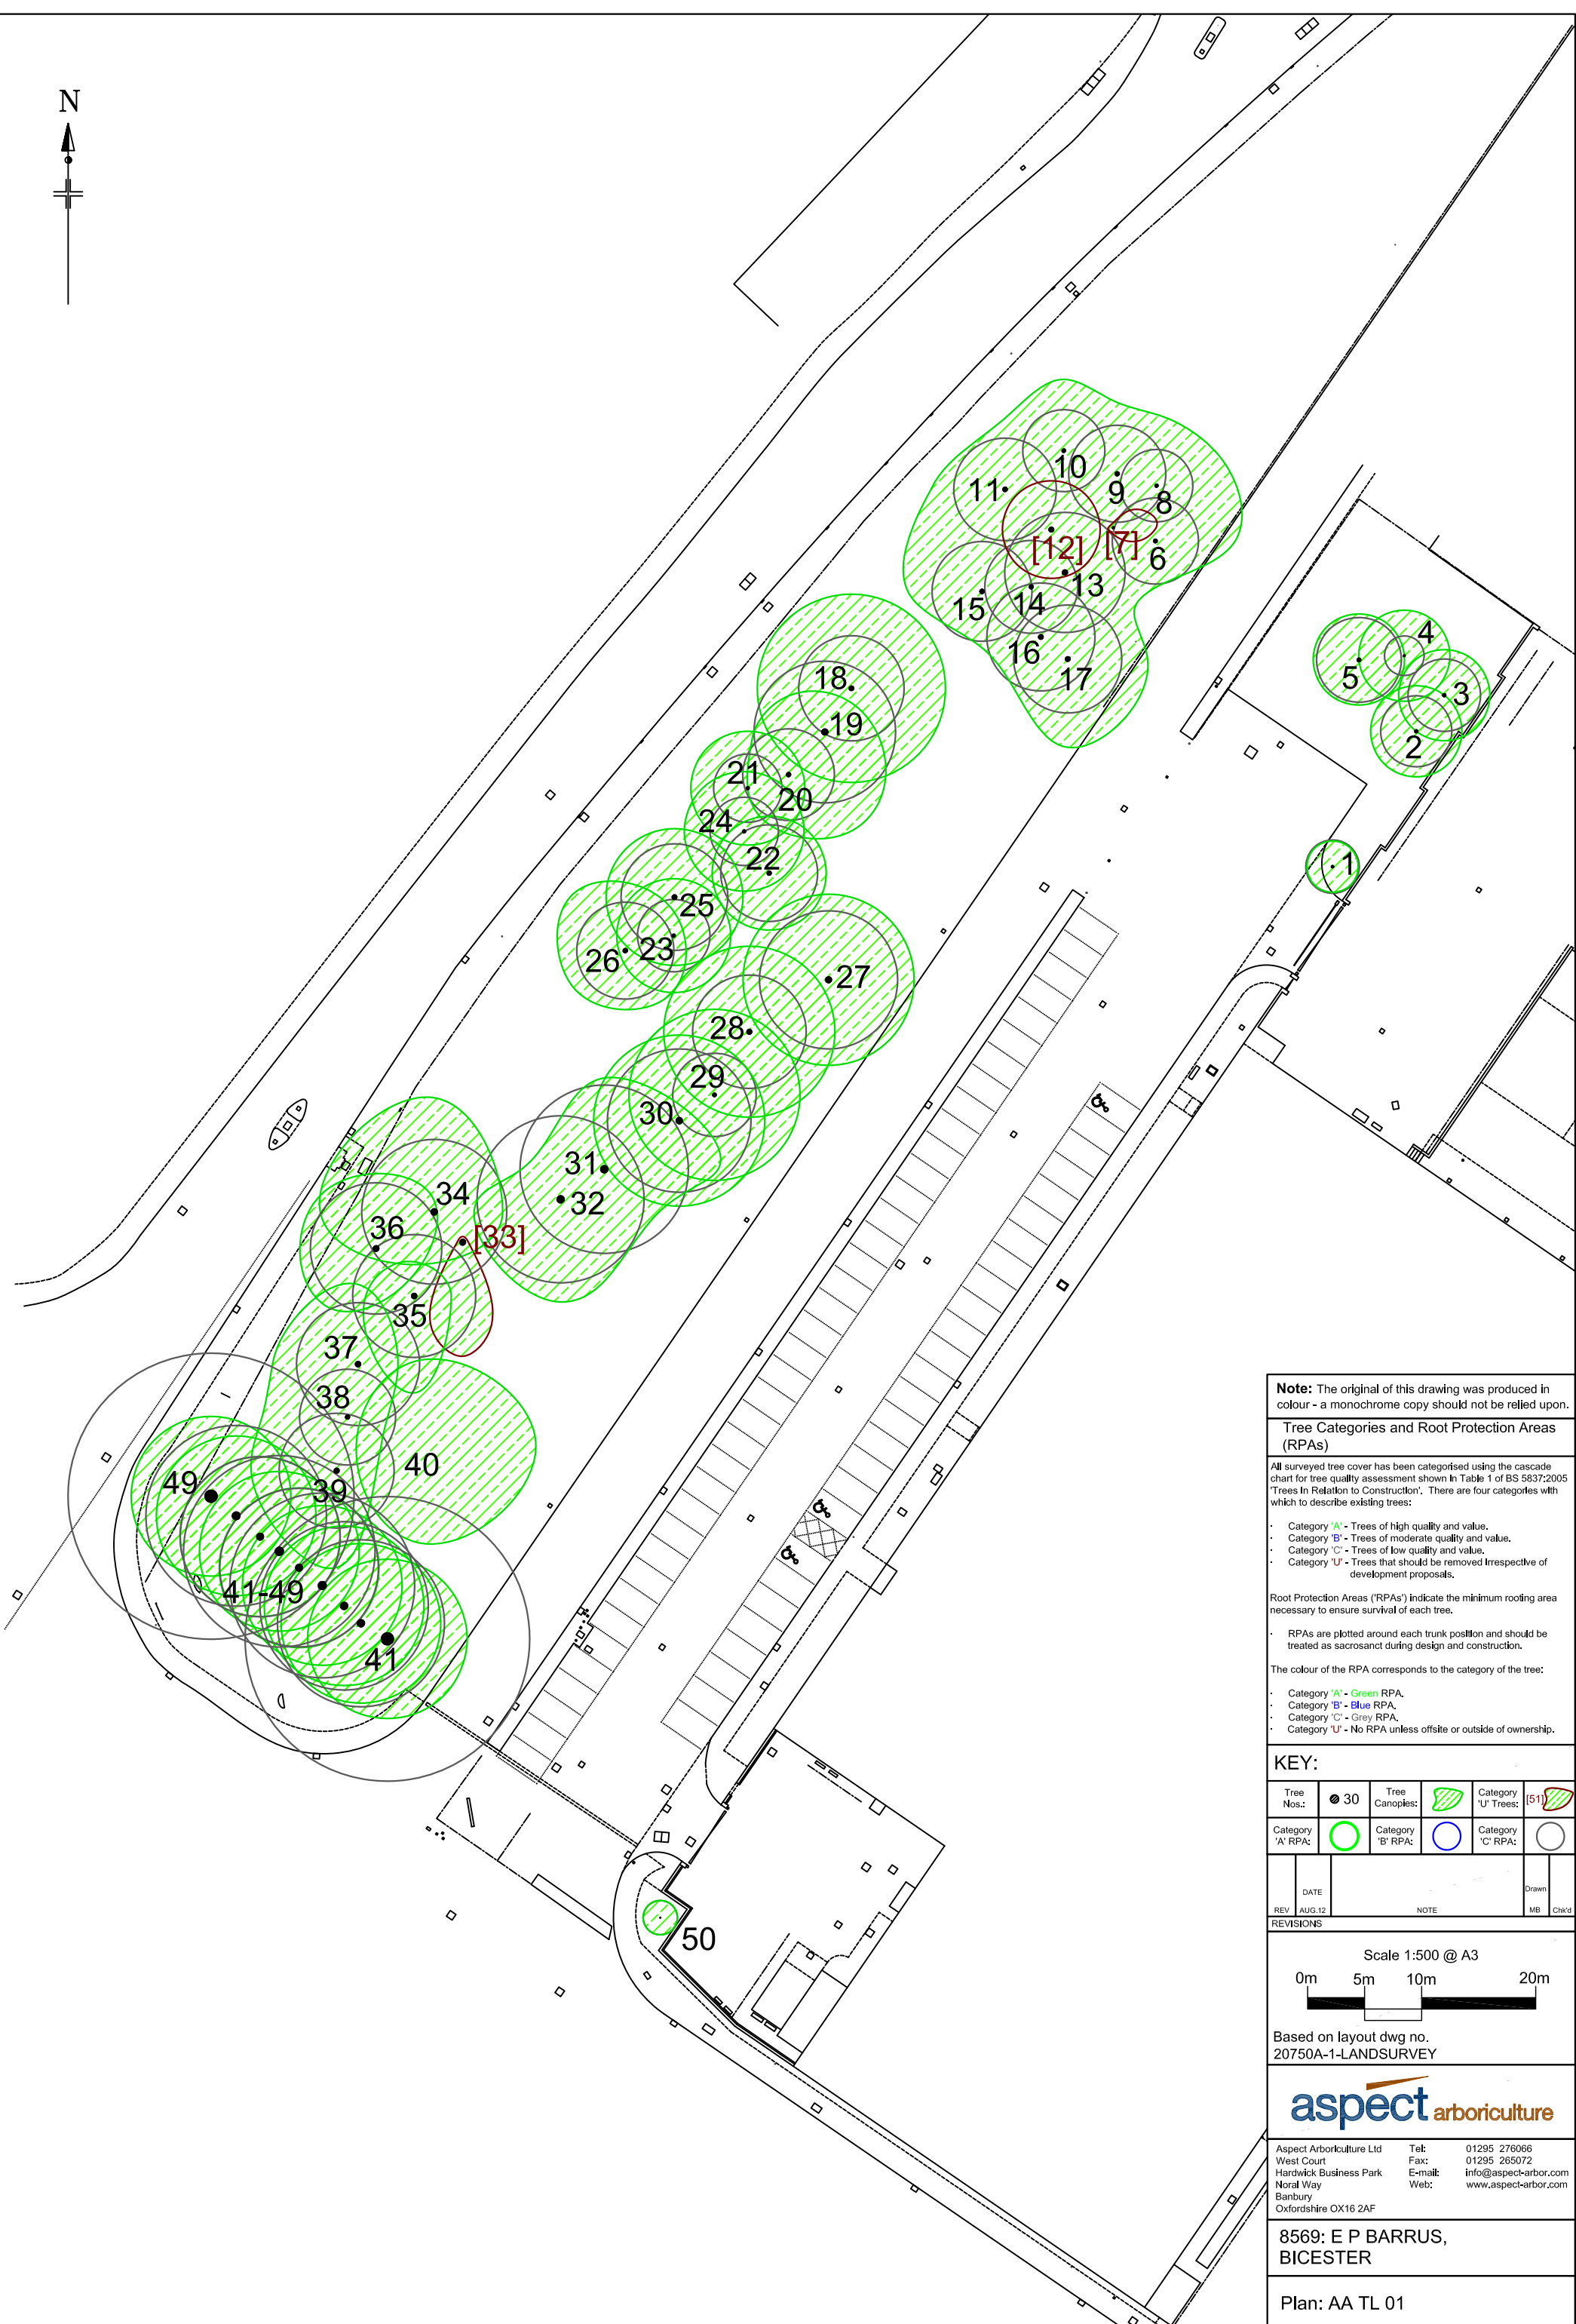
Plan: AA TL 01

Tree Categories and Root Protection Areas (RPAs)

All surveyed tree cover has been categorised using the cascade chart for tree quality assessment shown in Table 1 of BS 5837:2005 'Trees In Relation to Construction'. There are four categories with which to describe existing trees:

Root Protection Areas ('RPAs') indicate the minimum rooting area necessary to ensure survival of each tree.

- RPAs are plotted around each trunk position and should be treated as sacrosanct during design and construction.

An arboricultural appraisal was carried out to assess the existing trees relevant to the site, with details illustrated on the Tree Locations Plan (AA TL 01) and Tree Schedule (AA TS 01). The Tree Protection Plan (AA TPP 01) illustrates the impact of the proposals on existing trees which has informed the landscape design.

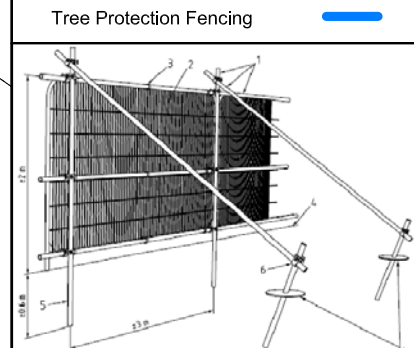
As shown in BS 5837:2012, Section 6, Figure 2.

- Key**
- 1 Standard scaffold poles
 - 2 Heavy gauge 2m tall galvanized tube and welded mesh infill panels
 - 3 Panels secured to uprights and cross-members with wire ties
 - 4 Ground level
 - 5 Uprights driven into the ground until secure (minimum depth 0.6m)
 - 6 Standard scaffold clamps

Tree Protection Fencing to be erected where indicated by the bold blue lines on the adjacent plan, prior to the commencement of any demolition or construction work.

Fencing specification to be compliant with BS 5837:2012 (illustrated above) and should be fit for the purpose of excluding construction activity and any other unacceptable disturbance from within the Root Protection Areas of retained trees, i.e.:

- A scaffold framework in accordance with Figure 2 above comprising of a vertical and horizontal framework, well braced to resist impacts, with vertical tubes driven into the ground spaced at maximum intervals of 3m. Onto this, welded mesh panels should be securely fixed with wire, scaffold clamps or cable ties. If required, fence bases or feet will be secured into the ground with upright scaffold tubes. Panels supported on unsecured rubber or concrete feet are not resistant to impact and should not be used.
