East – West Rail: Phase 1

Chiltern Railways Company Limited

Vibration from Switches & Crossings – Assessment and Mitigation

5114534-ATK-VIB-RPT-80003
Revisions A01

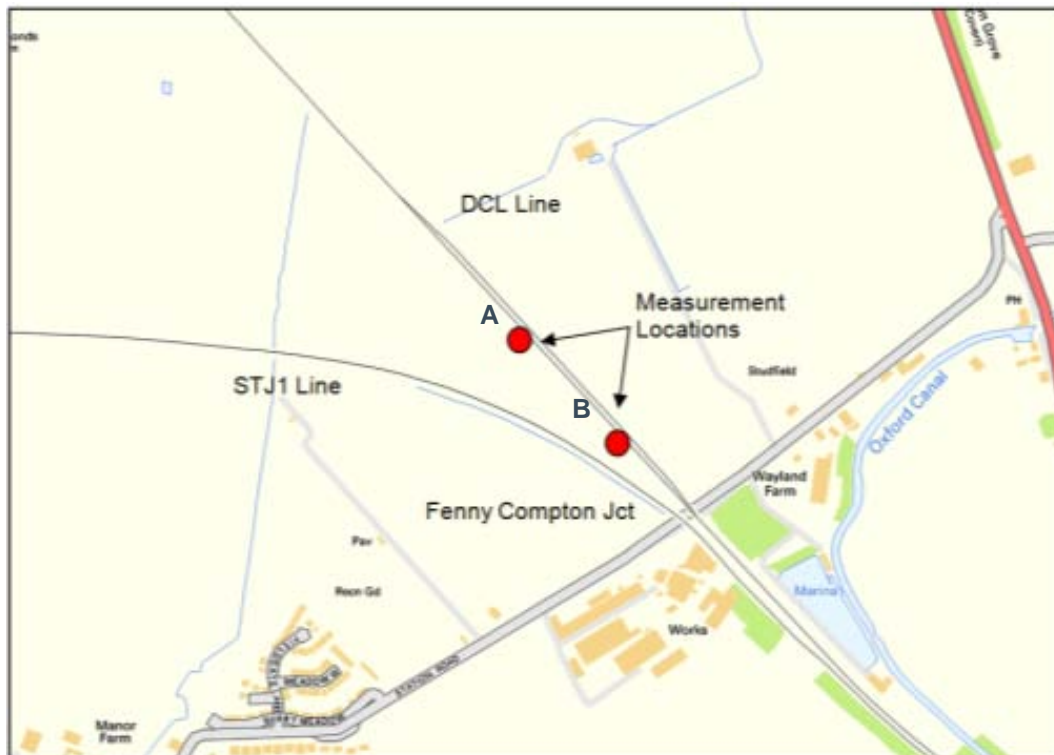
Figure 4. Vibration Monitoring Locations at Fenny Compton

- 3.4. The Fenny Compton Junction North was the only suitable accessible site with similar underlying geology (Charmouth Mudstone - stiff silty clay/blue lias), sufficient space to undertake the simultaneous vibration measurements and no site restrictions such as cuttings or features which would affect vibration measurements. The approximate location of the measurement site is shown in Figure 4 below.

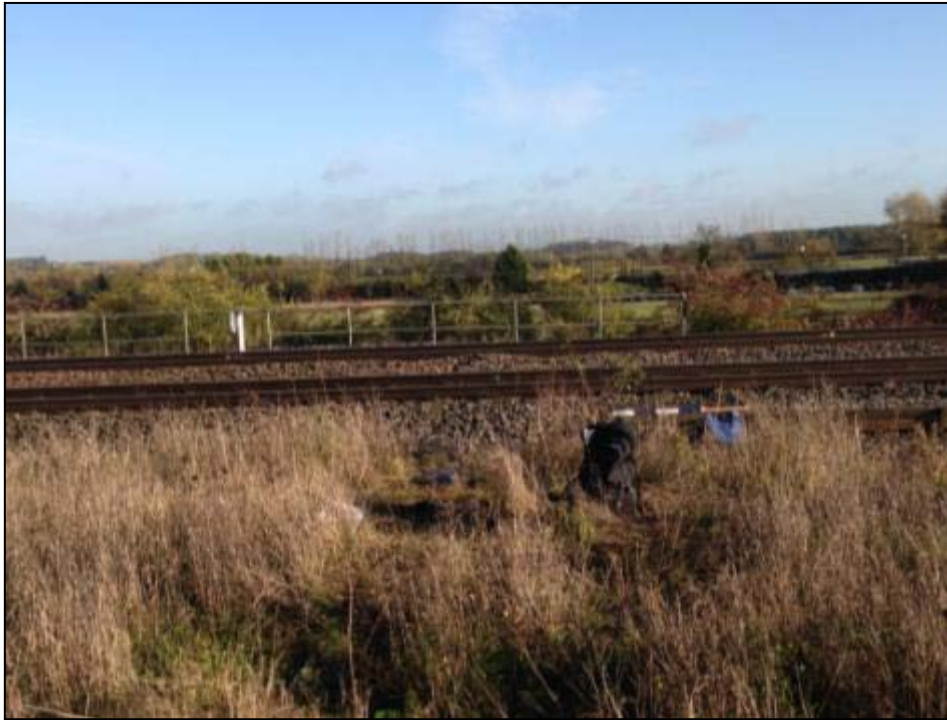
Figure 5. Position A

- 3.5. The measurement locations were at the Fenny Compton Junction, where the STJ1 line (Line to Kineton MOD) merges with the DCL lines (Banbury to Leamington Spa) on an embankment area of made ground understood to be on bedrock of Charmouth mudstone, a stiff silty clay/blue lias. Local ground conditions at the junction also included an amount of fill material consisting of ballast, rubble and stiff silty clay/blue lias similar to the surrounding geology.
- 3.6. Photographs of the measurement location are presented In Figures 5 and 6 below:

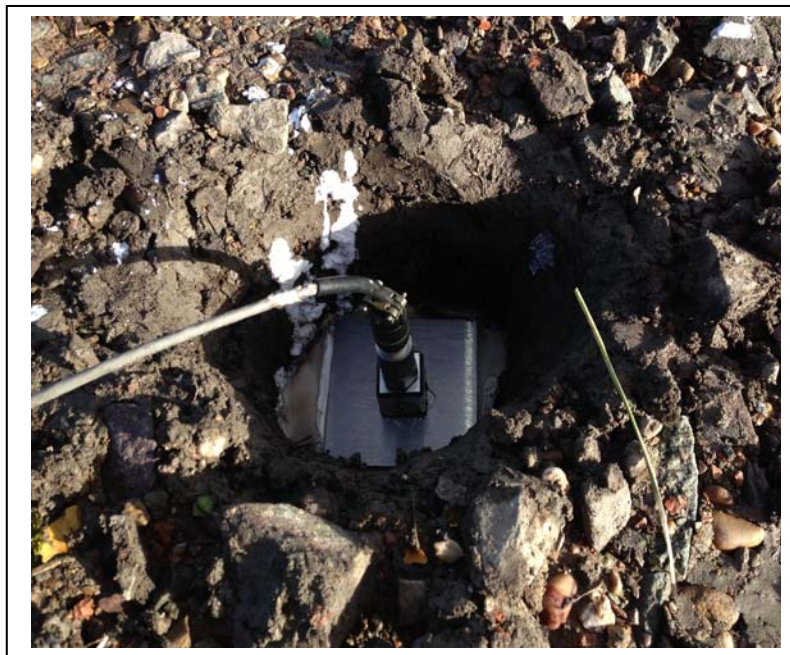
Figure 8. Example Measurement Position Accelerometer Set Up

- 3.9. At the two positions nearest to the track tri-axial accelerometers were used. For the remaining positions, mono-axial accelerometers were used to measure the Z-axis only. The orientation of the accelerometers in relation to the railway track as follows:
- X axis (horizontal) – perpendicular to the tracks
 - Y axis (horizontal) – parallel to the tracks
 - Z axis (vertical) – vertical to the tracks
- 3.10. An example of the measurement position set up can be seen in the Figure 8:

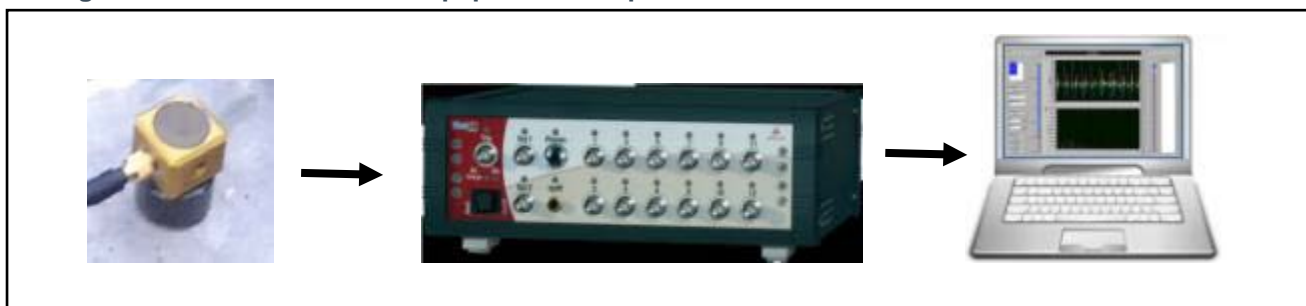
Figure 9. Measurement Equipment Set Up

3.11. Instruments used to undertake ground vibration measurements were provided by Acoustic1 Limited, Gracey & Associates and Campbell Associates. The general set up was a combination of tri-axial and mono-axial accelerometer connected to NetdB, a multi-channel acquisition unit, which communicated real-time with the dBFA software suite. The software (dBTrig) recorded the signals and gave the opportunity for real-time analysis and checks on-site. This set up is demonstrated in Figure 9 below.

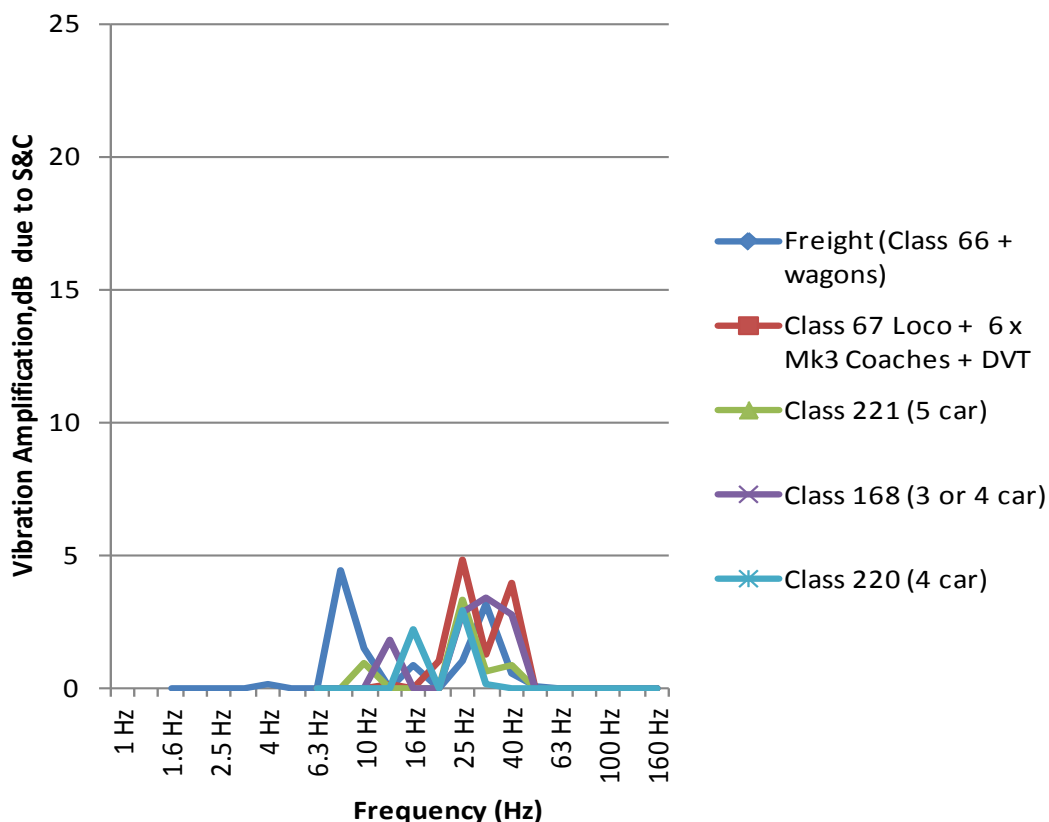
Figure 14. Average vibration amplification at 13.7m from track 2 for different types of trains

- 4.26. At 13.7m from the track 2, amplifications were observed at 25Hz to 40Hz. A peak was additionally observed at 8Hz for the freight trains. However the magnitude of the peaks was significantly lower (less than 5dB) compared with amplifications near track 1.

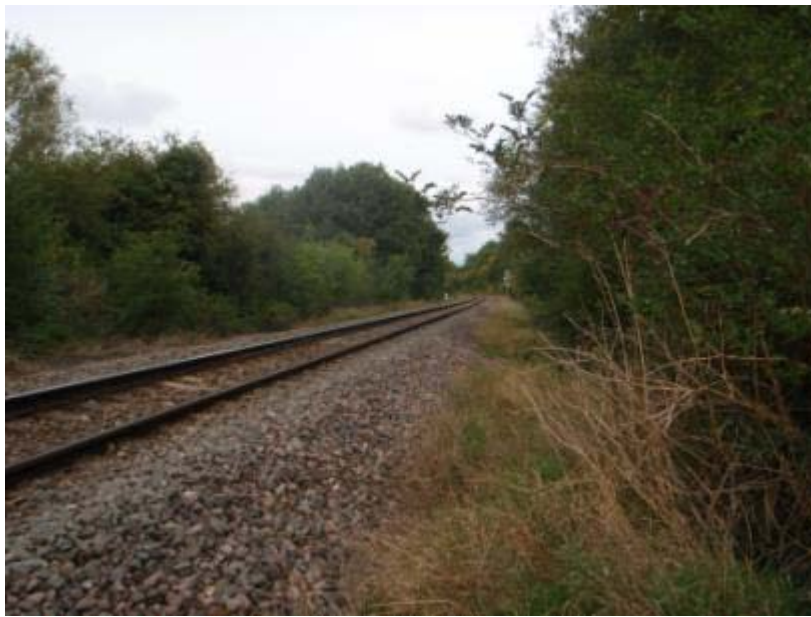
At this location, the track is situated on a straight alignment. The horizontal alignment looks satisfactory for the line speed. The vertical alignment at the vibration location is of a satisfactory condition, however at the Islip side of U/B OXD 50, between 29m 30ch and 32chain (the bridge end), there is a long vertical “slack”, see Photograph 2. This is 85m from the vibration monitoring site, however under visual inspection during dynamic loading, no excessive forces were heard or felt over this location.

Photograph 1: OXD Line looking towards Islip (Up direction)

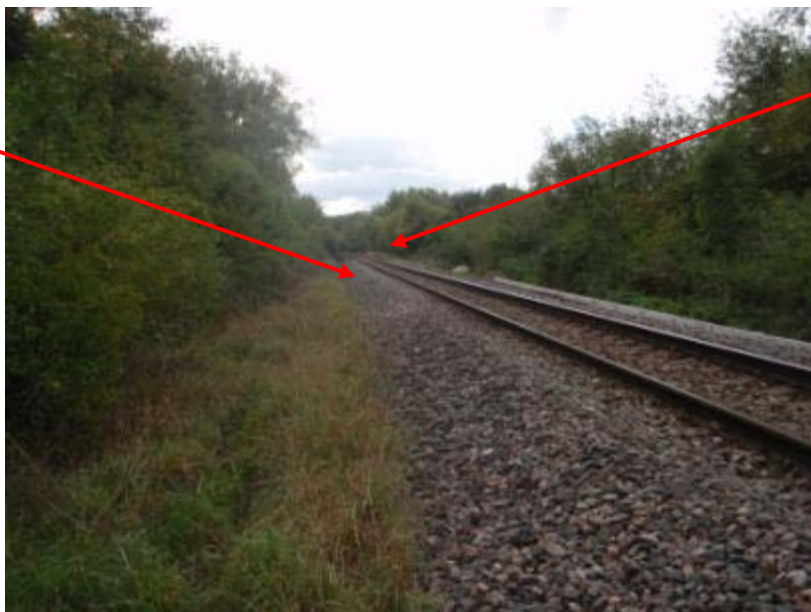
Long “slack” at
U/B OXD 50
bridge end

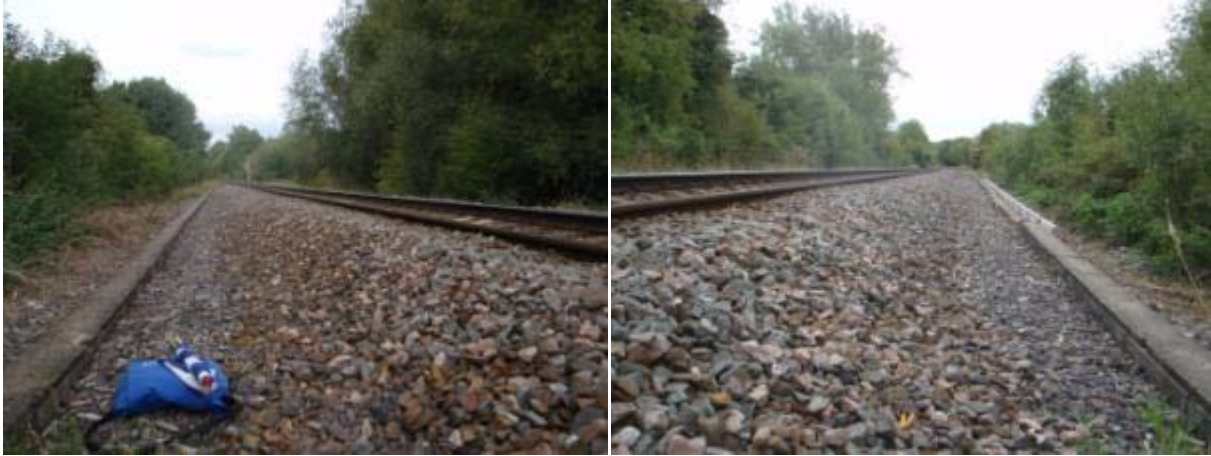
The ballast seems clean, well graded, and free of fines. The cess on both sides is lower than the formation (see photographs 4-7), and as a consequence the ballast shoulder is suitable to resist thermal forces. There is no evidence of any “wet spots” and the track was witnessed under dynamic loading (freight train) and there were no excessive vertical movements.

Photograph 4 and 5: Up Cess (right hand side facing Oxford) looking towards Islip (left) and Oxford (right) ballast shoulder and cess

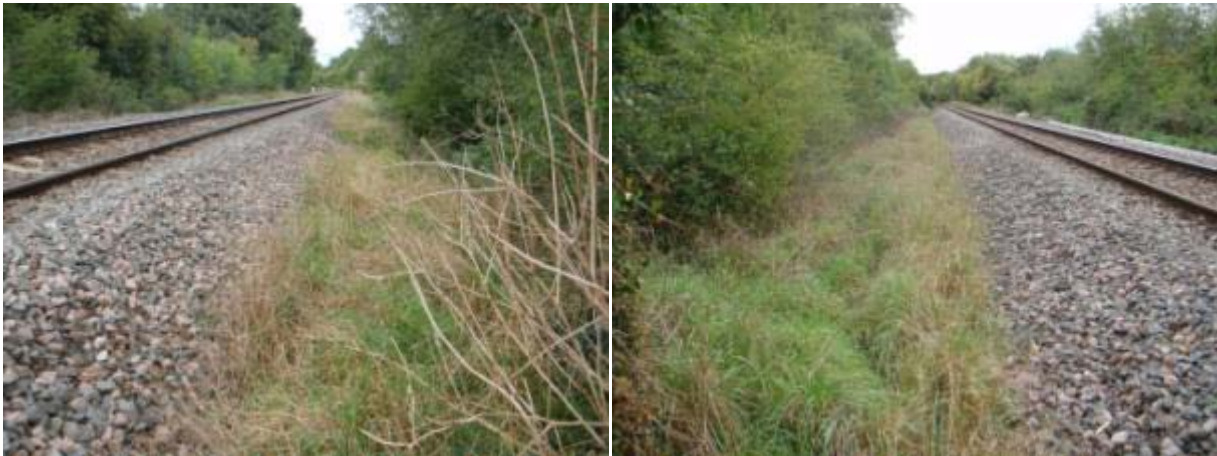
Photograph 6 and 7: Down Cess (left hand side facing Oxford) looking towards Islip (left) and Oxford (right) ballast shoulder and cess

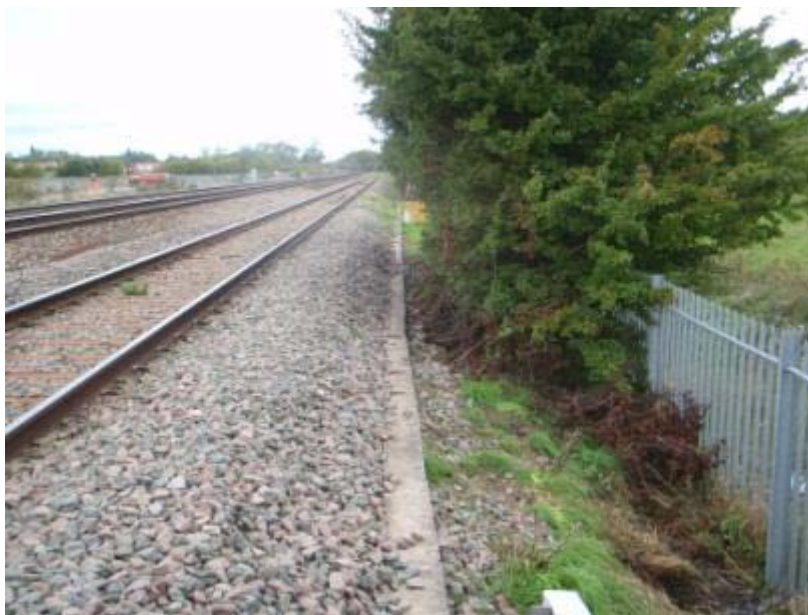
Photograph 8: DCL Line looking towards Aynho Junction

At this location, the track is situated on a straight alignment with the alignment going into a transition and right hand curve travelling in the up direction towards Oxford. The horizontal alignment looks satisfactory for the line speed. The vertical alignment at the vibration location is of a good condition. All the lines were witnessed under dynamic loading of freight and passenger trains, and all demonstrated good characteristics with no excessive movement under load.

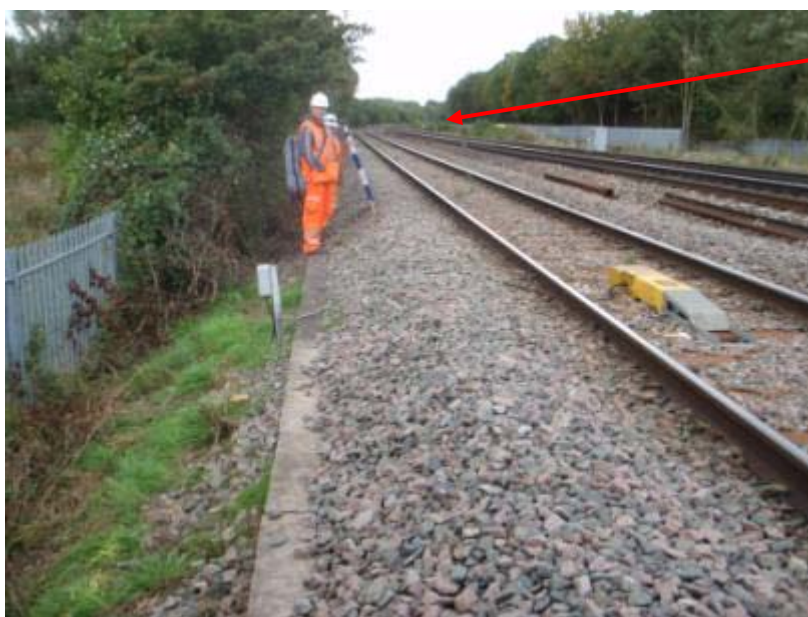
Photograph 9: DCL Line Looking towards Oxford

Right hand
curve

| Line | Rail | Sleepers | Fastenings | Welds/Joints | Comments |
|---|--|---|---|--|---|
| Up Passenger Loop | 113A Colivilles 1965 Running pattern, is approximately 50mm and is from the middle to the outside edge of the rail head | Steel | Pandrol fastclips | Thermit welds within 3m of monitoring site to the north and flashbutt welds within 8m to the south | AWS in the 4' within 4m of the monitoring site. (photograph 9) |

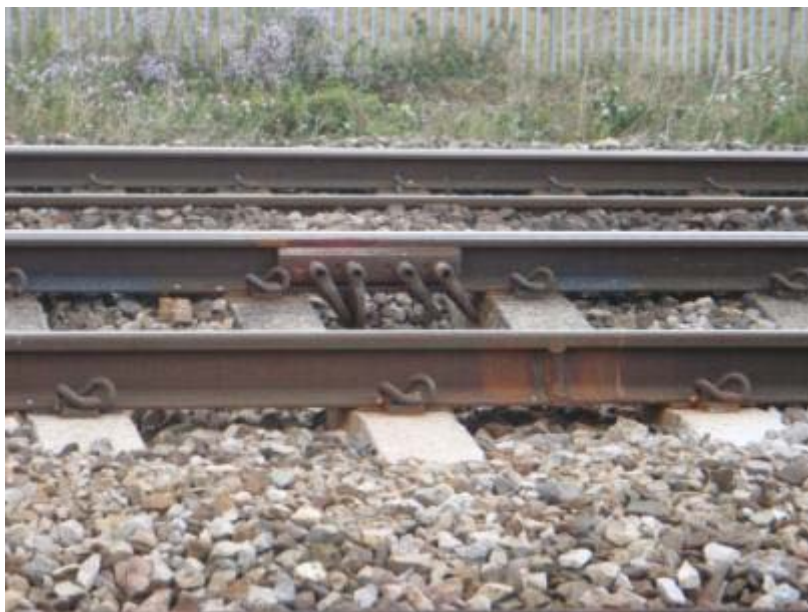
It was noted that on the Up Main, a thermit weld has been emergency clamped and that there was an L80 wide gap weld installed. There was no evidence of these causing any issues at present and under dynamic loading no excessive track movement or "banging" was noted.

Photograph 10: DCL Line Up Main 6' rail 65m 515yards. Thermit Weld Emergency clamped

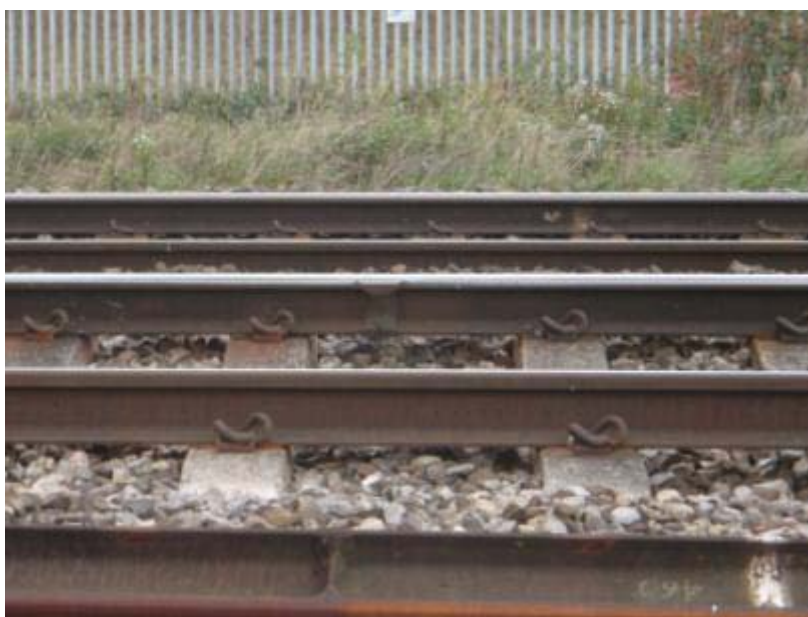
Photograph 11: DCL Line Up Main 6' rail 65m 501yards. L80 wide gap weld

| Line | Rail | Sleepers | Fastenings | Welds/Joints | Comments |
|---|--|---|---|--|---|
| Up Main | 113A The rail head shows evidence of recent rail grinding. The running pattern is approximately 40mm wide in the centre of the rail head. | Concrete F27 | Pandrol 401 | Thermit welds within 4m to the north. The 6' rail was emergency clamped. (photograph 10) Thermit welds within 8m to the south of the monitoring site. The 6' rail was an "L80" wide gap weld. (photograph 11) | Scrap rail situated in the 10' between the Up Main and Up Passenger Loop. Photograph 9. |

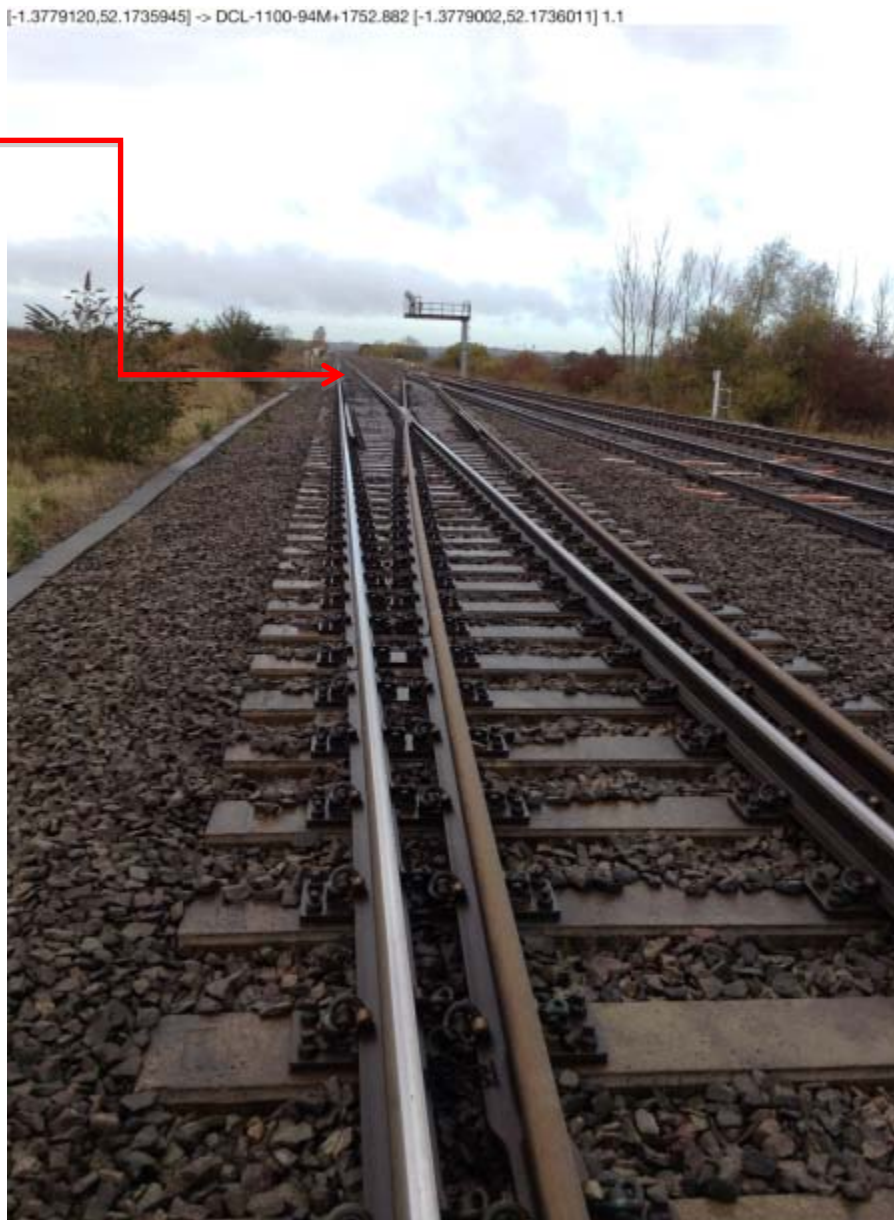
Photograph 12: DCL Line at 94m 79chain Looking towards Leamington Spa (direction of travel)

At this location, the track is situated on a straight alignment with the alignment straight alignment, transitioning into a left hand curve travelling in the Up direction towards Oxford. The horizontal alignment looks satisfactory for the line speed, however on the Down Main, a “long alignment” defect was noted. This is satisfactory for the line speed, however correction is recommended, and it is not likely to impact upon the vibration monitoring at this location. The vertical alignment at the vibration locations is in good condition. The Up and Down Main lines were witnessed under dynamic loading of freight and passenger trains, and all demonstrated good characteristics with no excessive movement under load.

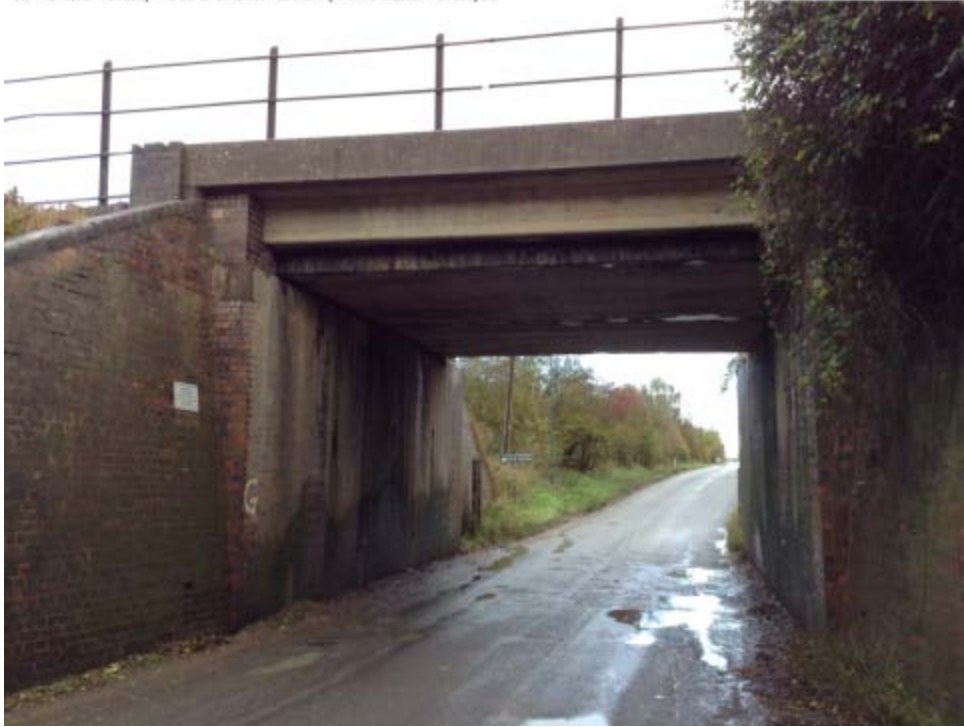
Photograph 15: Under Bridge 99, DCL 94m 77ch Western (Down cess) Elevation

Under bridge 99, is a precast concrete beam bridge on brick abutments and concrete cill beams. The bridge and abutments seemed to be in reasonable condition, and no major defects were noted as part of the inspection. The eastern elevation can be seen in photograph 15.
