Cotefield Farm, Bodicote OX15 4AQ

DESK TOP STUDY AND SITE INVESTIGATION REPORT

Prepared for: **BANNER HOMES**

Report Reference: BC008 RE001 Rev A

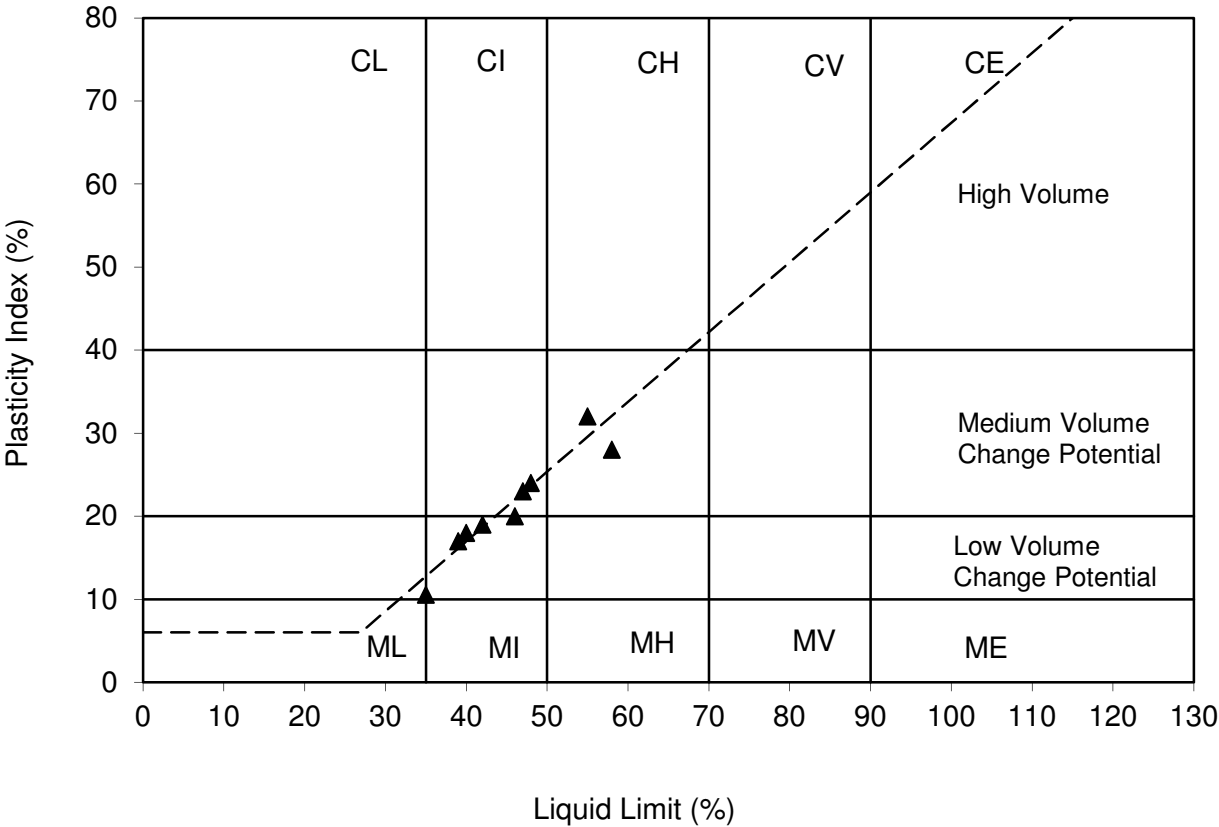
Figure 3

▲ Weathered Marlstone Rock Bed □ - - - A Line

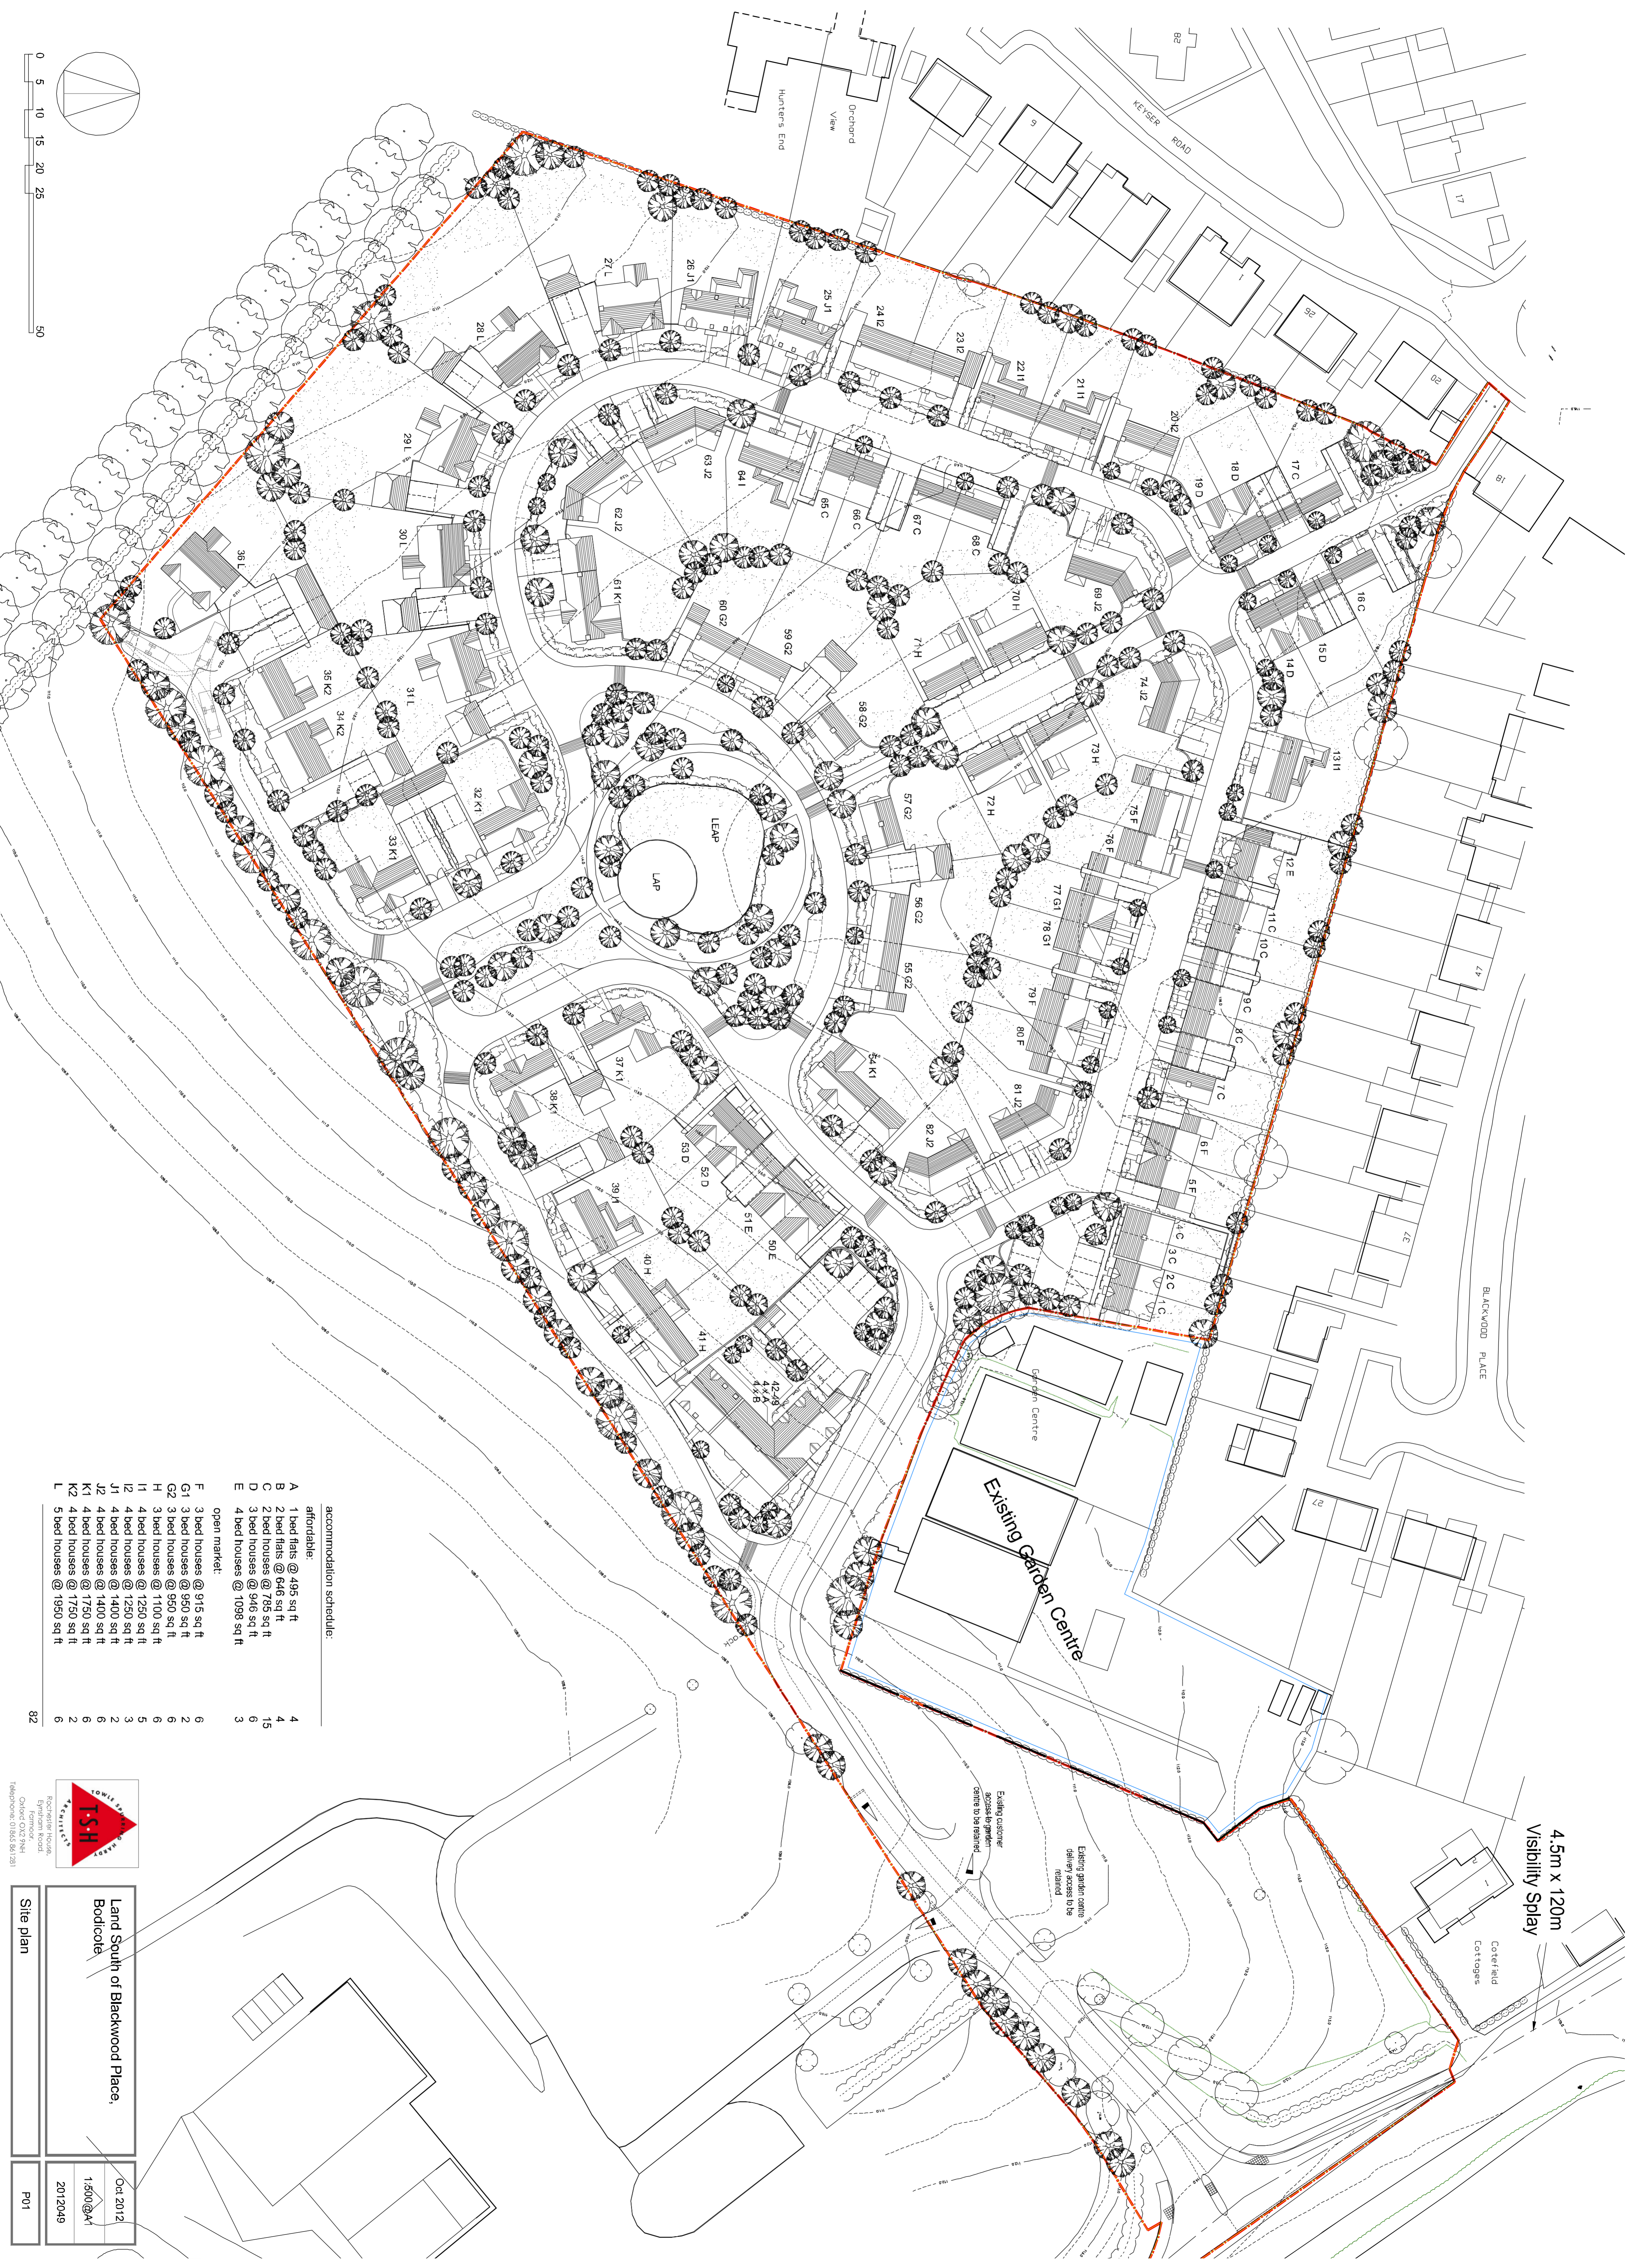
Date	Drawing No.	Scale
29/01/2013	121601-001	1:500
Drawn By	Checked by	Sheet Size
TH	JT	A3

- accommodation schedule:
- A 1 bed flats @ 495 sq ft
 - B 2 bed flats @ 646 sq ft
 - C 2 bed houses @ 785 sq ft
 - D 3 bed houses @ 946 sq ft
 - E 4 bed houses @ 1098 sq ft
- open market:
- F 3 bed houses @ 915 sq ft
 - G1 3 bed houses @ 950 sq ft
 - G2 3 bed houses @ 950 sq ft
 - H 3 bed houses @ 1100 sq ft
 - I 4 bed houses @ 1250 sq ft
 - J1 4 bed houses @ 1400 sq ft
 - J2 4 bed houses @ 1400 sq ft
 - K1 4 bed houses @ 1750 sq ft
 - K2 4 bed houses @ 1750 sq ft
 - L 5 bed houses @ 1950 sq ft

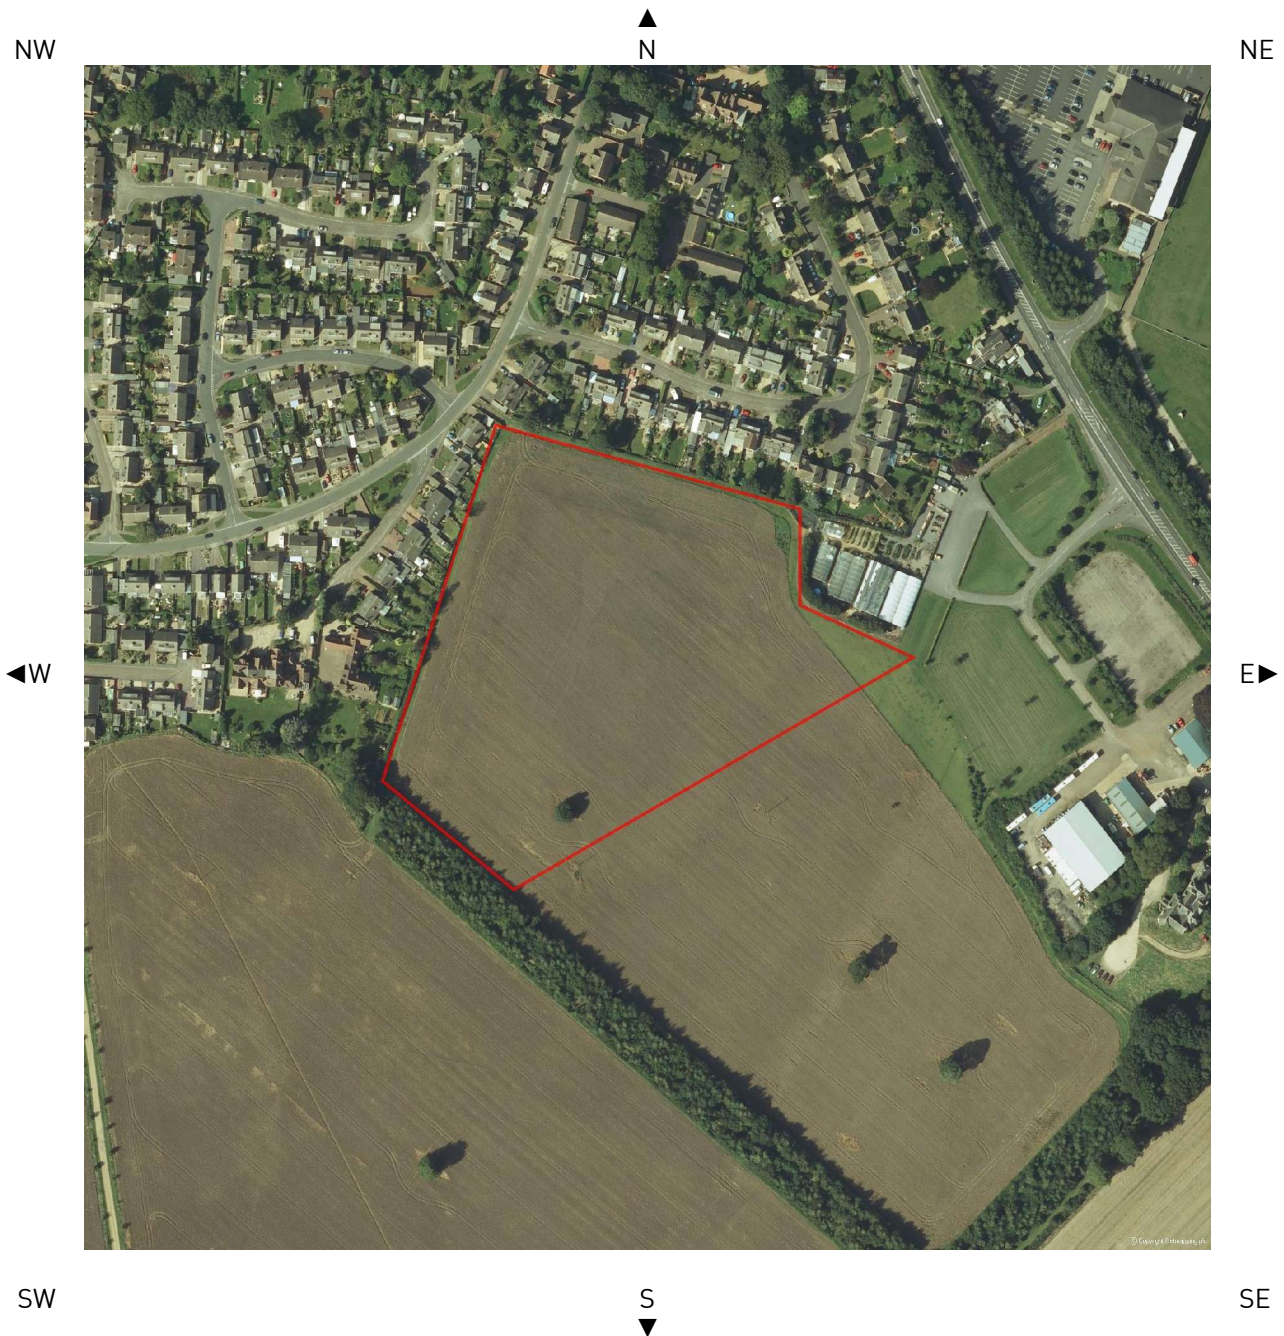
Aerial Photograph of Study Site

Site Name: COTEFIELD FARM, OXFORD ROAD, BODICOTE,
BANBURY, OX15 4AQ
Grid Reference: 446575,237487
Size of Site: 3.28 ha

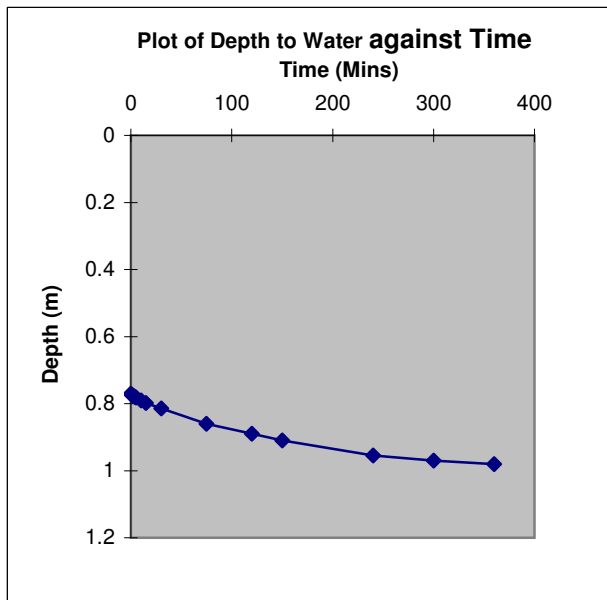
Trial Pit No: TP119
 Date: 07/12/2012

Remarks: Soakage rate insufficient to allow infiltration rate to be calculated

Soakaway Test	Project Oxford Road, Bodicote	Contract 12160J
		Figure A1
The Brownfield Consultancy

Three trial pits, denoted TP119, TP120 and TP121 were excavated in order to undertake soakaway tests. The soakaway test in TP119 undertaken in clay, failed to achieve a 75% reduction in head, a requirement under BRE 365.
