Review of the existing fence between the
settlement area and the flying field:
Heyford Park, Upper Heyford

Client: Dorchester Group
Date: August 2015

Code: D.0340

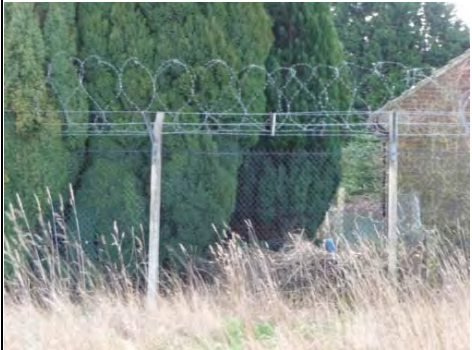
A	Coated galvanised chain link with concrete supports approx. 3m apart, 2.25m high topped with a 45° overhang of barbed wire to both sides. Some sections of fence also have rolled barbed wire on top of the overhang. A single strip of barbed wire runs along the fence at ground level.	<ul style="list-style-type: none"> • Chain link is strong and generally in good condition. • A small hole within the chain link was evident and big enough for a cat to fit through. • It appears that the chain link is buried into the ground although depth is unclear. • There are several saplings along this section of fence outside of the site boundary, some with branches growing through the fence onto site. • There is a lot of mature wooded vegetation within rear gardens of existing bungalows with branches overhanging the fence which could be by cats to climb over. • Wide gaps in between the barbed wire on the overhang provide access for cats. • Some uprights are showing signs of subsidence and appear to lean towards the airfield. • Overall in good condition. 	<p>Repair and enhance:</p> <ul style="list-style-type: none"> • Repair holes in chain link. • Cover gaps between barbed wire on the existing over hang with chain link. • Retrofit cat proof barrier to top of upright (at top of chain link) creating a 60° overhang. FENCE OPTION 3, APPENDIX 3.

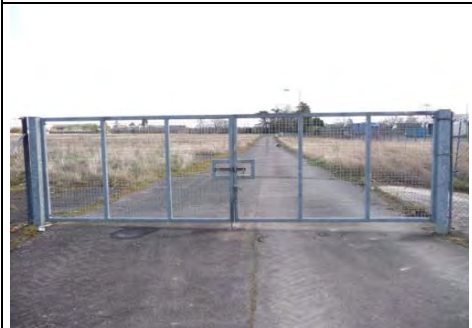
B	Lockable galvanised steel gate with galvanised chain link approx. 2.00m high.	<ul style="list-style-type: none"> • The chain link is in good condition. • There is a gap underneath the gate big enough for a cat/ small dog to fit through. • Cats may also be able to gain access though the handles of the gate and climbing over the top. • No overhang. • Gate above tarmac surface. Burrowing not a problem 	<p>Enhance:</p> <ul style="list-style-type: none"> • Gap at handles to be covered with rubber skirts. • A rubber skirt to be fitted to the bottom of gate. • 60° overhang added to the top of the gate. FENCE OPTION 3, APPENDIX 3.

<ul style="list-style-type: none"> • Overall in good condition.

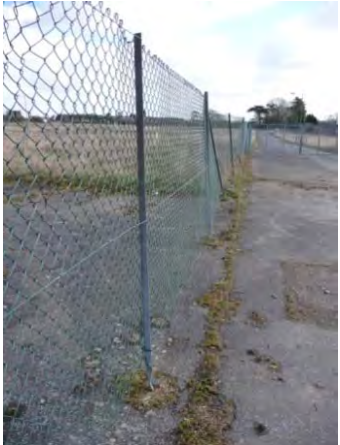
C	<p>Chain link fence with metal supports approx. 1.80m high with no overhang.</p>	<ul style="list-style-type: none"> • The chain link and uprights appear weak and in poor condition with sections leaning towards the airfield. • The chain link has been compromised in many places with uprights needing repair. • Cats would be able to climb over this fence. • The chain link is not fixed to the ground which creates opportunities for animals to pass underneath. • Chain link gauge may need strengthening. • Overall in poor condition. 	<p>Replace:</p> <ul style="list-style-type: none"> • Fence in poor condition and doesn't warrant enhancement. Replace with a suitable cat and dog proof fence type. FENCE OPTION 2, APPENDIX 3.

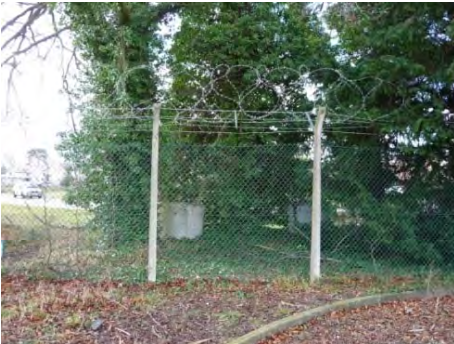
D	<p>Coated galvanised chain link with concrete supports approx. 2.50m apart, 2.50m high topped with a 45° overhang of barbed wire to both sides. The fence also has rolled barbed wire on top of the overhang. A single strip of barbed wire runs along the fence at ground level.</p>	<ul style="list-style-type: none"> • There are many mature trees close to the fence with branches overhanging. • Chain link is strong and in good condition. • Concrete supports in good condition. • Chain link does not appear to extend below ground level. • Gap between the top of the chain link and the barbed wire overhang allows access to cats. • Overall in good condition. 	<p>Enhance:</p> <ul style="list-style-type: none"> • Retrofit cat proof barrier to top of upright (at top of chain link) creating a 60° overhang. FENCE OPTION 3, APPENDIX 3. • Where trees are being retained it is advised that any branches over hanging the fence on the development side should be cut back to reduce the risk of the trees being used as a bridge. This is subject to Cherwell district council approval.

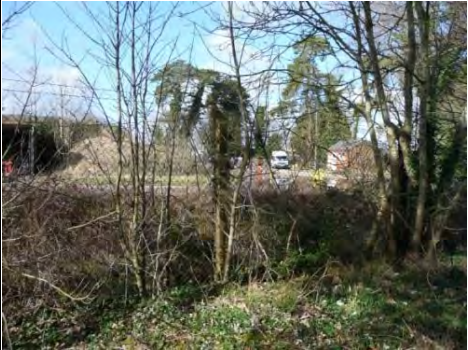
E	<p>Chain link approx. 2.50m high with concrete supports and a 45° overhang of barbed wire facing the airfield.</p>	<ul style="list-style-type: none"> • The overhang faces the opposite way towards the airfield. • Many trees growing along the fence line providing climbing opportunities. • Gate is in a dilapidated condition. 	<p>Enhance:</p> <ul style="list-style-type: none"> • Remove if access is not required and replace the gate with a more suitable cat and dog proof gate with a rubber

<p>There is a lockable steel chain link gate with barbed wire strips to its top.</p>	<ul style="list-style-type: none"> • Gaps underneath the gate and on top between the strips of barbed wire are big enough for a cat to fit through. • Overall the fence is in fair condition with gate in poor condition. 	<p>skirt closing any gaps underneath.</p> <ul style="list-style-type: none"> • Retrofit cat proof barrier to top of upright (at top of chain link) creating a 90° overhang on correct side of fence. FENCE OPTION 3, APPENDIX 3. • Where trees are being retained it is advised that any branches over hanging the fence on the development side should be cut back to reduce the risk of the trees being used as a bridge. This is subject to Cherwell district council approval.

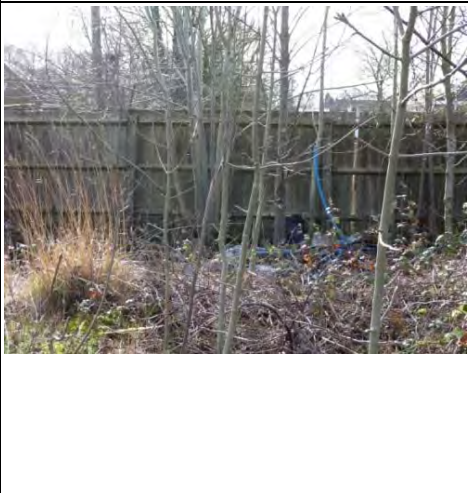
<p>F</p>	<p>Closed board fence approx. 1.80m high with concrete supports topped with a 45° overhang with strips of barbed wire.</p>	<ul style="list-style-type: none"> • Timber closed board fence in poor condition with many gaps and some panels missing. • The overhang faces the opposite way towards the airfield. • Barbed wire on overhang is in poor condition and has been compromised places. • There is a gap underneath fence. • Abundance of tall/overgrown vegetation adjacent to the fence line could provide a route for cats. • Wide gaps in between the barbed wire on the overhang provide access. • Overall in poor condition. 	<p>Replace:</p> <ul style="list-style-type: none"> • Fence in poor condition and doesn't warrant enhancement. Replace with a suitable cat and dog proof fence type. FENCE OPTION 2, APPENDIX 3. • Remove any tall/overgrown vegetation that could be used for climbing over the fence.

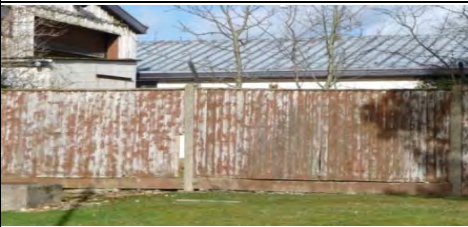
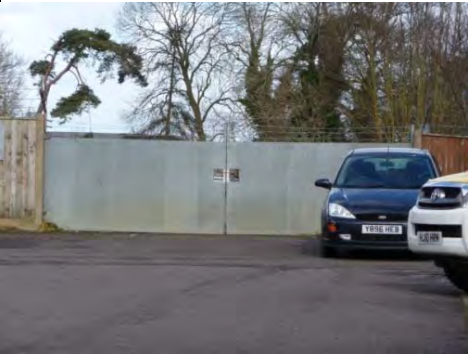
<p>G</p>	<p>Closed board fence approx. 1.8m high with 45° overhang. Concrete supports and concrete blocks along its base.</p>	<ul style="list-style-type: none"> • There are many gaps in the closed board fence and the horizontal concrete strips at ground level are broken in places. • There are several mature trees with overhanging braches within the 	<p>Repair and Enhance:</p> <ul style="list-style-type: none"> • Replace old close board fence with new timber and retrofit cat proof barrier to top of upright (at top of chain link) creating a 60° overhang on

<p>This section of fence also has a lockable galvanized steel gate with barbed wire on top but no overhang.</p>	<p>recommended 4m buffer for objects exceeding the height of the fence.</p> <ul style="list-style-type: none"> • Gate has gaps at handles that could be used for access or as a platform for cats climbing the fence. • Gaps in between the barbed wire strips on top of the gate are wide enough for a cat to fit through. • Overall in poor condition. 	<p>correct side of fence. FENCE OPTION 1, APPENDIX 3.</p> <ul style="list-style-type: none"> • Provide a 60° overhang to the metal gate and use chain link to block any gaps between the existing barbed wire strips. • Gap at handles/lock to be covered with rubber skirts. • Where trees are being retained it is advised that any branches over hanging the fence on the development side should be cut back to reduce the risk of the trees being used as a bridge. This is subject to Cherwell district council approval.

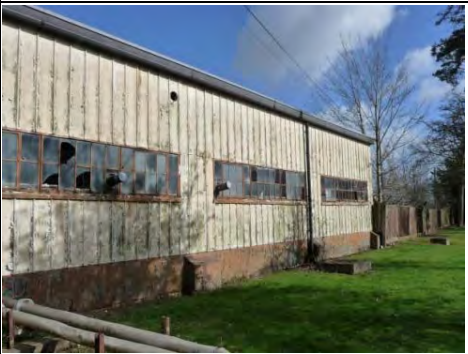
<p>H</p>	<p>Building façade.</p>	<ul style="list-style-type: none"> • Drain pipes on building offer climbing opportunity. • Reinforcement to base of the building provides platforms for jumping from. 	<p>Enhance:</p> <ul style="list-style-type: none"> • Anti-climb collars or pipe guards are required around drainpipes to secure the building façade. • See page 16 'Suggestions for securing the building façade as a pet barrier' for more details.

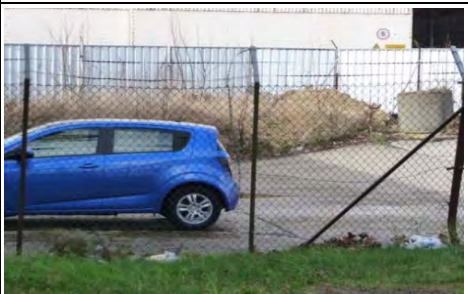
<p>I</p>	<p>Chain link with metal supports approx. 1.8m high with 45° overhang of razor wire strips.</p>	<ul style="list-style-type: none"> • Old chain link in disrepair. • Some of the strips of razor wire have become loose and are hanging from the fence. • The overhang is on the wrong side facing the airfield. • Chain link does not extend below ground level. 	<p>Replace:</p> <ul style="list-style-type: none"> • Fence in poor condition and doesn't warrant enhancement. Replace with a suitable cat and dog proof fence type. FENCE OPTION 2, APPENDIX 3.

<ul style="list-style-type: none"> • Gaps between the razor wire would allow access for cats. • Overall in poor condition.

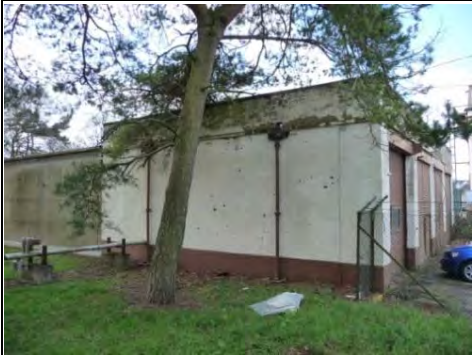
<p>J</p>	<p>Building facade.</p>	<ul style="list-style-type: none"> • Drainage pipes offer climbing opportunities. • Mature tree with branches over hanging the roof of the building providing access to cats. 	<p>Enhance:</p> <ul style="list-style-type: none"> • Anti-climb collars or pipe guards are required around drainpipes to secure the building façade. • See page 16 'Suggestions for securing the building façade as a pet barrier' for more details. • Where trees are being retained it is advised that any branches over hanging the fence on the development side should be cut back to reduce the risk of the trees being used as a bridge. This is subject to Cherwell district council approval.

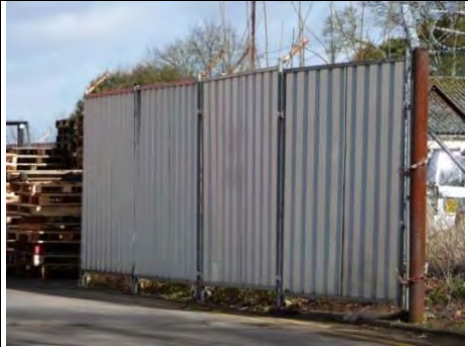
<p>K</p>	<p>Metal panelled fence in some areas with a 45° overhang of barbed wire strips.</p> <p>Other fence type include chain link approx. 1.8m high with metal supports and rolled razor wire on 45° overhang.</p>	<ul style="list-style-type: none"> • Metal panelled fence has wide gaps underneath providing access for cats. • Barbed wire strips are broken in part. • Chain link does not extend below ground level but in good condition. • Overhang is on the wrong side of the fence facing the airfield. • Wide gaps in between the barbed wire on the overhang provide access. • Wide gaps between changes in fence types provide access. • Adjacent objects to fence provide route for cats. 	<p>Replace:</p> <ul style="list-style-type: none"> • Fence in poor condition and does not warrant enhancement. Replace with a suitable cat and dog proof fence type. FENCE OPTION 2, APPENDIX 3.

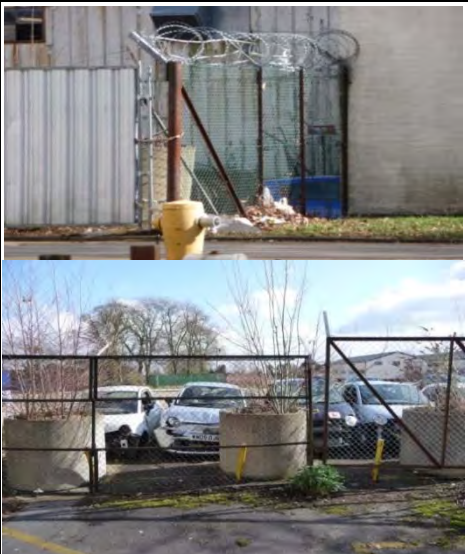
<p>L</p>	<p>Chain link fence with concrete supports approx. 1.8m high with 45° overhang of either barbed wire strips or razor wire strips.</p> <p>This section also includes a metal mesh gate with 45° overhang with barbed wire strips.</p> <p>This section also includes building facade which was not able to be assessed.</p>	<ul style="list-style-type: none"> • This fence is in very poor condition. • Chain link in disrepair. • Chain link does not extend below ground. • Gate is old and has large gaps underneath and in between large enough for cats and dogs to get through. Also in disrepair. • The overhang is facing the wrong way. • Wide gaps in between the barbed wire on the overhang provide access. 	<p>Replace:</p> <ul style="list-style-type: none"> • Fence in poor condition and does not warrant enhancement. Replace with a suitable cat and dog proof fence type. FENCE OPTION 2, APPENDIX 3. <p>Enhance:</p> <ul style="list-style-type: none"> • See page 16 'Suggestions for securing the building façade as a pet barrier' for more details.

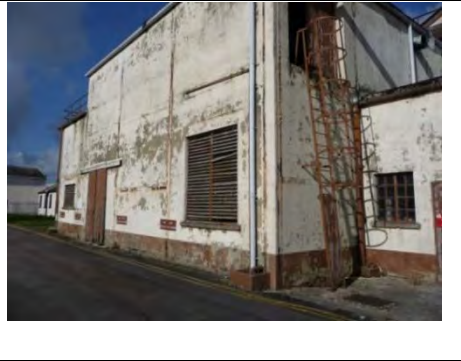
M	Building façade	<ul style="list-style-type: none"> • Numerous ways to climb this building including drain pipes and ladders. • Cats can access internal areas of the building. • Inadequate. 	<p>Enhance:</p> <ul style="list-style-type: none"> • Anti-climb collars or pipe guards are required around drainpipes to secure the building façade. • Ladder should be removed to prevent access. • See page 16 'Suggestions for securing the building façade as a pet barrier' for more details.

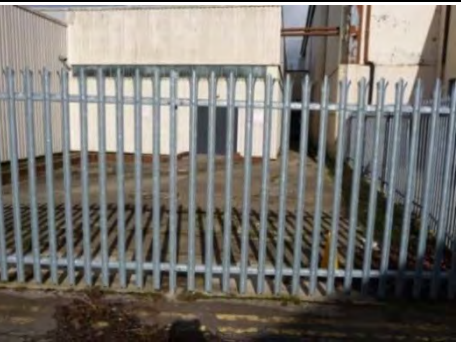
N	Galvanised steel security palisade fence approx. 2.00m high.	<ul style="list-style-type: none"> • Fence is in good condition although it does nothing to prevent access for cats. • Gaps in between bars and under the fence are big enough for a cat to fit through. • Hard surface beneath fence. 	<p>Enhance:</p> <ul style="list-style-type: none"> • Affix new chain link to fence blocking gaps between bars. • Retrofit cat proof barrier to top of upright creating a 60° overhang. FENCE OPTION 2, APPENDIX 3. • This will need to be confirmed with the fence manufacturer in terms of its load bearing capacity etc.

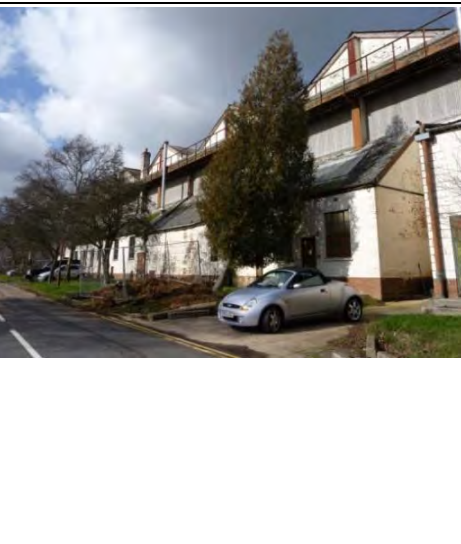
O	Building facade.	<ul style="list-style-type: none"> • Lots of climbing opportunities including drain pipes and ladders. • Several mature trees with branches over hanging rooftops makes this building very accessible to cats. 	<p>Enhance:</p> <ul style="list-style-type: none"> • Anti-climb collars or pipe guards are required around drainpipes to secure the building façade. • Roller barriers are required on low rooftops to prevent use as platforms to otherwise out of reach areas. • See page 16 'Suggestions for securing the building façade as a pet barrier' for more details. • Where trees are being retained it is advised that any branches over hanging the fence on the

<p>development side should be cut back to reduce the risk of the trees being used as a bridge. This is subject to Cherwell district council approval.</p>

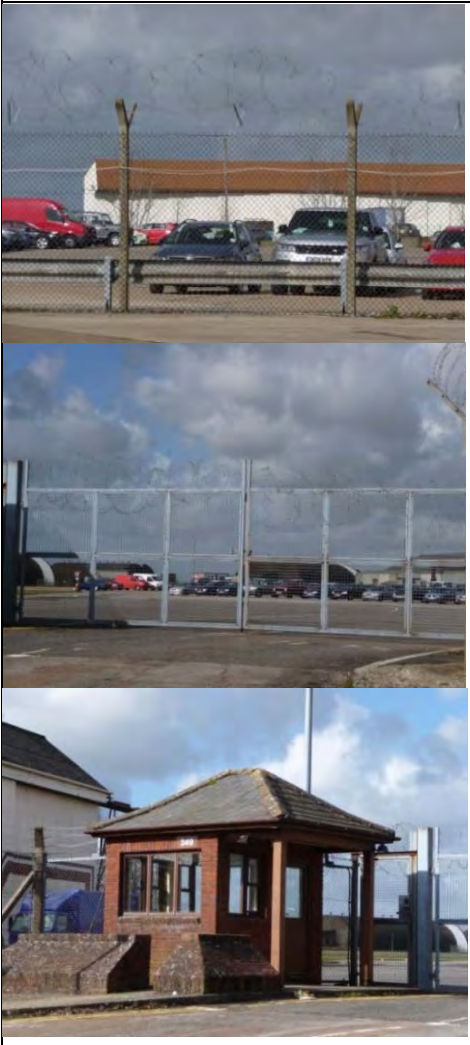
<p>P</p>	<p>Various fence types along this section including:</p> <ul style="list-style-type: none"> • Chain link with concrete supports approx. 2.50m high topped with rolled barbed wire on a 45° overhang. • Gates approx. 2.2m high topped with metal mesh and rolled barbed wire on top. • Gatehouse building also forms part of the airfield boundary. 	<ul style="list-style-type: none"> • The gates have no overhang and the rolled barbed wire has gaps large enough for a cat to fit through. • There is also a wide gap underneath gate. • Brick building provides several climbing opportunities for cats. • Chain link fence is in good condition however cats could easily get through the gaps between the barbed wire on the overhang. • Hard surface beneath fence in parts. 	<p>Enhance:</p> <ul style="list-style-type: none"> • Along the section of 2.50m high chain link fencing retrofit cat proof barrier to top of uprights (at top of chain link) creating a 60° overhang. FENCE OPTION 3, APPENDIX 3. • To top of gate retrofit cat proof barrier to top of uprights (at top of chain link) creating a 60° overhang. FENCE OPTION 3, APPENDIX 3. • Roller barriers required to roof of building on site side. Cats could use lower platforms to gain access to roof top and cross the fence line. • See page 16 'Suggestions for securing the building façade as a pet barrier' for more details.

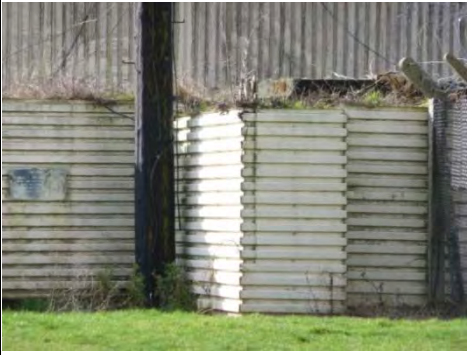
<p>Q</p>	<p>Metal construction blast wall structure, approx. 2.25m high and no overhang.</p>	<ul style="list-style-type: none"> • Fence providing no barrier for cats. • Telegraph pole could be used to climb over the structure. 	<p>Replace:</p> <ul style="list-style-type: none"> • Blast wall to be removed subject to separate planning application. Wall to be replaced with new chain link fence with pet barrier to top. FENCE OPTION 2, APPENDIX 3. • Replace any other fences in section with new chain link fence with pet barrier to top. FENCE OPTION 2, APPENDIX 3.

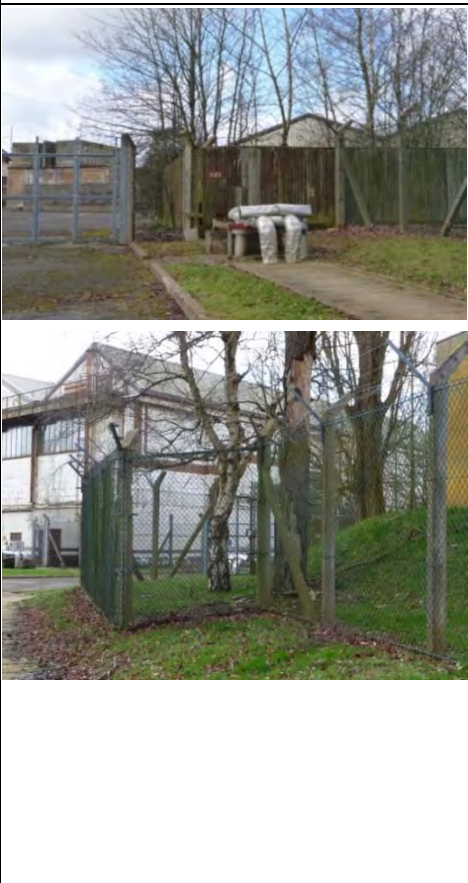
<p>R</p>	<p>Several types of fence including:</p> <ul style="list-style-type: none"> • Coated galvanised chain link with concrete supports approx. 2.50m high topped with a 45° overhang with either barbed wire strips or rolled barbed wire. • There are several metal gates topped with mesh and either strips or rolls of barbed wire but no overhang. • There is a small section of closed board fencing with topped with a 45° overhang with strips of barbed wire. 	<ul style="list-style-type: none"> • There are concrete block underneath the fence and gates which would deter animals from burrowing. • Gates have quite wide gaps beneath them and gaps at handles that a cat could fit through. • Gaps in the rolled barbed wire would allow access. • Closed board overhang is on the wrong side of the fence facing the airfield and in poor condition. • Concrete blocks beneath fence line would prevent burrowing. 	<p>Repair and Enhance:</p> <ul style="list-style-type: none"> • Replace old closed board fence with new timber and retrofit cat proof barrier to top of fence creating a 90° overhang. FENCE OPTION 1, APPENDIX 3. • Retrofit cat proof barrier to top of upright of the chain link fence to create a 90° overhang. FENCE OPTION 3, APPENDIX 3. • To top of gate retrofit cat proof barrier to top of uprights (at top of chain link) creating a 90° overhang. FENCE OPTION 3, APPENDIX 3. • Provide a rubber skirt to the base and handles/lock of the gate to block access. • Where trees are being retained it is advised that any branches over hanging the fence on the development side should be cut back to reduce the risk of the trees being used as a bridge. This is subject to

<p>Cherwell district council approval.</p>

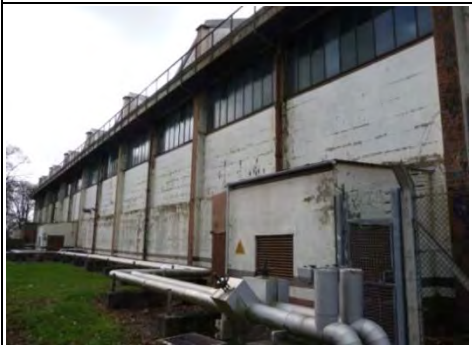
<p>S</p>	<p>Building facade</p>	<ul style="list-style-type: none"> • Many climbing opportunities including drain pipes and other platforms to jump from. • Would not prevent cats from climbing over. 	<p>Enhance:</p> <ul style="list-style-type: none"> • Anti-climb collars or pipe guards are required around drainpipes to secure the building façade. • Roller barriers are required on low rooftops to prevent use as platforms to otherwise out of reach areas. • See page 16 'Suggestions for securing the building façade as a pet barrier' for more details.

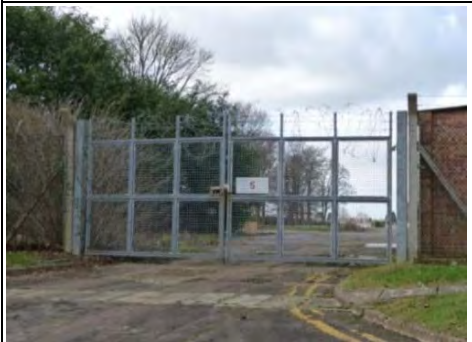
<p>T</p>	<p>Galvanised chain link fence approx. 2.50m high with concrete supports topped with a 45° overhang with strips of barbed wire. There is also a single line of barbed wire at ground level.</p> <p>Galvanised steel gate topped with mesh and rolled barbed wire but no overhang.</p>	<ul style="list-style-type: none"> • There are lots of mature trees on either side of this fence with overhanging branches that would make it easy to climb over. • Chain link doesn't appear to extend below ground level. • Wide gaps in between the barbed wire on the overhang provide access. • There is a wide gap underneath the gate that small dogs and cats could easily fit through. • Low growing hedgerow along camp road section of fence could help provide access for cats. 	<p>Relocate:</p> <ul style="list-style-type: none"> • Fence line should be relocated north of the development between the development site and the flying field. • New chain link fence with pet barrier to top to be erected. <p>FENCE OPTION 2, APPENDIX 3.</p>

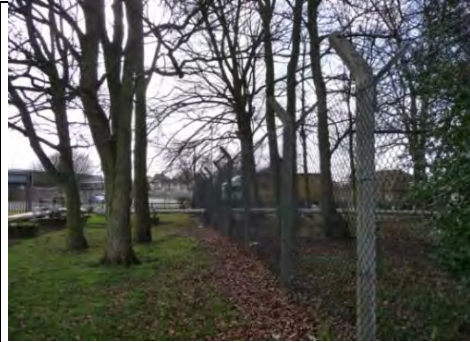
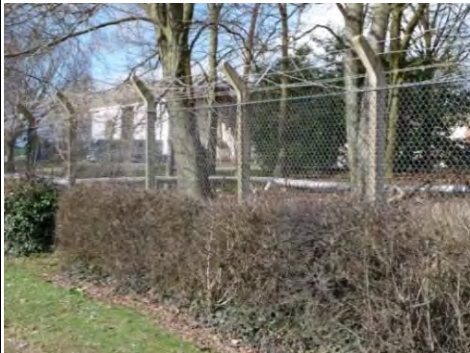
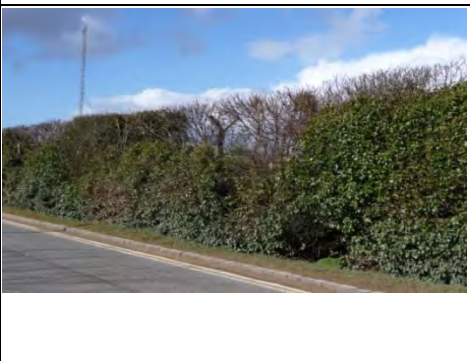
<p>U</p>	<p>Galvanised chain link approx. 2.50m high with concrete supports and topped with a 45° overhang with strips of barbed wire. There is also a line of barbed wire at ground level.</p>	<ul style="list-style-type: none"> • The existing hedgerow fronts the fence line along Camp Road and is approx. 3.00m high. • The existing hedgerow is slightly taller than the fence along this section so could help provide access for cats. • Chain link does not appear to extend below ground level. • Wide gaps in between the barbed wire on the overhang provide access. 	<p>Relocate:</p> <ul style="list-style-type: none"> • Fence line should be relocated north of the development between the development site and the flying field. • New chain link fence with pet barrier to top to be erected. <p>FENCE OPTION 2, APPENDIX 3.</p>

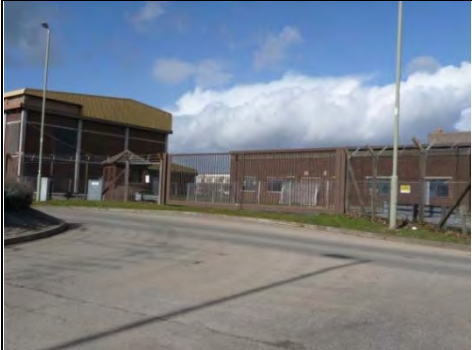
<p>V</p>	<p>Galvanised chain link fence approx. 2.50m high topped with concrete supports and topped with a 45° overhang with strips of barbed wire.</p> <p>There are several large metal gates near the roundabout along this fence line.</p>	<ul style="list-style-type: none"> • No hedgerow against fence at this section. • Concrete underneath gate but there are large gaps providing direct access for cats. • Gates have no overhang. • Wide gaps in between the barbed wire on the overhang provide access. • Gaps in the gates could provide additional access. 	<p>Relocate:</p> <ul style="list-style-type: none"> • Fence line should be relocated north of the development between the development site and the flying field. • New chain link fence with pet barrier to top to be erected. <p>FENCE OPTION 2, APPENDIX 3.</p>

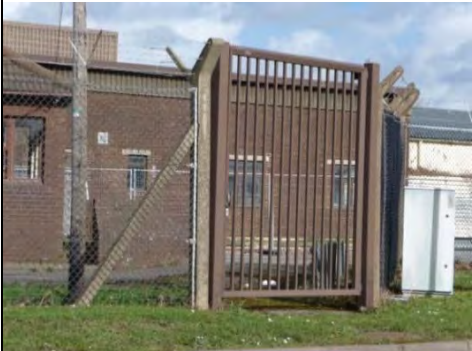
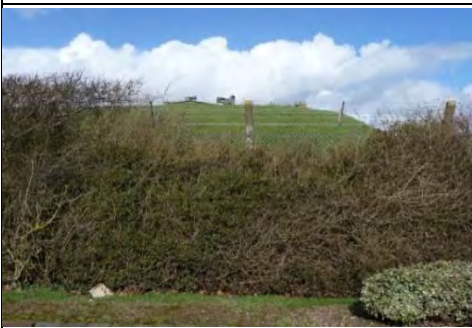
<p>W</p>	<p>Galvanised chain link fence approx. 2.50m high with concrete supports topped with a 45° overhang with strips of barbed wire.</p>	<ul style="list-style-type: none"> • 2.50–3.00m existing hedgerow runs along the front of this section of fence. • The existing hedgerow is slightly taller than the fence along this section so could help provide access for cats. • Wide gap between the top of the chain link and the strips of barbed wire provide access for cats. 	<p>Relocate:</p> <ul style="list-style-type: none"> • Fence line should be relocated north of the development between the development site and the flying field. • New chain link fence with pet barrier to top to be erected. <p>FENCE OPTION 2, APPENDIX 3.</p>

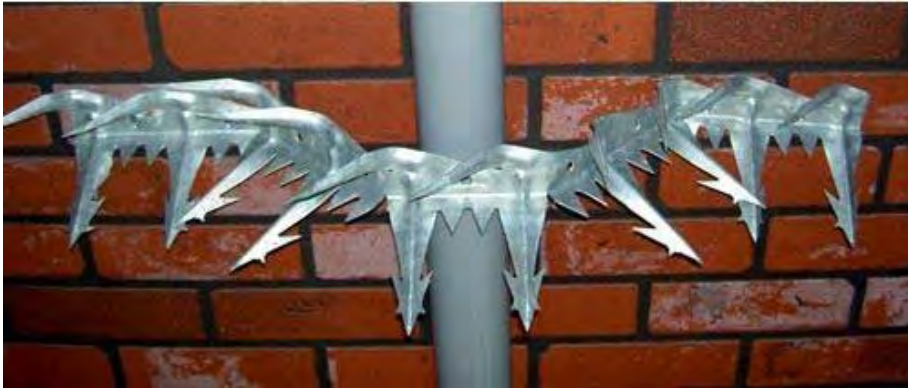
ANTI-CLIMB COLLARS - supplied by Insight Security or similar approved.

Secured to drainpipes and telegraph poles these anti-climb razor spike collars are intended to prevent people from climbing but would also prevent cats from climbing the buildings and gaining access across the fence line.

- it is strongly recommended that anti-climb spikes should wherever possible be installed at a minimum height of 2.2 metres from the ground (a higher minimum height restriction may apply for certain locations or where children may be present).

-It is also strongly recommended (and may be a legal requirement) that wherever Anti Climb Spikes are installed, "Warning Signs " should be displayed.

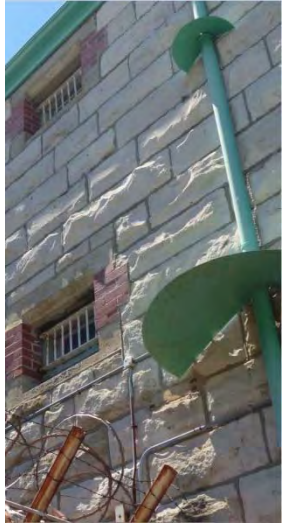
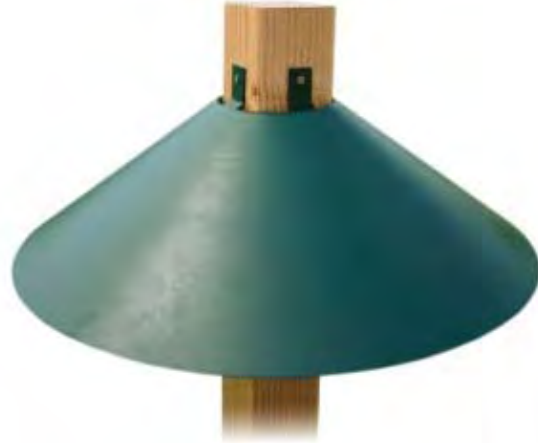
PREDATOR GUARDS – conical guards made from galvanised sheet metal. Information on how they are made can be found at www.sialis.org/conical

Galvanised steel cones fixed to drainpipes and telegraph poles would prevent cats from using them to climb over the buildings. It is recommended that the cones are 300mm in radius to be an effective cat barrier.

This would be a less aggressive option than the spiked anti-climb collars and warning signs would not be required.

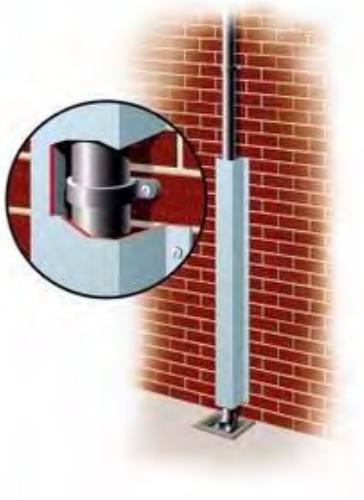
GALVANISED PIPE PROTECTORS – as supplied by JML Hardware or similar approved.

Pipe protectors are supplied in galvanised steel in 2.4 metre lengths with fixing holes at 300mm centres. Variations of profiles and lengths can be made on request.

The smooth surface would prevent cats from climbing the drain pipes to gain access over buildings. The pipe protector would need to be at least 2.4m in length to ensure it does not provide a ledge to aid cats jumping to the top of buildings.

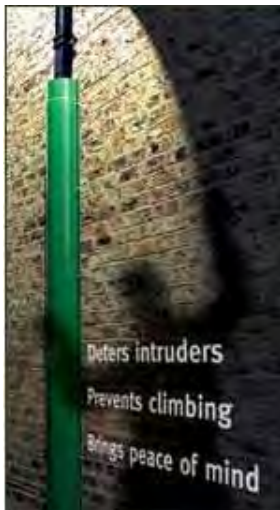
PLASTIC PIPE GUARDS – Yeoman anti-climb system as supplied by Yeoman Rainguard Rainwater Systems or similar approved

A similar system to the galvanised pipe protectors above but manufactured from glass reinforced plastic available in any colour. No maintenance painting required as the colour runs through the material. The guard encases the drain pipe with a smooth surface preventing cats from using the pipes to climb over the building. Intended to prevent people from climbing but would be an effective cat barrier.

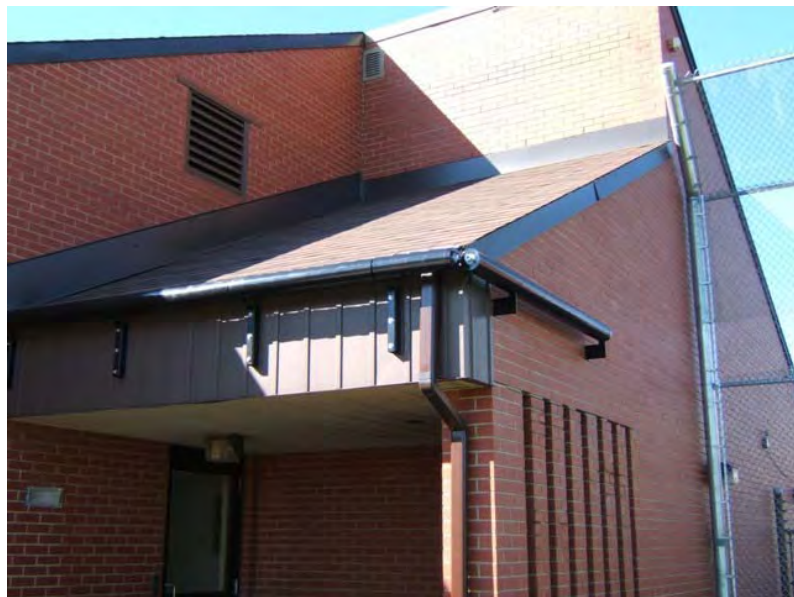
ROLLER BARRIERS - supplied by Insight Security or similar approved.

Secured to low building rooftops where there are other objects that are less than or equal to the height as the roof within a 3m radius. These objects could be used as platforms to jump onto the rooftop. Rotating barriers would prevent cats from accessing the rooftop as they would have no grip to climb over the edge. The system is intended to prevent people from climbing buildings but similar systems are available specifically for cats overseas that have proved an effective cat barrier.

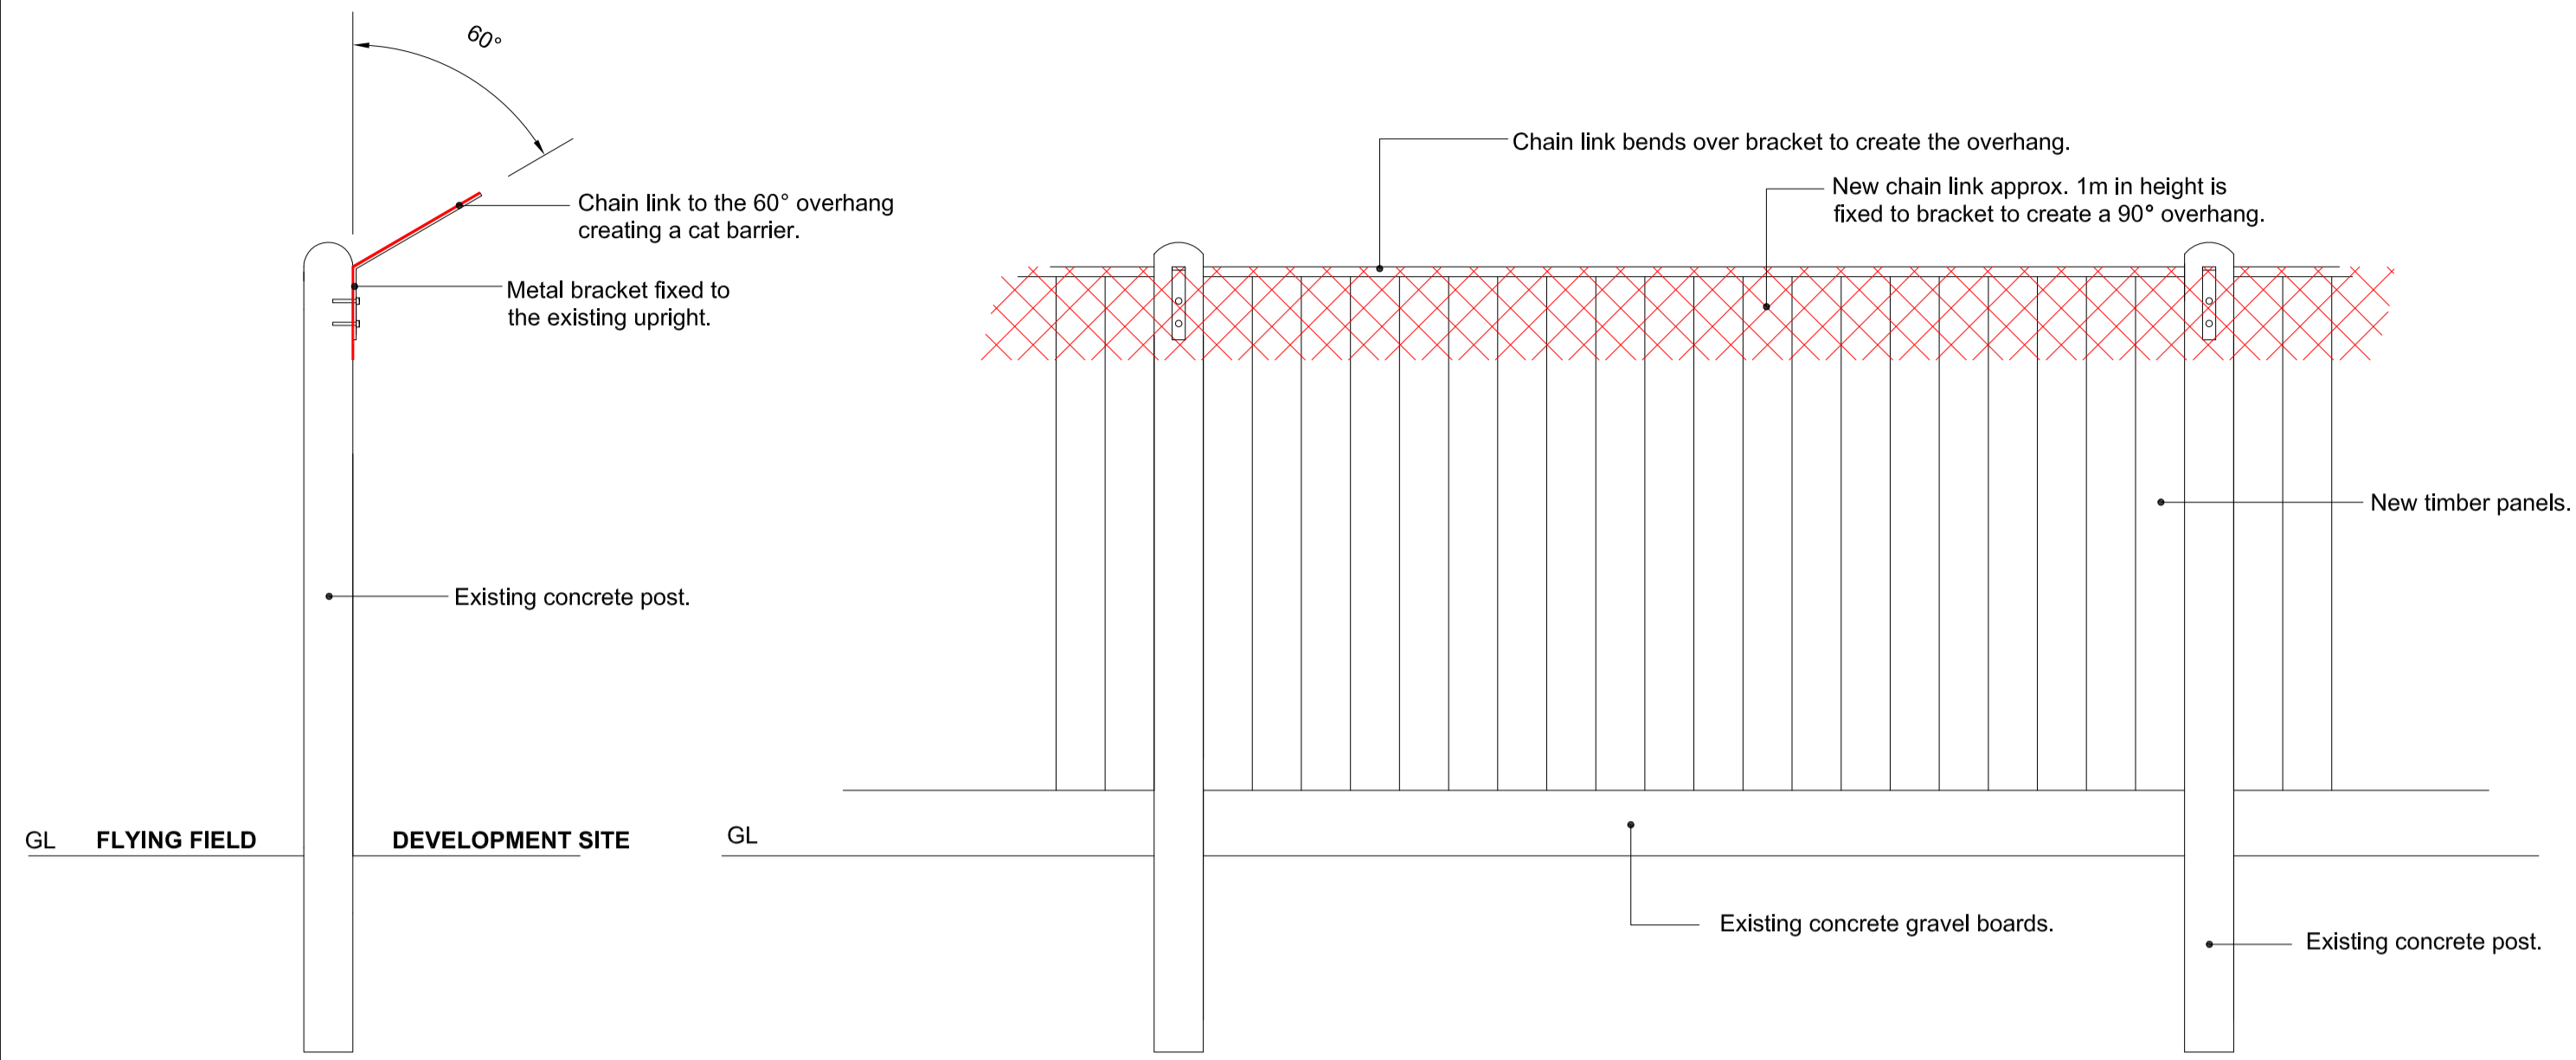
1. EXISTING CLOSEBOARD FENCE WITH CONCRETE UPRIGHTS
 Replace timber panels and retrofit cat barrier to top of fence by fixing metal bracket to the existing upright. Chain link is secured to the bracket creating a 60° overhang.

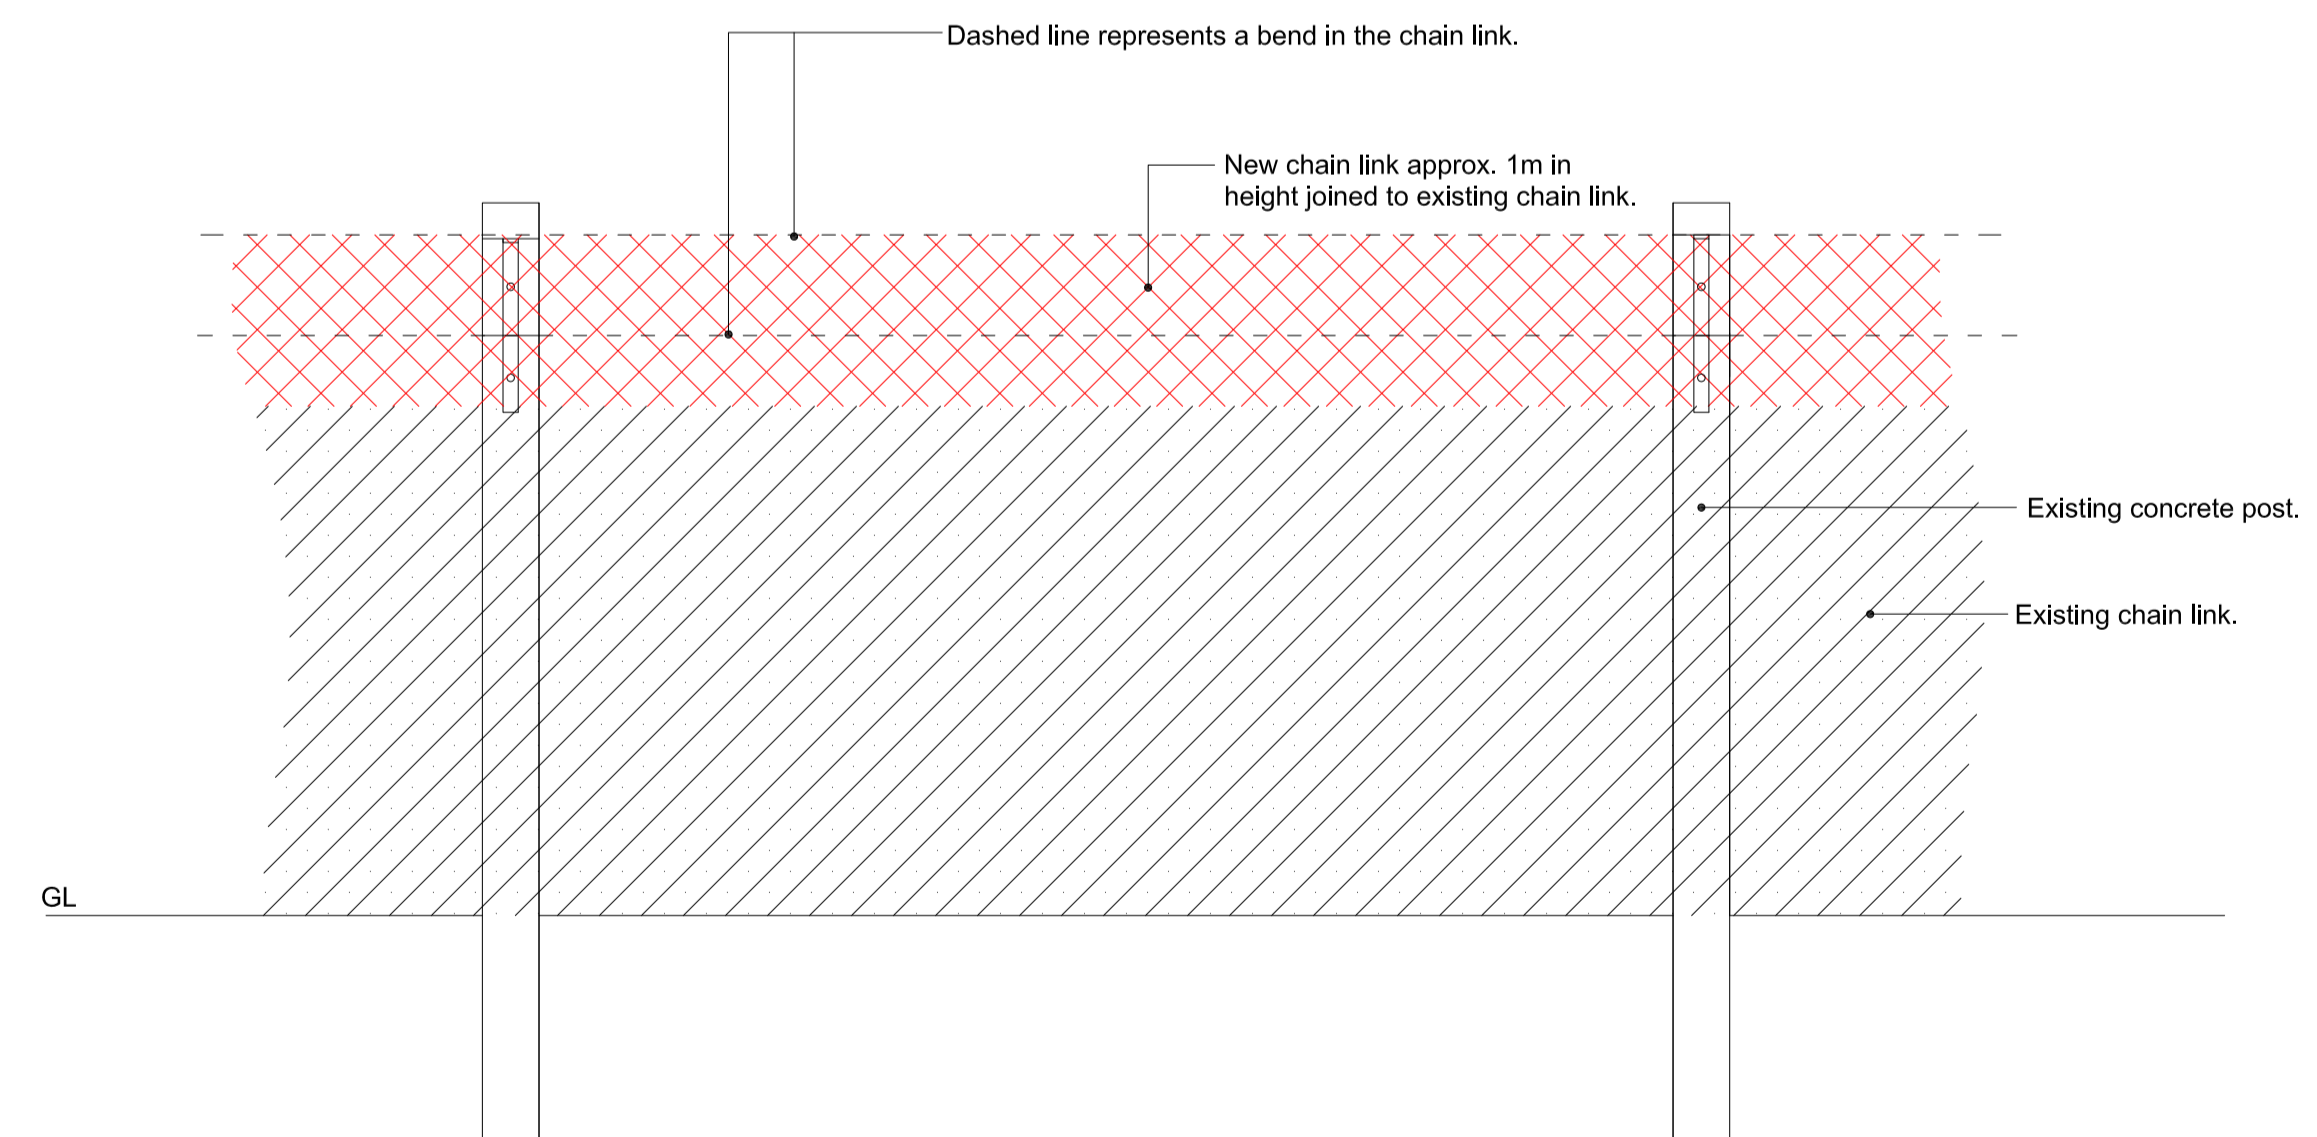
3. EXISTING CHAIN LINK FENCE WITH CONCRETE UPRIGHTS
 Retrofit cat barrier to top of fence by fixing metal bracket to the existing upright creating a 90° overhang. Chain link is secured to the bracket and joined to the top of the existing chain link.
