External Memo: technical note

To	Bicester Heritage Ltd
From	Alex Perry, Lepus Consulting
Subject	Updated Phase 1 survey report, March 2014
Code	LC-0062: RAF Bicester Phase II
Date	10 th April 2014
CC

Summary

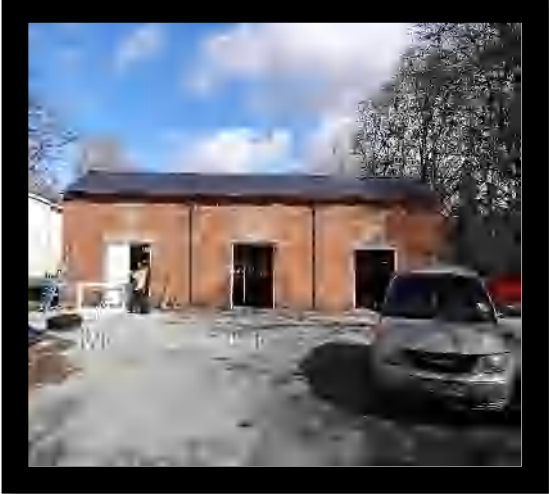
Building	Description	Evidence/Potential for bats	Recommendations
102	<p>Former storage/workshop building constructed from brick with recently re-roofed slate pitched roof and no gaps in tiles. Currently being renovated.</p>

No evidence - low potential	No further survey
100	<p>Former single storey toilet block constructed from brick with pitched slate roof. Currently being renovated.</p>

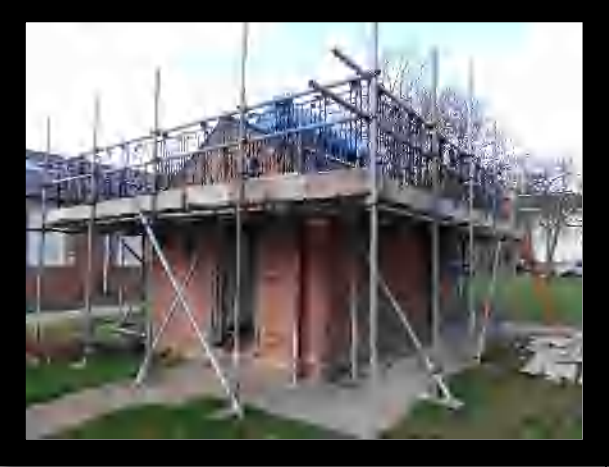
No evidence. Low potential	No further survey
94	Former large garage building with solid brick walls and flat roof.	No evidence and low	No further surveys

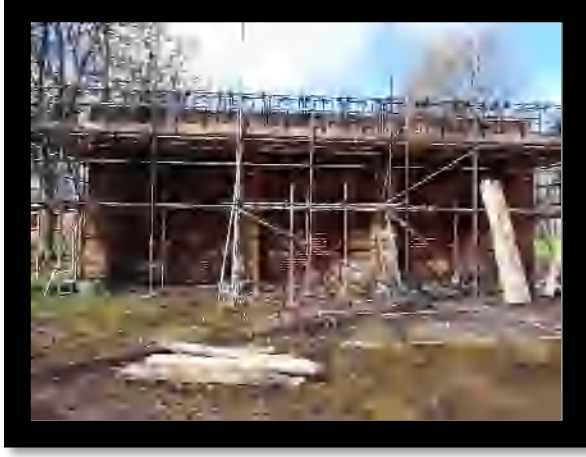
potential to support bats	
92	<p>Former workshop/store constructed from brick and slate/tile pitched roof. Unusual box roof structure with boarding.</p>

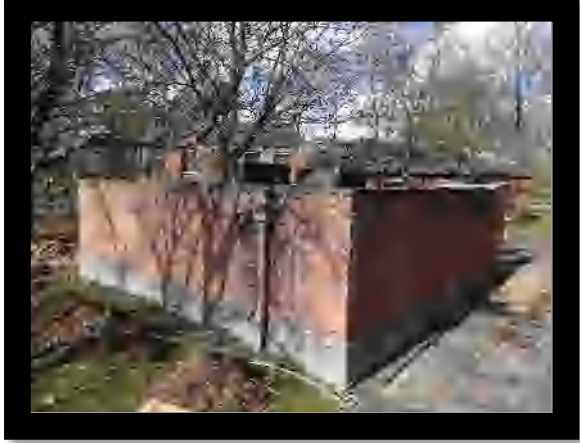
No evidence but high potential for roosting bats in roof structure and ridge	Further emergence surveys required.
91	<p>Former single storey fuel storage tank. Brick construction and flat roof. Only 2m in height.</p>

No evidence and no potential for bats	No further surveys
93	<p>Former large industrial building with surrounding blast walls. Constructed from concrete and brick with a flat roof.</p>	Evidence of night roost and feeding site (moth wings and bat	Further emergence checks and static bat logger to determine activity levels.

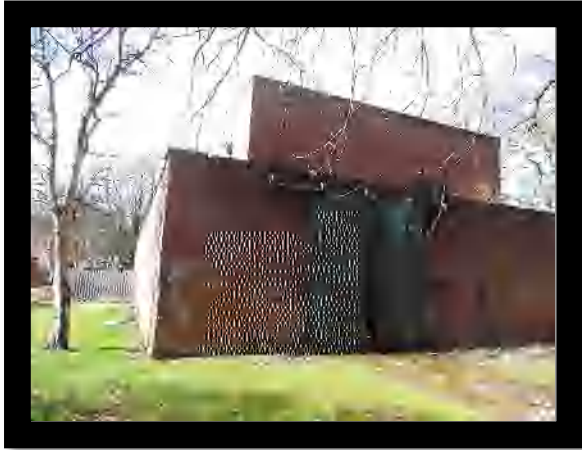
droppings)	
96	<p>Large single storey work shop building constructed from brick with slate tiled pitched roof.</p>

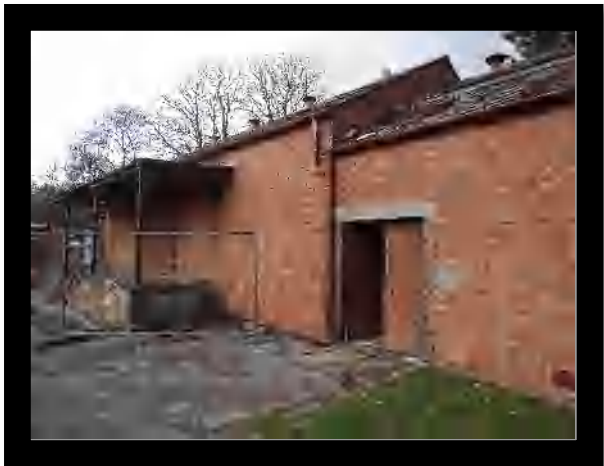
No evidence but potential bat roosting areas in the ridge area of the roof.	Further emergence surveys required.
83	<p>Former single storey chemical store constructed from brick with a flat roof.</p>

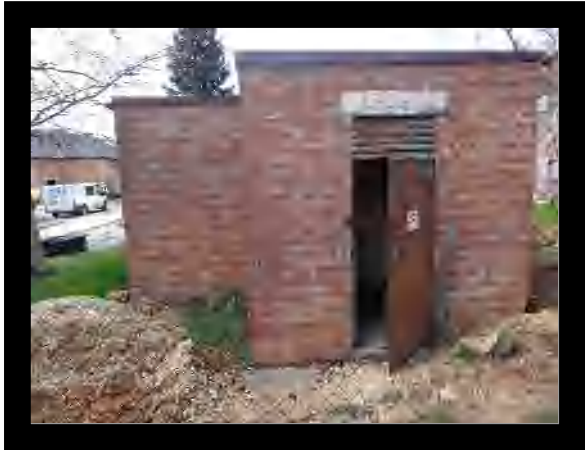
No evidence and no potential	No further surveys
90	<p>Large warehouse and workshop buildings with multiple rooms. Pitched slate roof and constructed from brick.</p>	No evidence-potential roost sites in roof area	Emergence surveys required.

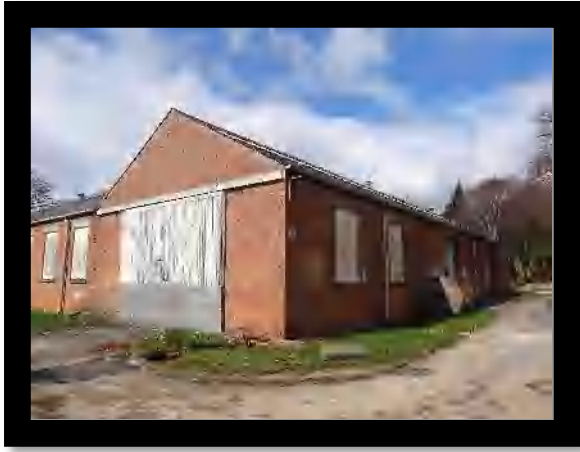
99	<p>Large warehouse and workshop buildings with multiple rooms. Pitched slate roof and constructed from brick.</p>

No evidence-potential roost sites in roof area	Emergence surveys required.
97	<p>Small single storey storage buildings currently used by on site contractors. Constructed from brick with flat roof.</p>

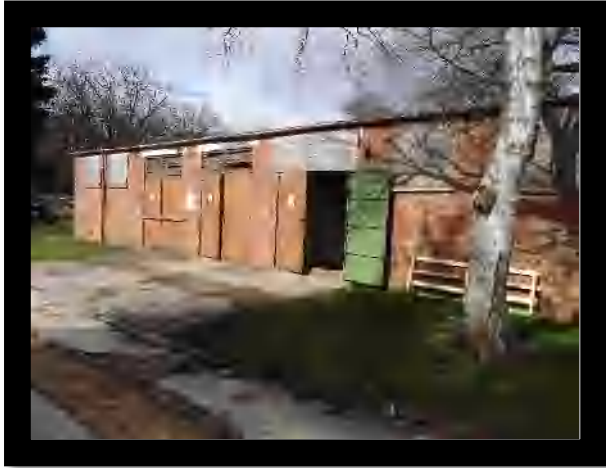
Low potential and no evidence of bats	No further surveys required.
98	<p>Former single storey brick incinerator building with flat roof and large chimney.</p>	Low potential with well-lit interior	No further surveys required.
