**Bat Survey Report for
Crockwell Farm,
Manor Road, Great Bourton,
Banbury, OX17 1QT**

Cotswold Wildlife Surveys

15th April 2016

Report Number: 2317-CWS-01

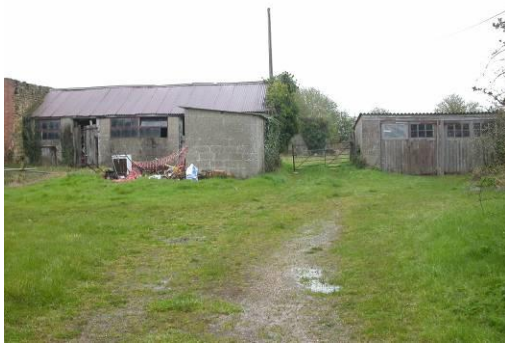
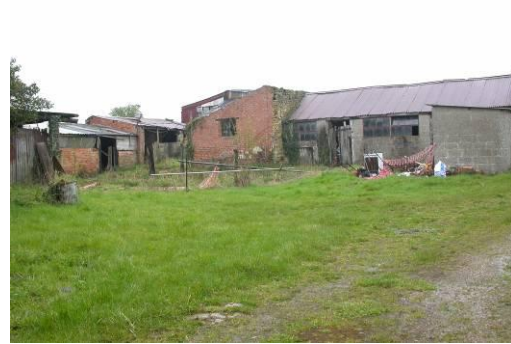
Figs. 1 & 2 Crockwell Farm

The site comprised six buildings, which included a garage block, a storage barn, a pigsty, a stable block, an open barn and a derelict barn (Figs. 1 and 2). The buildings were a combination of stone, brick and block construction, with a range of different roofs.

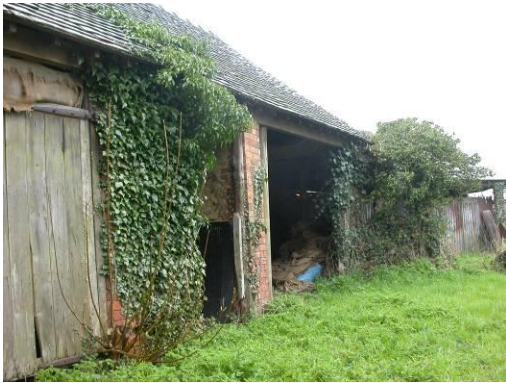
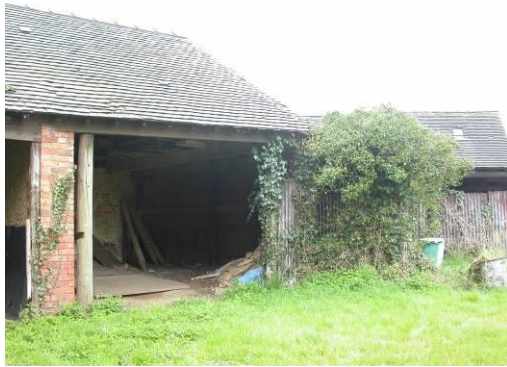
<p style="text-align: center;">Figs. 5 & 6 Garage block</p>

Building Name	Description	Figures
Garage block	<p>The garage block was a brick building with a pitched tiled roof (Figs. 5 and 6). This was generally sound throughout, with just a few slipped tiles on the roof verge. There were no suitable gaps for roosting bats and the brickwork was sound throughout. The front was open to the inside of the building.</p> <p>Internally the garage block was open to the underside of the roof which was unlined (Figs. 7 and 8). The building was brightly illuminated through the open front and was very heavily cobwebbed. The open nature of the building also made it very cold and quite drafty.</p>

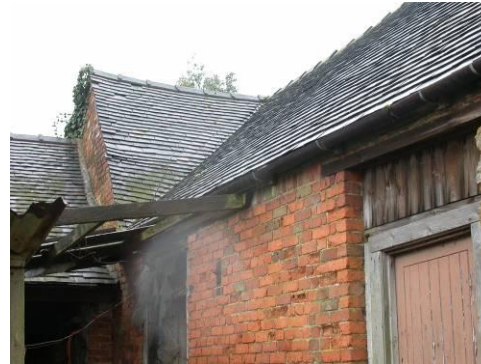
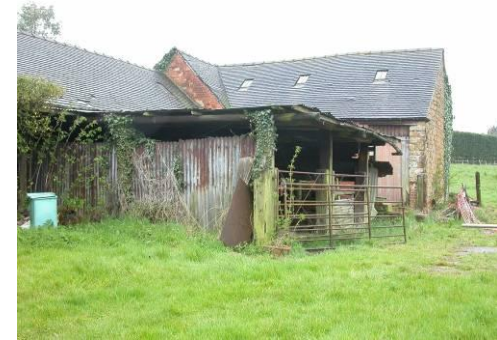
Figs. 9 & 10 Storage barn and lean-to

The storage barn was a brick building with a pitched tiled roof (Figs. 9 and 10). This was generally sound throughout, with just a few slipped tiles on the roof verges and ends. There were no suitable gaps for roosting bats and the brickwork was sound throughout. There was also a small, corrugated metal lean-to on the north elevation which was highly unsuitable for roosting bats.

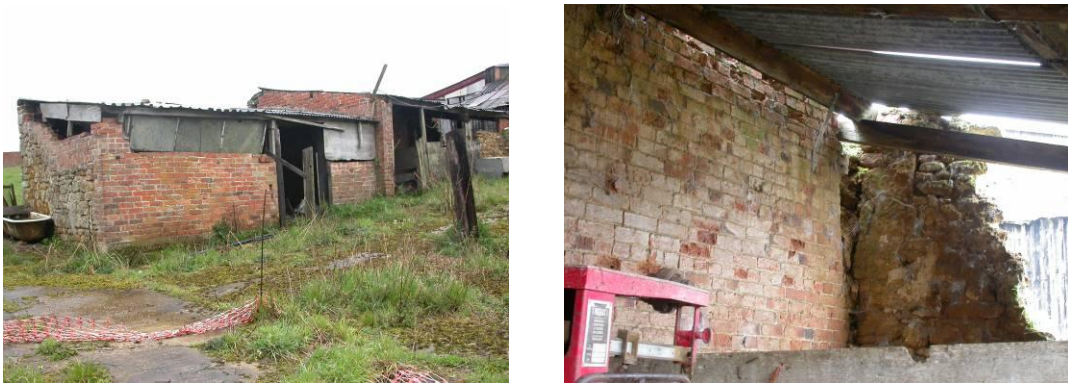
<p>Pigsty</p>	<p>The pigsty consisted of two adjoining brick structures with a sloping corrugated metal roof (Figs. 13 and 14). The walls were in a very poor state of repair, with areas which had collapsed. However, despite this, there were no suitable crevices for roosting bats.</p> <p>Internally the pigsty was cold and damp due to the poor state of repair and gaps and holes in the roof.</p>

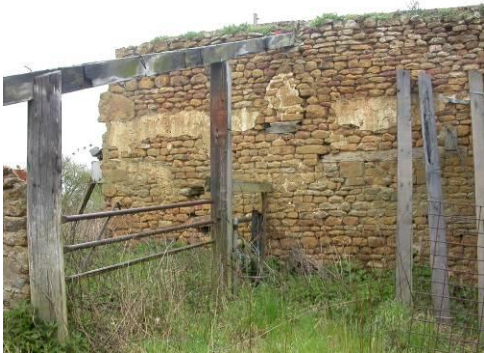
<p>Fig. 15 Derelict barn</p>

<p>Figs. 13 & 14 Pigsty</p>
<p>Derelict barn</p>	<p>On the western side of the stable block were the remains of a derelict barn which had since collapsed (Fig. 15). There were several timber posts left, but these held no suitable roosting features for bats.</p>

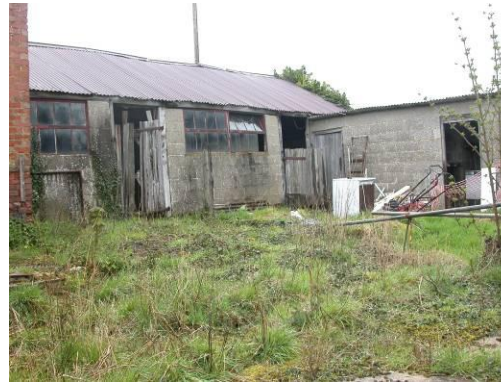
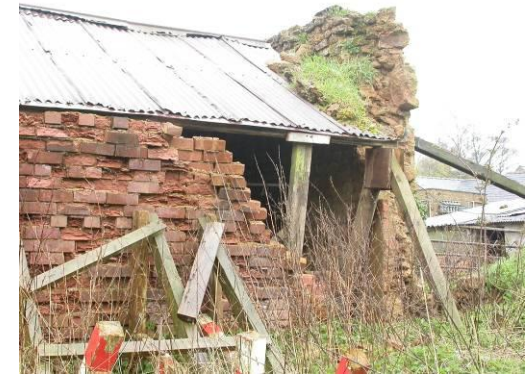
Figs. 16 & 17 Stable block

The stables were a combination of block, brick and stone (Fig. 16), with the rear brick wall having collapsed in one corner (Fig. 17). The roof was covered with corrugated metal sheets, which had some gaps between the panels and along the ridge.

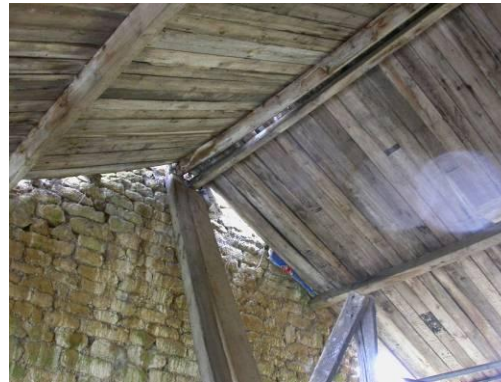
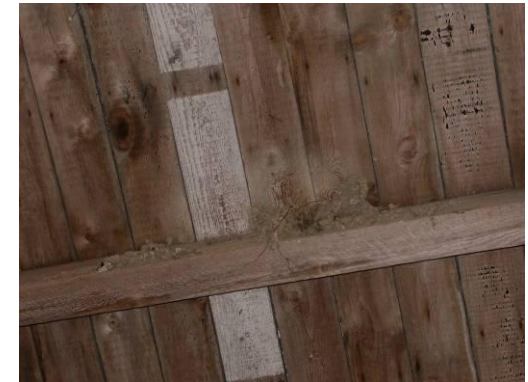
Figs. 18 & 19 Timber sarking lined roof of stable block

The building was lined with timber sarking, the boards tightly fitting. On one of the beams an old Swallow's nest was noted. The walls were in a poor state of repair and there were no suitable crevices for roosting bats.

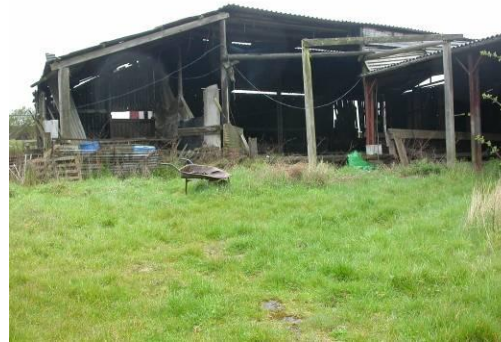
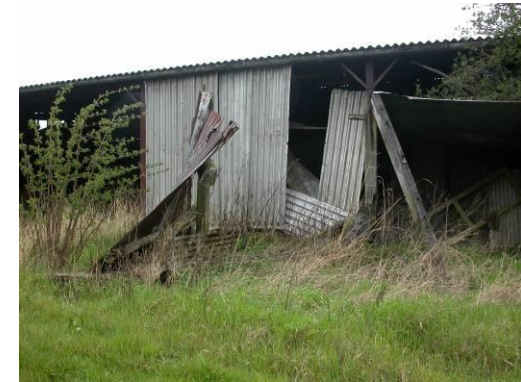
Figs. 18 & 19 Open barn

The open barn was a large structure which had been extended several times (Figs. 18 and 19). It had a timber and metal frame, with a corrugated metal roof and walls in places. There were a number of skylights in the roof, which along with the open sides made the barn very brightly illuminated (Figs. 20 and 21).

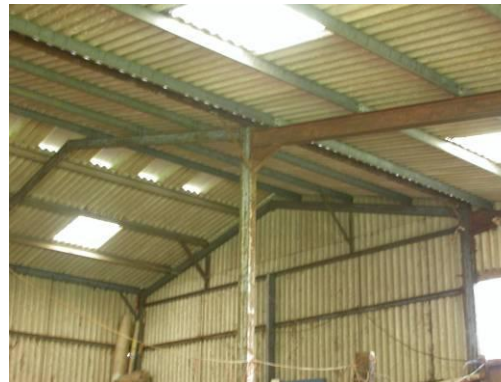
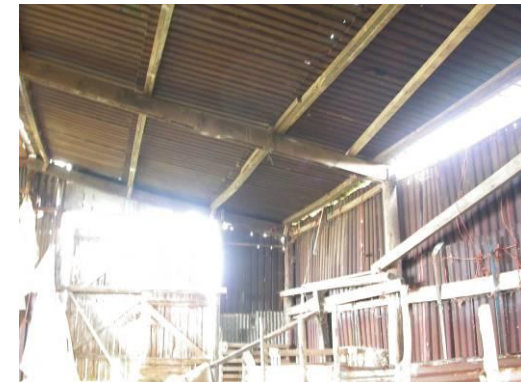
Figs. 20 & 21 Interior of open barn

The open barn was generally highly unsuitable for roosting bats, given the bright interior and exposed nature. However, some of the timber rafters were made from two boards, separated by blocks (Fig. 22). The latter were recessed creating deep, triangular shaped gaps. These appeared suitable for bats and in one of the gaps a single Brown Long-eared Bat was found (Figs. 22 and 23 overleaf).

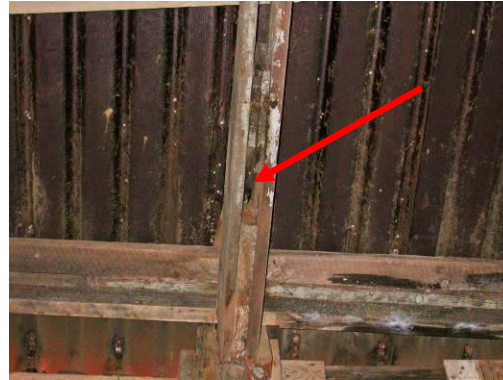
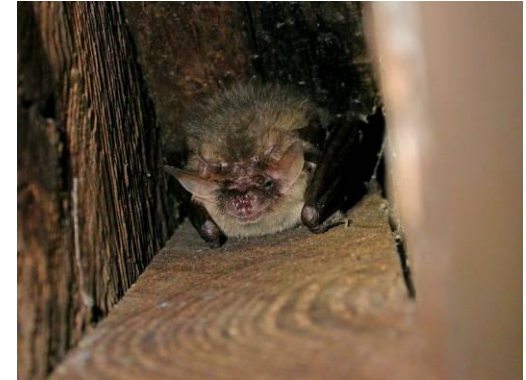
Figs. 22 & 23 Hibernating Brown Long-eared Bat in gap in rafter (arrowed)

A single Brown Long-eared Bat was found hibernating within a gap in a rafter in the large, open barn. The bat was considered to be hibernating as there was no evidence of any droppings, urine stains or feeding remains.

As the proposed works will result in the loss of the Brown Long-eared Bat hibernation site, appropriate mitigation will be needed, along with a licence from Natural England consenting to the loss of the roost.

It is therefore suggested that a large timber garden store, with an open front, is erected at the northern end of the site, potentially straddling the two gardens.

The structure will contain two Schwegler 1FF bat boxes (one in each gable end) to act as hibernation/roosting sites, whilst it will also provide a replacement nest site for the Swallows.

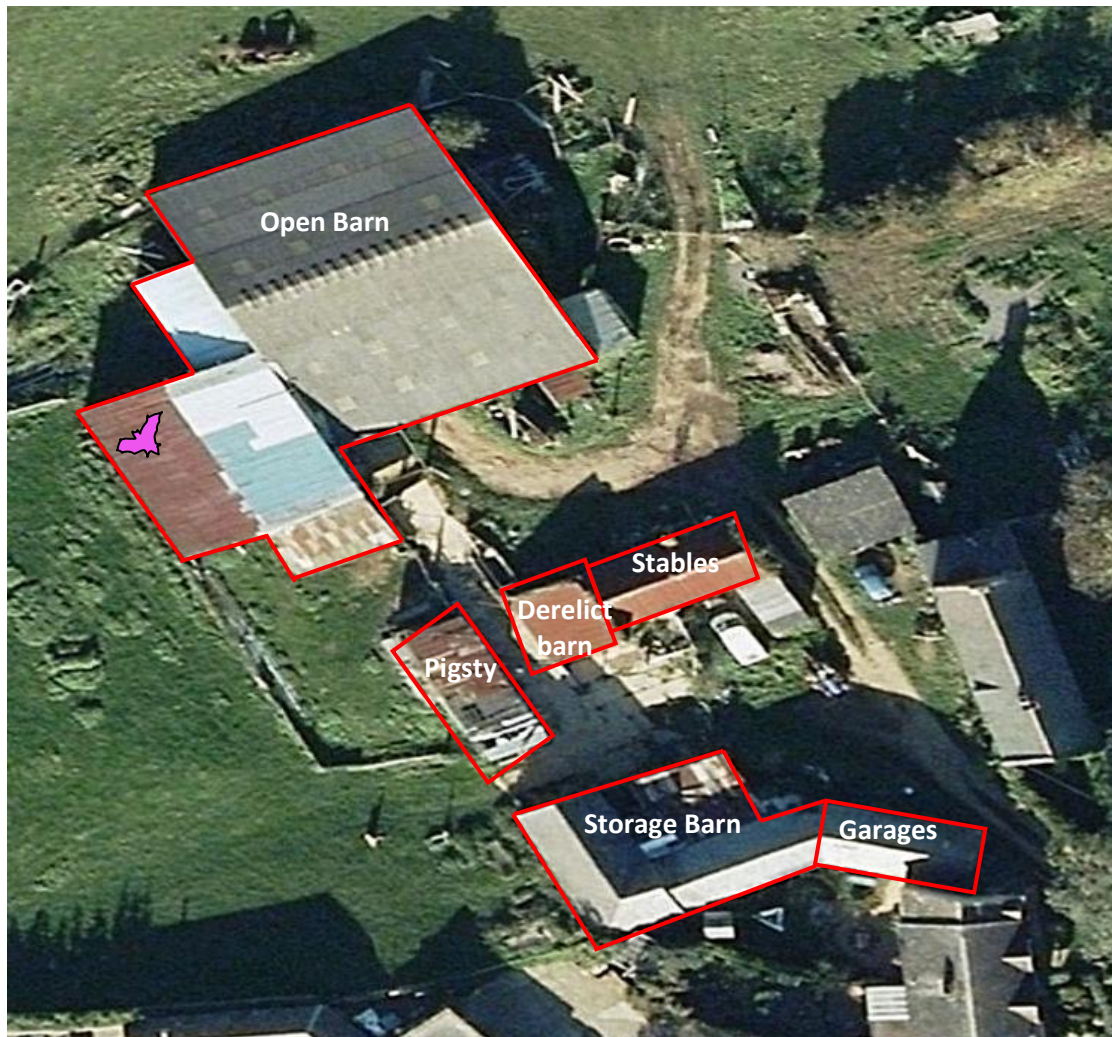
Appendix 3: Location of hibernating bat

Hibernating Brown Long-eared Bat
