CD 2.7 - 160104 RSA Plus revised access

Subject: 1361: White Post Road, Banbury

White Post Road, Bodicote, Banbury

Road Safety Audit Stage 1

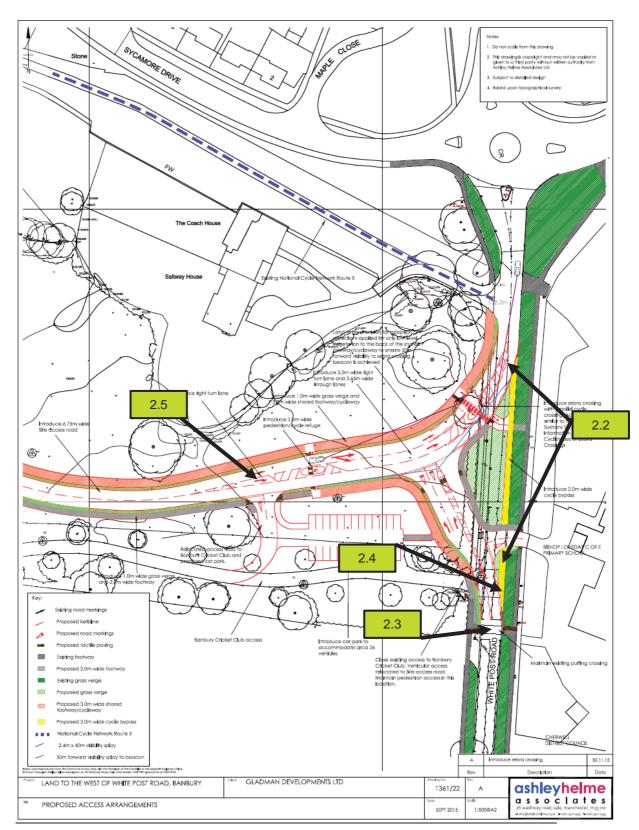
Appendix B

Location – General – On street parking

Location - White Post Road

Location - Existing Puffin crossing

Location – Southern end of cycle bypass

Location - Cricket Club right turn lane

Please refer to the following page for a plan illustrating the locations of the problems identified as part of this audit (location numbers refer to paragraph numbers in the report).

The need for additional off-street parking should be established. Parking within the visibility splays of junctions and crossings should be prohibited within the detailed design.

At detail design, measures should be provided to reduce the effect of any see through of the old road alignment.

The cycle bypass and shared footway cycleway should be extended to the south side of the puffin crossing which should also be upgraded to a Toucan crossing or a zebra crossing with a parallel cycle crossing.

The cycle bypass should be extended to the southern side of the puffin crossing (see problem 2.3) with a parallel kerbed separation build-out provided to protect cyclists entering the carriageway from other road users.

A consistent width right turn lane should be provided for the cricket club.

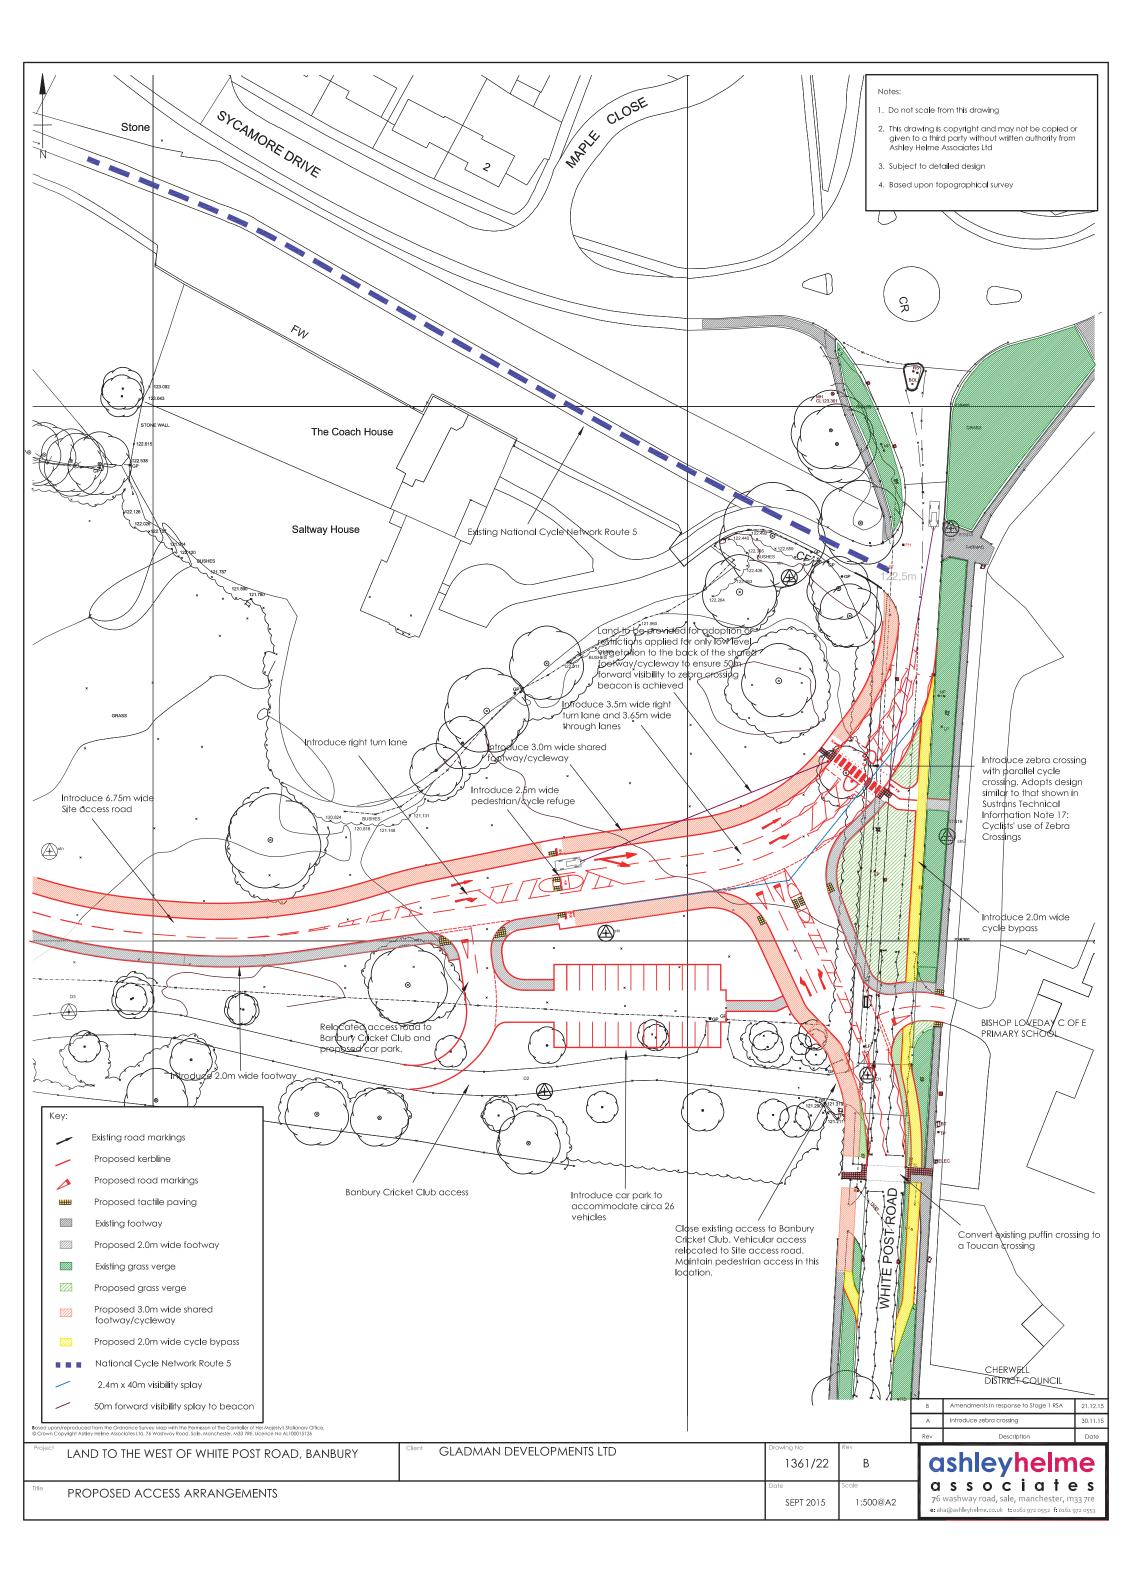
Drawing No. 1361/22 A

Please find attached the latest access arrangement drawing for the White Post Road, Banbury Site.

The drawing reflects the conference call discussion and subsequent email correspondence we had in October 2015. The revised access also takes into account the issues and recommendations identified in a Road Safety Audit which is also attached to this email.
