Desk Study and Site Investigation Report

Site: Underpass at Bicester

Client: A2 Dominion

Project Reference: JN0591

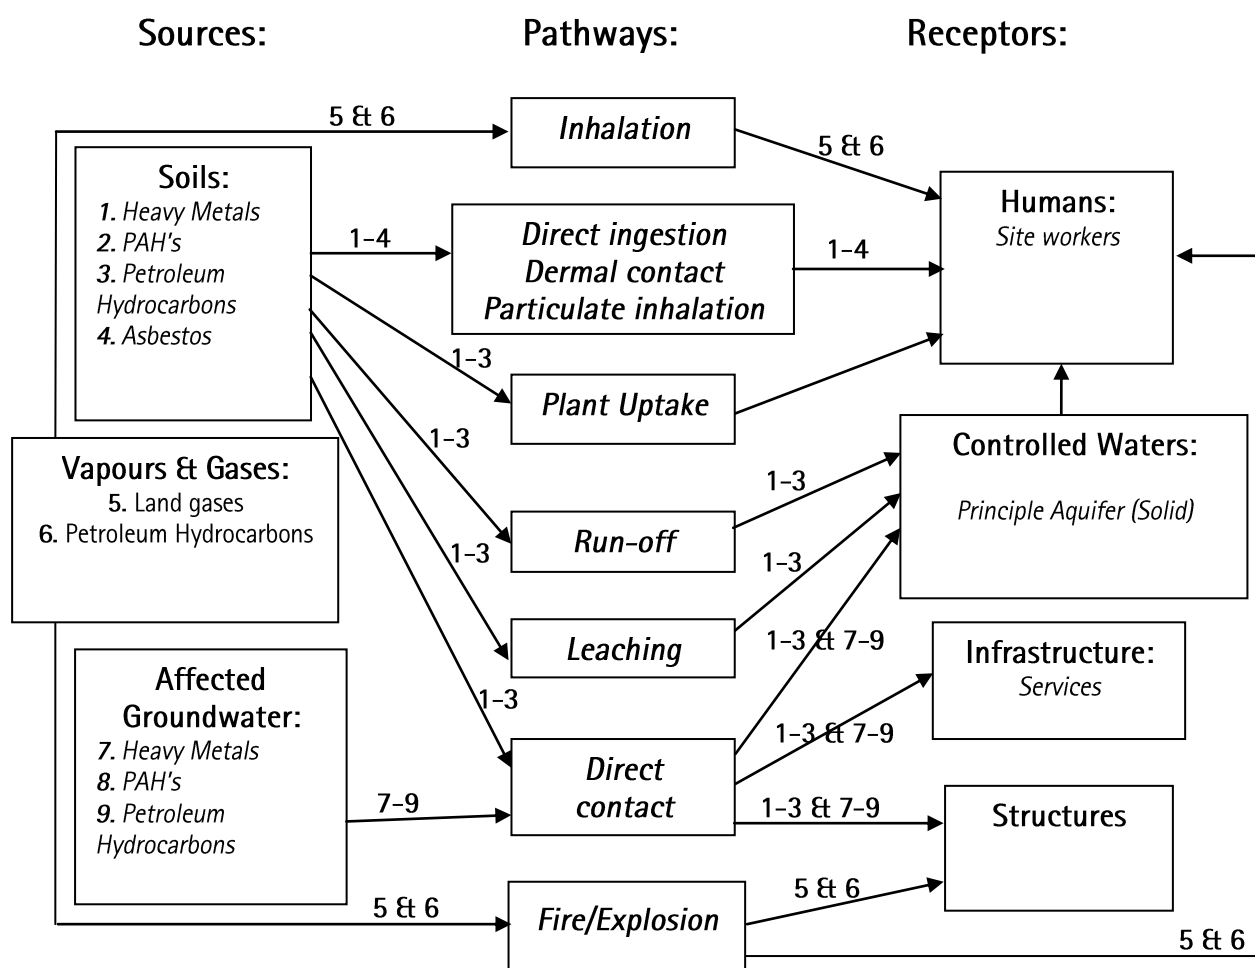
The following diagram shows the potential pollutant linkages identified for the site and summarises the preliminary conceptual model:

// denotes potential pollutant linkage not complete
