MUDDLE BARN FARM, SIBFORD GOWER, OX15 5RY

Extended Phase 1 Survey and Assessment & Bat Survey

**Report to
Yiangou LLP & clients Mr & Mrs Besterman**

July 2014

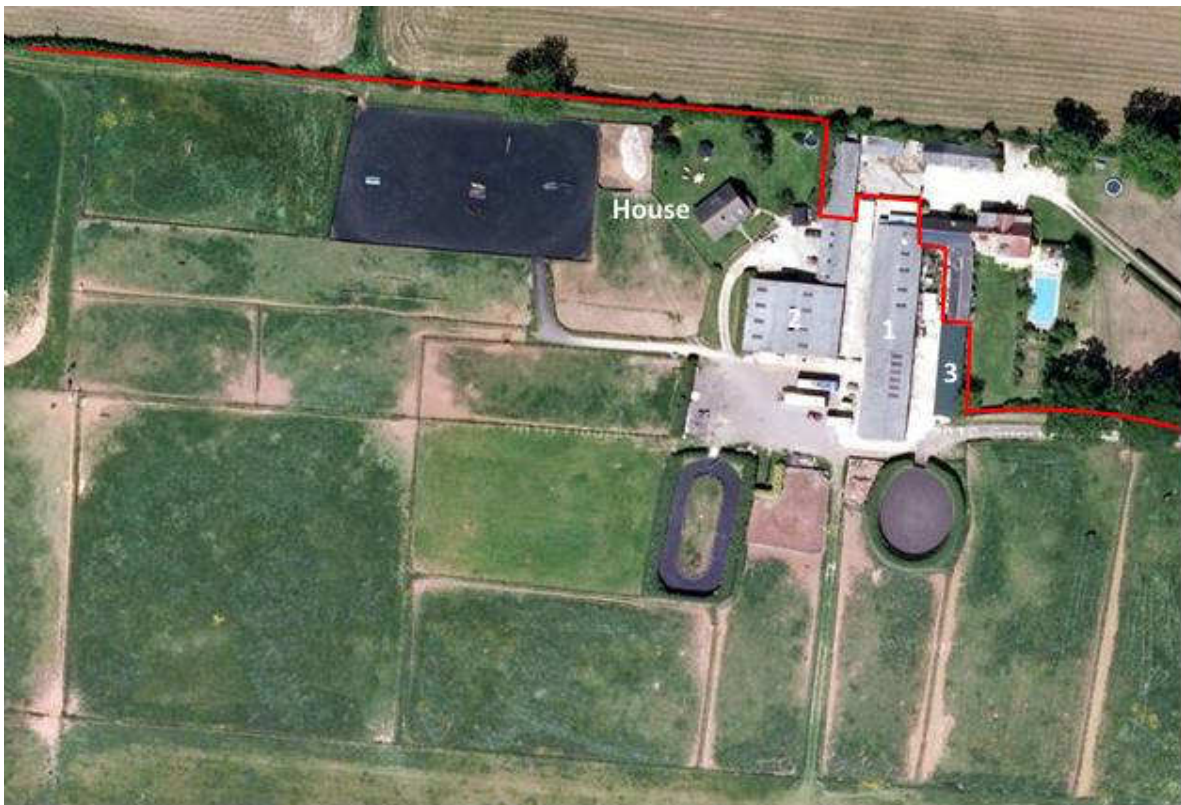
Figure 1 Aerial view of the buildings and adjacent paddocks

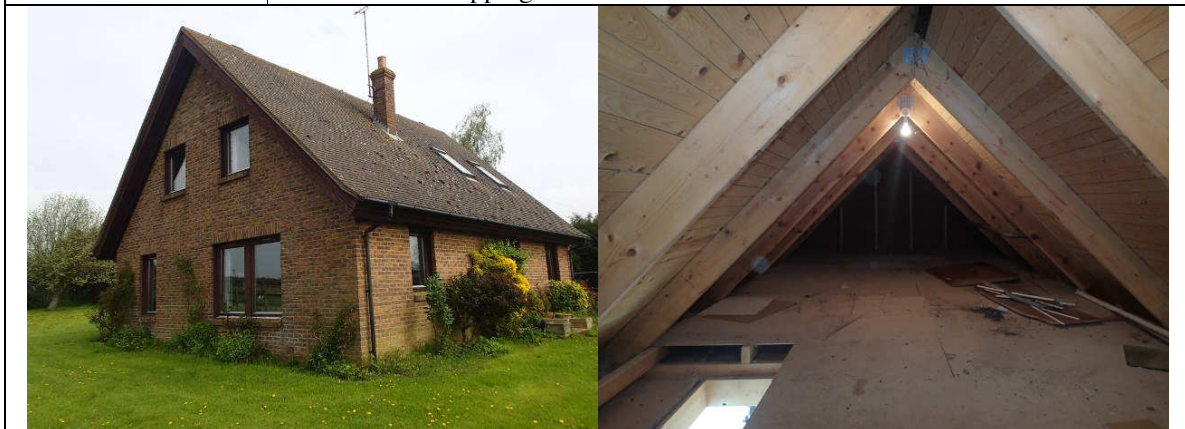
1 House

The house was lived in at the time of the search survey. It is a two-storey chalet style building with an attic. Refer to Appendix 1 (photographs).

Walls:	Red brick – in good condition. There were overhanging eaves around the wall tops. These comprised sawn timber planks with wide gaps between them and mesh on the underside. There were a few narrow gaps between the boards at the walls especially at the western end.
Roof/attic:	Twin pitched roof. Small, tight tiles on felt, which was tight on tongue-and-groove boards in the attic. The attic was about 1.5 m high and until recently was probably used for storage – there was a working electric light. There were two vents in the roof ridge. The felt was ripped around the western vent and daylight could be seen from inside the attic. There was a single boiler vent on the northern pitch and two dormer windows. A brick chimney with tight lead flashing and two dormer windows on the southern pitch.
Bat roosting opportunities:	At the wall tops where there is access for bats via gaps between the soffit boards and walls or ripped mesh on the underside. At the western ridge vent where the felt is ripped. In the roof structure around the base of the boiler vent.

Signs of bats:	A few old, small bat droppings in the attic at its western end (below the vent).
Comments:	A lot of mice droppings in the attic.

The old droppings found indicate that a bat has used the roof structure next to a vent in the attic of the house for a short time in past. No roosting bats from the house were seen during the evening surveys – the single common pipistrelle seen after dusk (later than this species emerging at other sites in the region) in the garden probably flew in from the north eastern side from the direction of the adjacent homestead as it extended its foraging activity as it became darker.

Precautionary measures for the proposed demolition of the house:

- *Resurvey the house in the summer (May – August) if it has not been demolished by summer 2016.*
- *Remove the roof and soffits by hand and hand tools.*
- *The removal of the roof and eaves to be overseen by a suitably experienced ecologist.*

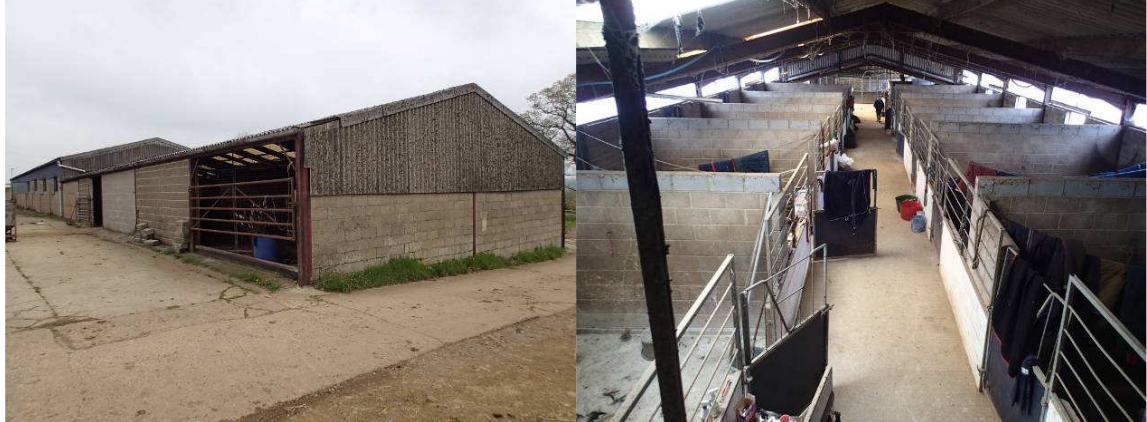
2 Barn/Stables 1

This was a large modern barn divided inside into horse stalls, a tack room at the northern end and a horse exercise circle at the southern end.

Walls:	Breeze block – good condition. There were open gaps about 25 cm high along the wall top in the horse stalls. Corrugated sheets at the top half of the end walls. Doorways on both sides – and a gated opening at the south western corner.
Roof:	Metal frame with a twin pitched single skin of corrugates roofing sheets. Clear roofing sheets acting as skylights
Bat roosting opportunities:	-
Signs of bats:	-
Comments:	Light and airy inside. Swallows nesting on the roof frame in the building.

The buildings, hedges and paddocks provide good potential nesting habitat for a variety of birds. No evidence of barn owls was found and all buildings were in use/disturbed. Swallows were seen collecting mud for nest building and nests were present in the Barn/Stables 1. There were also pigeon droppings in this building.

The buildings, garden and native and *Leylandii* hedgerows generally provides habitat for nesting birds. Swallows nest in Bulign1 (and potentially could nest in any of the buildings except the house).

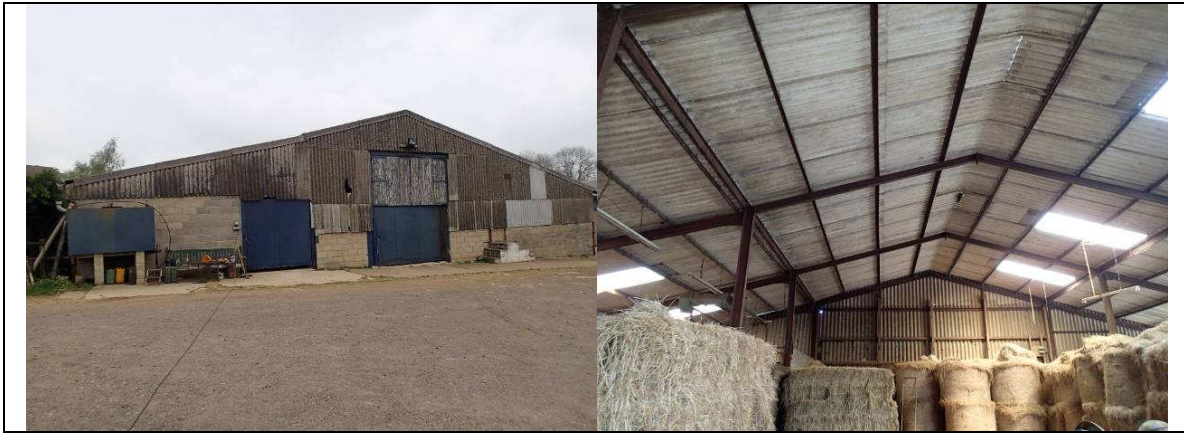
3 Barn/Stables 2

This was a large modern barn in two parts: (1) a high barn used for storing hay and materials etc and (2) lower horse stalls at the northern end.

Walls:	Low breeze block – good condition. Corrugated sheets around the top half of the walls. Several doorways – gaps around them.
Roof:	Metal frame with a twin pitched single skin of corrugates roofing sheets. Clear roofing sheets acting as skylights
Bat roosting opportunities:	-
Signs of bats:	-
Comments:	Light and airy inside.

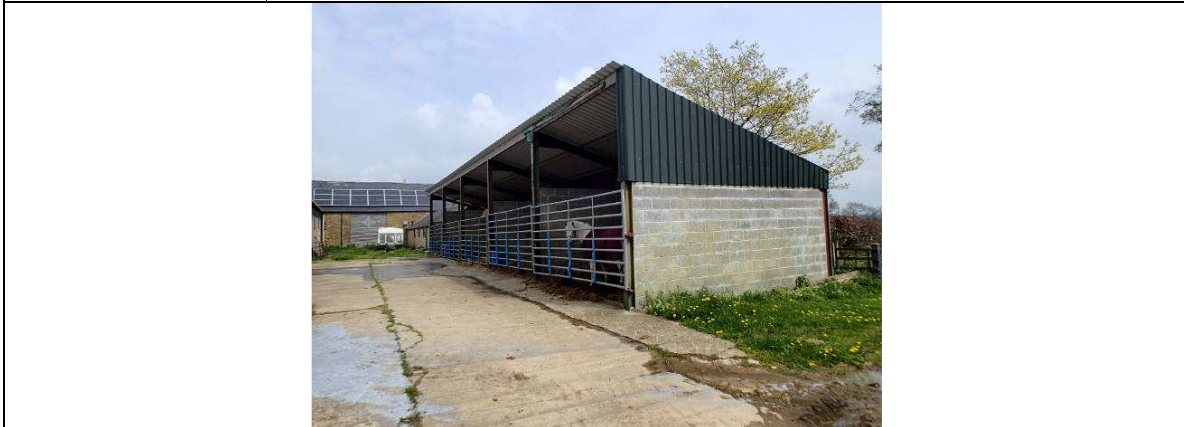
4 Barn/Stables 3

This was a high open-sided modern stable with horse stalls.

Walls:	Breeze block – good condition. Metal sheets around the top half of the walls. Gated and open to the front/western side into the yard.
Roof:	Frame with a single pitch and skin of corrugated roofing sheets.
Bat roosting opportunities:	-
Signs of bats:	-
Comments:	Light and airy inside.

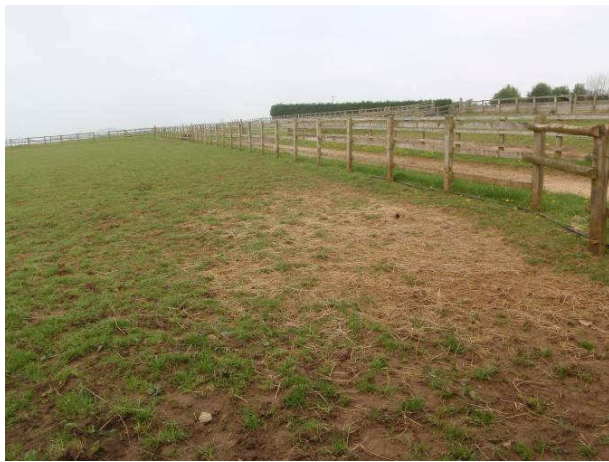
Photo 1 View of typical horse paddock

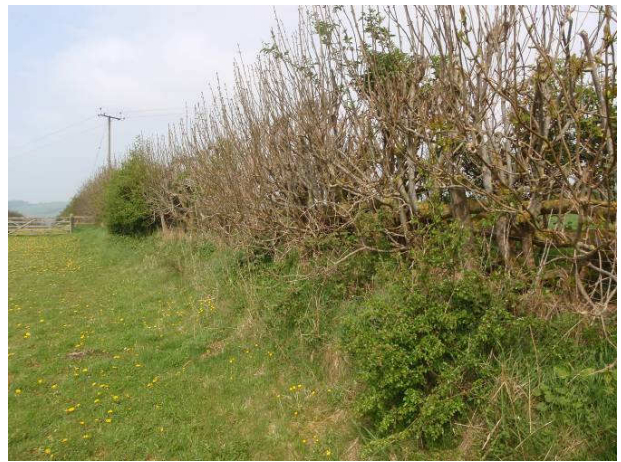
Photo 2 Northern boundary hedge showing old laid ash and grassy hedge bank

- *All hedges are retained and any new hedge planting, including 'gapping-up', comprises native berry and fruit bearing species.*
- *Standard tree protection measures are used to protect the northern boundary hedgerow during the works.*

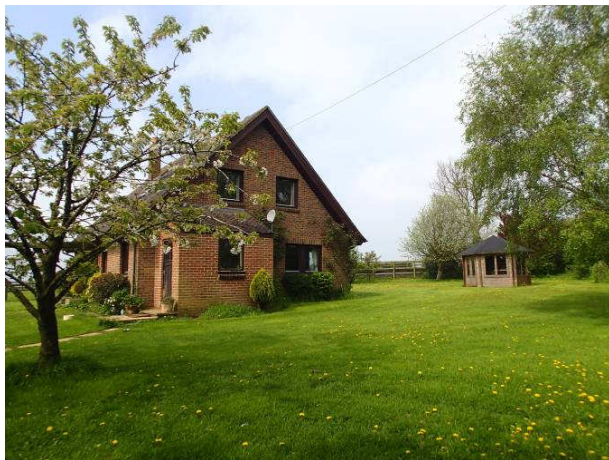
Photo 3 The house

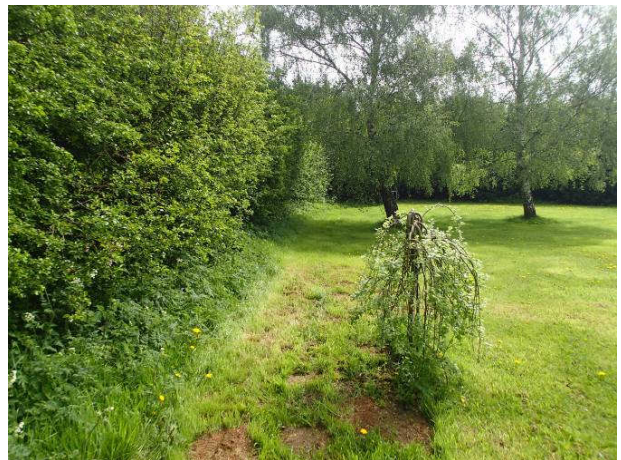
Photo 4 Hedgerow on northern boundary of the garden

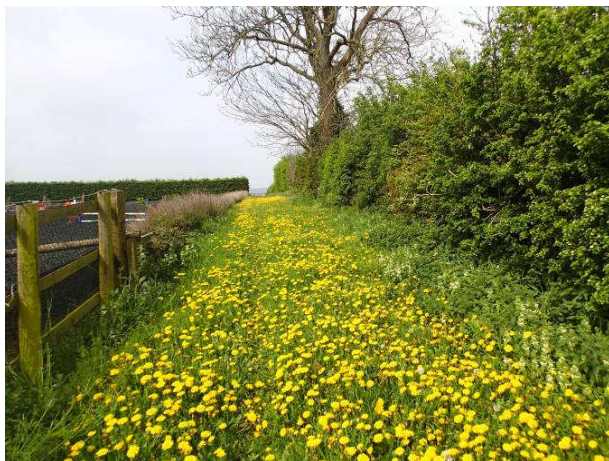
Photo 5 Hedgerow along the northern boundary next to a ménage.
