# 03 | Site Appraisal

## 3.2 Land Use

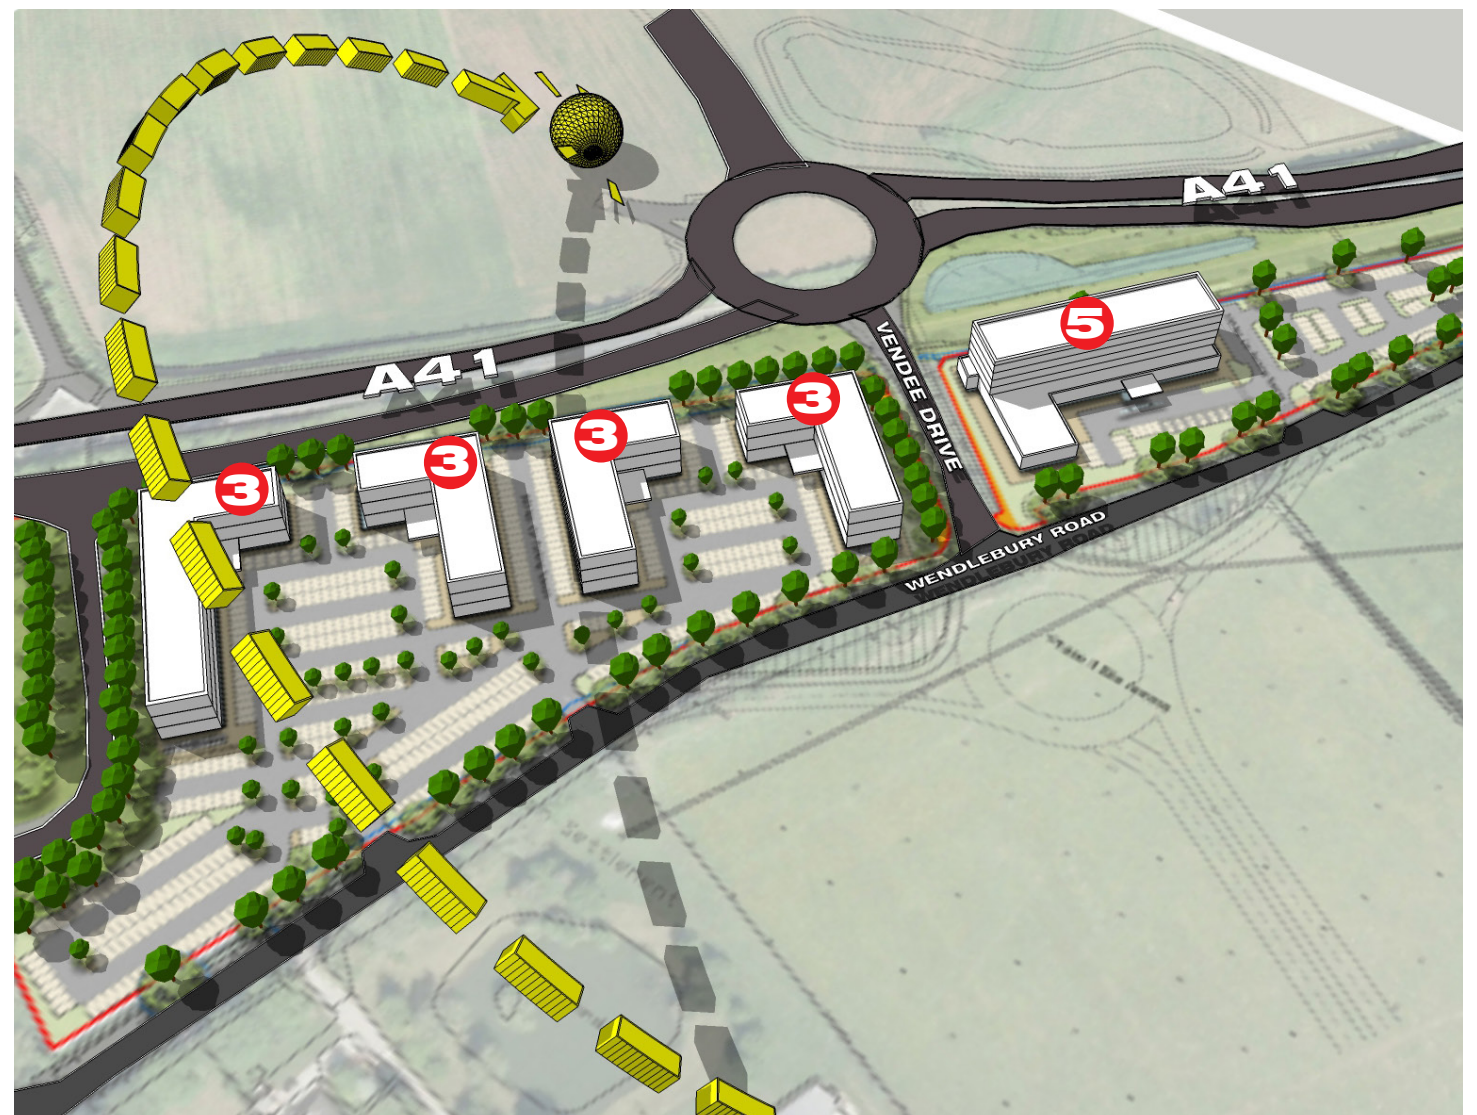
Sun Path and Building Heights

The southern tranche of land has office buildings 3 storey in height, set out in a regular formation with the short elevations facing the A41.

The northern tranche of land has a hotel 5 storeys in height, located to address the roundabout junction with the A41 and Vendee Drive.

**3** Number of Floors

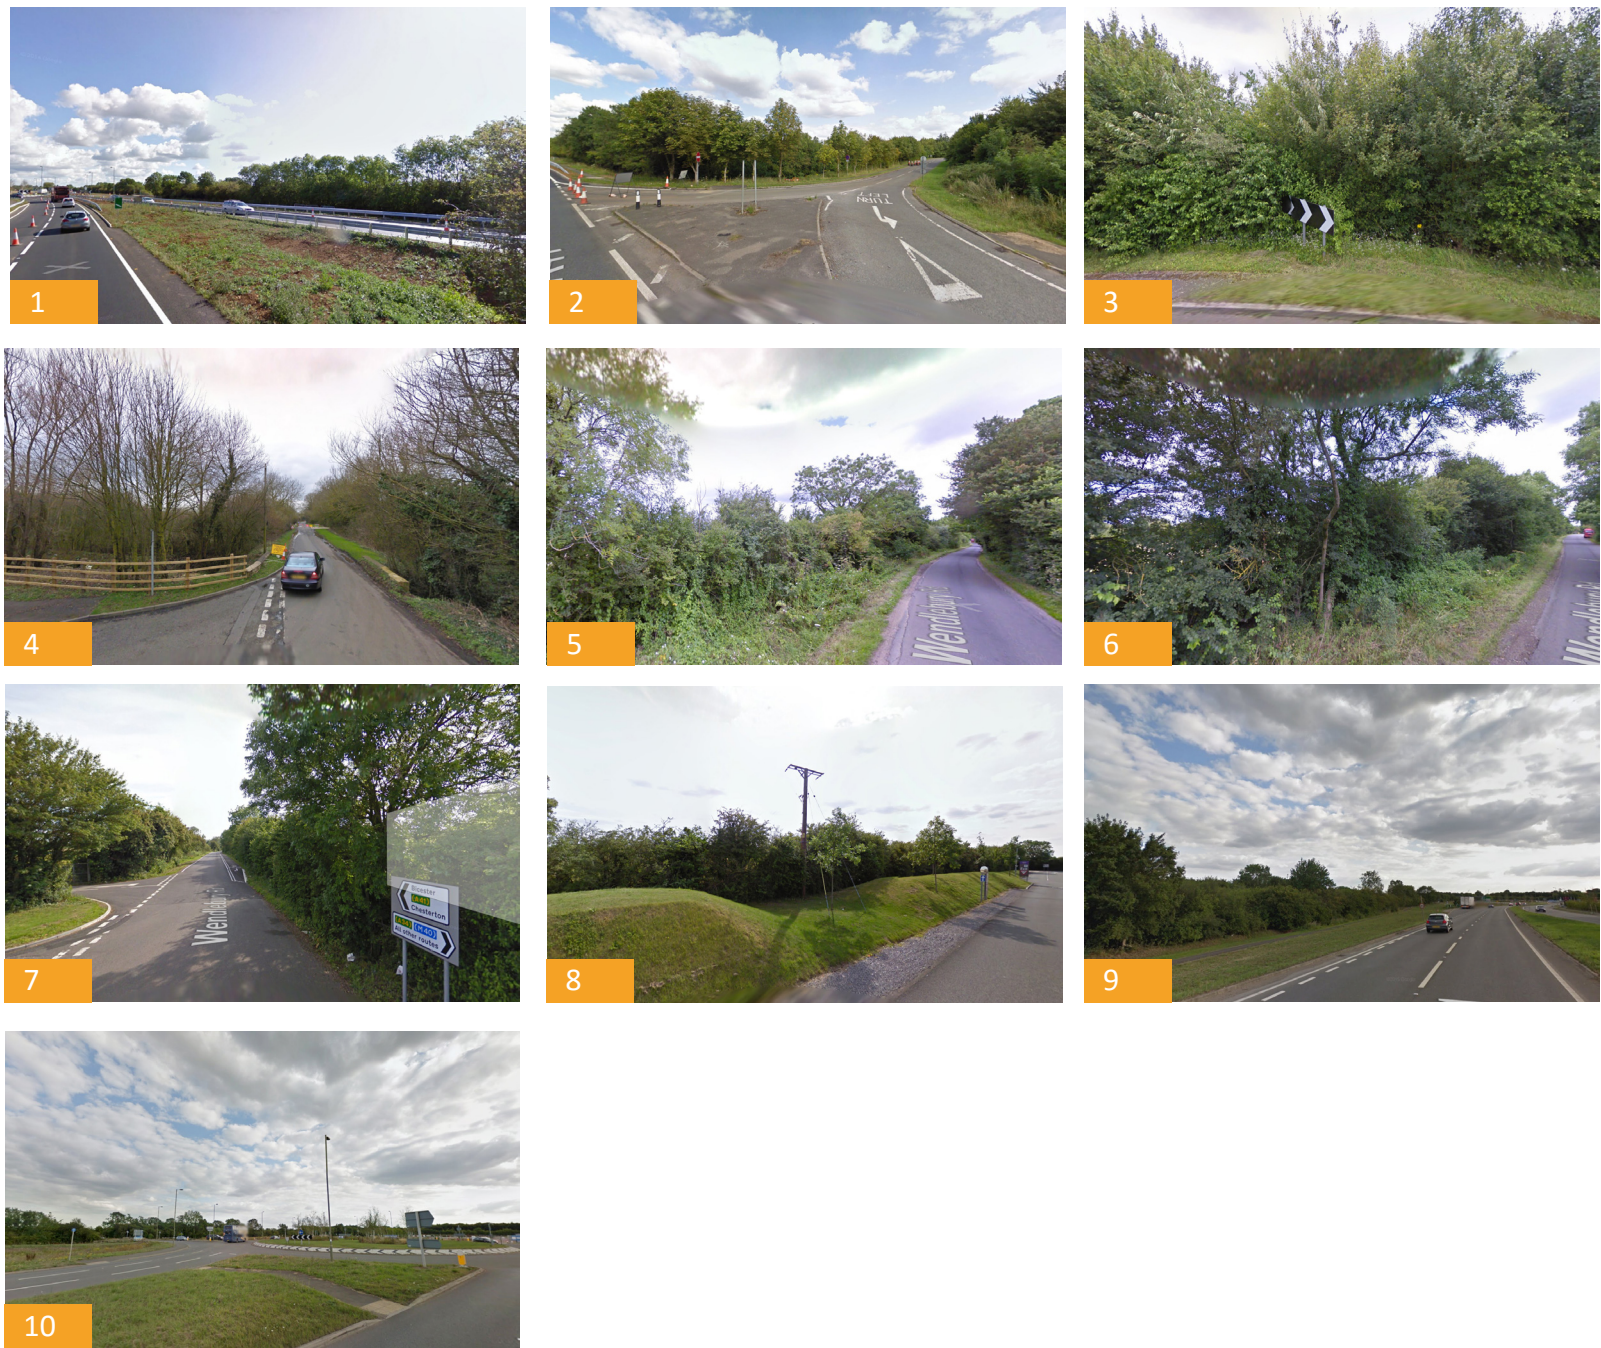
## 3.4 Existing Site Photos - A41 / Wendlebury Rd / Bicester Avenue Centre

The existing photographs shown below were taken around the boundary of the site.

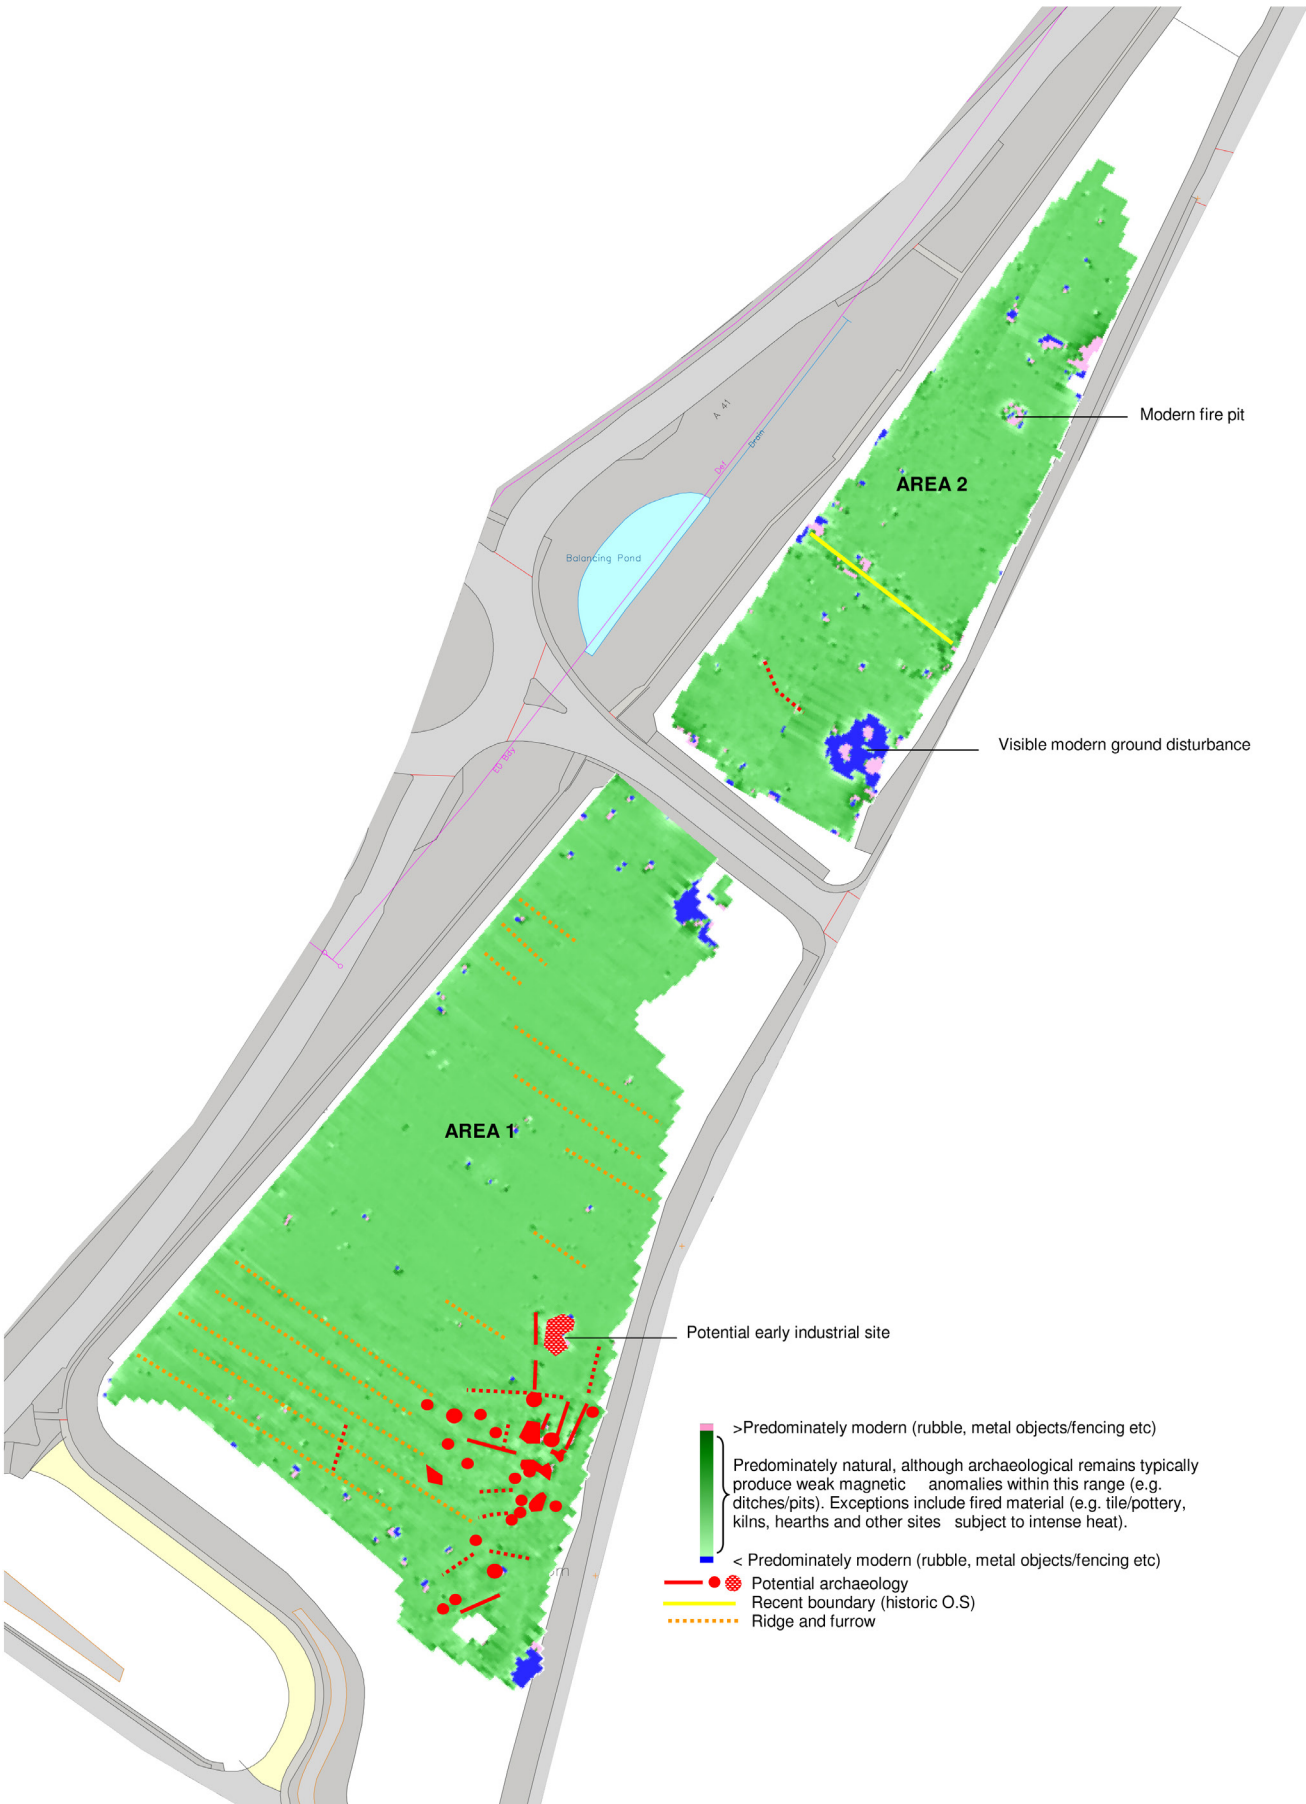
3.6 Archaeology Report Map

The survey recorded an array of probable ditches and pits adjacent to the mid-eastern boundary of Area 1, to the immediate west of Wendlebury Road (Fig. 3.6: red lines). A small group of relatively strong magnetic responses at the northern edge of this group might reflect some form of industrial activity (hatched red/annotated). Conceivably, these date from at least the Iron Age/Romano-British Periods, given the close proximity to similarly-dated settlement remains that were exposed during excavations of land to the immediate south/south-west (Cotswold Archaeology 2016). It seems likely that the construction of the modern Wendlebury Road and (possibly) earlier road will have partially/wholly eradicated traces of any continuation of occupation remains to the immediate east of the site boundary.

The survey registered slight traces of former ridge and furrow cultivation in Area 1 (dotted orange lines). Its minimal resolution in the final 'destriped' processed data is largely the result of its shared alignment with the survey traverse direction. It should be noted that the cultivation does not appear to significantly mask/truncate underlying features, thus reinforcing the relative absence of archaeological remains across the surveyed area.

For the most part, a west-north-west to east-south-east linear array of anomalies in the central part of Area 2 almost certainly relate to a recently removed field boundary (ibid, yellow line).

Elsewhere, stronger responses (pink and blue) include those induced by a relatively widespread zone of likely modern debris in the south-east corner of Area 2 (partially buried heavy duty polythene was visible on the surface) and the site of a recent bonfire in the mid northern part of the field (both annotated on Fig 3.6 ).

The described anomalies were recorded against a backdrop of predominately uniform natural geology (greenscale).

Elsewhere, (for the most part over the same geology) there is minimal geophysical evidence of further potential pits and ditches, although an isolated curvilinear anomaly recorded in the mid-southern part of Area 2 exhibits some potential as buried ditch.

The survey has successfully identified linear and discrete anomalies in the south-eastern part of the site that exhibit potential as archaeological remains in the form of short ditches and pits also including a possible site of industrial activity. These probably date from at least the prehistoric period, situated in close proximity to known Iron Age and Romano-British settlement remains. Elsewhere, the majority of the site appears to be relatively clear of geophysical indicators of further remains, with a possible isolated curvilinear ditch recorded in the northern region. However, it seems likely that traces of archaeological features might survive at the southern edge of the site that was not surveyed due to the presence of dense vegetation.
