Notes on Chancel Cottage

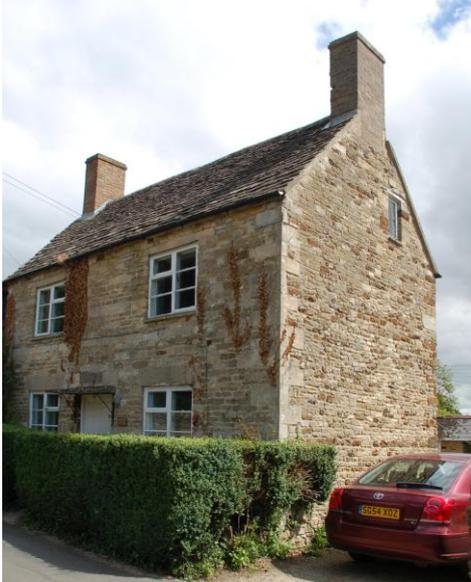
Chancel Cottage, from the SW.

The cottage is an L-shaped building, with a symmetrical west façade facing the road, and a rearward extension to the east from its northern end. The front and the extension are roofed in old Stonesfield slates, but the back slope of the main block is in modern cement tiles. There is no visible evidence that the building was ever thatched. On the façade the upstairs windows have narrow stone lintels constructed in three sections, the middle sections being supported by diagonal cuts, in the manner of keystones.

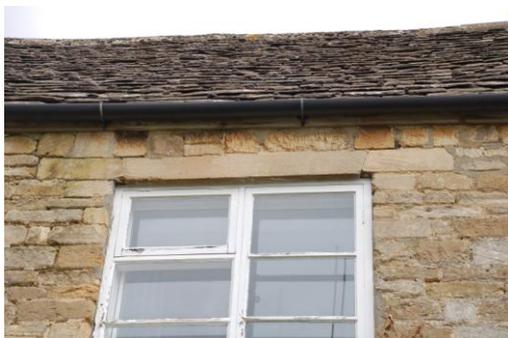
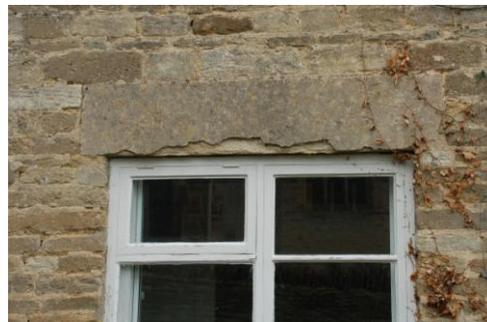
Those on the downstairs windows are thicker and in a shorter single piece, with etched lines to suggest jointing – the soft stone is beginning to flake. The pictures above show the right-hand windows, but those on the left are similar. The central front door and its canopy, and the windows themselves, all appear to be relatively modern. A modest string course of cut stones just below the upstairs windows is the only decorative element.

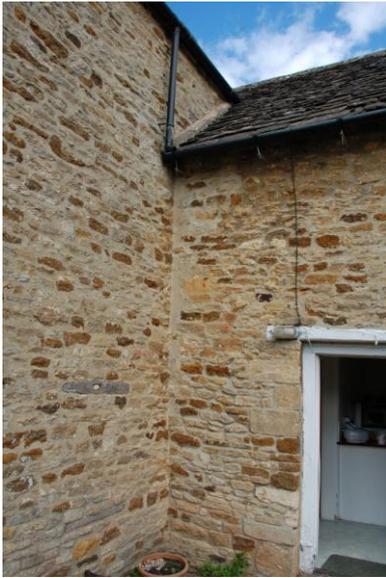
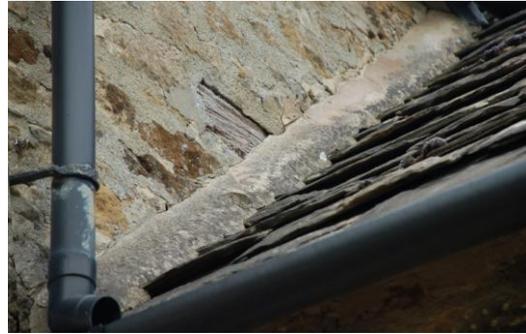
The rearward extension is butt-jointed to the main block, and its roof-line cuts across a timber inserted into the latter's rear wall (see below) – both suggesting that it was added later. However, since the style of the stonework is similar, it seems likely that this was done at an early date, but it is possible it replaced an earlier short extension designed simply to enclose the stairs to the cellar and upper floor, which lie beyond the rear wall of the main block.

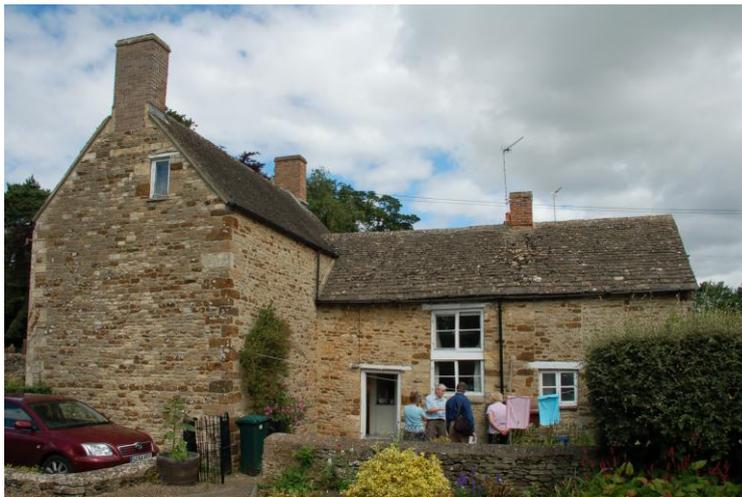
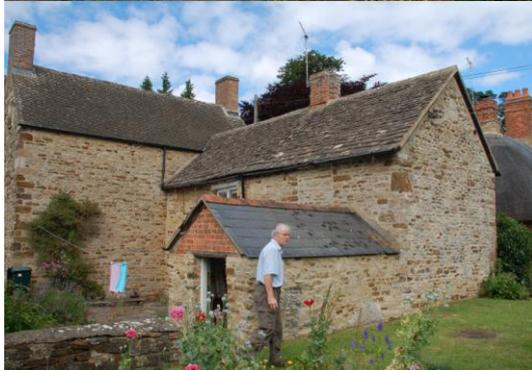
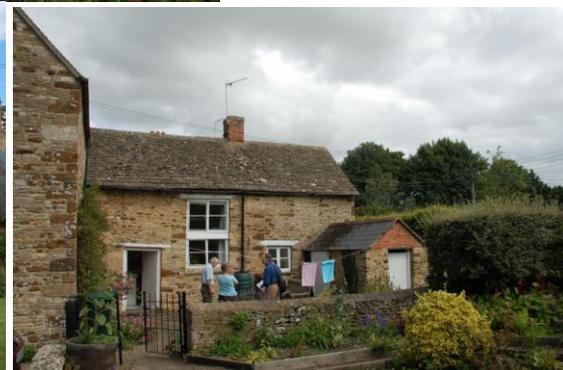
The extension proper evidently terminated with a rear wall in line with the existing chimney, and there is a distinct line of ironstone ashlar blocks in the south wall at this point, similar to those at the SE corner of the main block. However the building continued beyond this point in the form of a small stable block with a hayloft above.

The ground floor of this further extension has now been converted into a bathroom, with a window replacing the earlier doorway. (The left-hand end of its rough wooden lintel set oddly between two of the ashlar blocks). The loft window-opening has been blocked in, but its outline is still visible just left of the roof to the outside privy.

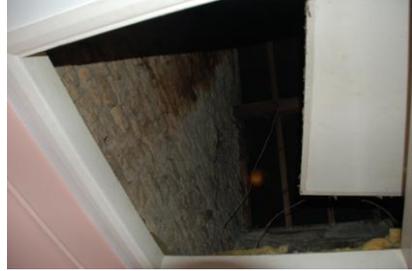
Again it is difficult to be certain this *was* a later addition – the roof shows no sign of alteration at this point, and the rear wall of the house, seen through a ceiling access panel, does not appear to have been fully pointed to make it weatherproof (although this is not very clearly shown in my photo).

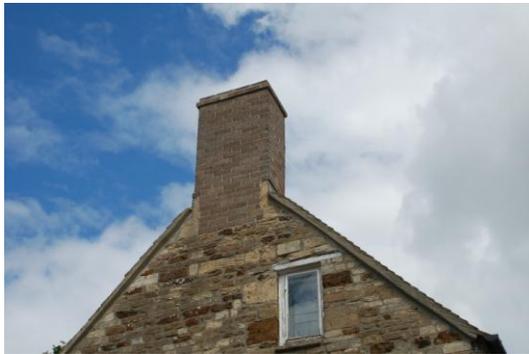
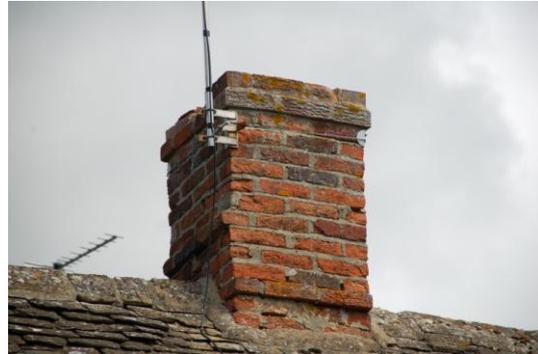
The two chimneys of the main building are in modern textured brick, but the extension chimney is in attractive old red brick, now rather weathered:

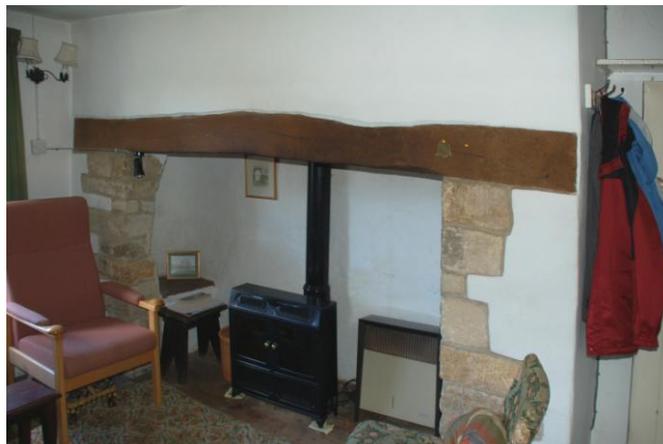
The principle downstairs room has a stone-flagged floor, and a broad open fireplace with twin inglenooks. This has been reopened in recent times after numerous vicissitudes.

Andrew Johnston remembers it in his grandparents' day having a black-leaded range or enclosed fire in the middle, flanked by cupboards on either side (inside the stone supports which were not then visible). He believes the stonework and the rather clean-

looking beam to be original, although it is less blackened than one might have expected. If it ever functioned as a cooking fireplace before the rear extension was added, there is no surviving evidence.

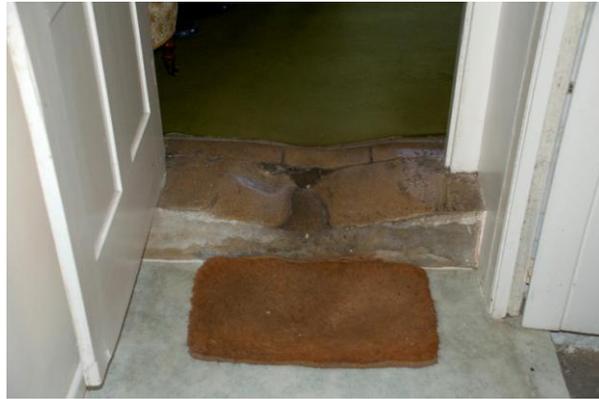
The heavily-worn stone threshold under the door leading in to this room from the rear extension is a notable feature. The front door also opens directly into this room, which therefore occupies more than half the downstairs area.

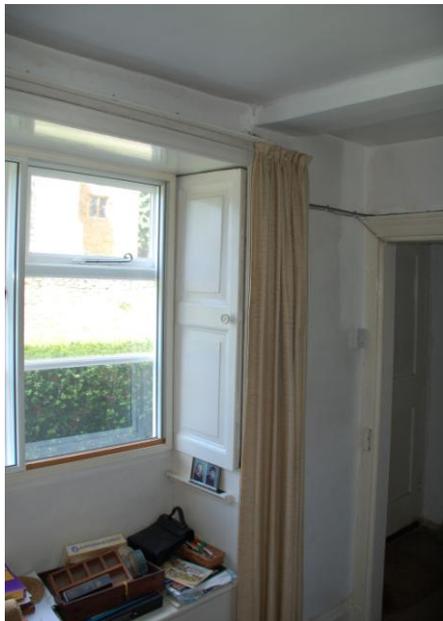
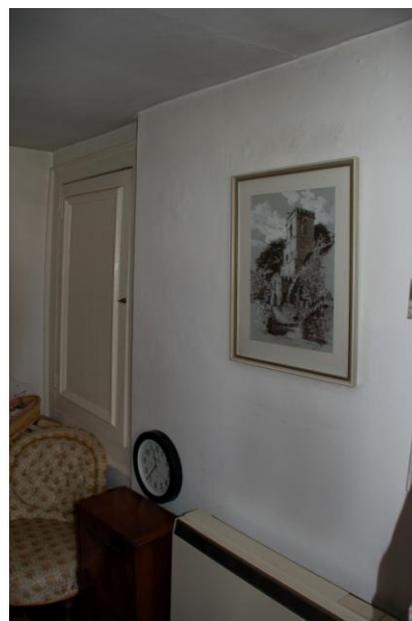
A door left of the front door leads into a smaller room lit only by a single window at the front. Like the window in the main room, this preserves its old shutters, which are scheduled – they cannot be closed, however, owing to the double-glazing units inserted to alleviate aircraft-noise from the former airbase at nearby Upper Heyford.

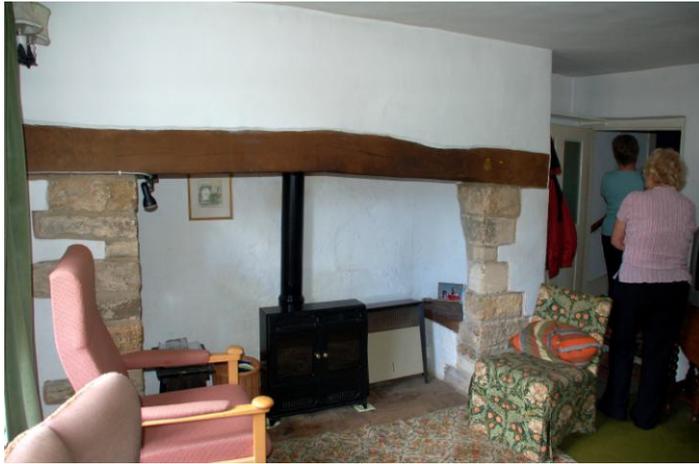
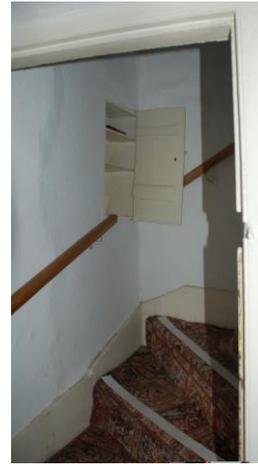
To the right of the fireplace in the main room, a door in the back wall leads into a narrow stairwell with a turn near the bottom, and an old wall-cupboard above.

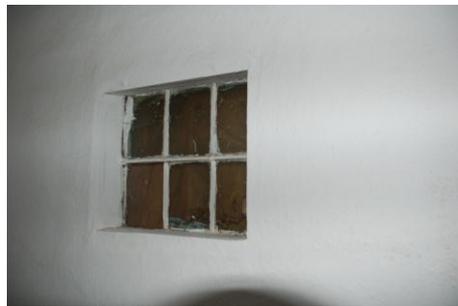
The stairs were once lit by a small window borrowing light from the upper floor of the rear extension. This ancient piece of glazing (possibly the oldest in the house) is now blocked on the extension side:

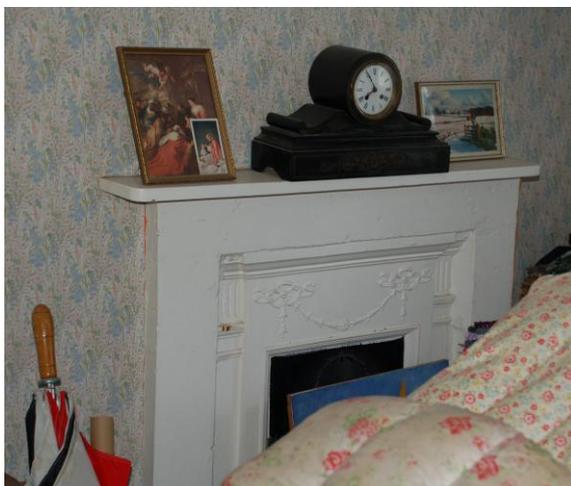
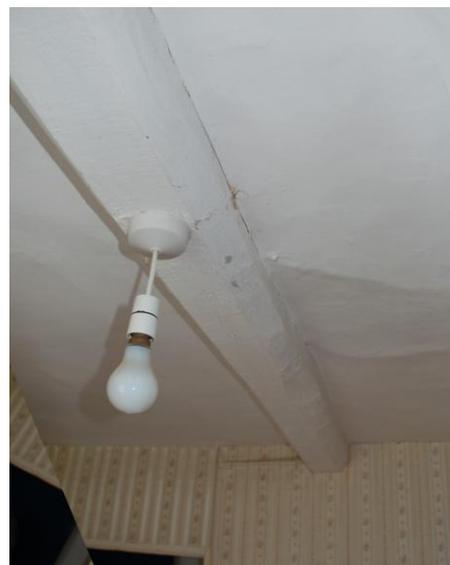
The two bedrooms in the main block have few noteworthy features. Any sign of a fireplace in the north bedroom is concealed by fitted furniture. The south bedroom has a Victorian iron fireplace in suitably classical style let into a plain fireplace which may be older, and originally an open fireplace. The north bedroom has a beam partly chamfered and partly showing the original surface where the bark has been stripped off:

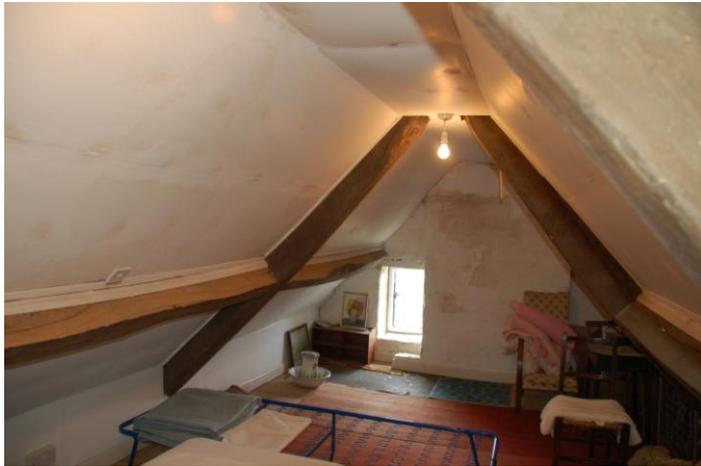
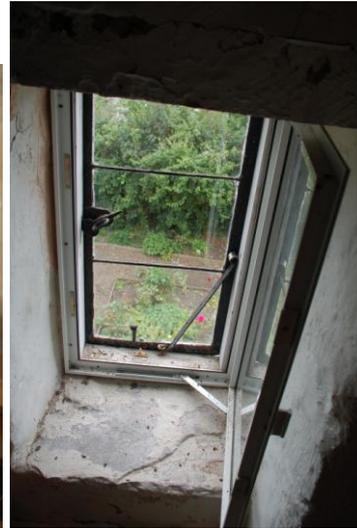
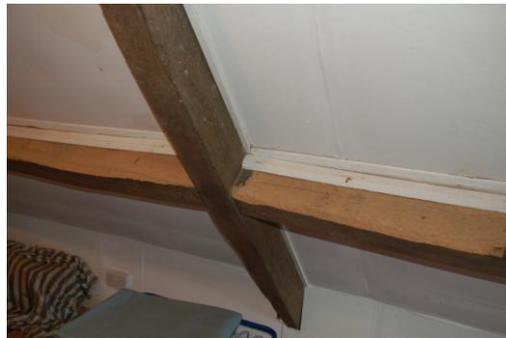
A further flight of stairs leads to an attic space running the length of the main block. This has been in use for many years, judging by the window at the southern end, tucked in beside the chimney.

An unusual feature is the way the purlins are butt-joined within the rafters.

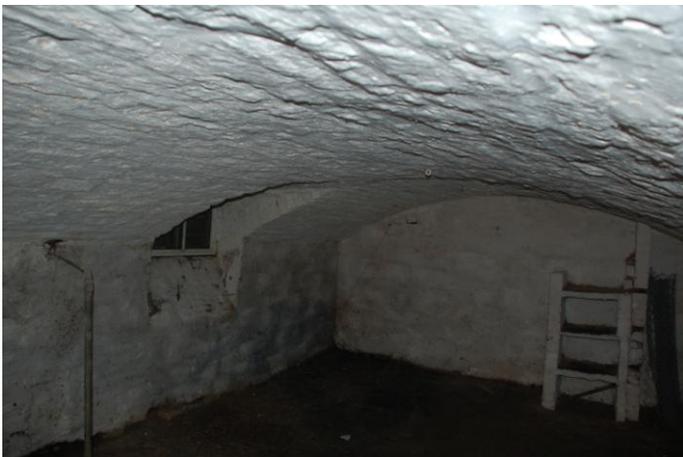
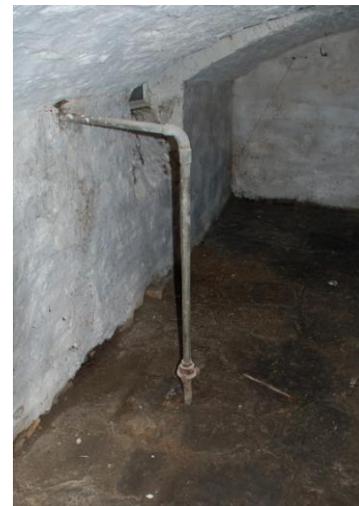
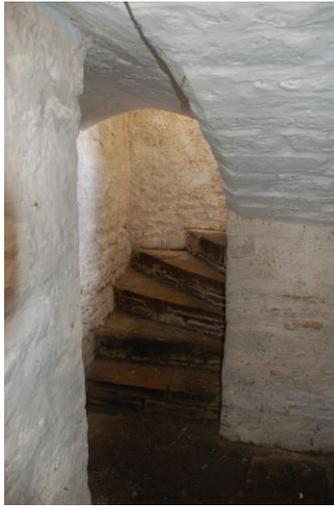
A barrel-vaulted cellar runs the full length of the main block fronting the road. It has a rough stone floor with a capped well half-way along the back wall from which a pipe leads to a (now disused) pump in the kitchen. Beyond it, a window provided some light from the back yard. A small brick and slate rack at the far end provided some cool storage, perhaps for dairy products.

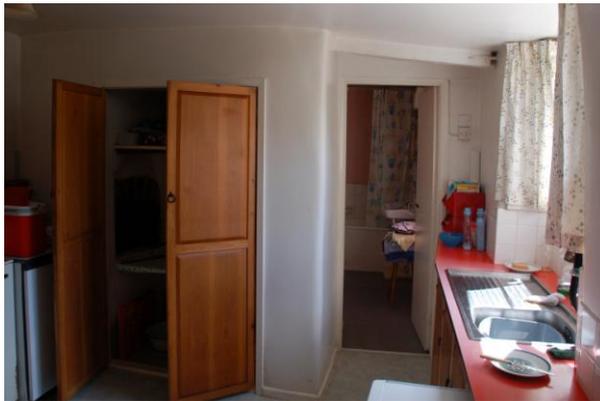
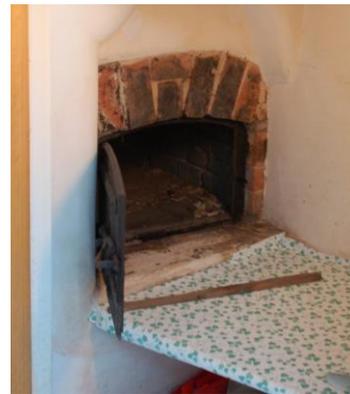
The cellar is reached by a stone stairway directly below the upper stairs, and accessed by a door from the rear extension, to which we now turn. Its function was clearly to provide the cottage with a more ample kitchen, and in earlier years its end (east) wall beneath the back chimney was formerly occupied by a kitchen range in a recess. Originally the recess would presumably have been an open cooking-fire with spits etc. When this space was converted in recent times into a deep cupboard, a substantial brick and iron baking oven was uncovered on the left side of the recess:

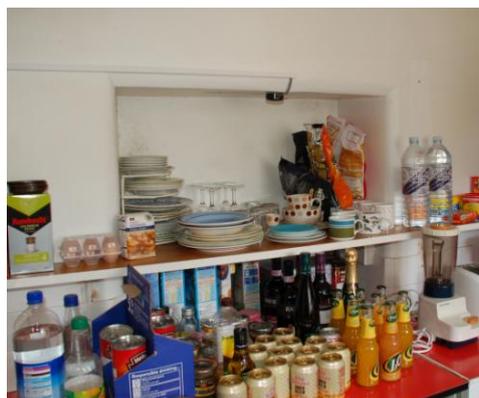
At the same time a large opening was created to the right of the cupboard/range area giving access to the former stable, which was converted into a bathroom. Another notable old feature is a shallow recess in the left-hand side wall of the kitchen, opposite the window, which no doubt originally housed a wall-cupboard:

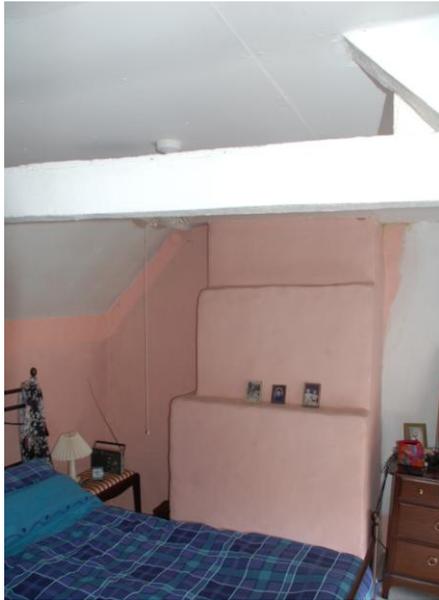
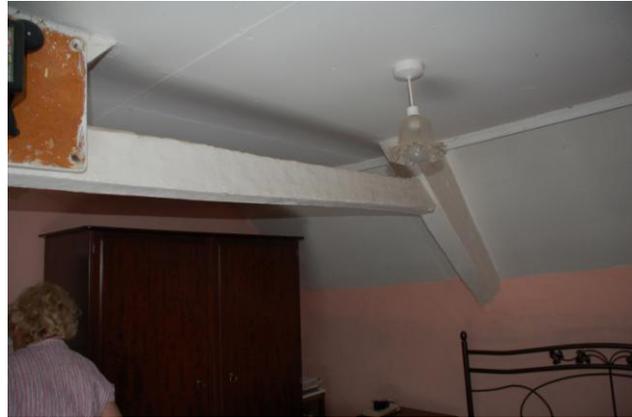
Despite its rather limited headroom, the loft area over the kitchen has long since been converted into a bedroom, accessed from the top of the main staircase. Apart from the exposed rafters, the most striking feature is the stepped chimney-stack at its far end, the brickwork plastered over. This would have radiated considerable heat when the range was alight. It seems unlikely it ever included a fireplace, and this was confirmed (as far as possible) by tapping.

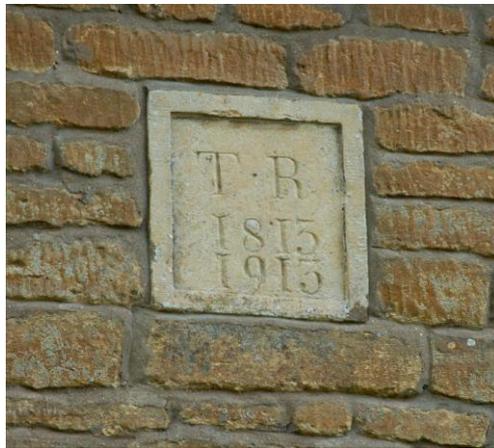
2) Fir Cottage has a plaque on the façade, inscribed TR 1813: the initials TR may well prove to be those of an earlier member of the Rogers family. (The date 1913 has also been squeezed in along the lower edge of the plaque, no doubt to indicate a rebuild – maybe the human remains were discovered during this operation).
