Bat Assessment
Initial Bat Survey & Roost
Characterisation Surveys

Stable block at
5 The Colony
Sibford Gower
OX15 5RY

(Revision A – 20th September 2018)

2017-03(08)

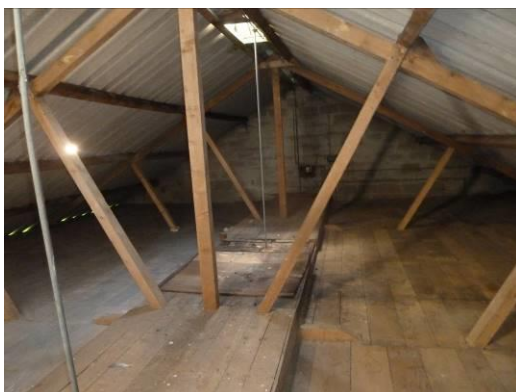
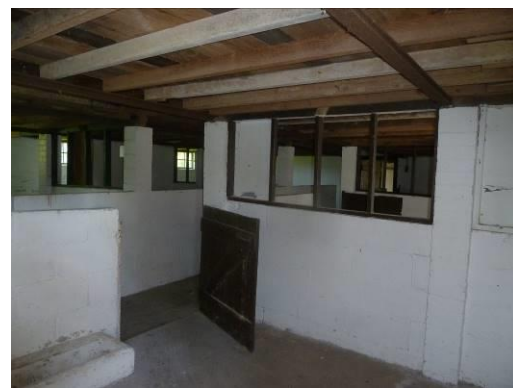
The former stable building occupied a broadly rectangular footprint and was constructed in blockwork with a gabled roof covered with asbestos cement sheeting. The underside of the roof did not benefit from any lining and no insulation was present at ceiling level. A separate roof void was present above the stable cells and was accessed via a permanent opening in the ceiling. No ridgeboard was present at the apex of this roof, although timber purlins were present throughout, and there was light spill from numerous places. Timber ceiling joists were exposed on their underside at ground floor level and timber king posts and purlins were visible in the roof void.

The ground floor of the barn was separated into cells via blockwork dividing walls but with flighted access possible throughout. The floor was finished with concrete and searching for evidence of bats was straightforward.

*Roof void**Ground floor showing flighted access and concrete floor*

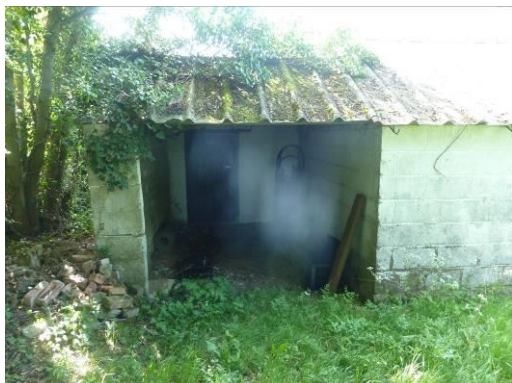
Bats could access the building via a permanently open doorway on the west elevation, via gaps at the eaves and via gaps at the roof apex. A small section of the stable building at the north-east corner was open-fronted and access was possible into the main stable building via a gap where the ceiling joist entered the blockwork wall. An active blackbird nest was recorded in this section during the initial inspection.

*Open-sided access with black bird nest*

- Evidence of an active blackbird nest was recorded during the surveys. The building should therefore be **surveyed for nesting birds** within two days prior to commencement of disturbing works by a competent person. Birds typically nest between March-September inclusive. If evidence of nesting birds is found at this time, no works should be undertaken that may cause disturbance until after all the chicks have dispersed.

An open-fronted bird box, such as that illustrated below, would be suitable for use by blackbird and should be erected on the eastern elevation of the converted building, perhaps under the eaves of the porch.

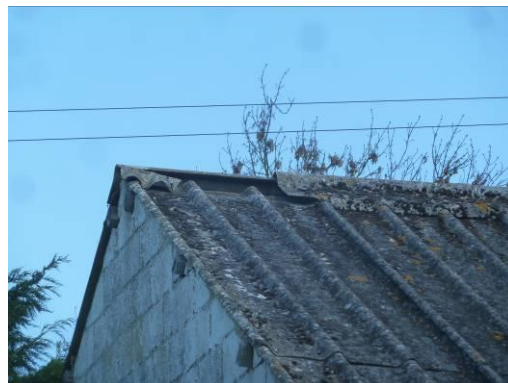
*Access at ridge*

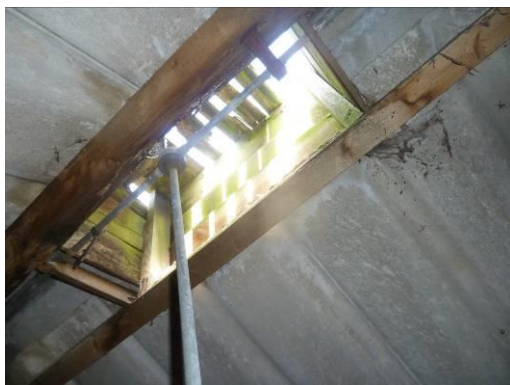
The roof void was noticeably warmer than the ground floor, although the open air vent in the roof in the centre of the roof as well as other gaps where the asbestos sheets met resulted in the void being fairly light and a little draughty. A far more sheltered area for roosting bats was against ceiling joists on the ground floor.

*Open air vent in roof*

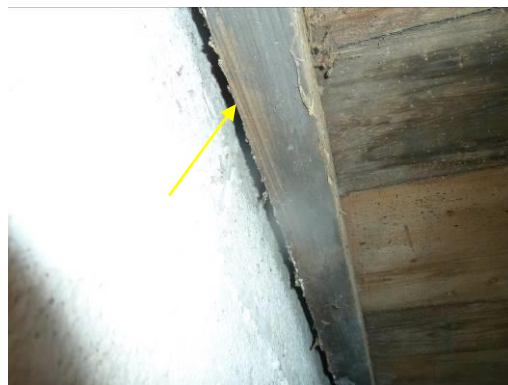
Internally, the gable ends and where the purlins met the blockwork were all well sealed, providing little roosting opportunities for bats on top of the gable walls, albeit gaps were present around these purlins on the external side of the gable walls. If there were gaps in the top of the breeze blocks, this could provide roosting opportunities for small numbers of crevice-dwelling bats

*Roosting opportunity between wall and ceiling*

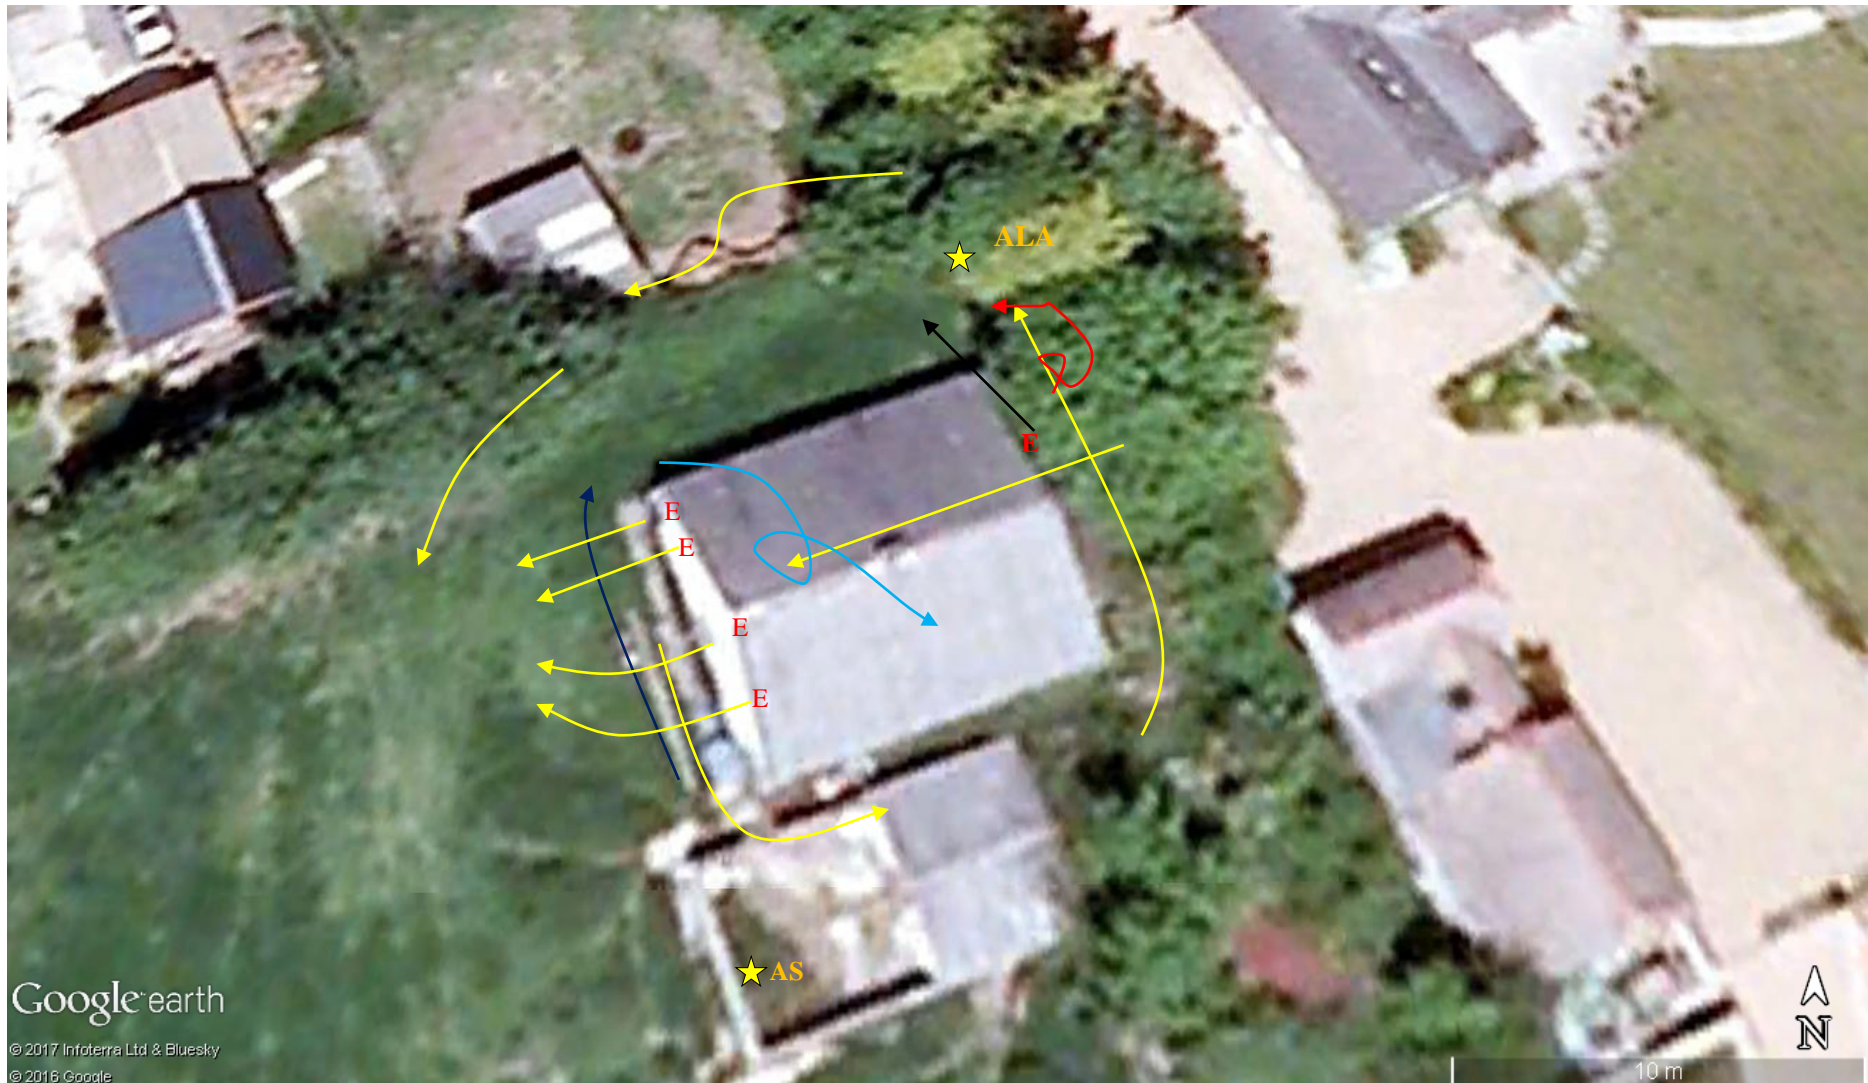
Two indeterminate, silent bats were seen to emerge from the open-fronted section of the north-east part of the building at 21:23 and 21:30hrs. The second bat emerged and re-entered the section of the building several times before flying off, presumably light-sampling. A lesser horseshoe was also recorded flying in and out of this section of the building at the very end of the building before flying off. Additionally, the occasional brown long-eared bat pass was noted during the course of the survey and both this species and lesser horseshoe can easily be missed by a bat detector if the bat does not fly past very close to the surveyor or the detector is not tuned appropriately. No other lesser horseshoe passes were recorded during the survey. Lesser horseshoe are considered uncommon but widespread in the county, whilst brown long-eared bats are common and widespread, according to Oxfordshire Mammal Group.

Four bats were seen to emerge from gaps next to the purlins on the western gable end with one bat emerging from each of the purlin gaps. Three of these bats were confirmed as common pipistrelle at 21:19, 21:22 and 21:27hrs whilst the fourth bat (pipistrelle in size and flight) was observed emerging at 21:25hrs but was silent.

Bat activity levels were high for the duration of the survey with frequent foraging and common pipistrelle recorded all around the building with later occasional passes by a *Myotis* bat and a brown long-eared bat, all of which were observed flying past or over the building and were not considered to have emerged.

No bats were seen to enter or emerge from the open doorway of the building; as such, it is considered that perhaps the building is used as a feeding perch during the course of an evening (either by brown long-eared or lesser horseshoe bats) as an updated internal inspection of the building prior to the start of the dusk survey and again at the end, revealed no roosting or active bats.

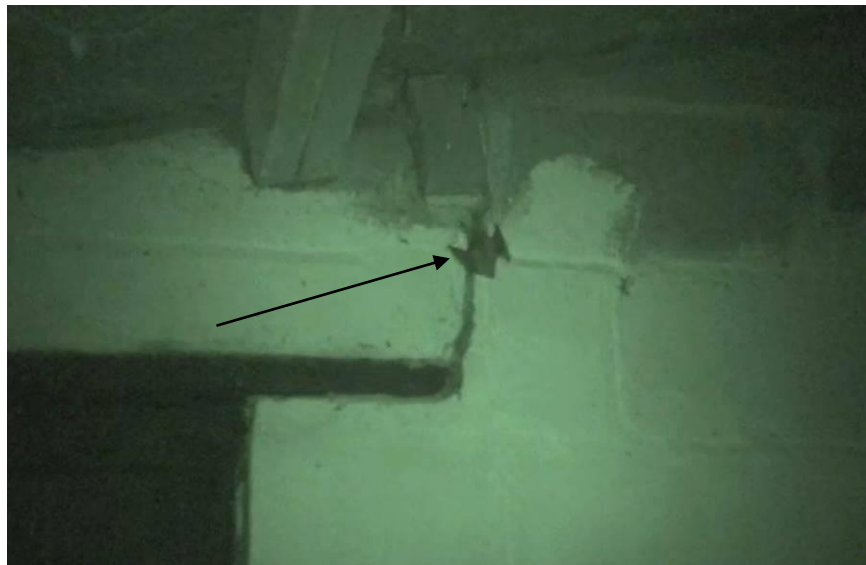
During the dawn re-entry survey on 9th June, a good amount of bat activity was recorded, with five species identified. There were numerous passes by common pipistrelle and brown long-eared bats foraging and commuting along the boundary vegetation. A single common pipistrelle entered a roost in a purlin on the western gable end at approximately 45 minutes before sunrise. At the same time, a brown long-eared bat entered the barn on the open-sided extension at the north-eastern corner. This bat was also detected by the night-vision camera and revealed the bat to land on the wall and crawl into a crack in the wall to roost.

BLE landing on wall before sunrise and entering building through the crack in the wall

A permanent replacement roost for the single brown long-eared bat roosting in the crevice in the wall of the open-fronted section of the existing building will be provided by way of 1x Build-in WoodStone bat box located at the eaves on the eastern elevation of the proposed dwelling (to replicate the existing crevice this bat has been using). This will replicate as closely as possible the location and orientation of this roost.

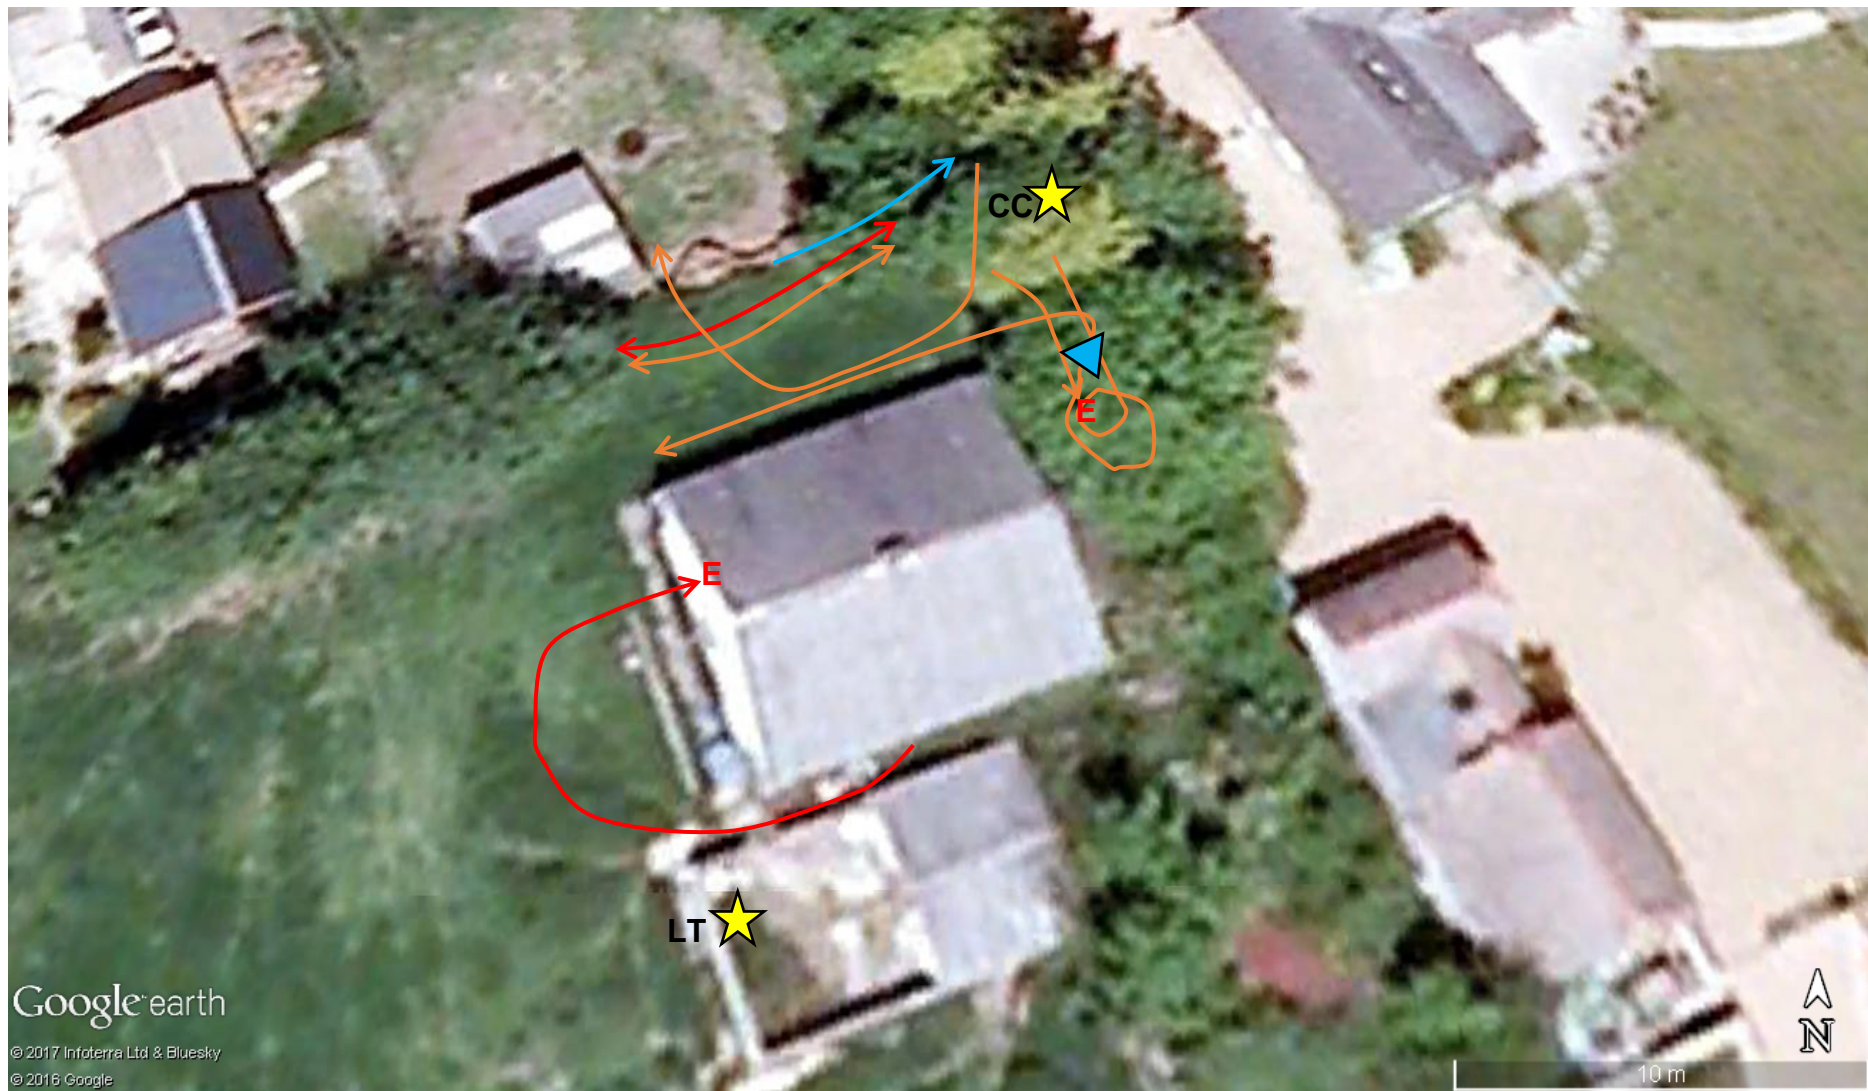
Figure 4: Bat Activity Map – Dawn 9th June 2017

Dawn results summary: day roost of 1 brown long-eared and a day roost of 1 common pipistrelle recorded.

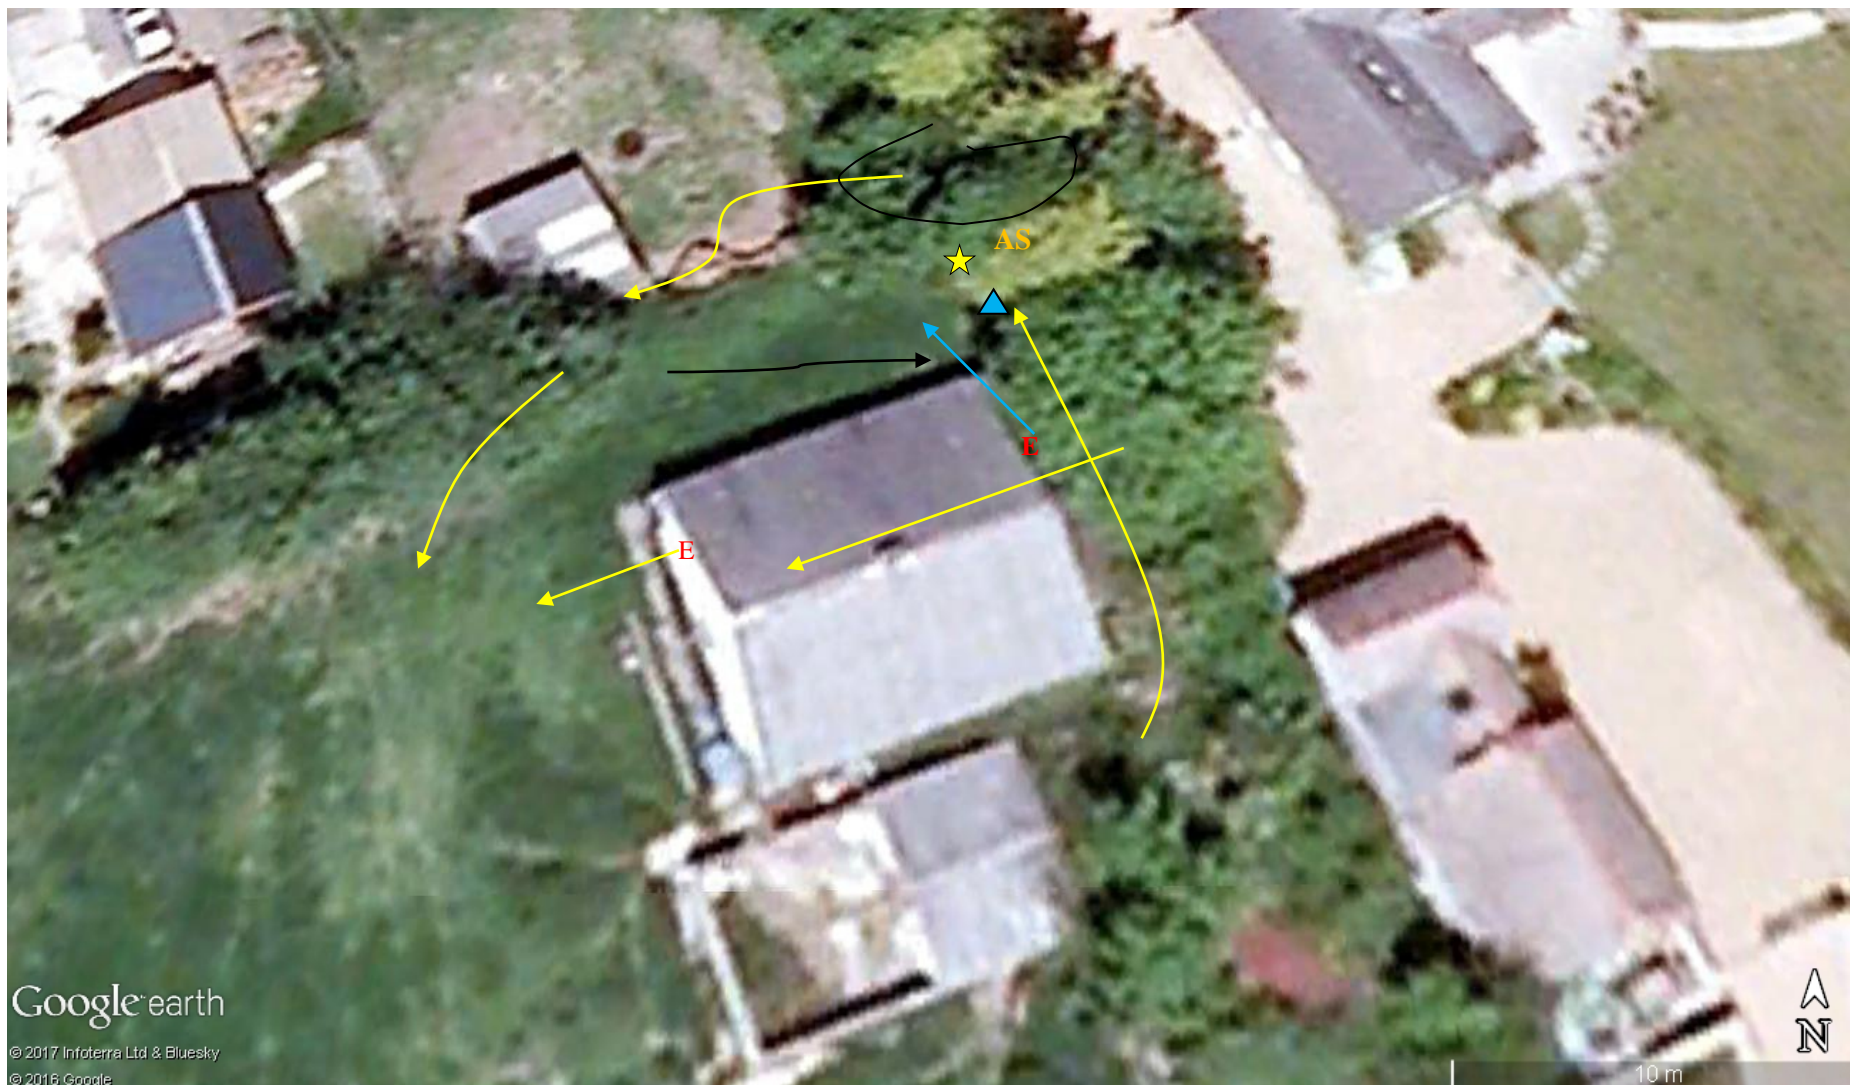
At 22:03hrs, some 34 minutes after sunset, a brown long-eared bat was observed emerging from the open section of the building. This was confirmed by the Anabat and by the night vision camera.

At 22:23hrs a brown long-eared bat was observed flying next to the open section of the building a couple of times before flying off. This was not detected by the night vision camera, as such the bat was not hanging up to feed.

Second dusk results summary: day roost of 1 brown long-eared bat and a day roost of 1 common pipistrelle recorded.

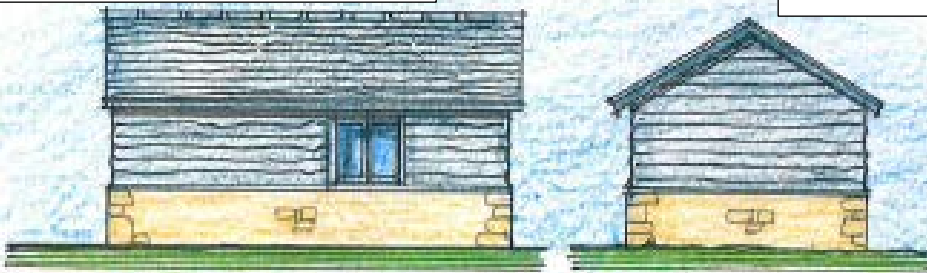
Garden store bat mitigation

Flighted bat access. Hole measuring 300mm x 300mm for use by brown long-eared and lesser horseshoe

No pre-fab trusses used in roof construction. Needs to be uncluttered for use by bats.

Roof underlined with type 1F bitumen felt OR timber sarking but no use of breathable roofing membrane here

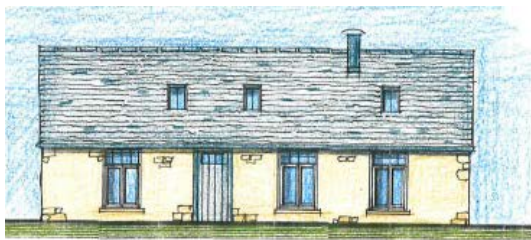
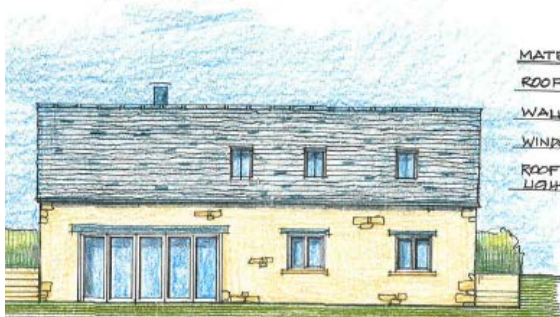
Proposed dwelling bat mitigation

2x Build-in Woodstone bat box for pipistrelle
