Preliminary Environmental Risk Assessment

Proposed Residential Dwellings at Land South of Camp Road

November 2016

Waterman Infrastructure & Environment Limited

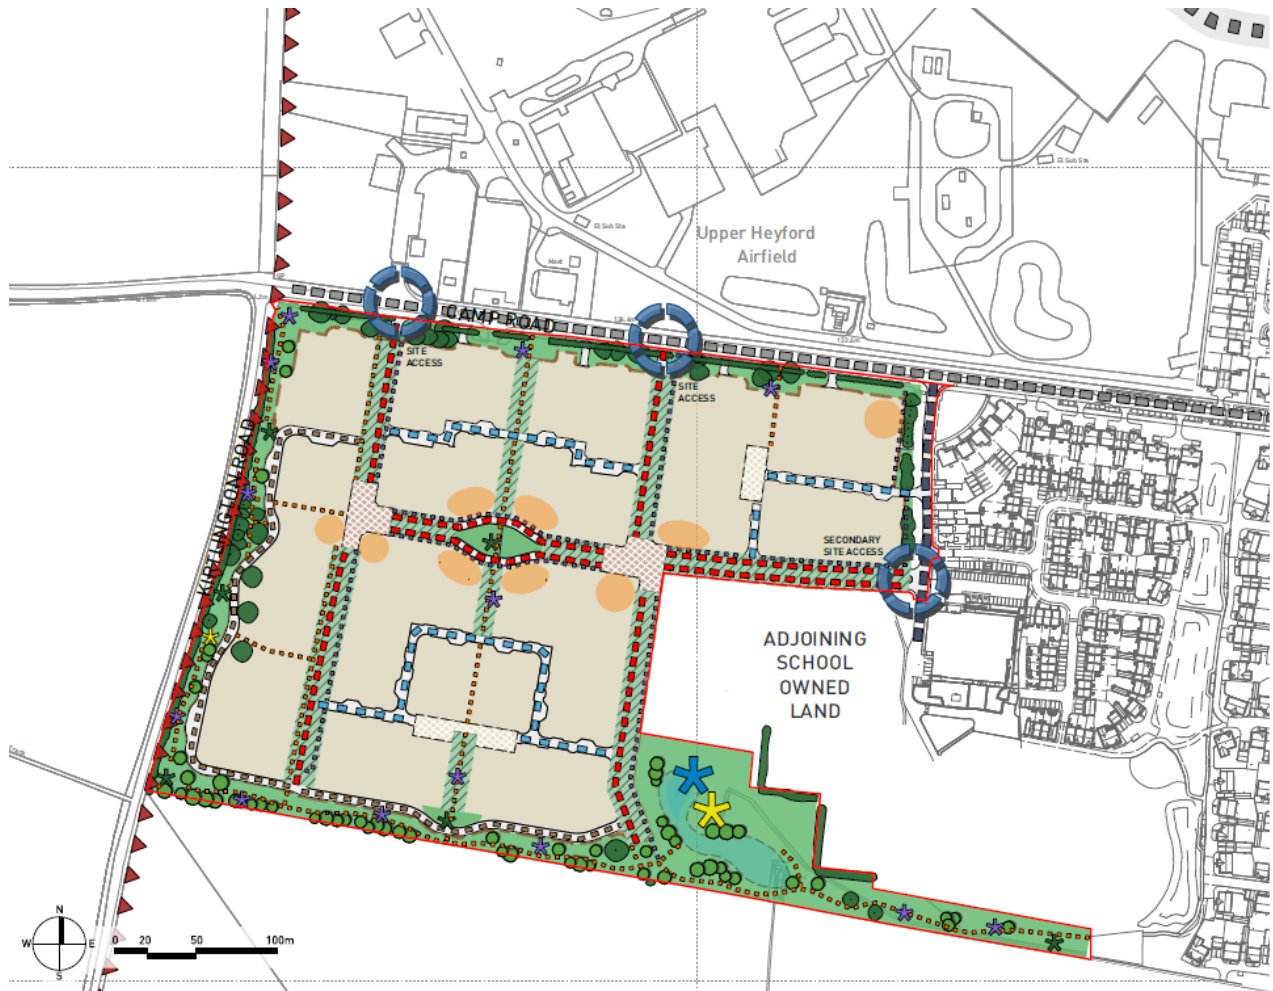
Figure 1: Current Application Site Layout shown by Red Line.

The Application Site is located within Former RAF Upper Heyford to the south of Camp Road. When Former RAF Upper Heyford was occupied by the United States Air Force (USFA) during the 1960s/1970s, the Application Site was converted to provide housing for service families. The accommodation was eventually refurbished (according to historical maps in 1974 to 1976), turned into a secondary school with accompanying baseball courts, and grassed areas. Currently the former school on the Application Site is disused and in disrepair.

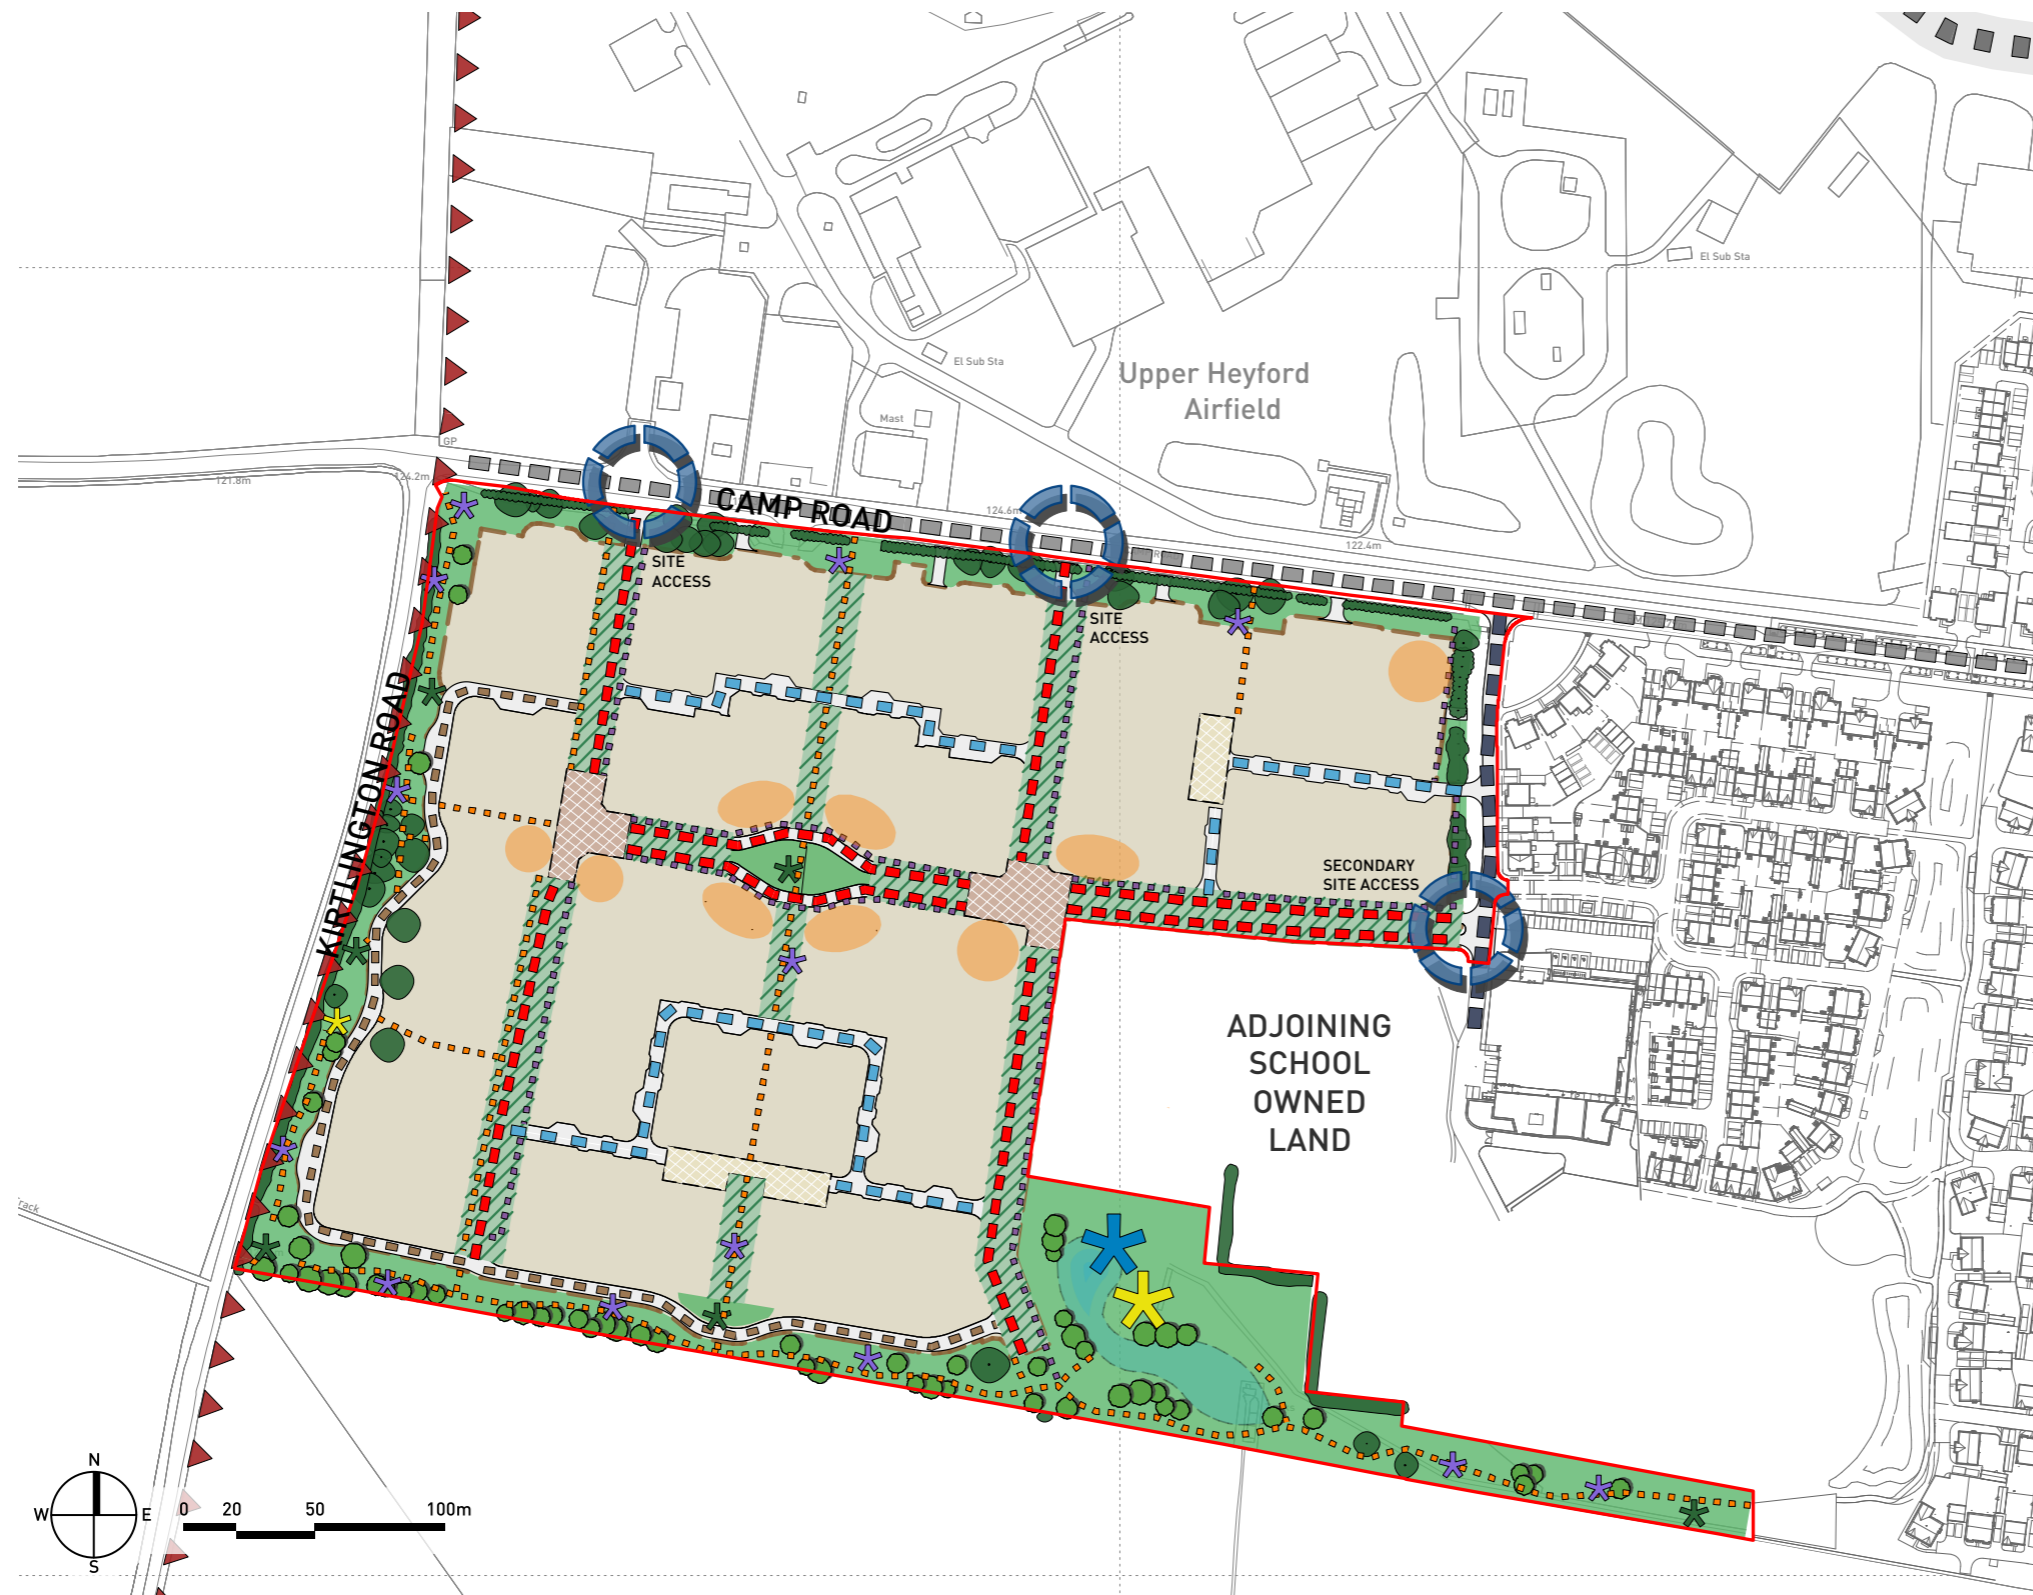
Project Details	WIB14371-100 Upper Heyford - Land South of Camp Road
Figure Title	Figure A2: Site Plan
Figure Ref	WIB14371-100_GR_PERA_A2D
Date	November 2016
File Location	\\nt-lncsl\weed\projects\lead14371\100\graphics\pera321\issued figures

- KEY:**
- APPLICATION AREA (12.04HA)
 - RESIDENTIAL LAND USE (8.90HA INC. GREEN CORRIDORS)
 - PUBLIC OPEN SPACE PROVISION (ALLOTMENT PROVISION ASSUMED OFF SITE. INCLUDES ATTENUATION AREA) (2.90HA)
 - ACCESS POINTS
 - CAMP ROAD
 - IZZARD DRIVE
 - PRIMARY SPACE
 - SECONDARY SPACE
 - PRINCIPAL ROUTE
 - MEWS / SHARED SURFACE
 - LANE
 - CYCLEWAY
 - PEDESTRIAN FOOTPATH
 - GREEN CORRIDIOR
 - NEIGHBOURHOOD EQUIPPED AREA OF PLAY
 - LOCAL EQUIPPED AREA OF PLAY
 - LOCAL AREA OF PLAY
 - TRIM TRAIL
 - EXISTING PORTWAY ROUTE
 - EXISTING VEGETATION TO BE RETAINED
 - INDICATIVE ENHANCEMENT VEGETATION
 - ATTENUATION POND
 - 3 STOREY DWELLINGS TO BE CIRCA 13M HEIGHT ABOVE FINISHED GROUND LEVEL THE REMAINDER WILL BE 2/2.5 STOREY DWELLINGS AT UP TO CIRCA 11.5M HEIGHT ABOVE FINISHED GROUND LEVEL

NOTE:
GROUND LEVEL ALLOWS FOR MAXIMUM 2M +/- EXISTING GROUND LEVEL. THIS ESTABLISHES APPROPRIATE DRAINAGE, BALANCE CUT & FILL AND BUILDING/ROAD ALIGNMENT TO CONSISTENT LEVEL.
