# Bicester Office Park

## Environmental Impact Assessment

### Volume 2: Technical Appendices

Prepared for:  
Scenic Land Developments Limited

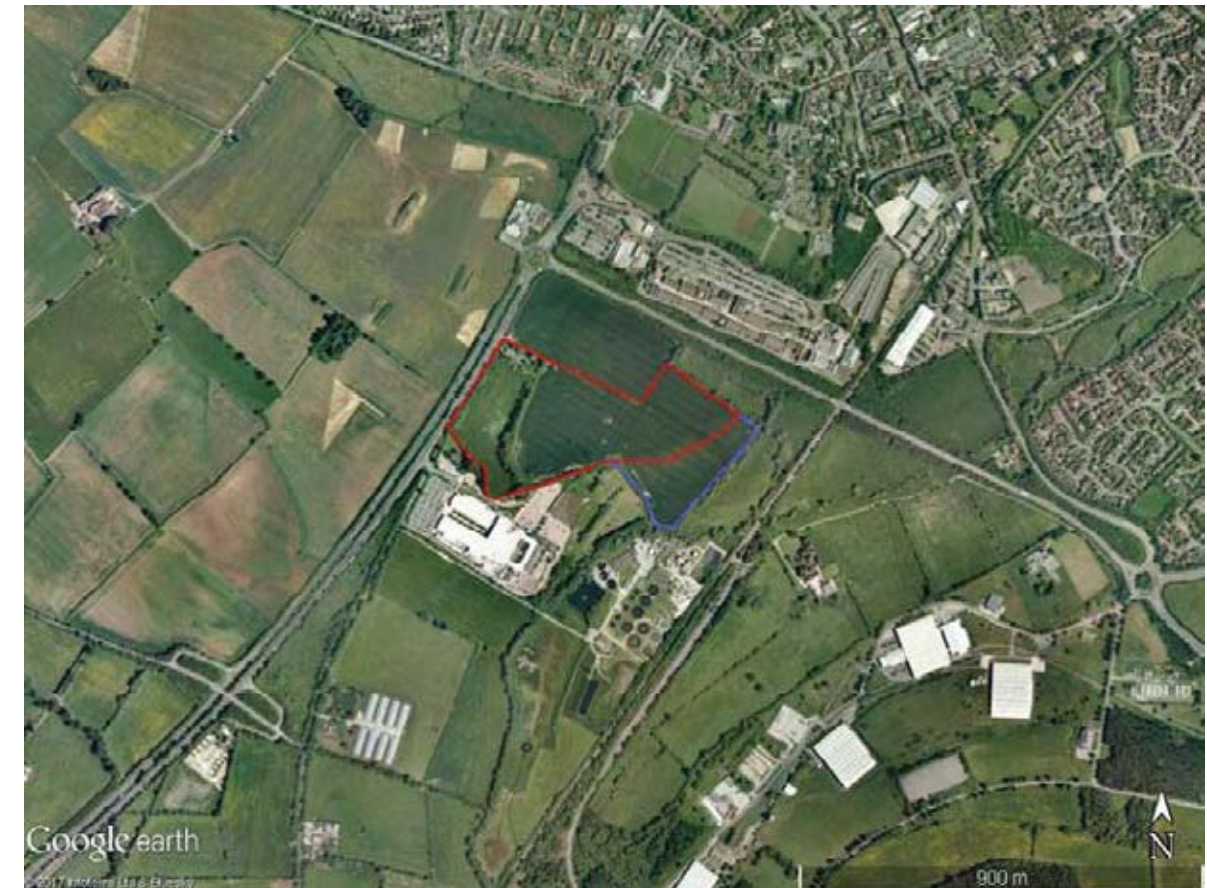
**Plate 1**  
**Aerial Photograph**

Plate 1, an aerial photograph of the Site, shows the Site in context with the surrounding landscape. Note that this landscape has changed since the image was taken and does not include the housing estate to the west or the supermarket to the north.

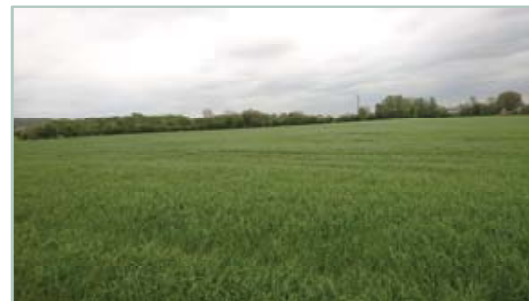
**Plate 2**  
**Semi-improved grassland**

Part of the Site (in the south-west) can be seen on aerial photos as a rough grassland, but this has been incorporated into the arable field.

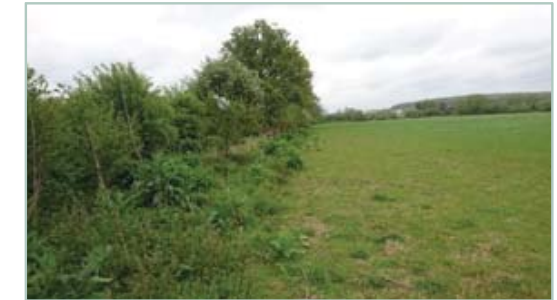
**Plate 3**  
**Arable margin**

The grassland is dominated by meadow fescue and includes a range of common flowering species such as lesser burdock, spear thistle and cleavers. The margins of the area recently taken into arable management is more diverse and includes species associated with woodlands and hedgerows such as Lords-and-Ladies and cow parsley. In the north east of the Site the margins include an unusual amount of comfrey.

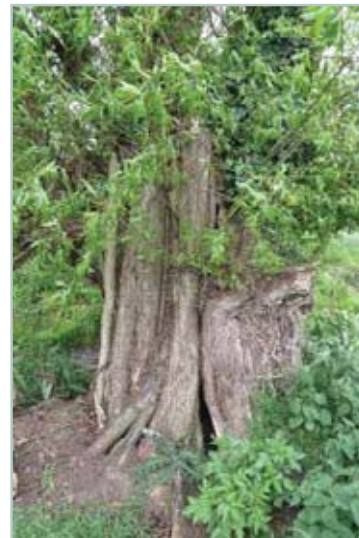
**Plate 5  
Willow (G4)**

Some of these are suitable for roosting bats, such as the pollarded willow pictured, which has a large hollow at the base, creating a cavity.

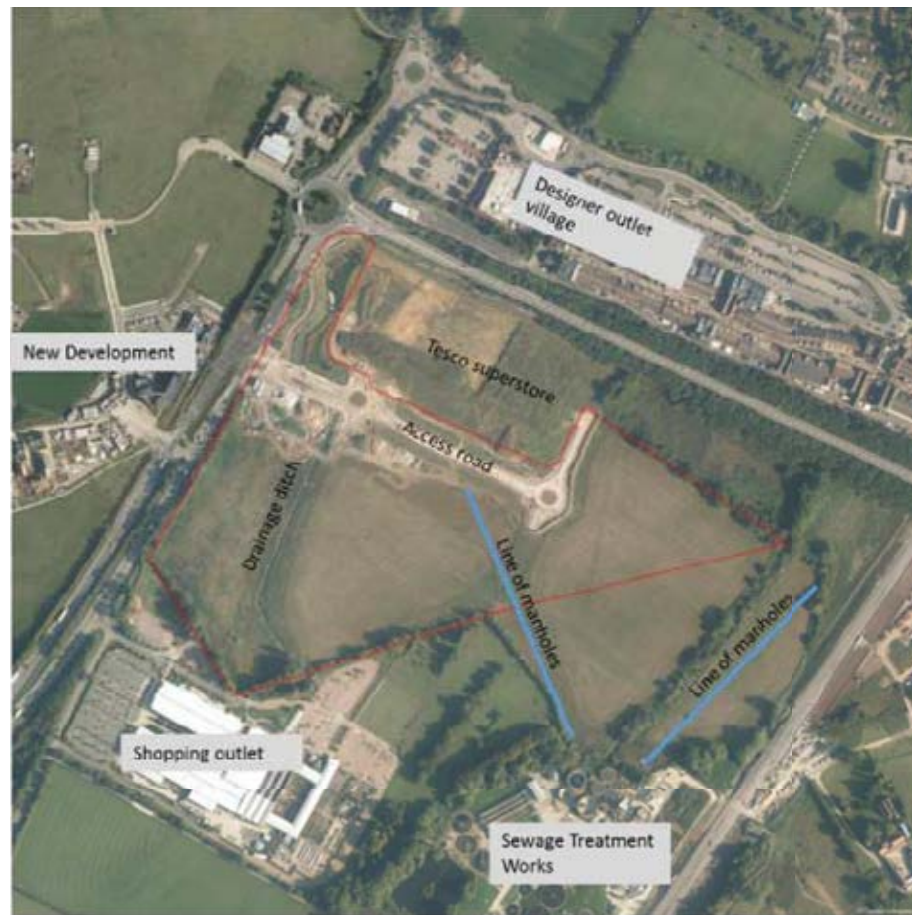
Figure 2-1 Annotated aerial photograph (base photograph dated 2015)

A site walkover was undertaken on Wednesday 15<sup>th</sup> March 2017. Further details are below and with an annotated aerial photograph as Figure 2-1.

The site is located within the southern conurbation of Bicester. The site is generally flat, with a slight drop to the south and east. The access is along an access road in the west, the south of this access road is bunded (northern boundary of the agricultural fields). This bund is between 1.5m and 2m. A surface inspection of the bund indicates that it is likely constructed with site won material.

Access to the site is along an access road to the west. In the north, and north of the access road, is a manmade pond with associated landscaping. Along the south of the access road is a 1.5m to 2m high bund (Section 2.1.1). The majority of the site is south and east of the access road and comprises open agricultural land. There was both evidence of grazing (fencing) and cultivation (shallow plough ruts). A drainage channel runs north / south, from the access road to the southern boundary, along the north of the drainage channel – near the access road – is an area used for material storage. This area had plastic and concrete pipework, gravel and wood chippings. Two heaps of wood, comprising tree branches and timber up to 3m high, are in the south of the site. In the central and southern areas of the site is a line of manhole covers (Figure 2-1), these appear to flow to the adjacent sewage treatment works (Section 2.2). Around some of the manhole covers were wet wipes, indicating that these locations have been blocked and cleared out (and possibly overflowed).

No natural surface water features are present on site, however a manmade ditch runs north / south in the west of the site (see Figure 2-1). Adjacent to the south and the east of the site are drainage ditches, as shown in Figure 3-3 as light blue features. These are minor tributaries of the larger river (Lanford Brook – dark blue in Figure 3-3).

A series of manholes were present across the central and southern areas of the site as detailed in Section 8 and present on Figure 2-1. These flow to the sewage treatment works about 200m south of the site.

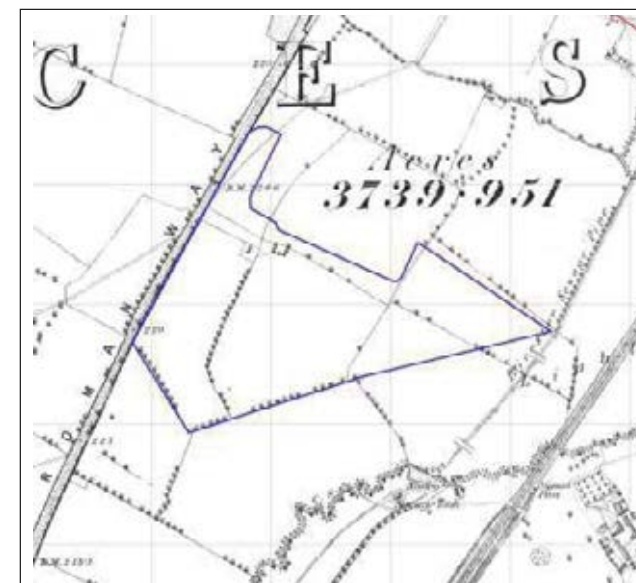
Figure 4-1 Extract of the 1880 map

Prior to 1880, the site was agricultural land with field boundaries throughout the site. Of particular interest is the western field boundary, which remained constant throughout the mapping and is now the drainage ditch running through the site. A single, small building was present in the west of the site (Figure 4-1). Prior to 1898, a second small building has been constructed in the west of the site. These buildings were removed by 1950. Prior to 1985 two different buildings were constructed in the west of the site and a new drain had been laid in the central to the site running north / south, and by 2002 a third building had been constructed (Figure 4-2). This layout was present up to and including the 2014 map.

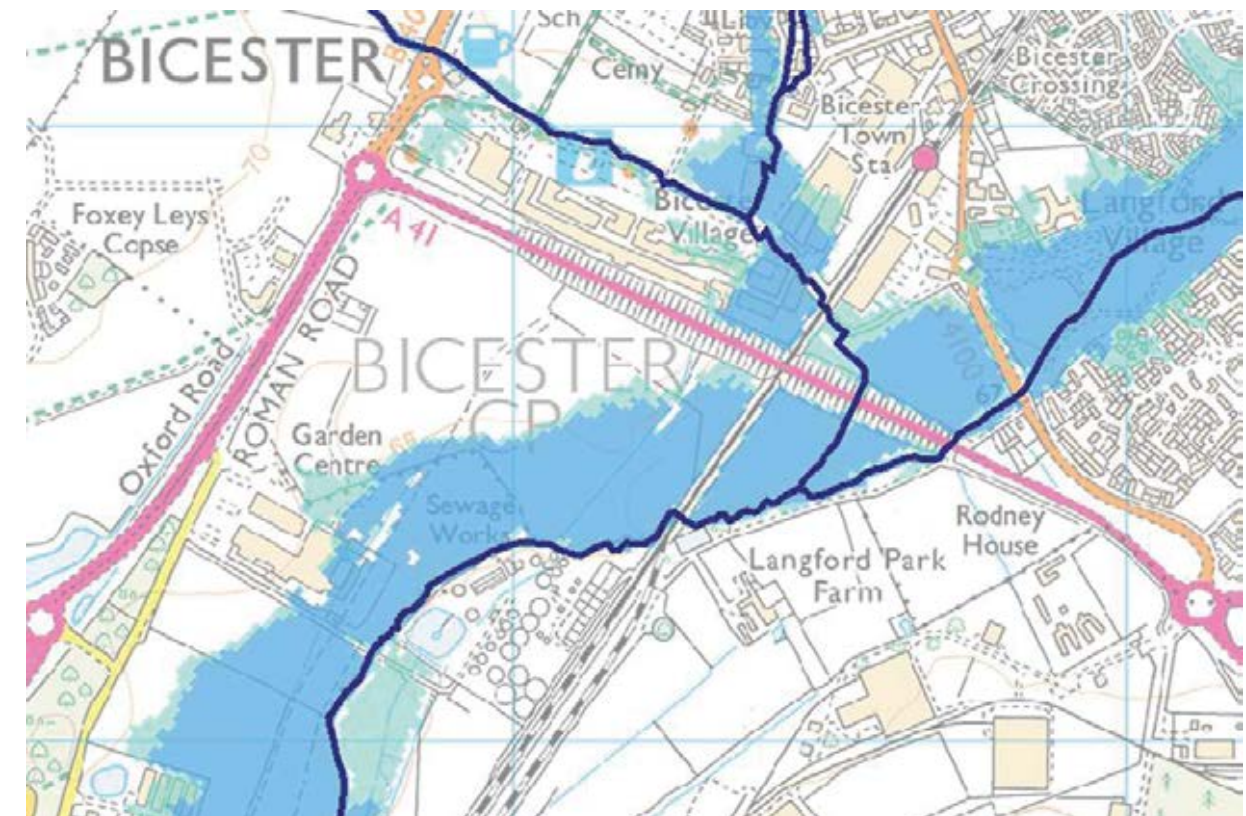
The dark blue area is zone 3 and light blue zone 2. All other areas are within zone 1. It should be noted that the whilst the EA regularly update the flood maps the boundary between the zones are approximate and tend to be conservative. A flood risk assessment that will be required in support of a revised planning application would identify the zones more accurately.

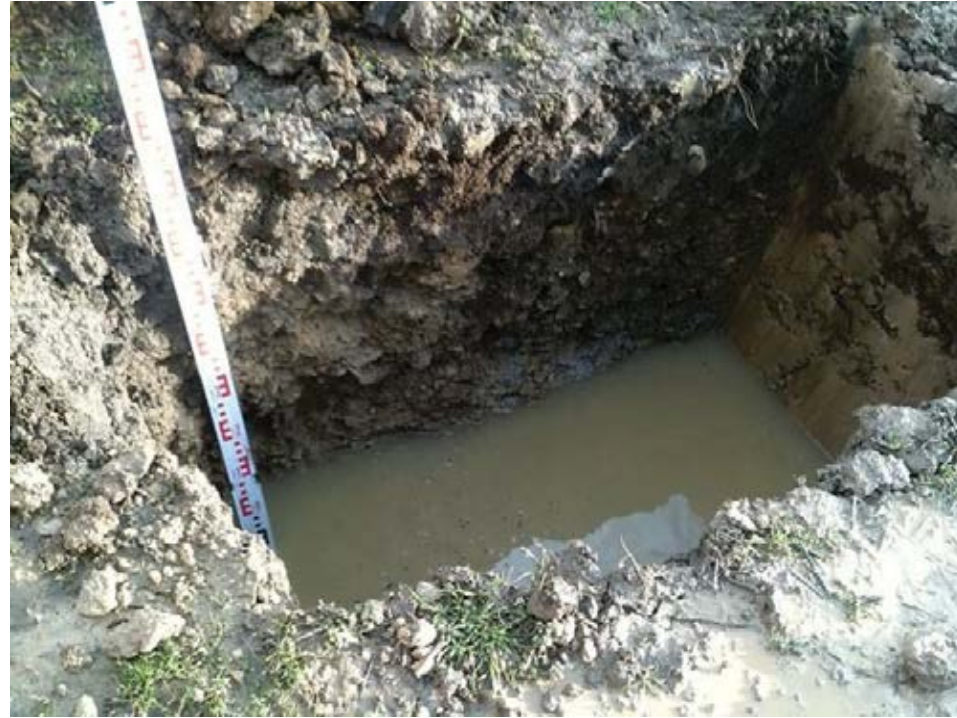
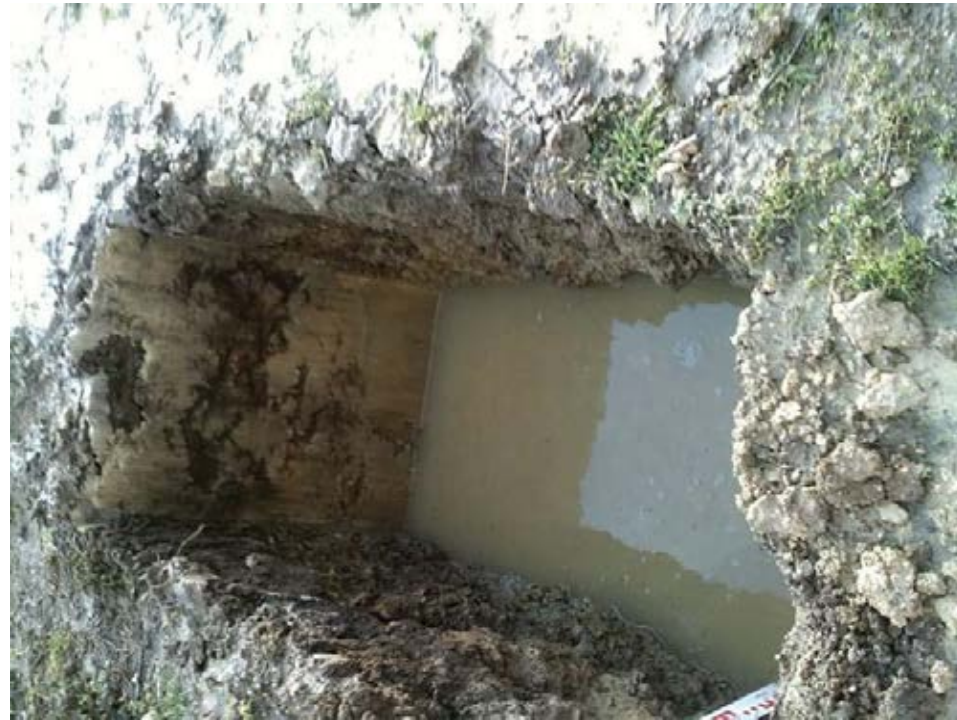
Trial pit 06 north face

Samples and In-situ Tests				Water	Backfill	Description of Strata	Depth (Thickness)	Material Graphic Legend
Depth	No	Type	Results					
0.20	1	D				POSSIBLE MADE GROUND: Grass over firm brown slightly gravelly slightly sandy CLAY. Sand is fine. Gravel is fine to coarse angular argillaceous limestone. (TOPSOIL)	0.25	[Cross-hatch pattern]

0.50	2	D				Firm light yellowish brown slightly sandy gravelly CLAY. Sand is fine to coarse. Gravel is fine to coarse angular to sub angular argillaceous limestone.	(0.85)	[Horizontal line pattern]

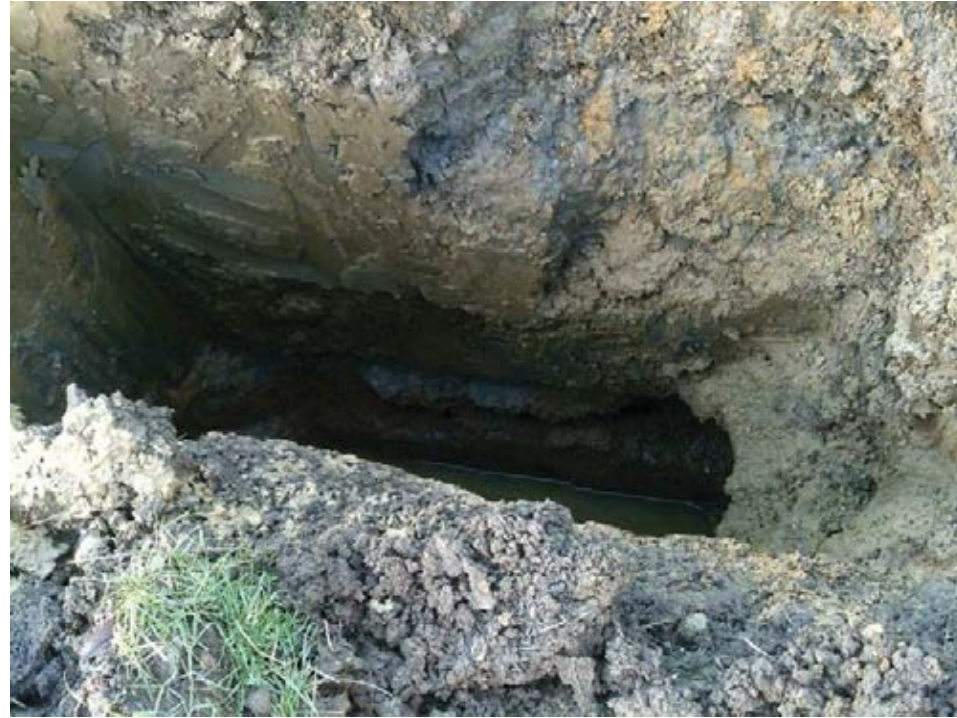
Trial pit 11 west face

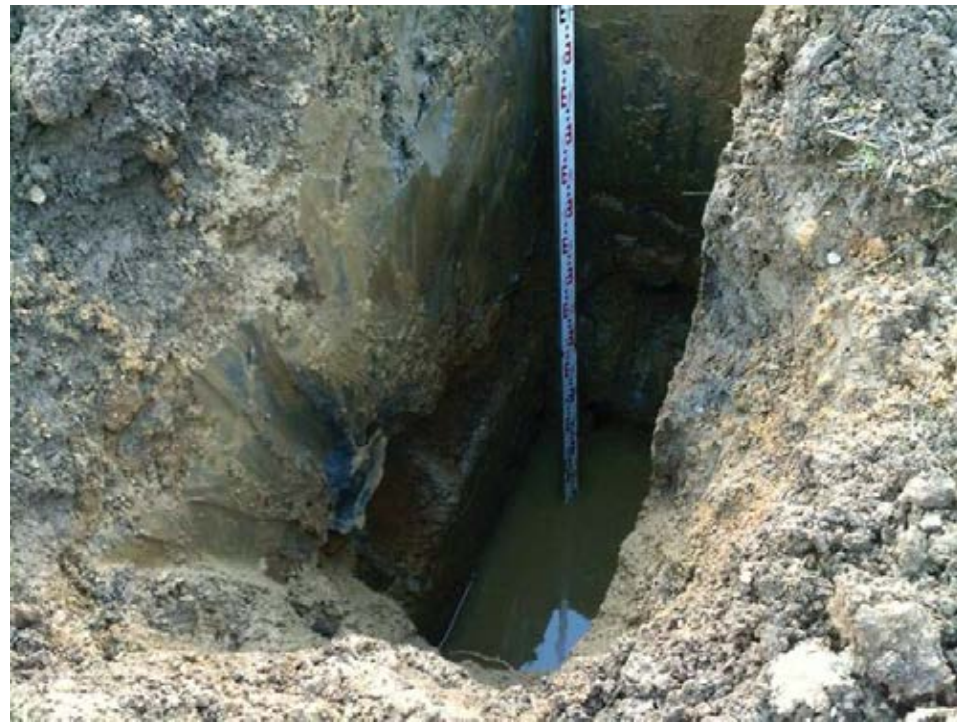
Trial pit 11 south face

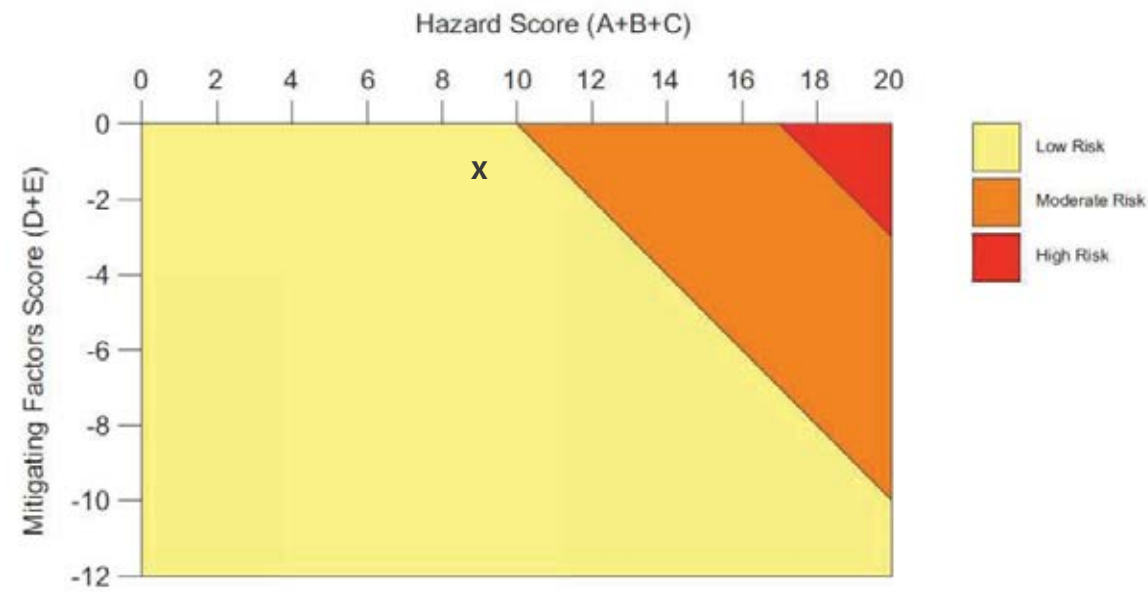
Final Hazard Score	Risk of encountering an Aerial dropped UXO	Implication
-9 - 9	Low Risk	No further UXO risk assessment likely to be required
10 - 17	Moderate Risk	Detailed UXO Risk Assessment required
17 - 20	High Risk	Detailed UXO Risk Assessment required.

This risk assessment methodology is intended as a generic tool. A small number of sites with unusual site specific conditions may require additional consideration of the hazard scoring.

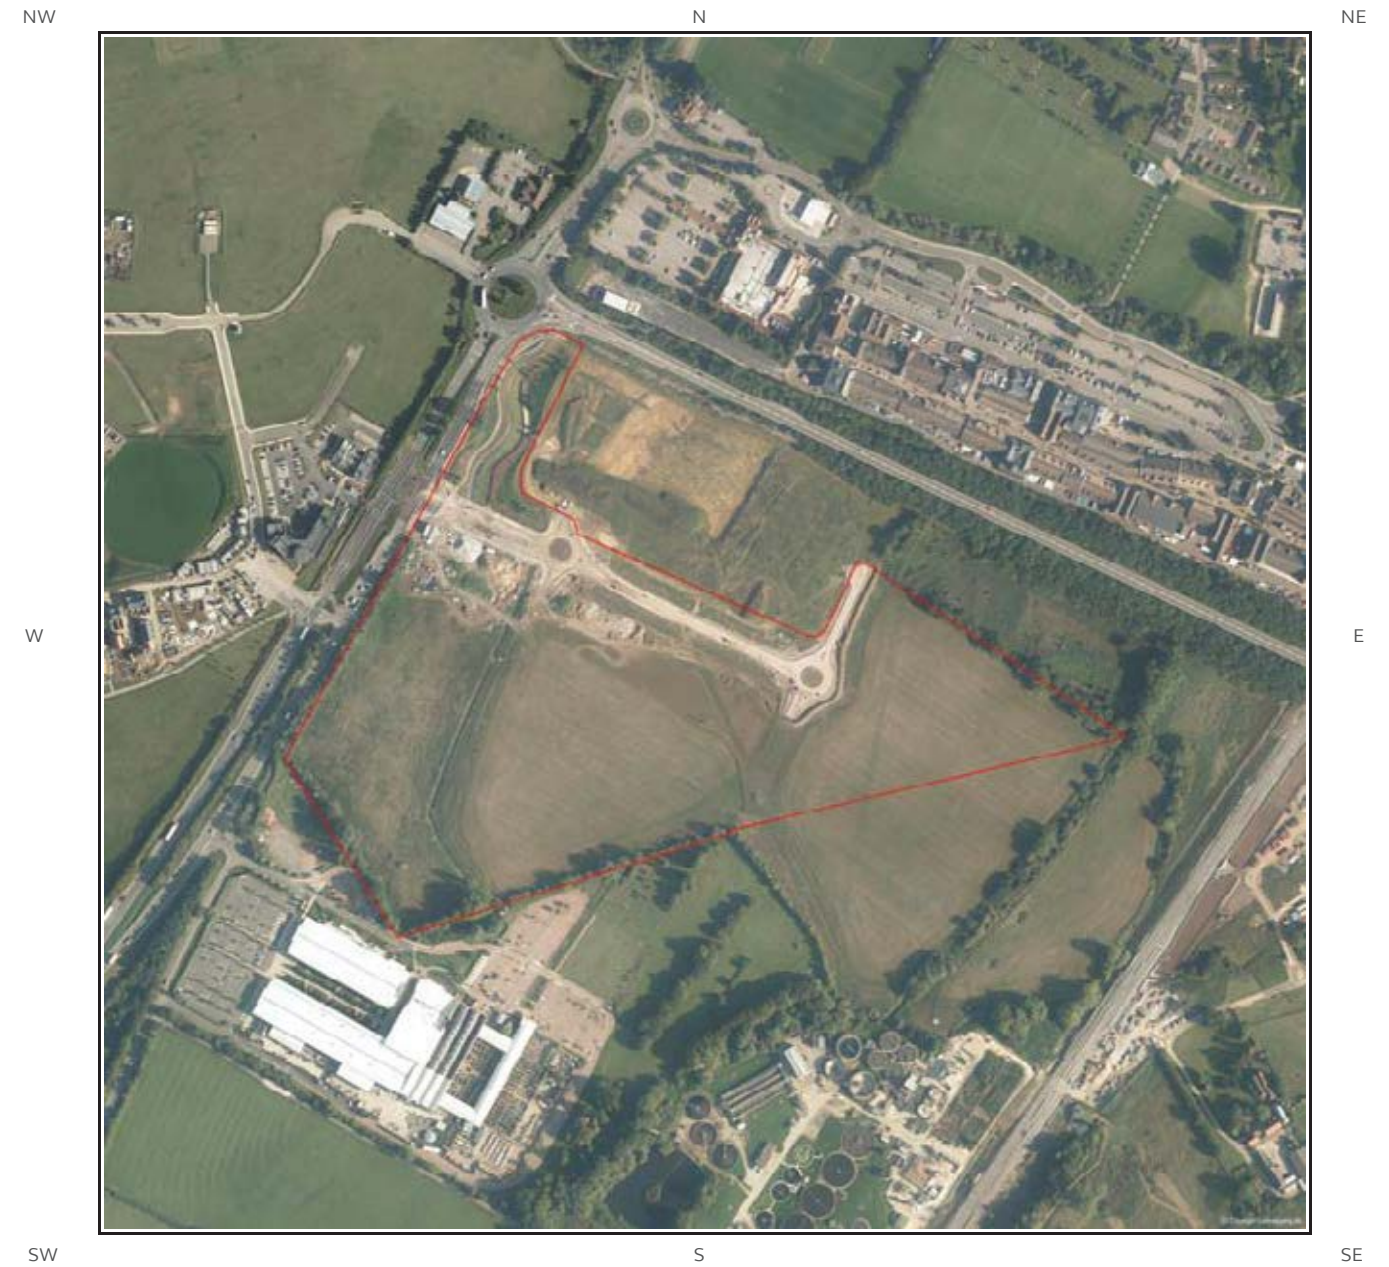
Aerial Photograph Capture date: 06-Sep-2015  
Grid Reference: 457807,221589  
Site Size: 14.50ha

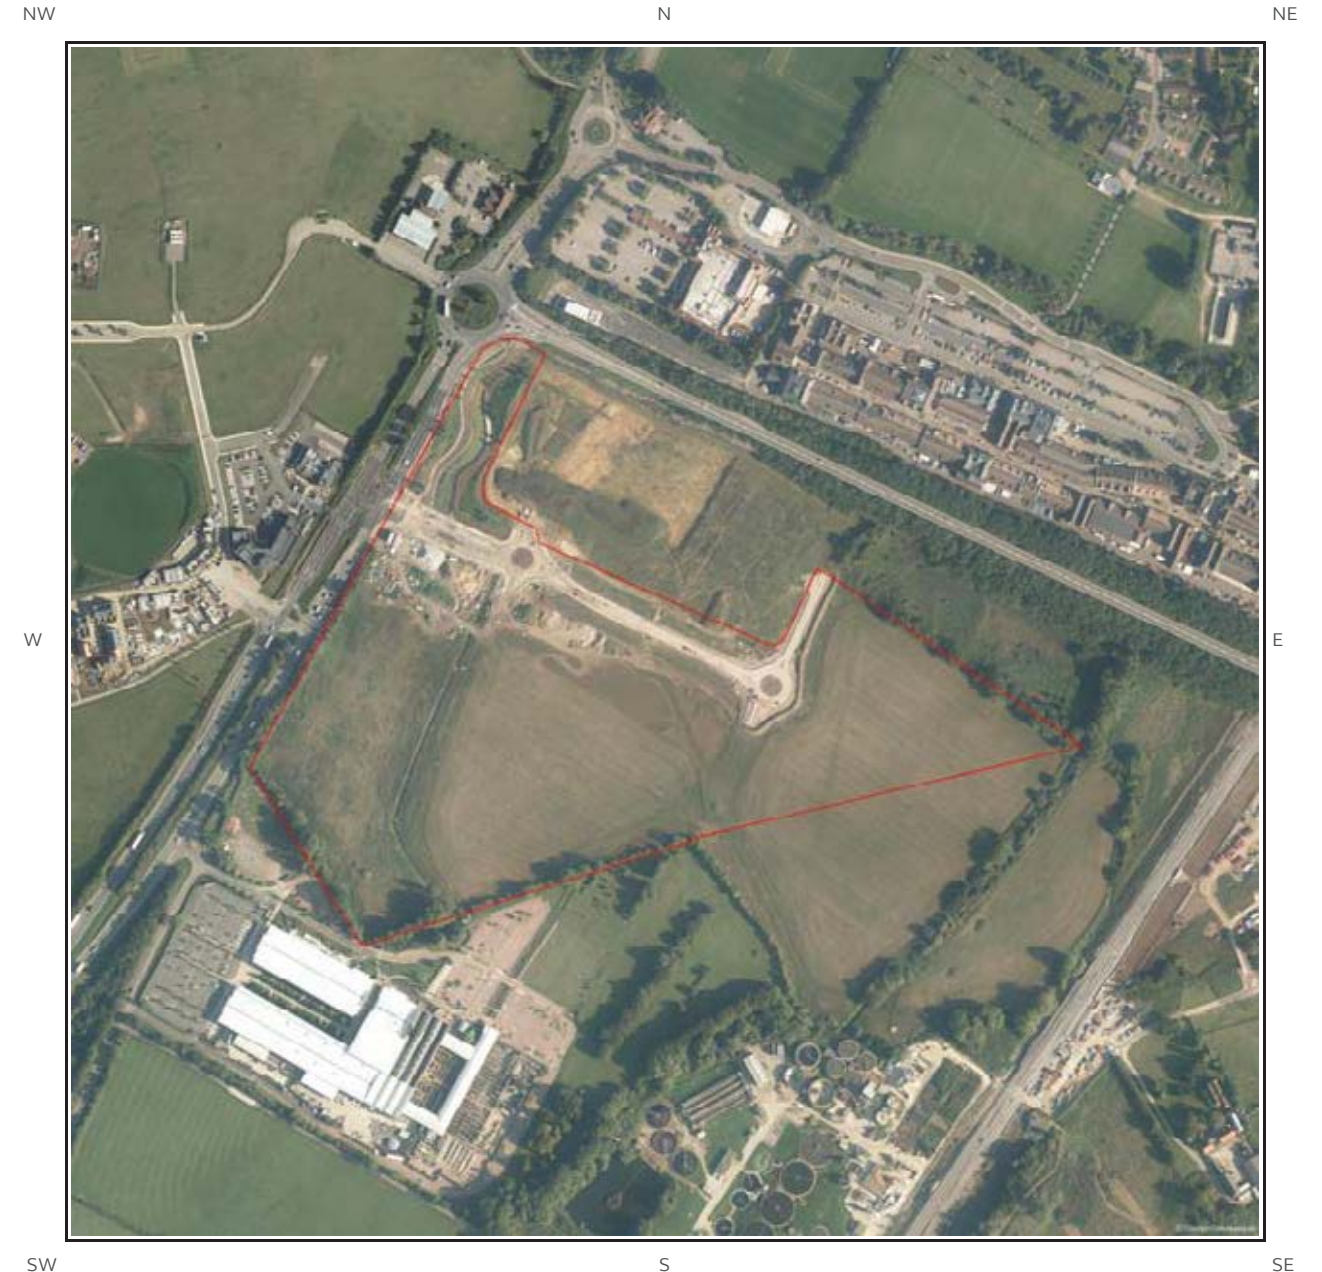
Aerial Photograph Capture date: 06-Sep-2015  
Grid Reference: 457807,221589  
Site Size: 14.50ha

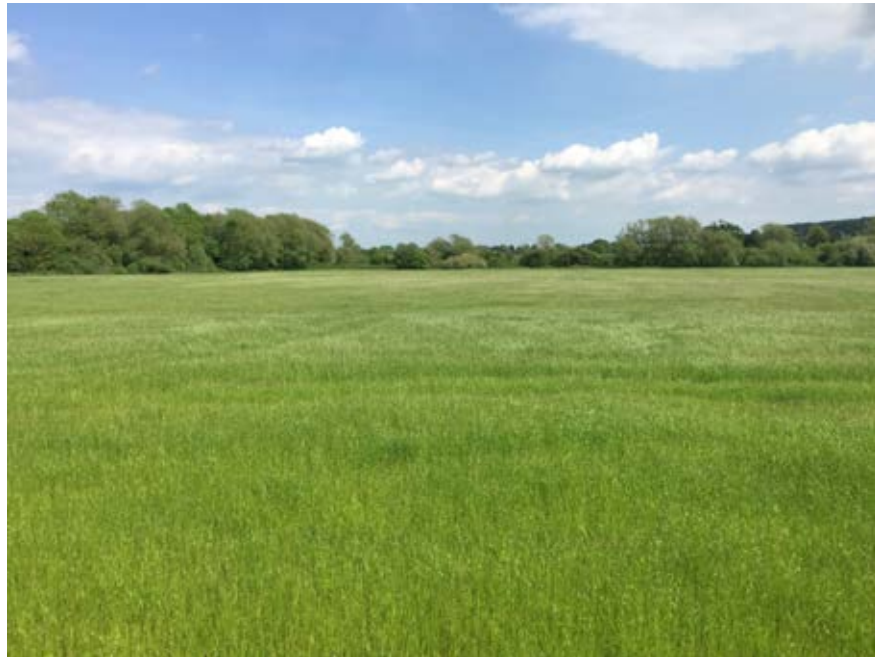
Plate 1: Eastern half of Proposed Development site, looking east

- 10.35** The site forms a parcel of agricultural land which, at the time of visiting, contained crops up to knee height (Plates 1 – 3). The site forms an irregular shape which is divided into two portions due to a large linear trench which runs north to south and then dog-legs to the east (Plate 4). The periphery of the site is bound by high hedge rows to the south-east, south-west and west. A Tesco Superstore and its access road are situated to the north of the site and the A41 followed by open fields lie to the west. The site, as a whole, is very flat.

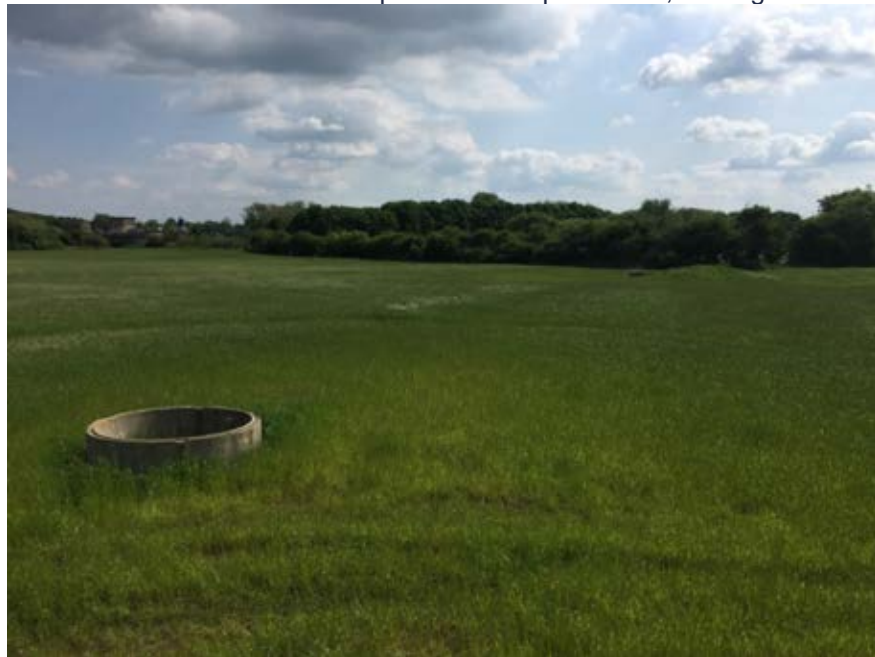
Plate 2: Proposed Development site looking south, showing man-hole rings in central section of site

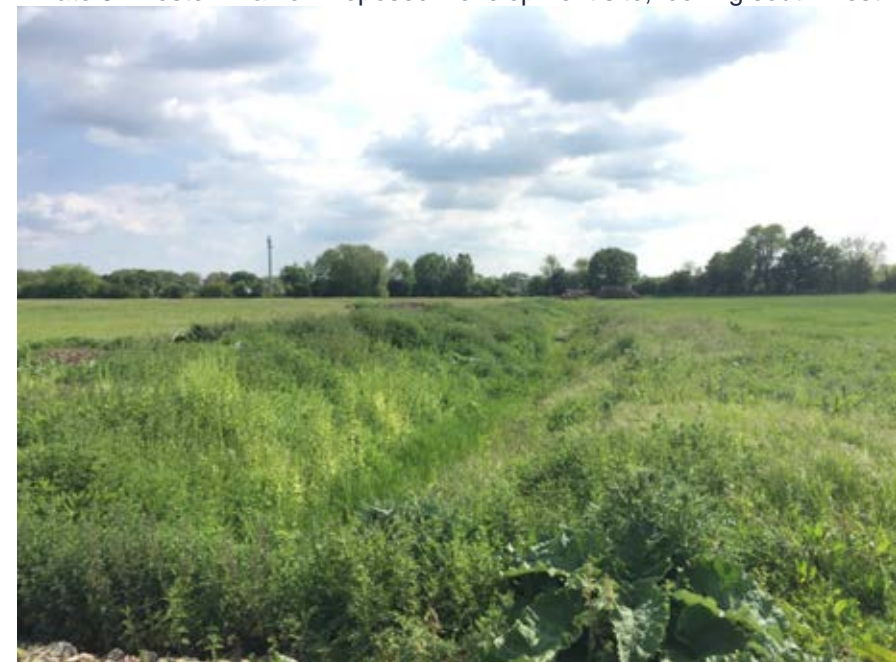
Plate 4: Field Boundary trench running north to south, looking south

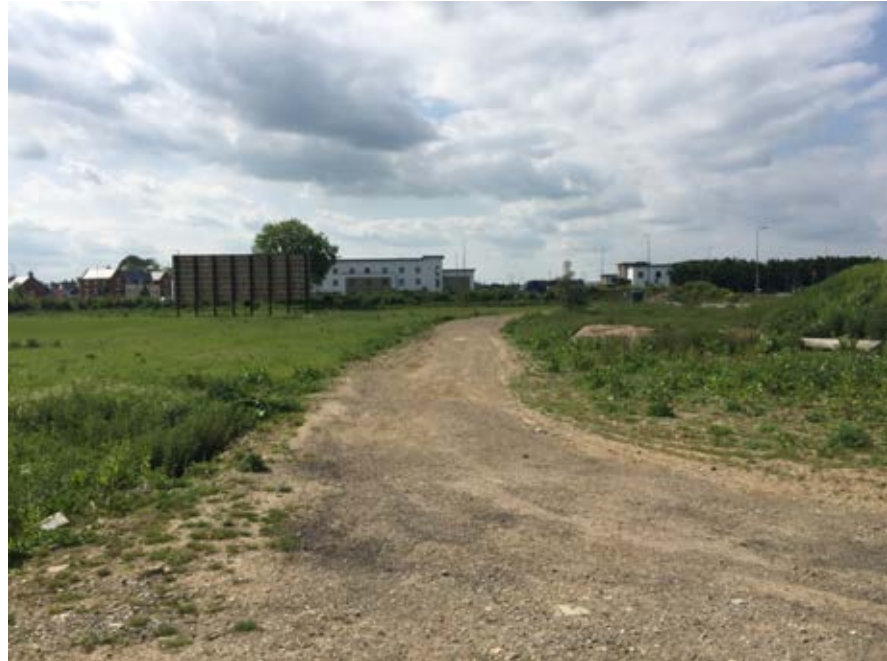
- 10.36** The north-western corner of the site showed signs of temporary works in the area with the presence of a gravel track and building debris (Plate 5). It was thought this was either the remains of the land belonging to the farm that once stood in the area, or the remains of a compound area in connection with the construction of the Tesco Superstore. Two concrete manhole rings were visible above ground in a north-south alignment towards the eastern boundary of the site (Plate 2). This was presumably the result of the new sewer pipeline that was installed in 2010 and monitored by a watching brief (site 235).

Plate 5: Gravel track in north-west corner of Proposed Development site, looking west

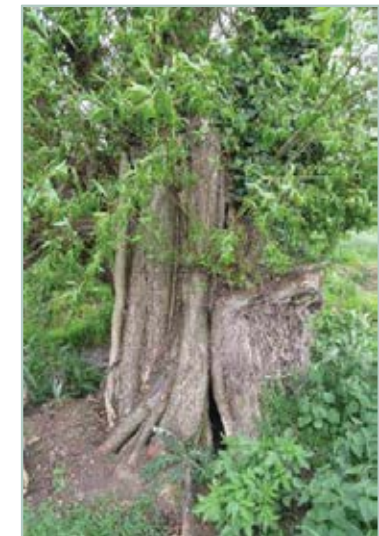
**Plate 5**  
**Willow (G4)**

Some of these are suitable for roosting bats, such as the pollarded willow pictured, which has a large hollow at the base, creating a cavity.

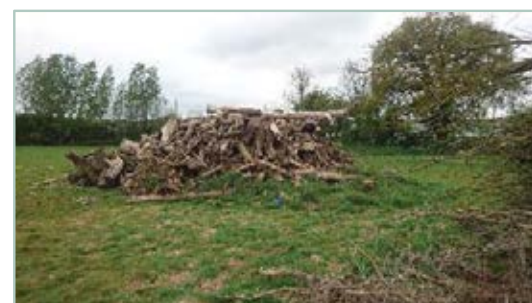
Plate 7  
Log pile

Two large piles of wood, which appear to comprise trees felled from clearance of bank side vegetation.

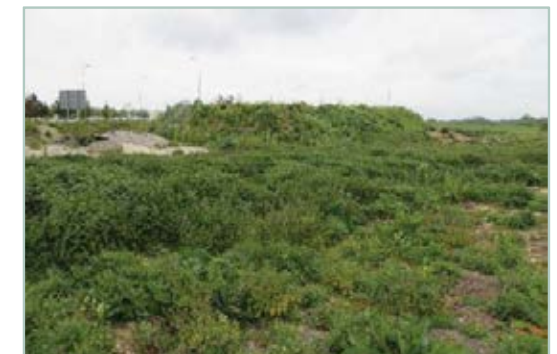
Plate 8  
Spoil heap

There is a spoil heap in the north west of the Site and an earth bank that forms a boundary between the new supermarket and the Site.

The banks are likely to have been grass seeded, but also include colonising species present in the spoil heap and disturbed areas such as cleavers and bristly oxtongue as well as wild mignonette, white campion and charlock.

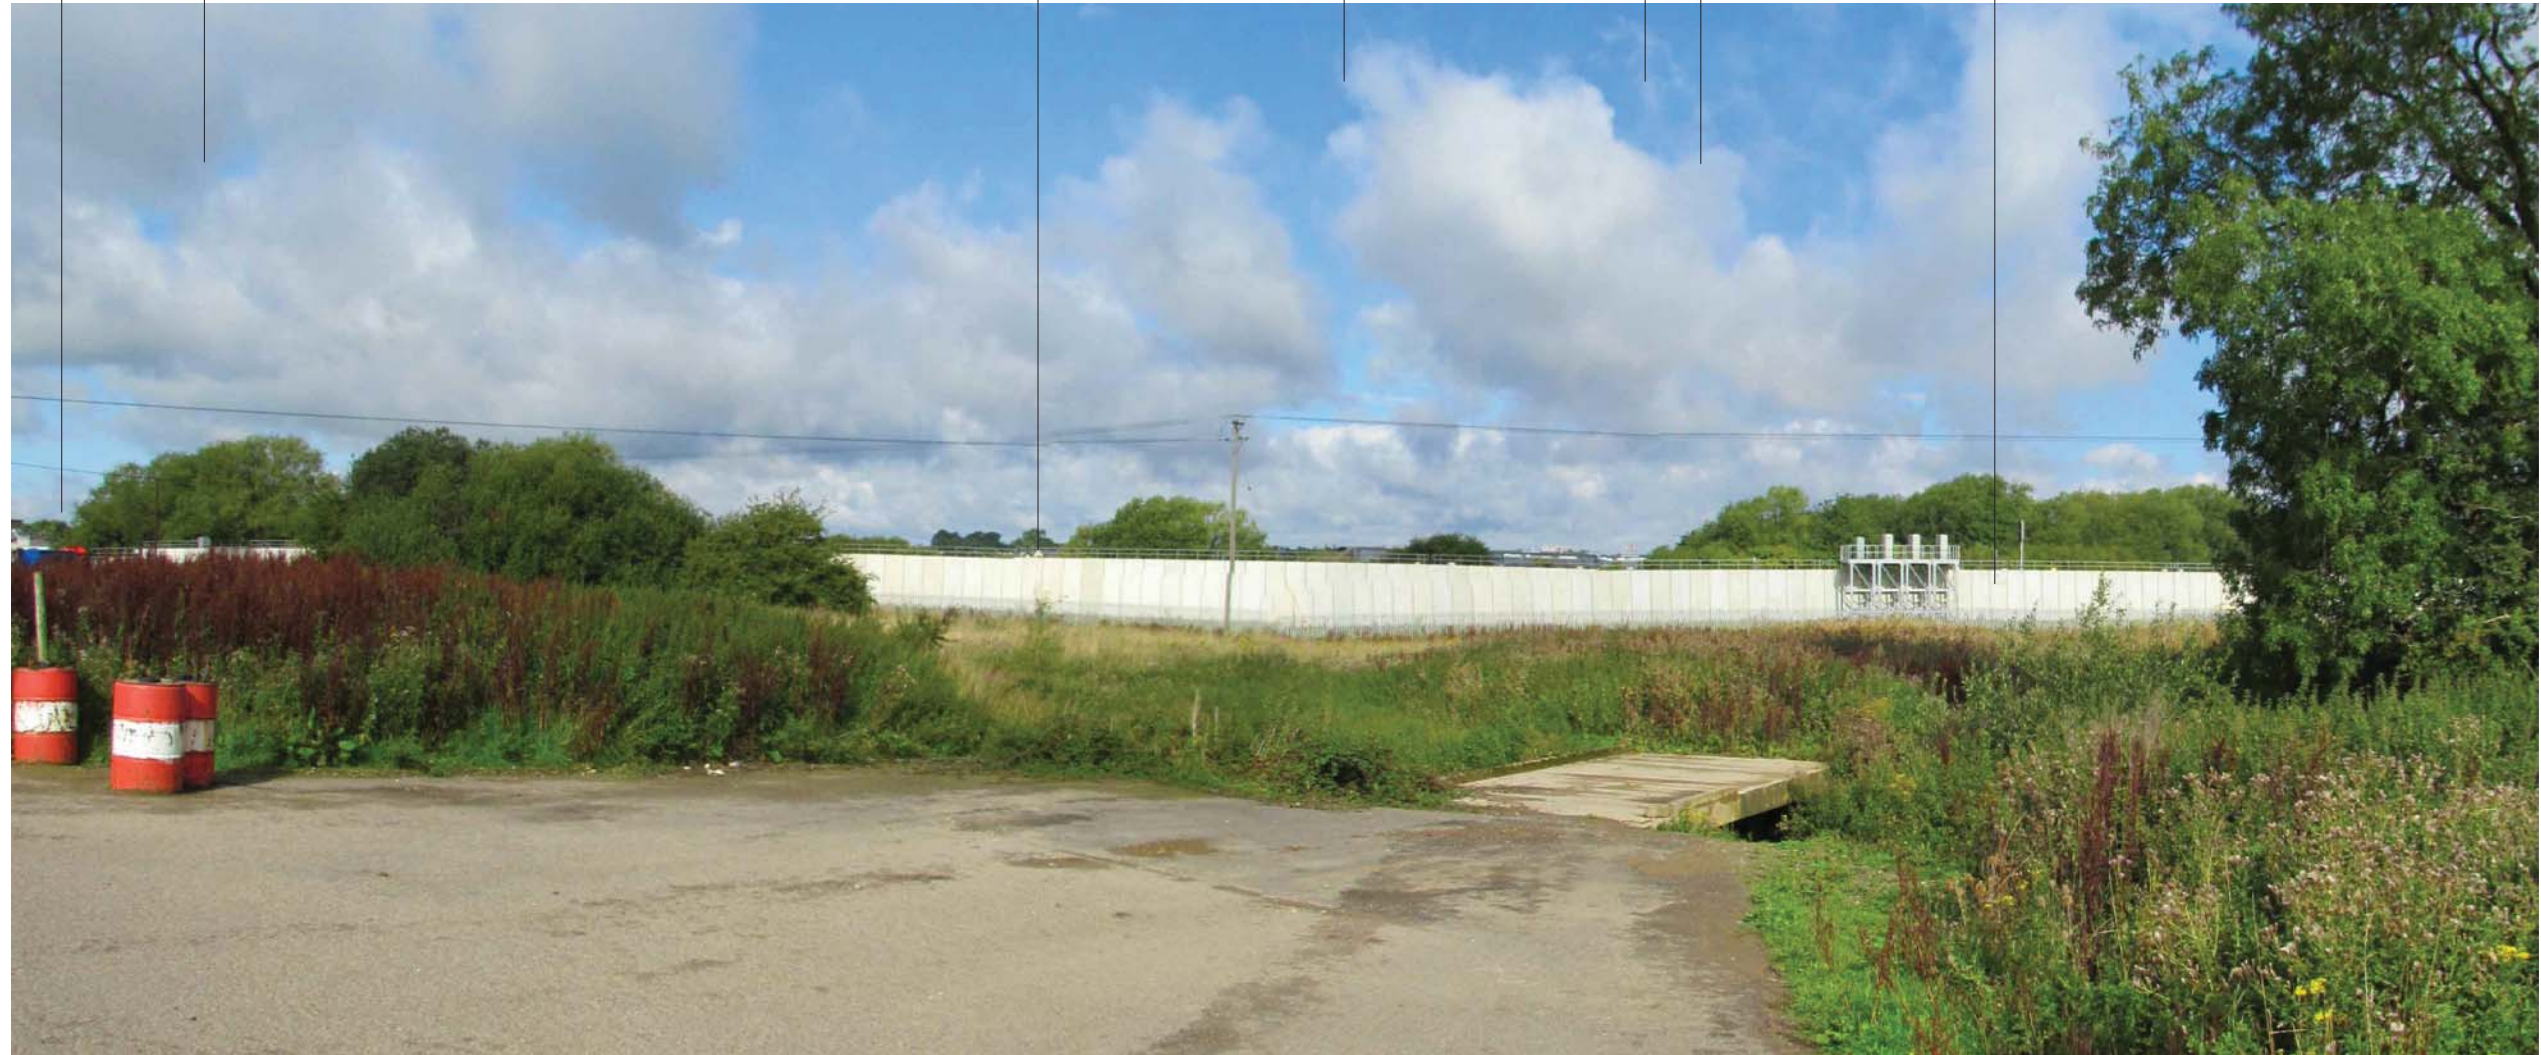
View Location 11 - From northern edge of future Graven Hill residential development area.

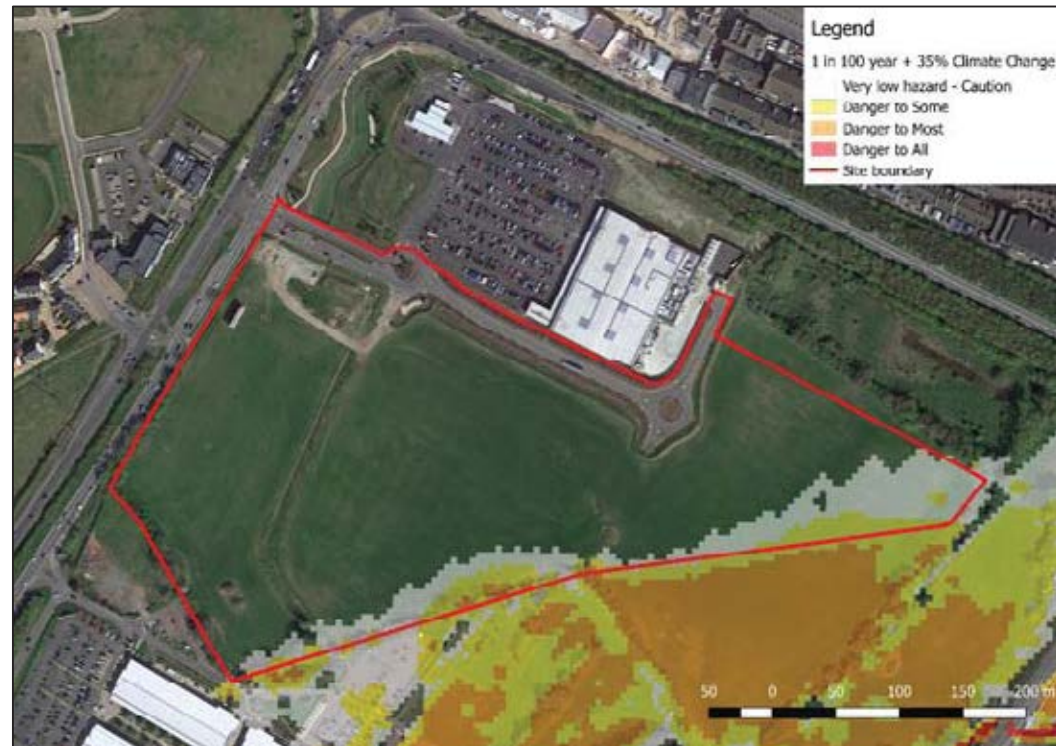
Figure 4-3 Fluvial flooding hazard map for 1 in 100 year storm event + 35% climate change (Contains Environment Agency Information © Environment Agency and/or database right) Imagery © Google 2017, Map data © Google 2017)

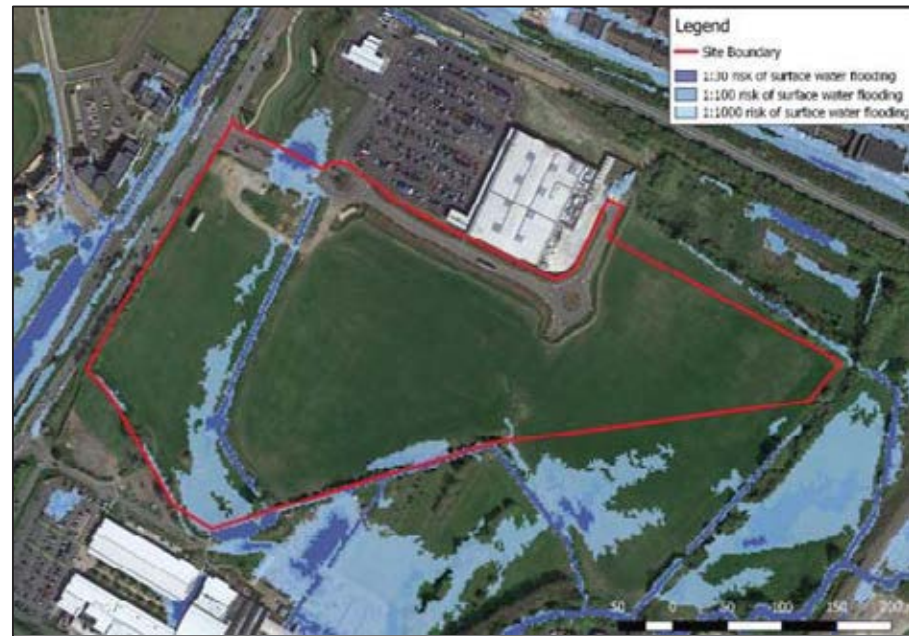
The Environment Agency surface water map shows that the majority of the site is at very low risk of surface water flooding (i.e. less than 1 in 1,000 annual probability of surface water flooding in any year). **Figure 4-4** has been reproduced using the EA flood extent data. The map shows that there is an area at high risk of flooding (less than a 1 in 30 annual probability of surface water flooding) from the north to the south of the site. This corresponds to the location of the drainage ditch. The EA's model results typically show between 300 to 600mm of flooding with localised spots between 600 to 900mm for the 1 in 100 annual exceedance probability event as shown in **Figure 4-5**.

Figure 4-4 Environment Agency's surface water flood extents map with indicative red line boundary. Accessed 16/8/17 (© Environment Agency copyright and/or database right 2015. All rights reserved. Some features of this map are based on digital spatial data from the Centre for Ecology & Hydrology, © NERC (CEH). Soils Data © Cranfield University (NSRI) and for the Controller of HMSO 2013. Imagery © Google 2017, Map data © Google 2017)

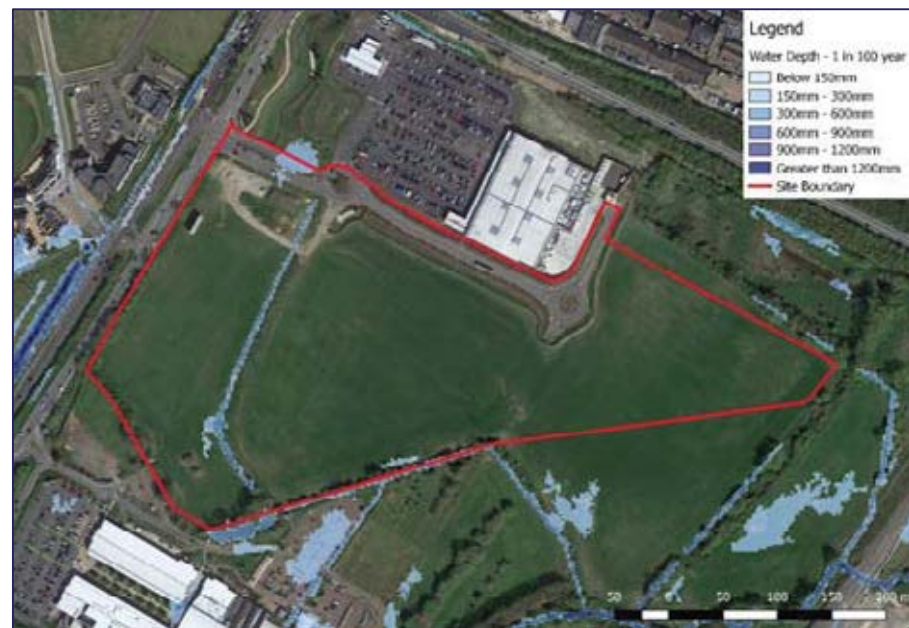
Figure 4-5 EA's surface water flood depth map for 1 in 100 annual probability event with indicative red line boundary. Accessed 16/8/17 (© Environment Agency copyright and/or database right 2015. All rights reserved. Some features of this map are based on digital spatial data from the Centre for Ecology & Hydrology, © NERC (CEH) and © Lead Local Flood Authorities. Soils Data © Cranfield University (NSRI) and for the Controller of HMSO 2013. Imagery © Google 2017, Map data © Google 2017)

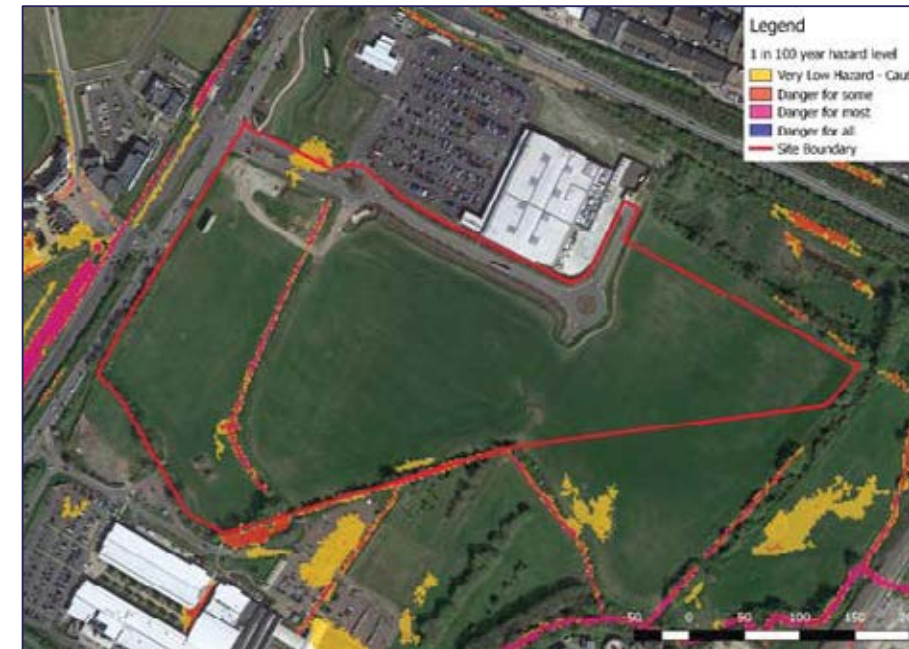
Figure 4-6 shows that for the 1 in 100 annual probability event, the flooding in the locality of the drainage ditch has areas which pose a 'Danger for most', 'Danger for some' and areas 'Very Low Hazard – Caution'. There is also a 'Very Low Hazard – Caution' areas along the south eastern and northern boundary with localised spots of 'Danger for some' on Lakeview Drive.

Figure 4-6 Environment Agency's surface water flood hazard map for the 1 in 100 annual probability event with indicative red line boundary. Accessed 16/8/17 (© Environment Agency copyright and/or database right 2015. All rights reserved. Some features of this map are based on digital spatial data from the Centre for Ecology & Hydrology, © NERC (CEH). Soils Data © Cranfield University (NSRI) and for the Controller of HMSO 2013. Imagery © Google 2017, Map data © Google 2017)
