# Bicester Office Park

## Environmental Impact Assessment

### Volume 2: Technical Appendices

Prepared for:  
Scenic Land Developments Limited

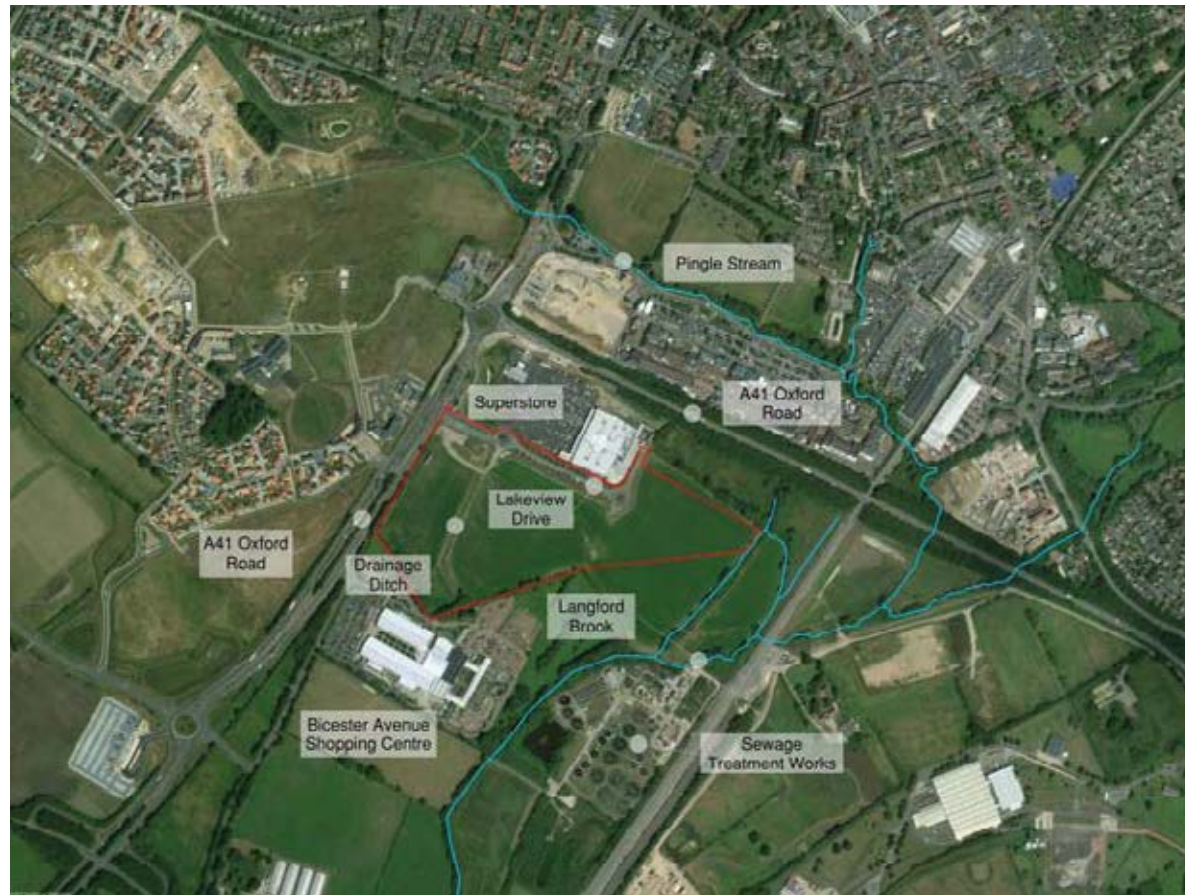
Figure 1

- 2.1 This drainage strategy has been produced in support of an outline planning application for a 13Ha site known as the Bicester Office Park. BuroHappold has been involved with the development since 2007 when the first outline planning application was submitted, and have produced both Flood Risk Assessments and Drainage Strategies in support of the initial phases of development.
- 2.2 The site is located on the western side of Bicester, adjacent to the Bicester Outlet Shopping Village. An aerial view of the site is shown in figure 1 below.

- 2.3 It can be seen in figure 1 that a spine road (Lakeview Drive) to serve the development has been constructed in addition to a Tesco store. As part of the primary infrastructure contract both surface water and foul water drainage networks were constructed. These were designed to provide capacity to serve the development proposals covered by the outline planning application.

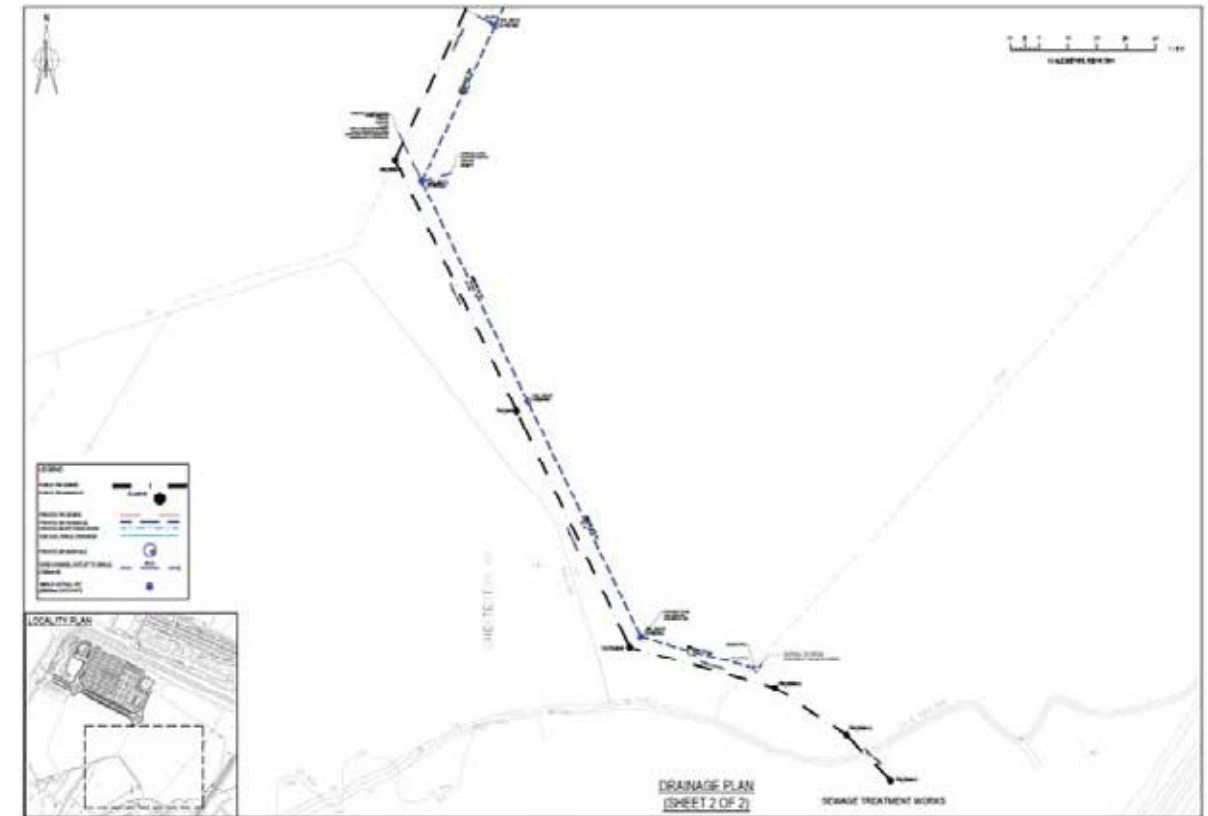
The black dotted line shows the line of the public foul sewer it should be noted that there will be a 6 metre easement centred on the line of the sewer.
