Bat Assessment
Initial Bat Survey & Roost
Characterisation Surveys

**Stable block at
5 The Colony
Sibford Gower
OX15 5RY**

2017-03(08)

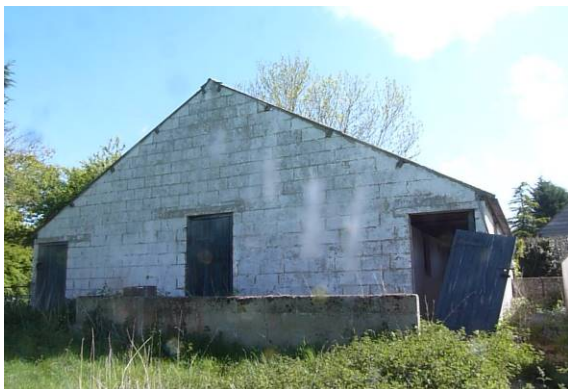
West elevation

The former stable building occupied a broadly rectangular footprint and was constructed in blockwork with a gabled roof covered with asbestos cement sheeting. The underside of the roof did not benefit from any lining and no insulation was present at ceiling level. A separate roof void was present above the stable cells and was accessed via a permanent opening in the ceiling. No ridgeboard was present at the apex of this roof, although timber purlins were present throughout, and there was light spill from numerous places. Timber ceiling joists were exposed on their underside at ground floor level and timber king posts and purlins were visible in the roof void.

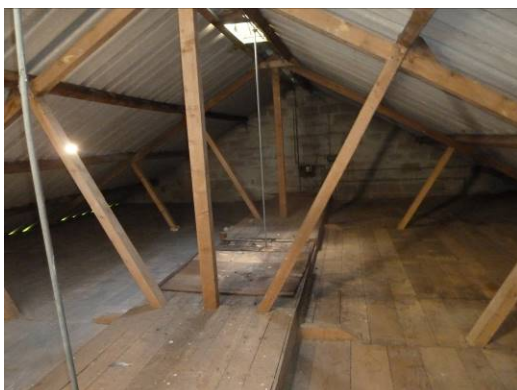
Roof void

Internally, the gable ends and where the purlins met the blockwork were all well sealed, providing little roosting opportunities for bats on top of the gable walls, albeit gaps were present around these purlins on the external side of the gable walls. If there were gaps in the top of the breeze blocks, this could provide roosting opportunities for small numbers of crevice-dwelling bats

There was no ridgeboard against which bats could perch, although two timbers did run along the length of the roof and would have provided a suitable surface for perching bats. Other roosting opportunities were present between the last ceiling joist and the blockwork wall where there was a gap of around 20mm and potentially on top of the eaves, although this would likely be a little light and draughty.

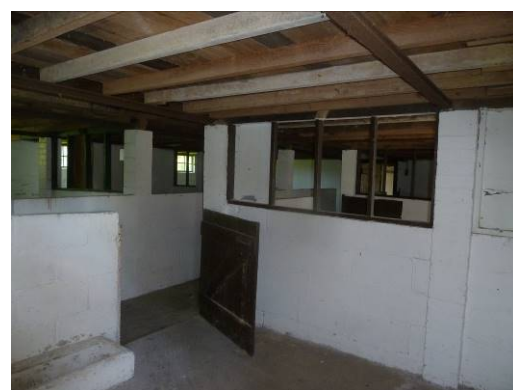
The ground floor of the barn was separated into cells via blockwork dividing walls but with flighted access possible throughout. The floor was finished with concrete and searching for evidence of bats was straightforward.

Ground floor showing flighted access and concrete floor

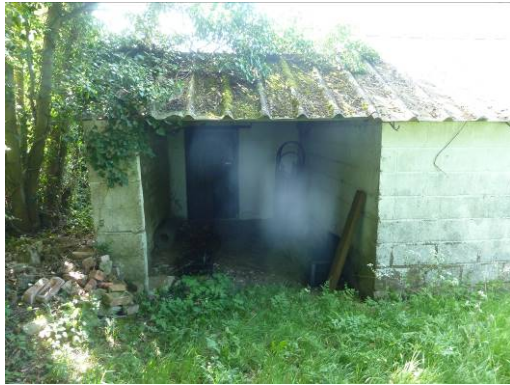
Bats could access the building via a permanently open doorway on the west elevation, via gaps at the eaves and via gaps at the roof apex. A small section of the stable building at the north-east corner was open-fronted and

access was possible into the main stable building via a gap where the ceiling joist entered the blockwork wall. An active blackbird nest was recorded in this section during the initial inspection.

Open-sided access with black bird nest

- Evidence of an active blackbird nest was recorded during the surveys. The building should therefore be **surveyed for nesting birds** within two days prior to commencement of disturbing works by a competent person. Birds typically nest between March-September inclusive. If evidence of nesting birds is found at this time, no works should be undertaken that may cause disturbance until after all the chicks have dispersed.

An open-fronted bird box, such as that illustrated below, would be suitable for use by blackbird and should be erected on the eastern elevation of the converted building, perhaps under the eaves of the porch.

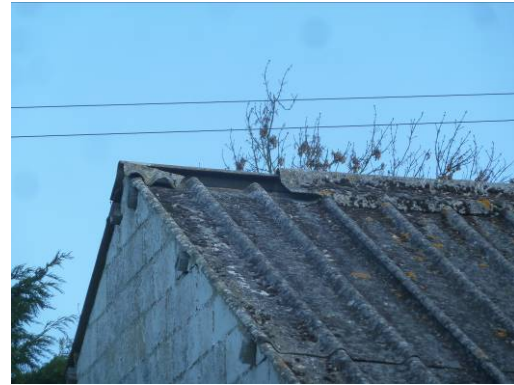
Access at ridge

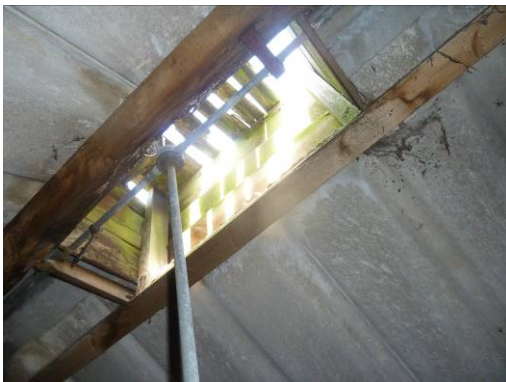
The roof void was noticeably warmer than the ground floor, although the open air vent in the roof in the centre of the roof as well as other gaps where the asbestos sheets met resulted in the void being fairly light and a little draughty. A far more sheltered area for roosting bats was against ceiling joists on the ground floor.

Open air vent in roof

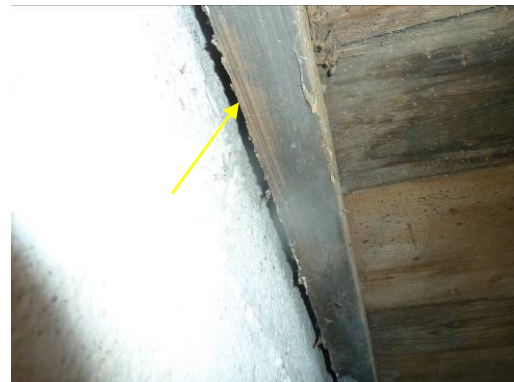
Roosting opportunity between wall and ceiling

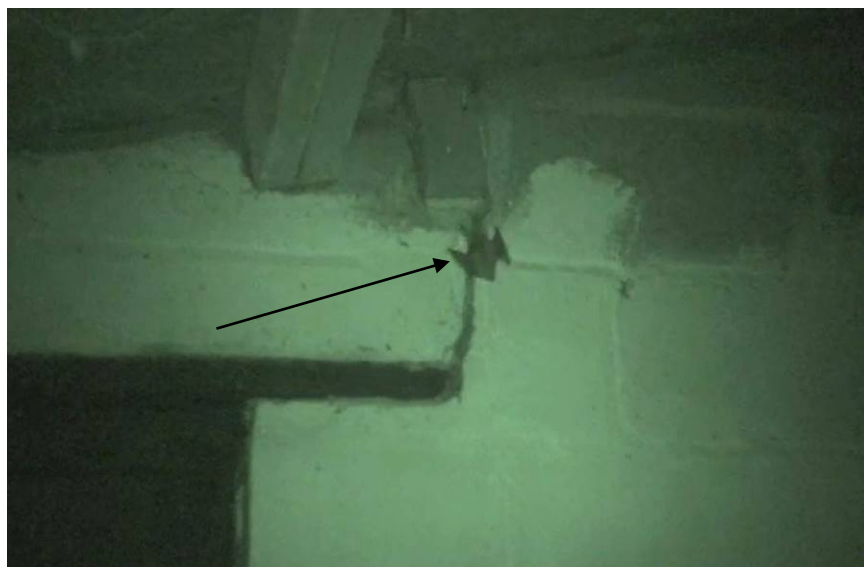
During the dawn re-entry survey on 9th June, a good amount of bat activity was recorded, with five species identified. There were numerous passes by common pipistrelle and brown long-eared bats foraging and commuting along the boundary vegetation. A single common pipistrelle entered a roost in a purlin on the western gable end at approximately 45 minutes before sunrise. At the same time, a brown long-eared bat entered the barn on the open-sided extension at the north-eastern corner. This bat was also detected by the night-vision camera and revealed the bat to land on the wall and crawl into a crack in the wall to roost.

BLE landing on wall before sunrise and entering building through the crack in the wall

A permanent replacement roost for the single brown long-eared bat roosting in the crevice in the wall of the open-fronted section of the existing building will be provided by way of a Build-in Woodstone bat box located just above door height (to replicate the existing crevice this bat has been using) in an open-fronted porch at the eastern elevation. This will replicate as closely as possible the location and orientation of this roost whilst also providing a potential covered feeding area for brown long-eared and even lesser horseshoe. It is important that no security lights or similar are fitted inside this porch in order to maintain suitable roosting, light sampling and foraging conditions for brown long-eared and lesser horseshoe.
