Our ref: R1742B-L05
29th March 2018

Upper Heyford – Dorchester Phase 8 In-Situ Validation

SGP have been instructed to produce a validation report for Dorchester Phase 8 following the demolition of the former buildings and removal of hardstanding. A site location plan including the approximate location of validation entries is provide within Drawing D01.

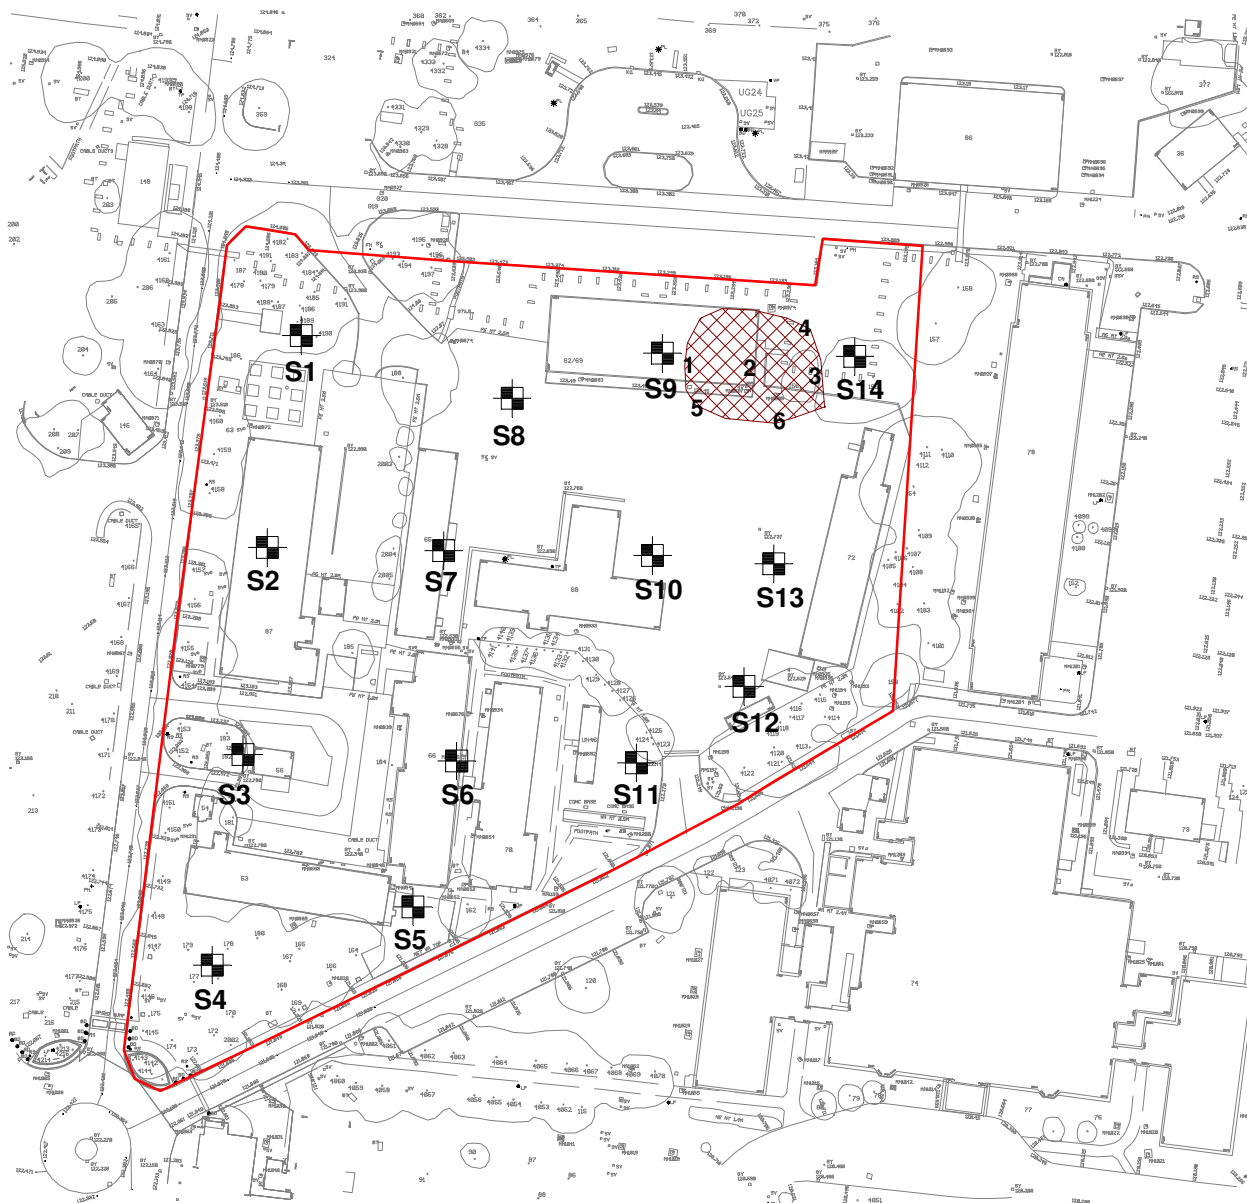
Drg No:
D01

Fourteen in-situ samples were collected from the exposed formation level soils where accessible with depth validation photos showing the extent of the 0-400mm depth range appended to this report and sampling locations reproduced in Drawing D01. Assuming an approximate area of 12,870m², the volume of validated soils is effectively 5,150m³, exceeding the specified sampling rate of 1 sample per 500m³ (1 per 368m³ achieved). A photographic record detailing the depth of the soil profiles is provided below:

In-situ Sample Location

Drawing:
Phase 8 in-situ Validation

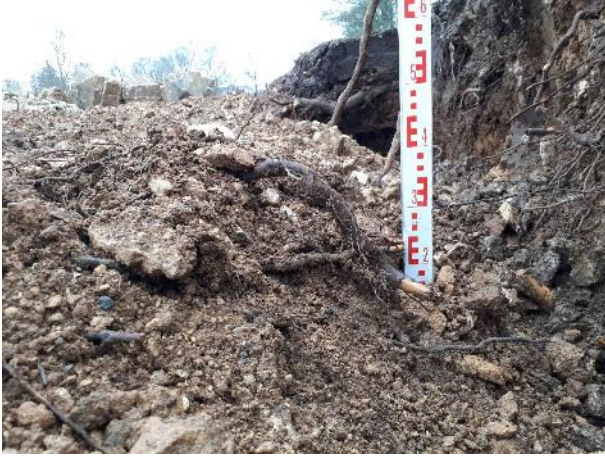
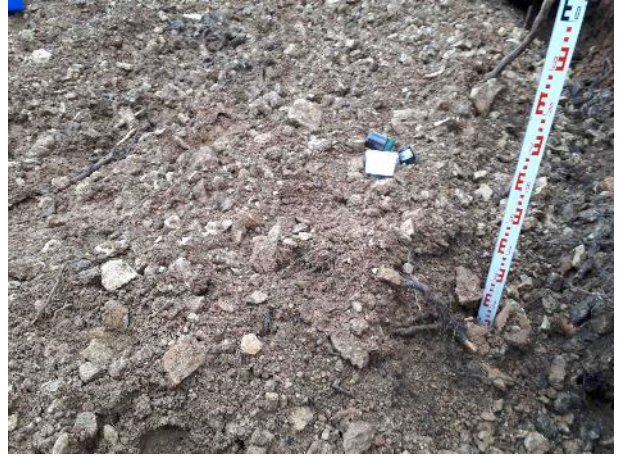
Sampled soils comprised a dark brown clayey topsoil and/or a gravel of angular cobbles (weathered limestone bedrock) within a light brown sandy clay matrix, typical of the natural soils encountered across the wider Heyford development. No inclusions of anthropogenic material such as ash or clinker were observed.

Exceedances of other determinants was limited to two minor exceedances for vanadium in samples Ph8-S1 and Ph8-S3 with concentrations of 77 and 89 mg/kg respectively compared to the criteria of 75 mg/kg. Concentrations are typical of those recorded within the natural ground across the wider Heyford Development area and attributed to the underlying ironstone domain bedrock which is reported to have a normal background concentration (NBC) of >128 mg/kg vanadium.

The S4UL criteria for vanadium increases to 410 mg/kg based on residential garden soils with plant uptake resulting in no exceedances. It is therefore considered that there is no risk to human health from vanadium in the site soils.
