# Building 488: Combined Dining Room and Institute

Recording Level: 3

## History/ Function

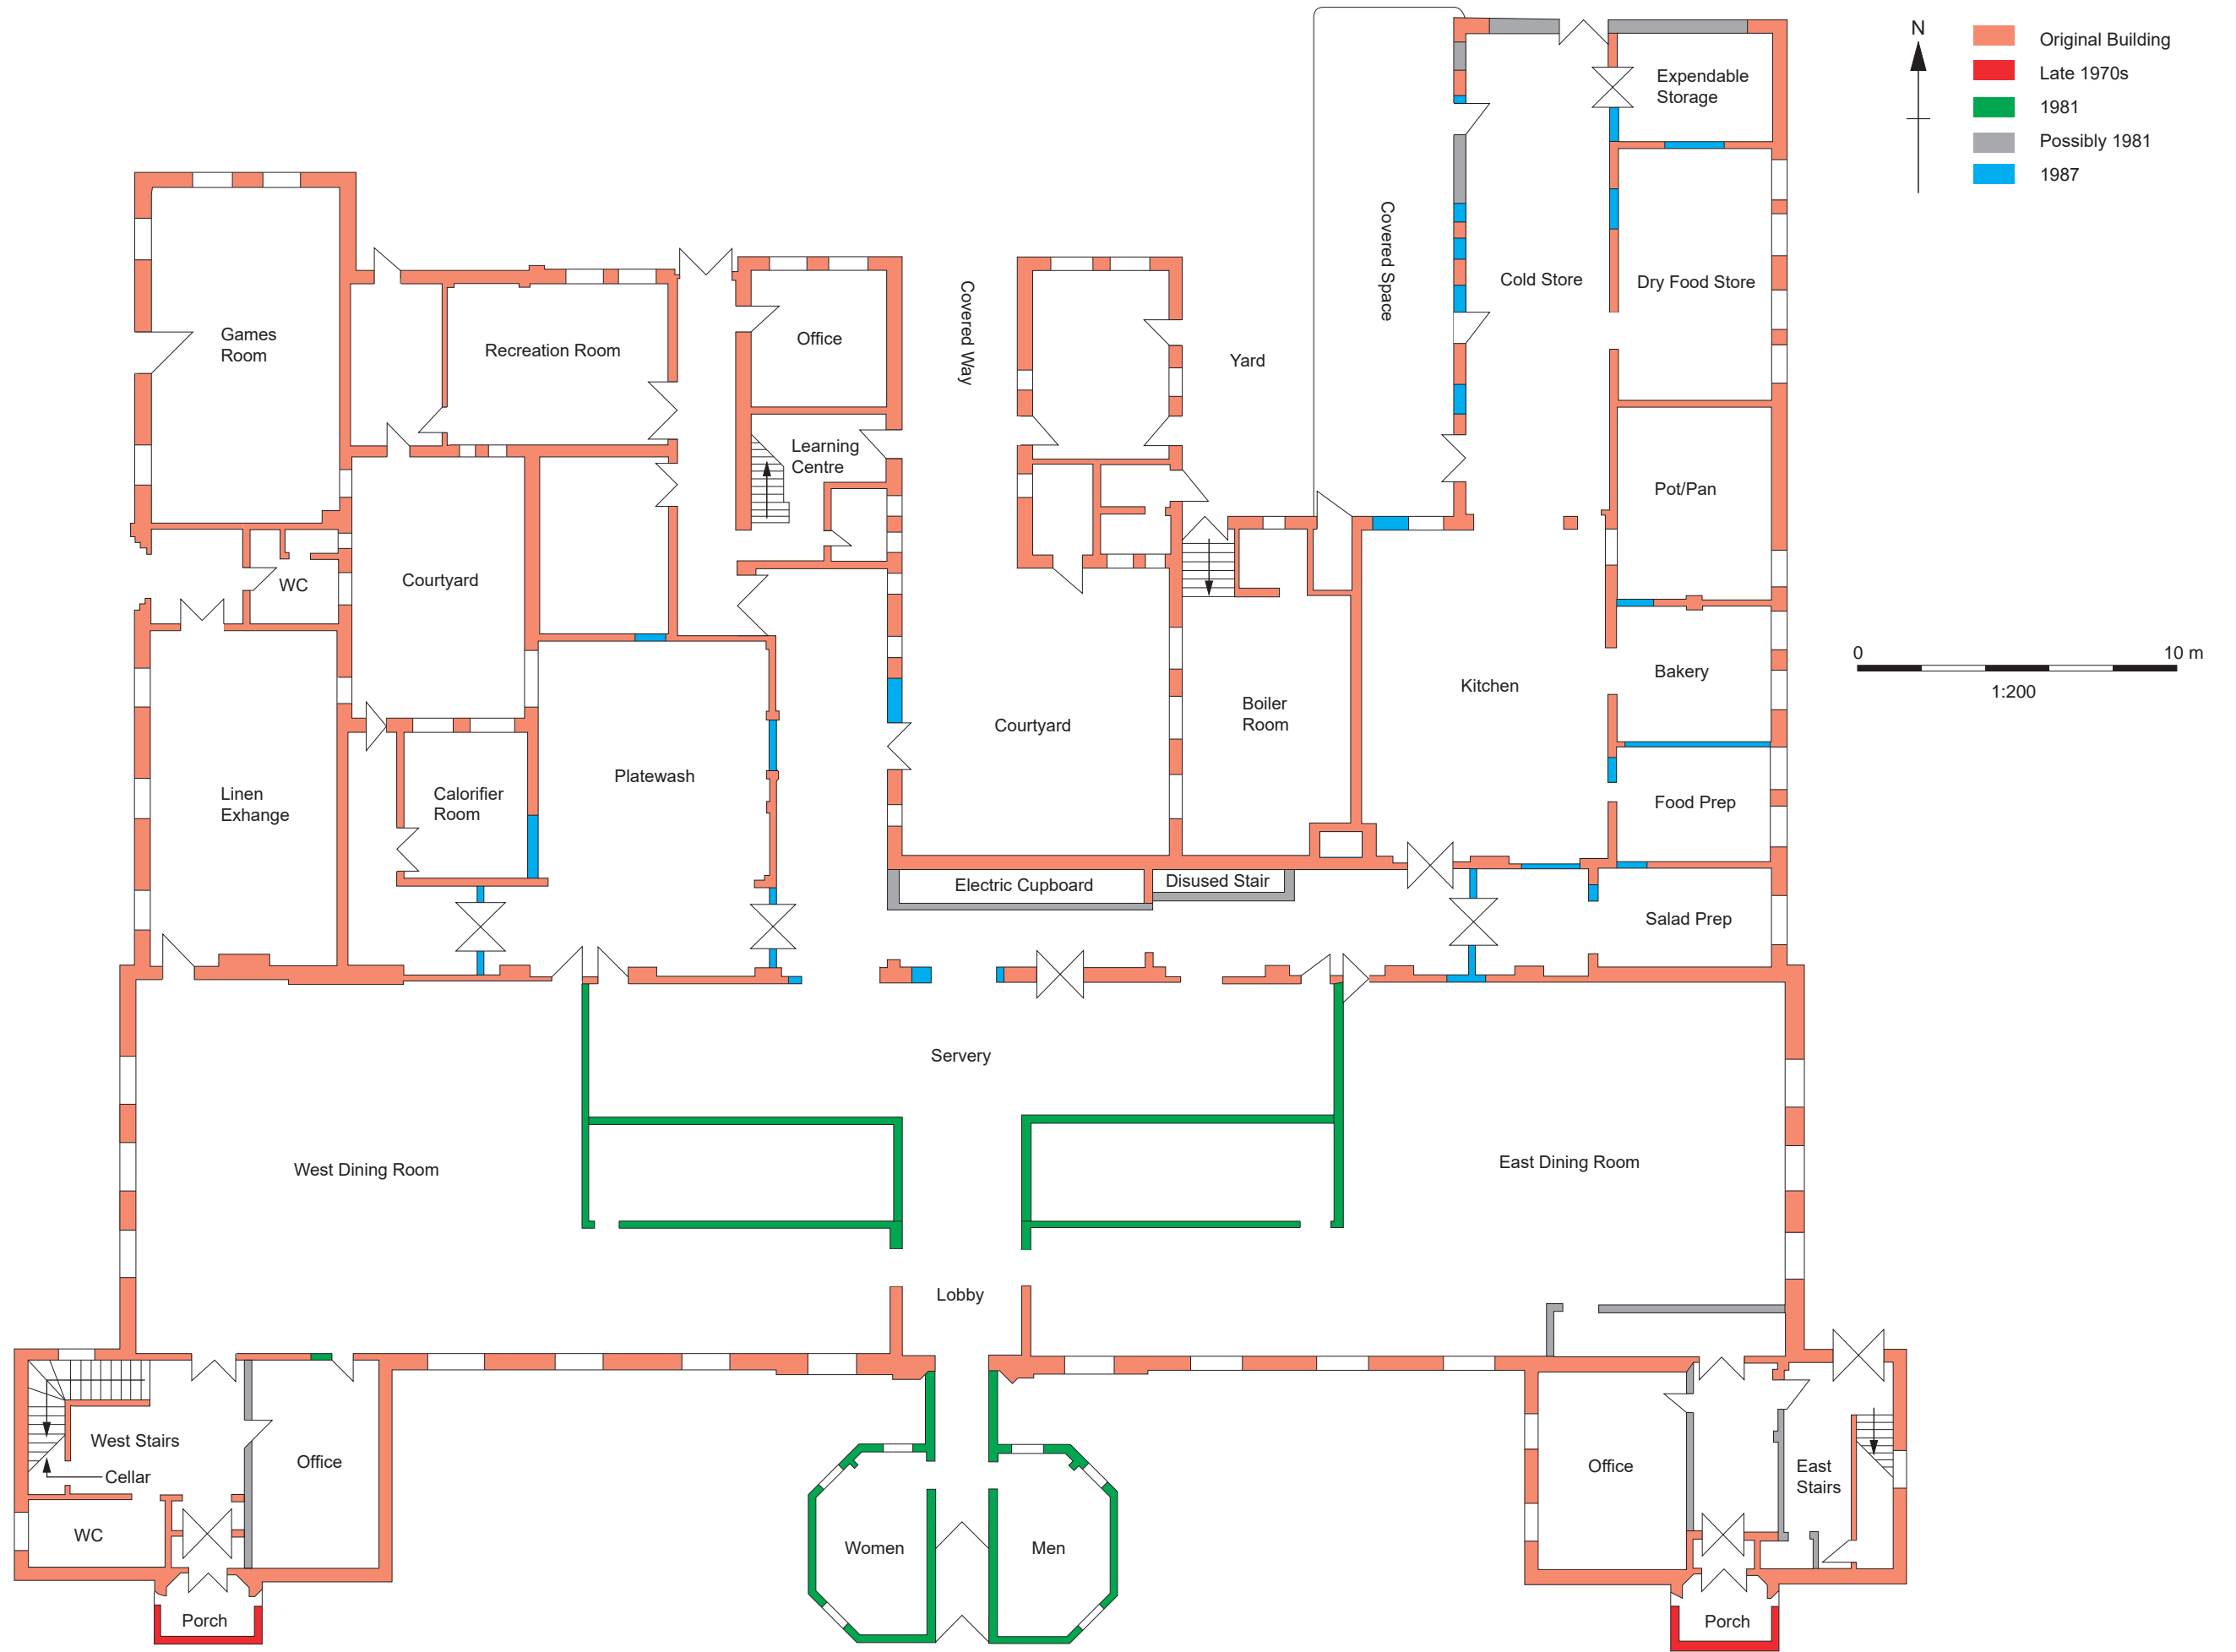
Figure 488.1: Ground floor plan

A two storey Art Deco building with wings to either side and a small single storey central entrance block form the dominant front elevation (Plate 488.1); a range of single storey connected units form the rear service buildings, with the exception of a small range of rooms bridging the central yard entrance (Plate 488.2) (Fig.488.1).

The late 1980s octagonal entrance building contains a male and a female WC to either side of the corridor (Fig.488.1). This corridor with an arched plastic roof leads from the modern metal doors to the original door opening, although this is evident only when exiting the corridor into the lobby which has a tiled floor and exposed brick walls (Plate 488.14).

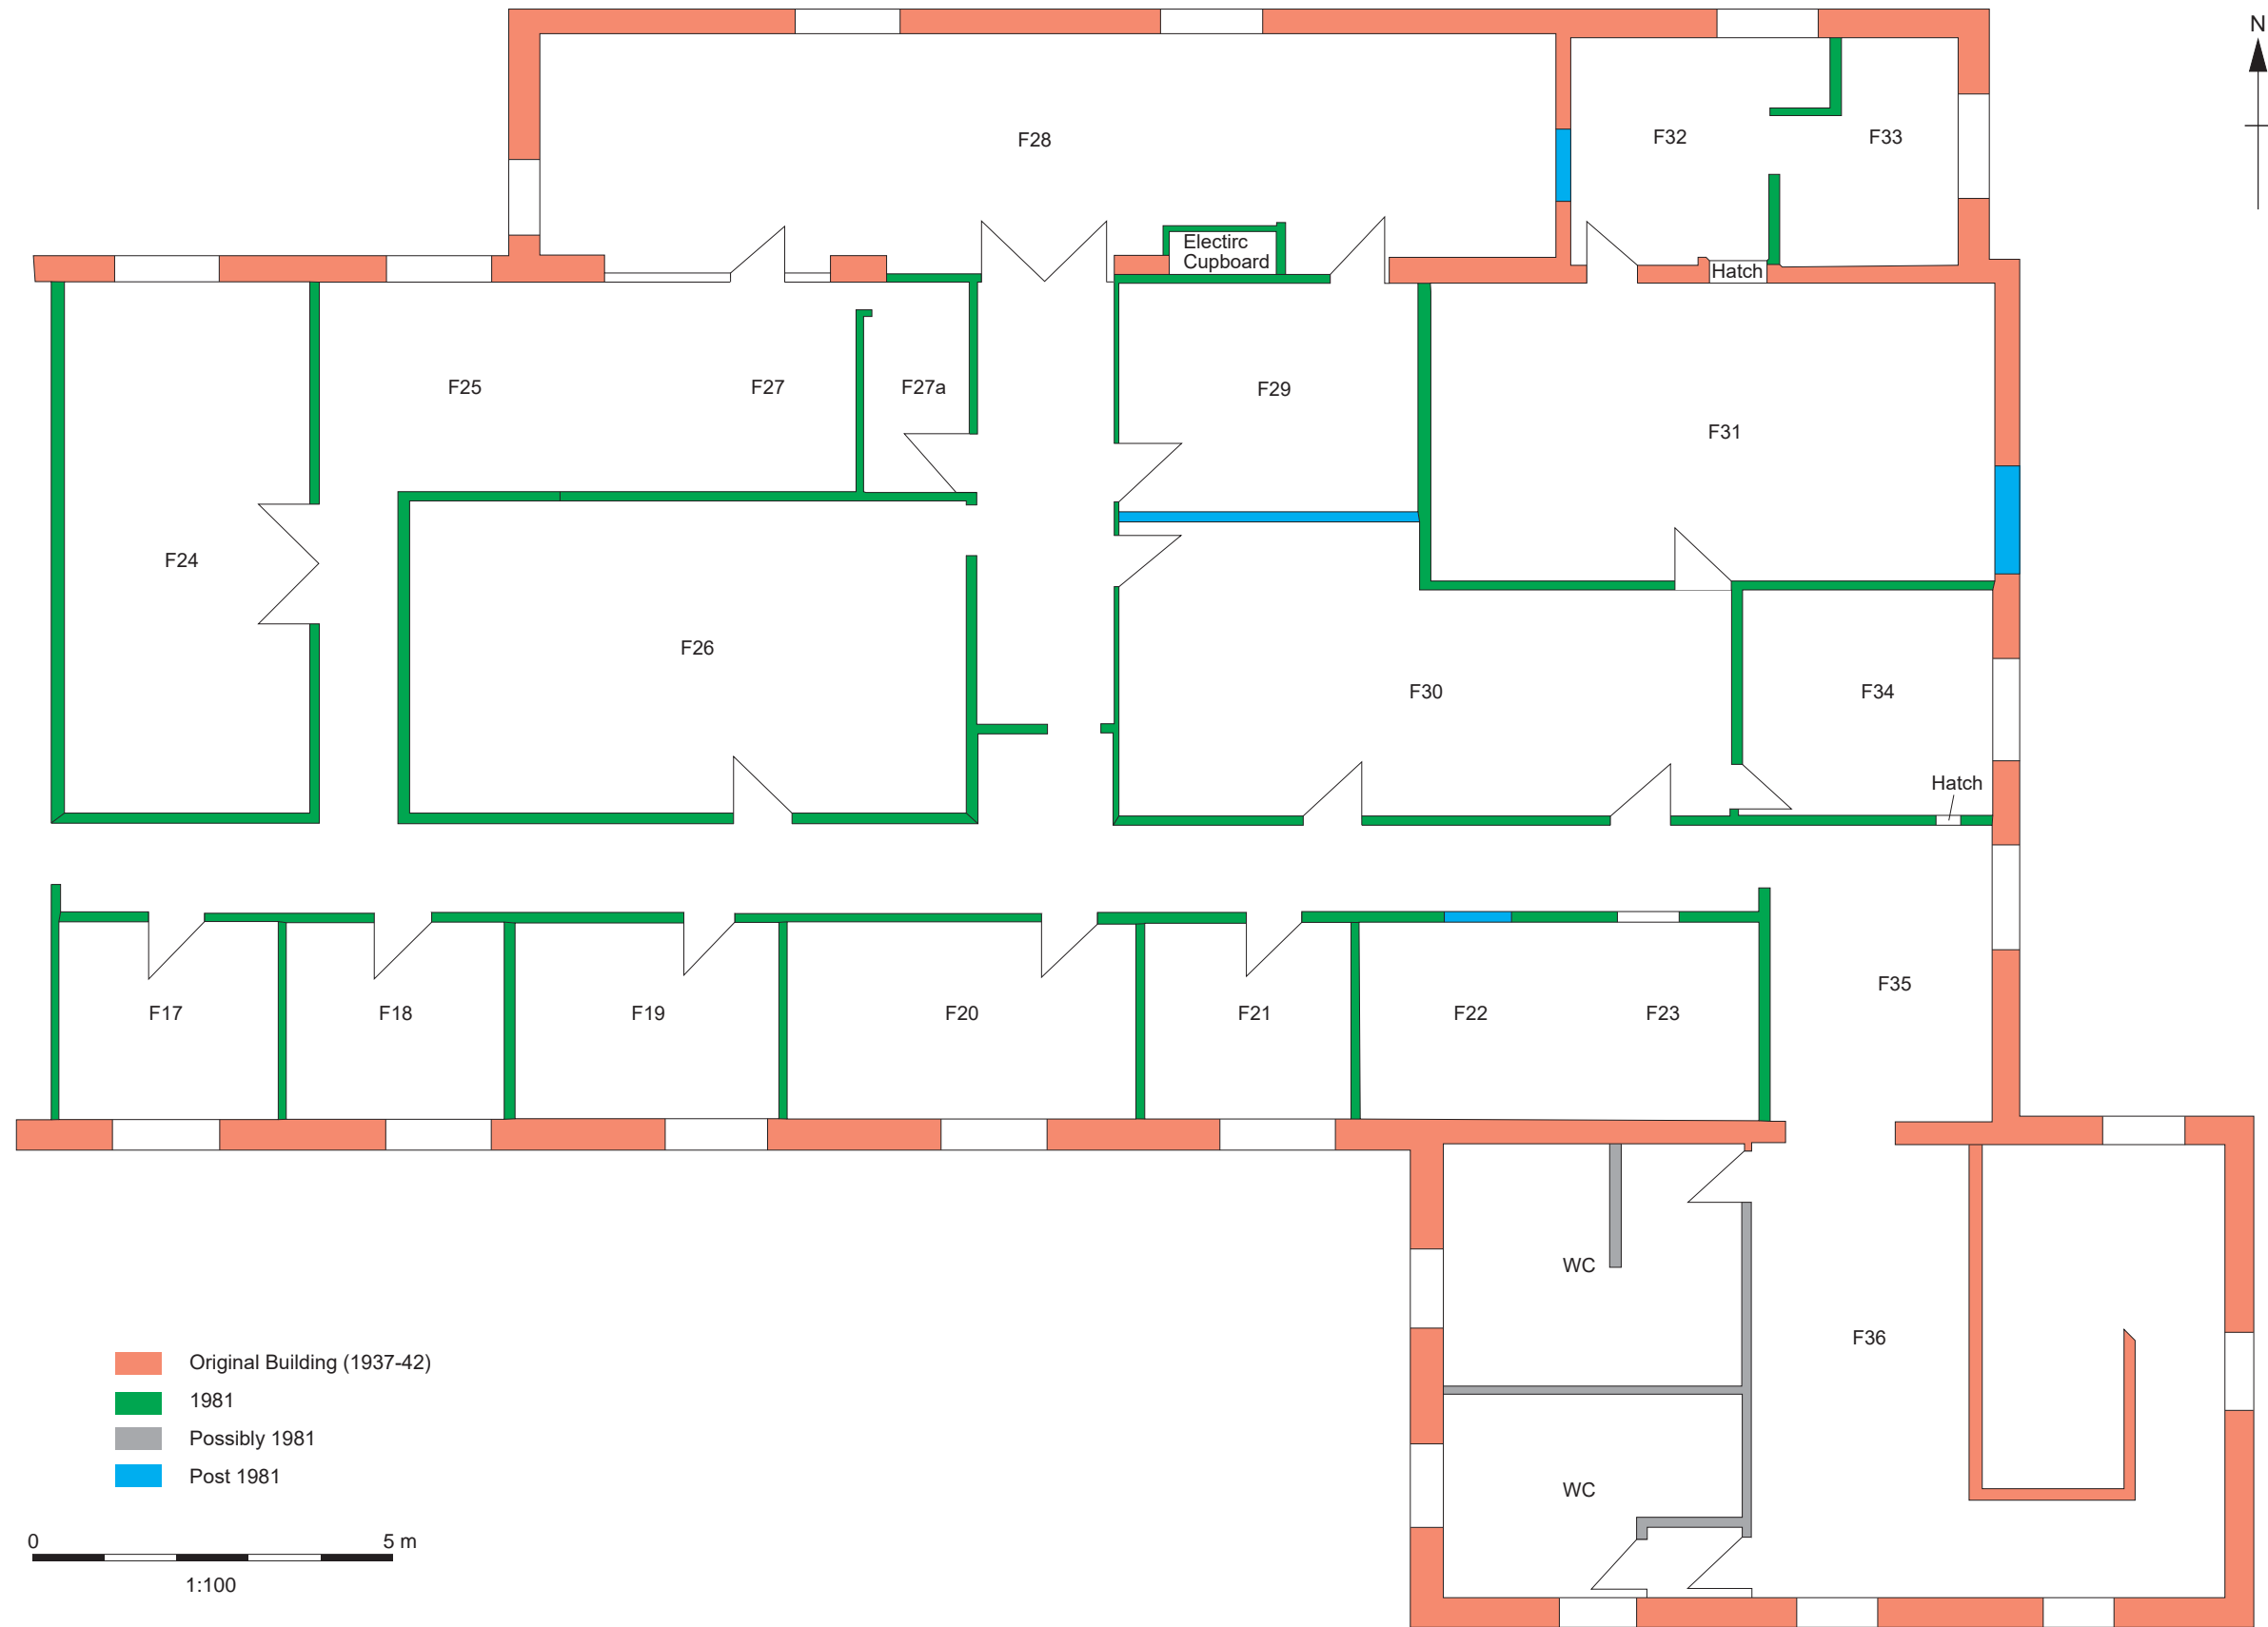
Figure 488.3: First floor plan, east wing

The original design plans show this area as an open plan landing and cloak room, much the same as the ground floor below (Fig.488.3). The most recent phase sectioned-off the cloak room and installed male and female WCs. The external walls of the landing and stairwell do not have the recessed dado, although a dark blue painted line runs around the landing and down the stairs, including across the later partition.

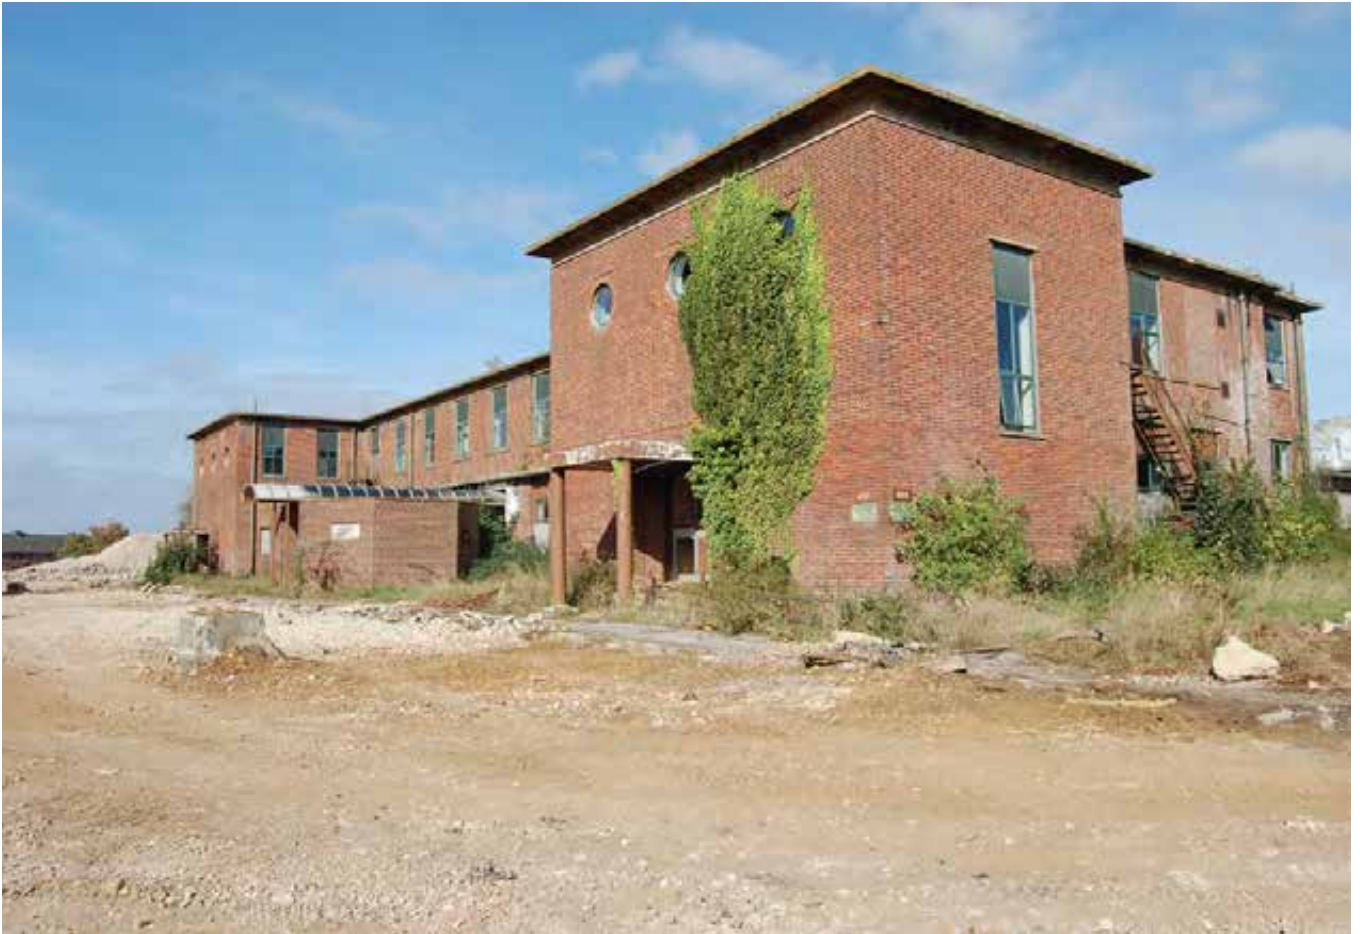
*Plate 488.1 South (front) and east elevations*

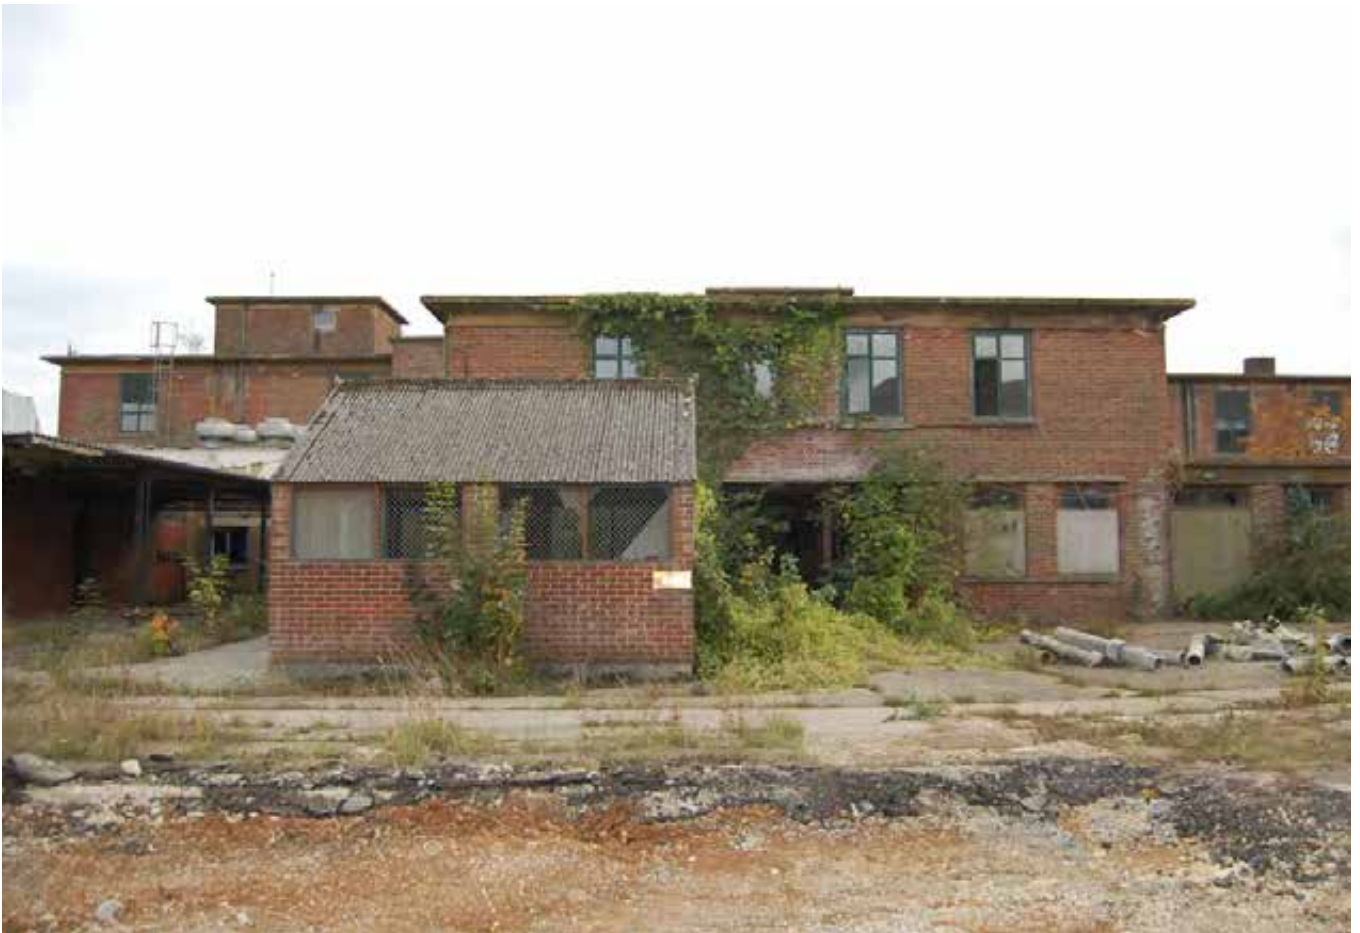
*Plate 488.2 North (rear) elevation*

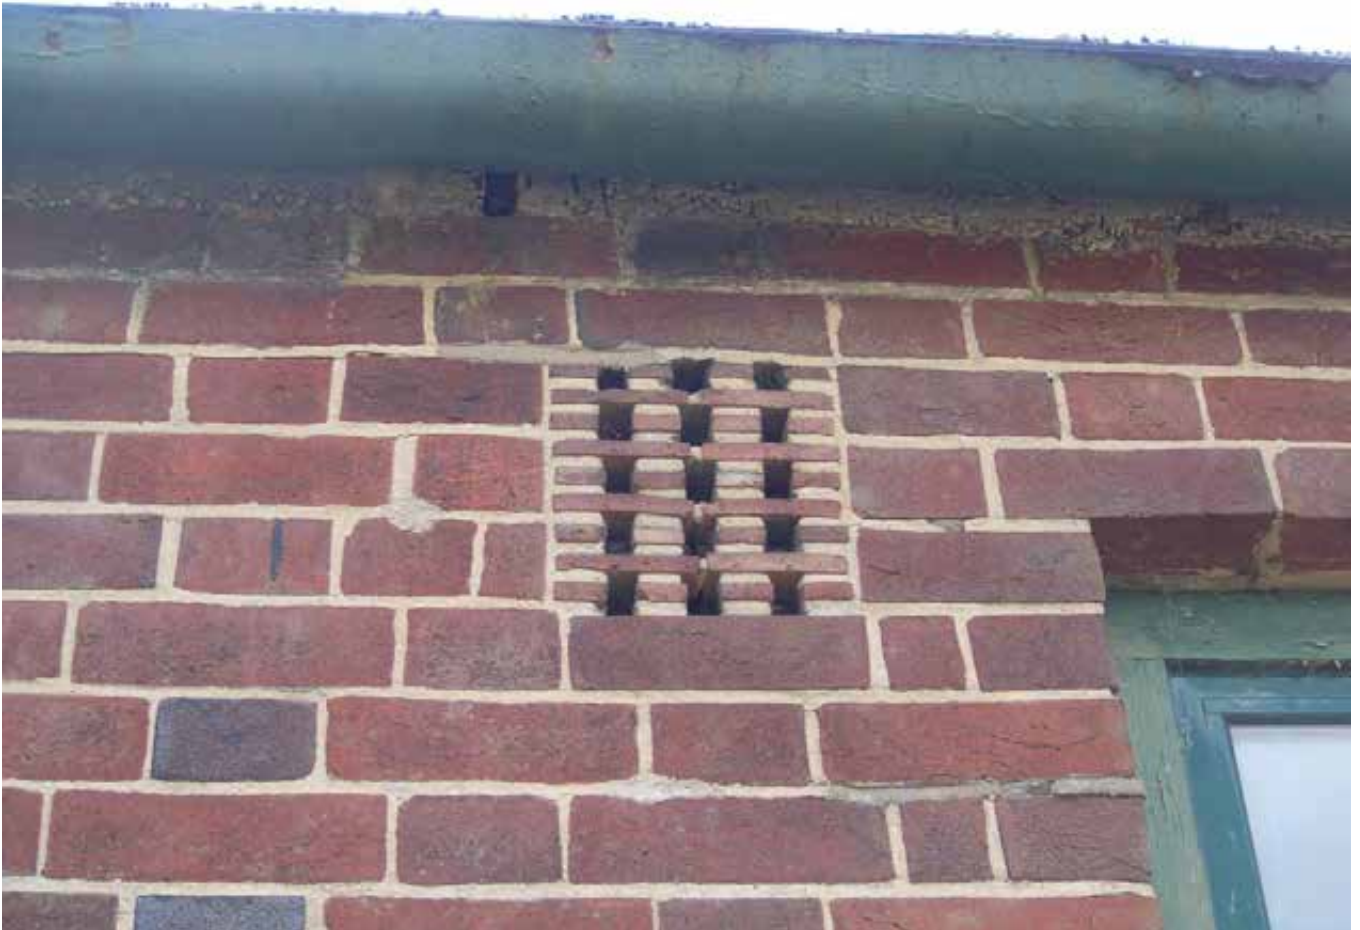
The protected flat roof, constructed from reinforced concrete, overhangs the dark reddish brown permanent brick walls. The concrete first floor pad extends to the elevations and forms a continuous lintel for the windows. It stops short of the front elevation of the wings which are of uninterrupted brickwork other than the apertures. Vents are built into the walls and are created from pieces of ceramic tile mortared together to form an open vent (Plate 488.3).

*Plate 488.3 Example of a vent*

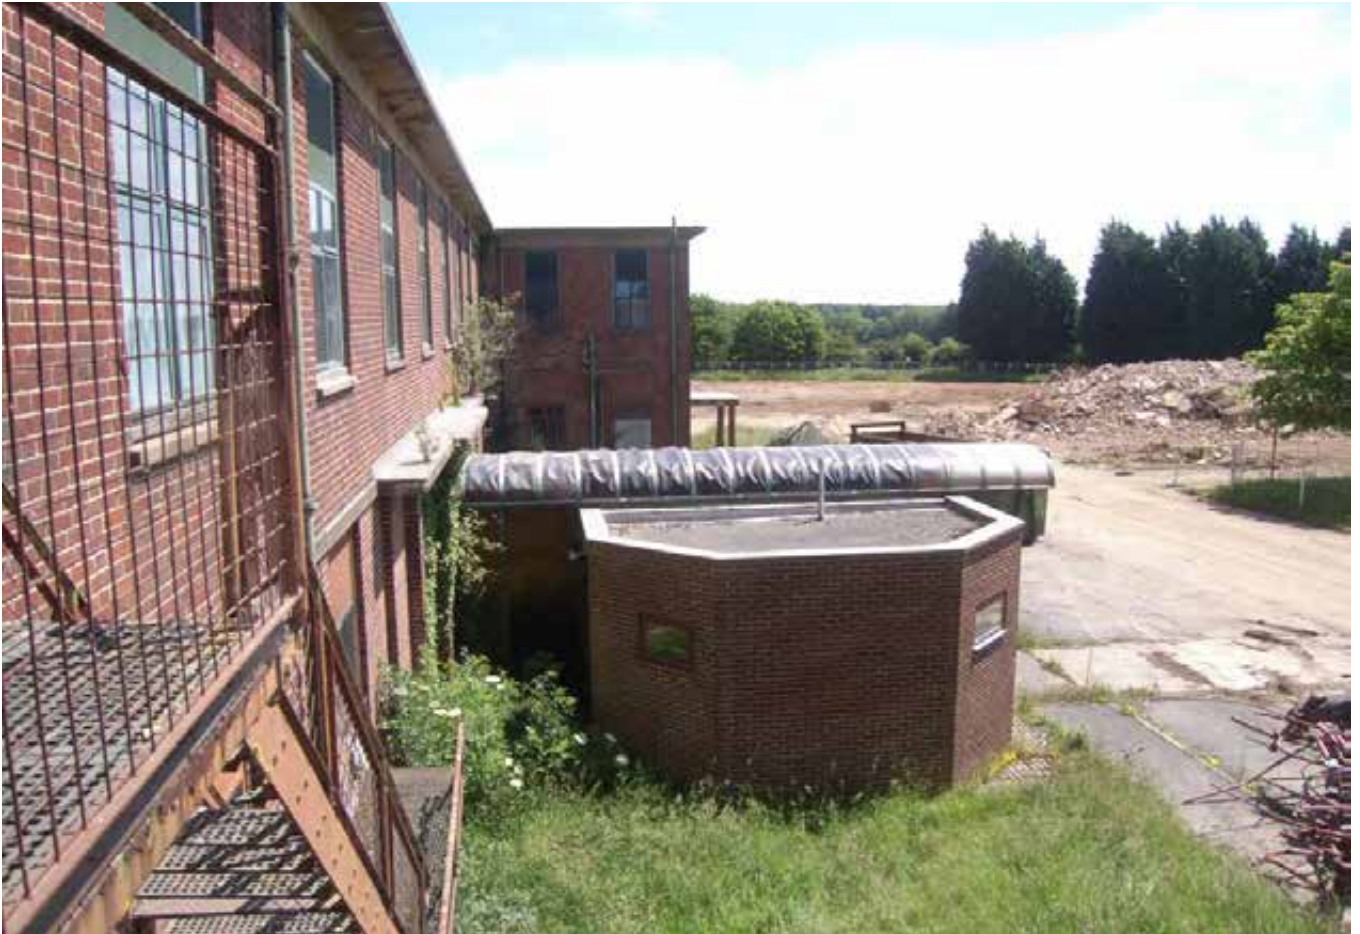
The footprint of the main structure of the building is as-built, with the exception of the front entrance block, extended from the central doorway, and the two open porches added to the front entrances of the wings at either side of the front elevation. These three original white art deco doorways are obscured by the later additions and brown paintwork (Plate 488.4). The original narrow, shallow white-painted concrete canopy survives over the central doorway, although it is almost completely obscured by the later entrance block extension (Plate 488.5).

The later entrance extension is an elongated octagon in plan and has a central walkway roofed in curved plastic. According to photographs posted on the *website raf-upper-heyford.org* (not reproduced here), the porches on the wings were in existence by the late 1970s, predating the entranceway extension, which may have been constructed as part of the 1986 catering and dining alterations.

*Plate 488.5 The entrance block extension*

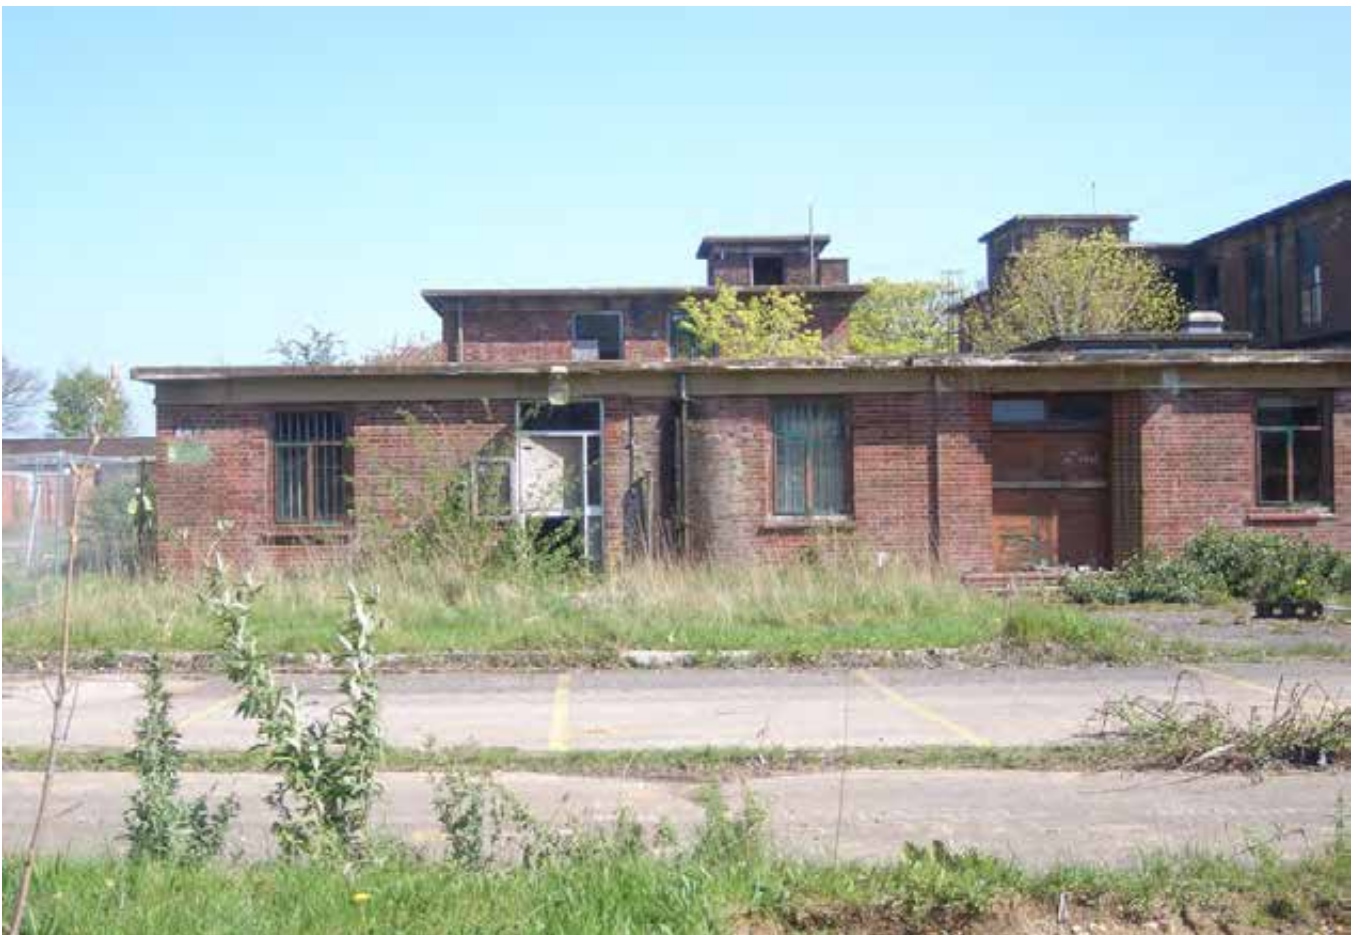
A tank room to the same design and proportions as the rest of the building is above the bathroom of the former NAAFI dormitories, and a similar tank room and lift room are above the first floor service rooms of the upper dining area; these are only accessible via ladders to the roof and so were inaccessible at the time of recording (Plate 488.6).

*Plate 488.6 The two second storey tank rooms visible in the roofline*

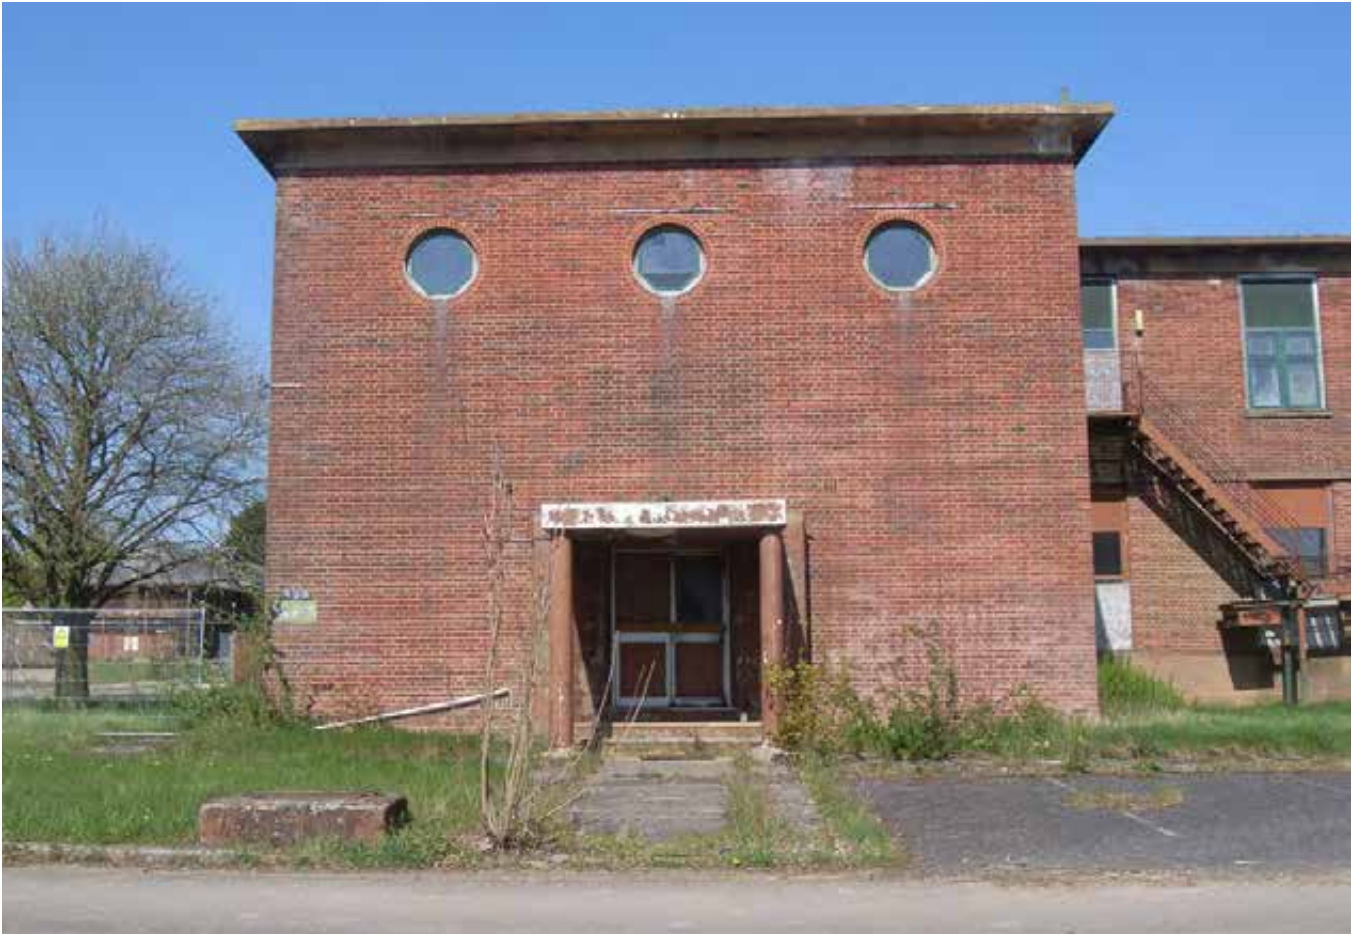
The round windows on the first floor have the original lead flashing above, intended to deflect rainwater from the glass and frames. The replacement frames are wooden and form an octagon (Plate 488.7).

*Plate 488.7 The west wing south elevation*

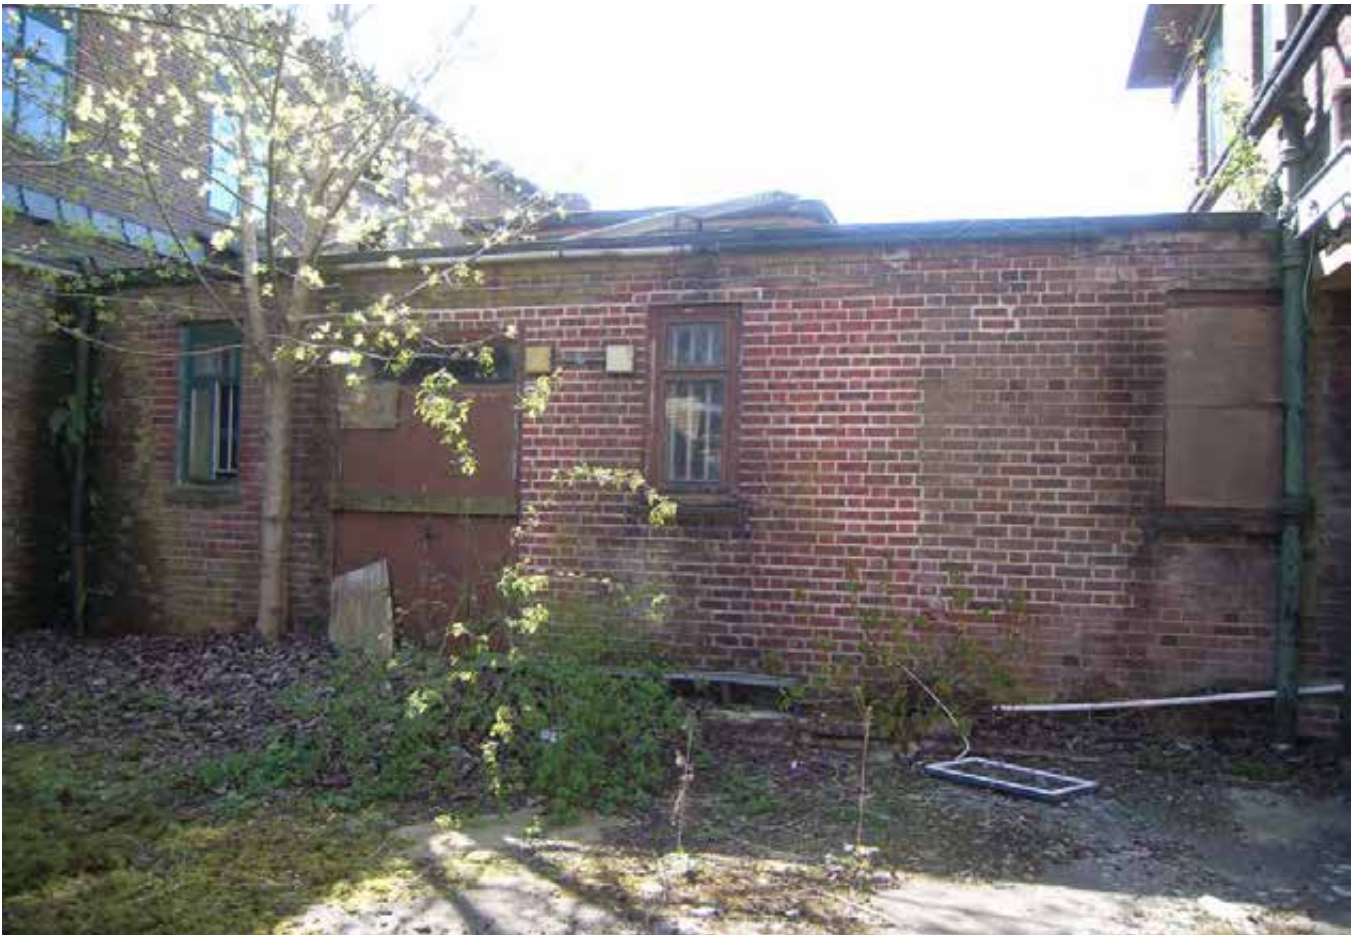
There is much evidence of the alteration of the apertures in the external walls, mainly to the rear service rooms (Plate 488.8), some of which do not appear on the surviving drawings and so pre-date those alterations indicated in 1981 and 1986. The ground floor windows to the wings which face towards the entrance have been only partially blocked using brickwork, however, the remainder of the windows to the two-storey block were blanked-off at the top of the existing frames with the installation of the suspended ceiling (Plate 488.9). To the upper floor they are black, to maintain the appearance of a window, whilst the ground floor panels have been painted in brown to match the ground floor woodwork. The first floor window to the north end of the east elevation of the former dining area was bricked-up completely with the addition of the Server Room (Plate 488.10).

*Plate 488.8 An example of alterations to the apertures in the rear range*

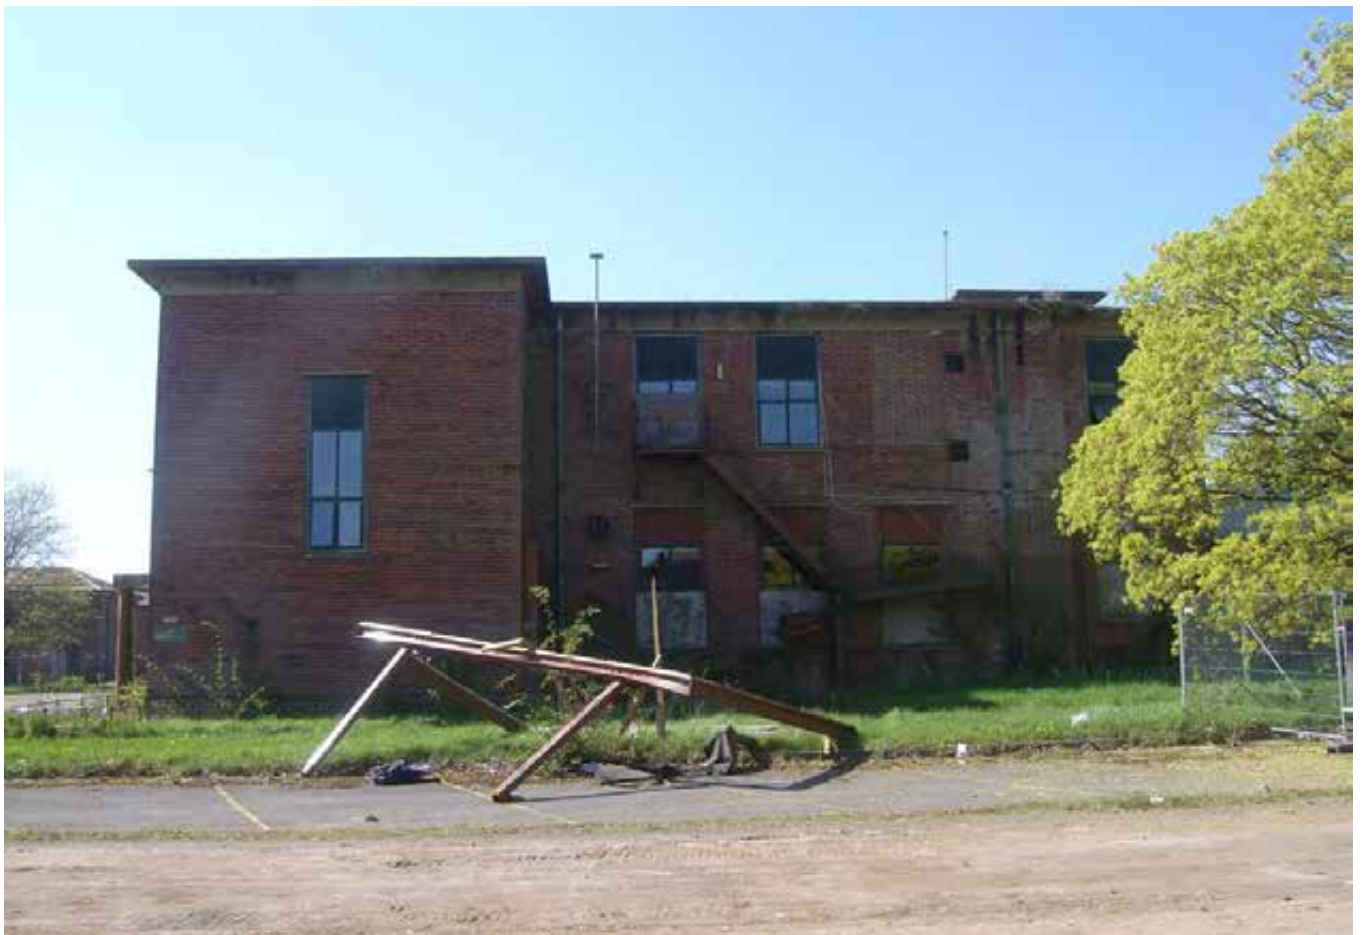
*Plate 488.10 East elevation*

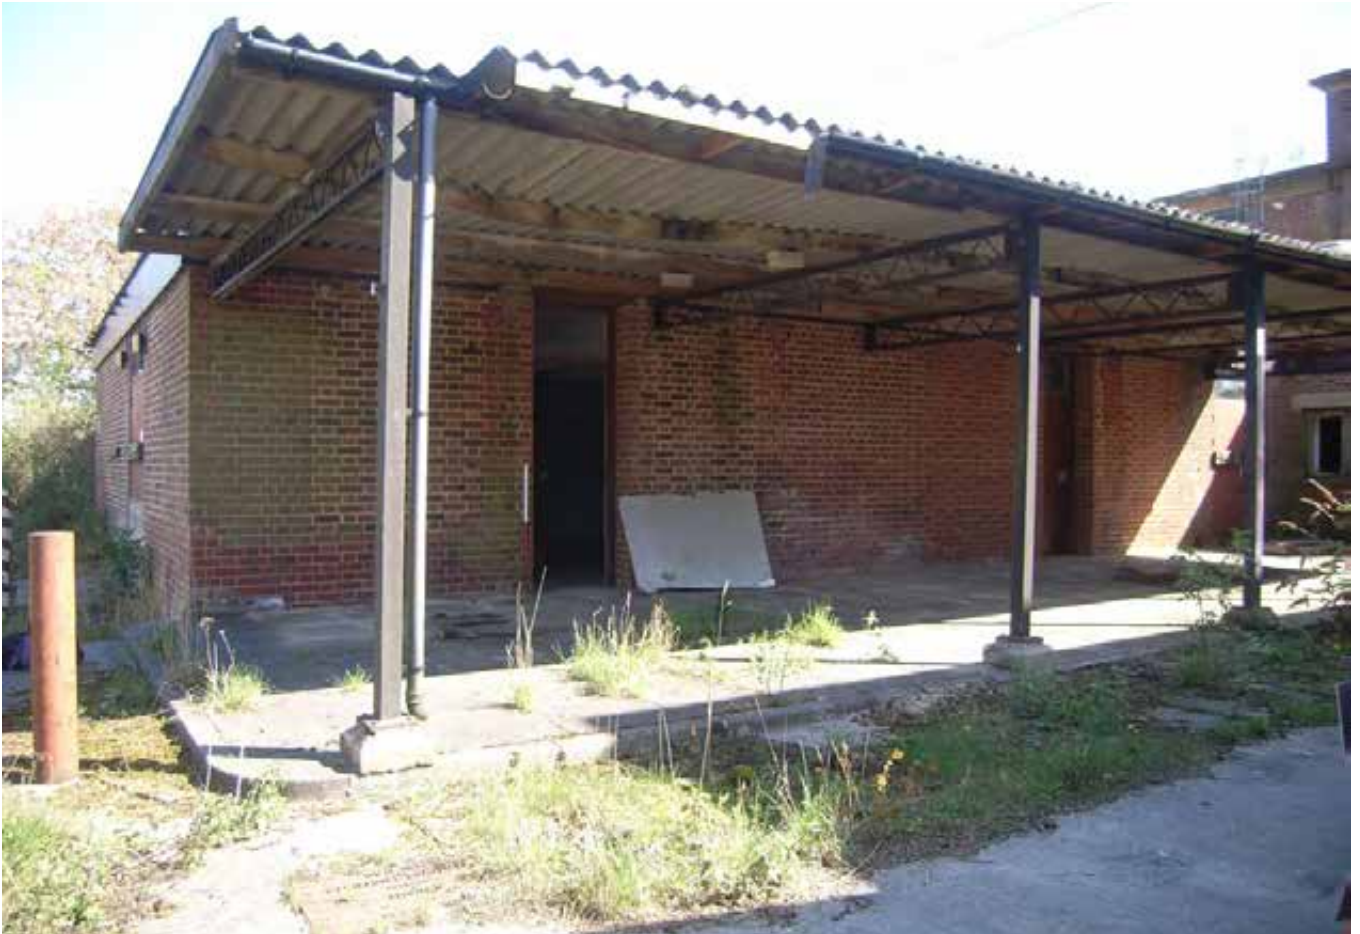
The open yard to the north-east, at the rear of the building has a later open timber, steel and corrugated asbestos structure forming a covered area along the eastern edge of the yard (Plate 488.11). Art Deco style metal gates secure the central yard; although these are likely to be a later replacement, they are in keeping with the style of the architecture.

*Plate 488.11 The covered area of the service yard*

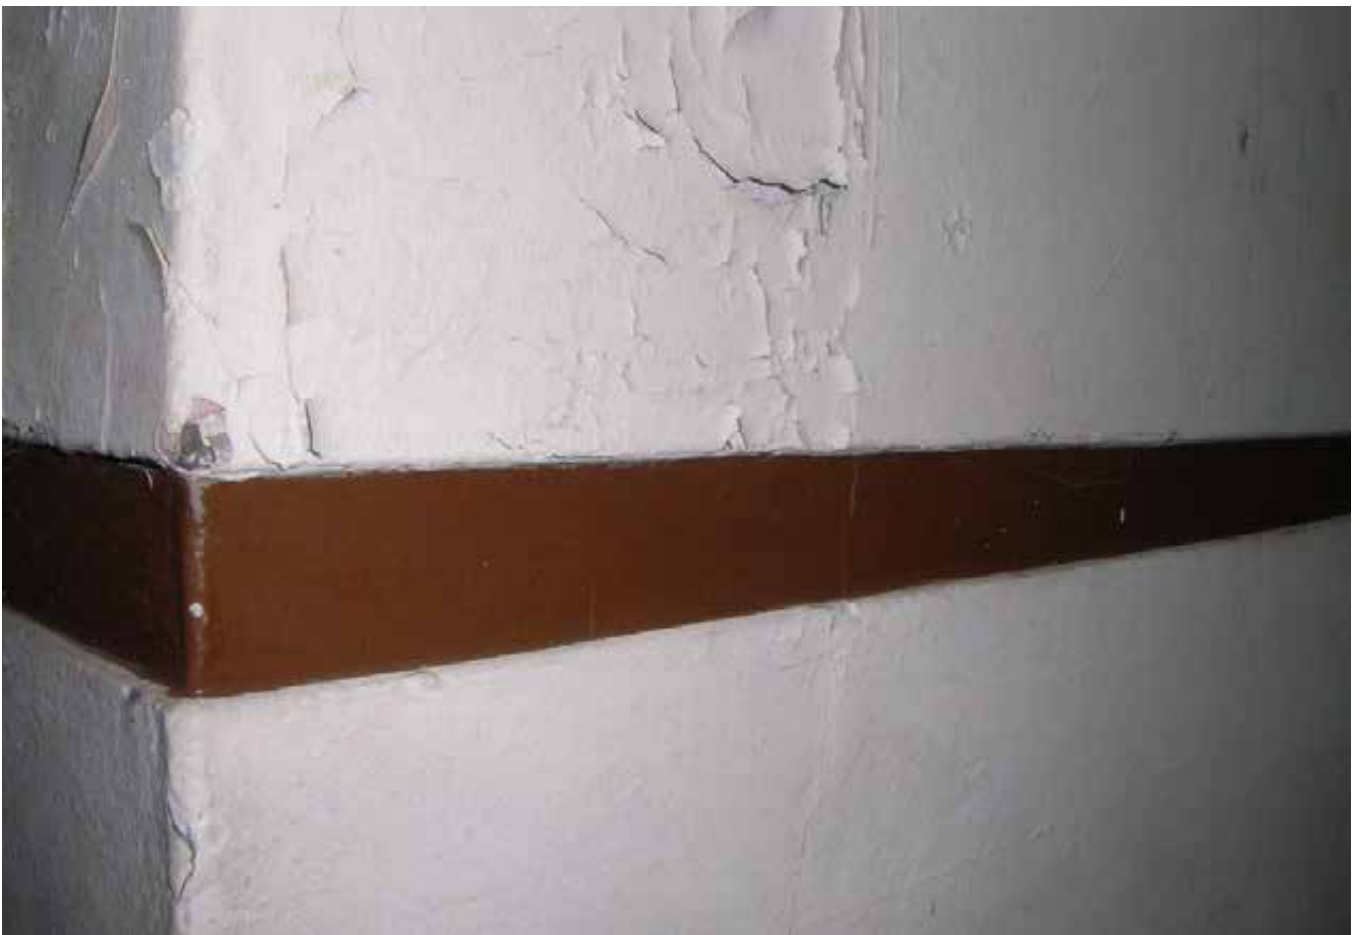
A shallow recessed dado signifies the primary walls in much of the interior of the building with the exception of the external walls of the wings (Plate 488.12).

*Plate 488.12 An example of the recessed dado*

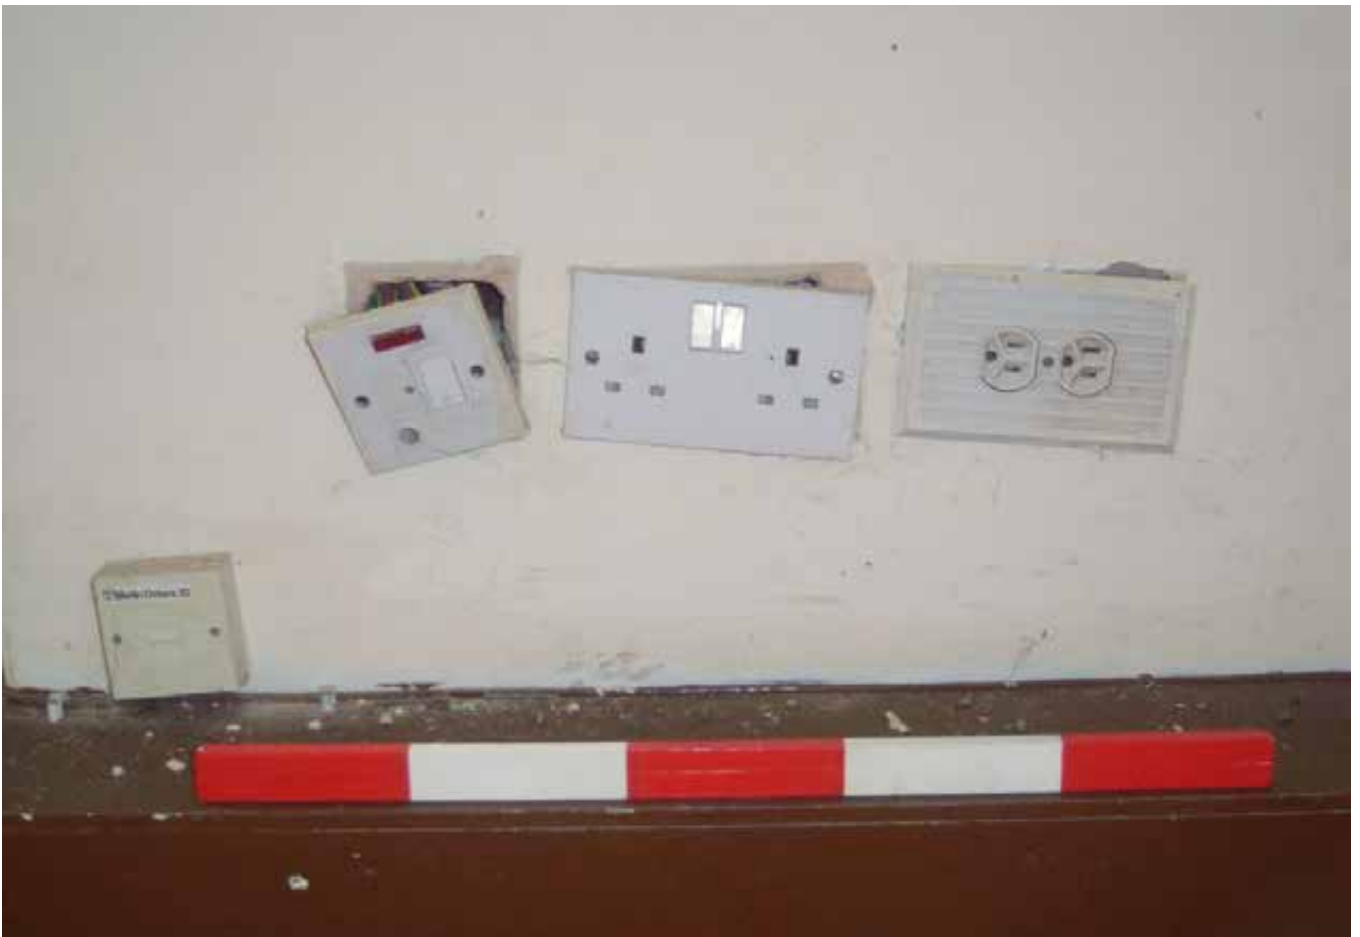
All of the office areas have American power sockets in addition to the British sockets (Plate 488.13).

*Plate 488.13 An example of the American and British power sockets*
