# Building 488: Combined Dining Room and Institute

Recording Level: 3

## History/ Function

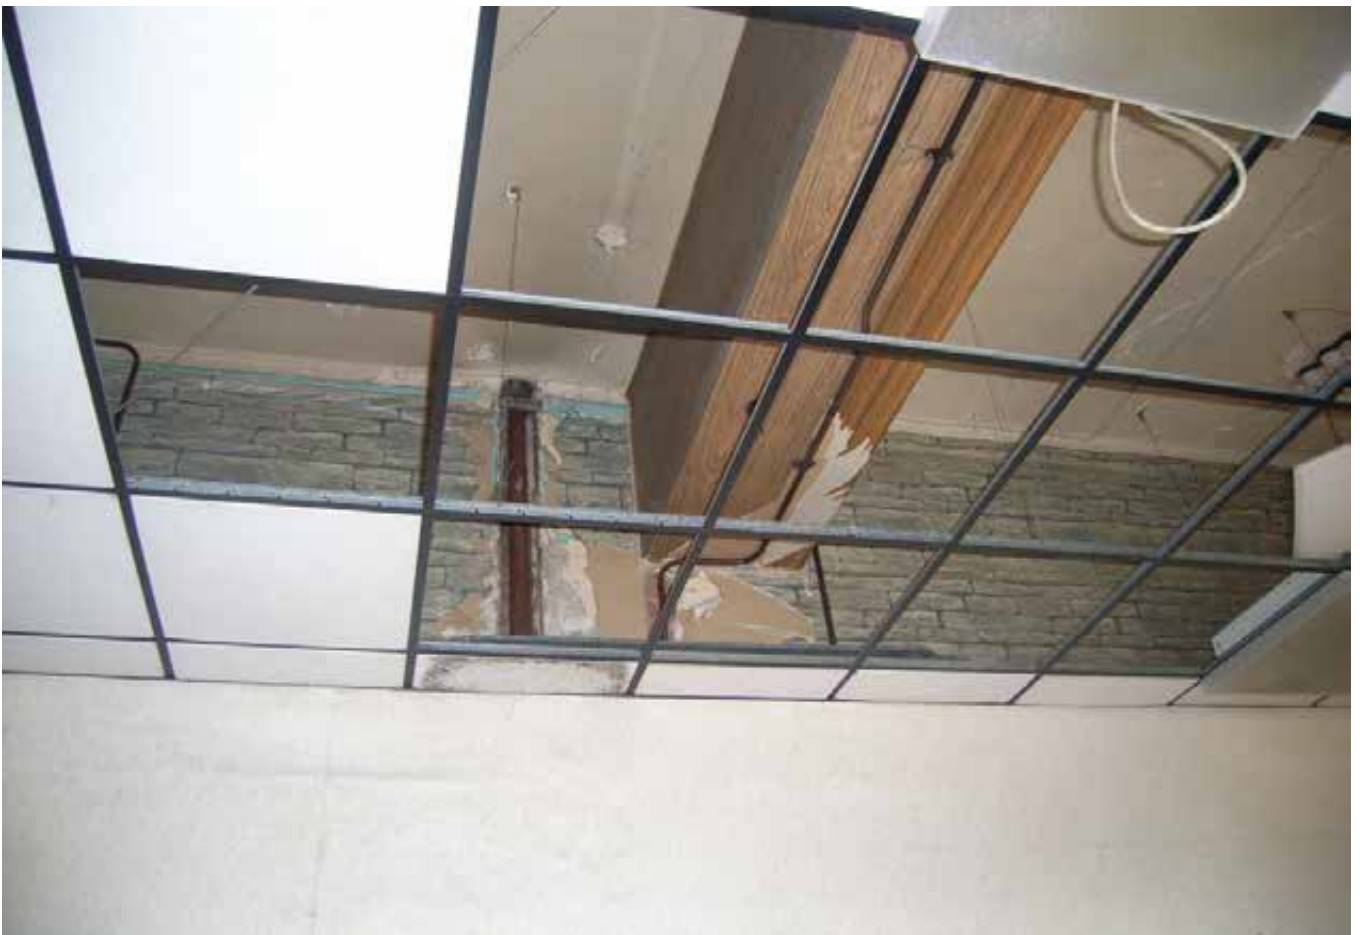
There is a suspended ceiling contemporary with the 1986 refitting of the room which conceals the beams of the concrete ceilings and areas of the former decorative scheme. This décor was trying to emulate a traditional style building with stonework-effect and brickwork-effect wall papers with wood-effect wallpaper to the concrete beams (Plate 488.18).

*Plate 488.18 The former décor scheme in the dining room*

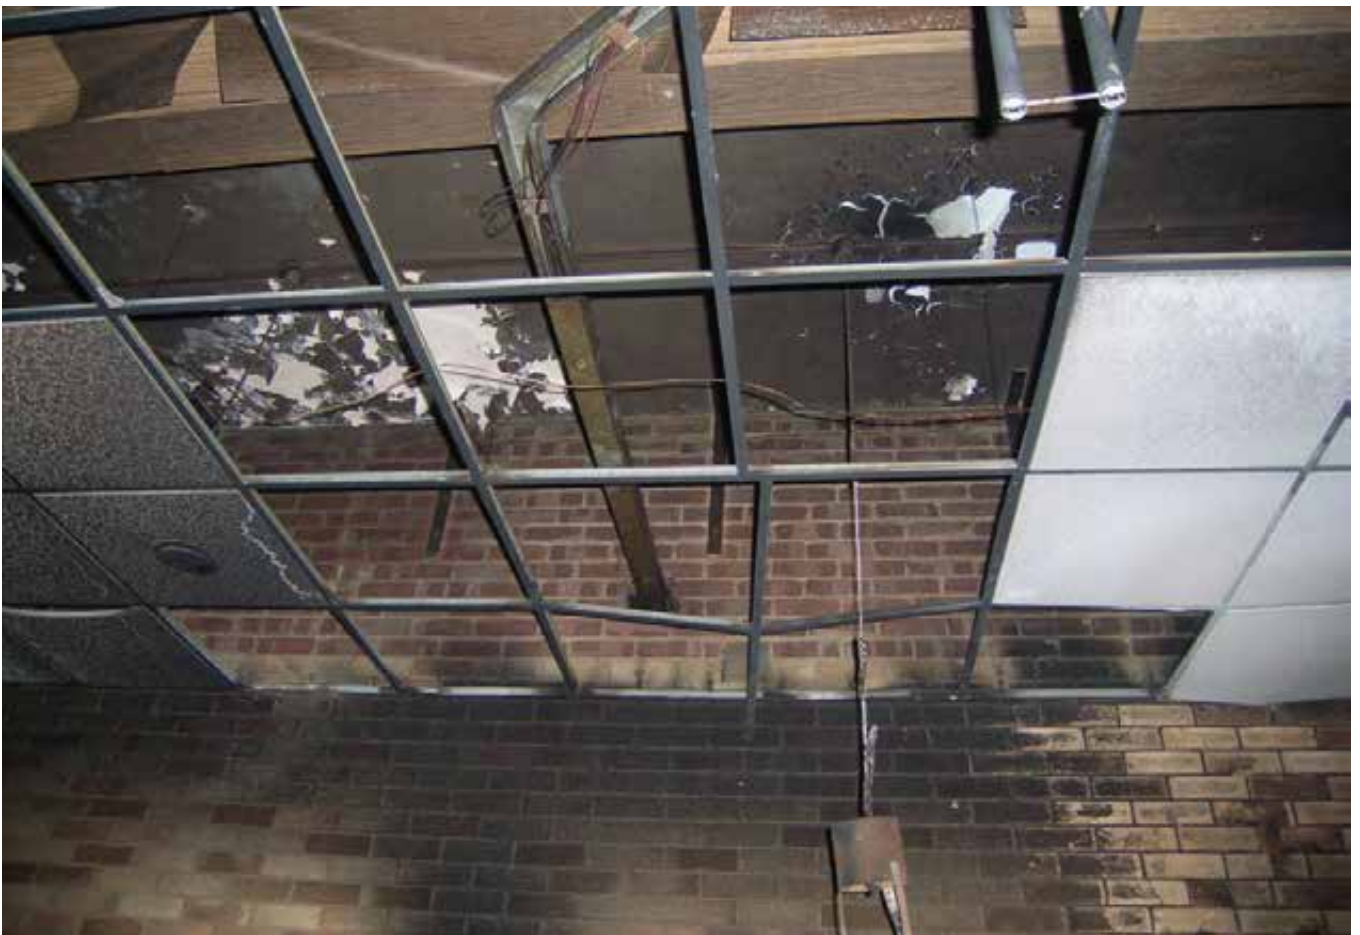
The serveries are not as the 1986 drawing, with references on the drawing to temporary works superseding the planned work. The fronts of the stainless steel serving line counters are covered with red leather effect plastic, and the walls are covered with wood effect plastic to dado height to match the style of the dining room booths (Plate 488.19). The block wall separating the serveries from the kitchen area can be seen above the suspended ceiling, indicating that the ceiling is contemporary with the wall and décor. The buff and orange-brown bricks used to construct the east and west walls of the servery are only used to the height of the suspended ceiling; above this, cheaper commons are used (Plate 488.20).

*Plate 488.20 The types of brick used in the servery wall*

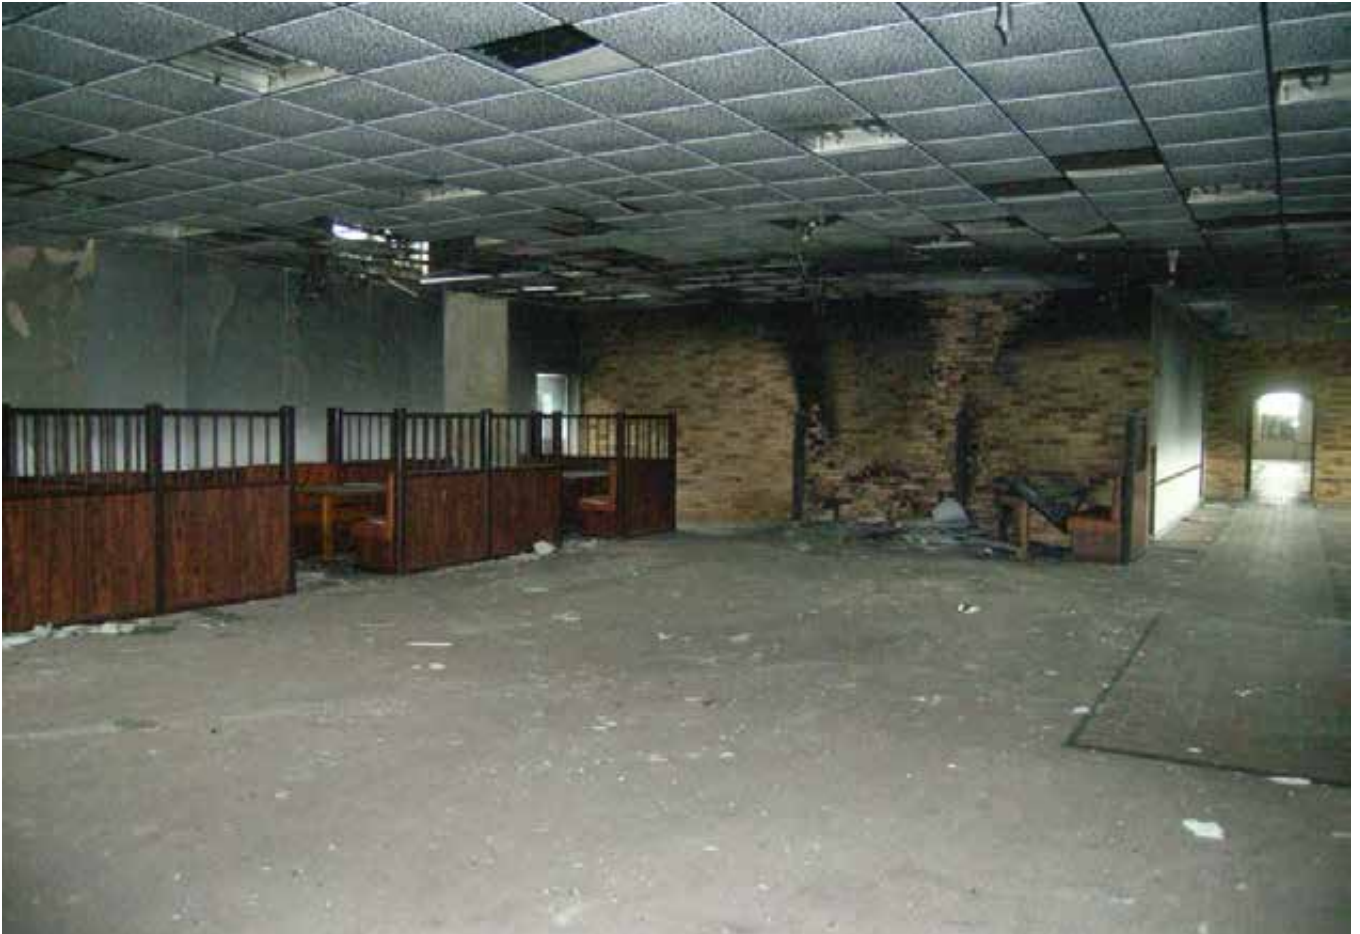
The western dining room has had some fire damage from recent vandalism (Plate 488.21) which has also melted the entrance way plastic roof.

*Plate 488.21 The west dining room*

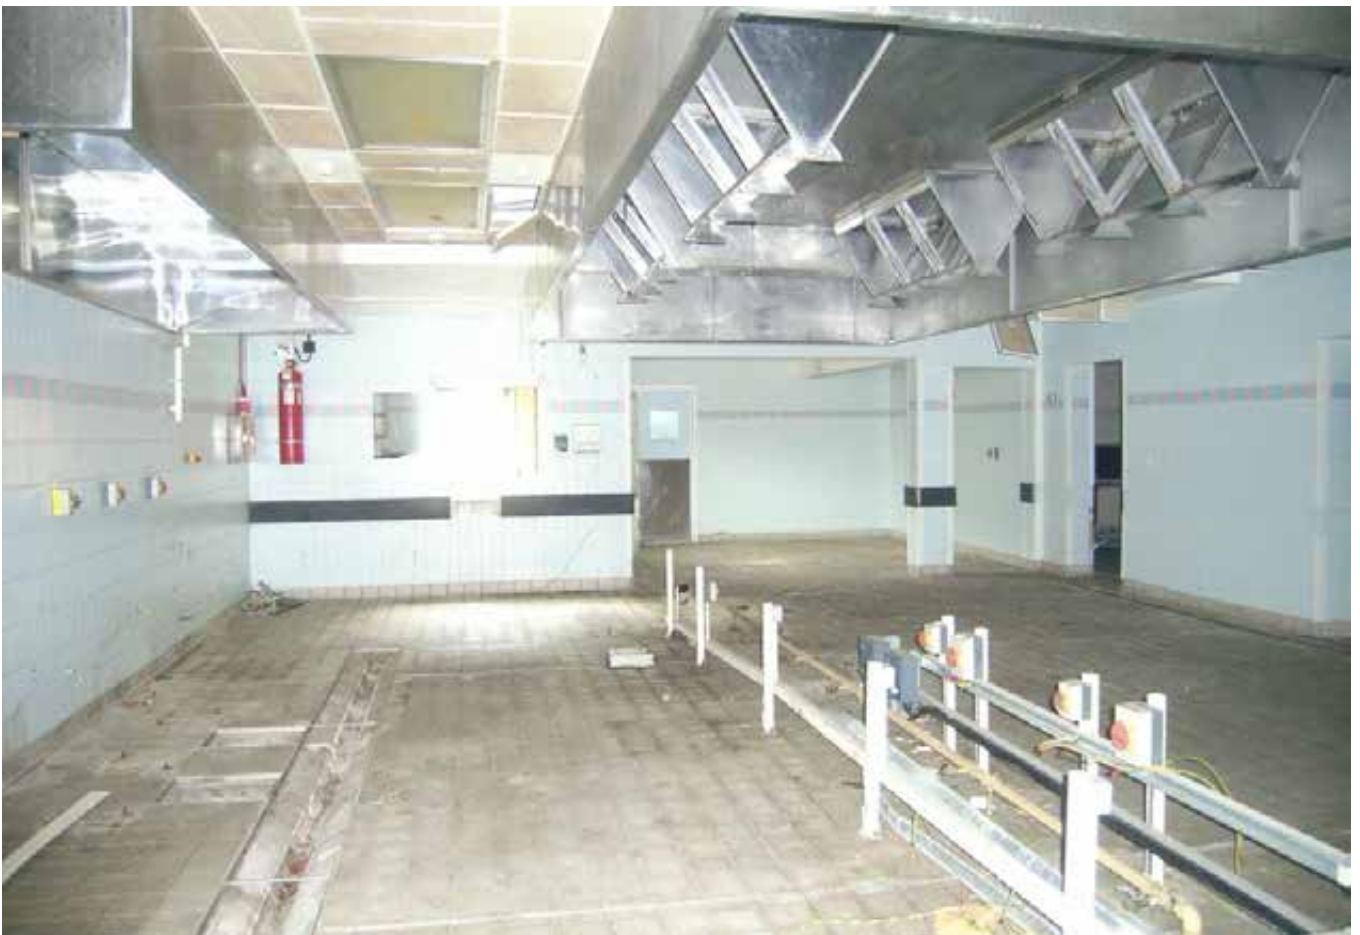
The floors are tiled with cream non-slip tiles which rise to form the skirting. Drainage channels are in the floor of the kitchen area and some of the preparation areas. The concrete slab forms the ceiling in most areas with suspended ceilings in the corridors and kitchen which conceals services, including the ducting serving the large stainless steel extractors in the kitchen ceiling (Plate 488.24).

*Plate 488.24 The kitchen*

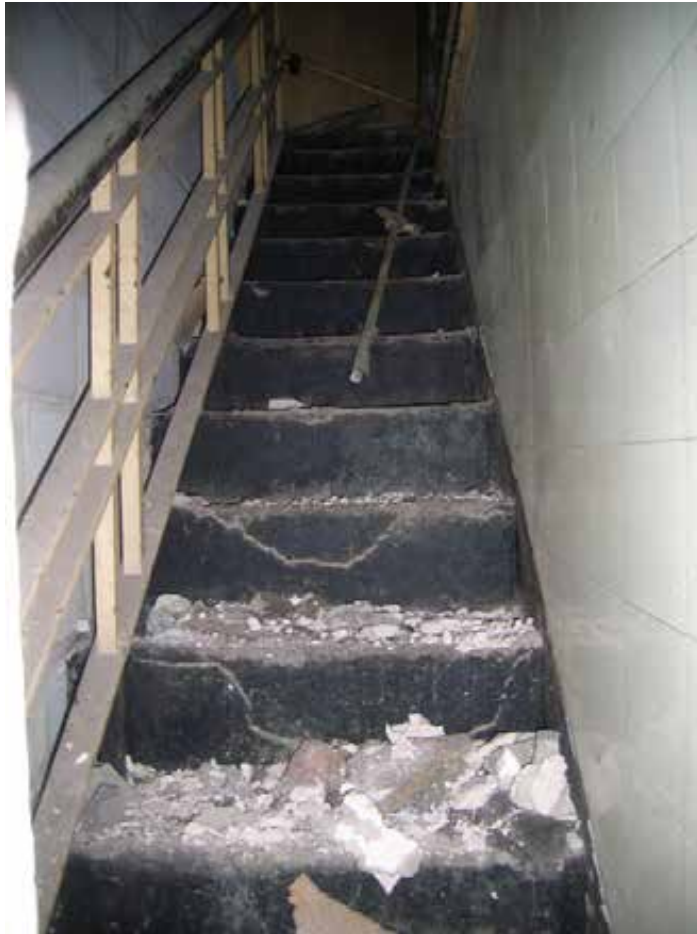
The corridor between the platewash and the kitchen houses the electrical control panels; to the east of this is a blocked-in area and cupboard concealing an original staircase which formerly lead to the upper dining room. This was photographed via a small hole in the aerated concrete block partition which covers it (Plate 488.29). No evidence of the staircase is visible on either floor.

*Plate 488.29 The blocked in staircase*

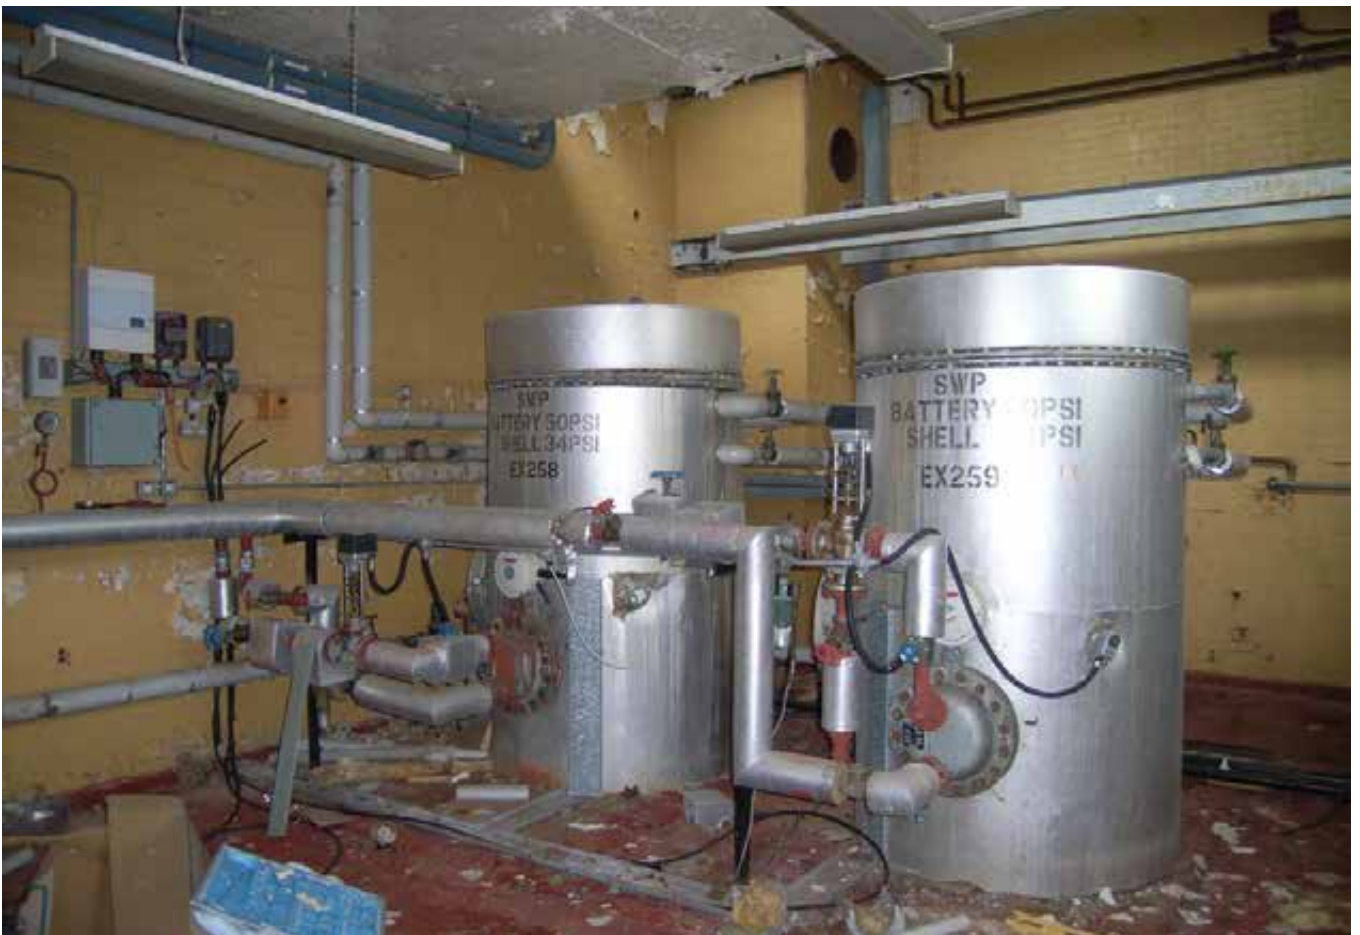
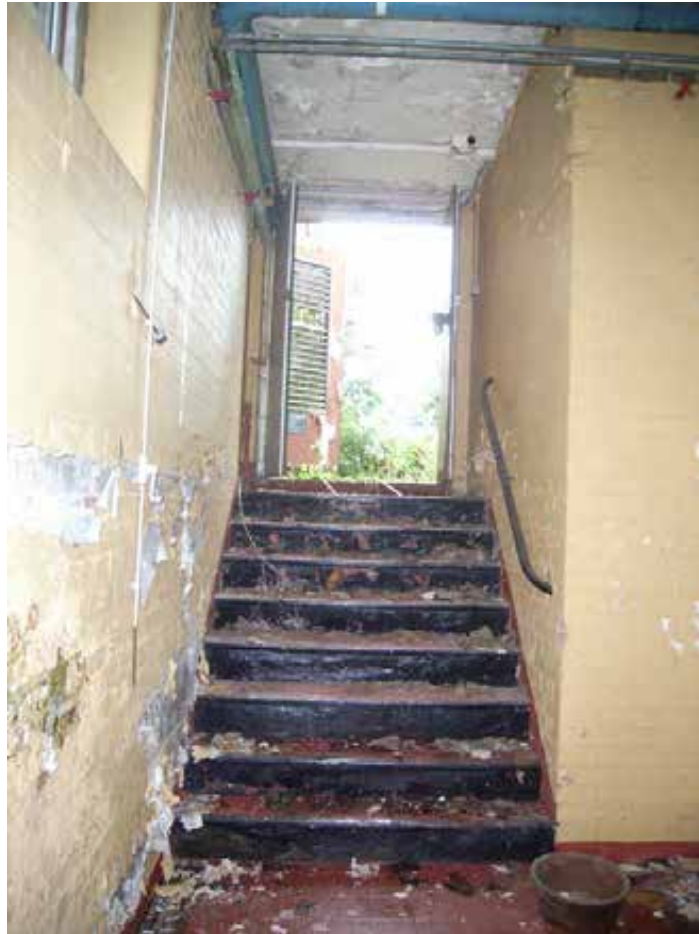
To the south of the service yard is the below-ground Plant/Boiler Room and the adjacent Valve Room. Now containing modern plant, the Boiler Room does retain trenches and brick bays for former equipment (Plates 488.32 & 33).

*Plate 488.32 The boiler room*

*Plate 488.33 The steps from the boiler room to the yard*

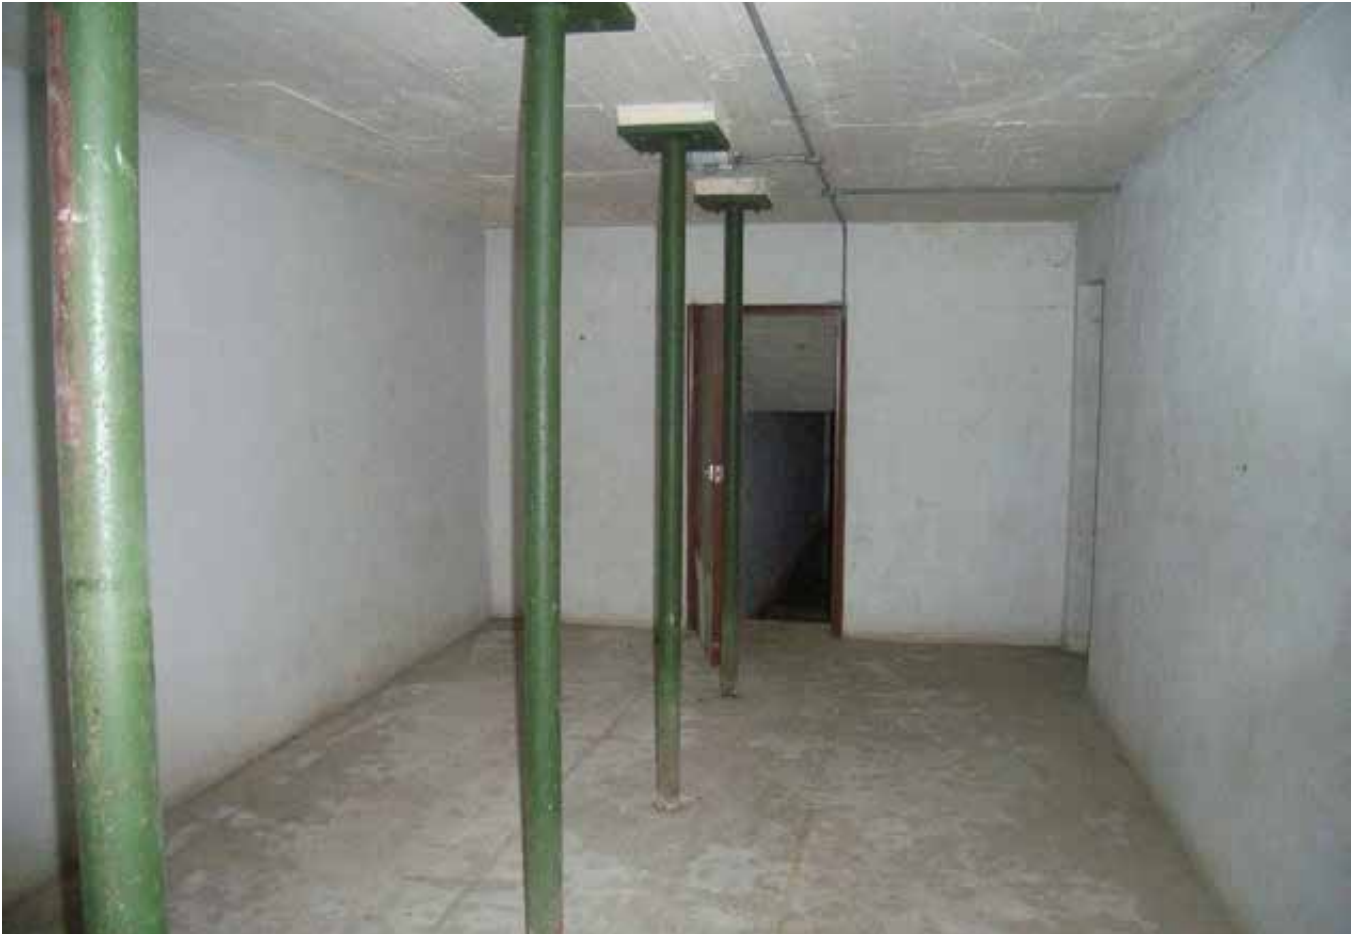
The basement is accessed via the doorway beneath the staircase in the west wing. Insufficient light and structural problems prevented recording, but rooms leading off the main room were evident. The poured concrete structure can be clearly seen in the ceiling (Plate 488.41).

*Plate 488.41 The basement*

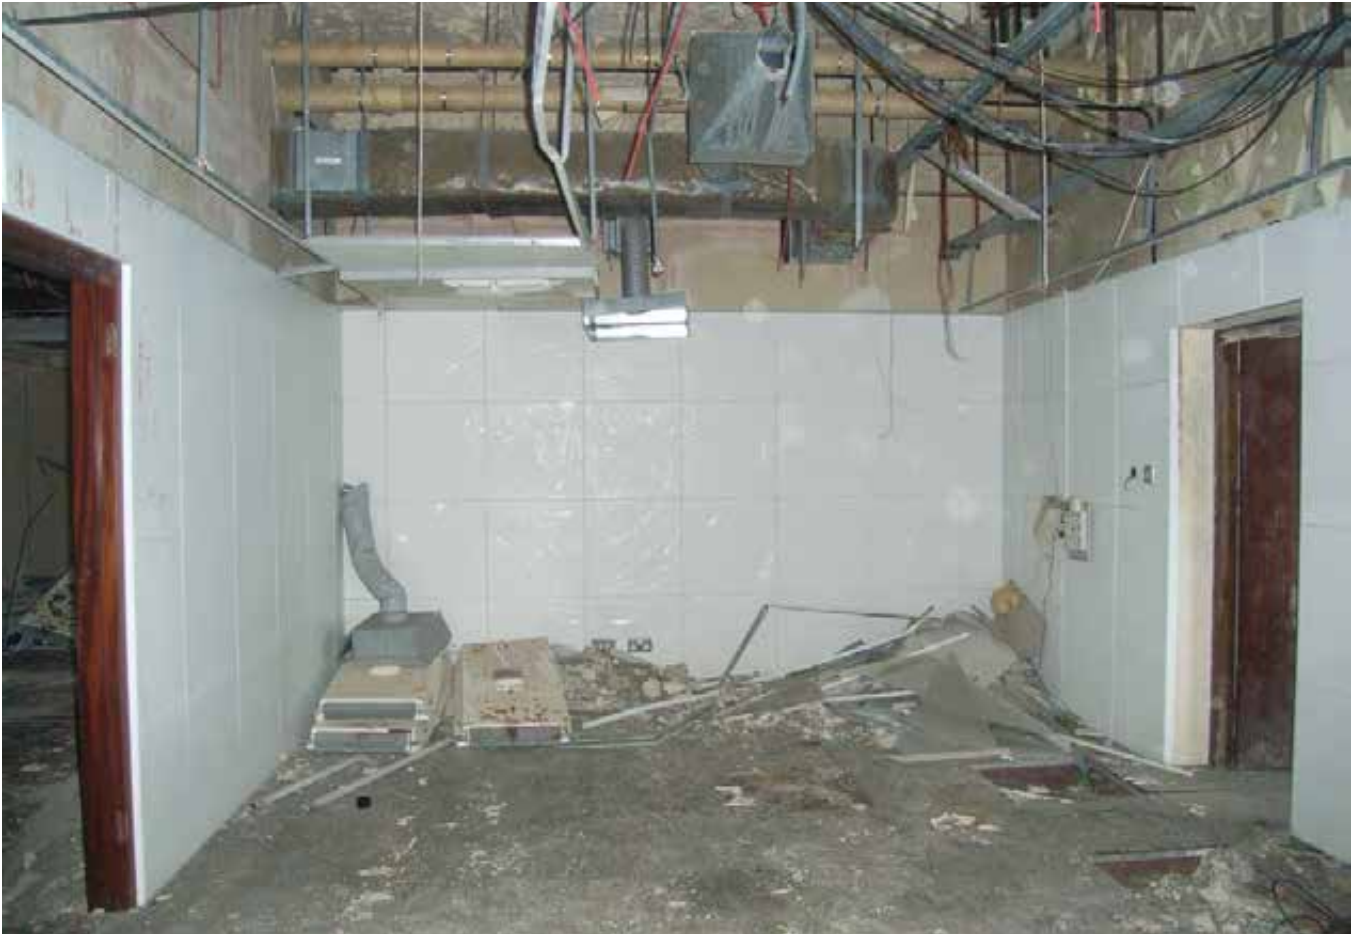
A server room towards the north east corner in F31 has caused a computer floor to be installed, and a ramp has been installed to allow access from F30. The window in the east wall has been blocked at an unknown date, although it was still open in 1981 when the floor was divided up into offices; presumably the window was blocked specifically to allow for the change of use. The walls of this room are clad in plastic tiles to help prevent dust. The suspended ceiling has recently been removed, showing the extractor fans required to cool the room (Plate 488.47).

*Plate 488.47 The server room*

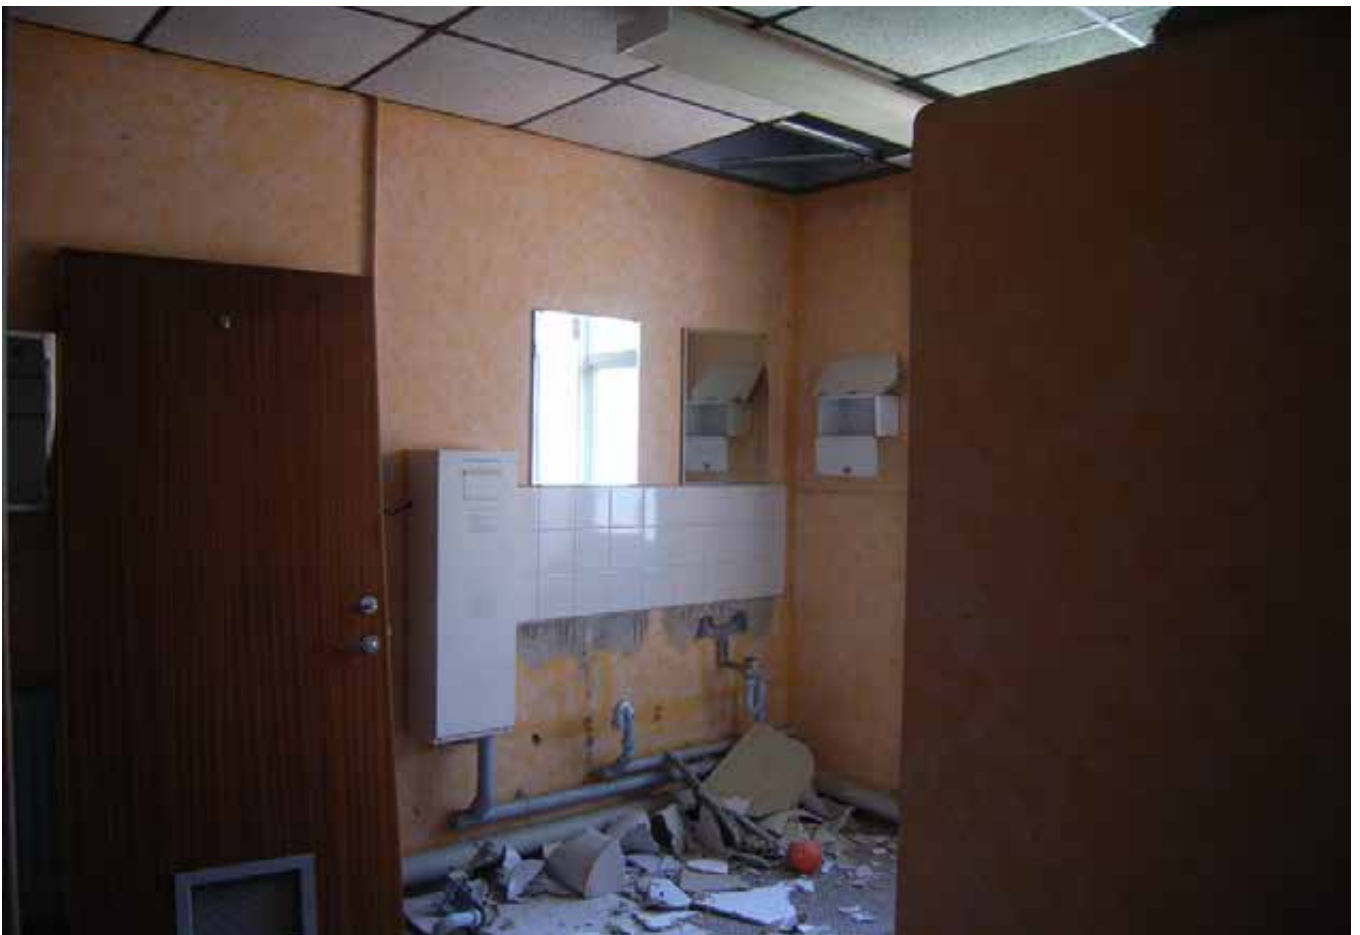
The ladies WC has been redecorated in stippled orange with the former blue décor visible above the suspended ceiling, the men's is the same blue, which extends above the suspended ceiling, suggesting that the WC additions probably occurred before the 1981 works (Plate 488.50).

*Plate 488.50 The ladies WC in the east wing*
