Heyford Park, Camp Road Development Objection

London North Western (LNW) Route Level Crossing Risk Assessment

Somerton User Worked Crossing/Footpath Bridleway Crossing with Miniature Stop Lights

15 March 2018

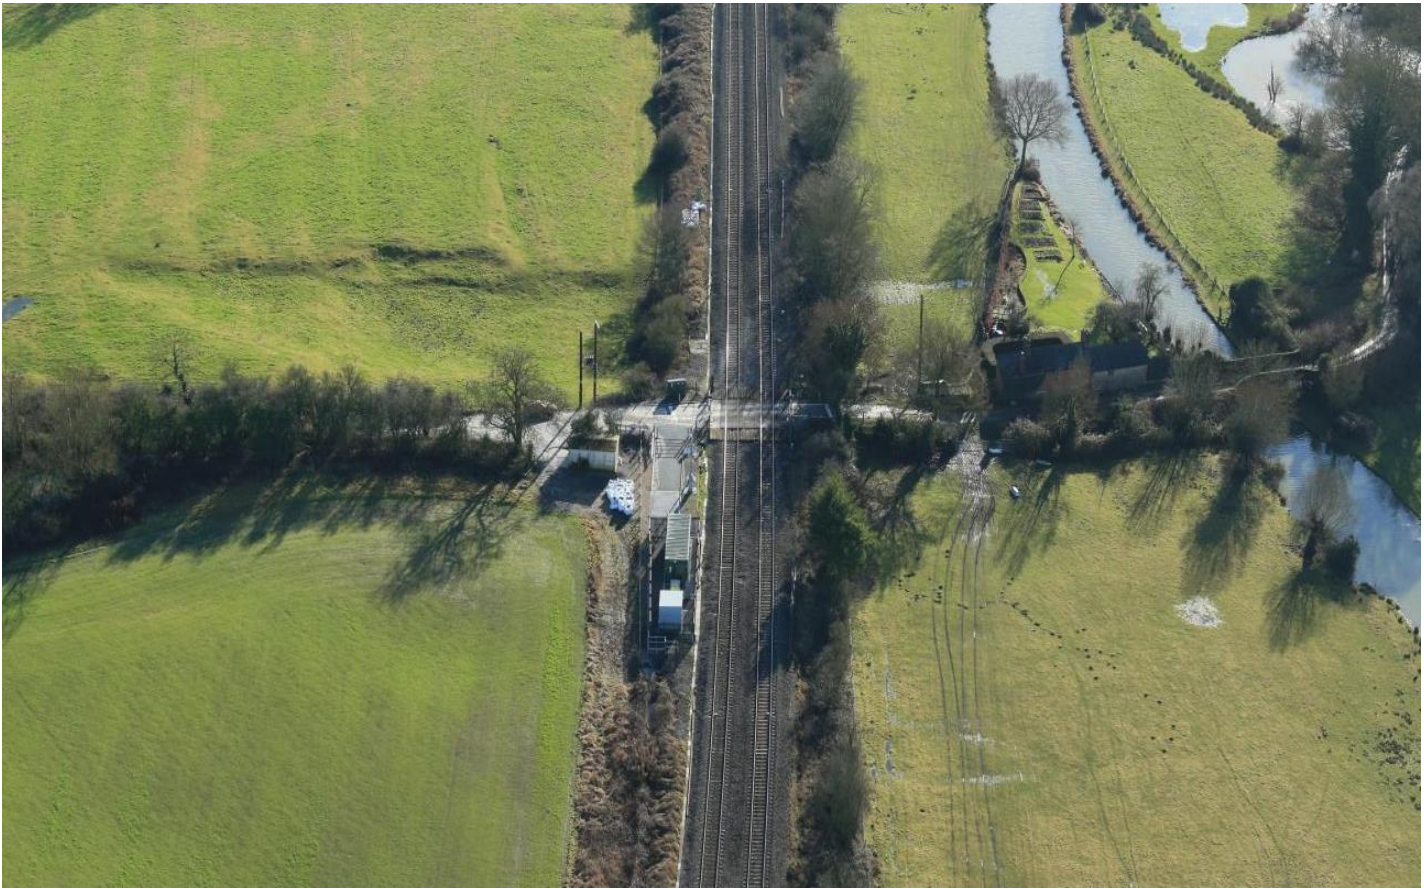
Aerial view of Somerton Level Crossing

Somerton User Worked Crossing/ Bridleway crossing is located between Leamington Spa and Banbury stations on the DCL line (Didcot to Chester Line) that takes passenger and freight services between Birmingham and London Marylebone, formally known as The Chiltern Mainline. The immediate surrounding areas of the crossing consist mainly of fields, farmland and footpaths that are used for arable/pastoral farming and recreational purposes.

Located immediately to the West of the crossing lies a residential property, known as Mill Cottages and around 150 meters further West is another residential dwelling, known as Somerton Mill. These properties are split in between by the Oxfordshire Canal with a small canal bridge that links the access road. Located further beyond the second property is also the River Cherwell meaning that the area is known to be a wetland during the winter months. The occupiers of these properties are the predominant authorised users of the locked gated crossing, however there is also vehicular access granted, in addition, to the farmer of the land to the North West of the crossing. In addition to this there is also a public footpath/bridleway which runs adjacent to the user worked crossing.

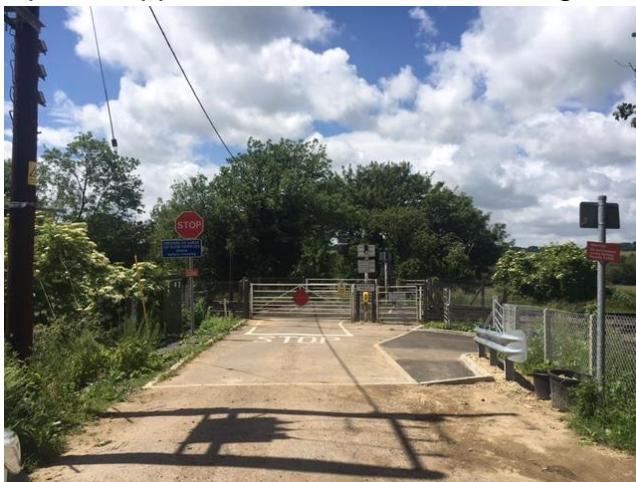
Up side approach of Somerton Crossing

The approach from the East or up side is via a fairly long private track that runs between fields spurring off Somerton Road. This track is set on a slight decline which is made up of a rough stone, brick and mud surface which is used to access a number of fields before gradually descending down towards the crossing where for the last few meters become a tarmac road surface. This area has a white stop marking and a white stop line painted onto the surface which can become obscured with mud during the winter months due to the transfer of dirt from the access track.

On the final approach to the crossing warning signage becomes immediately noticeable with a 770 gates warning sign, 782 risk of grounding sign, 783 drivers of long or low vehicles must call prior to crossing, a STOP sign and a partial 784.1 sign dictating that drivers of large or slow vehicles must call prior to crossing. All of these are post mounted in an elevated position on the left hand side, also known as the nearside approach to the crossing so that they can be seen by approaching vehicles.

Once at the STOP marking a red target sign has been installed onto the gate of the private user worked crossing with additional instructional signage for the miniature stop lights installed on the right hand side. These signs include a CC08Z red/green light sign, CC09Z instructions sign and a large name plate with the direct connect telephone positioned underneath. These signs have been installed between the bridleway element of the crossing and the private user worked crossing because both parts to this hybrid crossing use the same active warning to determine whether it is safe to cross. Additionally installed on the bridleway gates are a CC14Z instructions sign to guide pedestrians and horseback riders across. N.B all of the signs mentioned above can be seen in section 10 Appendix B.

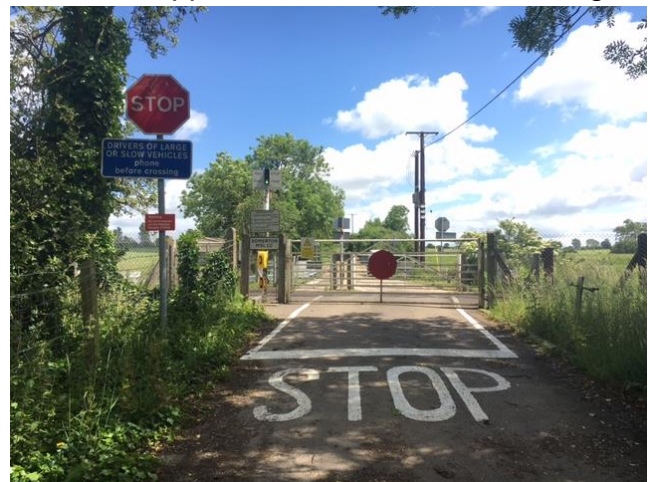
Down side approach of Somerton Crossing

The approach from the West or down side leads from the two properties, as mentioned above, and mirrors that of the up side approach in particular the signage and layout. However unlike the descending approach on the up side of the crossing the down side approach rises slightly up to the crossing deck which is flat and straight, it is on this side that there is a greater risk of grounding although it is not likely considering the vehicle types which use this crossing, however this is why the warning signs have been installed. Once again during the winter months in particular due to the muddy dirt track the stop markings and lines can become obscured and hard to visualise.

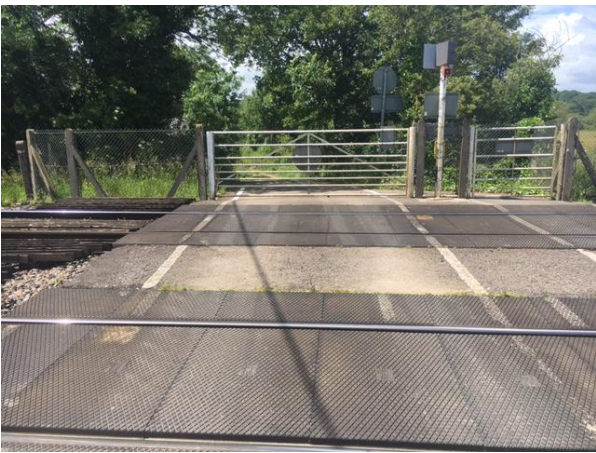
Up side across crossing

The level crossing deck is made up of a rubber surface which crosses over two lines and is split in the middle by a tarmac surface. The crossing deck is flat and straight which runs at a 90 degree angle from the approach path with white lining in place to

determine the edges of each element of the crossing. In addition to this low level solar lights have been installed to the edges of the bridleway section of the crossing to guide pedestrians in a “runway style” over the railway during periods of darkness.

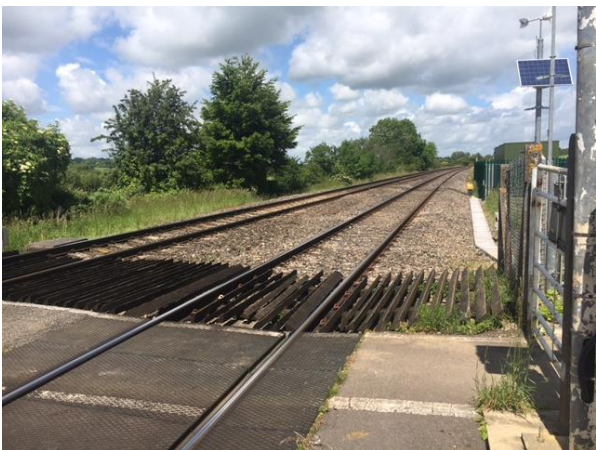
Up side towards up train approach

Minimum sighting distance required (m)	Available sighting distance (m)	Comments	Warning time provided by sighting distance (seconds)
Upside looking towards up train approach	335	270	Measured to the vegetation on the down side at the point of track curvature	6.71
Upside looking towards down train approach	335	991	Measured to a track side cabinet in the distance	24.63
Down side looking towards up train approach	348	312	Measured to past the 75 sign to the vegetation on the curve on the up side	7.75
Down side looking towards down train approach	348	991	Measured to a track side cabinet in the distance	24.63

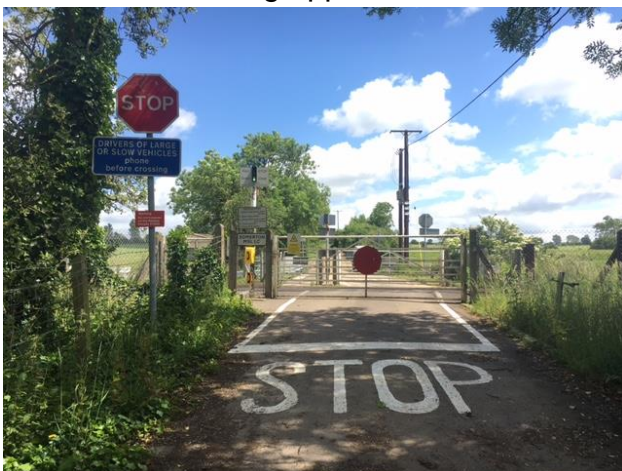
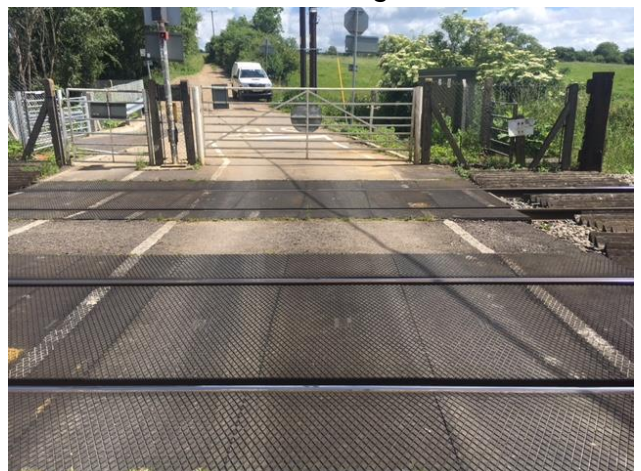
Down side crossing approach

Down side across crossing

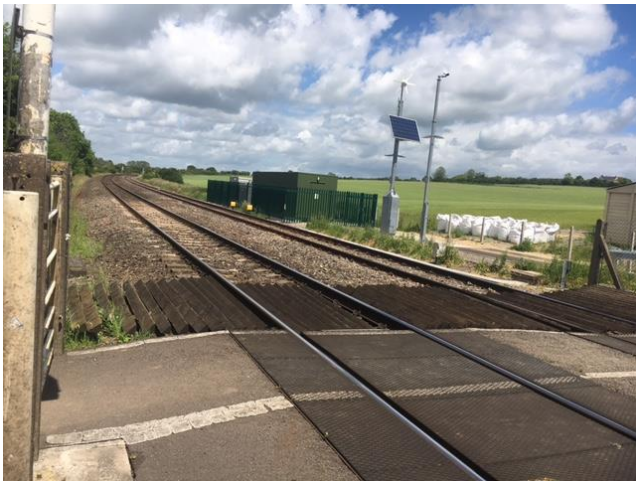
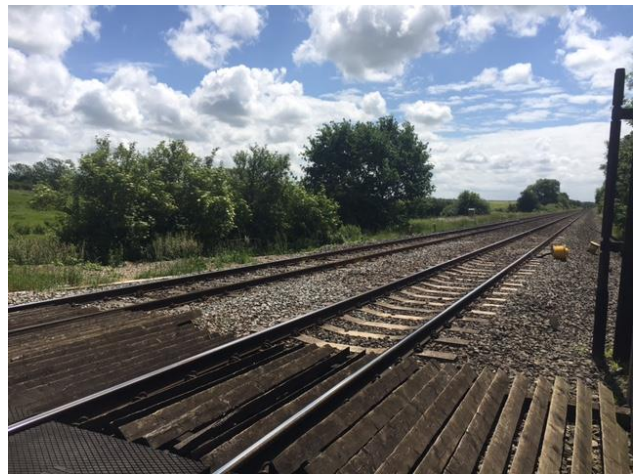
Down side towards up train approach

Down side towards down train approach

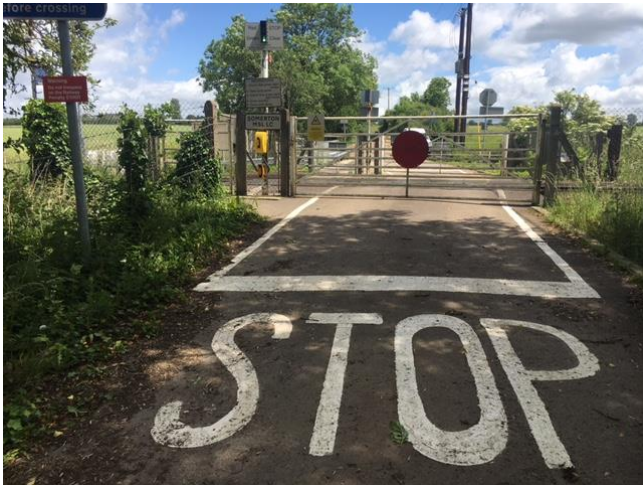
Down side crossing approach

Down side across crossing
