Heyford Park Primary School

Desk Study and Site Investigation

For Dorchester Living

Doc ref: 04583-HYD-SCH-XX-RP-GE-1000

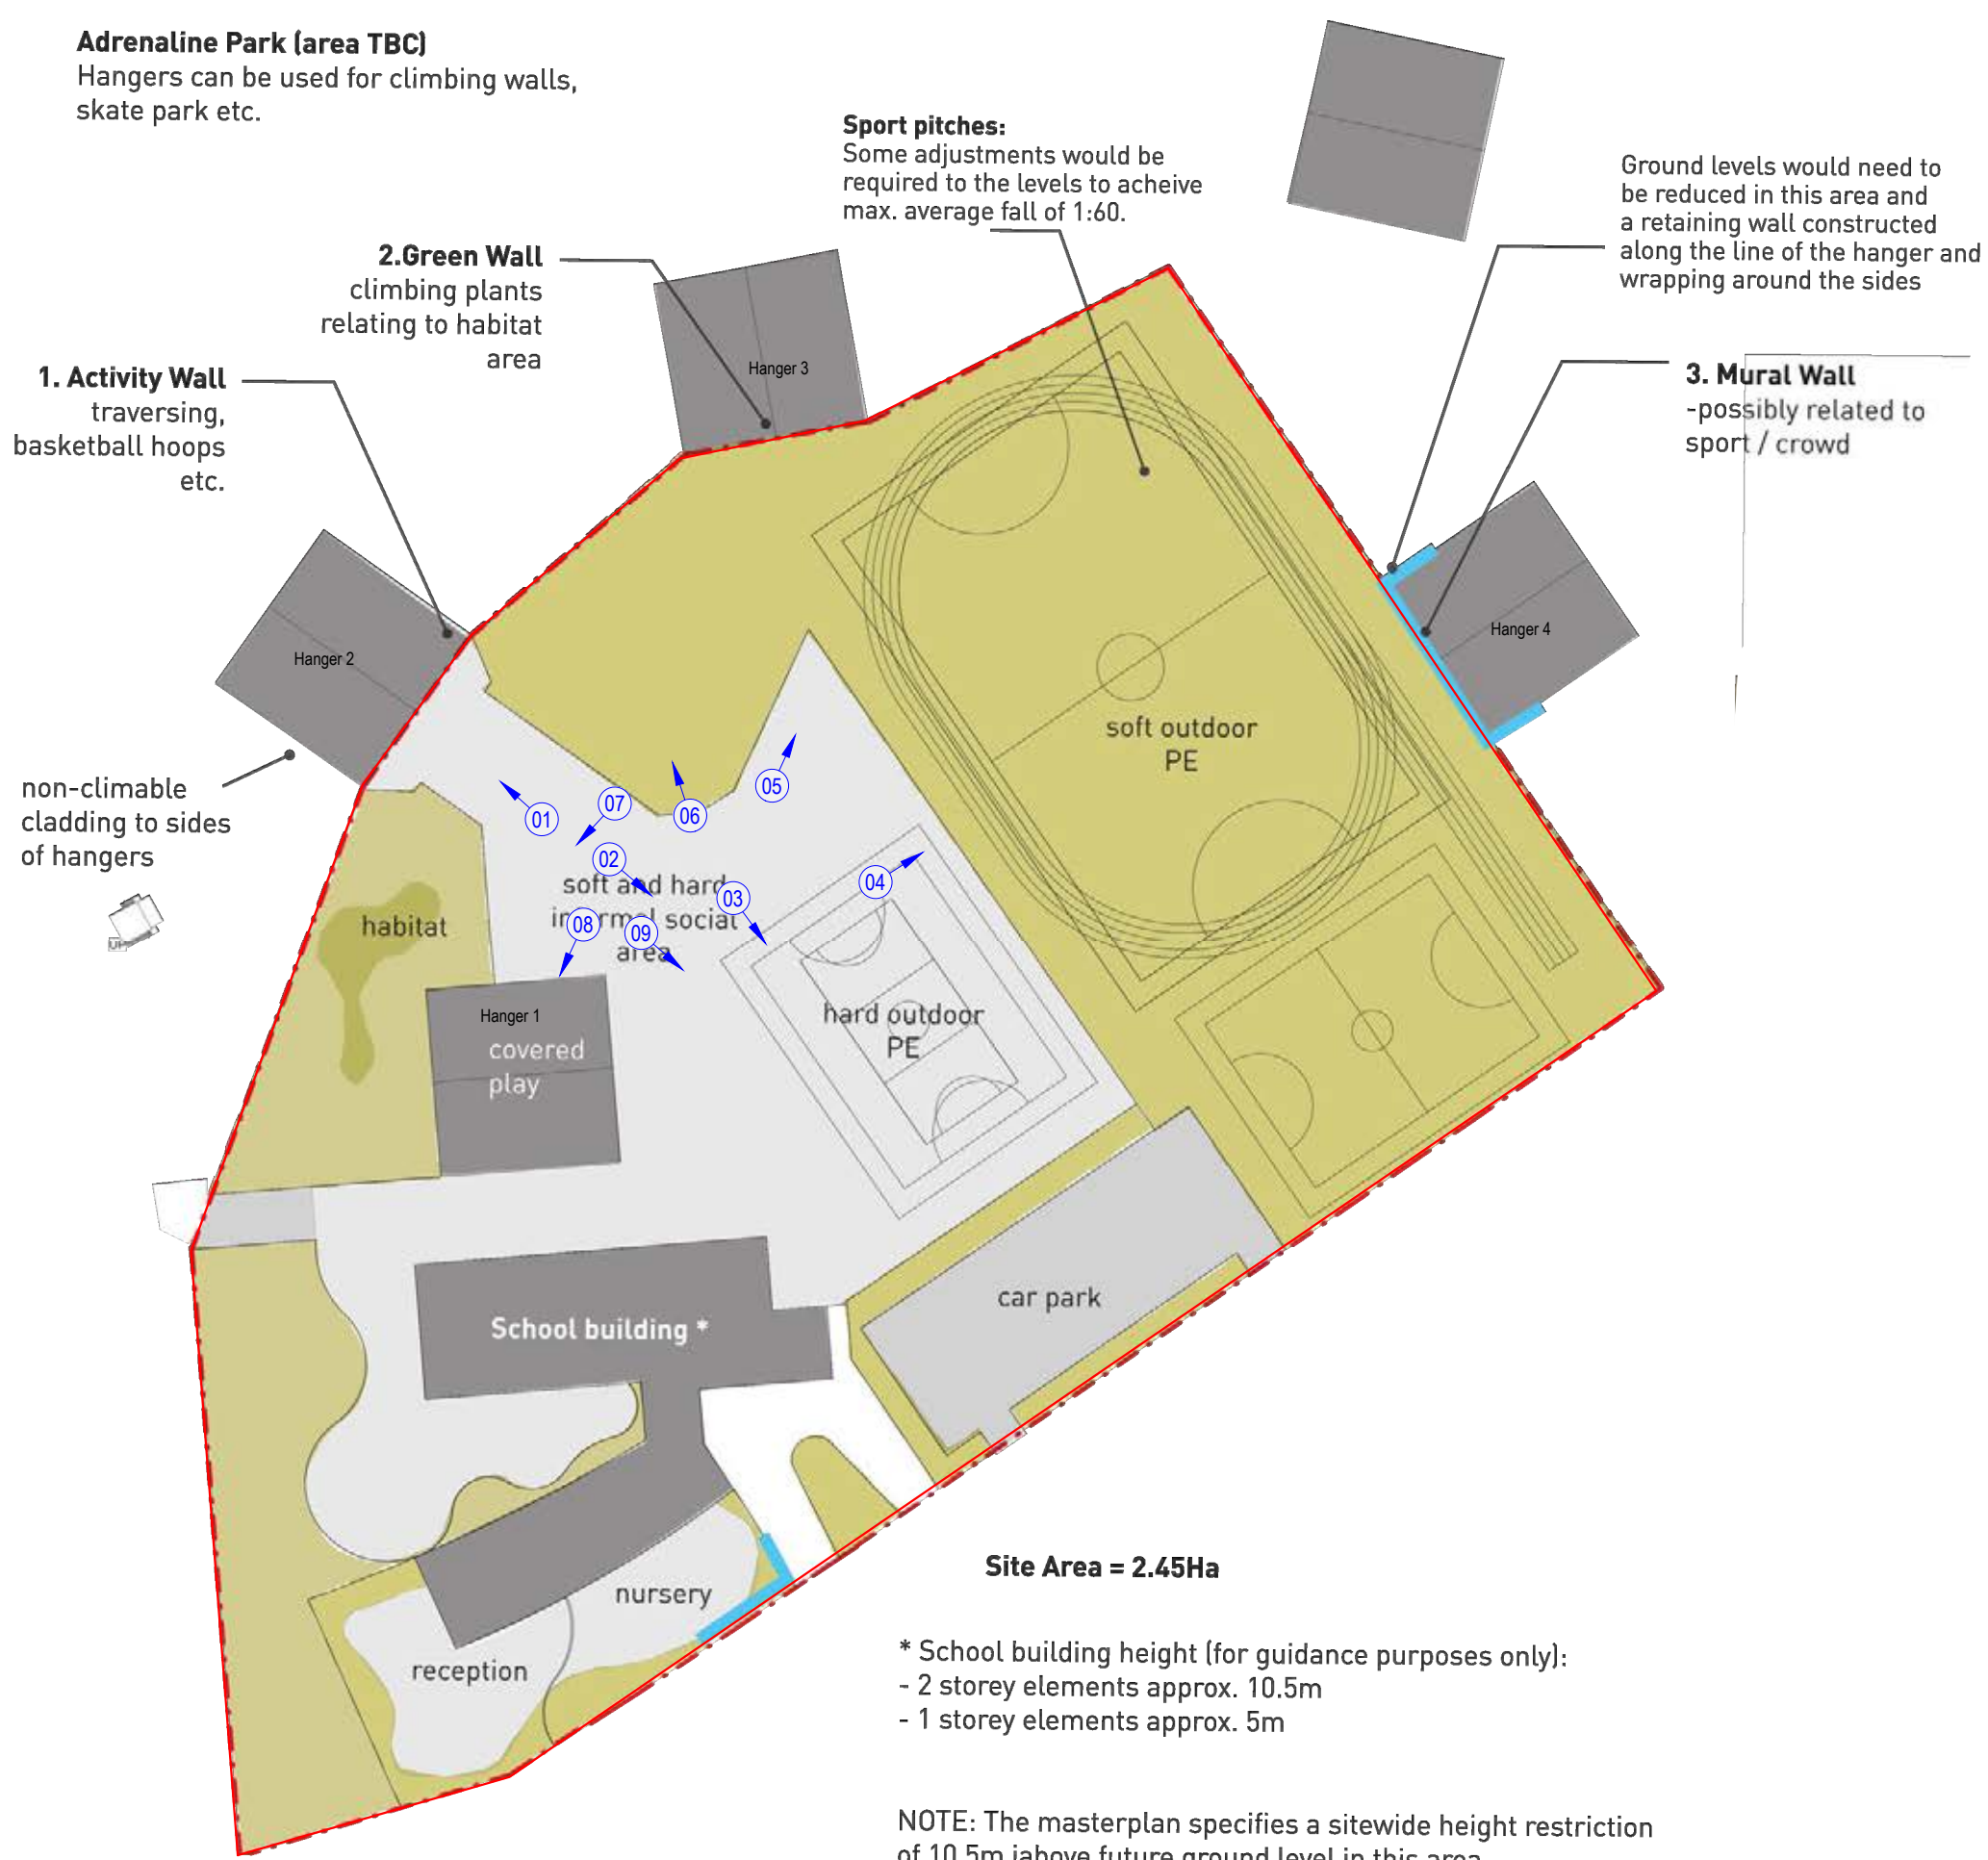
Site Area = 2.45Ha

* School building height (for guidance purposes only):
- 2 storey elements approx. 10.5m
- 1 storey elements approx. 5m

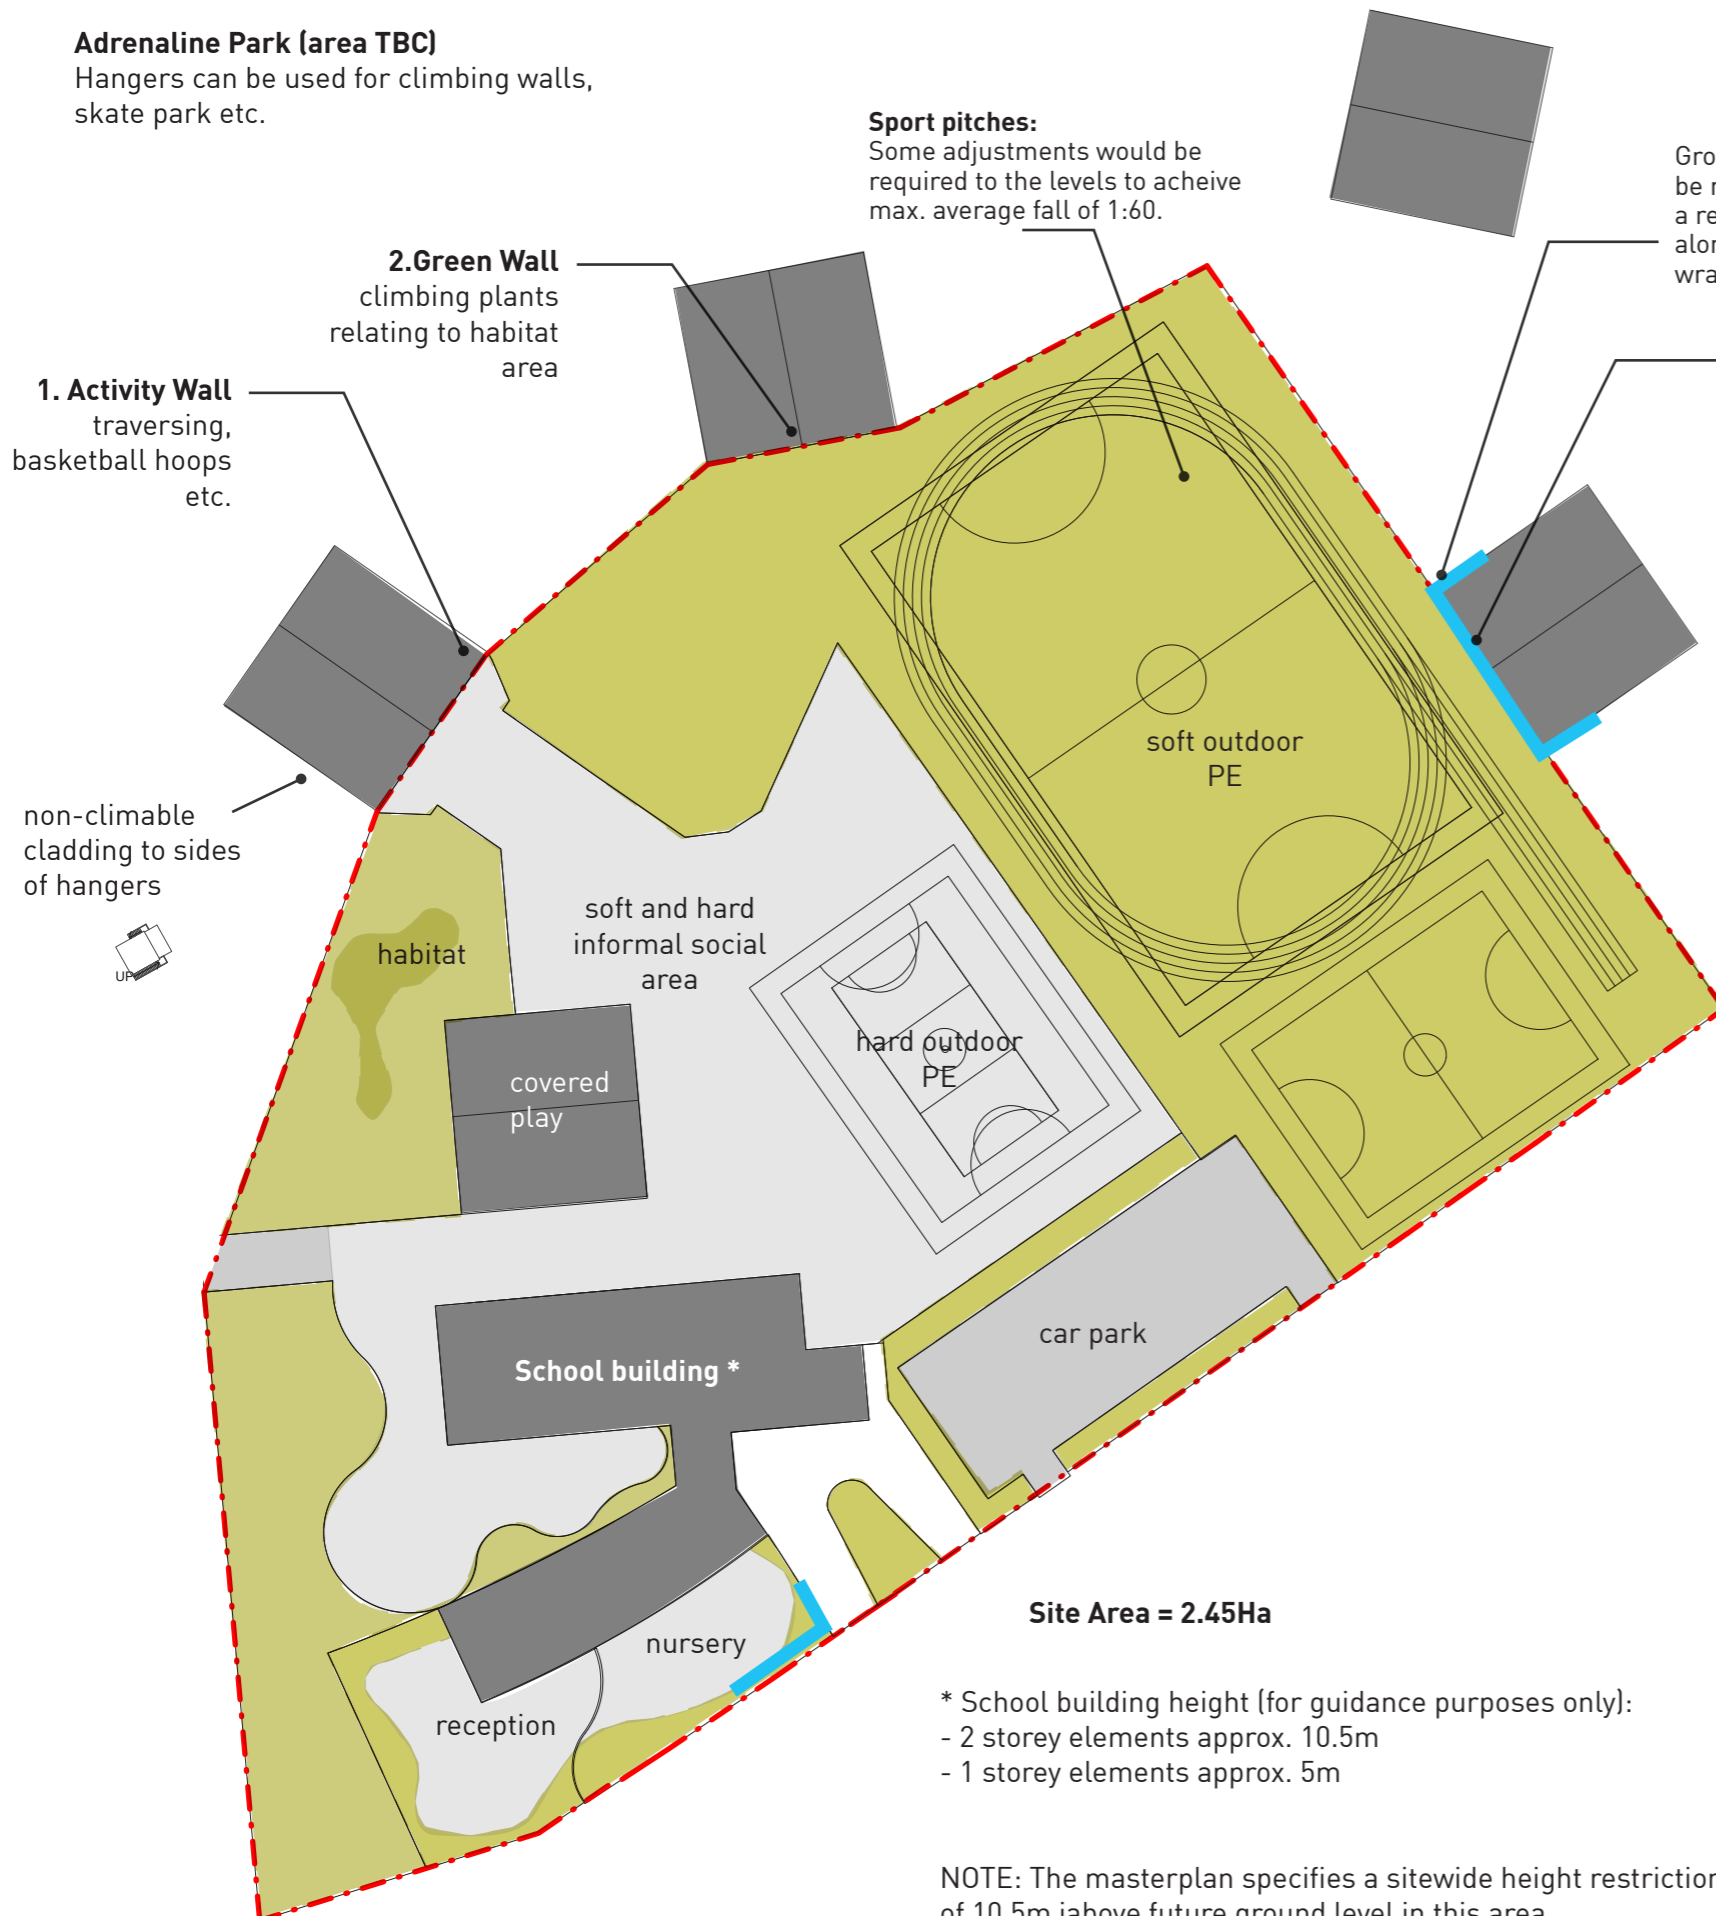
* School building height (for guidance purposes only):
- 2 storey elements approx. 10.5m
- 1 storey elements approx. 5m

NOTE: The masterplan specifies a sitewide height restriction of 10.5m above future ground level in this area.

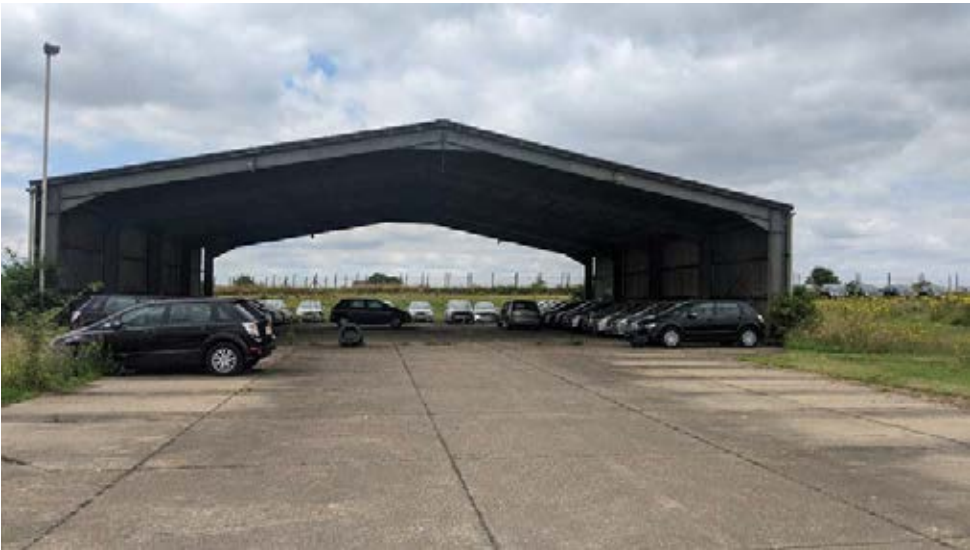
<p>Desk Study Photograph 1</p>

<p>Date: 15/07/2021</p>	
<p>Direction Photograph Taken: Northwest</p>	
<p>Description: Existing aircraft hangar.</p>

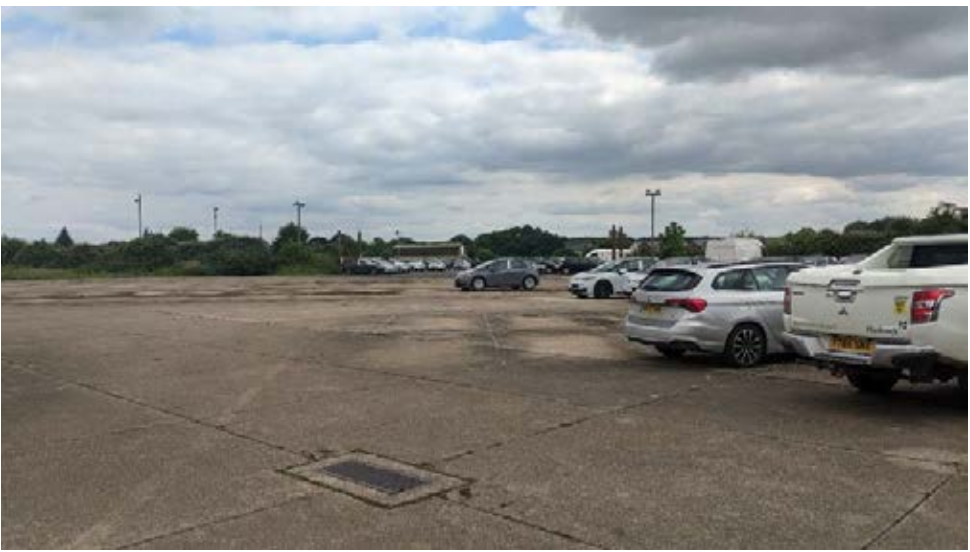
<p>Desk Study Photograph 2</p>

<p>Date: 15/07/2021</p>	
<p>Direction Photograph Taken: Southeast</p>	
<p>Description: Looking across hardstanding in centre of site.</p>

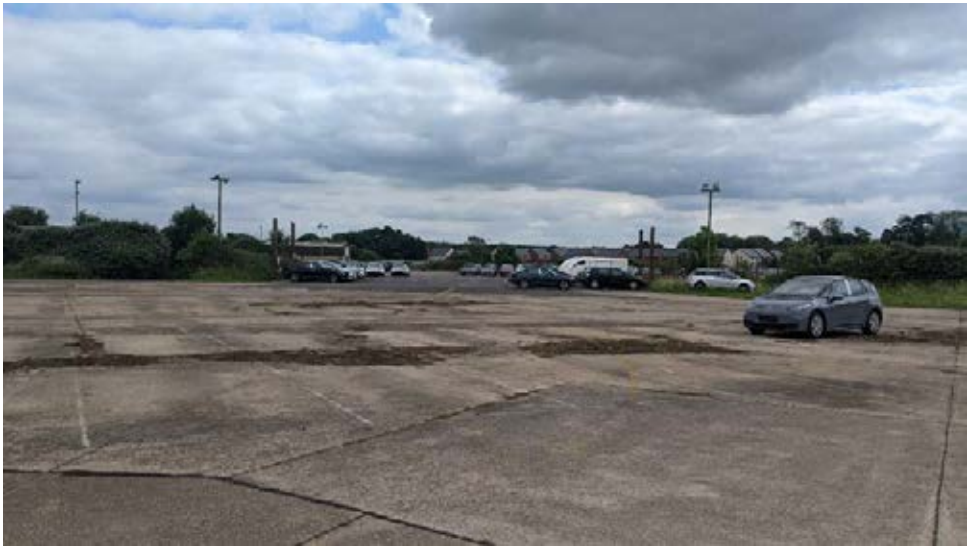
<p>Desk Study Photograph 3</p>

<p>Date: 15/07/2021</p>	
<p>Direction Photograph Taken: South</p>	
<p>Description: Looking across hardstanding in centre of site.</p>

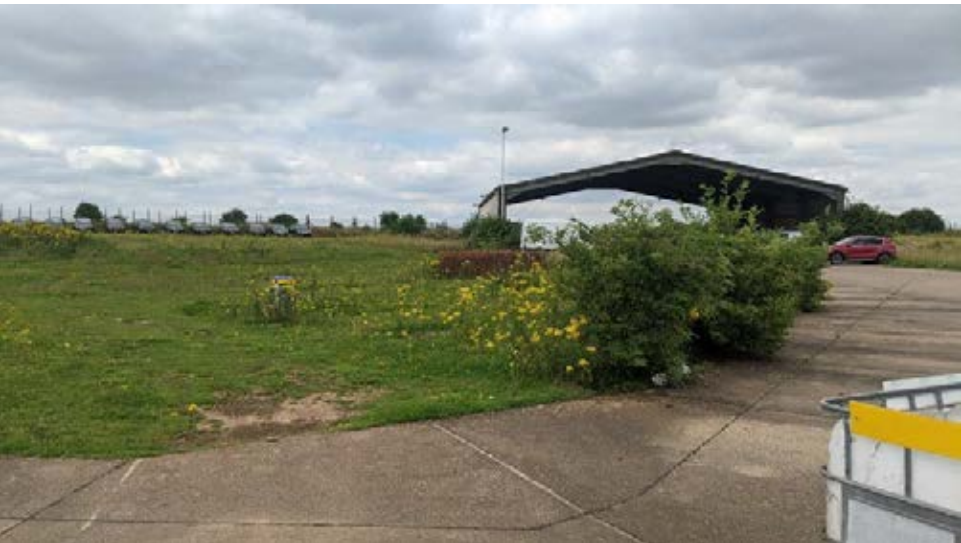
<p>Desk Study Photograph 6</p>

<p>Date: 15/07/2021</p>	
<p>Direction Photograph Taken: North</p>	
<p>Description: Looking across northern part of the site.</p>

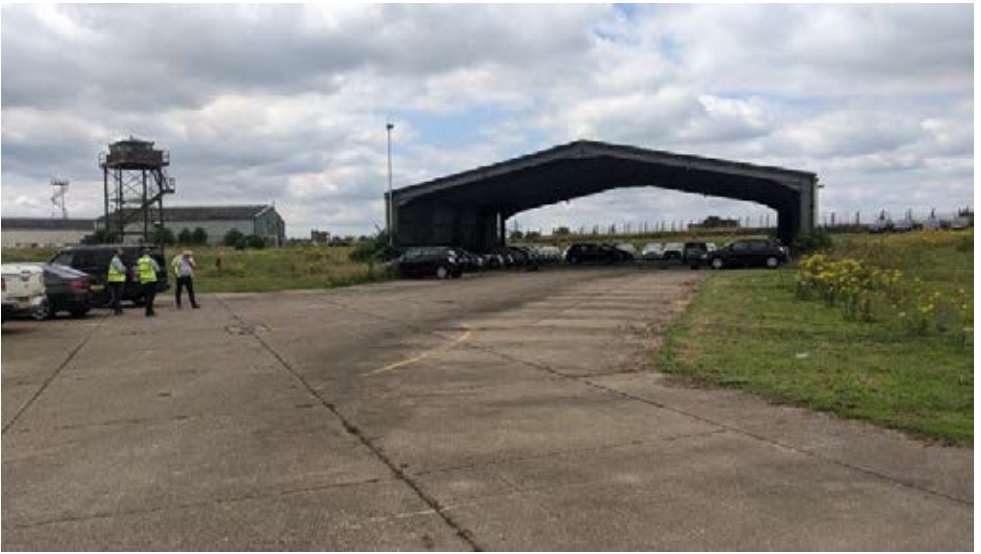
<p>Desk Study Photograph 7</p>

<p>Date: 15/07/2021</p>	
<p>Direction Photograph Taken: Southwest</p>	
<p>Description: Looking across western part of the site.</p>

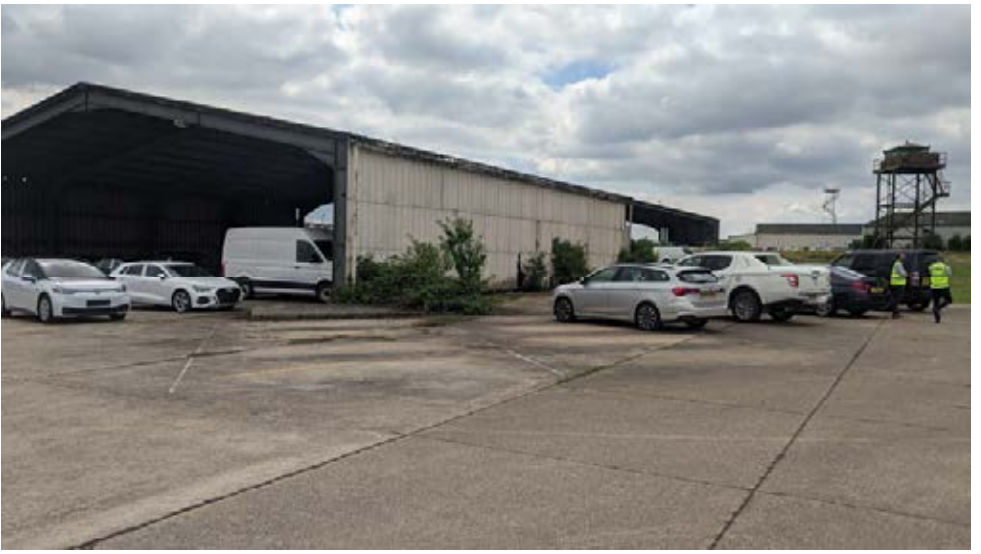
<p>Desk Study Photograph 8</p>

<p>Date: 15/07/2021</p>	
<p>Direction Photograph Taken: Southwest</p>	
<p>Description: Looking towards hangar in centre of site (to be retained as covered play).</p>

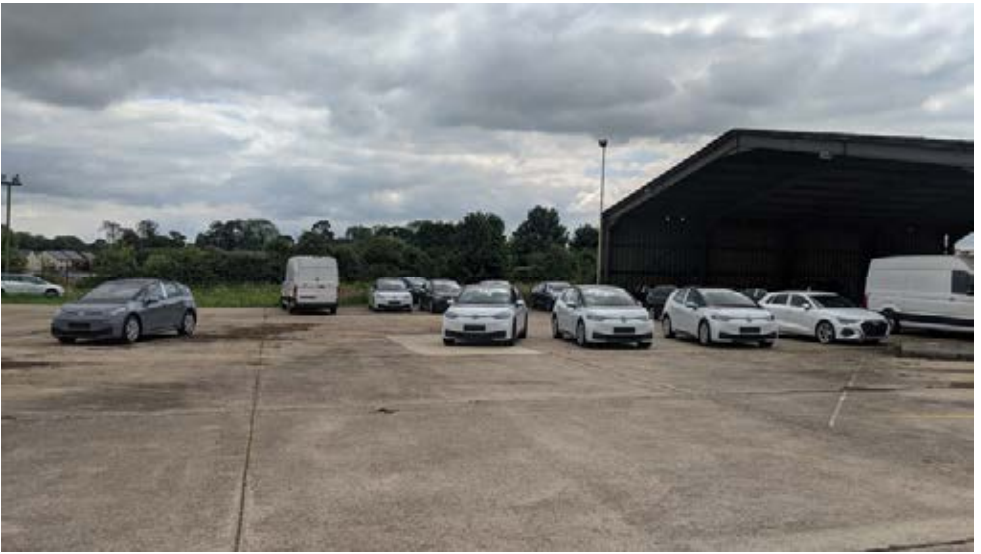
<p>Desk Study Photograph 9</p>

<p>Date: 15/07/2021</p>	
<p>Direction Photograph Taken: Southeast</p>	
<p>Description: Looking across southern part of the site.</p>

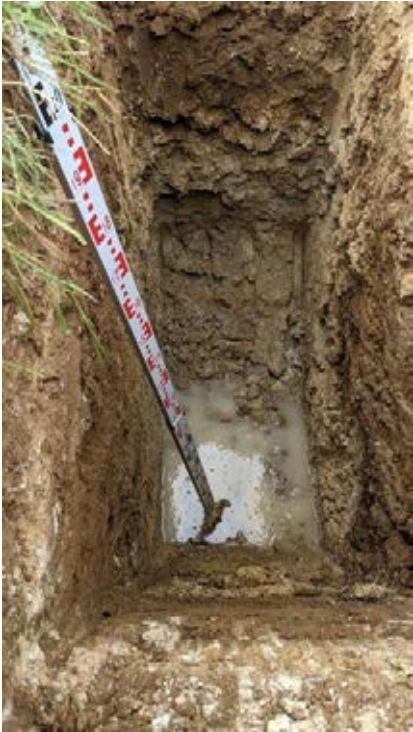
<p>Site Investigation Photograph 22</p>

<p>Date: 05/08/2021</p>	
<p>Direction Photograph Taken: n/a.</p>	
<p>Description: TP311</p>

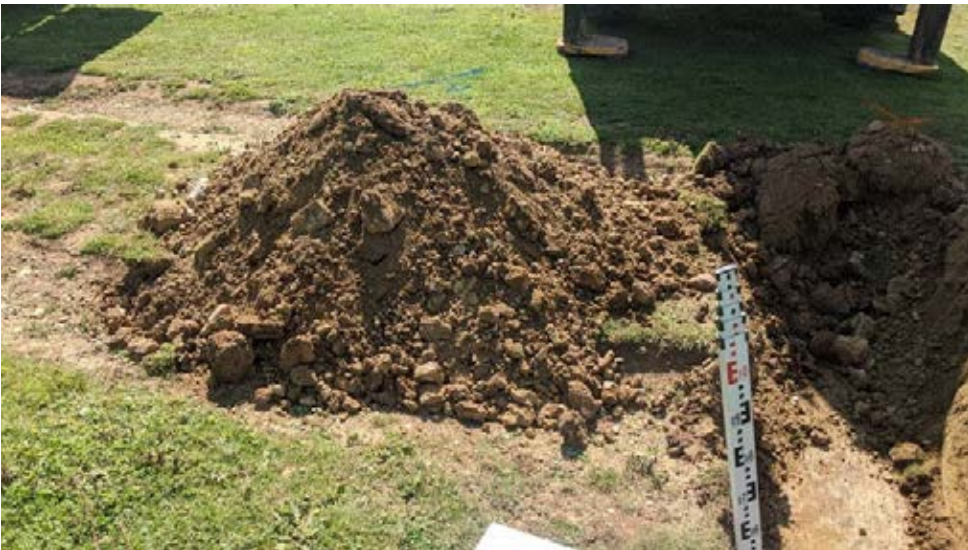
<p>Site Investigation Photograph 35</p>

<p>Date: 04/08/2021</p>	
<p>Direction Photograph Taken: n/a.</p>	
<p>Description: Arisings TP312</p>
