# Arboricultural Impact Assessment

Cotefield Farm  
Oxford Road  
Bodicote  
Banbury  
OX15 4AQ

**Jonathan Hazell**  
**Independent arboricultural consultancy**  
**27 March 2017**

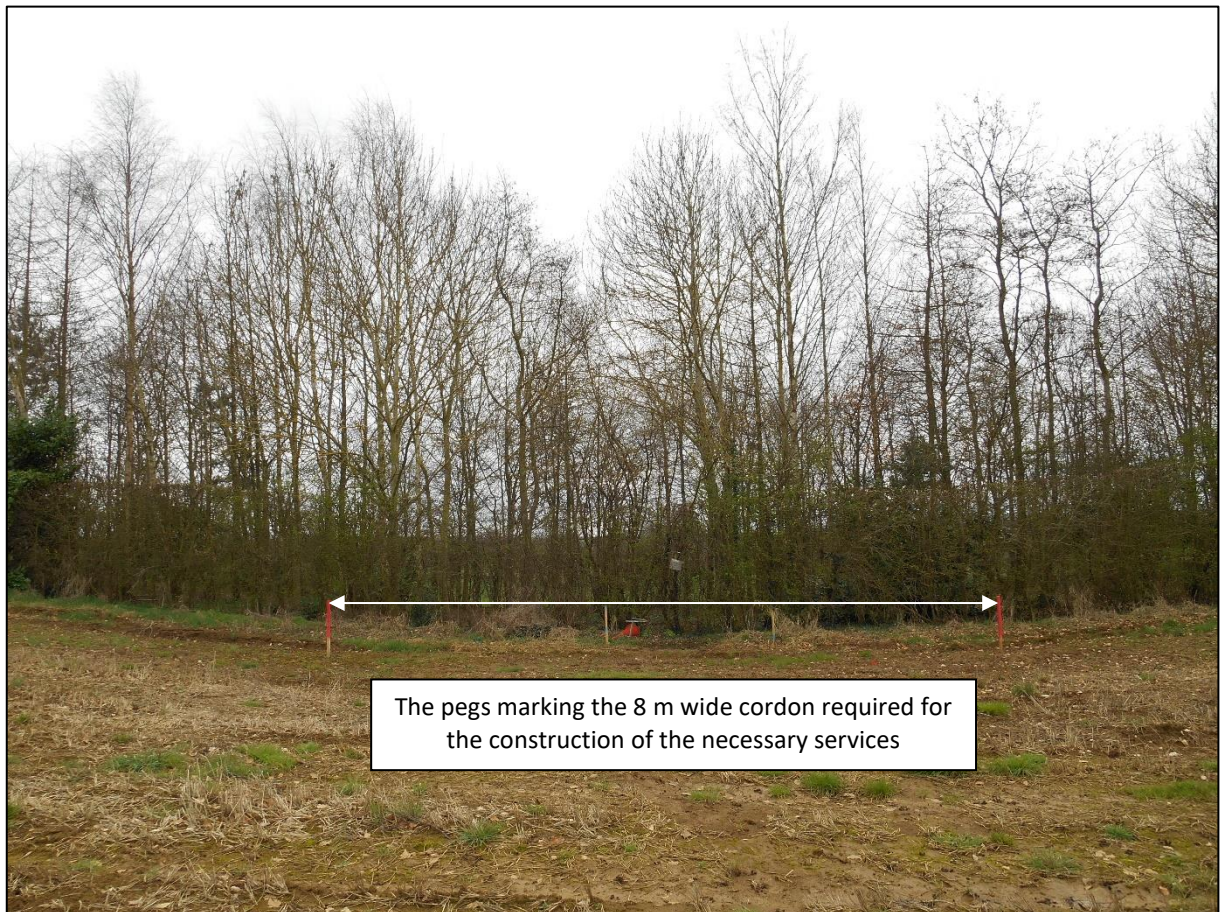
- 3.2 The planting belt to be breached was identified by RPS in their report reference JKK5617 – Blossom Field, Cotefield Farm, Arboricultural Impact Assessment, dated 28 November 2014 as G5. The extent of the breach, an 8 m wide cordon, is marked on site by red pegs as seen in image 1 below:

*Image 1: the extent of the proposed breach, looking south west*

- 4.1 The trees that are required to be removed for the drainage will not be directly replaced, nor would they have been with the previous drainage scheme. The quality of the stock to be lost is unremarkable, and the impact of their removal is equivalent to the impact of the previous drainage scheme.

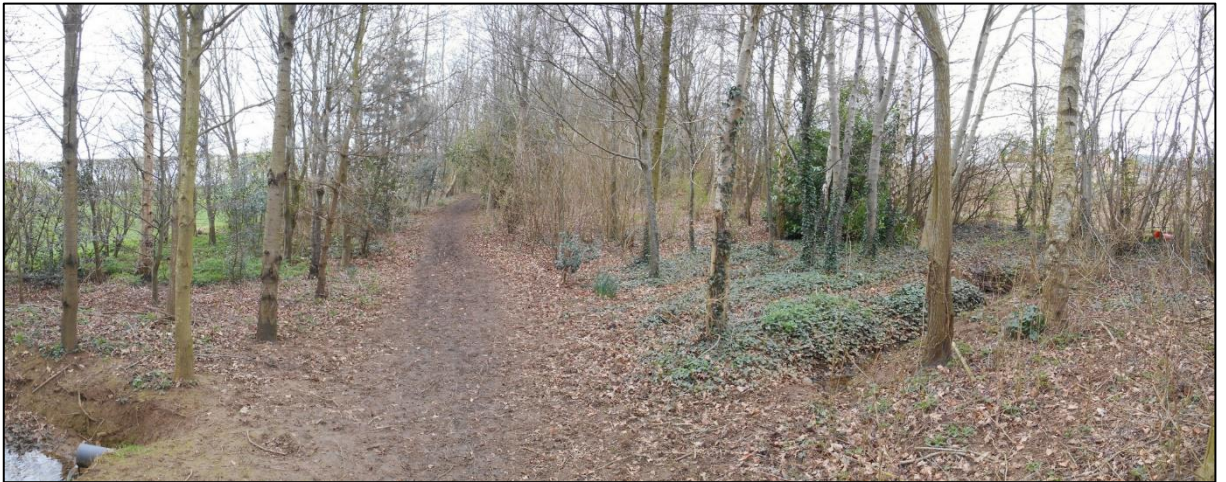
- 3.5 The under-storey includes hazel, holly and laurel. On either side of the planting belt the single line of hawthorn trees has been treated as a hedge, faced and topped at 2.4 m. An informal and unsurfaced path much used by dog walkers' meanders through the planning belt, see image 2 below:

*Image 2: the informal path, looking north west*
